Situation Photo Log

Friday, September 21, 2012

Kalamazoo River / Enbridge Spill

Prepared by:
Matthew Haak
START-USEPA
Situation Unit Leader

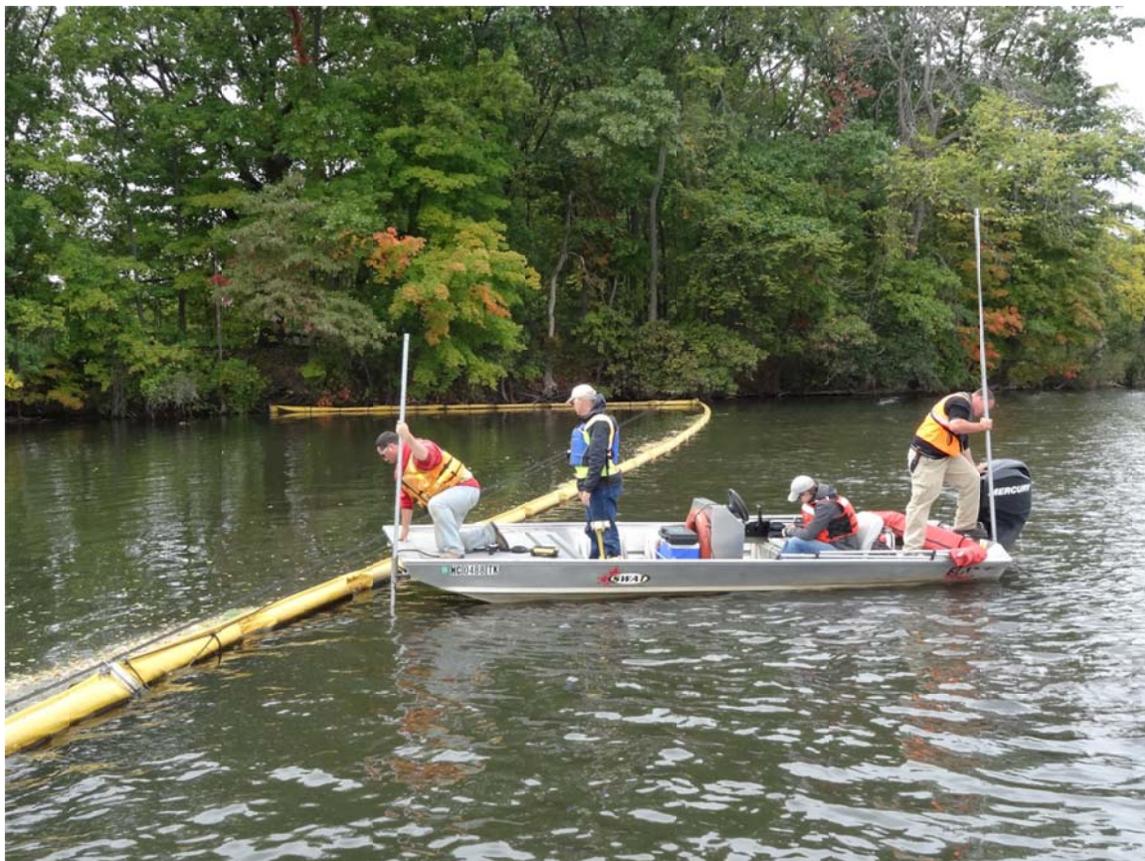
24. Morrow Lake Delta observed a poling crew operating along Gate B.

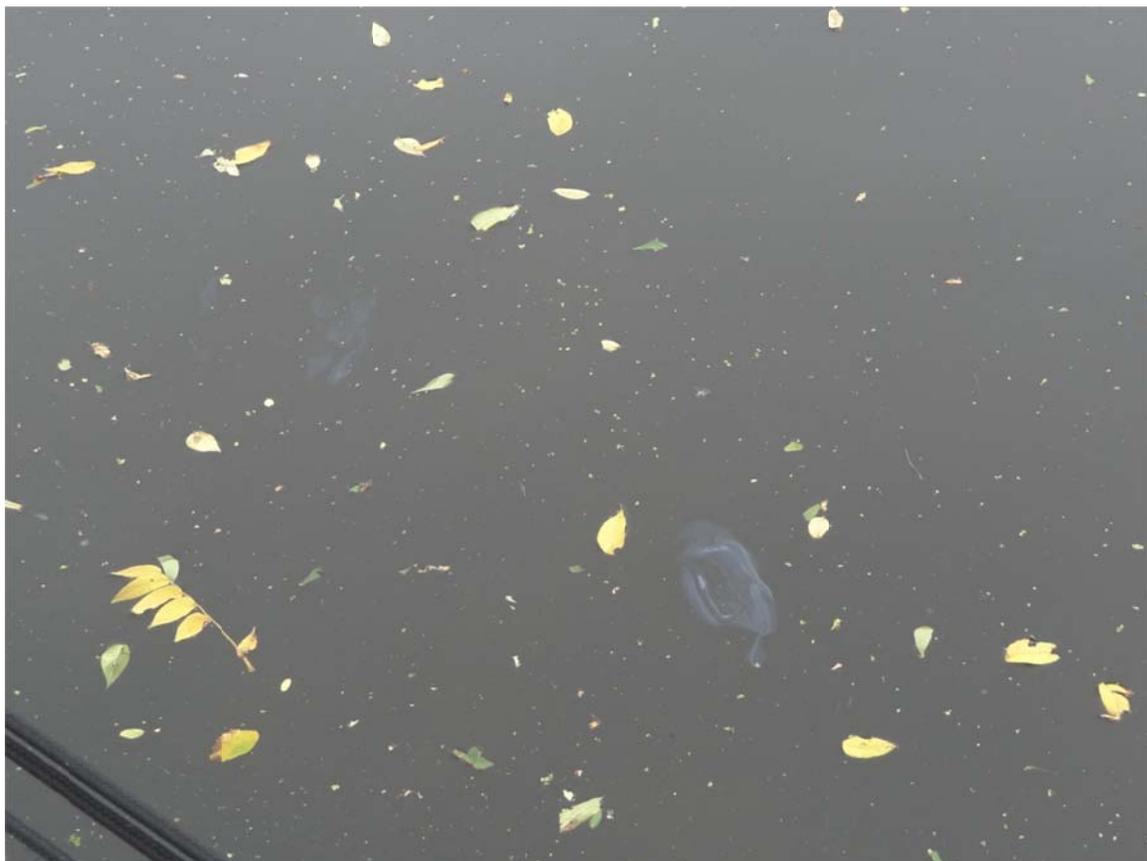
25. Observed sheen collecting along Gate B.

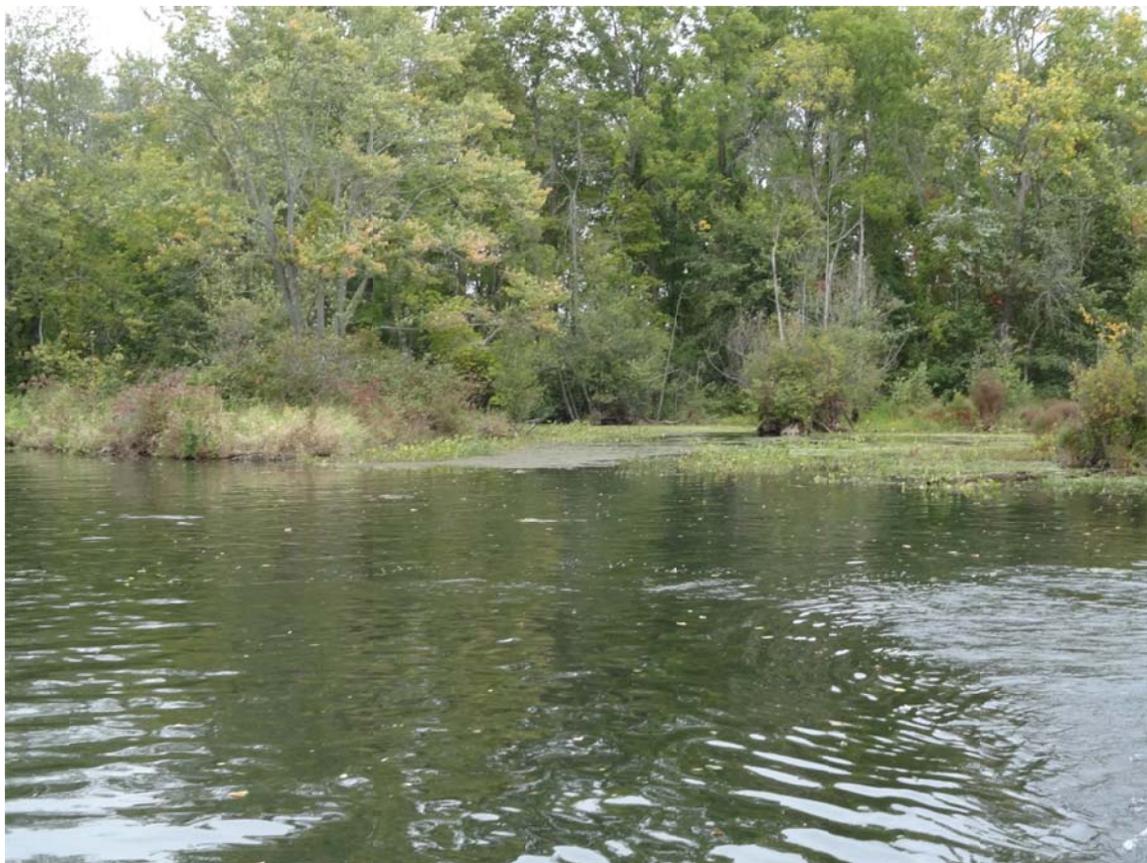
26. MP36.5 RDB area where sheen was observed.

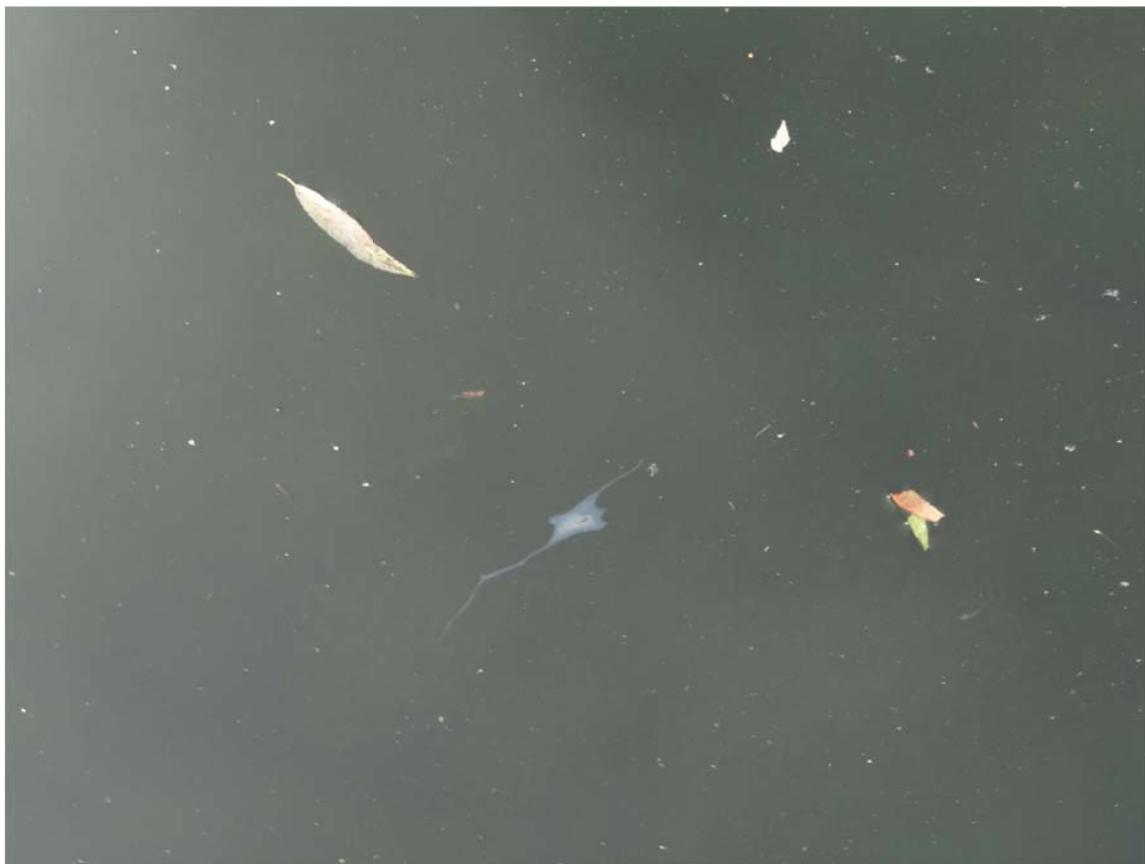
27. MP36.5 RDB sheen and tar globs observed.

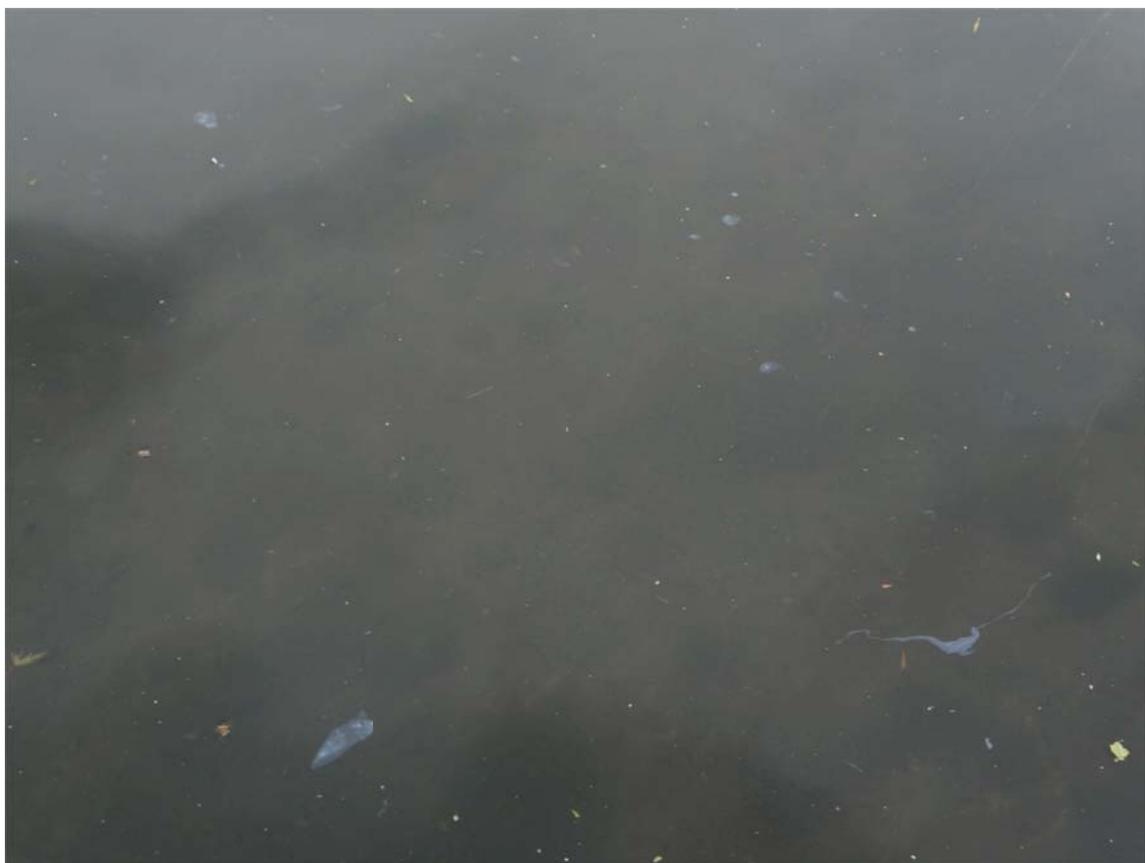
28. MP36.5 RDB sheen and tar globs observed.

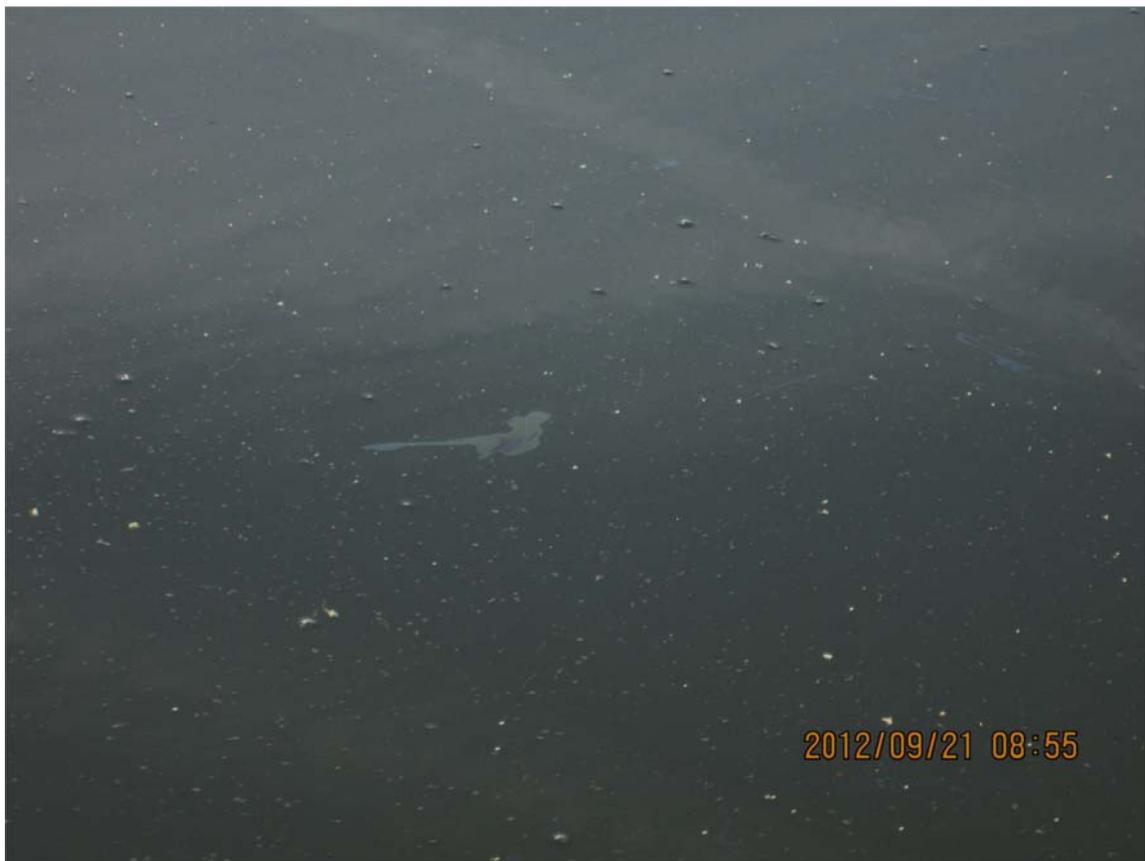
29. Morrow Lake sheen and tar globs observed between Rowe Island and the north shore.

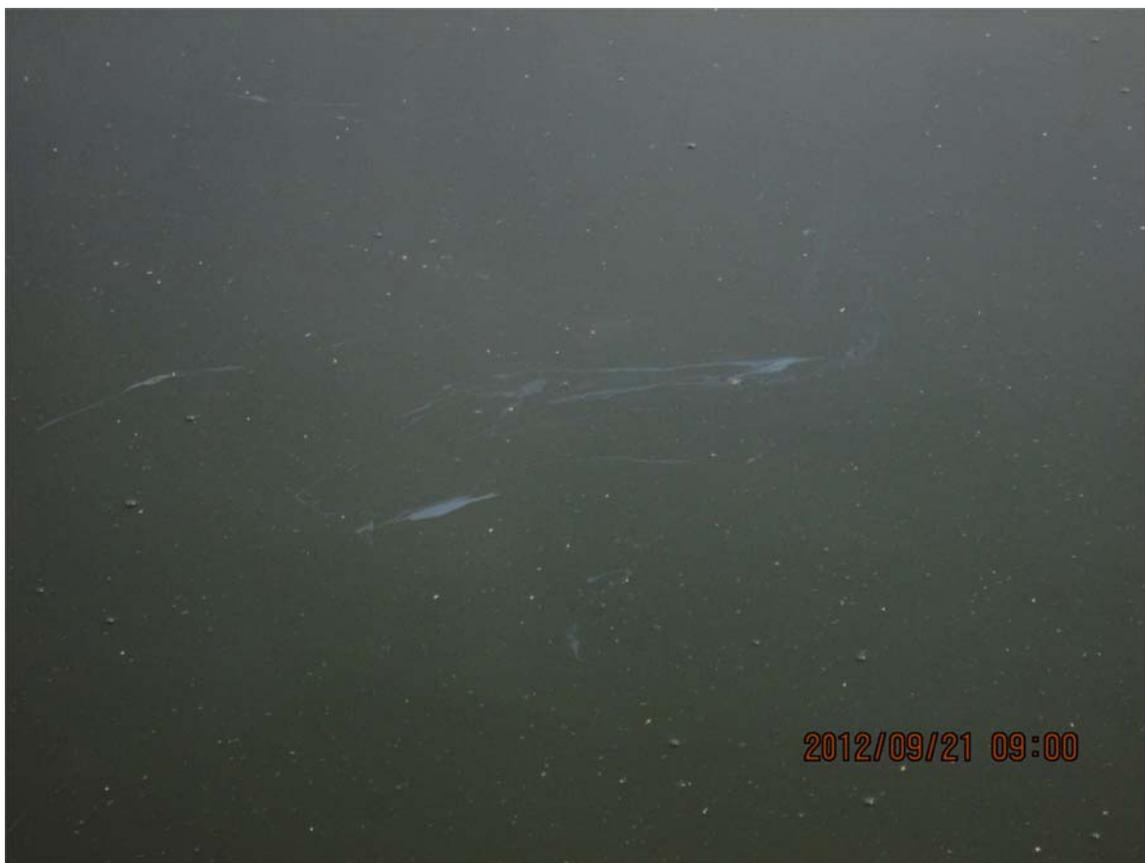
30. Morrow Lake MP38.4 north shore sheen and tar globs observed.

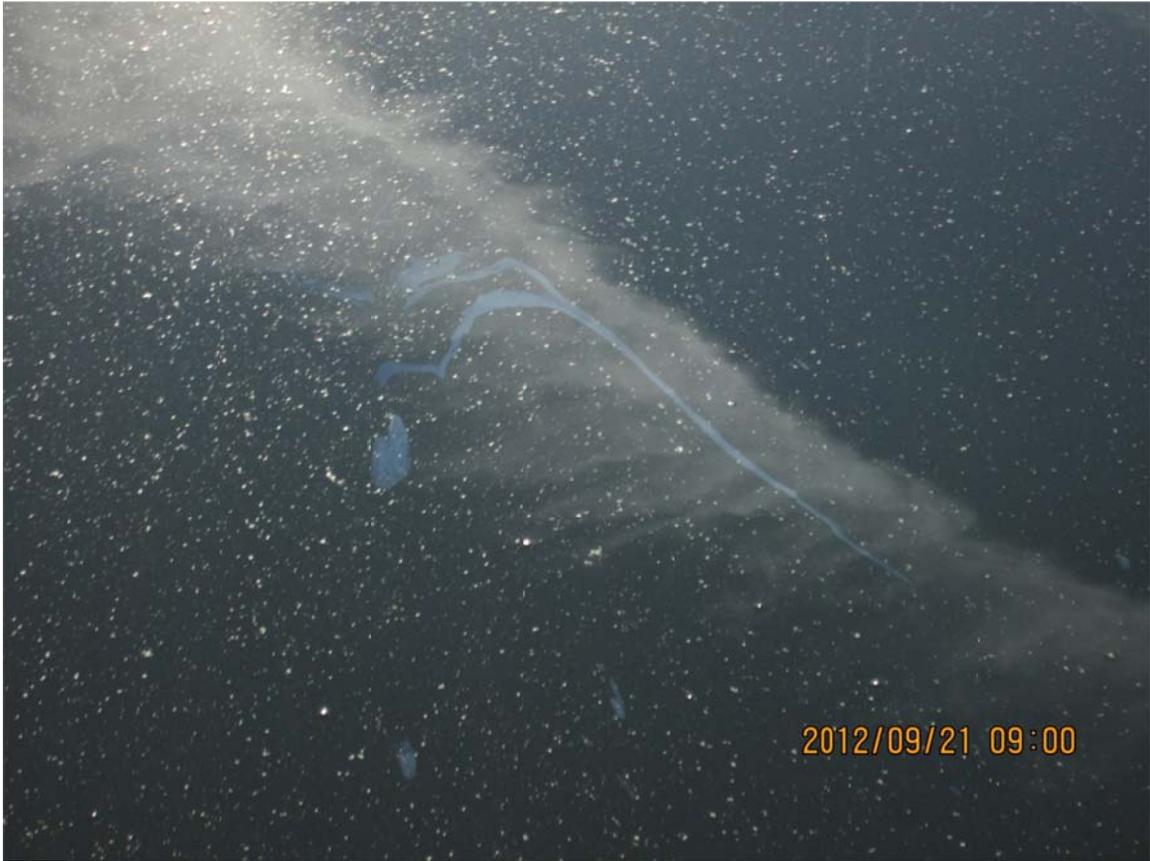
31. Morrow Lake MP38.4 north shore sheen and tar globs observed.

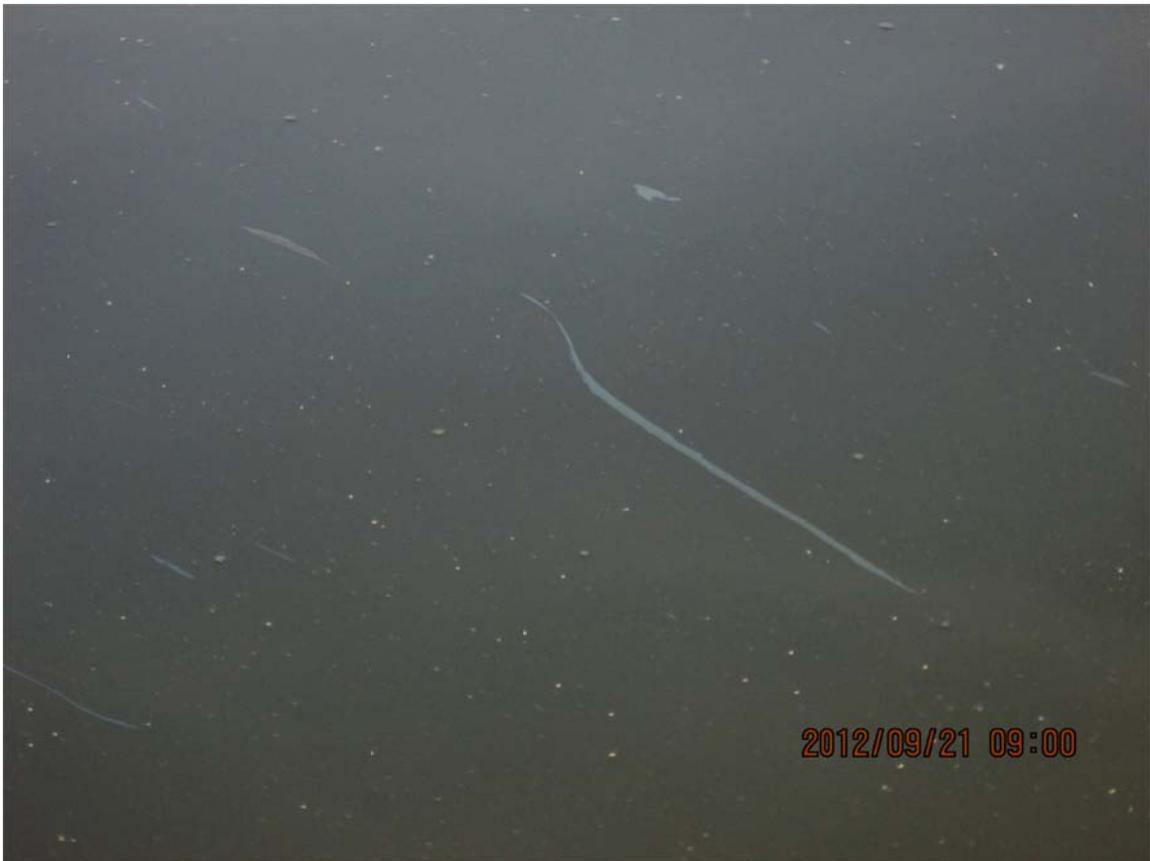
32. Morrow Lake MP38.4 north shore sheen and tar globs observed.

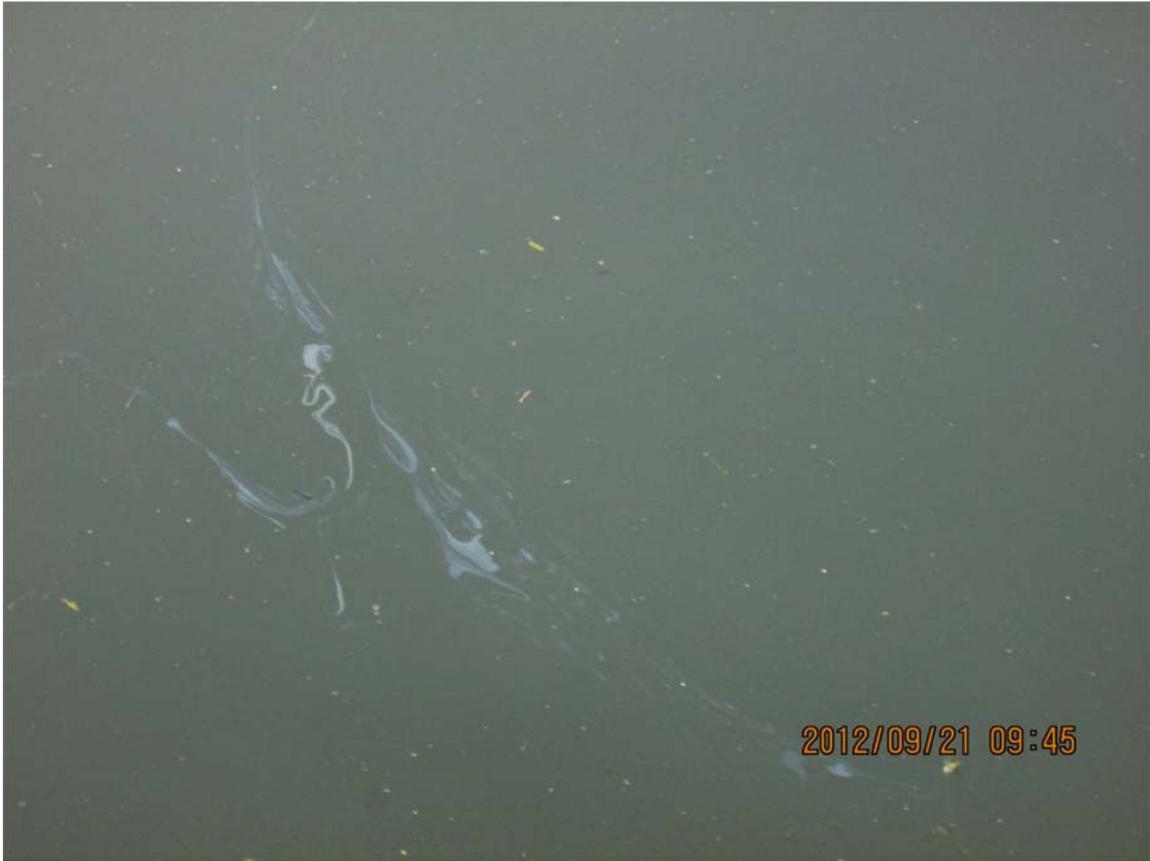
33. Morrow Lake Delta sheen observed collecting along Gate E.

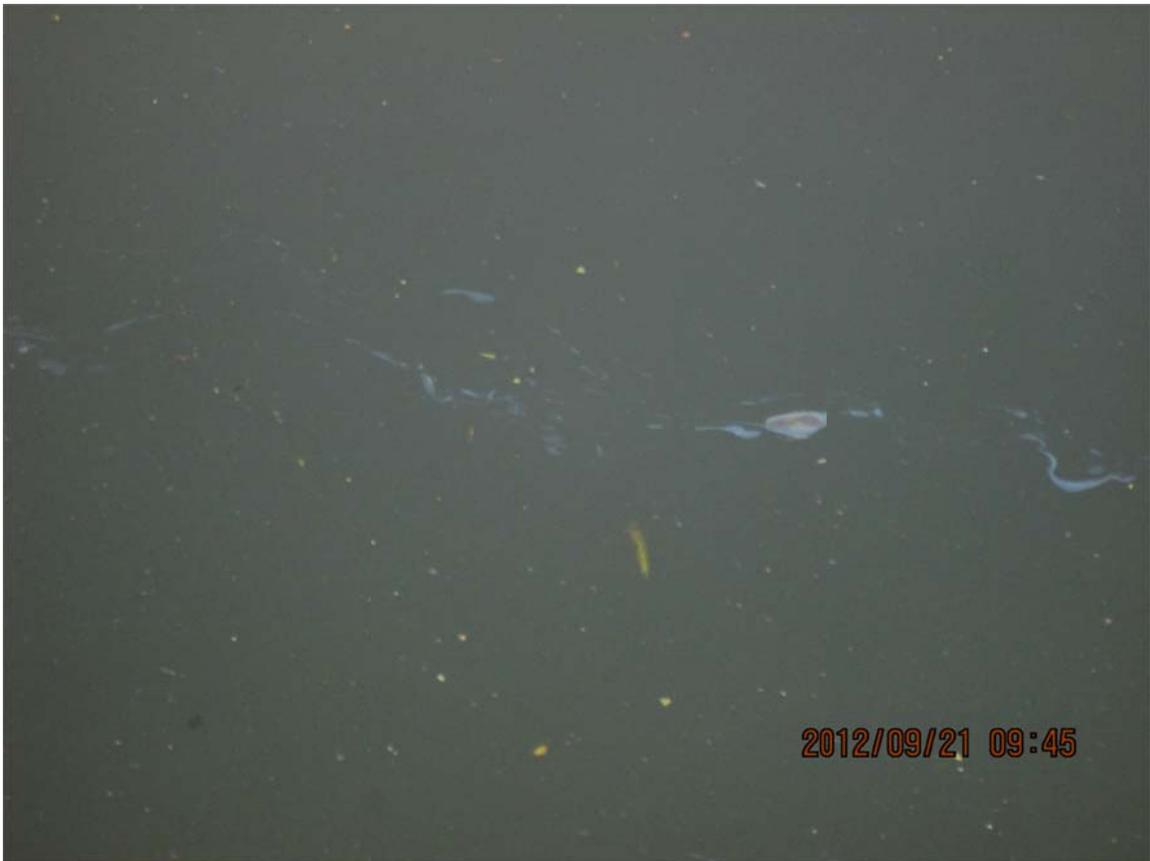
34. Morrow Lake Delta sheen observed collecting along Gate E.

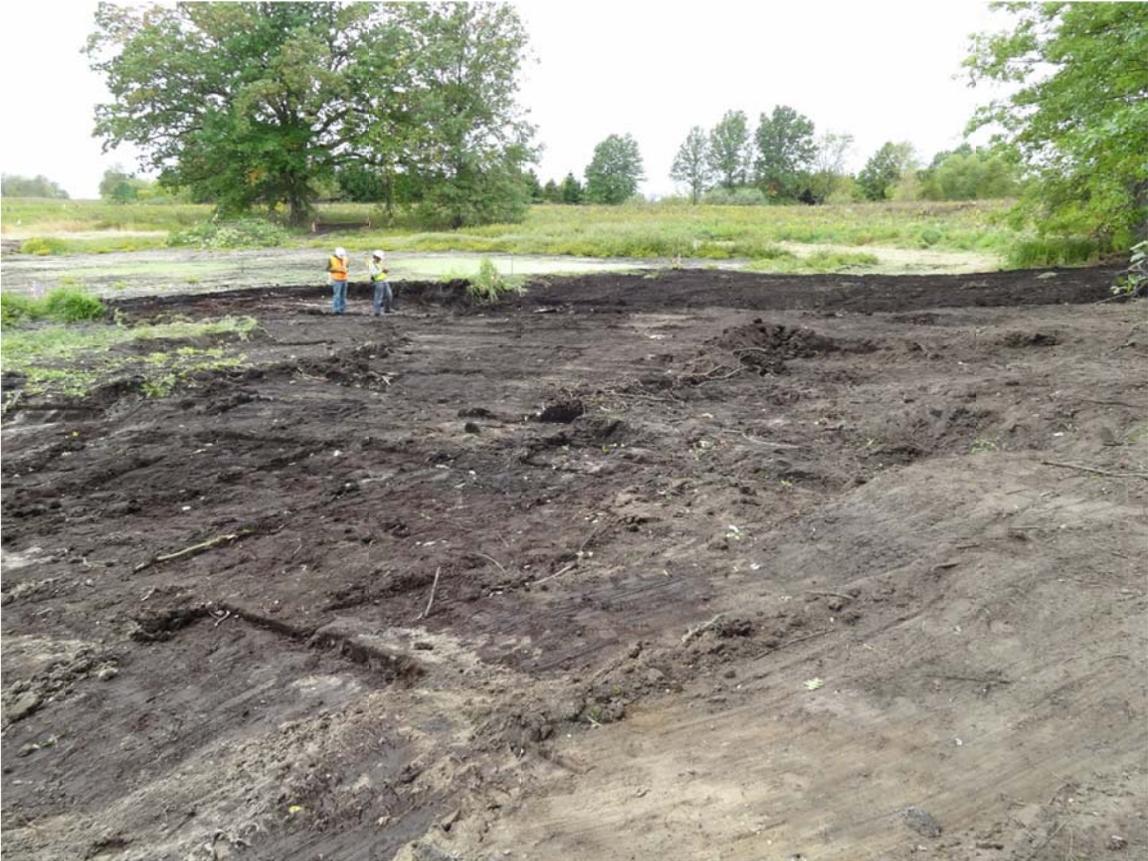
35. Source area excavation.

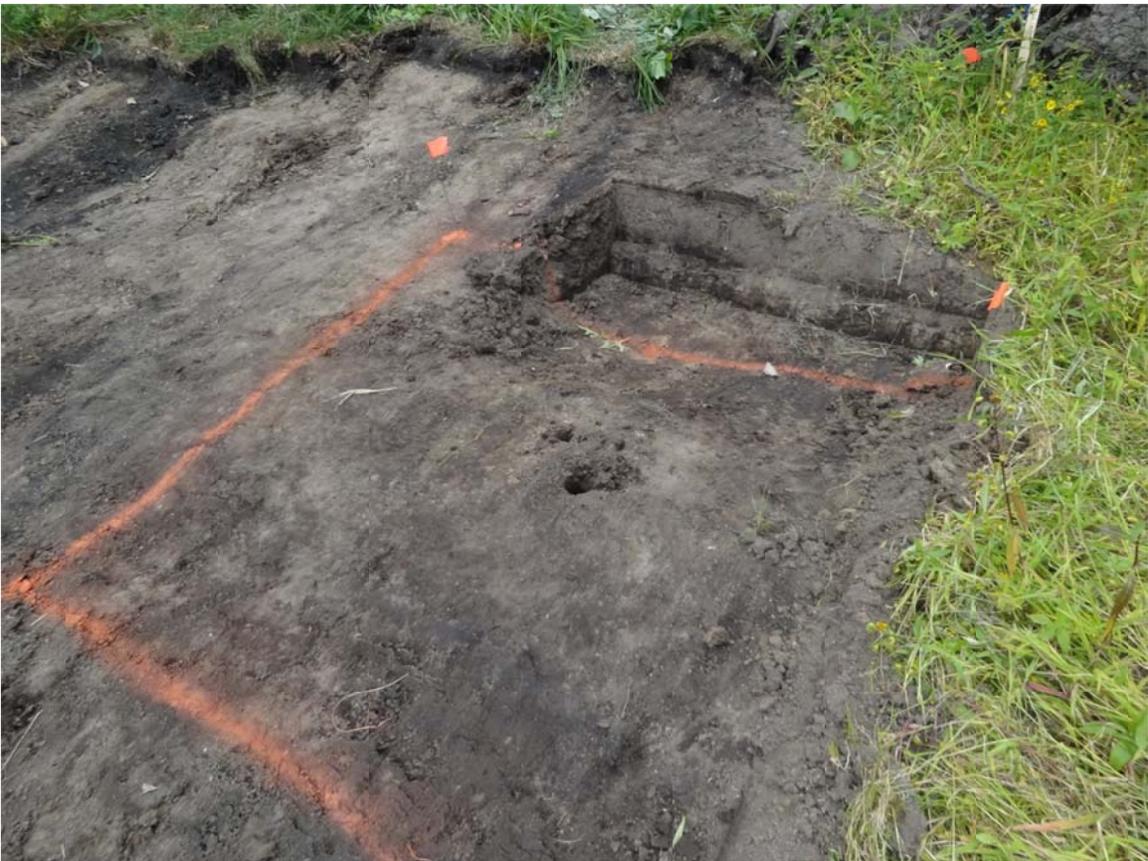
36. Source area excavation.

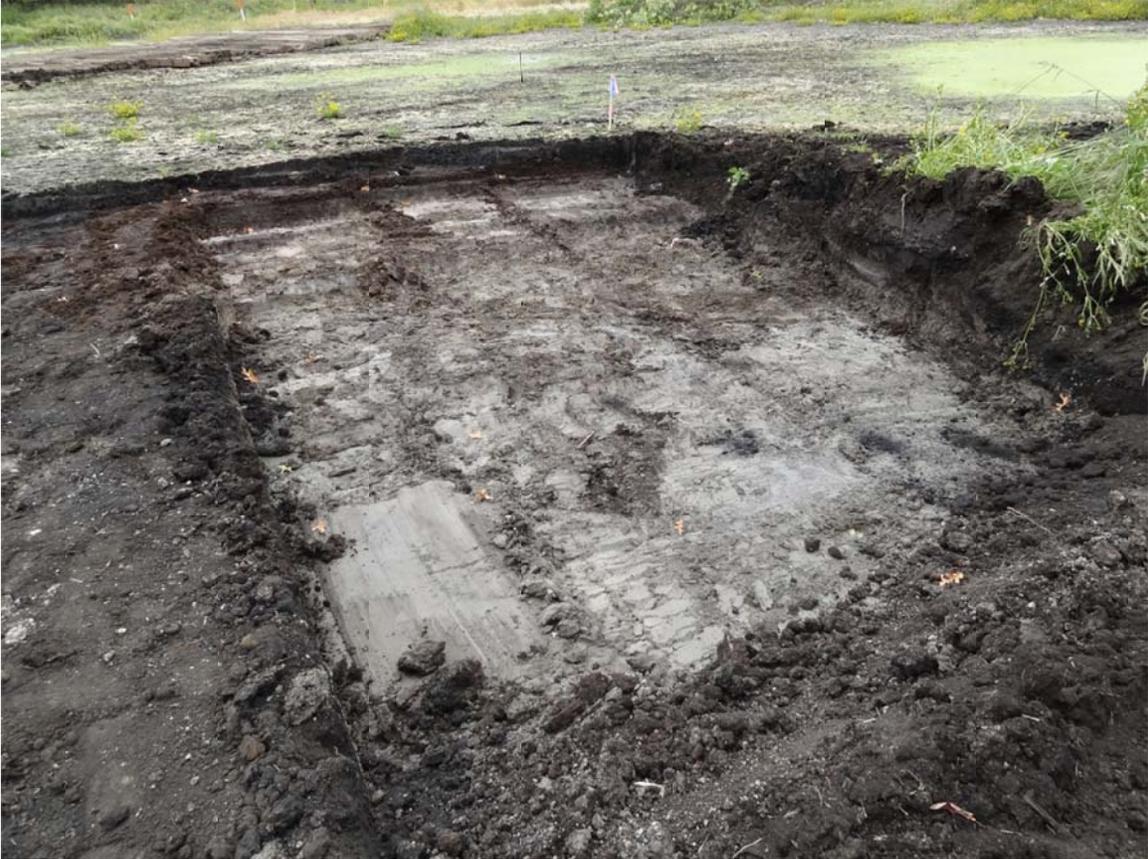
37. Source area excavation.

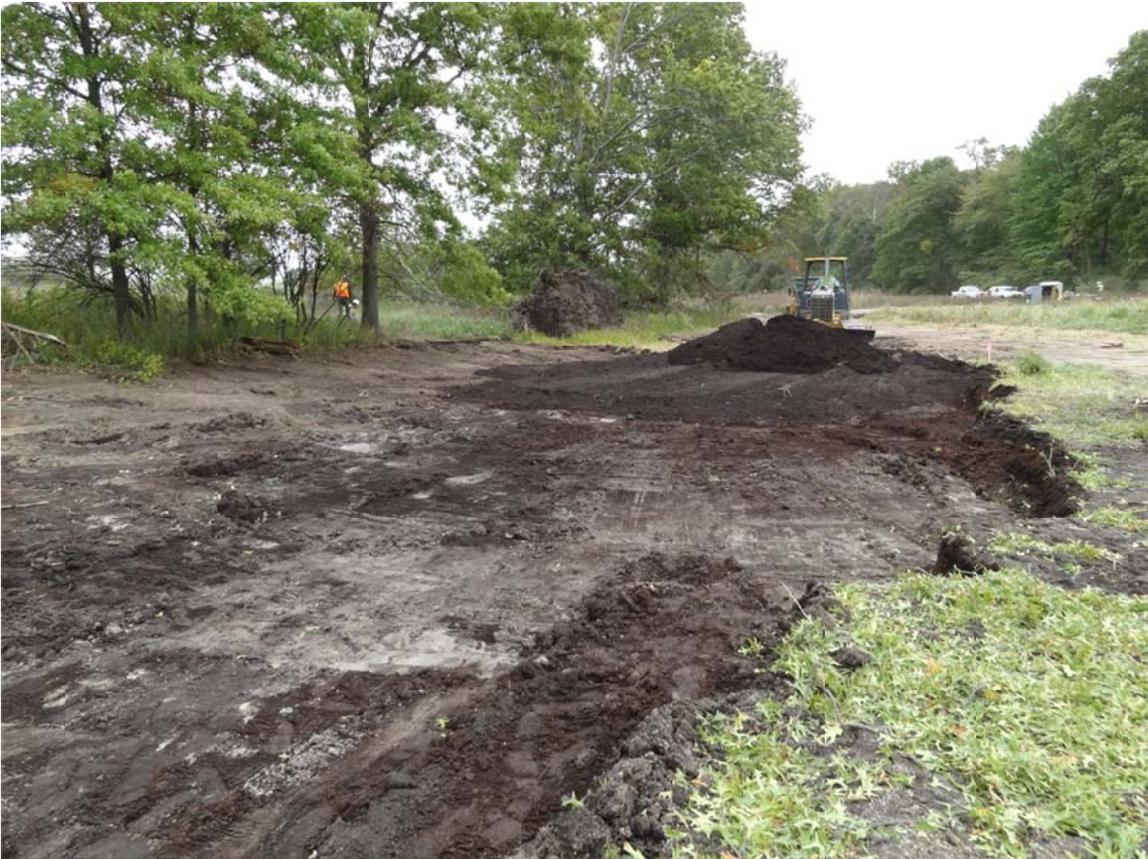
38. Source area observed crew backfilling the excavation.

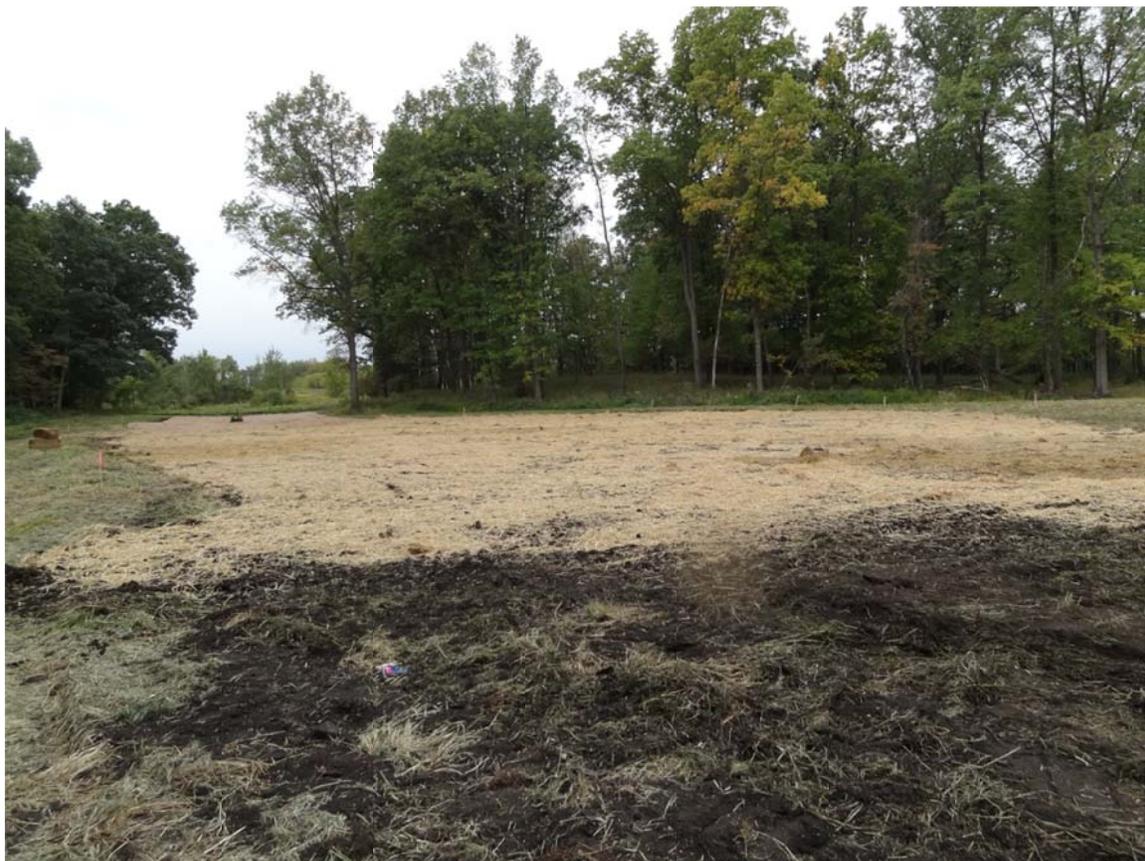
39. Source area Swale restored .

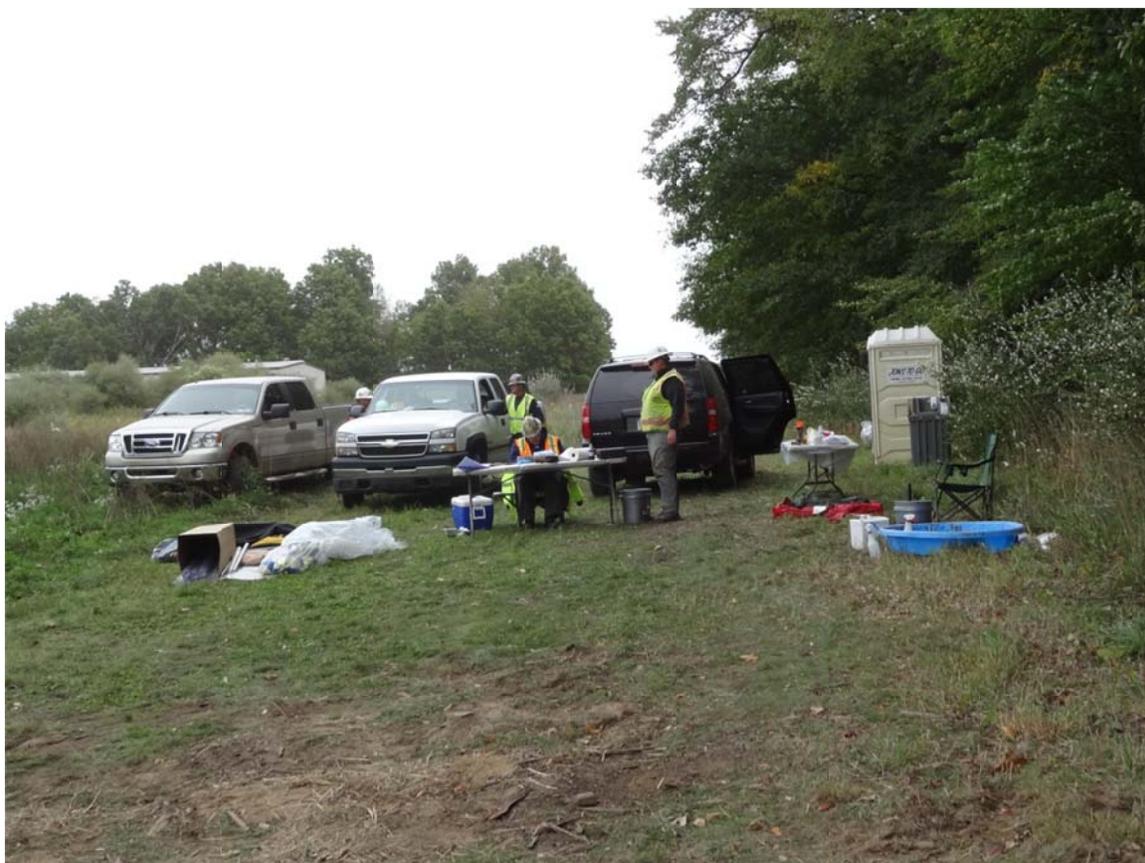
40. Source area core logging team.
