# Situation Photo Log

Monday, September 24, 2012

Kalamazoo River / Enbridge Spill

Prepared by:  
Larry Rader  
START-USEPA  
Situation Unit Leader

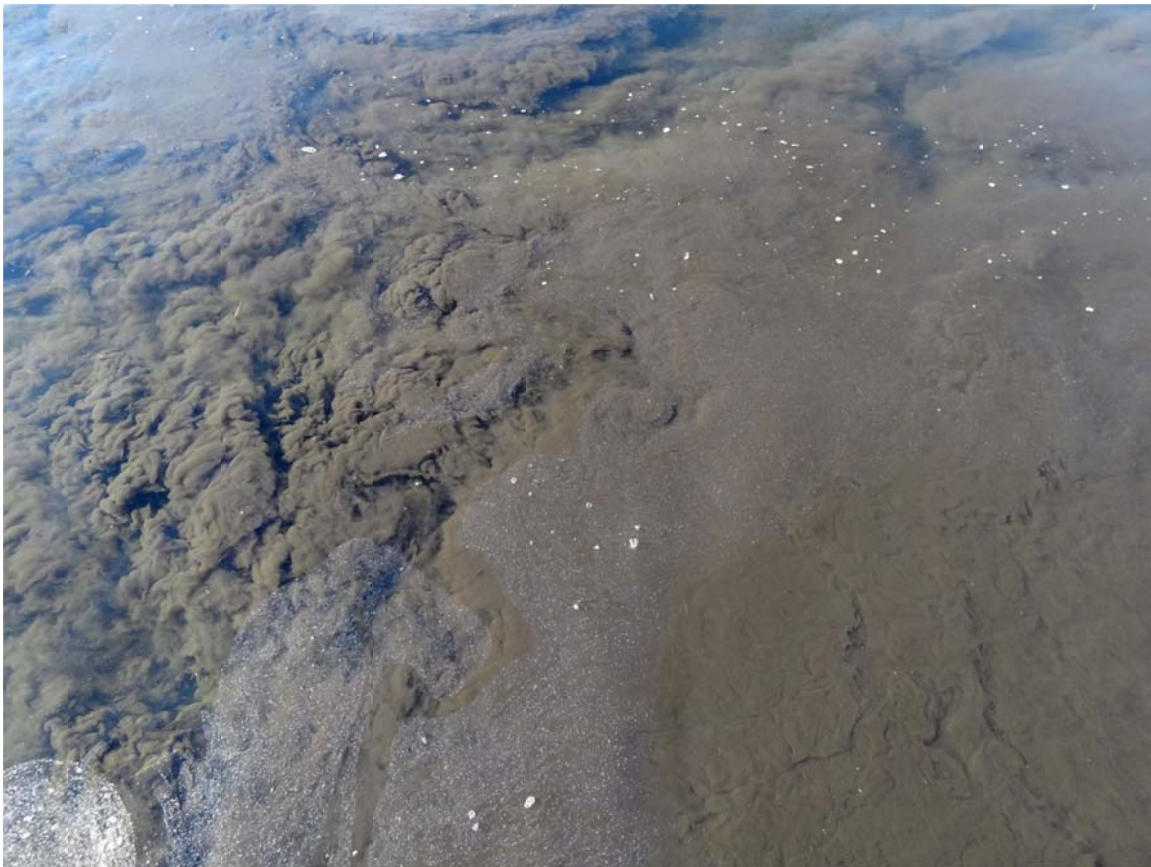
1. MP4.50 LDB, sheen and tar globules observed following agitation by boat.

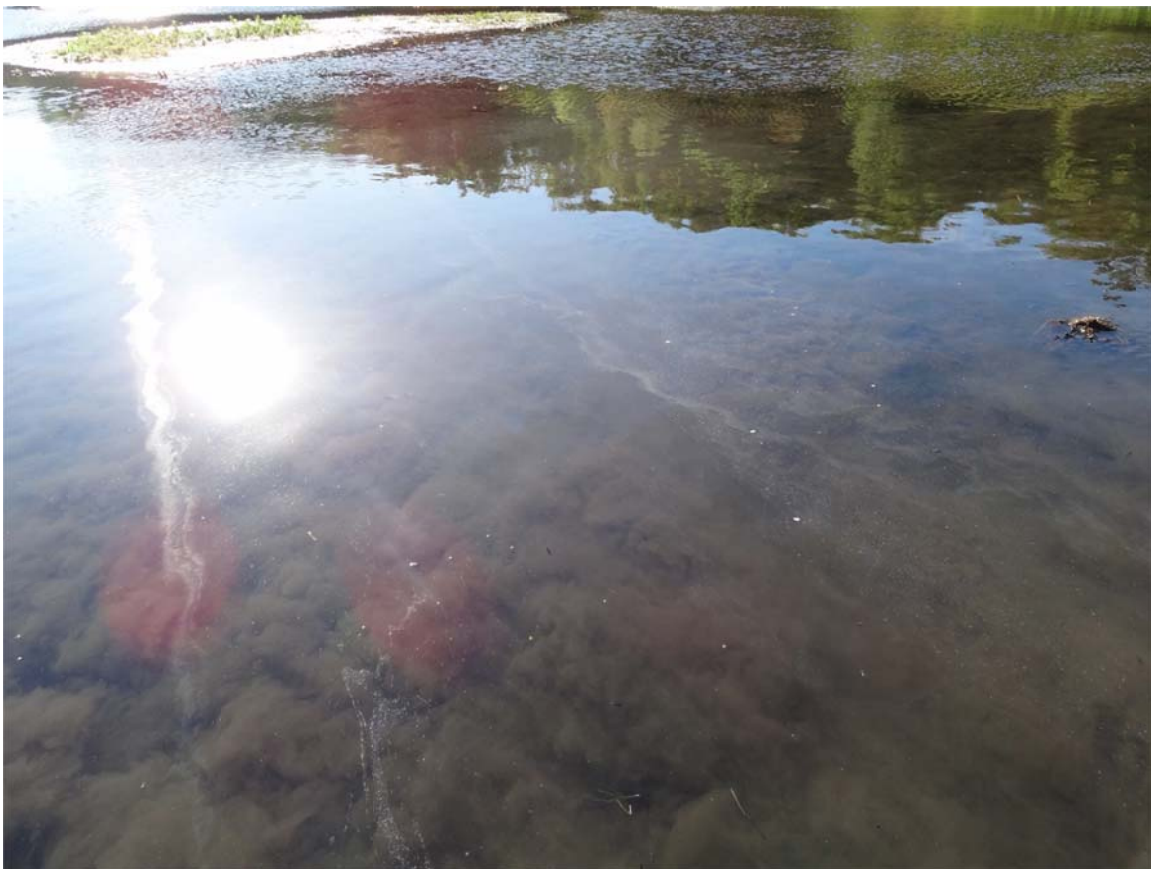
2. MP4.50 LDB, sheen and tar globules observed following agitation by boat.

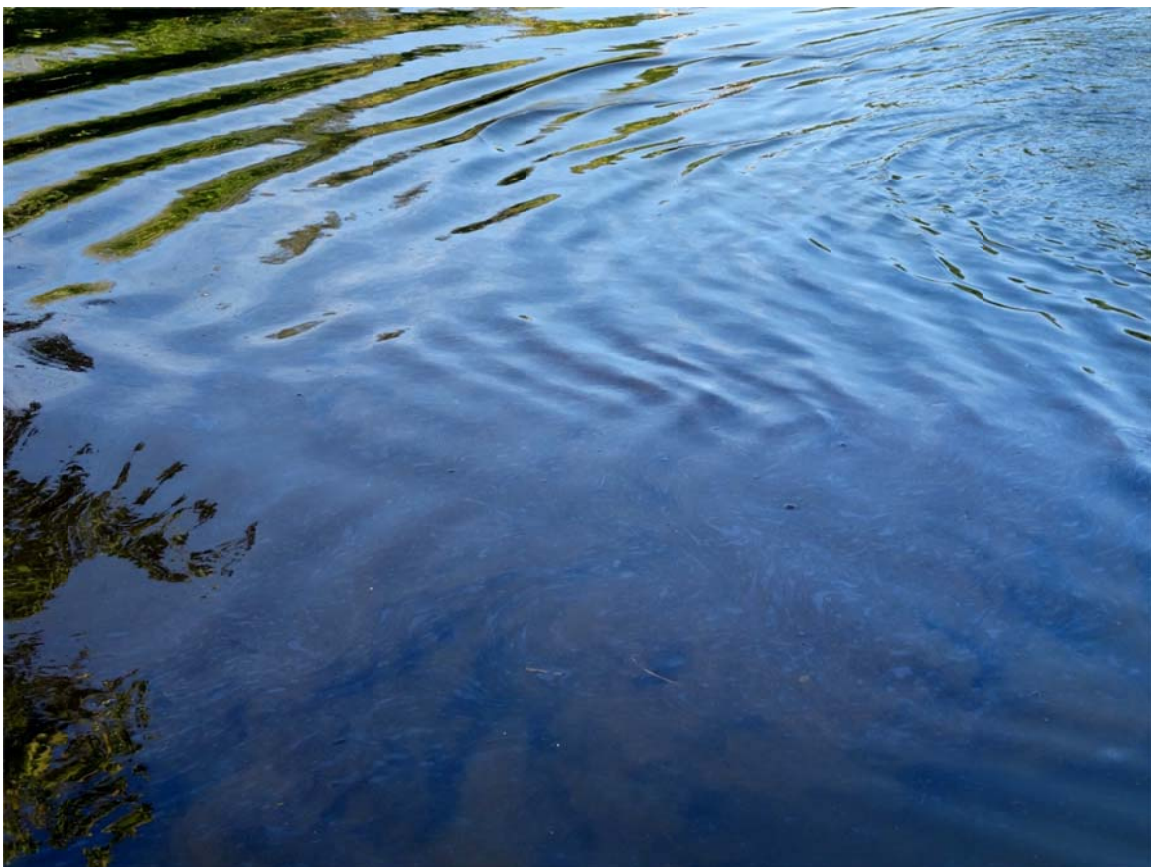
3. MP5.75 LDB, observed sheen and tar globules.

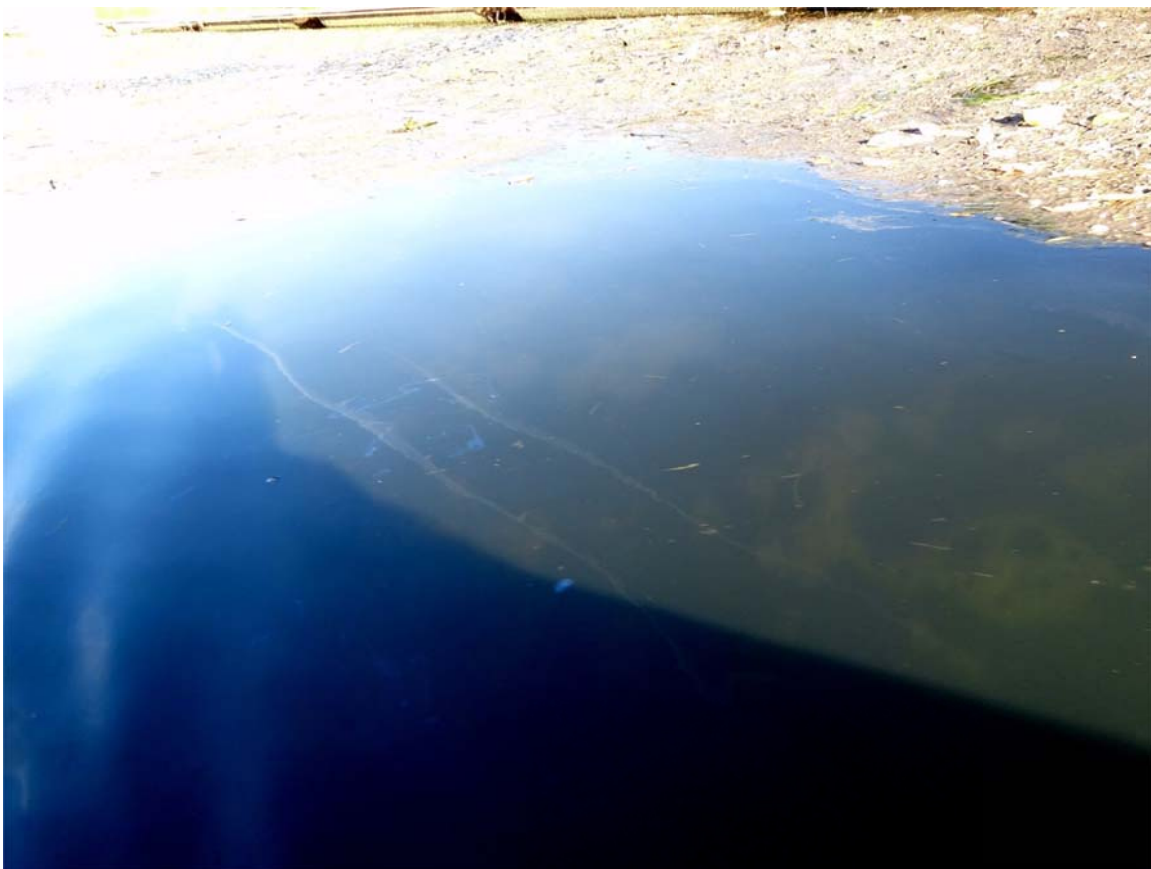
4. Observed sheen and tar globules in containment at Ceresco Dam control point.

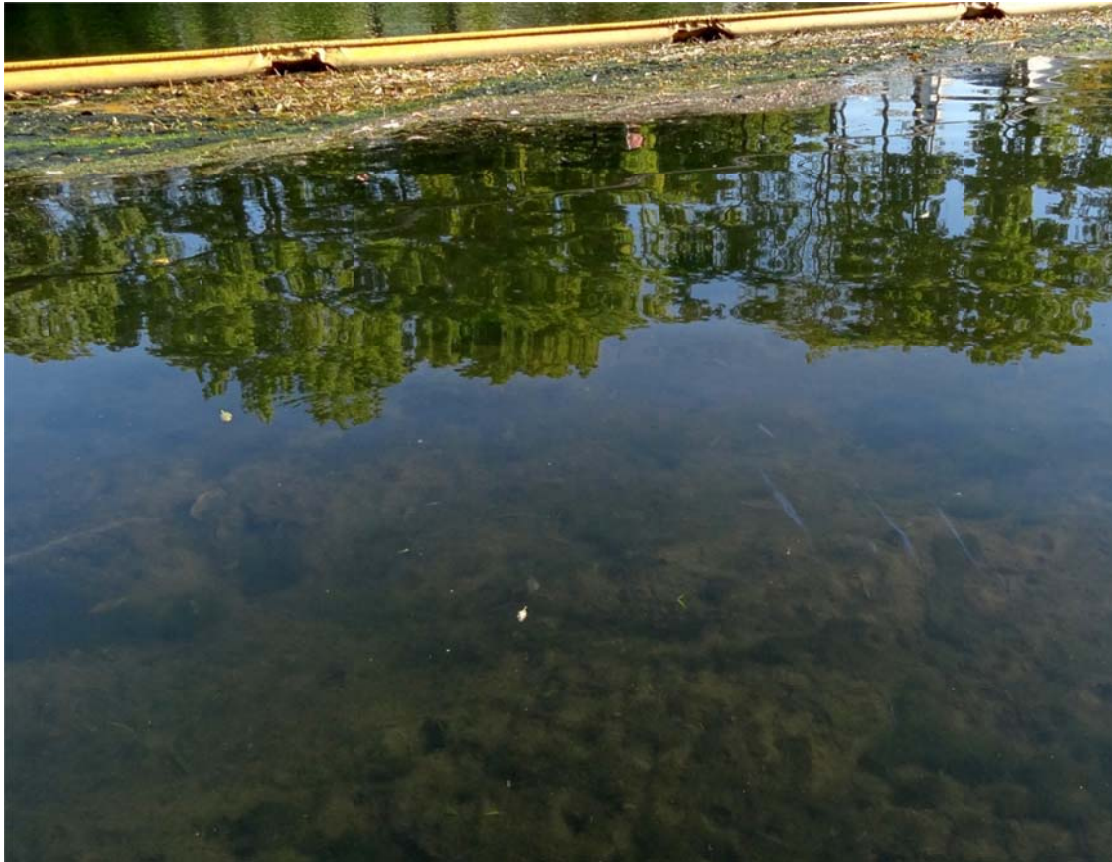
5. Ceresco Dam control point, sheen and tar globules observed within containment.

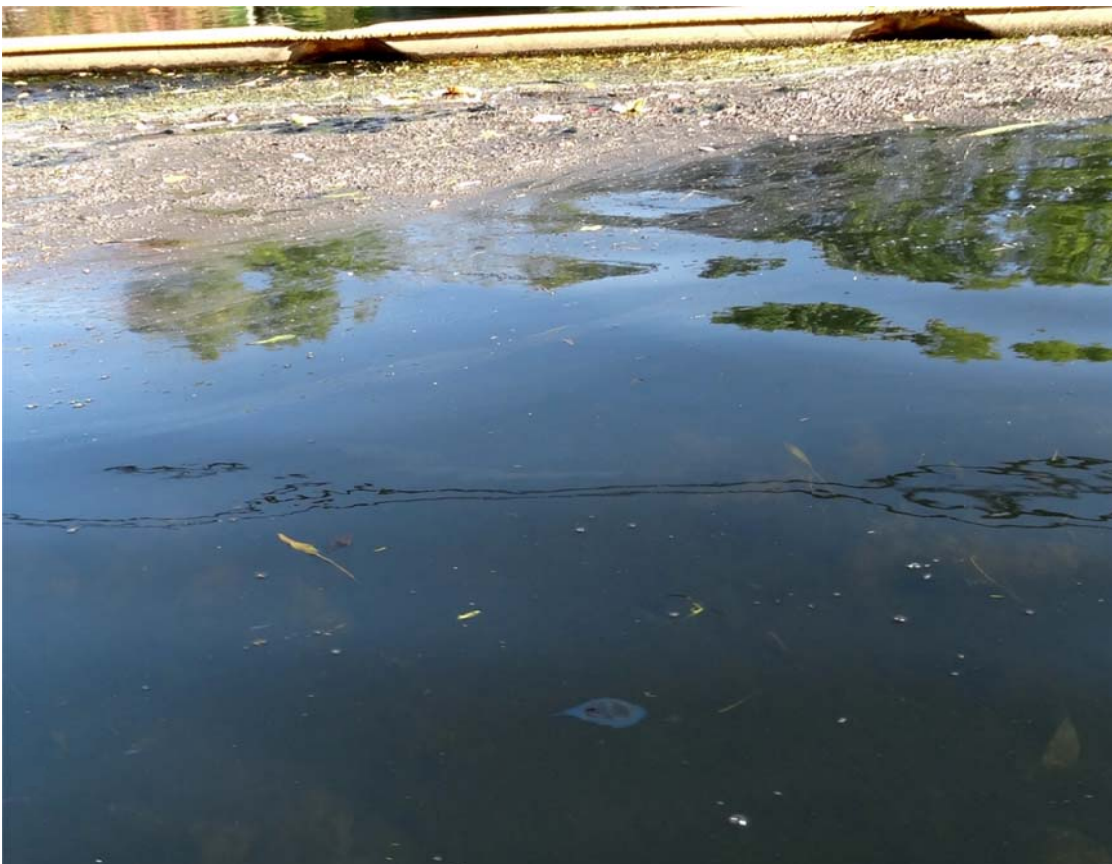
6. Sheen and tar globules observed within Ceresco Dam containment.

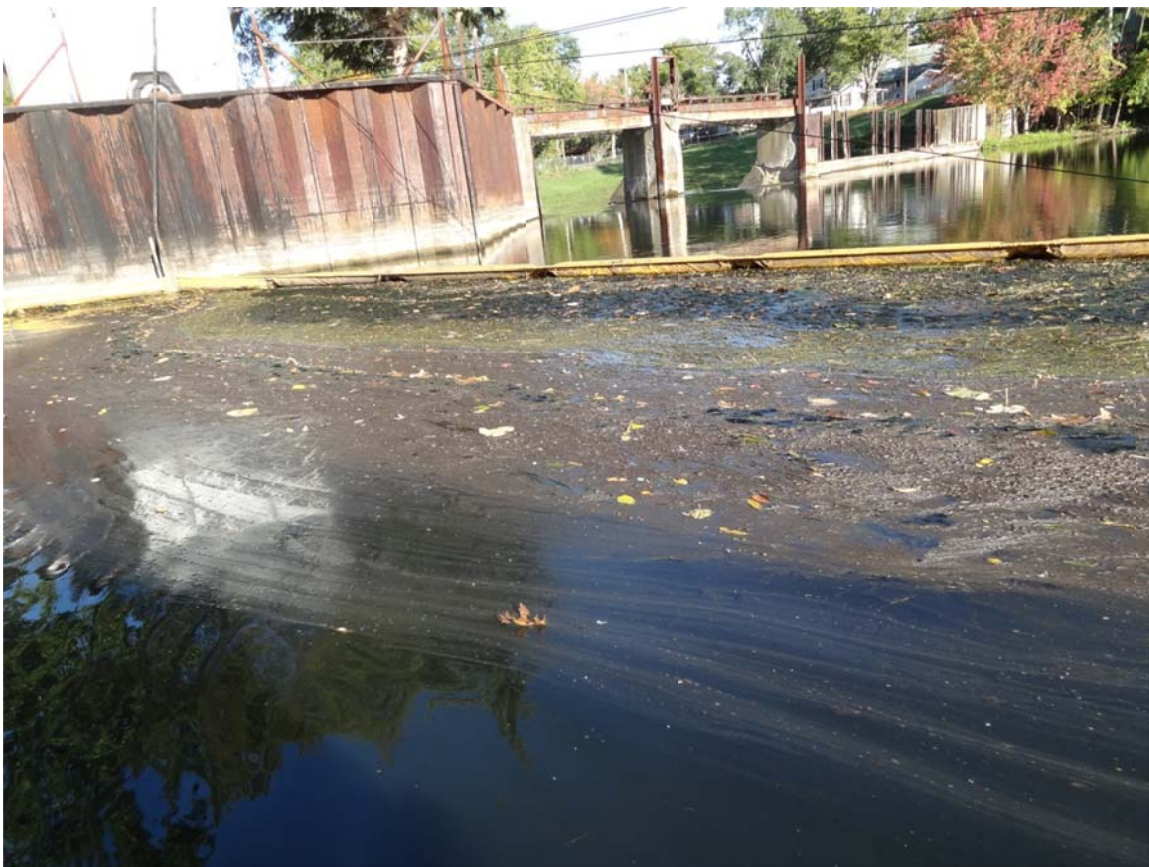
7. Ceresco Dam control point, debris and sheen observed within containment.

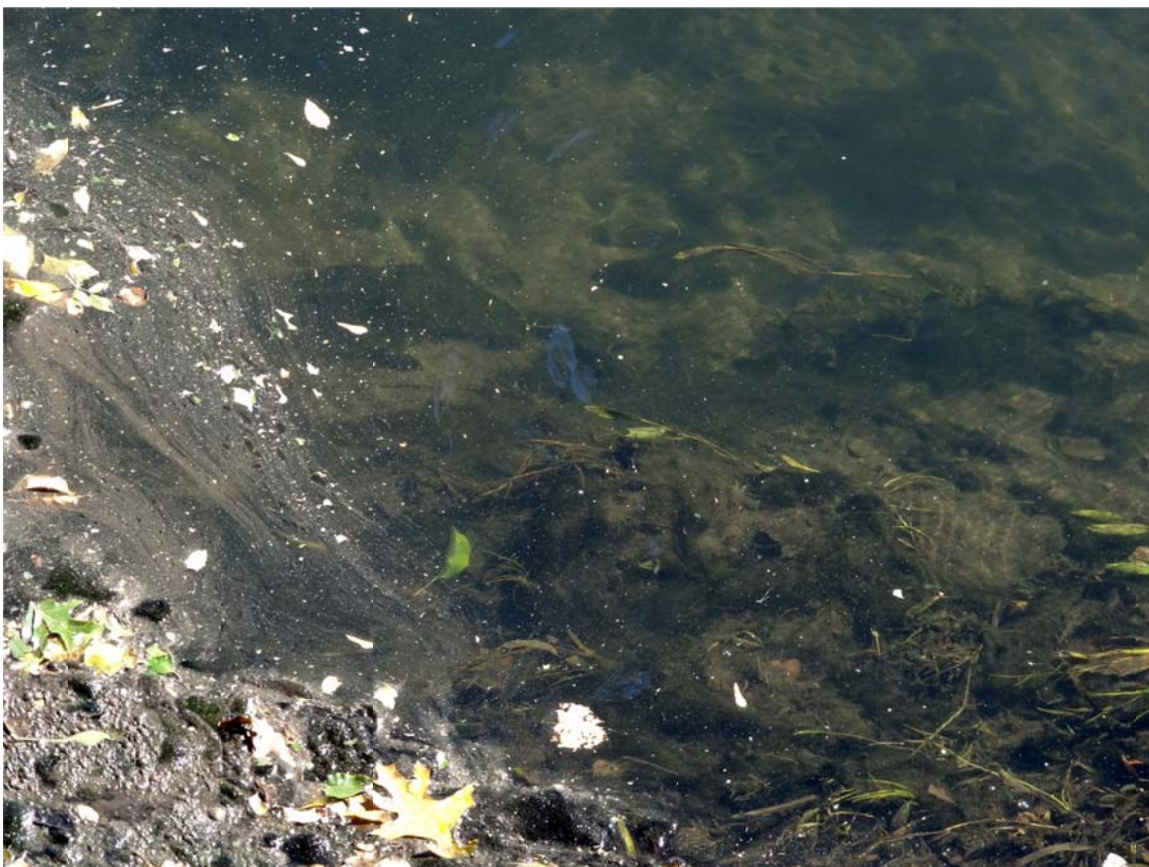
8. Ceresco Dam control point boom, sheen observed within debris.

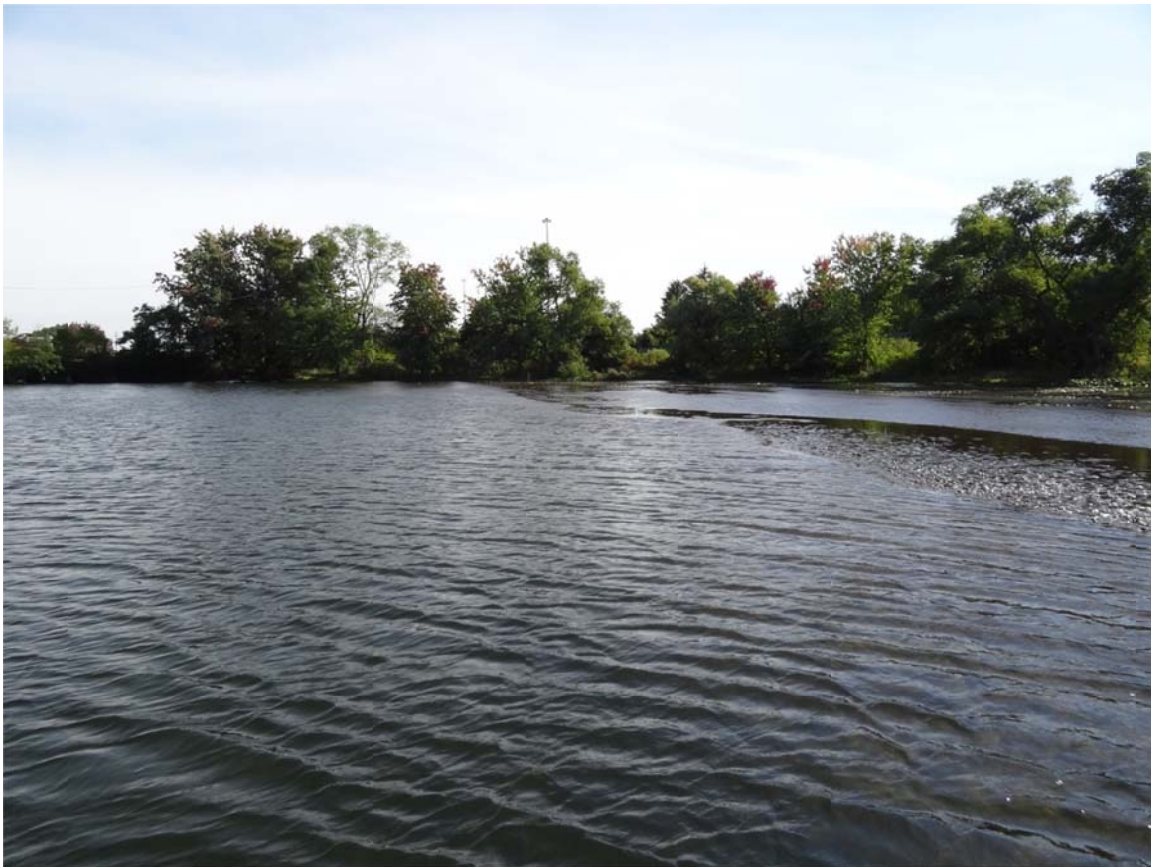
9. North end of Mill Ponds, no sheen observed.

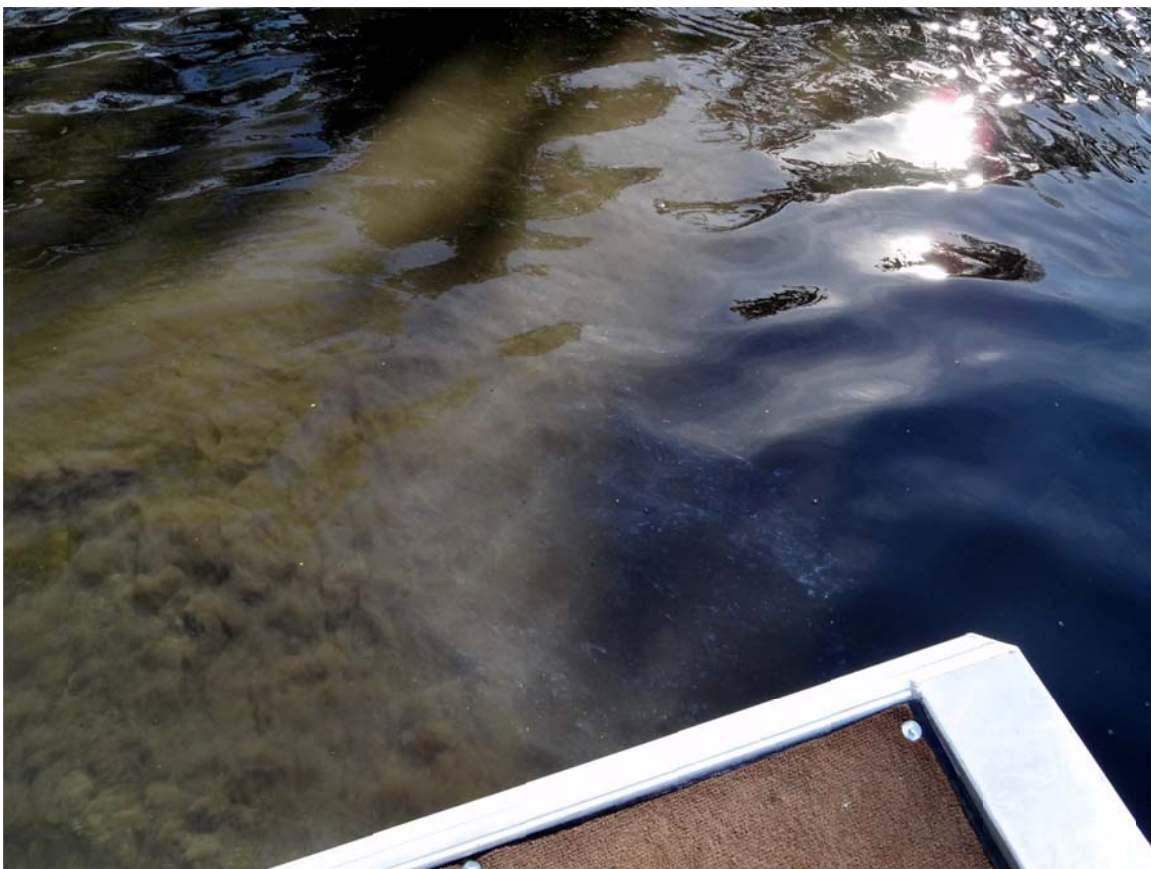
10. Mill Ponds, sheen and tar globules observed following agitation by boat.

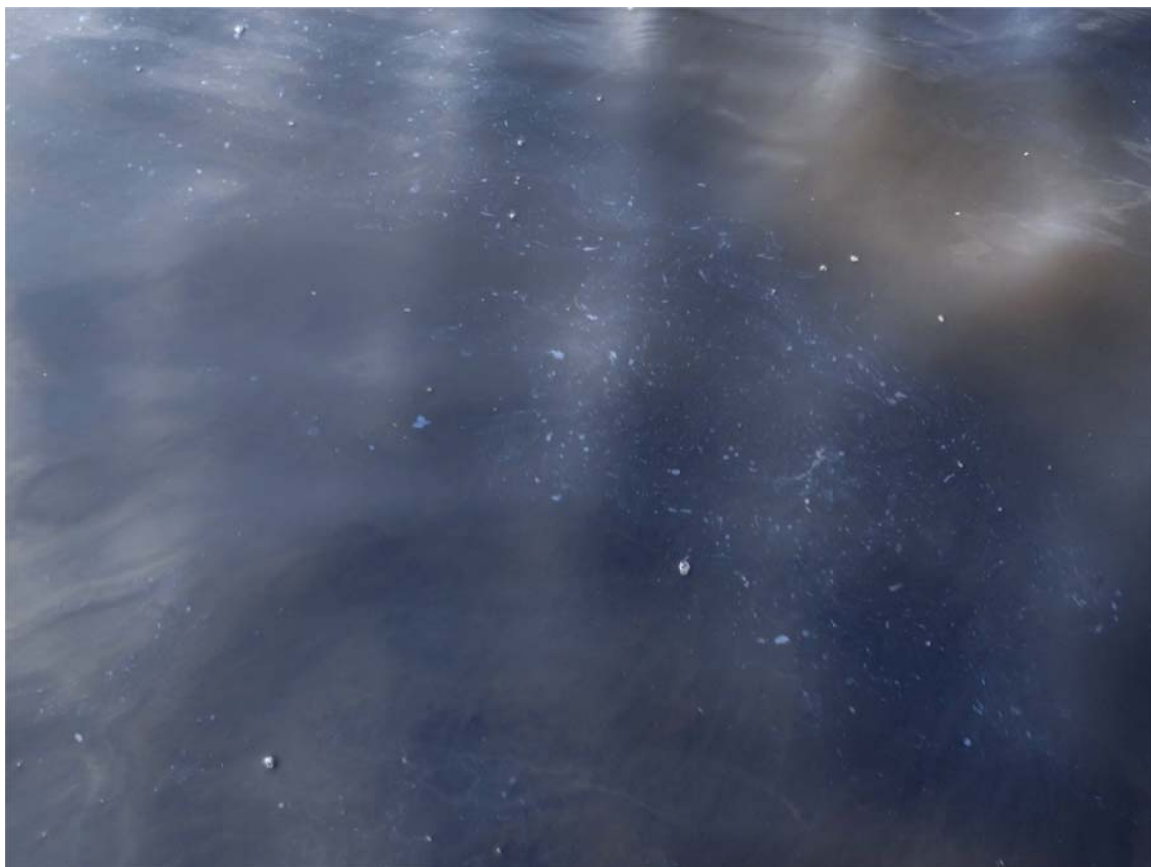
**11. Sheen observed near MP 15.75 (north end of Mill Ponds) following agitation by boat.**

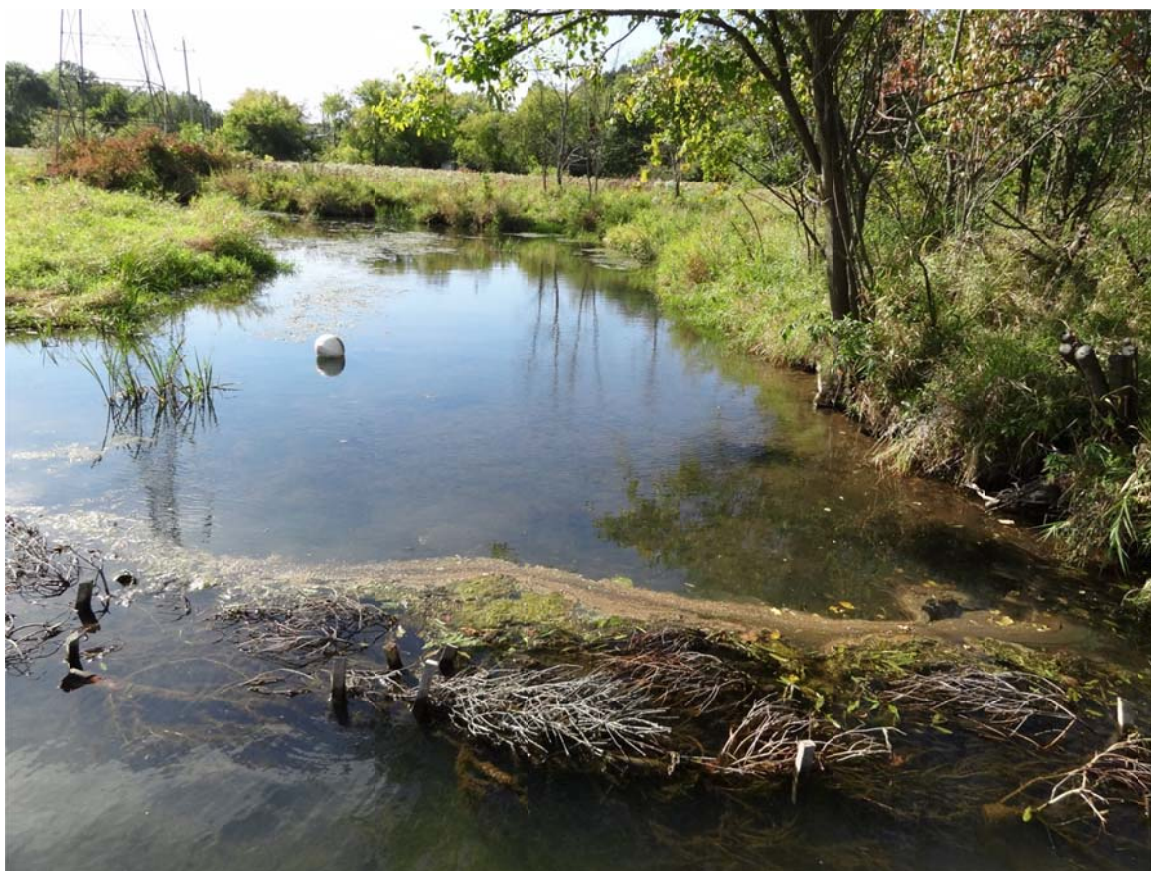
**12. MP 10.75 sediment trap. No sheen observed.**

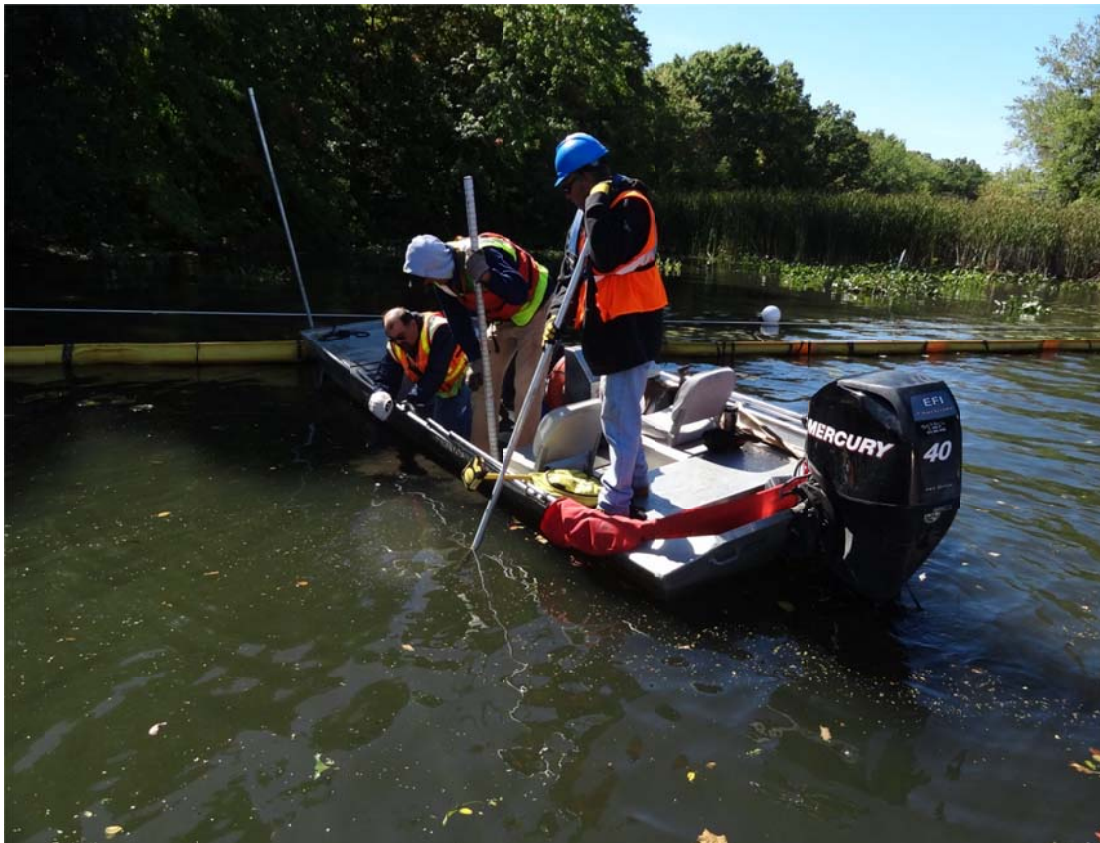
13. Poling and bathymetry crew observed along southern shoreline of Morrow Lake Delta.

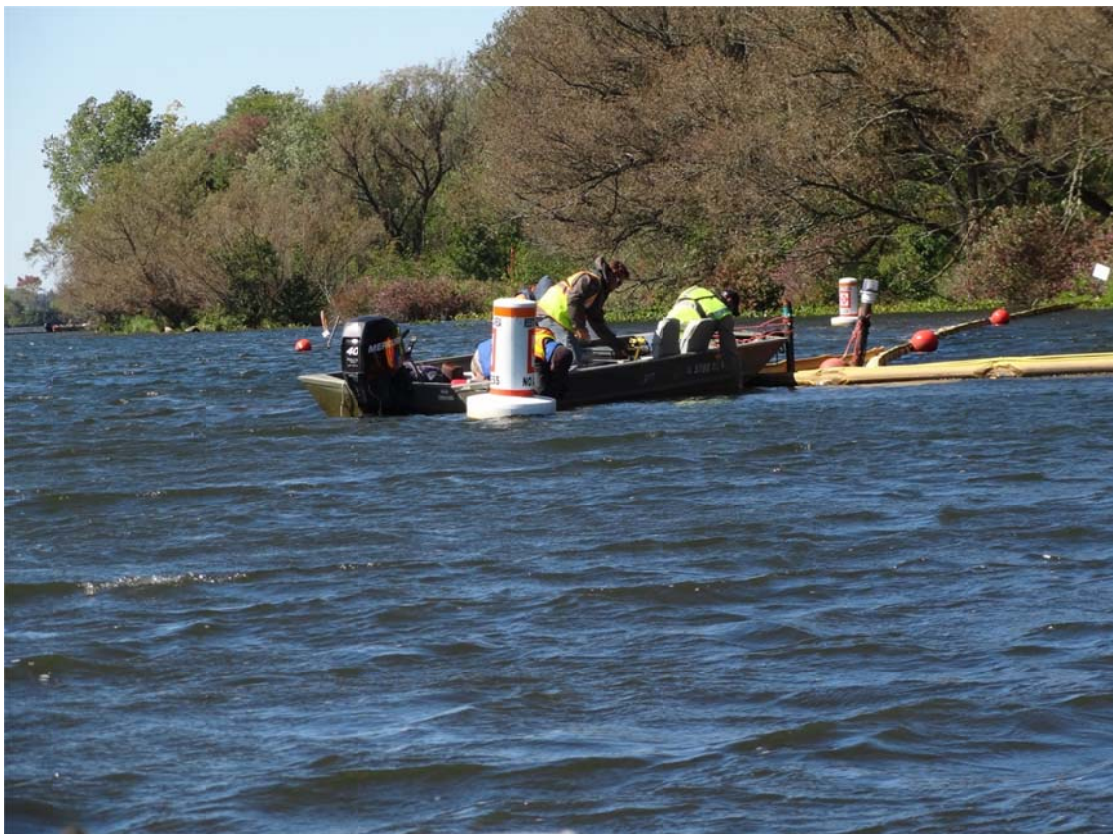
14. Poling and bathymetry crew observed along northern shoreline of Morrow Lake Delta.

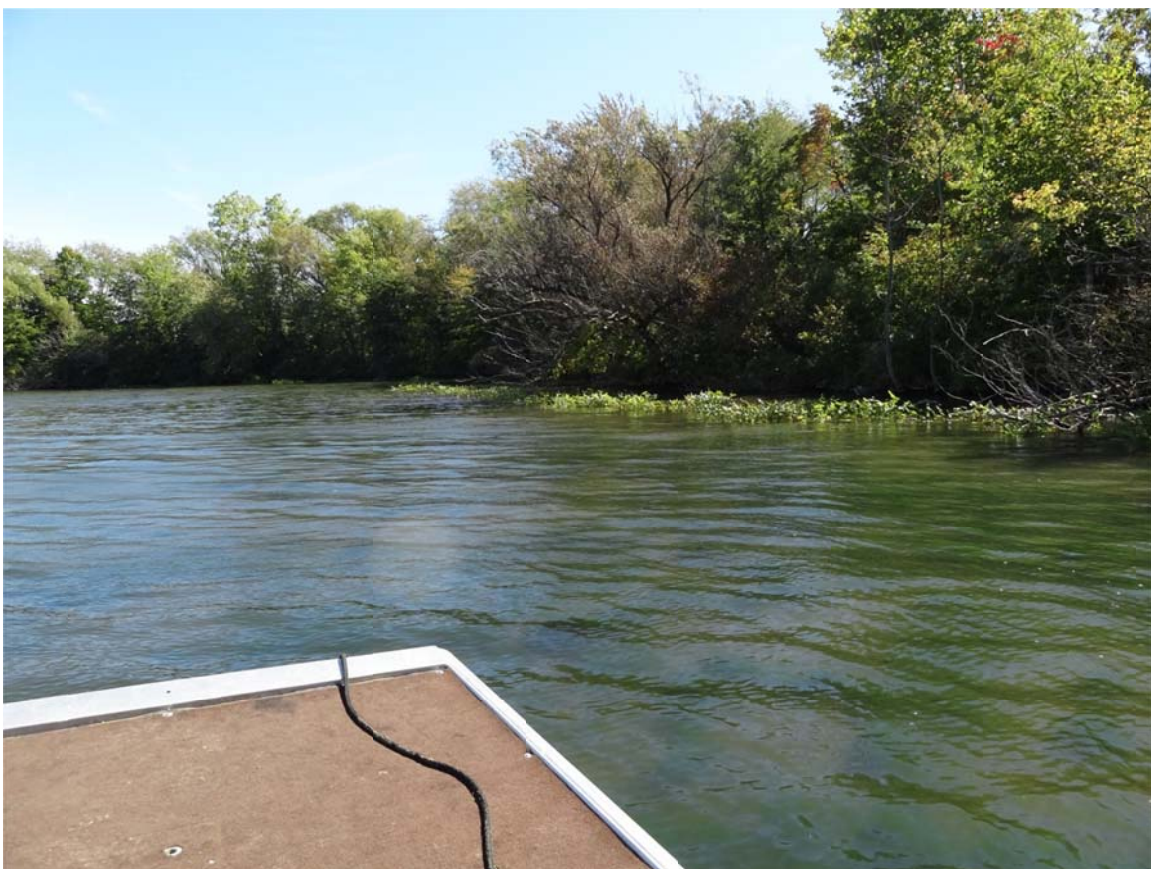
15. South cove of Morrow Lake, no sheen observed.

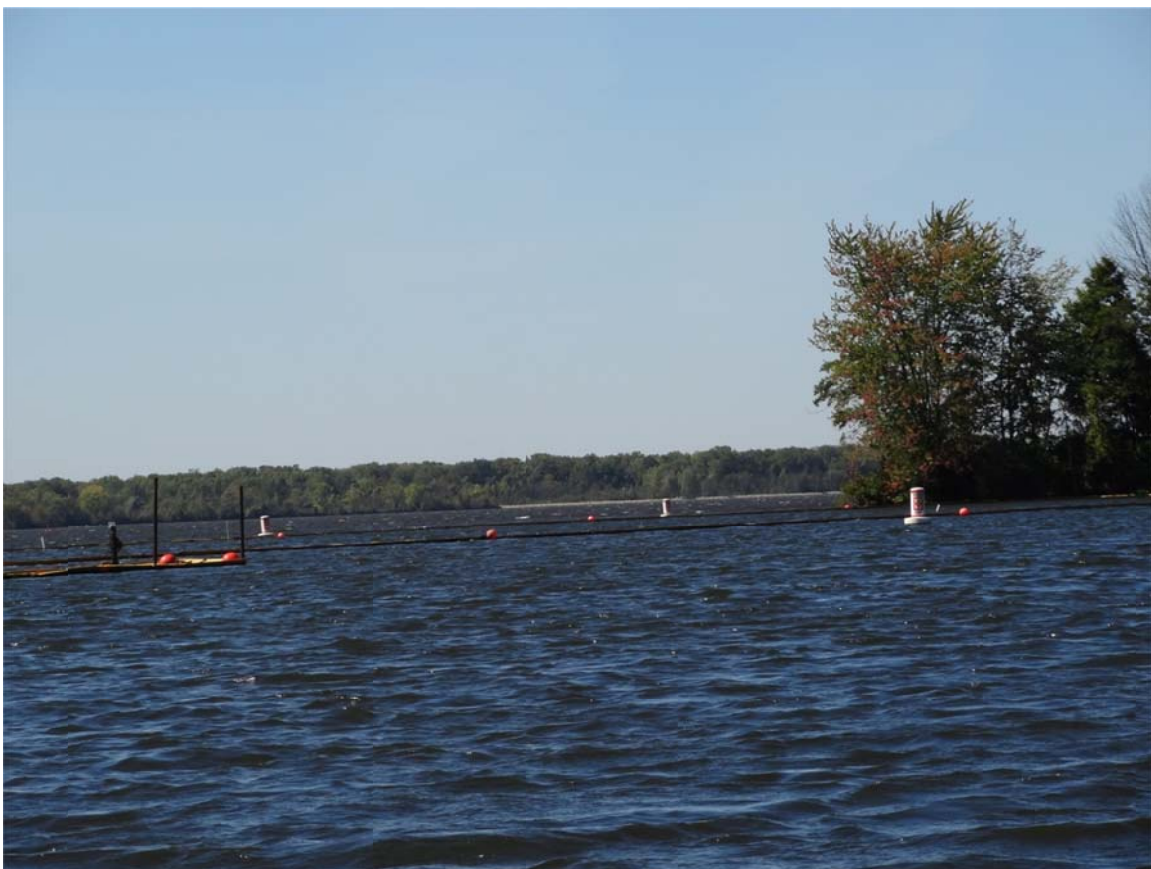
16. E4 boom configuration, high winds and choppy water observed on Morrow Lake.

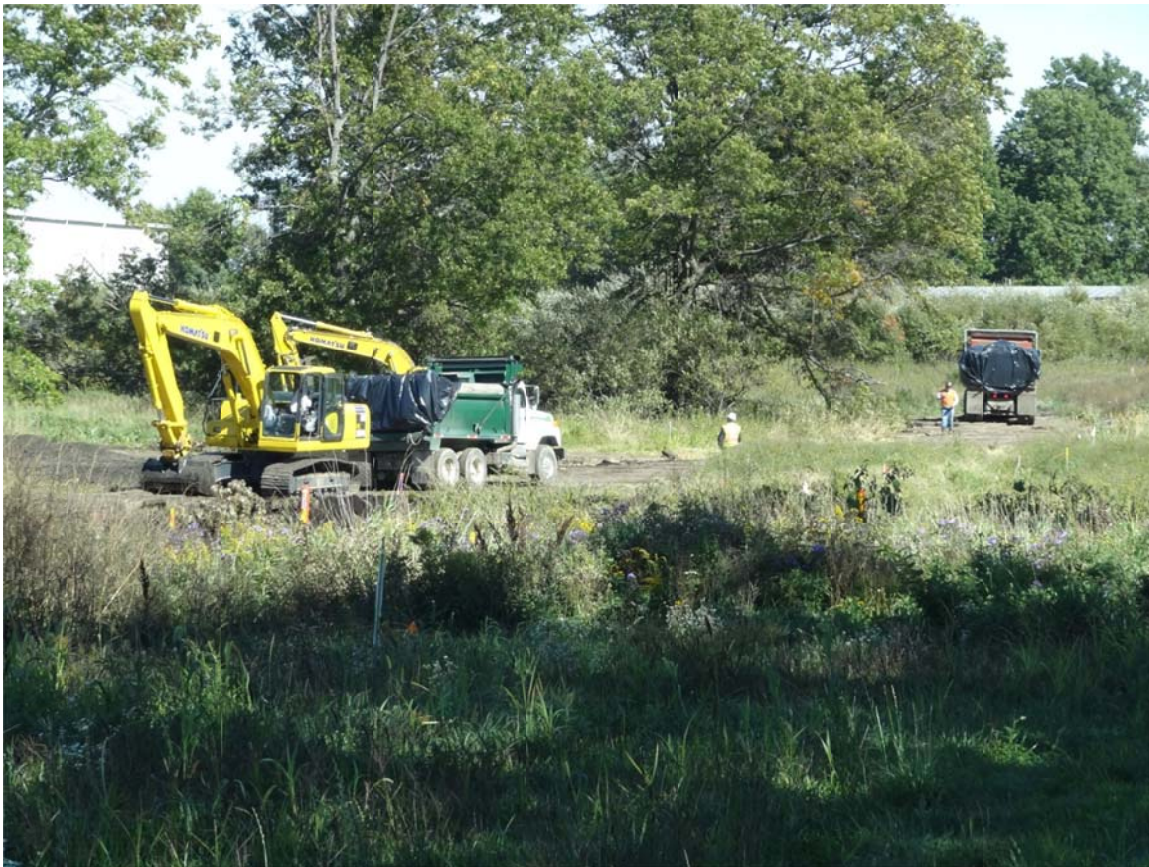
17. Source Area, scraping activities continue.

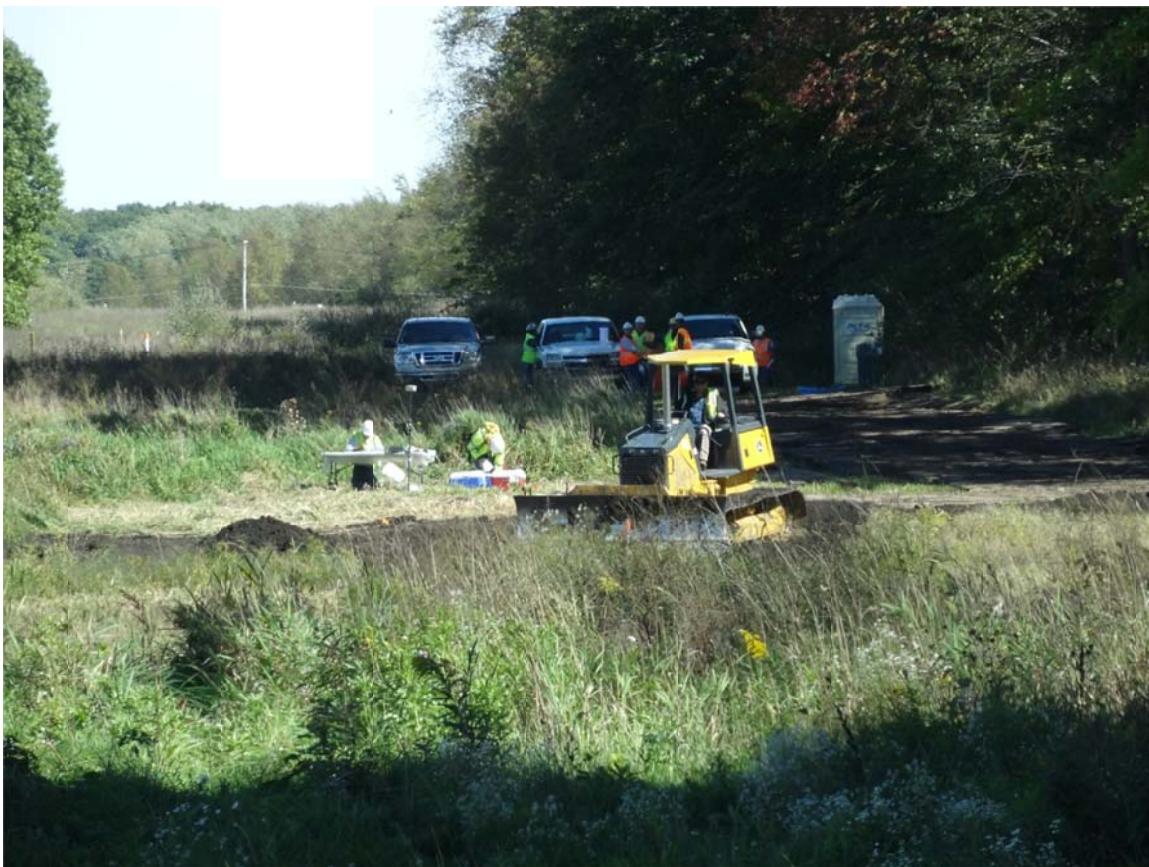
18. Source Area, backfilling activities continue.
