Situation Photo Log

Tuesday, September 25, 2012

Kalamazoo River / Enbridge Spill

Prepared by:
Larry Rader
START-USEPA
Situation Unit Leader

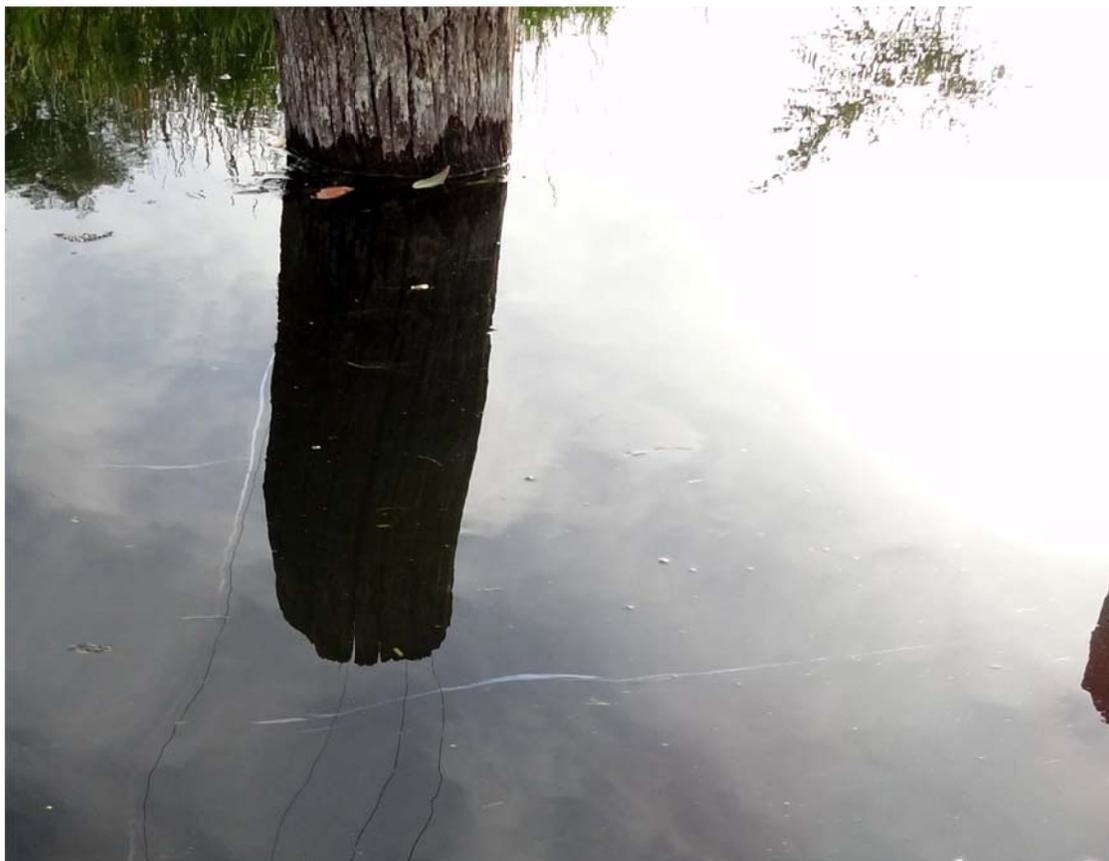
1. MP5.63 RDB, sheen and tar globules observed at trestle above Ceresco Dam.

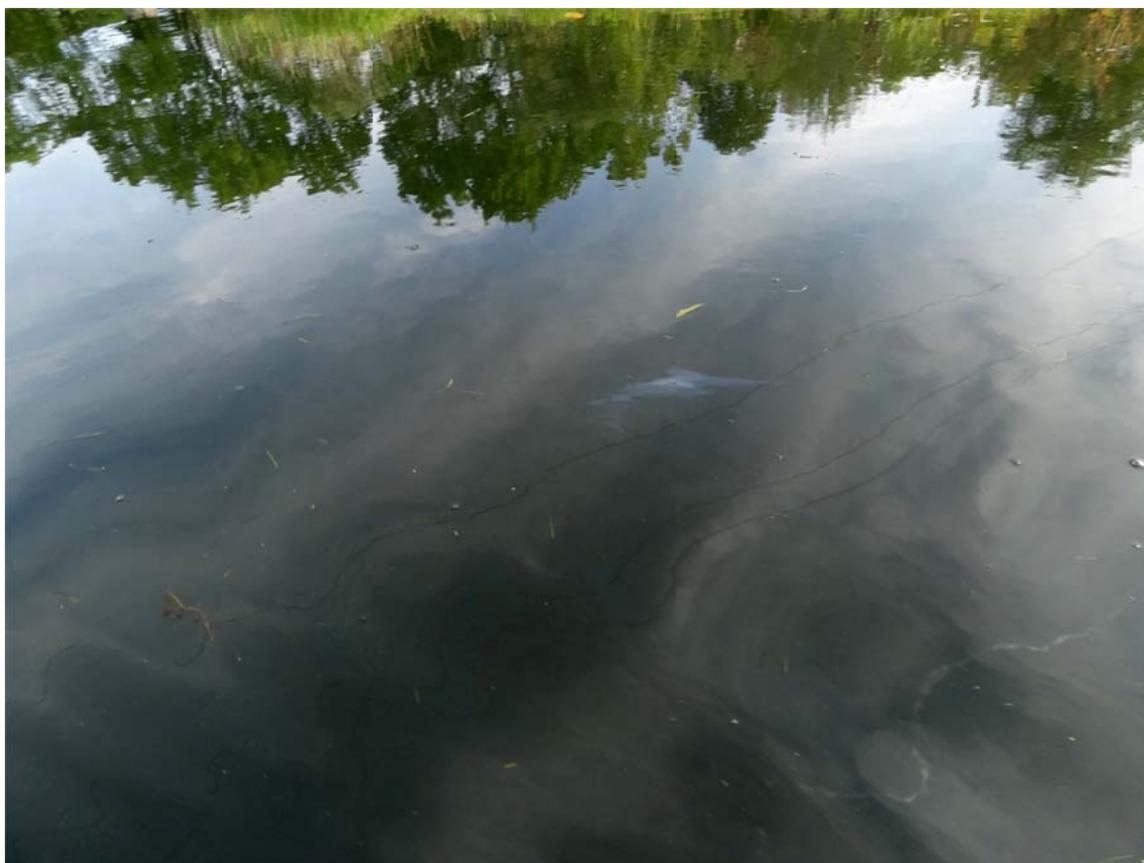
2. MP5.63 LDB, sheen and tar globules observed at trestle above Ceresco Dam.

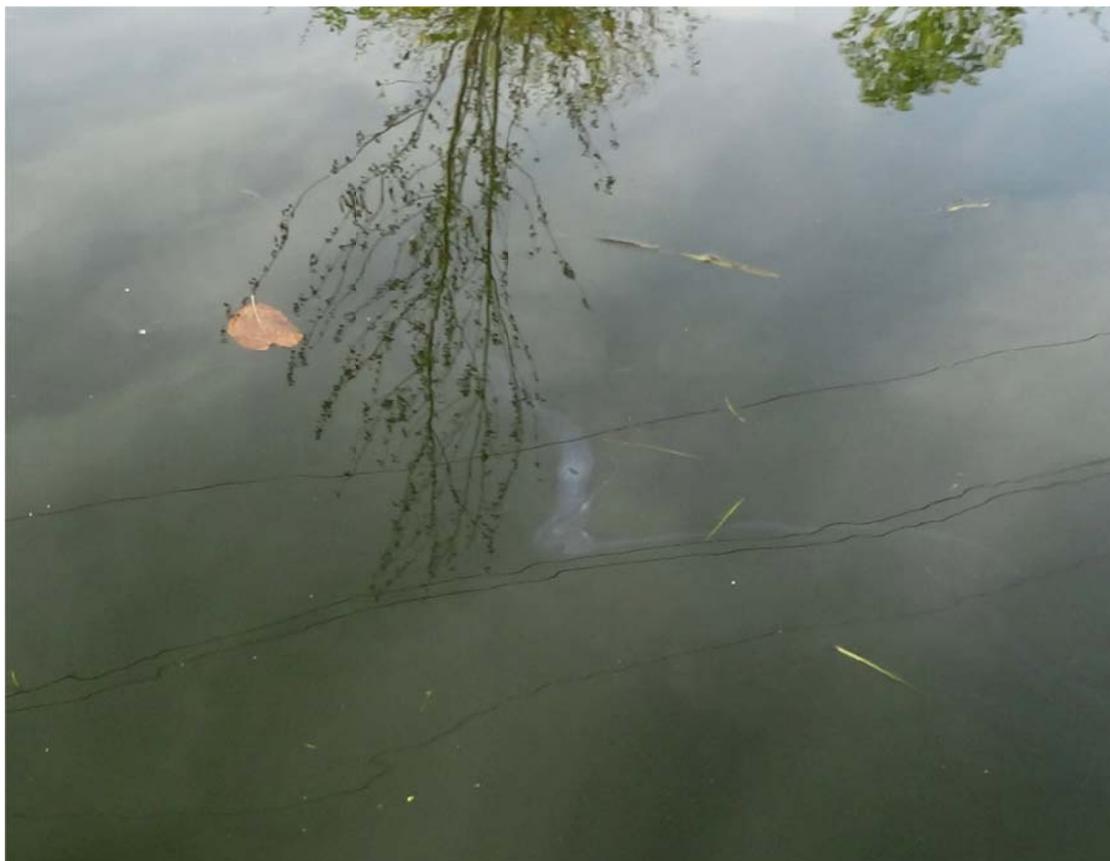
3. MP5.75 LDB, observed sheen and tar globules.

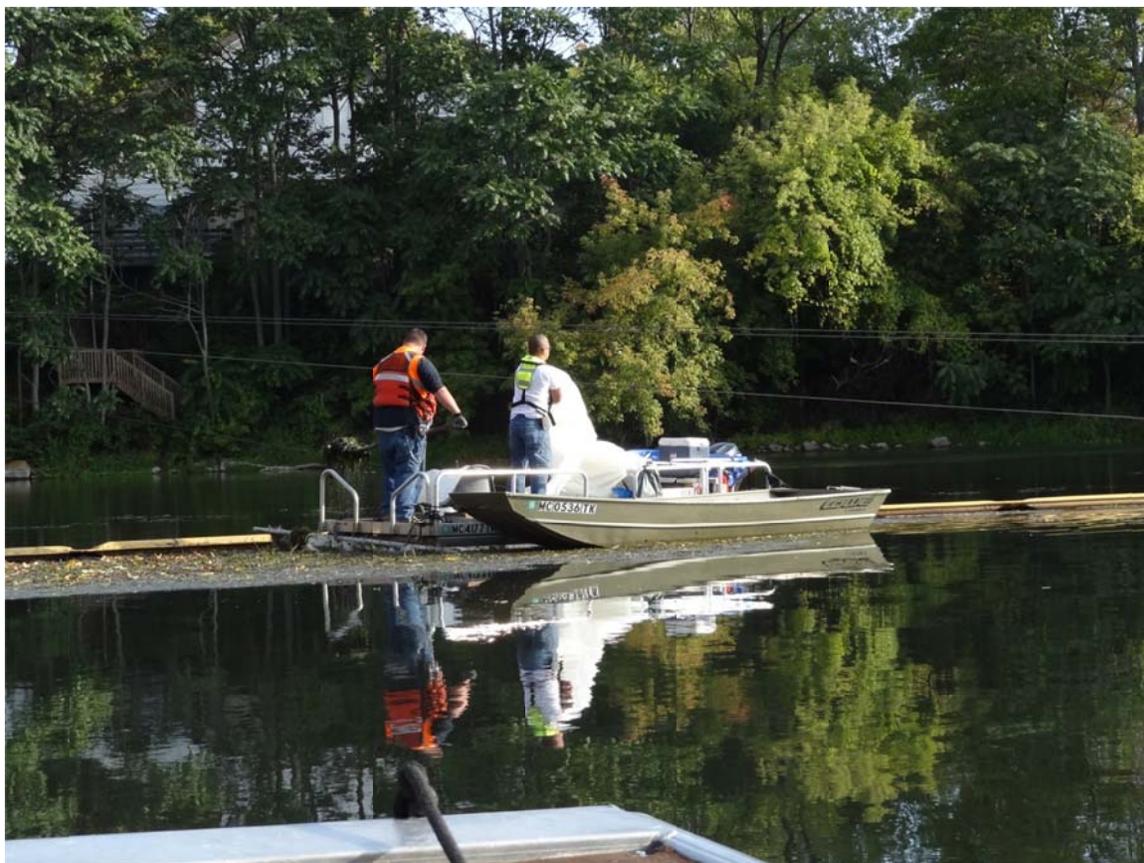
4. Crews removing vegetation from Ceresco Dam control point.

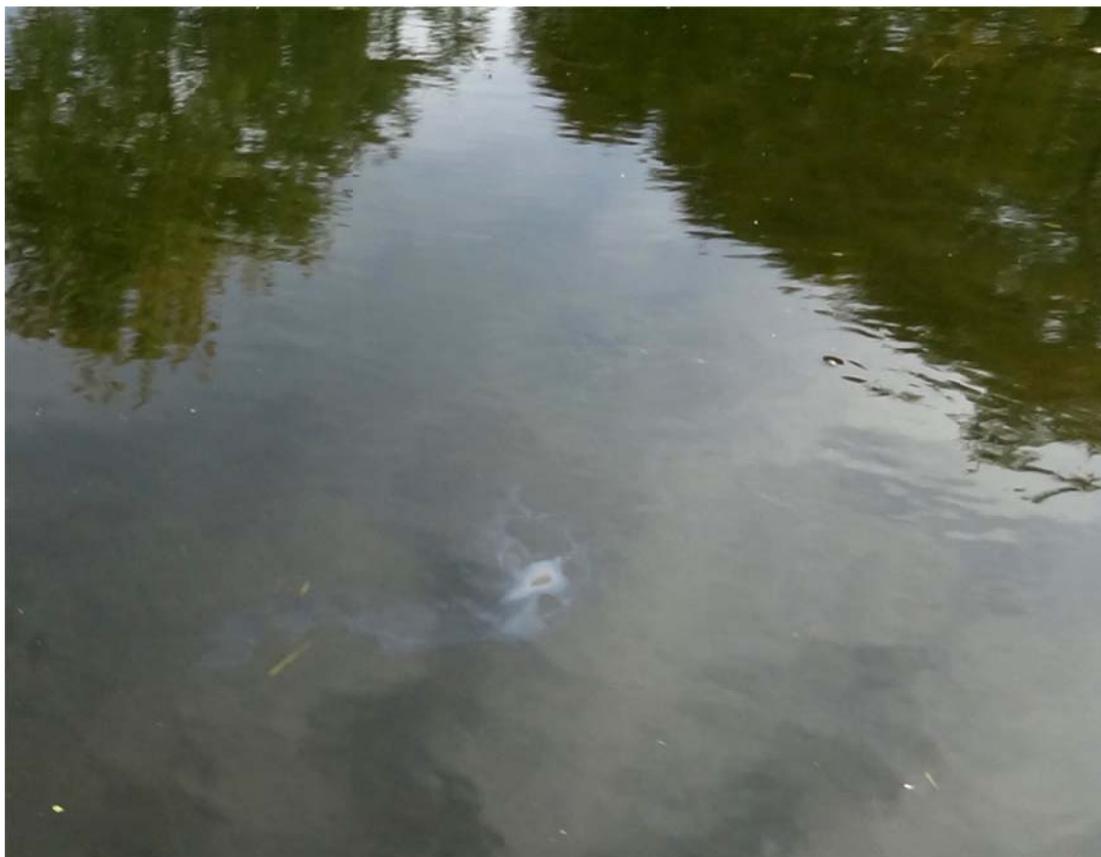
5. Ceresco Dam control point, sheen and tar globules observed within containment.

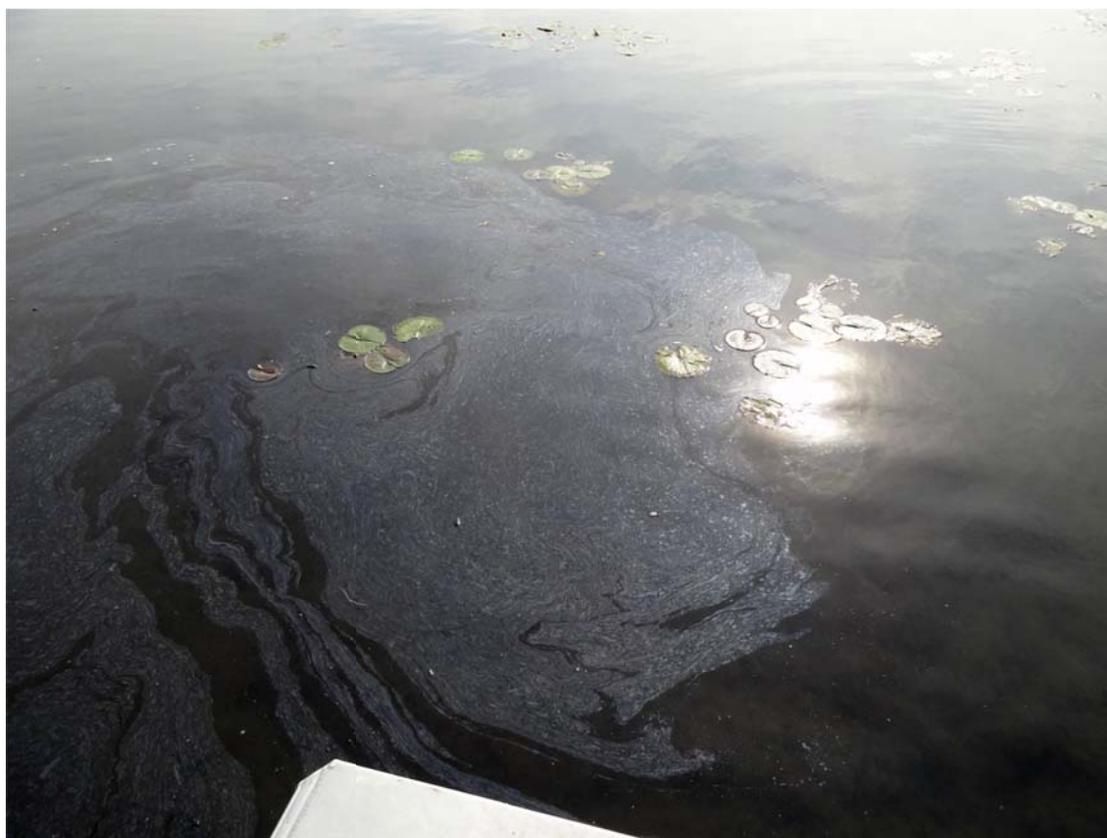
6. MP 14.5 RDB, sheen observed following agitation by boat in north end of south Mill Pond.

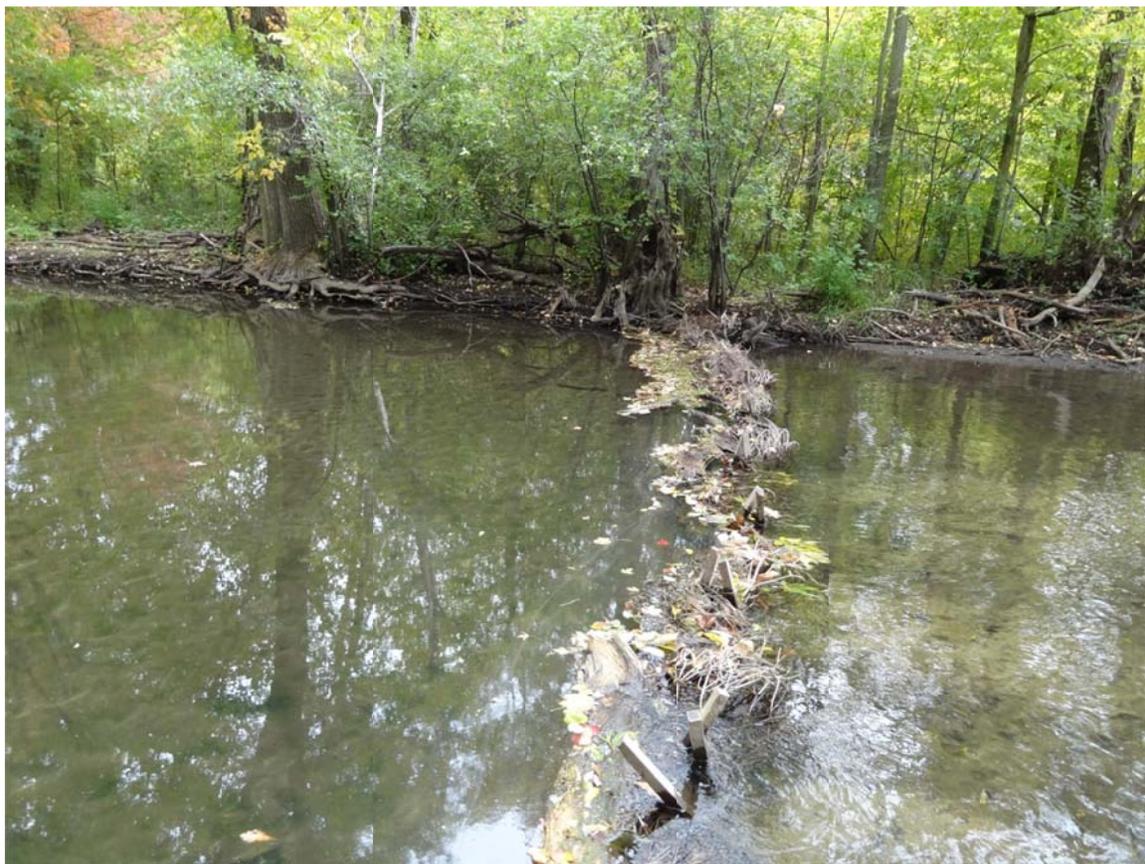
7. MP 36.1 sediment trap. No sheen observed.

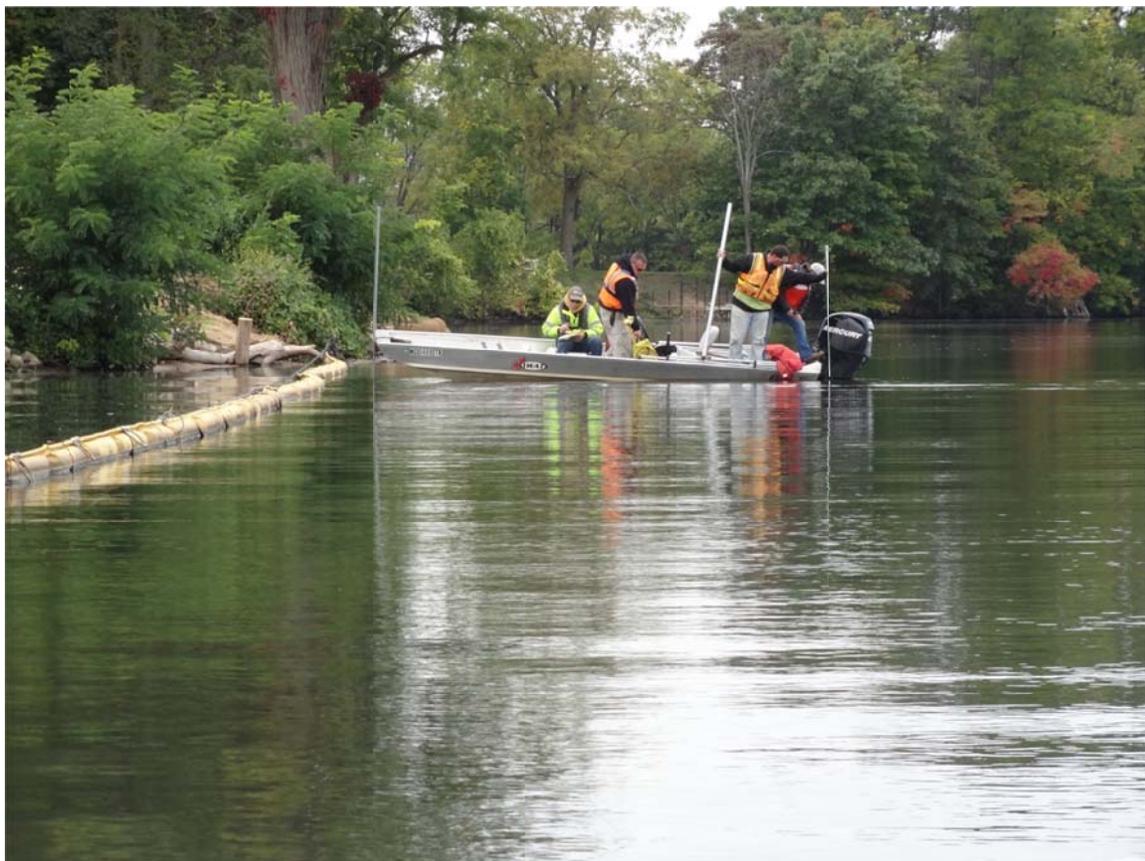
8. Bathymetry and poling crew working along southern shore of Morrow Lake Delta.

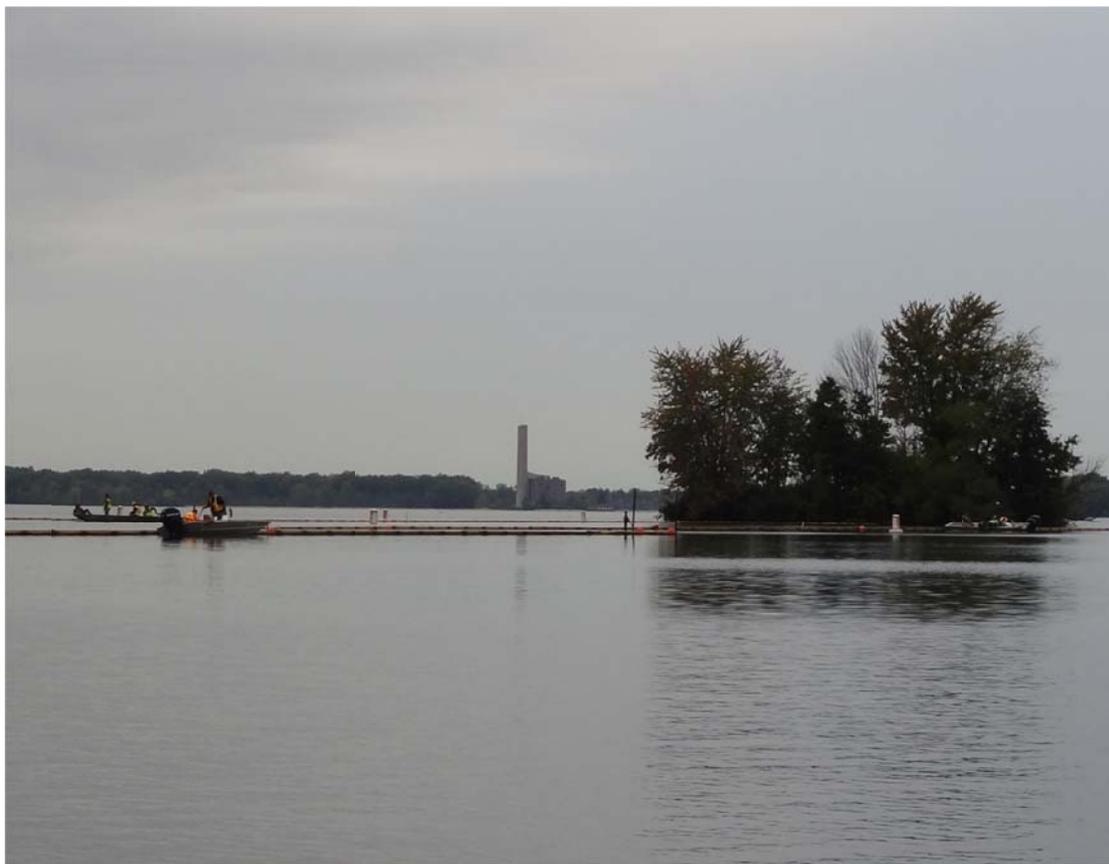
9. Three boat crews operating along E 4.0 boom.

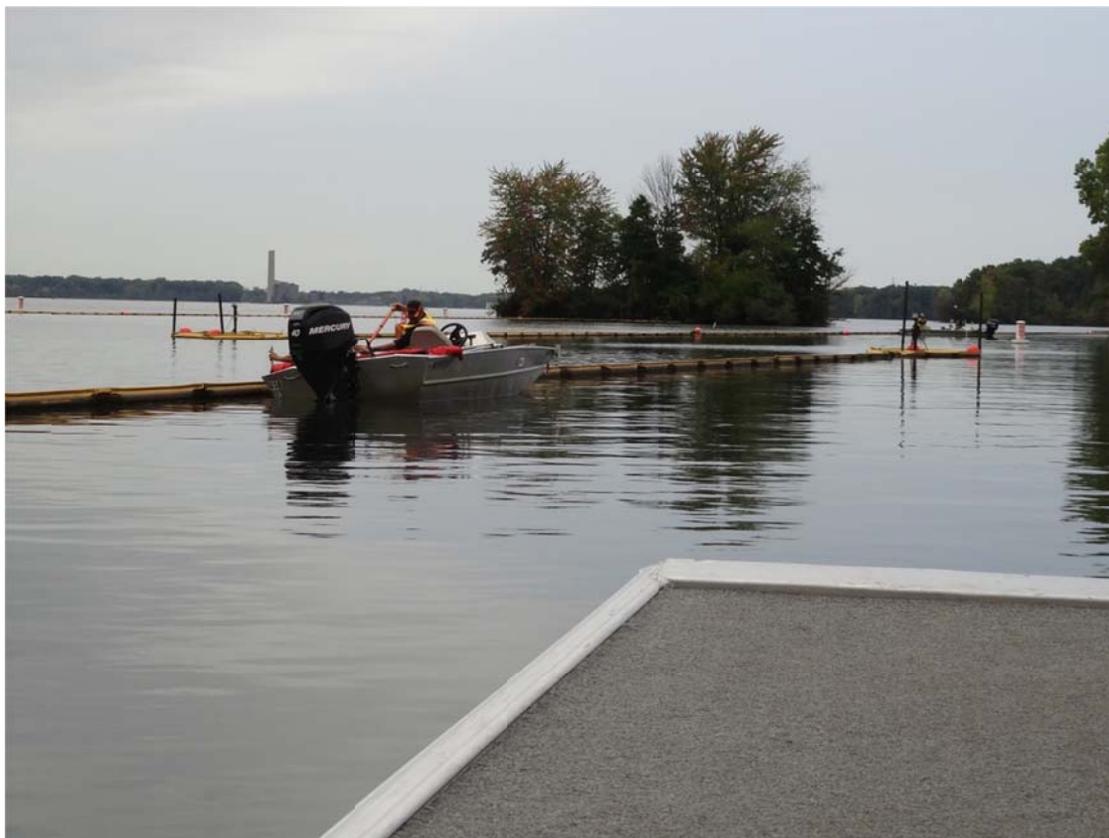
10. Sediment curtain inspection crew operating along E4.0 containment system.

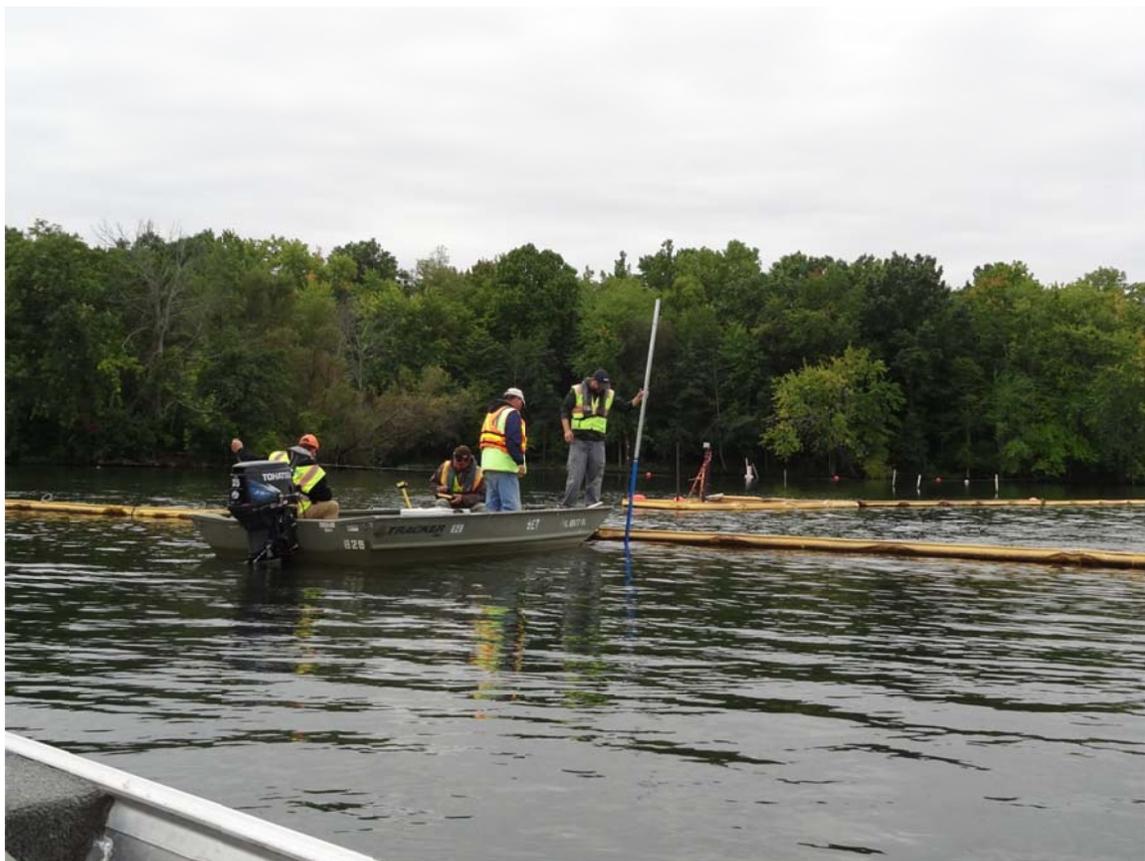
11. Bathymetry and poling crew working along E4.0 containment system.

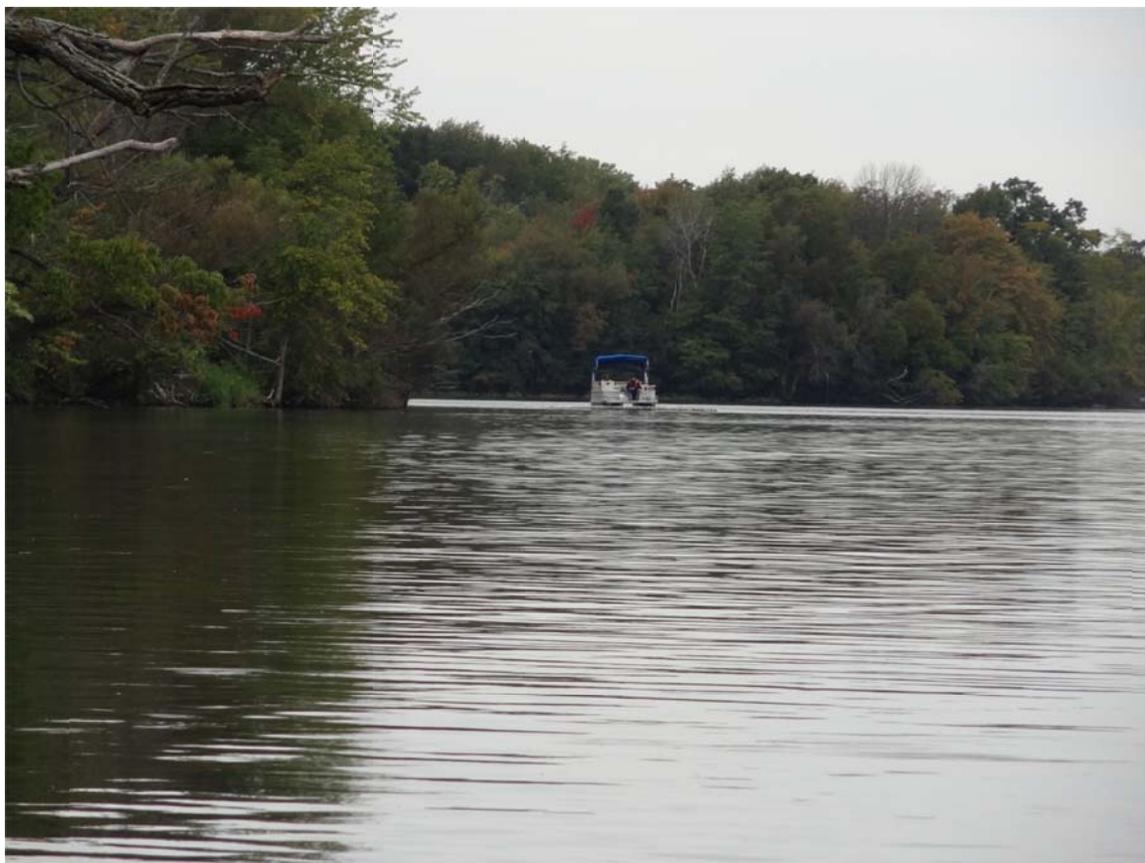
12. Sheen sweeper boat operating in southern cove of Morrow Lake. Sheen and tar globules observed.

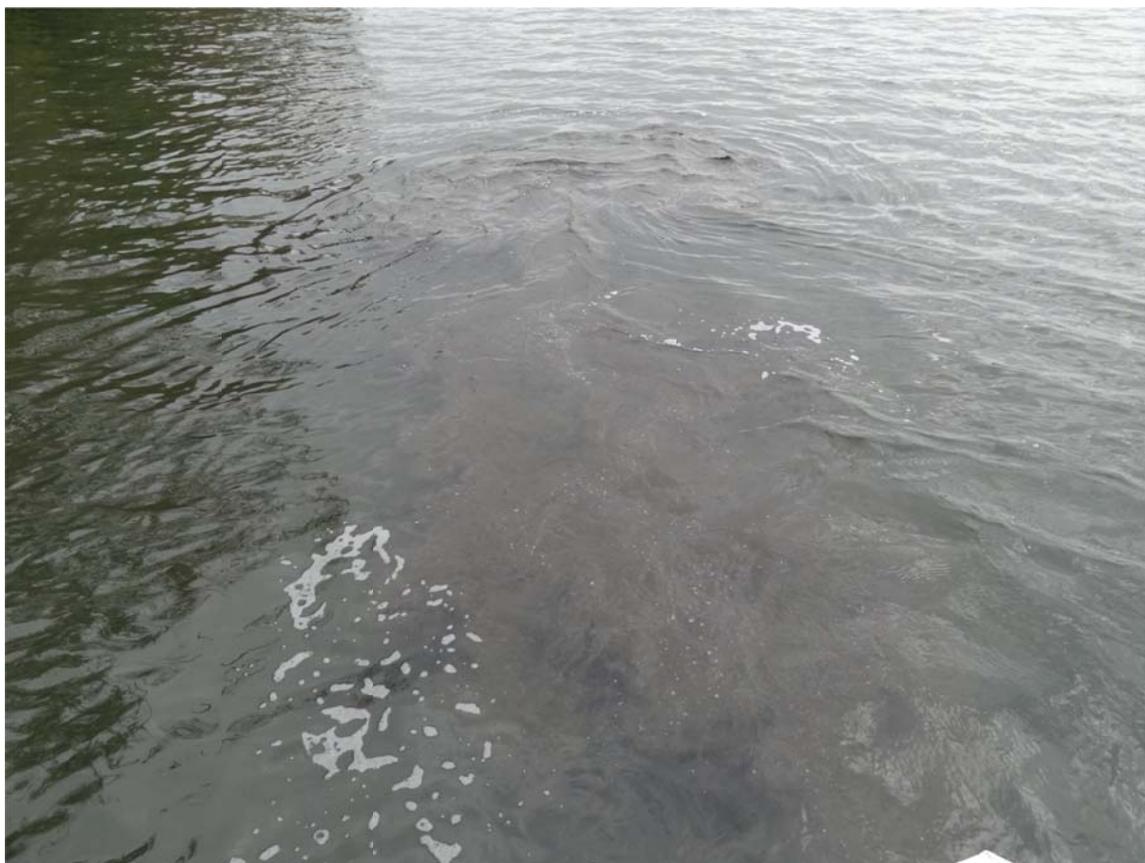
13. Sheen observed in northern cove of Morrow Lake following agitation by boat.

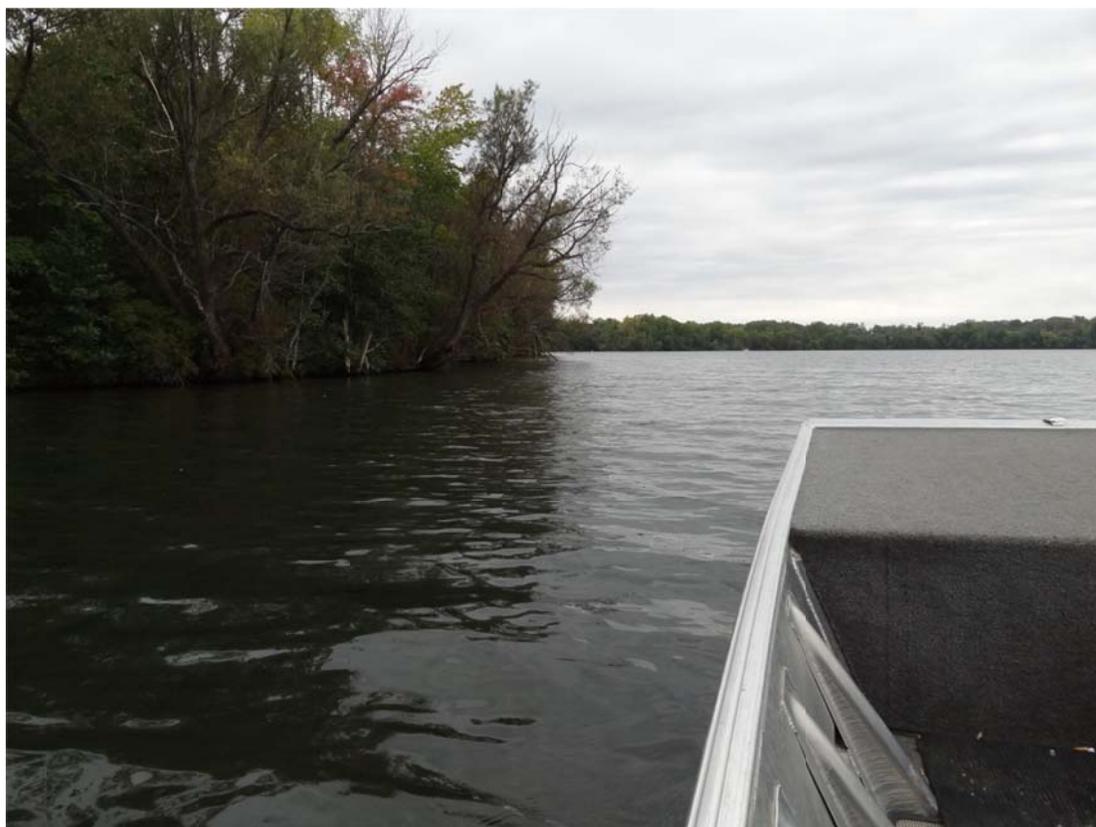
14. View of northern cove of Morrow Lake looking south.
