# Situation Photo Log

Wednesday, September 26, 2012

Kalamazoo River / Enbridge Spill

Prepared by:  
Larry Rader  
START-USEPA  
Situation Unit Leader

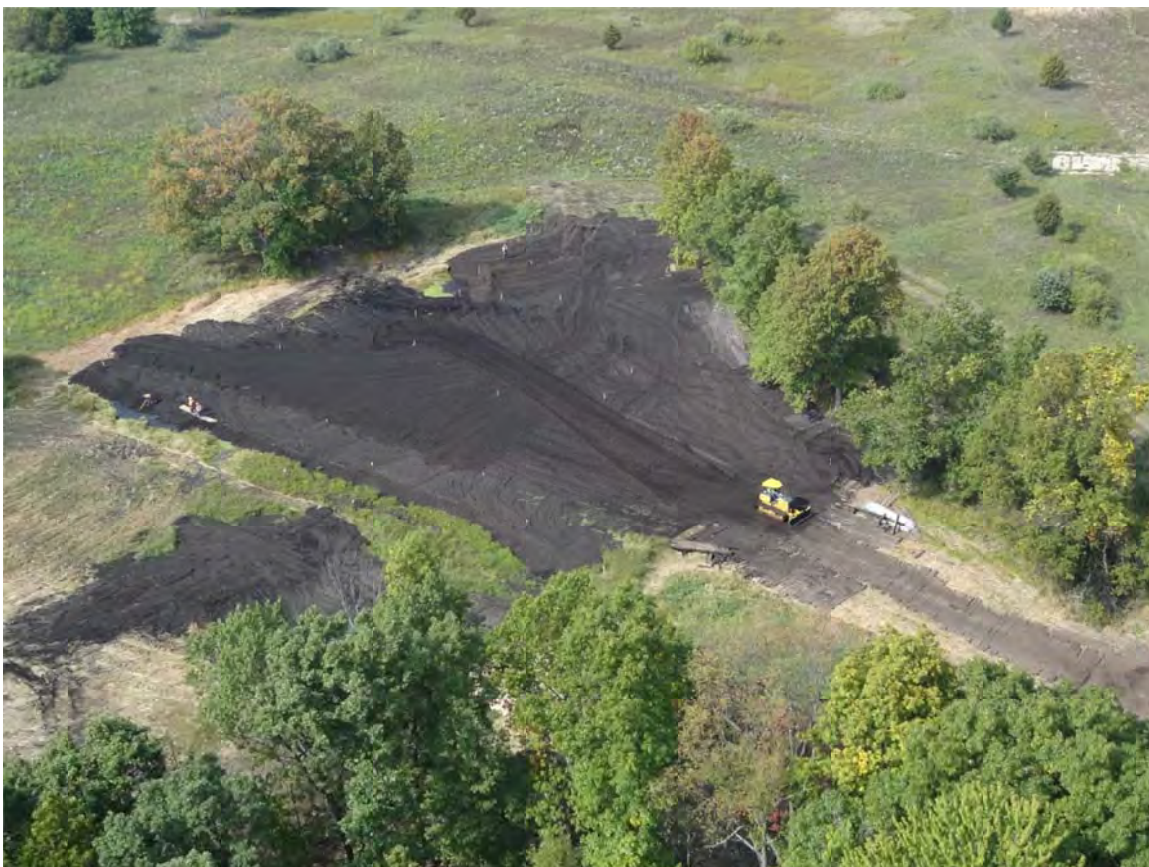
1. Source Area, crews observed grading cover material.

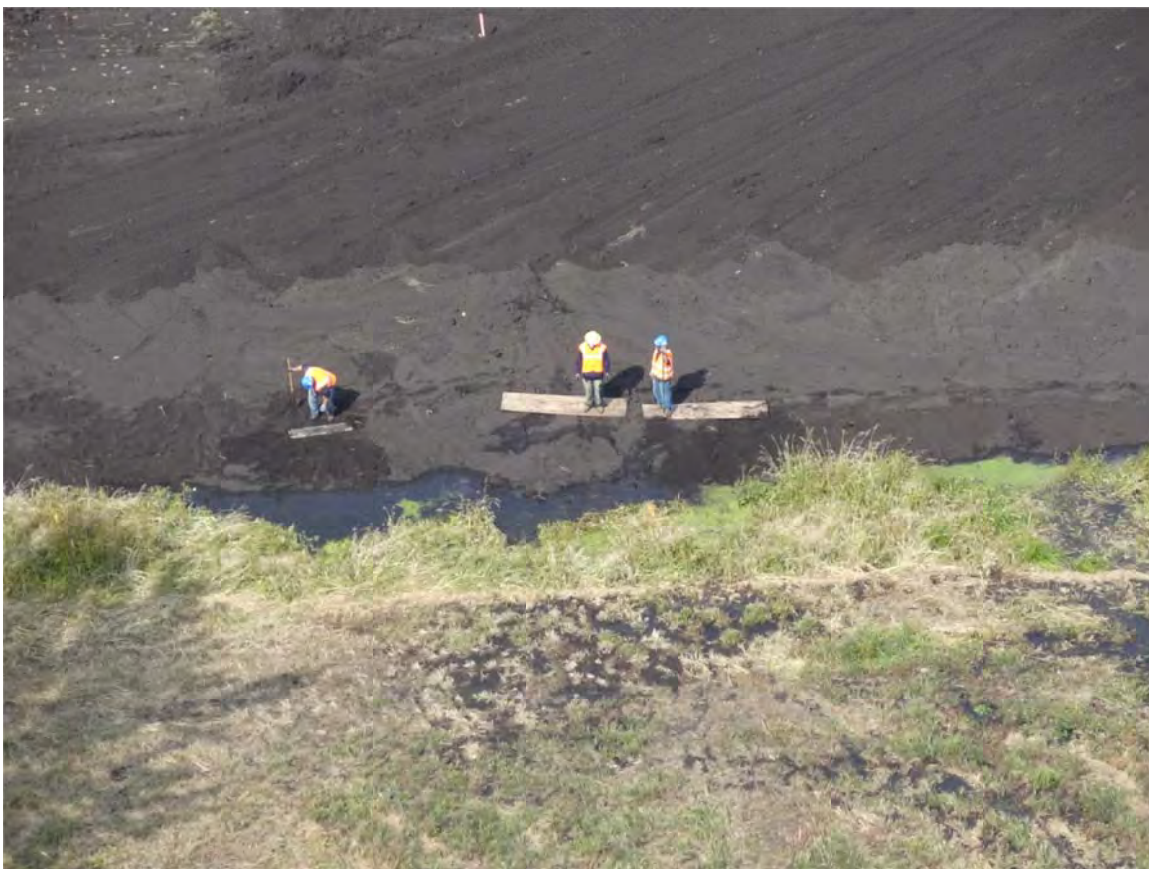
2. Source area, crews observed along southern edge of backfilled area.

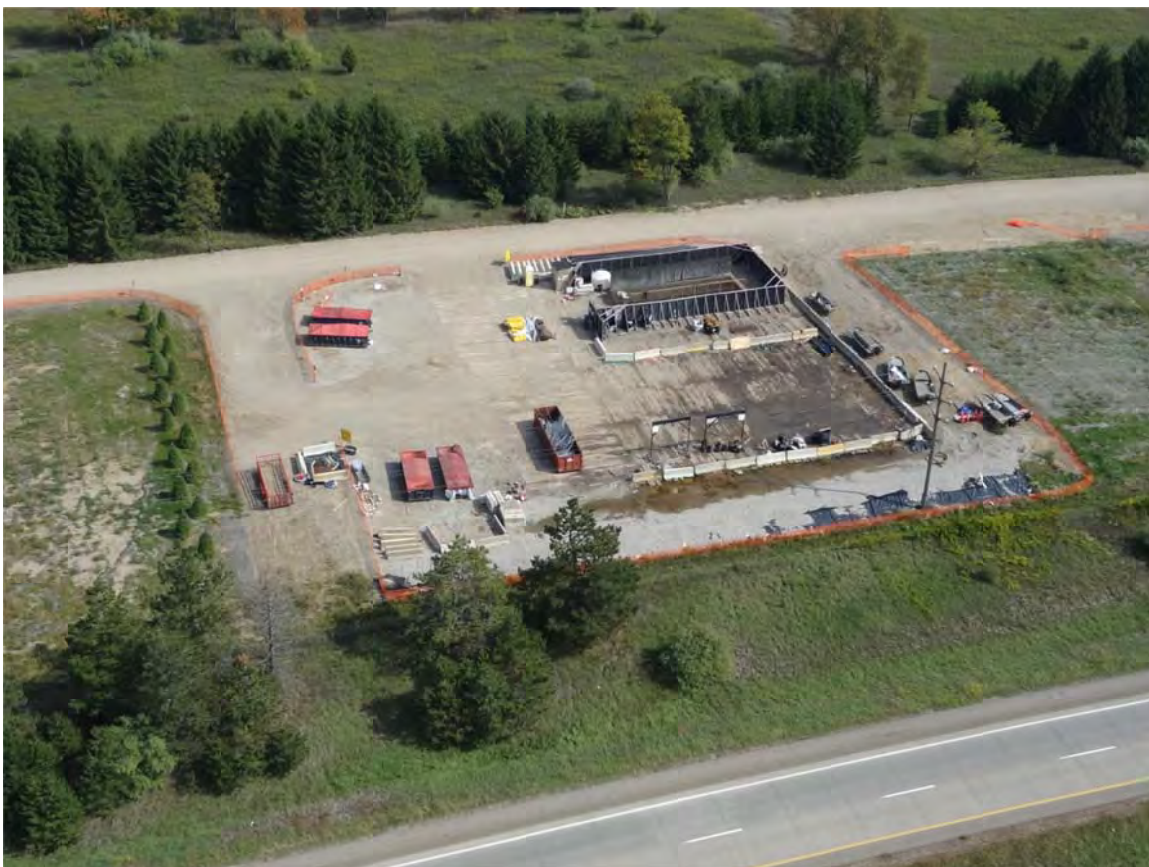
3. Frac-Tank City, no activity observed.

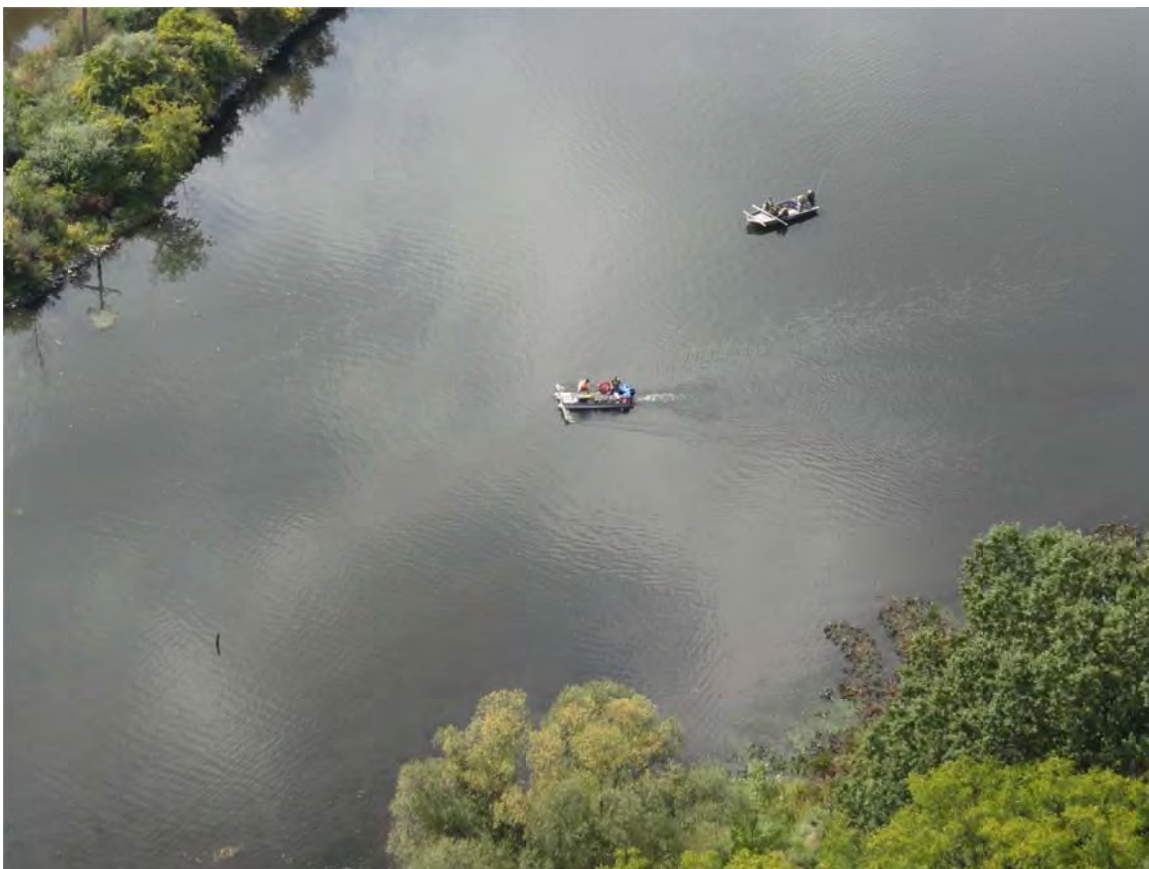
4. MP 5.75, one poling crew and one sheen sweeper boat observed in afternoon overflight.

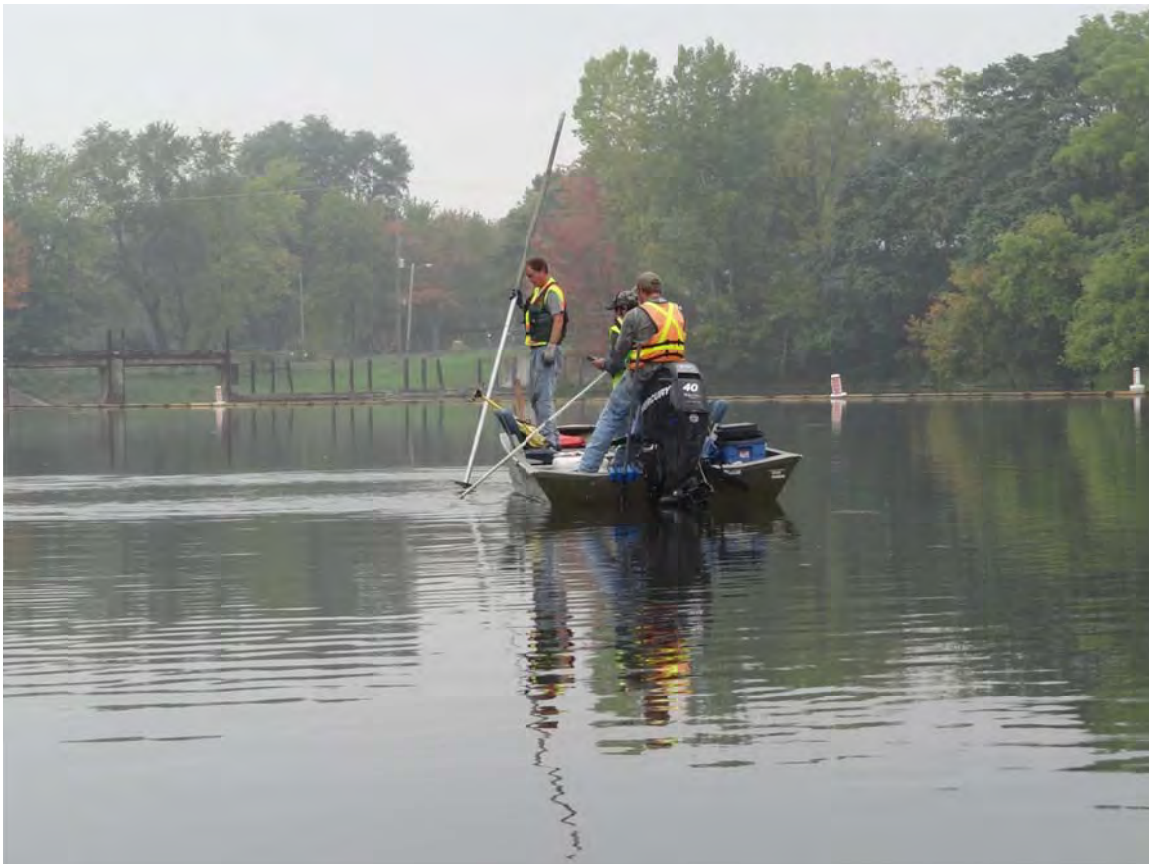
5. MP 5.75 above Ceresco Dam, observed poling crew working in main river channel.

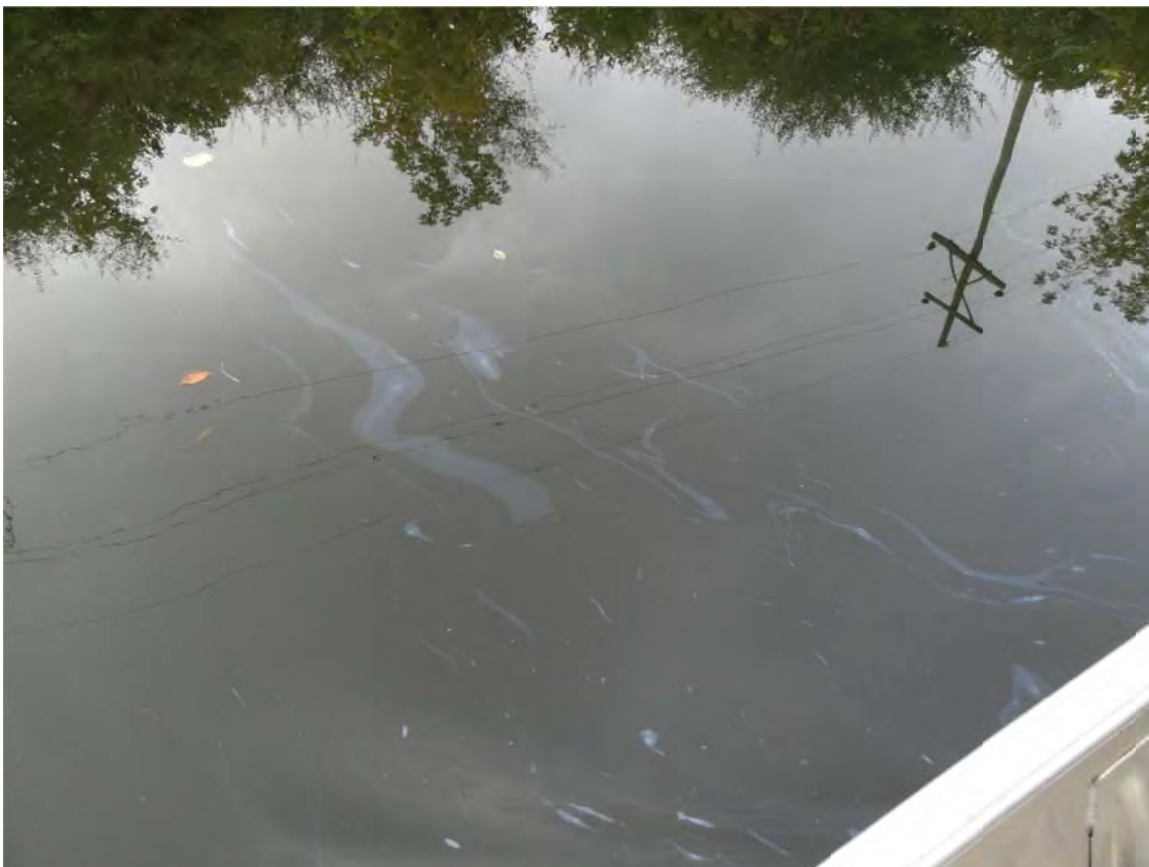
6. MP5.75 LDB above Ceresco Dam, observed sheen upstream from poling crew.

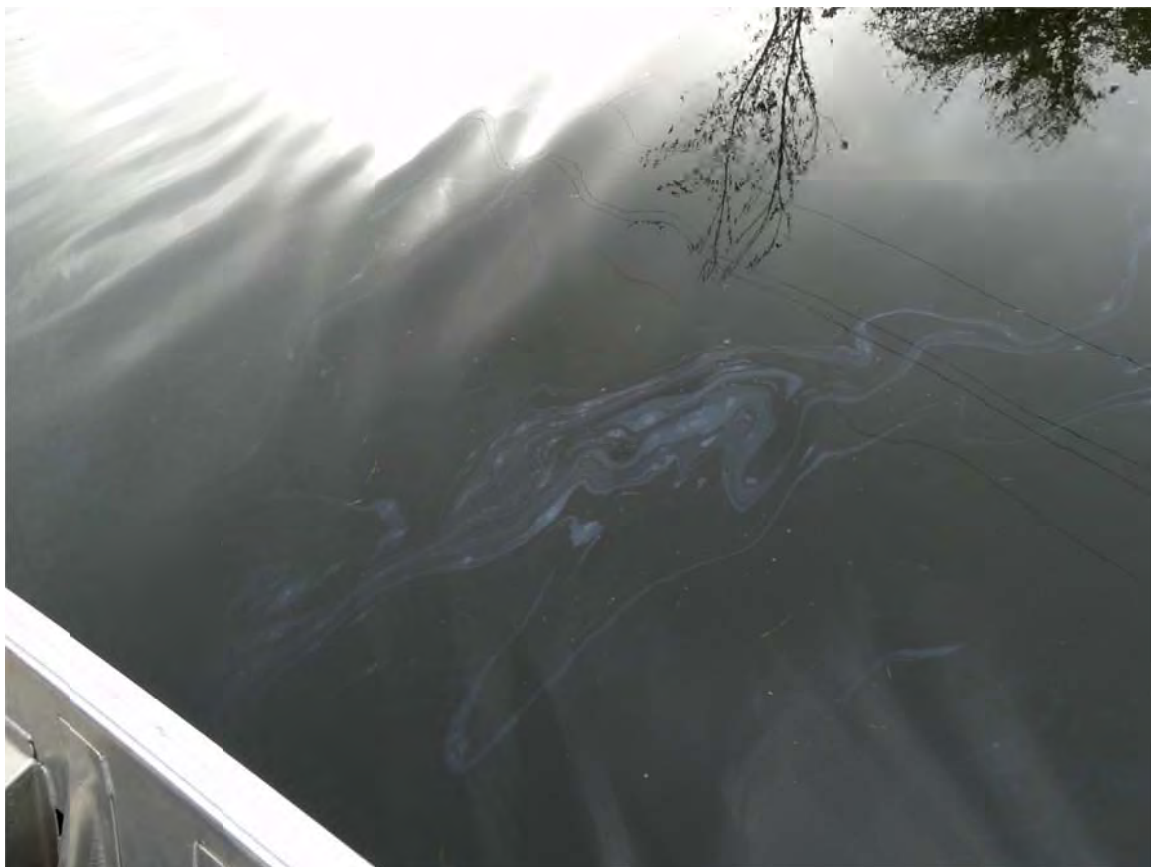
7. MP 5.75 observed non-agitated sheen and tar globules upstream from poling crew.

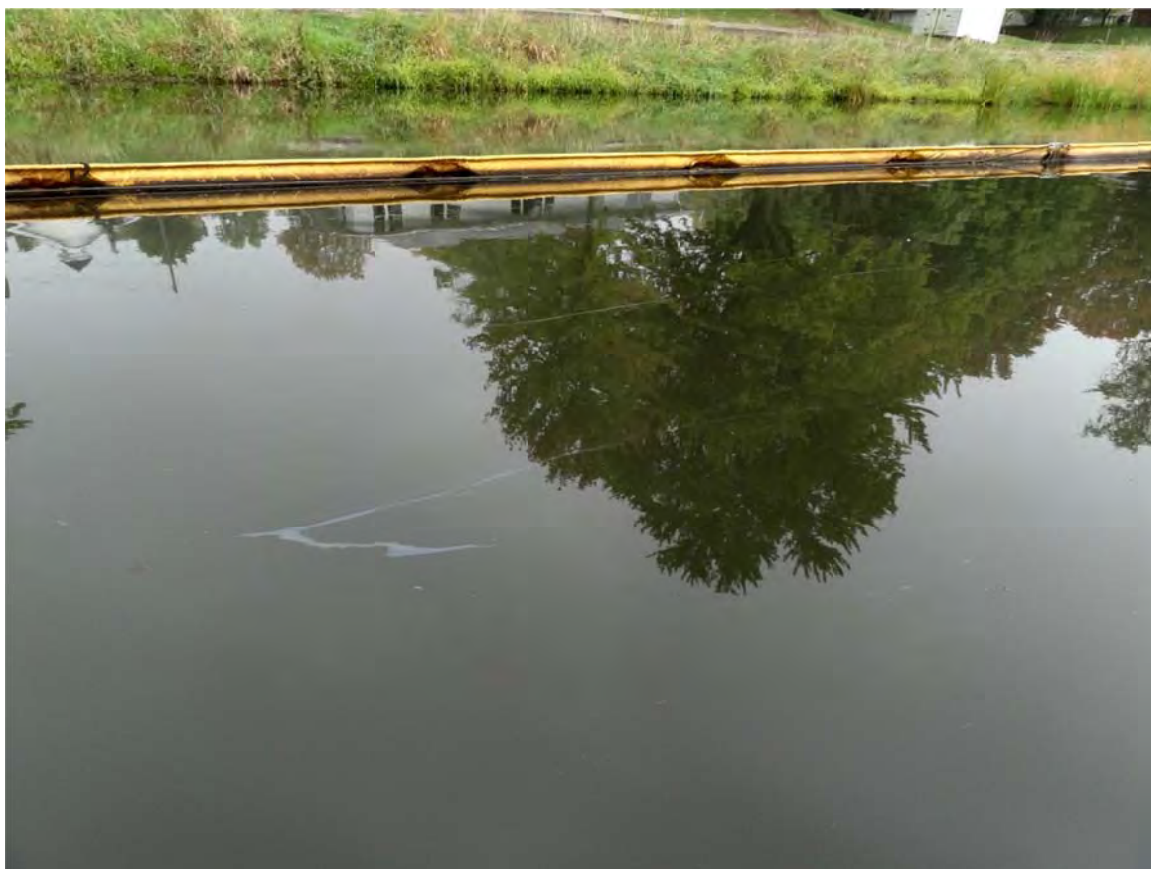
8. Ceresco Dam, sheen and tar globules observed upstream from containment boom.

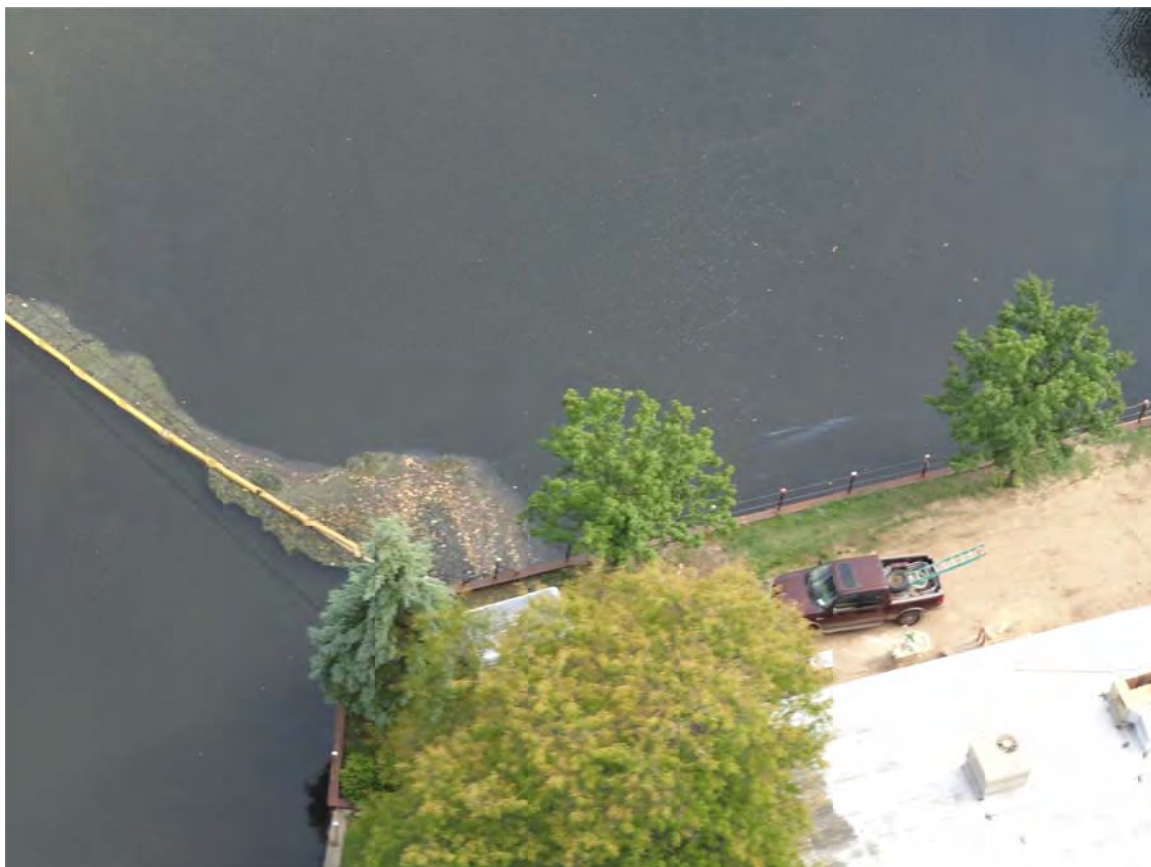
**9. Ceresco Dam, sheen observed along impoundment behind containment boom during afternoon overflight.**

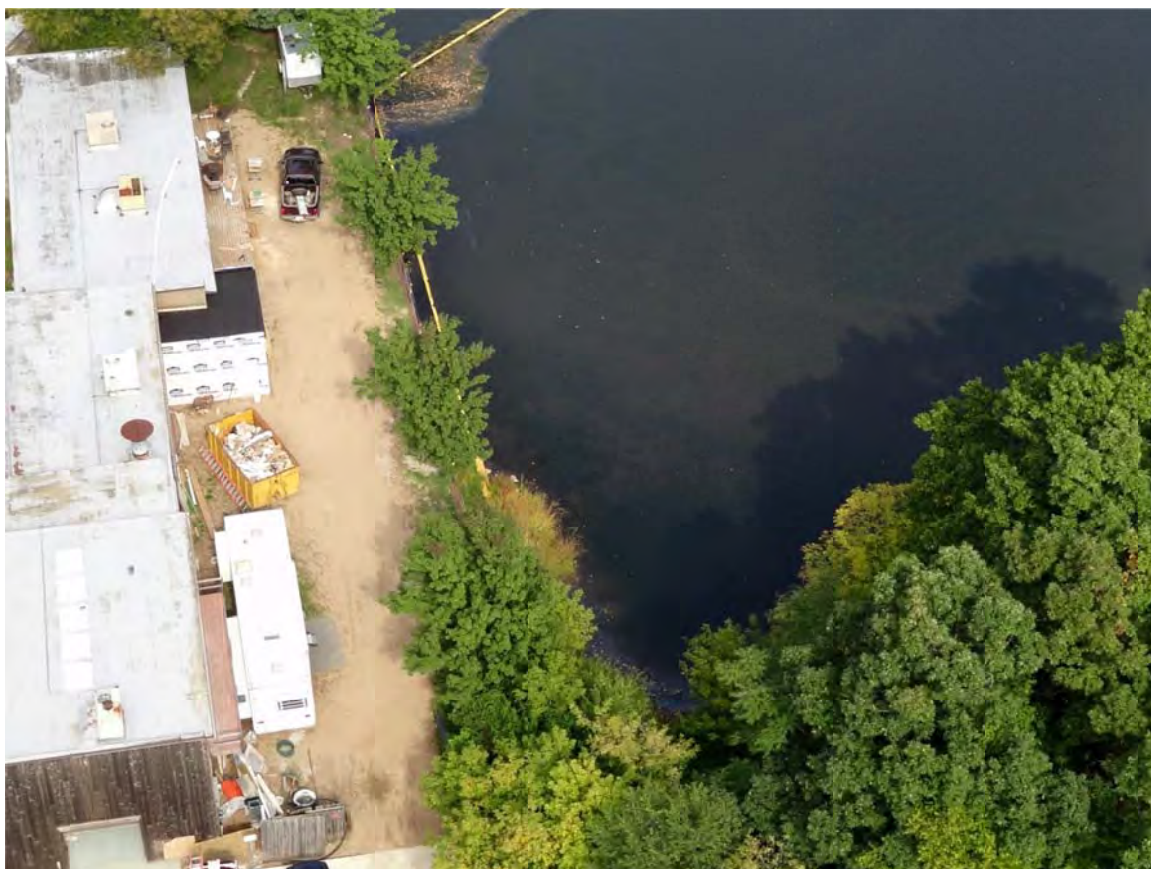
**10. Ceresco Dam, observed sheen along impoundment and in southwest corner above dam.**

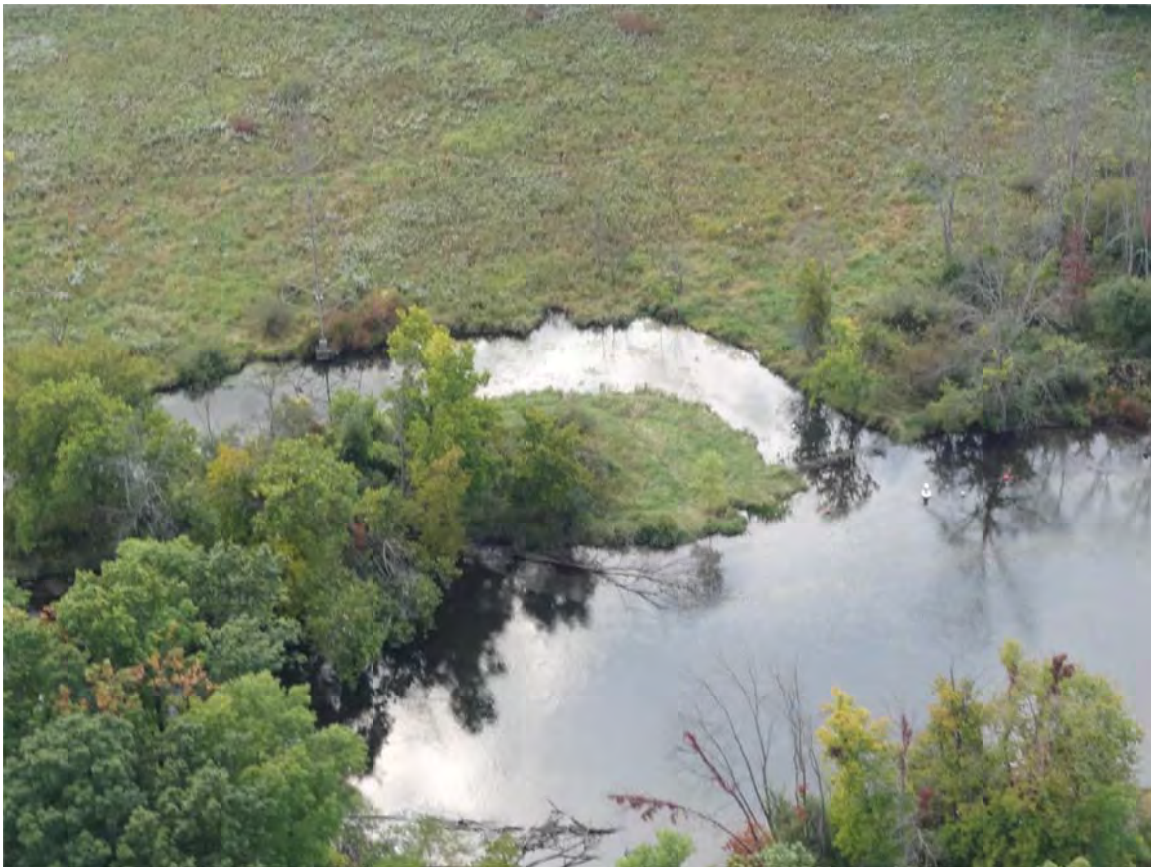
11. MP10.75 sediment trap, no sheen observed.

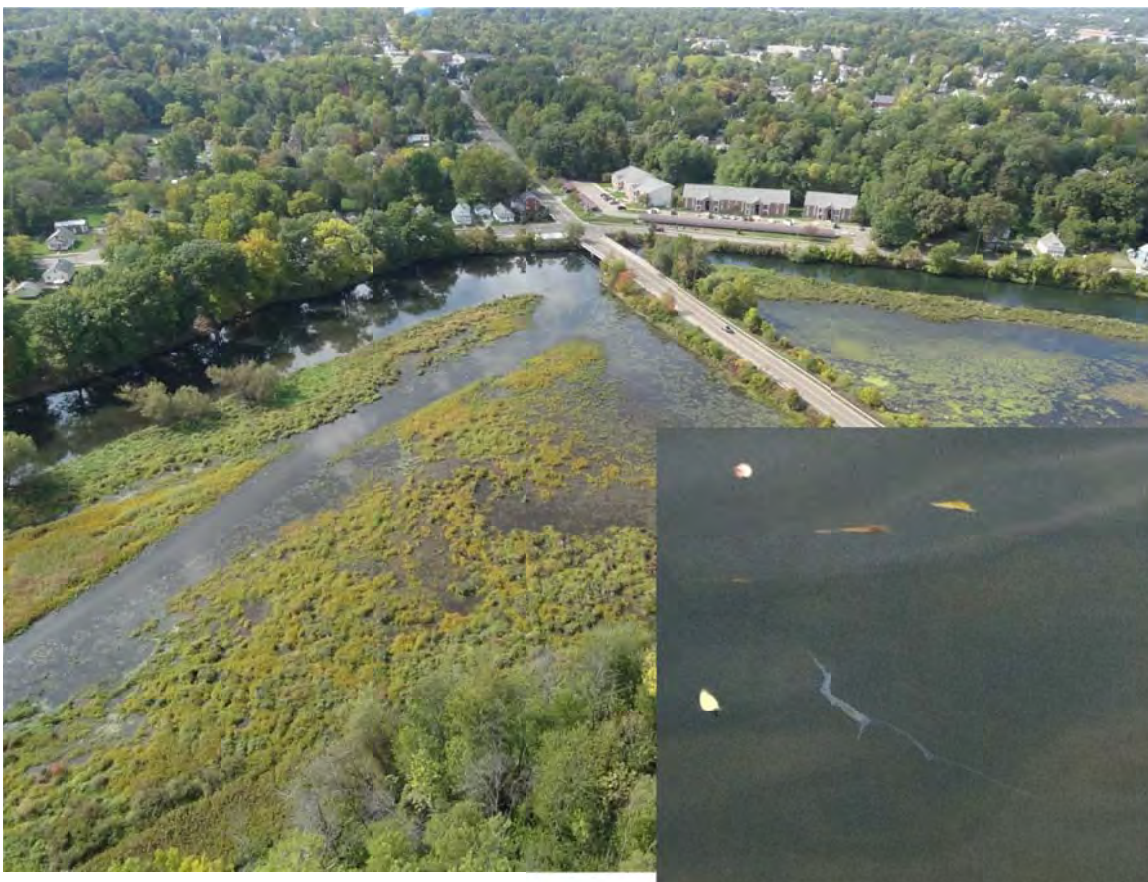
12. MP15.5 South Mill Pond, no sheen observed during overflight. Sheen was observed during boat survey.

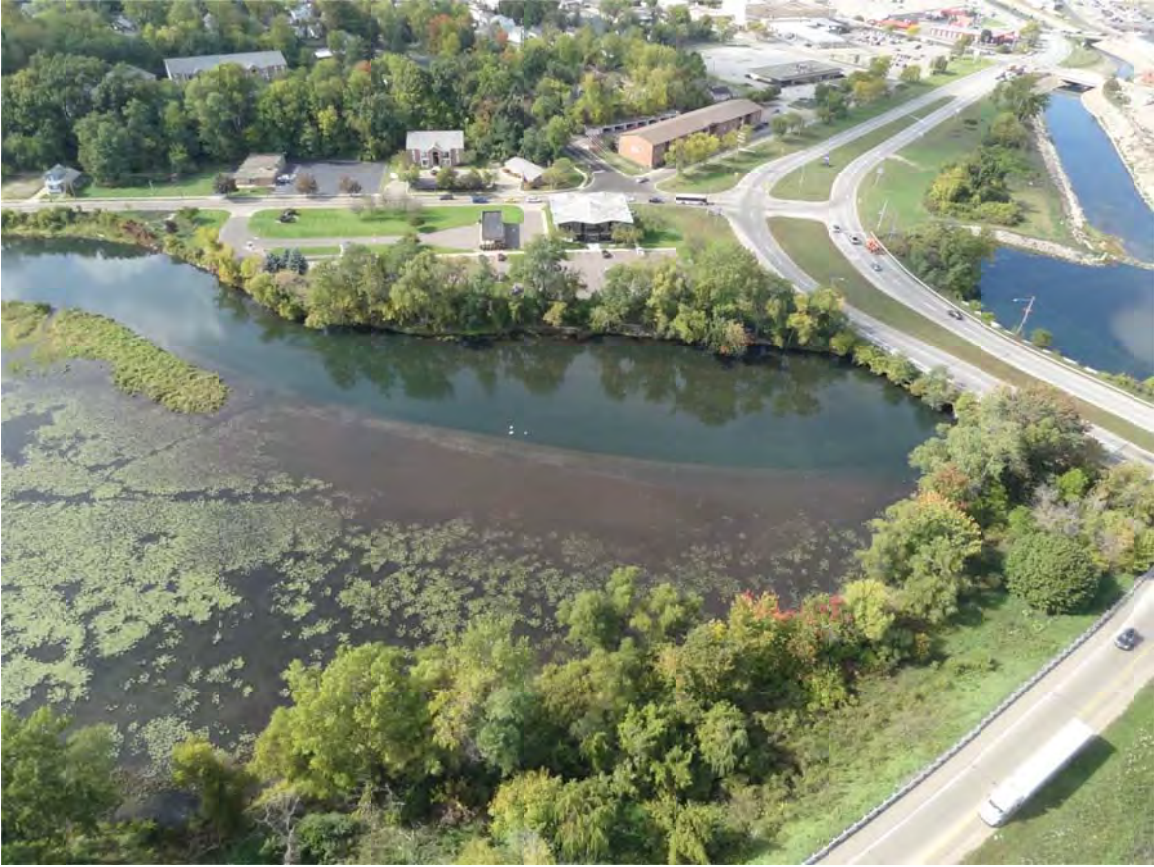
13. MP15.75 North Mill Pond, no sheen observed during overflight.

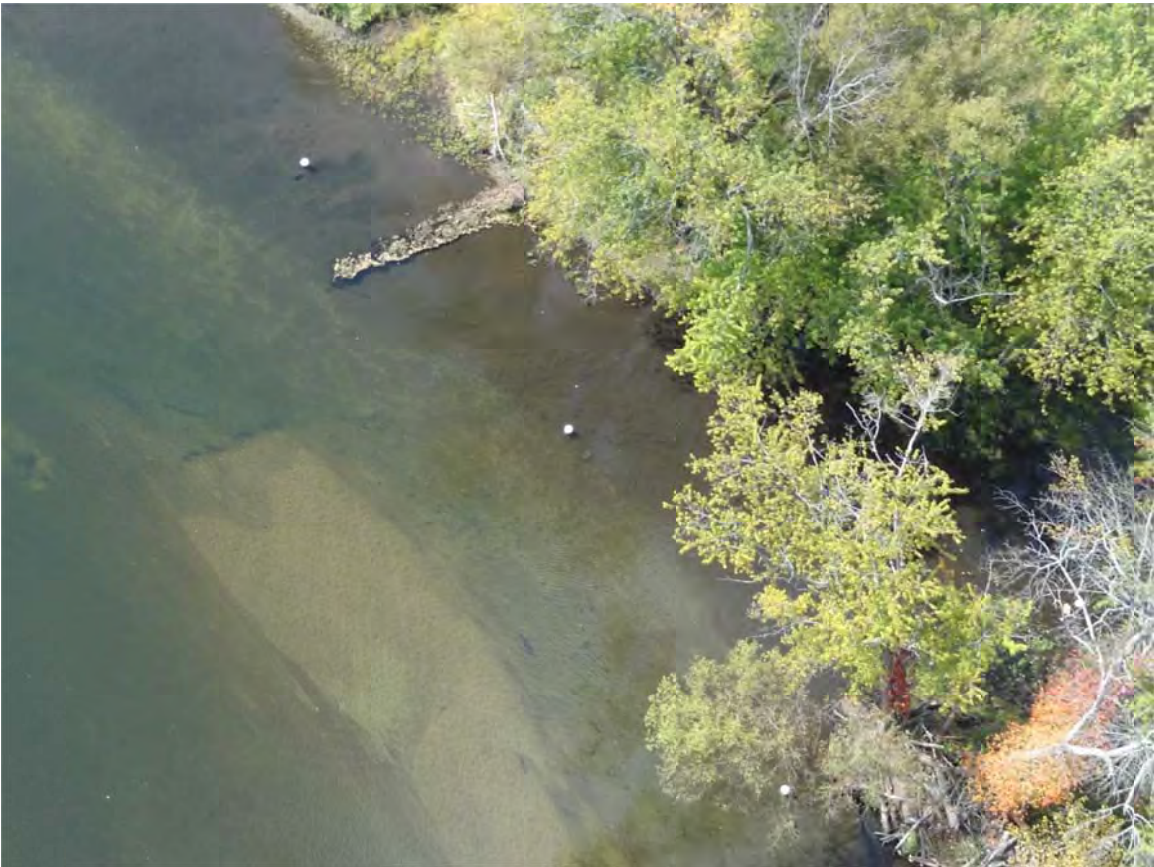
14. MP33.0A, observed sediment trap structure in place.

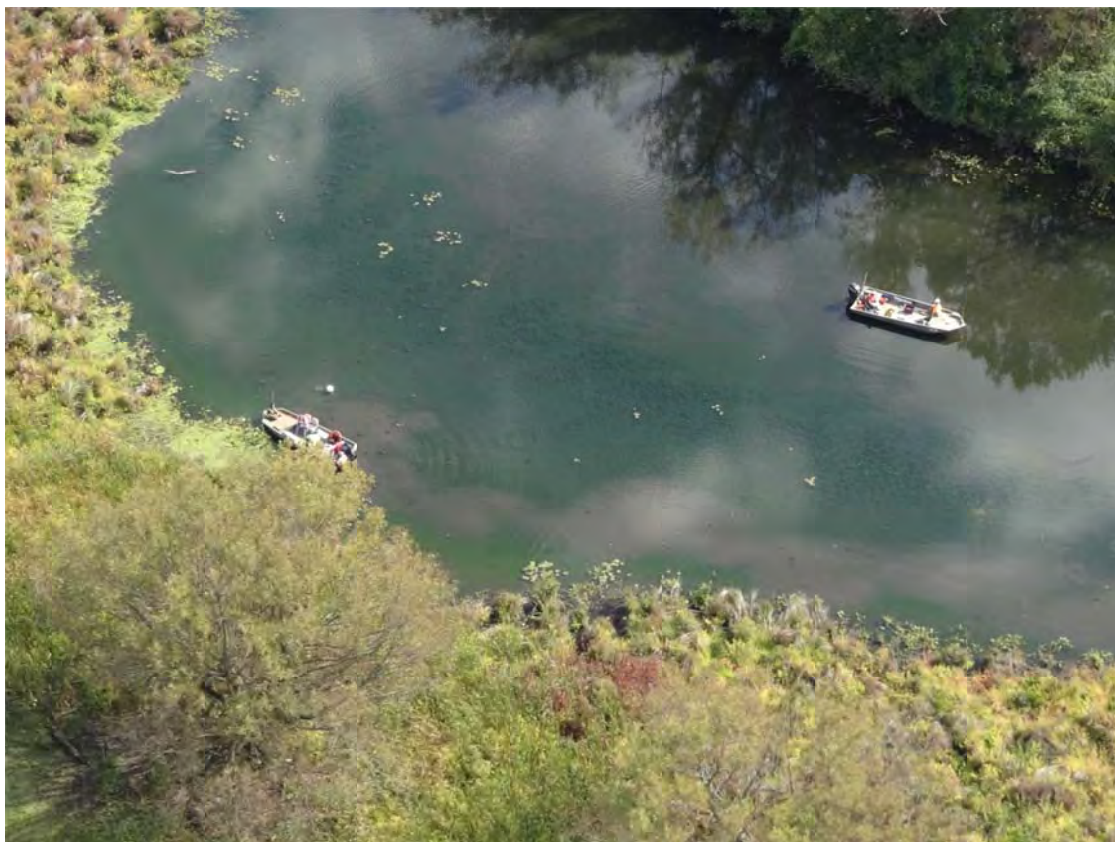
**15. Morrow Lake Delta, Delta A, two bathymetry and poling boats observed.**

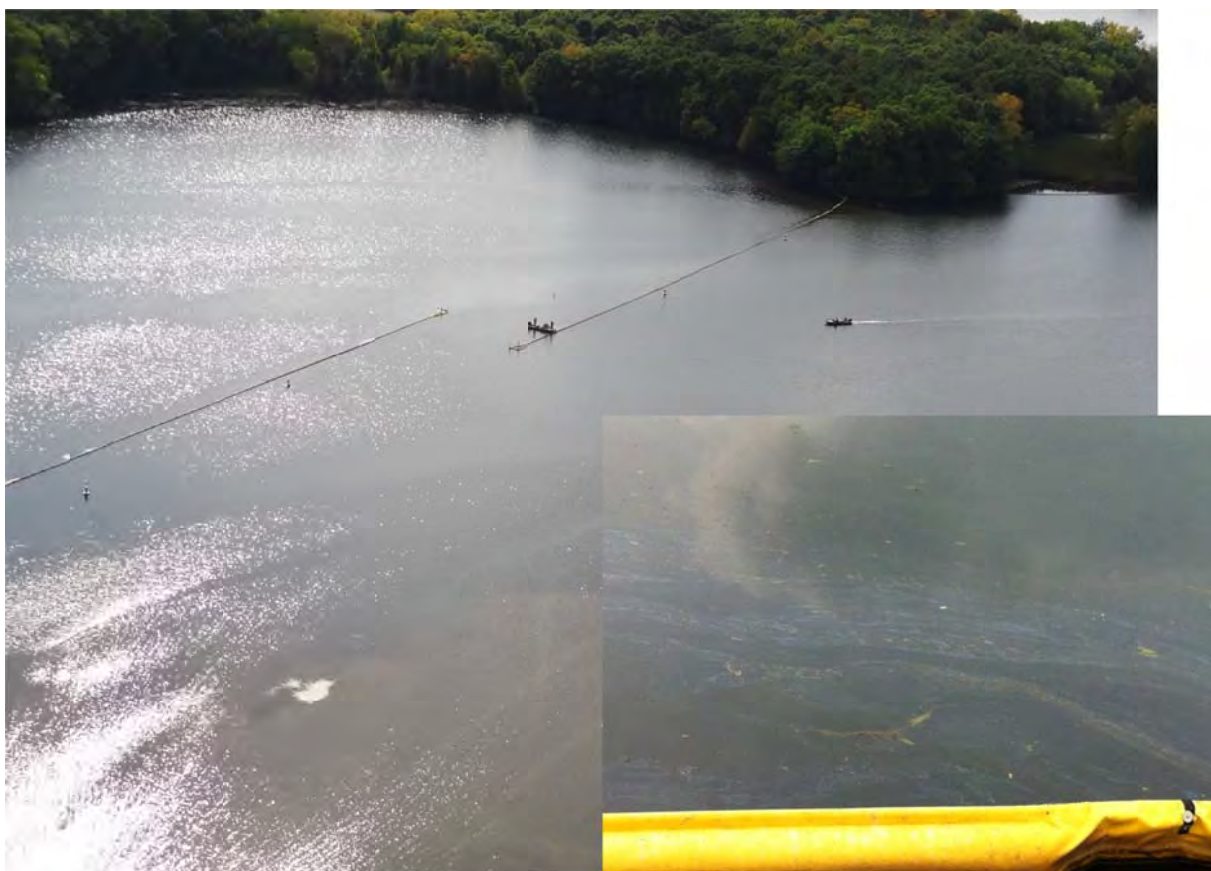
**16. Morrow Lake Delta, observed two boats operating along boom configuration C. Sheen observed along boom during morning inspection.**

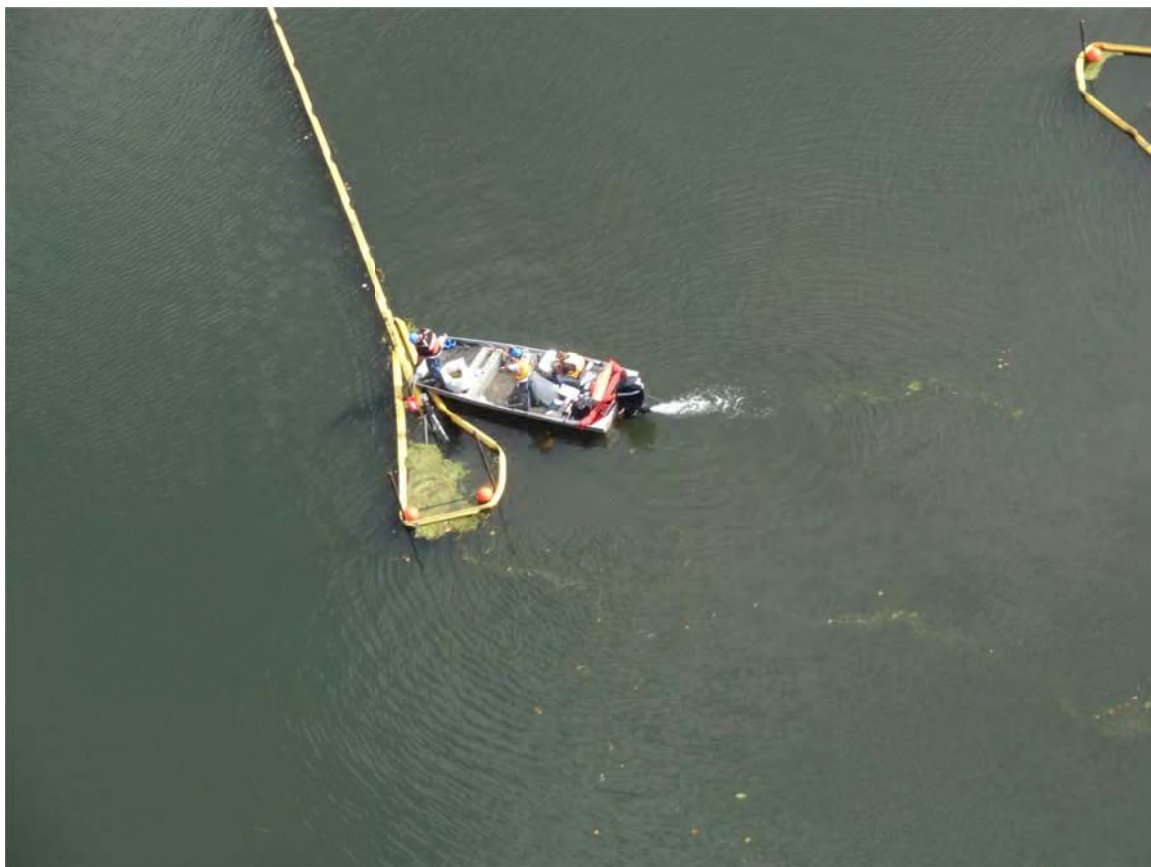
**17. Morrow Lake Delta, observed a crew performing boom maintenance on configuration E.**

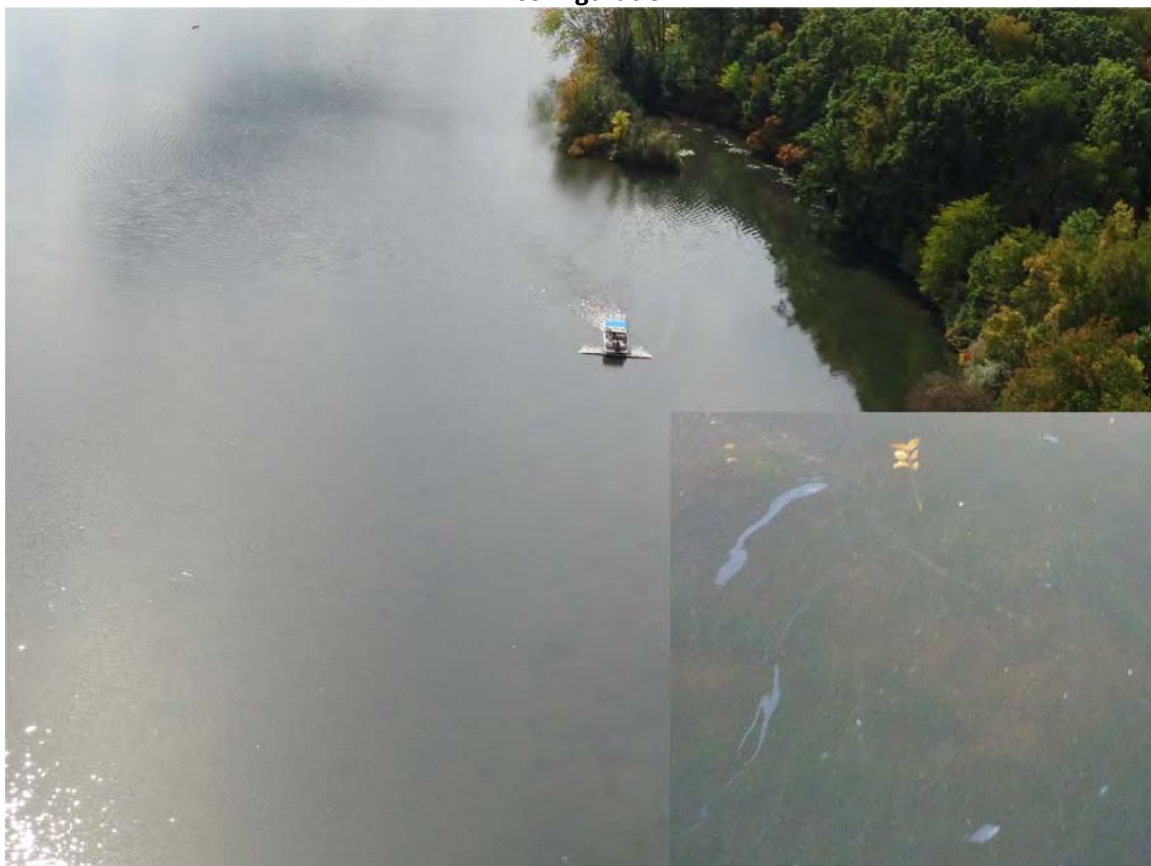
**18. Morrow Lake north cove, observed the sweep boat operating. Sheen was observed in north cove during morning inspection.**

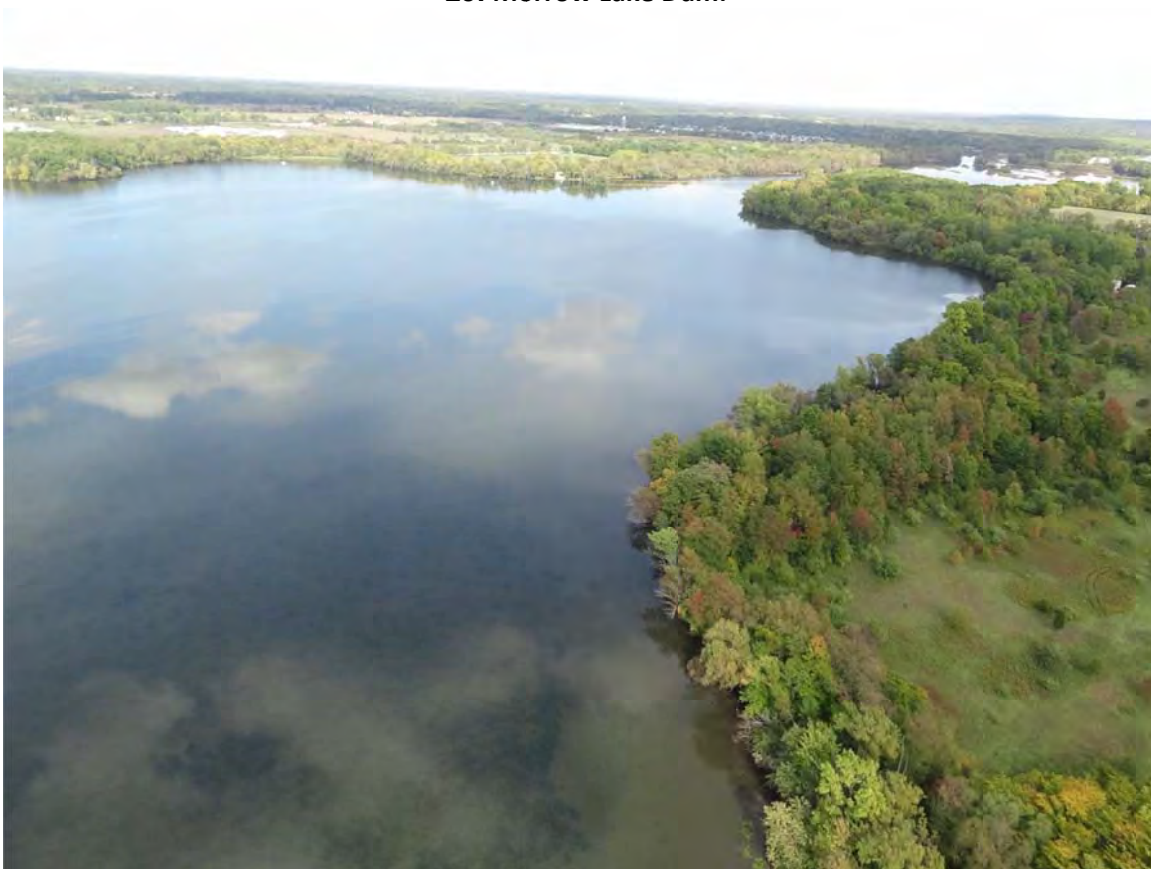
20. South cove of Morrow Lake Delta. No sheen observed from air.
