# Situation Photo Log

Thursday, September 27, 2012

Kalamazoo River / Enbridge Spill

Prepared by:  
Larry Rader  
START-USEPA  
Situation Unit Leader

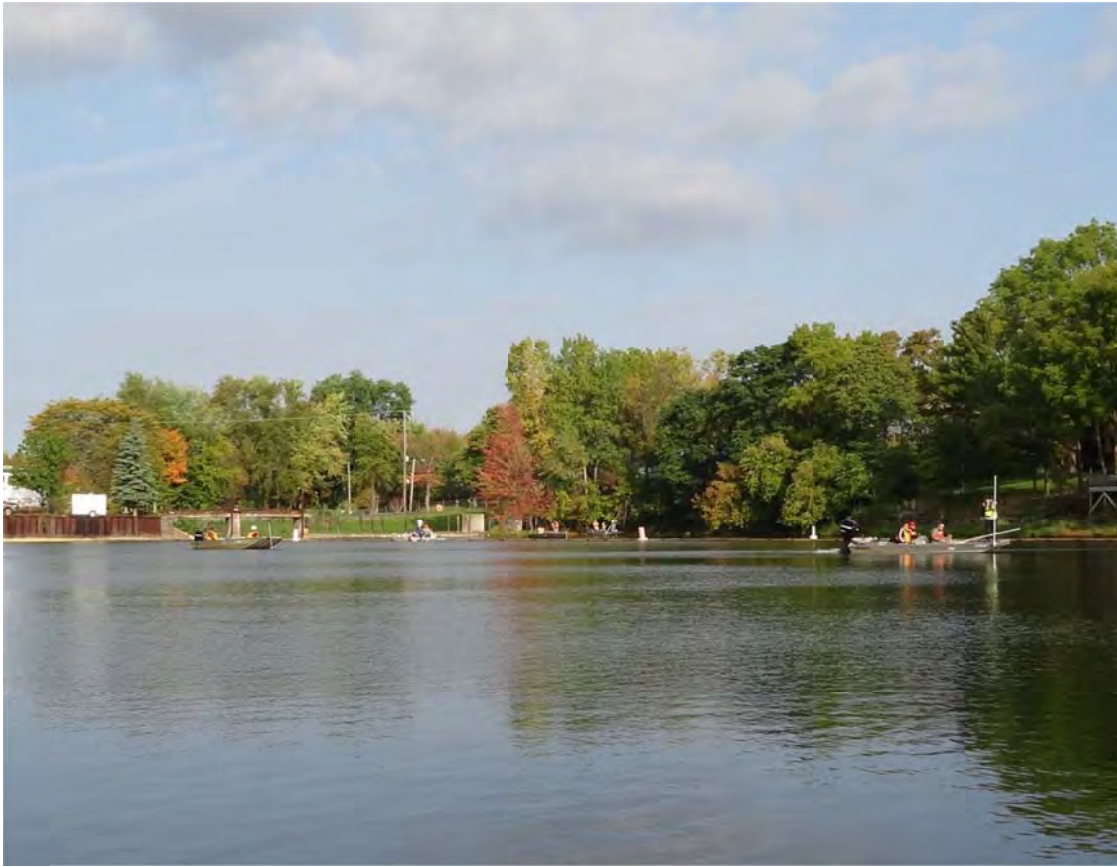
**1. MP5.75 river channel, view of poling crews and vegetation removal activities above Ceresco Dam.**

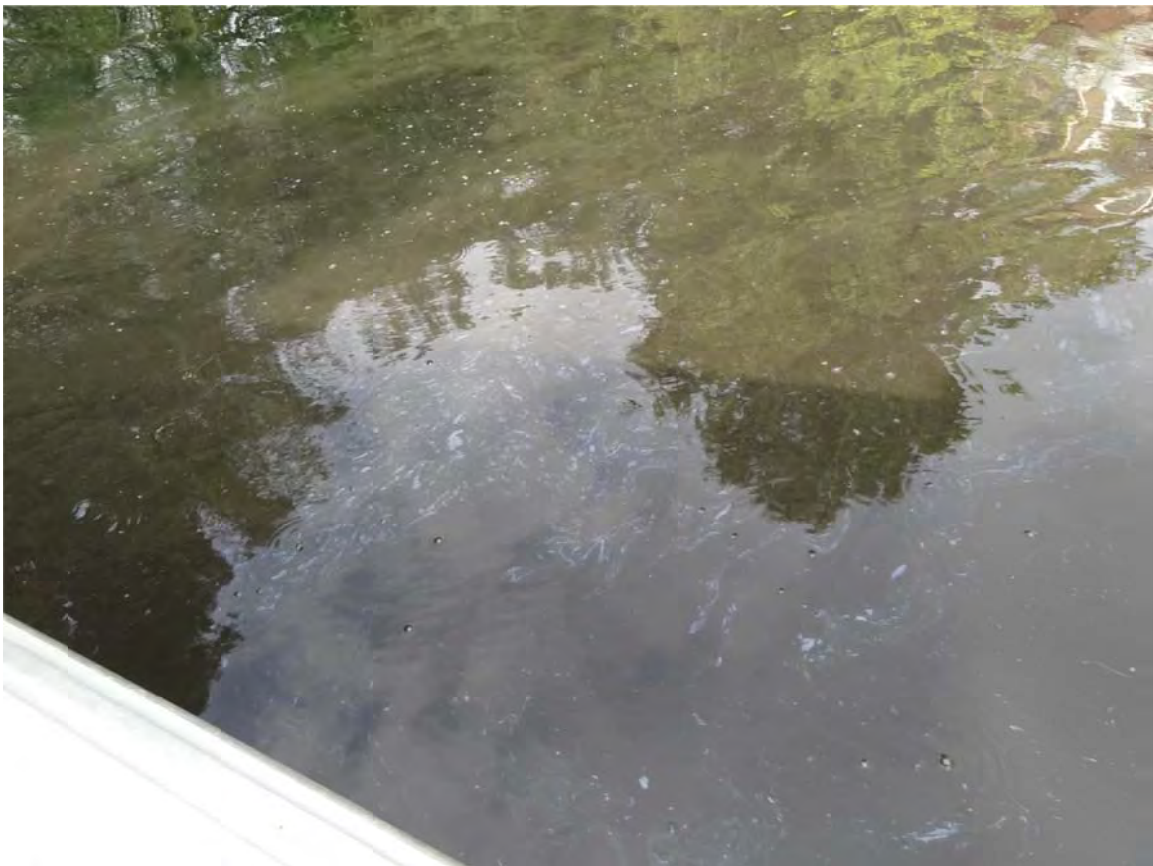
**2. Ceresco Dam, boat-agitated sheen observed along LDB in southwest corner above dam.**

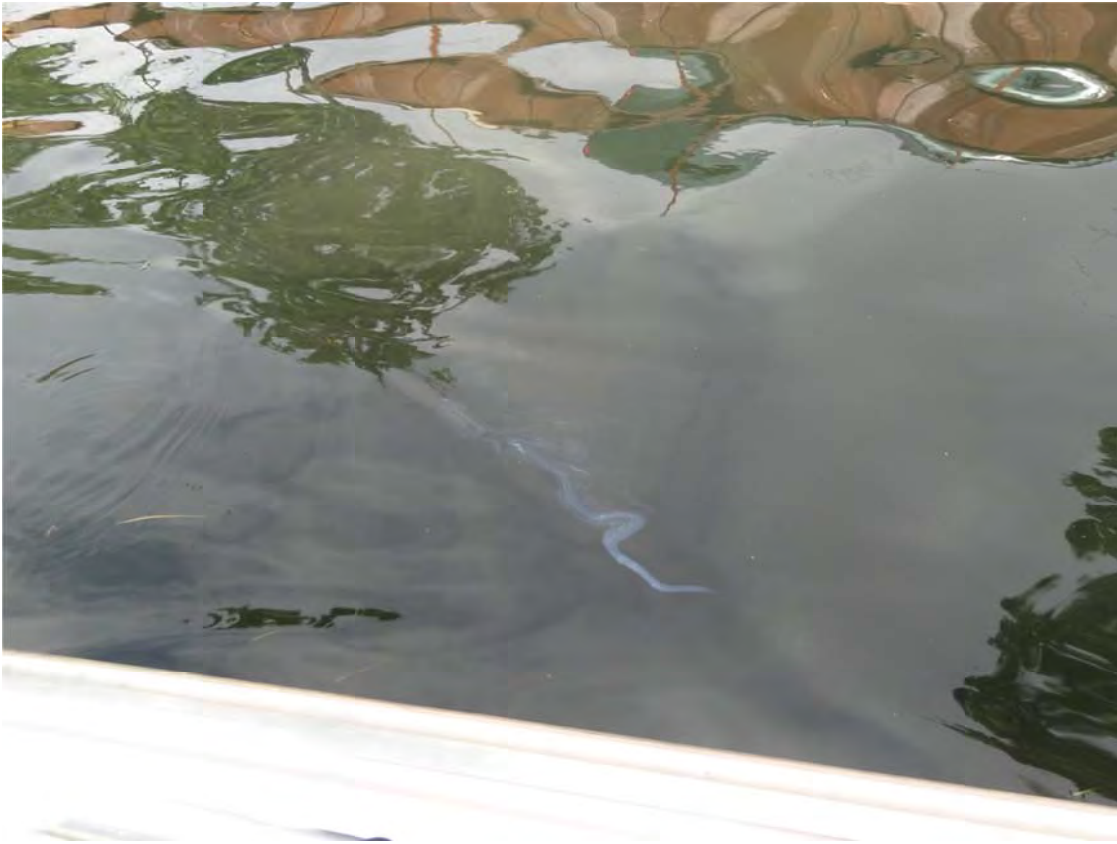
3. Spontaneous sheen observed along impoundment within containment above Ceresco Dam.

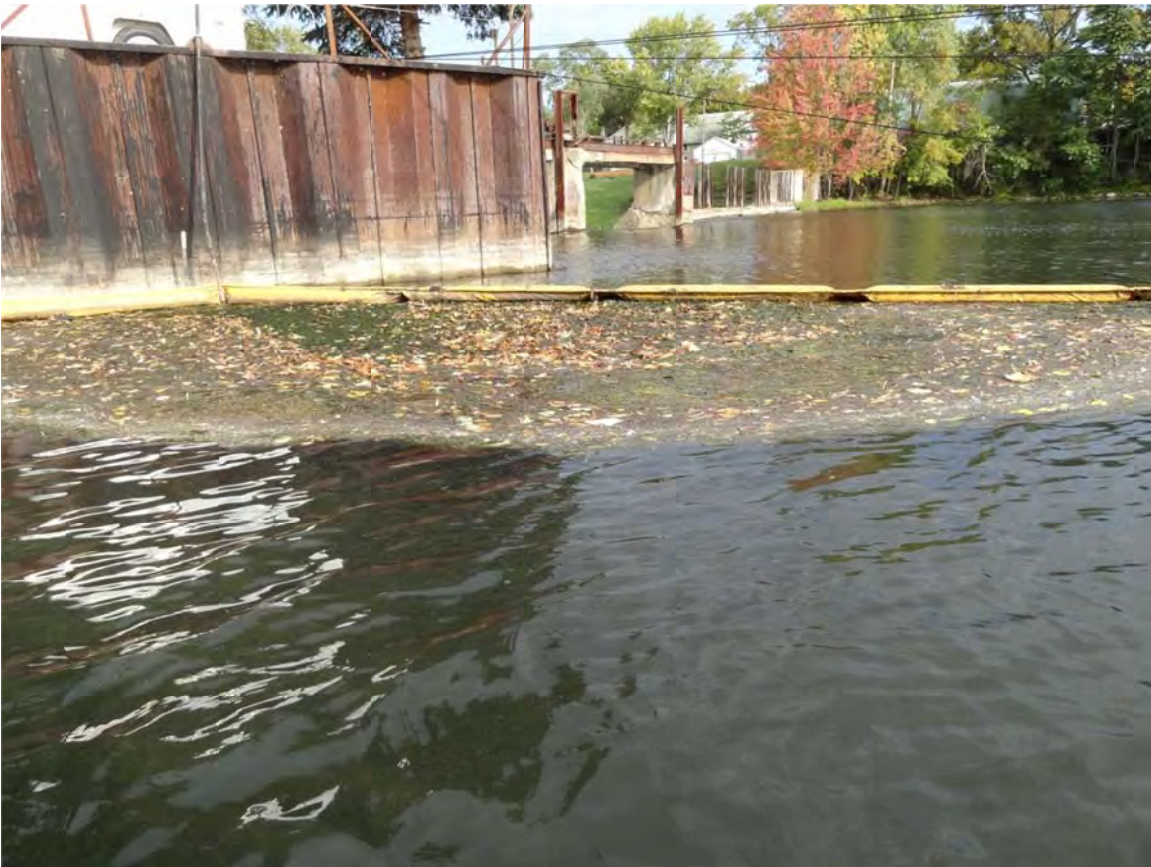
4. Sheen and vegetation within containment above Ceresco Dam.

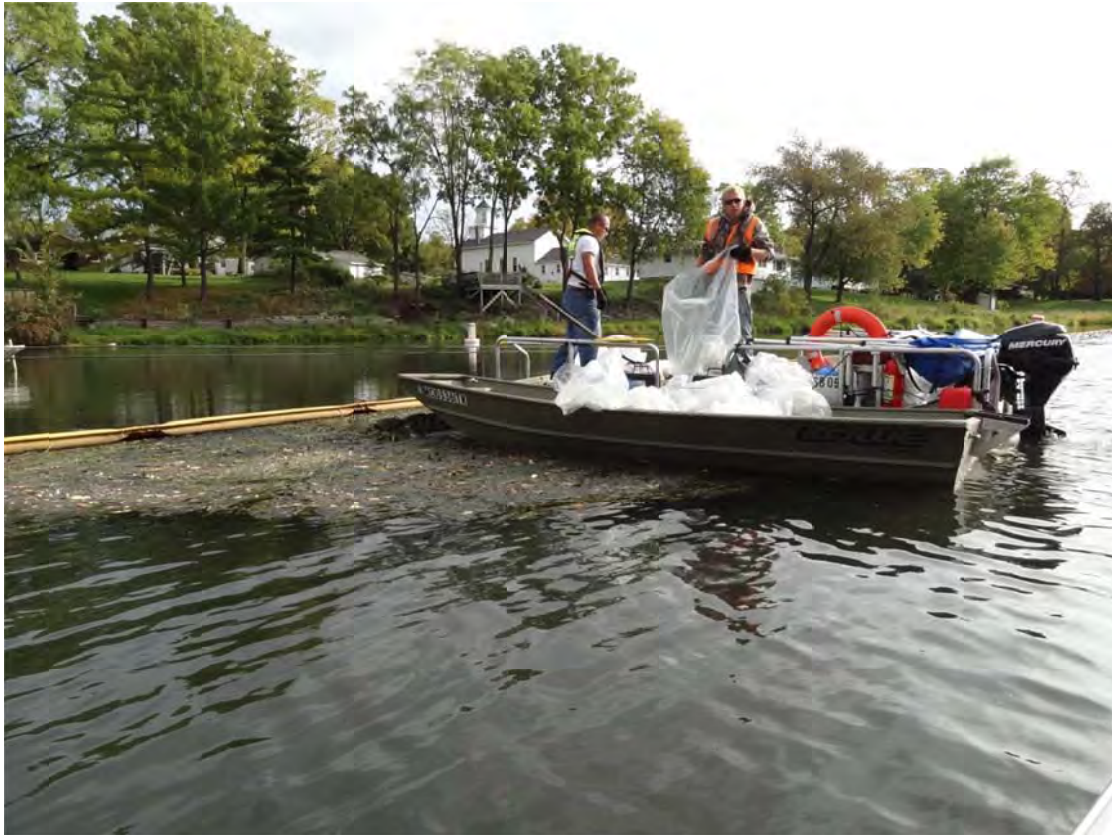
5. Crews removing debris from Ceresco Dam control point.

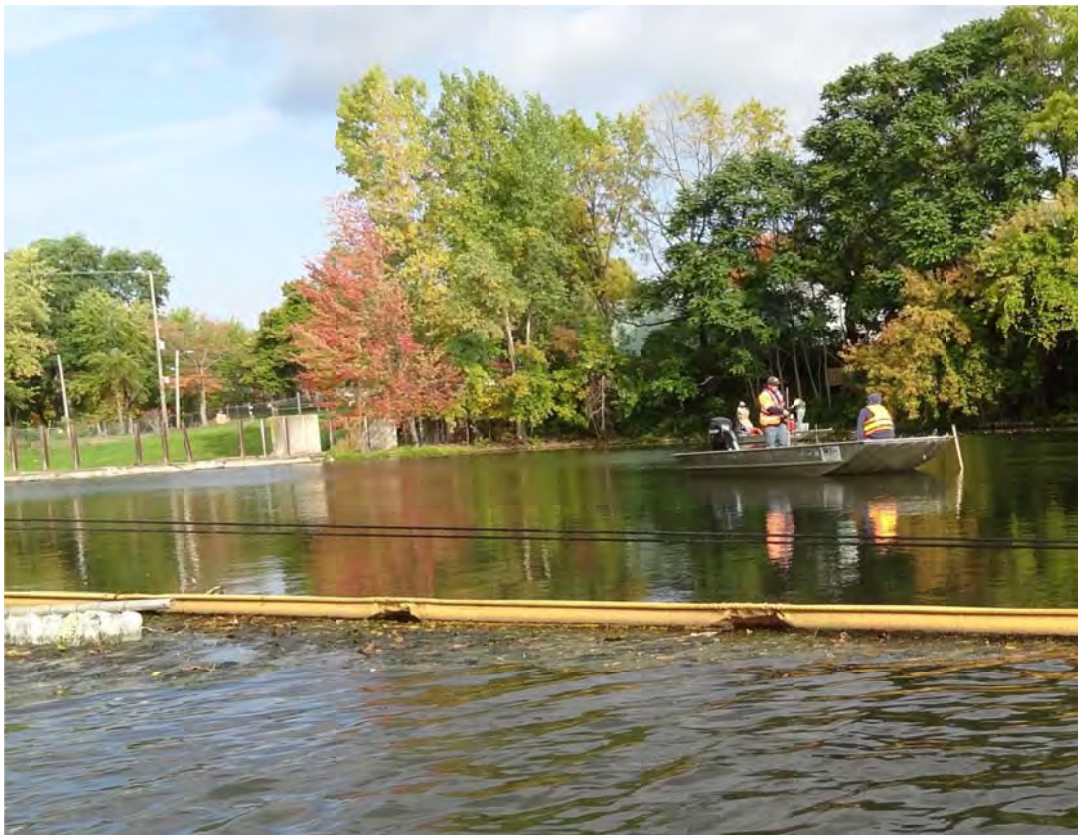
6. Ceresco Dam control point, poling crews observed on downstream side of boom along RDB.

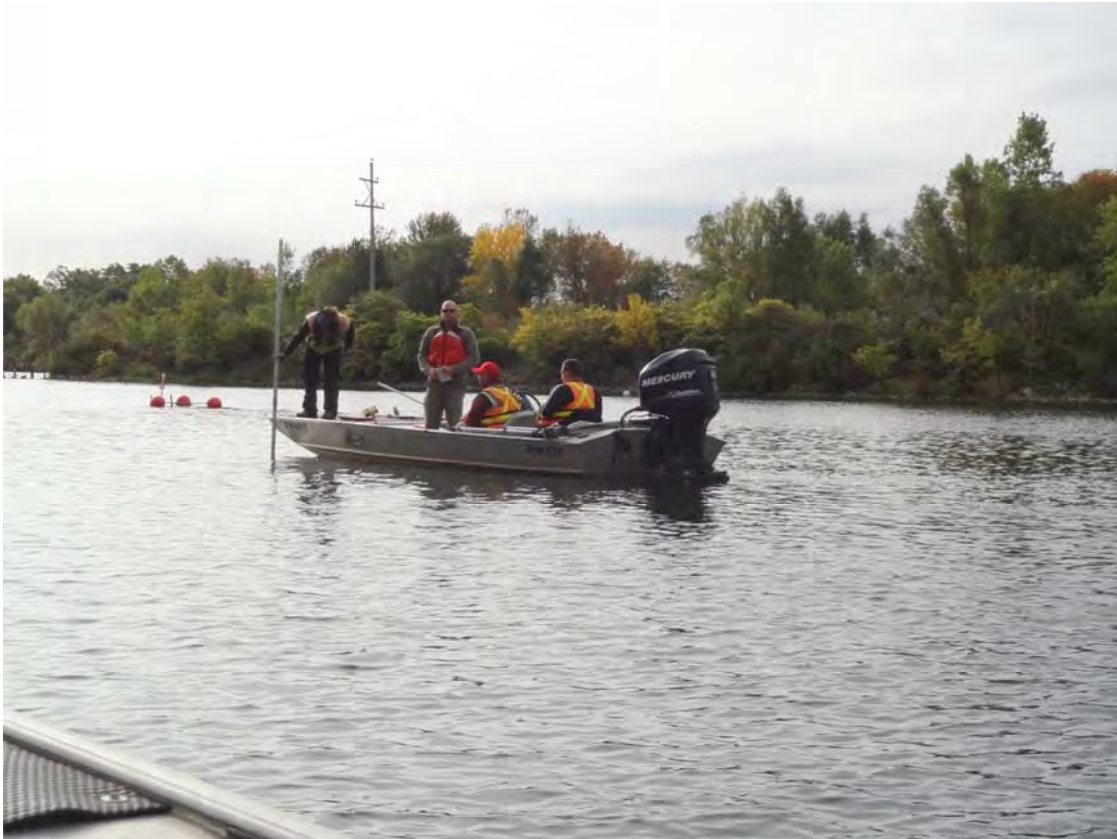
7. MP 5.75, poling crew working in main river channel.

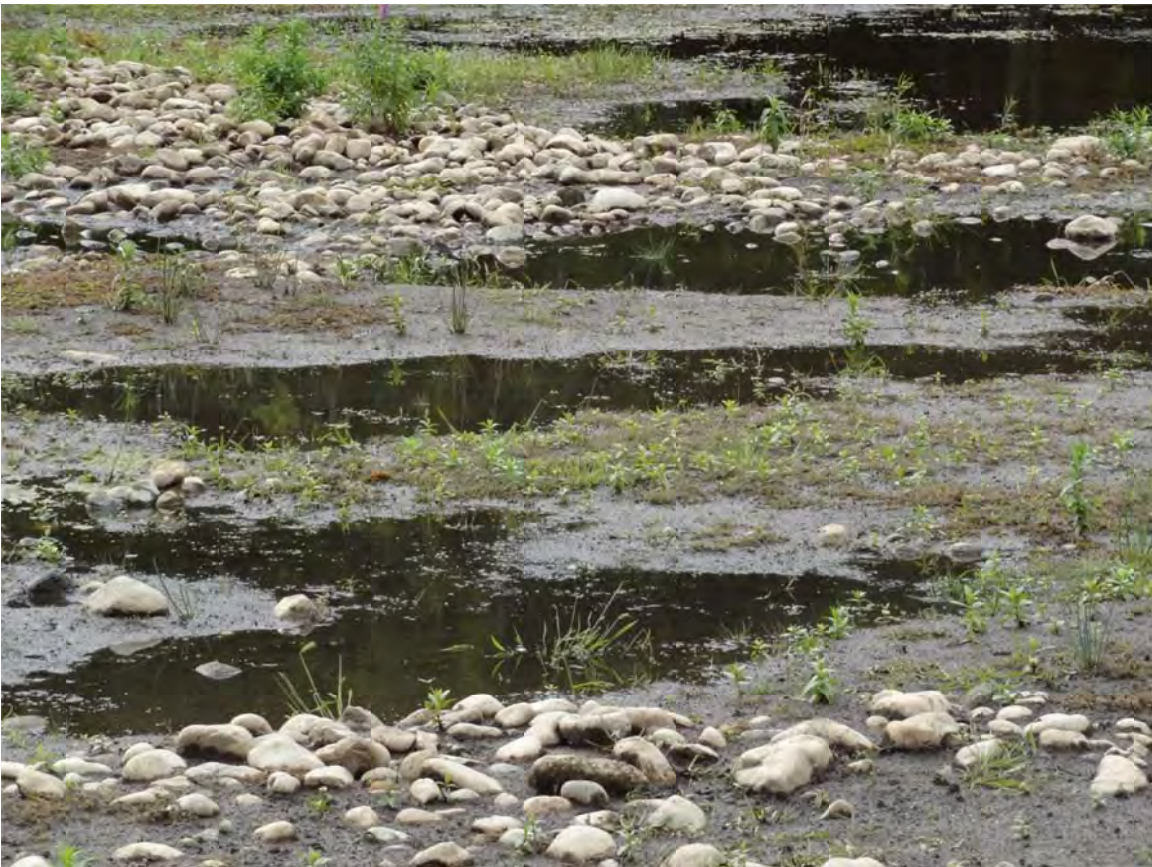
8. Standing water on Island F, no sheen observed.

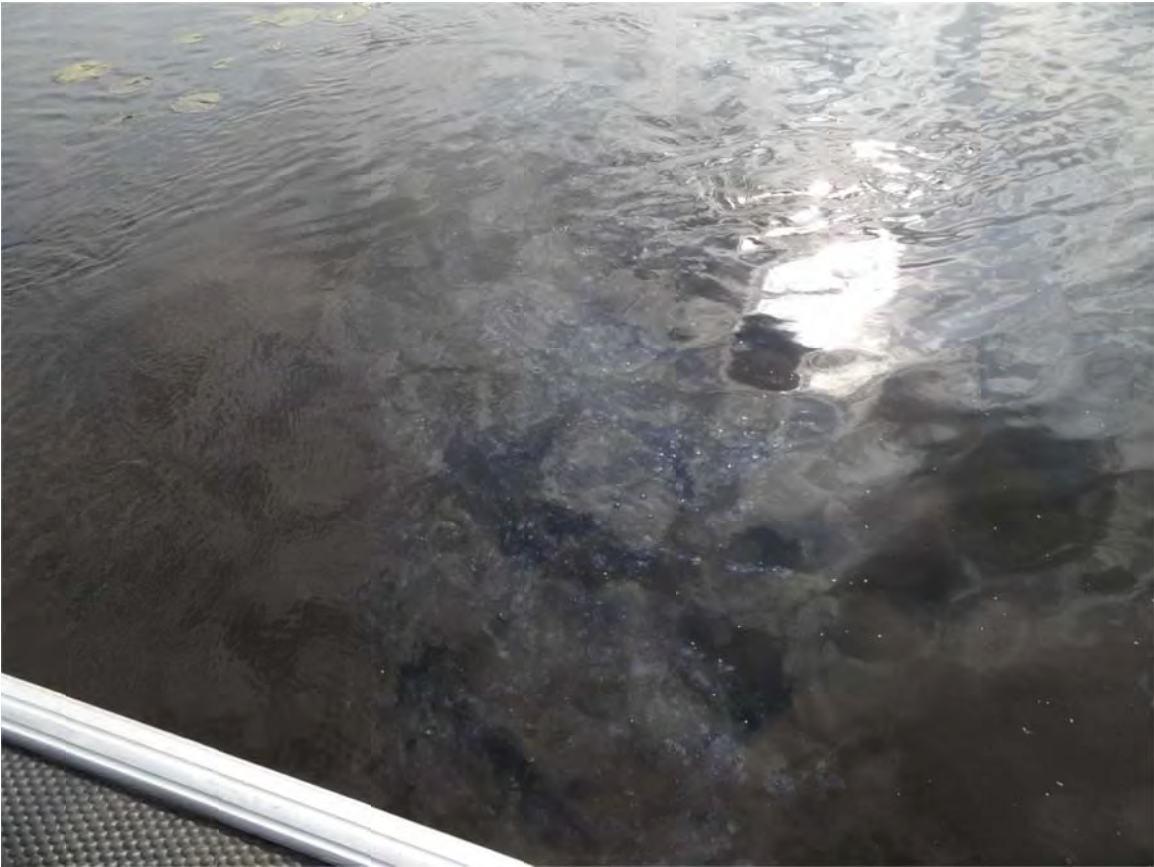
9. Boat-agitated sheen observed at MP 15.5 RDB (South Mill Pond).

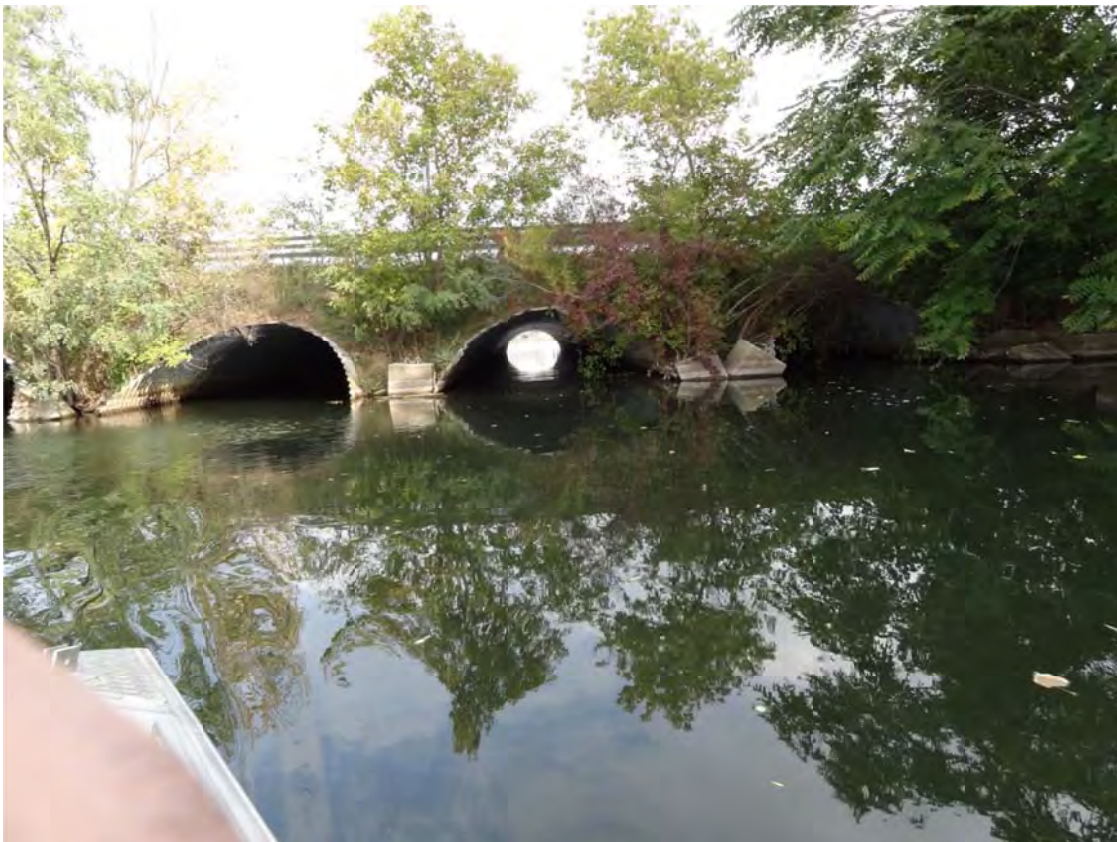
10. Culverts at MP 15.75 (North Mill Pond). No sheen observed.

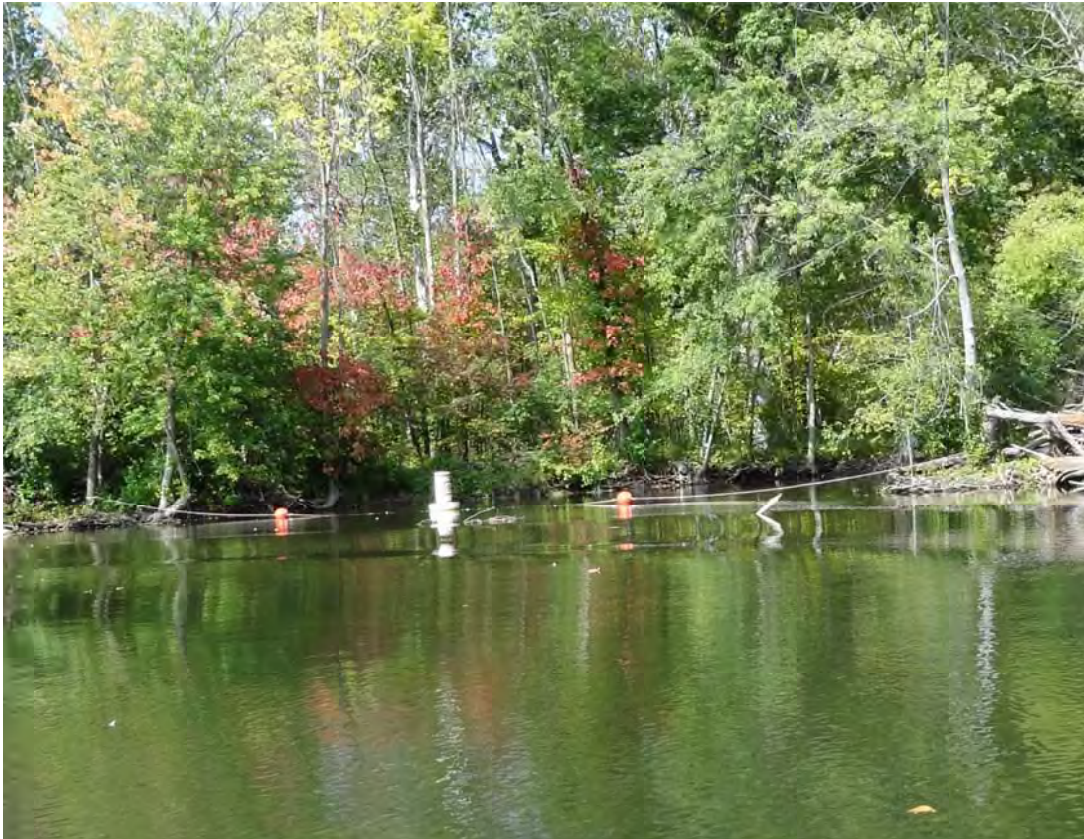
**11. Sediment trap at MP 36.1, no sheen observed.**

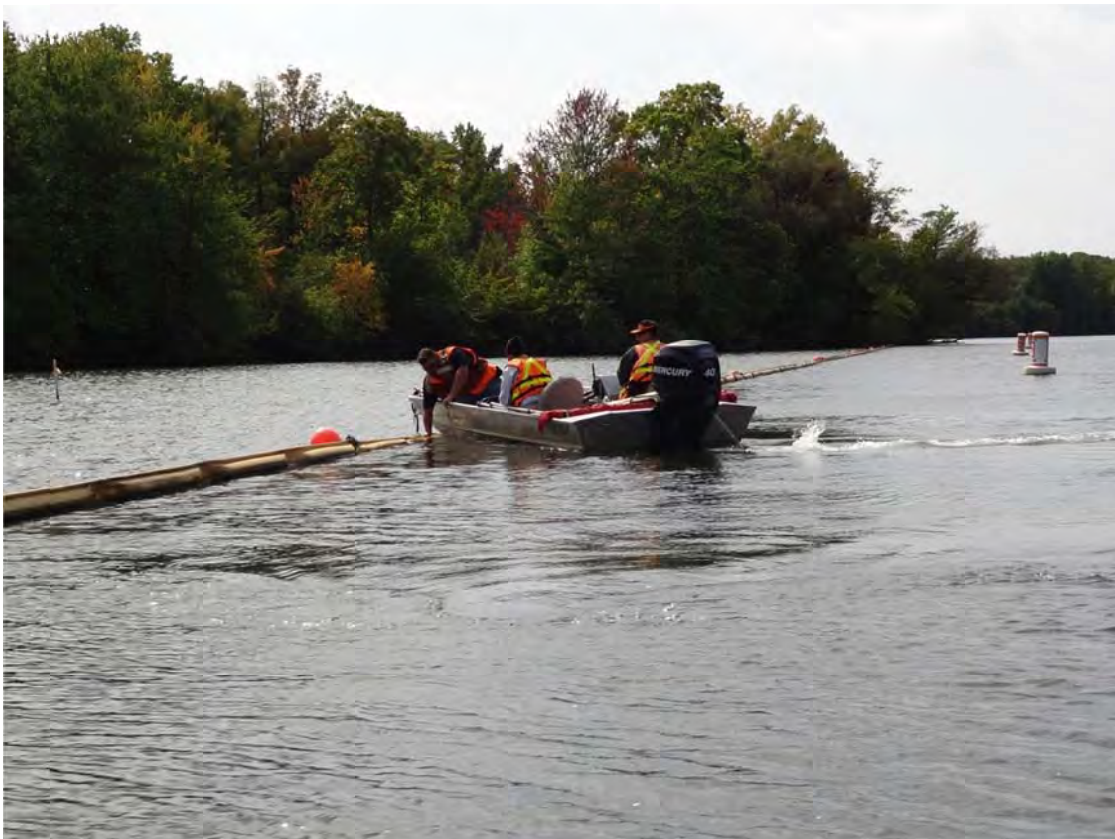
**12. Crews inspecting and adjusting sediment curtain boom in Morrow Lake Delta.**

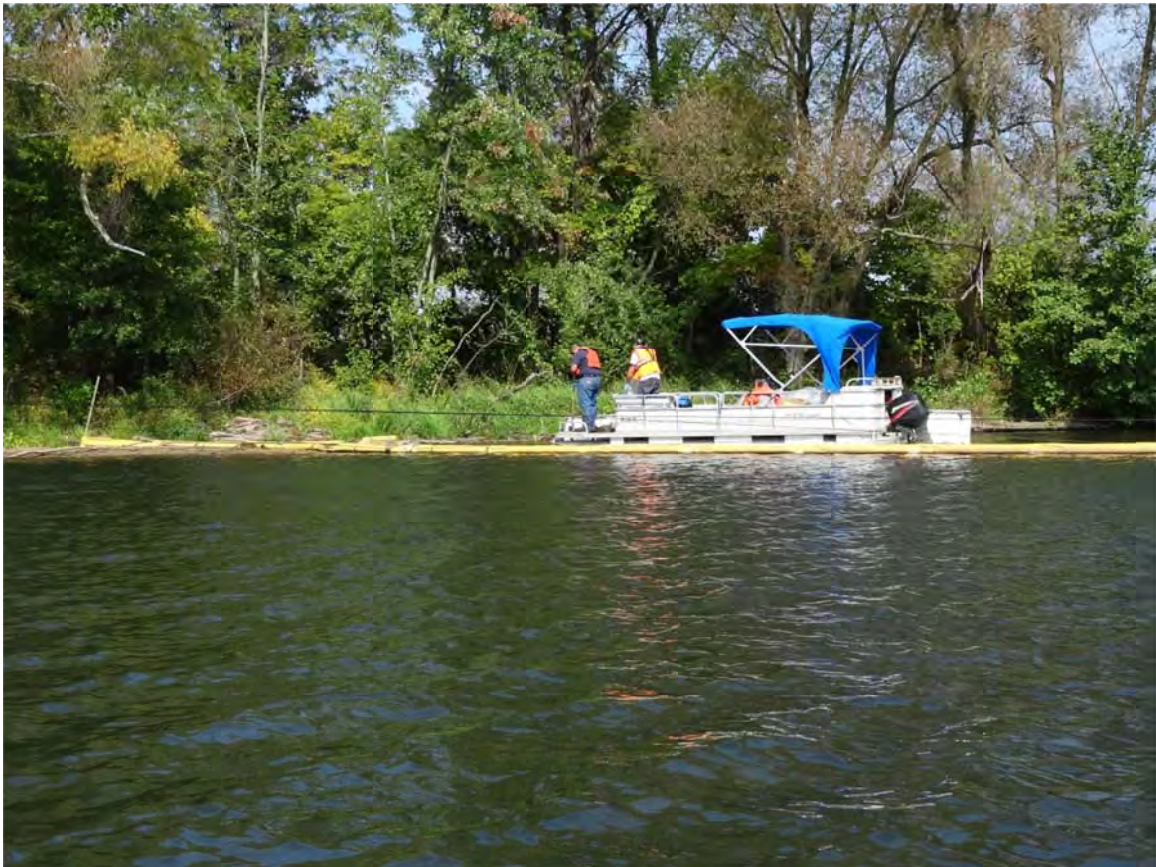
13. Crew observed removing debris from E4.0 containment system.

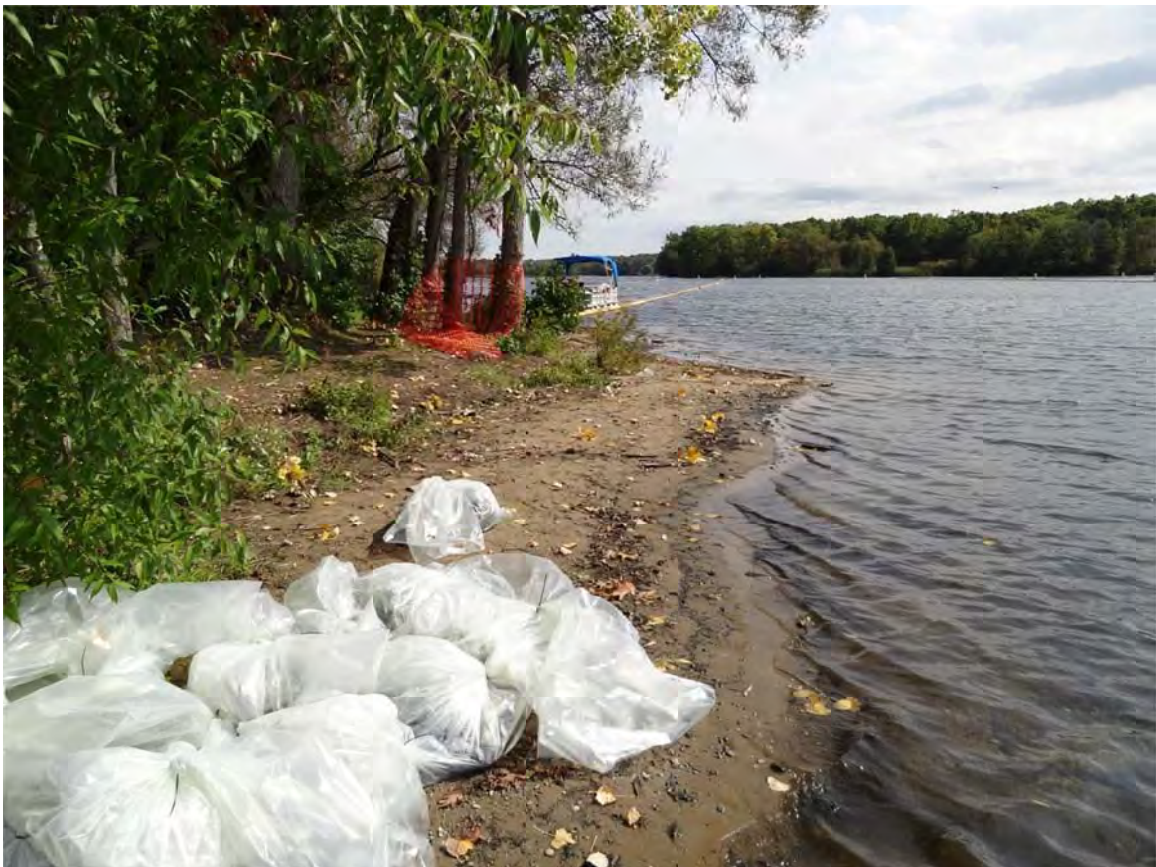
14. Vegetation debris bags staged at E4.0 boat launch for removal.

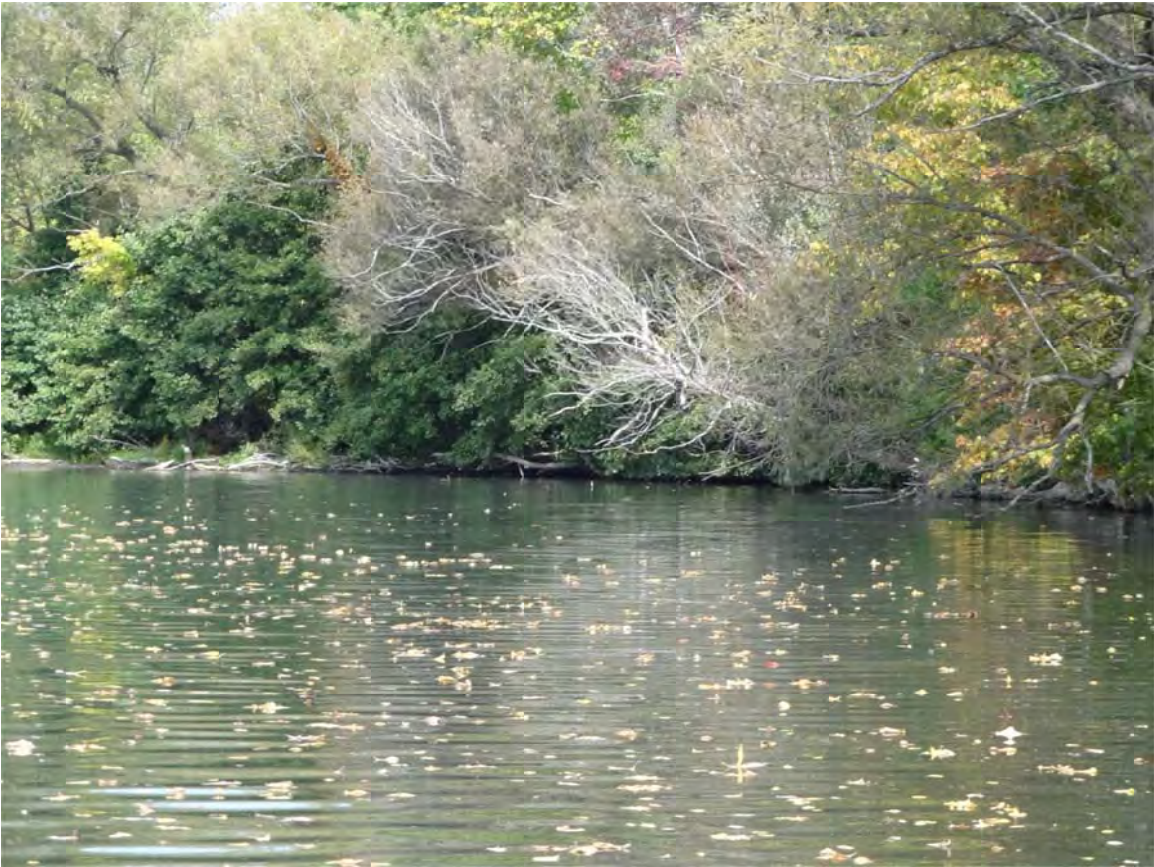
**15. Northern cove of Morrow Lake, no sheen observed.**

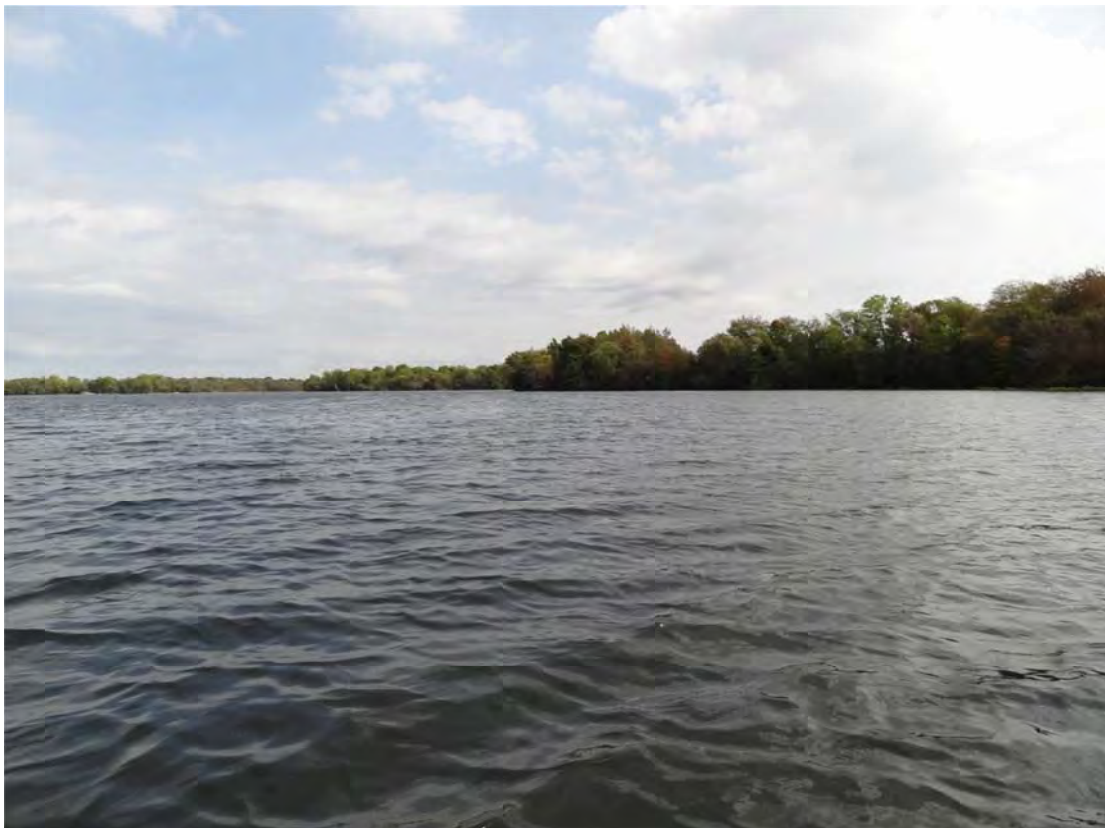
**16. Southern cove of Morrow Lake, no sheen observed.**
