# Situation Photo Log

Friday, September 28, 2012

Kalamazoo River / Enbridge Spill

Prepared by:  
Larry Rader  
START-USEPA  
Situation Unit Leader

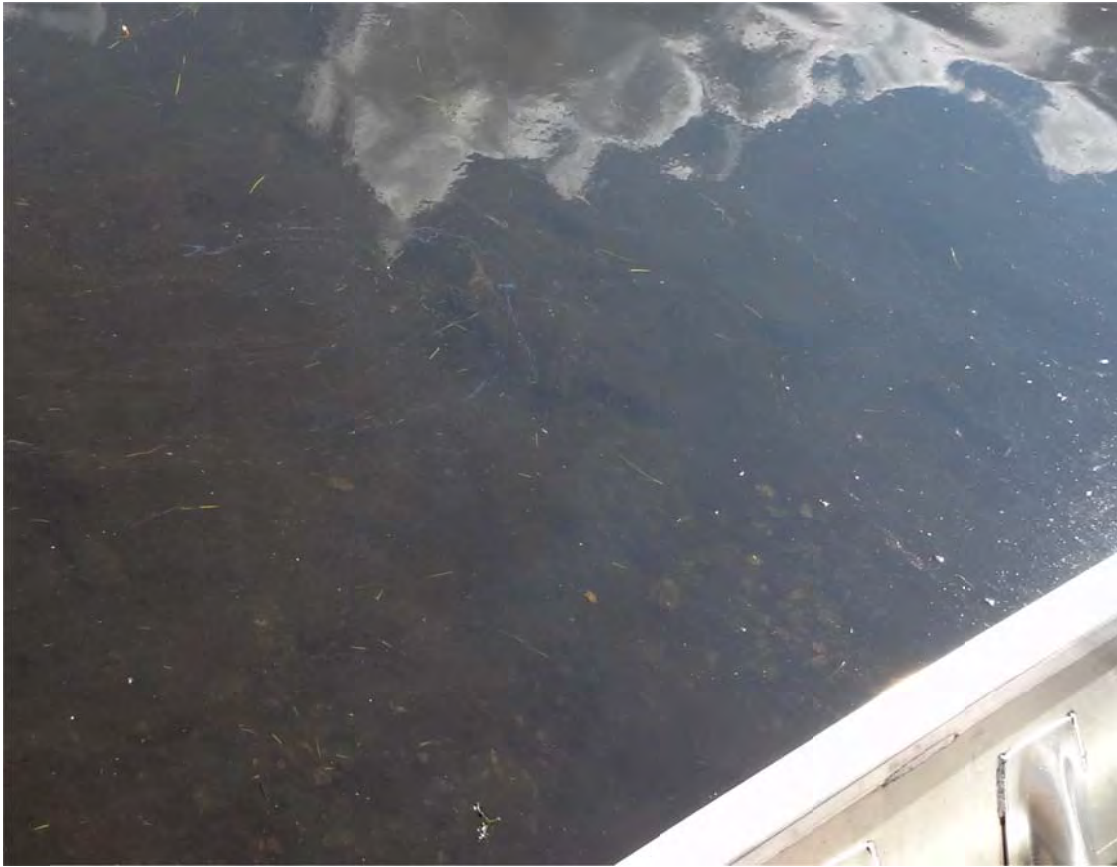
1. Sheen ribbons observed at C0.4 boat launch.

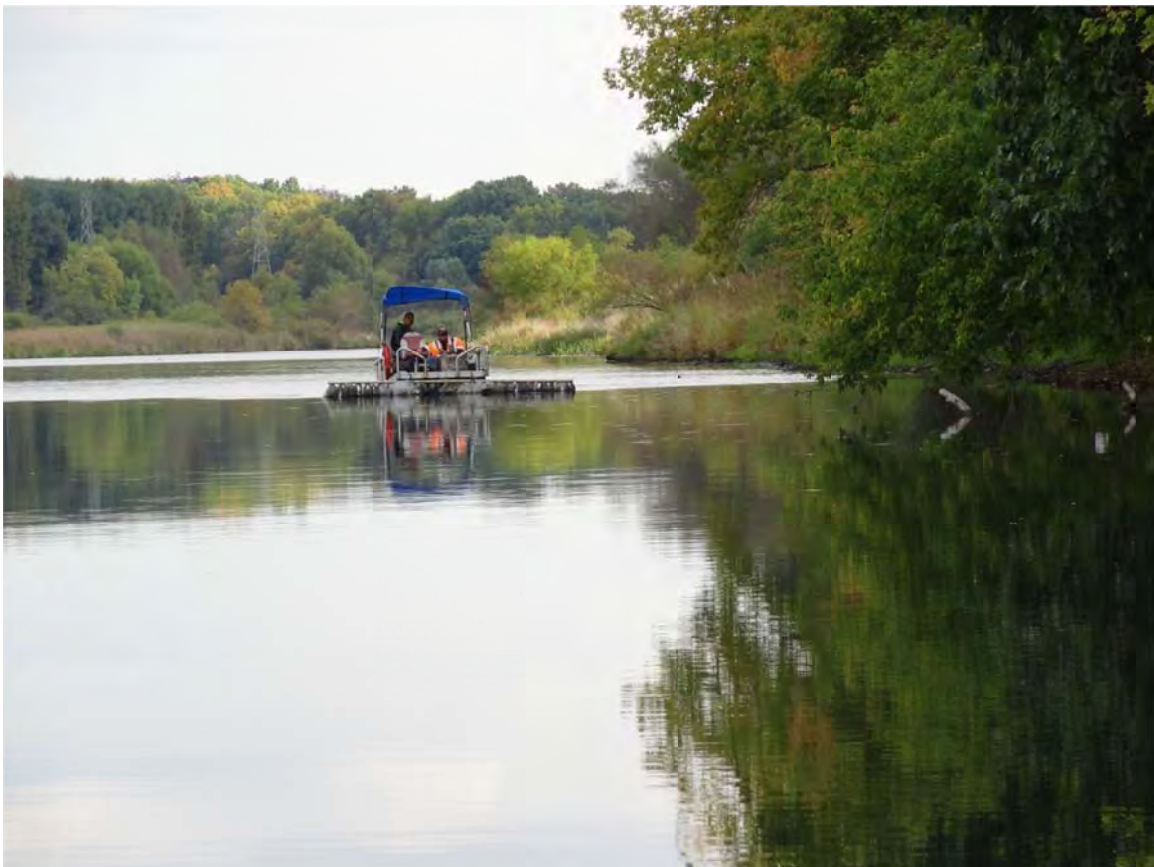
2. Sheen sweeper boat operating along LDB across from C0.4 boat launch.

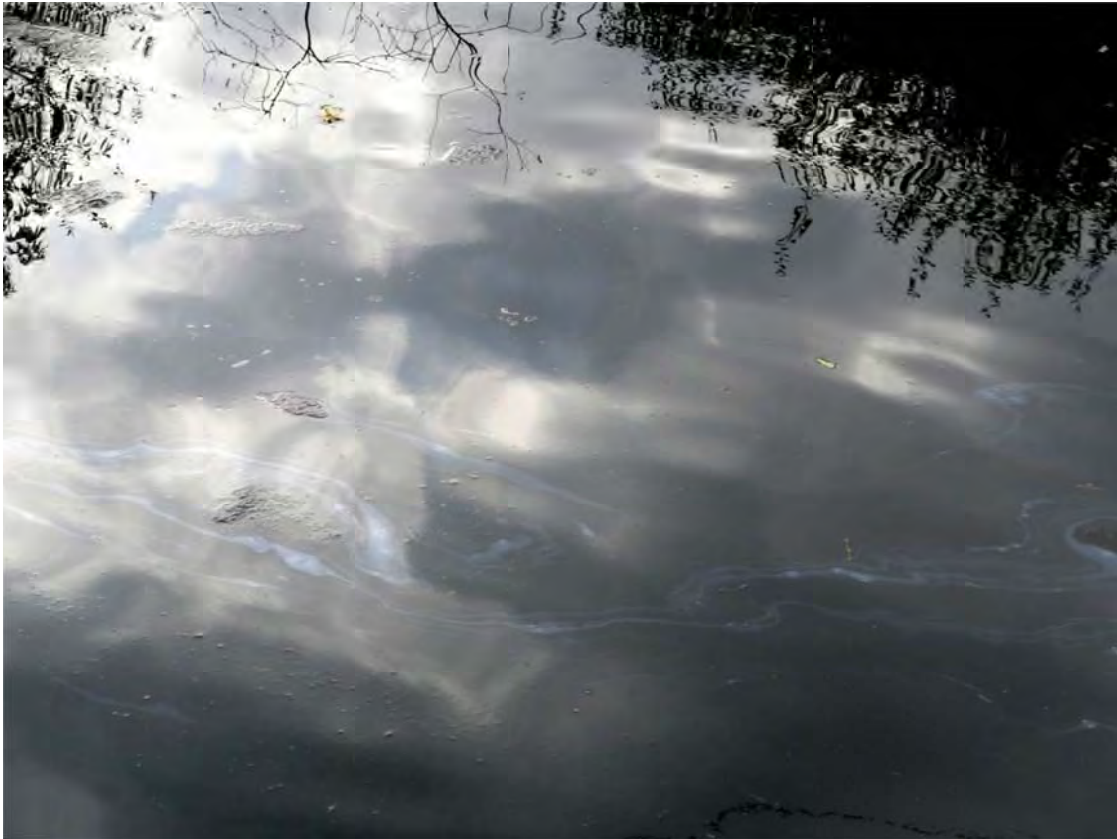
3. MP5.75 LDB, spontaneous sheen observed just downstream from trestle.

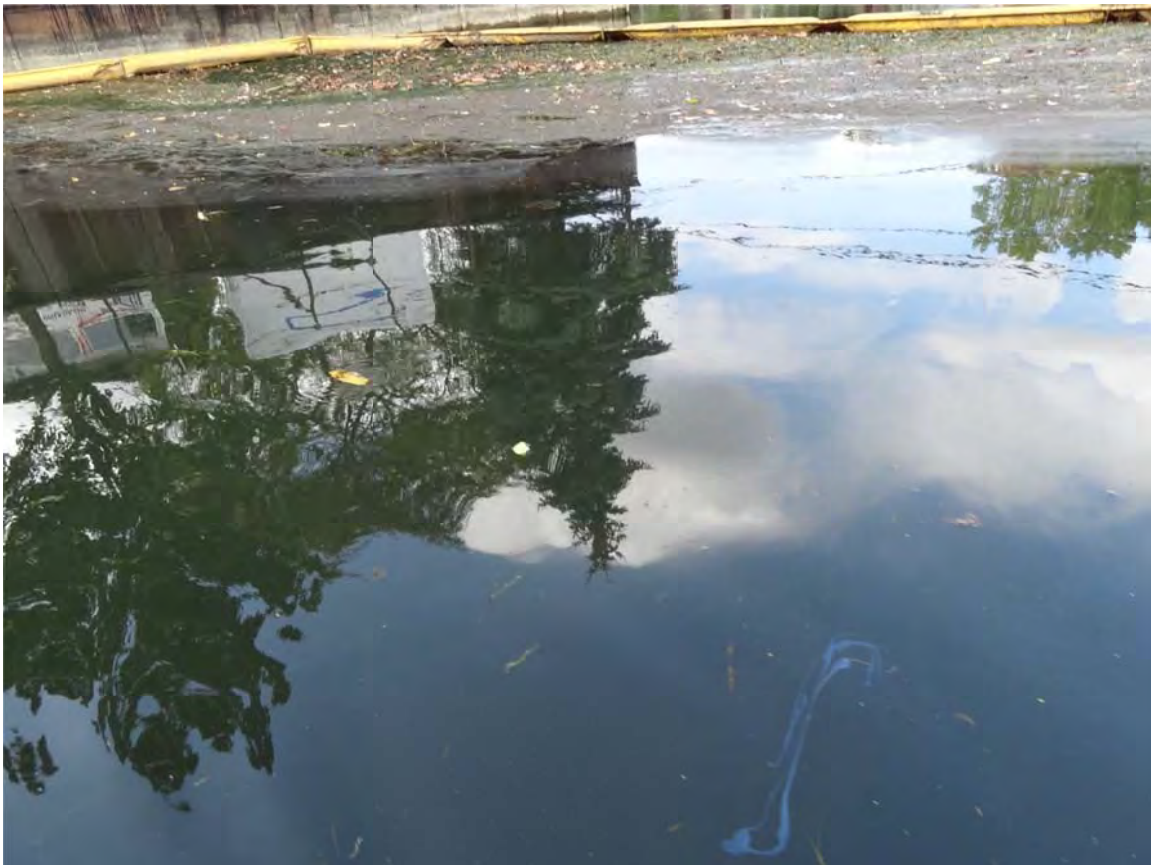
4. Ceresco Dam, spontaneous sheen observed along containment above dam.

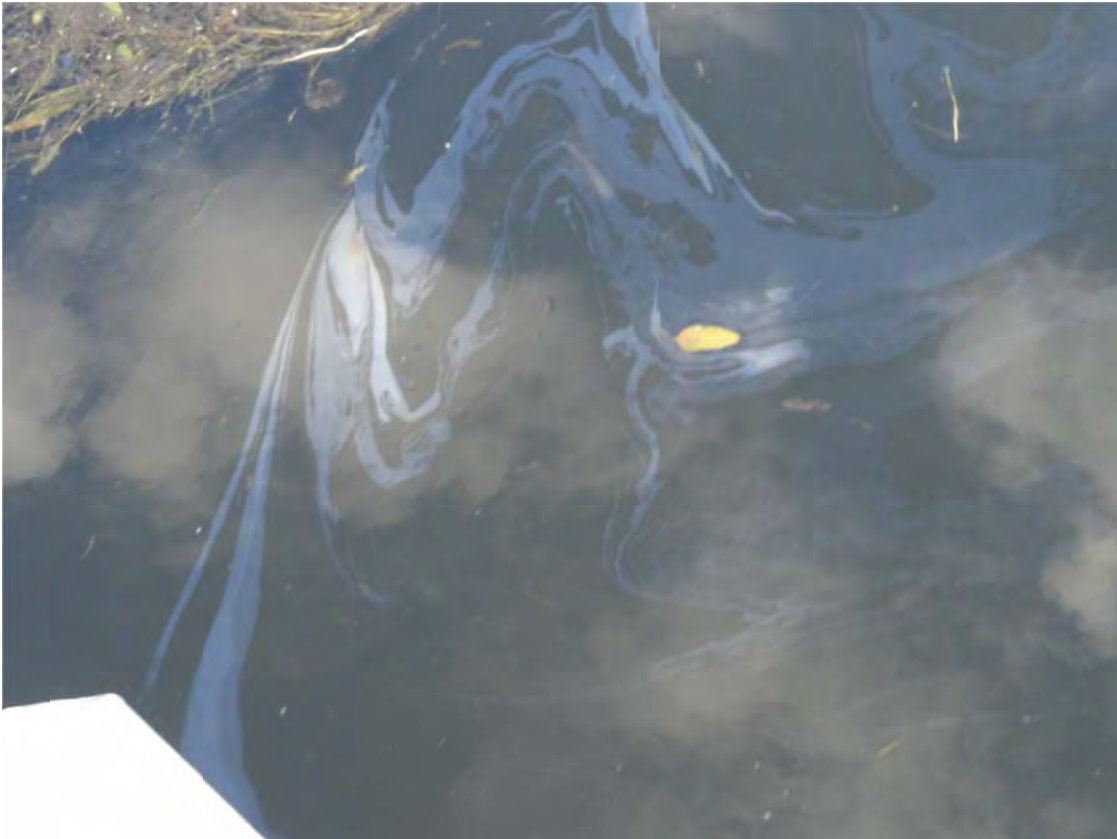
5. Spontaneous sheen observed along containment boom at Ceresco Dam.

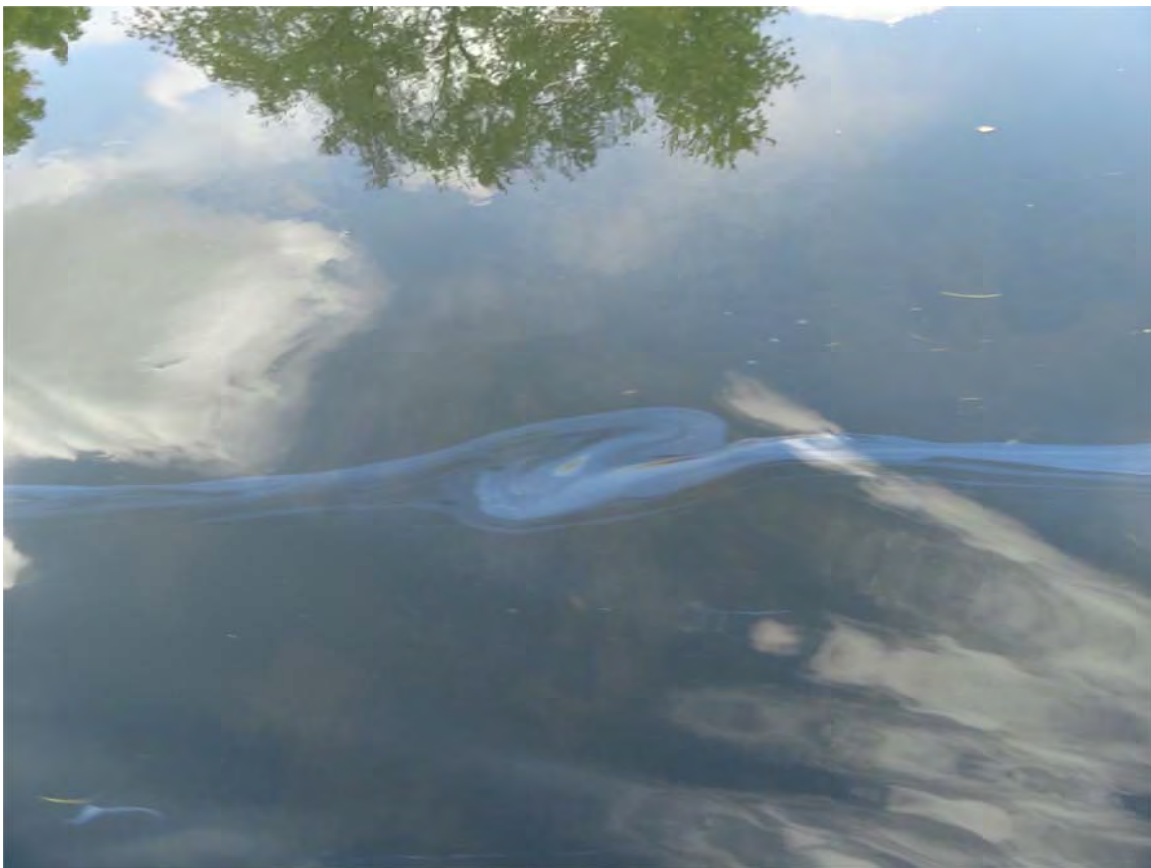
6. Sheen and tar globules within containment at Ceresco Dam.

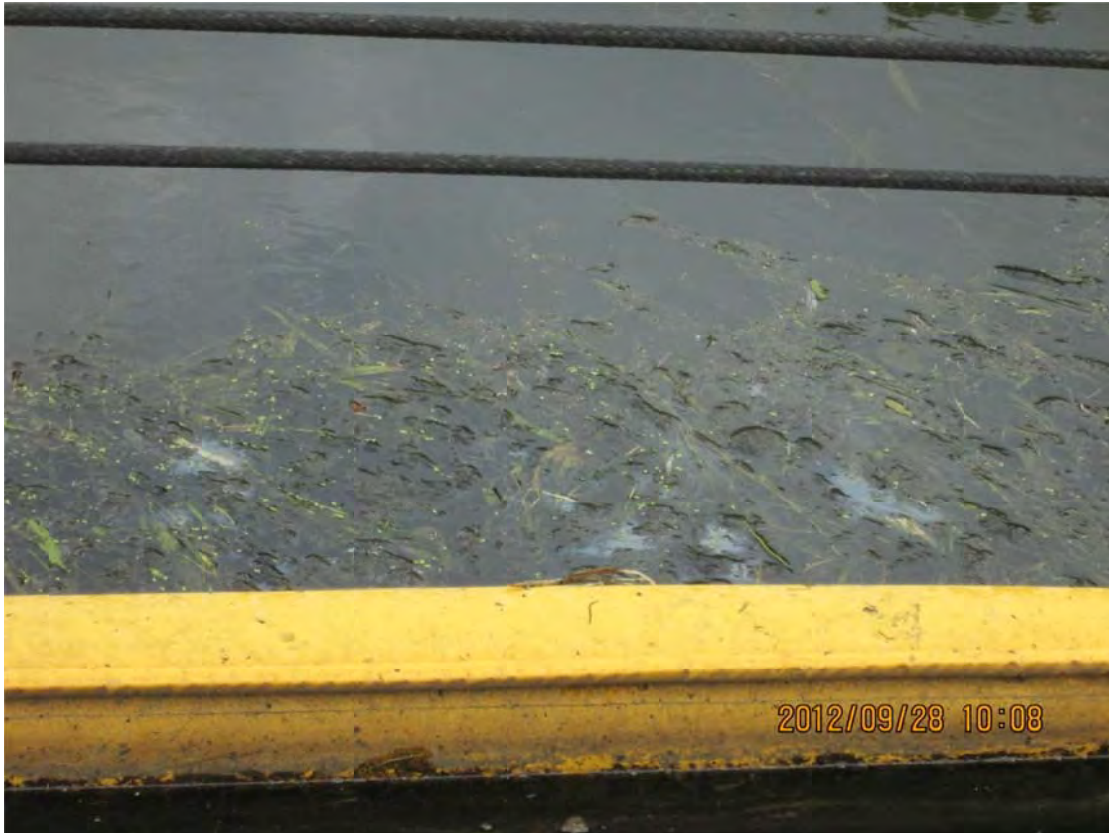
7. Sheen within debris in Ceresco Dam containment.

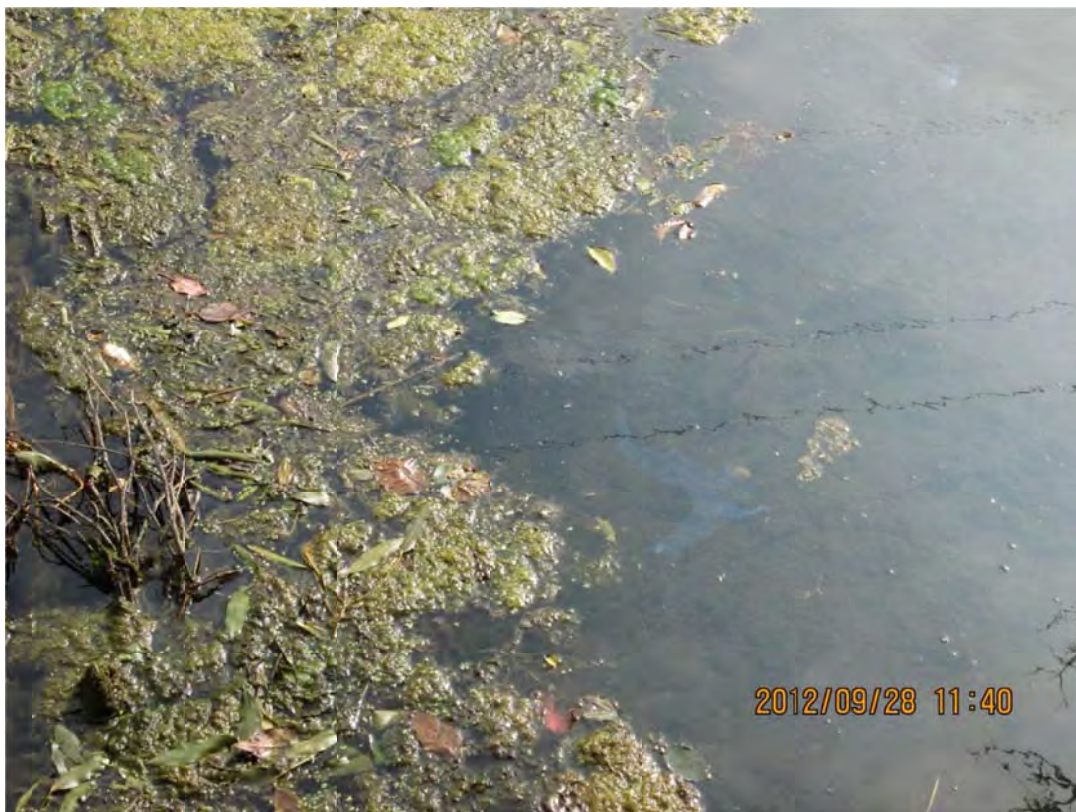
8. MP 10.75 LDB sediment trap, sheen observed behind sediment trap structure.

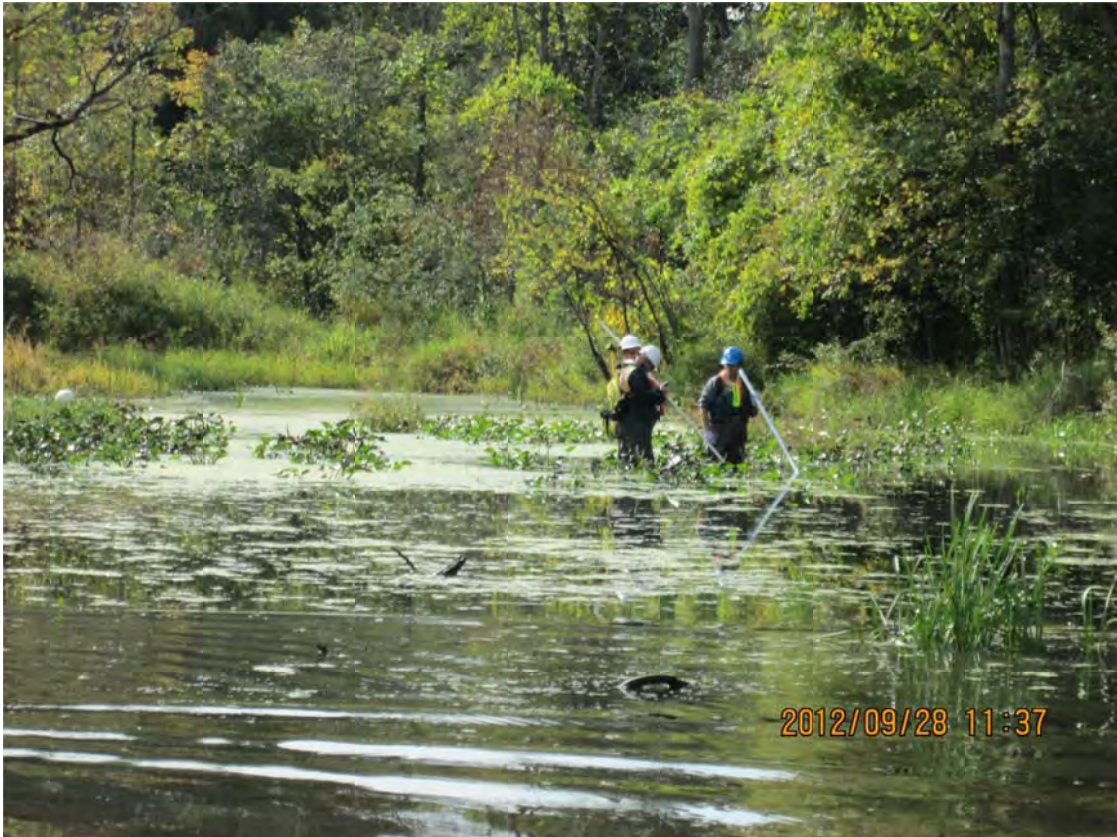
9. MP 10.5 L2, poling crew working in back channel.

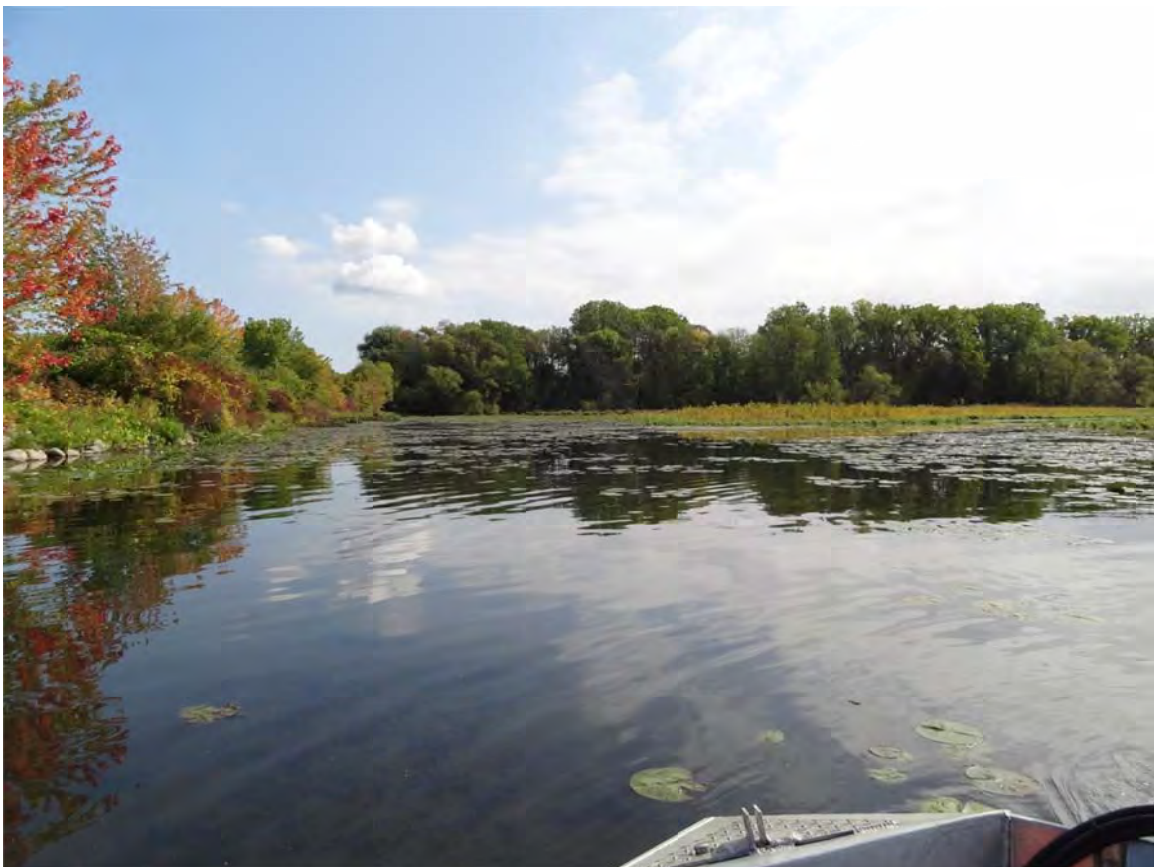
10. MP 15.5 RDB (South Mill Pond), no sheen observed.

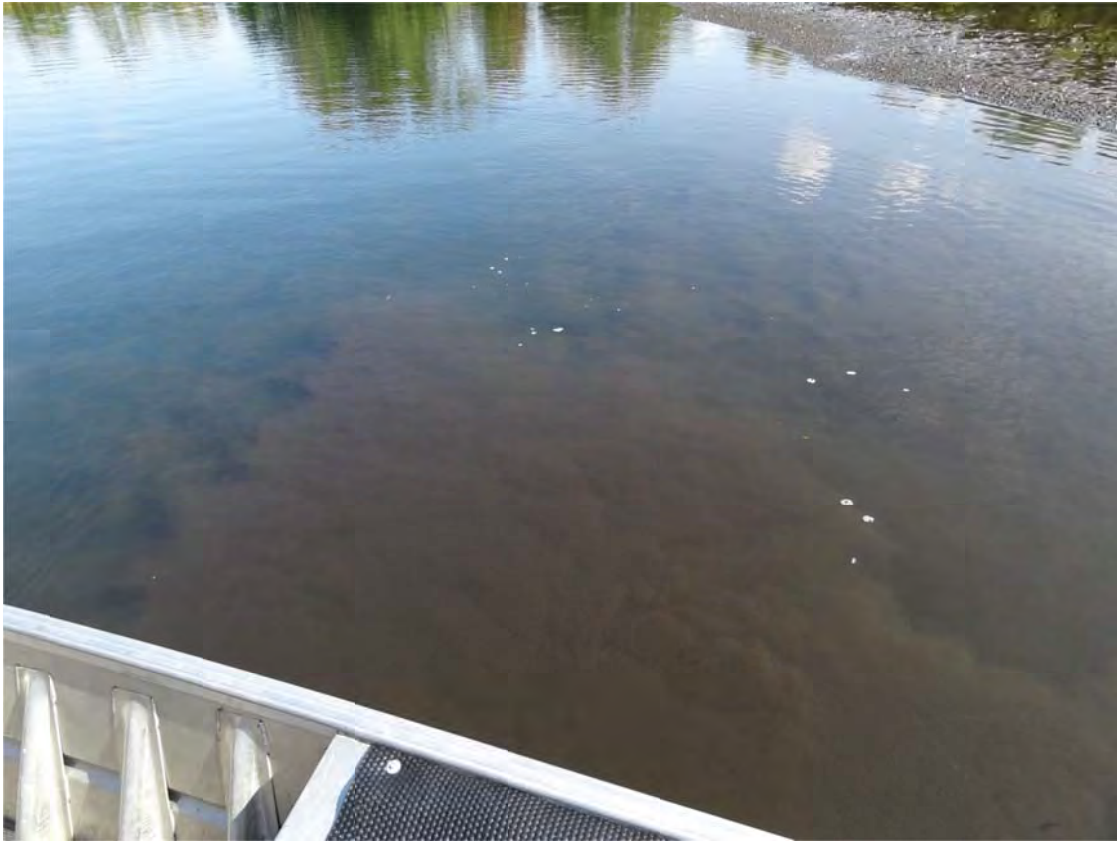
**11. Boat-agitated sediment in north end of north Mill Pond (MP15.75), no sheen observed.**

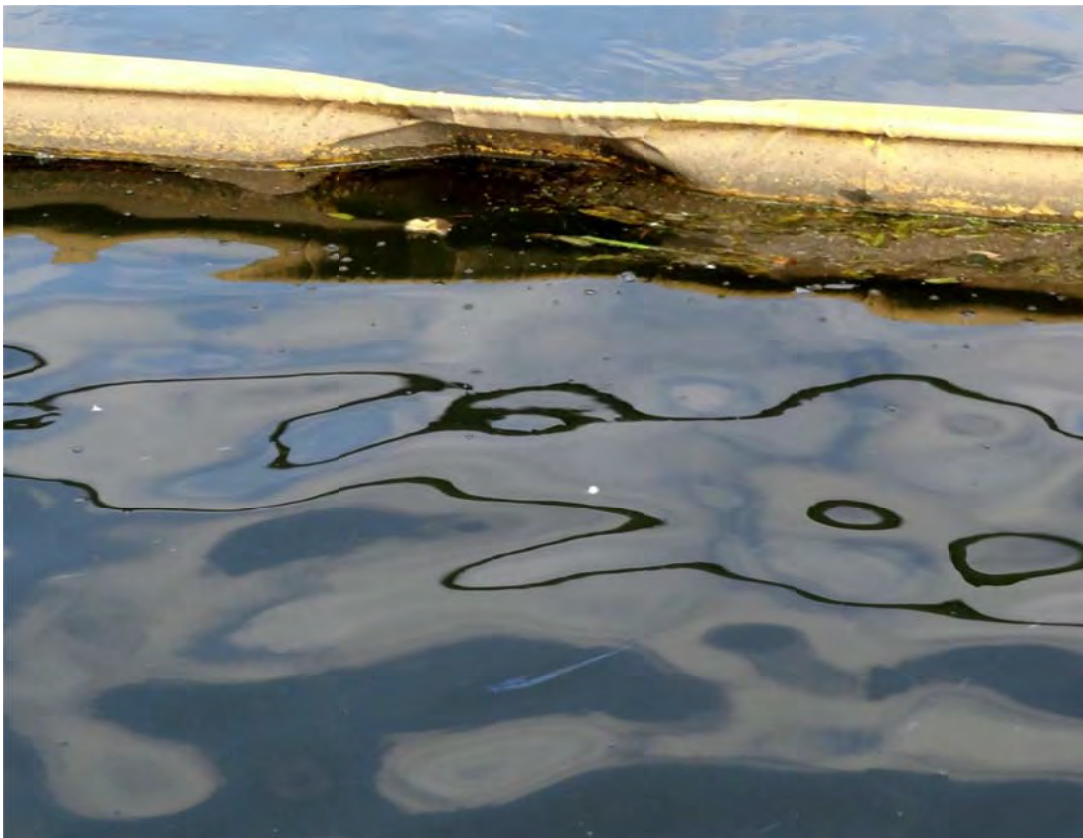
**12. Spontaneous sheen ribbons observed along boom C2 in Morrow Lake Delta.**

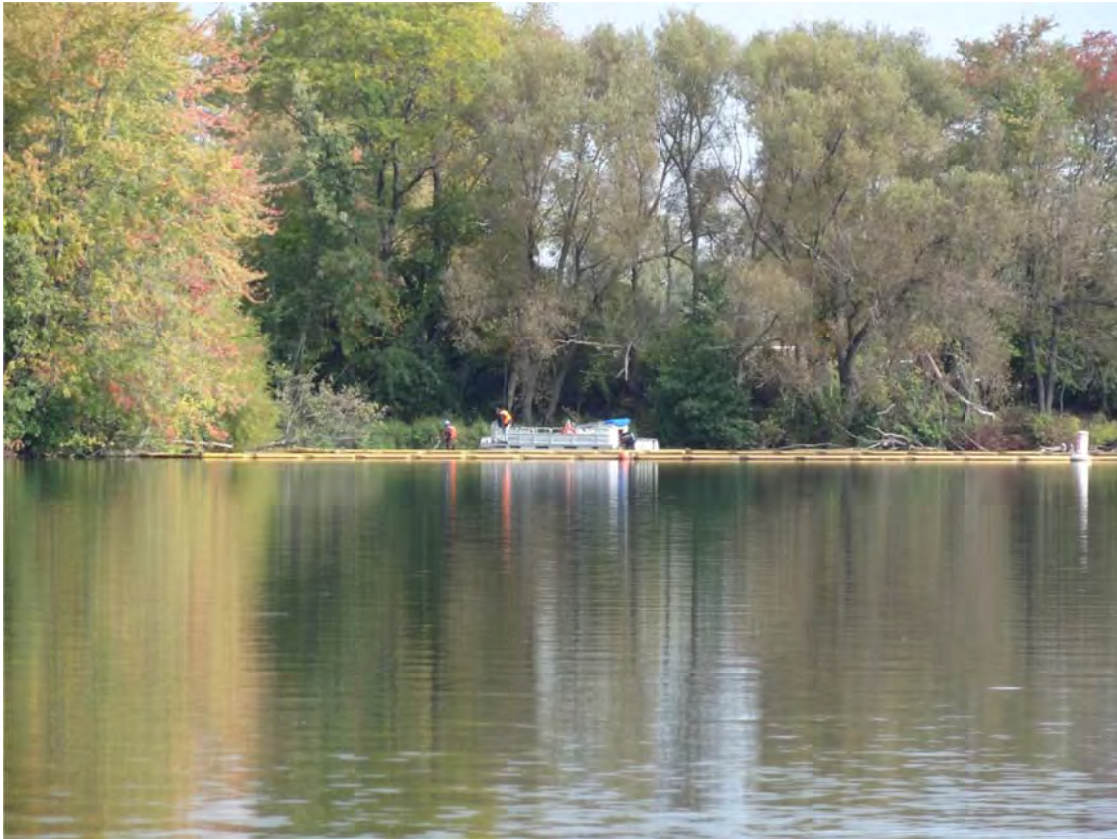
**13. Crews removing debris from E4.0 control point in Morrow Lake Delta.**

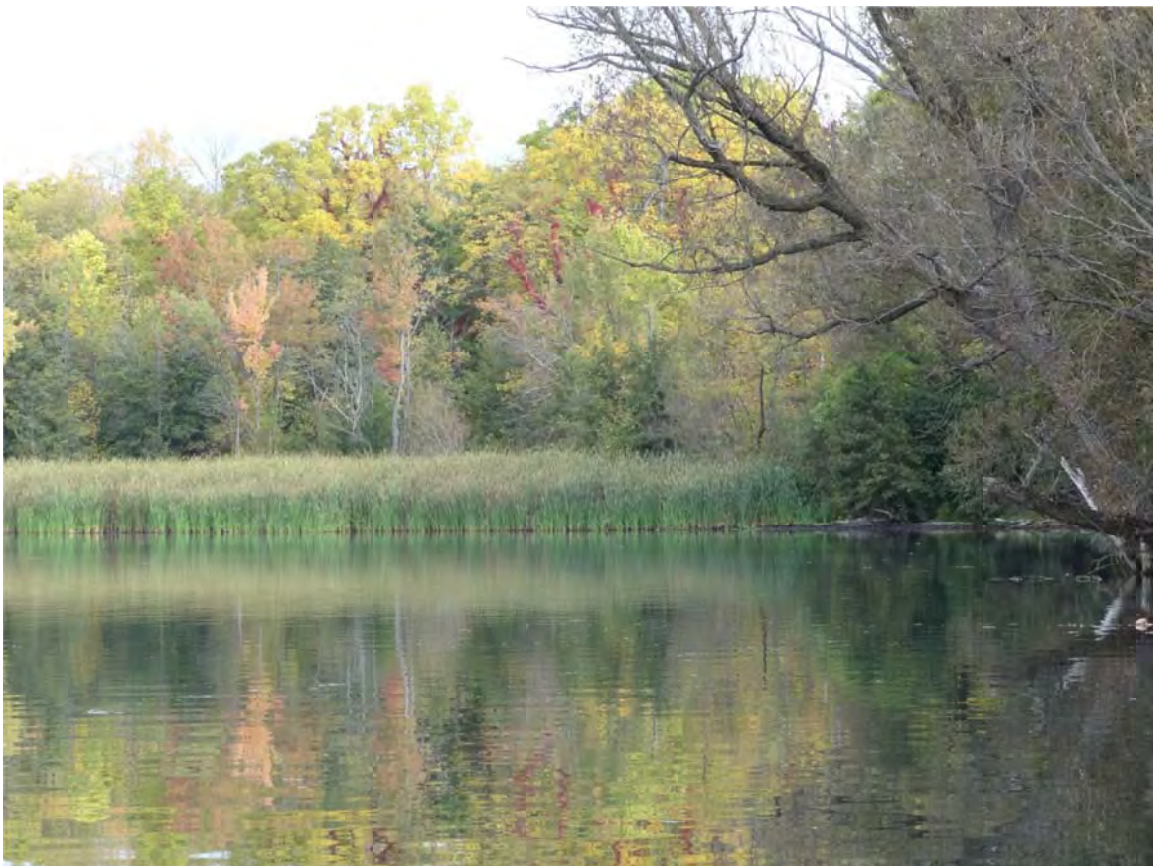
**14. North cove on Morrow Lake, no sheen observed.**
