# Situation Photo Log

Monday, October 1, 2012

Kalamazoo River / Enbridge Spill

Prepared by:  
Larry Rader  
START-USEPA  
Situation Unit Leader

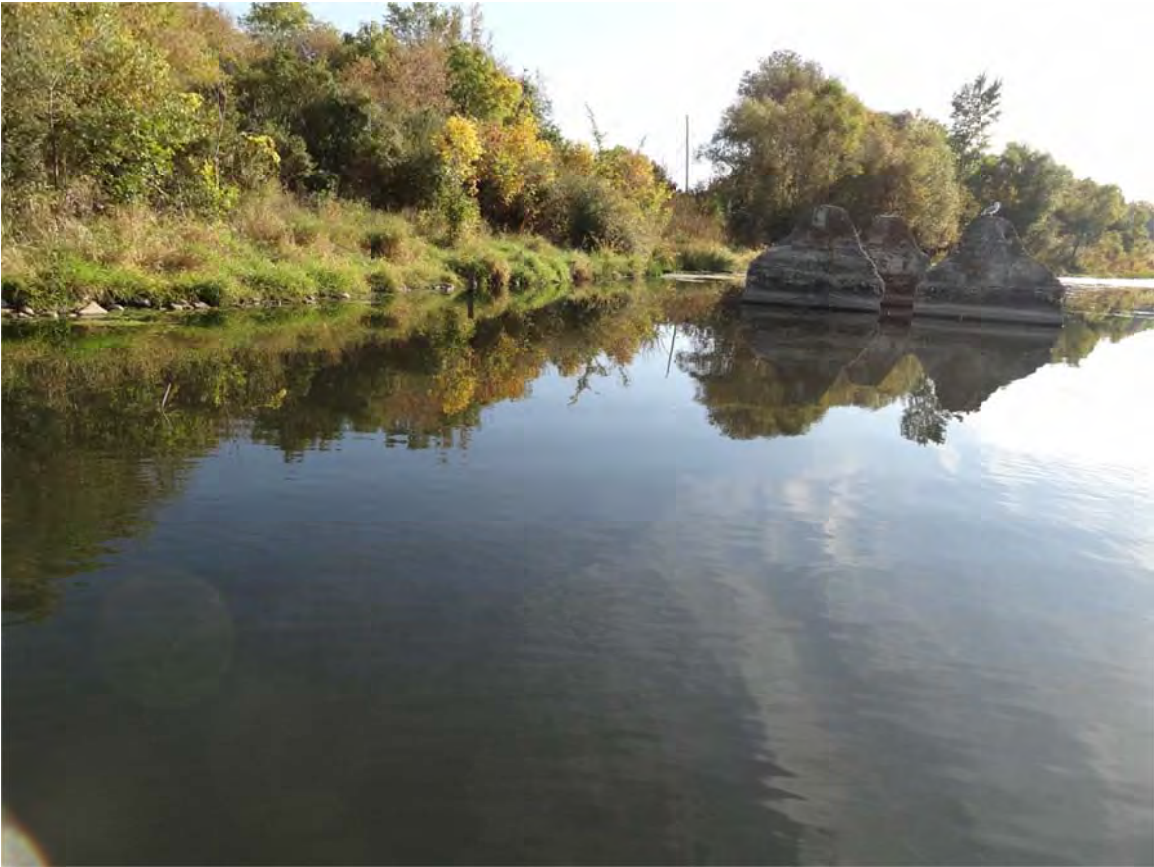
1. MP 5.63 RDB, no sheen observed along shoreline upstream of trestle.

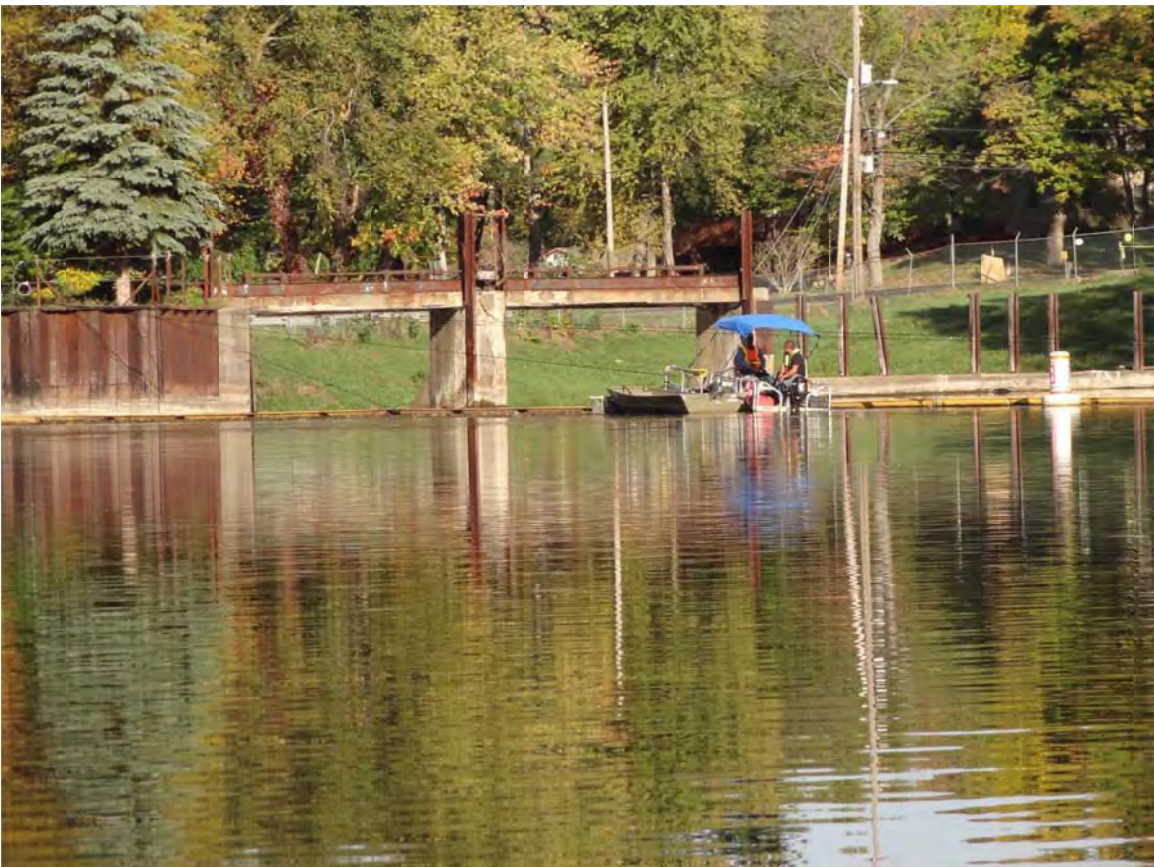
2. Crews removing debris from Ceresco Dam control point.

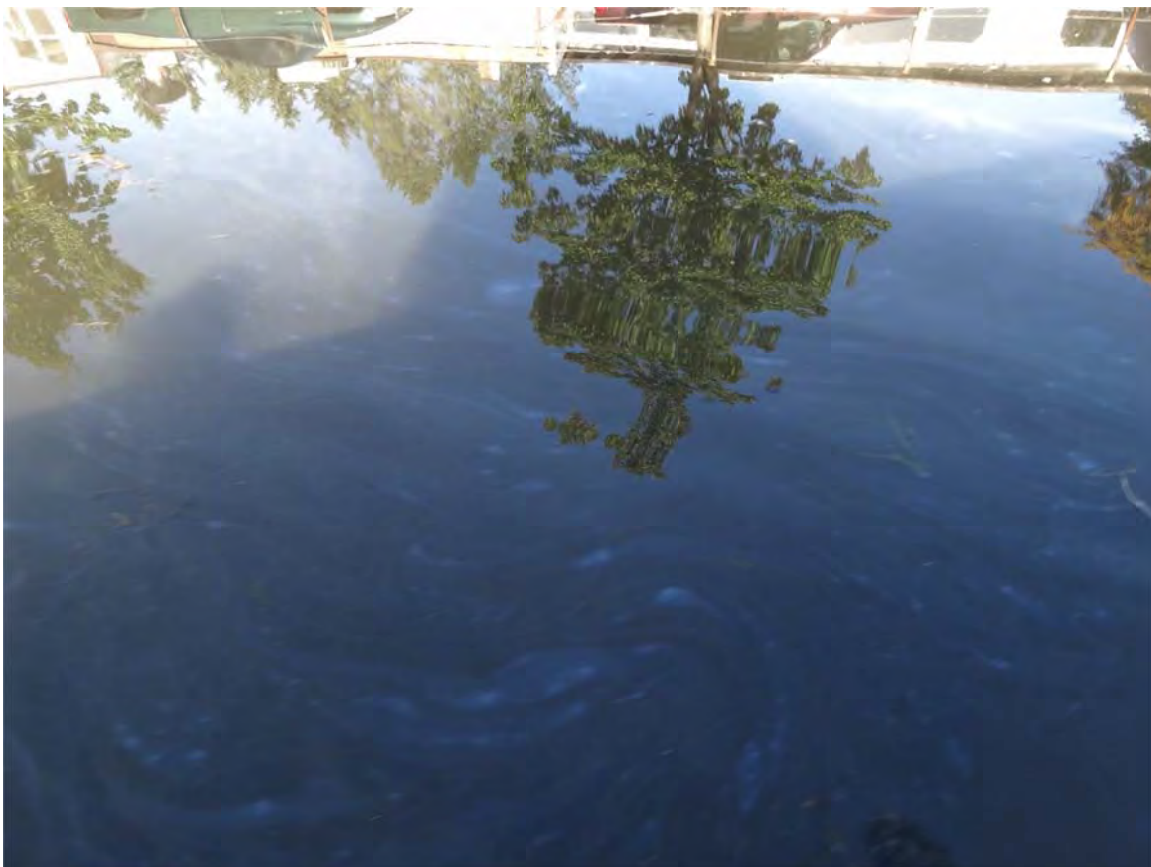
3. Sheen observed within containment at Ceresco Dam control point.

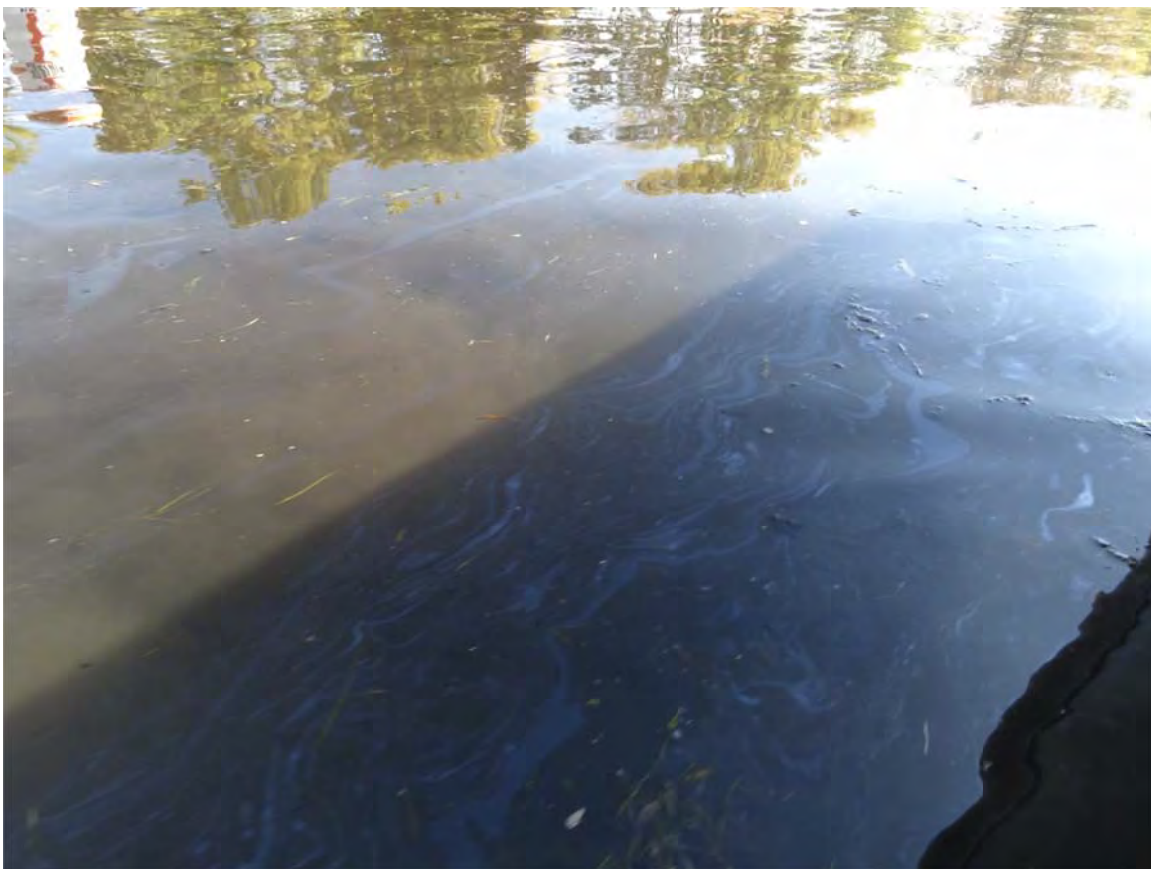
4. Sheen and tar globules observed within containment along Ceresco Dam control point.

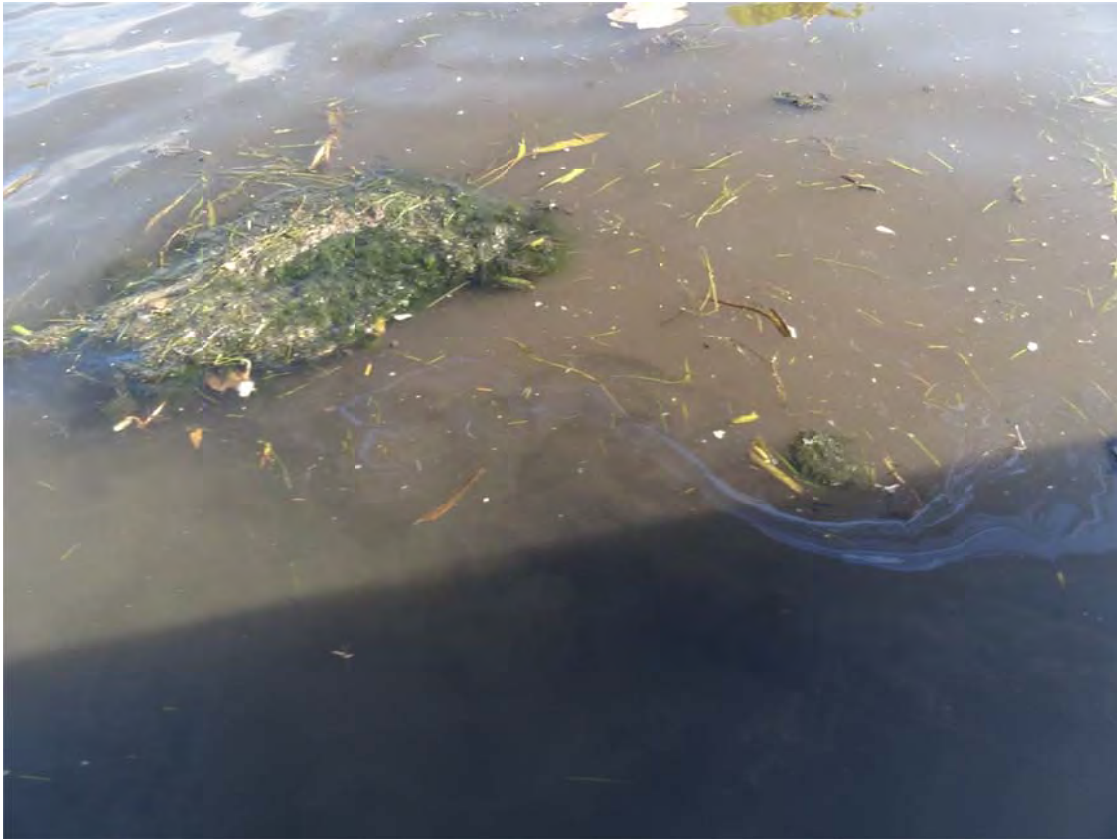
5. Sheen and debris observed within containment along Ceresco Dam control point.

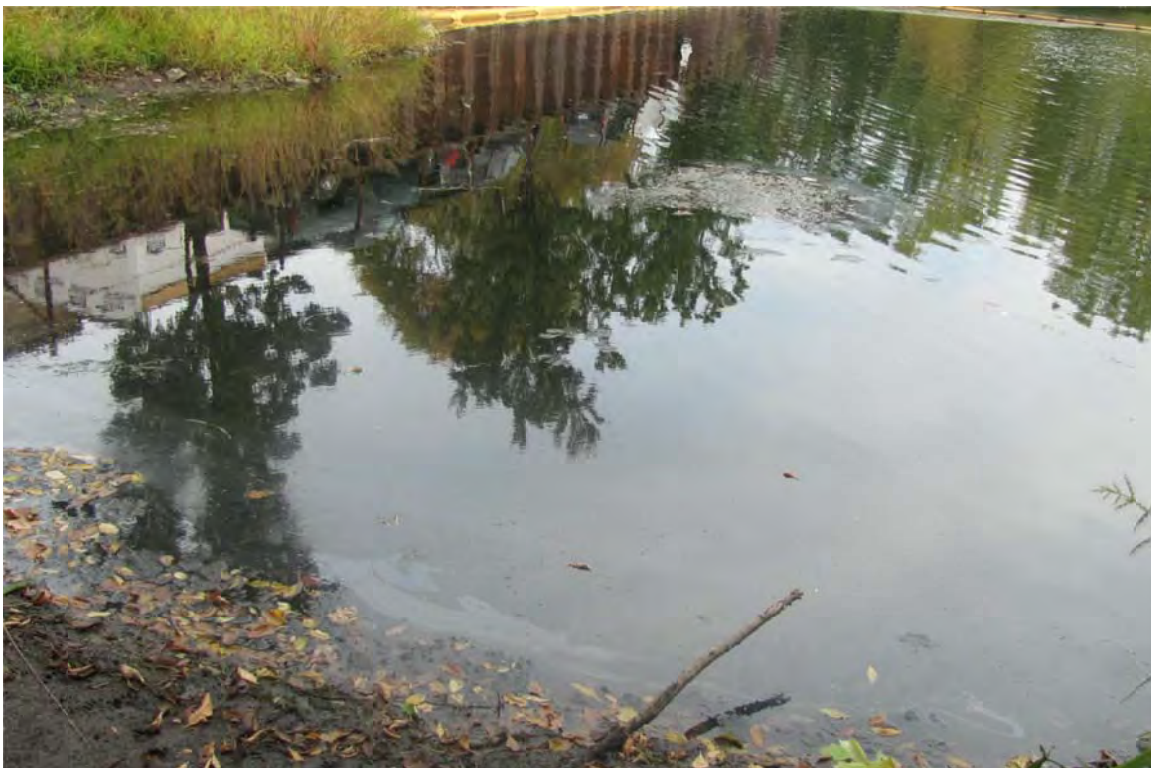
6. Sheen observed along LDB at Ceresco Dam near upstream portage.

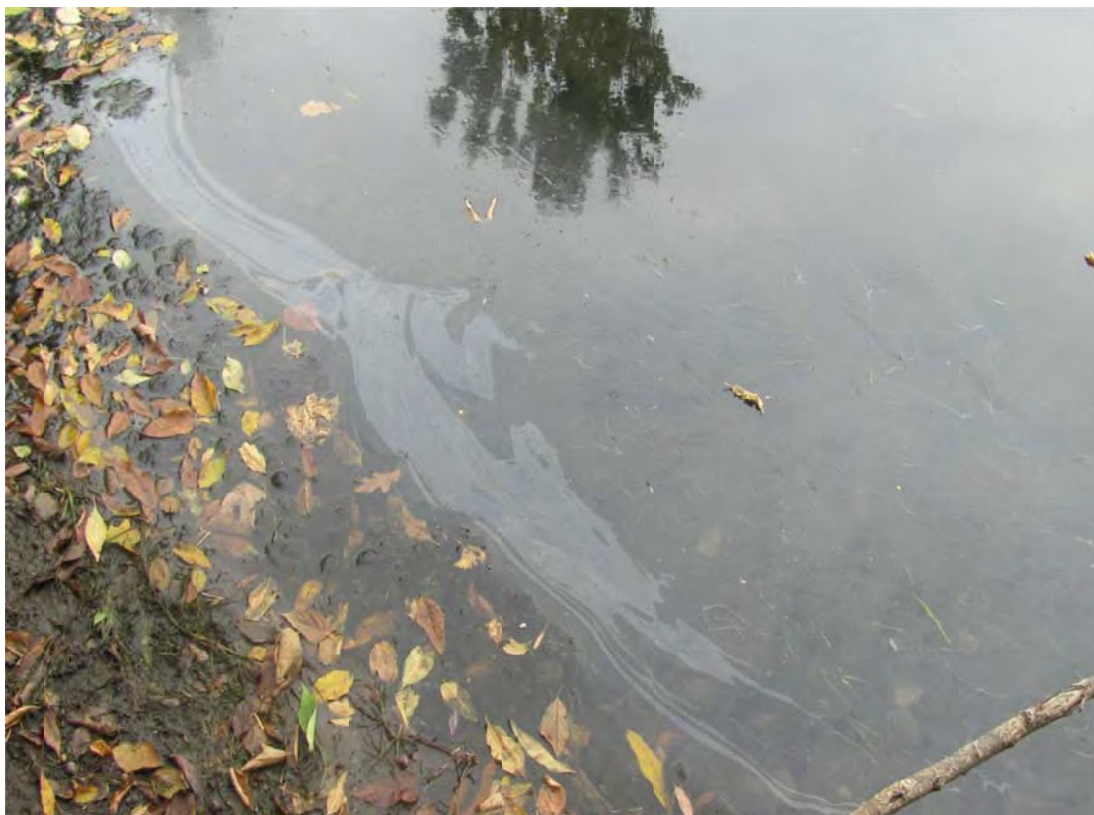
7. Sheen observed along LDB at Ceresco Dam near upstream portage.

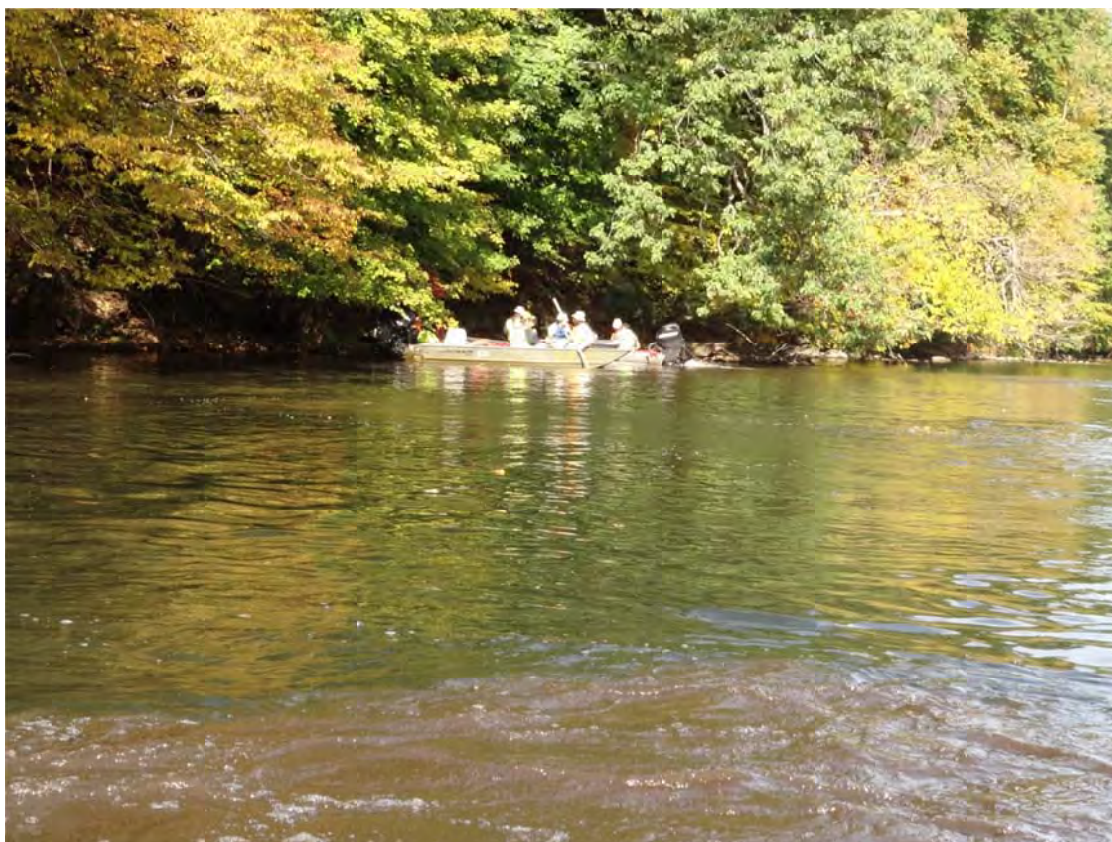
8. RI crews collecting samples along LDB near MP 8.0.

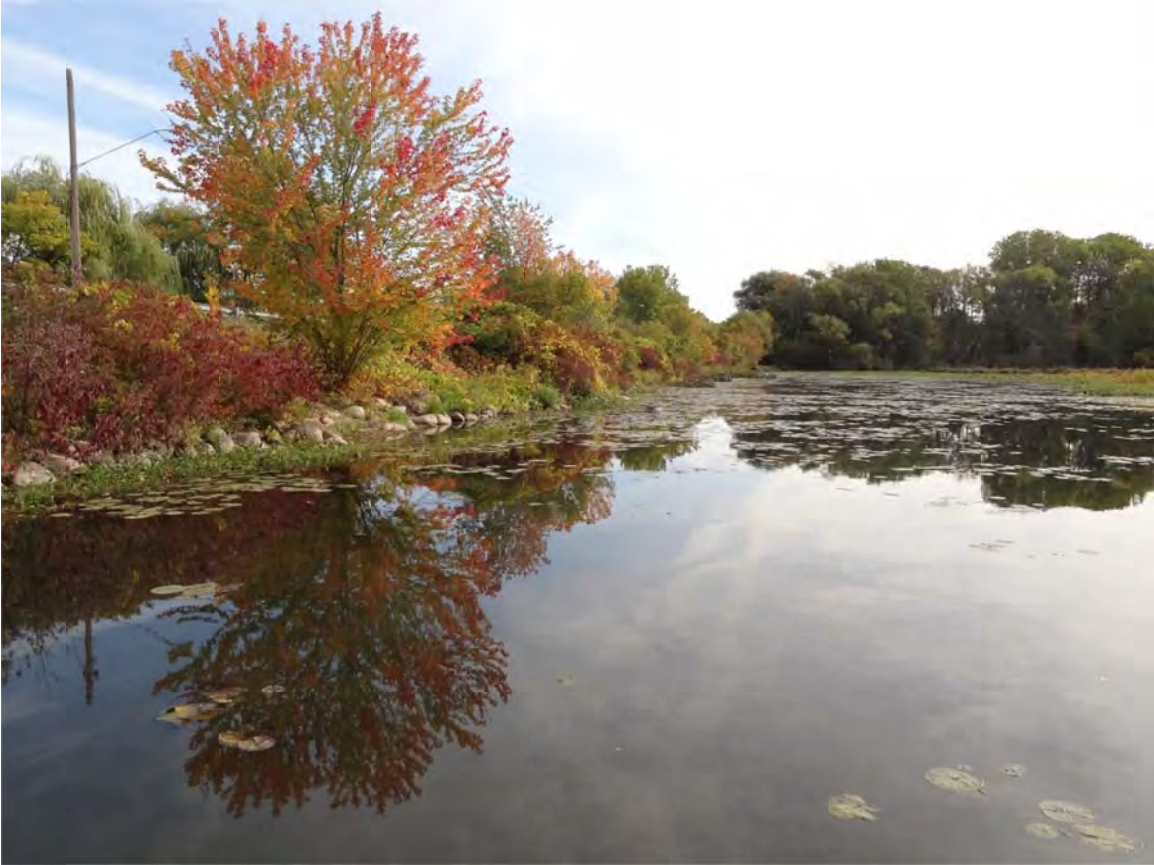
9. MP 15.5 South Mill Pond RDB of river channel, no sheen observed.

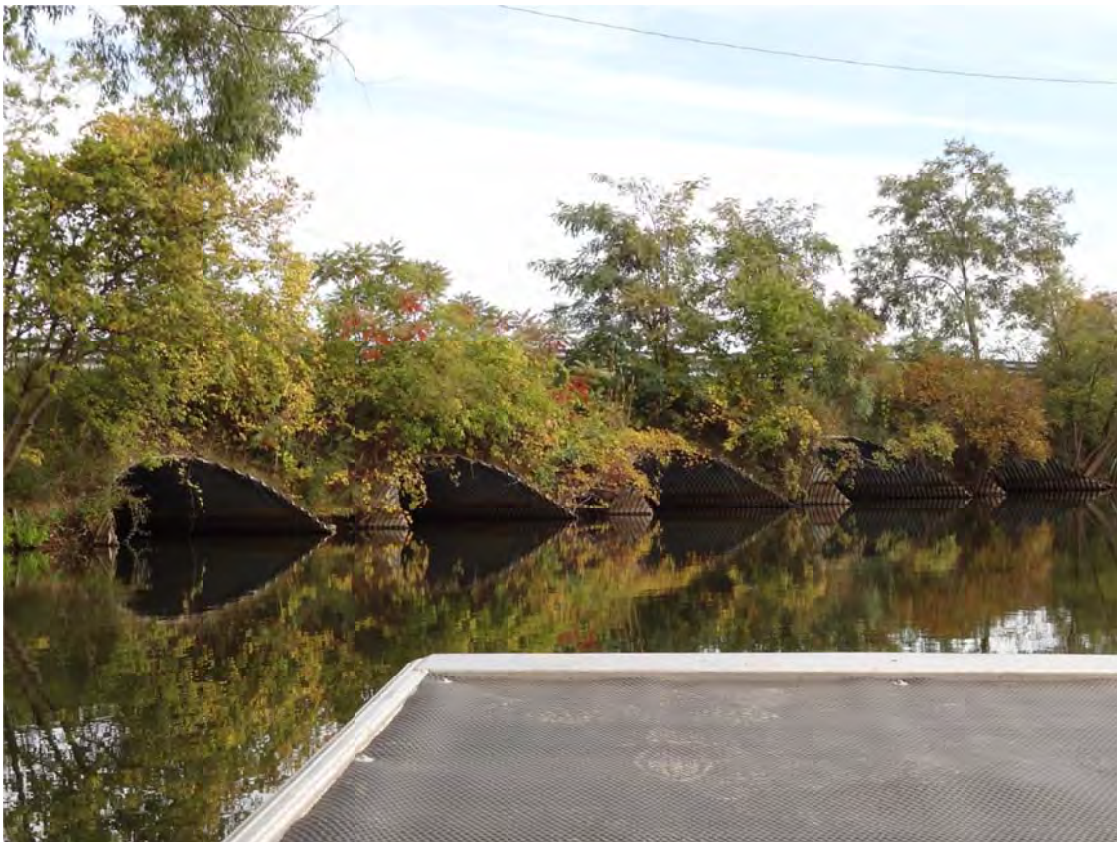
10. View of culverts at MP 15.75 in North Mill Pond. No sheen observed.

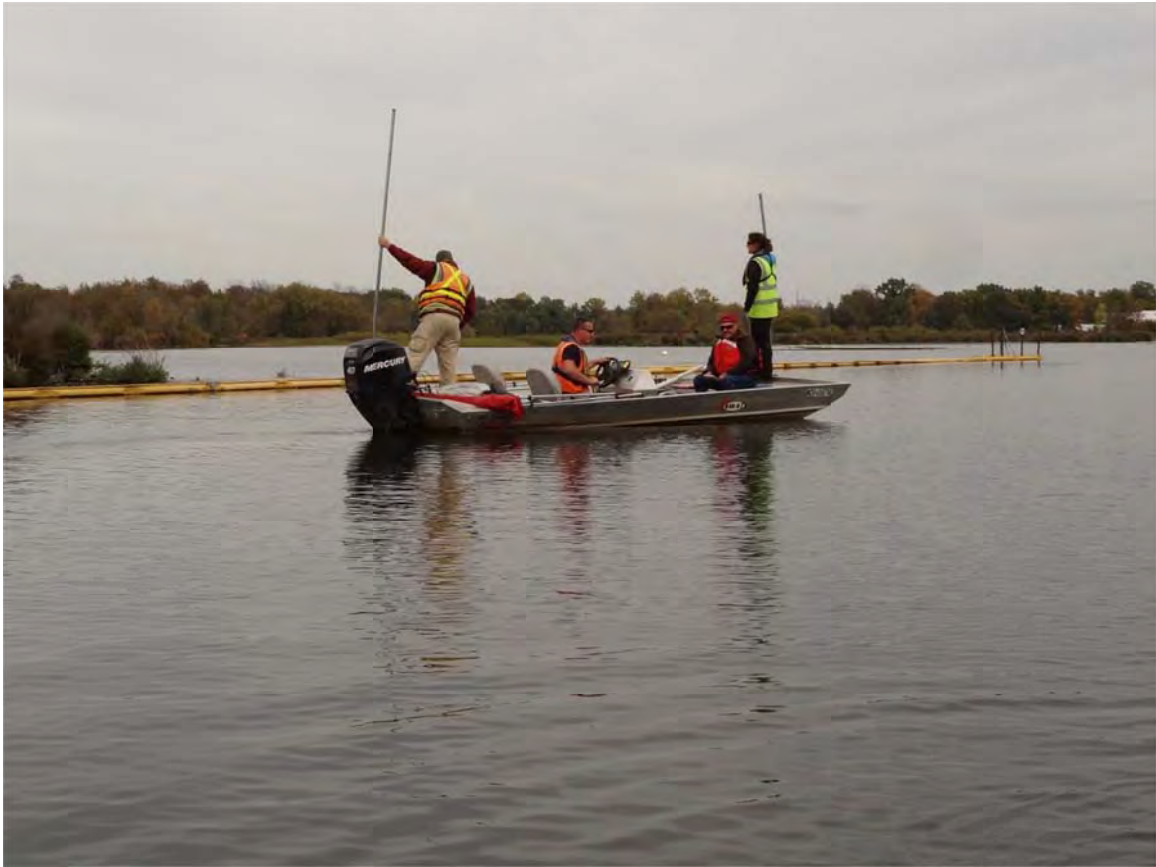
11. Poling crew operating along boom B in Morrow Lake Delta.

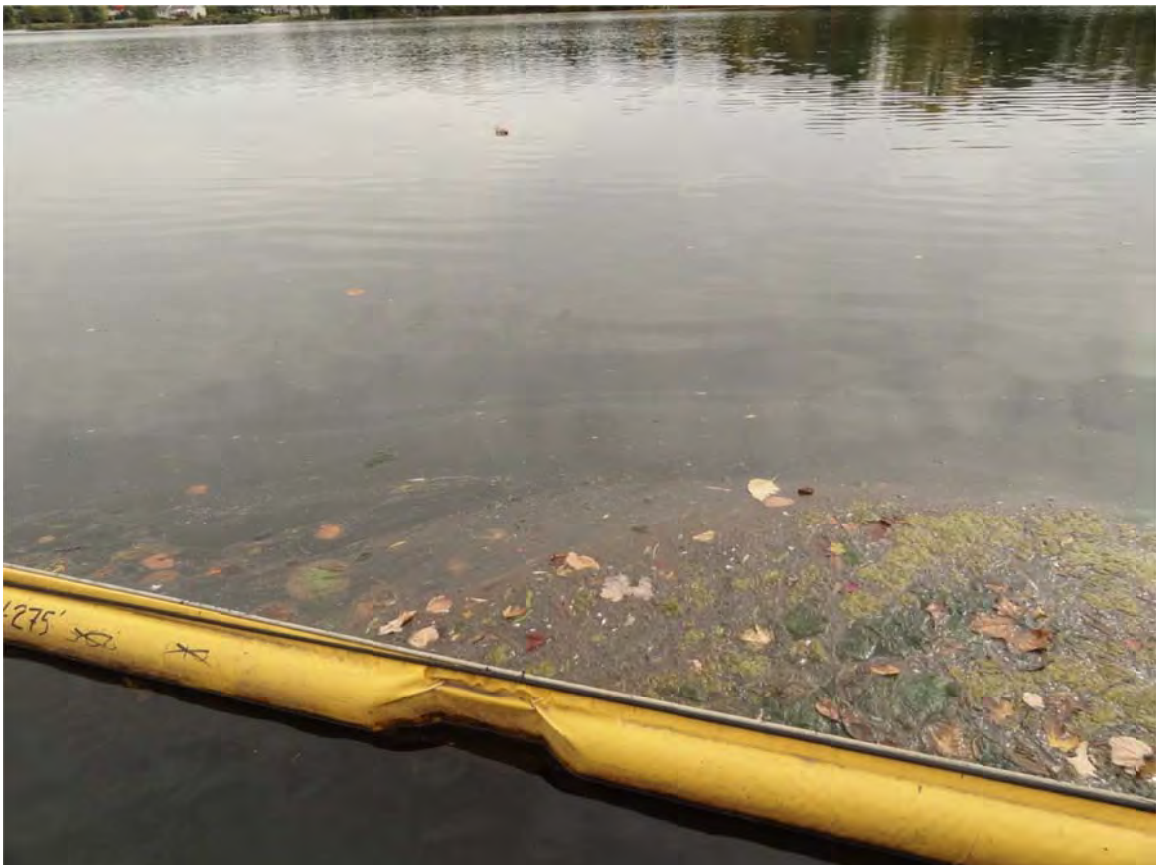
12. Boom configuration C in Morrow Lake Delta. Sheen observed along containment boom.

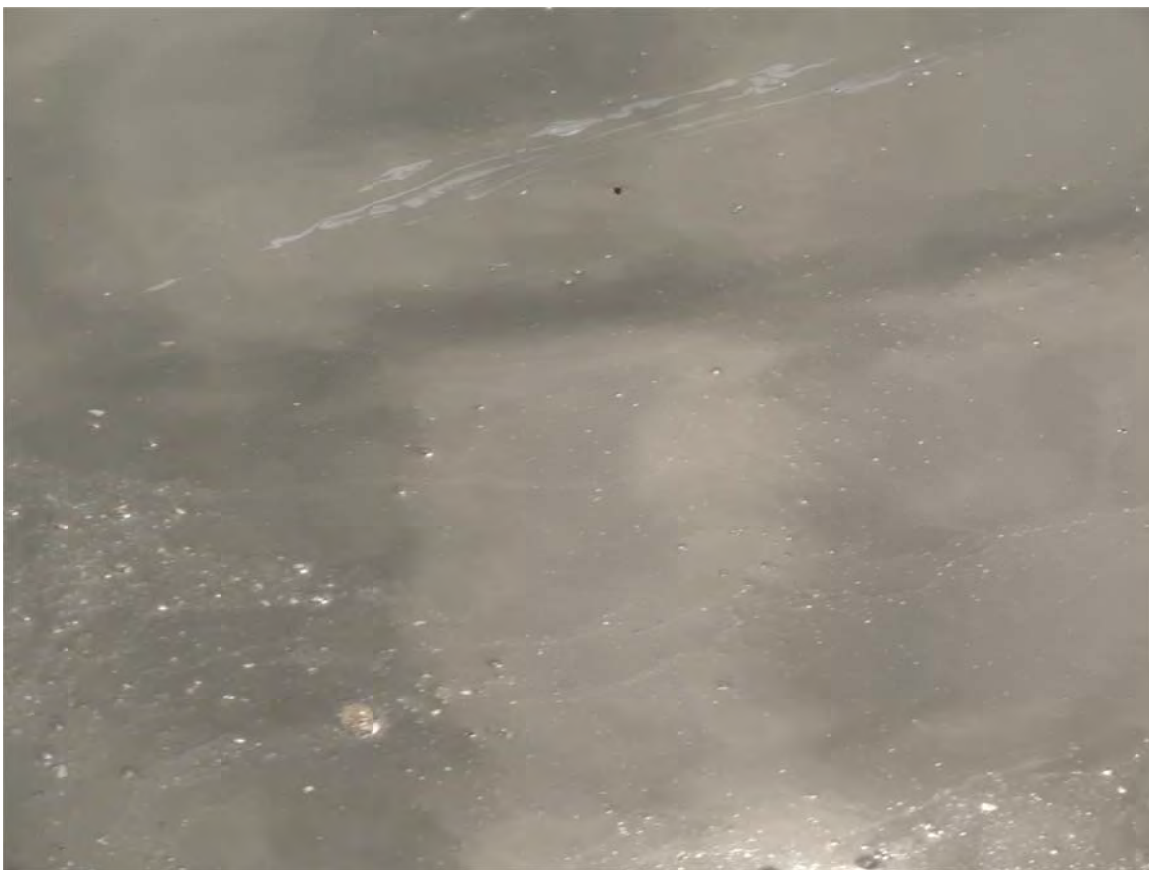
**13. Sheen and tar globules observed along boom C in Morrow Lake Delta.**

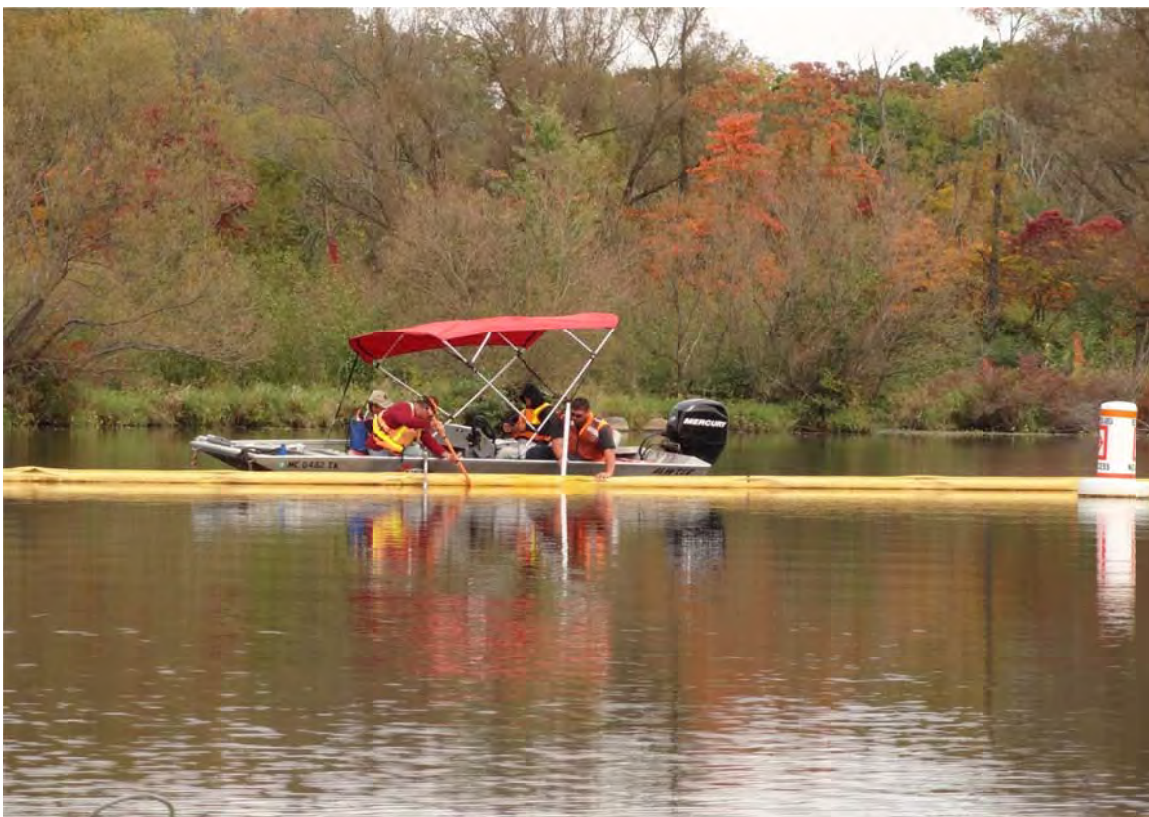
**14. Curtain inspection crew observed working along boom E2.**

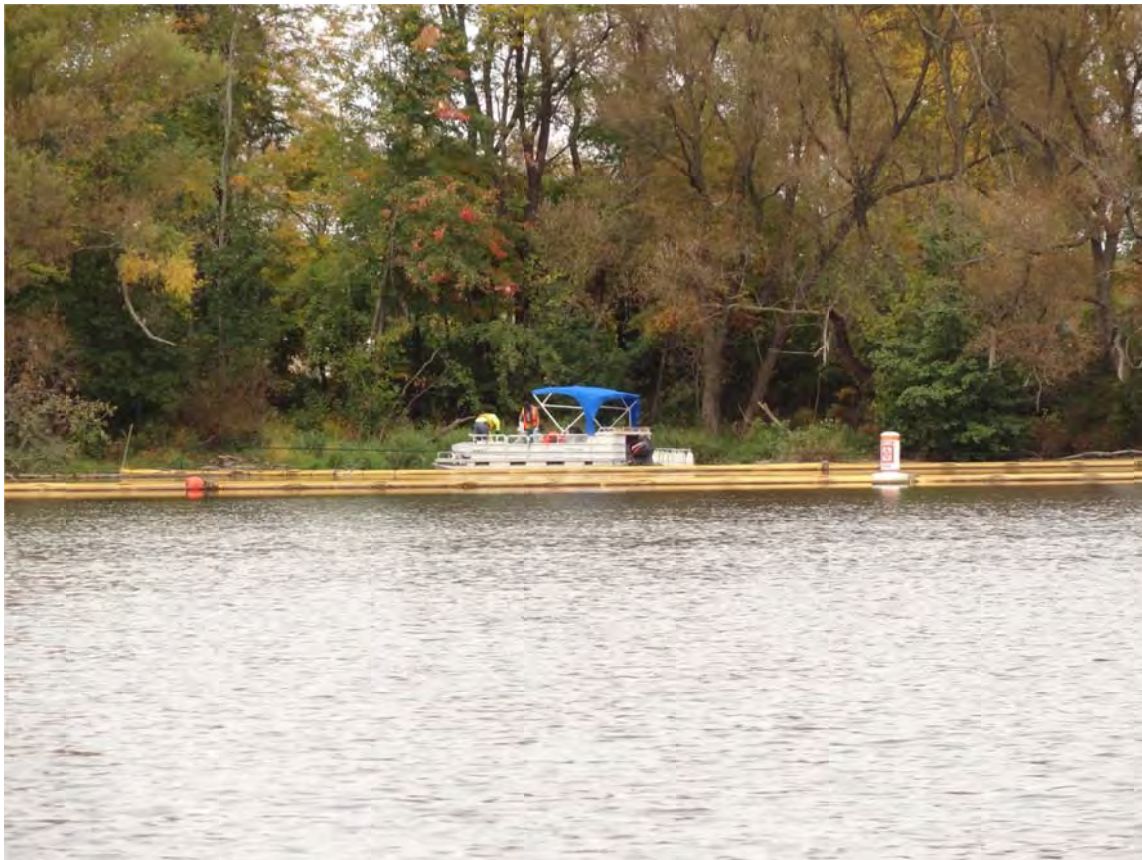
**15. Crews removing debris from E2 control point boom in Morrow Lake Delta.**

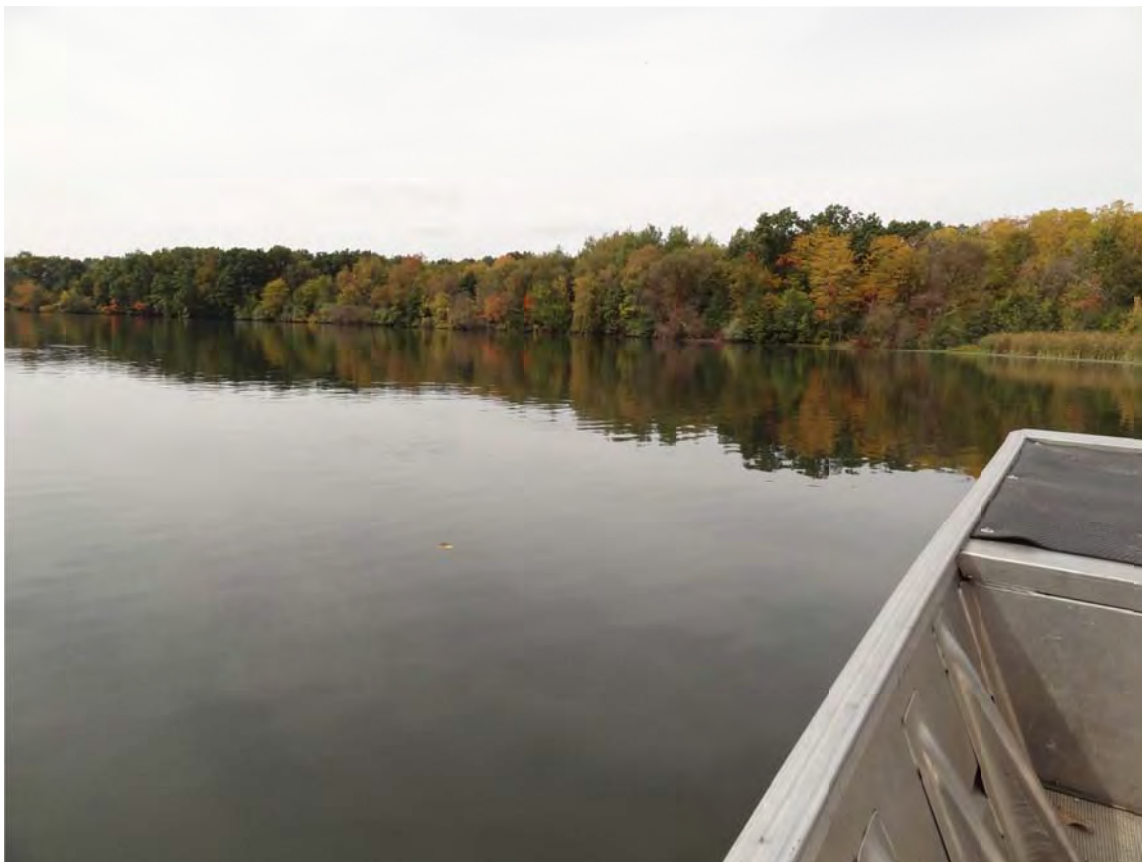
**16. North cove of Morrow Lake. No sheen observed.**

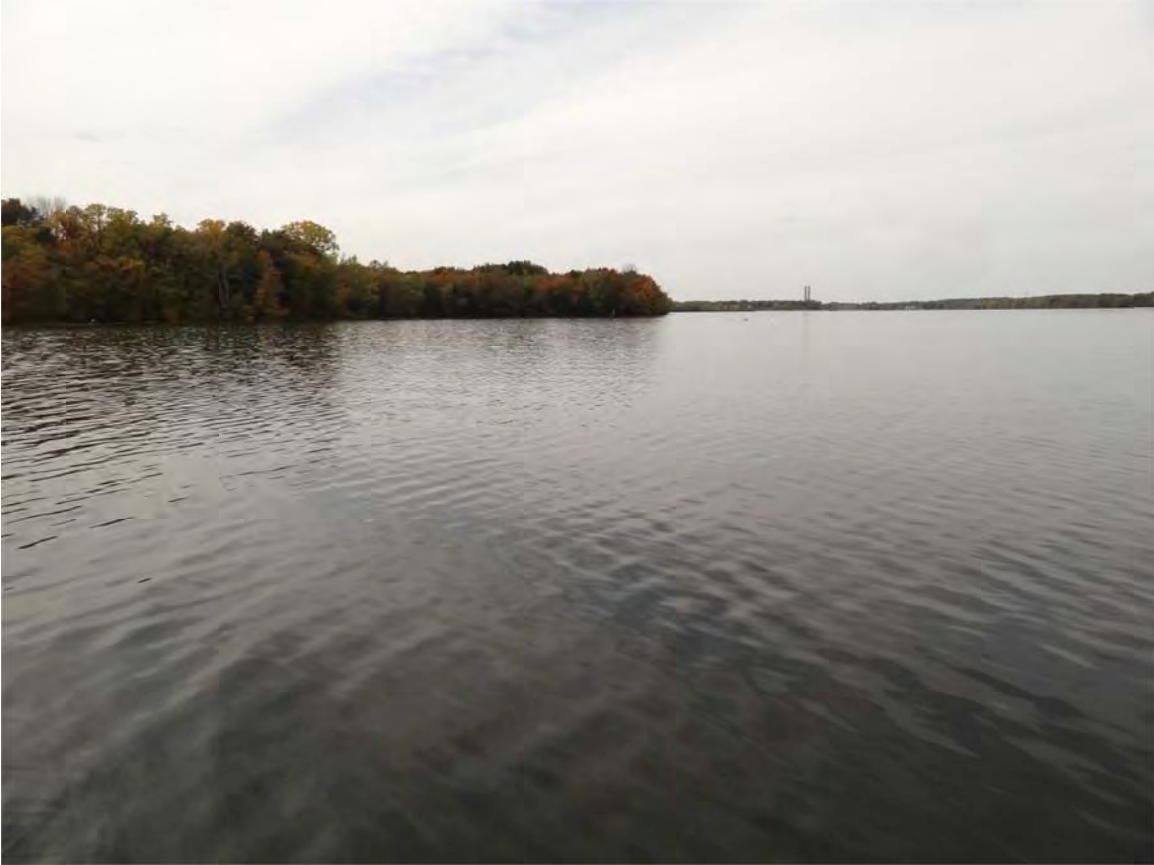
**17. South cove of Morrow Lake, no sheen or tar globules observed.**

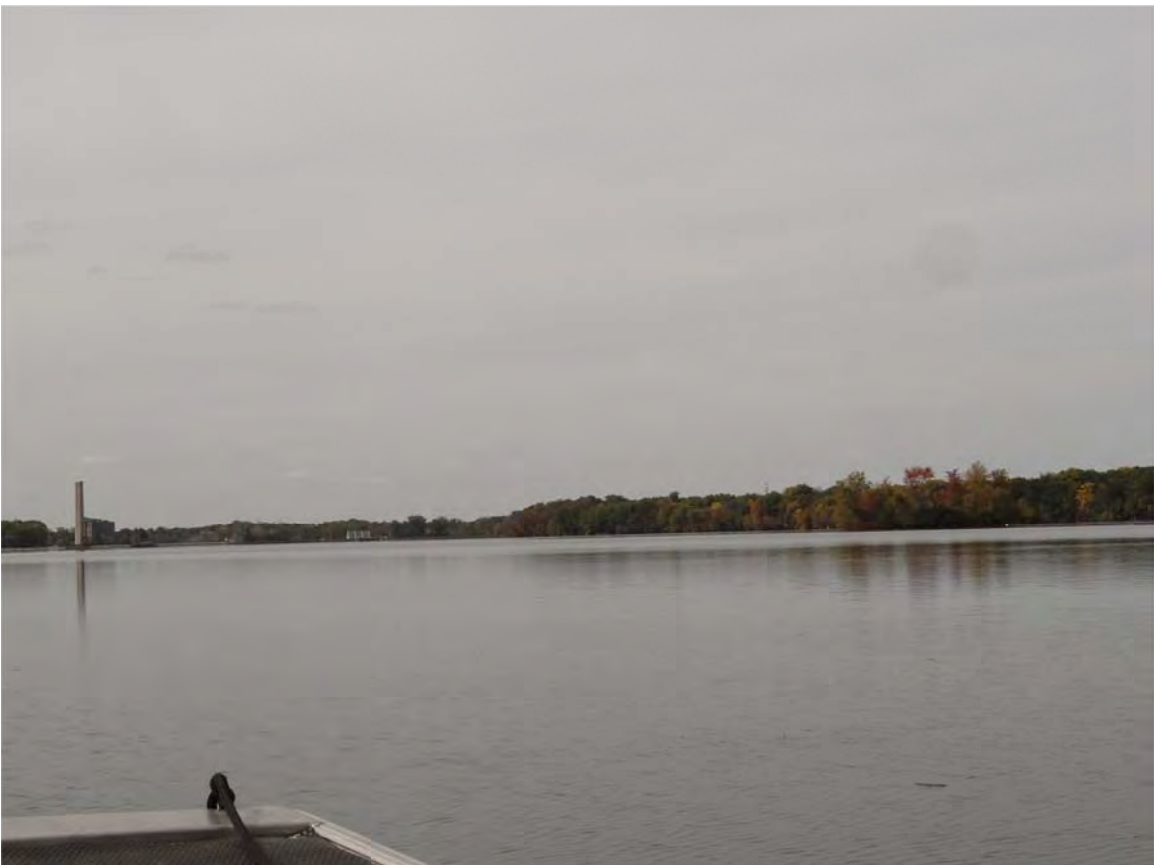
**18. Main river channel of Morrow Lake, no sheen or tar globules observed.**
