Situation Photo Log

Tuesday, October 2, 2012

Kalamazoo River / Enbridge Spill

Prepared by:
Larry Rader
START-USEPA
Situation Unit Leader

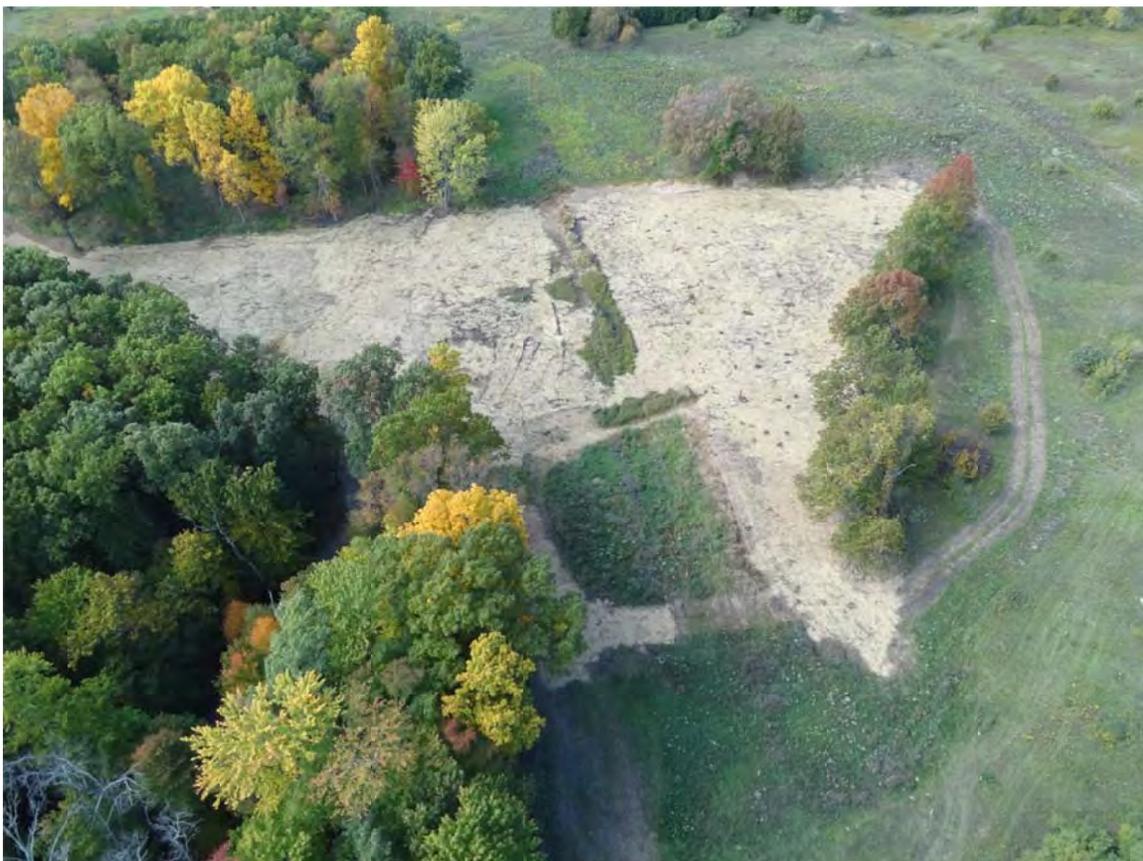
1. Source Area, restoration activities appear complete.

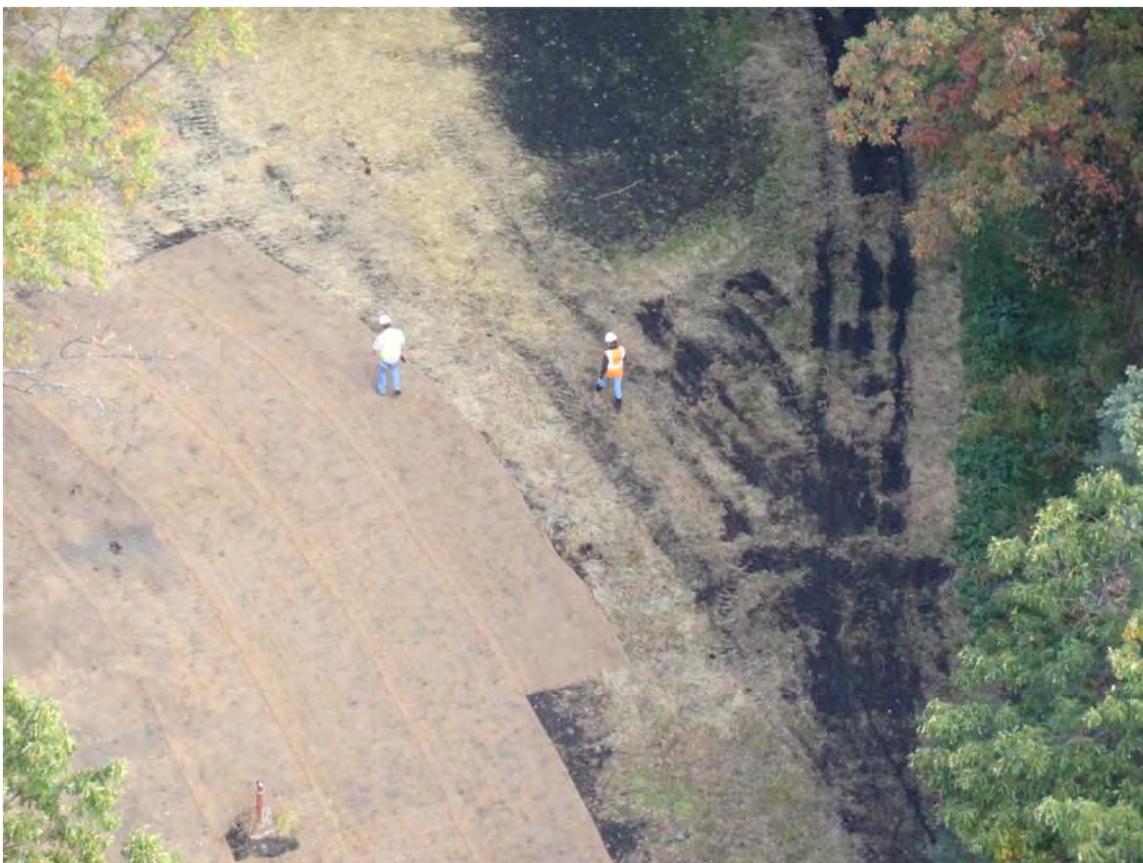
2. Source area, crews observed inspecting monitoring wells south of the pipeline.

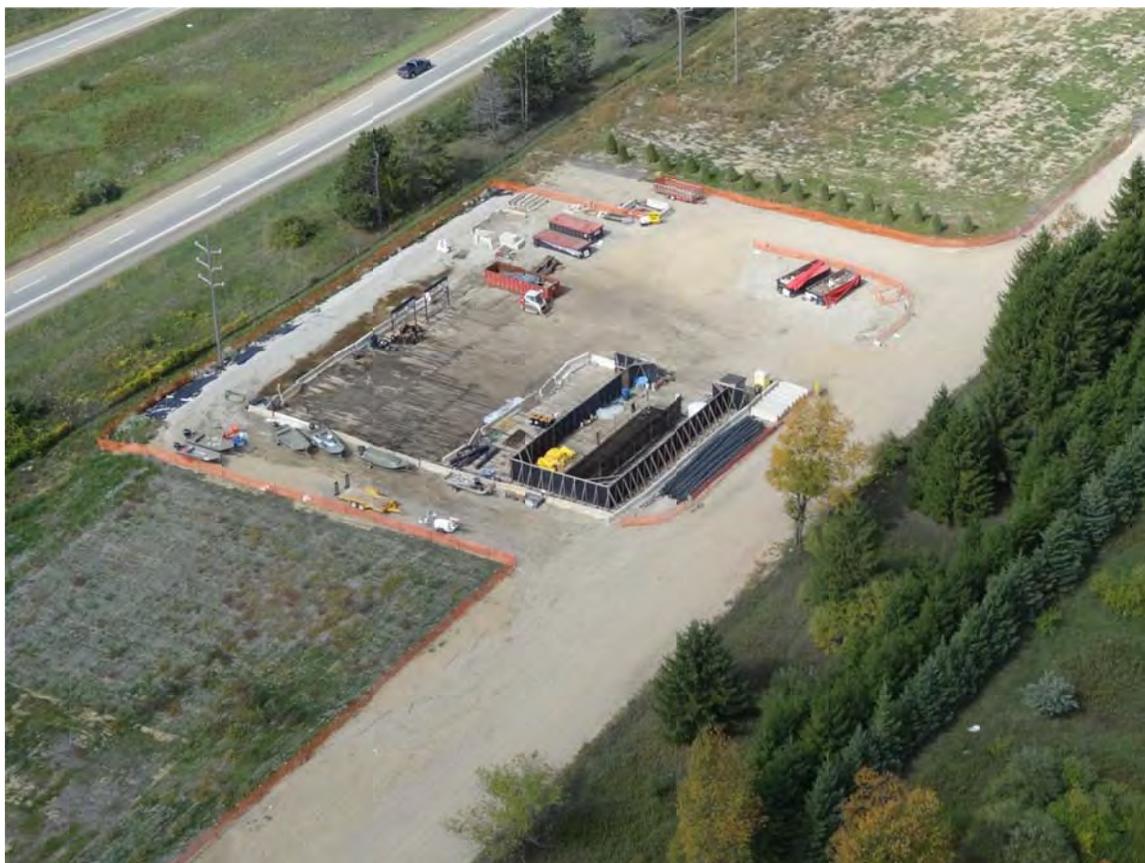
3. Frac-Tank City, no activity observed.

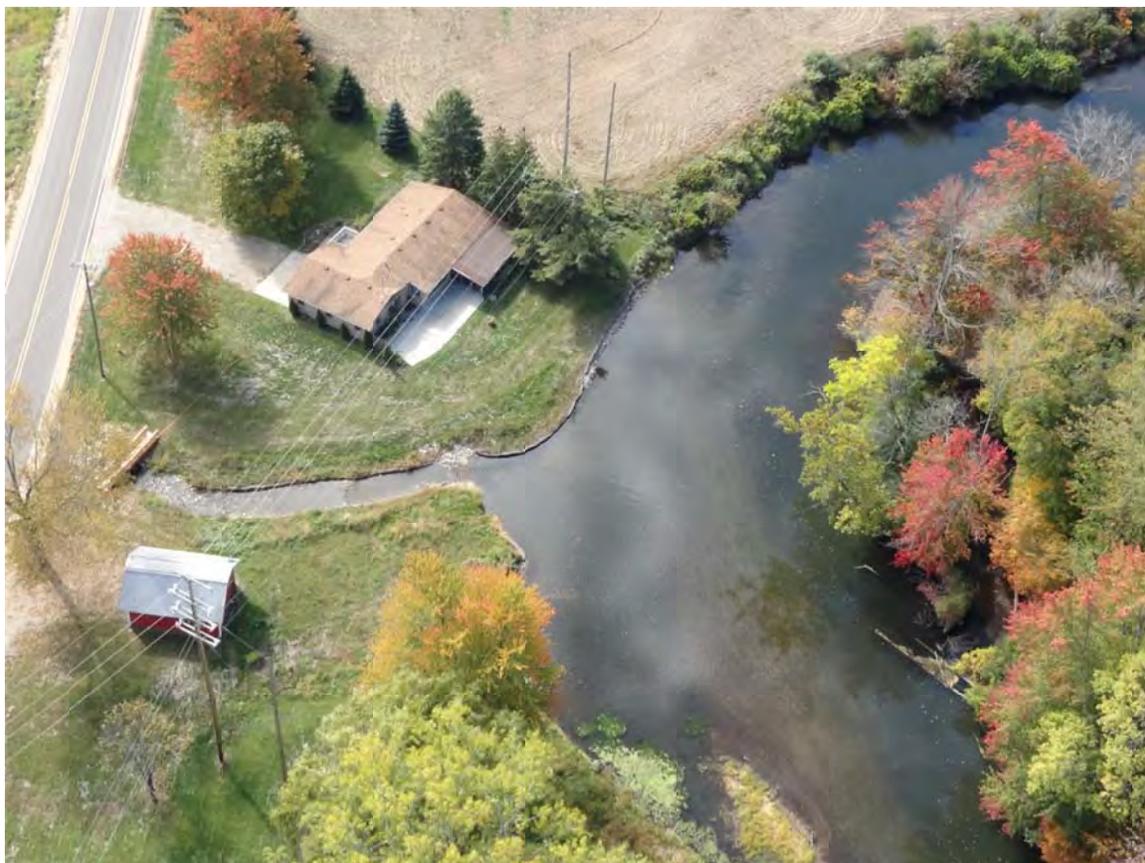
4. Confluence, no sheen or activity observed.

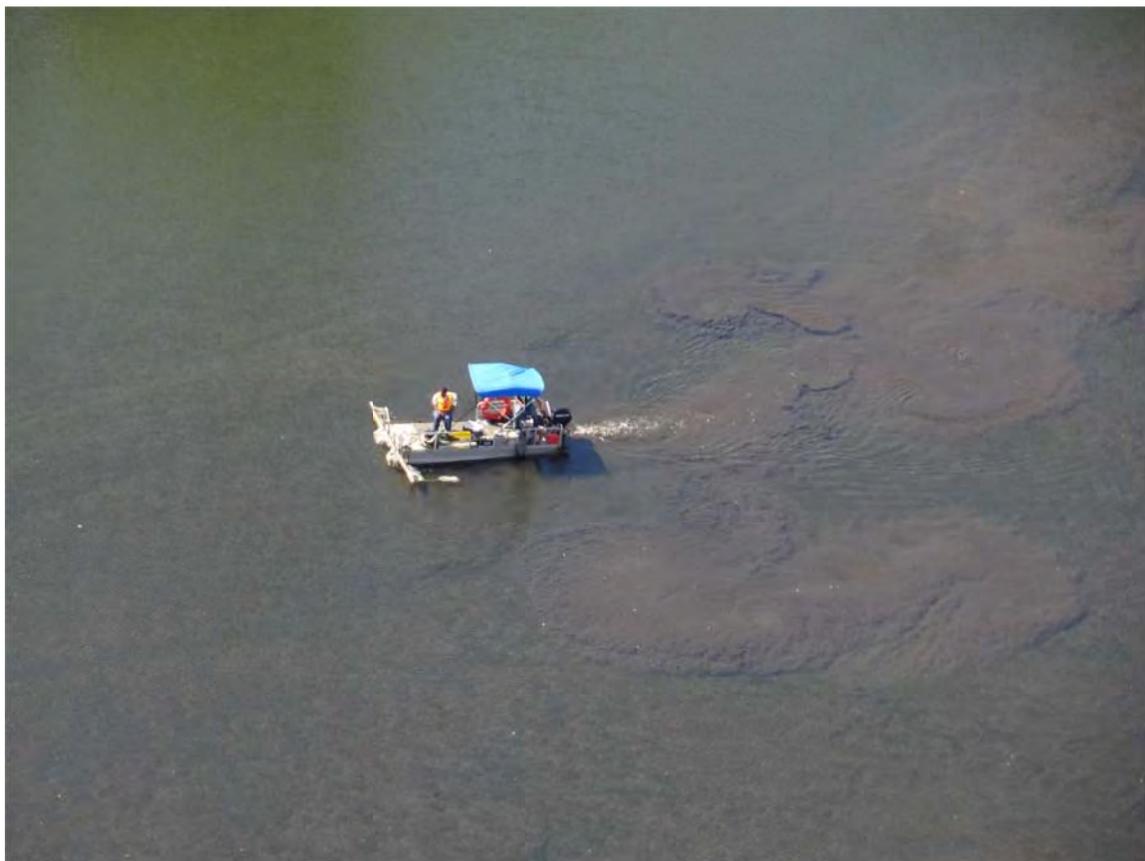
5. Sheen sweeper boat observed in river channel near MP 5.00.

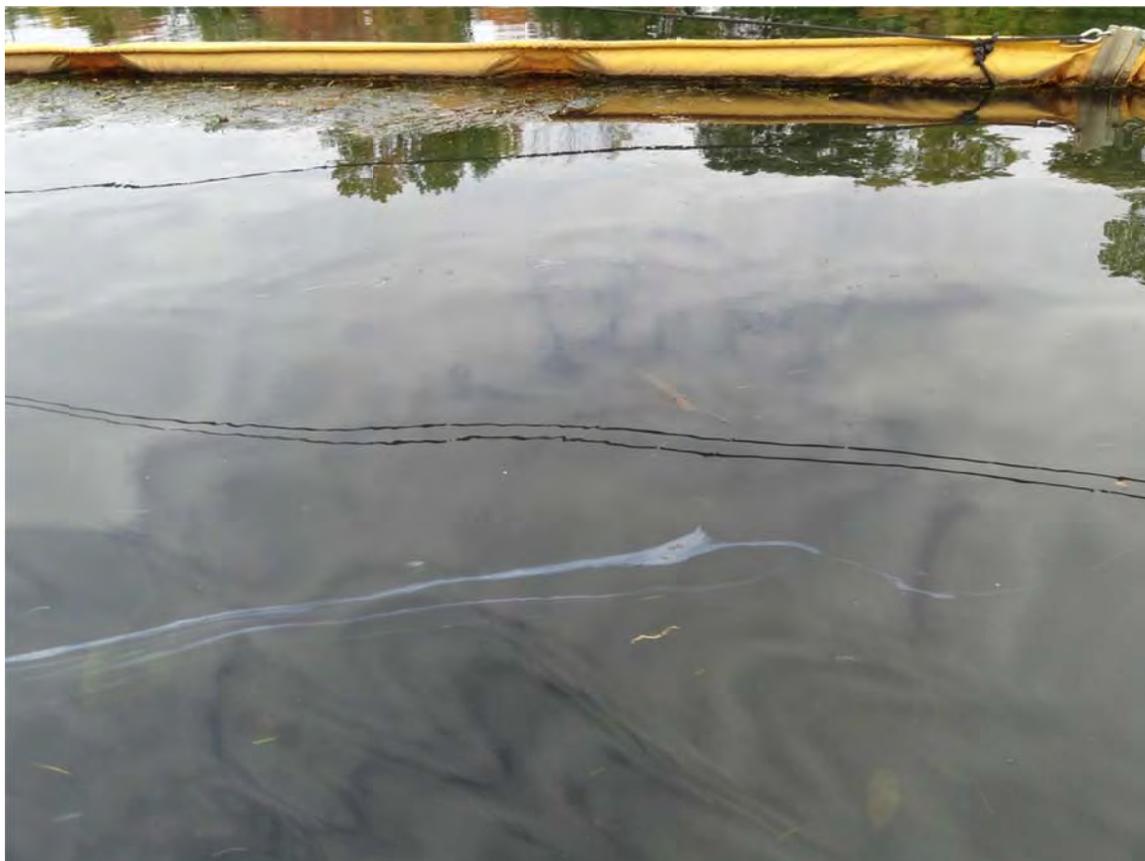
6. Sheen observed along Ceresco Dam control point.

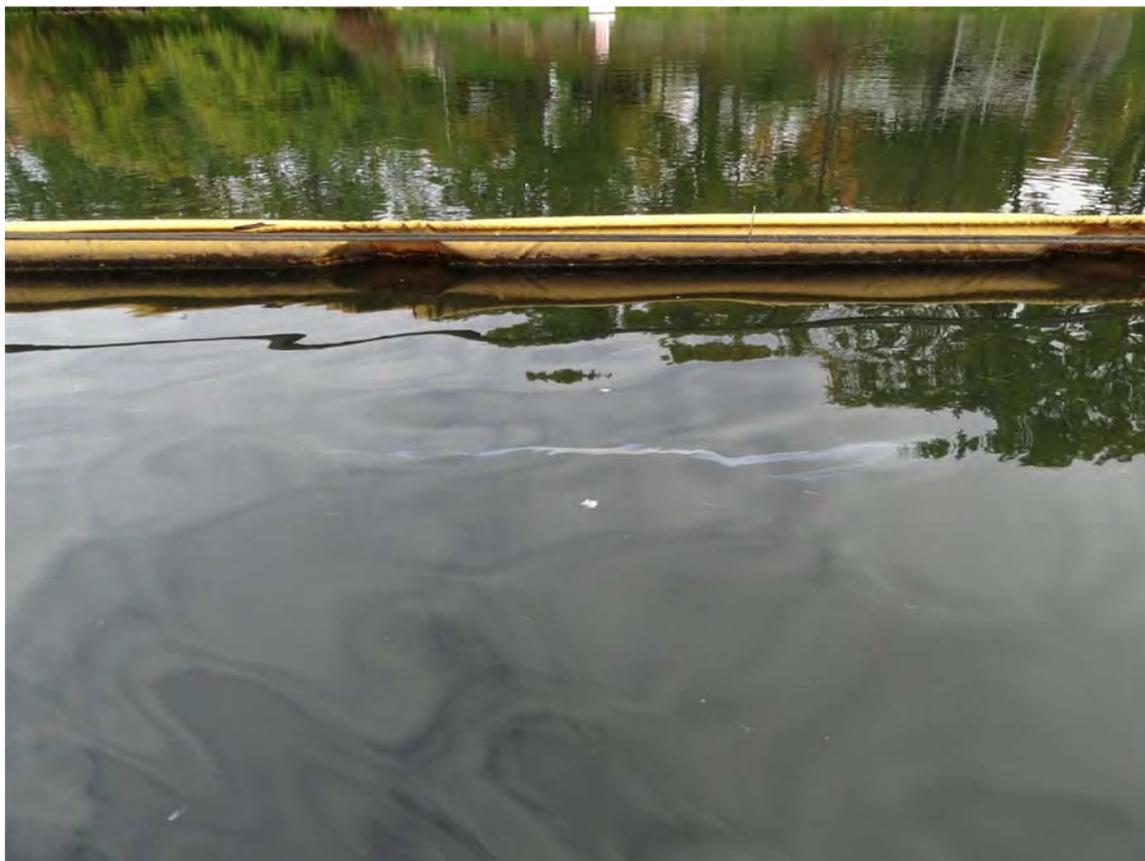
7. Sheen and tar globules observed along Ceresco Dam control point.

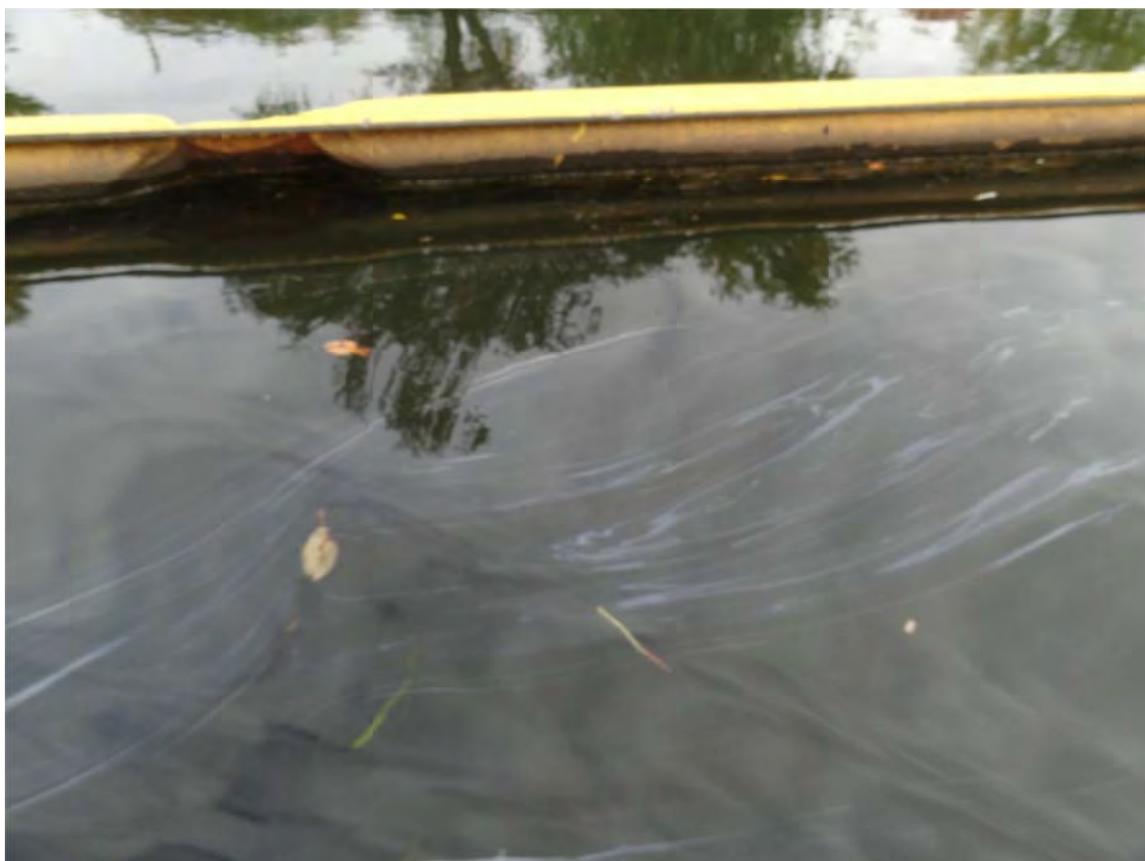
8. Sheen observed along Ceresco Dam control point.

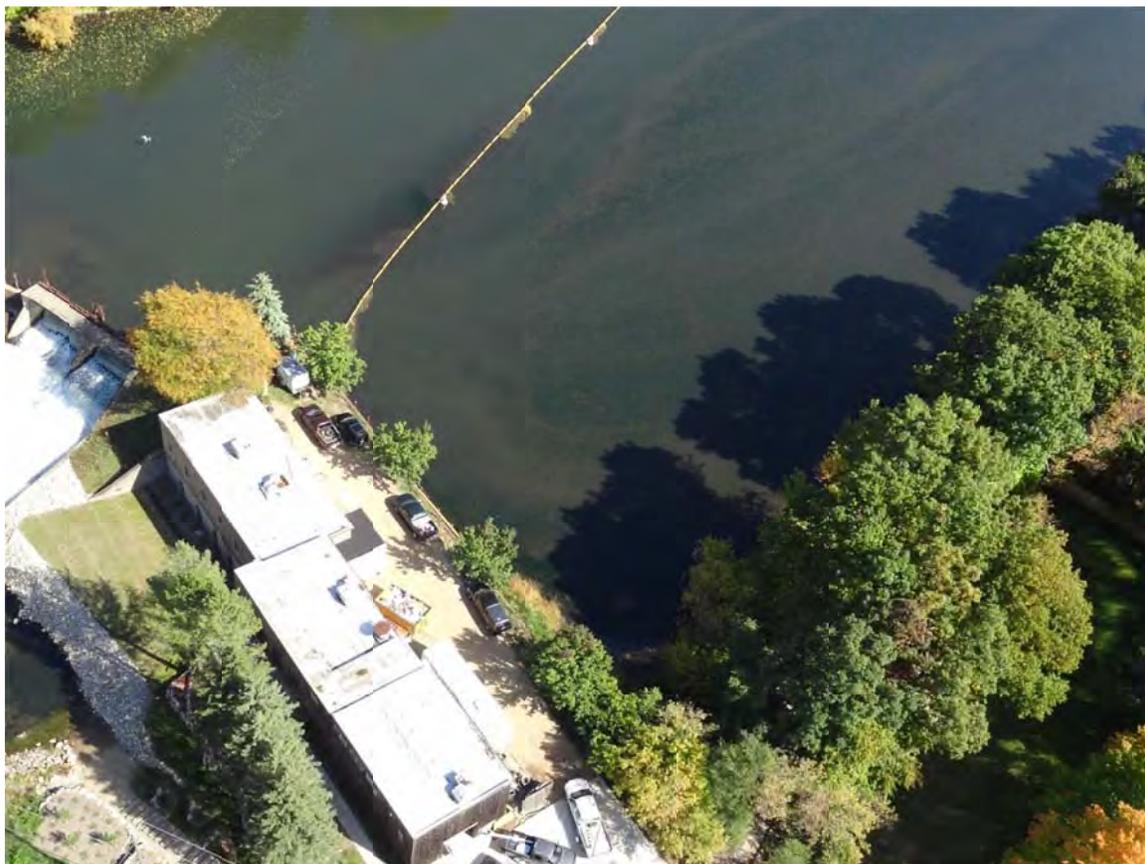
9. Overview of Ceresco Dam during afternoon overflight, no sheen observed.

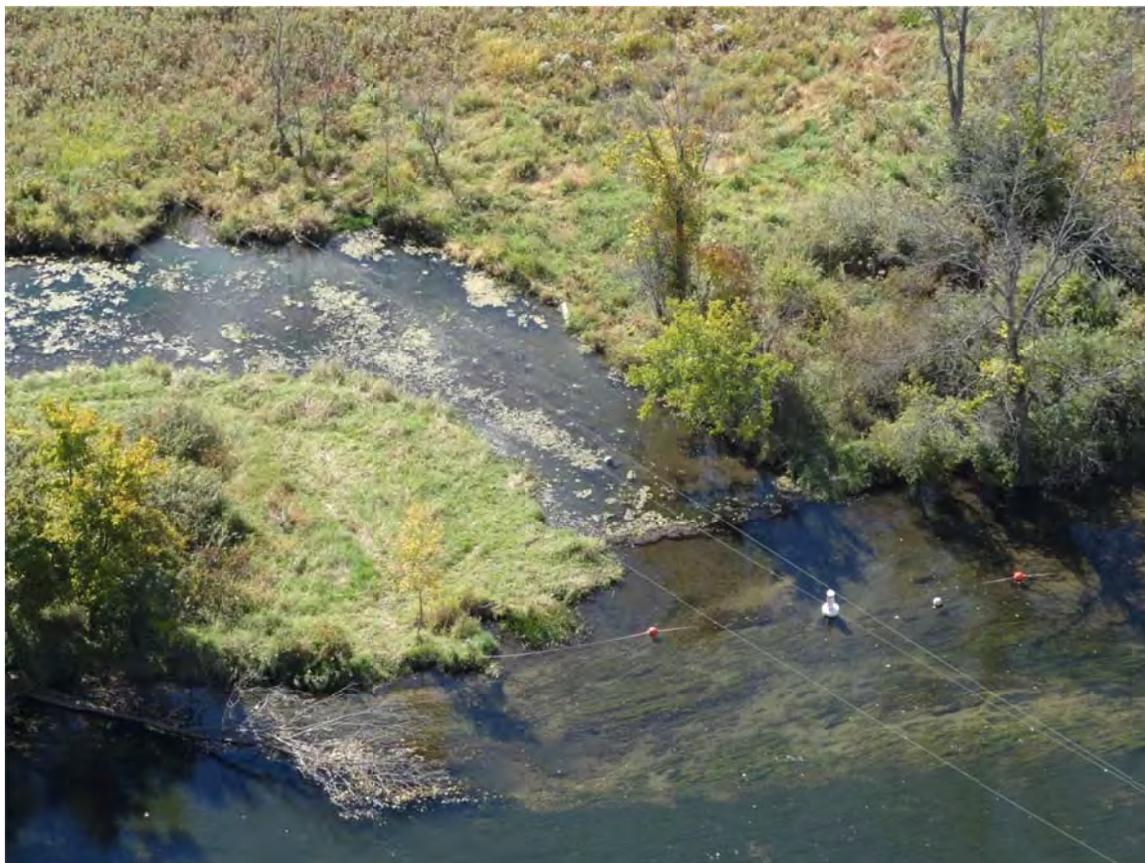
10. MP10.75 sediment trap, no sheen observed.

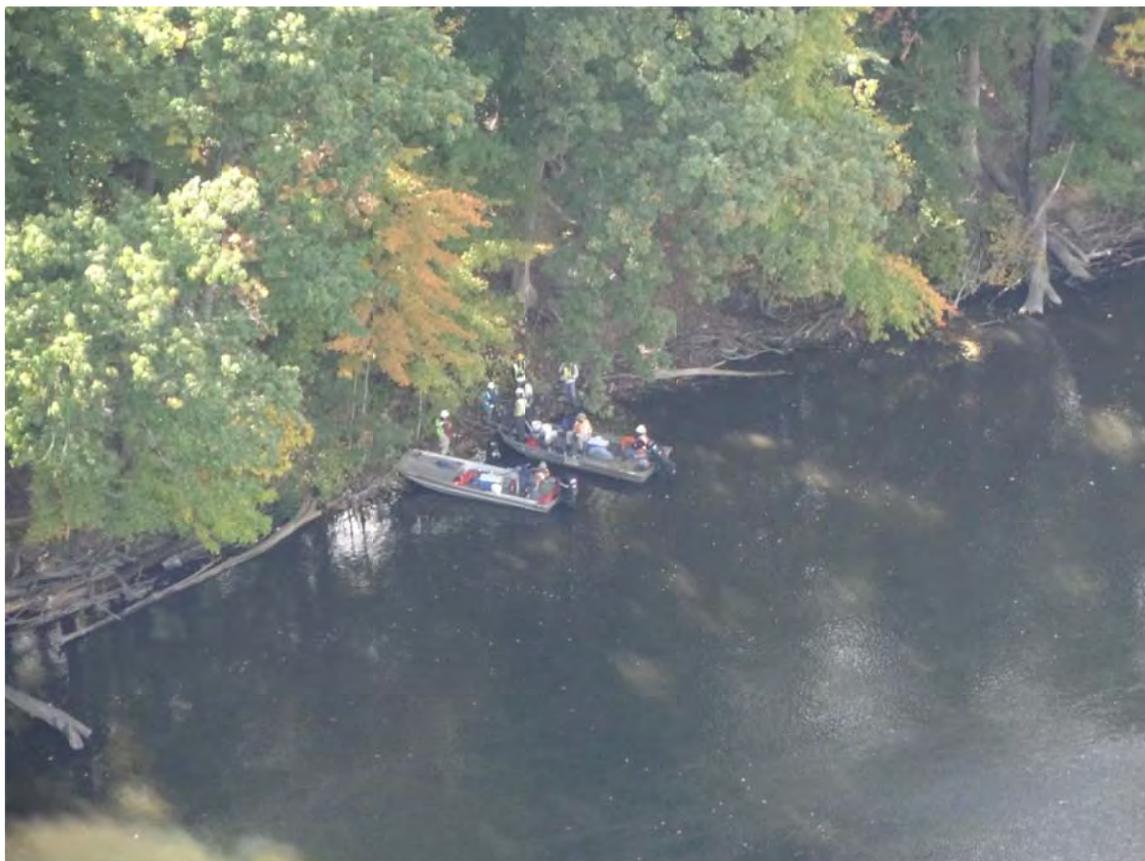
11. RI crews observed along LDB near MP 14.5 upstream from Mill Ponds.

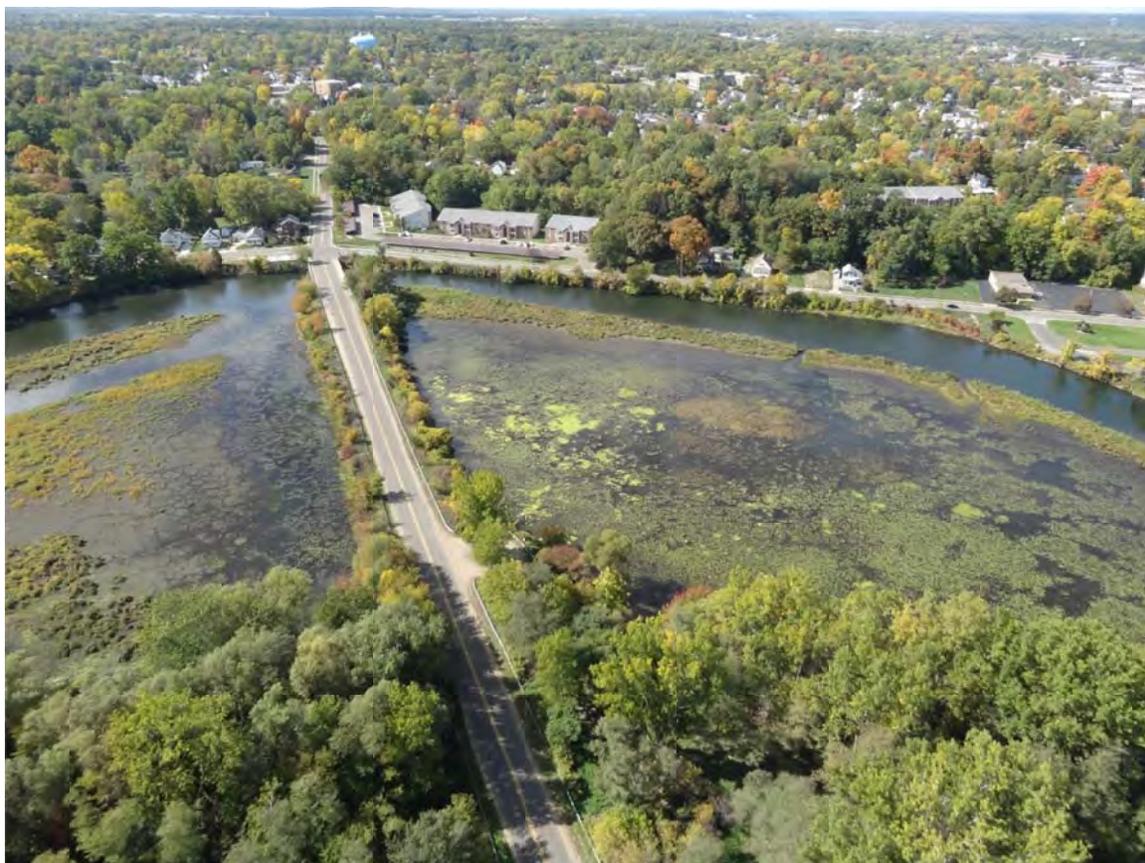
12. MP15.5 Mill Ponds, no sheen observed during overflight.

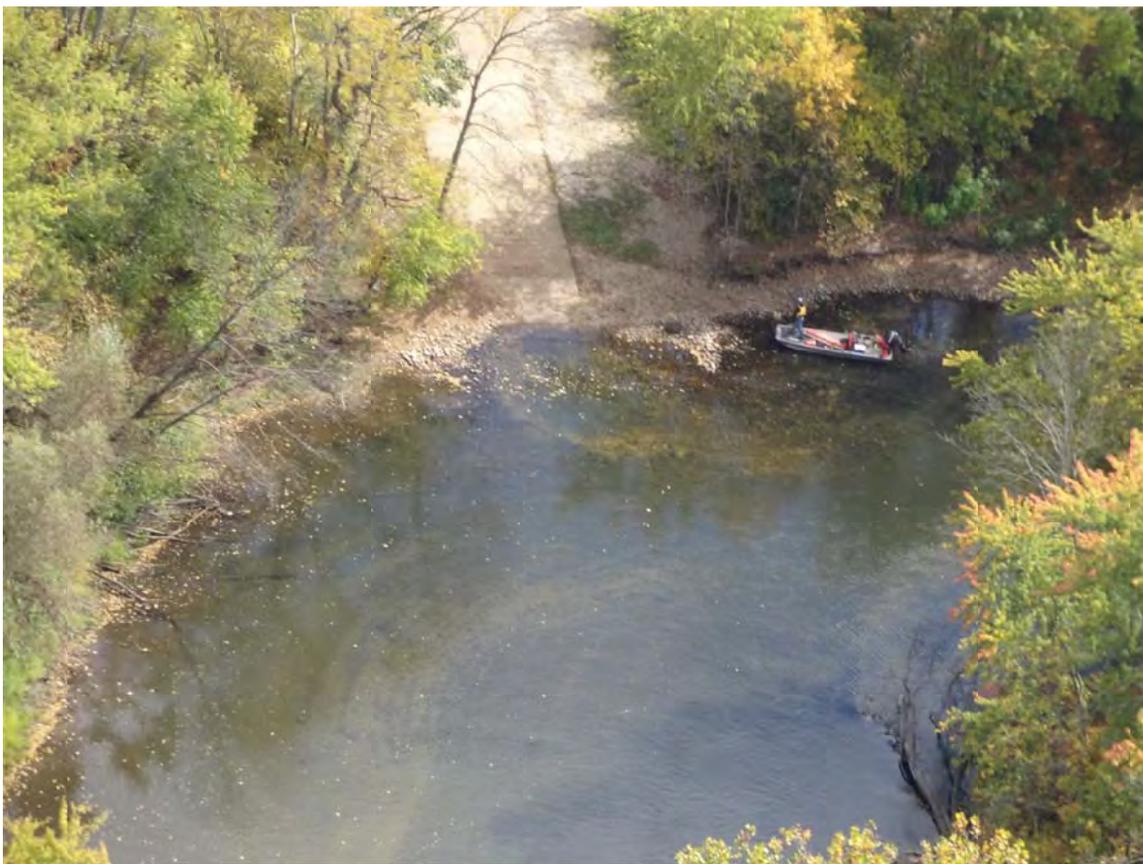
13. Enbridge safety boat observed at Fort Custer boat launch.

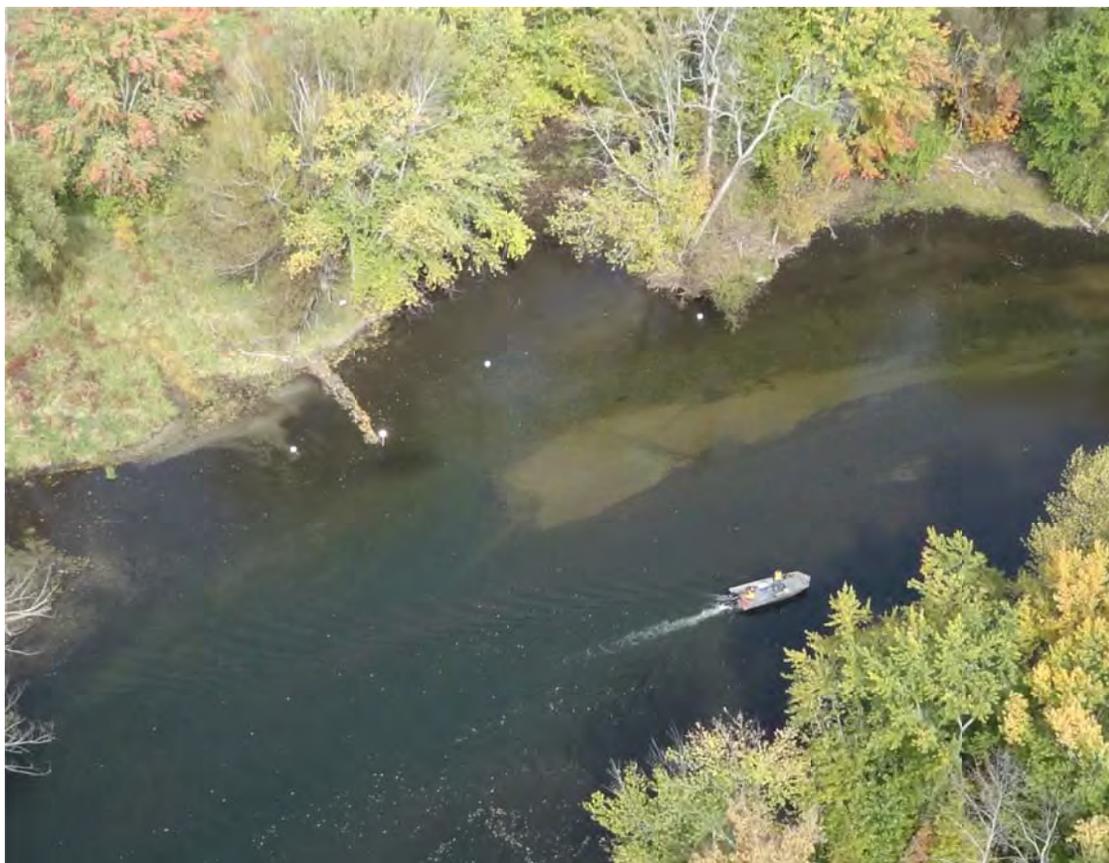
14. MP33.0A, observed boat crew near sediment trap.

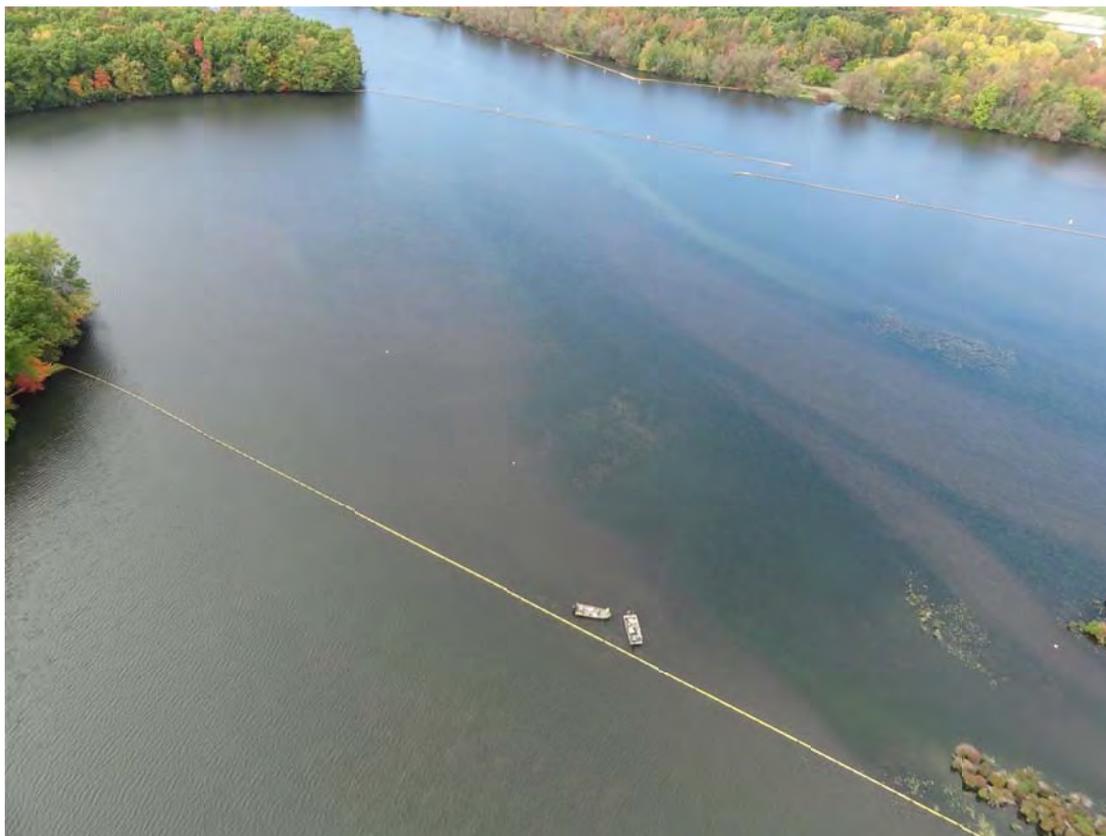
15. Morrow Lake Delta, poling crew observed along boom configuration B.

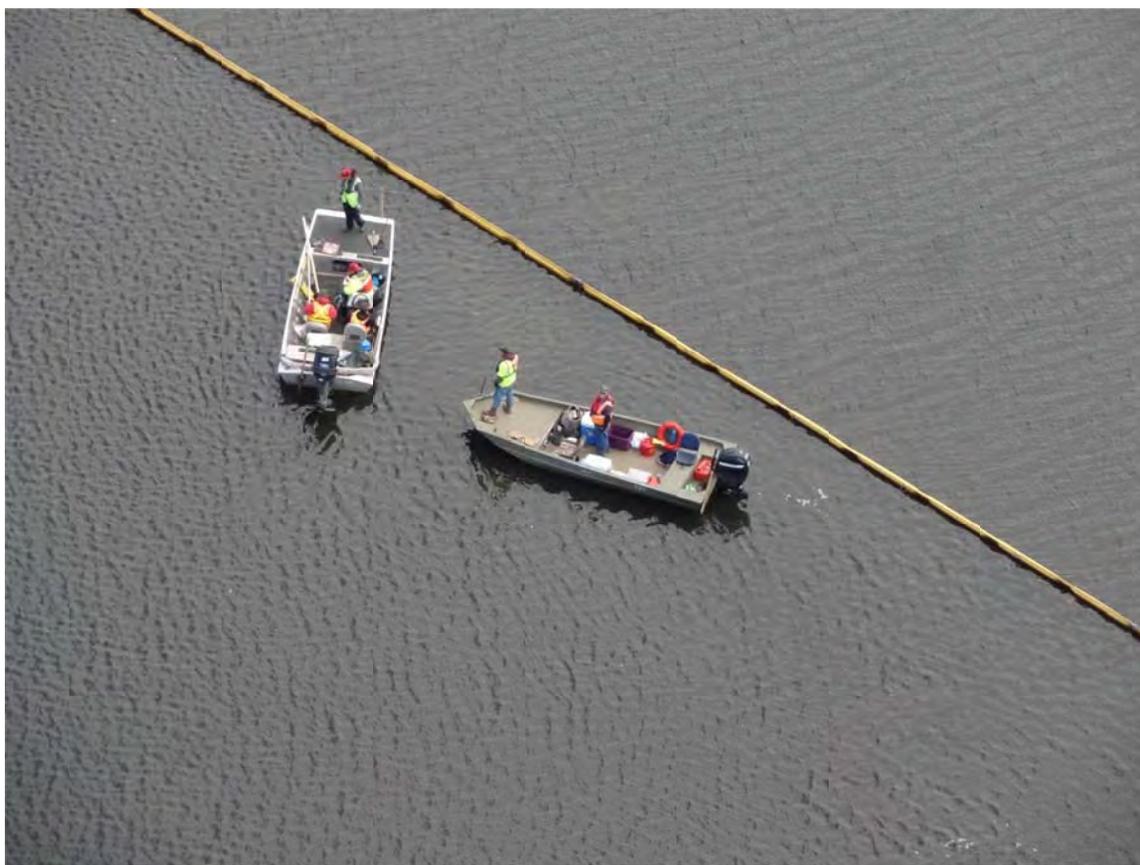
16. Morrow Lake Delta, poling crew observed along boom configuration B.

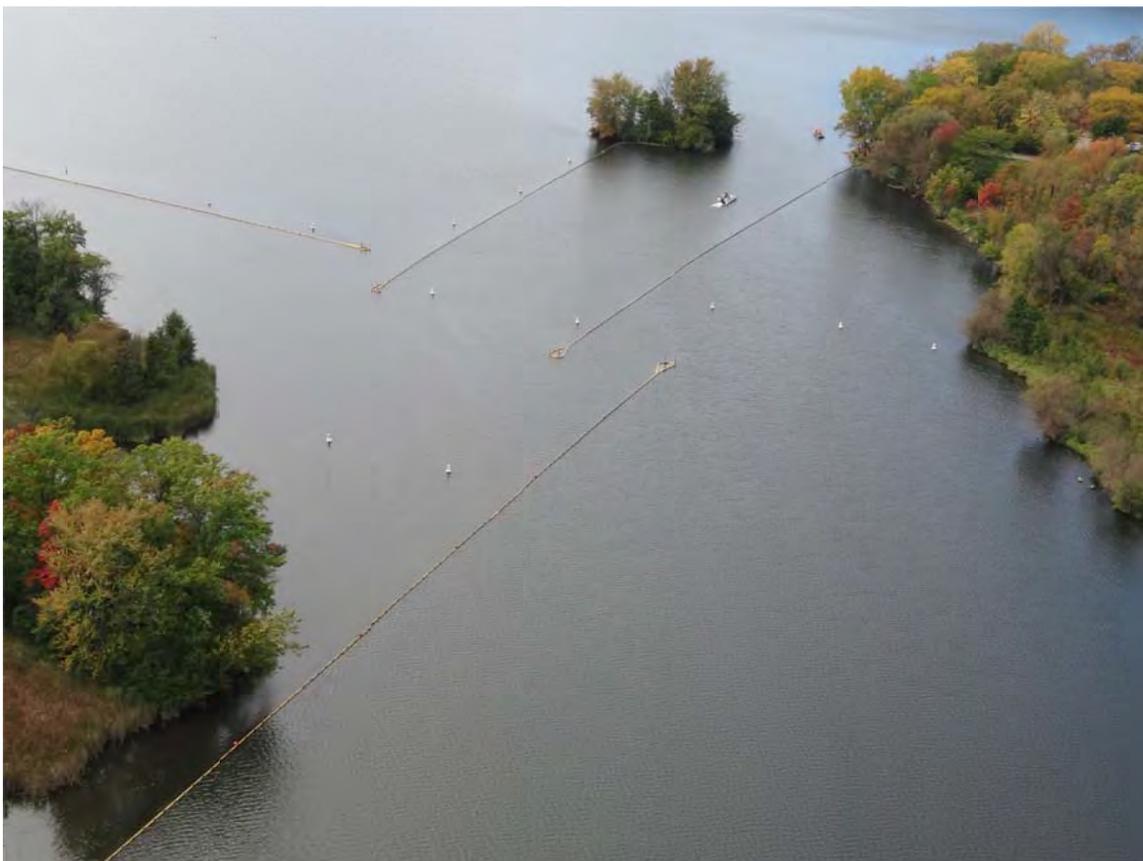
17. Overview of boom configuration at neck of Morrow Lake Delta.

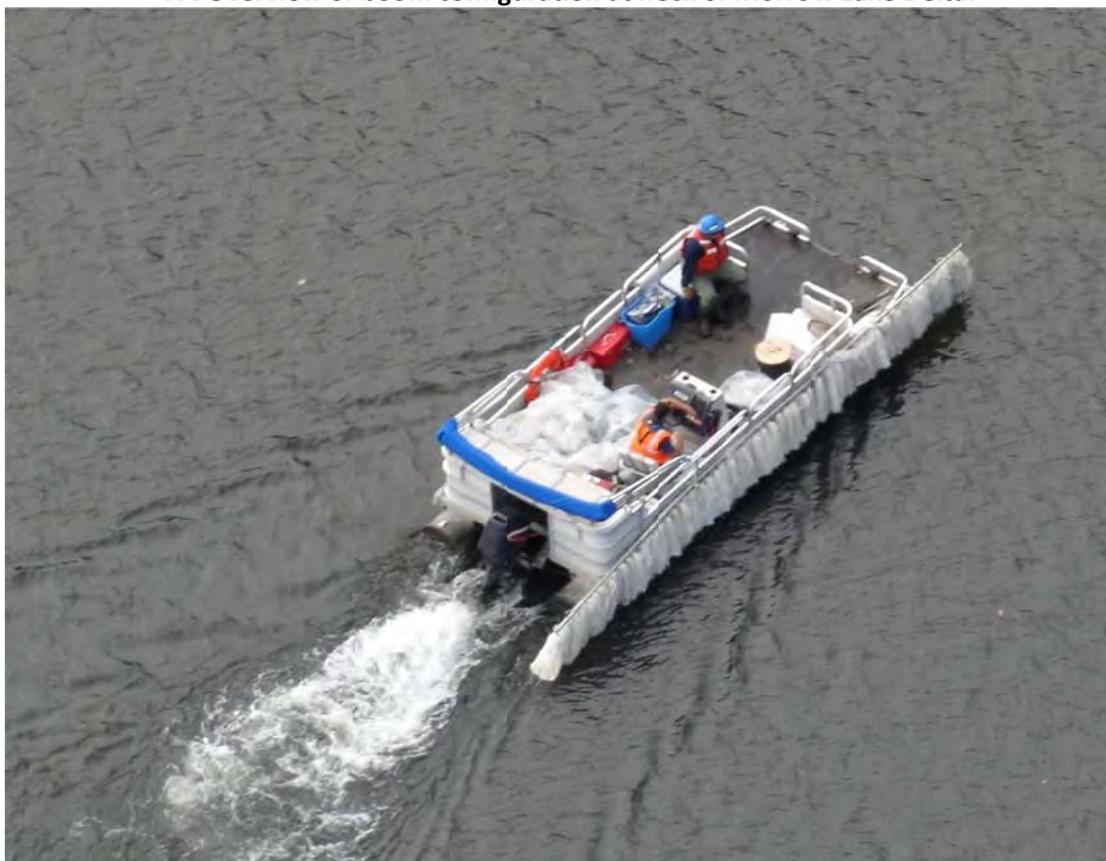
18. Pontoon boat crew observed hauling debris bags to the E4 boat launch.

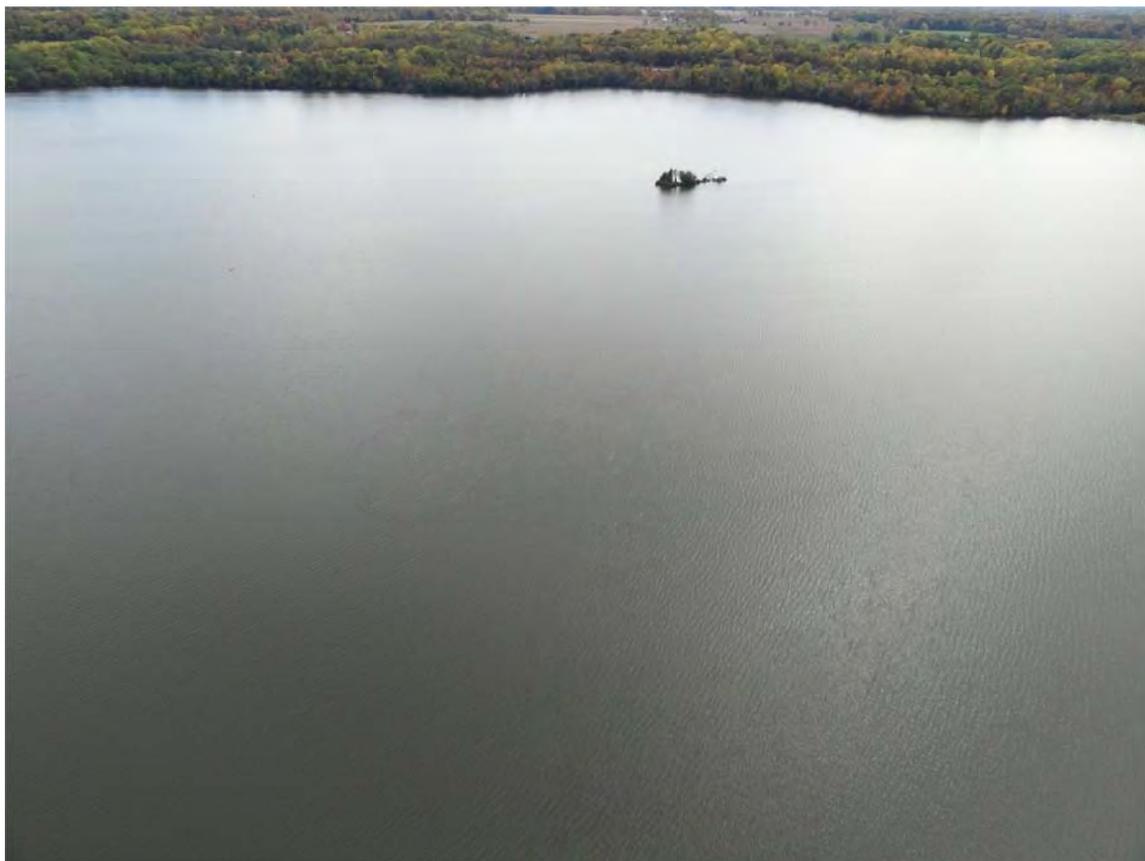
19. Main channel of Morrow Lake, no sheen observed.

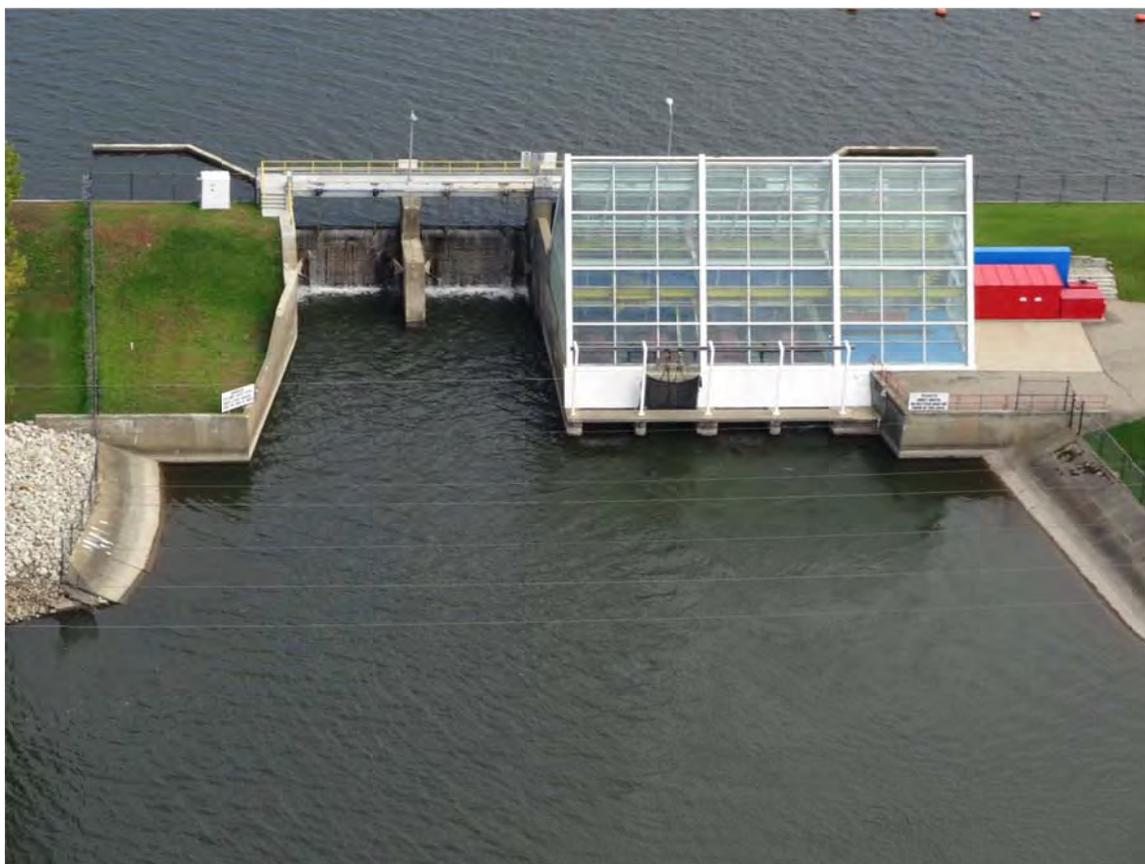
20. Morrow Lake Dam, flow observed through both spillways.
