# Situation Photo Log

Saturday, October 6, 2012

Kalamazoo River / Enbridge Spill

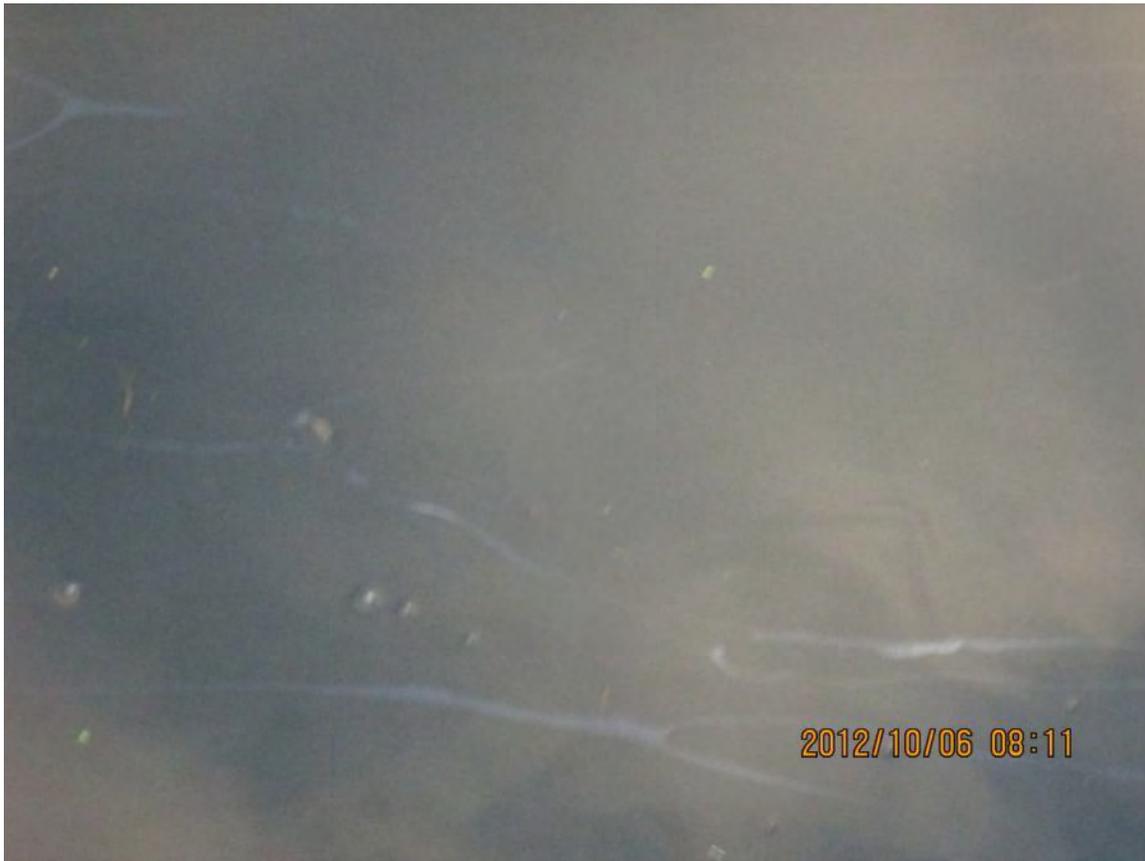
1. MP5.35 LDB, spontaneous ribbons of sheen observed along shoreline.

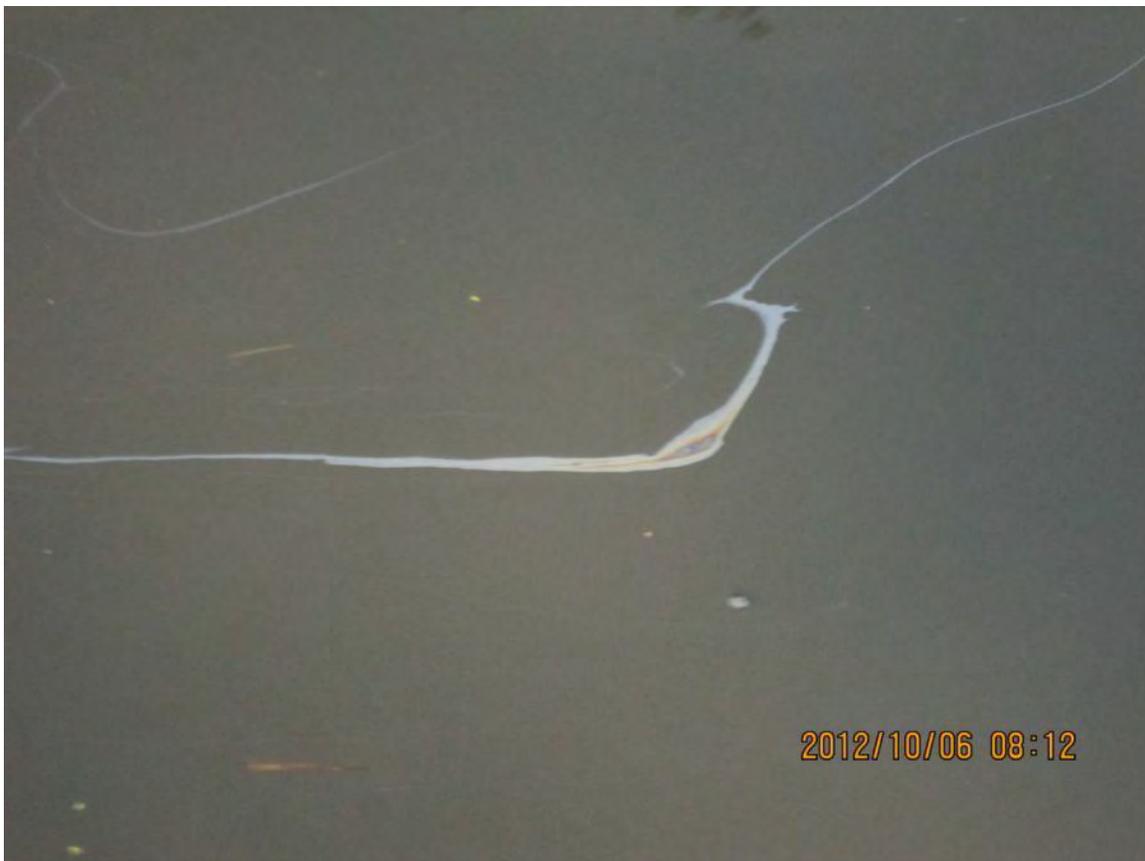
2. MP5.40 LDB, spontaneous sheen and tar globule observed along shoreline.

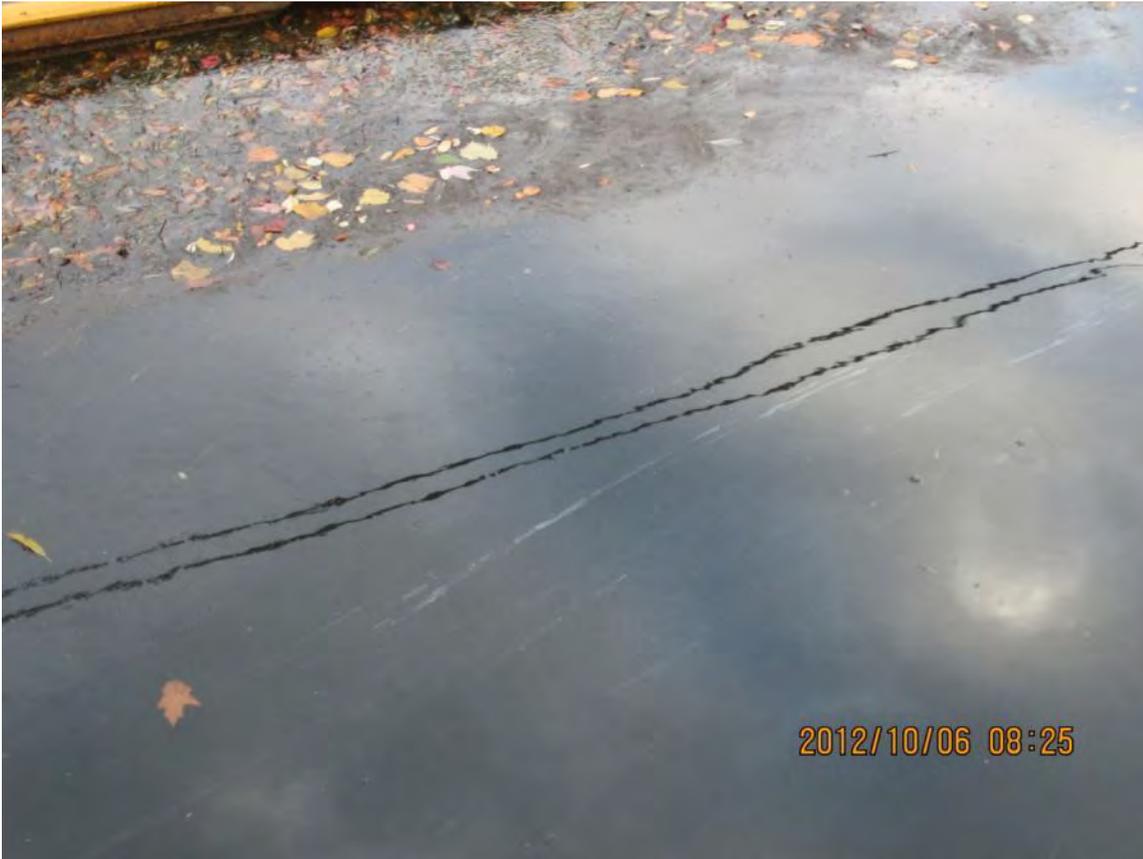
3. Spontaneous sheen and debris within containment at Ceresco Dam control point.

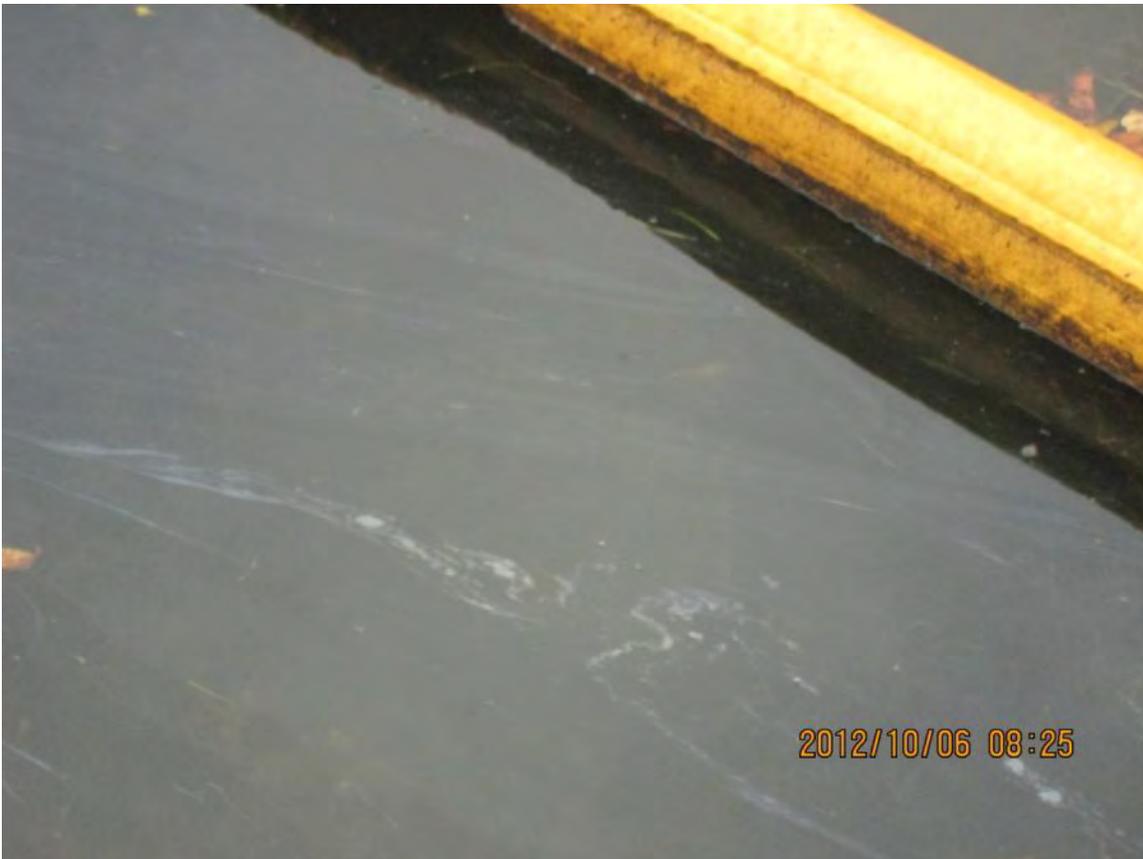
4. Spontaneous ribbons of sheen observed within containment at Ceresco Dam control point.

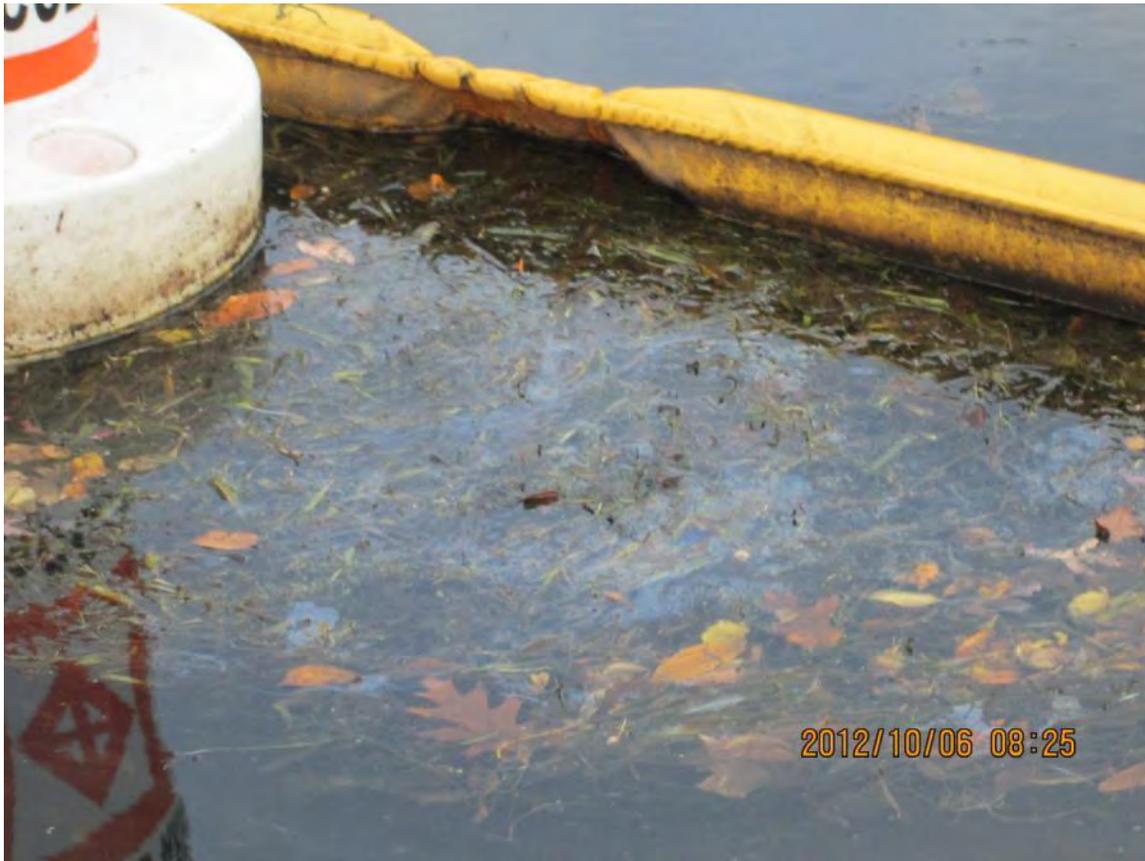
5. MP5.70 sheen observed within debris along Ceresco containment boom.

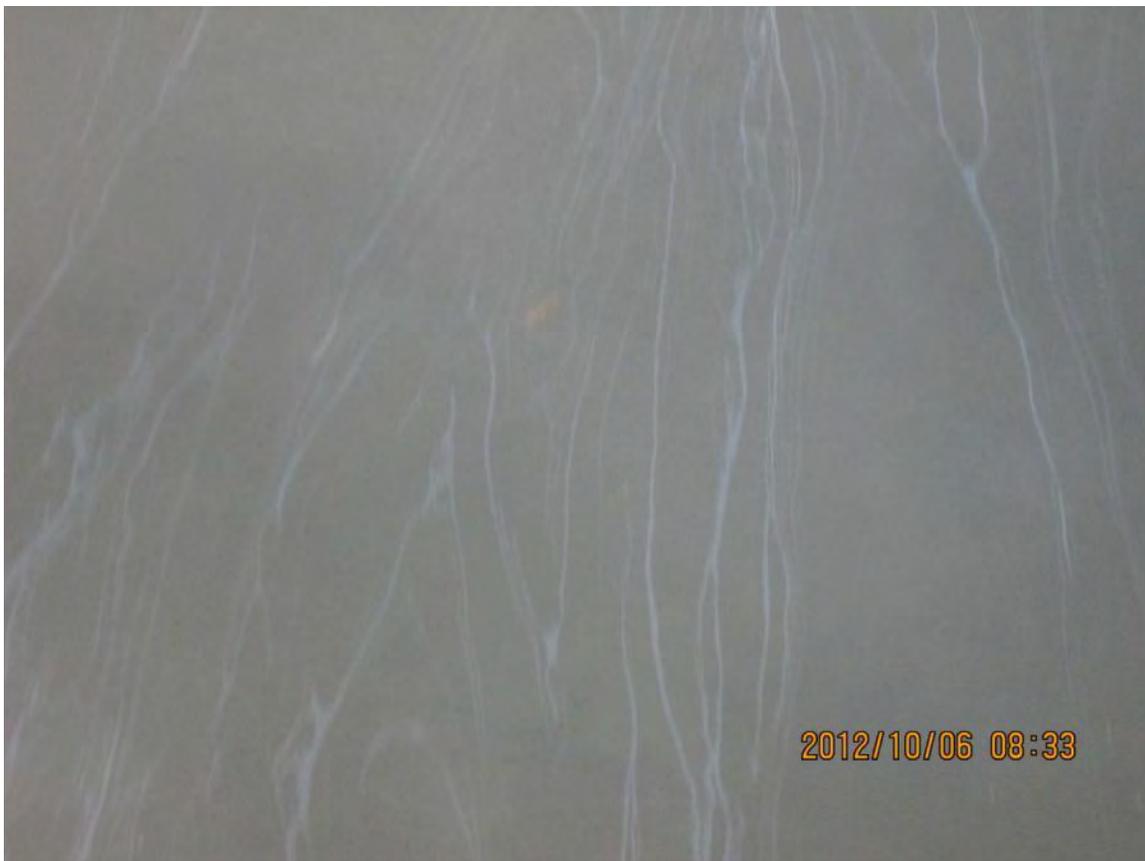
6. MP5.65 spontaneous ribbons of sheen observed within containment at Ceresco Dam control point

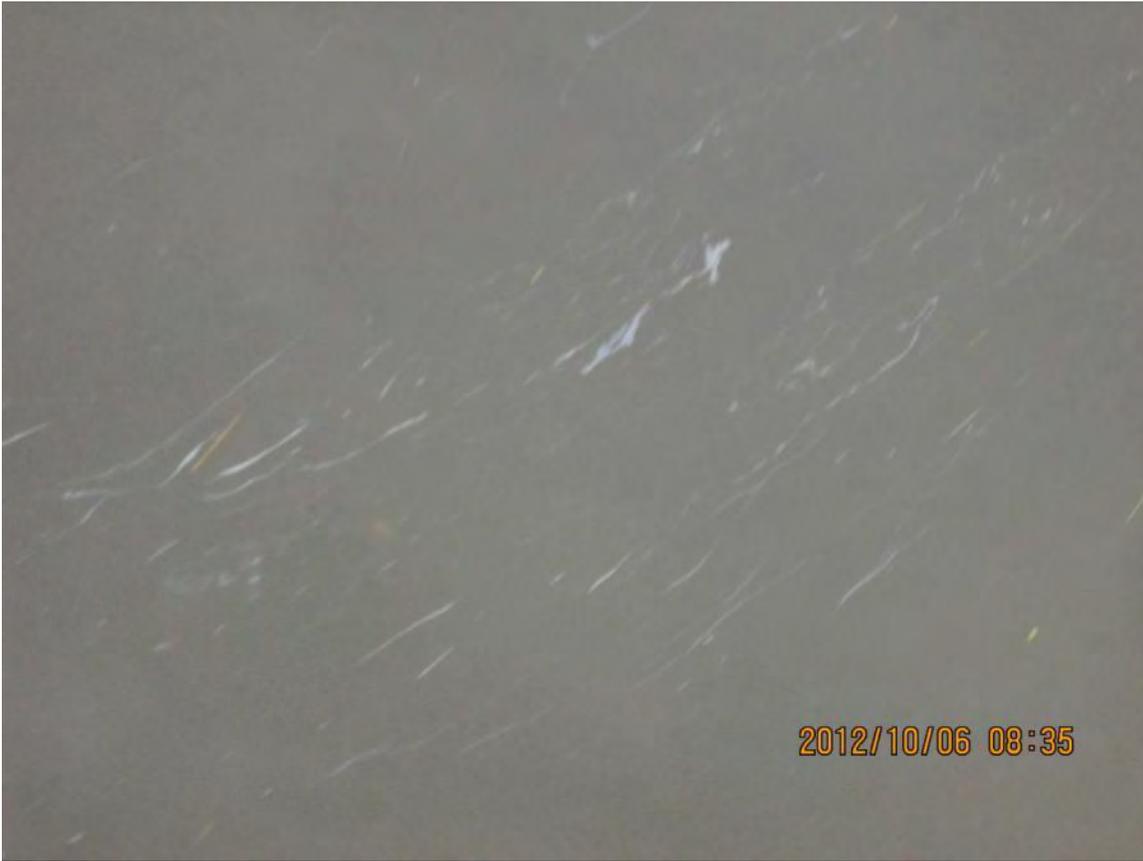
7. MP 5.65 RDB spontaneous ribbons of sheen observed.

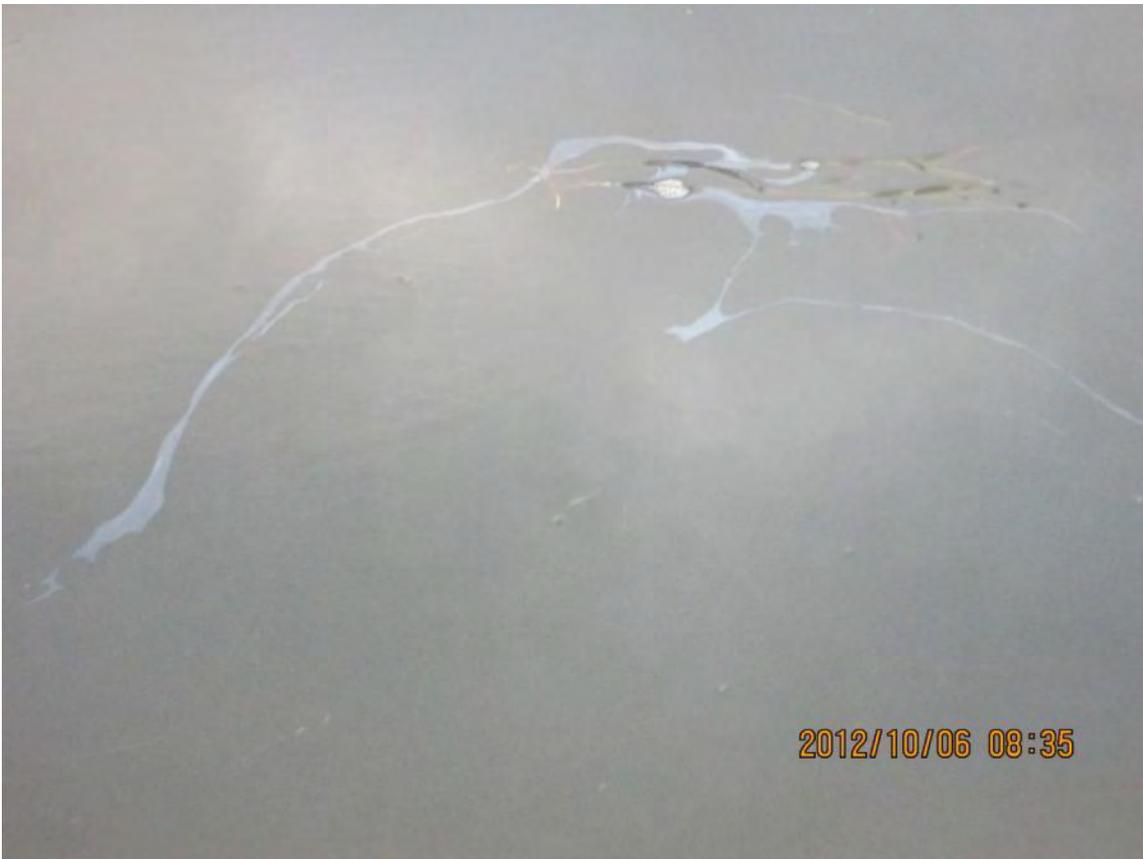
8. MP 5.63 RDB spontaneous ribbon of sheen observed.

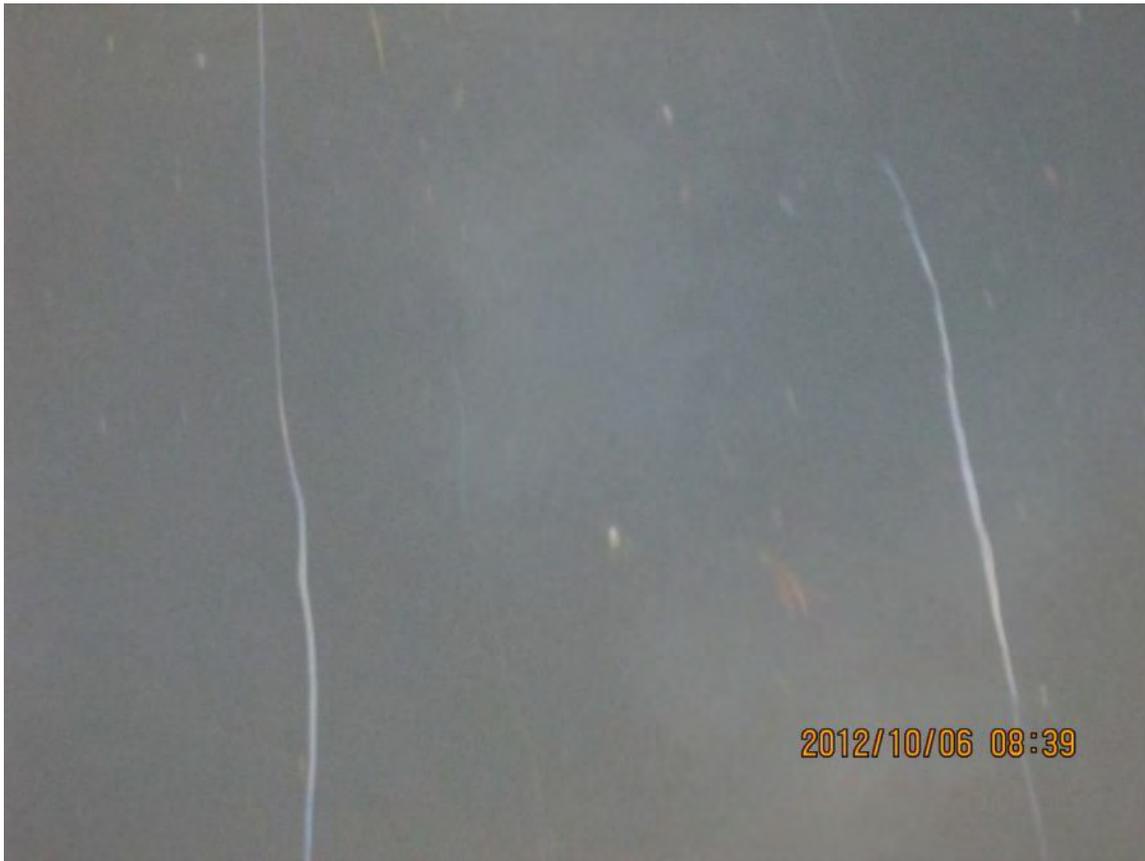
9. MP5.60 spontaneous ribbons of sheen observed.

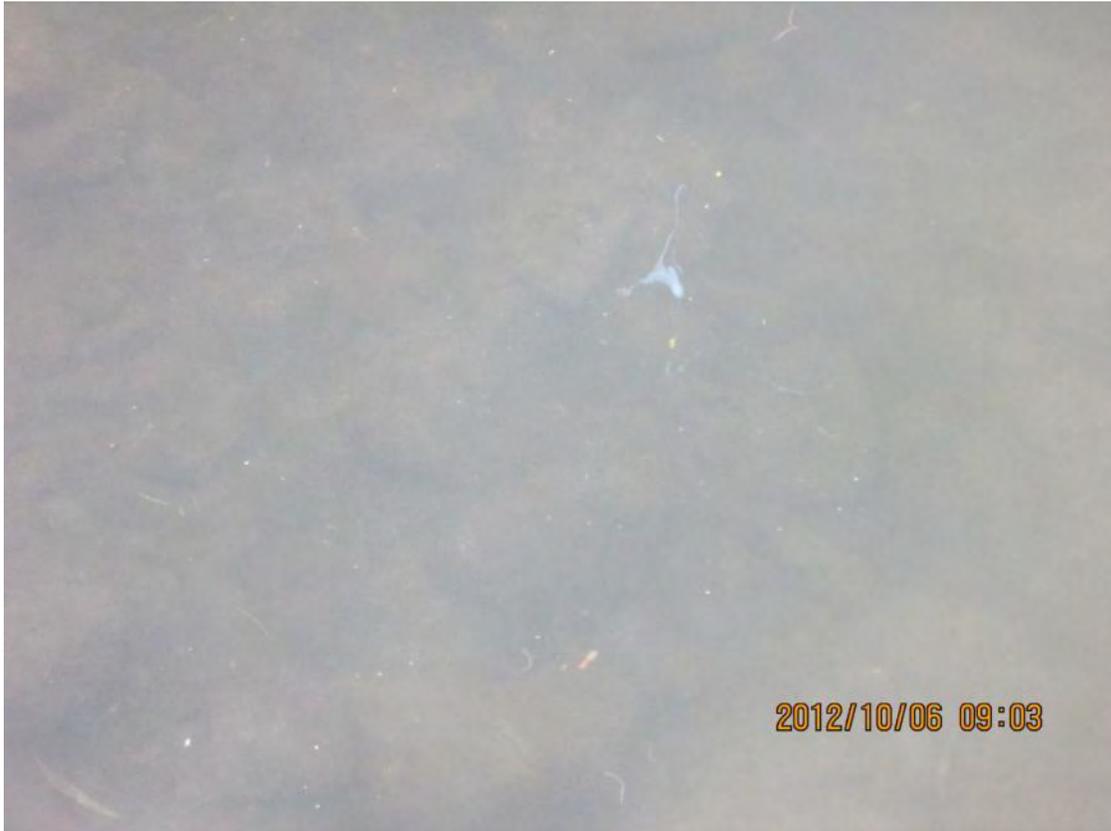
11. Spontaneous sheen observed from South Mill Pond. Quantity of sheen observed did not warrant a sweep boat.

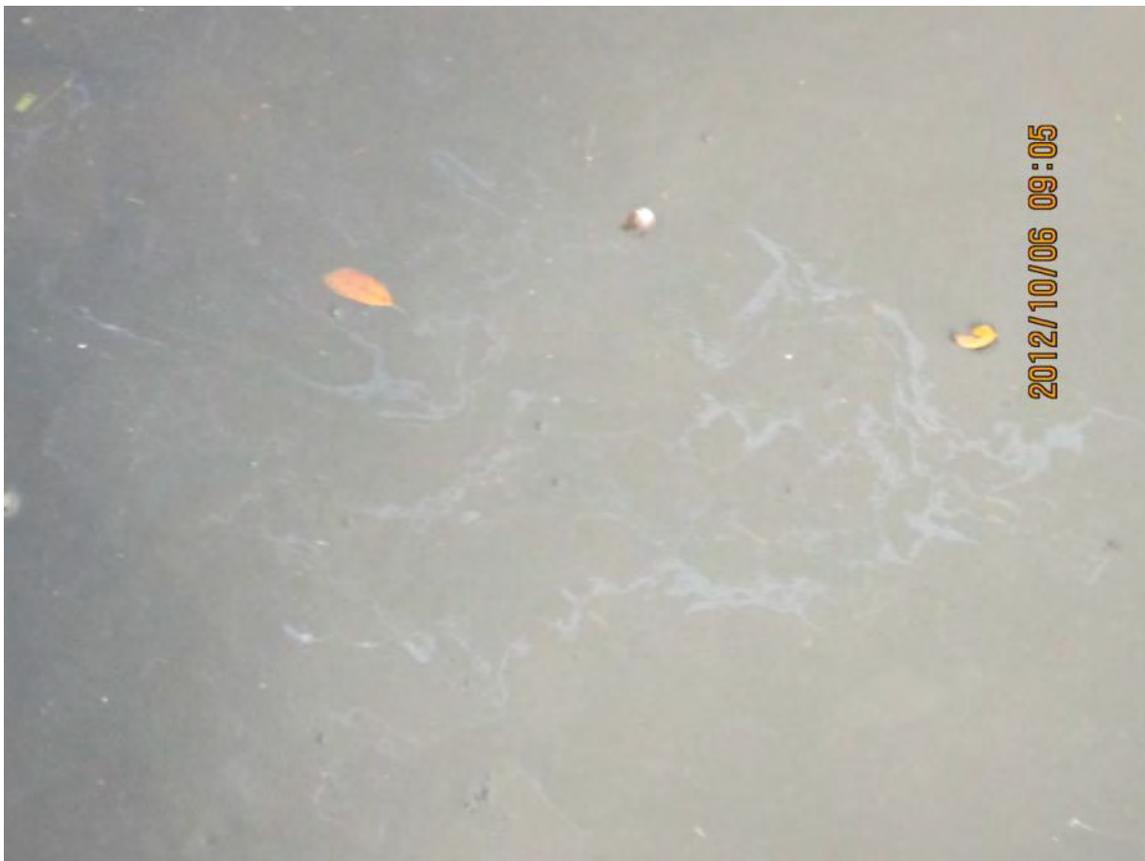
12. Spontaneous ribbons of sheen observed from South Mill Pond. Quantity of sheen observed does not warrant a sweep boat.

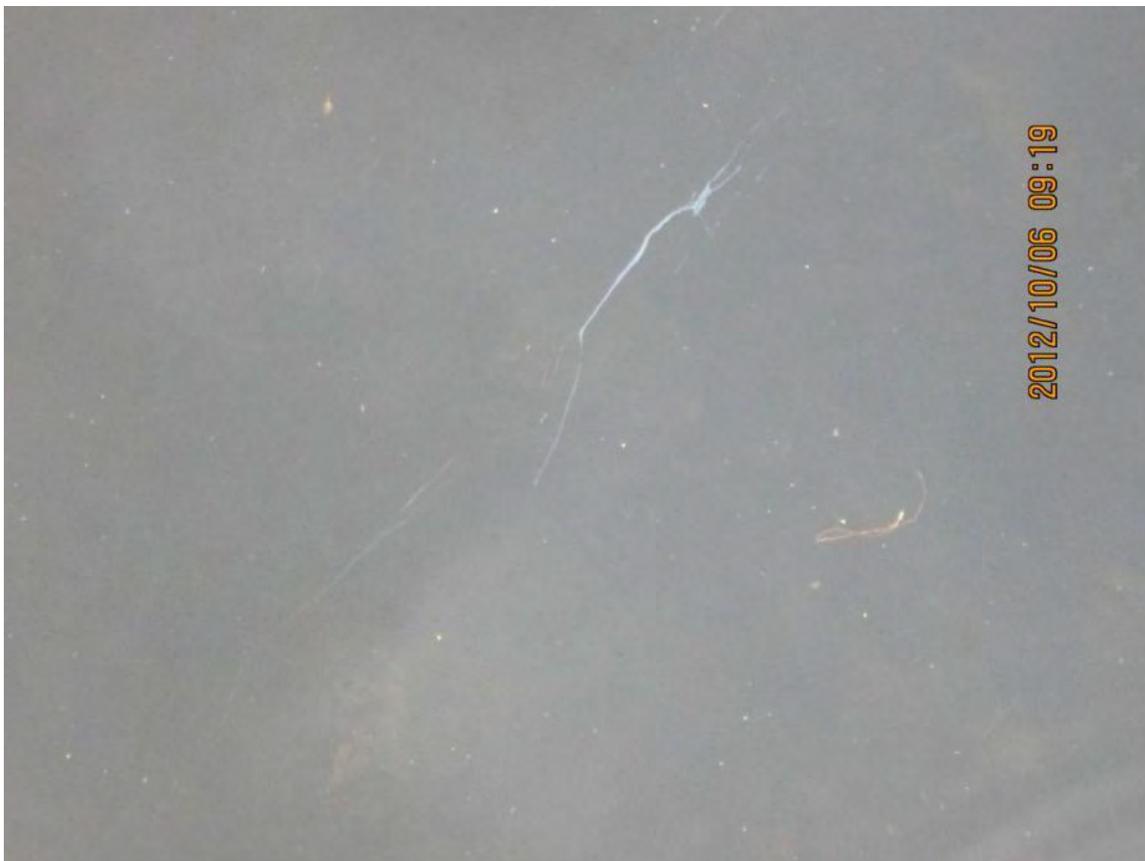
14. Spontaneous ribbon of sheen passing under Custer Road Bridge at MP21.50. Quantity of sheen observed did not warrant a sweep boat.

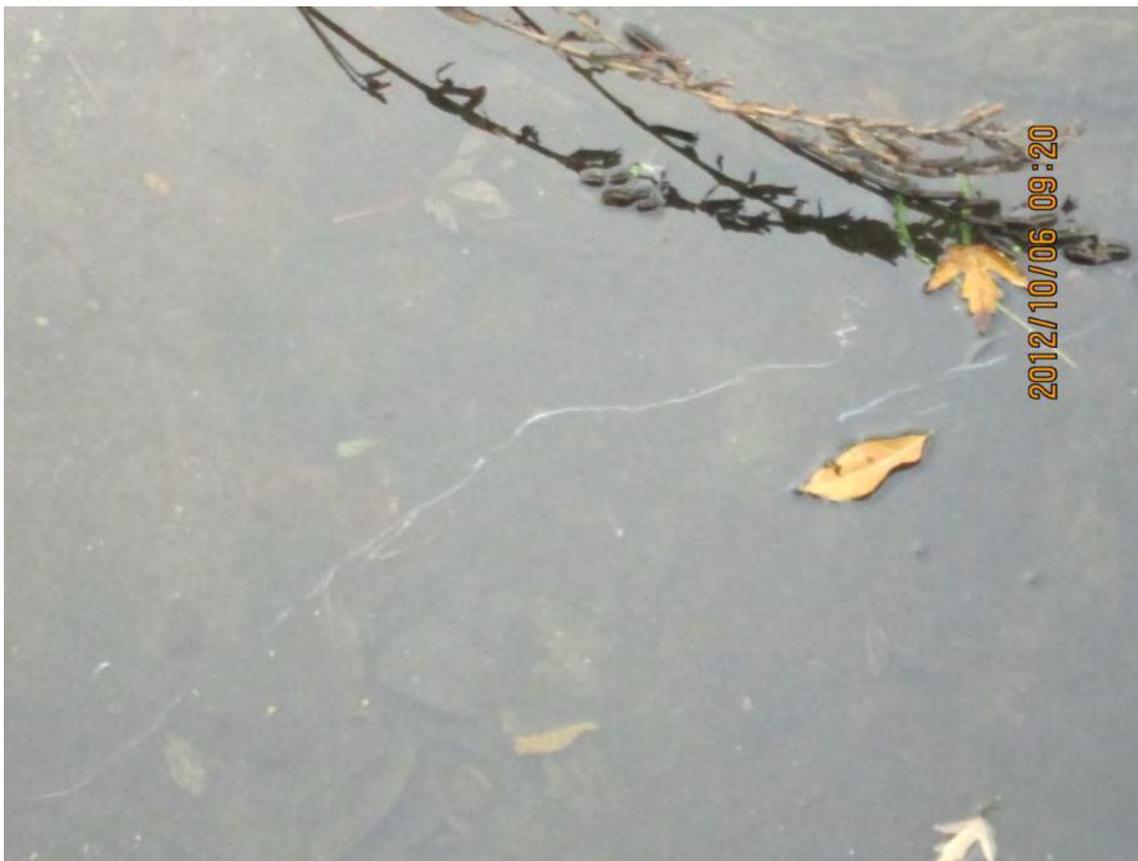
15. Spontaneous ribbons of sheen observed along shoreline east of Custer Road Bridge. Quantity of sheen observed did not warrant sweep boat.
