# Situation Photo Log

Monday, October 8, 2012

Kalamazoo River / Enbridge Spill

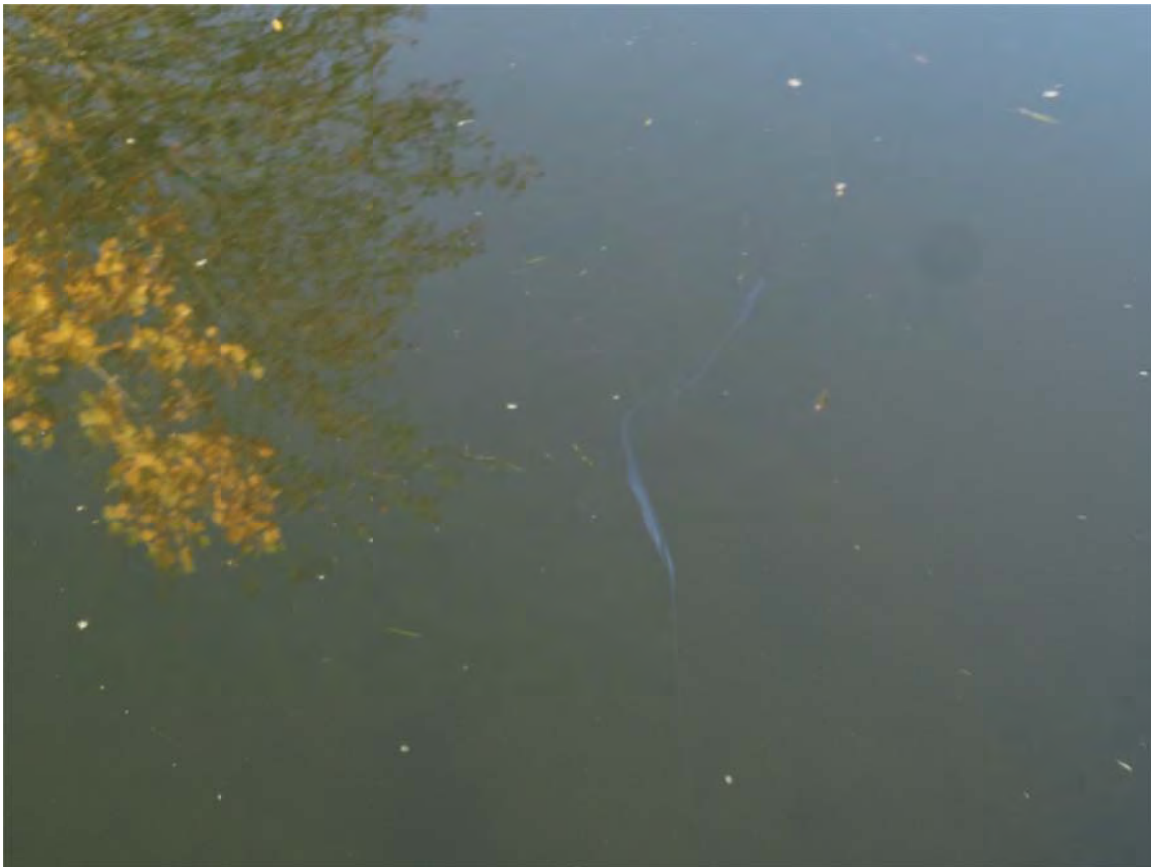
1. MP5.35 LDB, spontaneous ribbons of sheen observed along shoreline.

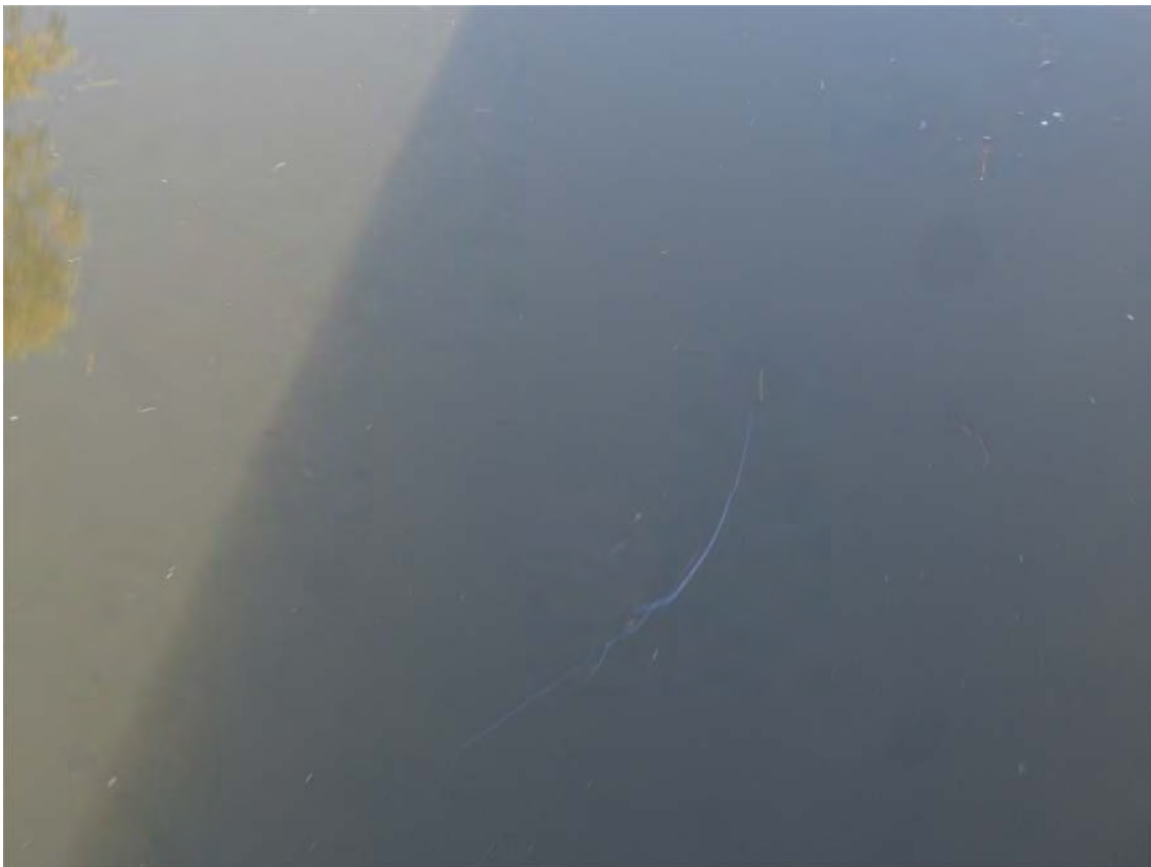
2. MP5.45 LDB, spontaneous sheen and tar globule observed along shoreline.

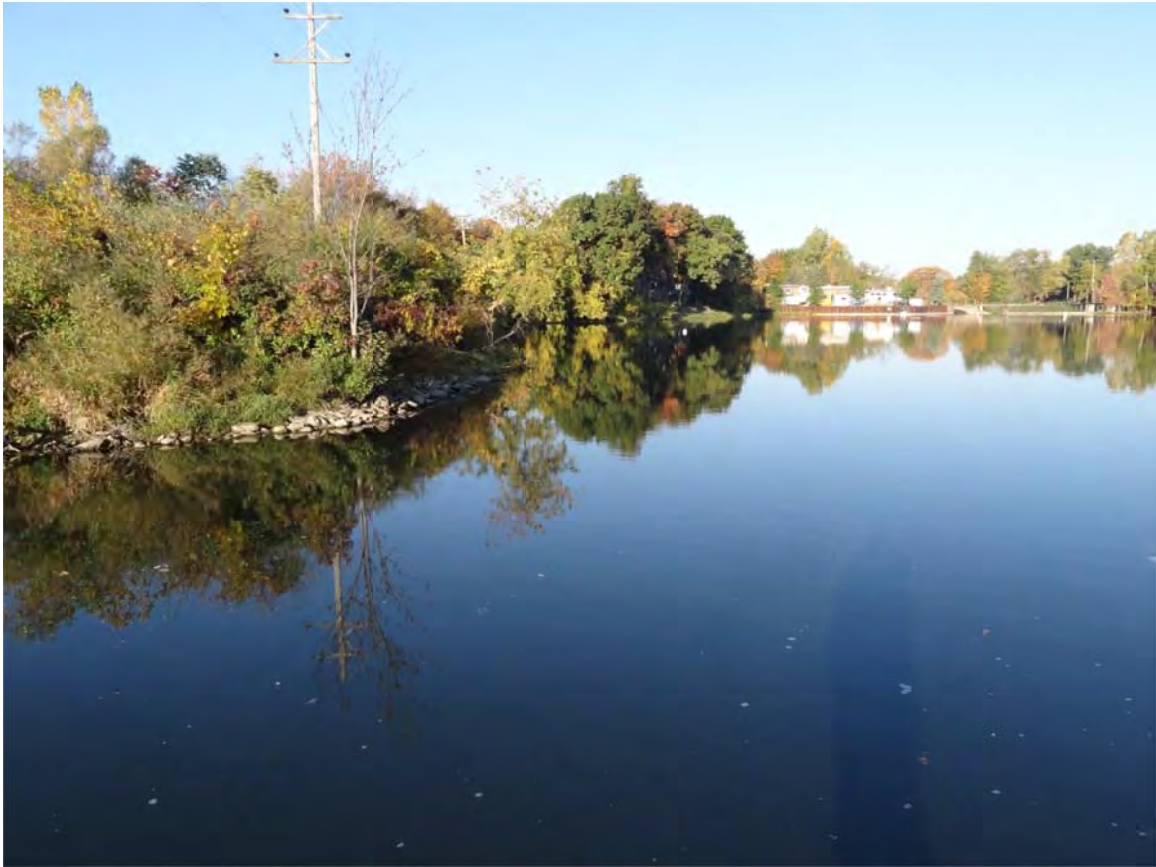
3. MP5.63 LDB no sheen observed.

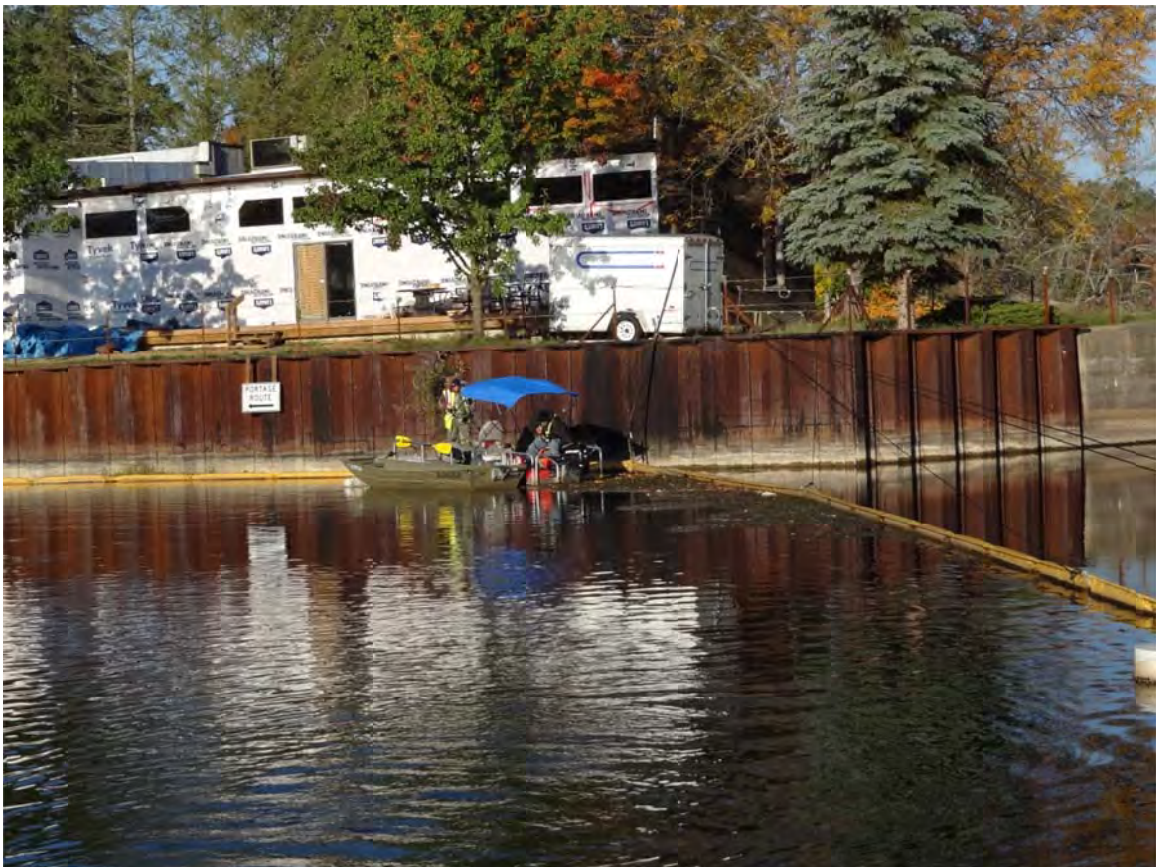
4. Ceresco Dam control point observed the boom maintenance crew.

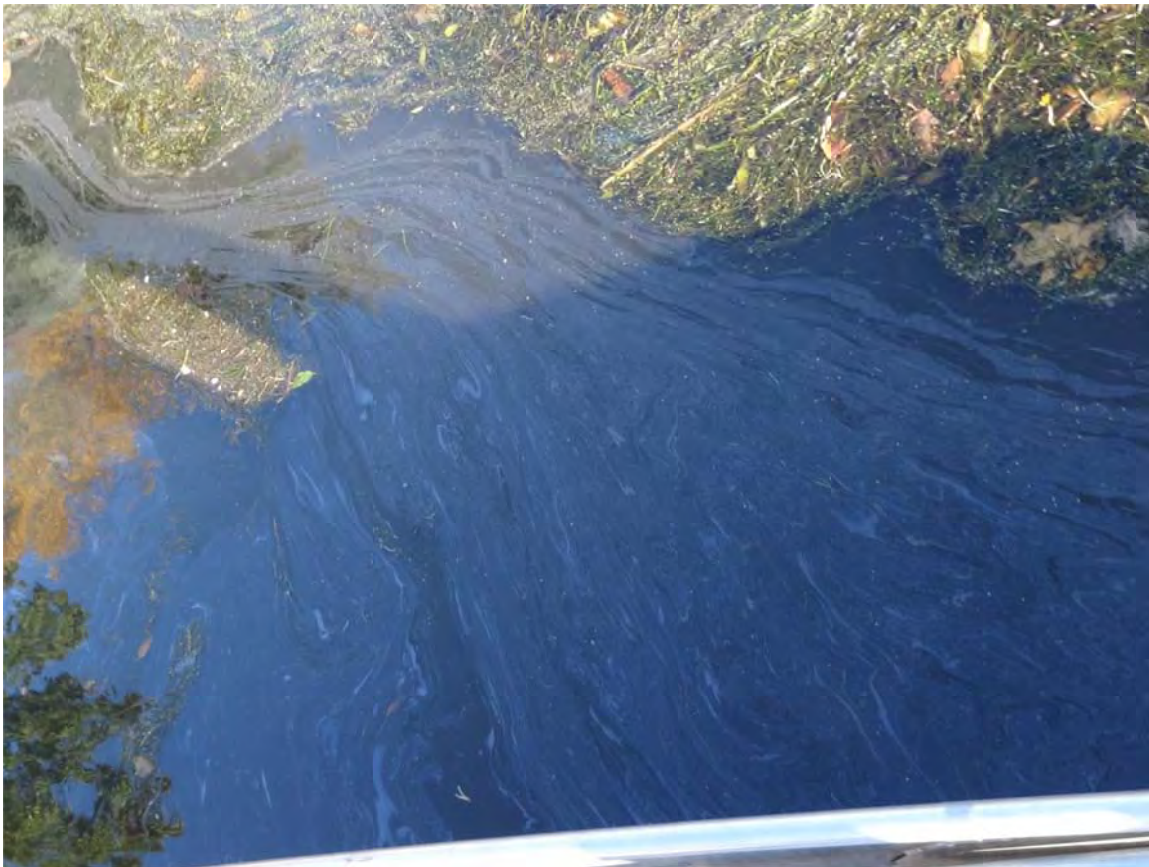
5. MP5.70 sheen observed within debris along Ceresco containment boom.  
Sheen appeared to be caused from the boom maintenance boat.

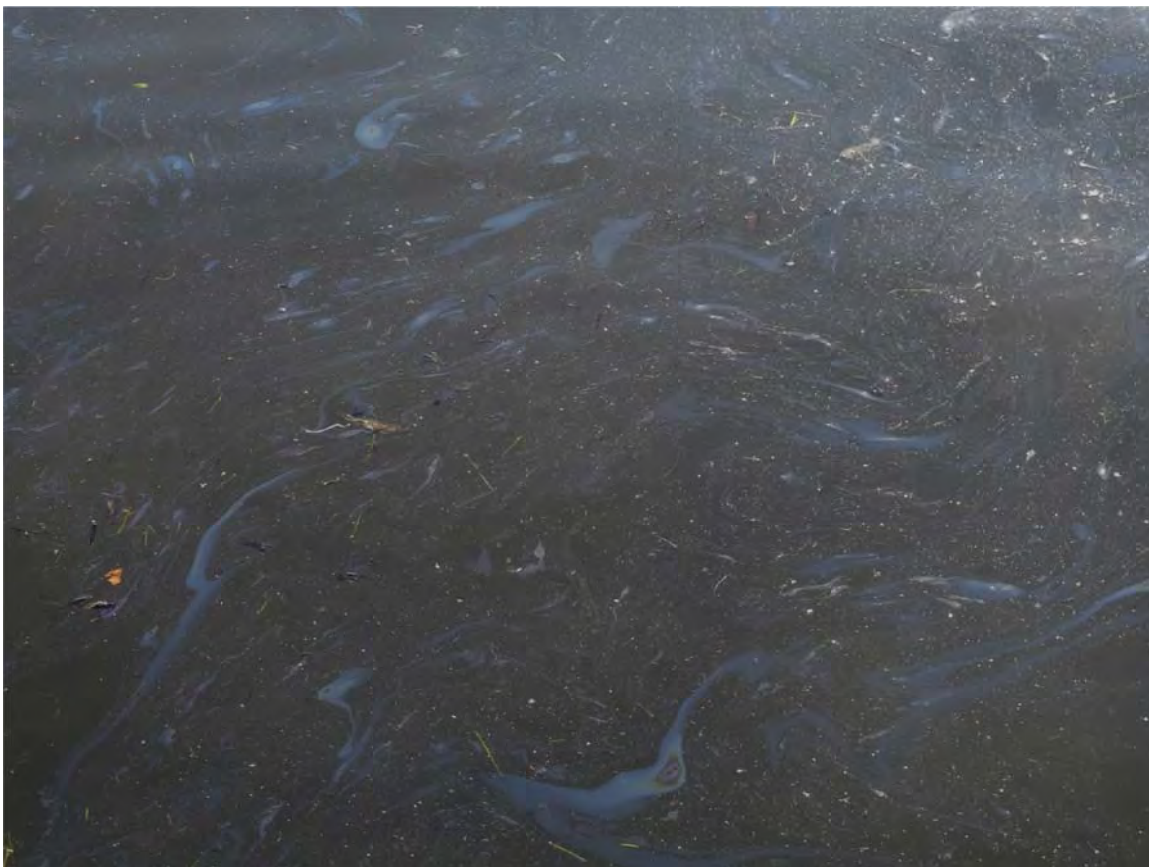
6. MP5.70 sheen observed within debris along Ceresco containment boom.  
Sheen appeared to be caused from the boom maintenance boat.

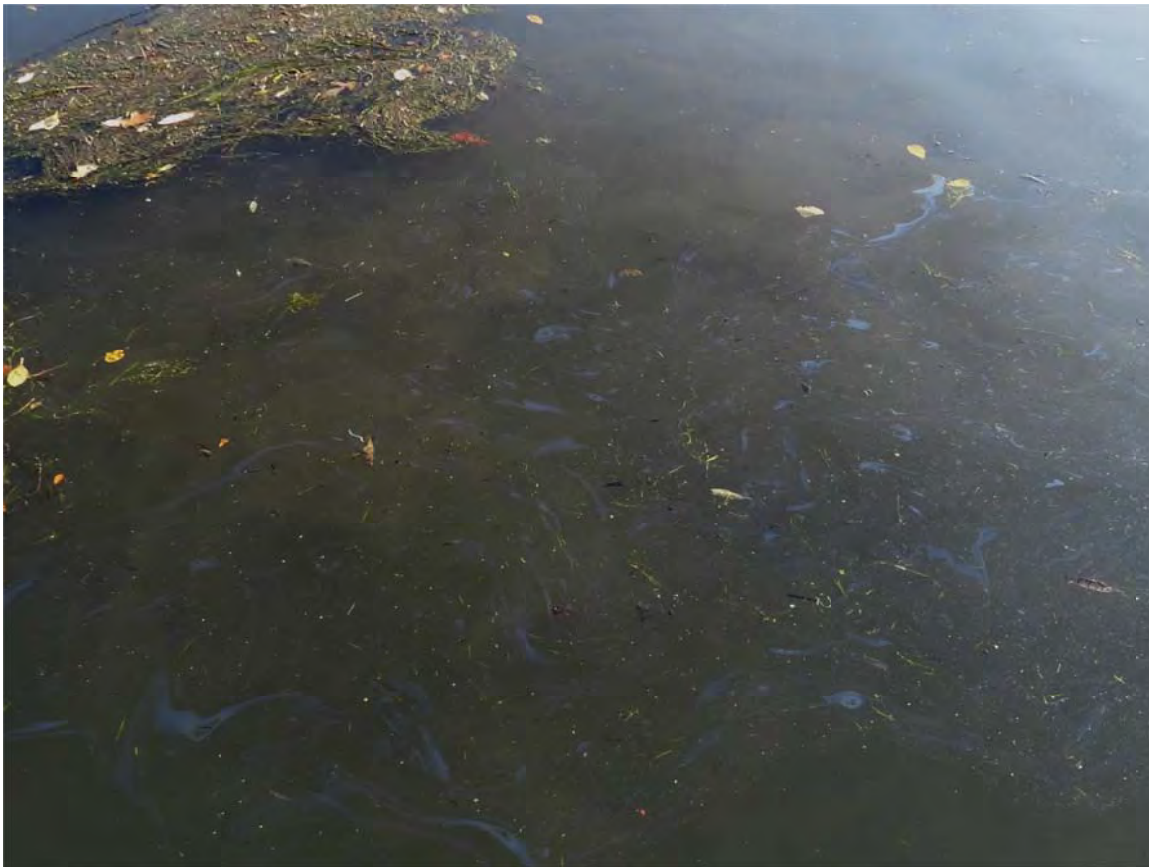
7. MP5.70 sheen observed within debris along Ceresco containment boom.  
Sheen appeared to be caused from the boom maintenance boat.

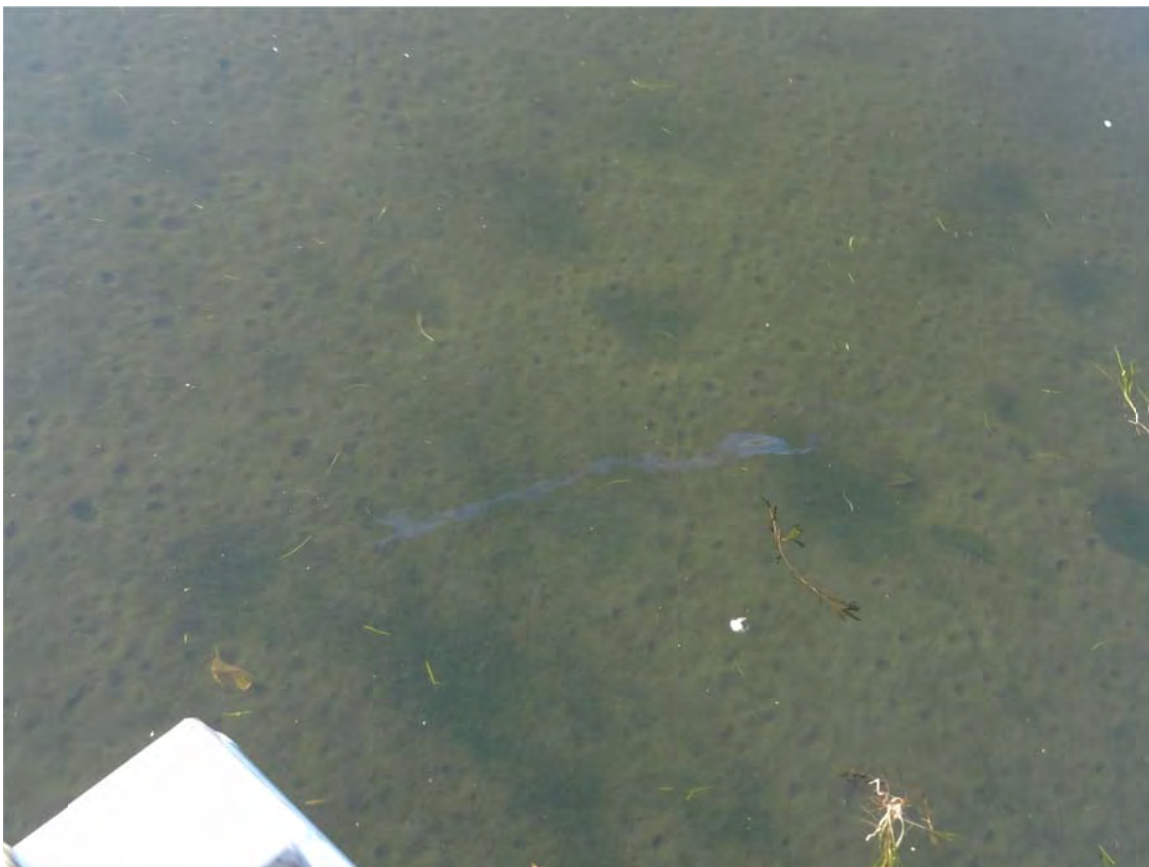
8. MP 5.63 RDB spontaneous ribbon of sheen observed.

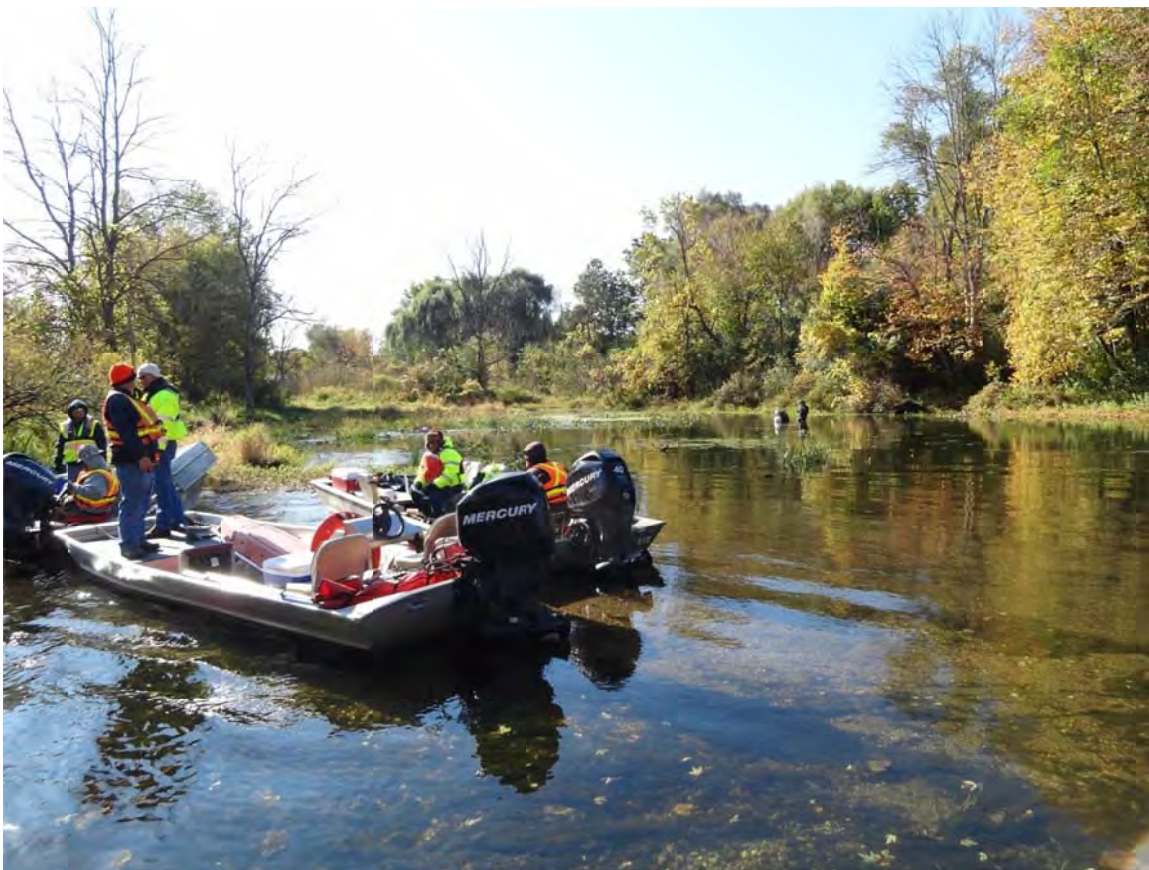
9. MP10.5 Sediment Trap observed a sampling crew.

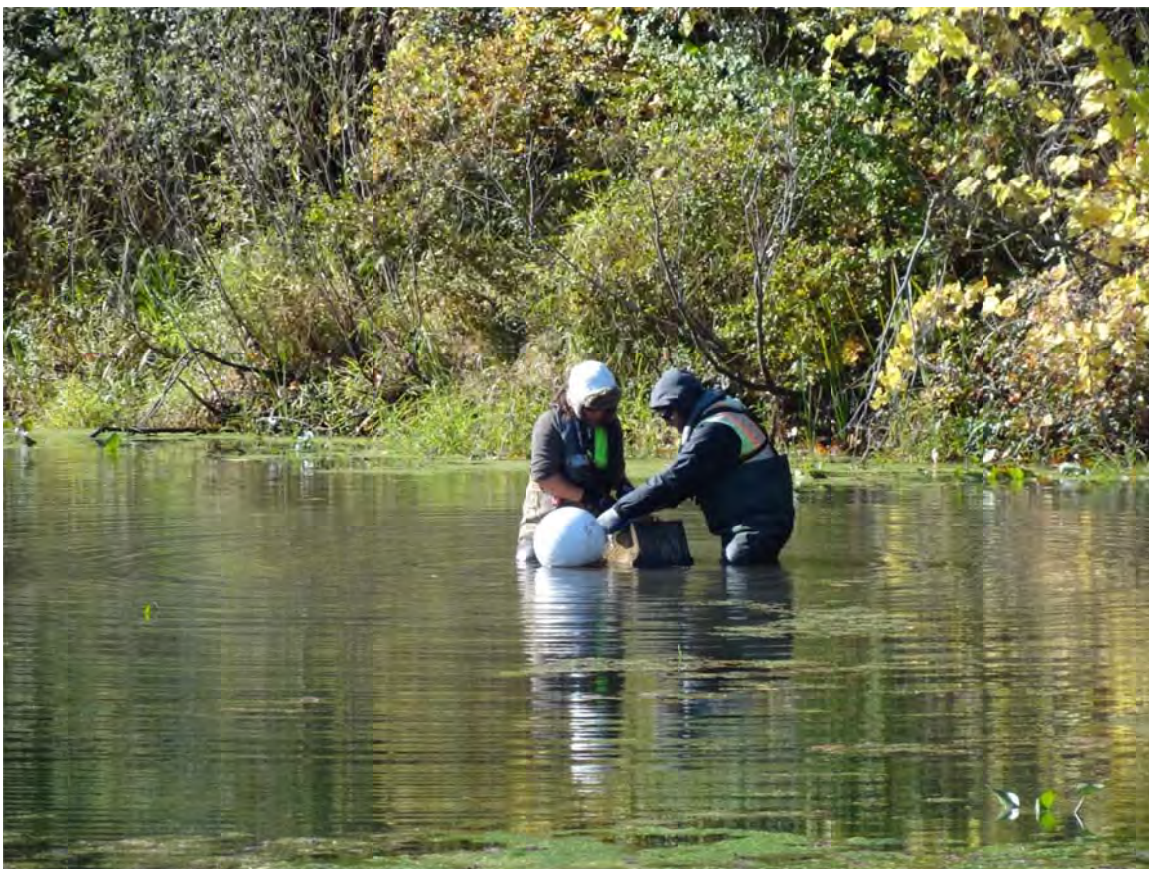
10. MP10.5 Sediment Trap observed a sampling crew.

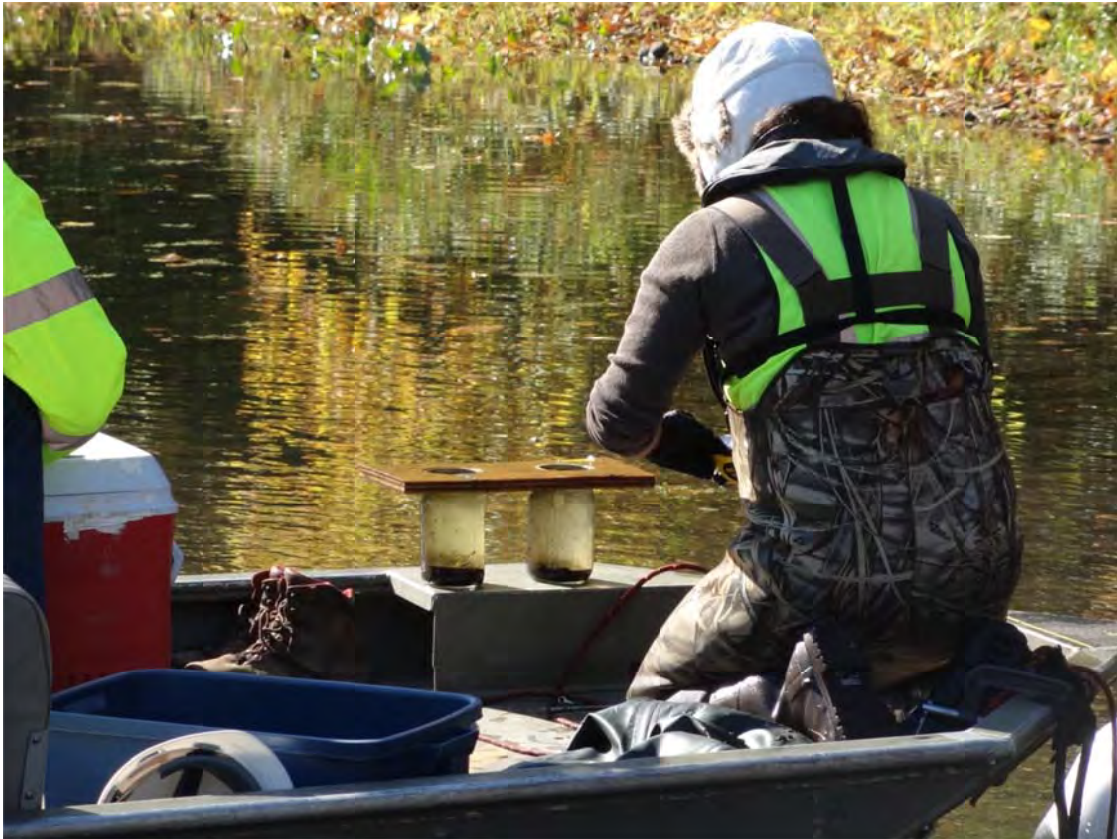
11. MP10.5 Sediment Trap observed a sampling crew.

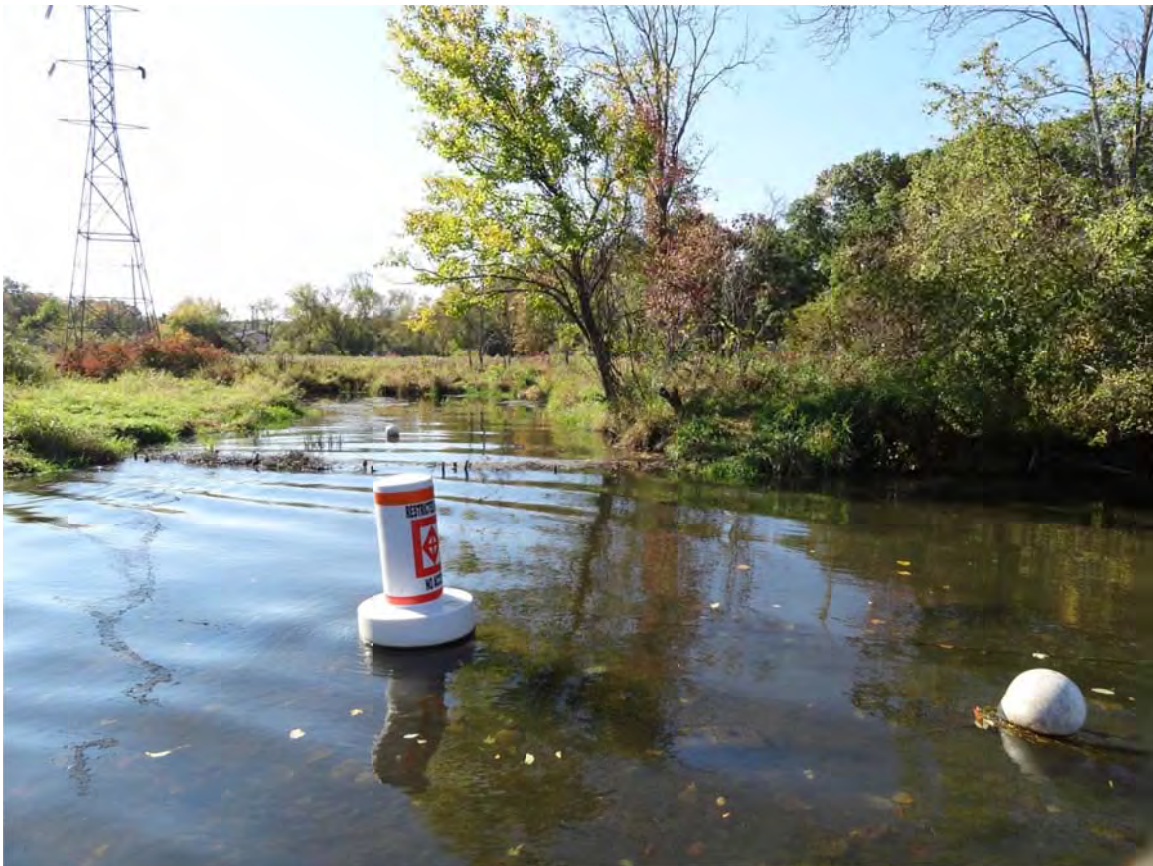
12. MP10.75 Sediment Trap no sheen observed.

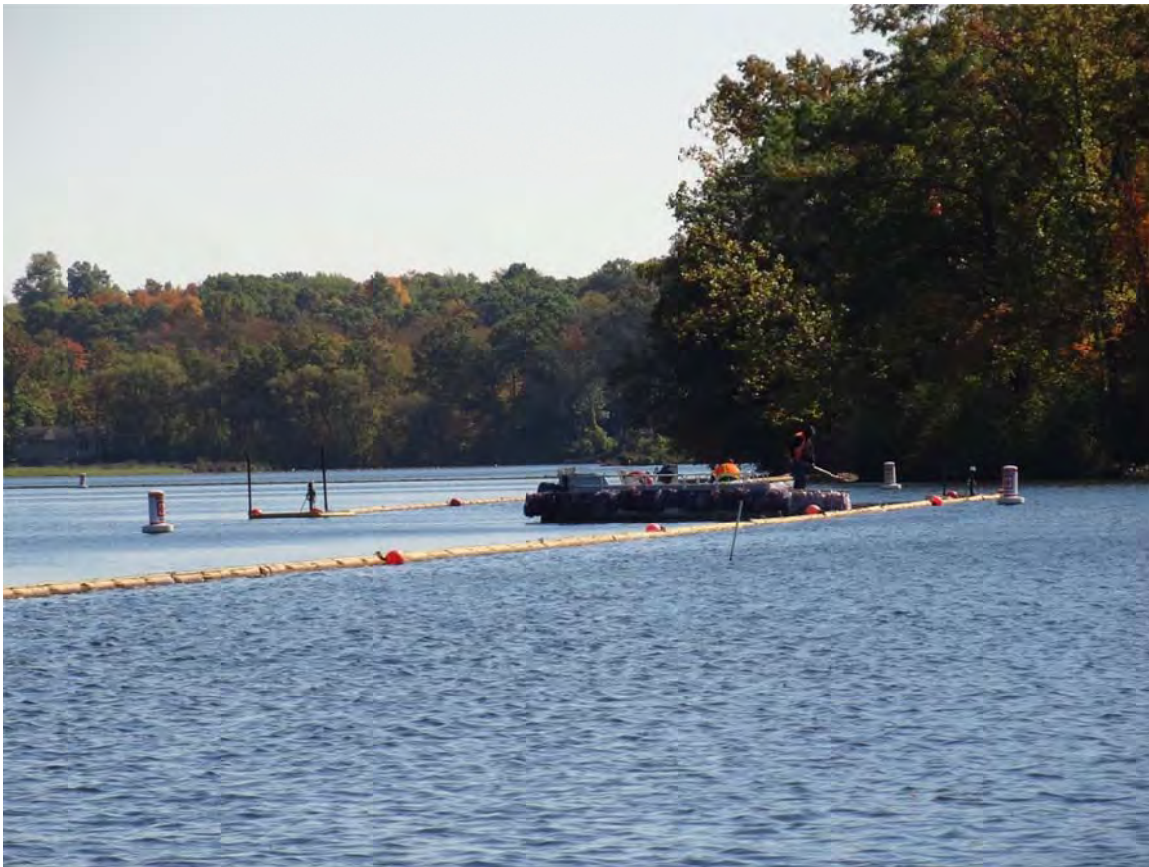
**13. Morrow Lake Delta Gate E observed a crew removing debris from the boom.**

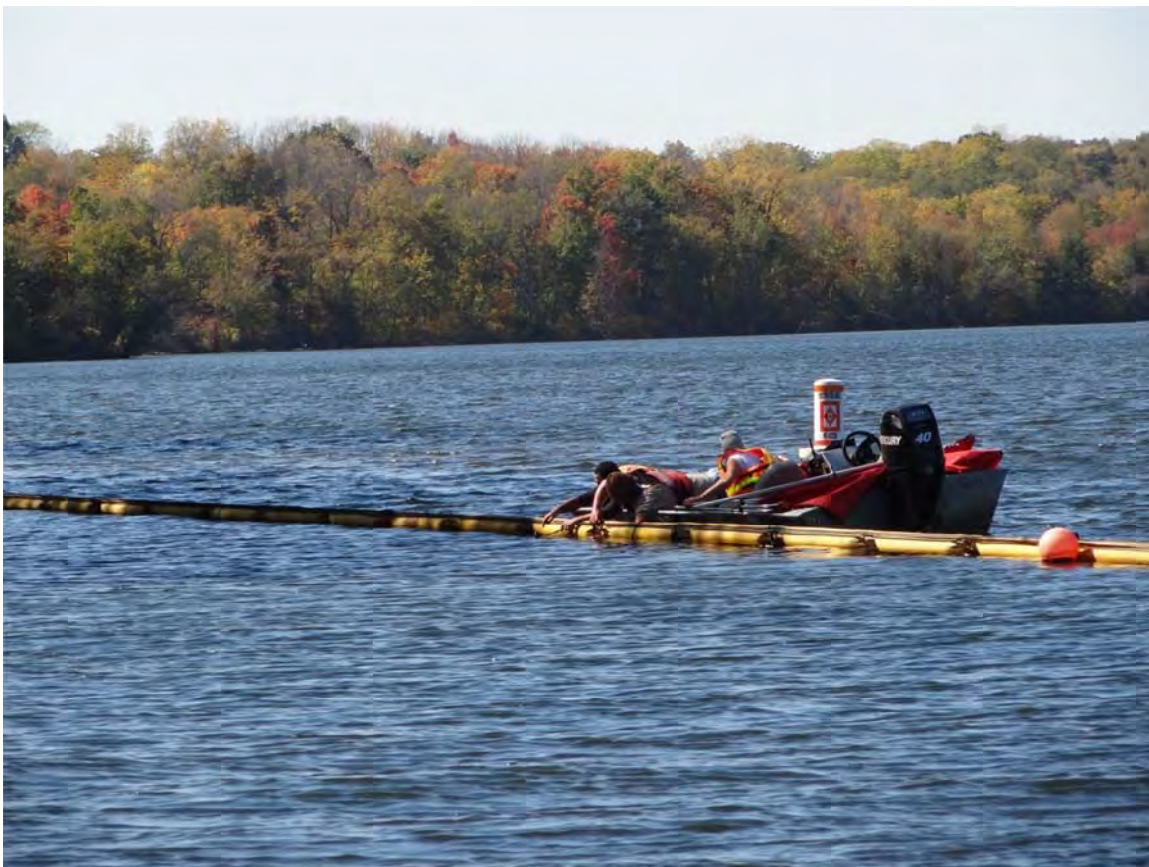
**14. Morrow Lake Delta Gate F observed a crew performing adjustments to the curtain.**

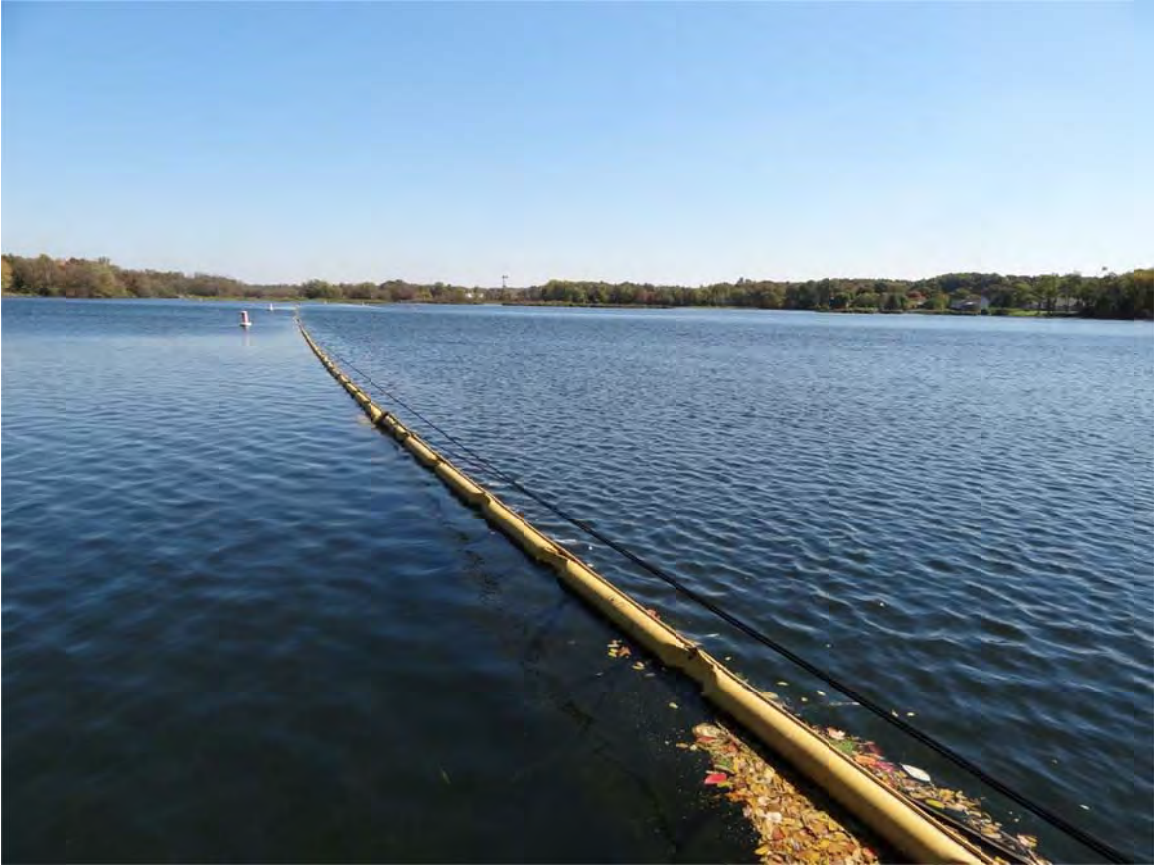
**15. Morrow Lake Delta Gate C no sheen observed.**

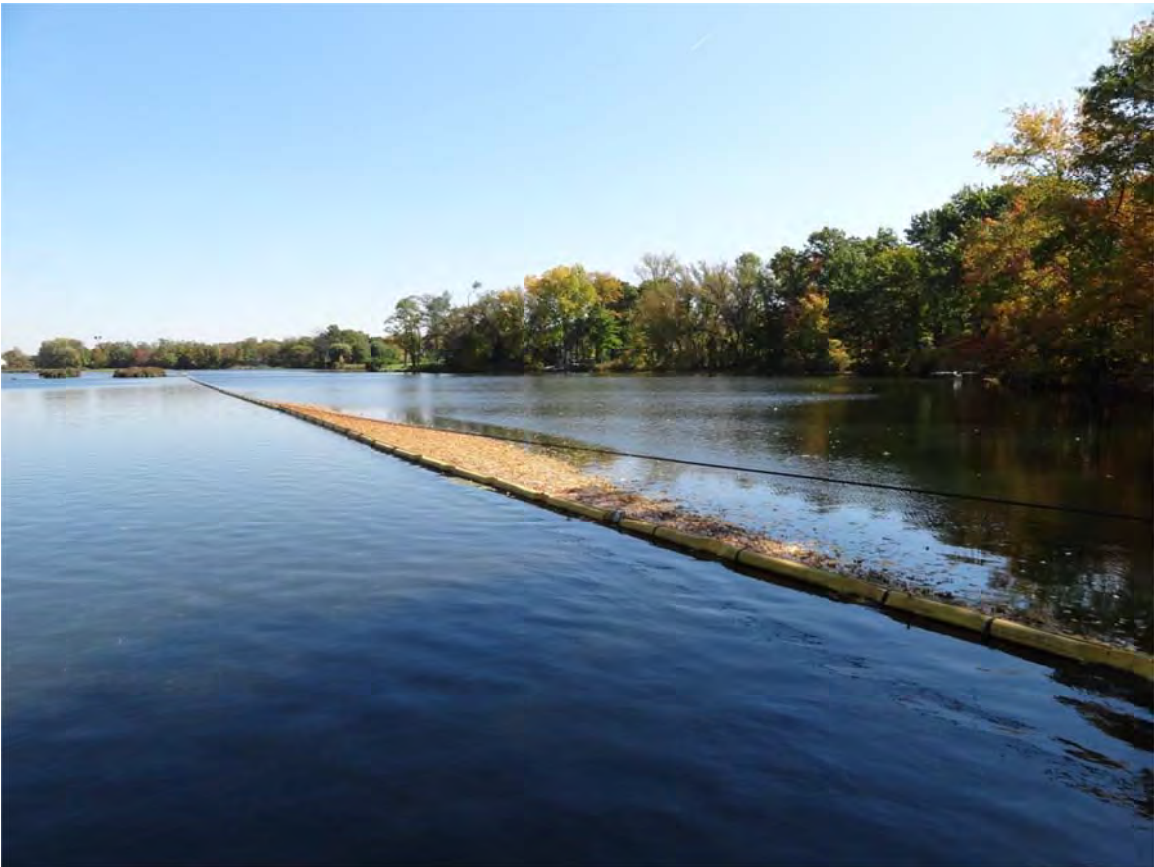
**16. Morrow Lake Delta Gate B no sheen observed.**

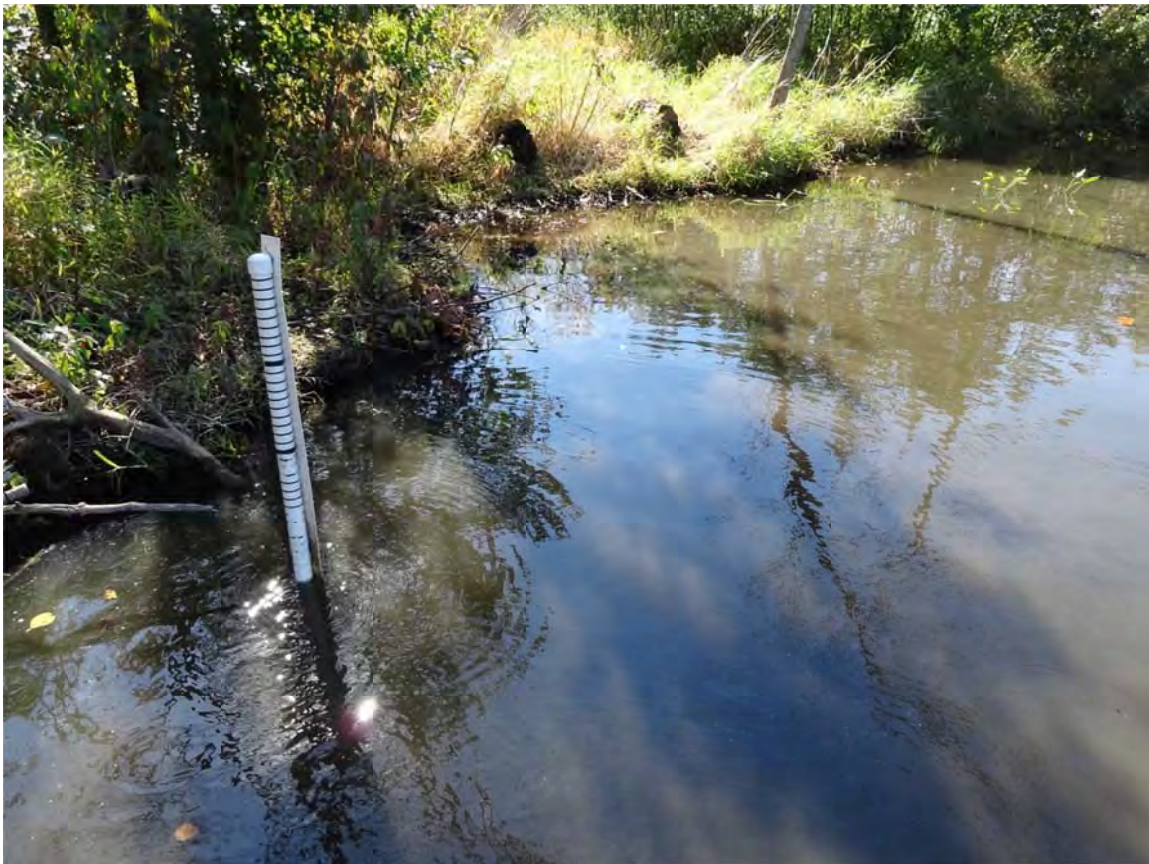
17. MP36.5 LDB 35<sup>th</sup> Street Bridge sheen observed when the boat reversed from the gage.

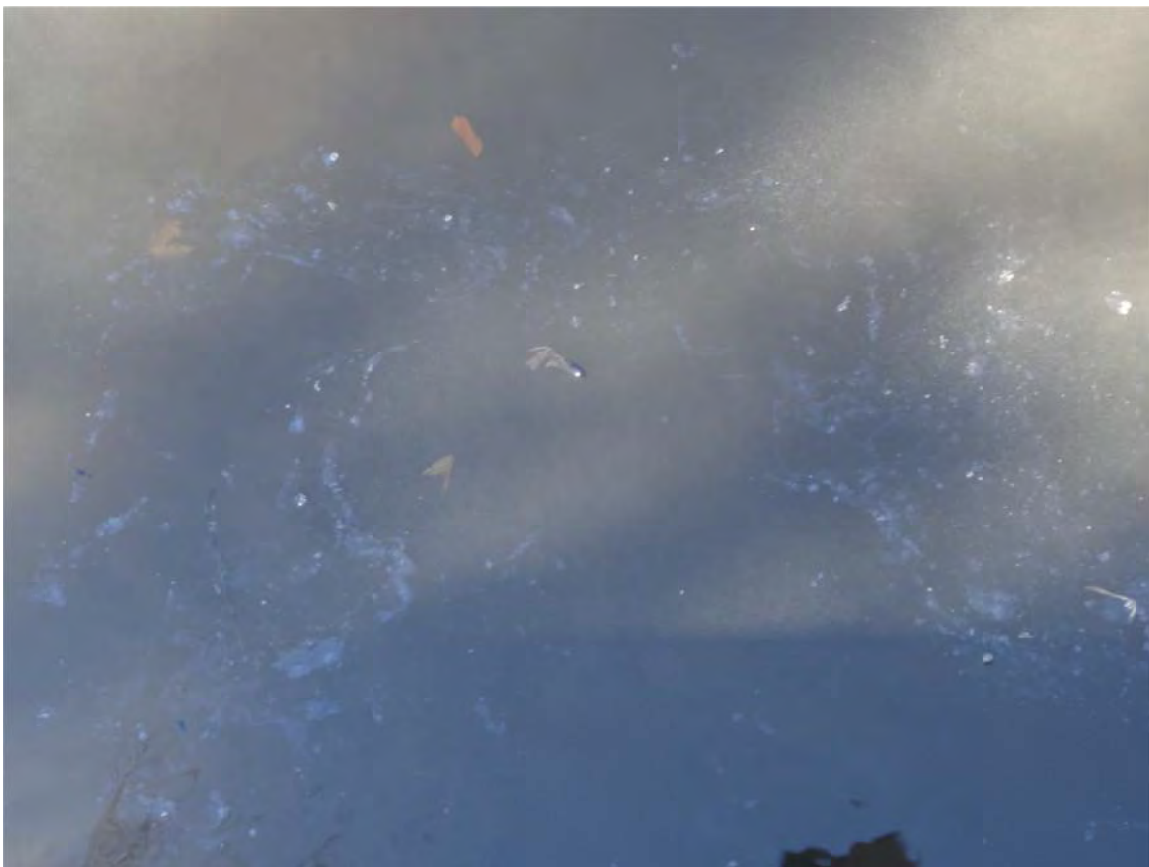
18. MP36.5 LDB 35<sup>th</sup> Street Bridge sheen observed when the boat reversed from the gage.

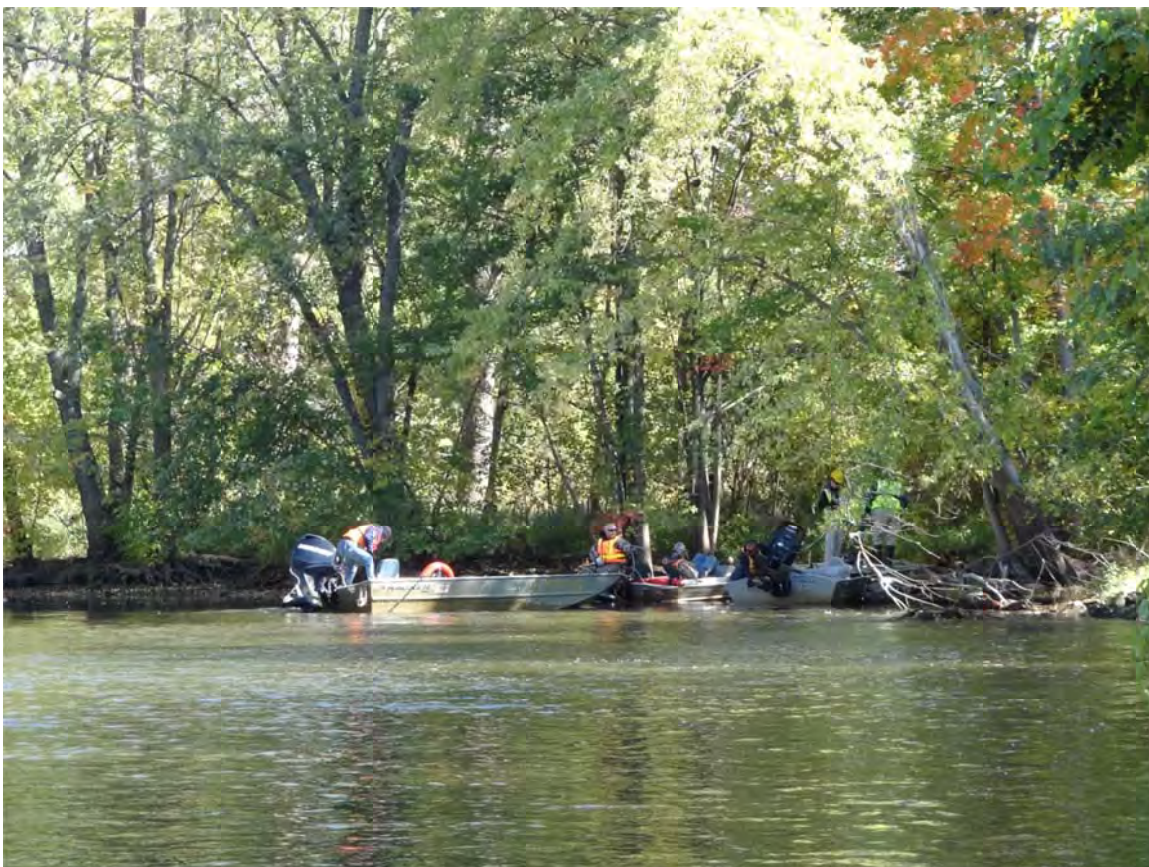
19. MP34.5 LDB background sampling crew observed.

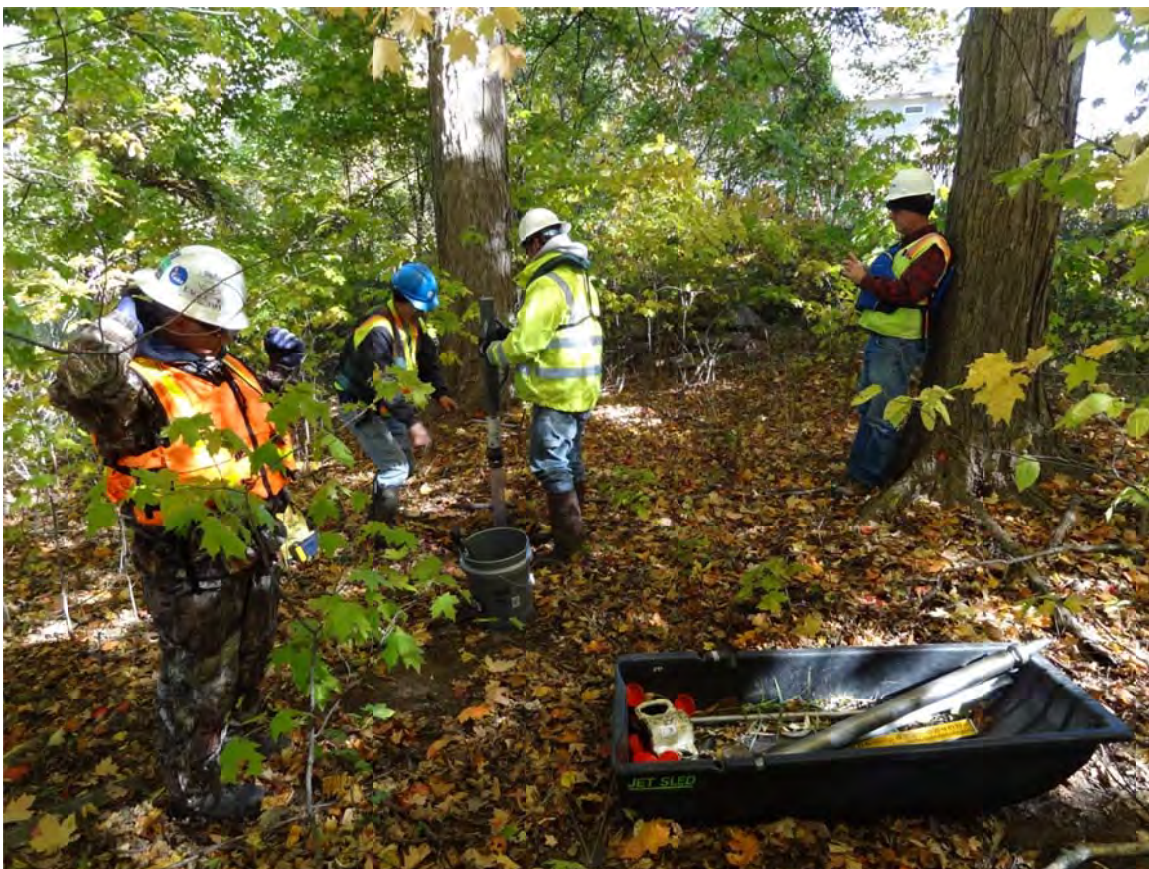
20. MP34.5 LDB background sampling crew observed.

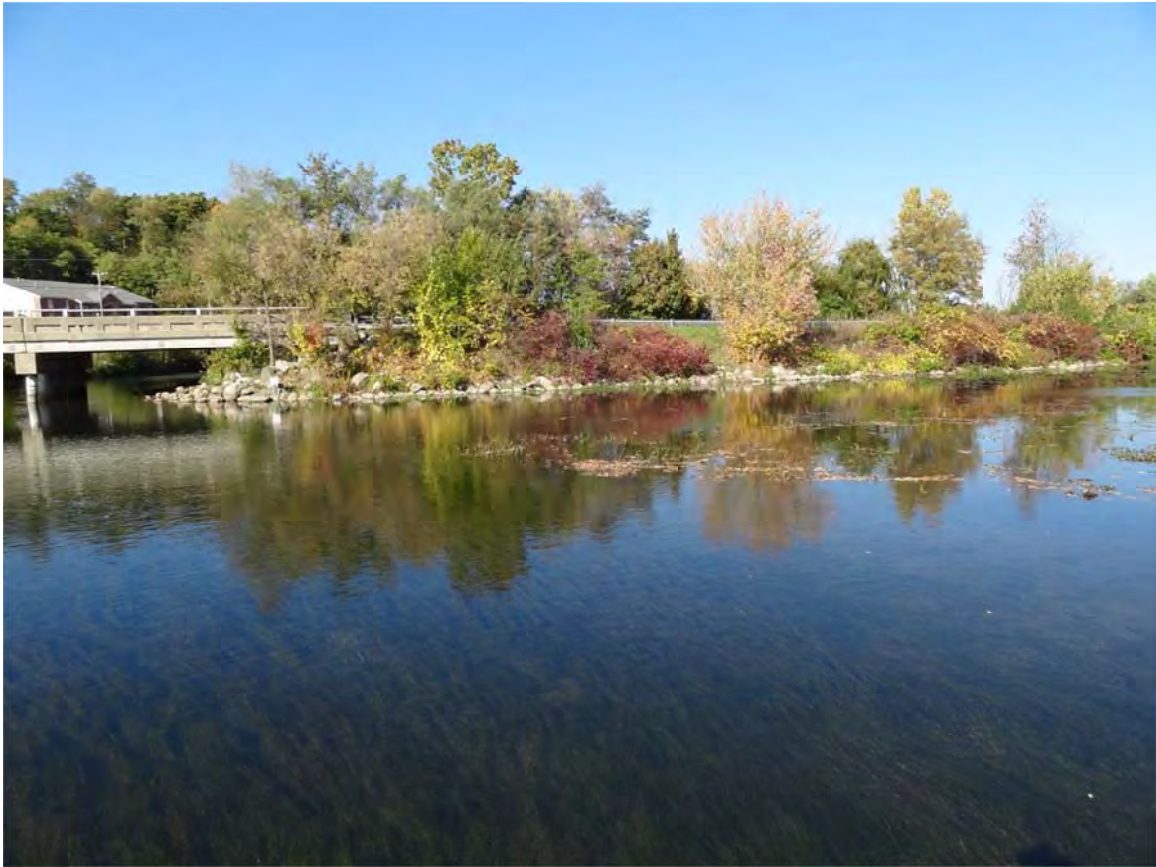
21. MP15.5 South Mill Pond no sheen observed.

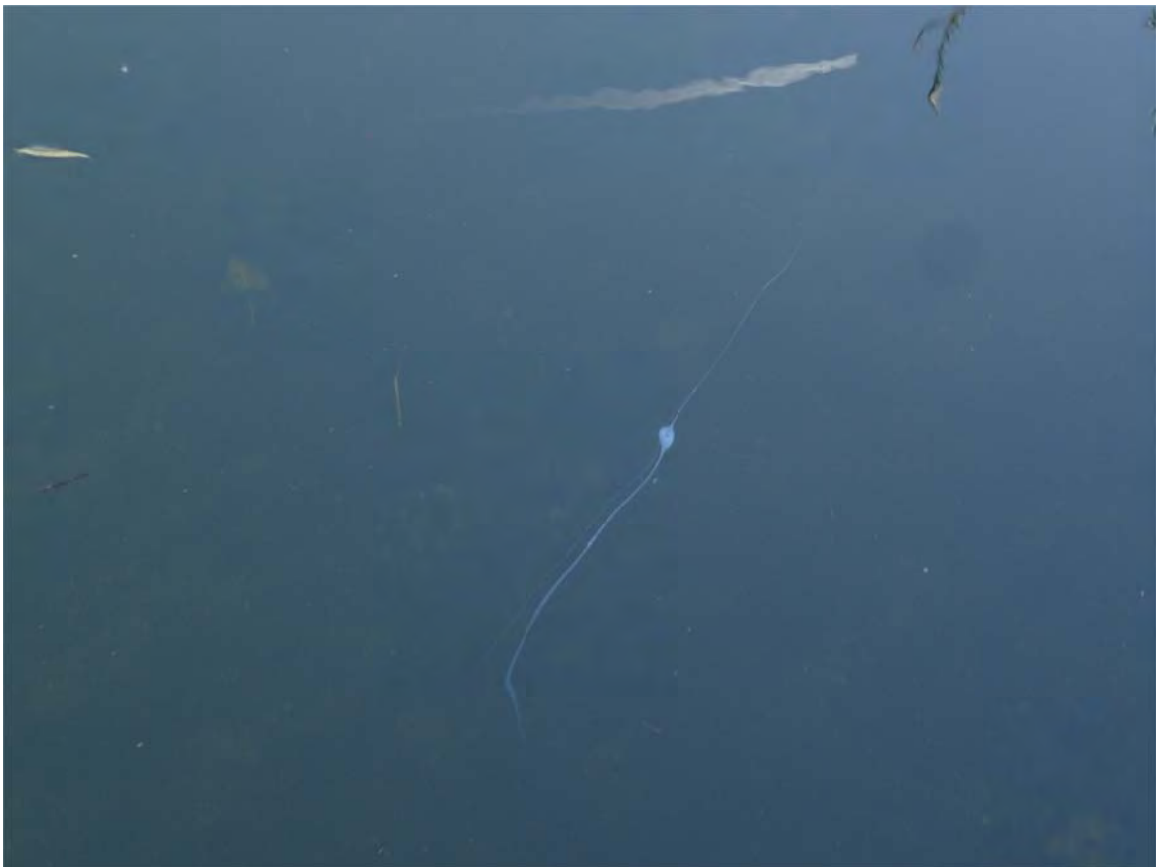
22. MP15.6 LDB spontaneous ribbon of sheen observed.
