# Situation Photo Log

Tuesday, October 9, 2012

Kalamazoo River / Enbridge Spill

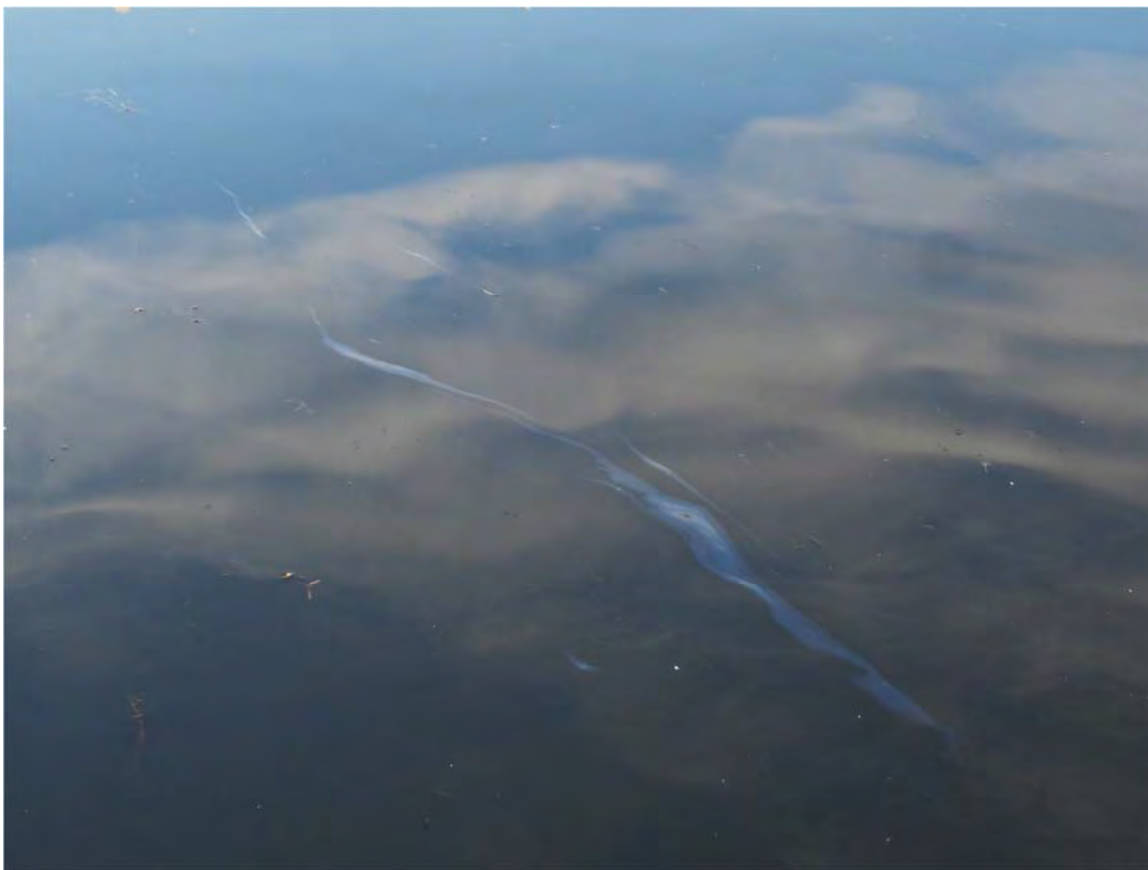
1. MP5.35 LDB, spontaneous ribbons of sheen observed along shoreline.

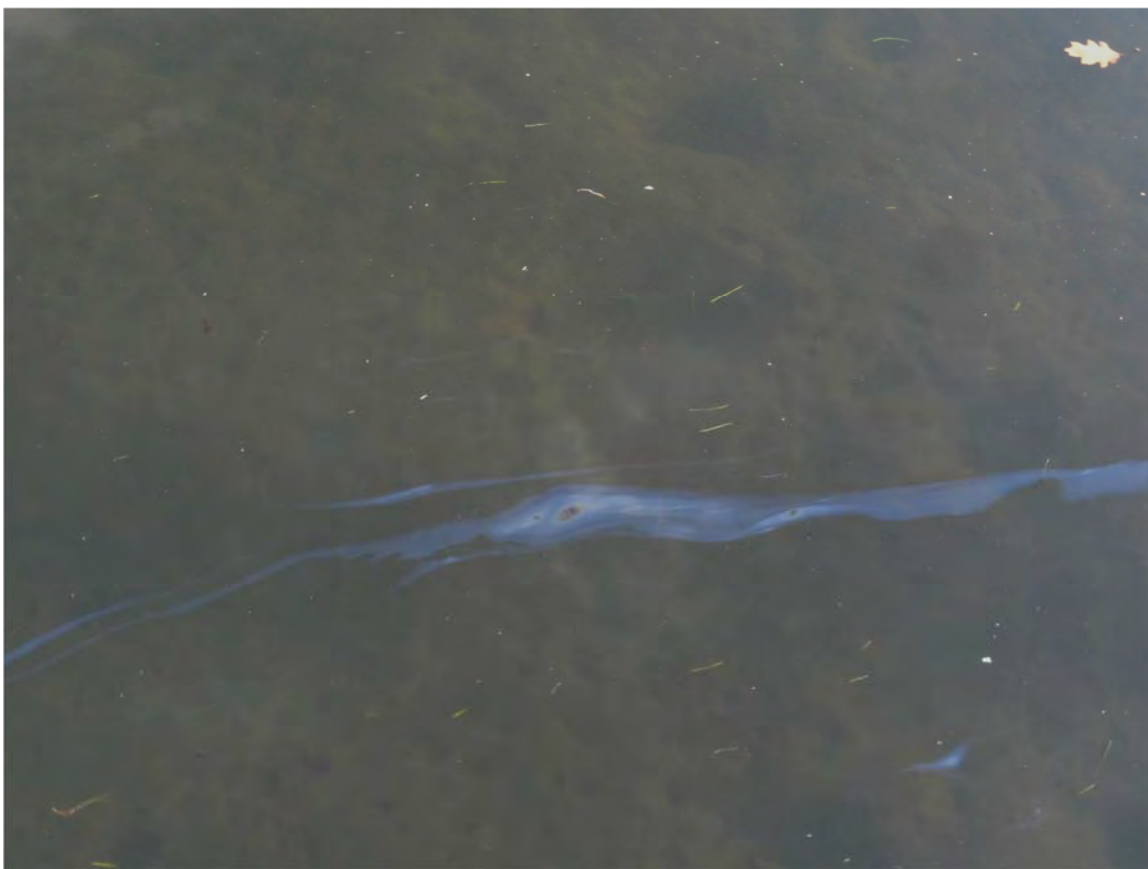
2. MP5.35 LDB, spontaneous sheen and tar globule observed along shoreline.

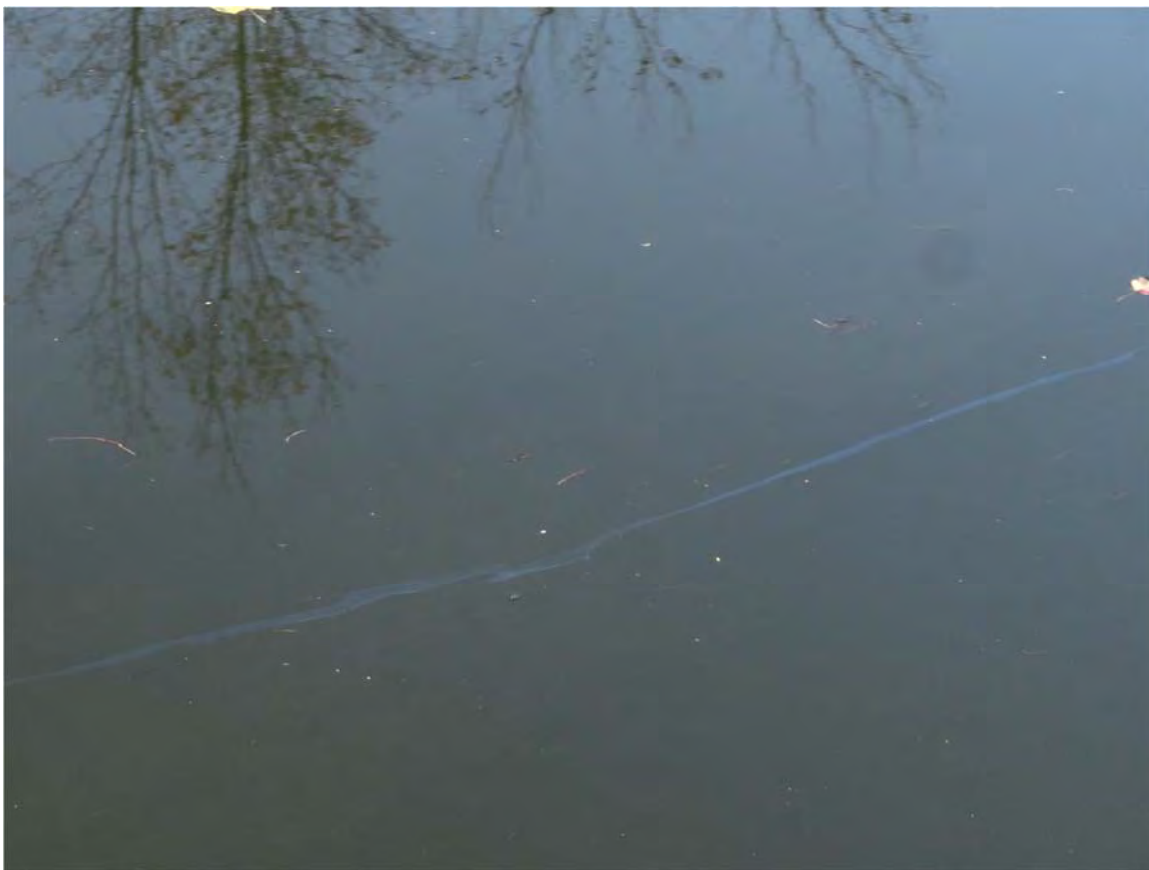
3. MP5.45 LDB, spontaneous sheen and tar globule observed along shoreline.

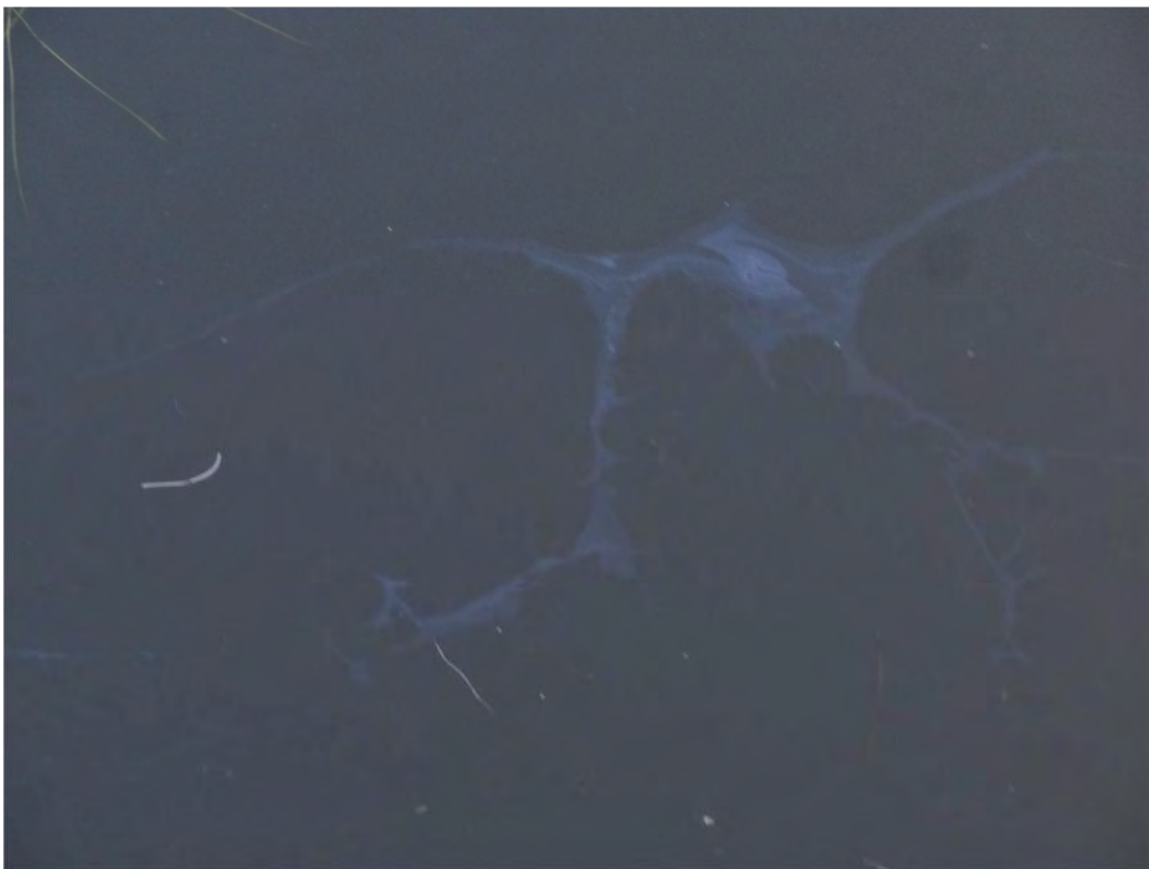
4. MP5.55 LDB, spontaneous sheen and tar globule observed along shoreline.

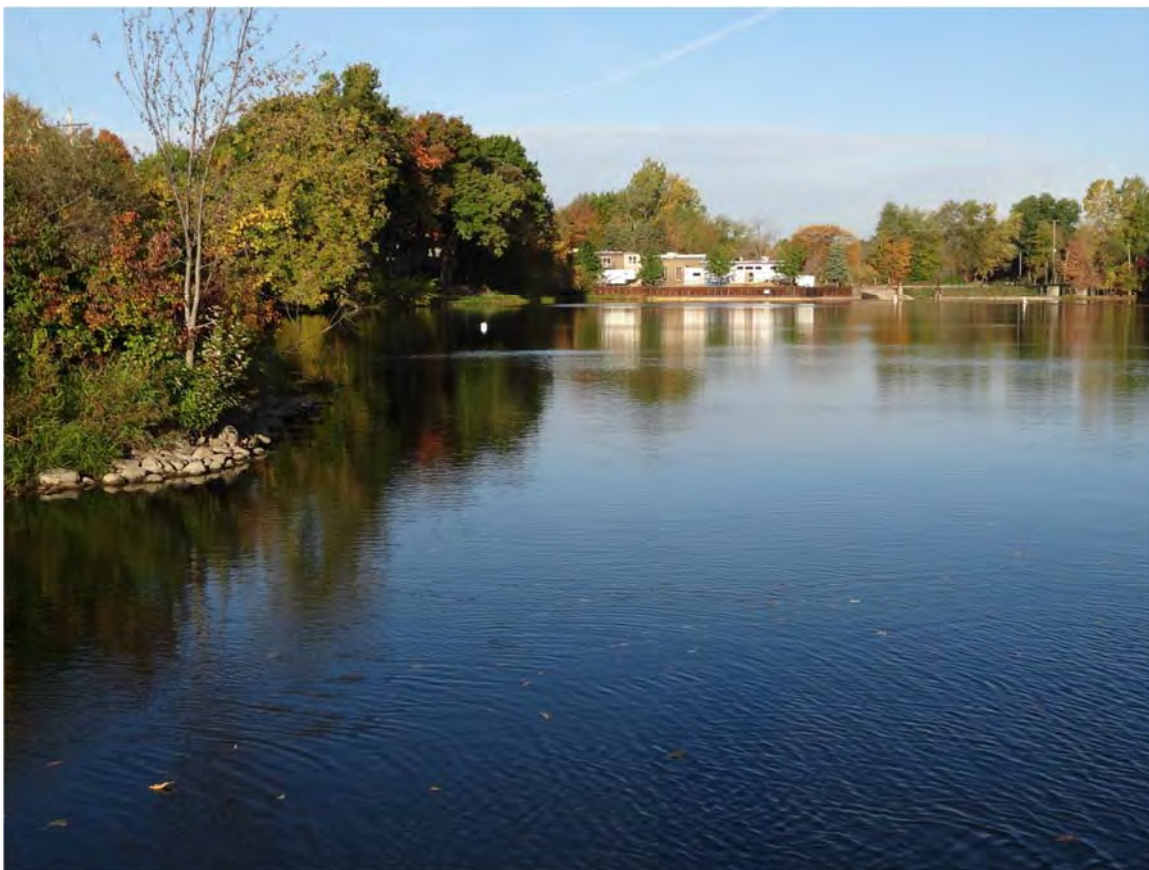
5. MP5.63 LDB no sheen observed.

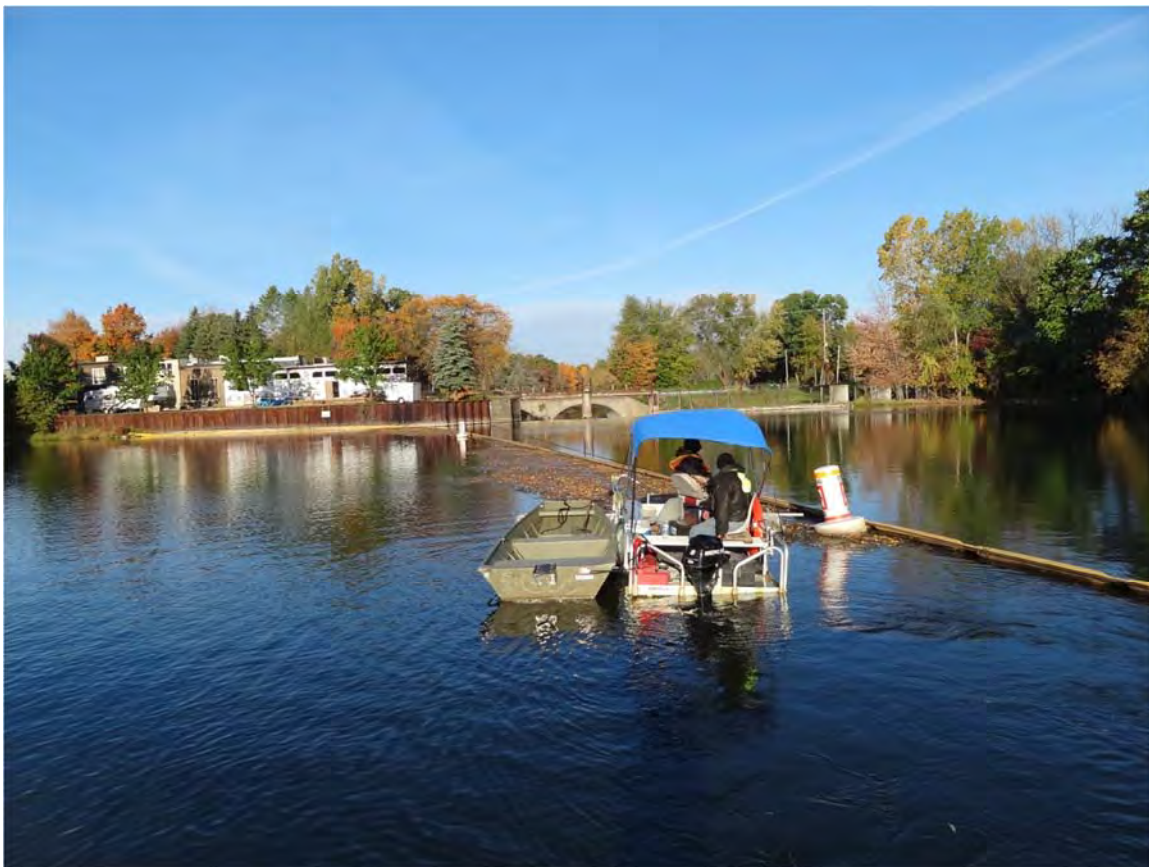
6. Ceresco Dam Control Point observed the boom maintenance crew operating.

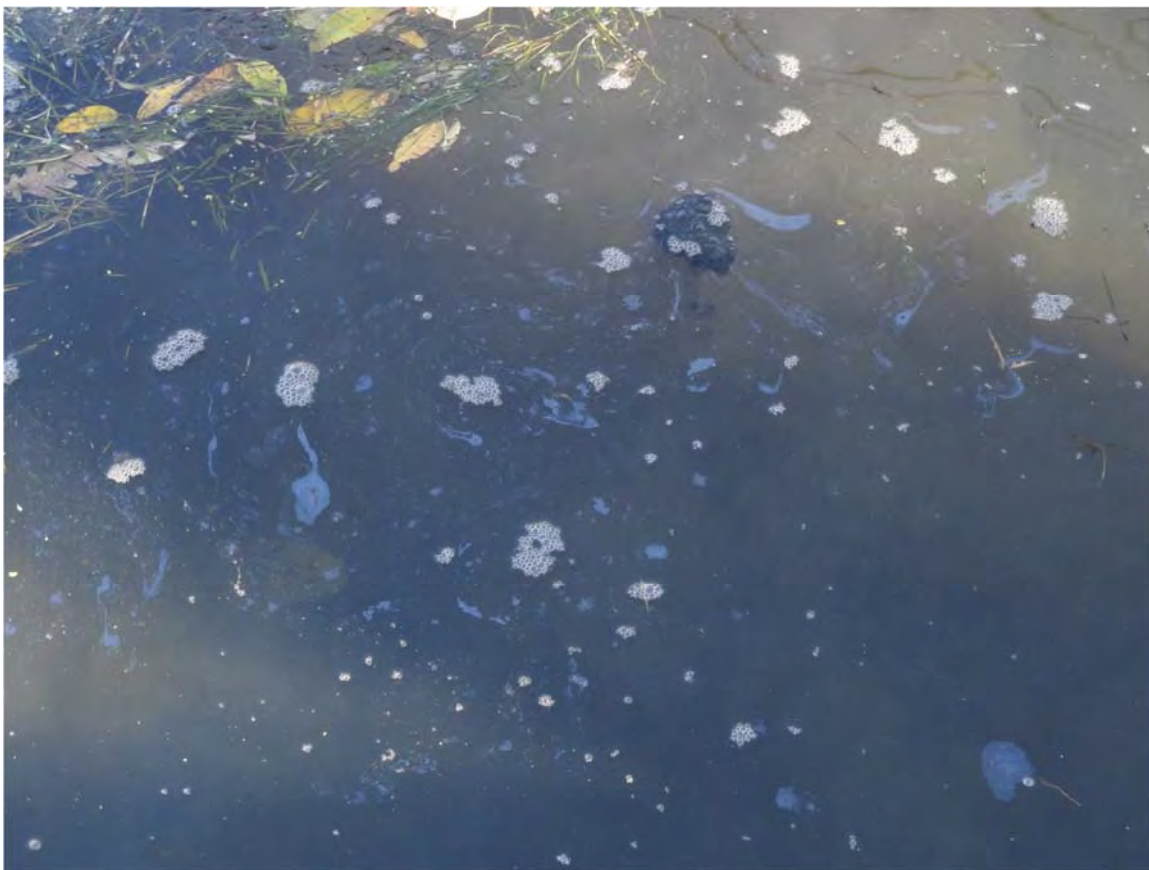
7. MP5.70 sheen observed within debris along Ceresco containment boom.

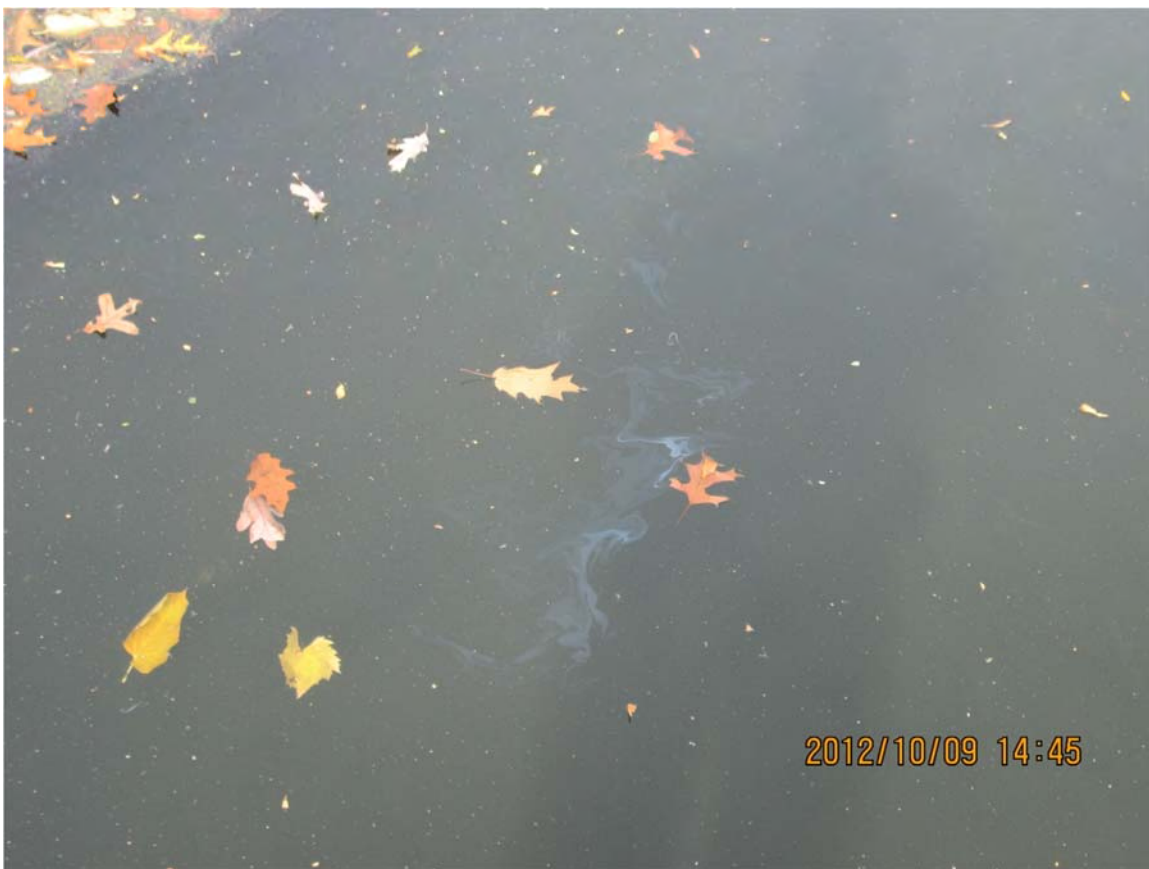
8. MP5.70 sheen observed within debris along Ceresco containment boom.

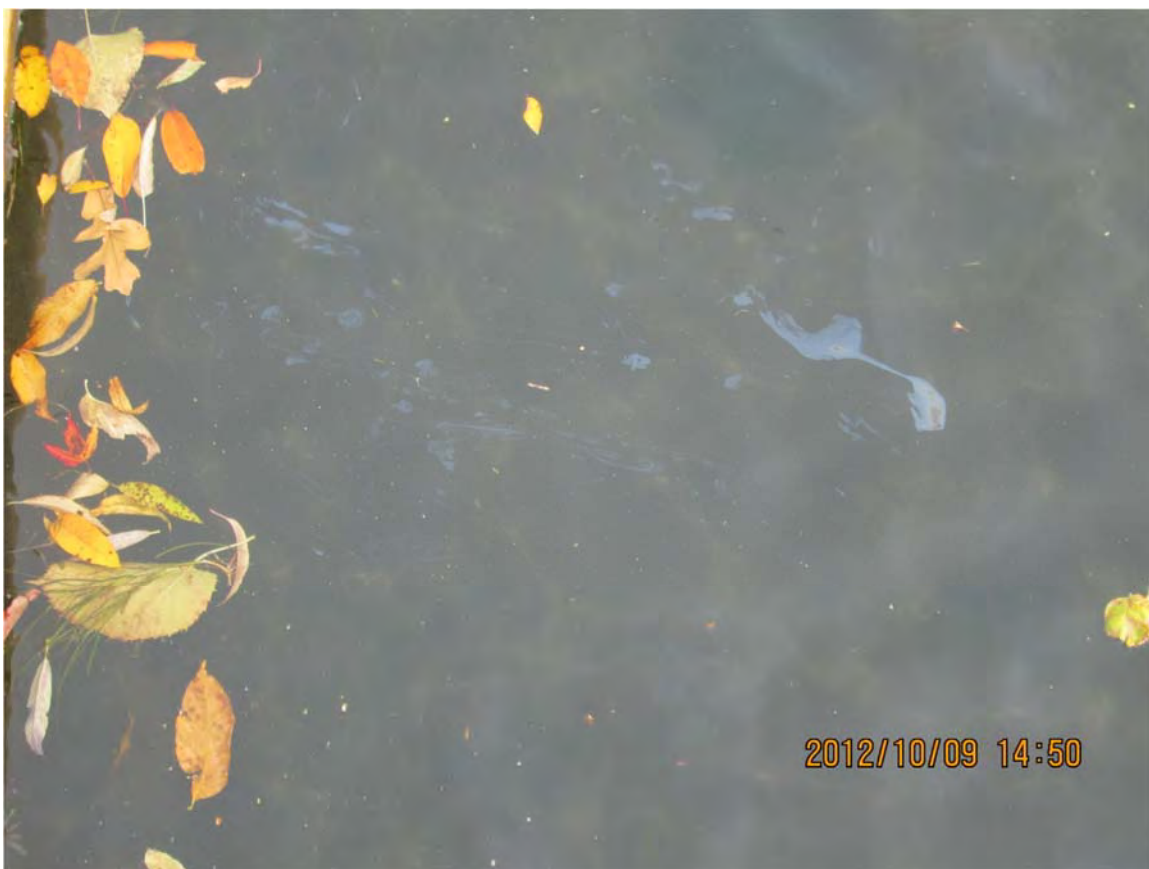
9. MP5.70 sheen observed within debris along Ceresco containment boom.

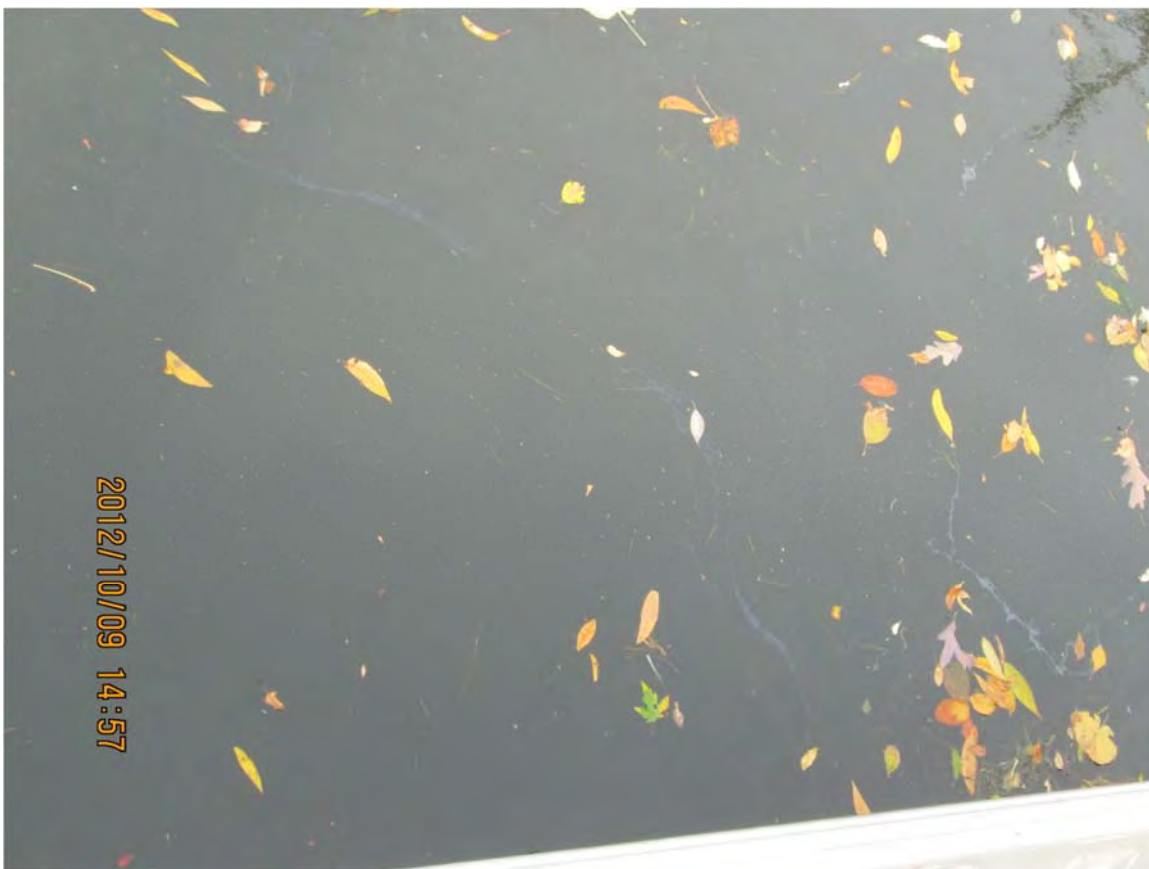
10. MP5.55 RDB spontaneous sheen observed.

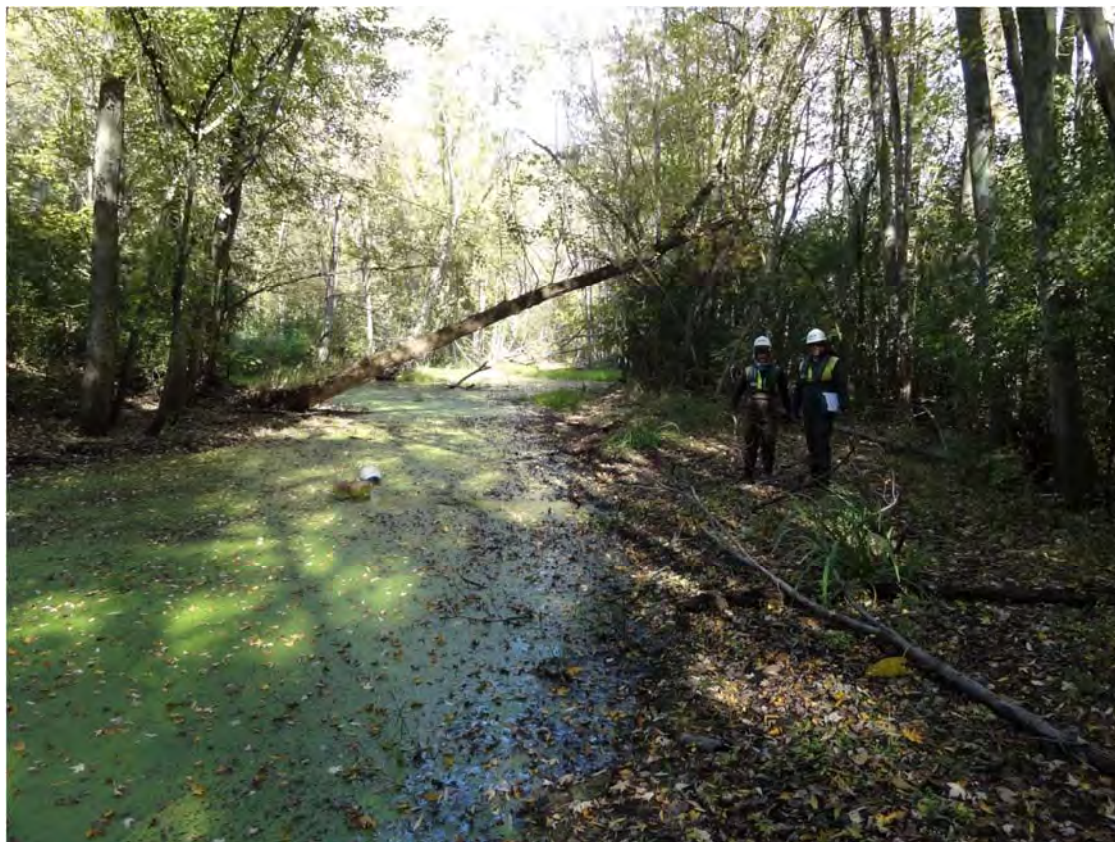
11. MP19.25 Sediment Trap observed a sampling crew.

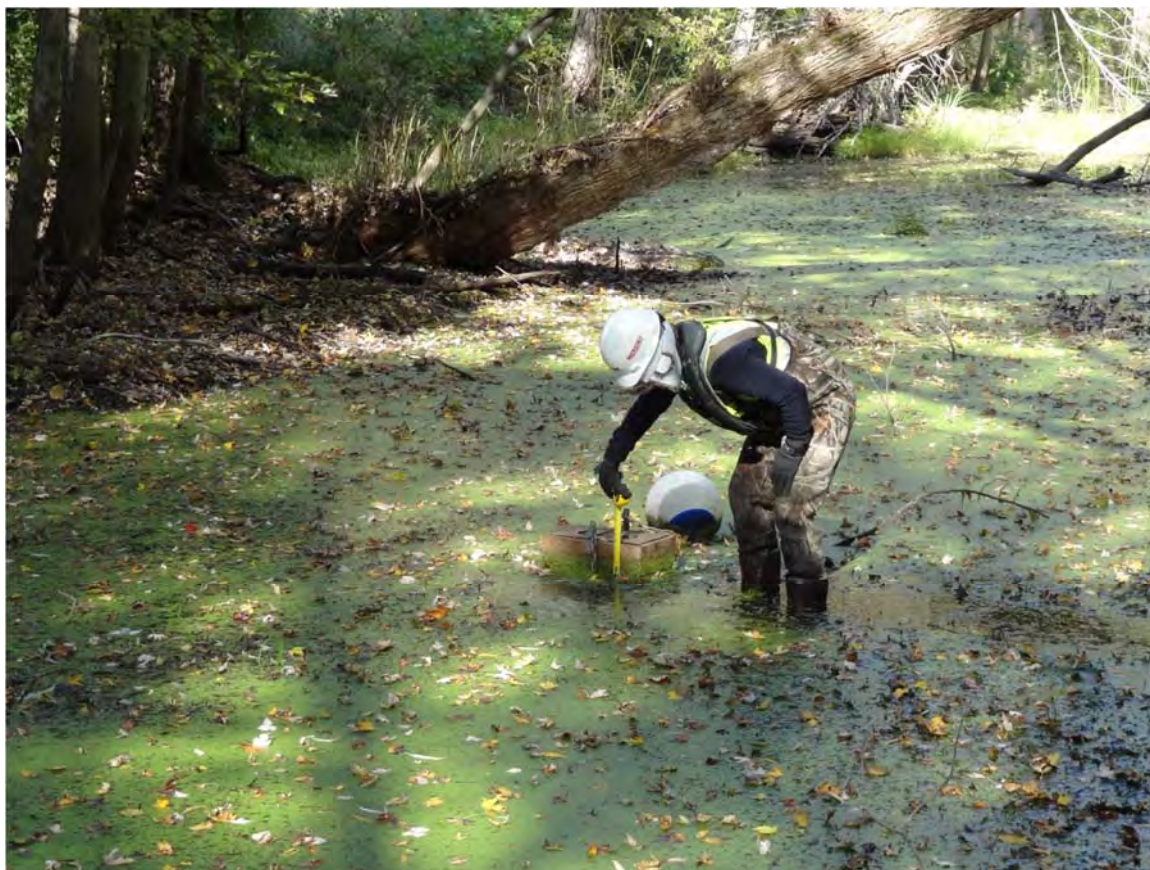
12. MP19.25 Sediment Trap observed a sampling crew.

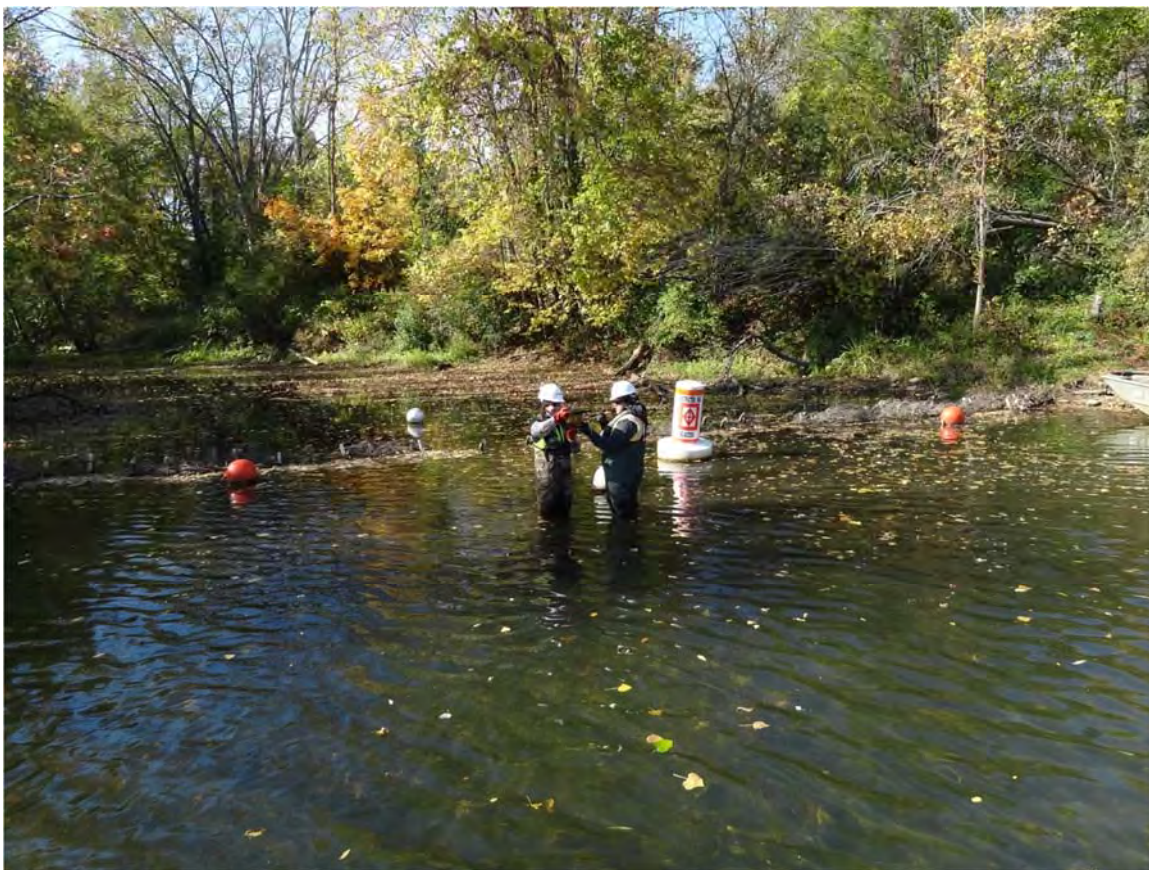
13. MP19.25 Sediment Trap observed a sampling crew.

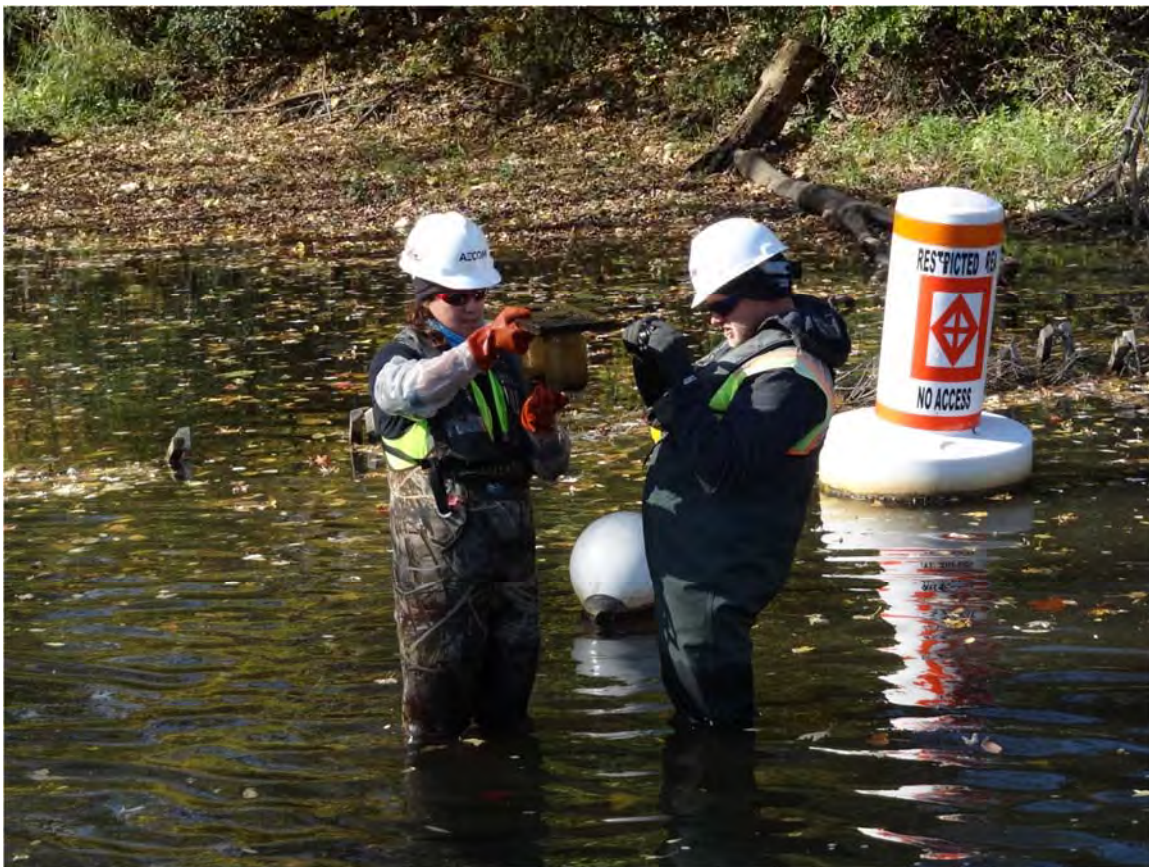
14. MP19.25 Sediment Trap observed a sampling crew.

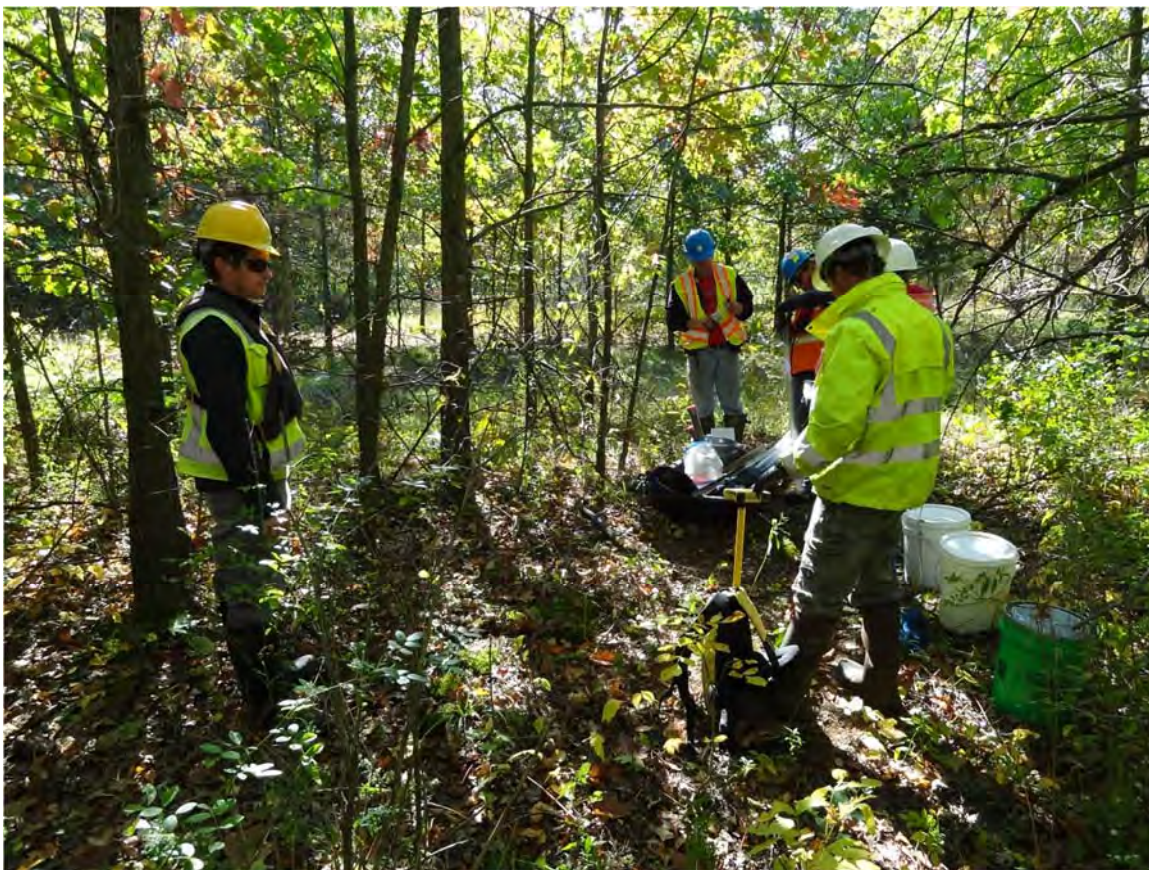
15. MP13.5 Overbank background sampling crew observed.

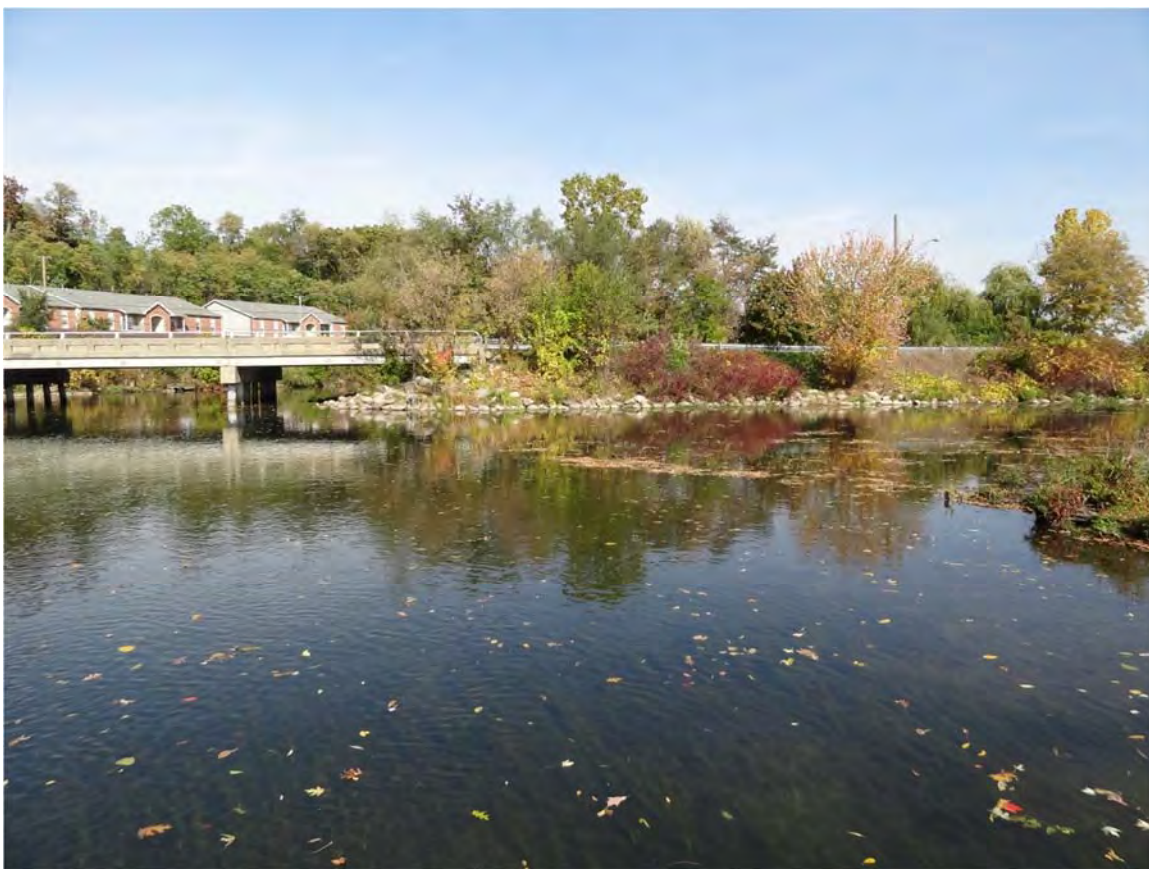
16. MP15.5 South Mill Pond no sheen observed.

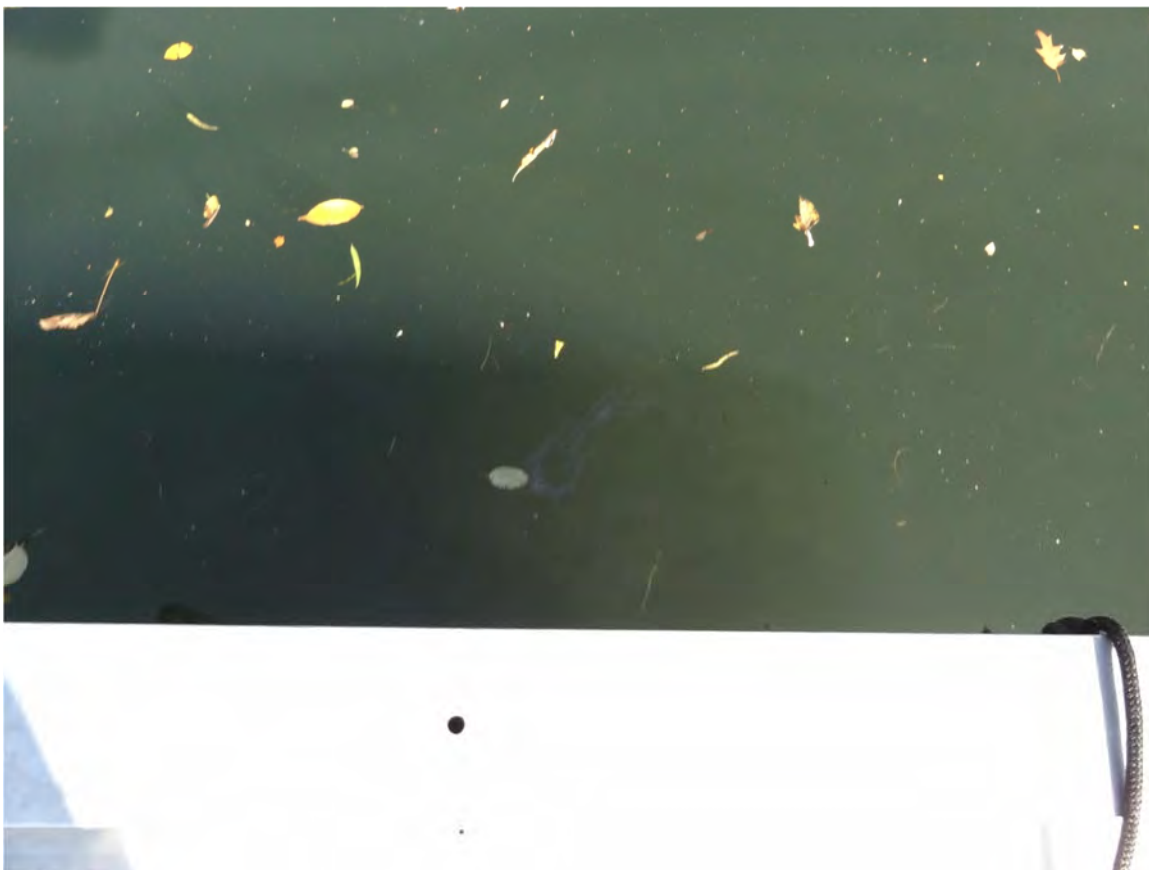
**17. MP15.55 LDB sheen observed, quantity of sheen would not warrant a sweep boat.**

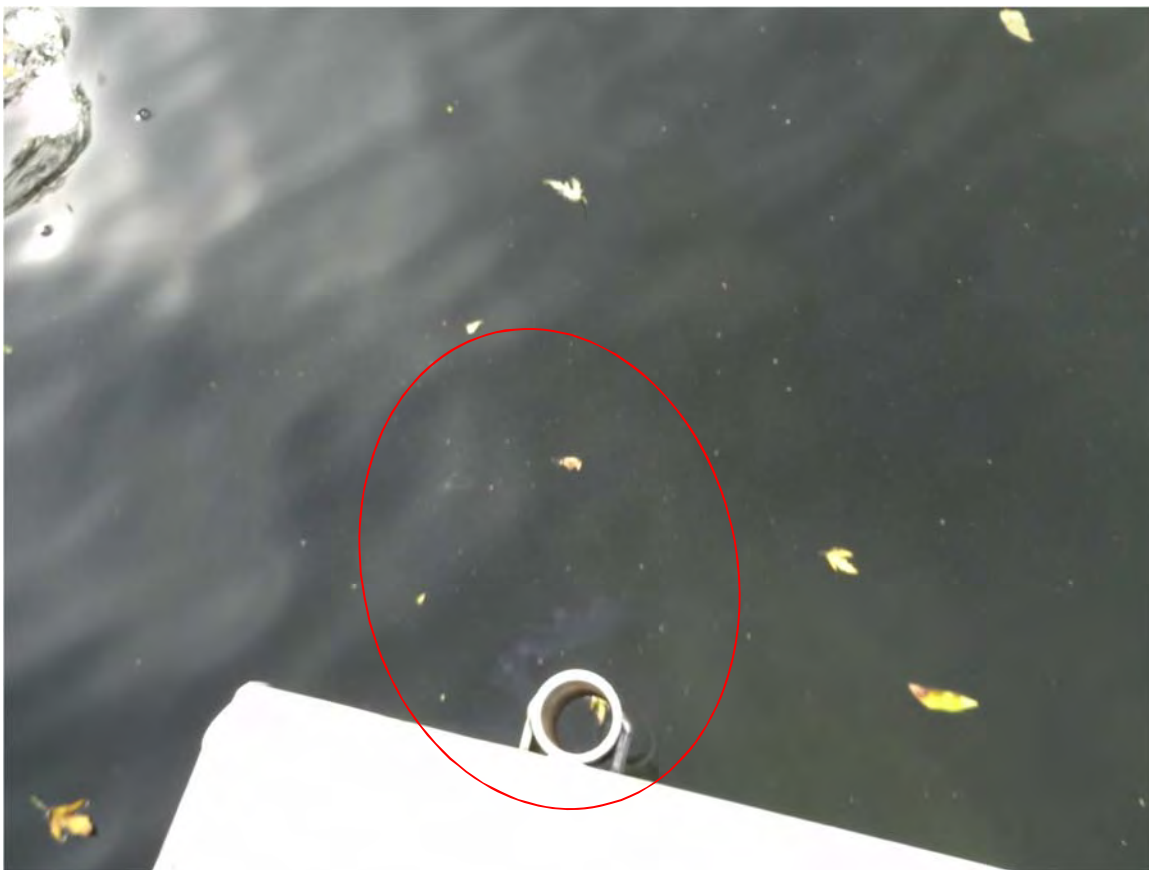
**19. Morrow Lake South Cove sheen observed quantity of sheen would not warrant a sweep boat.**

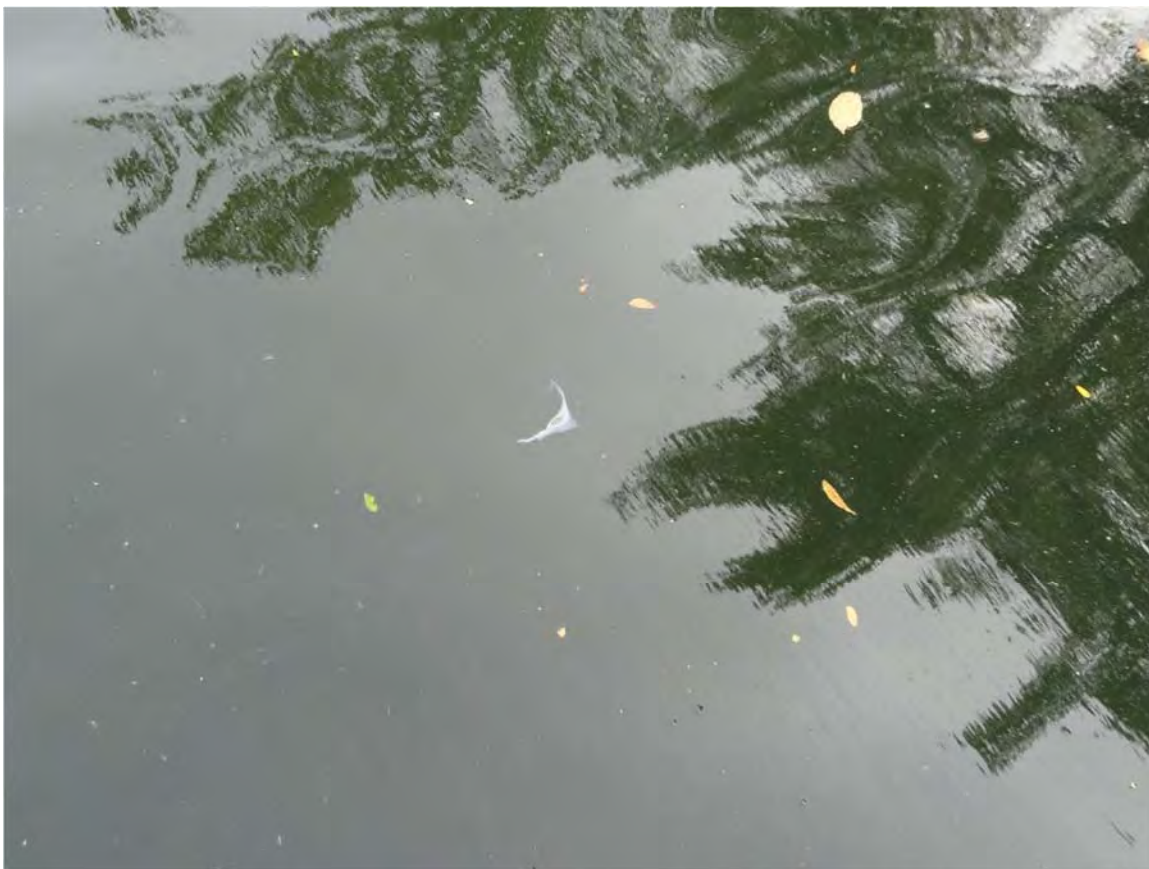
**20. Morrow Lake Delta sheen observed along Gate E.**

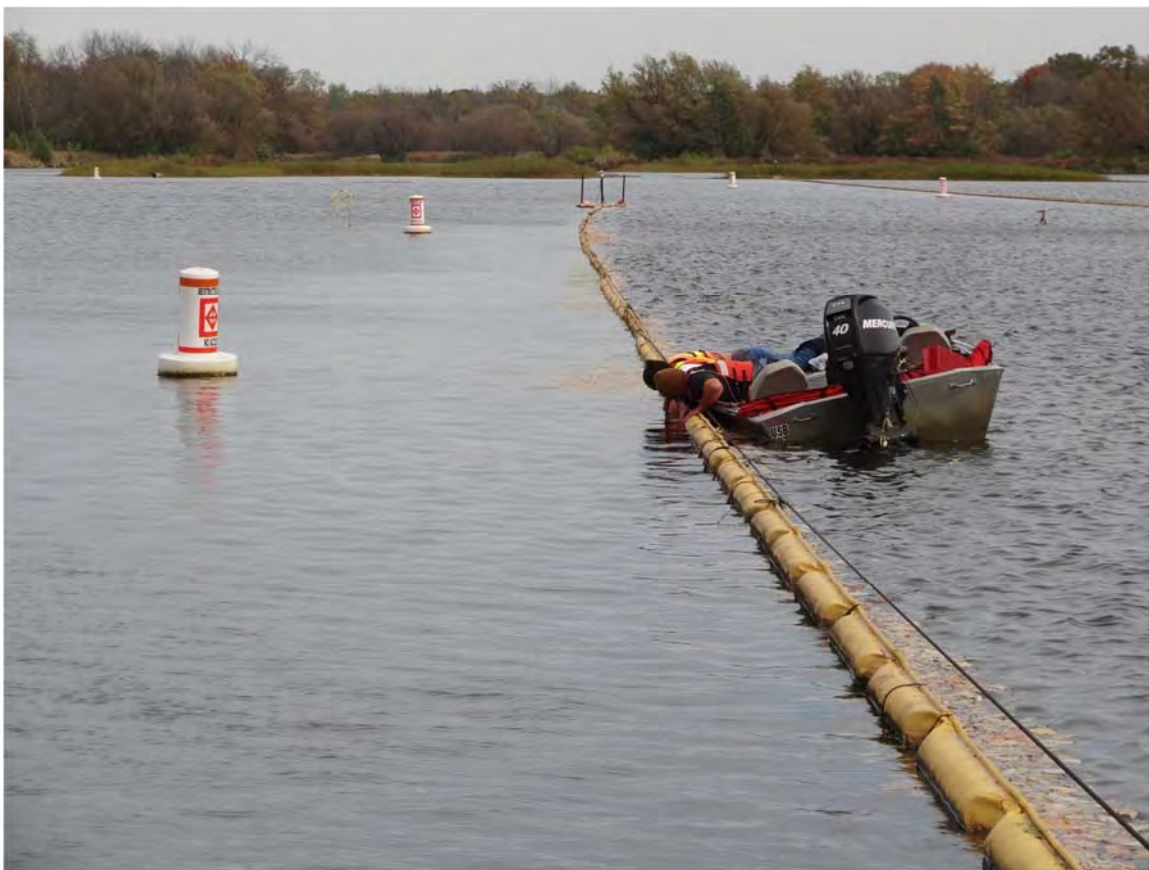
**21. Morrow Lake Delta Gate C observed a crew performing curtain maintenance.**

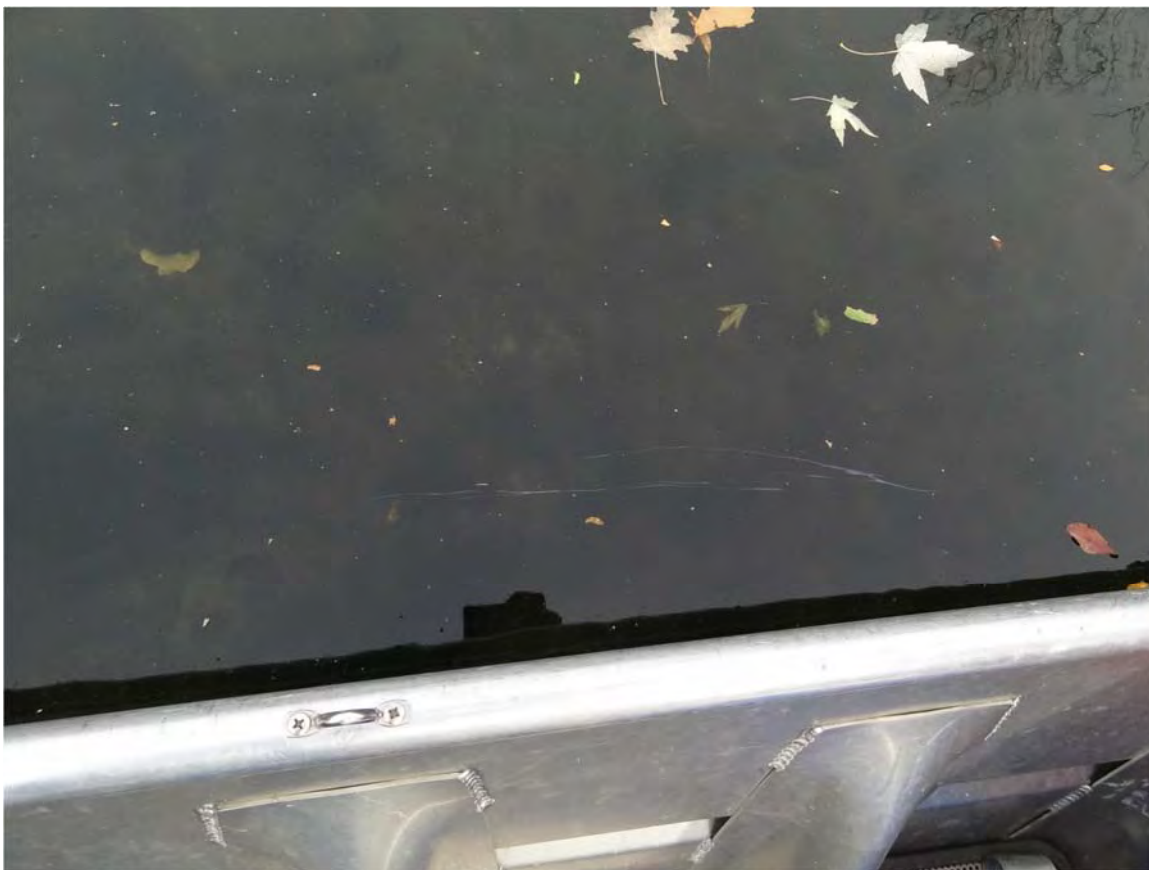
23. MP36.25 sheen observed, quantity of sheen would not warrant a sweep boat.

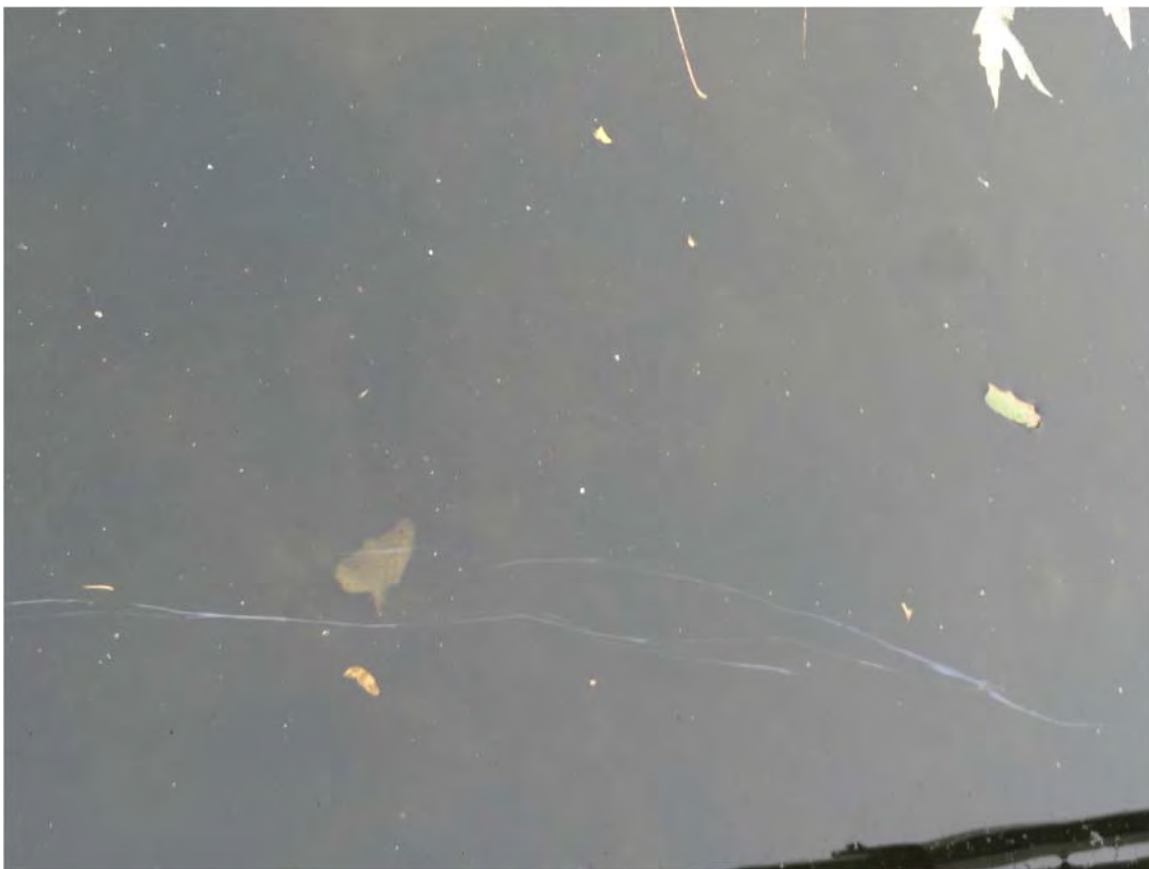
24. MP36.25 sheen observed, quantity of sheen would not warrant a sweep boat.
