# Situation Photo Log

Thursday, October 11, 2012

Kalamazoo River / Enbridge Spill

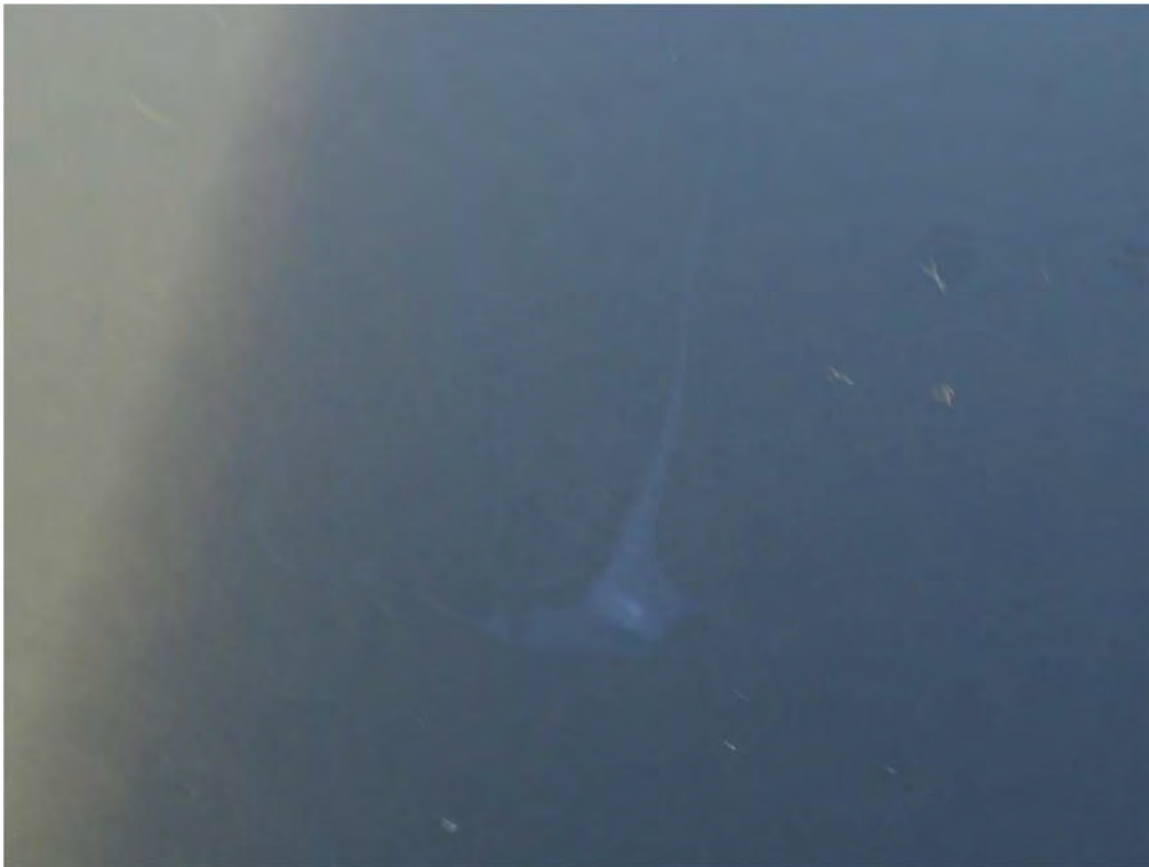
1. MP5.45 LDB, spontaneous ribbons of sheen observed along shoreline.

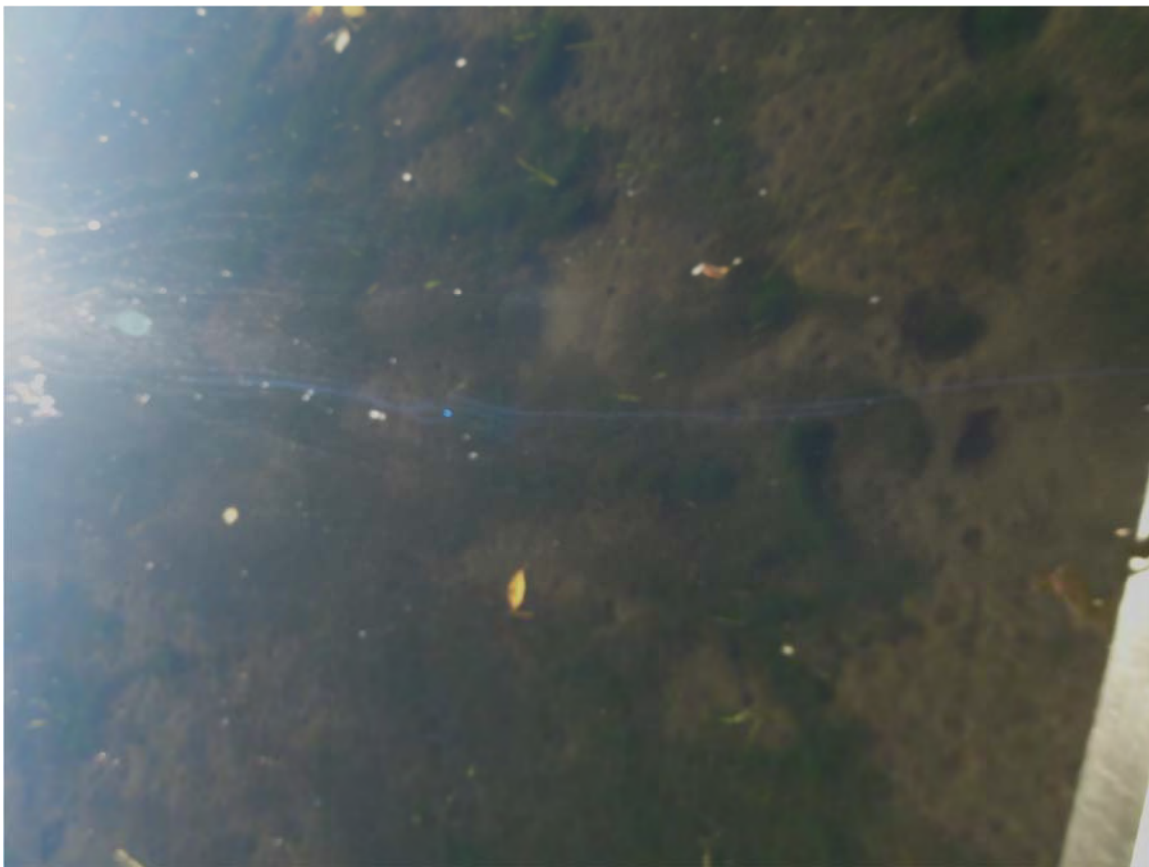
2. MP5.45 LDB, spontaneous ribbons of sheen observed in the center channel.

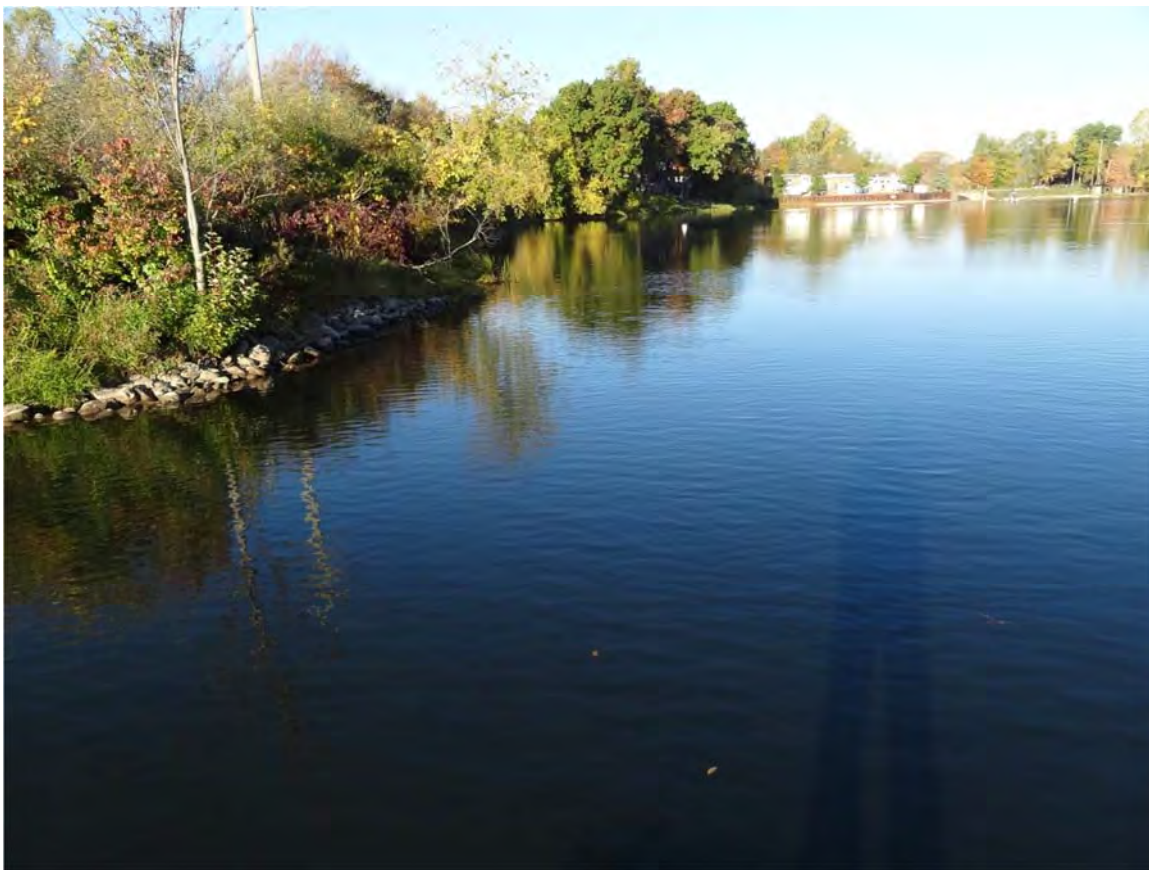
3. MP5.63 No sheen observed.

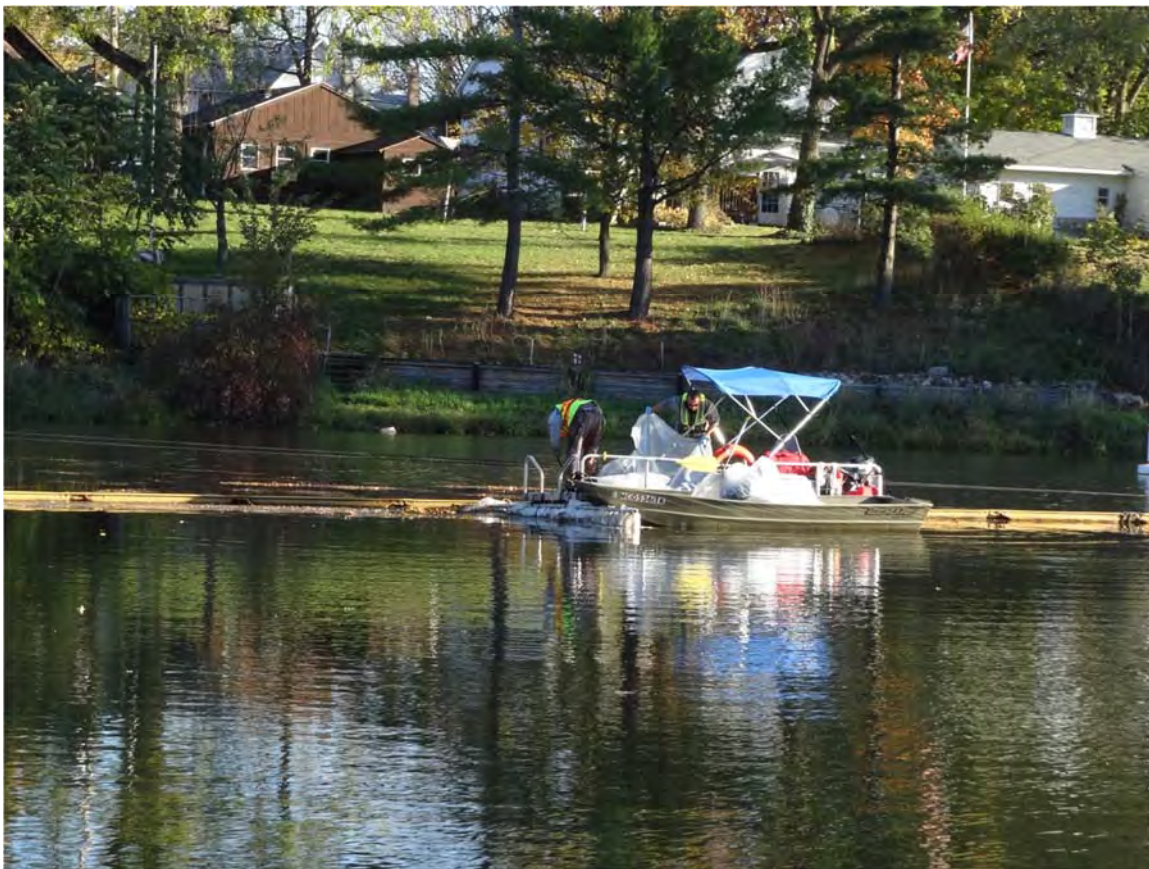
4. Ceresco Dam control point boom observed a crew removing debris from along the boom.

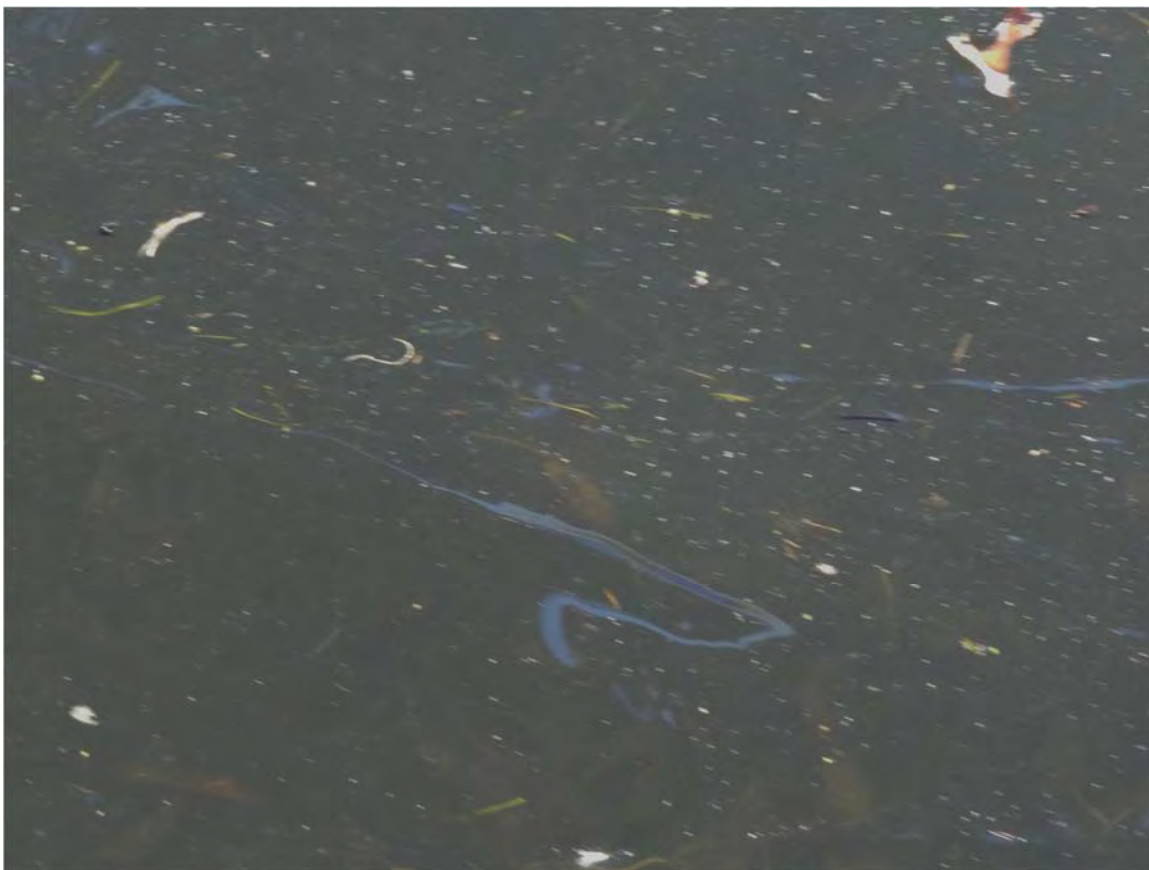
5. Sheen and tar globs observed collecting along the Ceresco Dam control point boom.

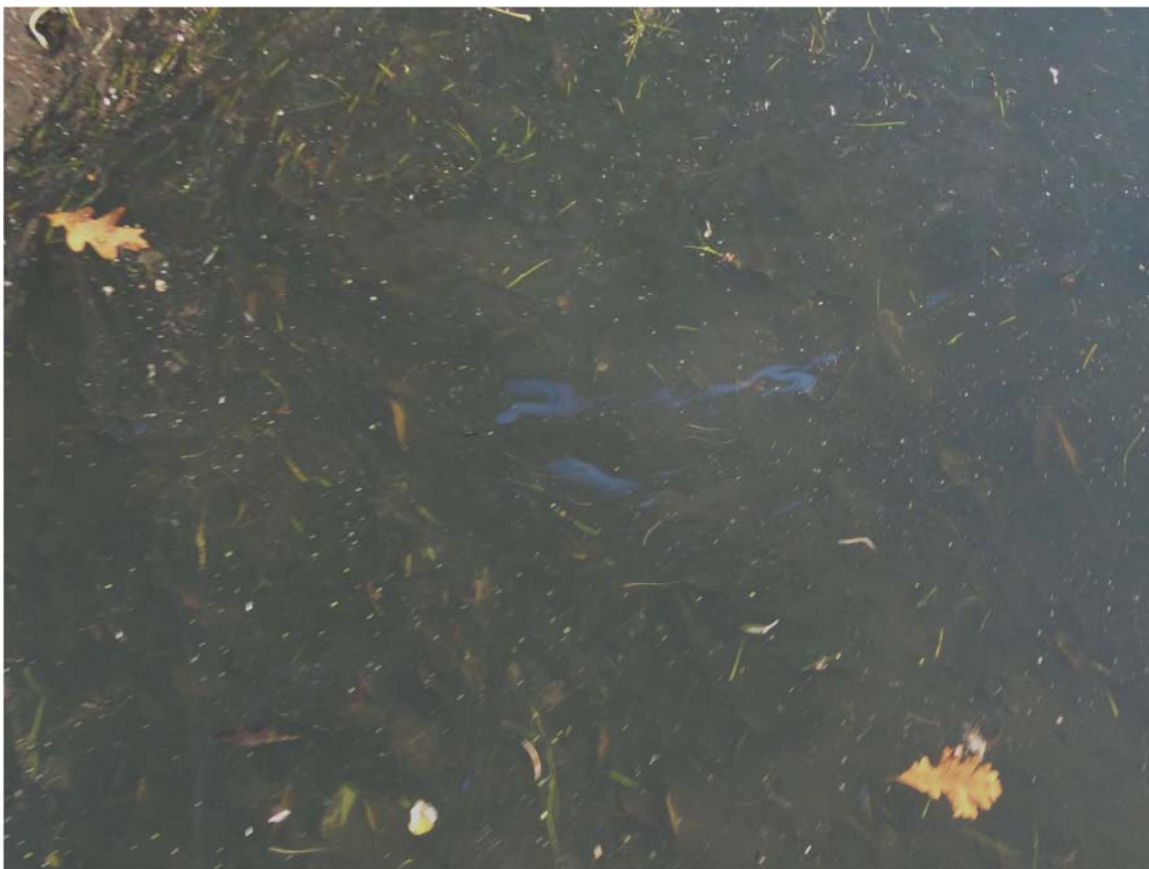
6. Sheen and tar globs observed collecting along the Ceresco Dam control point boom.

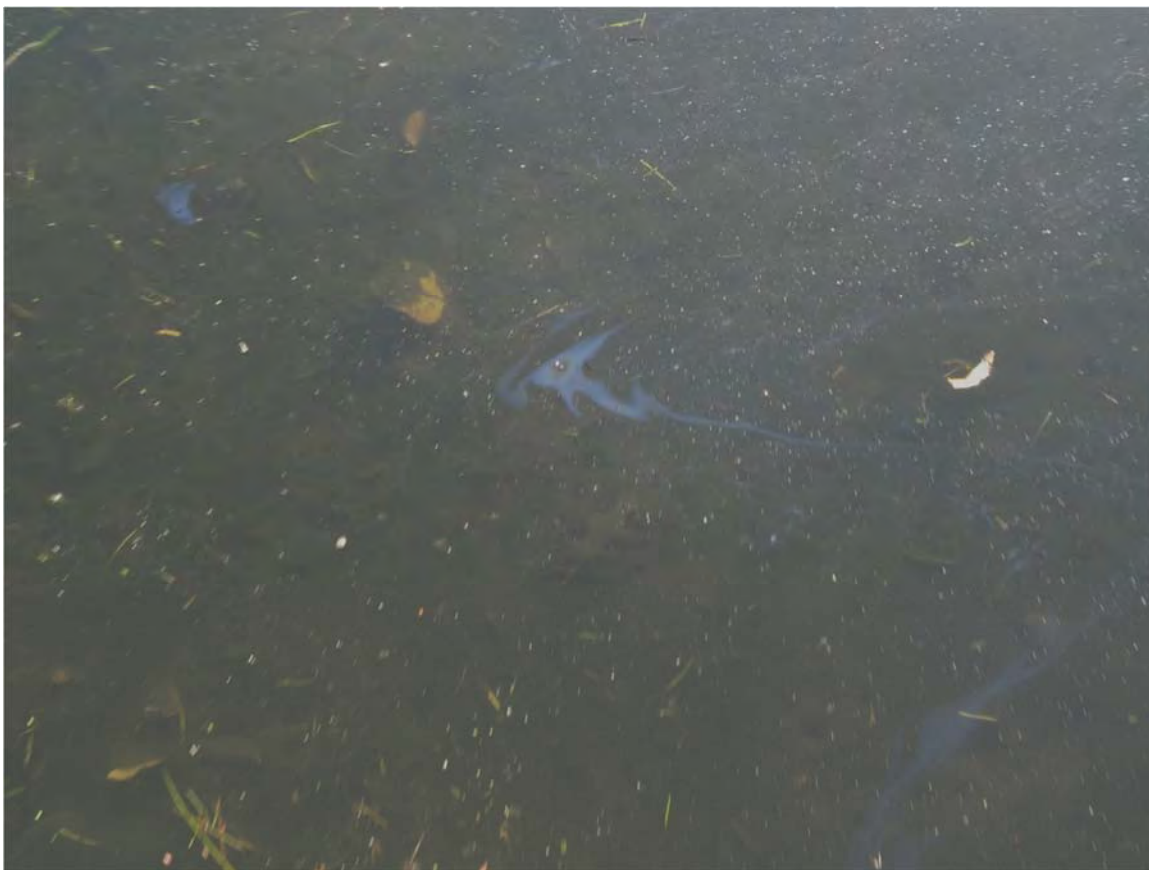
7. Sheen and tar globs observed collecting along the Ceresco Dam control point boom.

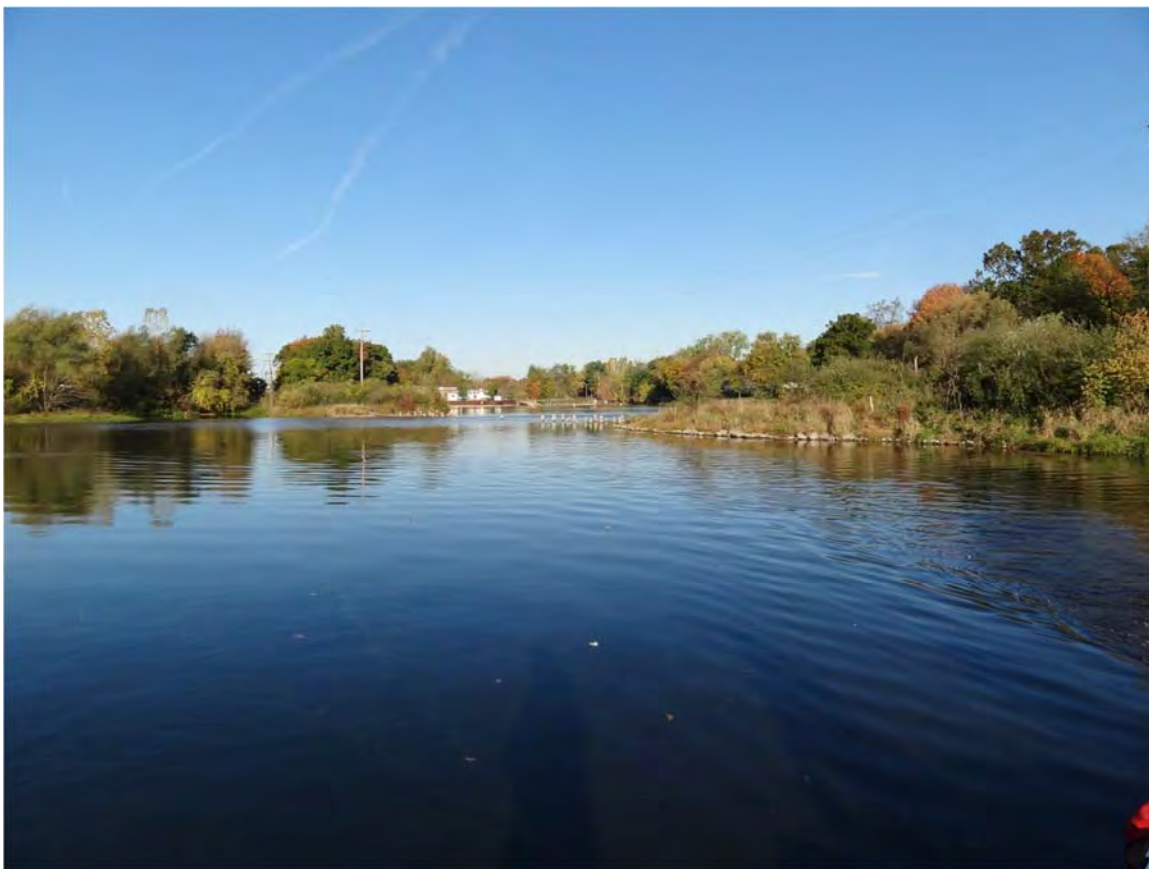
8. MP5.55 RDB area where sheen was observed.

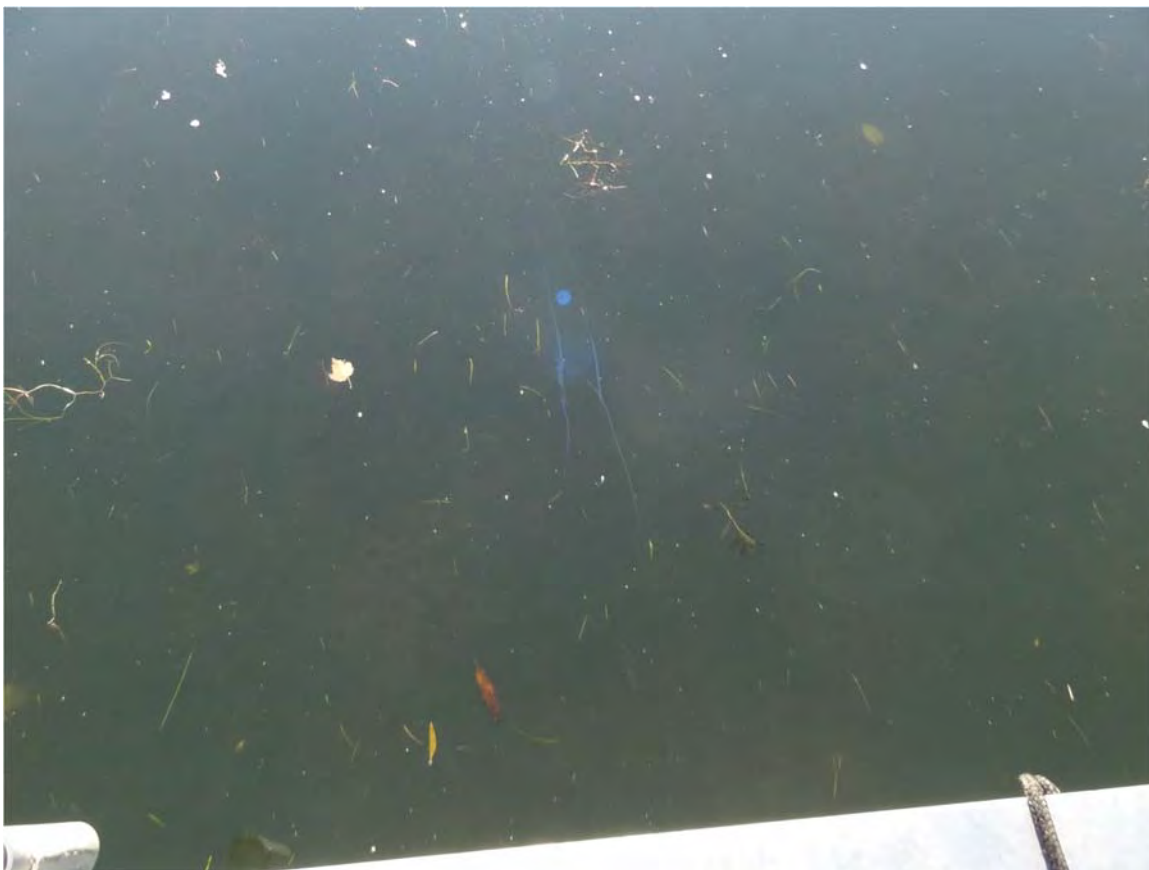
9. MP5.55 RDB sheen was observed.

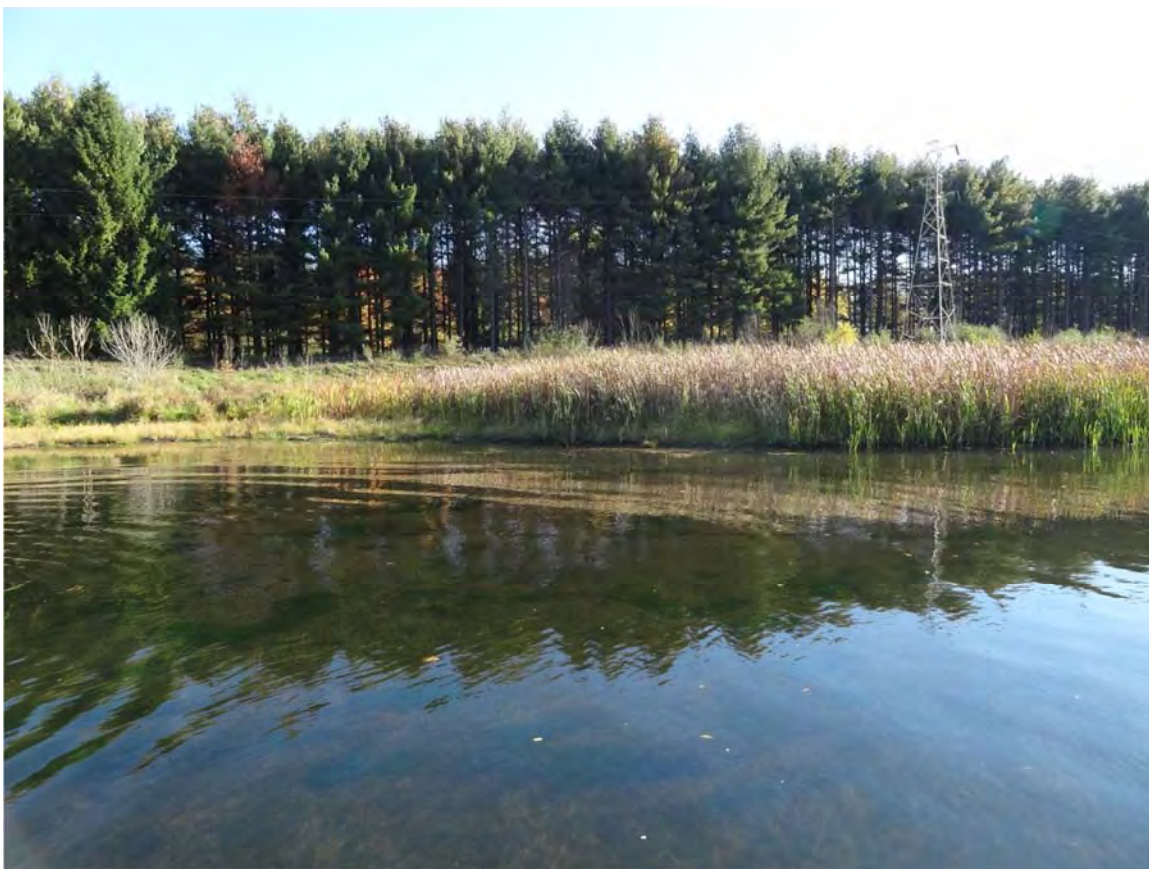
10. MP5.0 RDB area where sheen was spotted from the previous day's overflight. No sheen was observed during today's investigation.

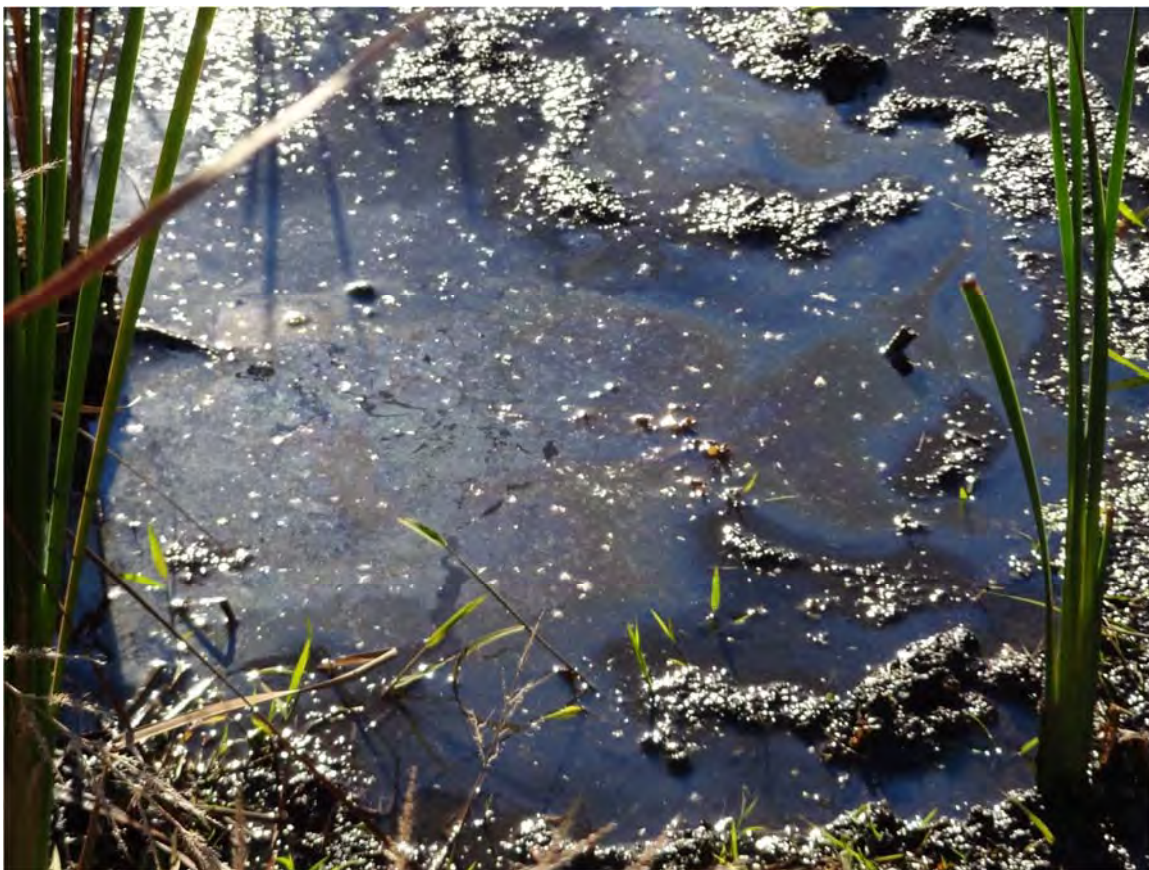
**11. MP5.0 RDB area where sheen was spotted from the previous day's overflight.  
Sheen observed during today's investigation appeared to be organic.**

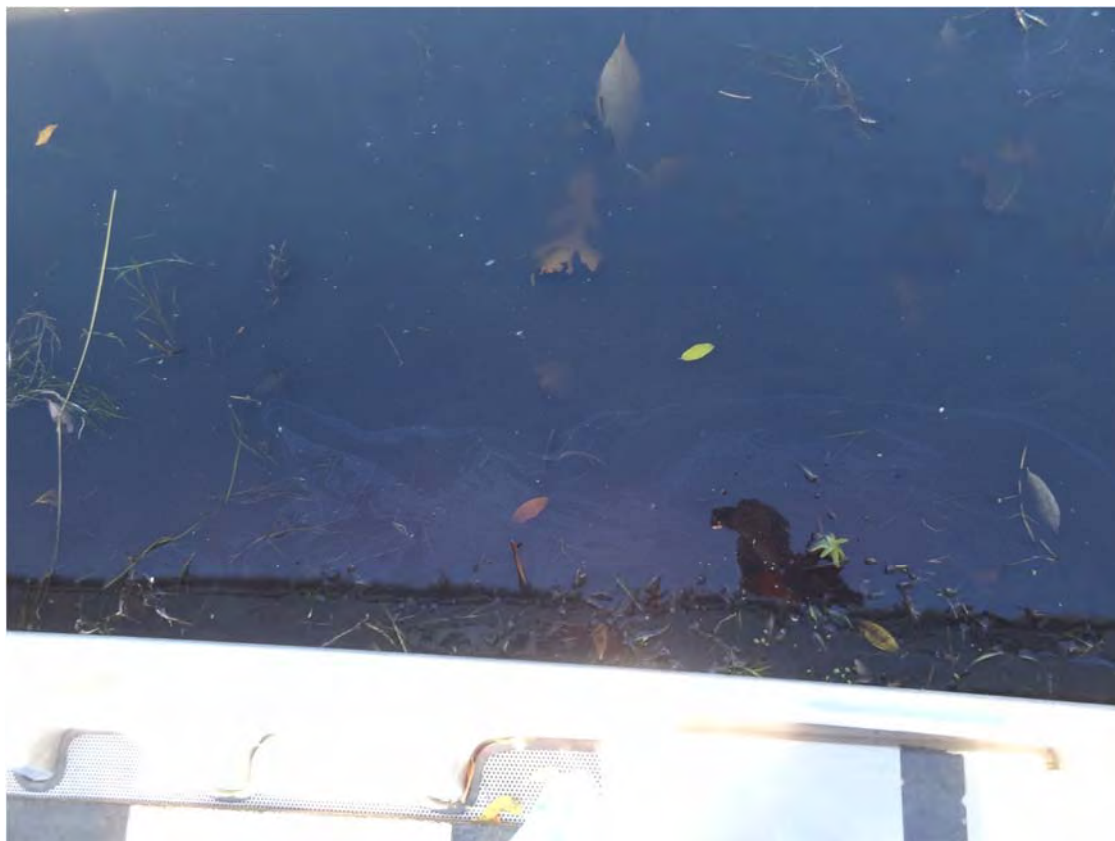
**12. MP5.0 RDB sheen generated when using a poling to propel the boat out  
to deeper water.**

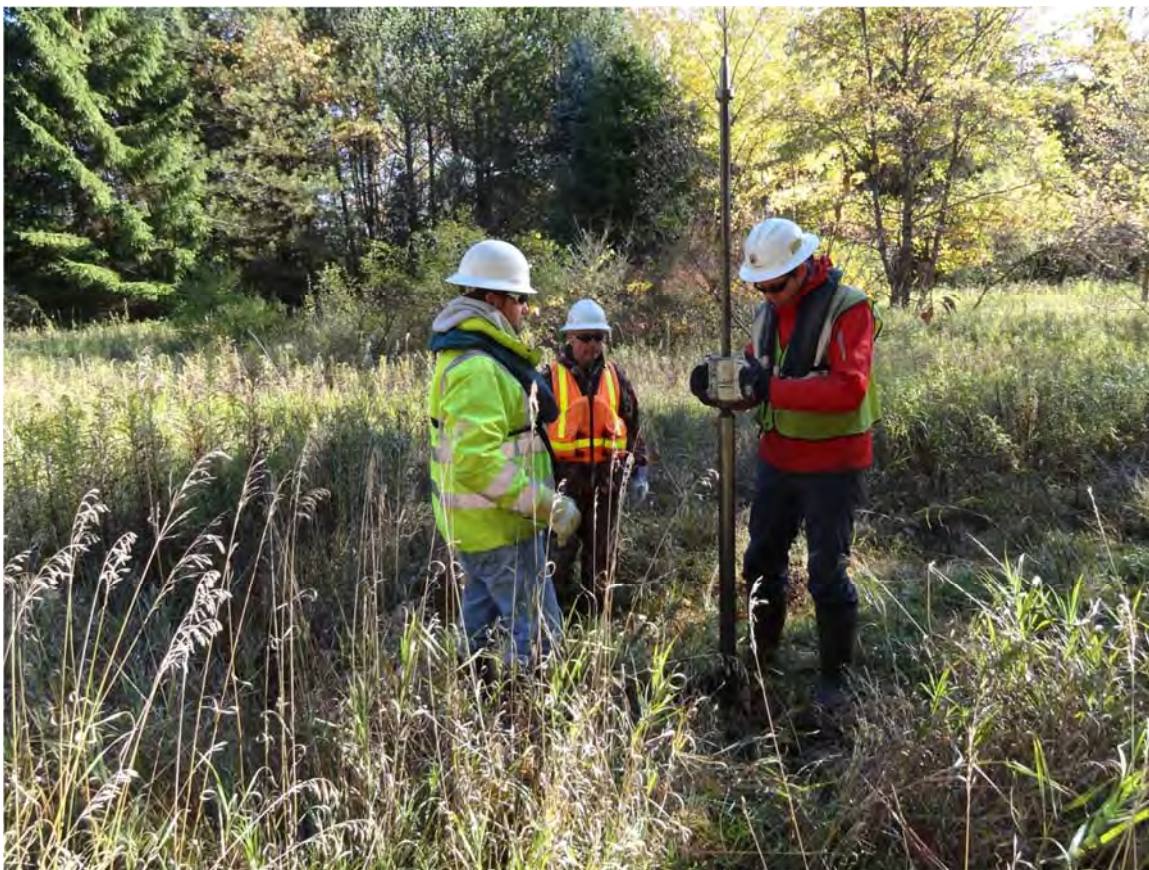
13. MP5.0 observed a RI crew performing background soil sampling.

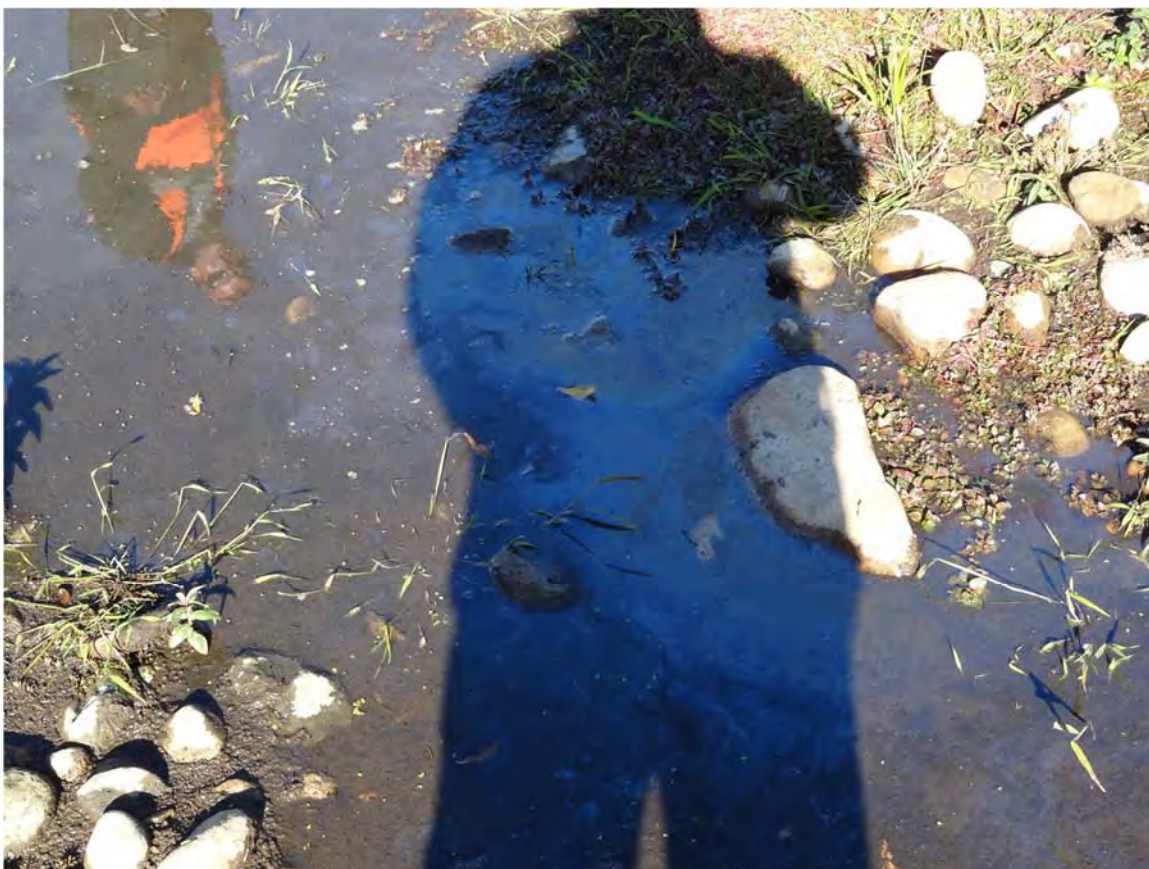
14. Former Island F area where sheen was spotted from the previous day's overflight. Sheen observed during today's investigation appeared to be organic.

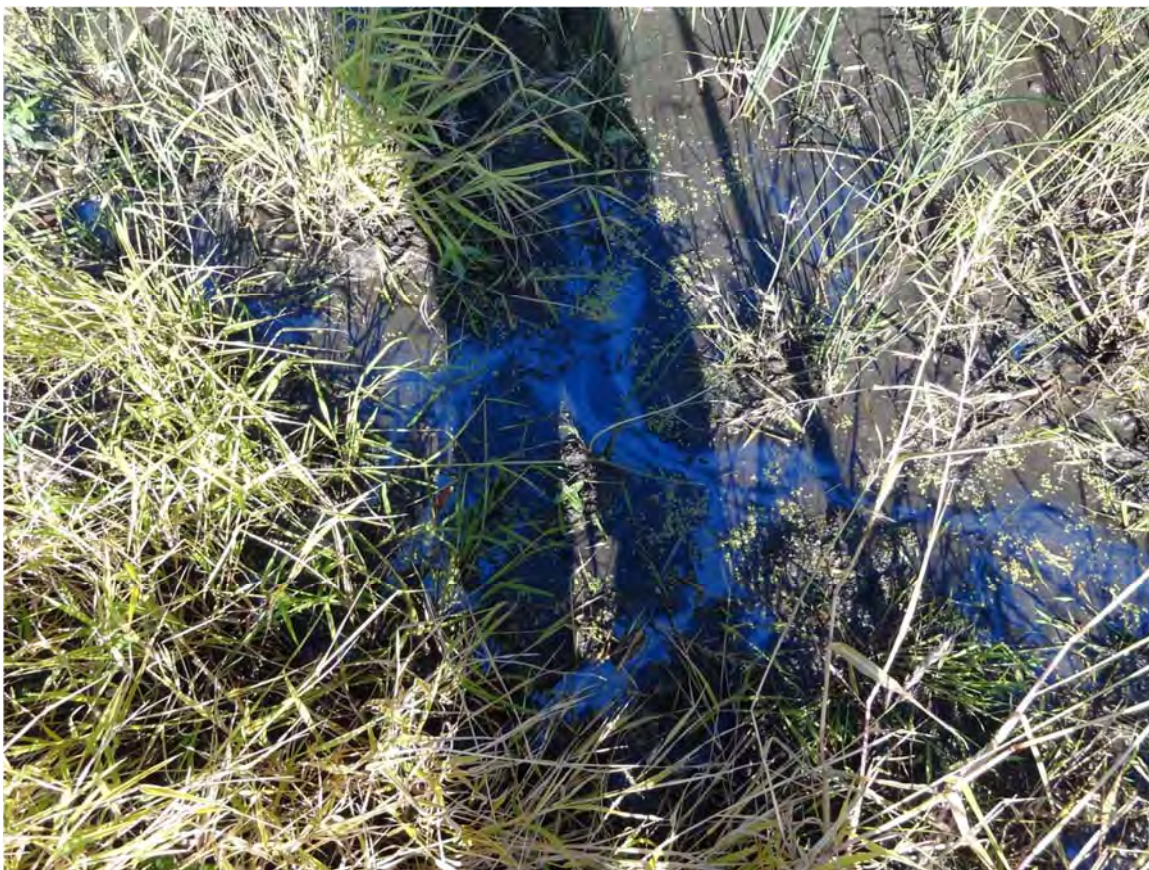
15. MP3.25 RDB area where sheen was spotted from the previous day's overflight. Sheen observed during today's investigation appeared to be organic.

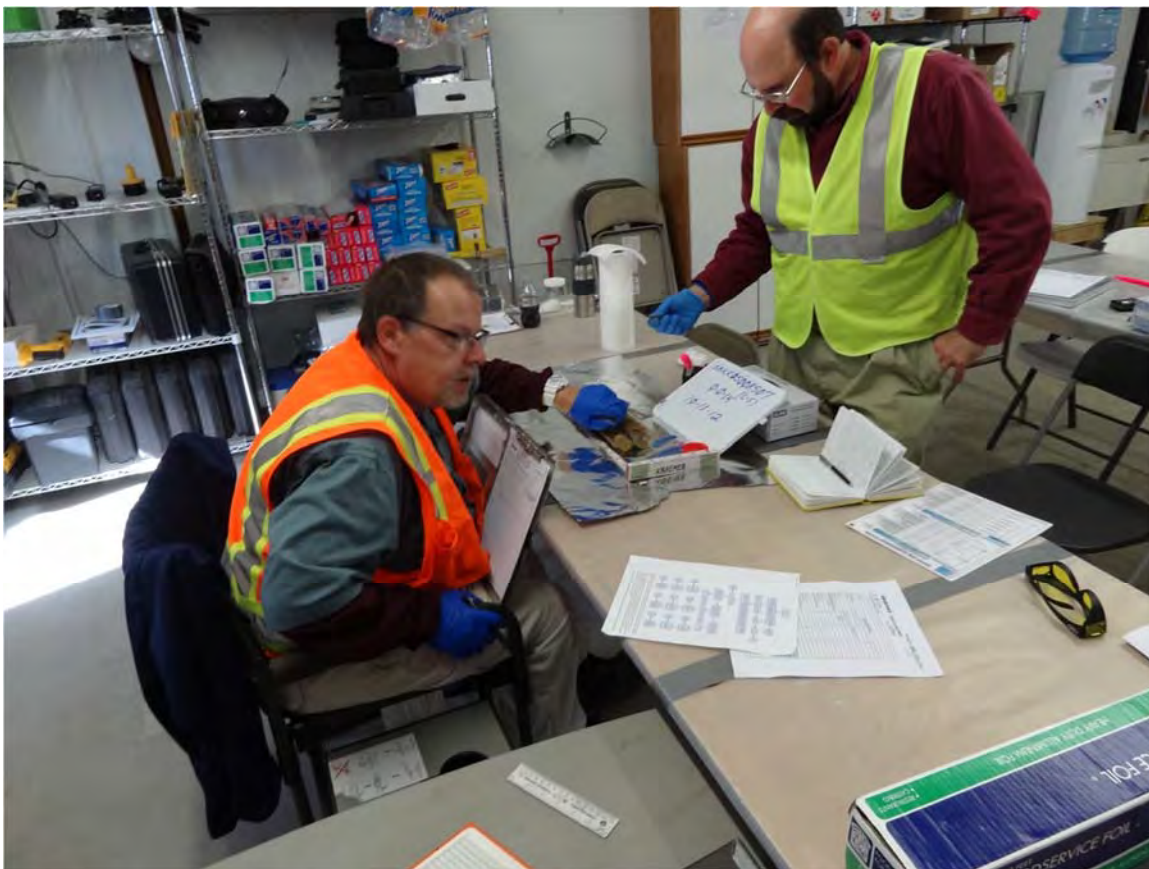
16. Observed a crew analyzing the RI background samples.

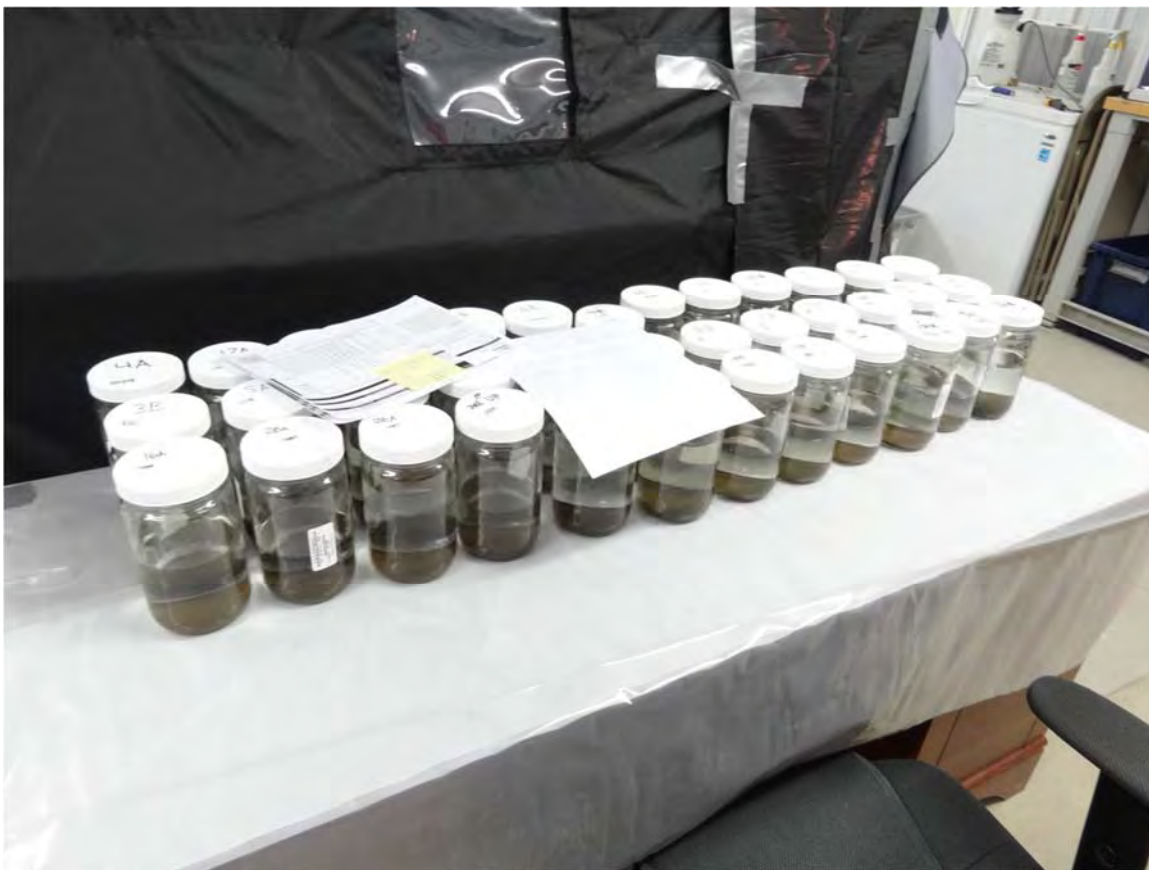
17. Observed the Walling Tube samples being allowed to settle.

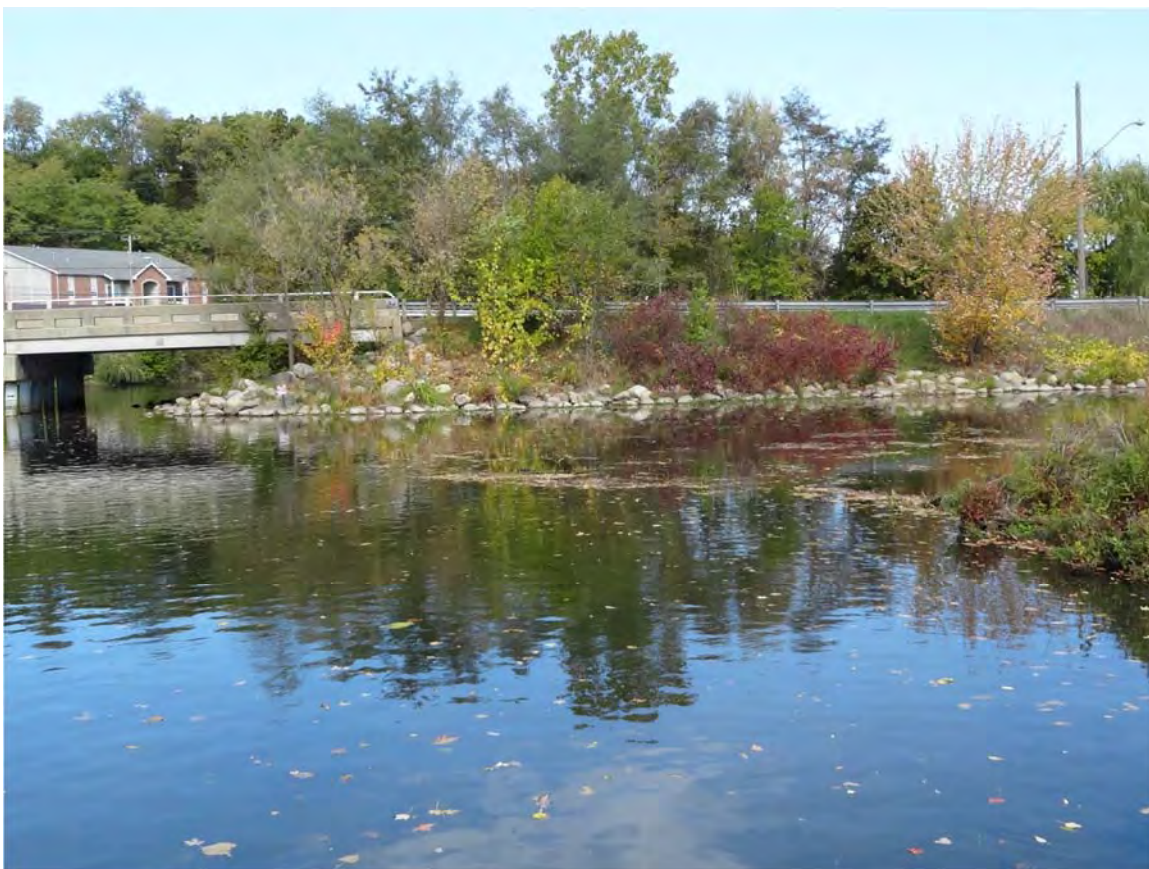
18. MP15.5 South Mill Pond a very small spot of sheen was observed, quantity of sheen would not warrant a sweep boat.

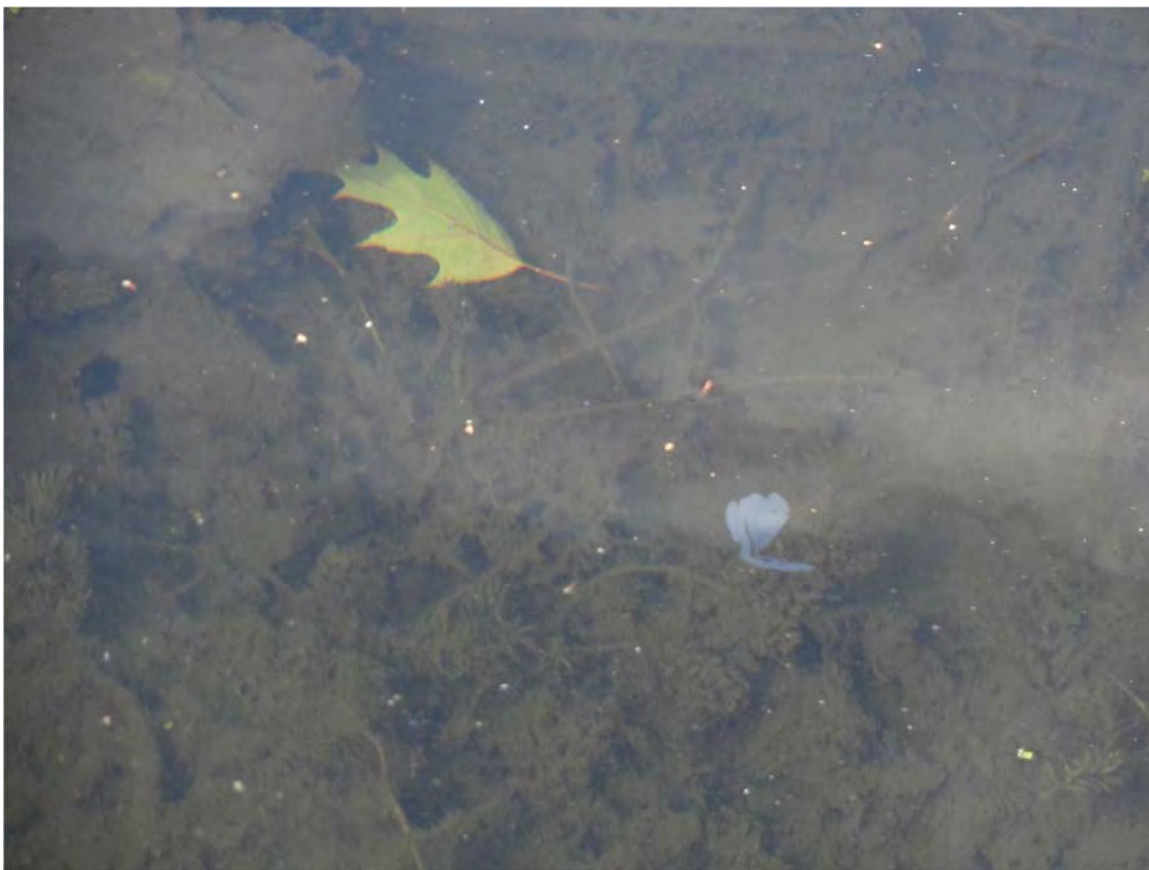
**19. MP15.5 South Mill Pond a very small spot of sheen was observed, quantity of sheen would not warrant a sweep boat.**

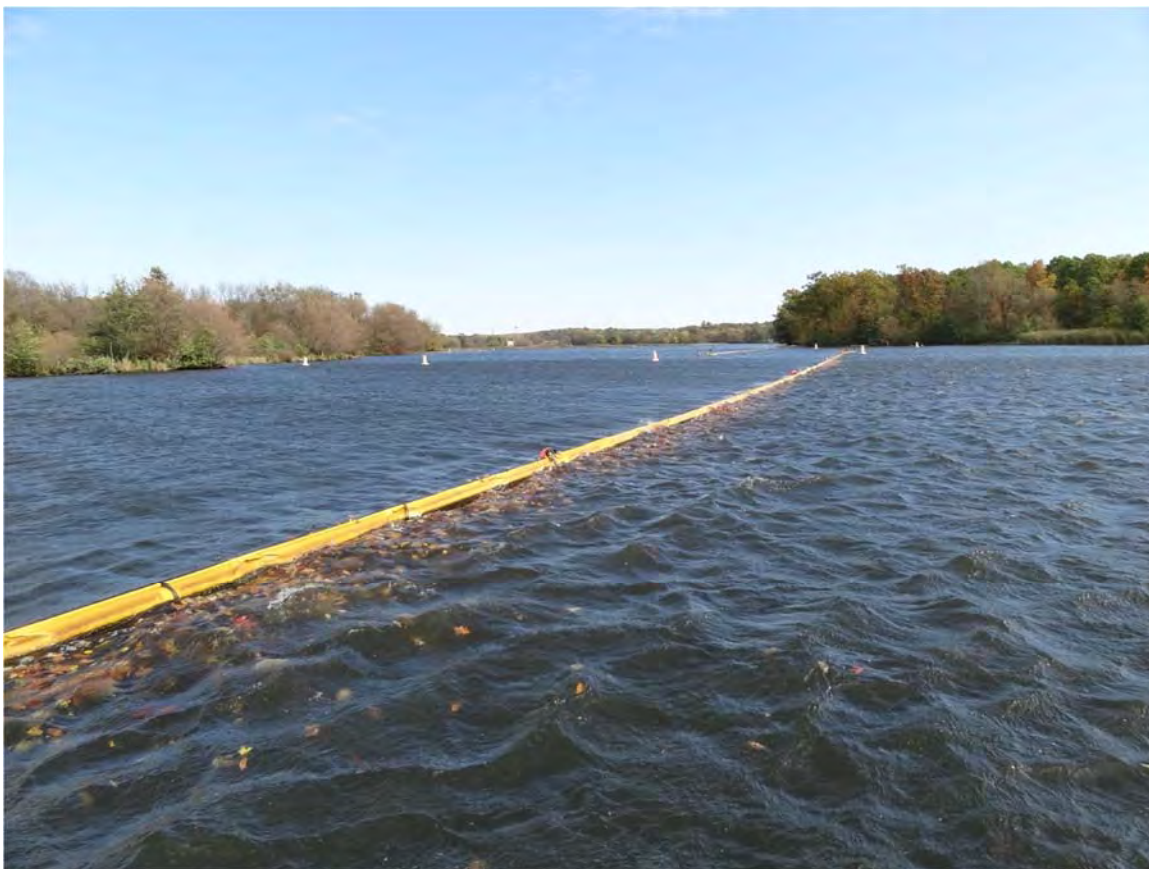
**20. Morrow Lake Delta Gate E no sheen observed, extremely windy conditions were experienced.**

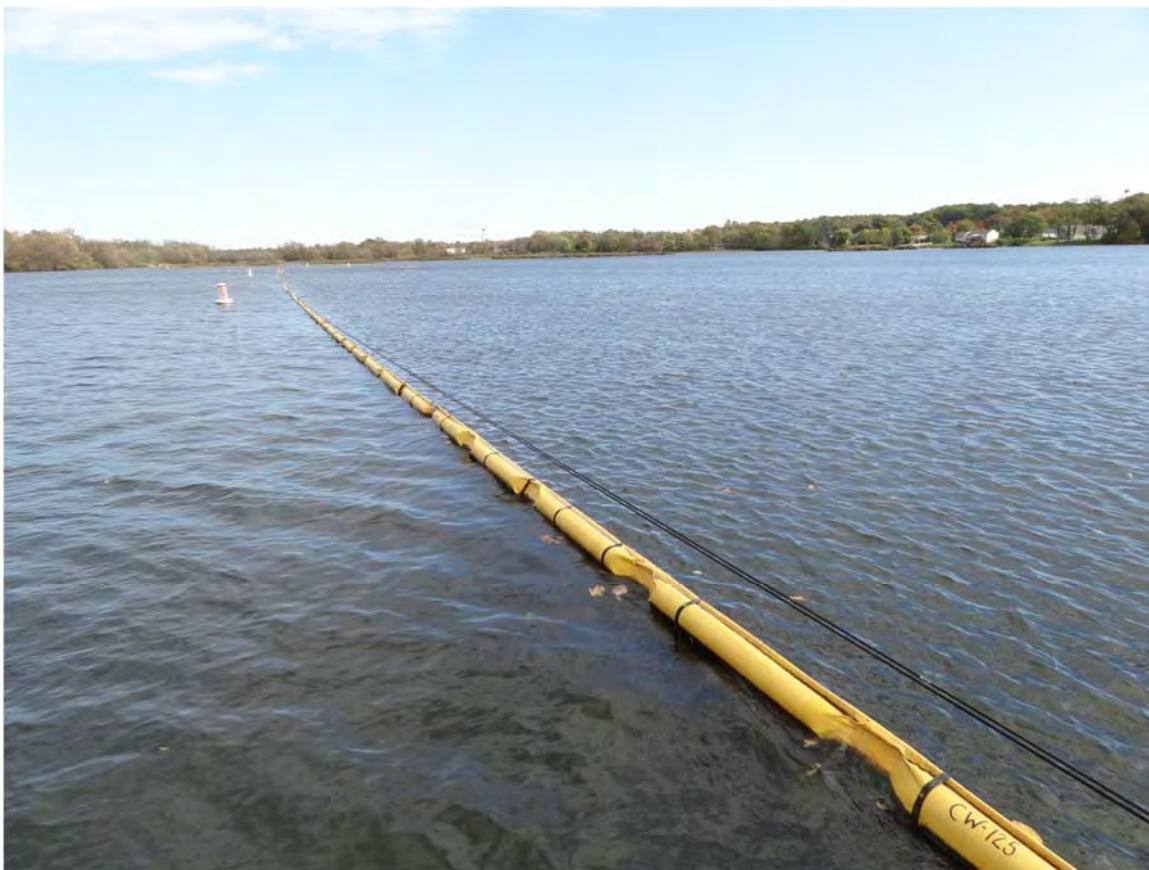
**21. Morrow Lake Delta Gate C no sheen observed, extremely windy conditions were experienced**

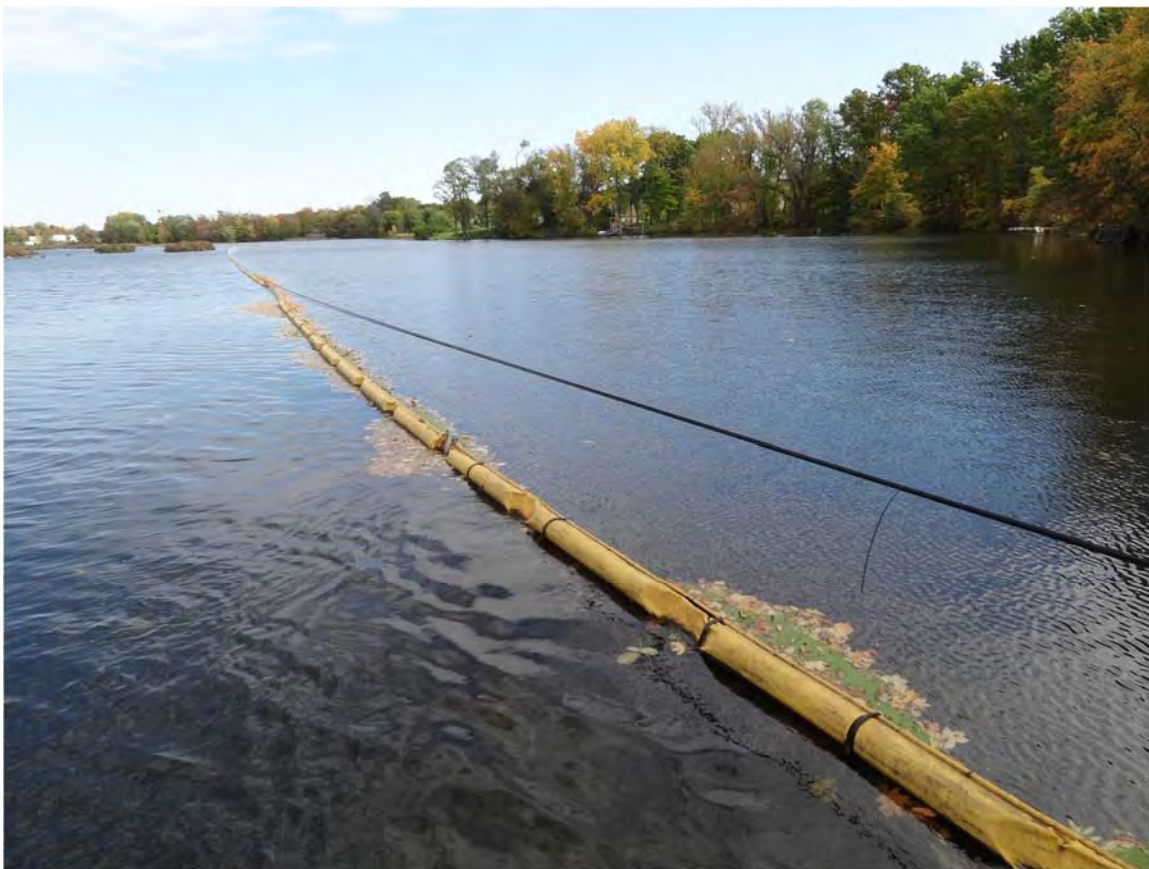
**22. Morrow Lake Delta Gate B no sheen observed, extremely windy conditions were experienced.**
