# Situation Photo Log

Thursday, October 11, 2012

Kalamazoo River / Enbridge Spill

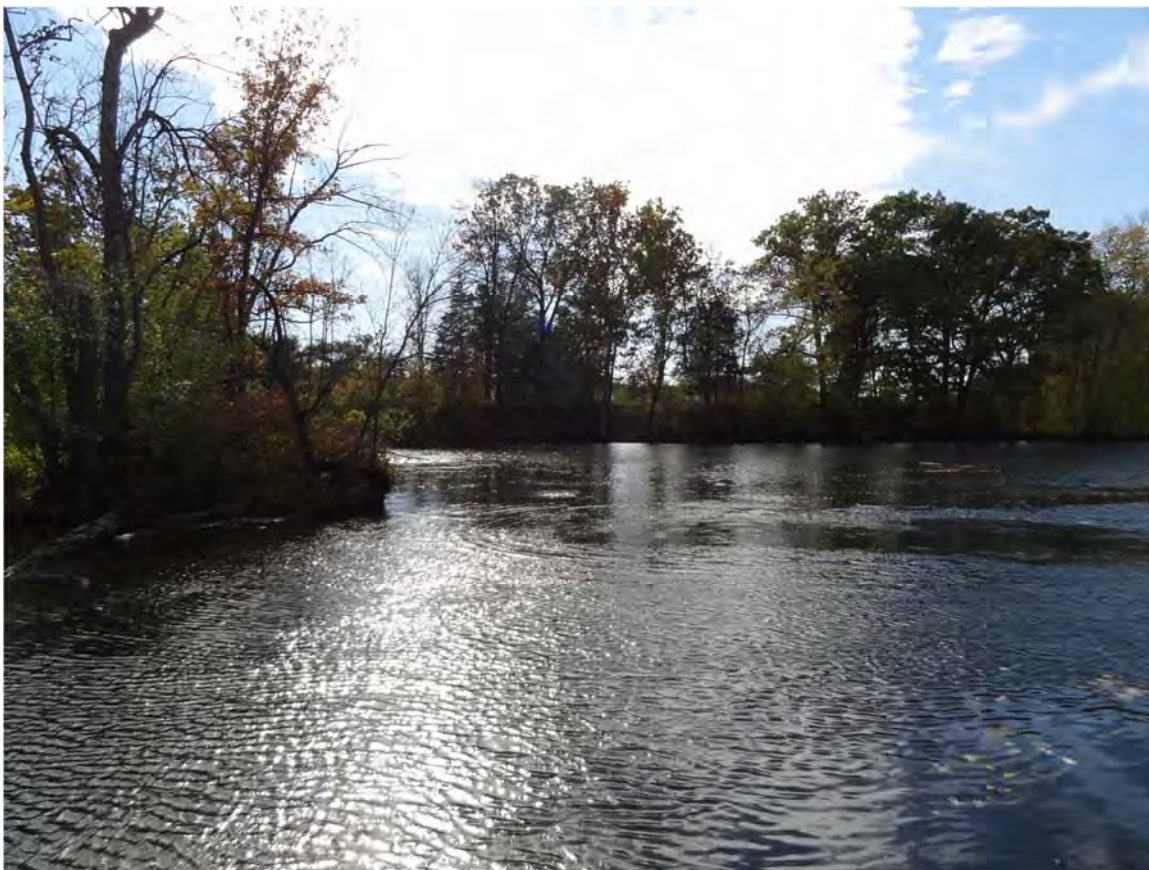
23. MP36.25 area where sheen was observed.

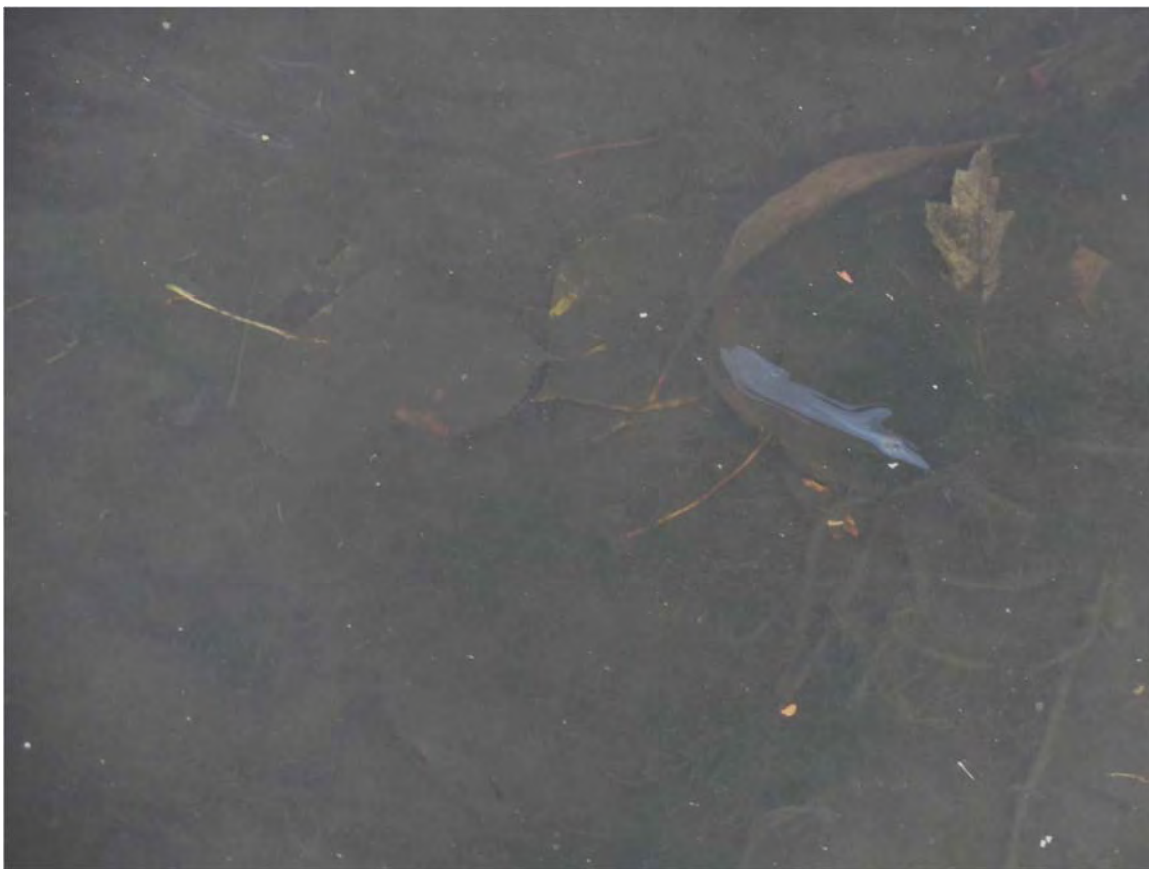
24. MP36.25 sheen observed, quantity of sheen would not warrant a sweep boat.

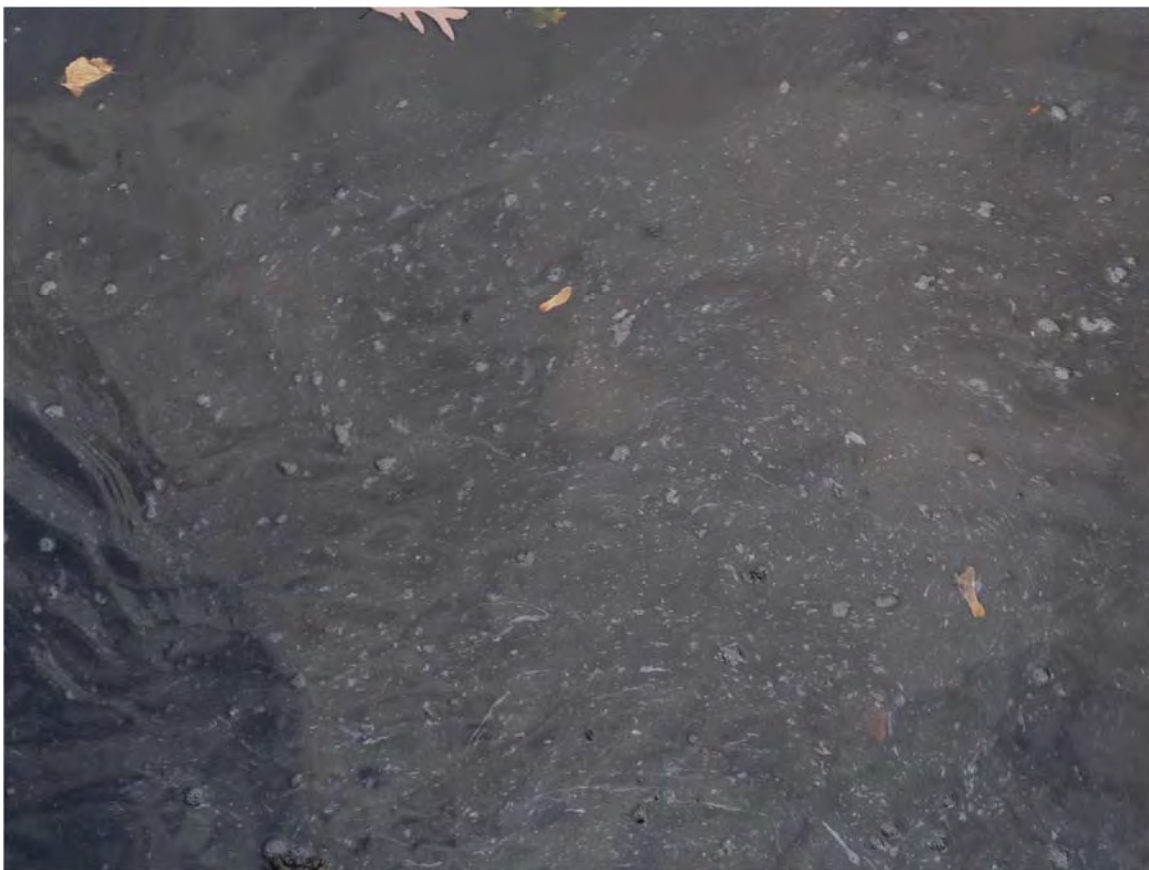
25. MP36.25 sheen observed when the boat reversed out of the area.

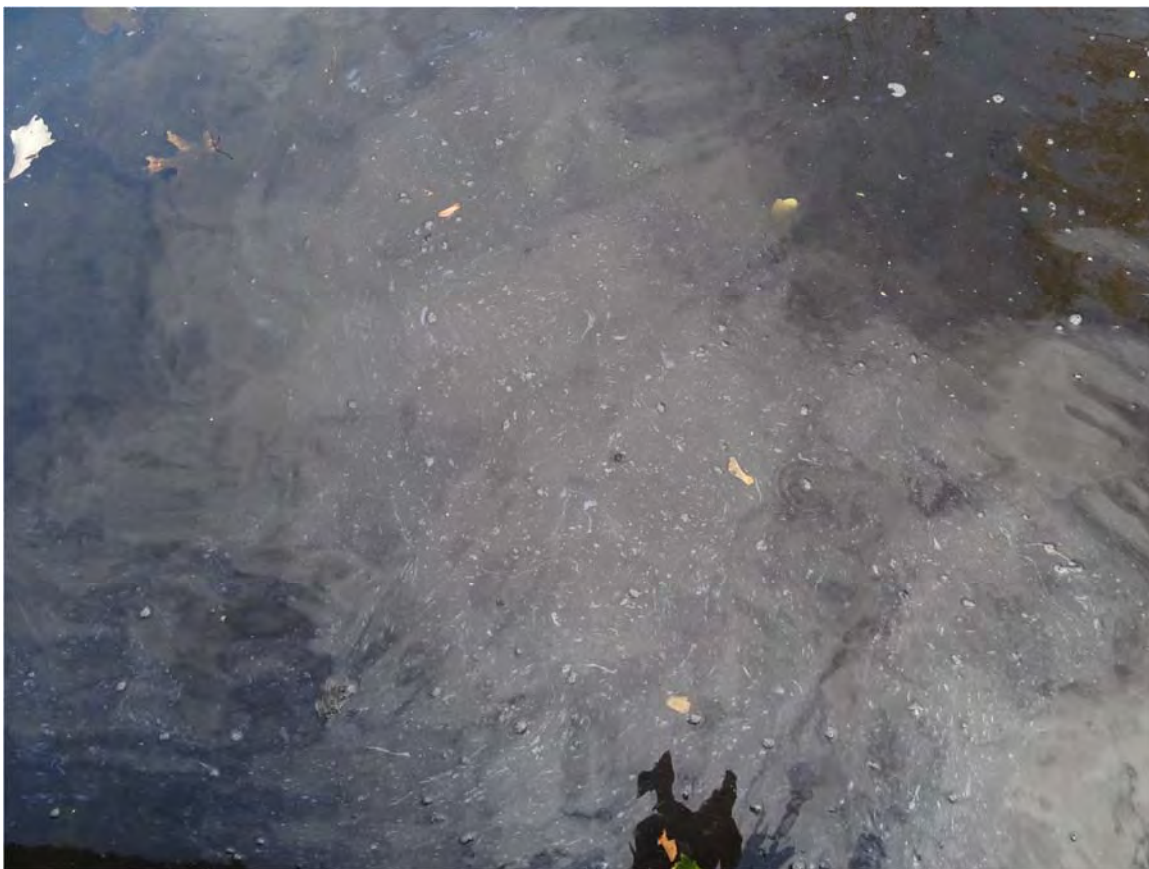
26. MP36.25 sheen observed when the boat reversed out of the area.

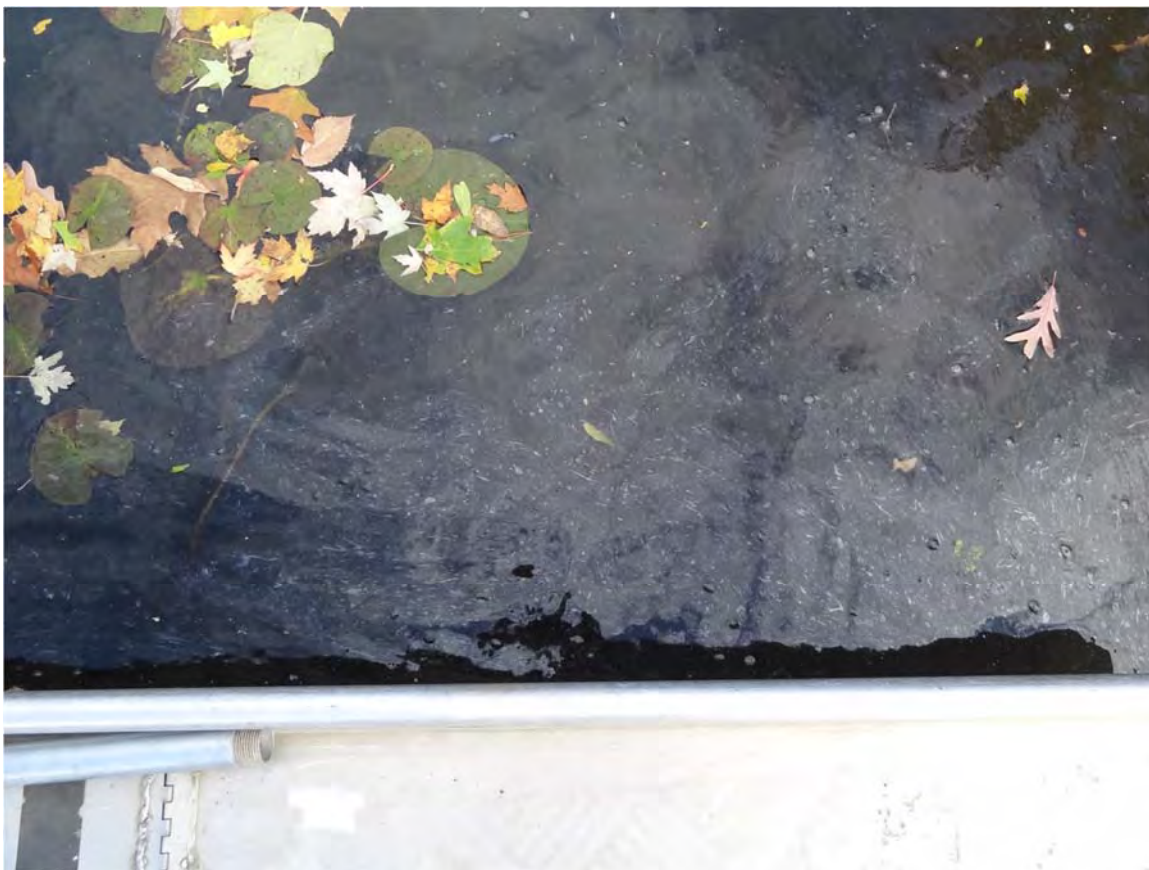
27. MP36.25 sheen observed when the boat reversed out of the area.

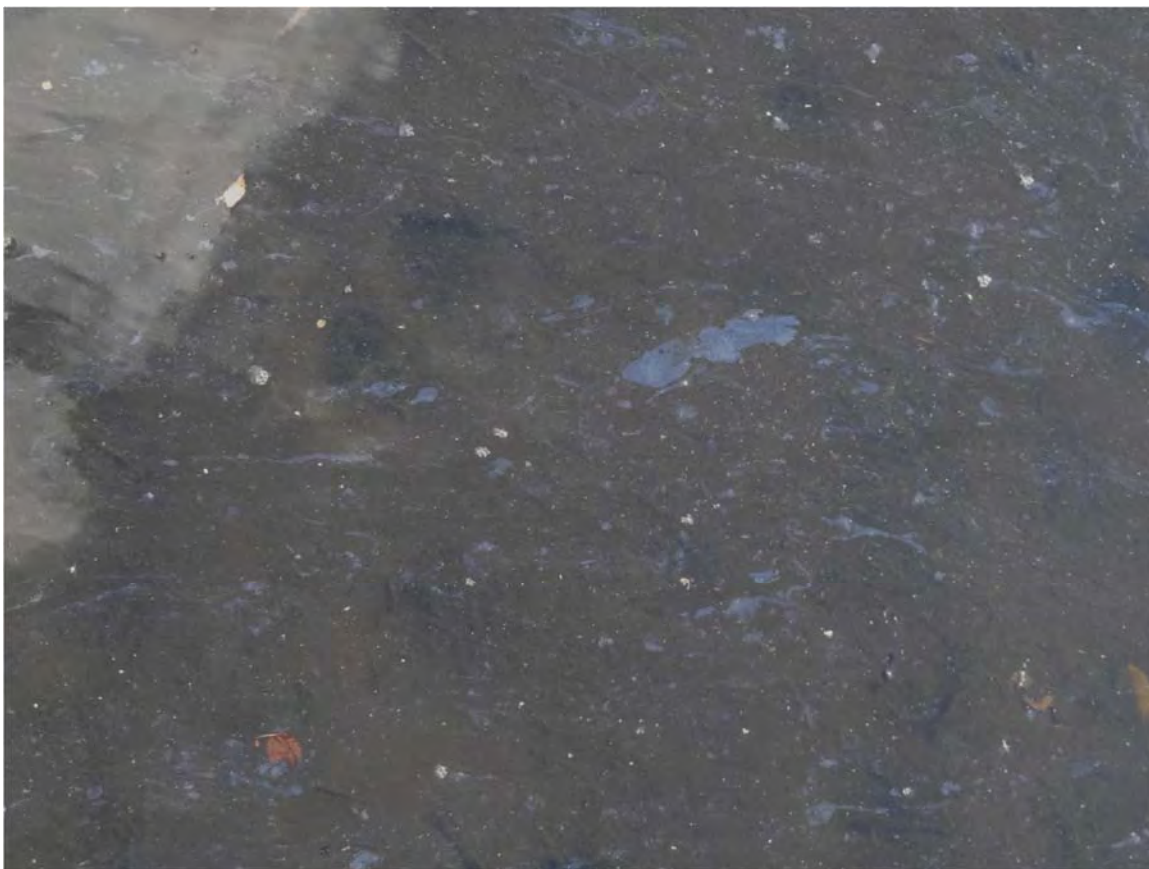
28. MP36.25 sheen observed when the boat reversed out of the area.
