# Situation Photo Log

Monday, October 15, 2012

Kalamazoo River / Enbridge Spill

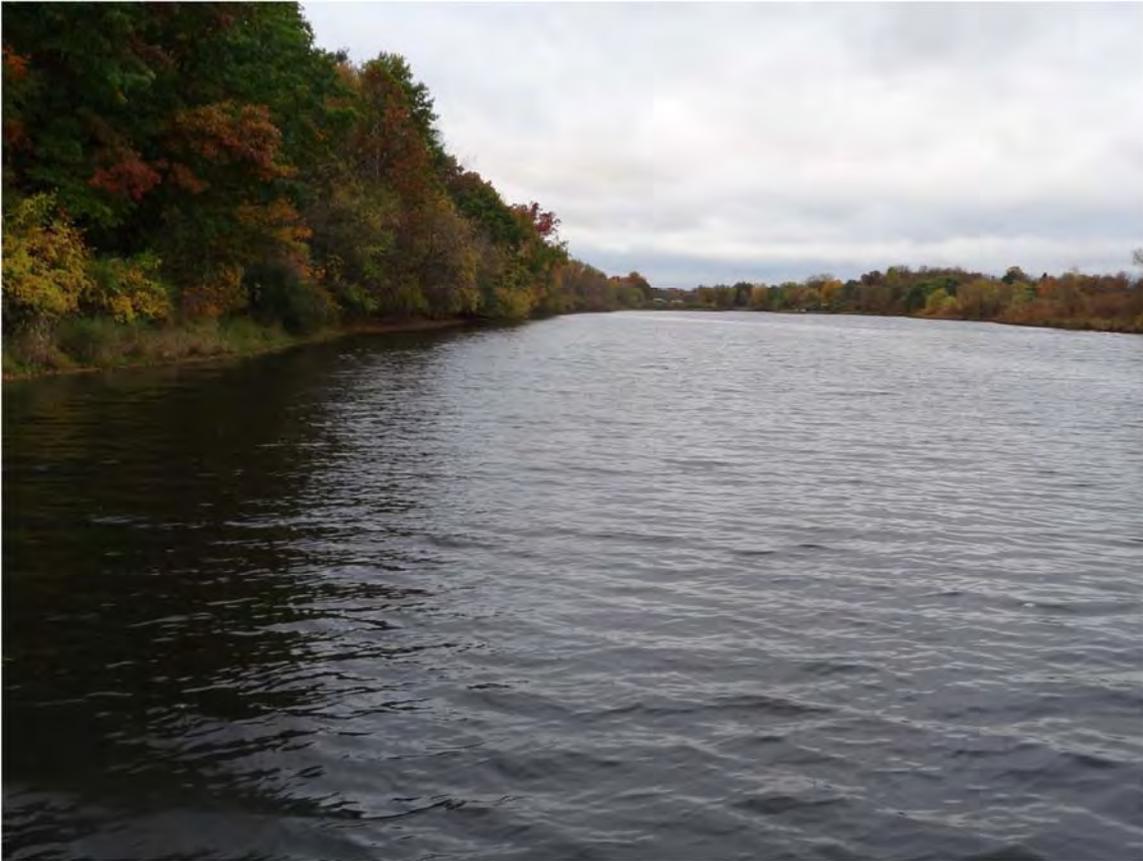
1. MP5.25 – MP5.45 RDB area where ribbons of sheen and tar globs were observed.

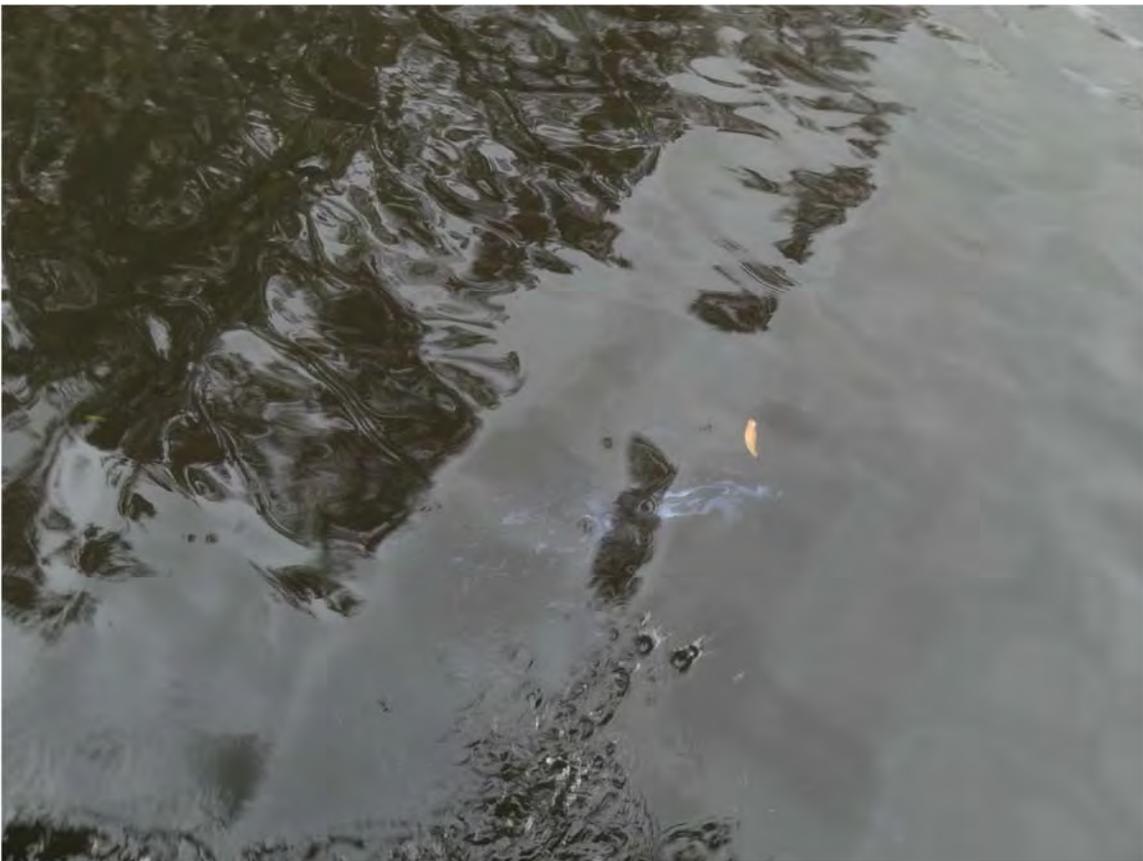
2. MP5.45 RDB sheen and tar globs were observed.

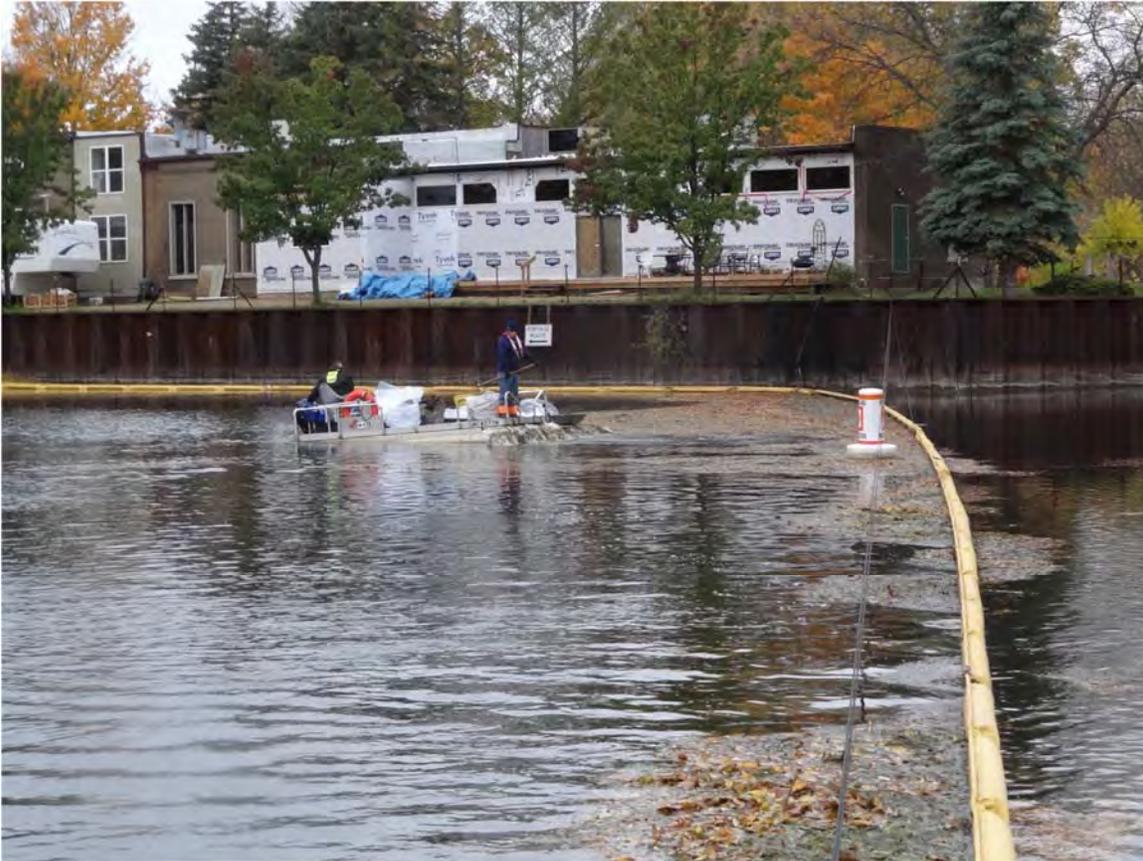
3. Ceresco Dam Control Point Boom observed a crew removing debris from the boom.

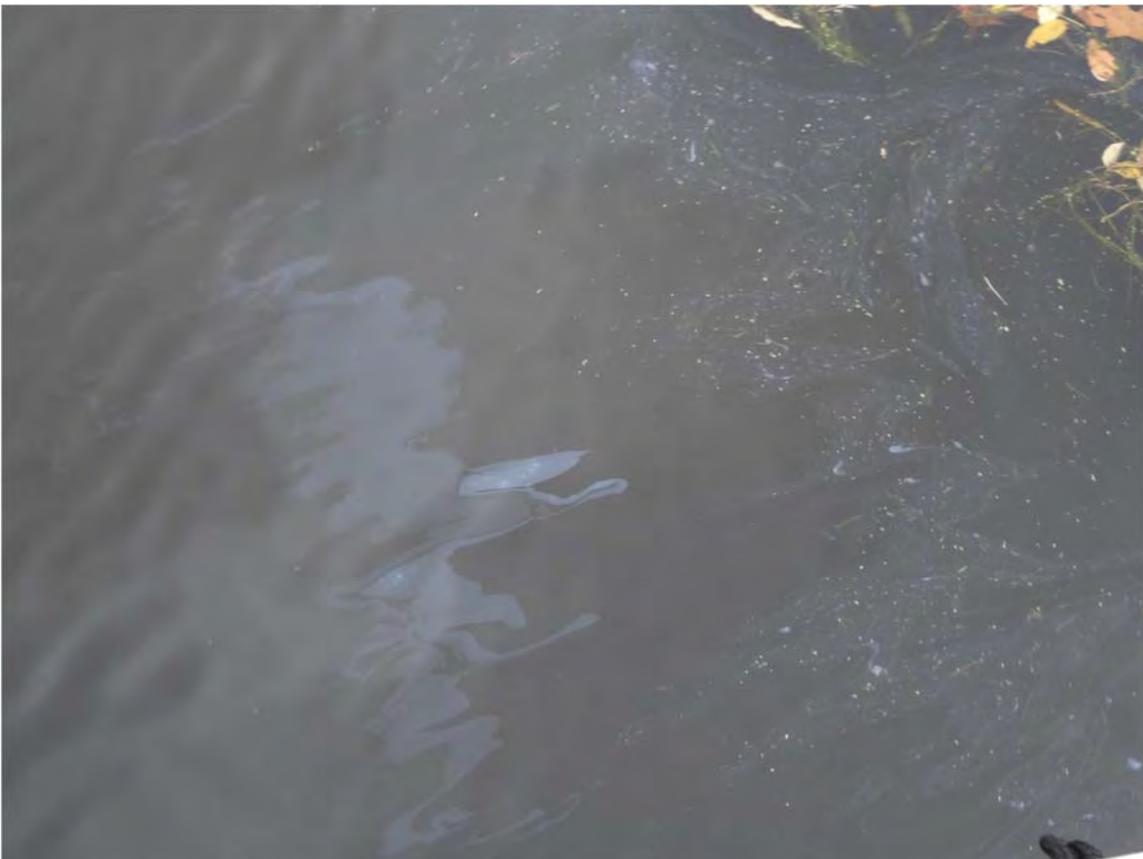
4. Ceresco Dam Control Point Boom observed sheen collecting along the boom.

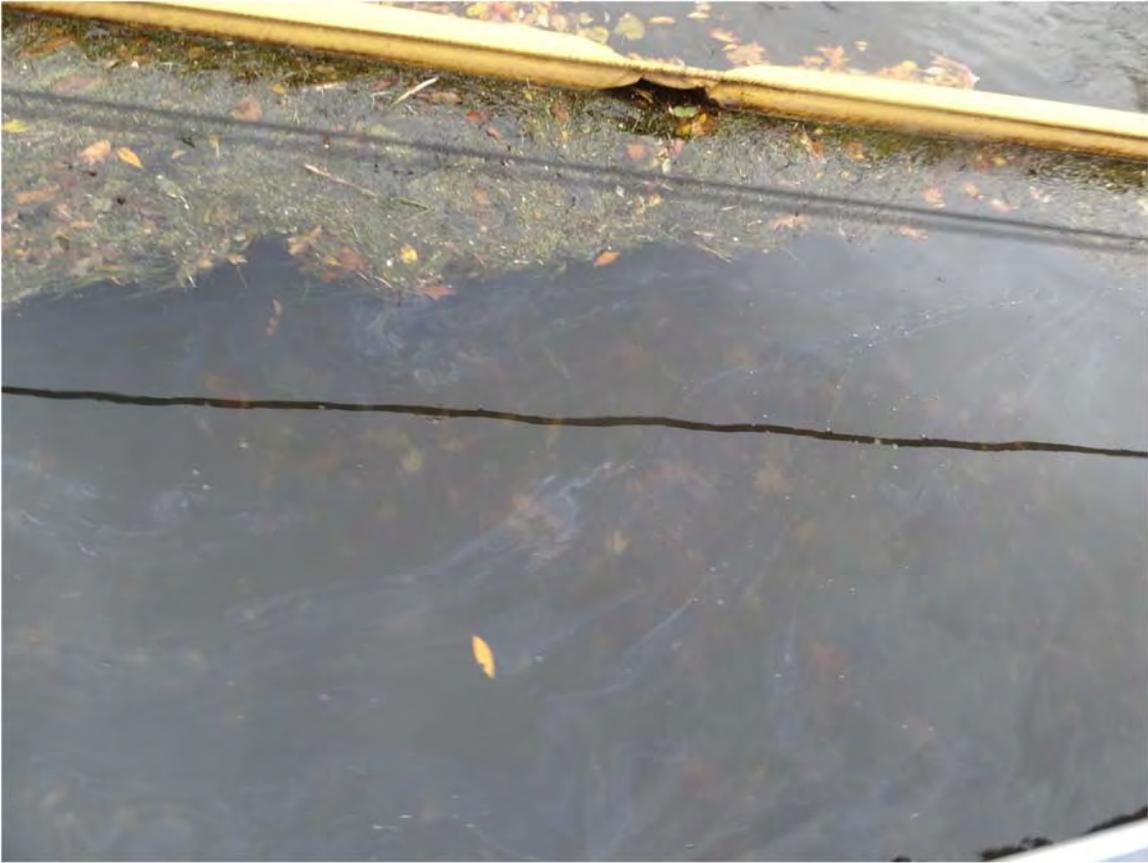
5. Ceresco Dam Control Point Boom observed sheen collecting along the boom.

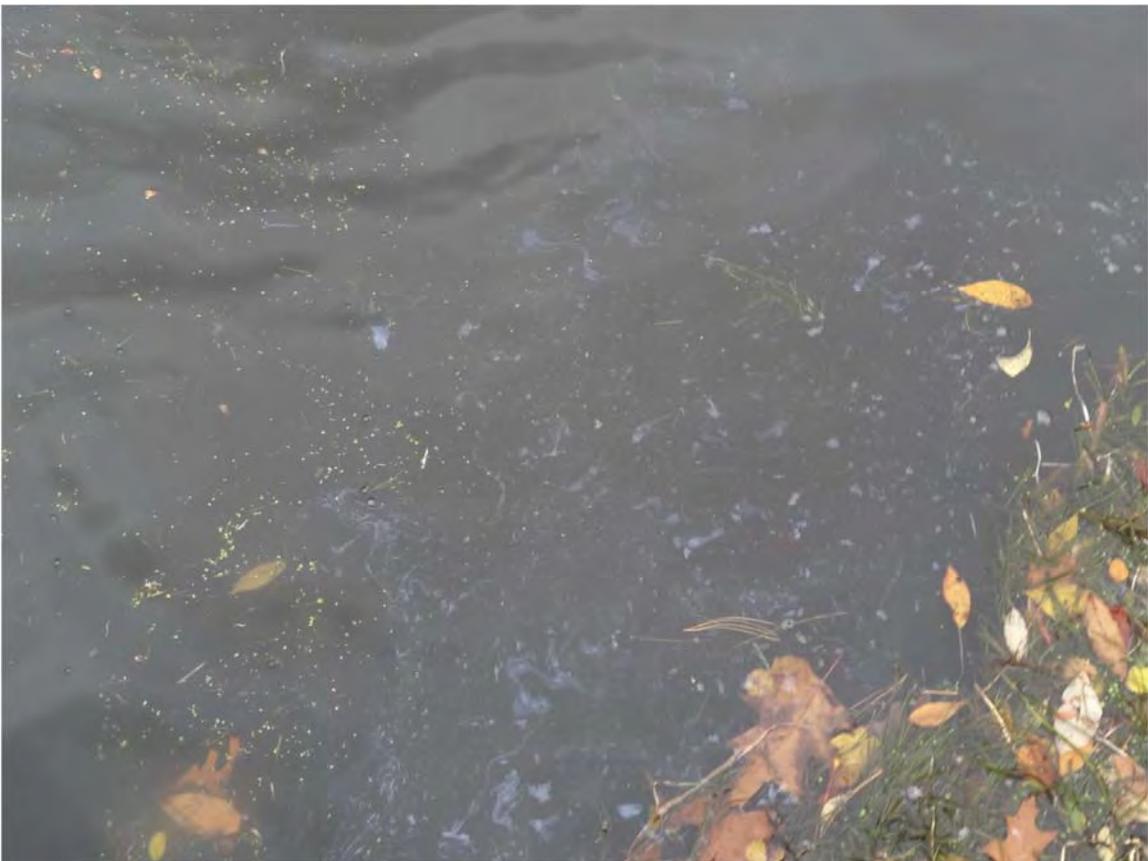
6. Ceresco Dam Control Point Boom observed sheen collecting along the boom.

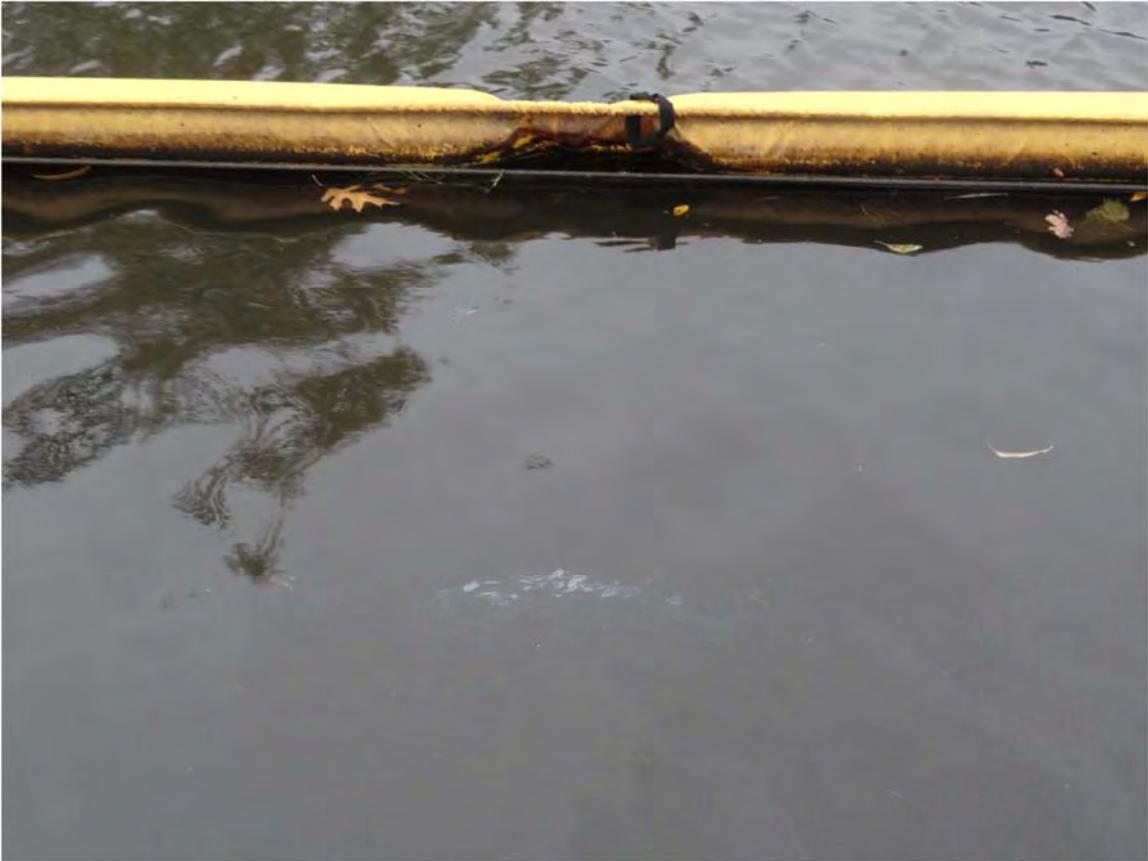
7. Ceresco Dam Control Point Boom observed sheen collecting along the upstream portion of the boom.

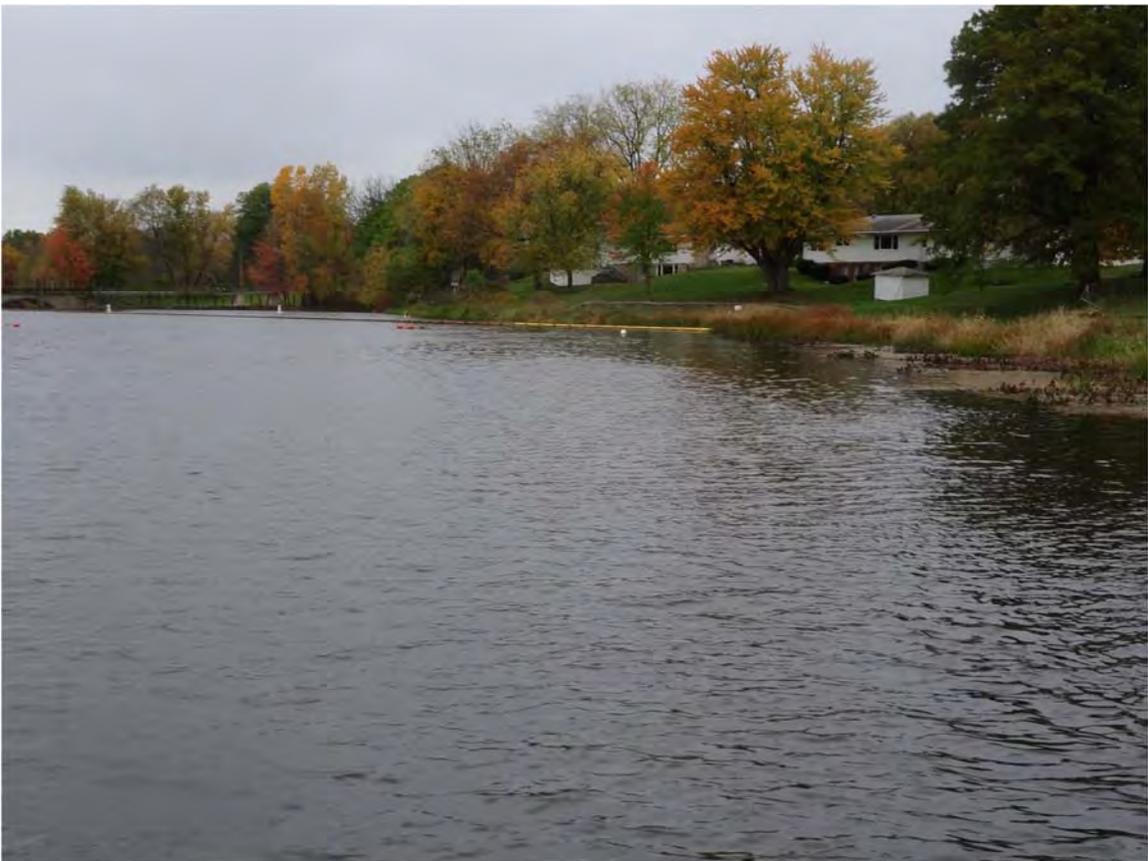
8. MP5.70 RDB area where sheen and tar globs were observed flowing down to the Ceresco Dam Control Point Boom.

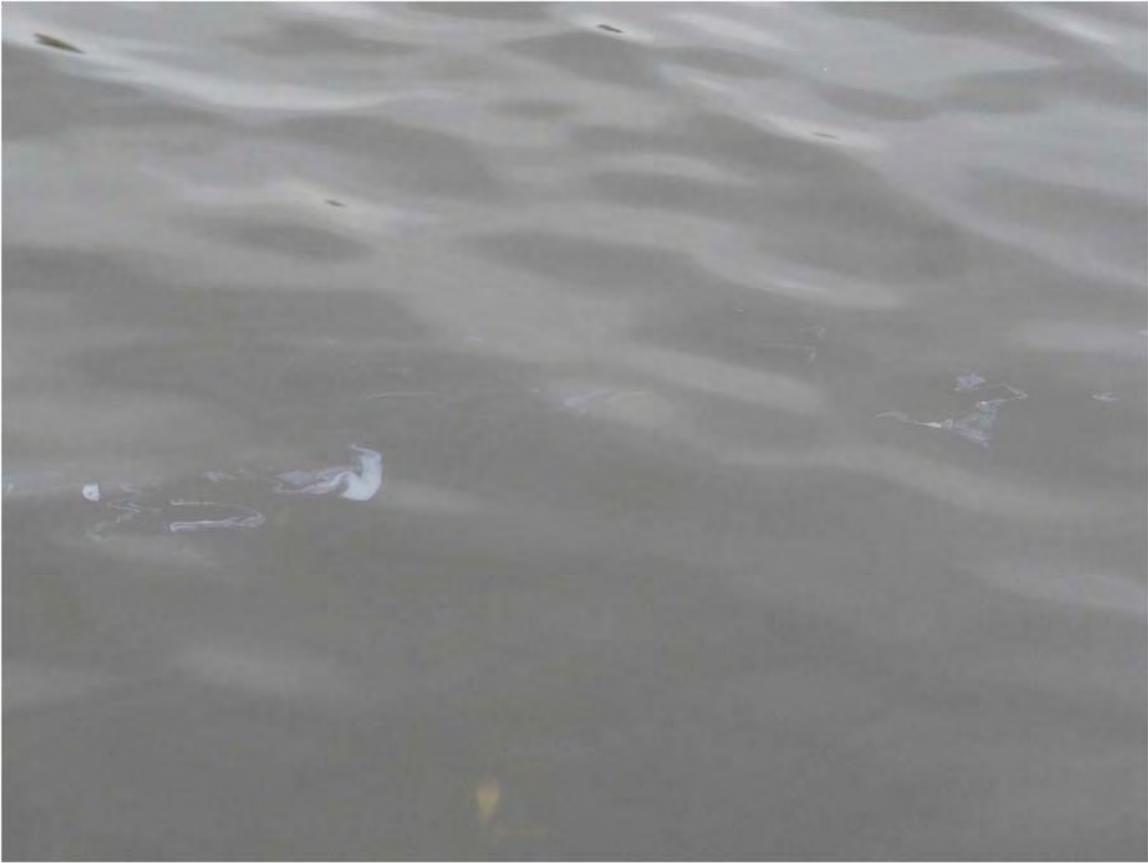
9. MP5.70 RDB sheen and tar globs were observed flowing down to the Ceresco Dam Control Point Boom.

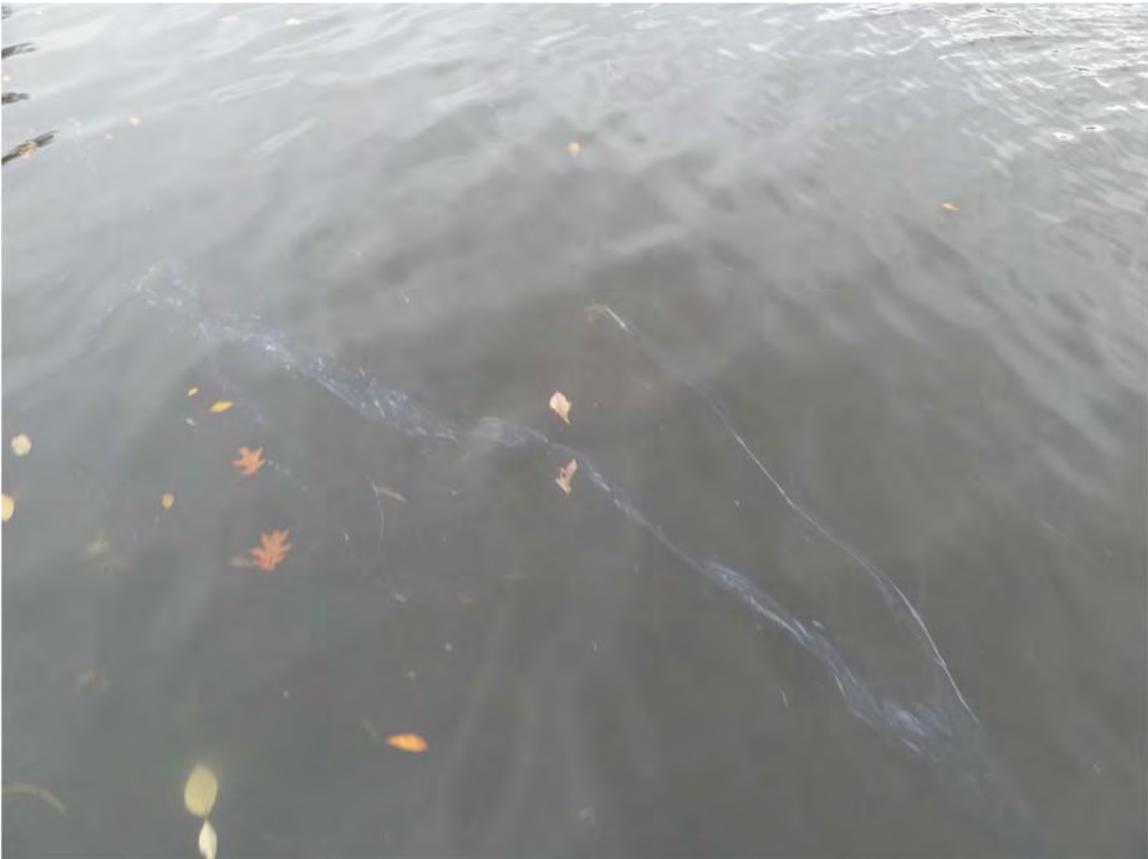
10. MP5.70 RDB sheen and tar globs were observed flowing down to the Ceresco Dam Control Point Boom.

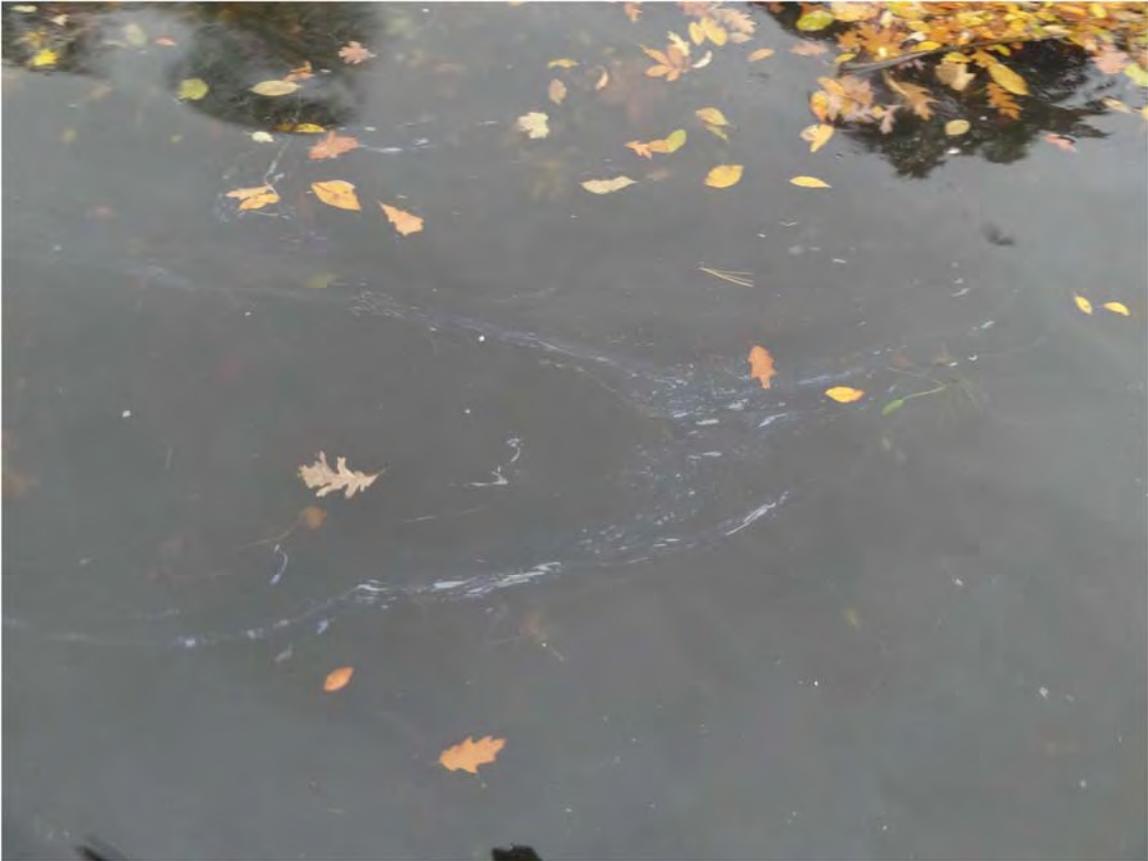
11. MP5.70 RDB sheen and tar globs were observed flowing down to the Ceresco Dam Control Point Boom.

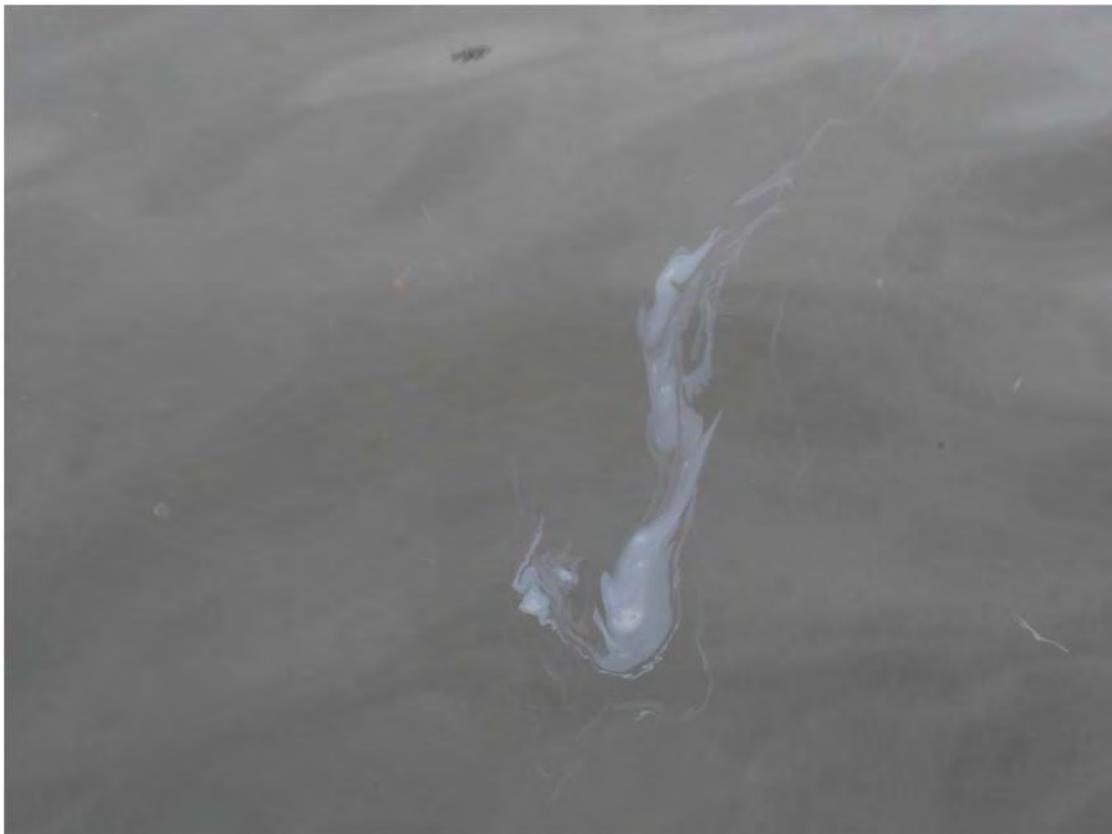
12. MP5.63 RDB sheen and tar globs were observed flowing down to the Ceresco Dam Control Point Boom.

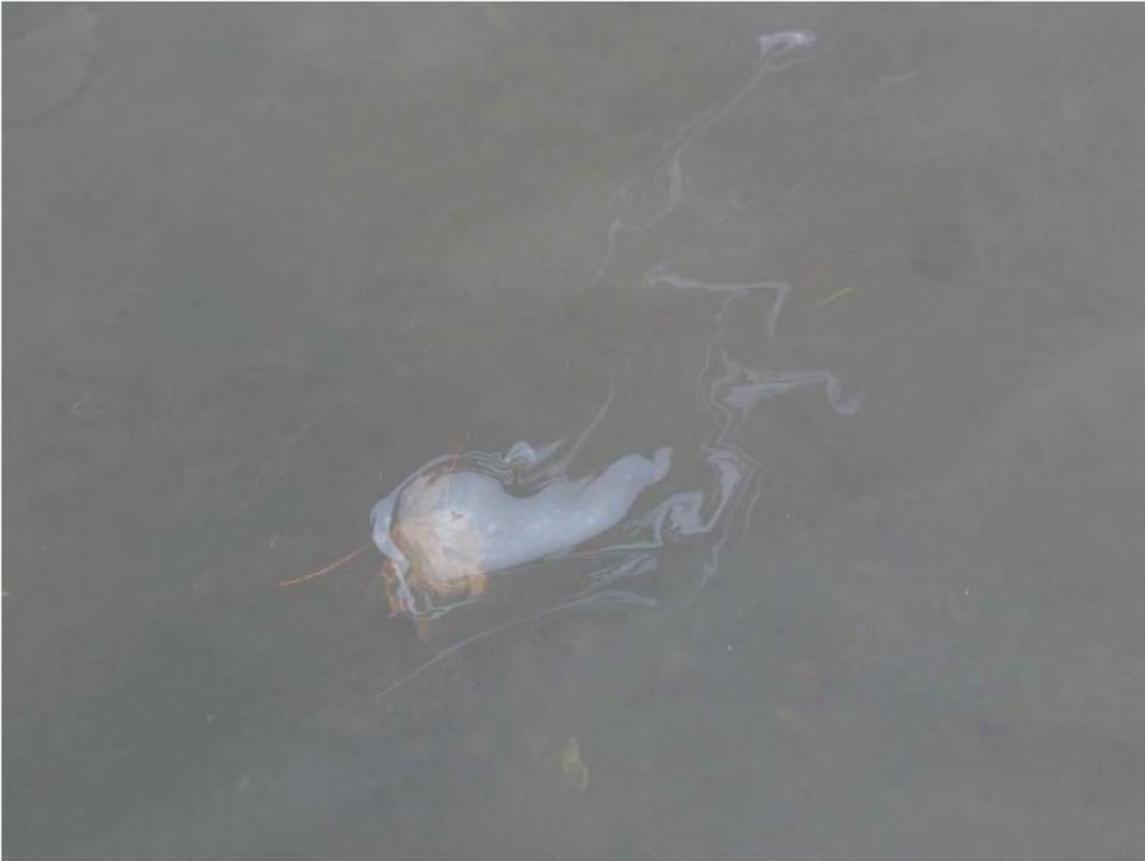
**13. MP5.63 RDB sheen and tar globs were observed flowing down to the Ceresco Dam Control Point Boom.**

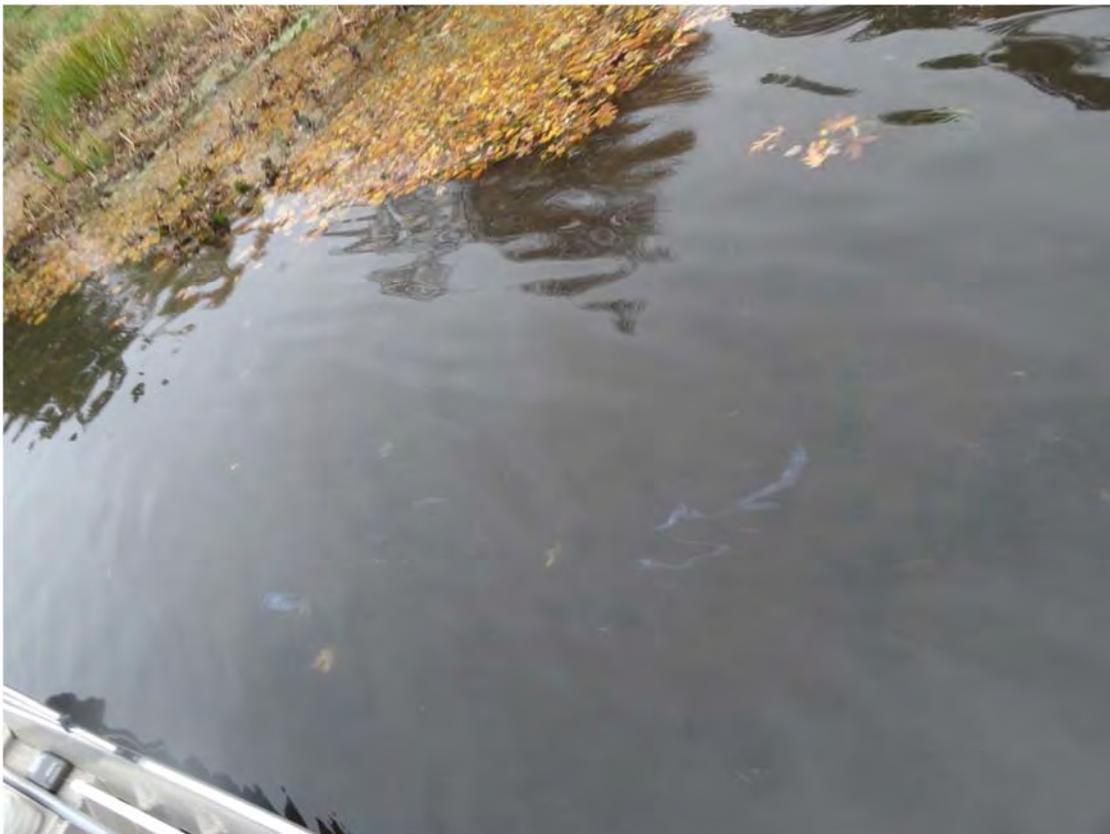
**14. MP5.63 RDB sheen and tar globs were observed flowing down to the Ceresco Dam Control Point Boom.**

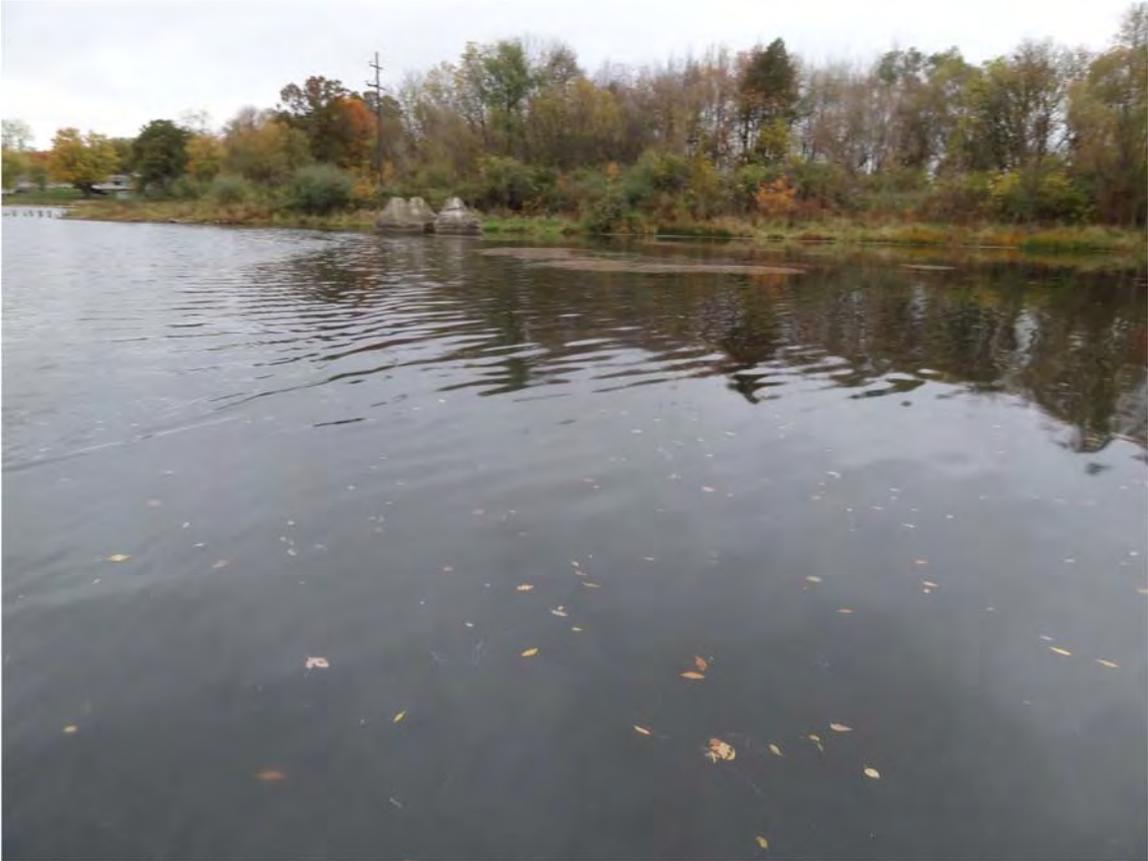
**15. MP5.55 Center channel area where sheen and tar globs were observed.**

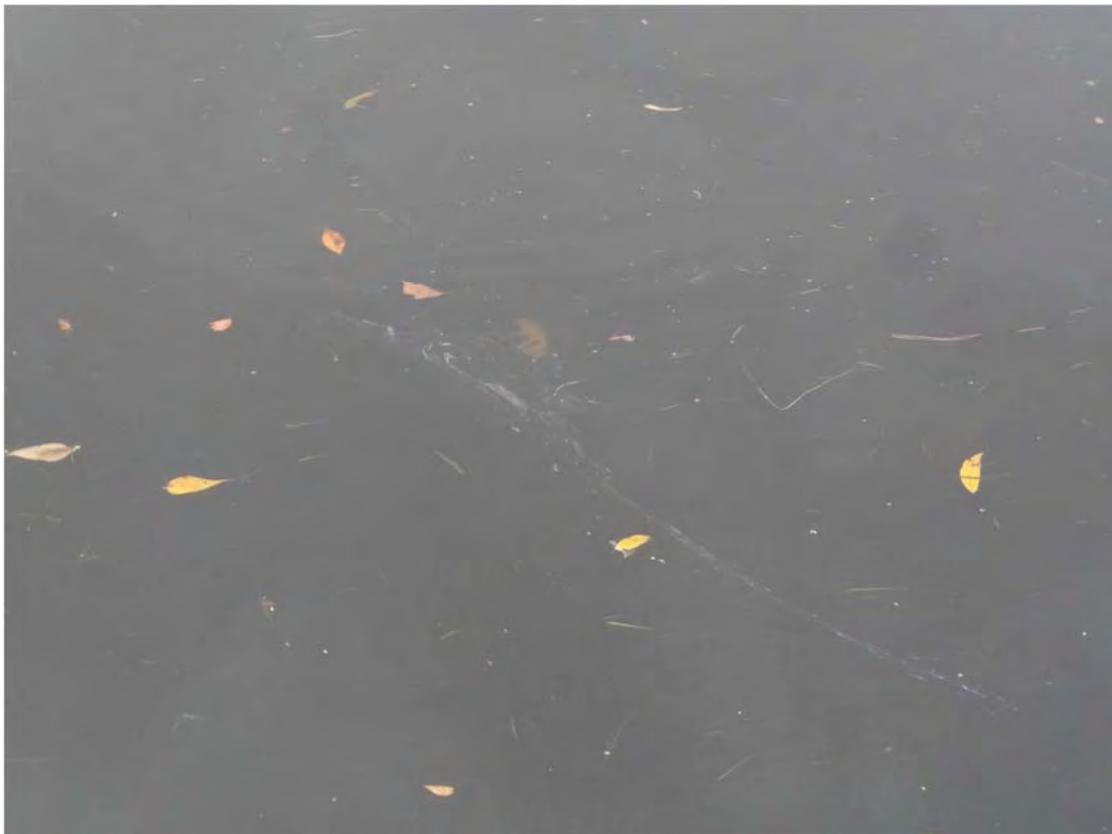
**16. MP5.55 Center channel sheen and tar globs were observed.**

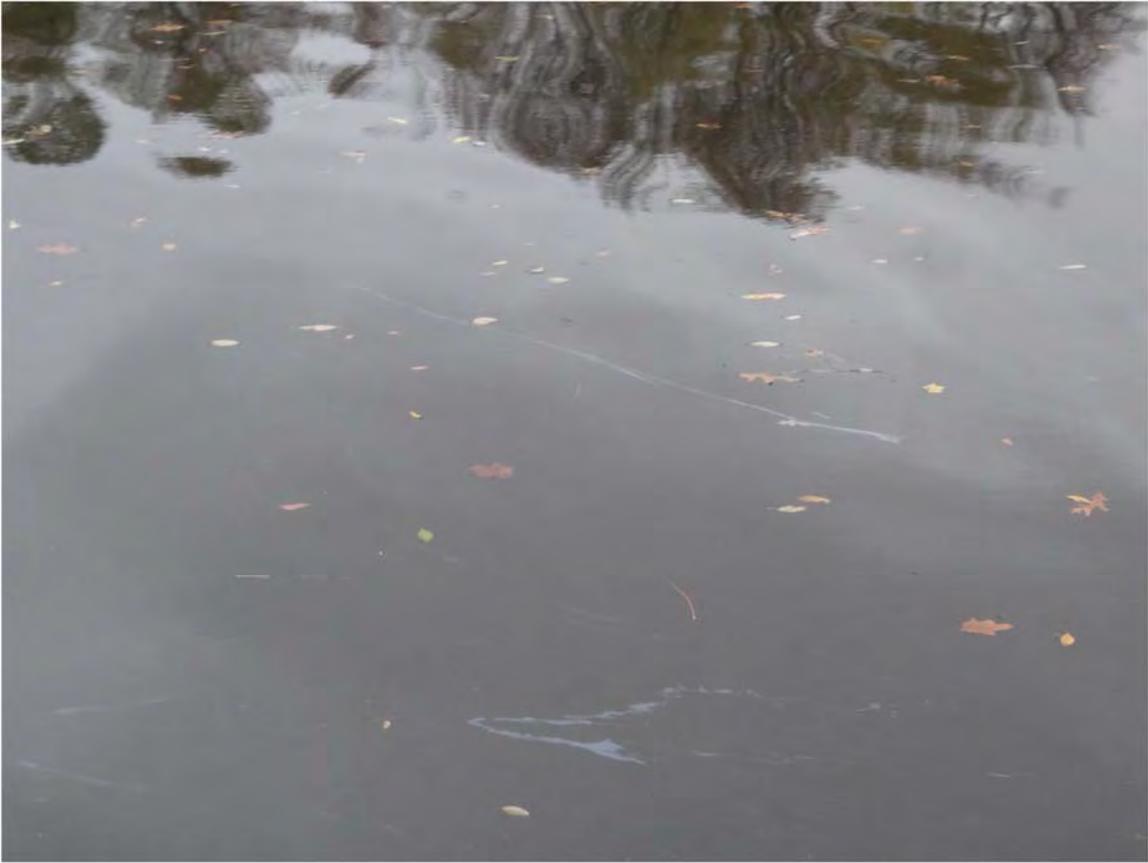
17. MP5.55 center channel sheen and tar globs were observed.

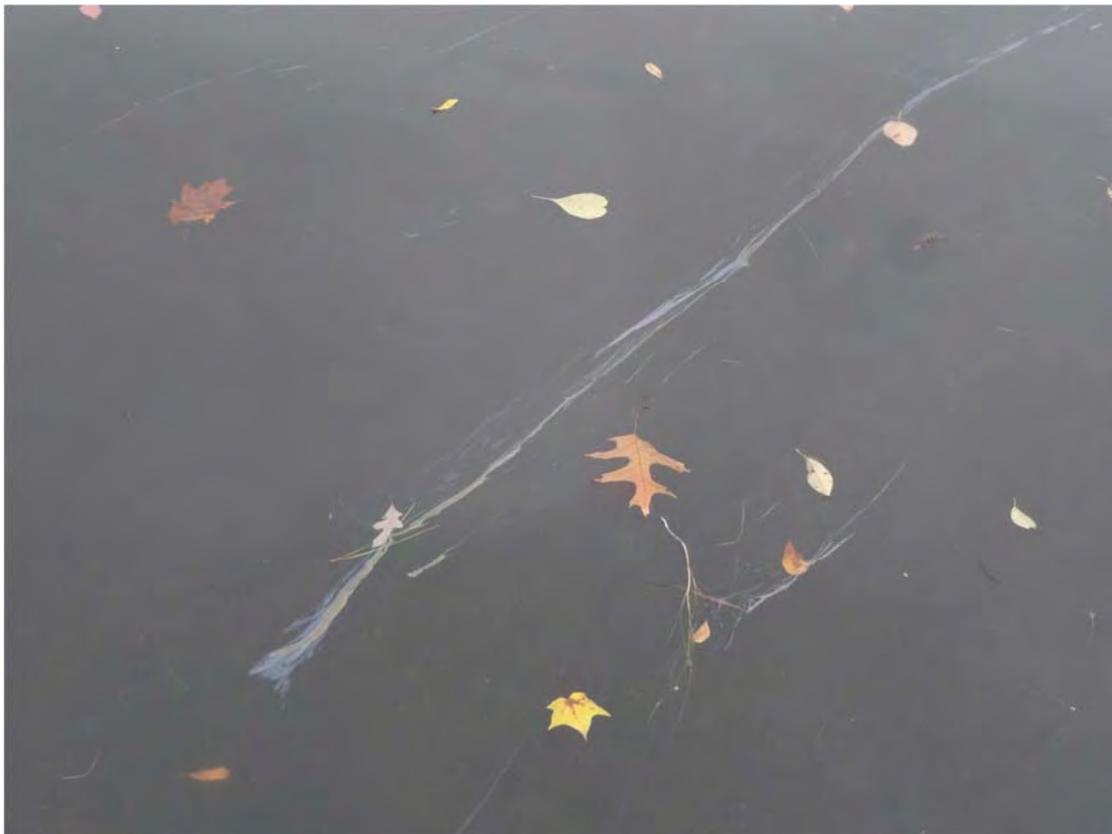
18. MP5.55 Center channel sheen and tar globs were observed.

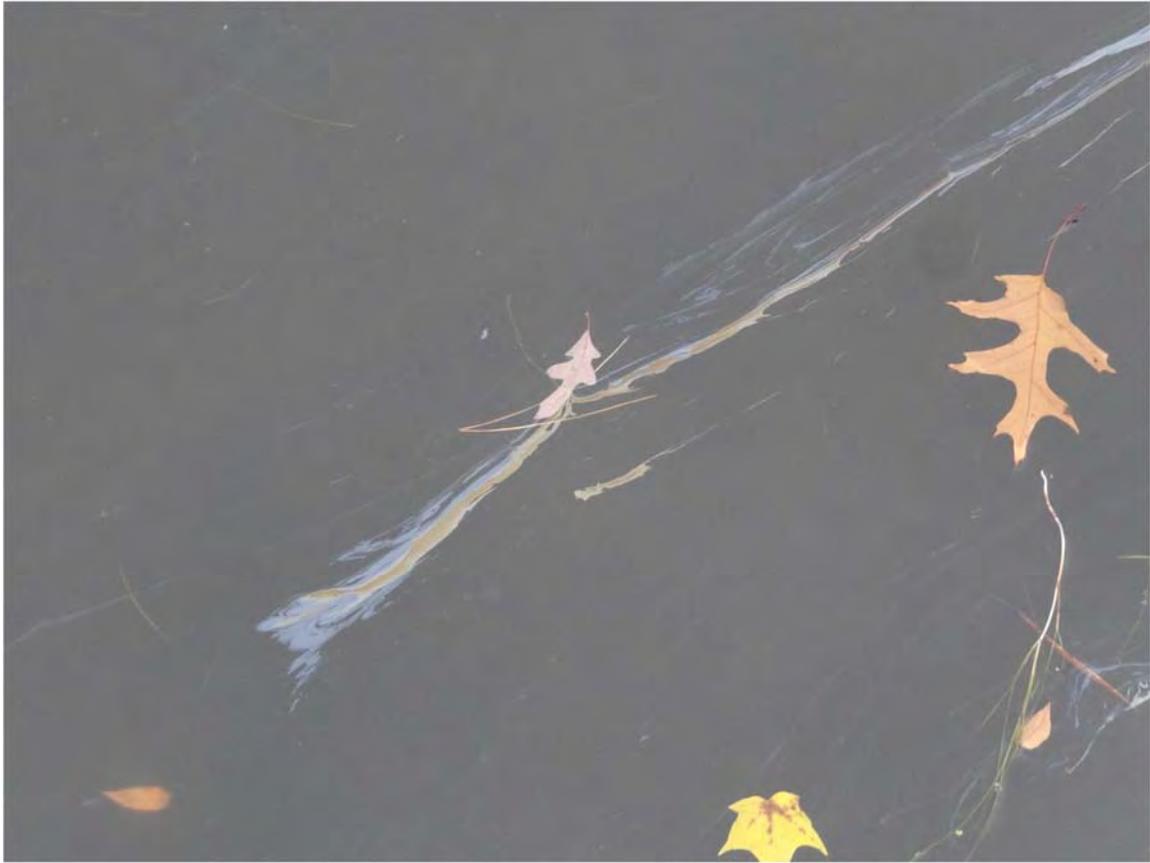
19. MP5.55 Center channel area where sheen and tar globs were observed.

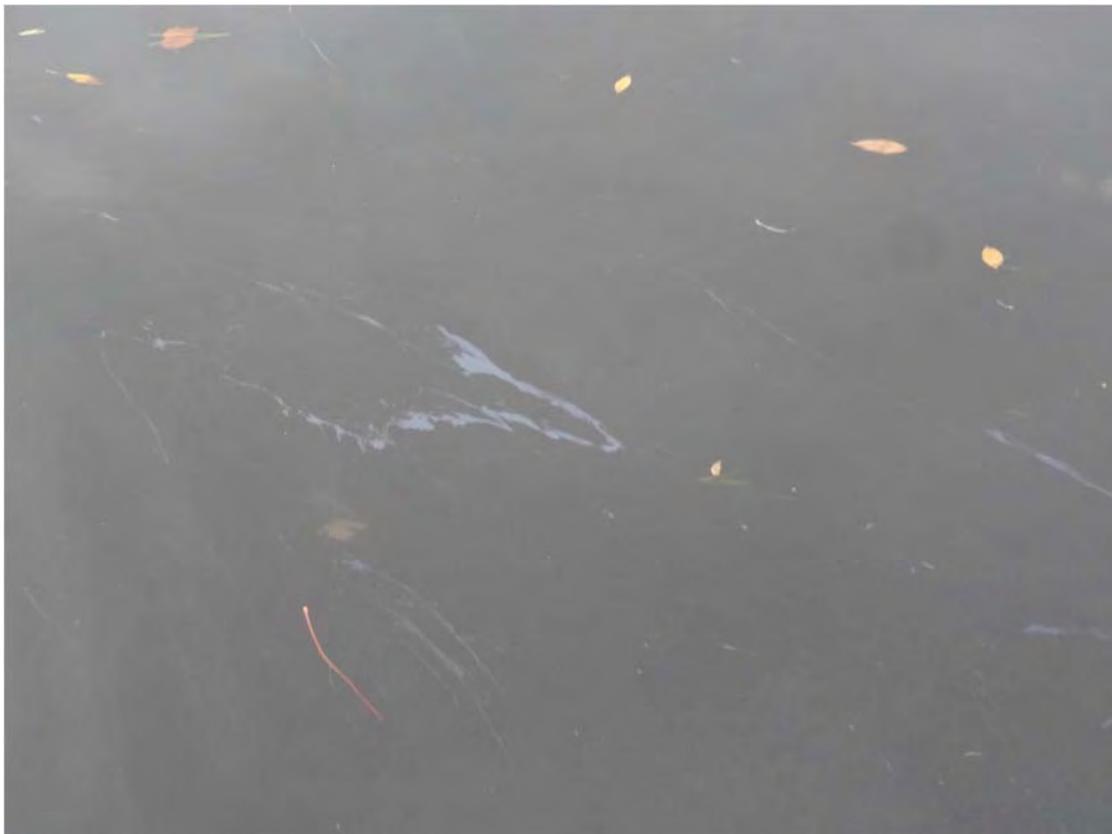
20. MP5.55 Center channel sheen and tar globs were observed.

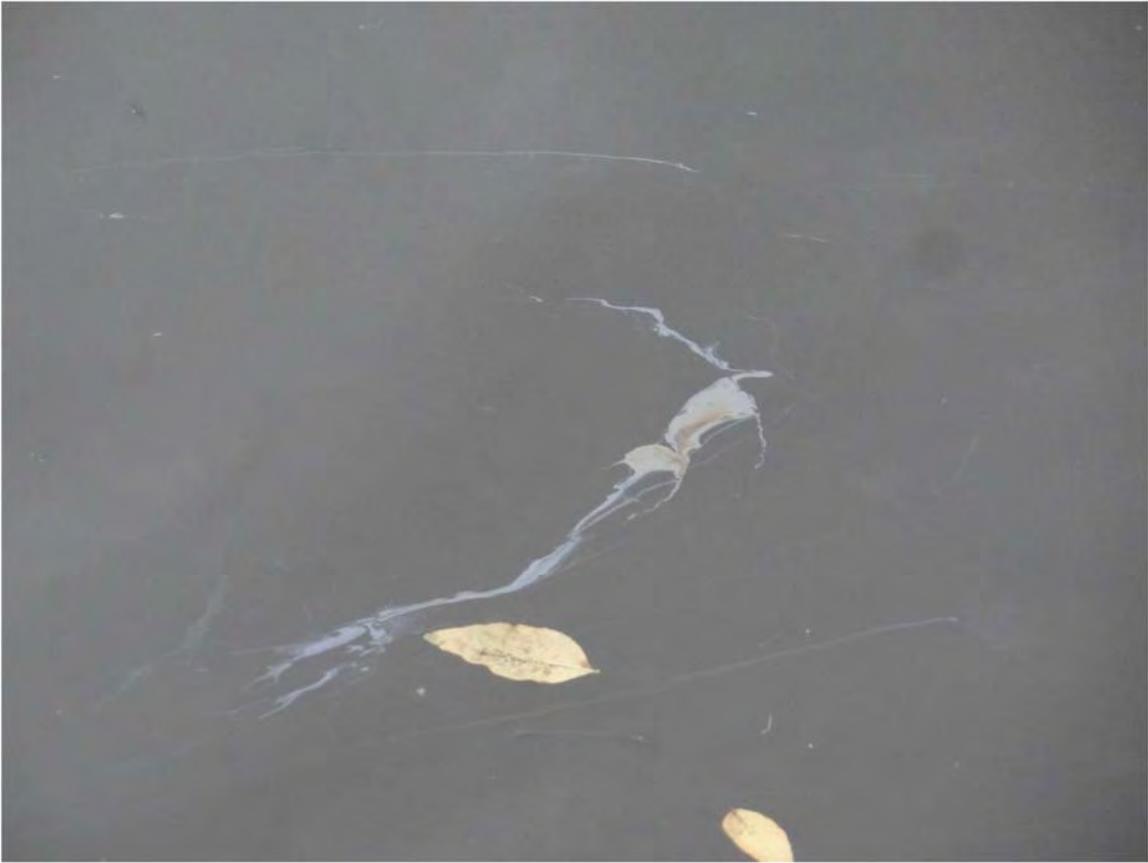
21. MP5.55 Center channel area where sheen and tar globs were observed.

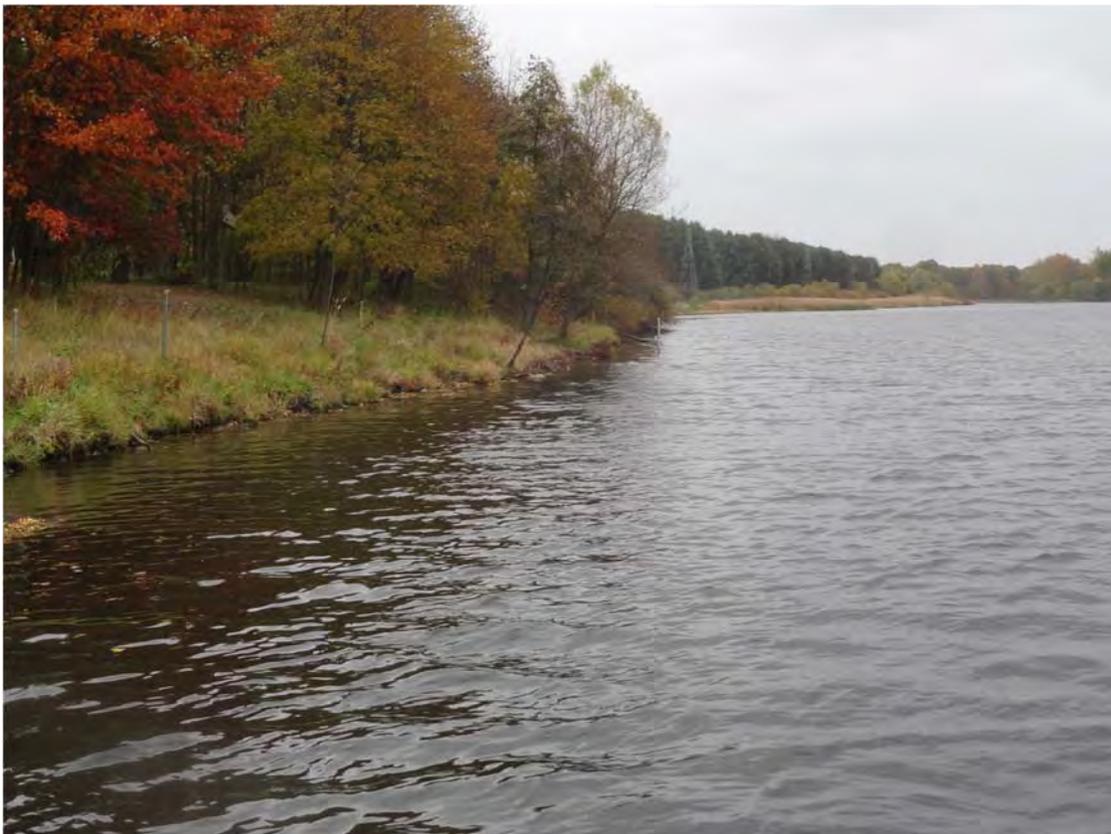
22. MP5.0 RDB area where sheen and tar globs were observed.

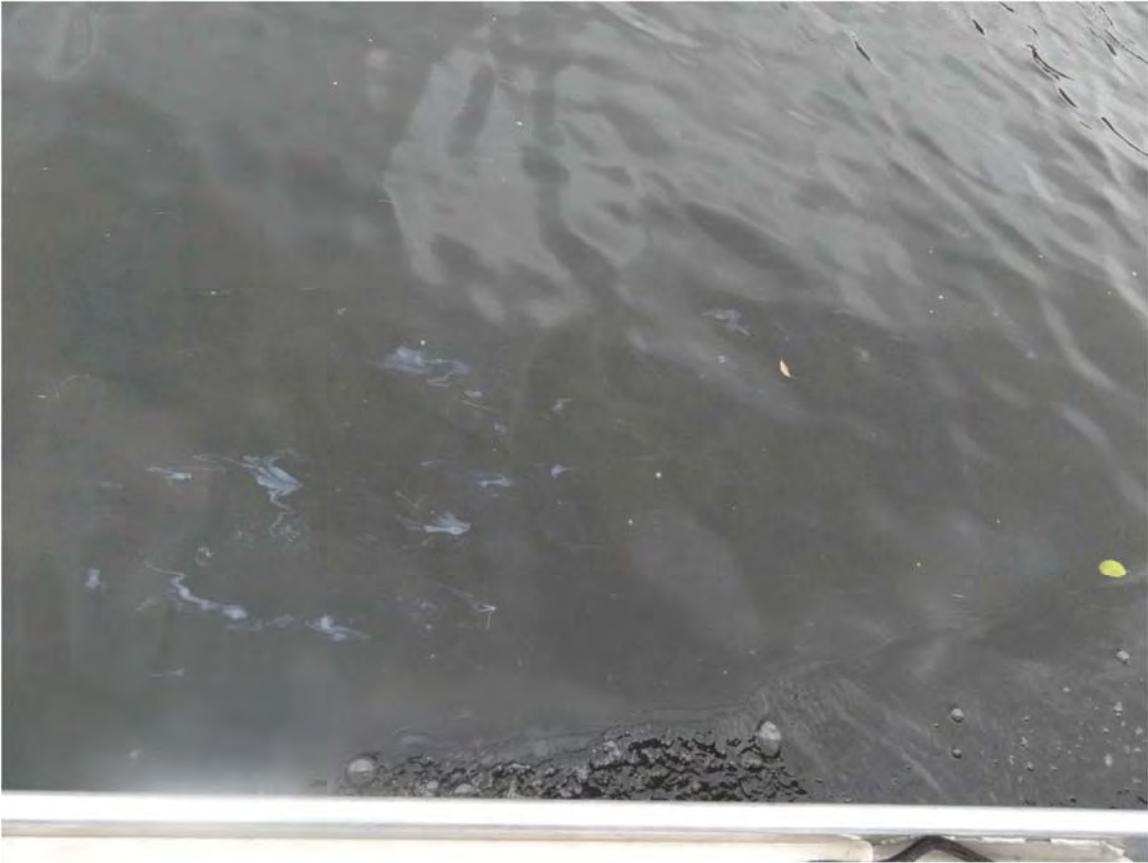
23. MP5.0 RDB sheen and tar globs were observed.
