# Situation Photo Log

Monday, October 15, 2012

Kalamazoo River / Enbridge Spill

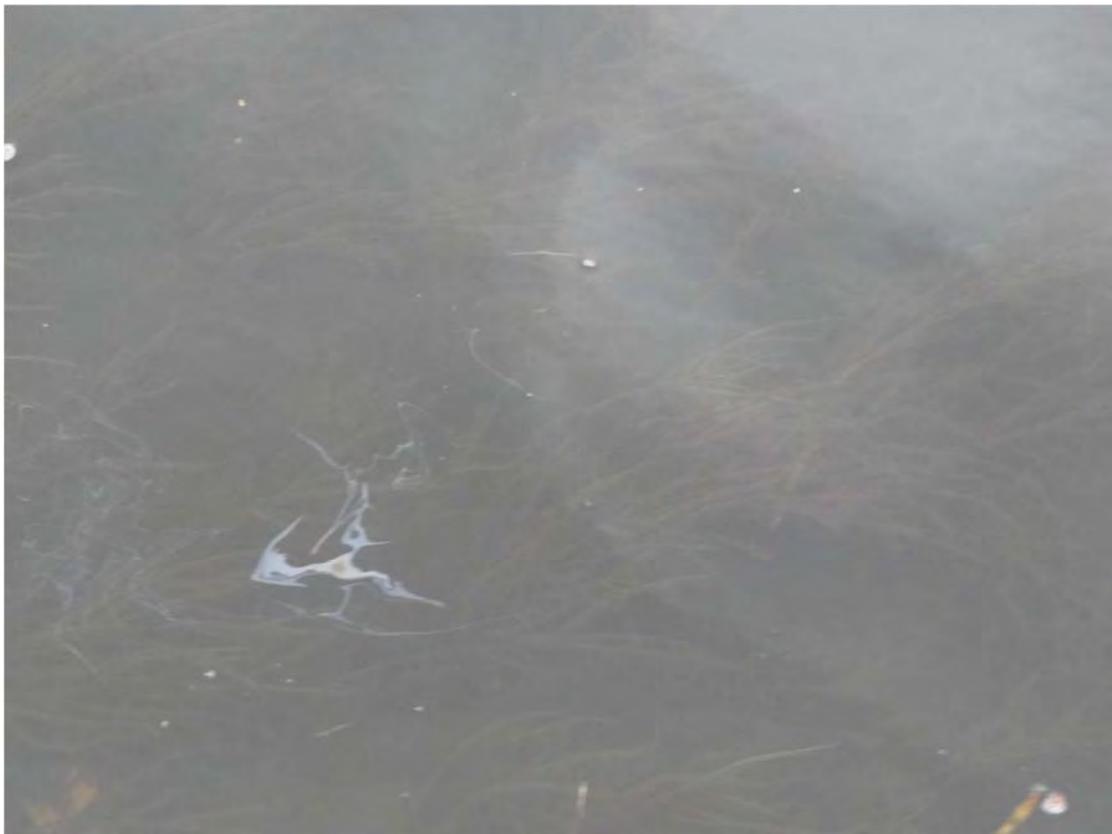
24. MP5.0 RDB sheen and tar globs were observed.

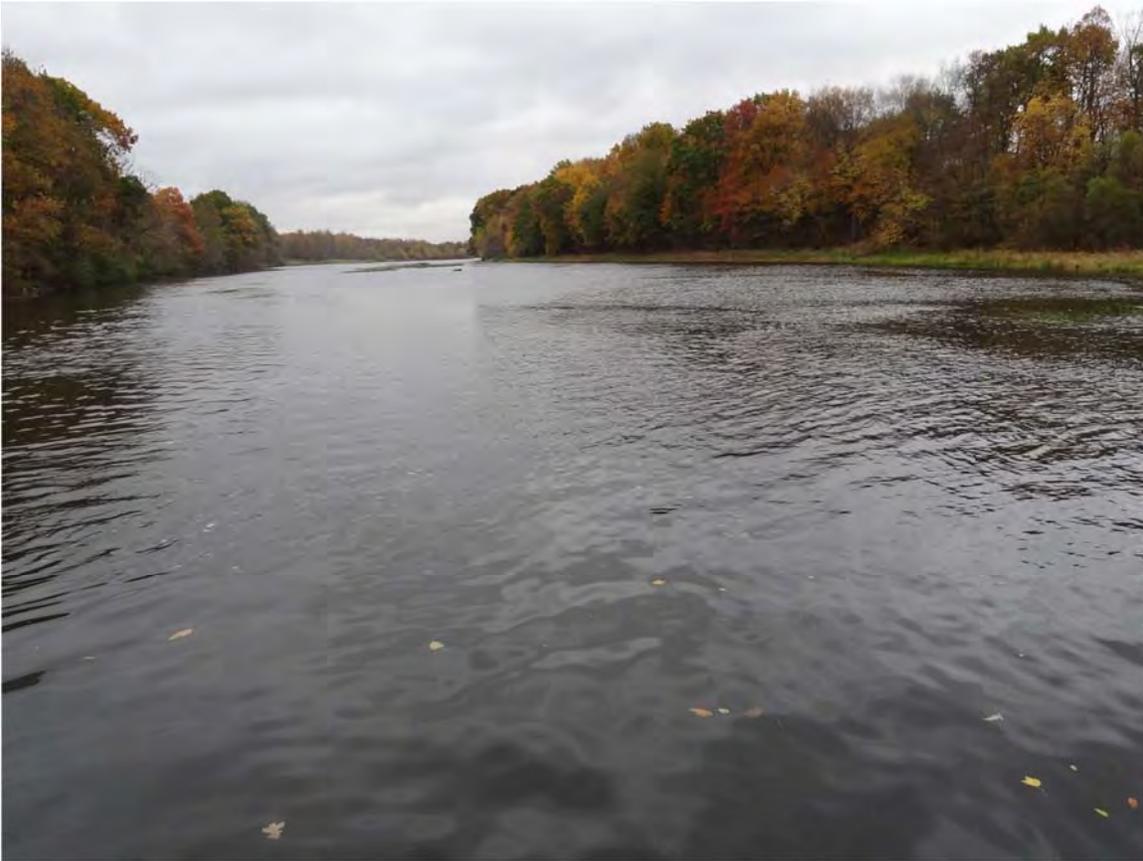
25. MP4.5 center channel sheen and tar globs were observed.

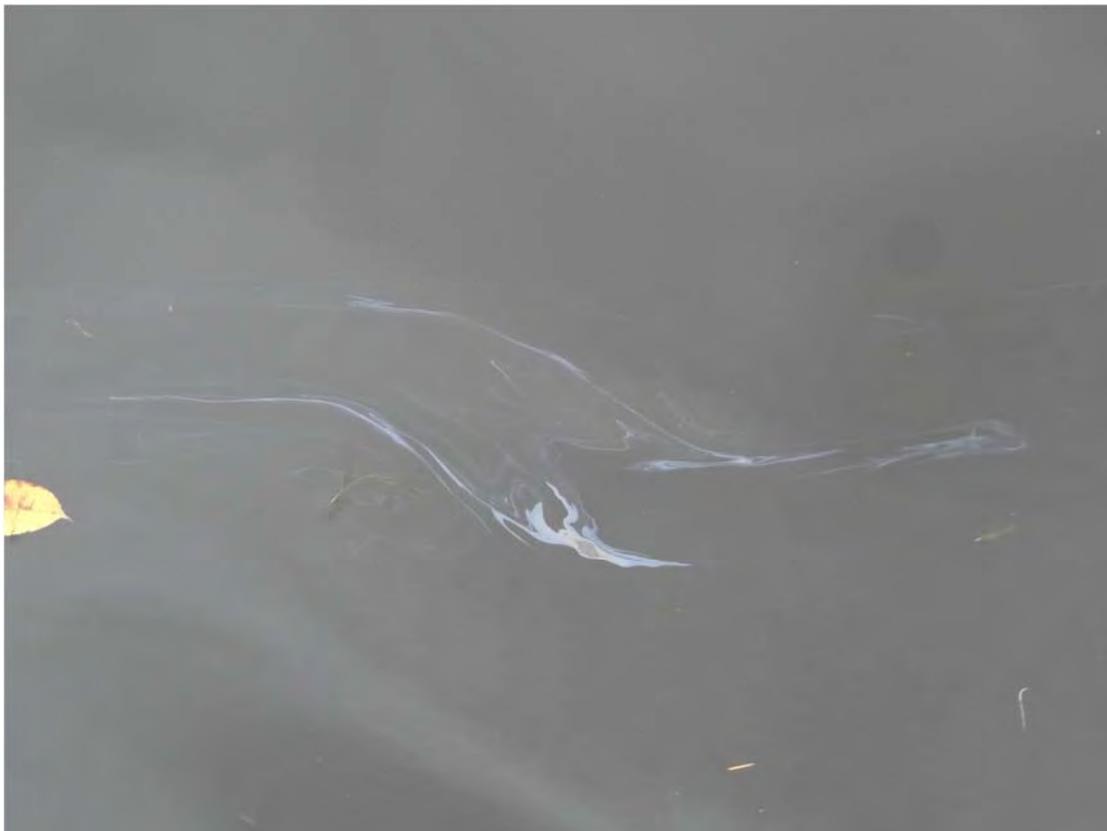
26. MP4.5 center channel sheen and tar globs were observed.

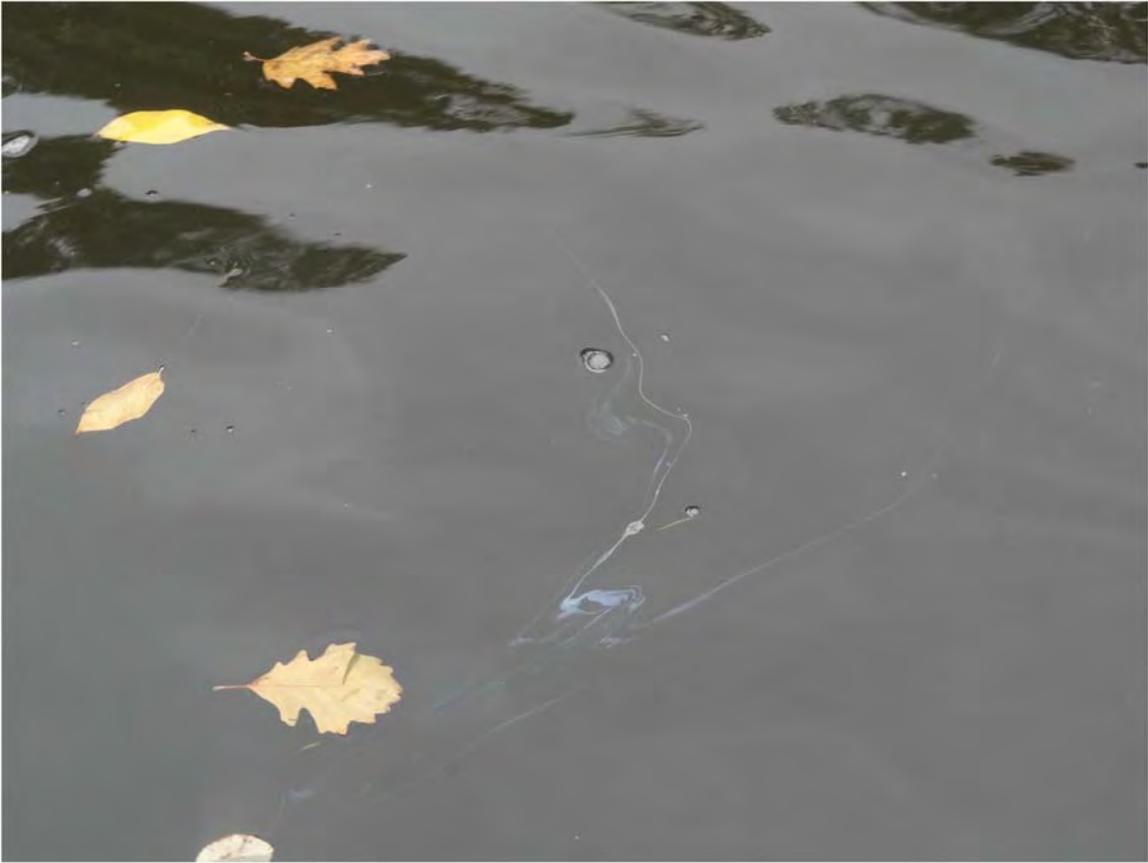
27. MP4.5 center channel sheen and tar globs were observed.

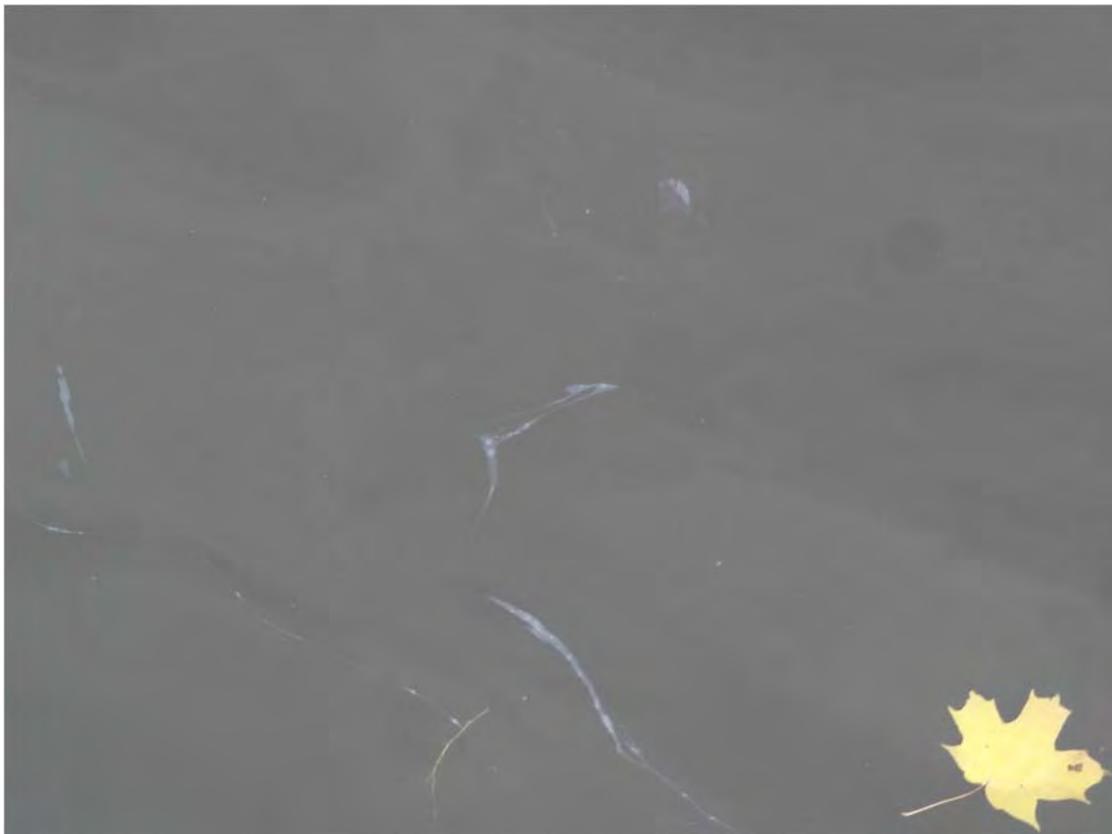
28. MP4.5 center channel sheen and tar globs were observed.

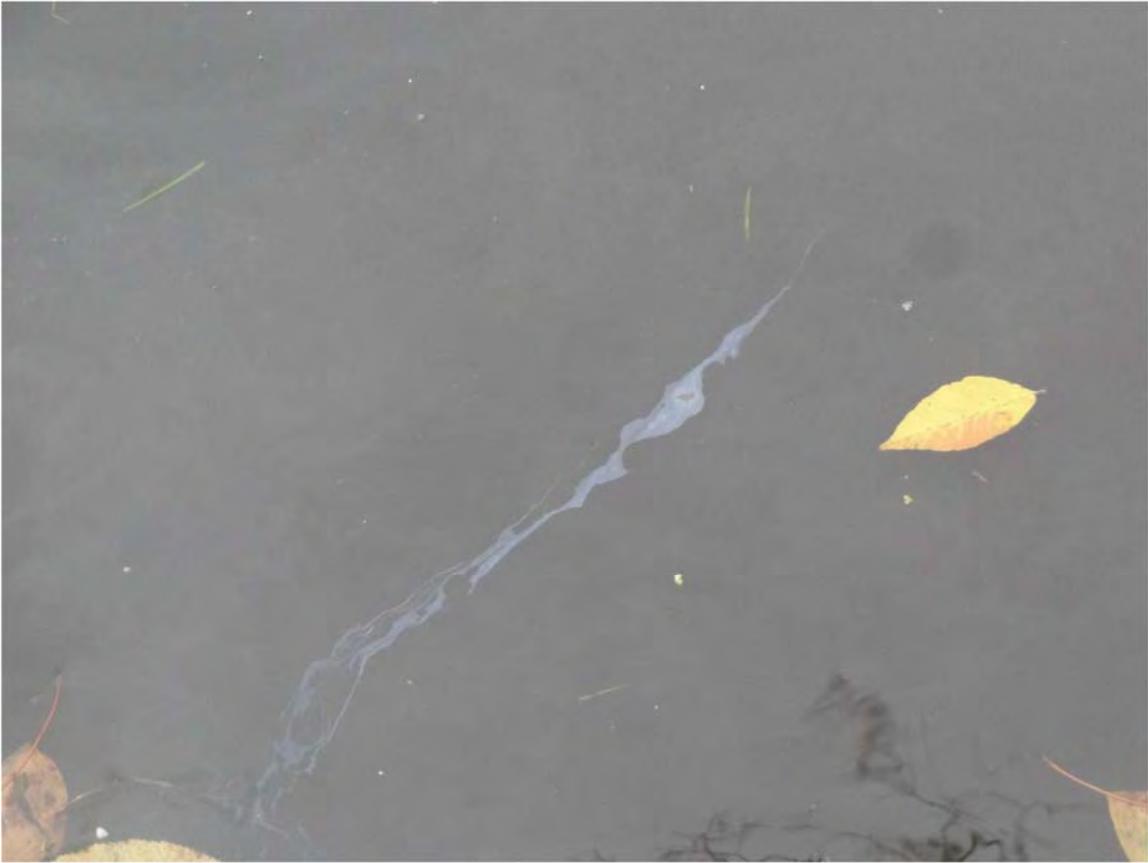
29. C0.4 Boat launch sheen and tar globs were observed near the water level gauge.

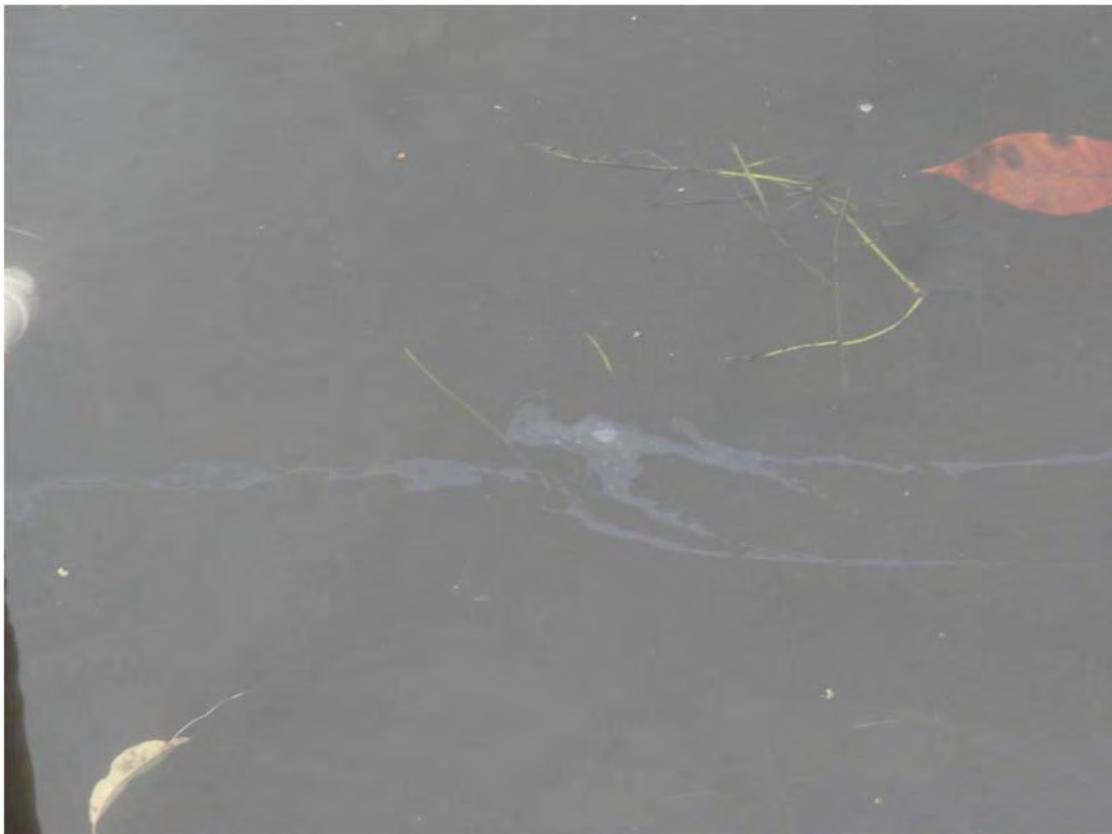
30. C0.4 Boat launch sheen and tar globs were observed near the water level gauge.

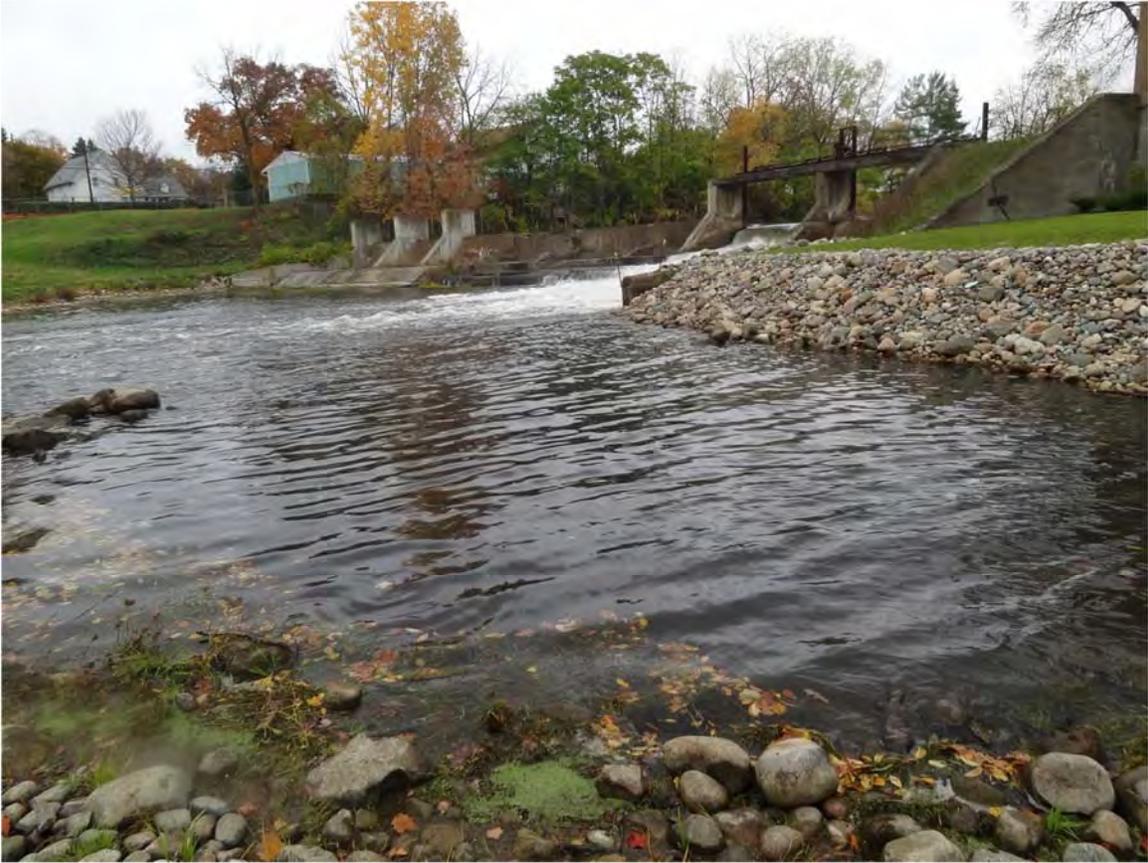
31. Portage below Ceresco Dam sheen observed.

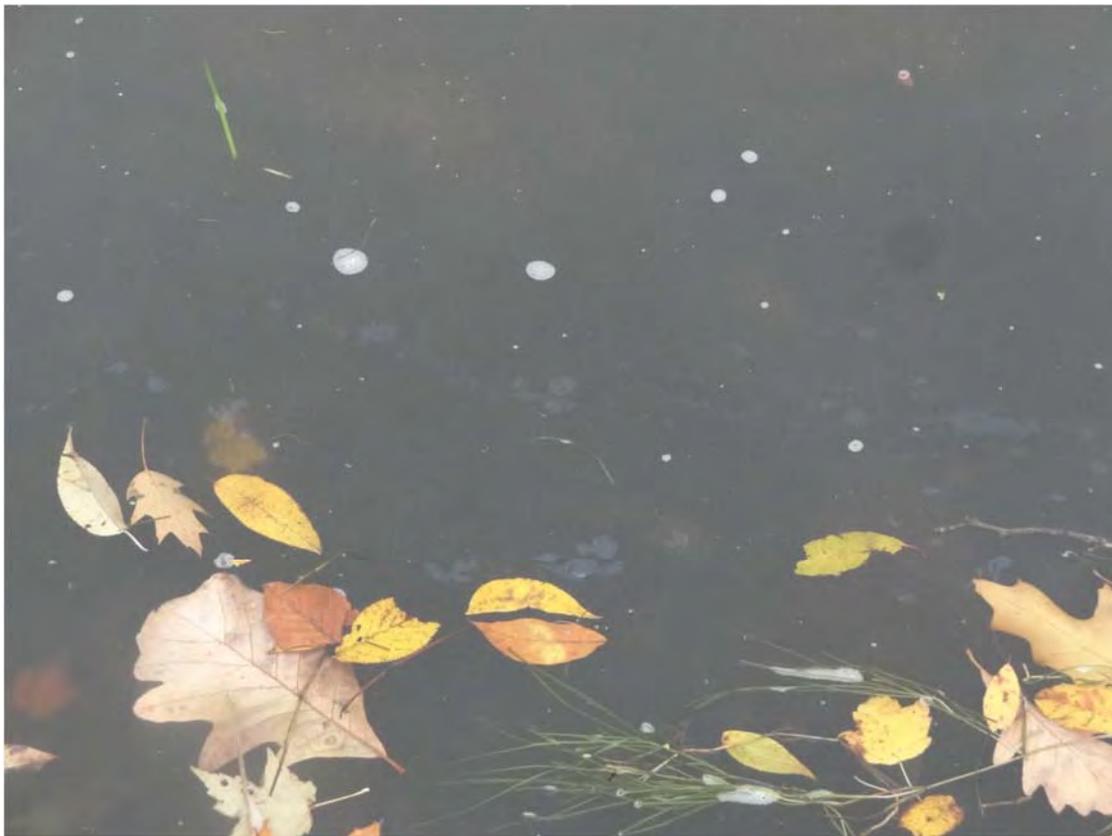
32. Portage below Ceresco Dam sheen observed.

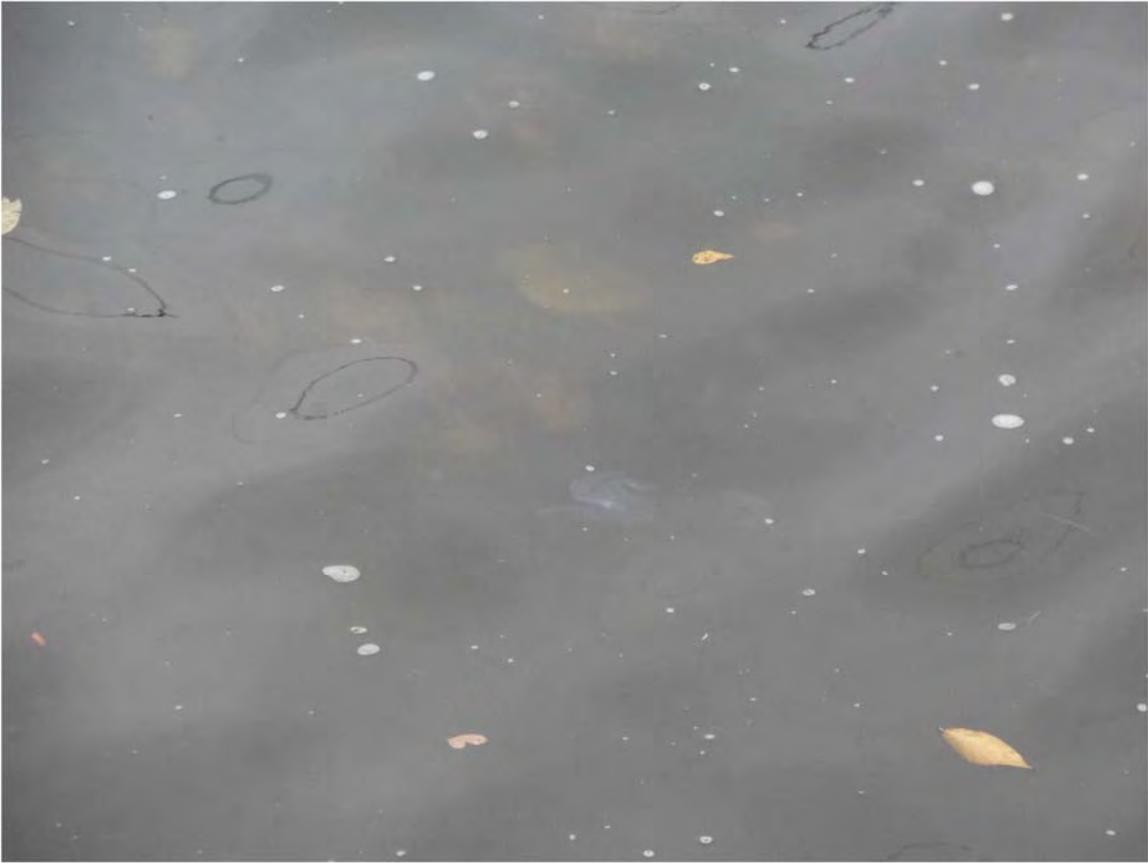
33. Portage below Ceresco Dam sheen observed.

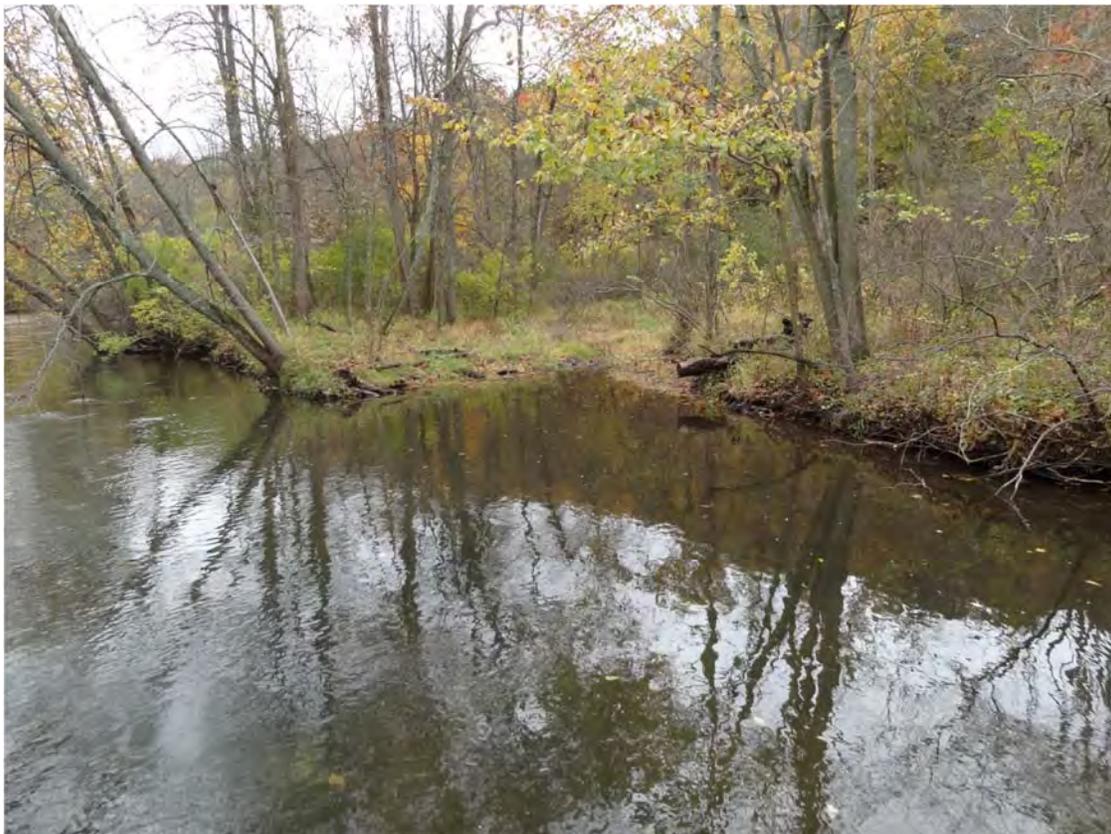
34. MP8.5 L1 small ribbons of sheen observed.

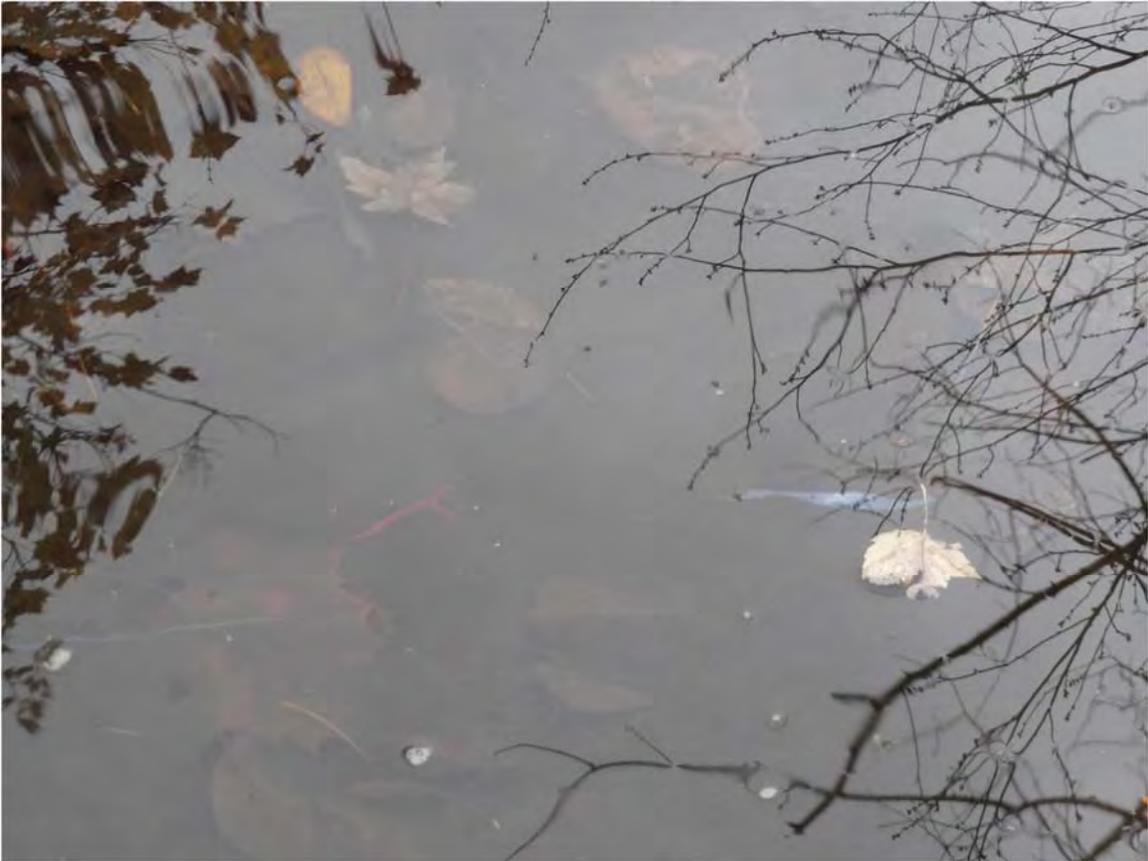
35. MP8.5 L1 small ribbons of sheen observed.

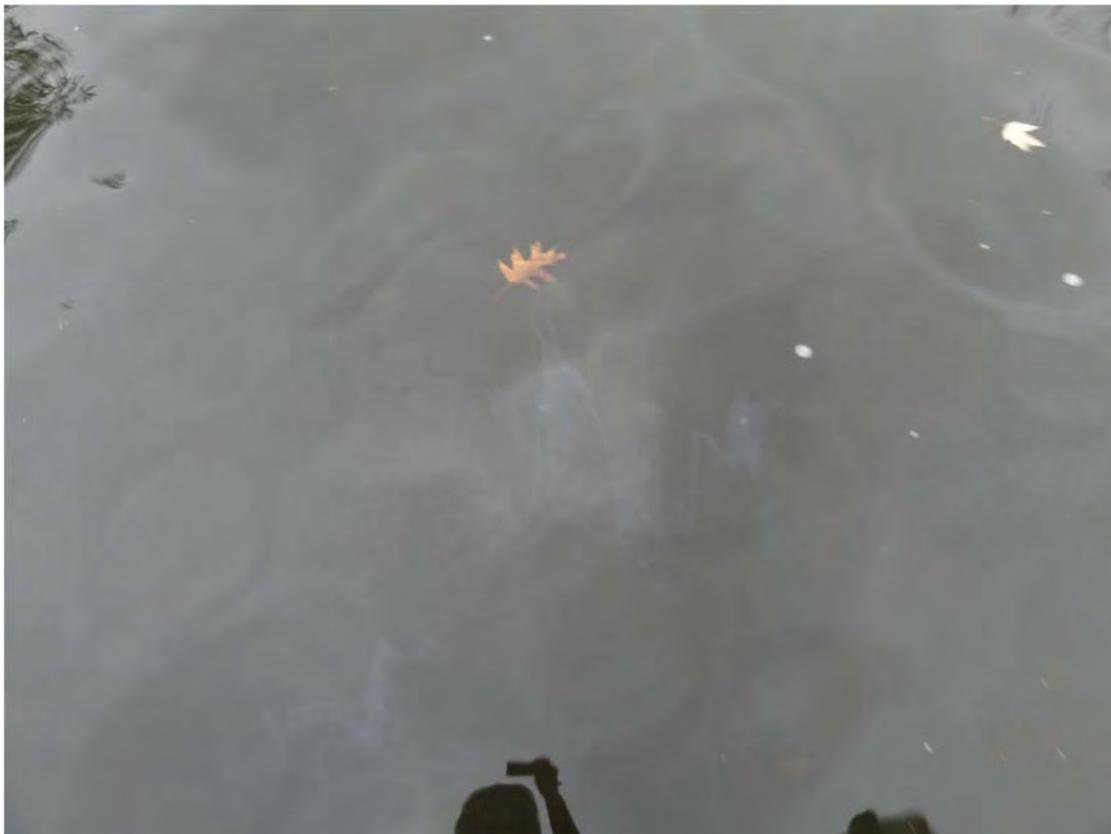
36. MP14.70 LDB sheen and tar globs were observed.

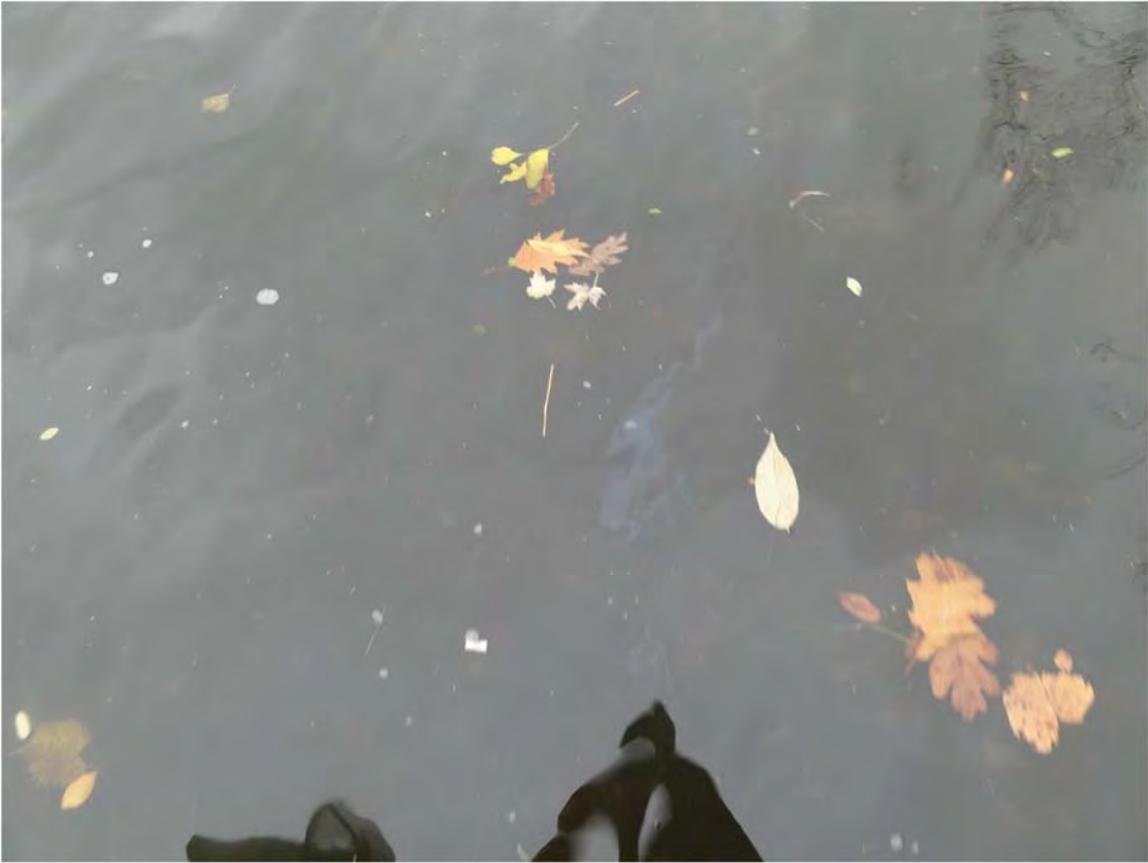
37. MP14.70 LDB sheen and tar globs were observed.

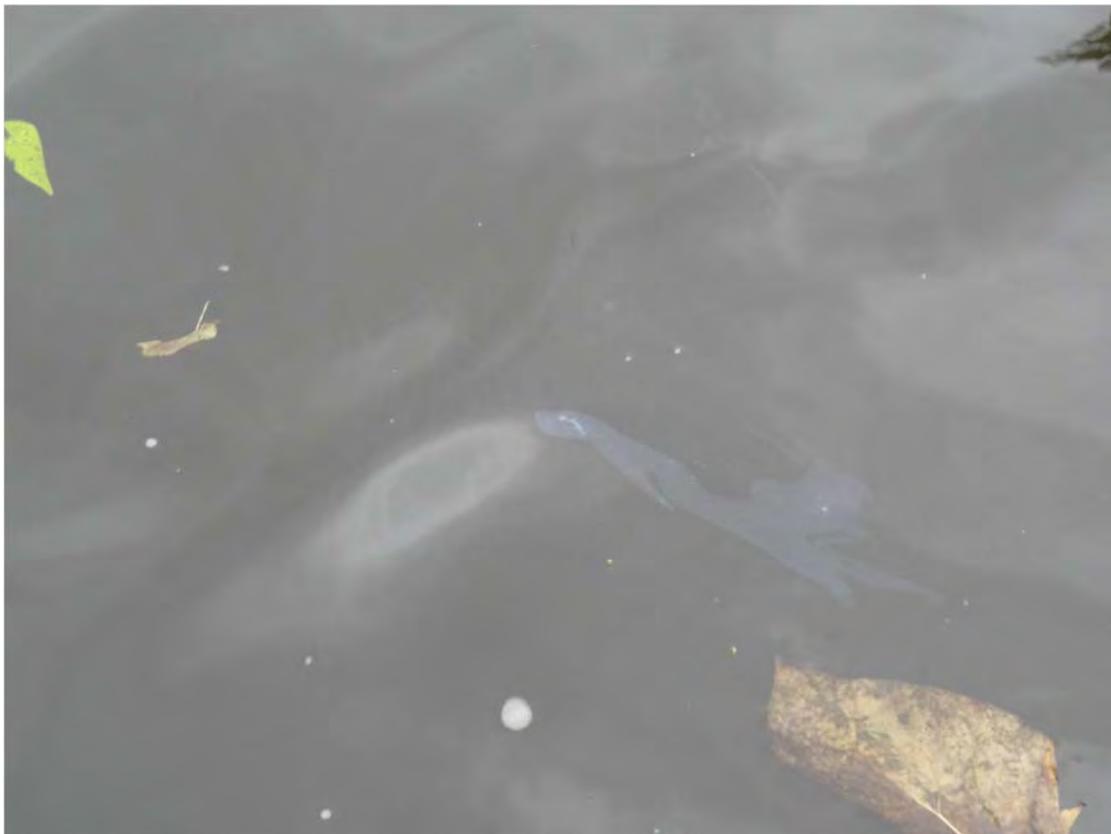
38. MP14.70 LDB sheen and tar globs were observed.

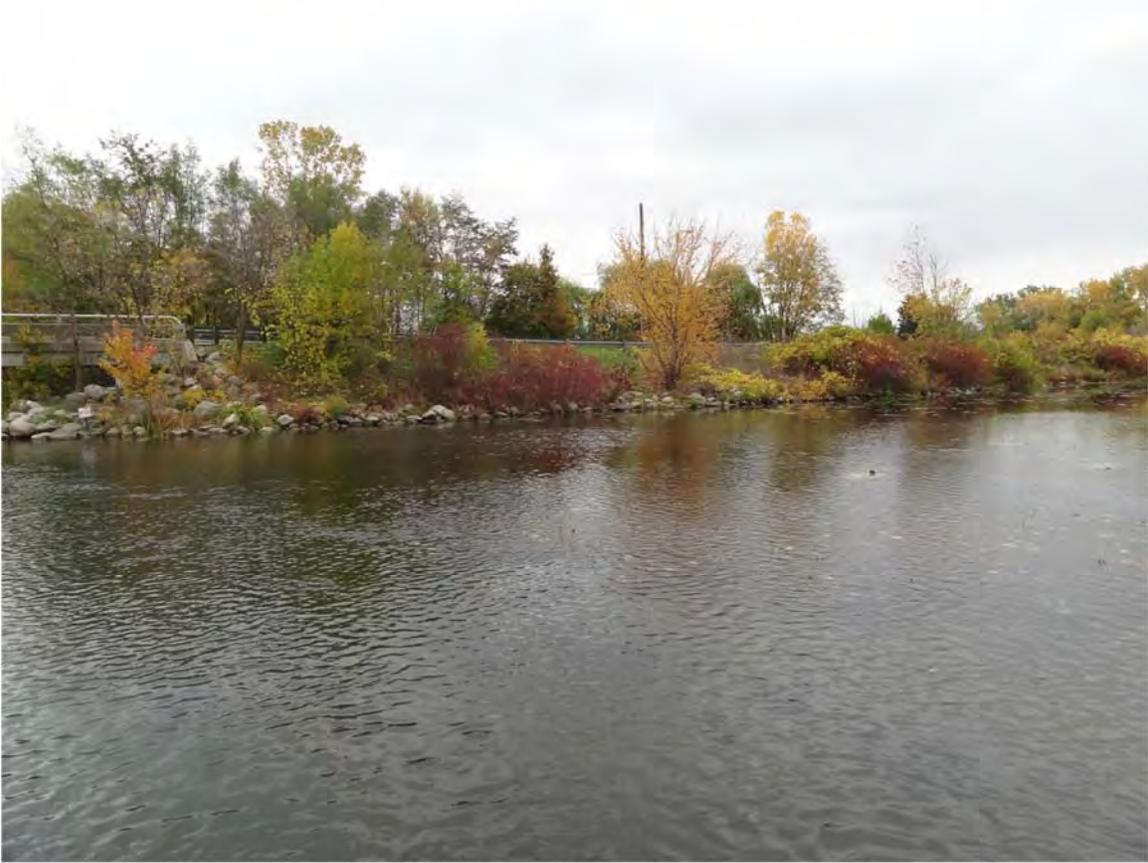
39. MP15.5 South Mill Pond no sheen observed.

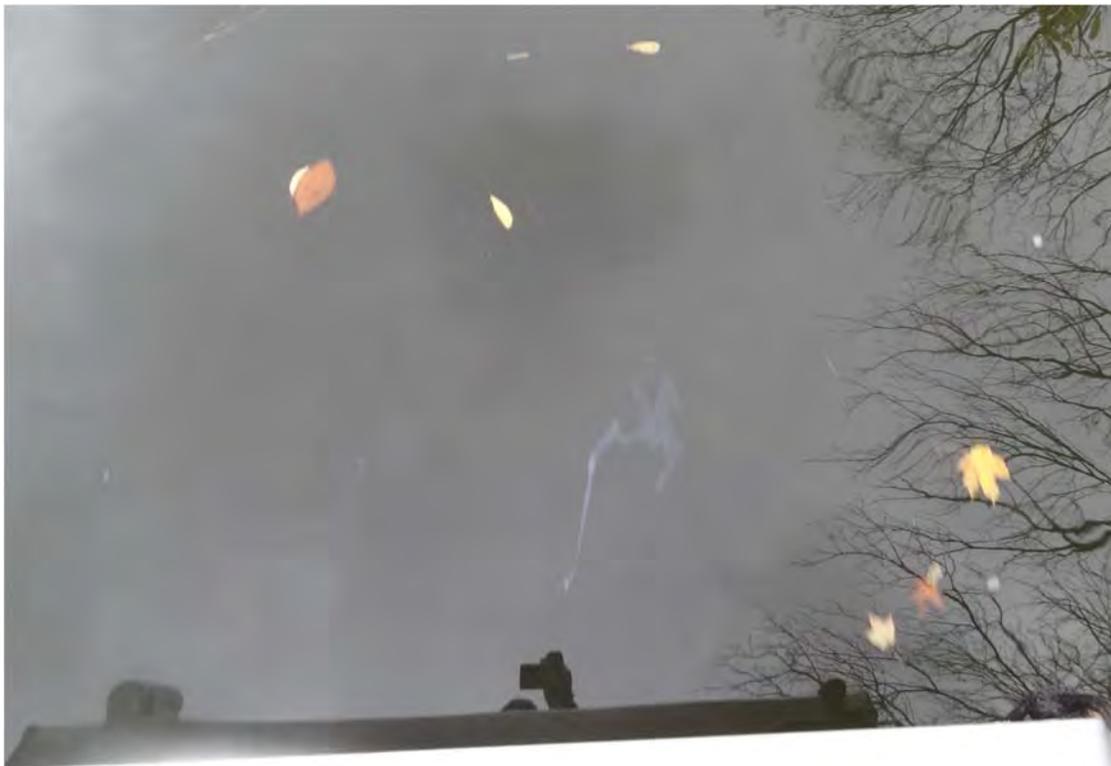
40. MP15.65 RDB sheen and tar globs were observed.

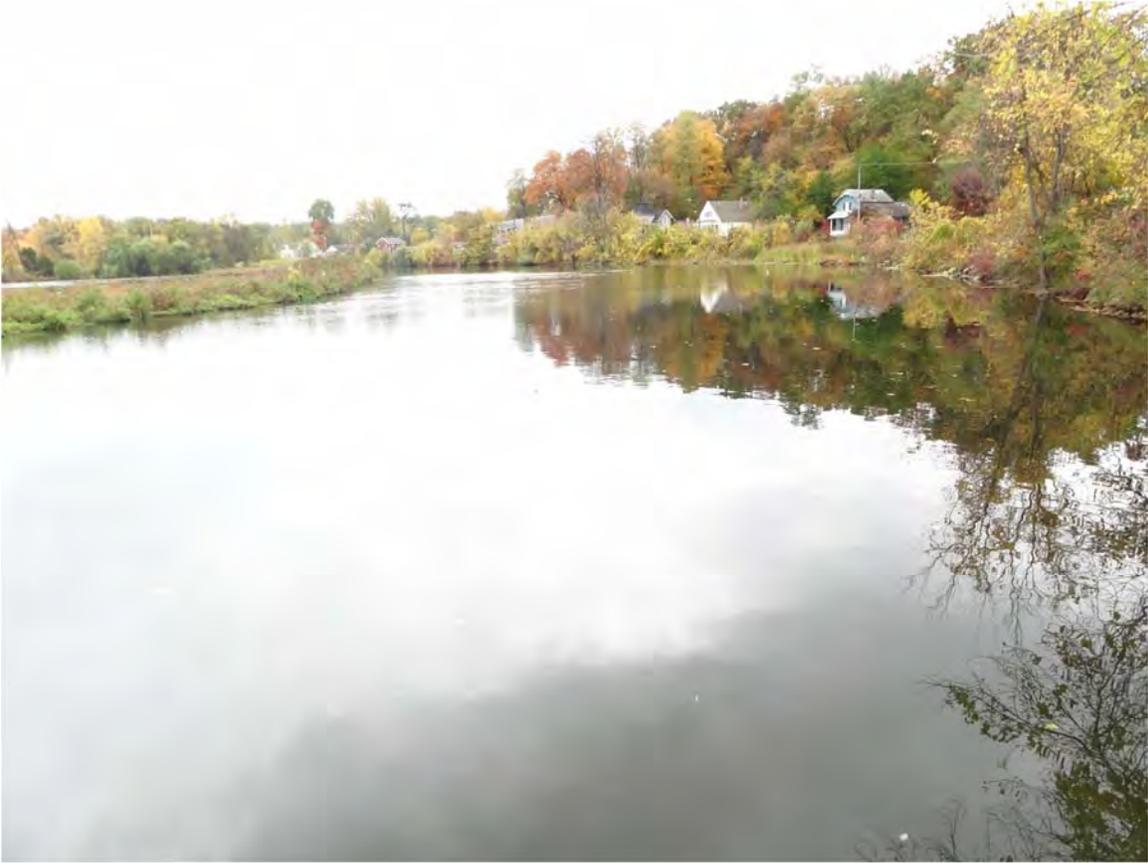
41. MP15.65 LDB area were sheen and tar globs were observed.

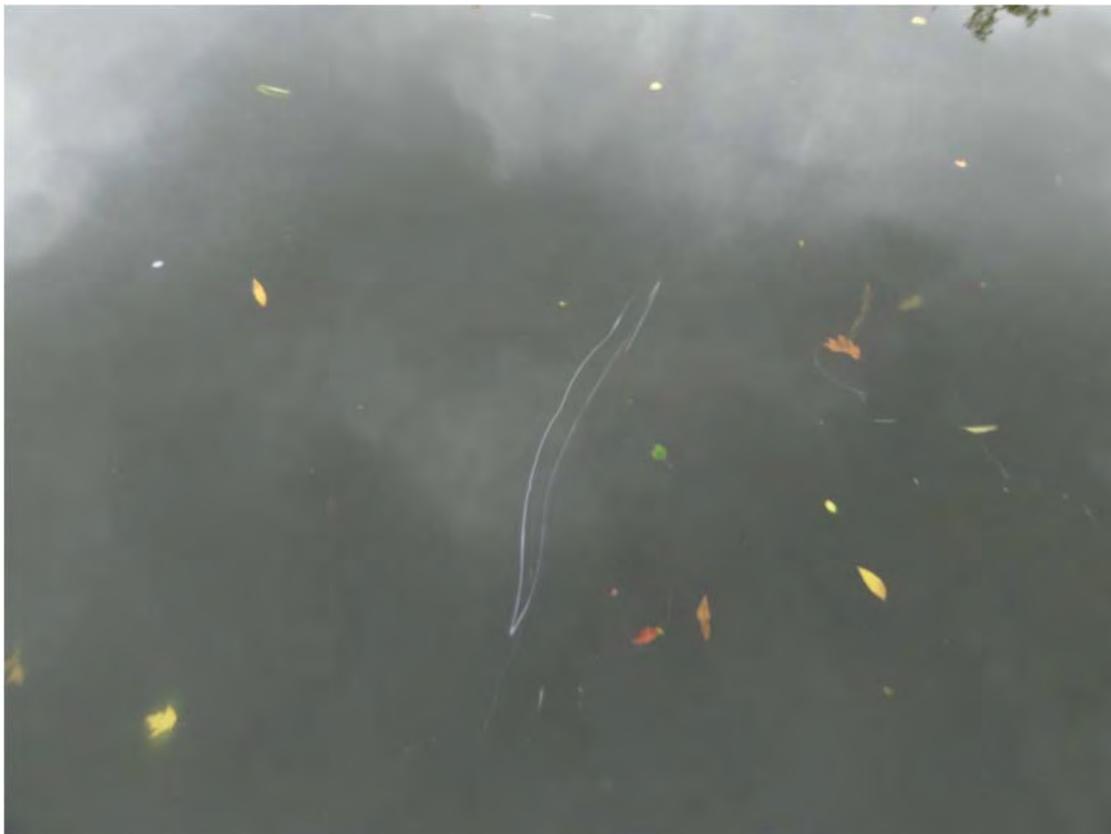
42. MP14.65 LDB sheen and tar globs observed.

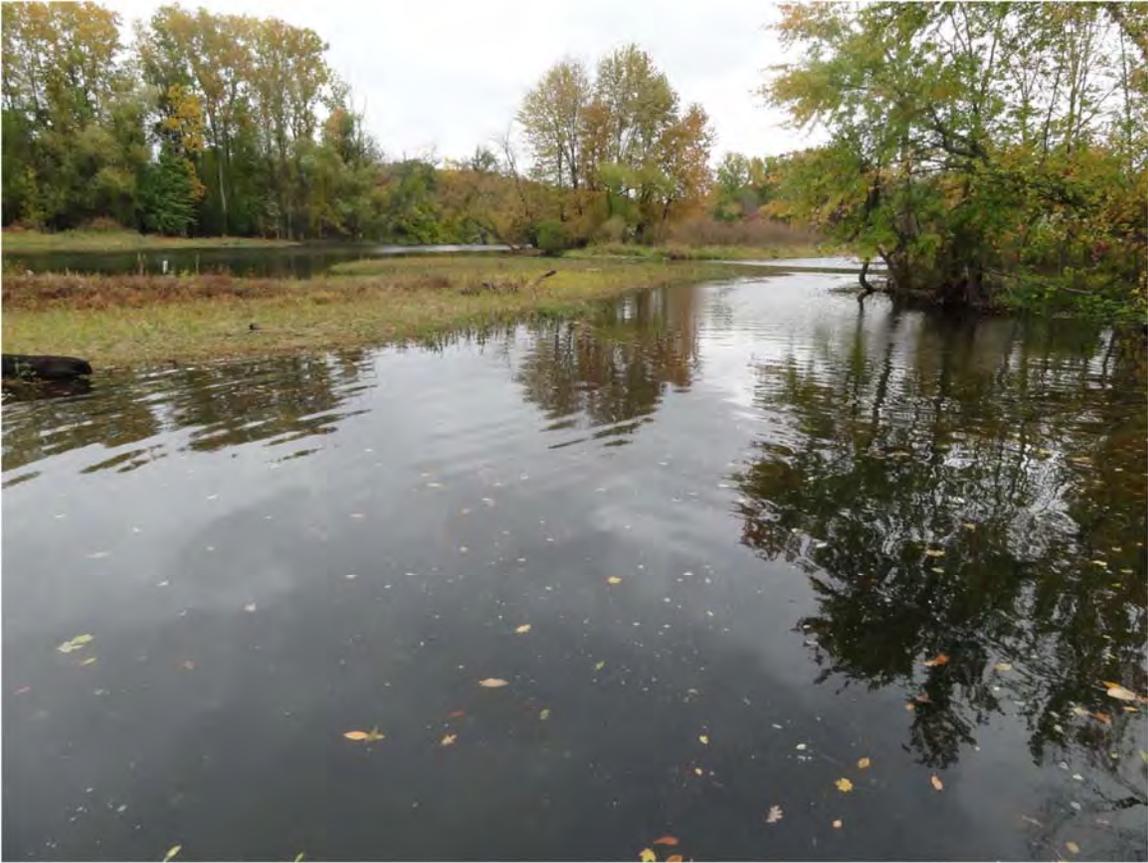
43. MP15.0 LDB area where sheen and tar globs were observed.

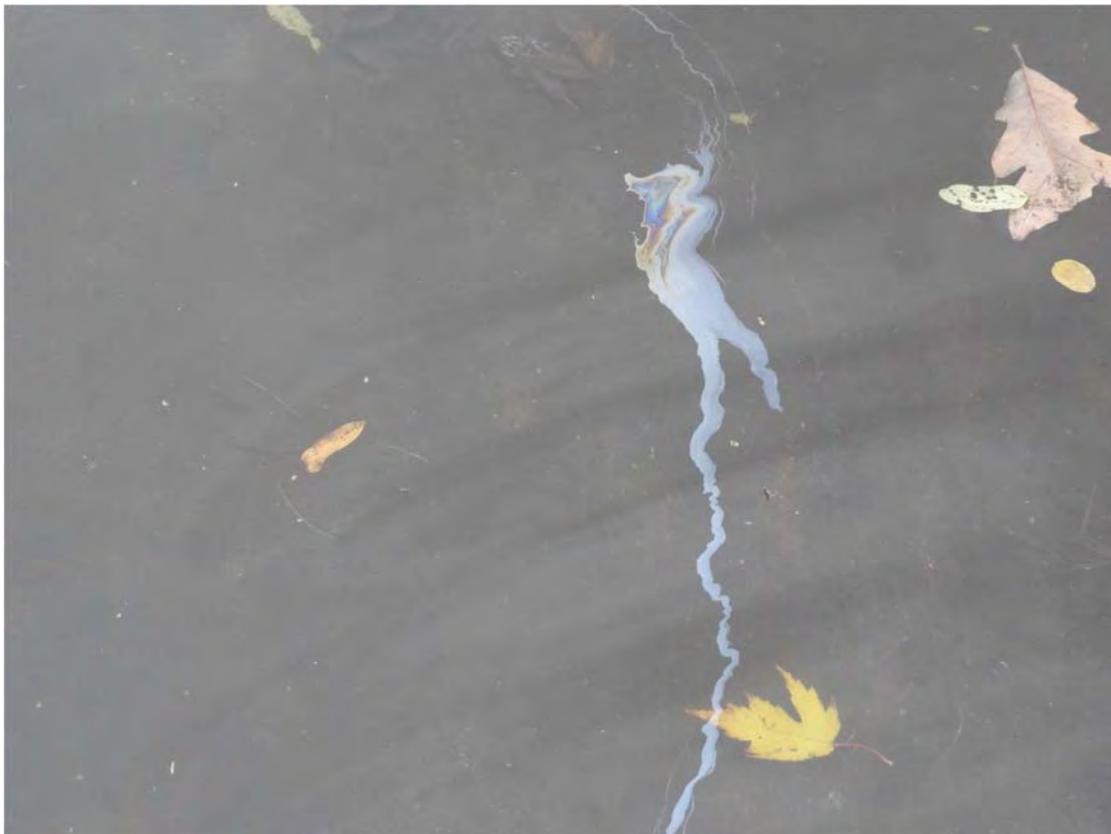
44. MP15.0 LDB sheen and tar globs were observed.

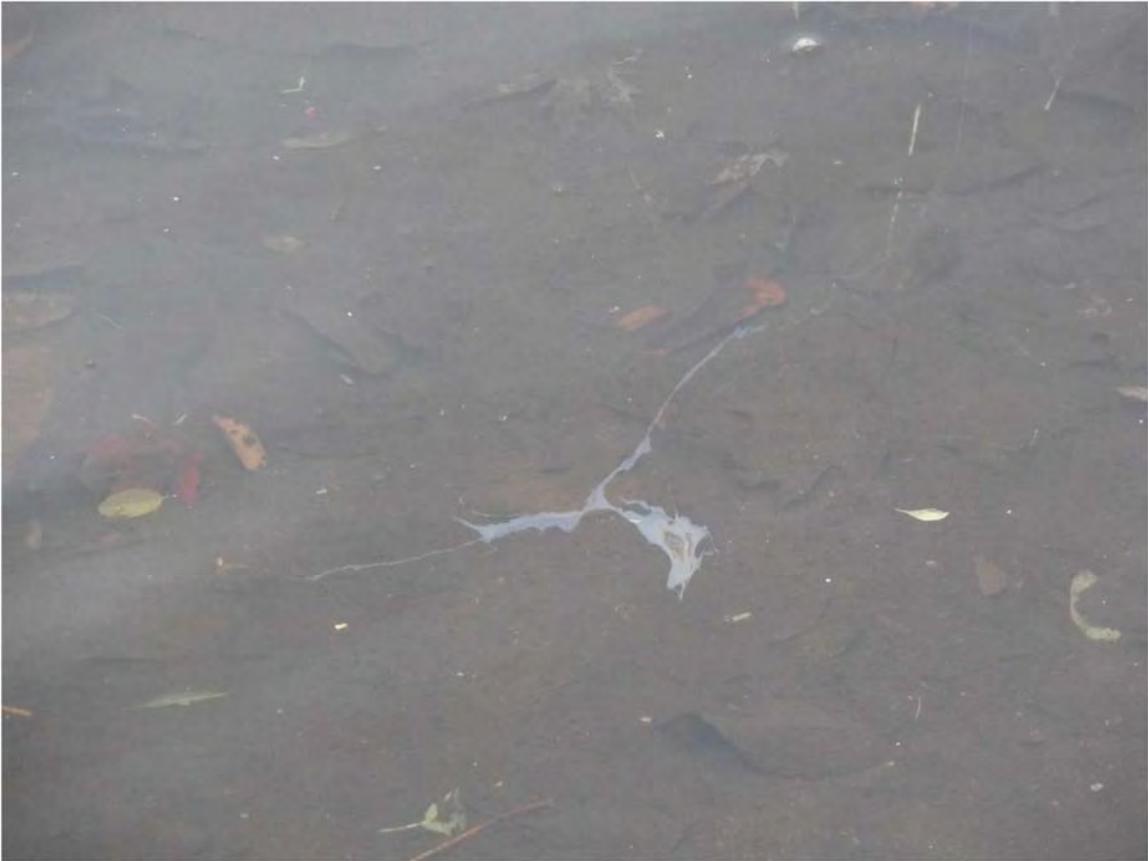
45. MP15.0 LDB sheen and tar globs were observed.

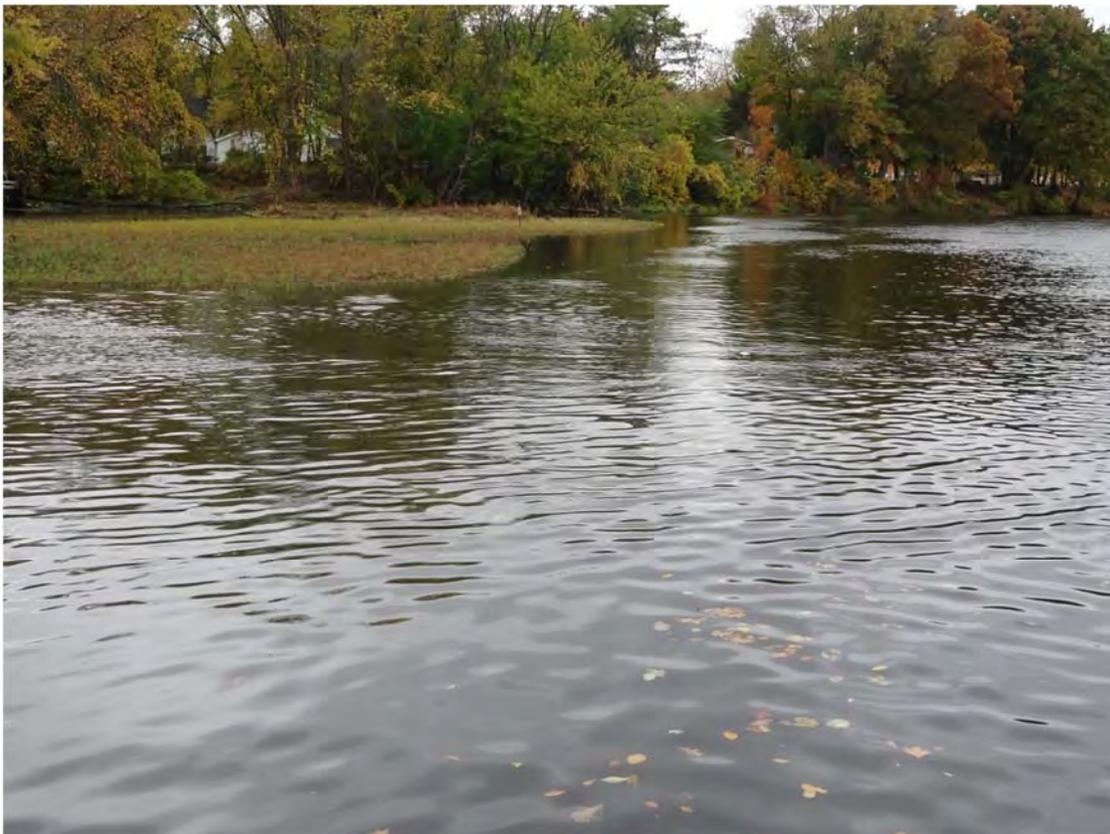
46. MP15.0 LDB area where sheen and tar globs were observed.

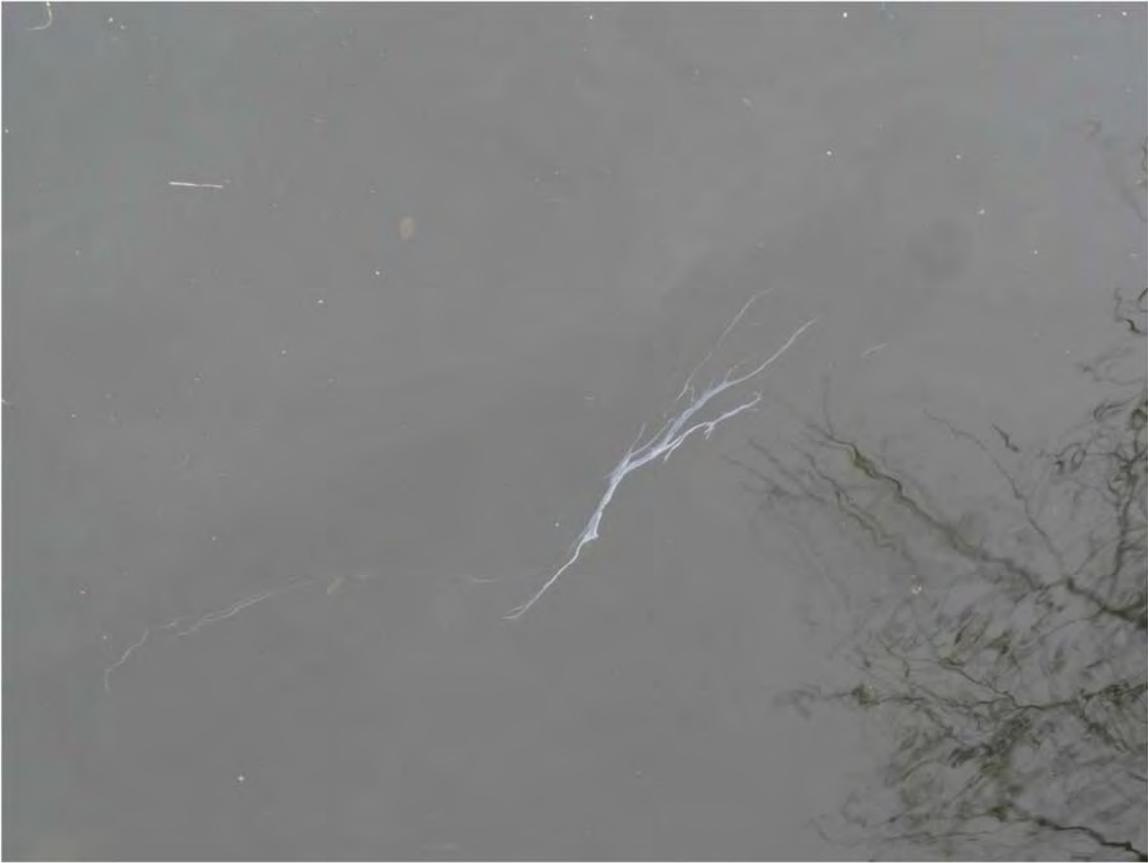
47. MP15.0 LDB sheen and tar globs were observed.
