# Situation Photo Log

Monday, October 15, 2012

Kalamazoo River / Enbridge Spill

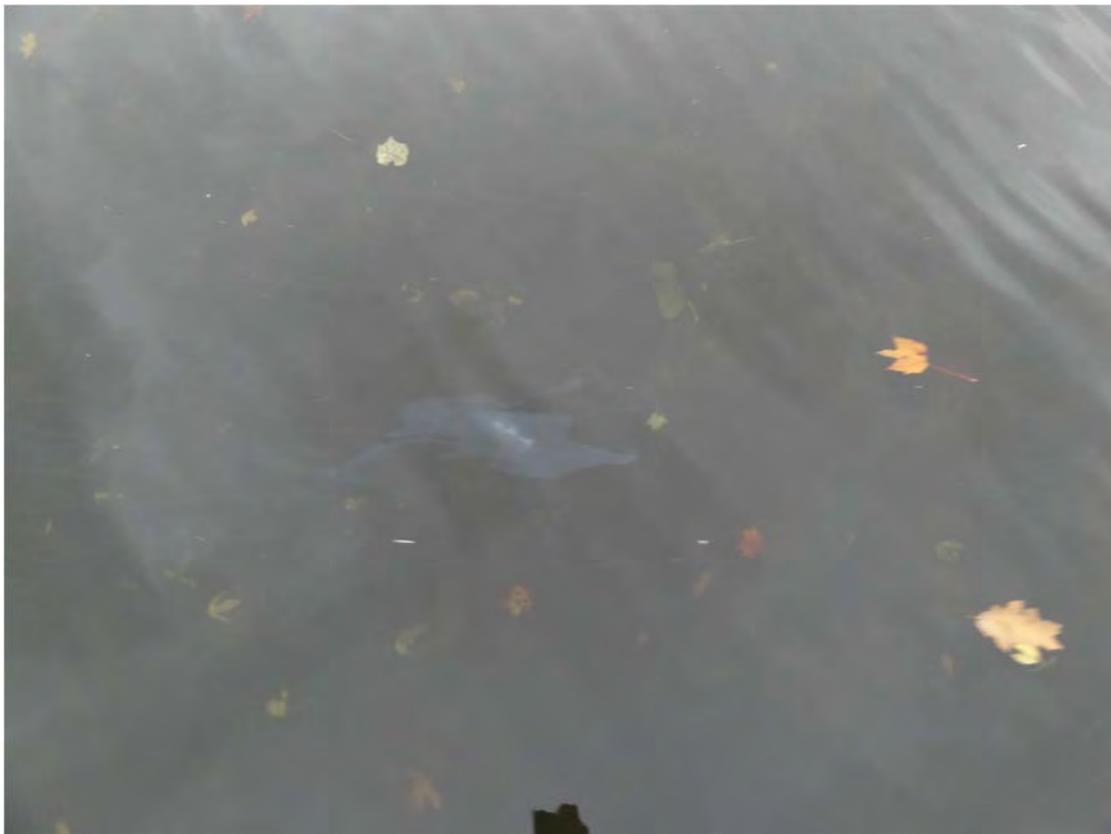
48. MP15.0 LDB sheen and tar globs were observed.

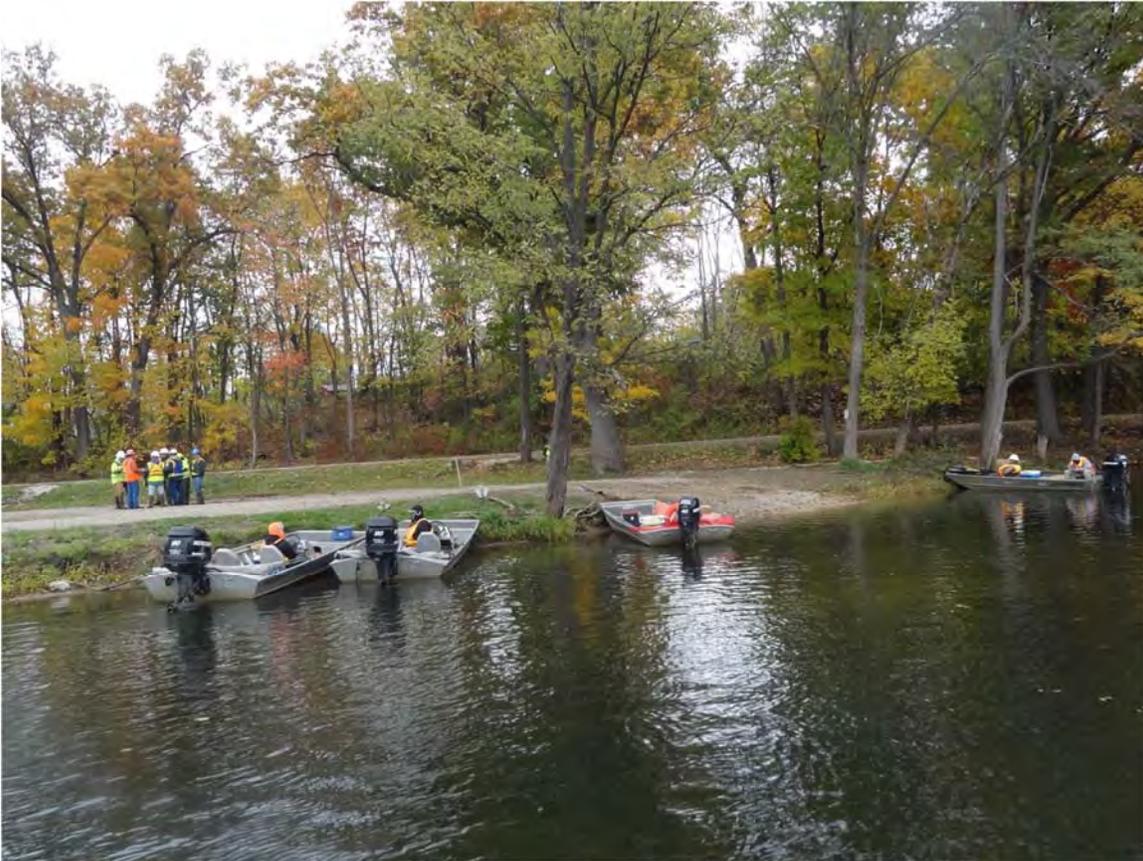
49. C5 Boat launch observed the RI crew preparing to depart.

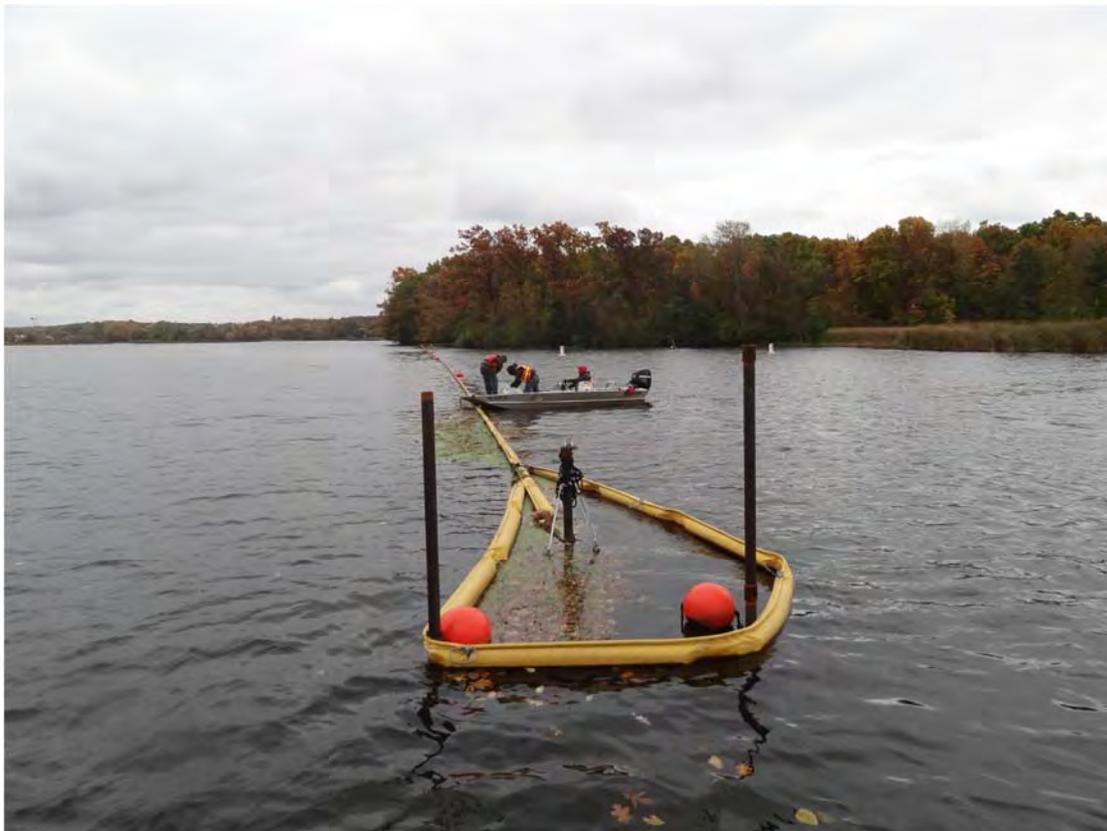
50. Morrow Lake Delta Gate E observed a crew removing debris from the boom.

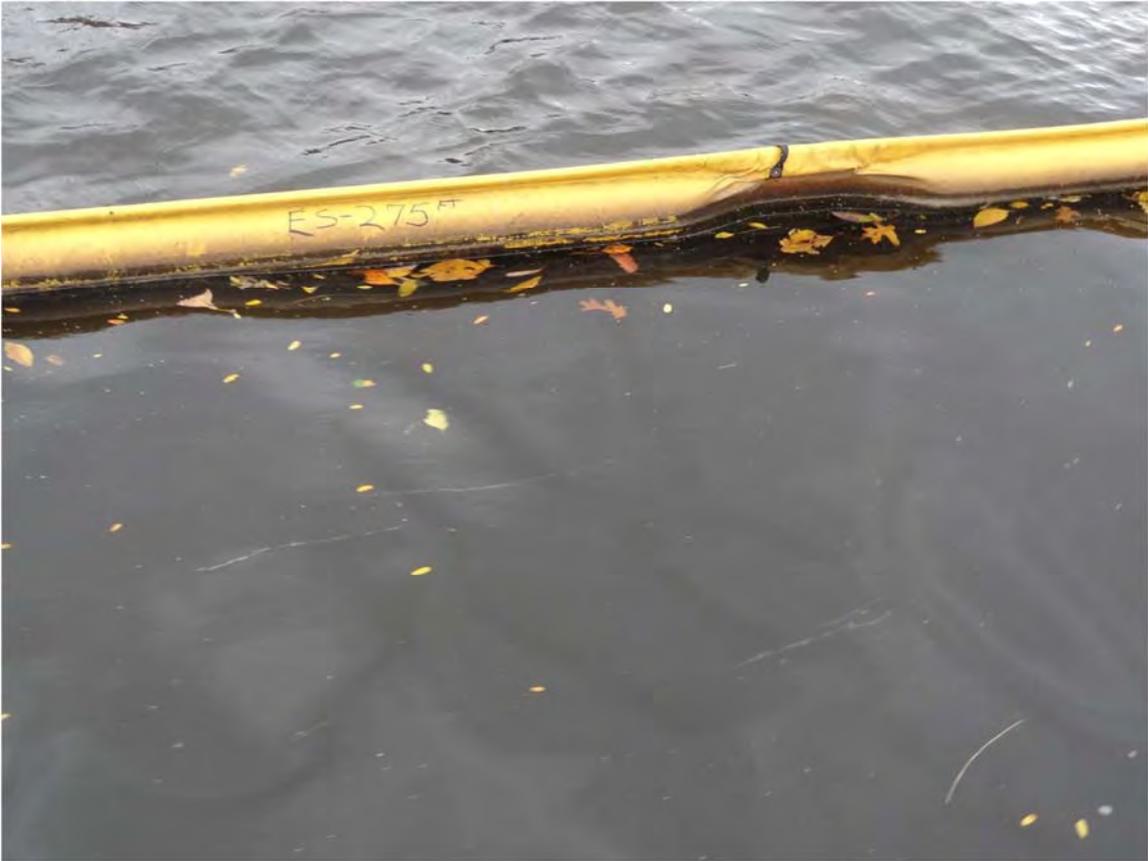
51. Morrow Lake Delta Gate E sheen and tar globs were observed.

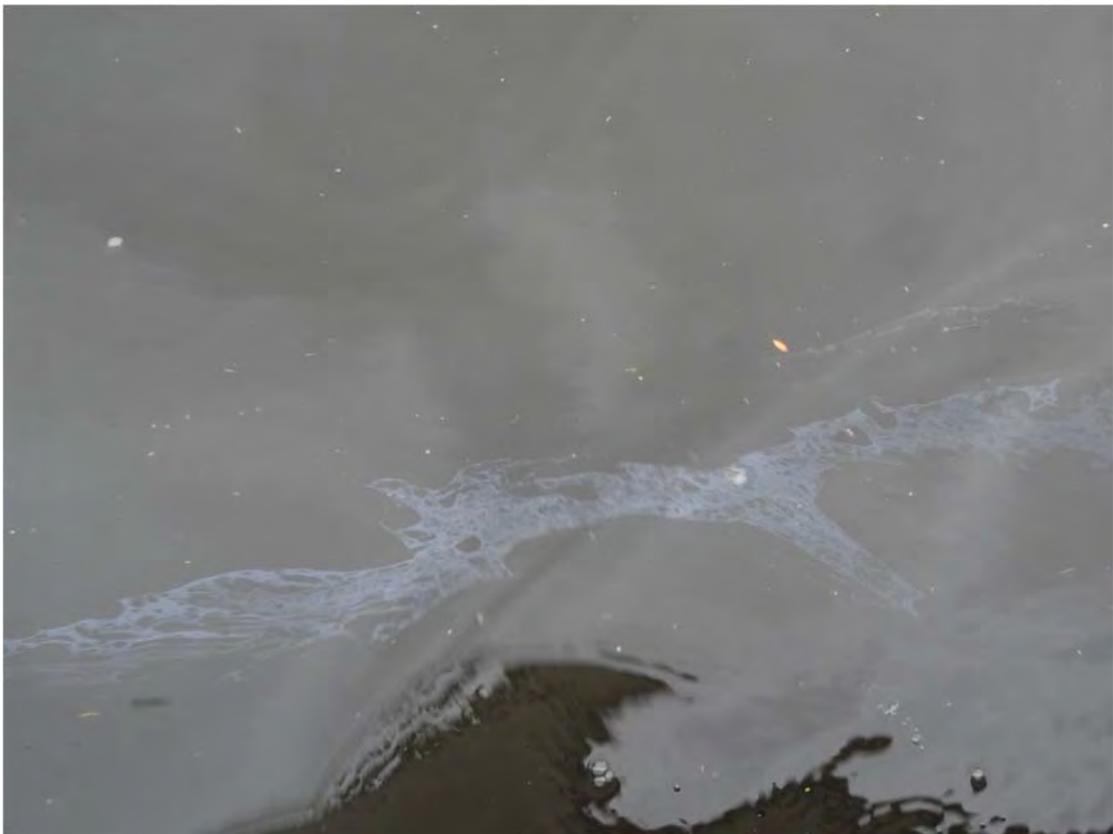
52. Morrow Lake Delta Gate E sheen and tar globs were observed.

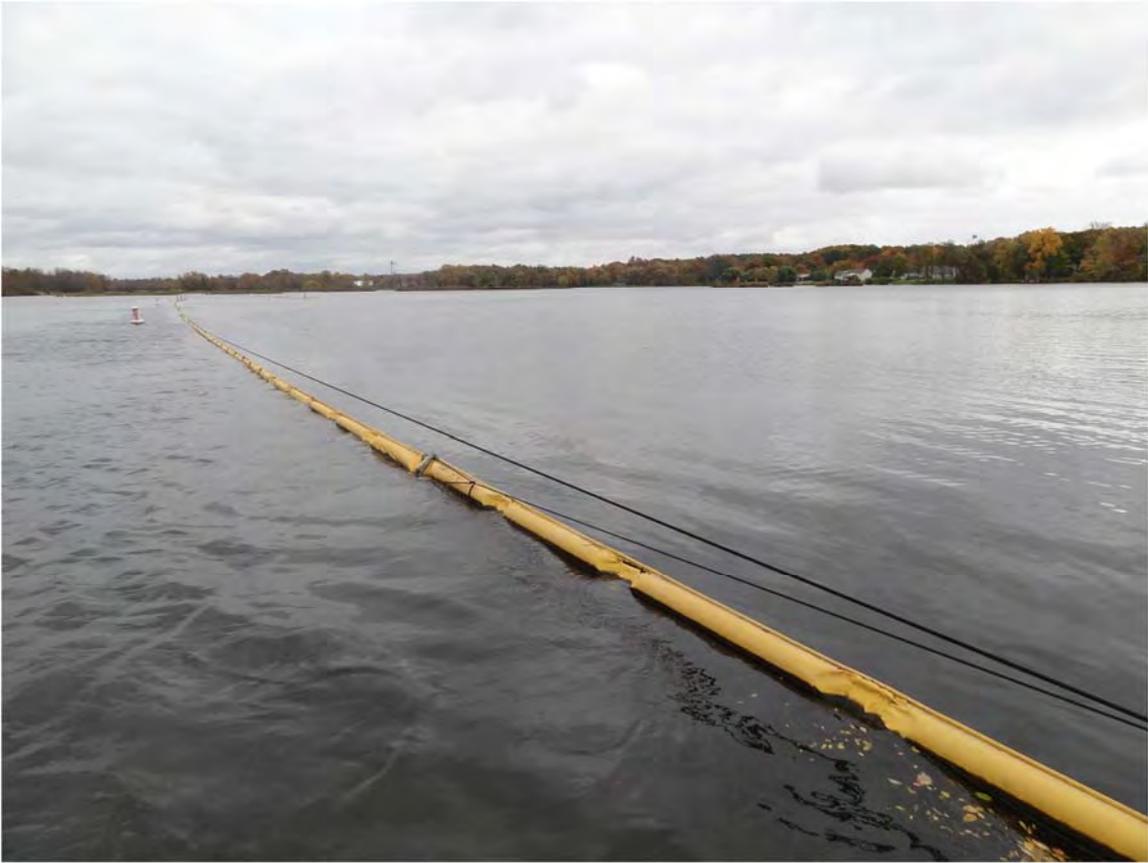
**53. Morrow Lake Delta Gate C sheen and tar globs were observed.**

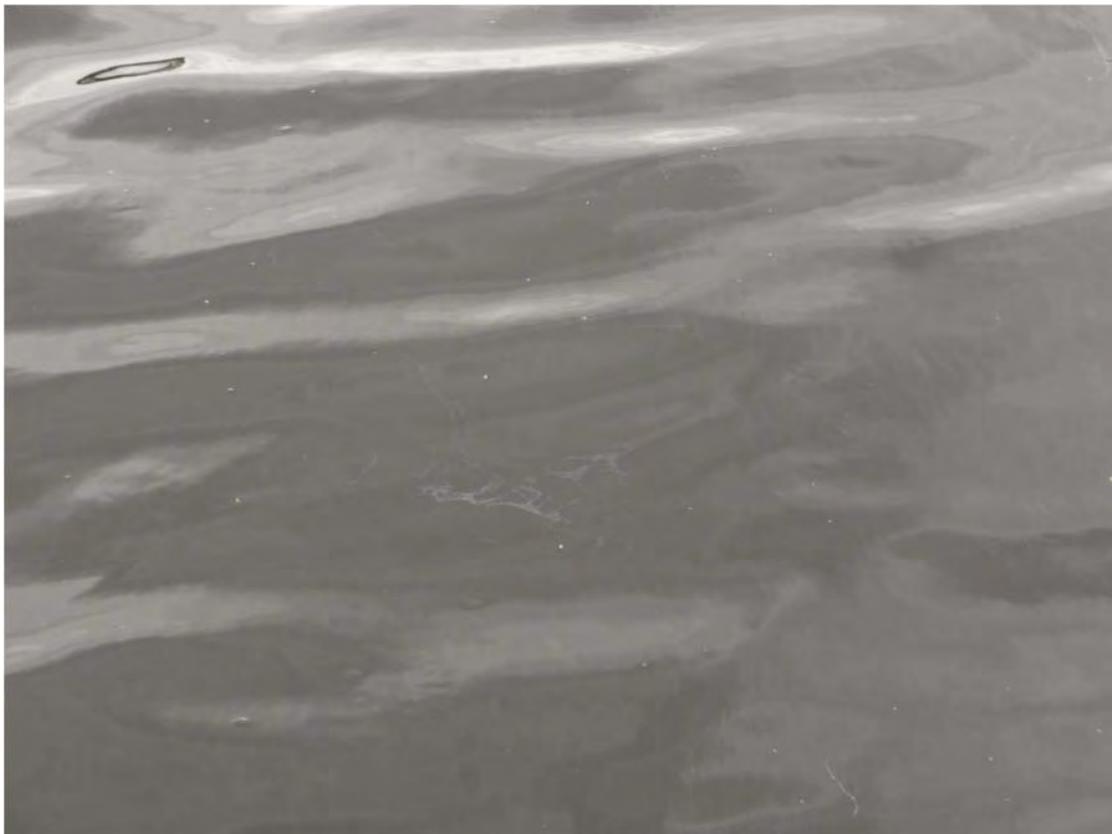
**54. Morrow Lake Delta Gate C sheen and tar globs were observed. Sheen sweep was required based on the area of sheen observed.**

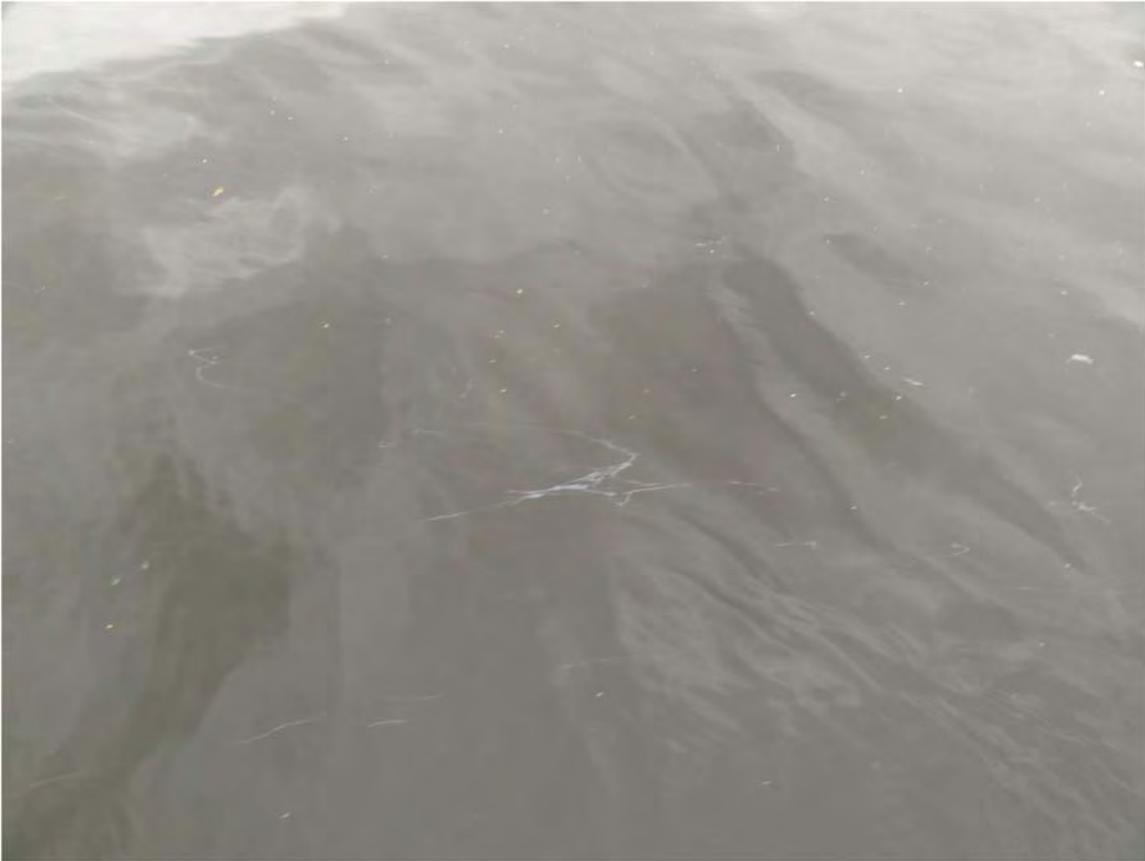
**55. Morrow Lake Delta Gate C sheen and tar globs were observed. Sheen sweep was required based on the area of sheen observed.**

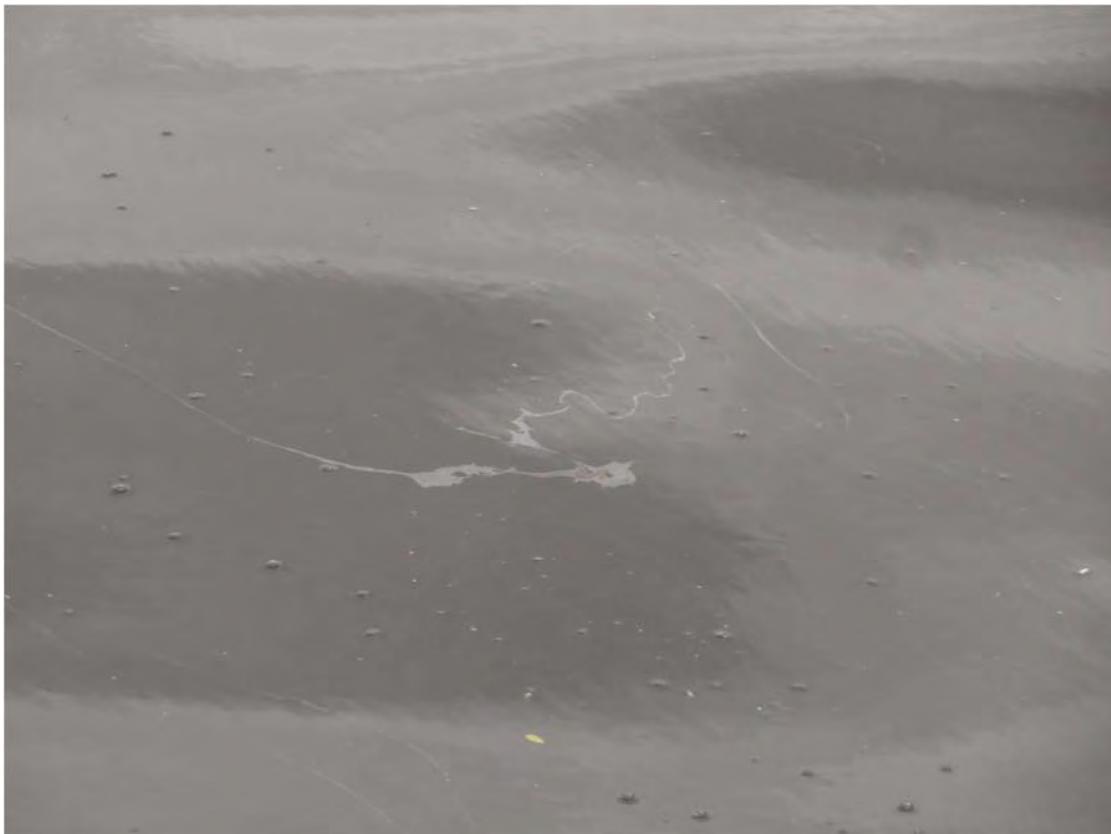
**56. Morrow Lake Delta Gate C sheen and tar globs were observed. Sheen sweep was required based on the area of sheen observed.**

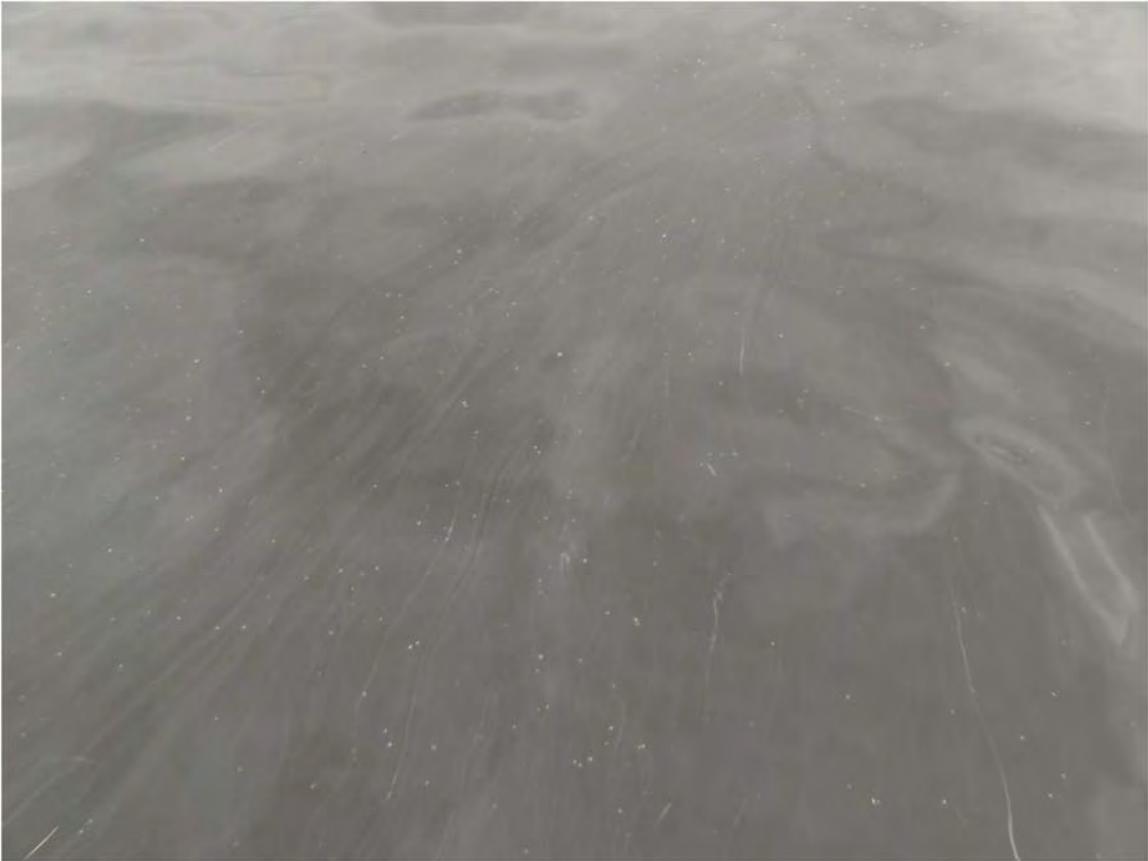
**57. Morrow Lake Delta Gate C sheen and tar globs were observed. Sheen sweep was required based on the area of sheen observed.**

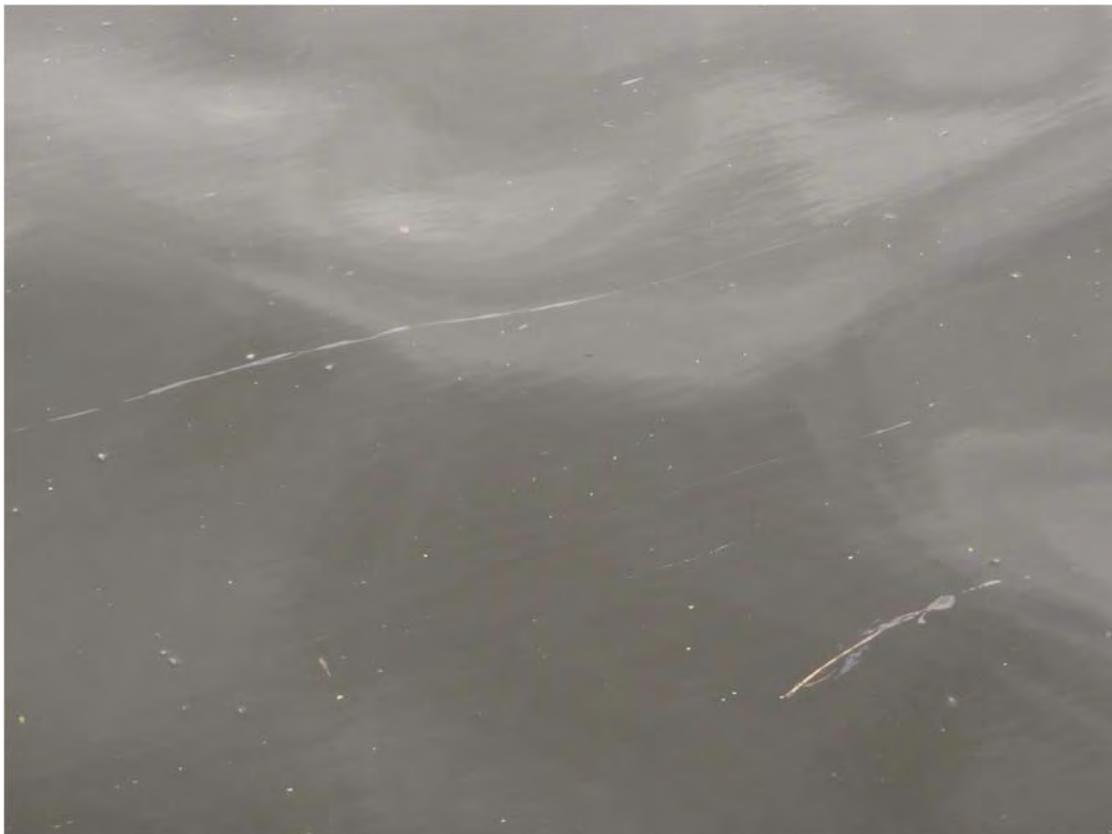
**58. Morrow Lake Delta Gate C sheen and tar globs were observed. Sheen sweep was required based on the area of sheen observed.**

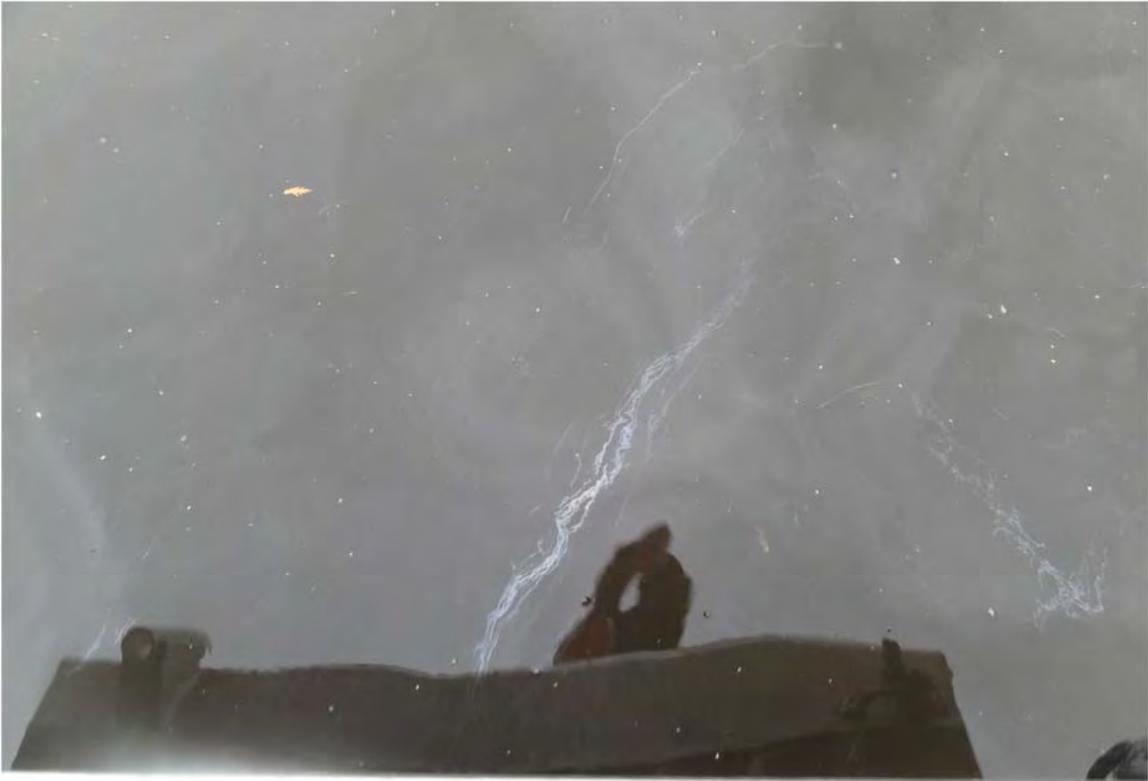
**59. Morrow Lake Delta Gate C sheen and tar globs were observed. Sheen sweep was required based on the area of sheen observed.**

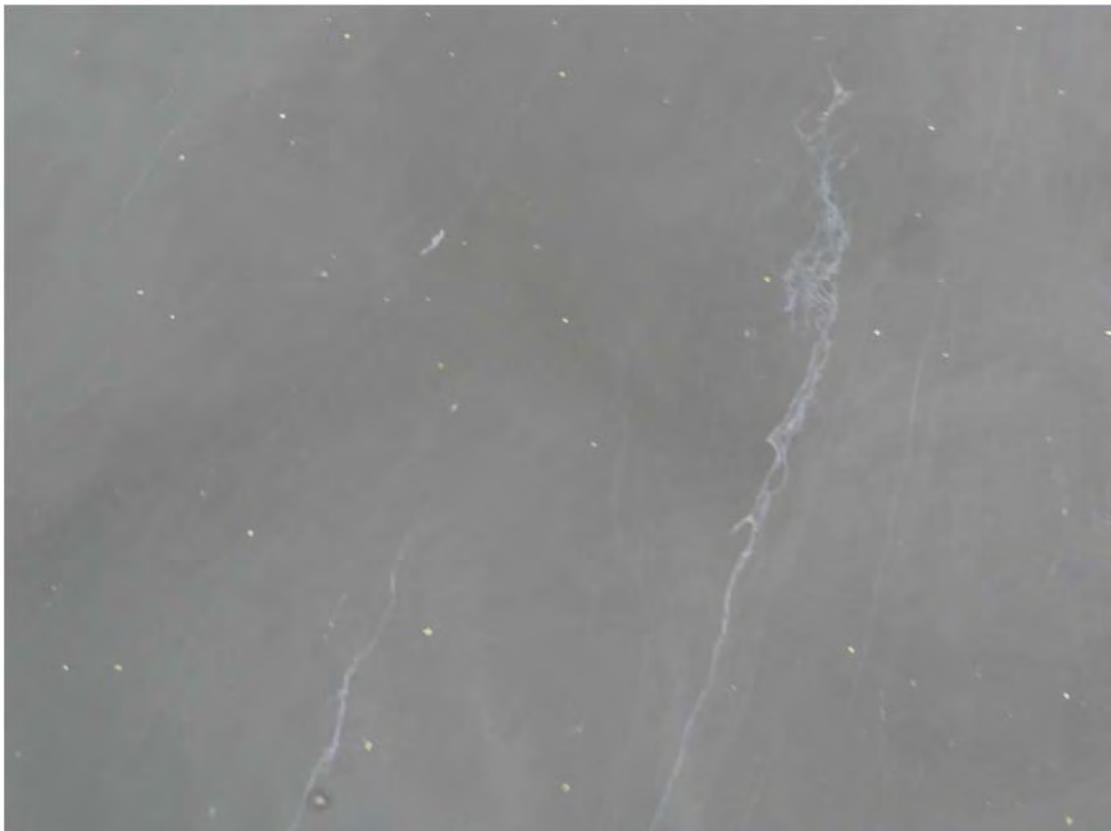
**60. Morrow Lake Delta Gate C sheen and tar globs were observed. Sheen sweep was required based on the area of sheen observed.**

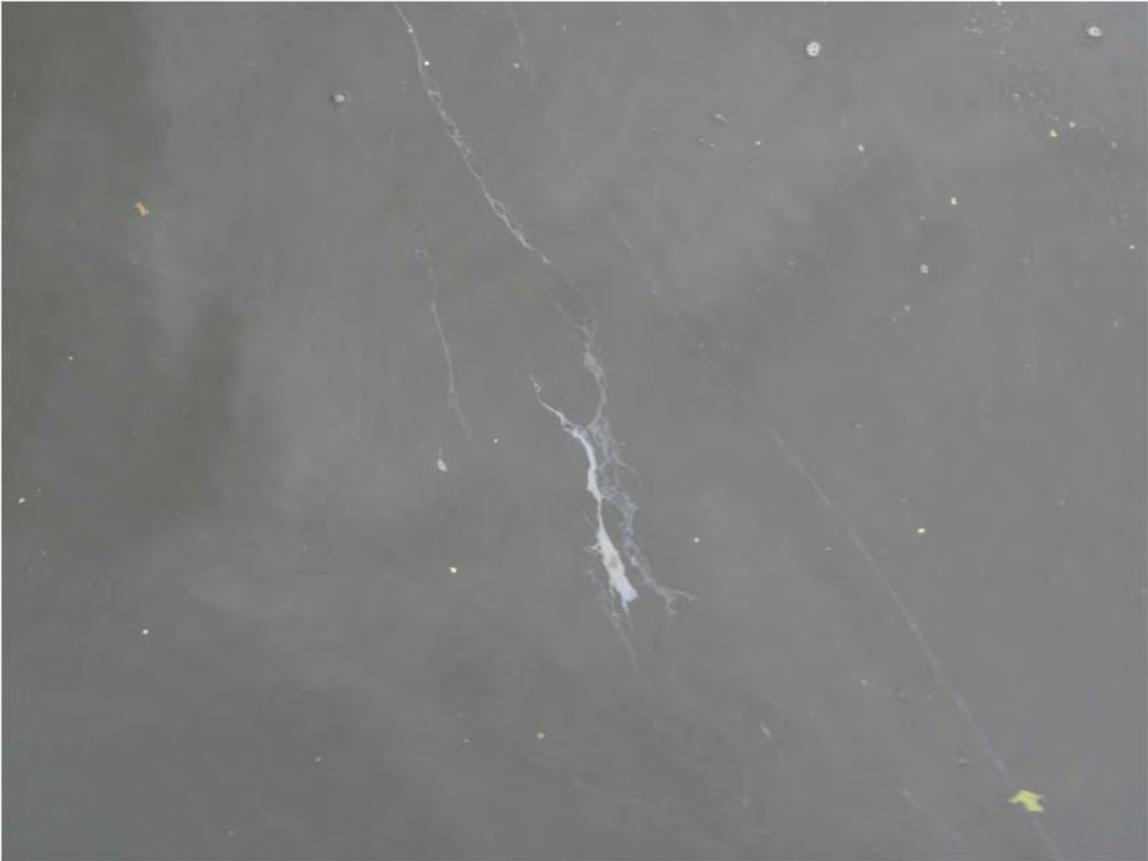
**61. Morrow Lake Delta Gate C sheen and tar globs were observed. Sheen sweep was required based on the area of sheen observed.**

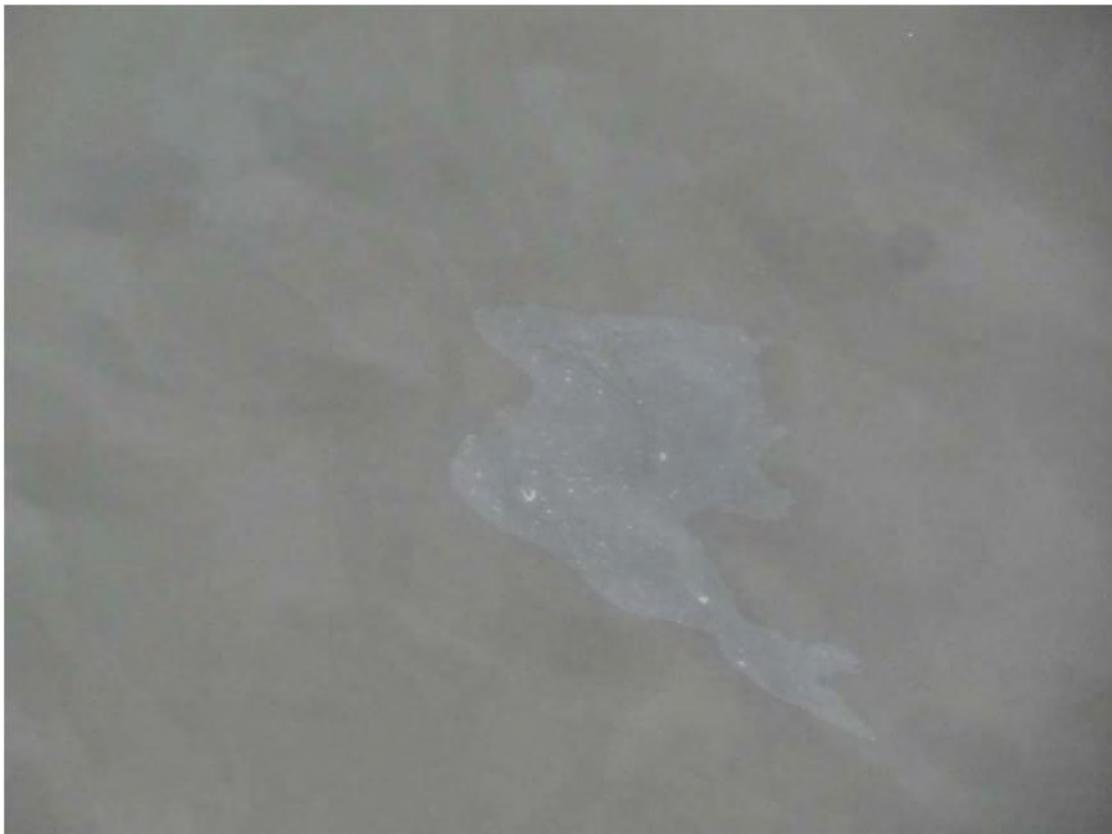
**62. Morrow Lake Delta west cove sheen and tar globs were observed.**

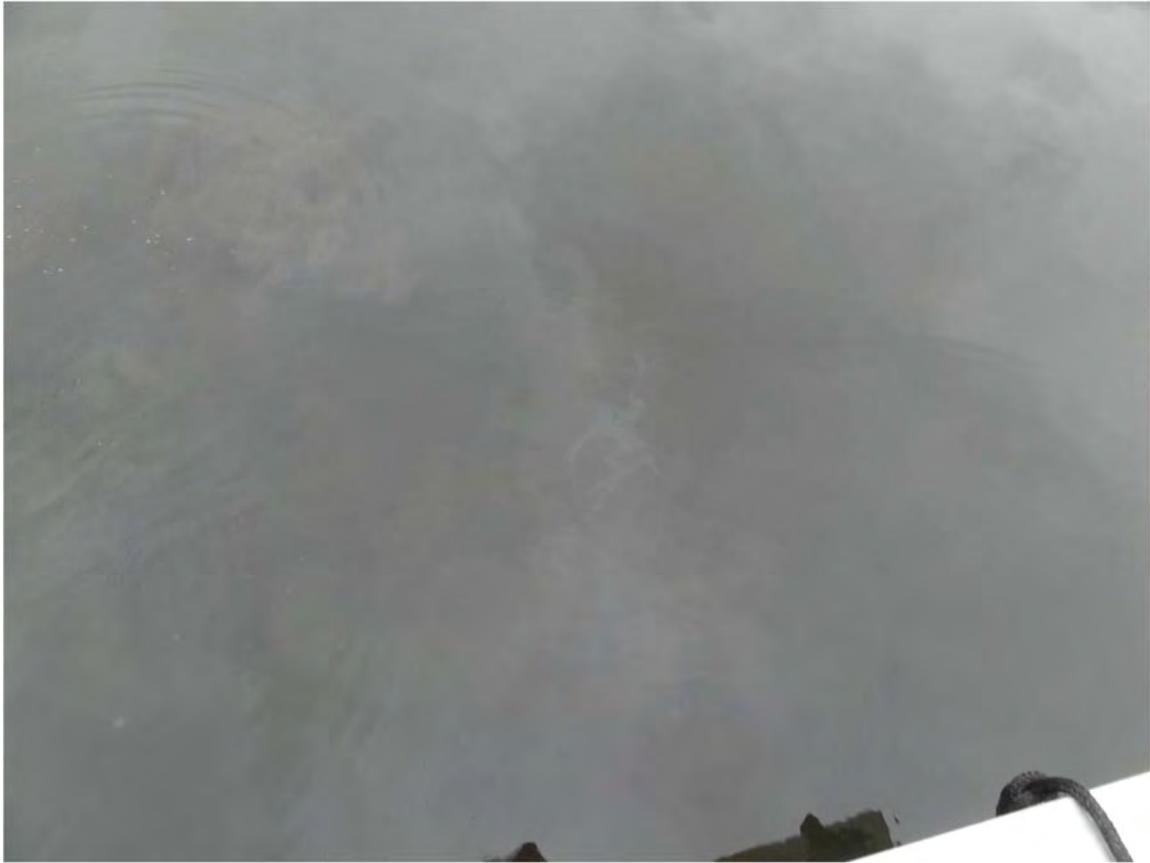
63. Morrow Lake Delta west cove sheen and tar globs were observed.

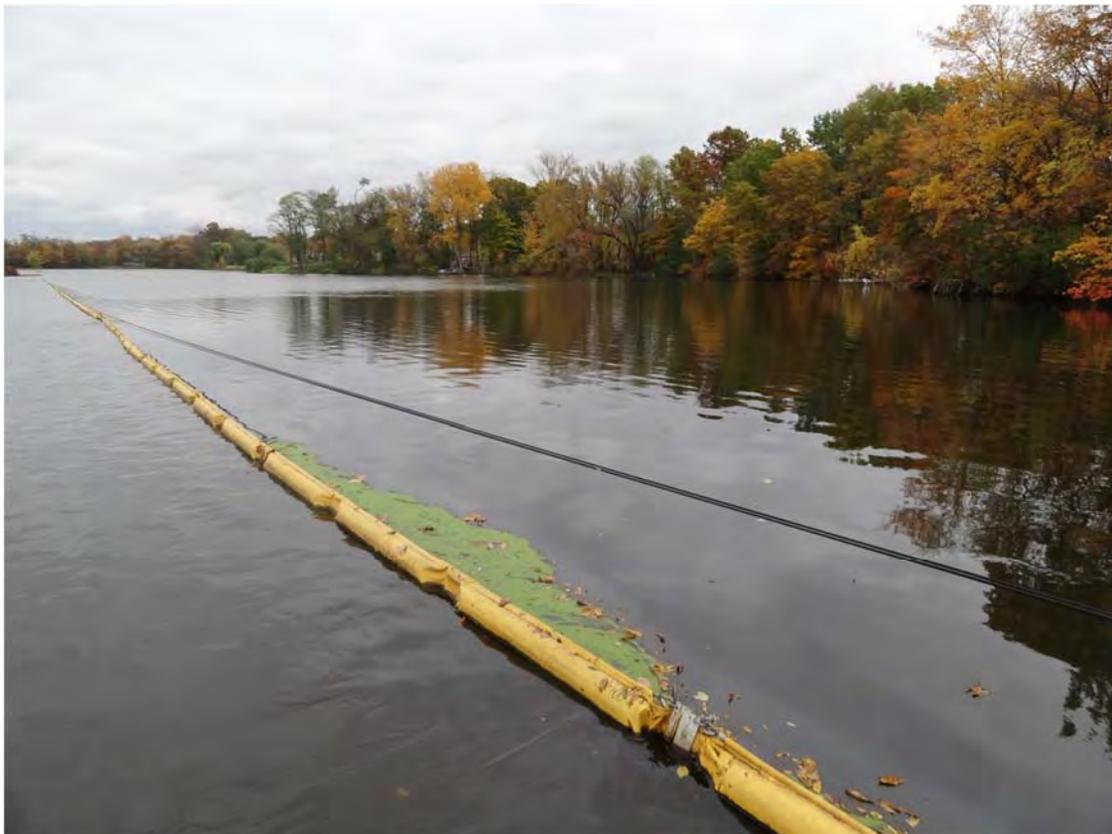
64. Morrow Lake Delta Gate B sheen and tar globs were observed.

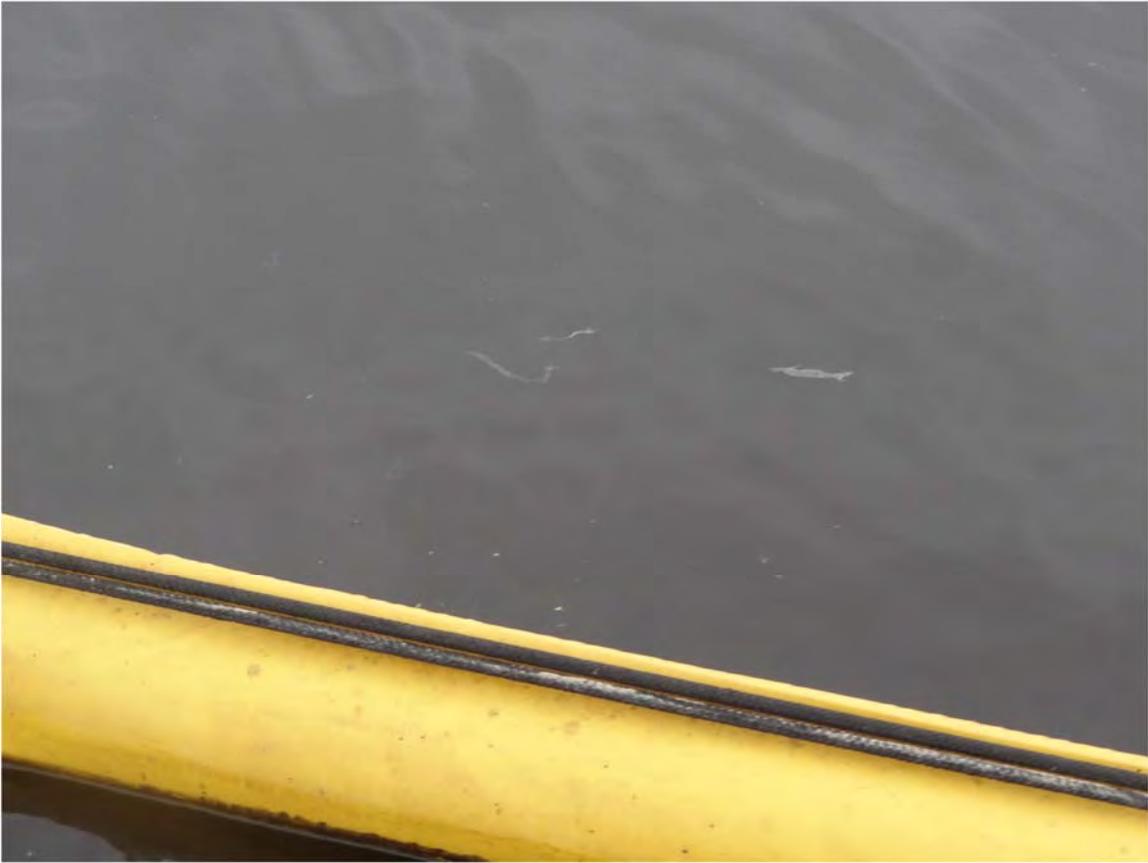
65. Morrow Lake Delta Gate B sheen and tar globs were observed.

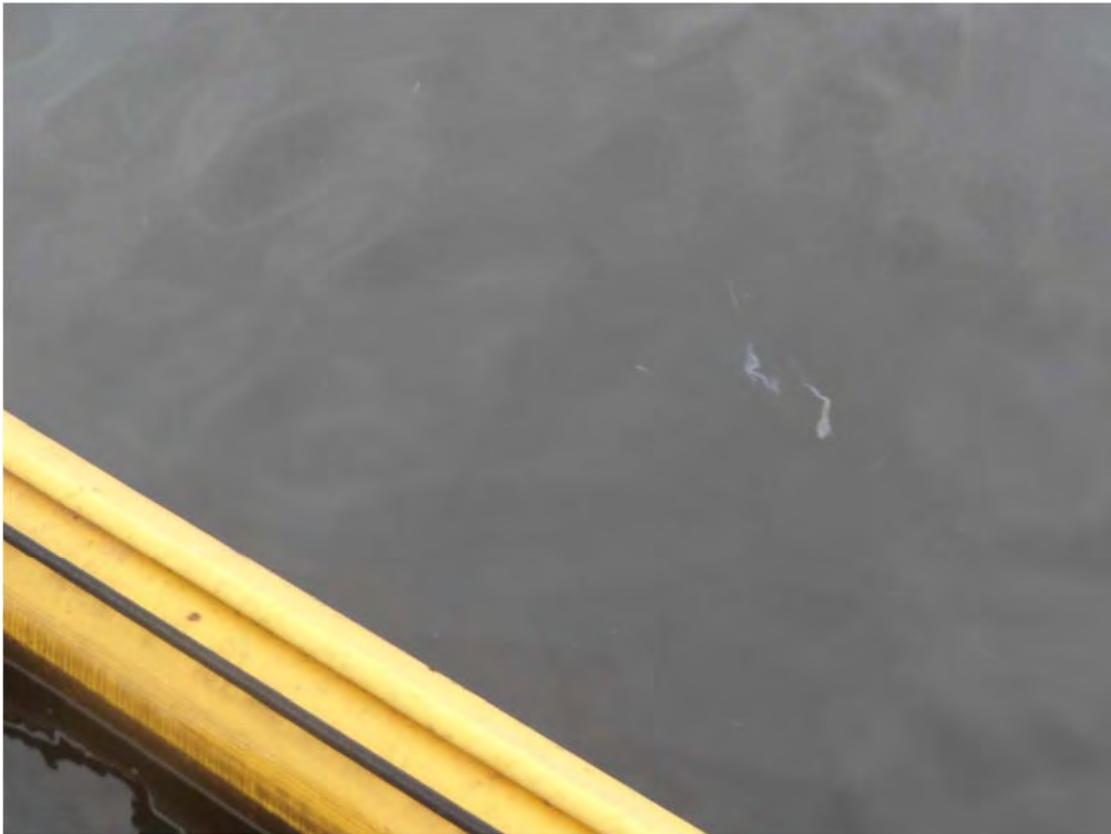
66. Morrow Lake Delta Gate B sheen and tar globs were observed.

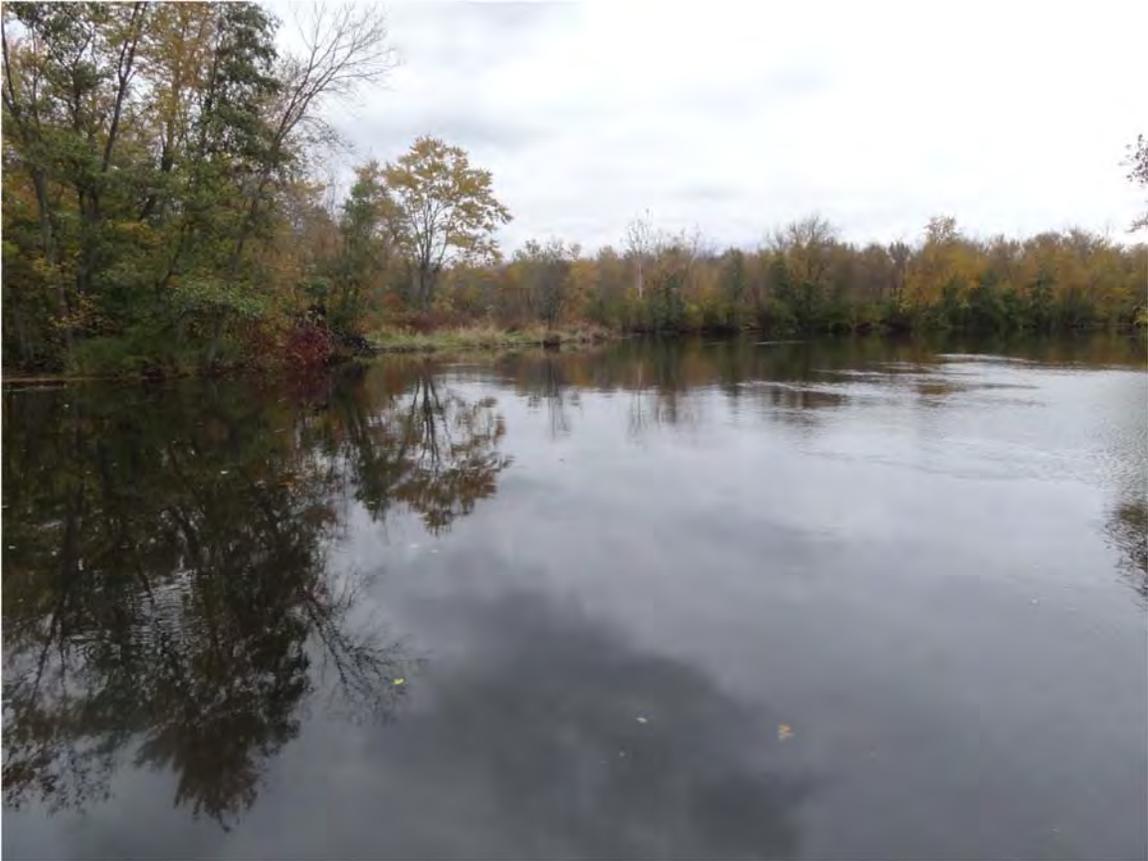
67. MP36.5 RDB area where sheen and tar globs were observed.

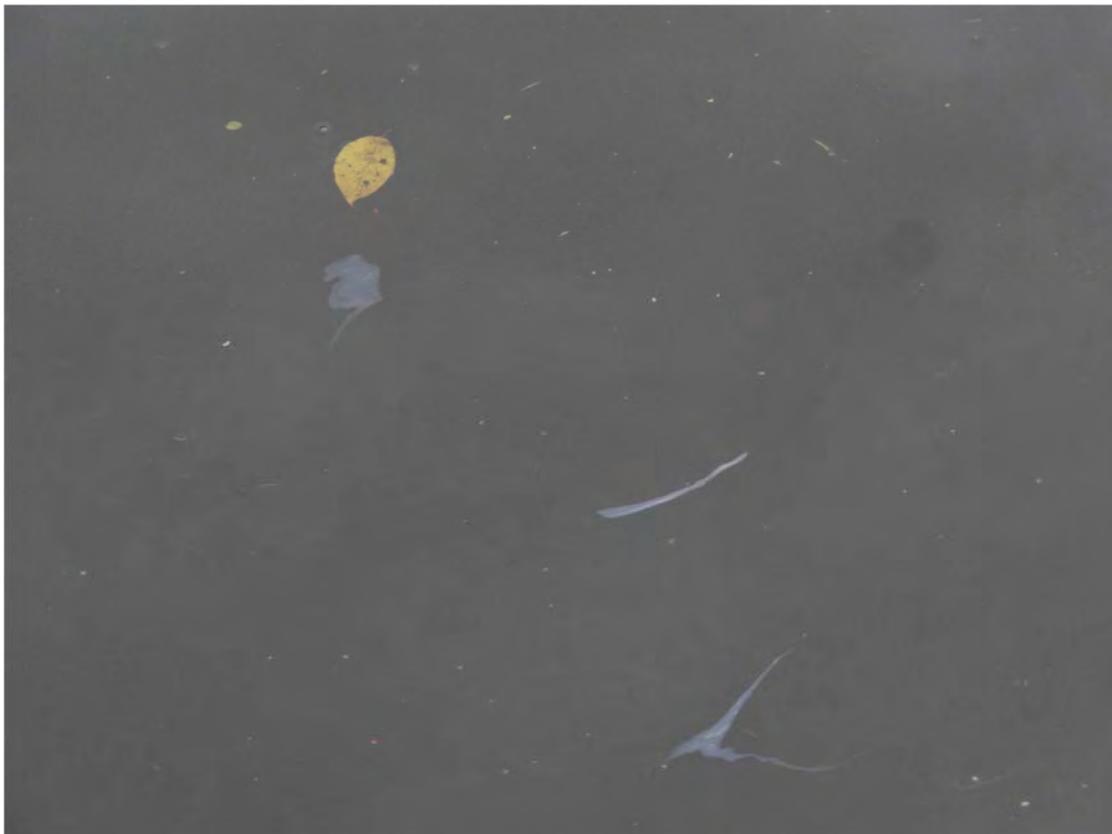
68. MP36.5 RDB sheen and tar globs were observed. Sheen sweep was required based on the area of sheen observed.

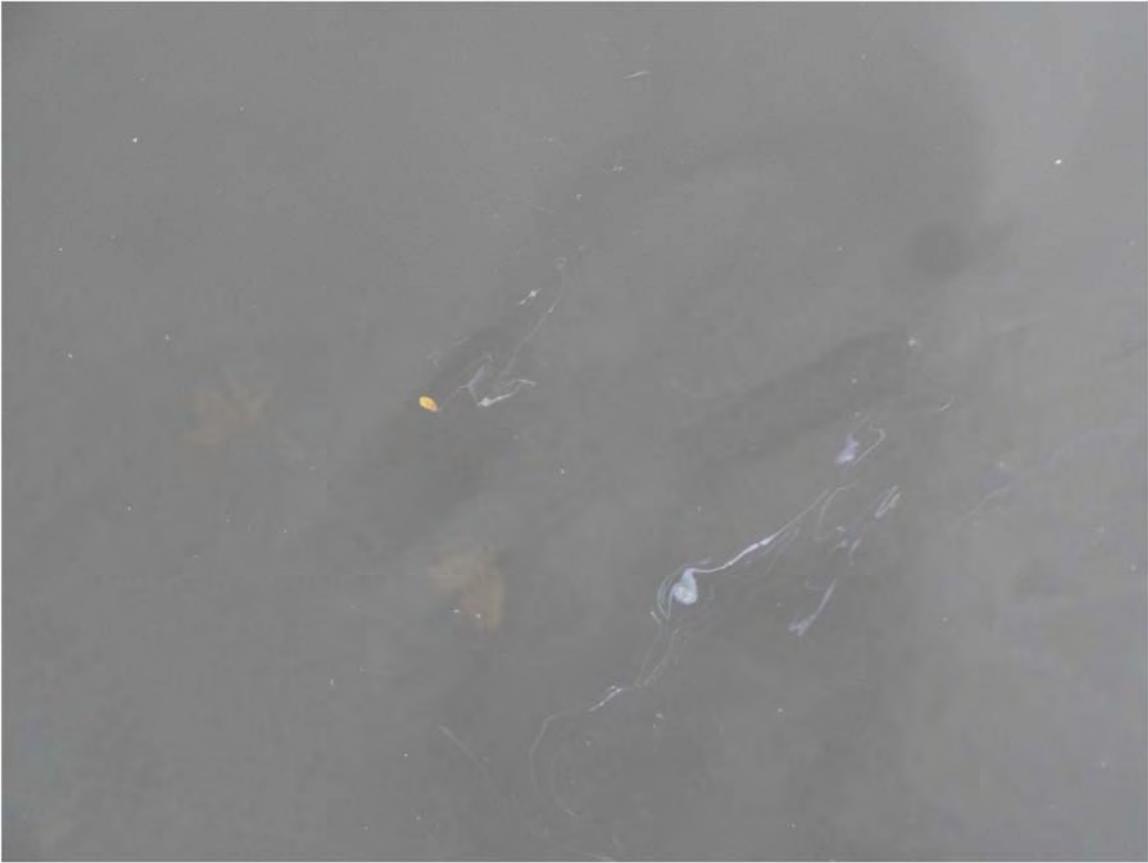
**69. MP36.5 RDB sheen and tar globs were observed. Sheen sweep was required based on the area of sheen observed.**

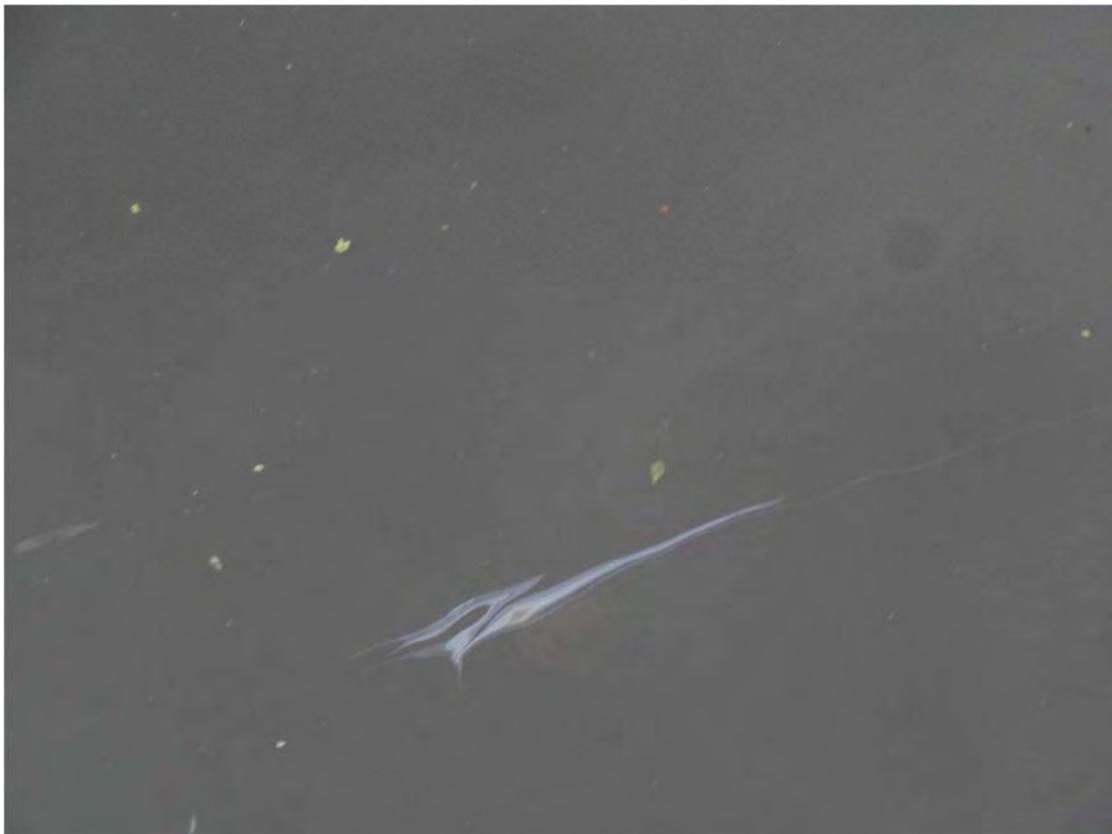
**70. MP36.5 RDB sheen and tar globs were observed. Sheen sweep was required based on the area of sheen observed.**
