Situation Photo Log

Tuesday, October 16, 2012

Kalamazoo River / Enbridge Spill

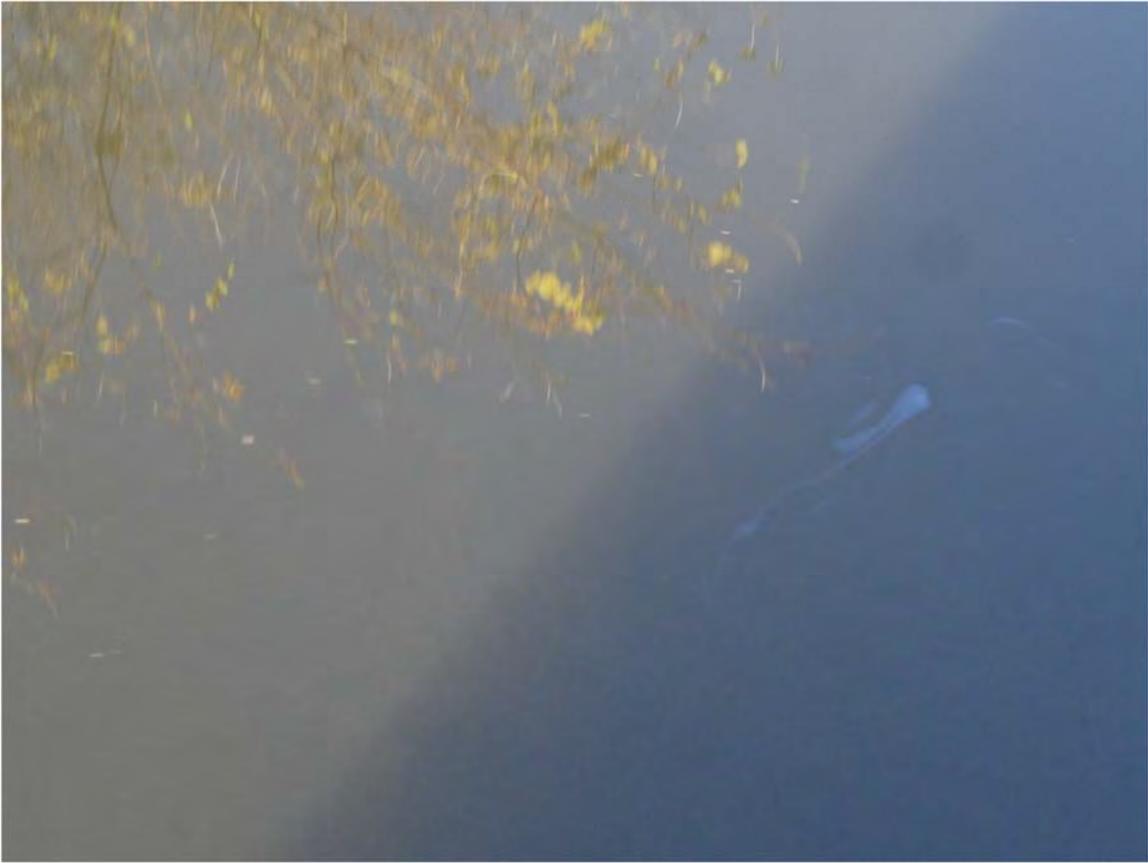
1. MP5.35 ribbons of sheen and tar globs were observed.

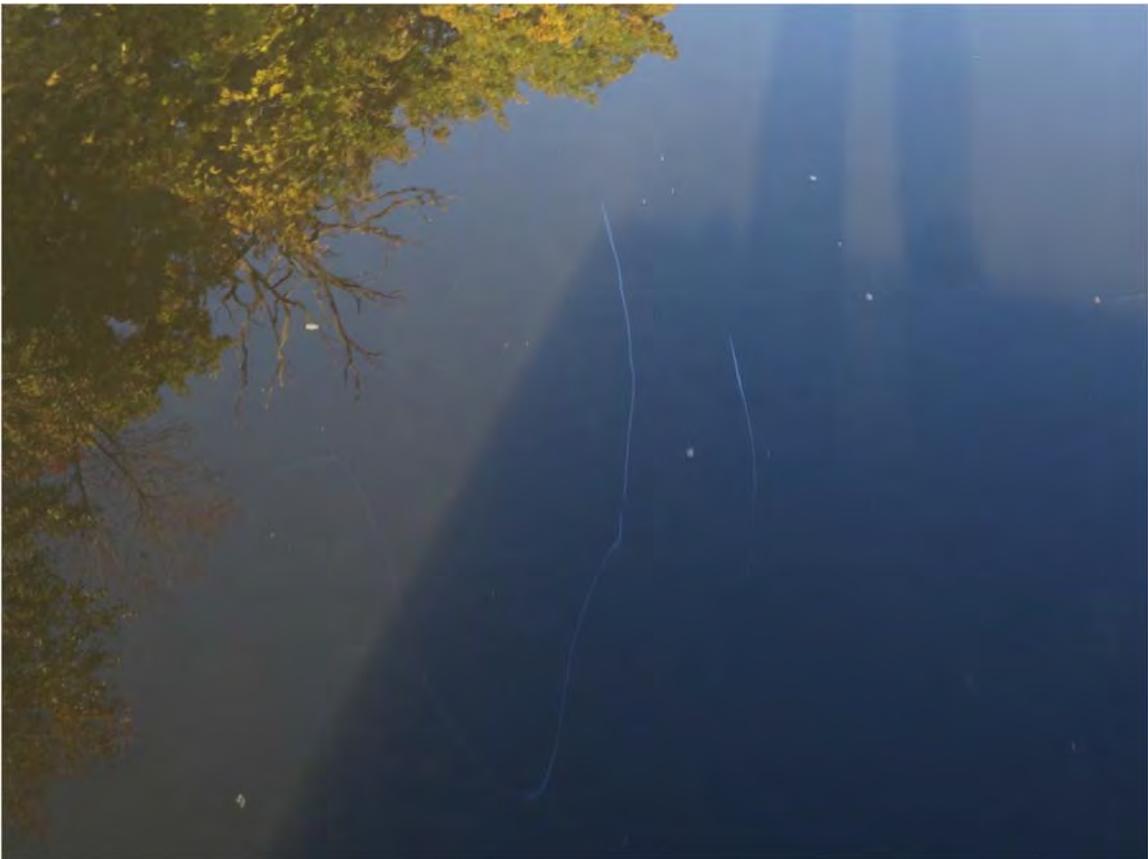
2. MP5.45 RDB sheen and tar globs were observed.

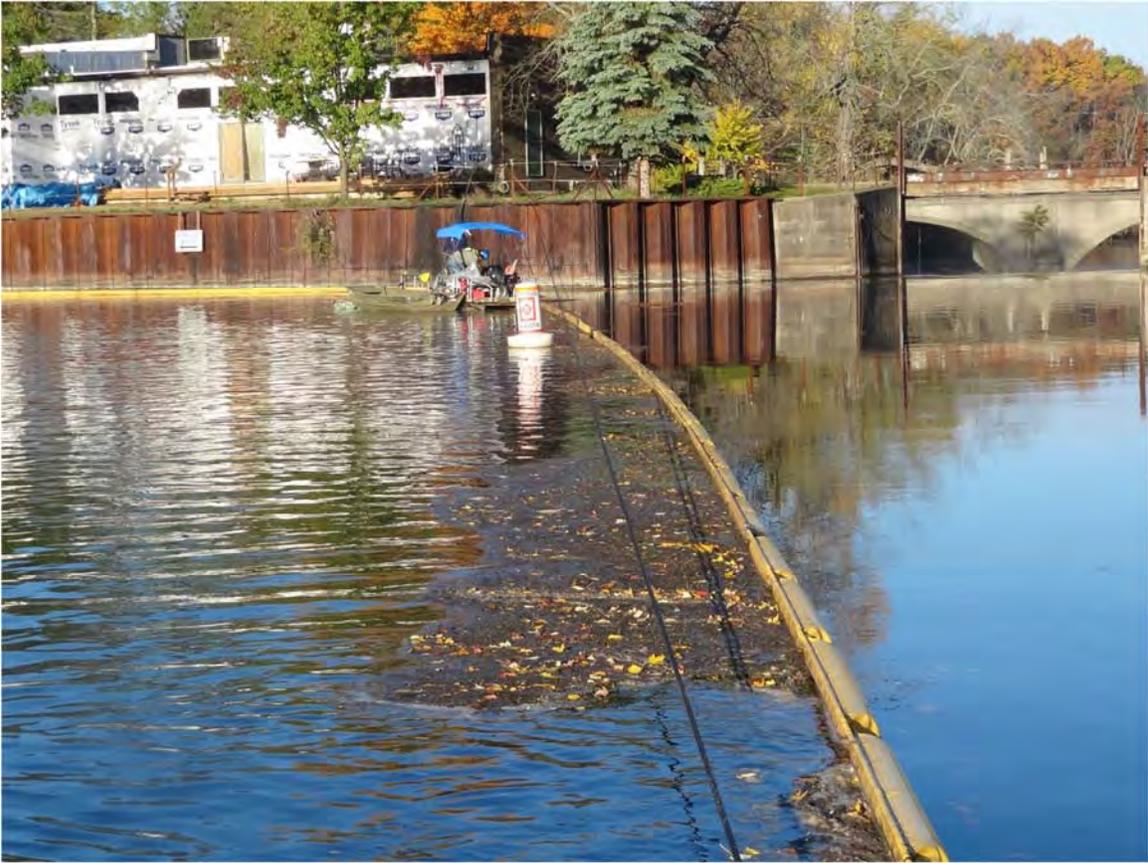
3. Ceresco Dam Control Point Boom observed a crew removing debris from the boom.

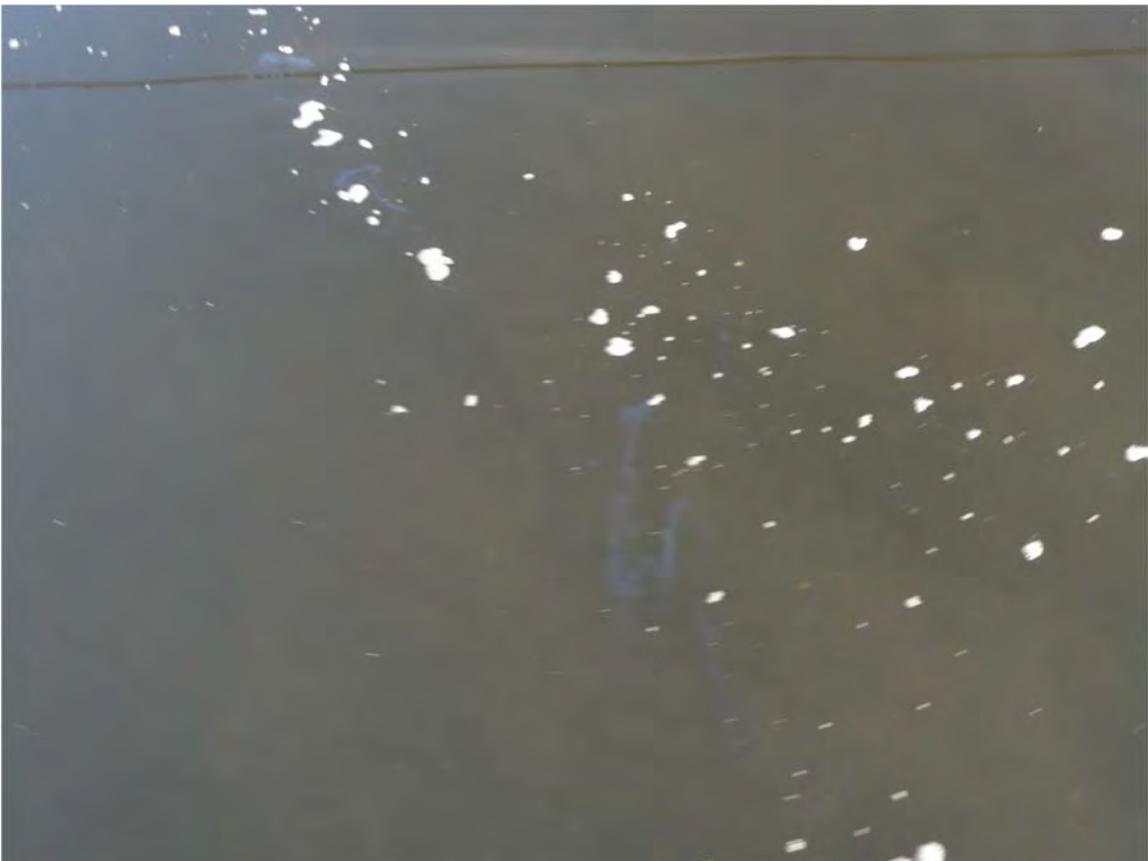
4. Ceresco Dam Control Point Boom observed sheen collecting along the boom.

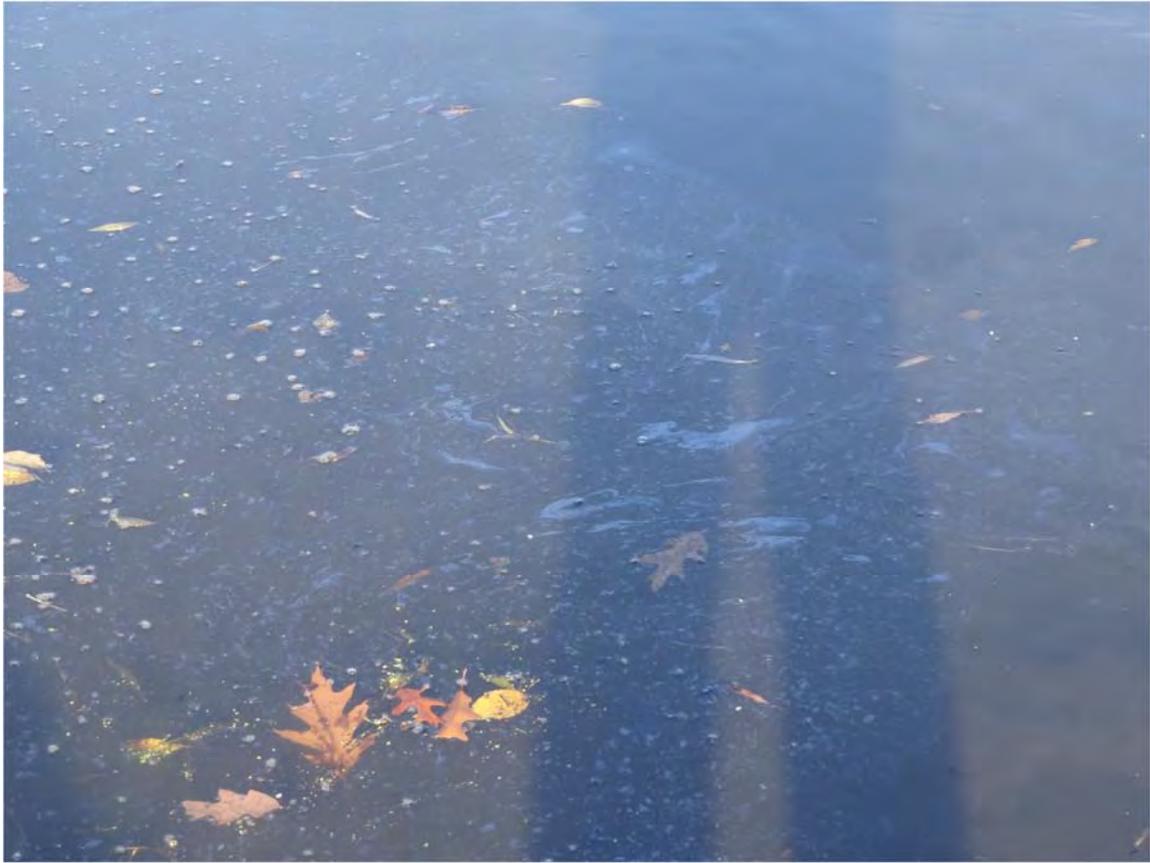
5. Ceresco Dam Control Point Boom observed sheen and tar globs when the boat reversed away from the boom.

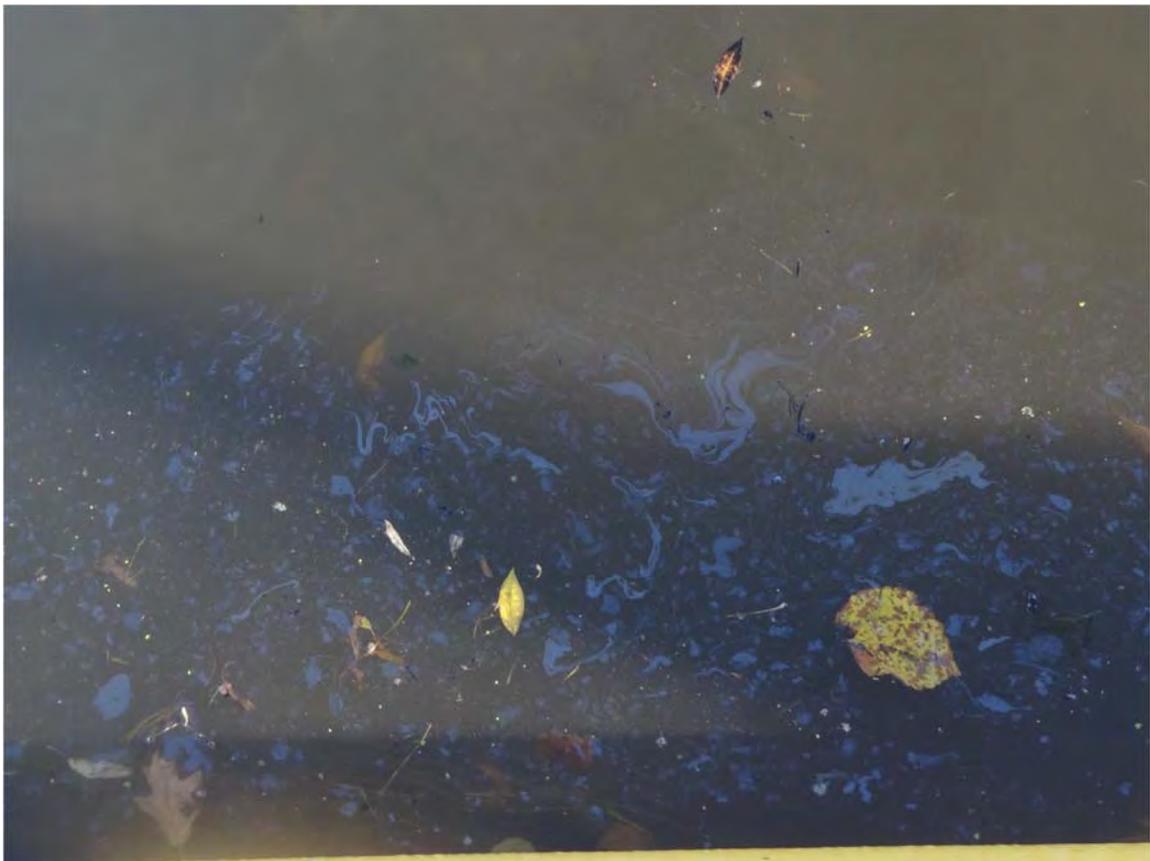
6. Ceresco Dam Control Point Boom observed sheen and tar globs when the boat reversed away from the boom.

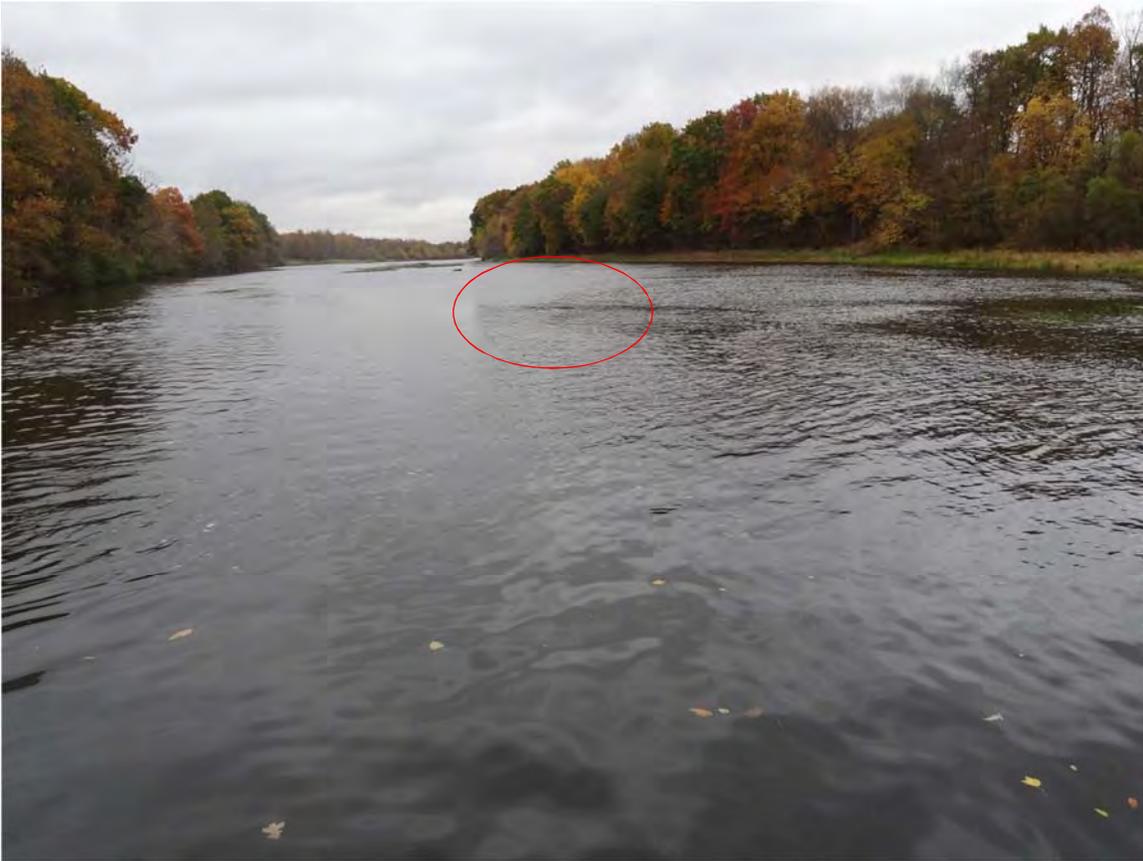
7. MP4.5 Area where we removed a navigational hazard from the river and generated sheen.

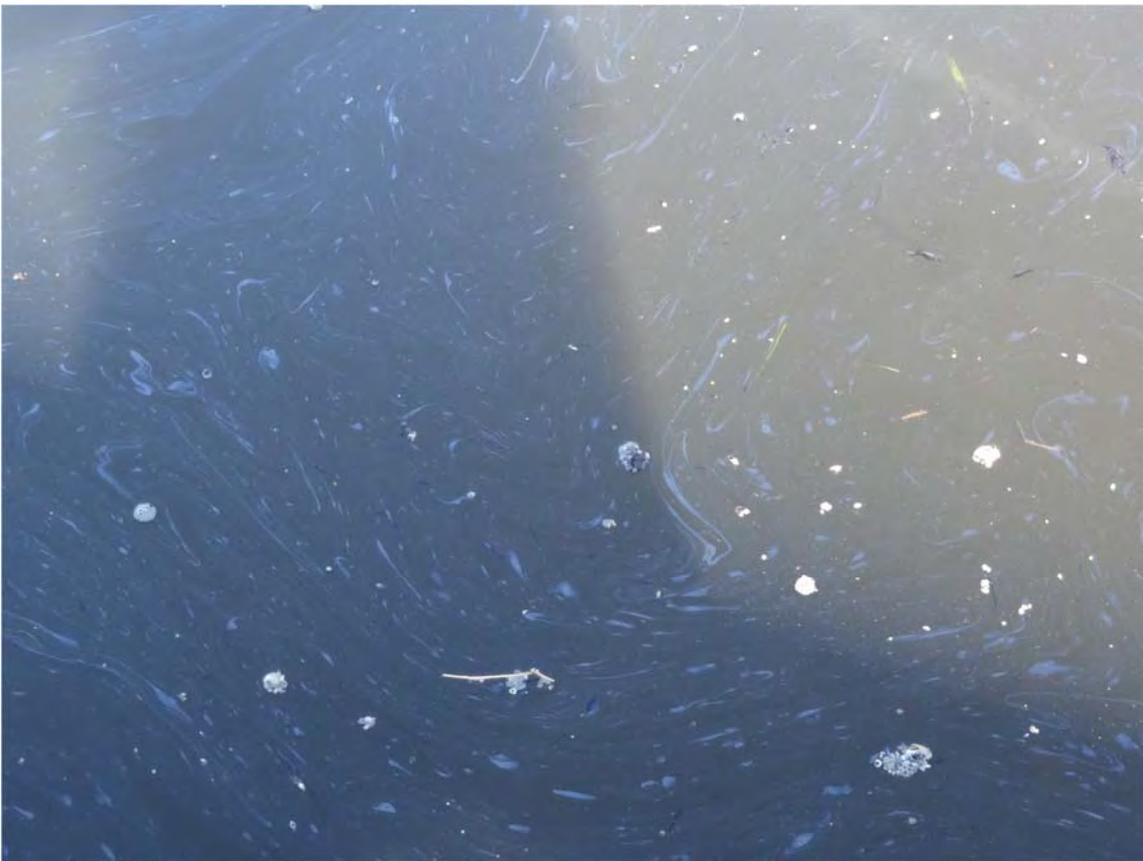
8. MP4.5 sheen generated by the boat while removing a navigational hazard from the river.

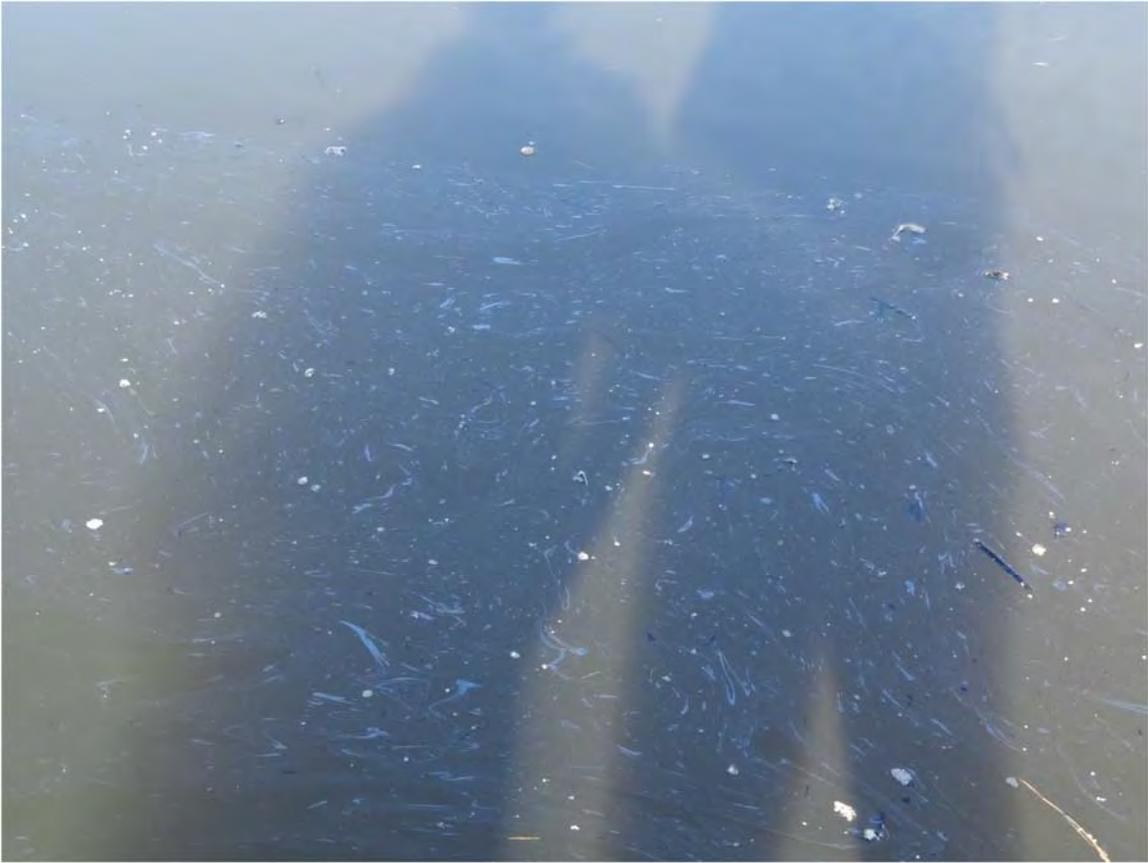
9. MP4.5 sheen generated by the boat while removing a navigational hazard from the river.

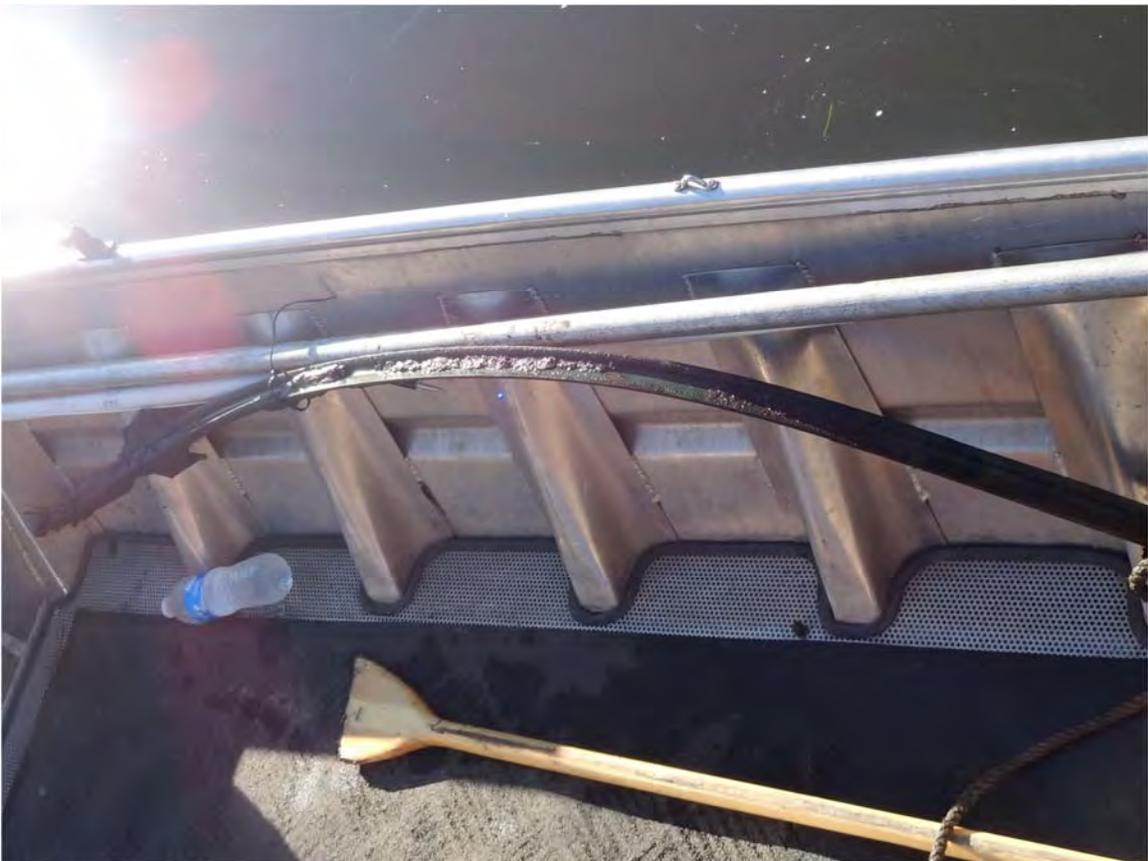
10. MP4.5 navigational hazard removed from the river.

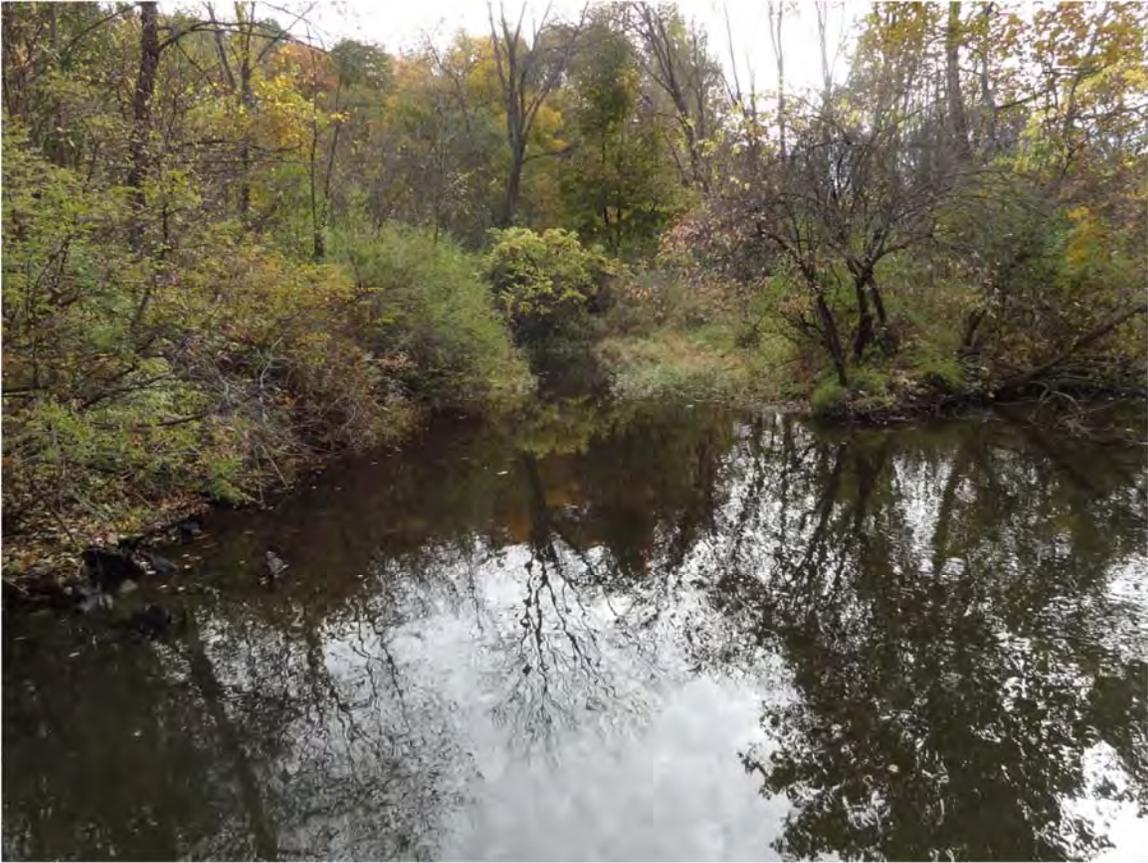
11. MP8.75 R1 while inspecting the area the boat agitated the sediment and sheen was observed.

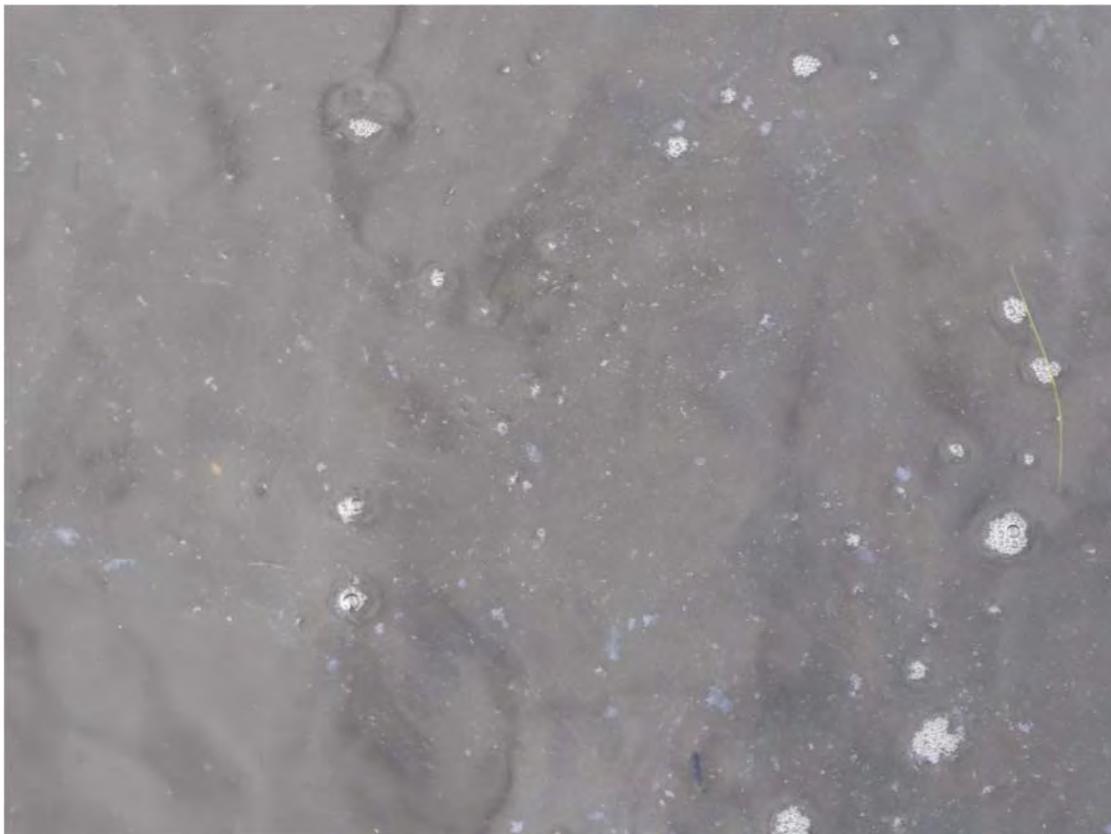
12. MP8.75 R1 while inspecting the area the boat agitated the sediment and sheen was observed.

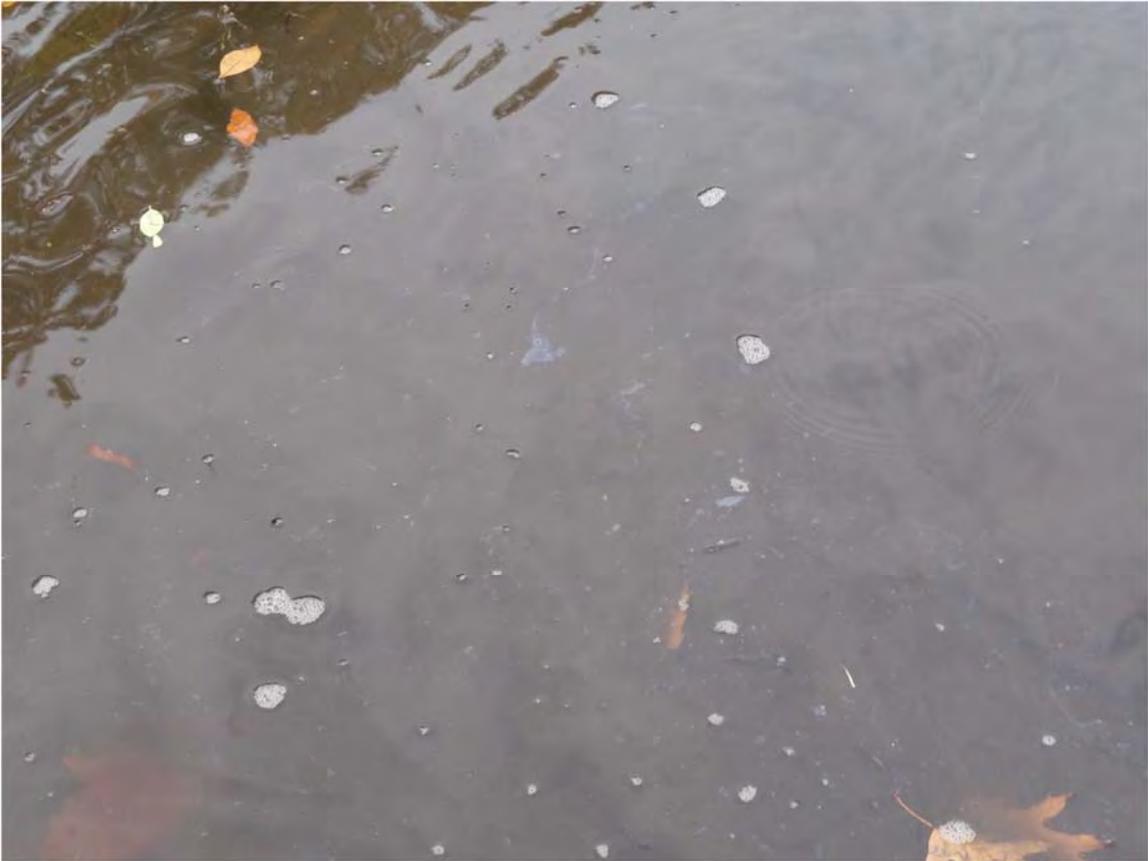
13. MP8.75 R1 while inspecting the area the boat agitated the sediment and sheen was observed.

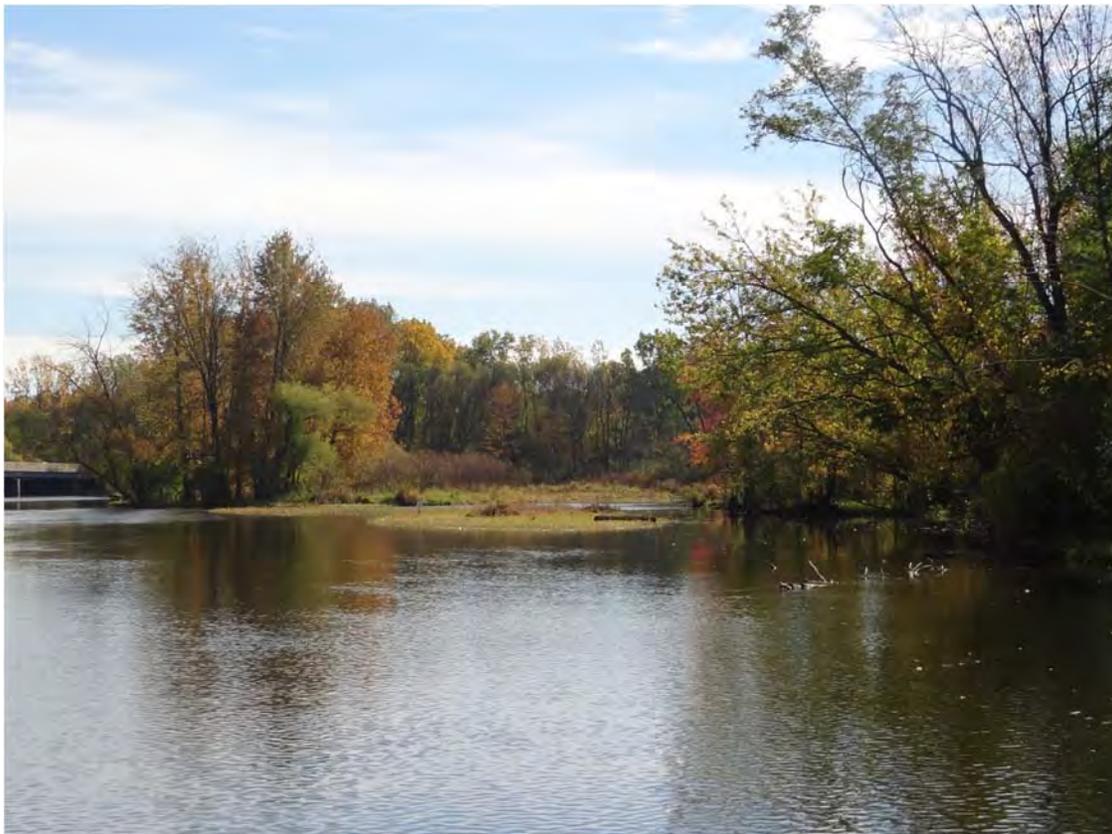
14. MP15.0 LDB sheen observed around the island.

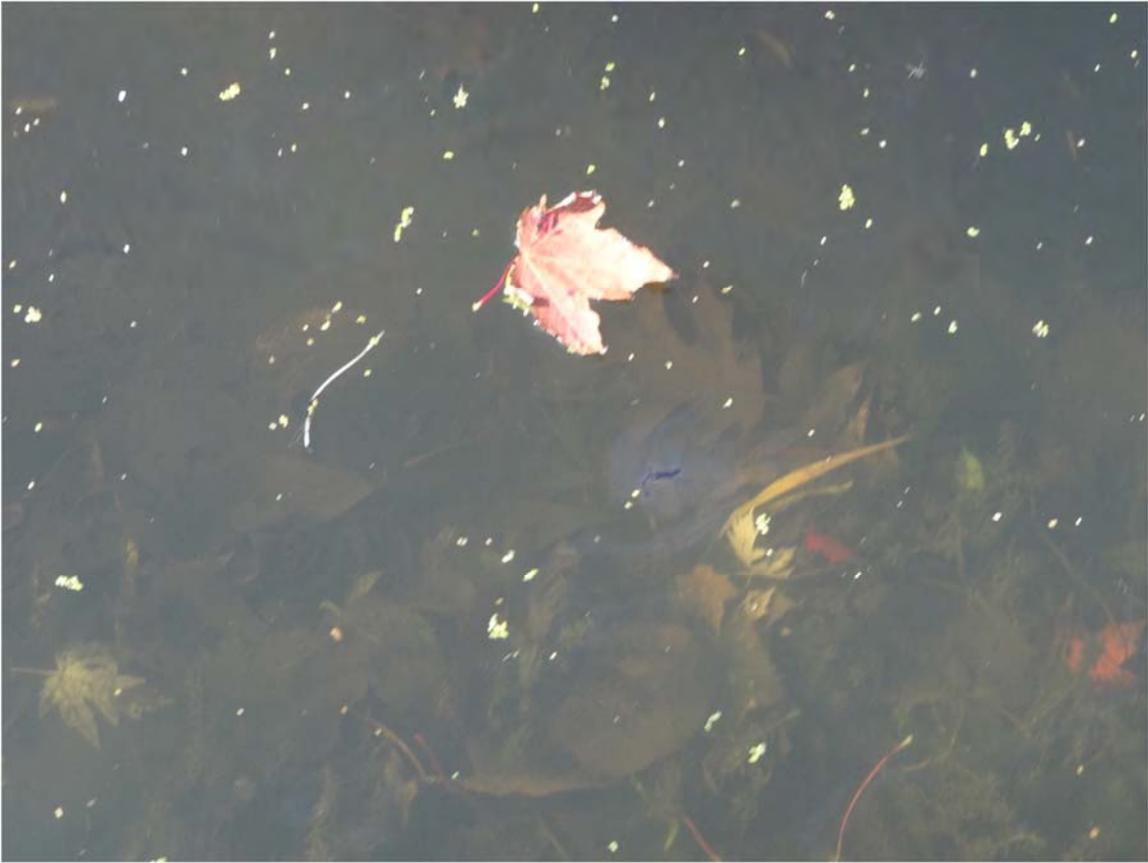
15. MP15.0 LDB sheen observed around the island.

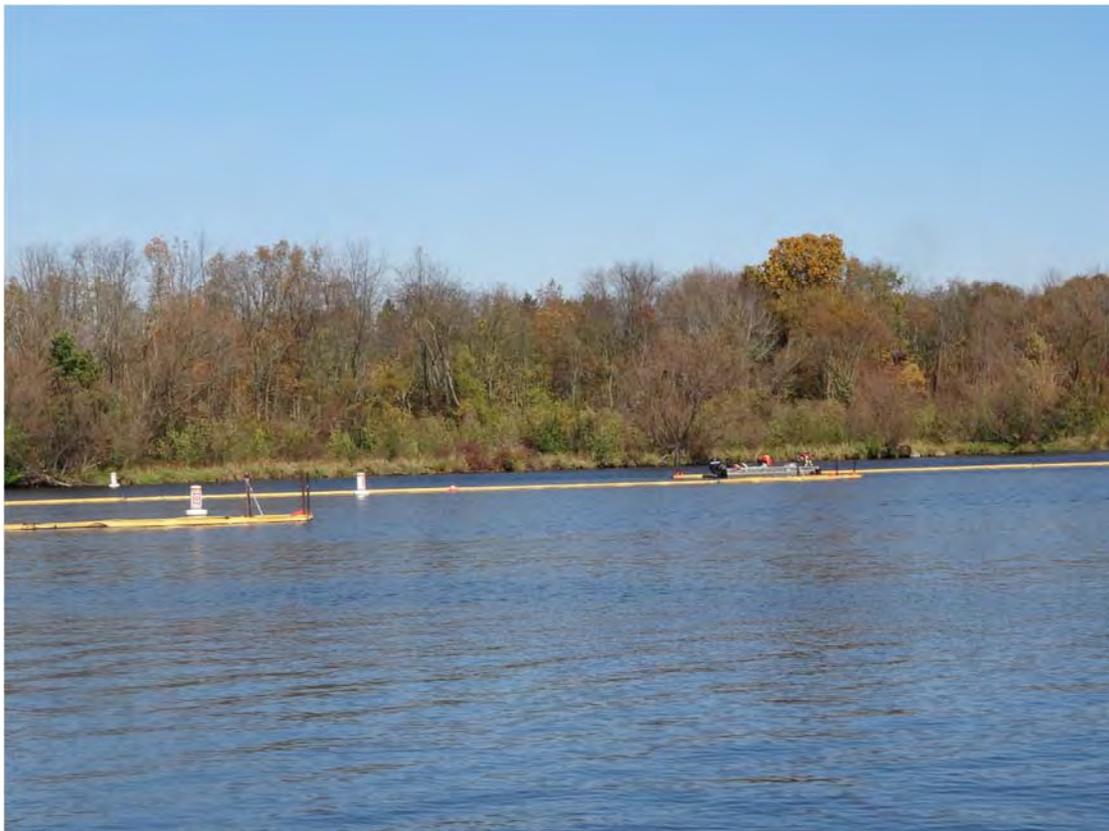
18. Morrow Lake Delta Gate E observed a crew removing debris from the boom.

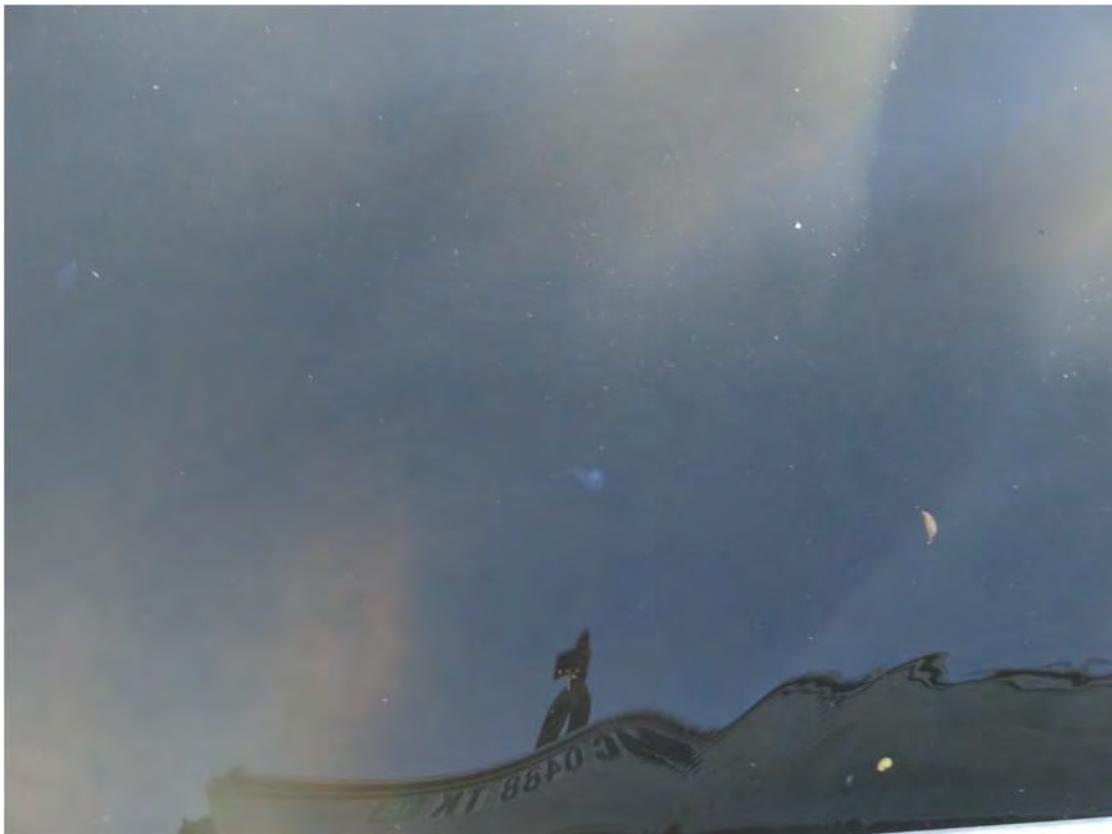
20. Morrow Lake south cove ribbons of sheen observed. Quantity of sheen did not require a sweep boat.

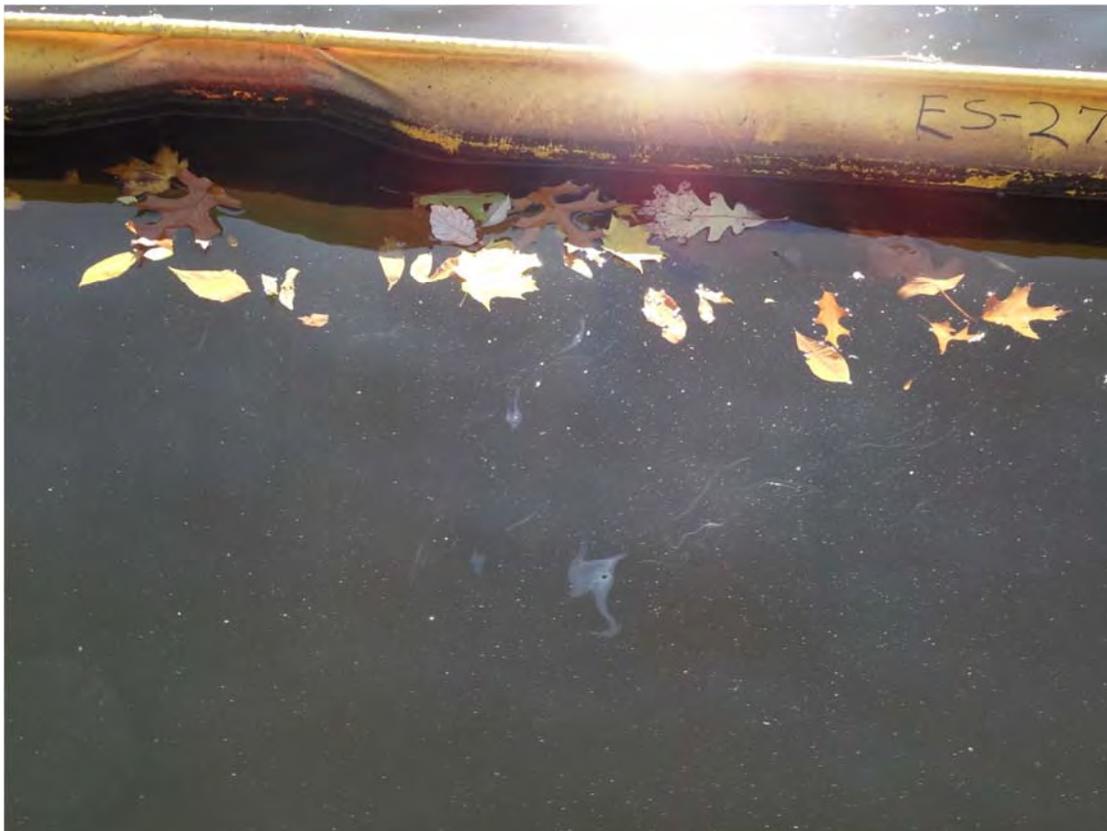
22. Morrow Lake Delta Gate E sheen and tar globs observed collecting along the boom.

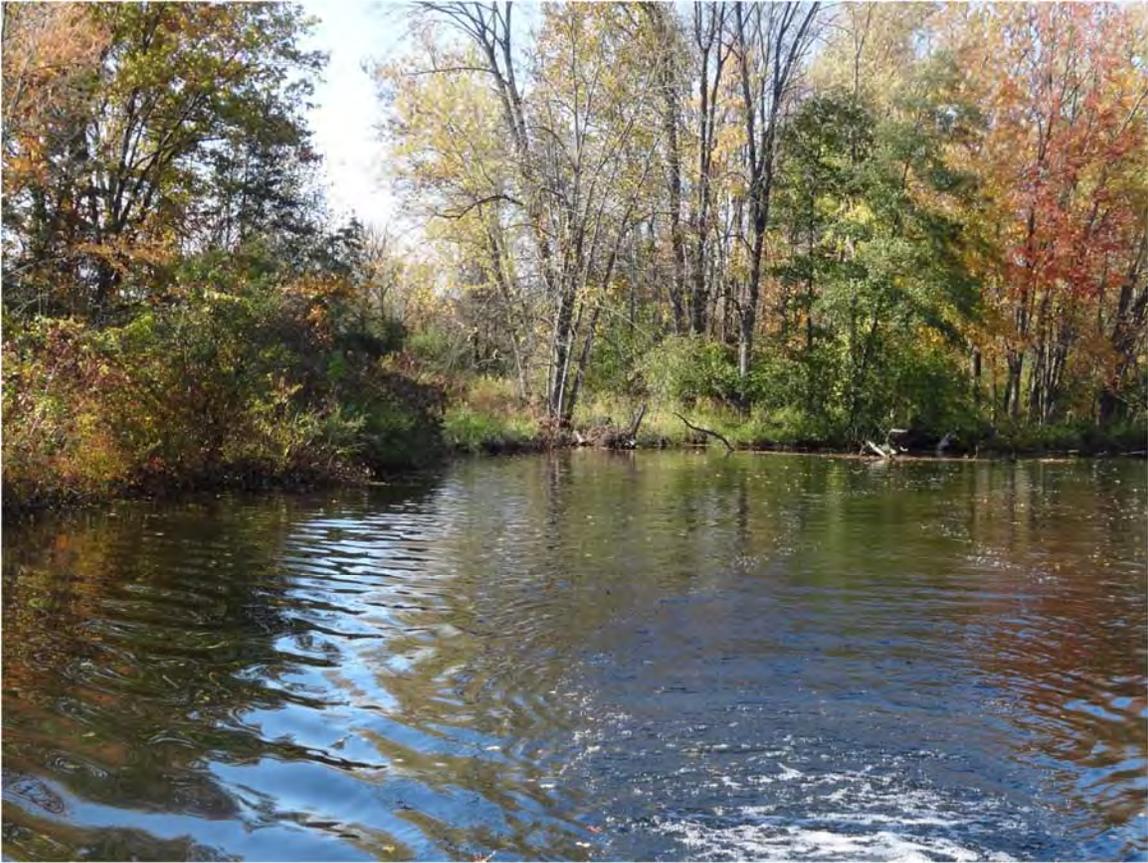
23. MP36.25 LDB sheen was observed. The quantity of sheen did not warrant a sweep boat.

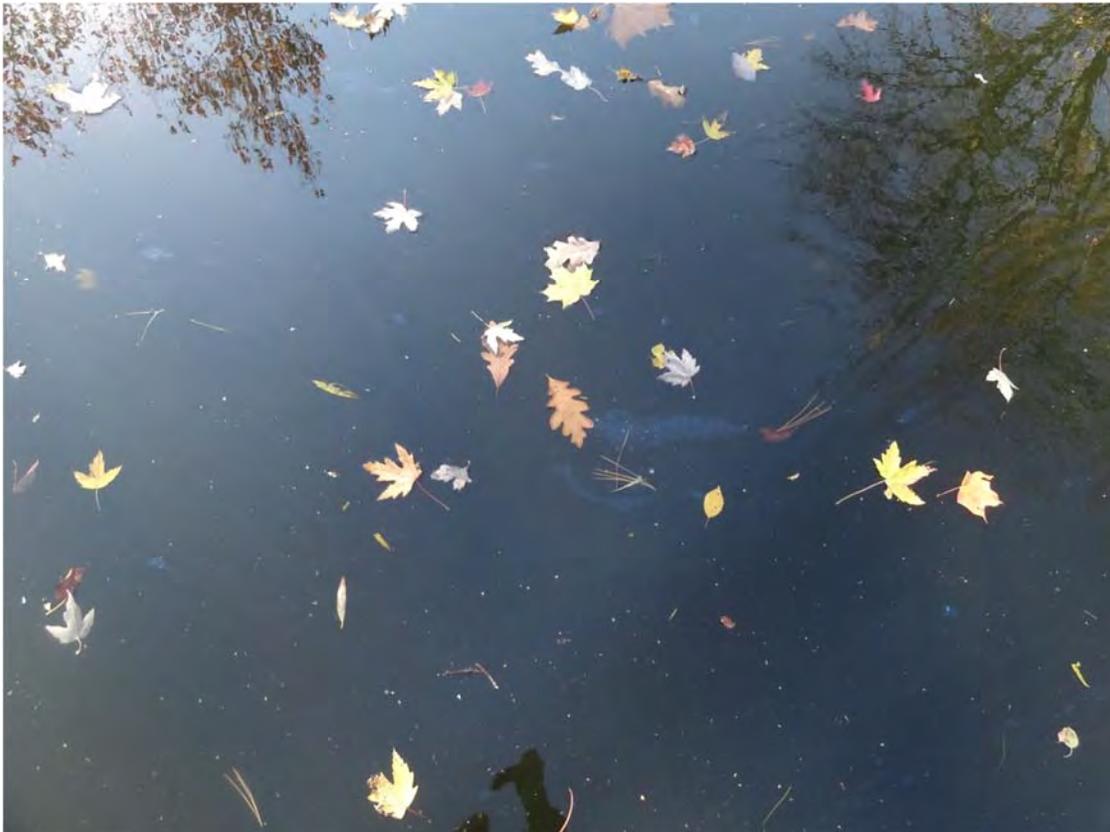
24. MP36.25 LDB sheen was observed. The quantity of sheen did not warrant a sweep boat.

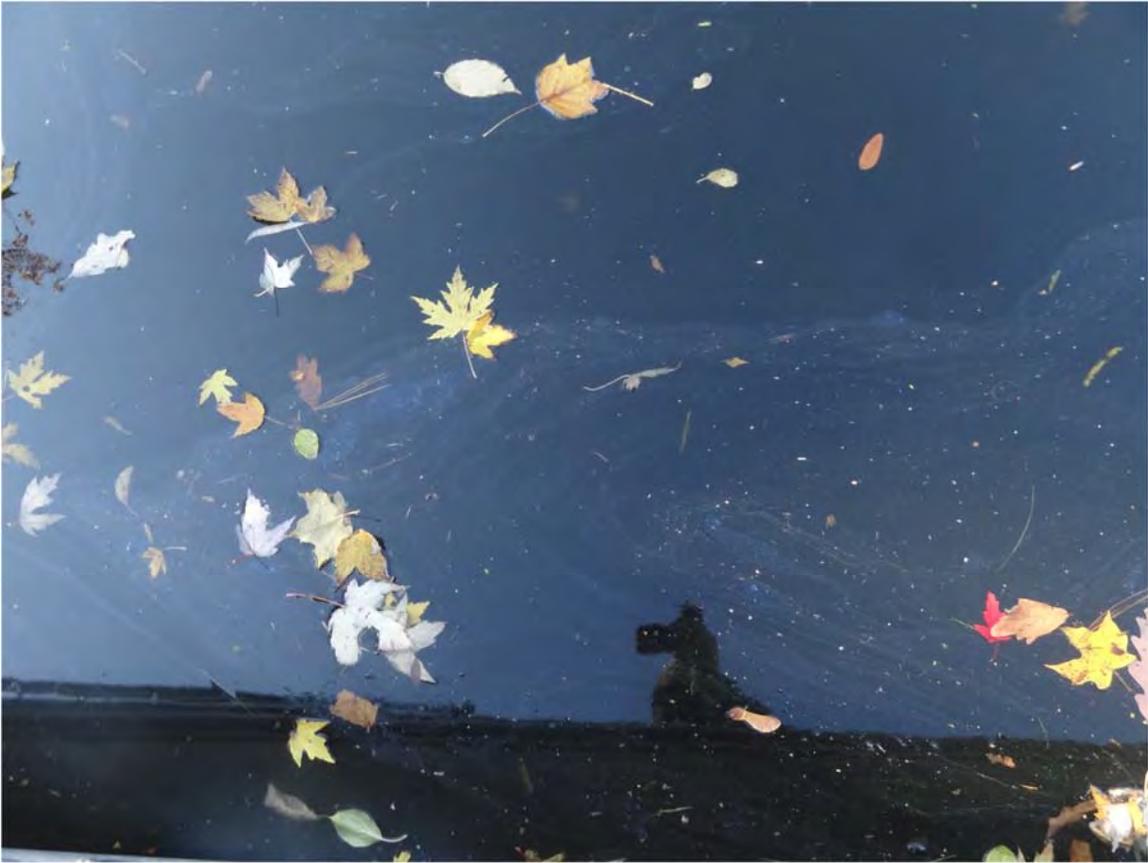
25. MP36.25 LDB sheen was observed. The quantity of sheen did not warrant a sweep boat.

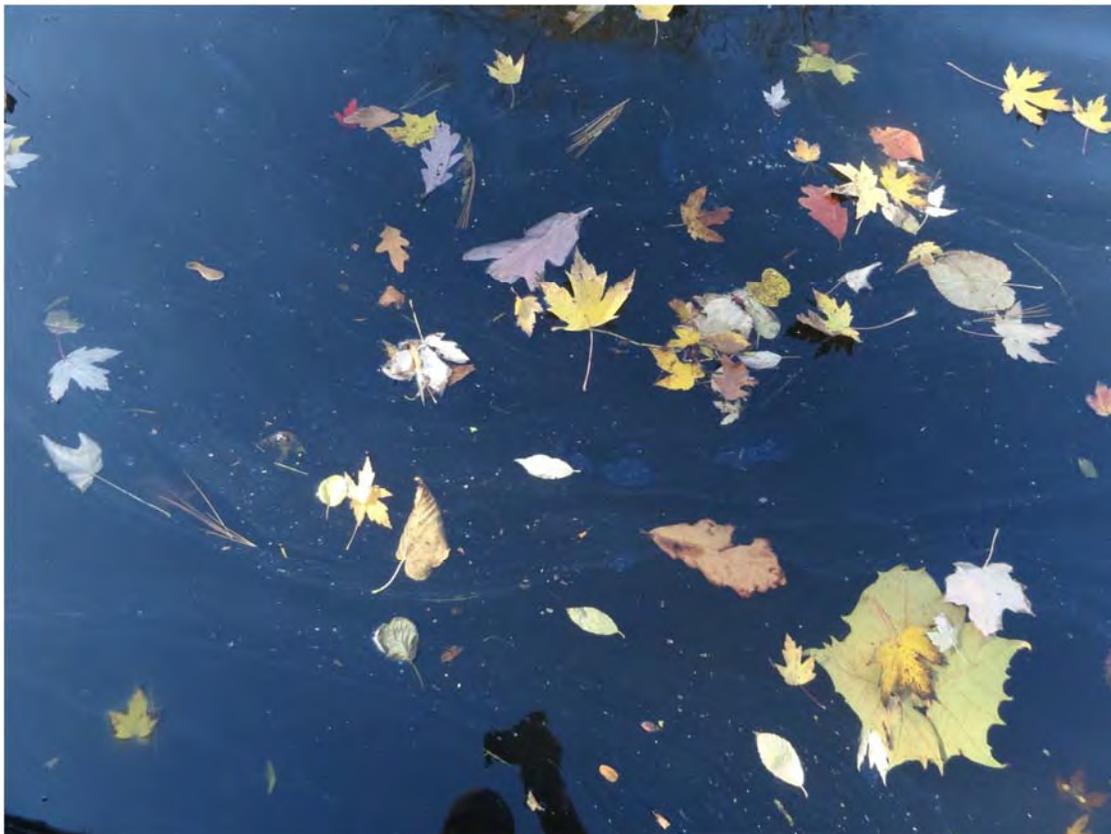
26. MP36.25 LDB sheen was observed. The quantity of sheen did not warrant a sweep boat.
