# Situation Photo Log

Friday, October 19, 2012

Kalamazoo River / Enbridge Spill

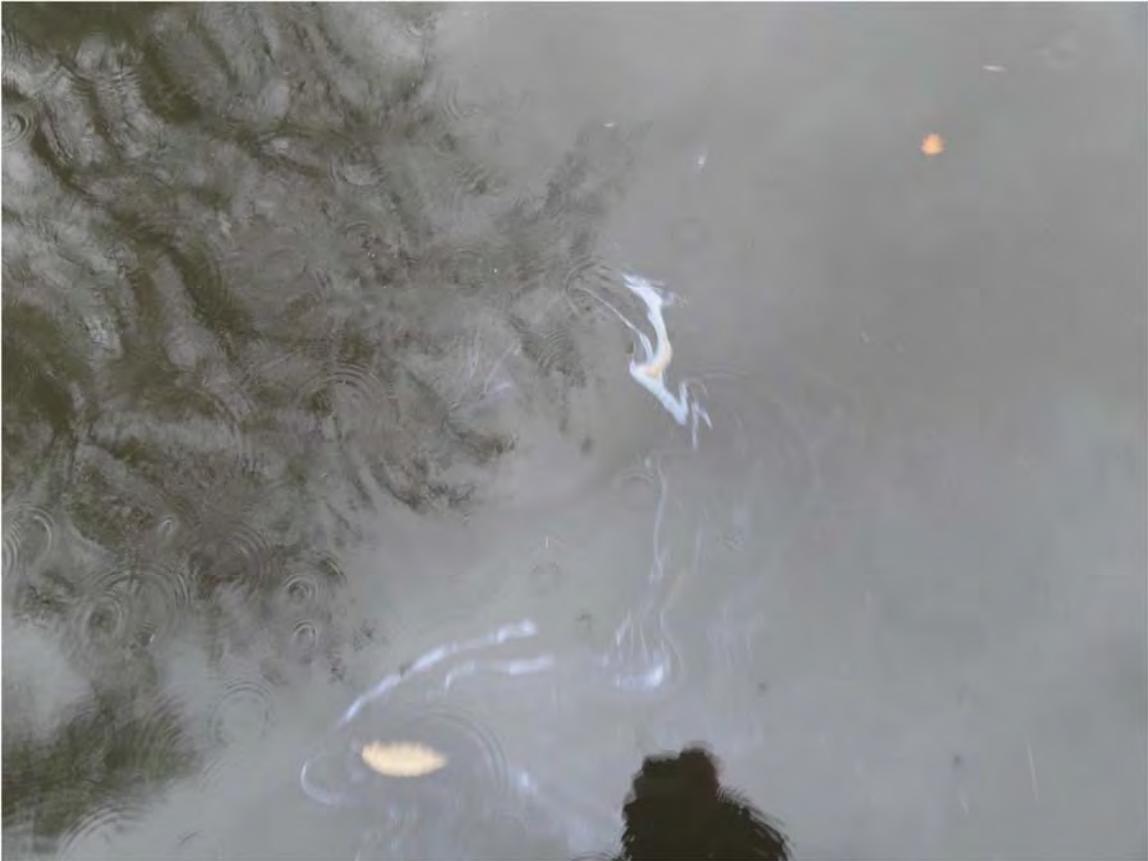
1. MP5.35 ribbons of sheen and tar globs were observed.

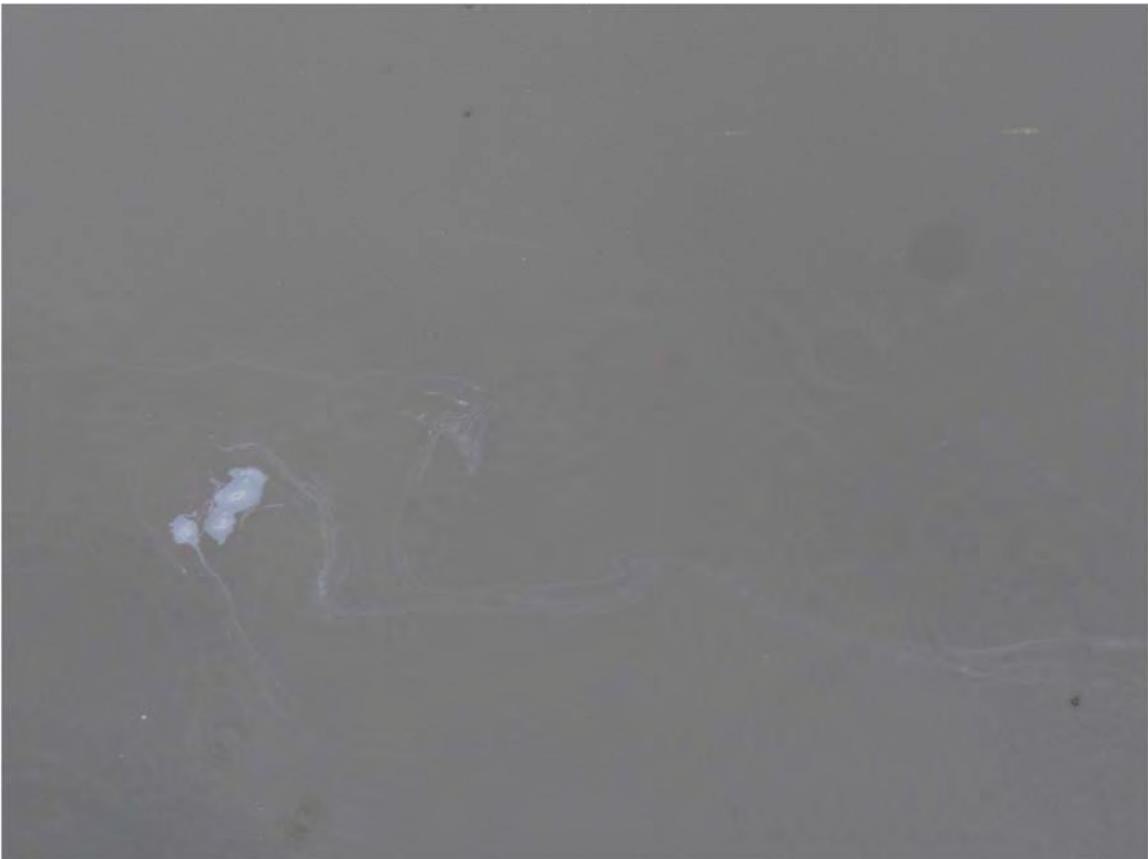
2. MP5.45 RDB sheen and tar globs were observed.

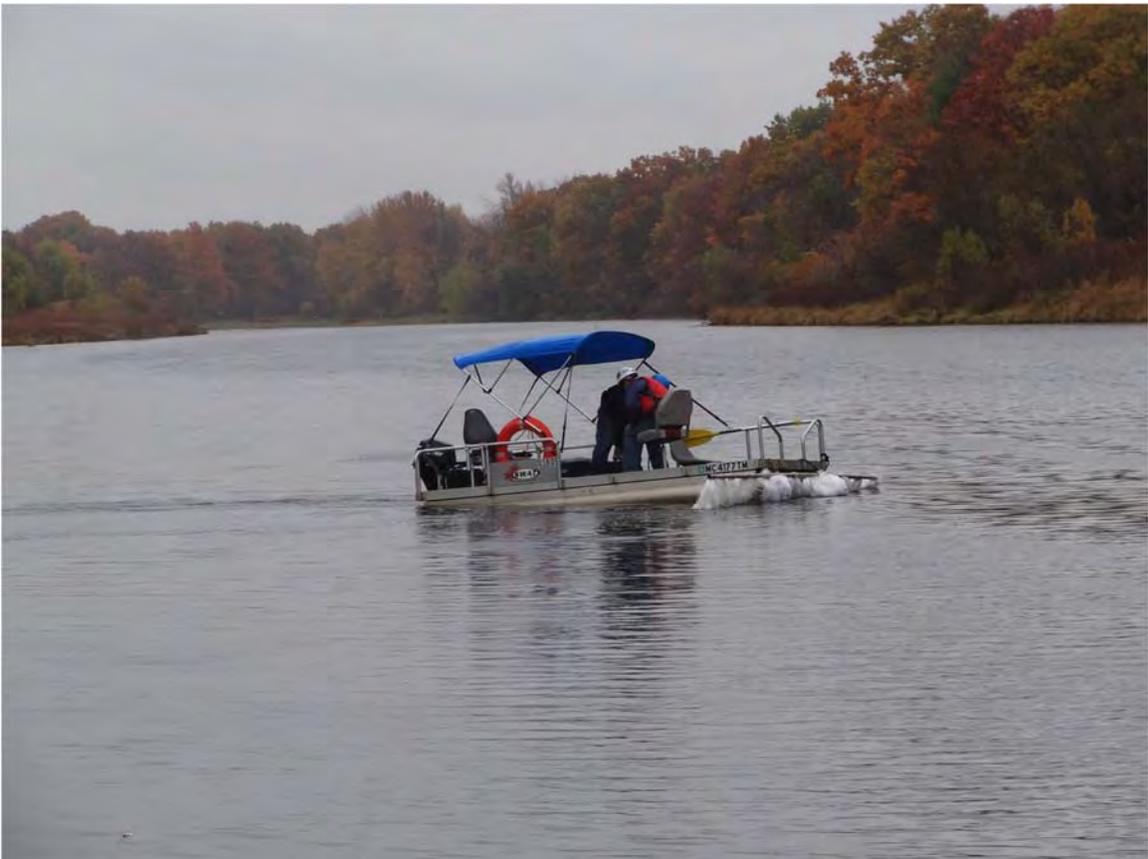
4. Observed the sheen sweep boat departing the C0.4 boat launch.

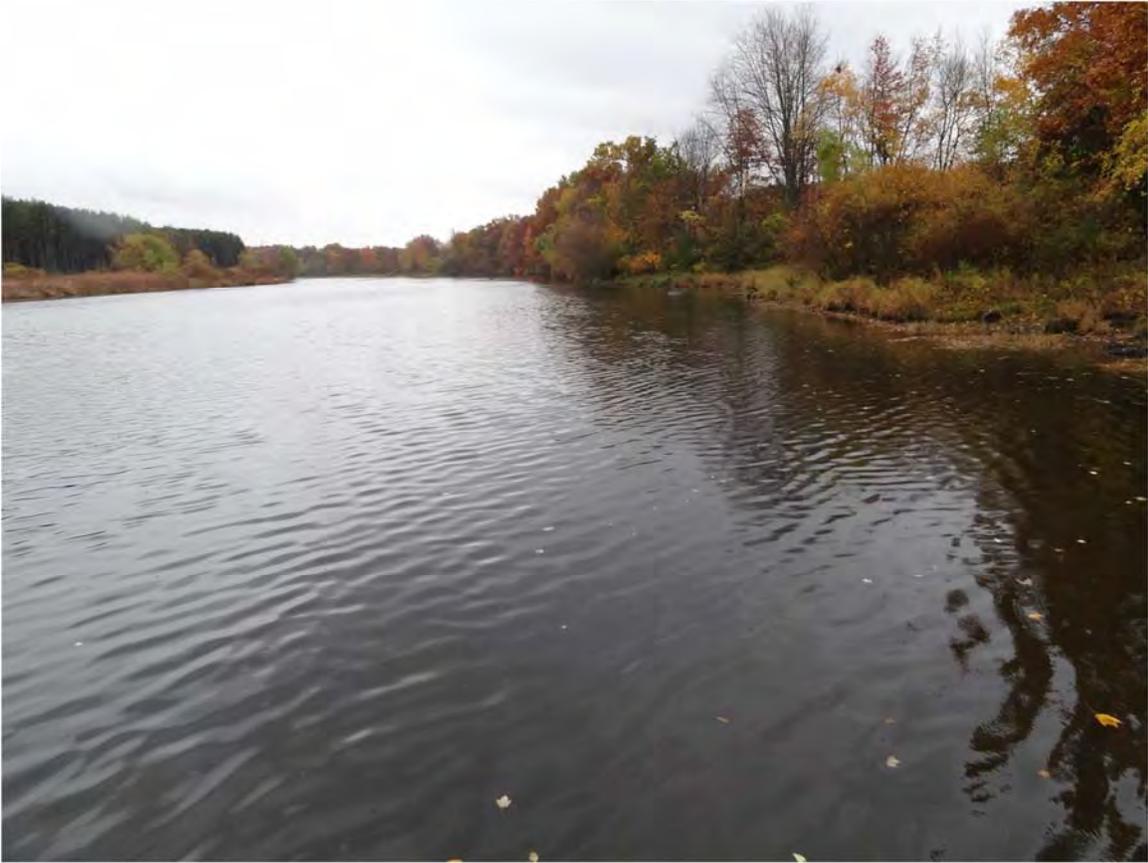
5. MP4.85 LDB area where sheen and tar globs were observed.

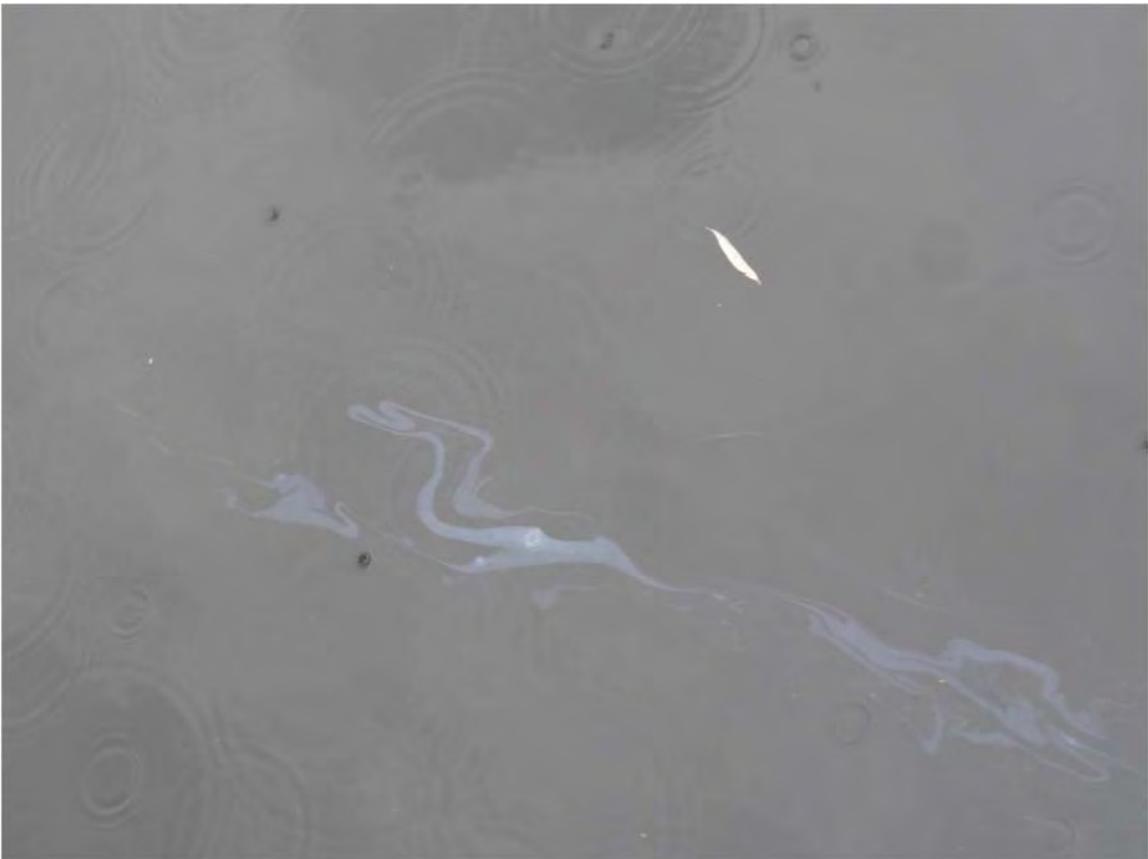
6. MP4.75 LDB sheen and tar globs were observed.

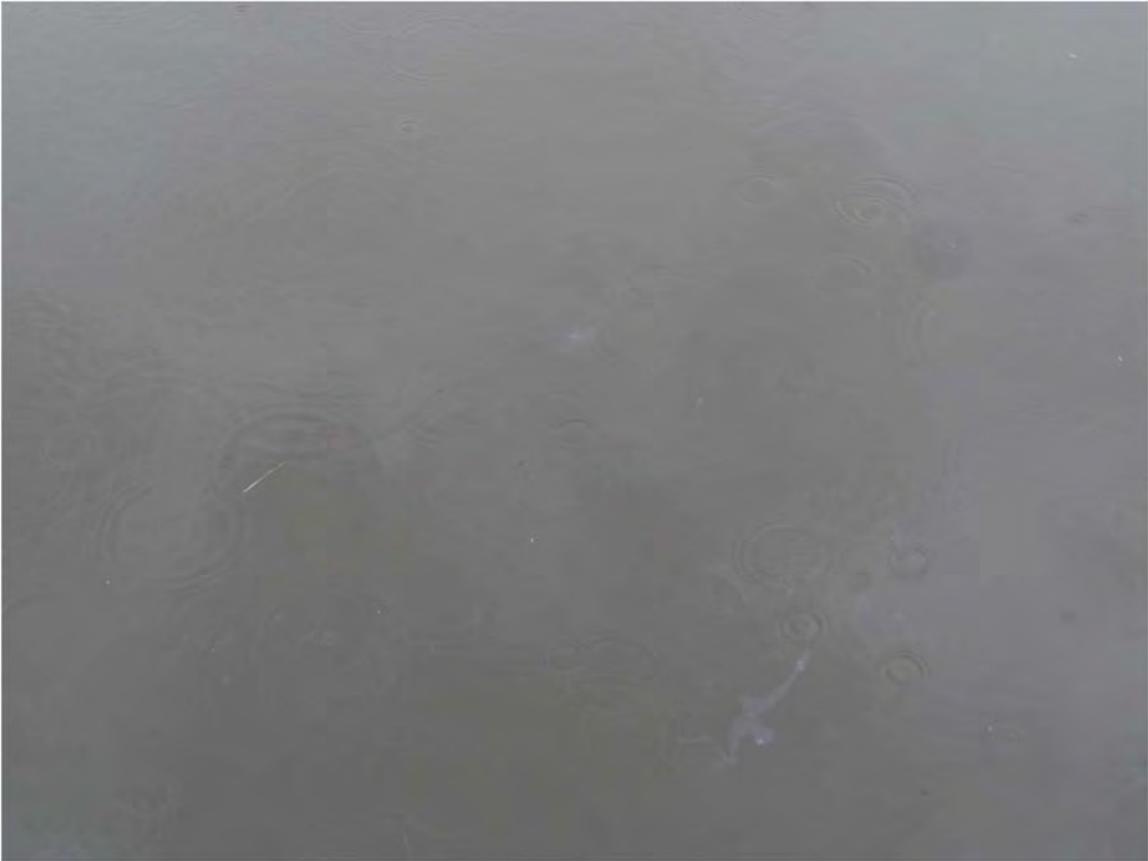
7. MP4.65 RDB sheen and tar globs were observed.

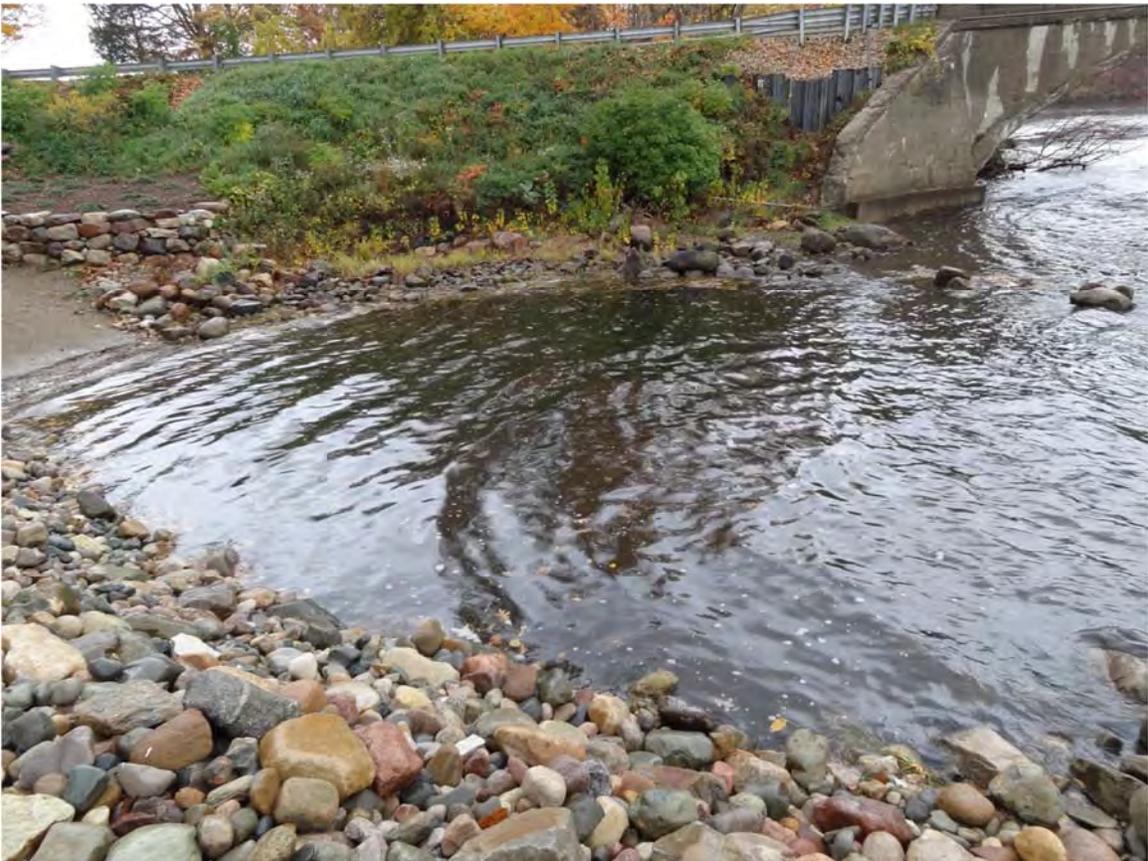
8. Portage below Ceresco Dam sheen and tar globs observed.

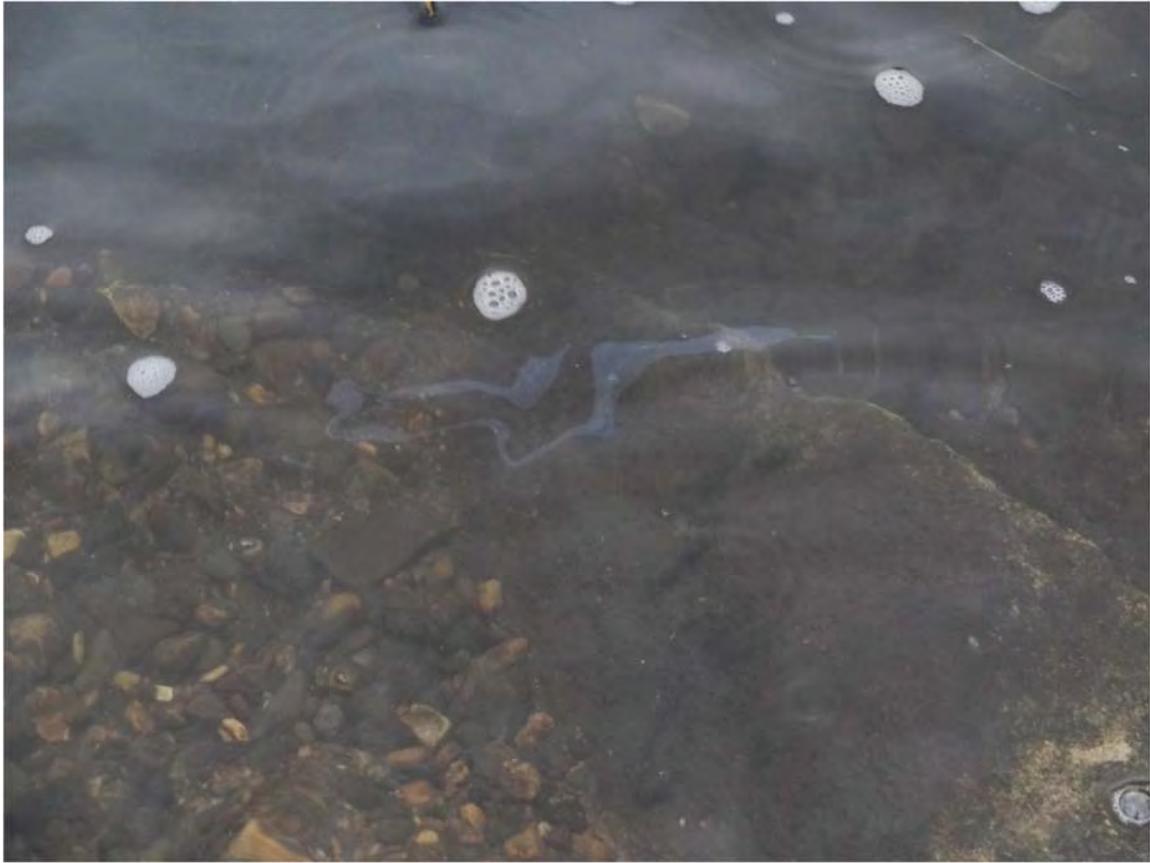
9. Portage below Ceresco Dam sheen and tar globs observed.

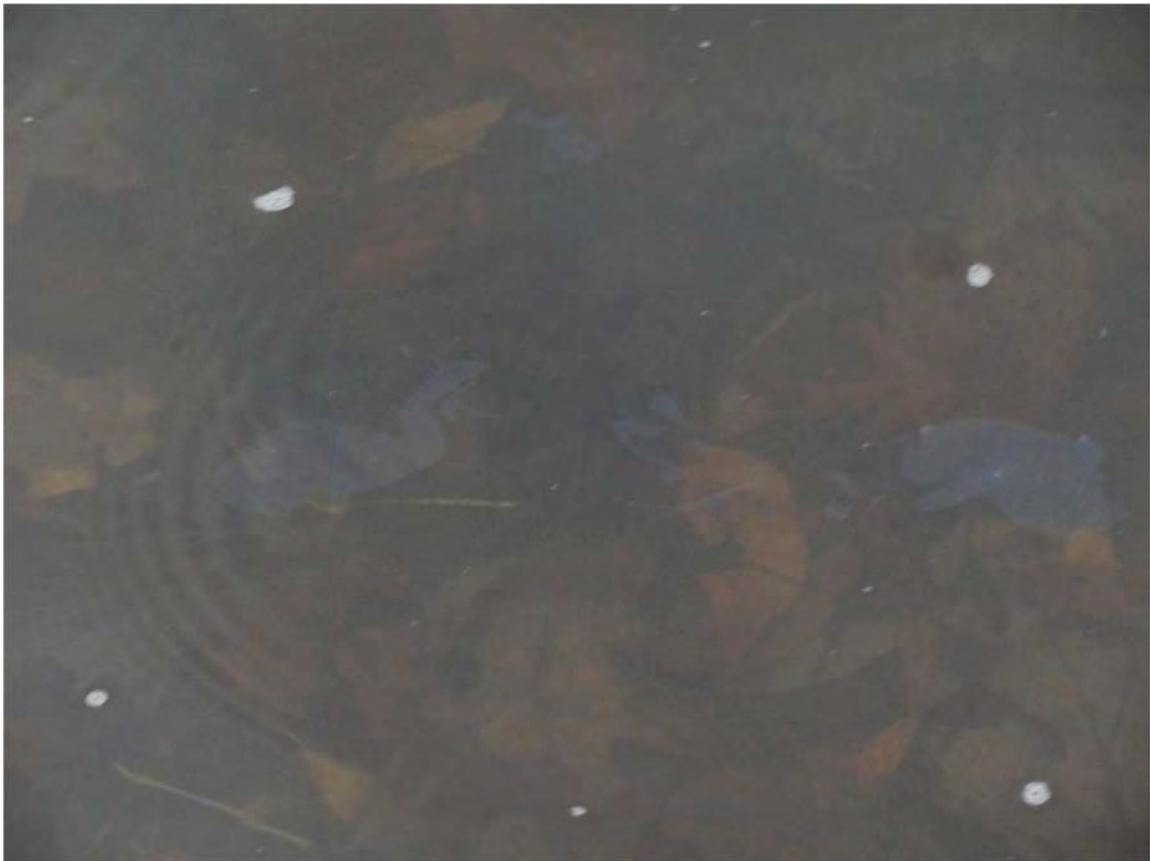
10. Portage below Ceresco Dam sheen and tar globs observed.

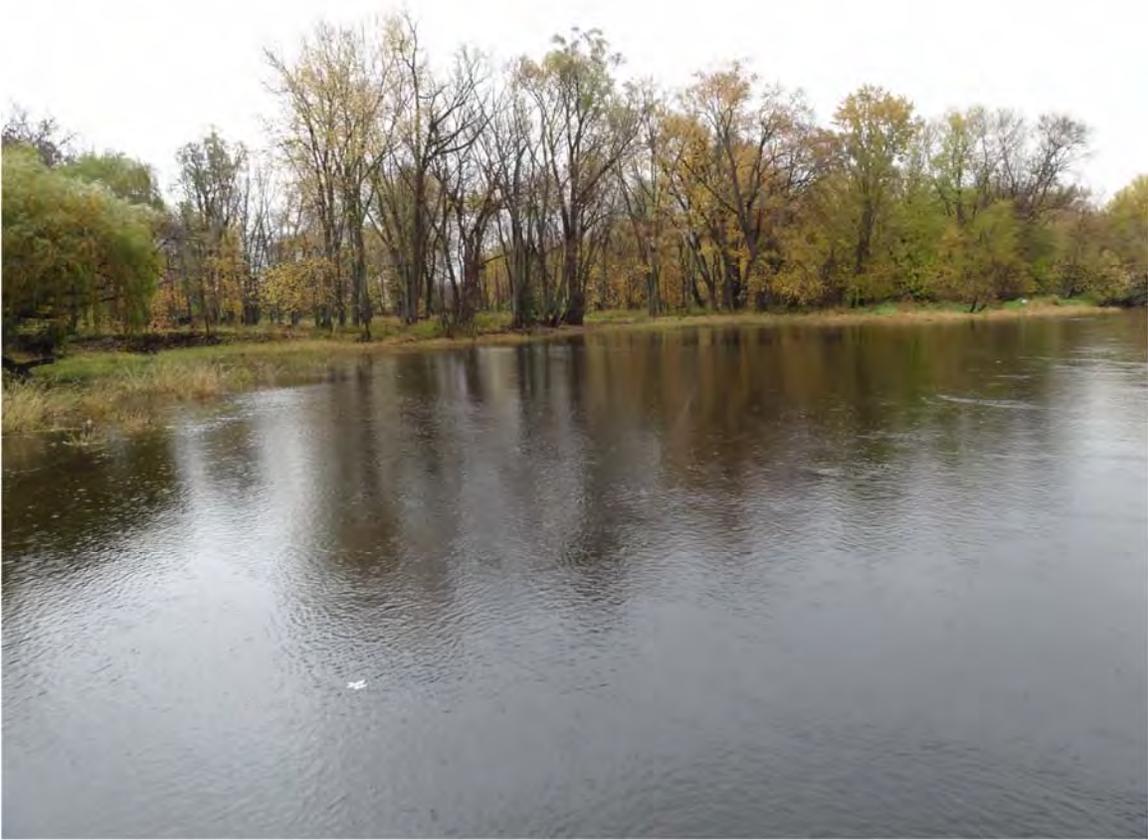
11. MP26.25 RDB river levels rising.

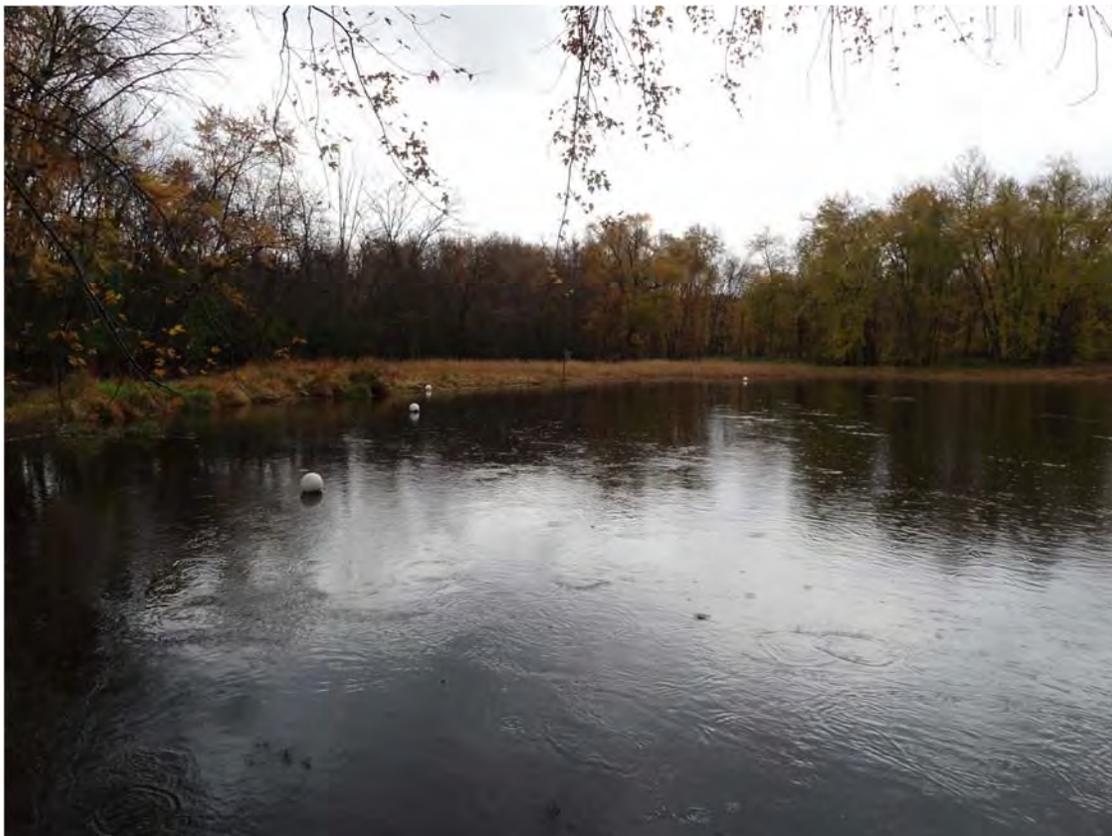
12. MP26.0 RDB Sediment Trap river levels observed rising.

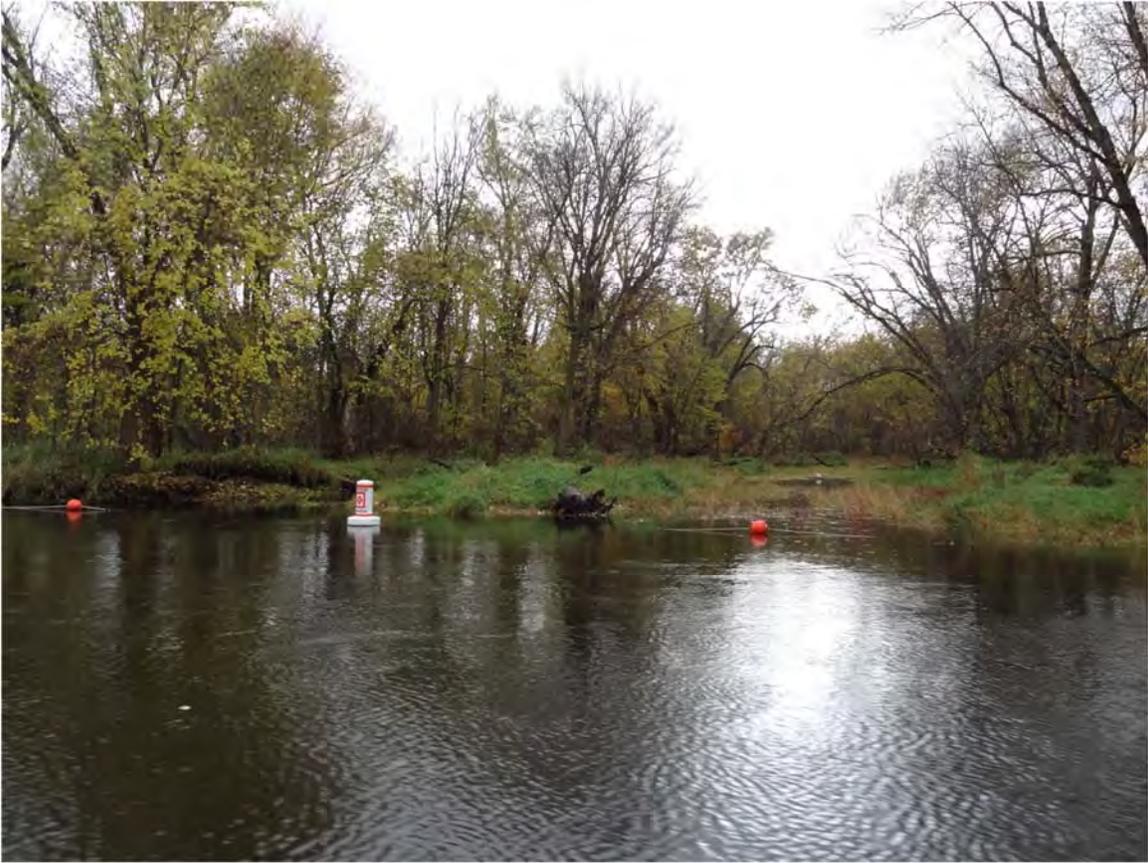
13. MP28.25 RDB Sediment Trap river levels observed rising.

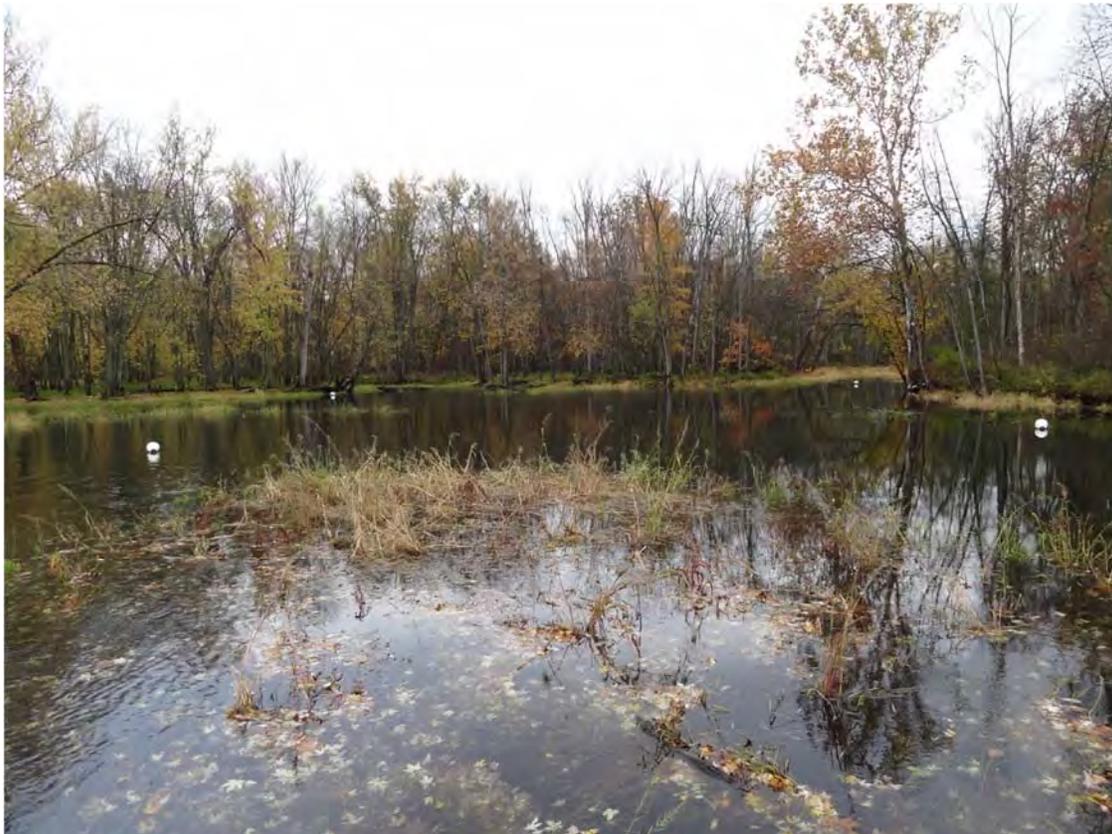
14. MP30.8 LDB Sediment Trap river levels observed rising.

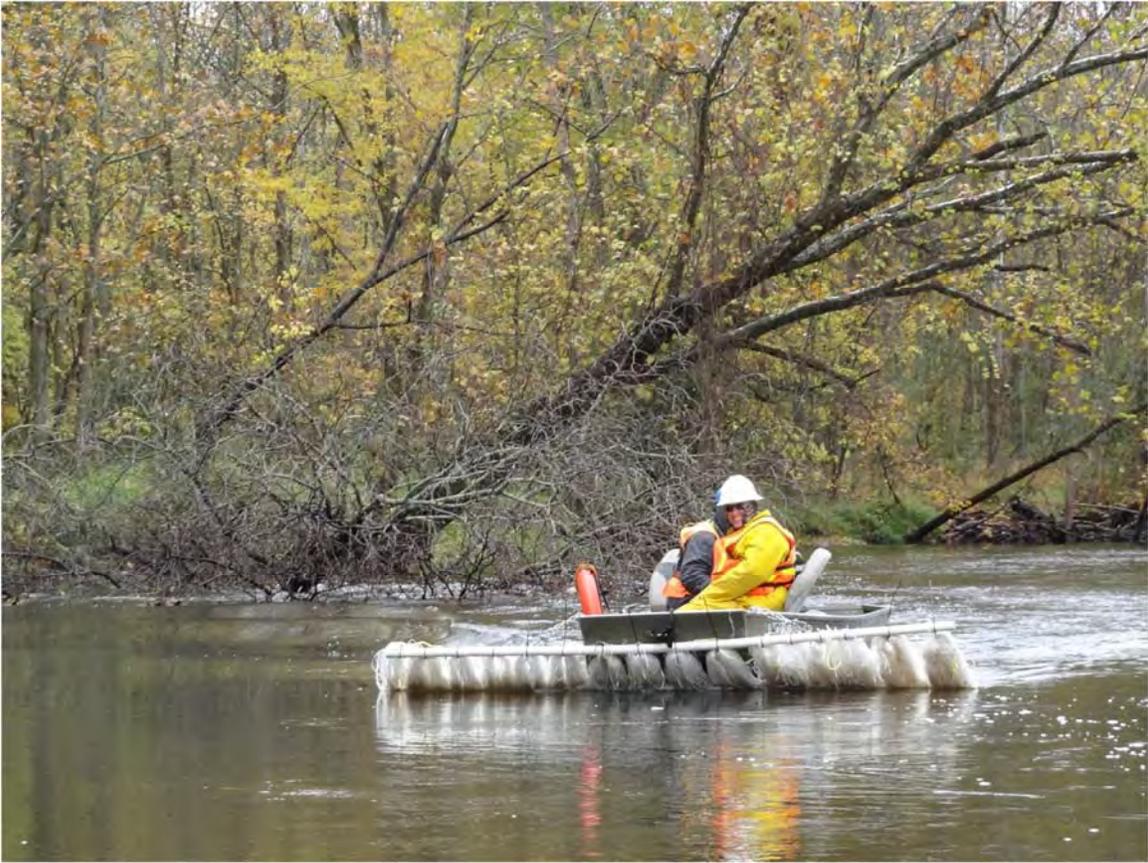
15. Observed a sheen sweep boat operating between MP21.5 – MP28.25.

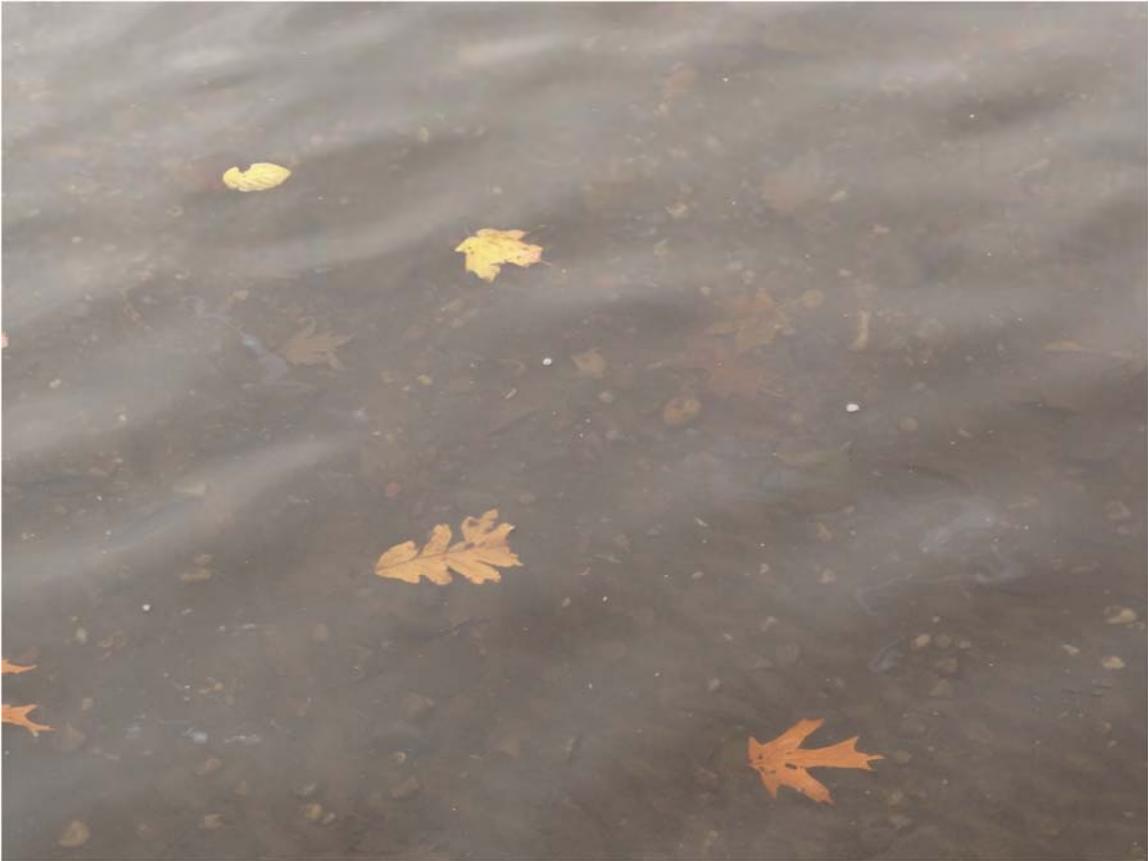
17. E4 Boat Launch observed sheen and tar globs.

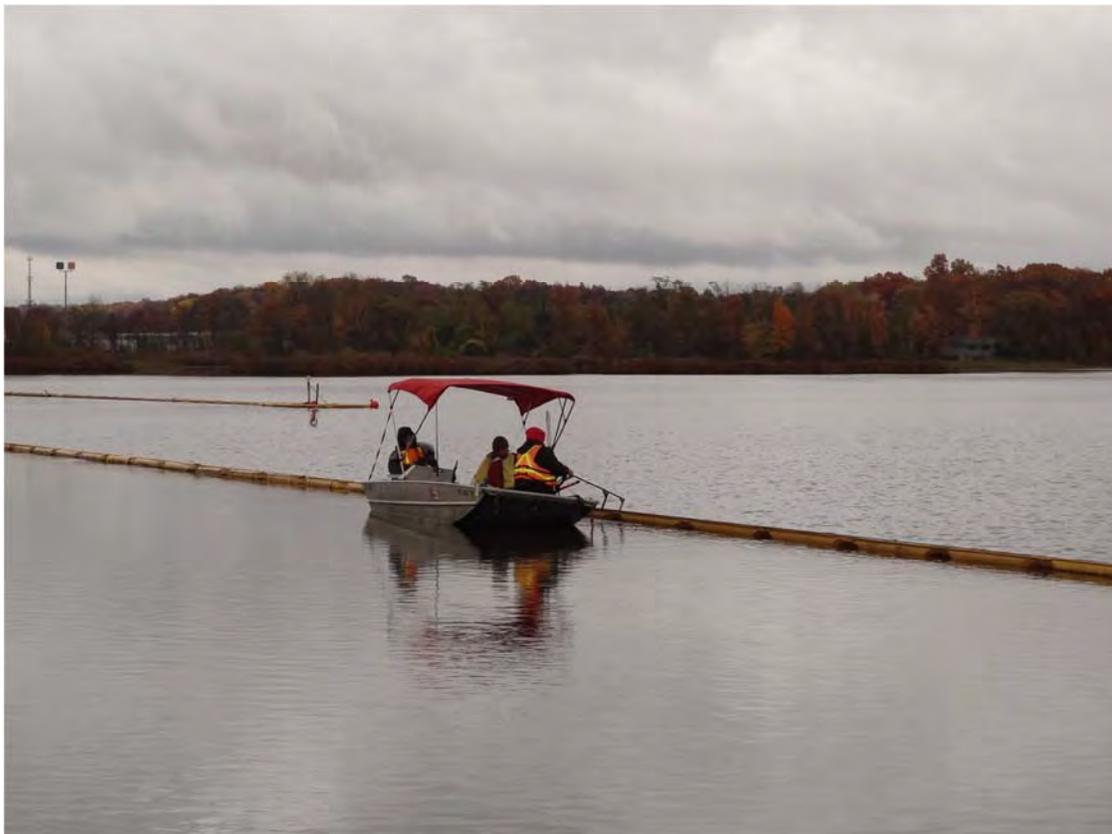
18. Morrow Lake Delta observed a crew inspecting the curtain along Gate C.
