Situation Photo Log

Saturday, October 20, 2012

Kalamazoo River / Enbridge Spill

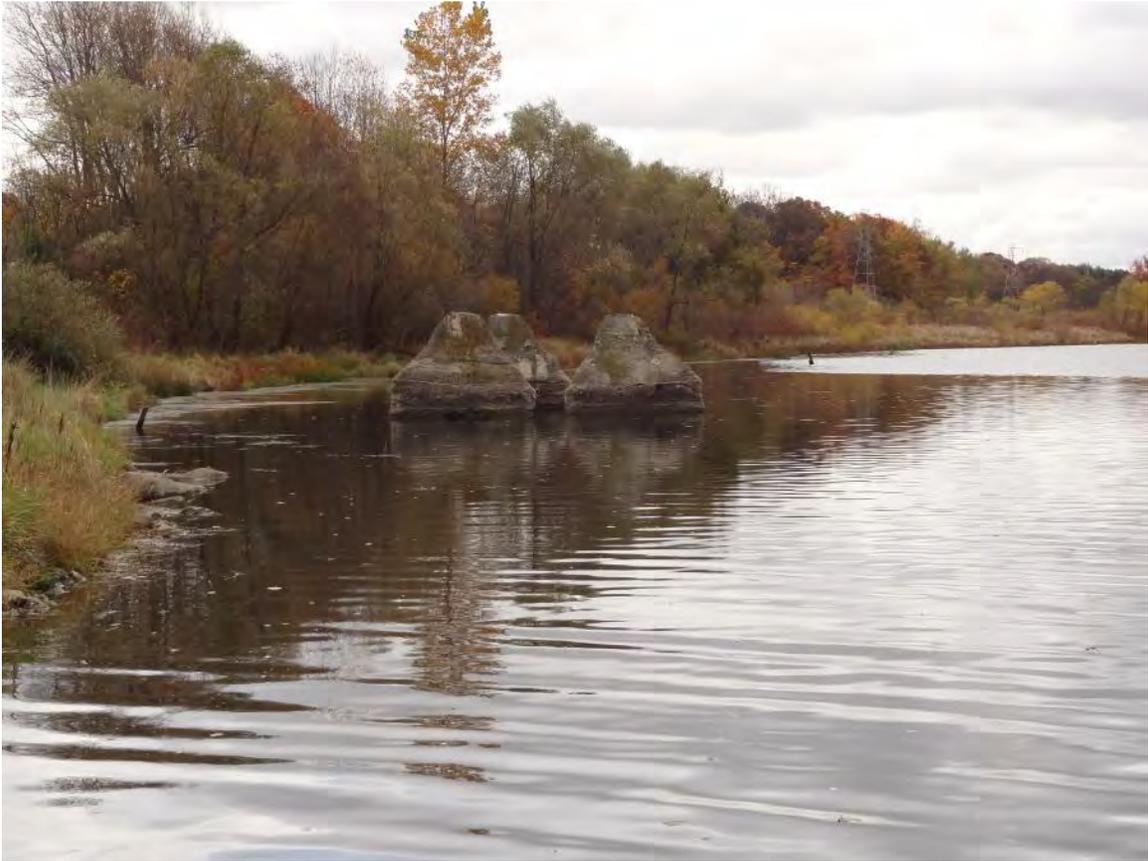
1. MP5.55 RDB area where sheen and tar globs were observed.

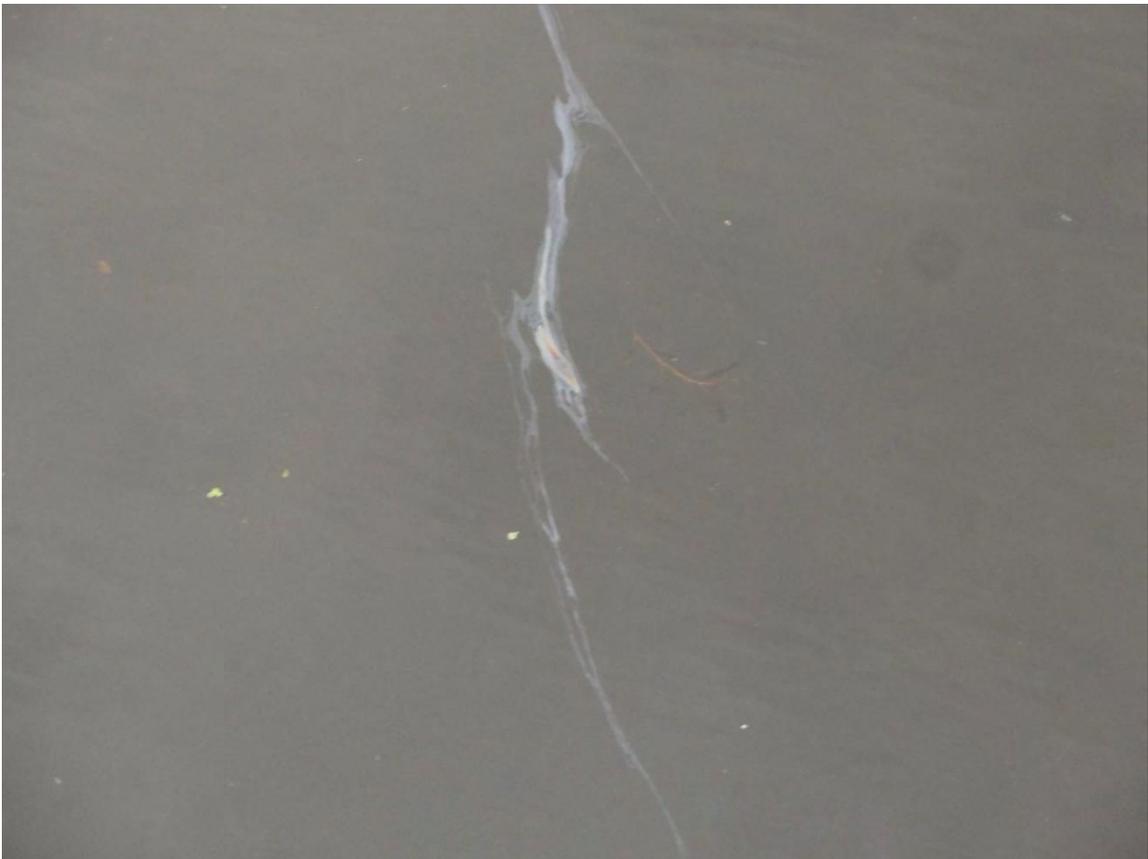
2. MP5.50 RDB sheen and tar globs were observed.

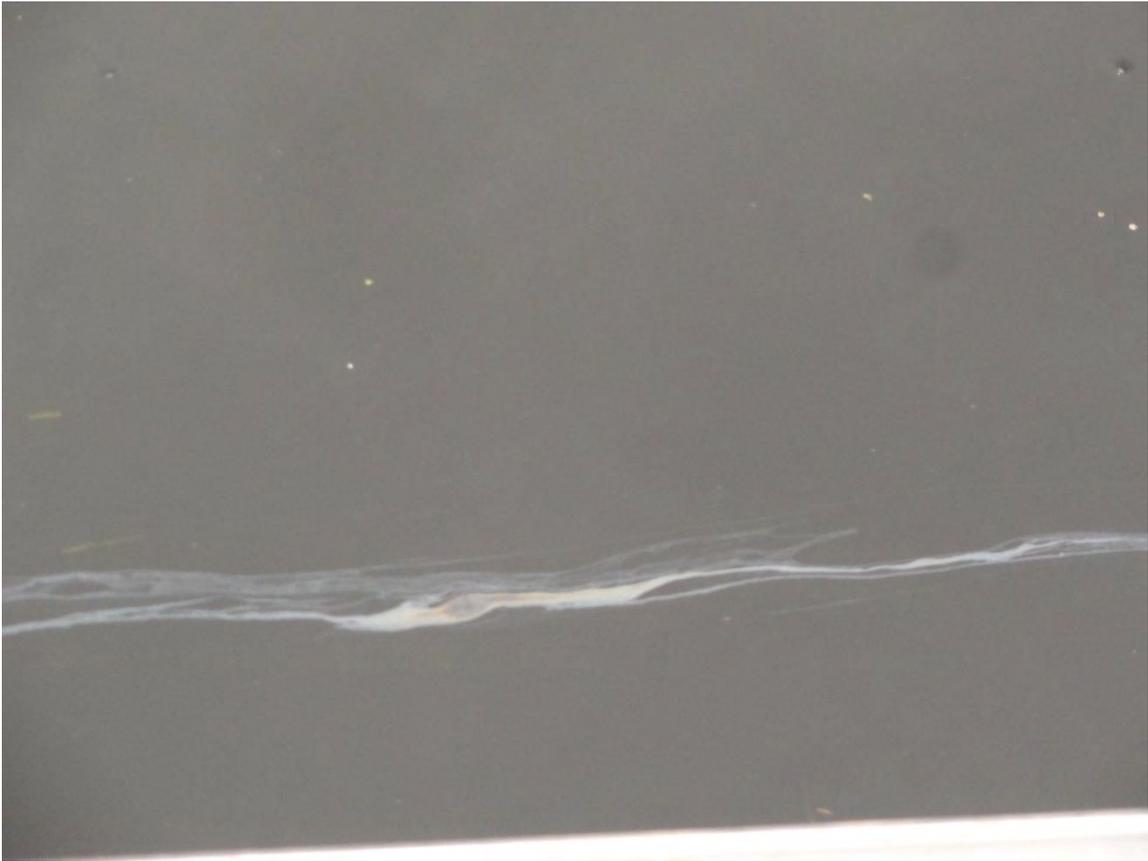
3. MP5.55 RDB sheen and tar globs were observed.

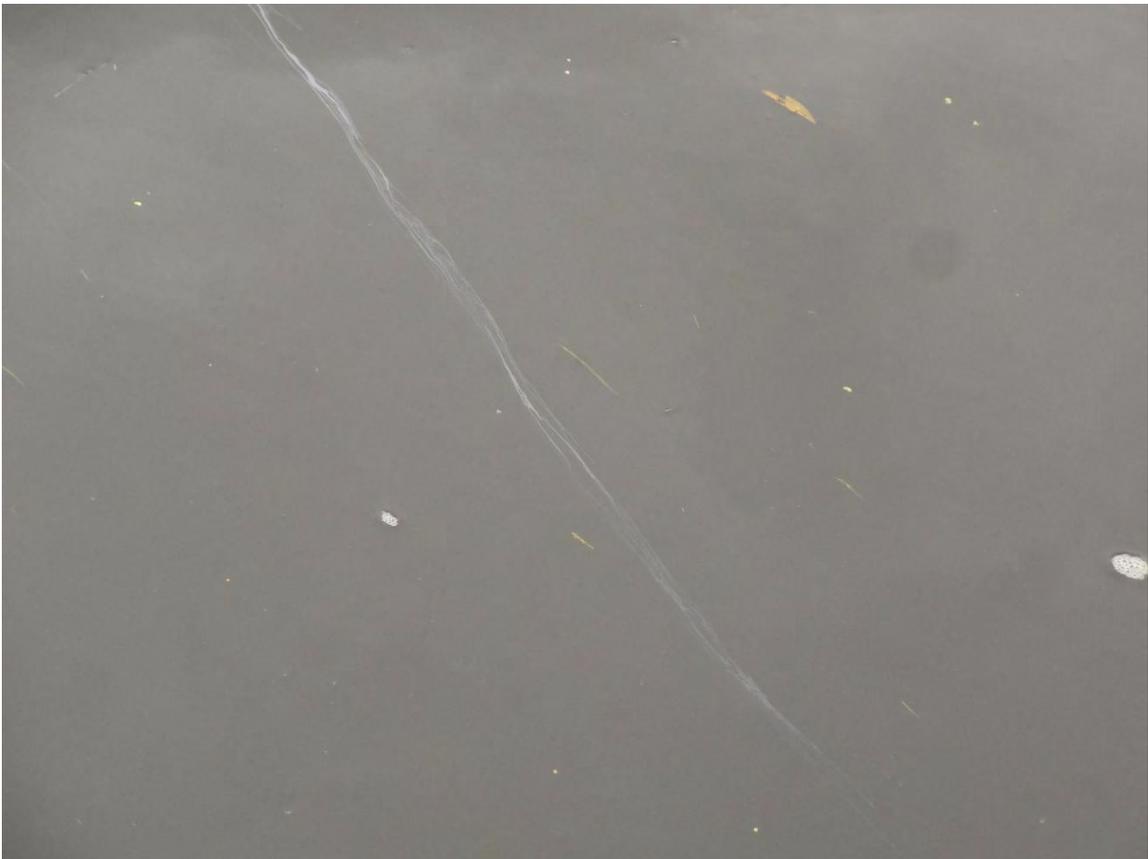
4. MP5.60 RDB ribbons of sheen observed.

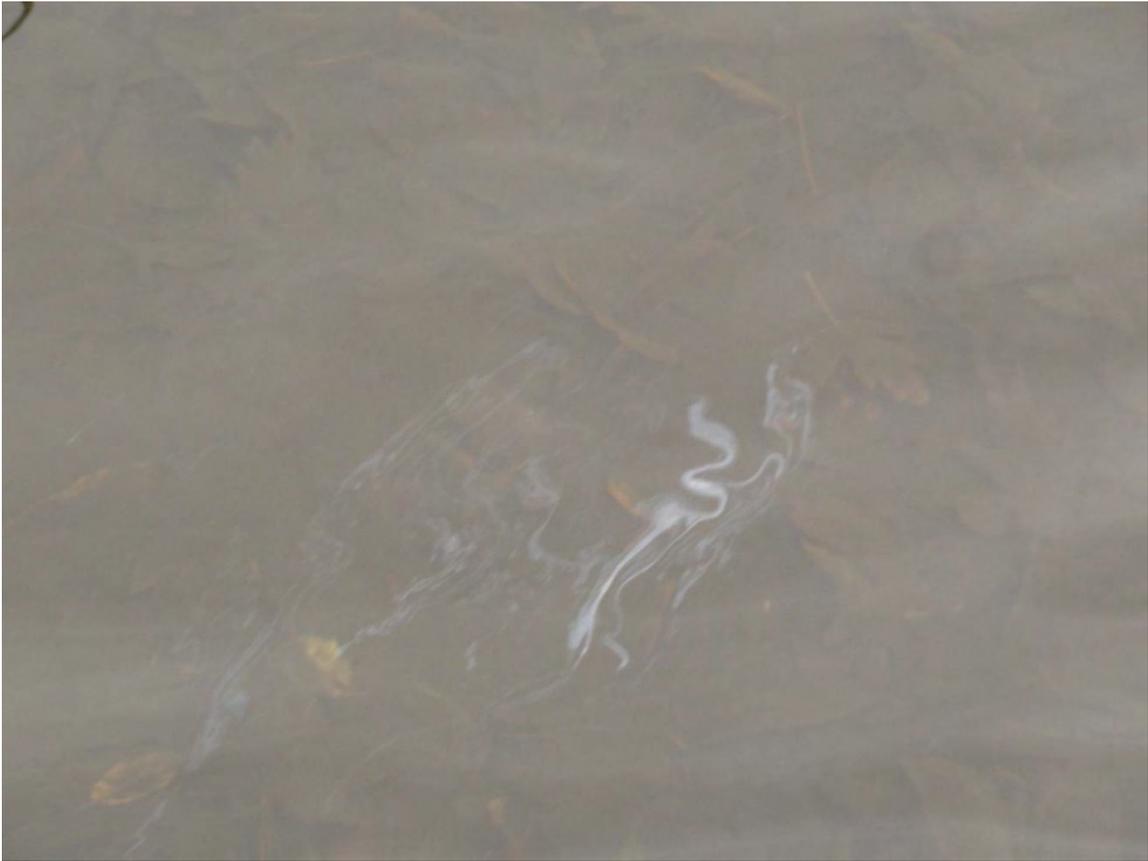
5. MP5.63 RDB ribbons of sheen were observed.

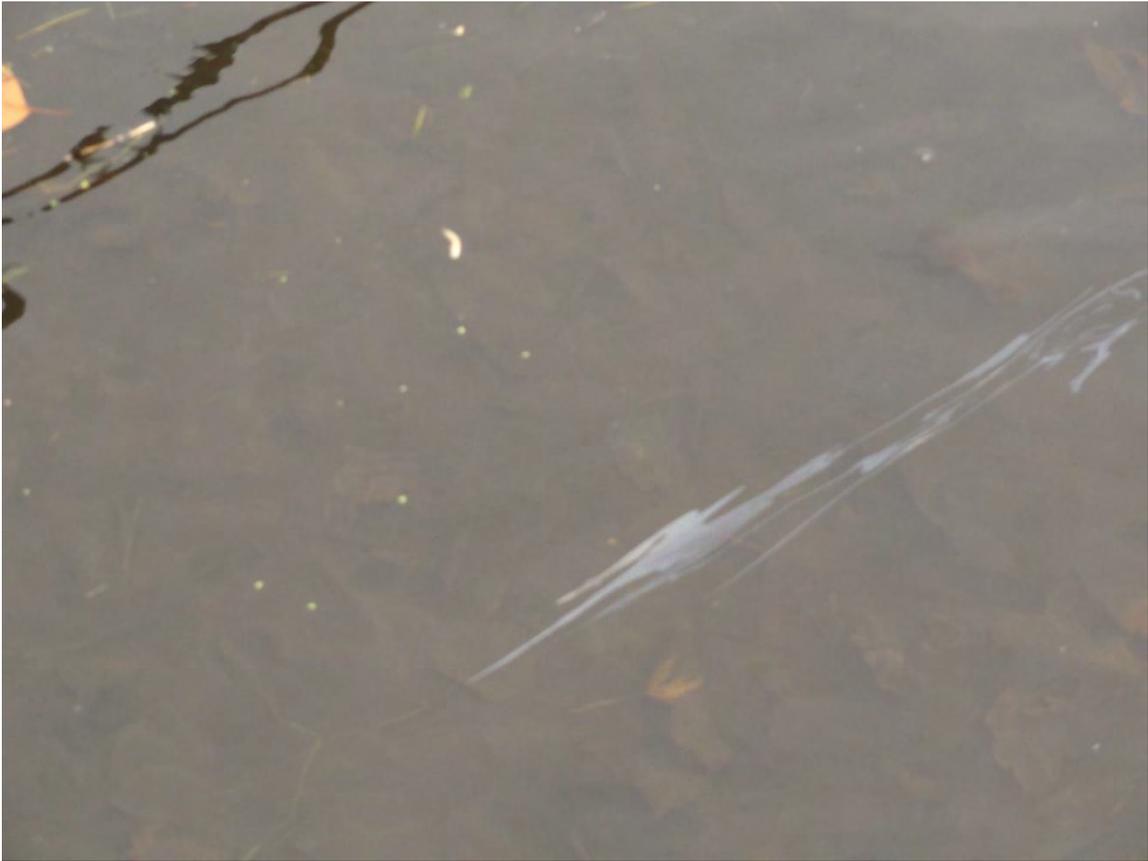
7. Ceresco Dam Control Point observed sheen collecting along the boom.

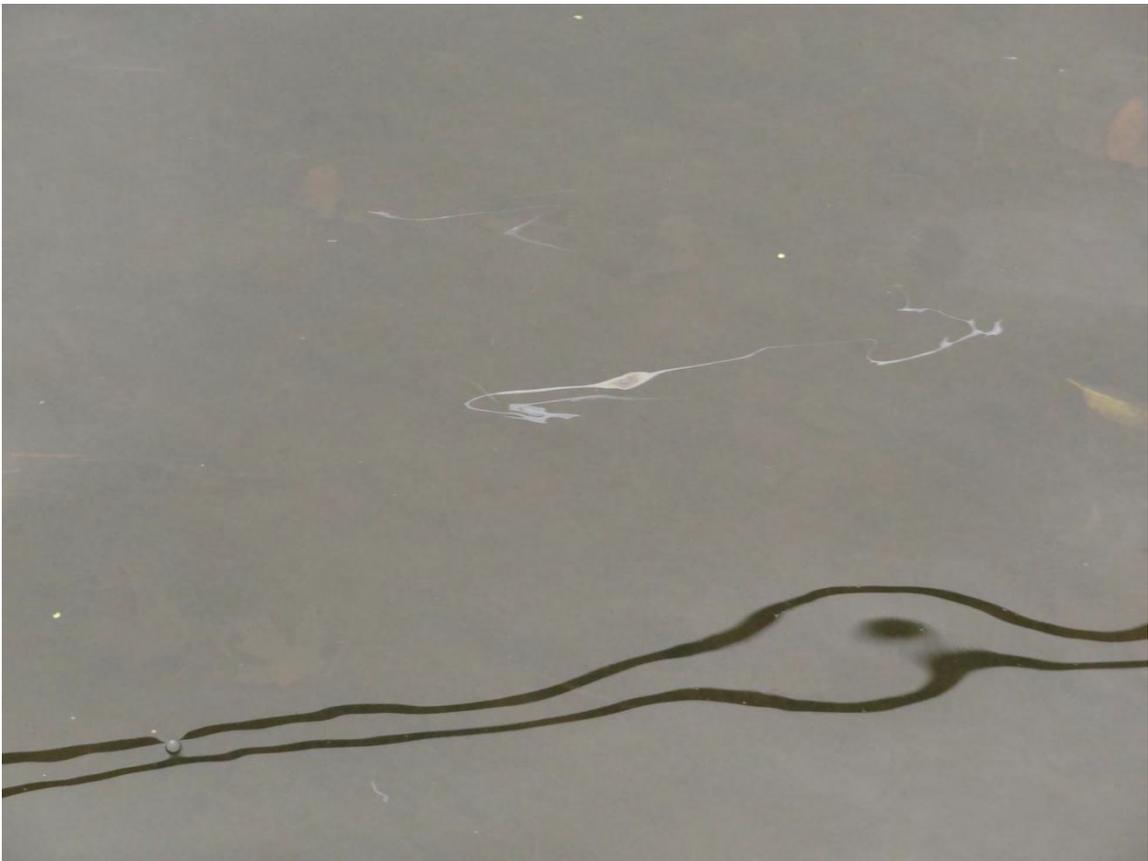
8. Ceresco Dam Control Point Boom observed sheen and tar globs collecting along the boom.

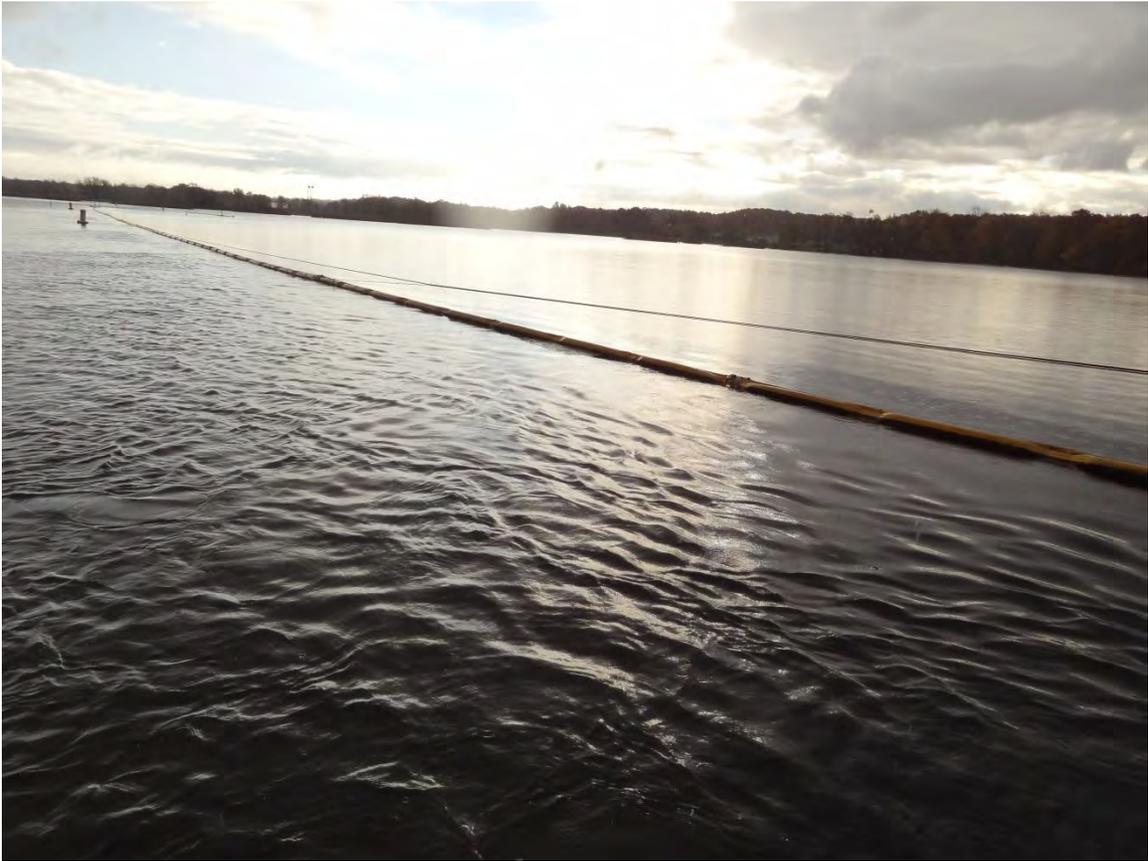
9. Morrow Lake Delta Gate C West sheen observed collecting along boom.

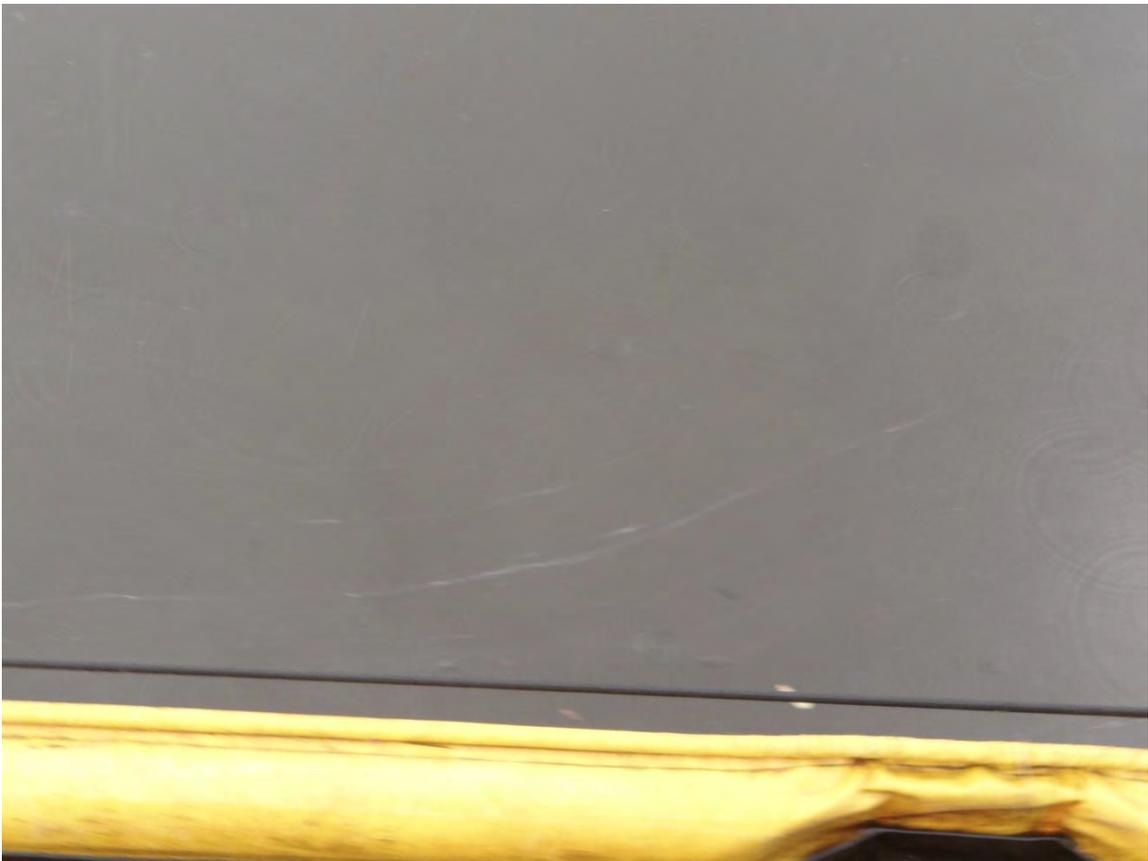
10. Morrow Lake Delta Gate C West observed ribbons of sheen collecting along boom.

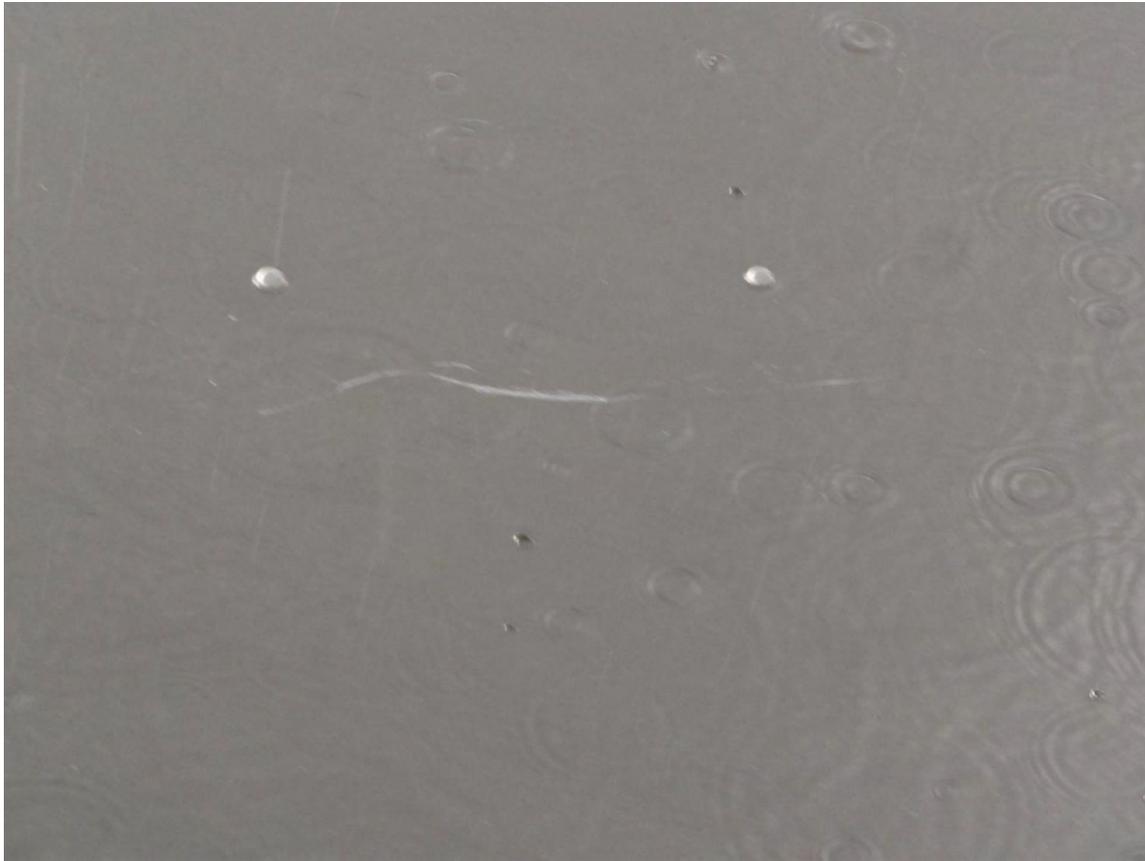
11. Morrow Lake Delta Gate C West observed sheen collecting along boom.

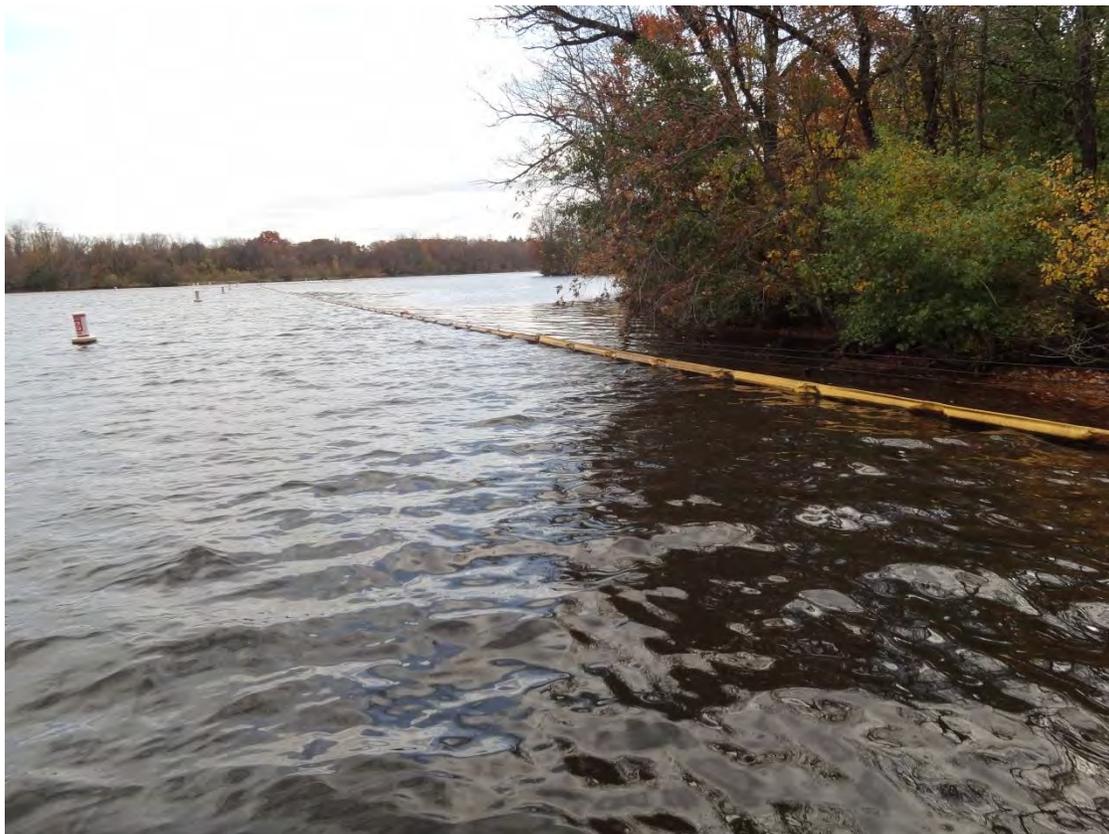
12. Morrow Lake Delta Gate F South observed sheen collecting along boom.

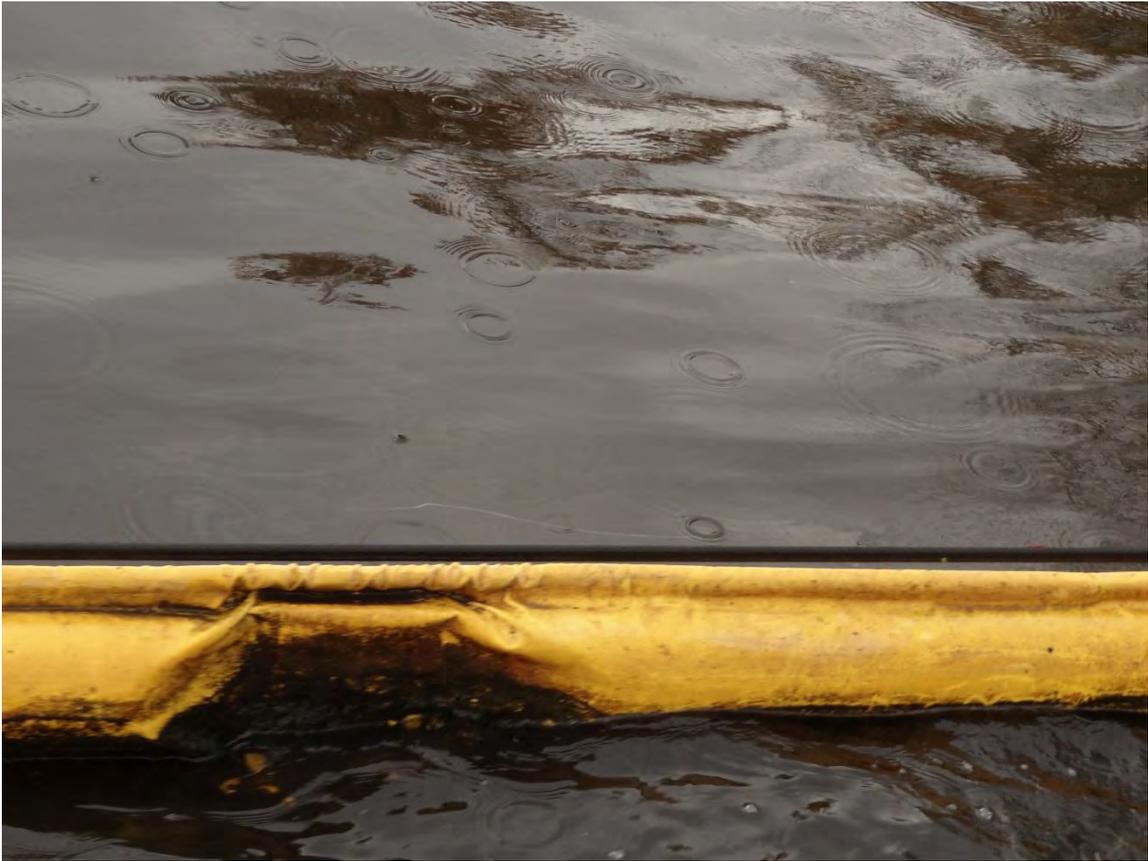
13. Morrow Lake Delta Gate F South observed sheen collecting along boom.

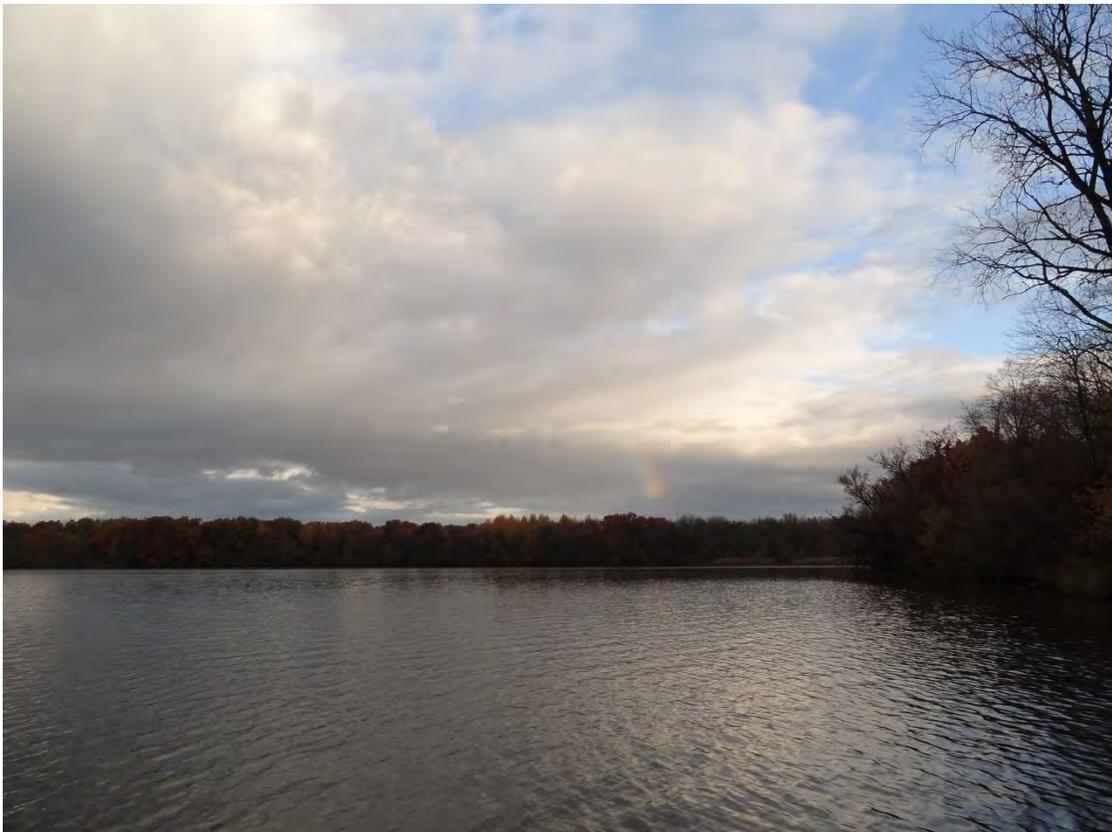
14. Morrow Lake North Cove sheen was observed. Amount of sheen did not warrant response.

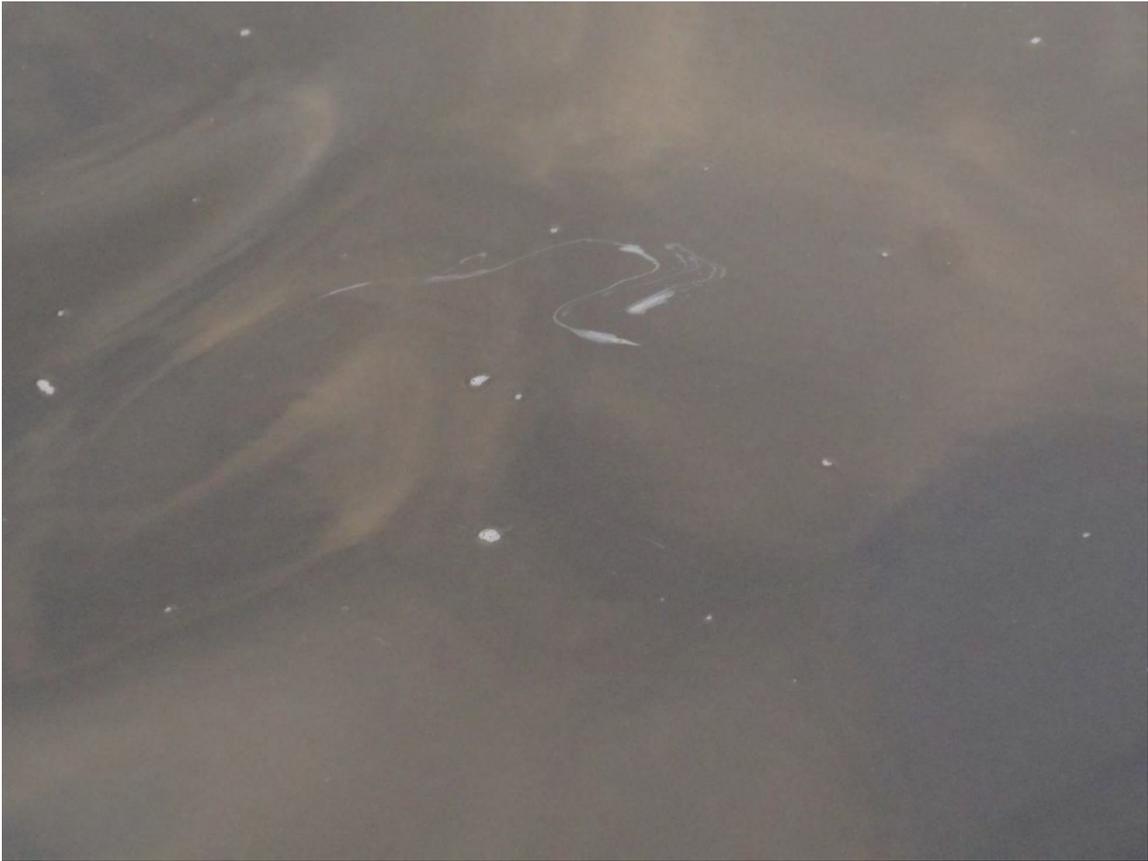
15. Morrow Lake North Cove observed ribbons of sheen. Amount of sheen did not warrant response.
