# Situation Photo Log

Thursday, October 25, 2012

Kalamazoo River / Enbridge Spill

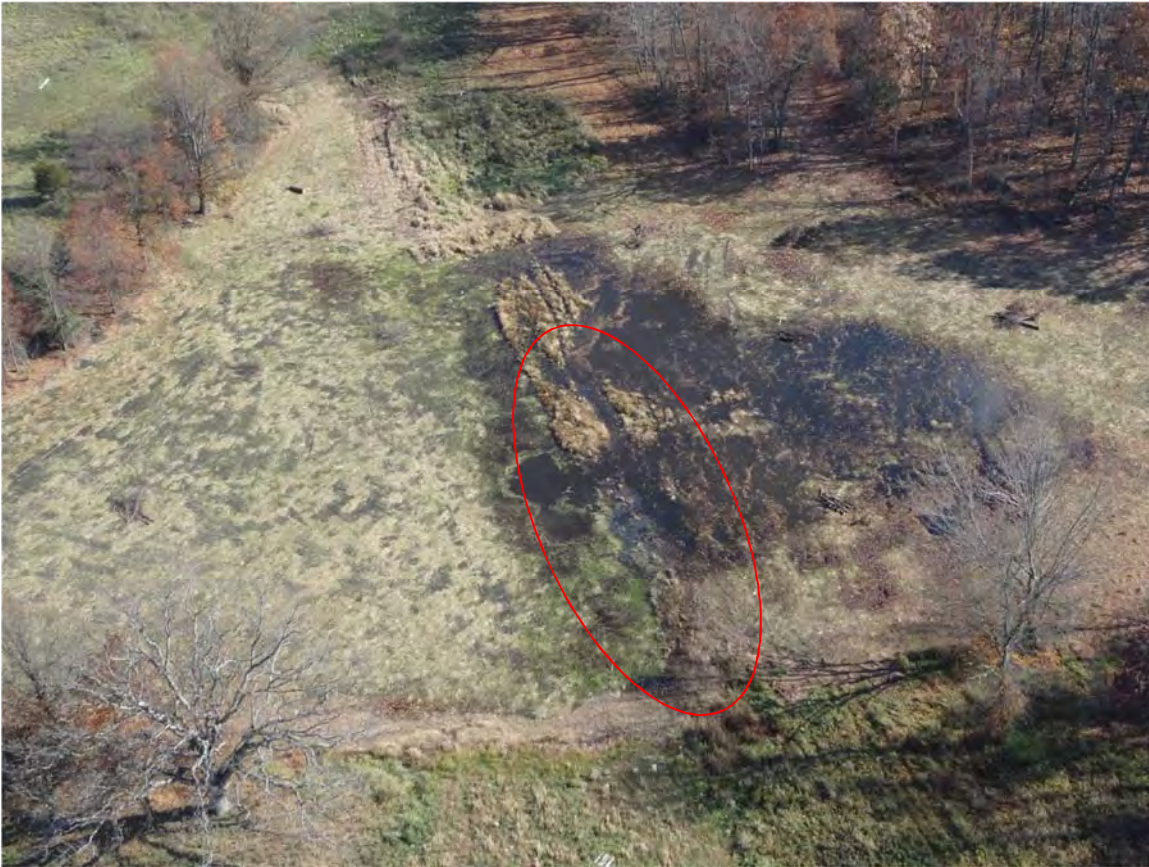
1. Source area sheen observed.

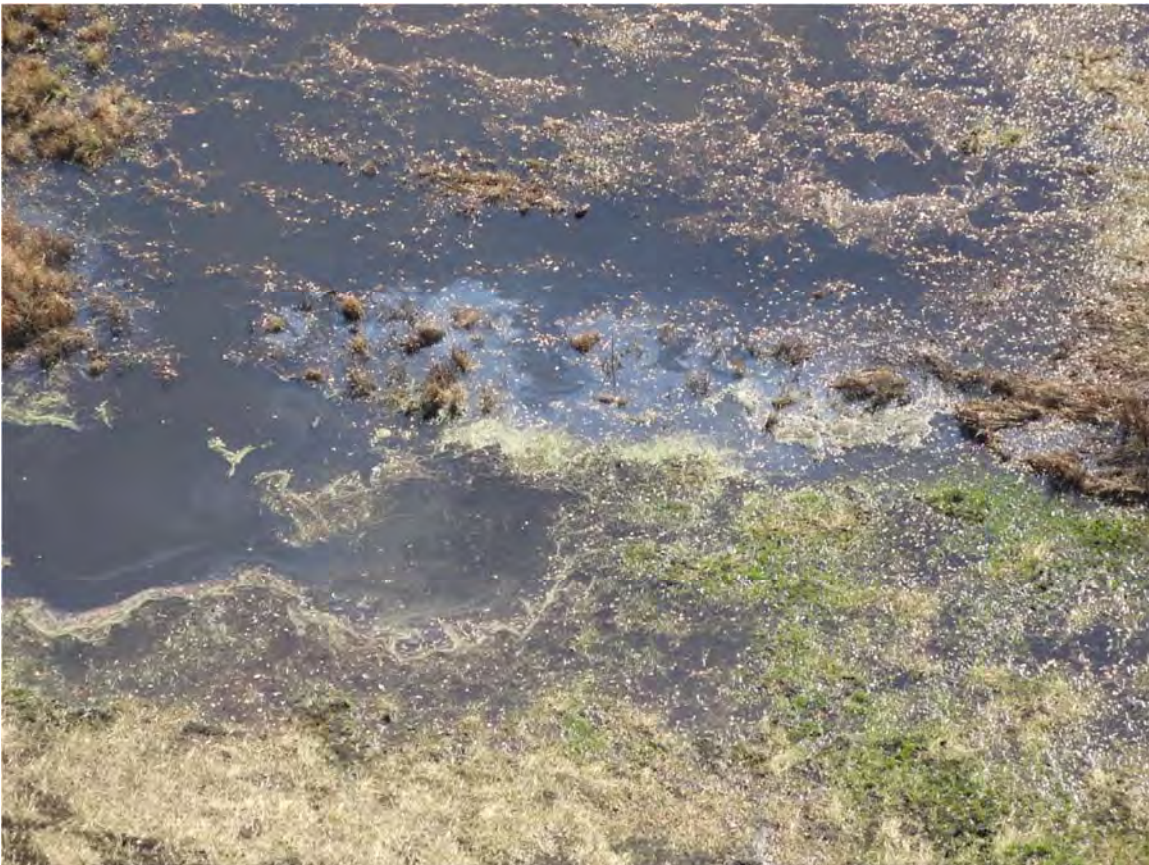
2. Source area sheen observed.

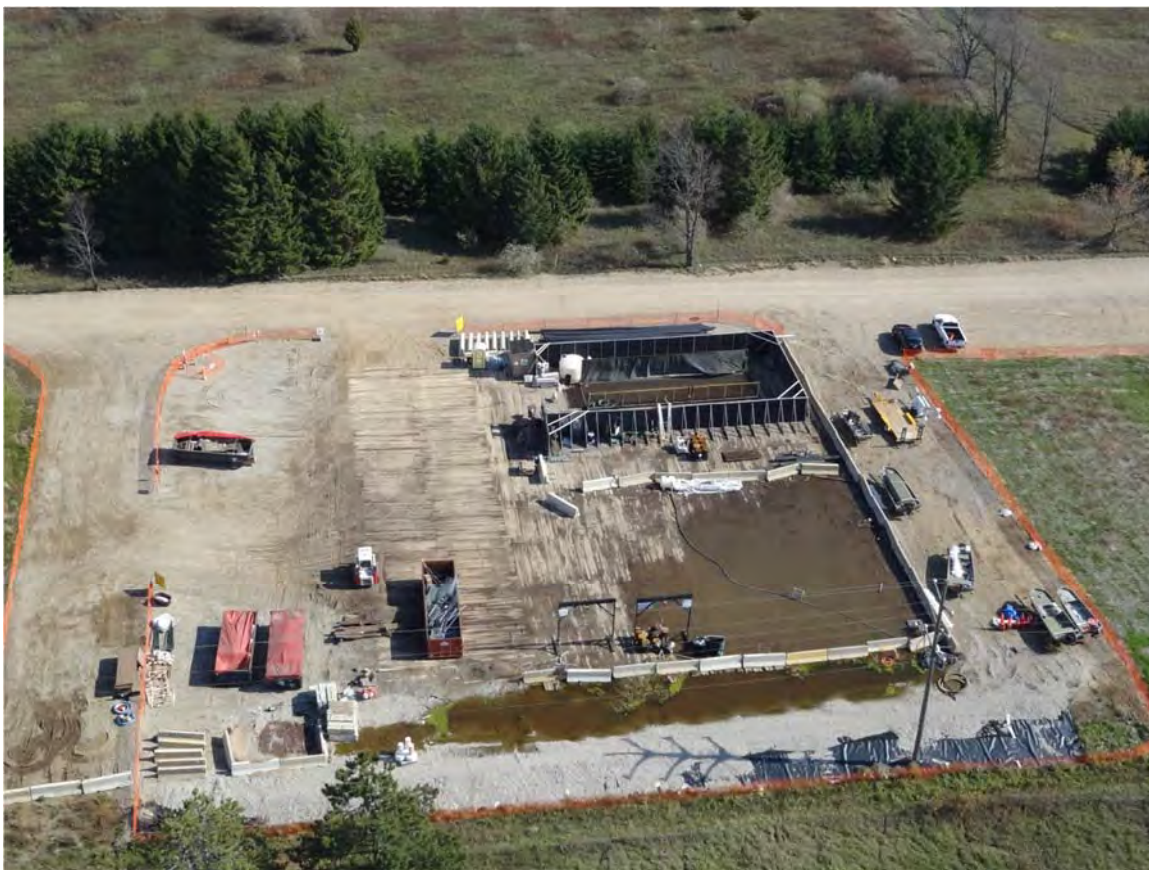
3. Frac-Tank City observed standing water.

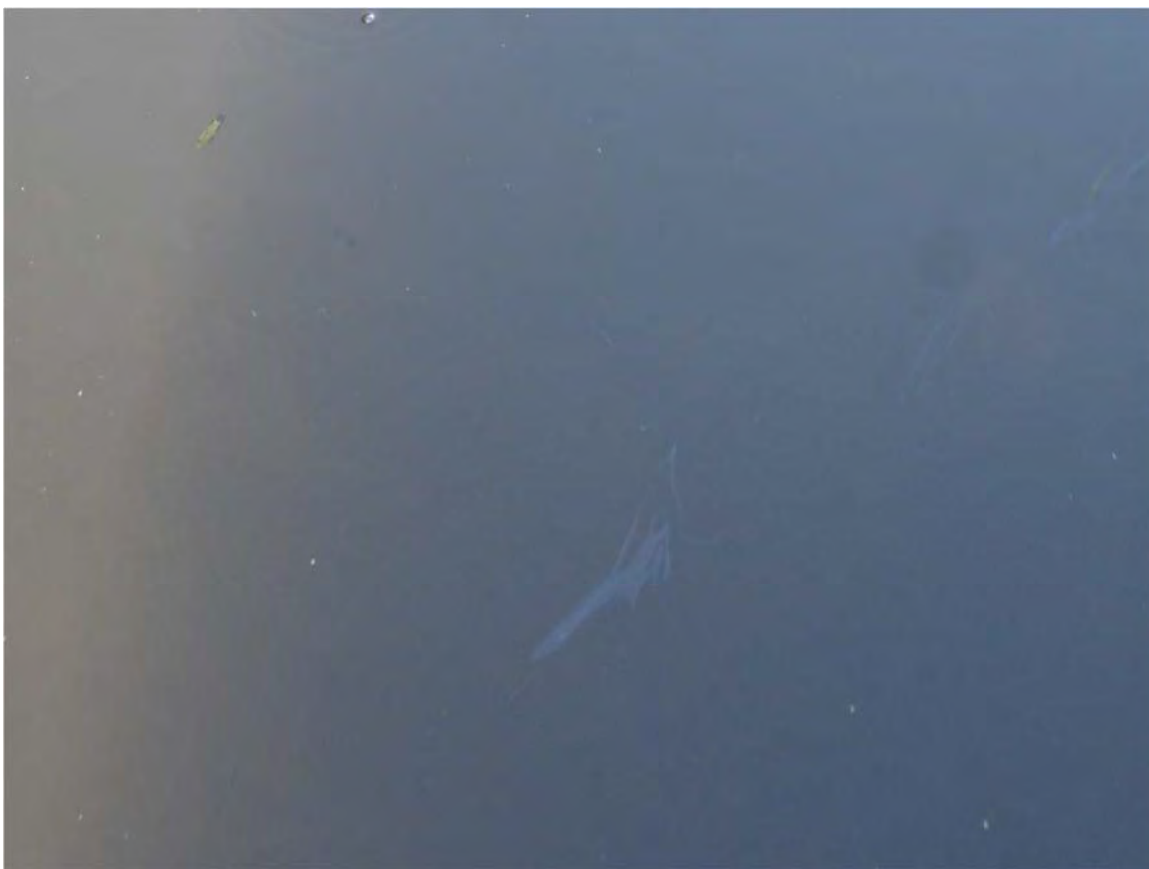
6. MP5.35 LDB spontaneous sheen observed.

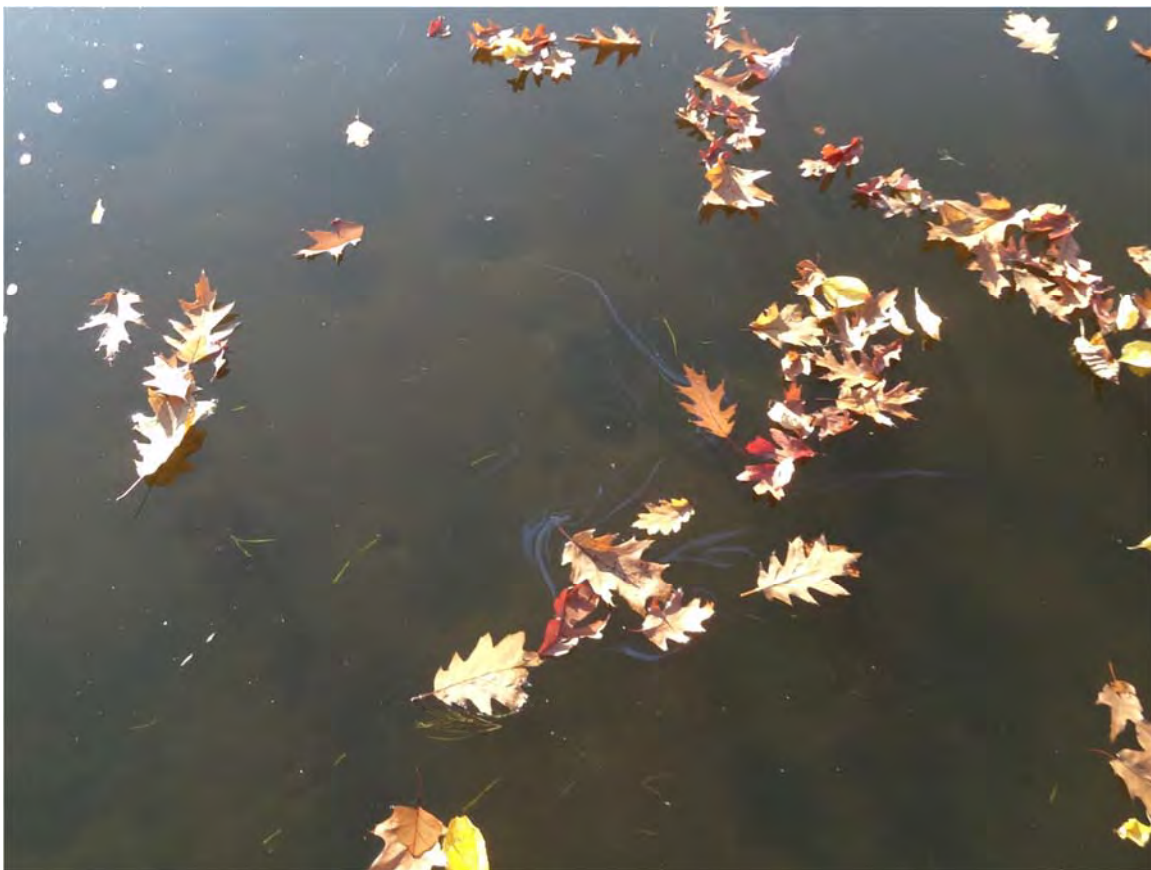
7. MP5.45 LDB spontaneous sheen observed.

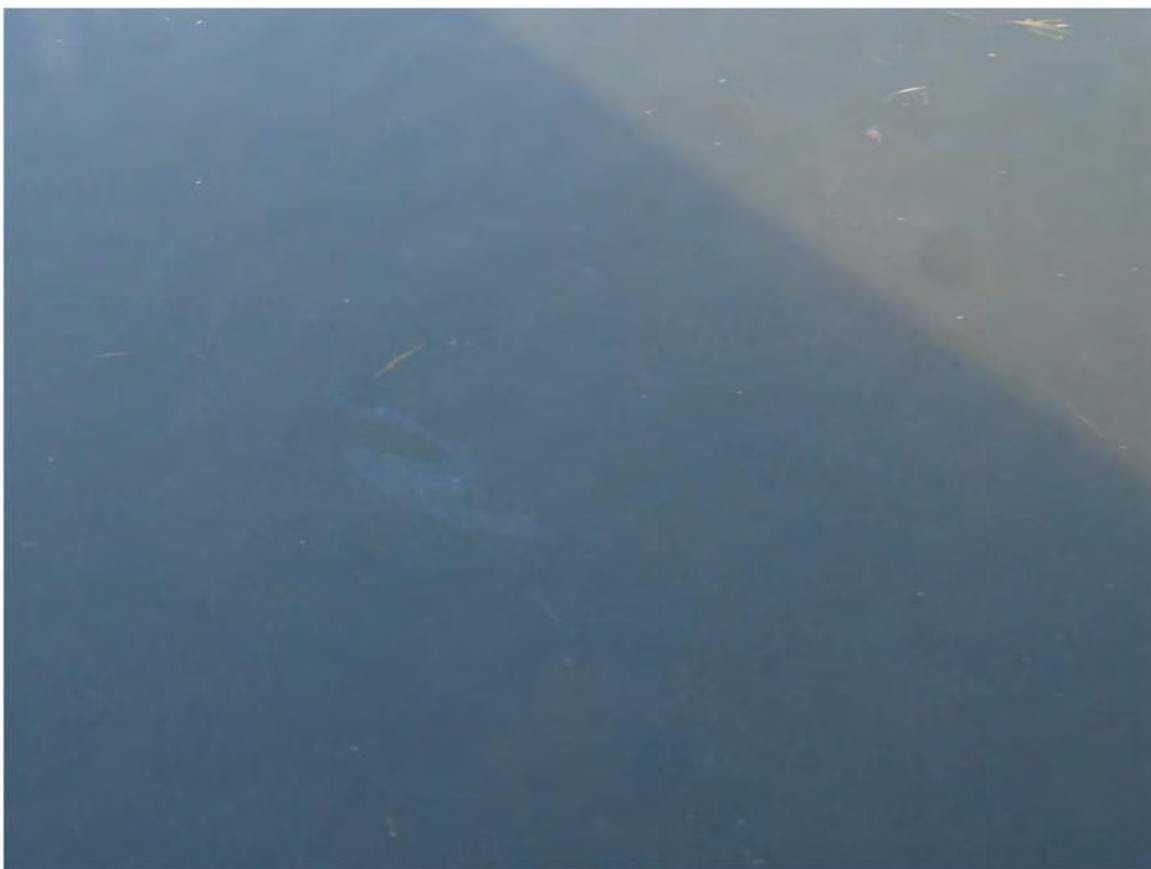
8. MP5.63 LDB spontaneous sheen observed.

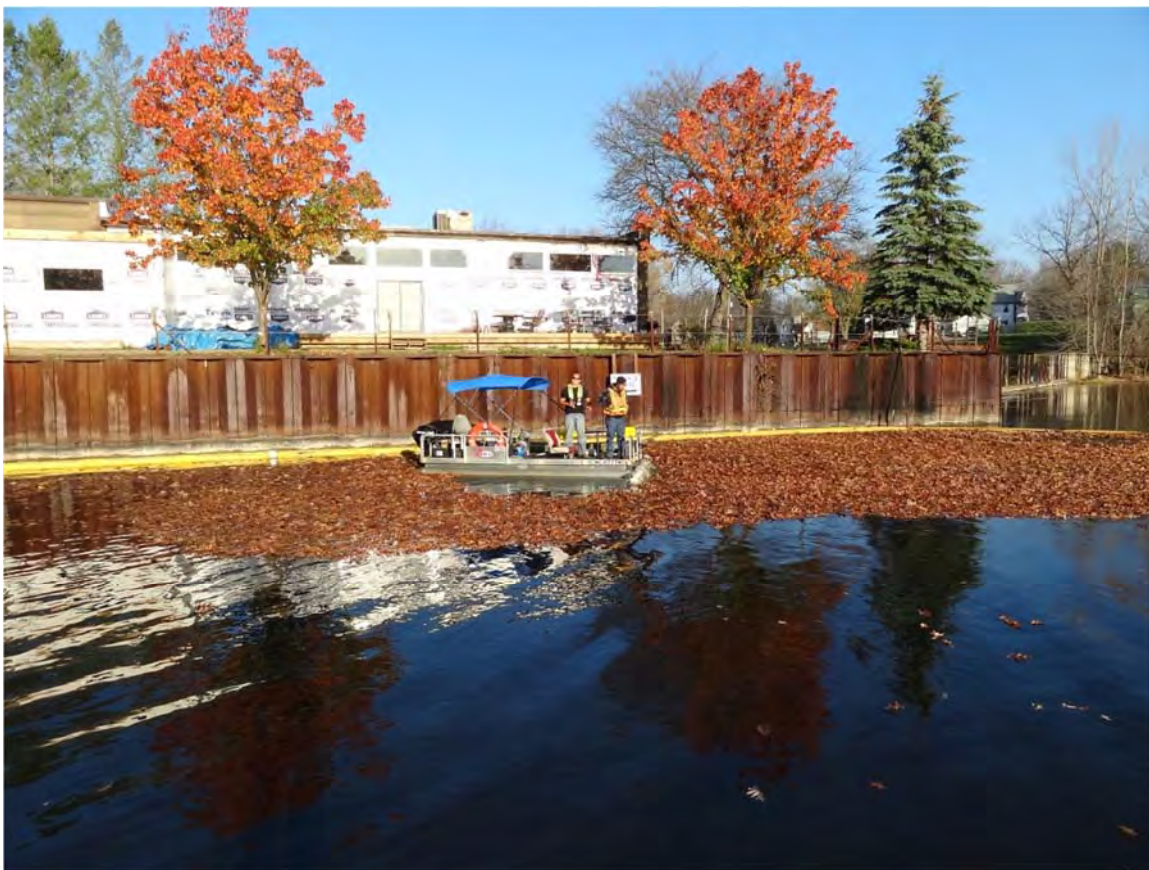
9. Ceresco Dam observed a crew preparing to remove debris from the control point boom.

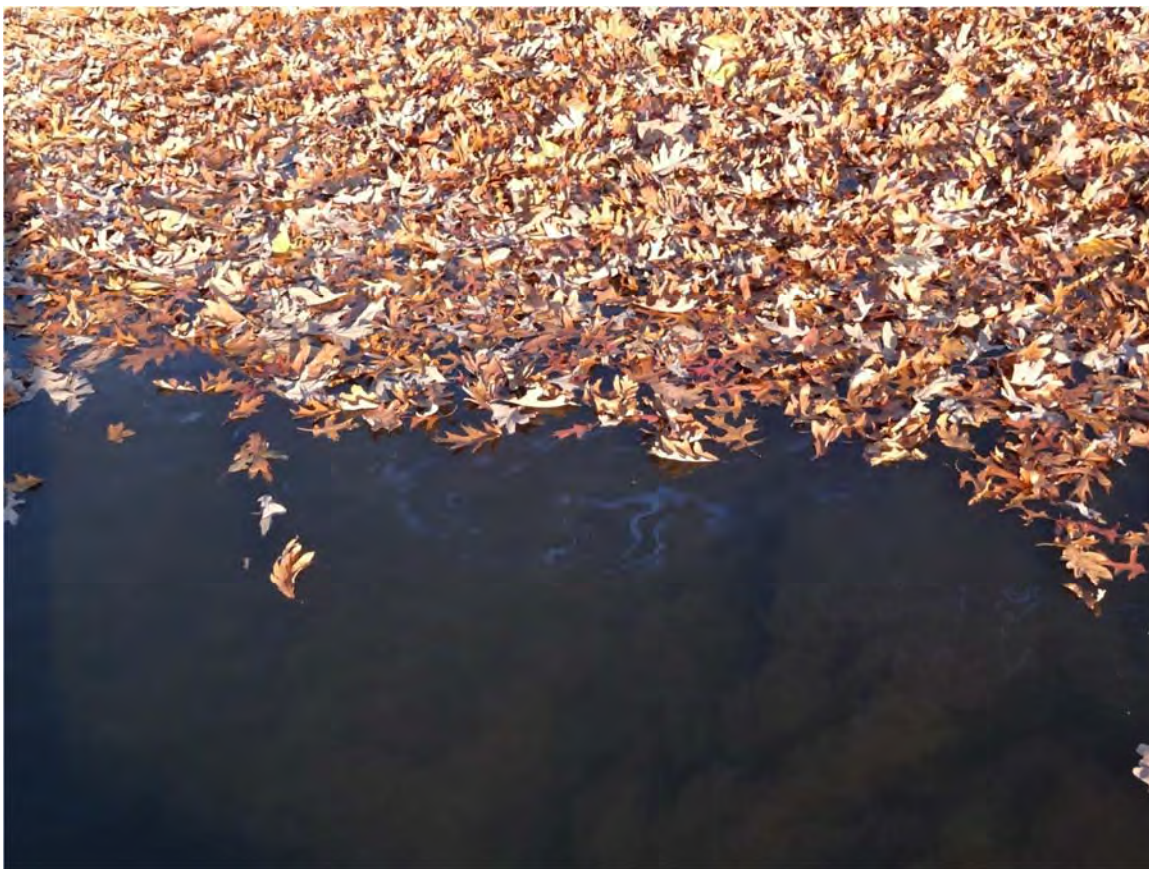
10. Ceresco Dam observed sheen and tar globs collecting along the boom.

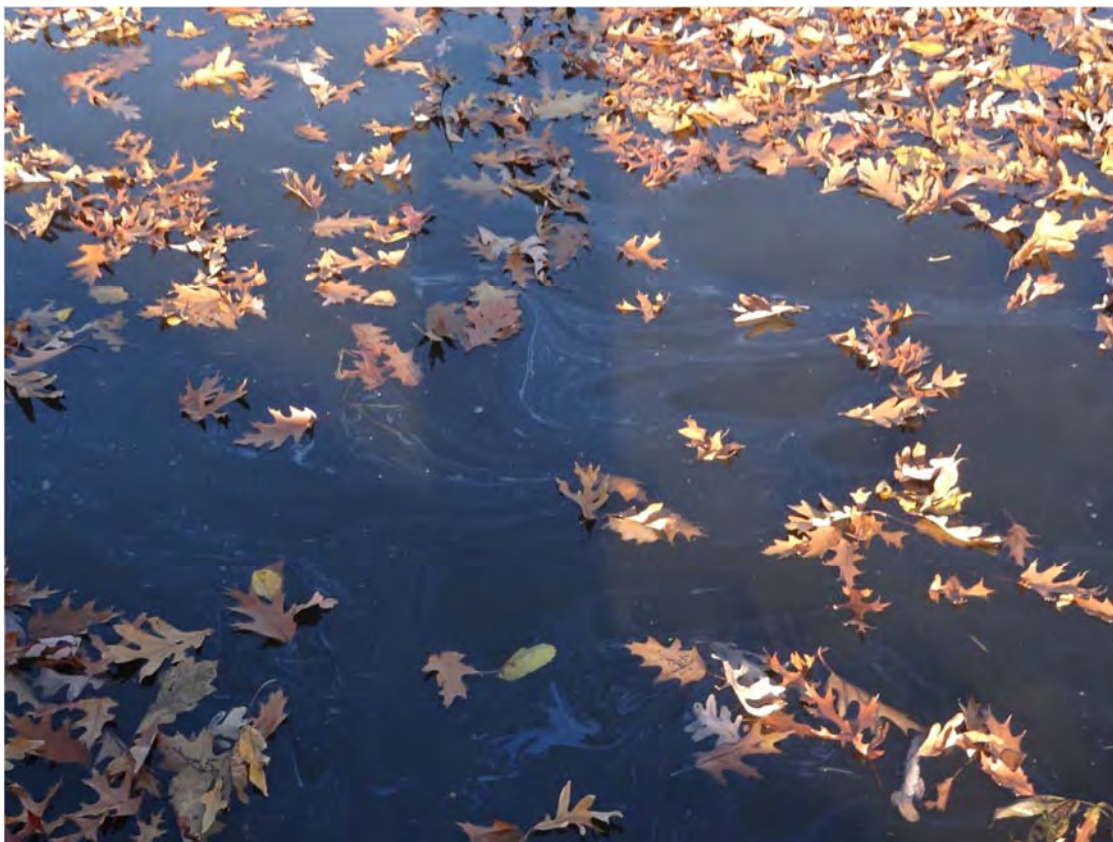
11. Ceresco Dam observed sheen and tar globs collecting along the boom.

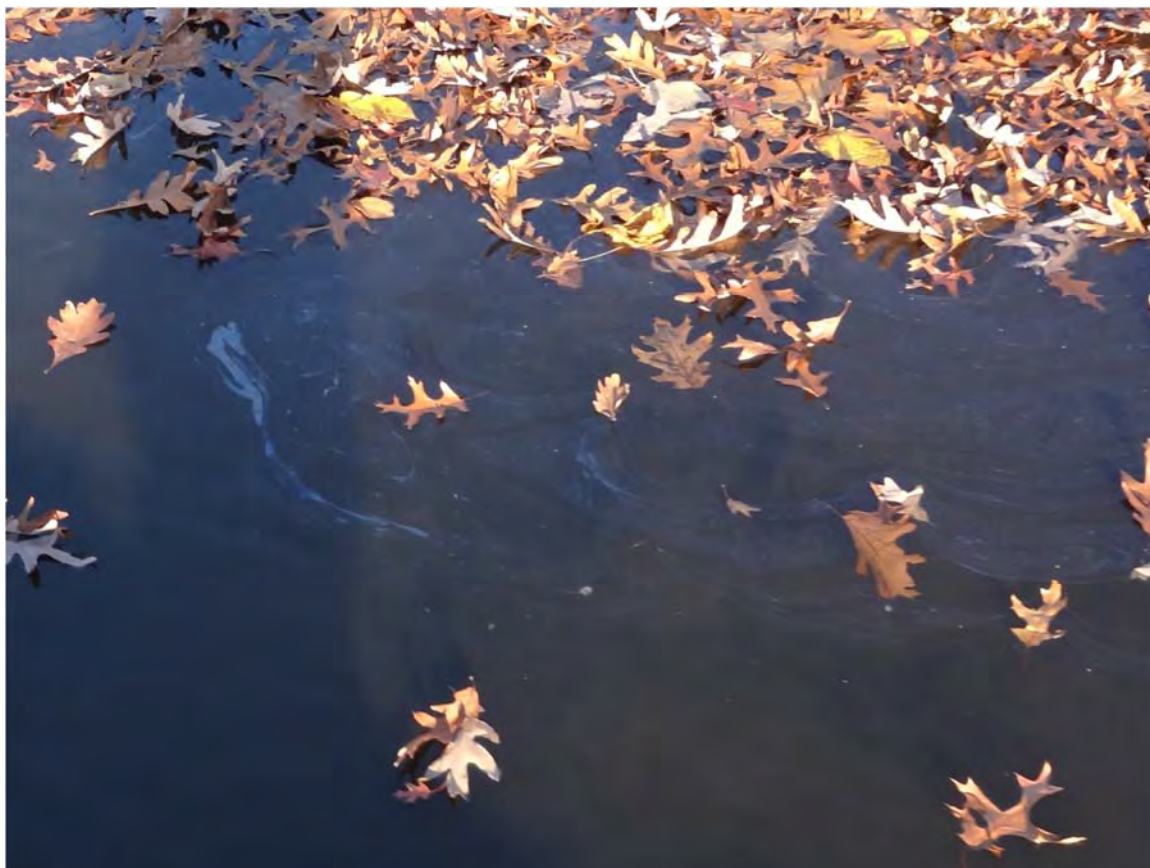
12. Ceresco Dam observed sheen and tar globs collecting along the boom.

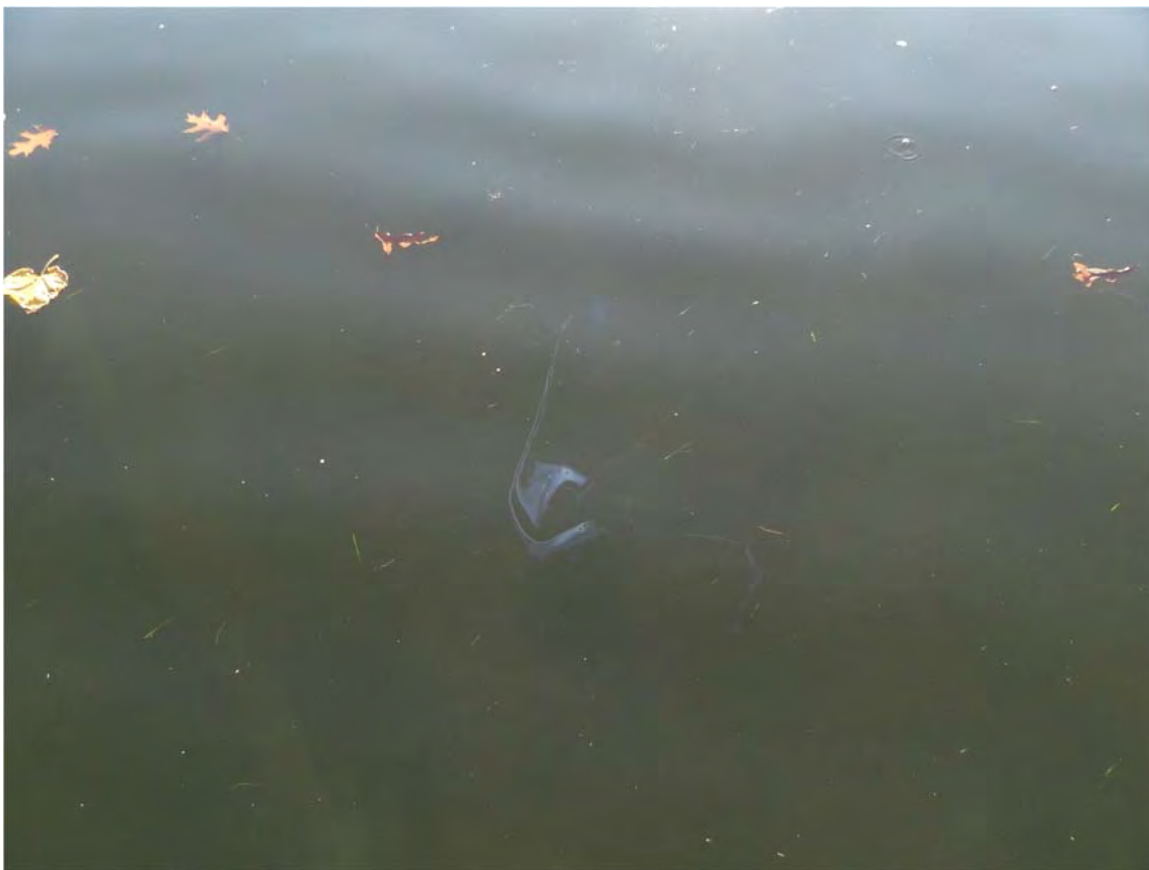
13. MP5.55 RDB area where spontaneous sheen and tar globs observed.

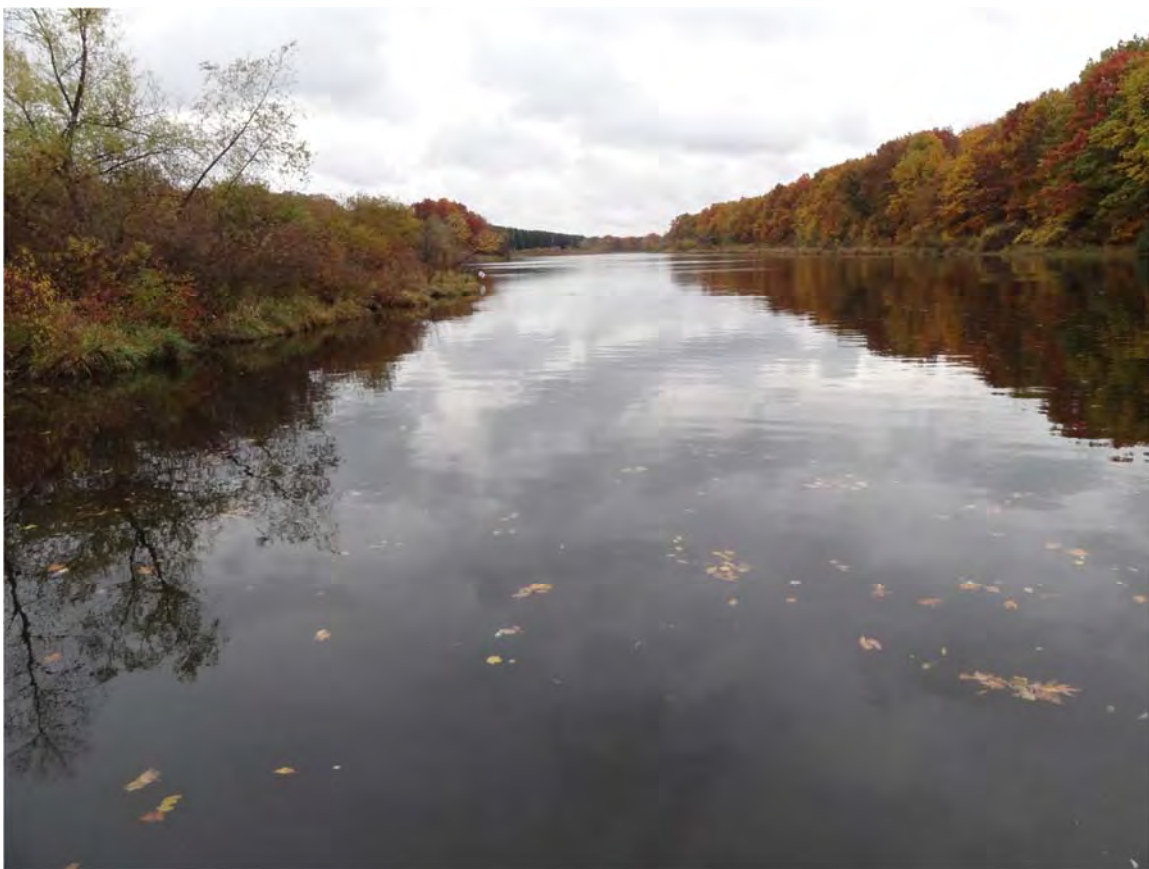
14. MP5.25 RDB area where spontaneous sheen and tar globs observed.

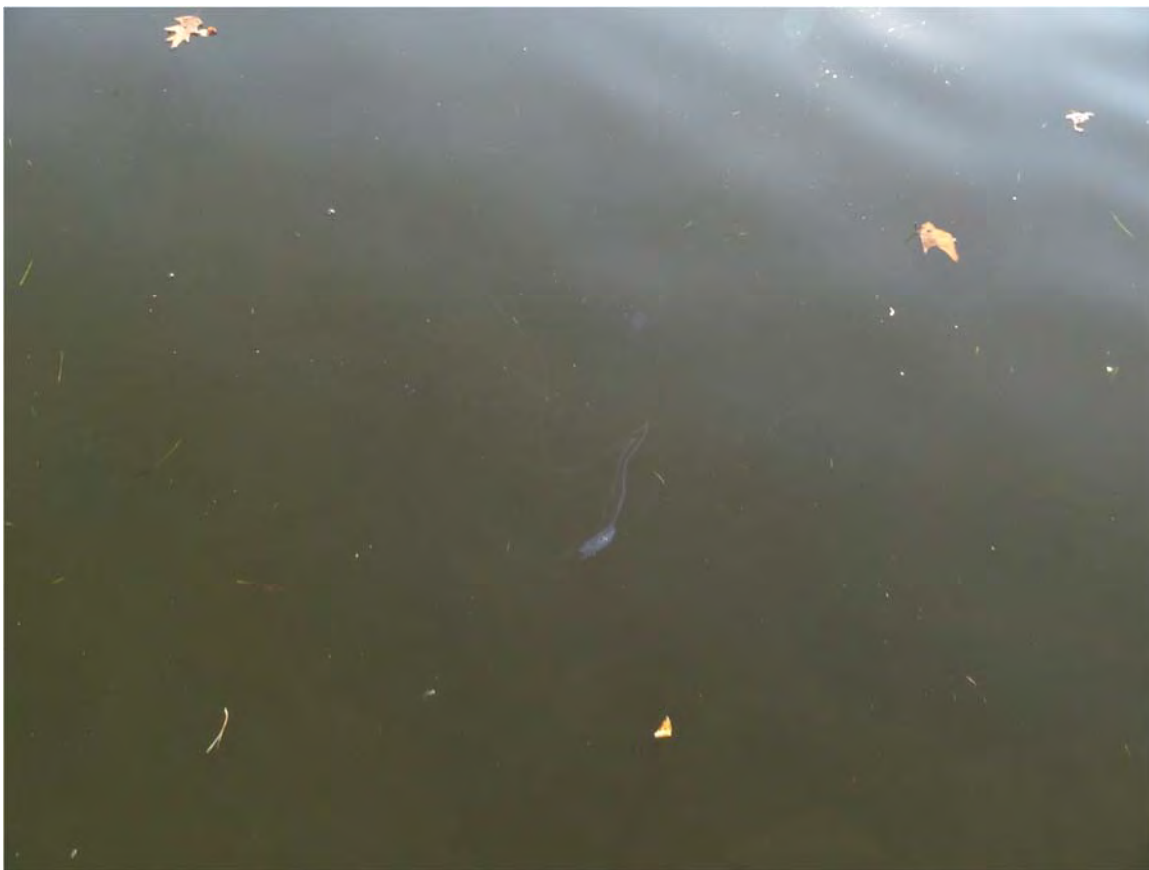
15. MP5.25 RDB spontaneous sheen and tar globs observed.

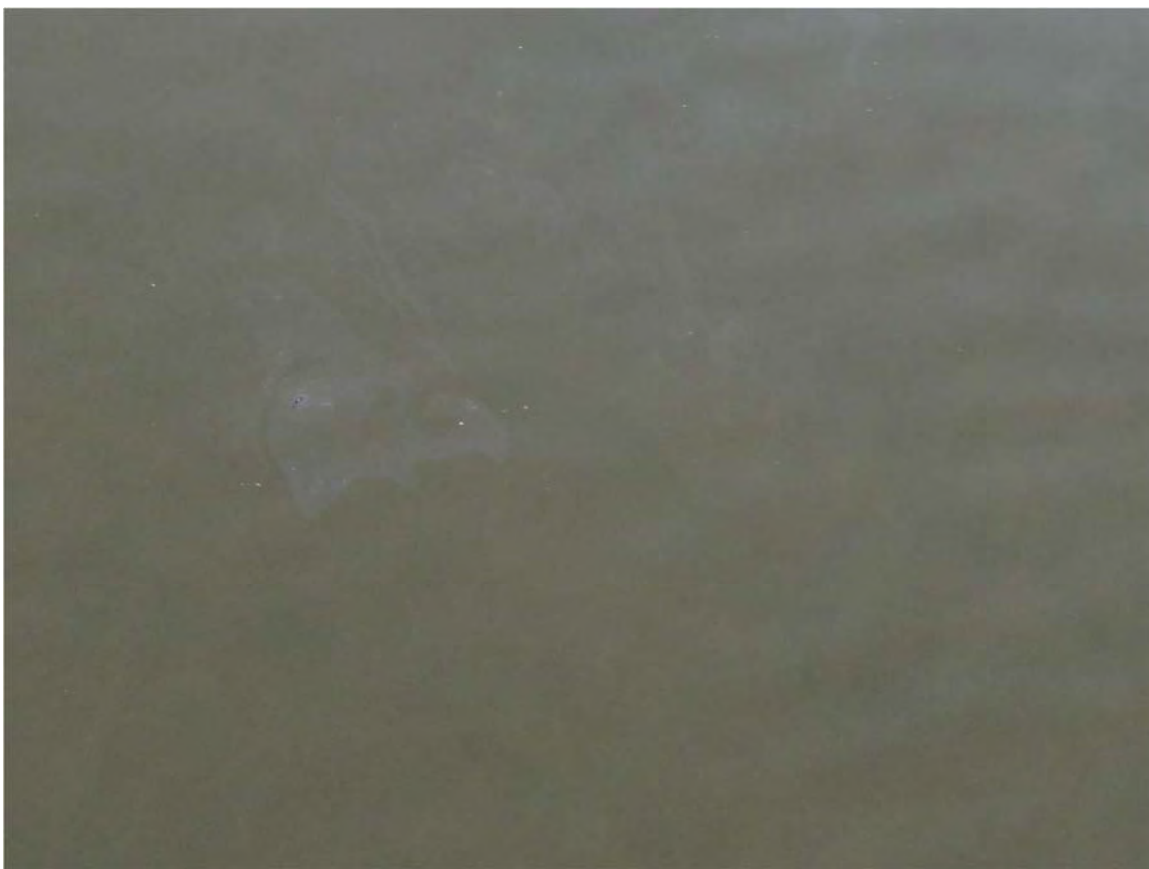
16. MP5.25 RDB spontaneous sheen and tar globs observed.

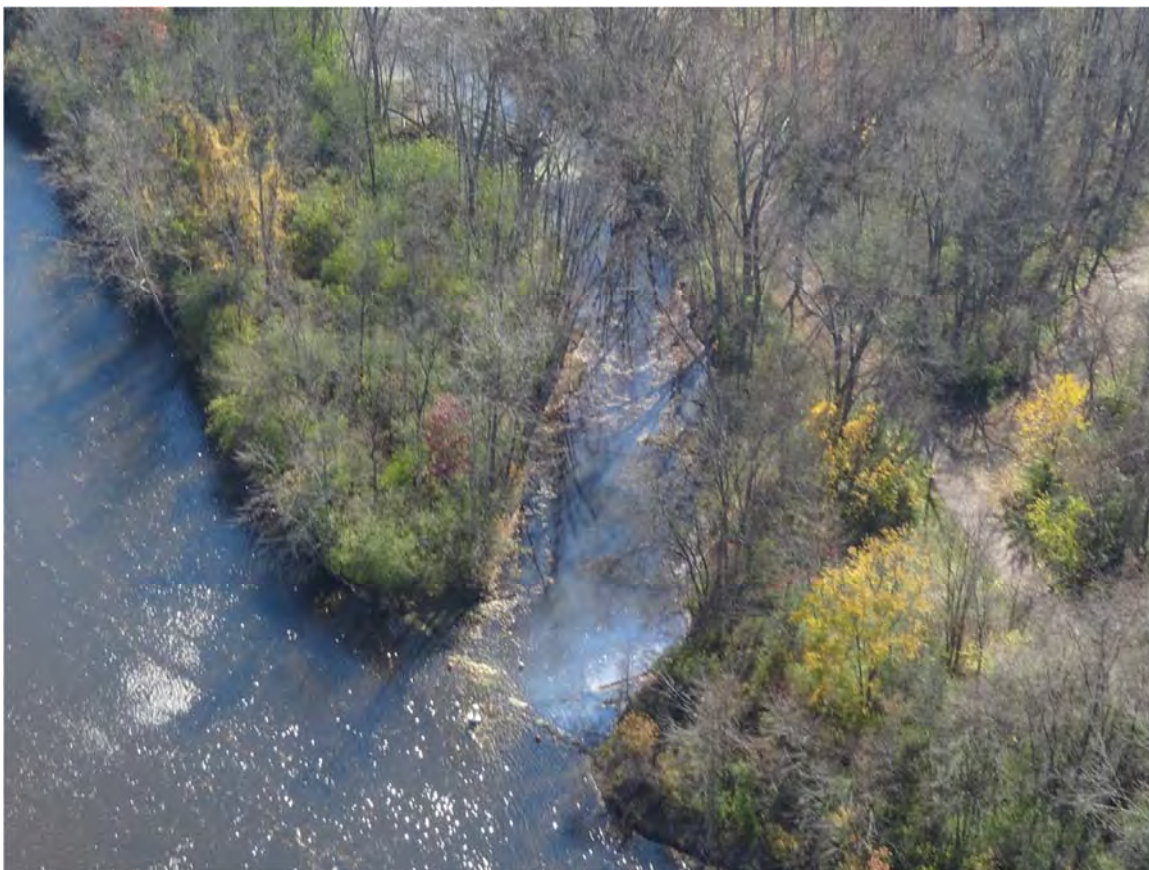
**25. MP19.25 Sediment Trap observed sheen collecting.**

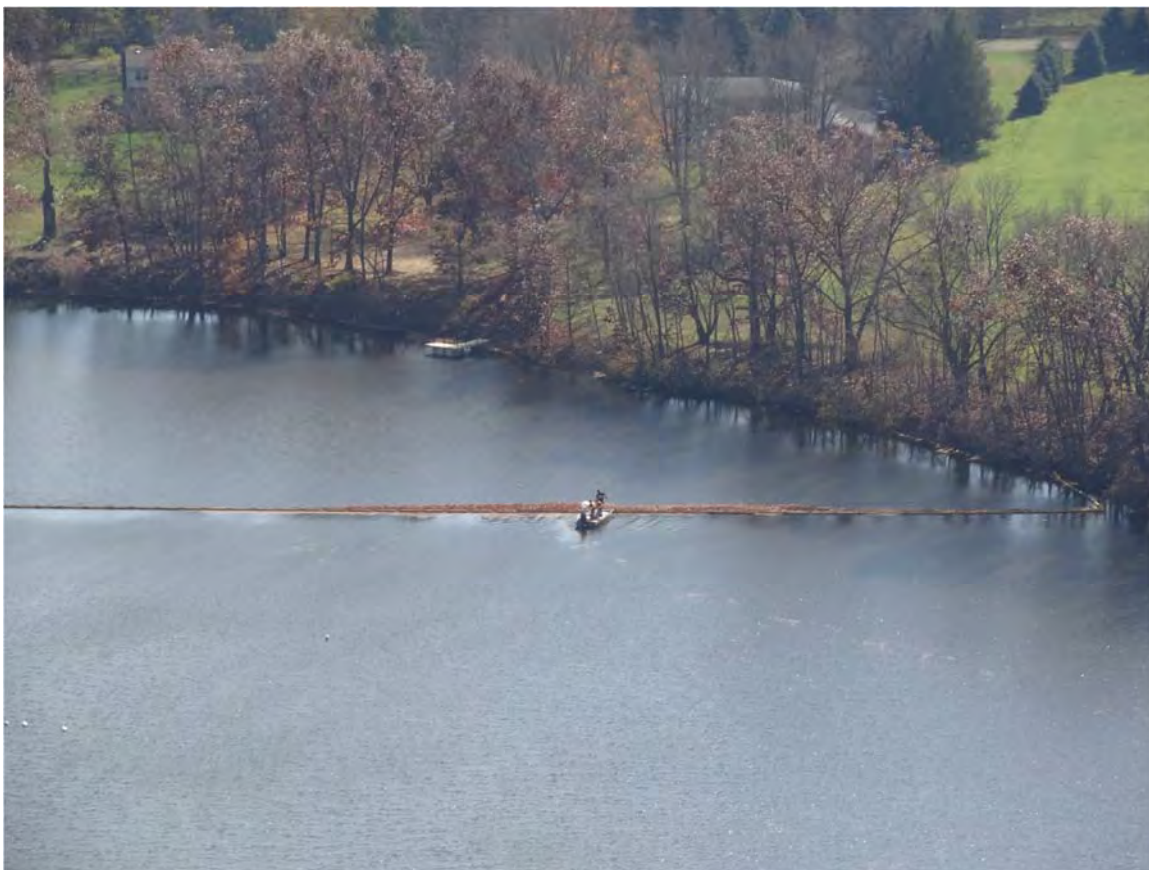
**33. Morrow Lake Delta observed a crew removing debris from Gate B.**
