# Situation Photo Log

Saturday, October 27, 2012

Kalamazoo River / Enbridge Spill

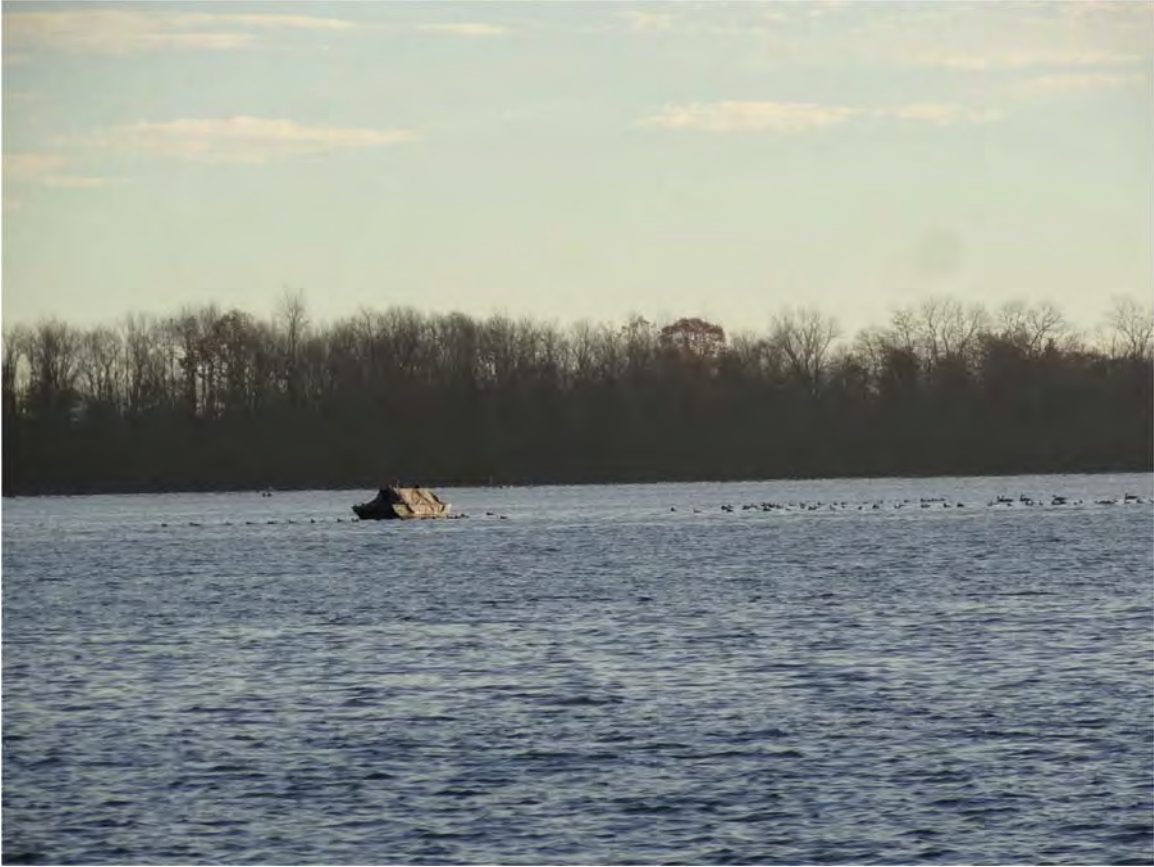
**1. Morrow Lake hunter observed between Rowe Island and the little island.**

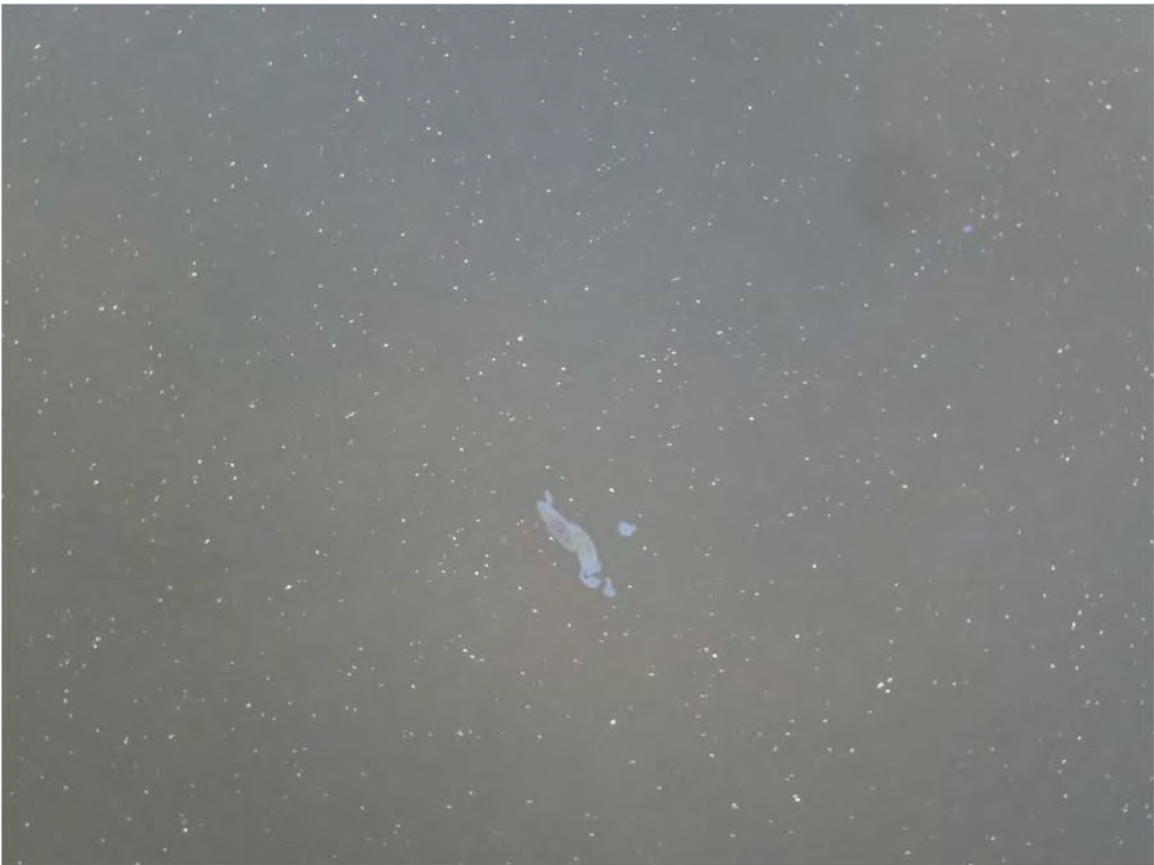
**2. Morrow Lake south cove sheen and tar globs observed. Quantity of sheen would not require a sweep boat.**

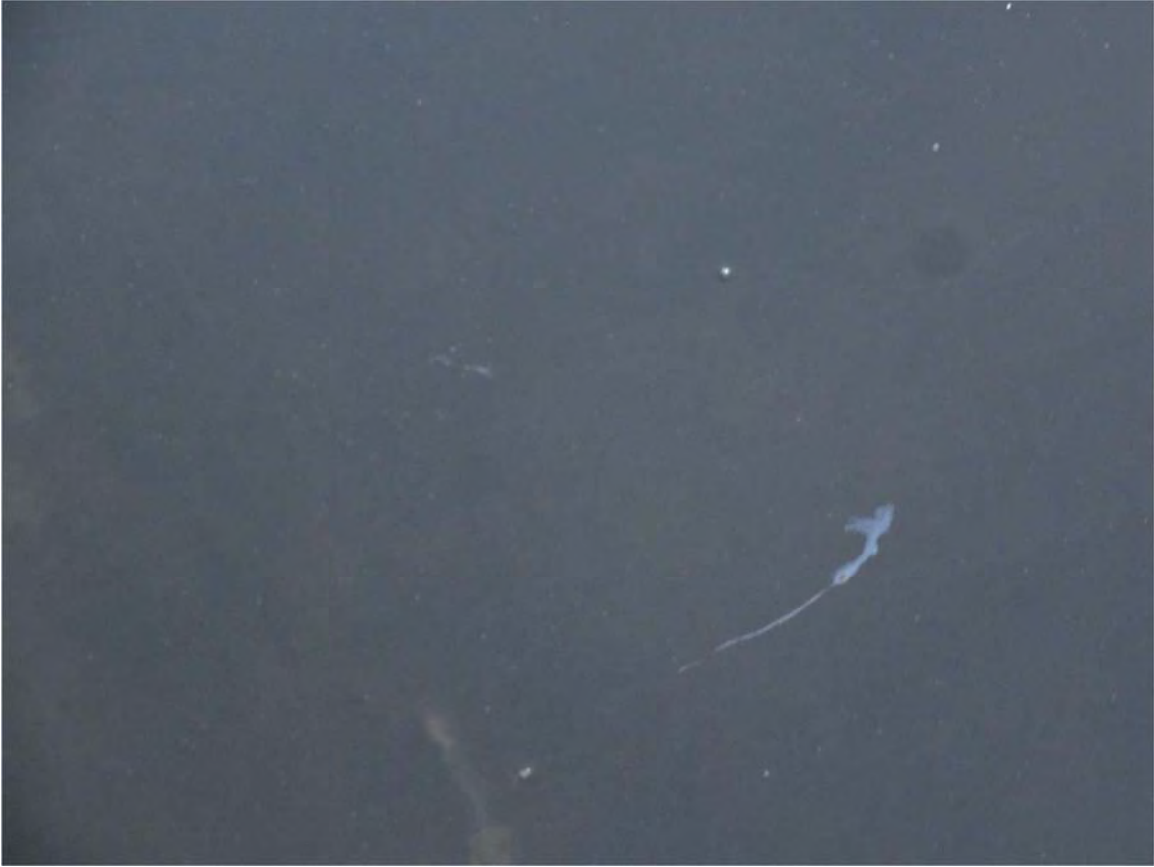
3. Morrow Lake south cove sheen and tar globs observed. Quantity of sheen would not require a sweep boat.

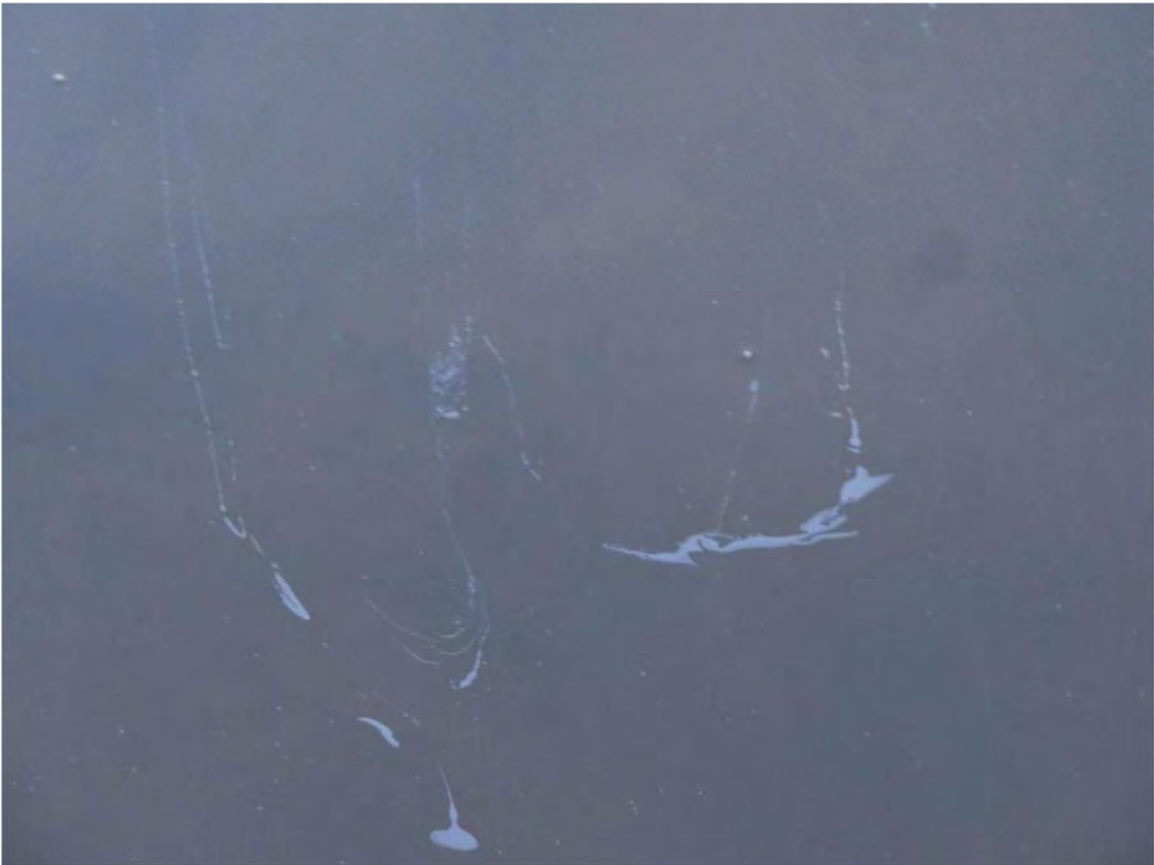
4. Morrow Lake south cove sheen observed. Quantity of sheen would not require a sweep boat.

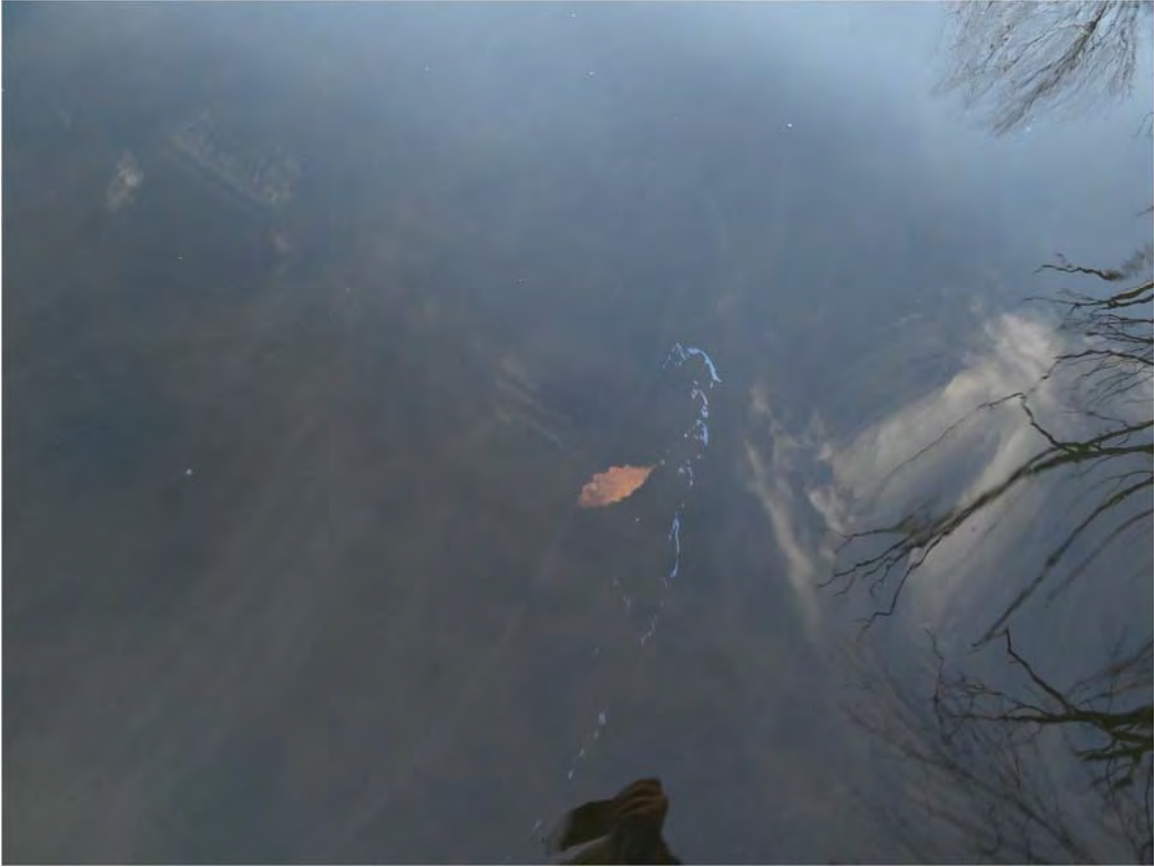
5. Morrow Lake south cove sheen observed. Quantity of sheen would not require a sweep boat.

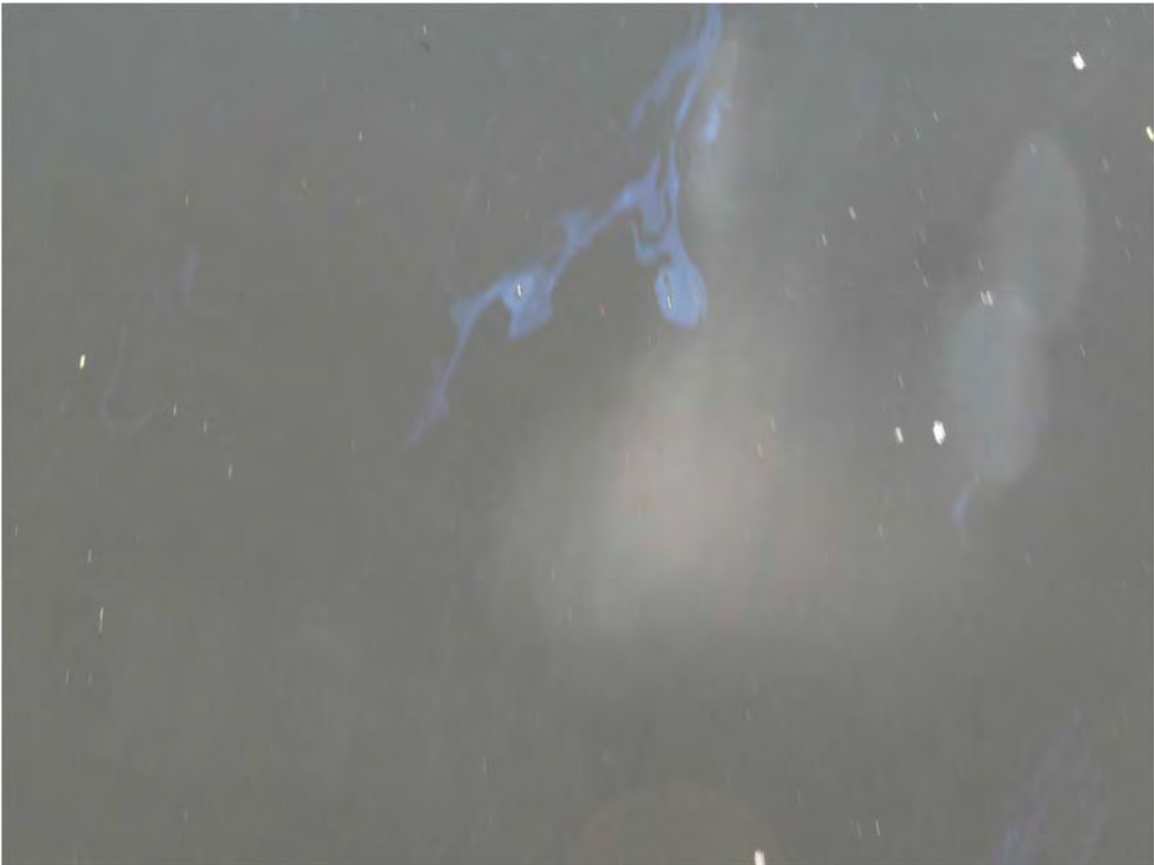
6. Morrow Lake Delta observed sheen and tar globs collecting along Gate E. Quantity of sheen would not require a sweep boat.

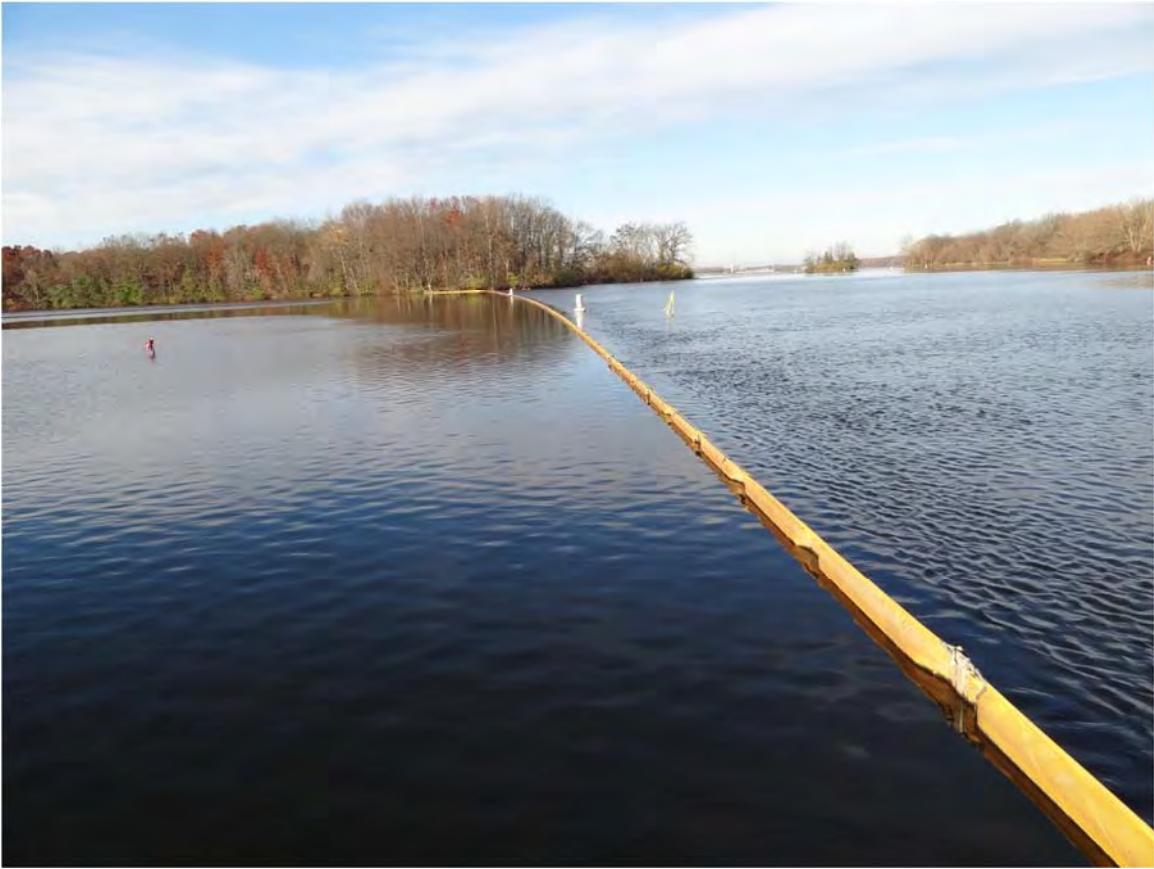
7. Morrow Lake Delta Gate C observed sheen and tar globs collecting along the boom.

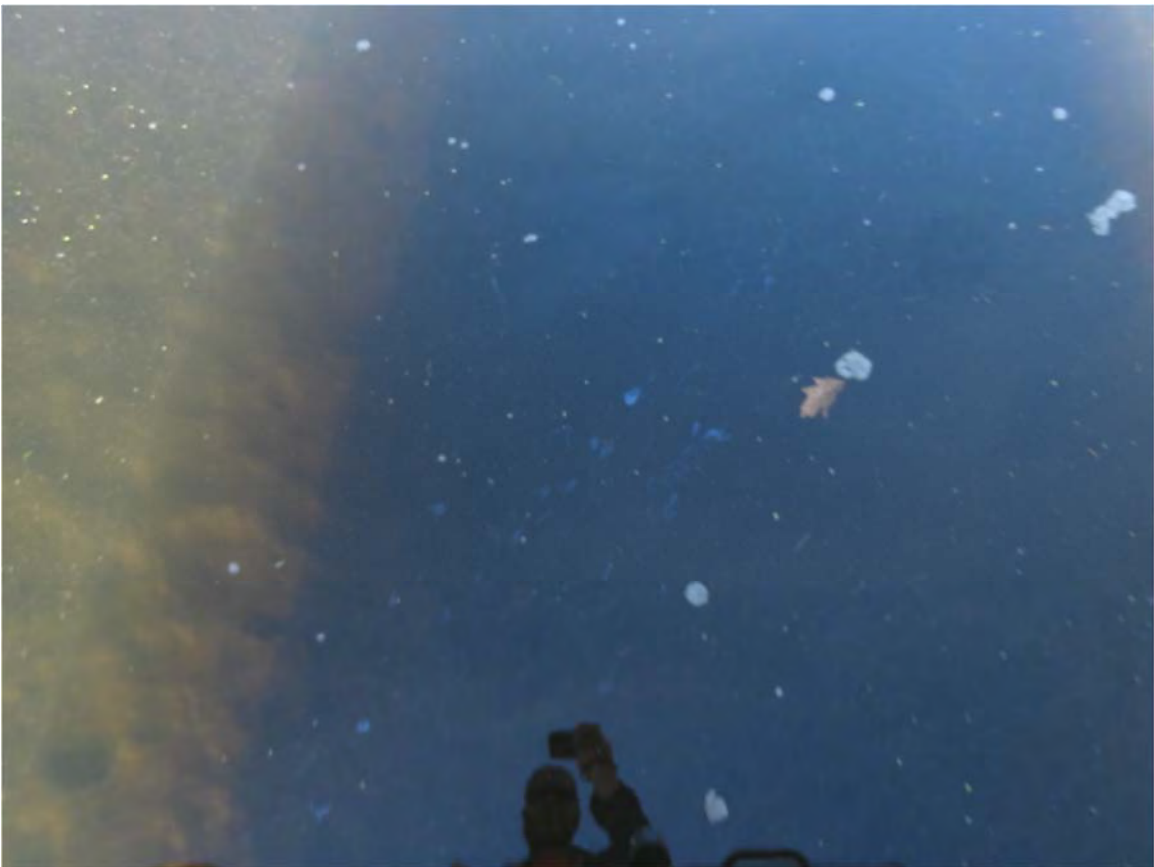
8. Morrow Lake Delta Gate C observed sheen and tar globs collecting along the boom.

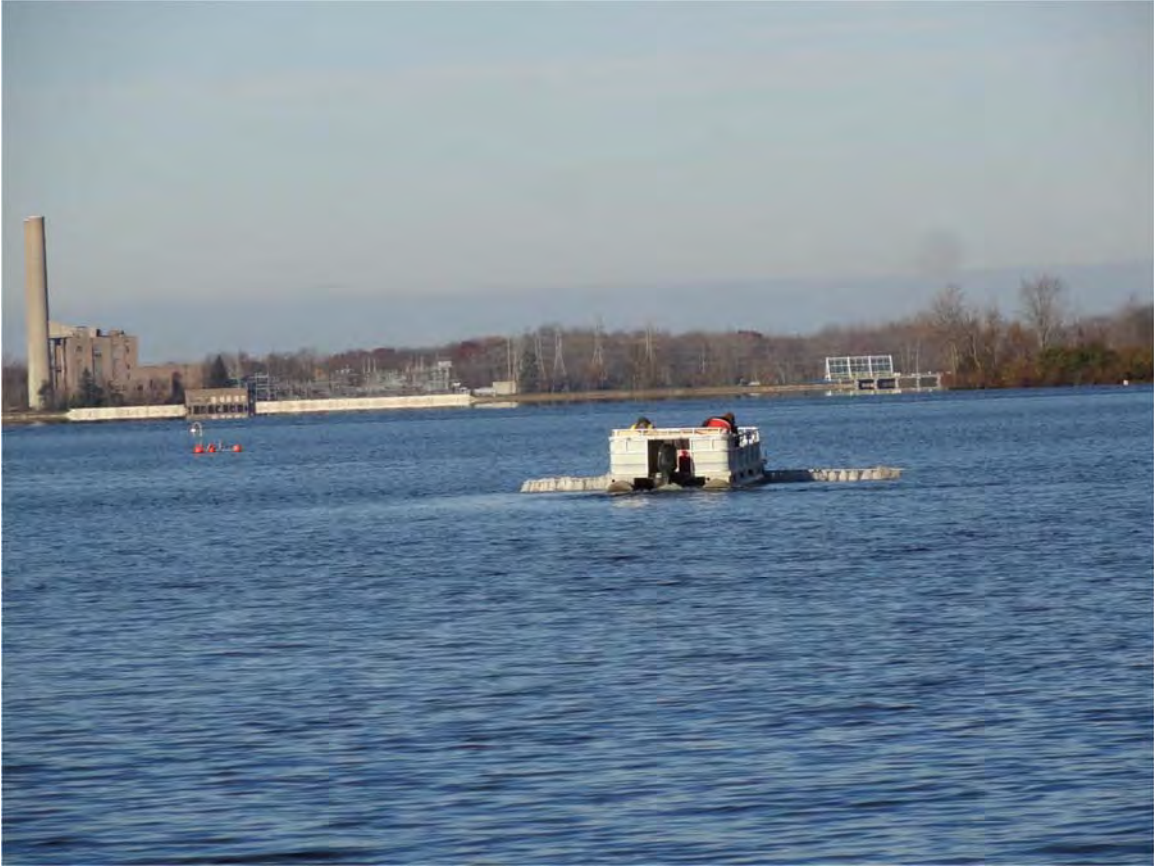
9. Morrow Lake Fan observed the sweep boat operating.

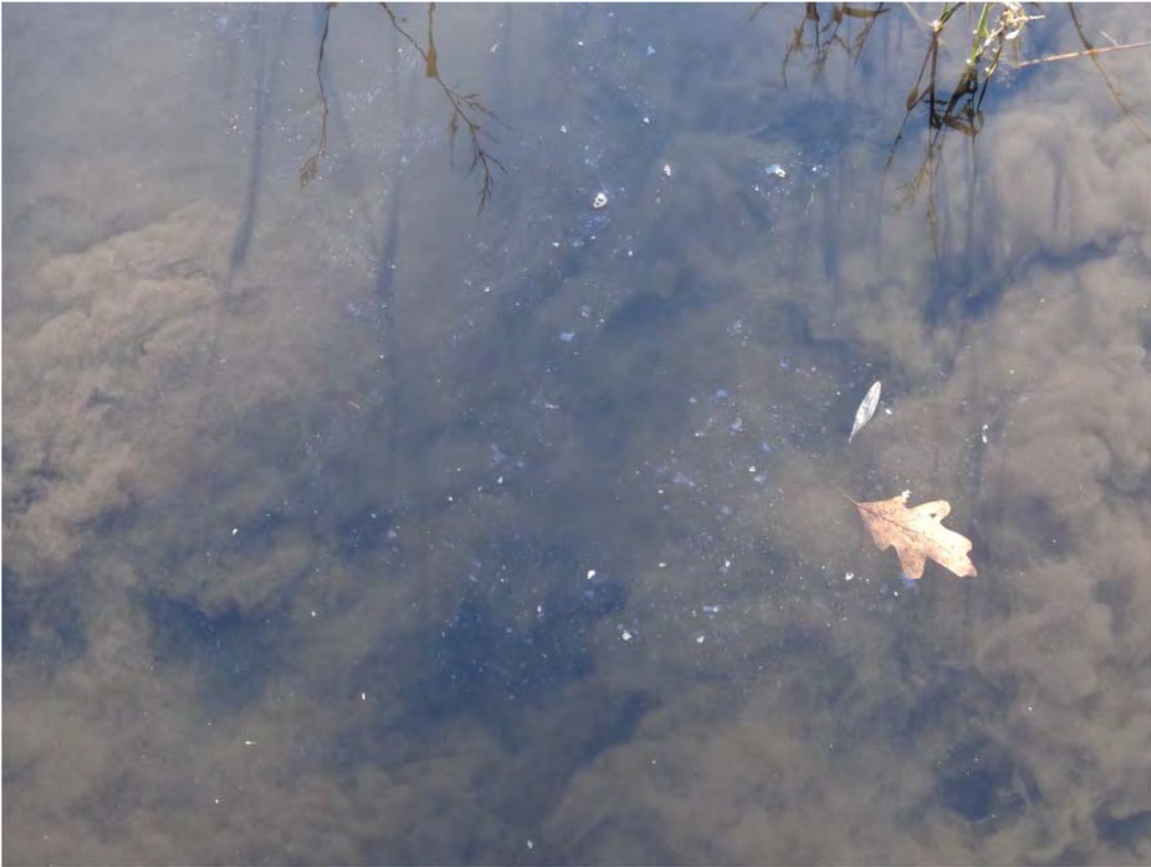
11. MP26.0 Sediment Trap boat generated sheen observed.

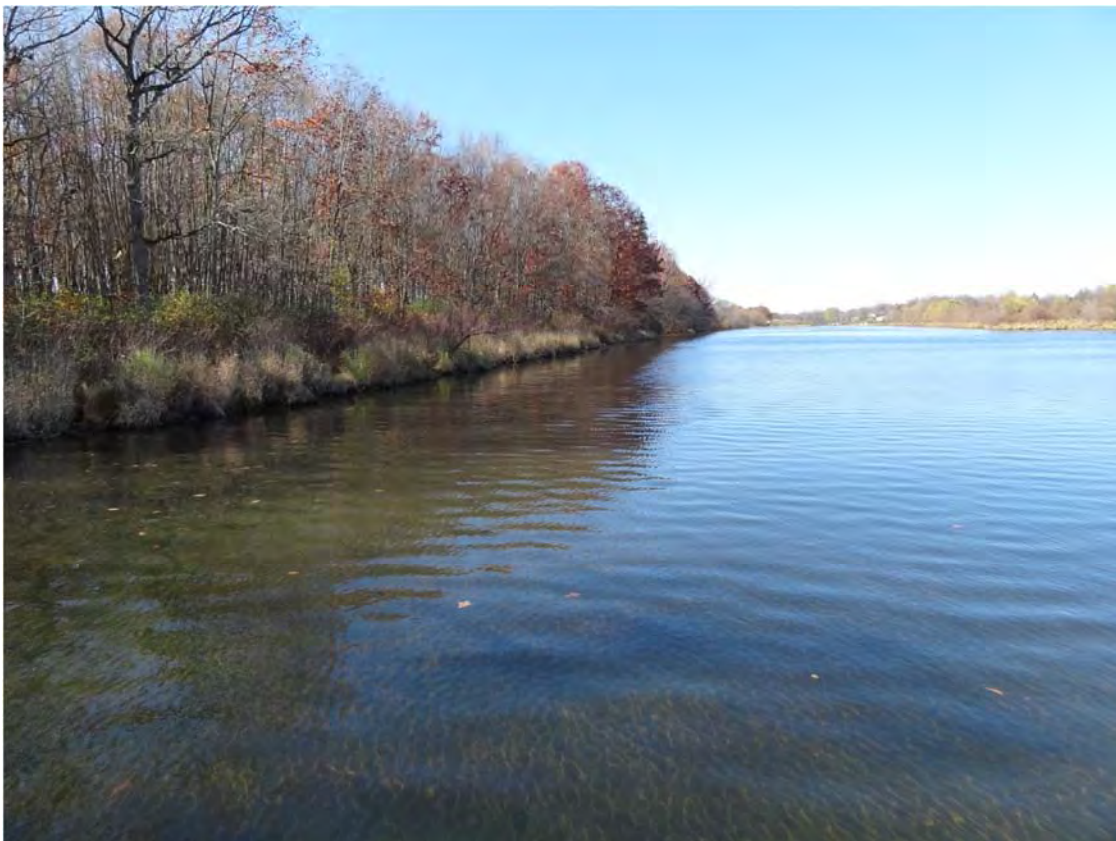
12. MP5.15 LDB Area where sheen and tar globs were observed.

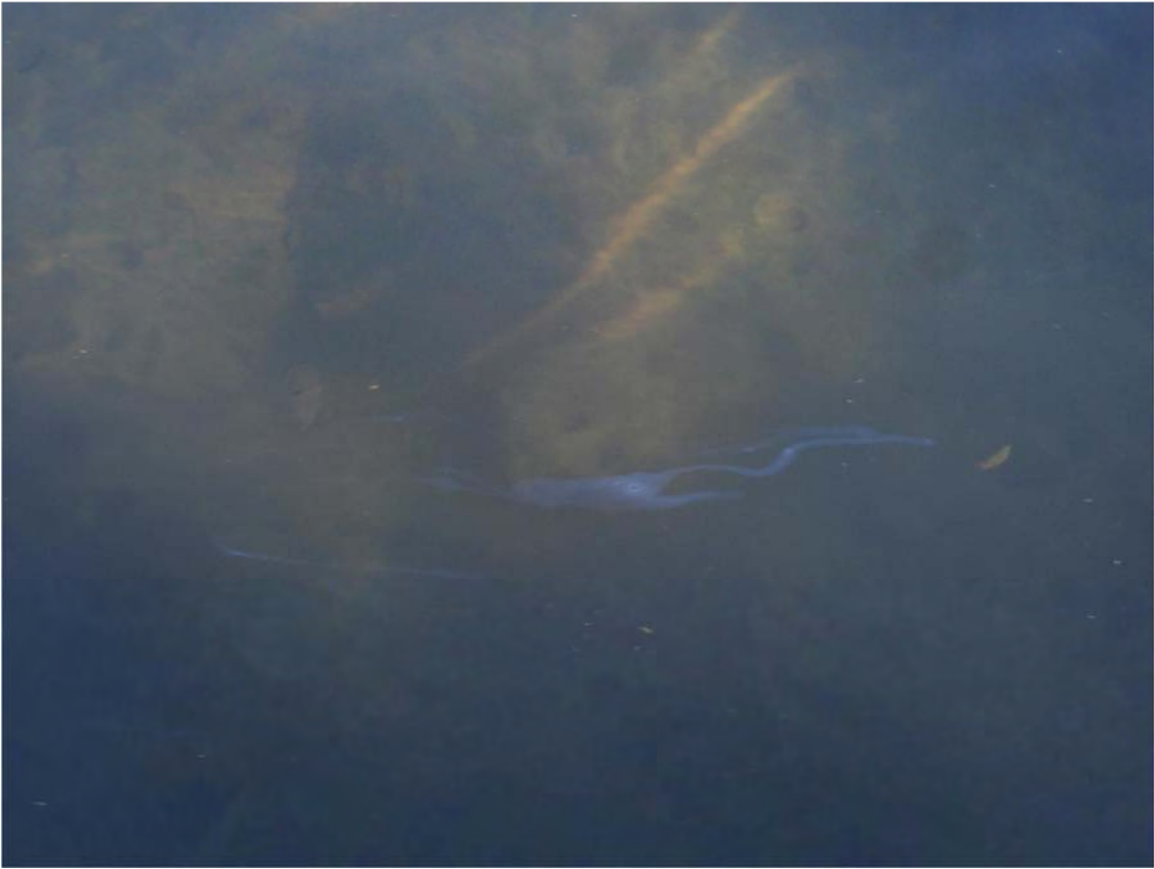
13. MP5.15 LDB sheen and tar globs observed.

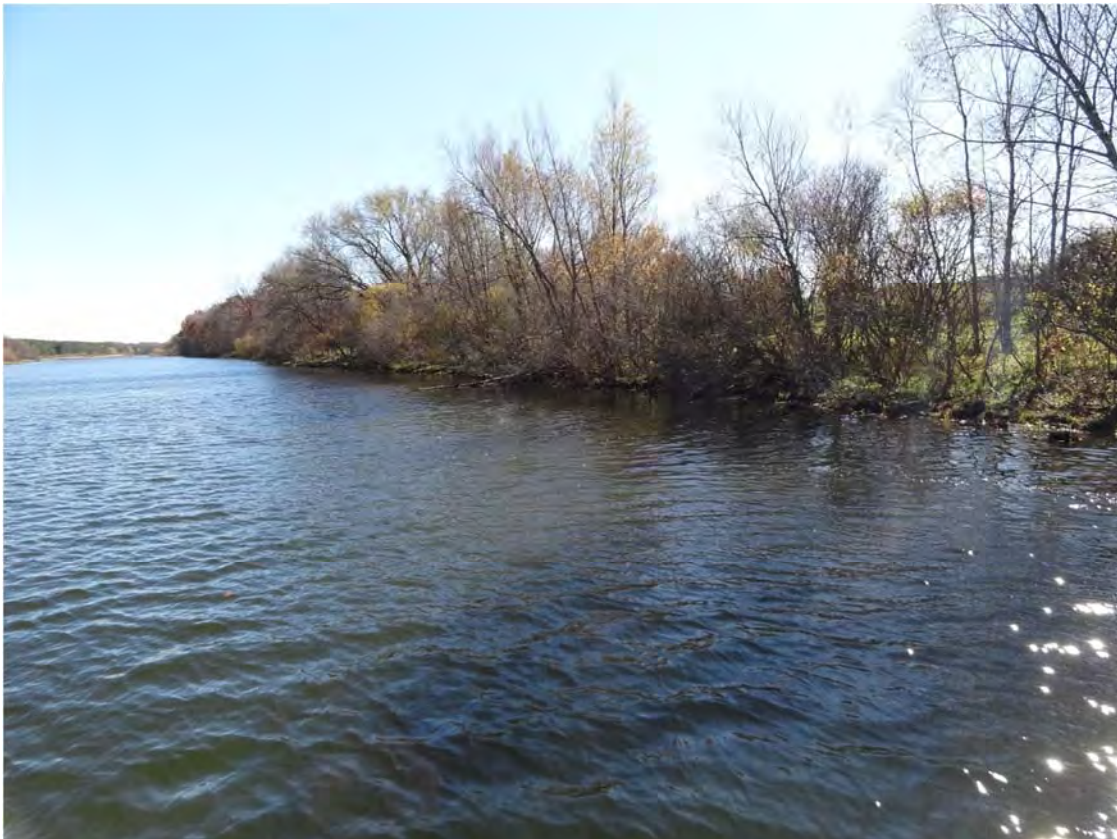
14. MP5.45 LDB area where sheen and tar globs were observed.

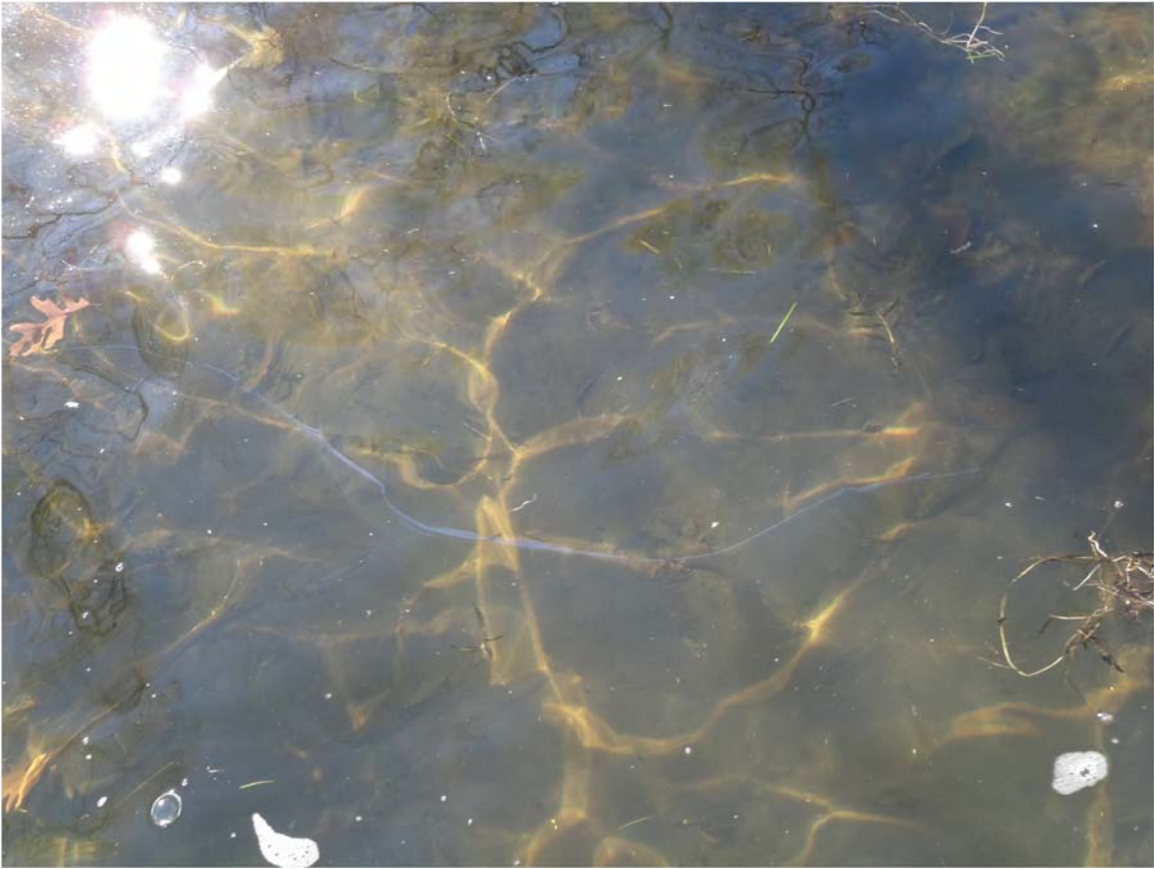
15. MP5.45 LDB sheen and tar globs observed.

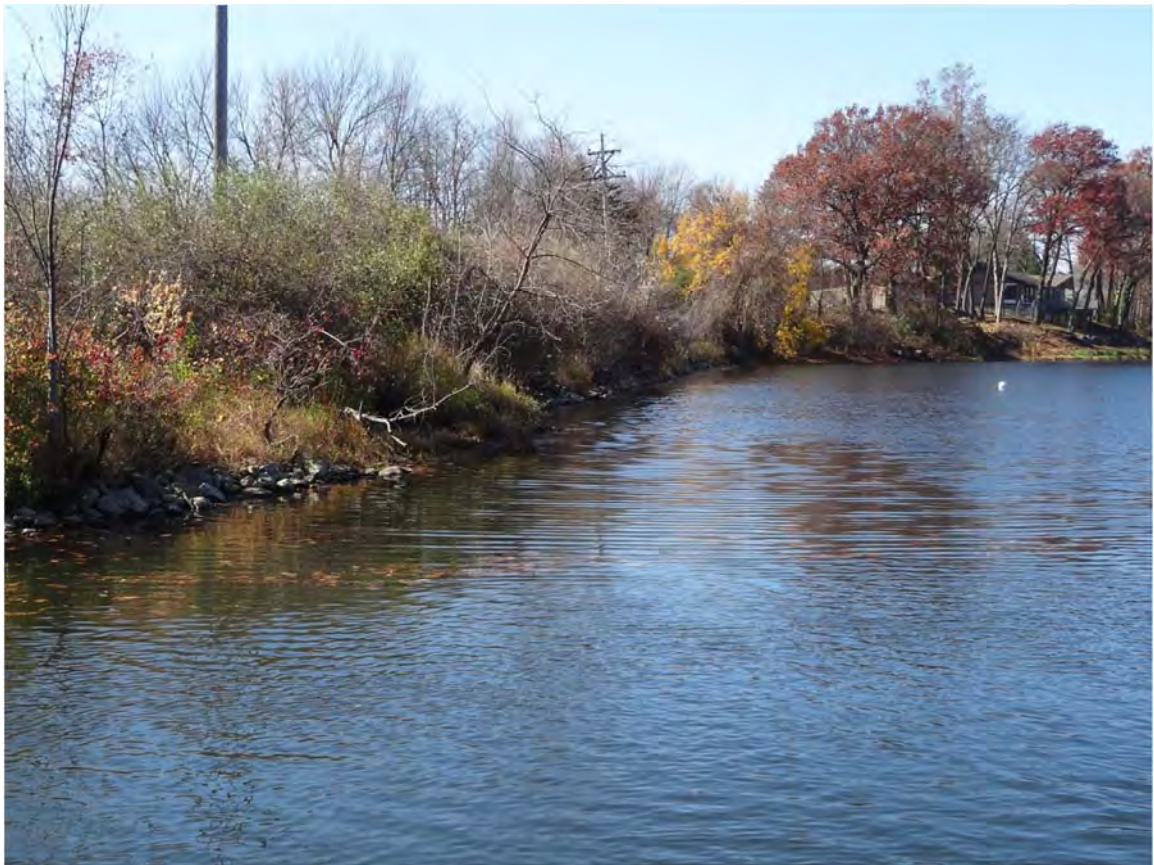
16. MP5.63 LDB area where sheen and tar globs were observed.

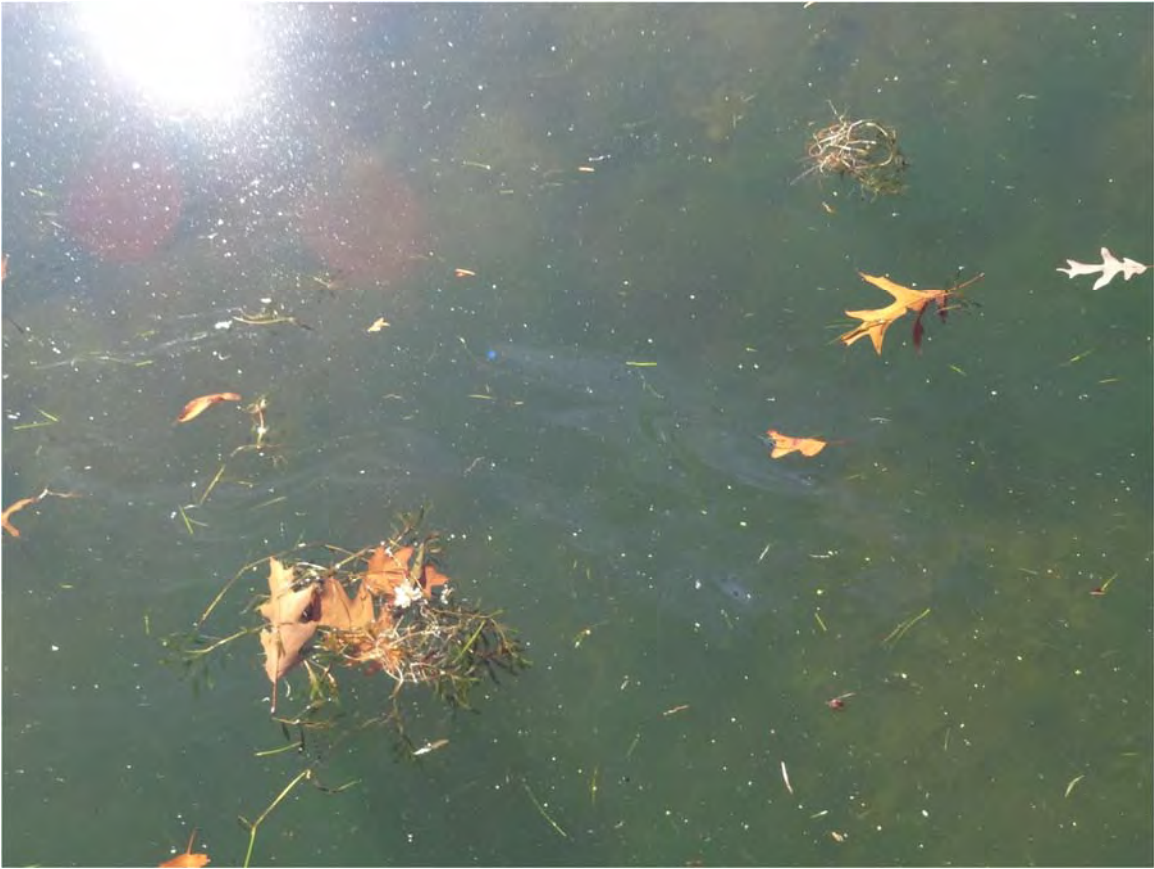
17. MP5.63 LDB sheen and tar globs observed.

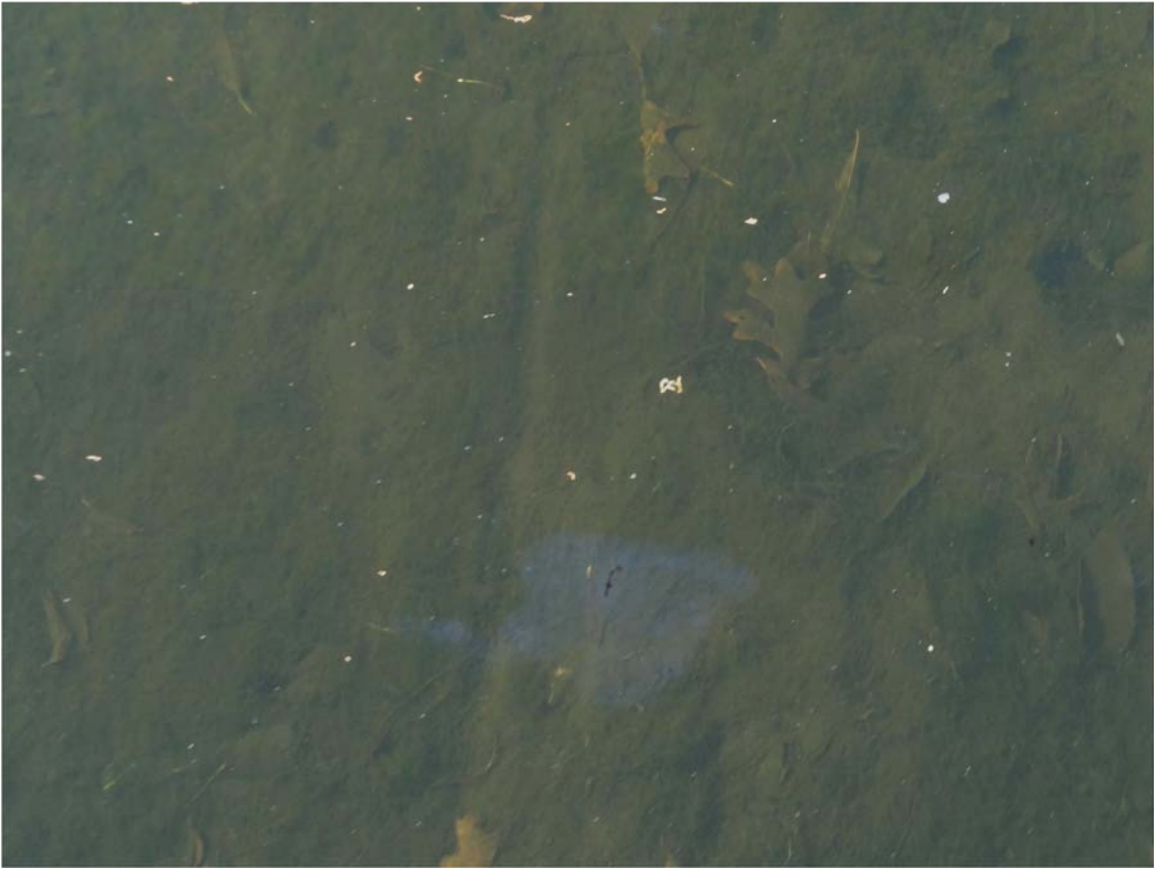
19. Observed sheen and tar globs collecting along the Ceresco Dam Control Point Boom.

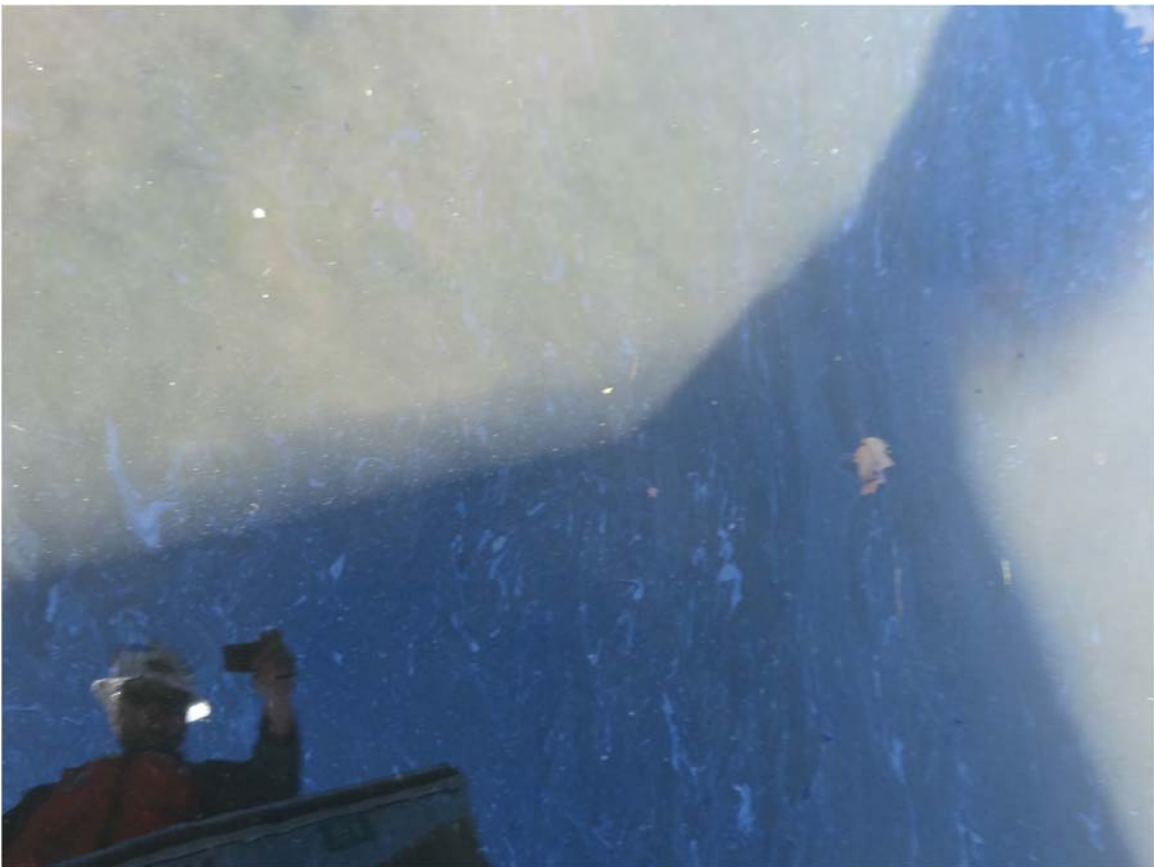
20. Ceresco Dam Control Point Boom boat generated sheen.

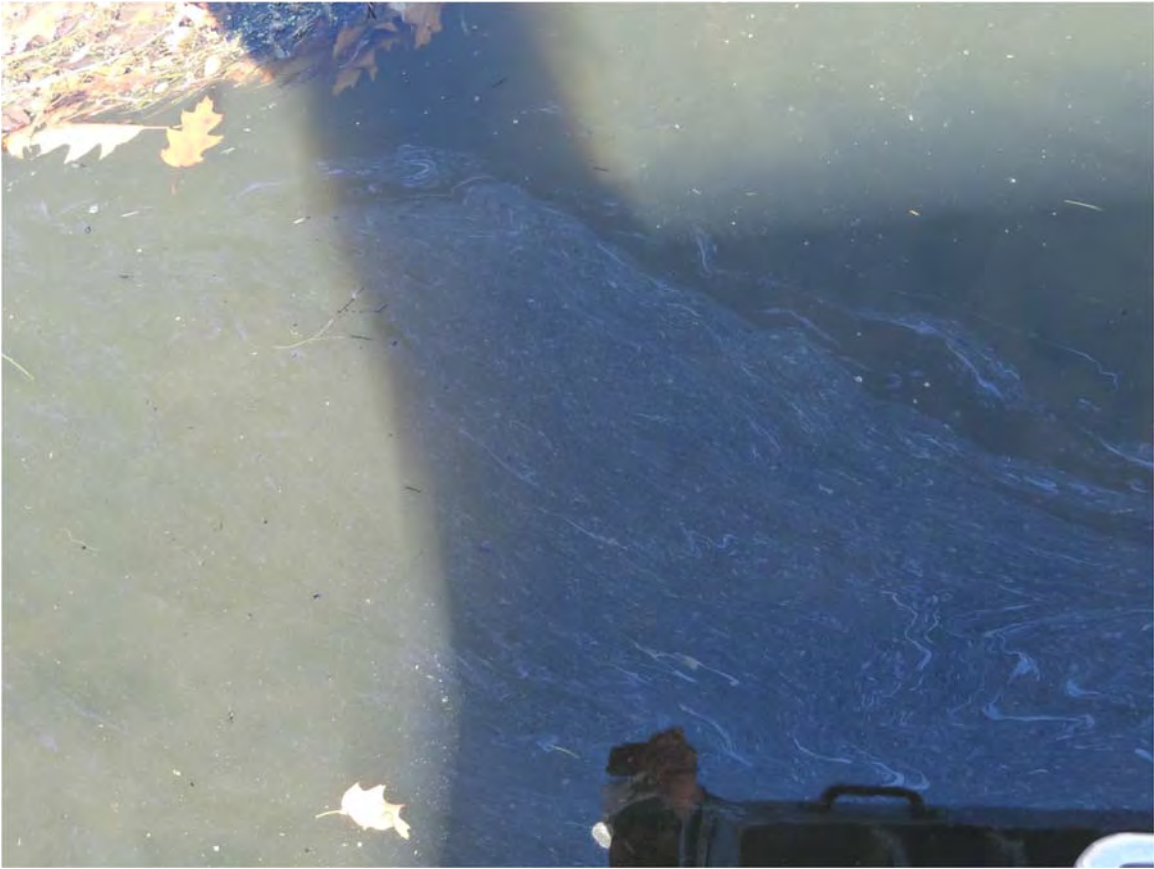
21. Ceresco Dam Control Point Boom boat generated sheen.

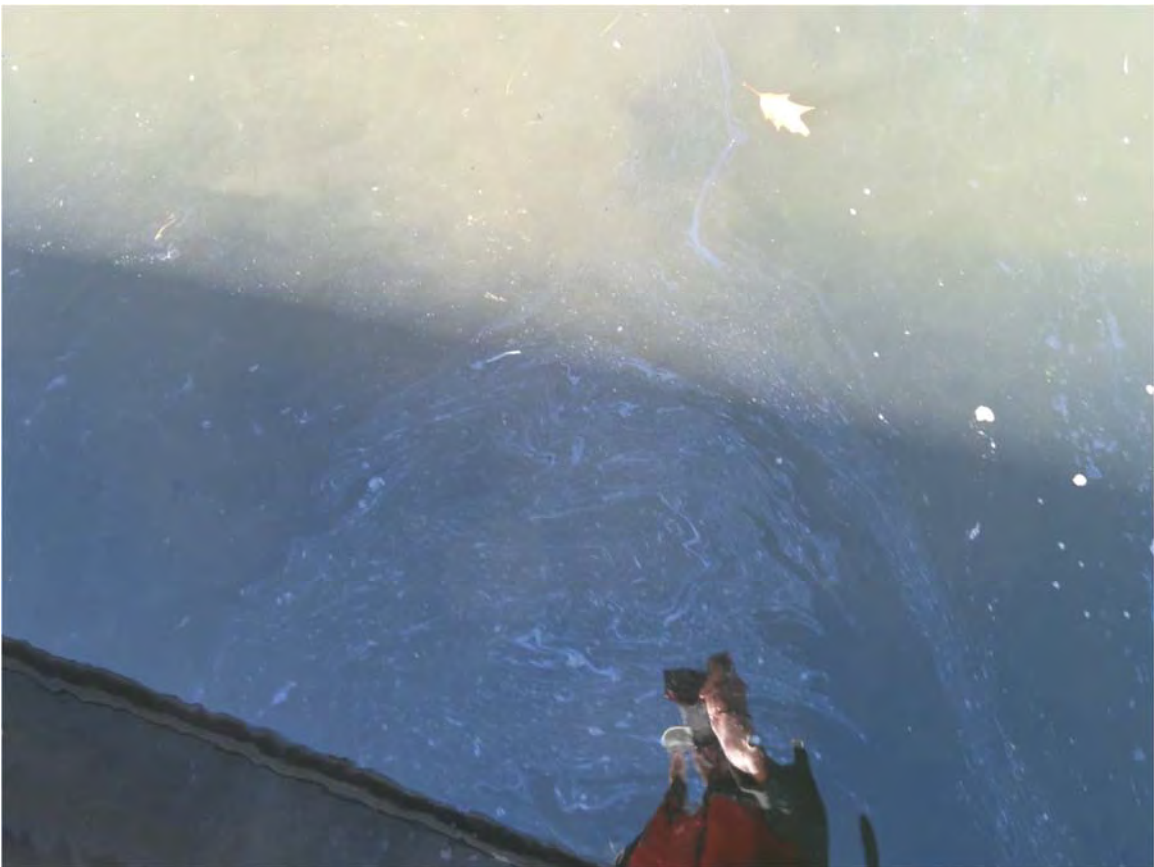
22. Ceresco Dam Control Point Boom boat generated sheen.
