# Situation Photo Log

Monday, October 29, 2012

Kalamazoo River / Enbridge Spill

Prepared by:  
Larry Rader  
START-USEPA  
Situation Unit

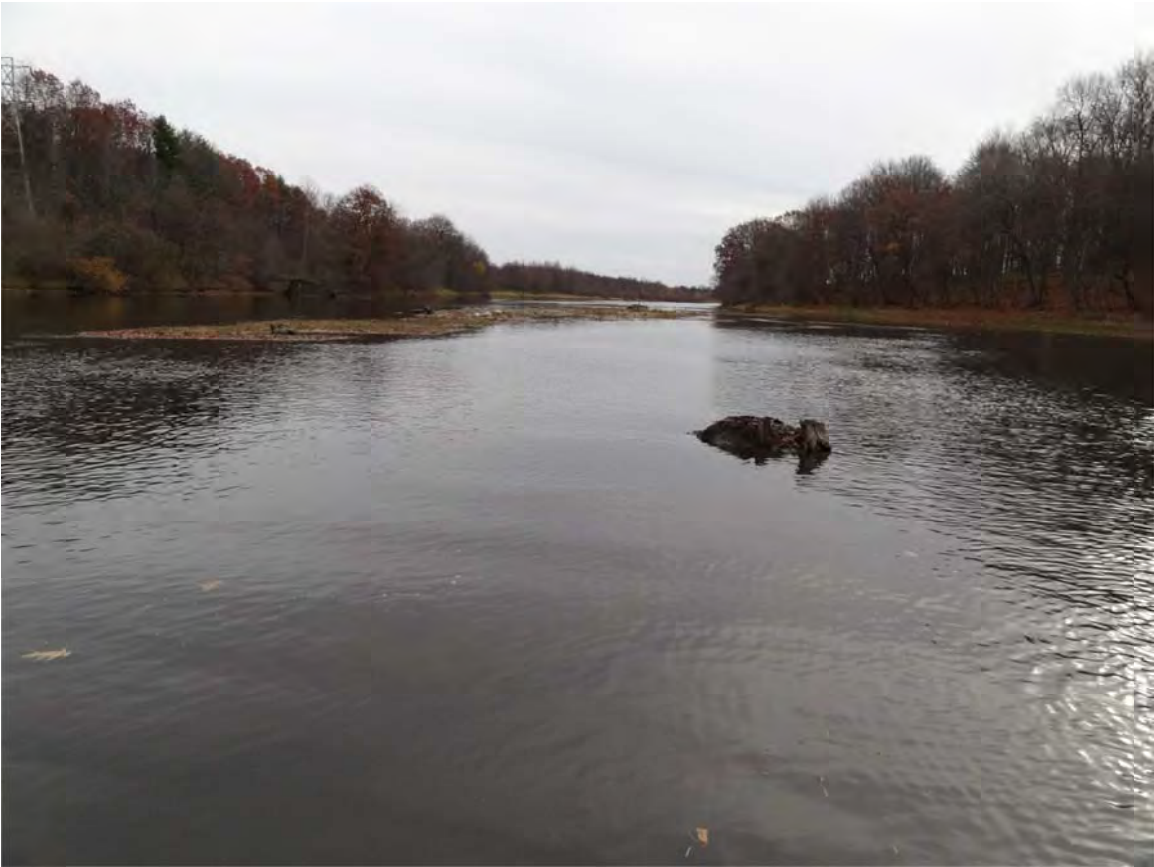
1. MP 4.5 river channel, boat generated sheen and tar globules observed.

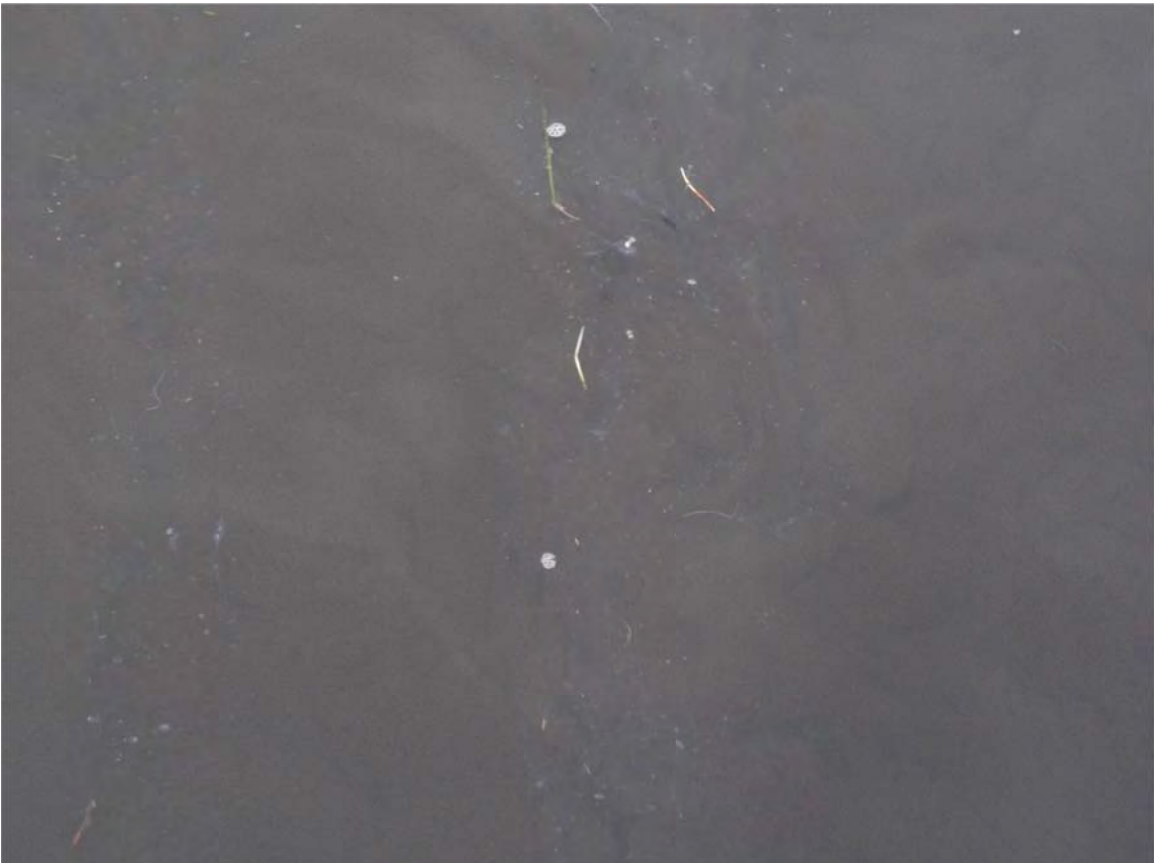
2. MP 4.5, boat generated sheen and tar globules observed.

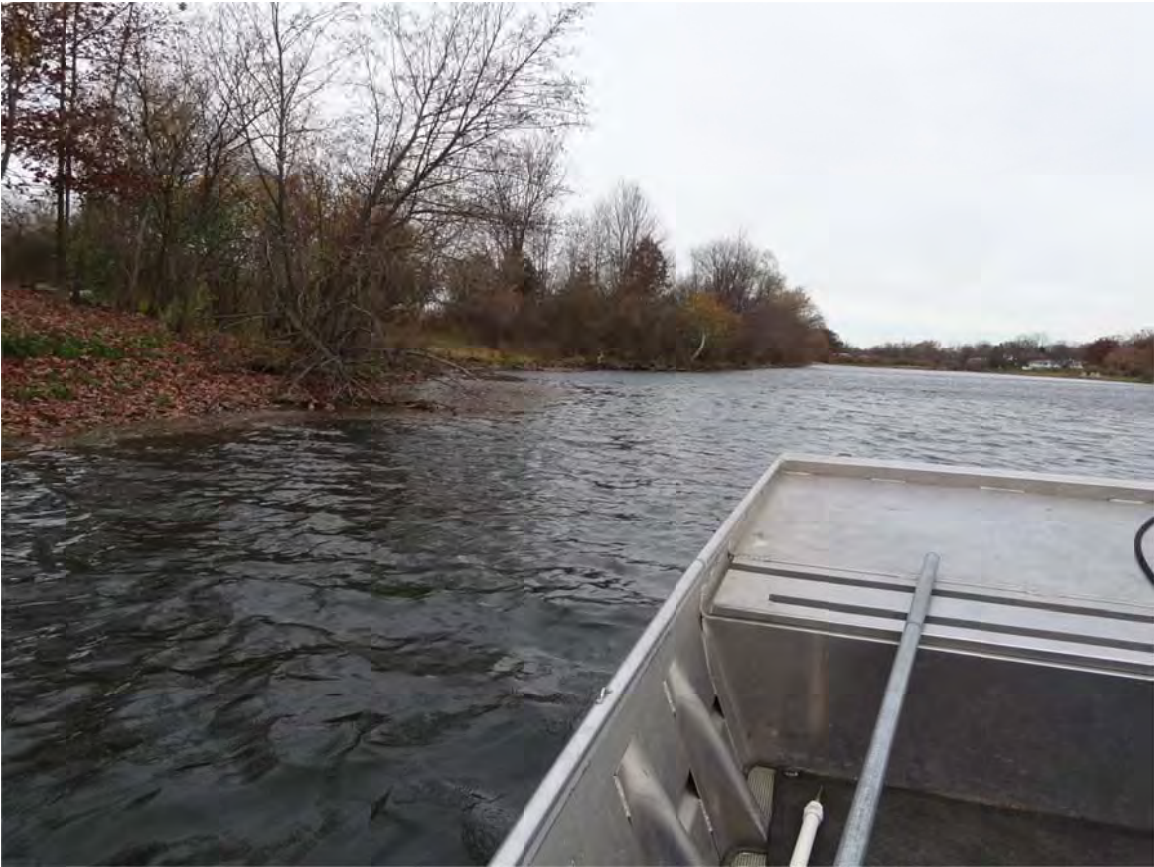
3. MP 5.25 LDB, no sheen observed in choppy water.

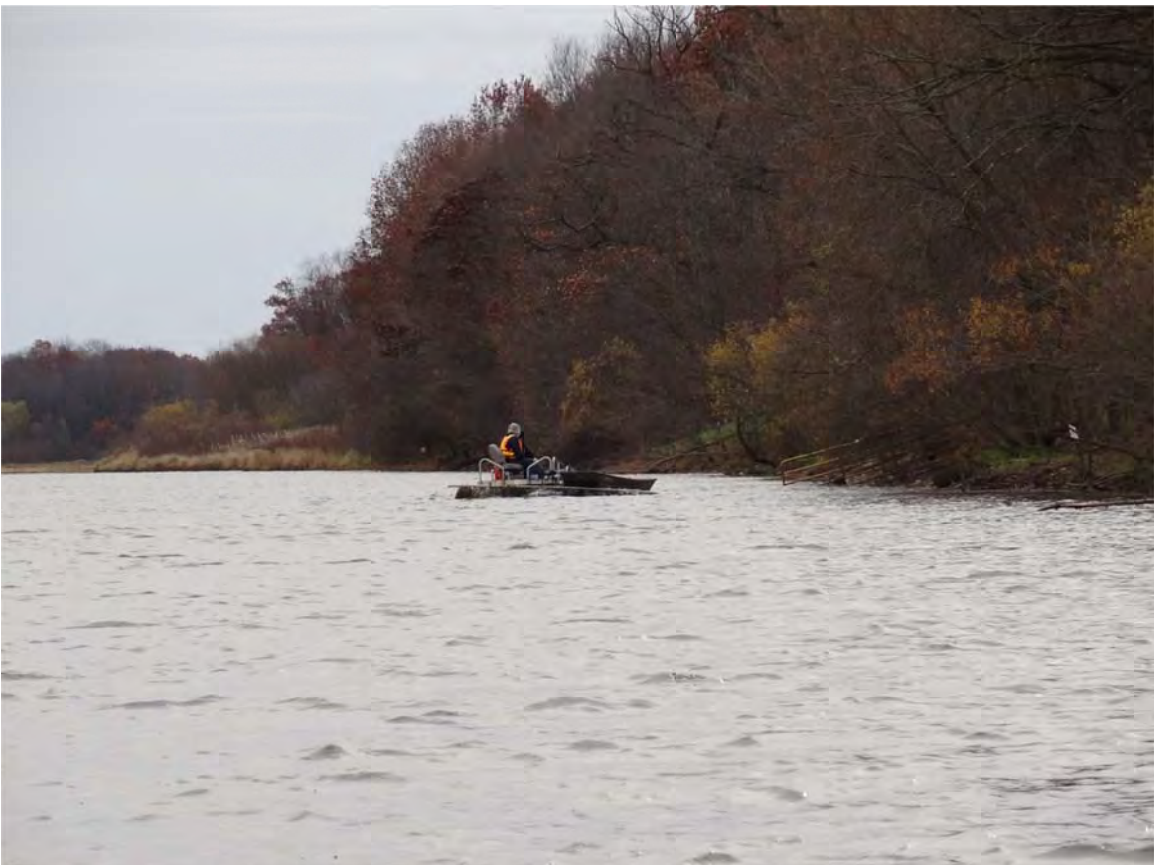
4. MP 5.25 LDB, sheen sweep boat observed.

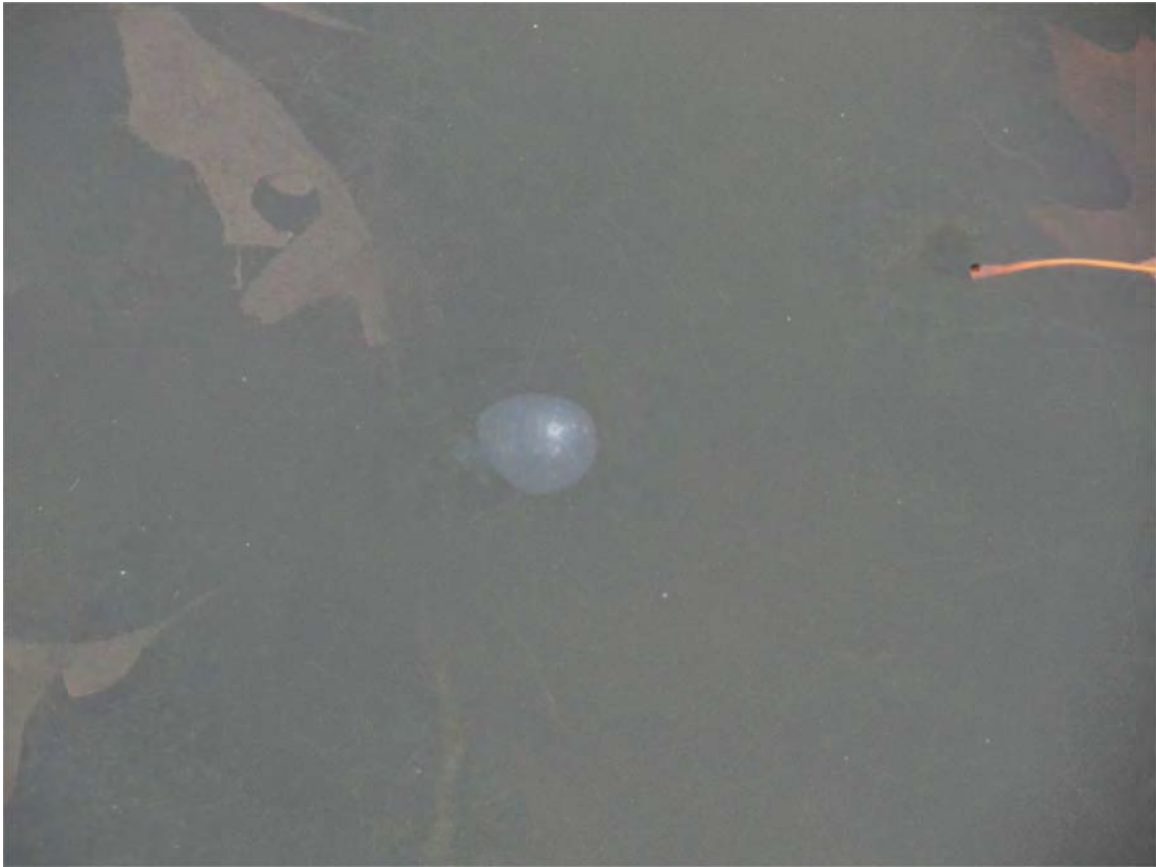
5. MP 5.75 RDB, spontaneous sheen and tar globule observed near pyramids at trestle above Ceresco Dam.

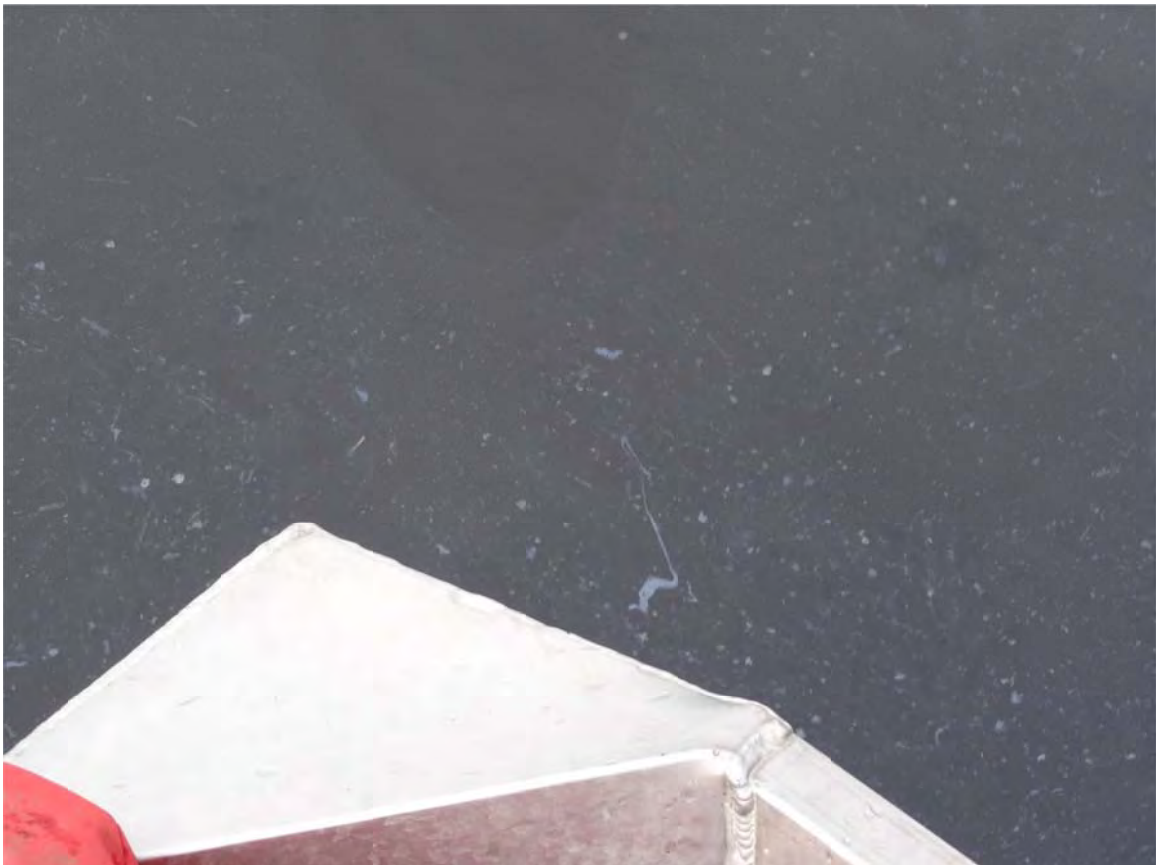
6. MP 5.75 RDB, boat generated sheen observed near trestle above Ceresco Dam. Sheen quantity would not warrant a sweep boat response.

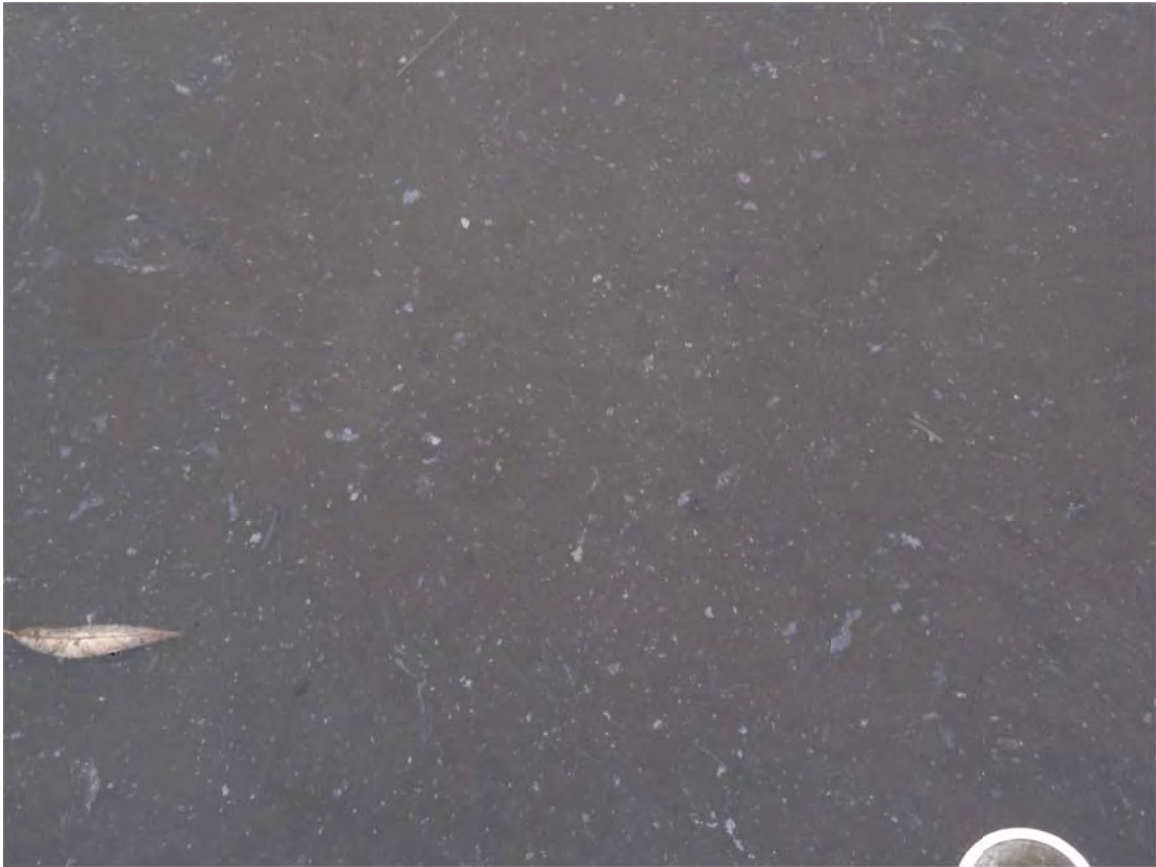
7. MP 5.75 RDB, boat generated sheen observed near trestle above Ceresco Dam. Sheen quantity would not warrant a sweep boat response.

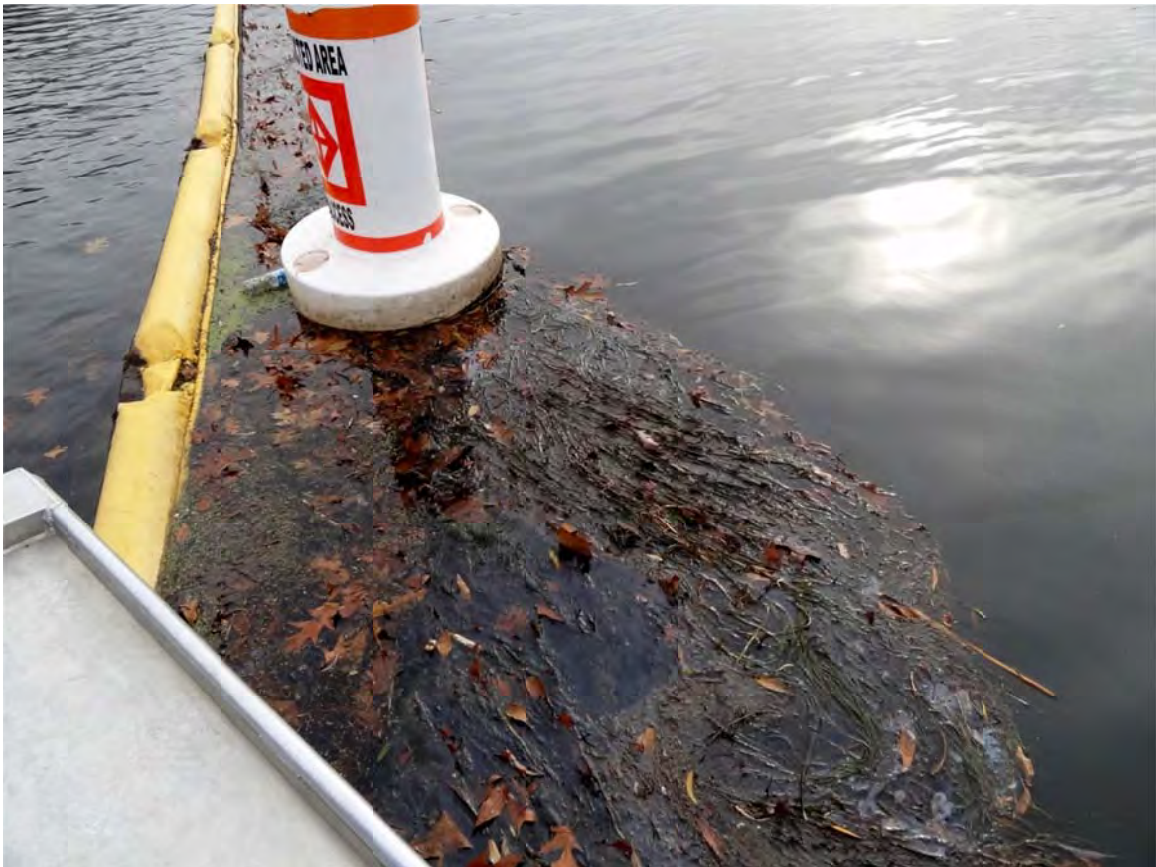
8. Ceresco Dam control point, sheen observed within debris at control point.

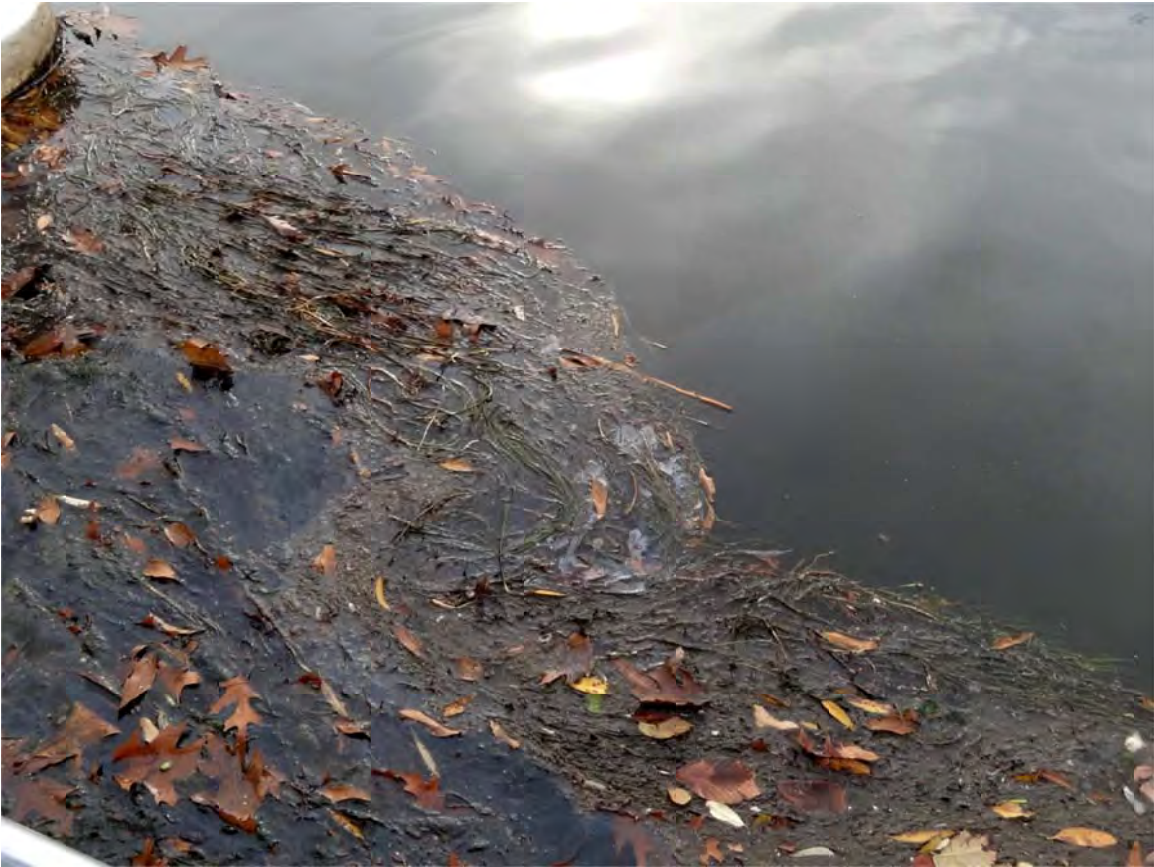
9. Ceresco Dam control point, sheen observed within debris at control point.

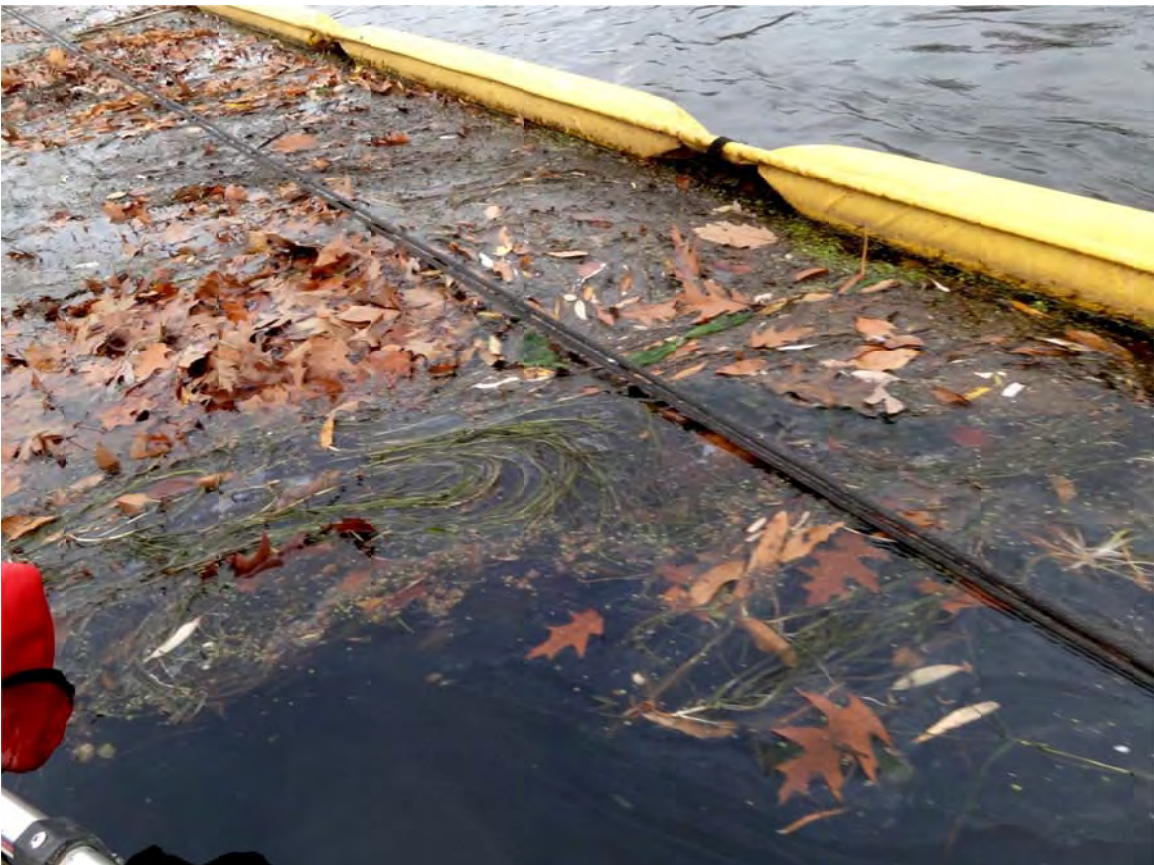
10. Ceresco Dam control point, sheen and tar globules observed within debris at containment point.

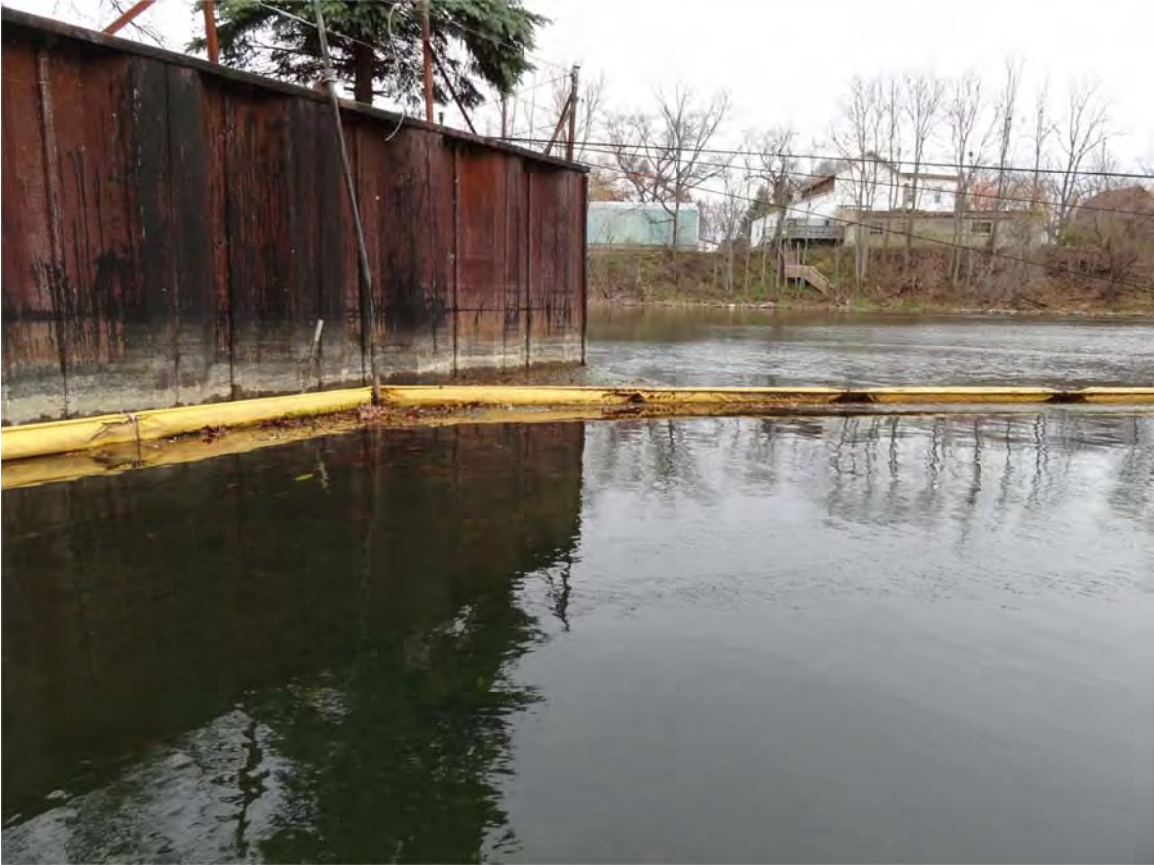
**11. Ceresco Dam control point, sheen and tar globules observed.**

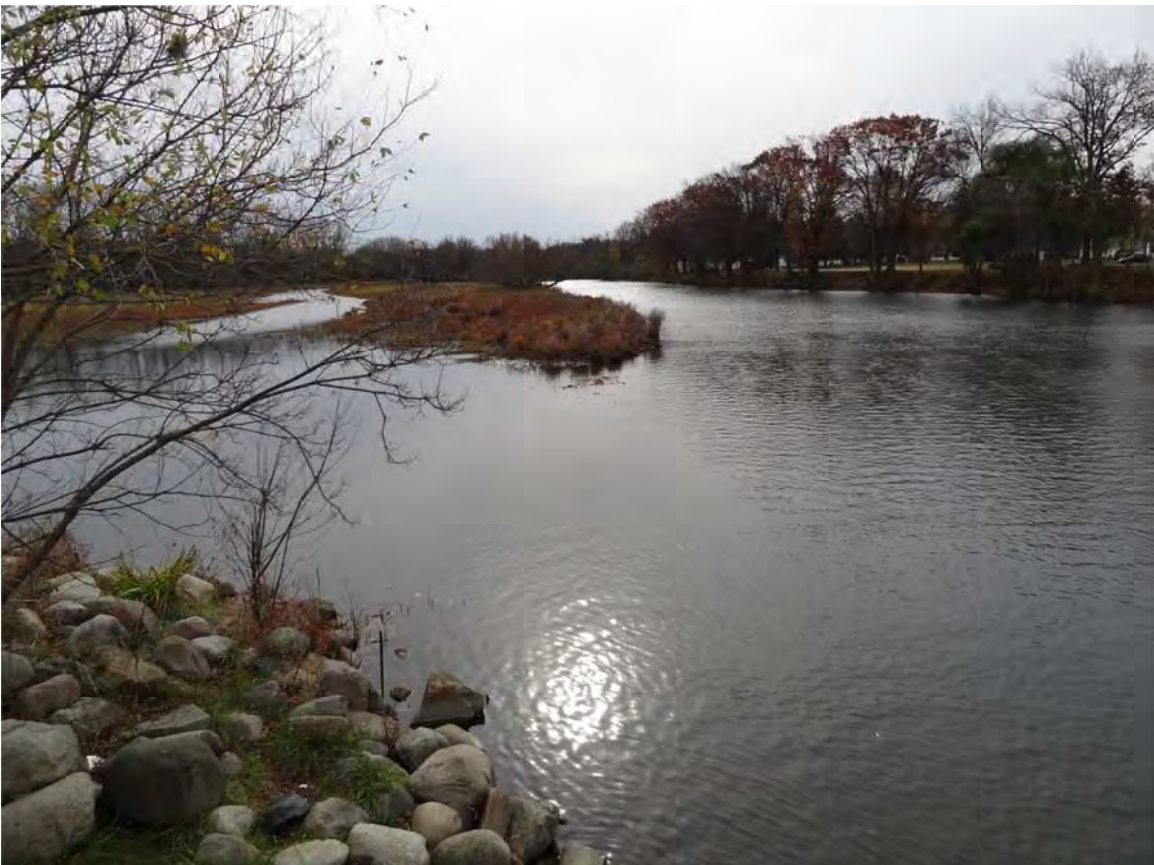
**12. MP 15.0, south end of Mill Ponds, no sheen observed.**

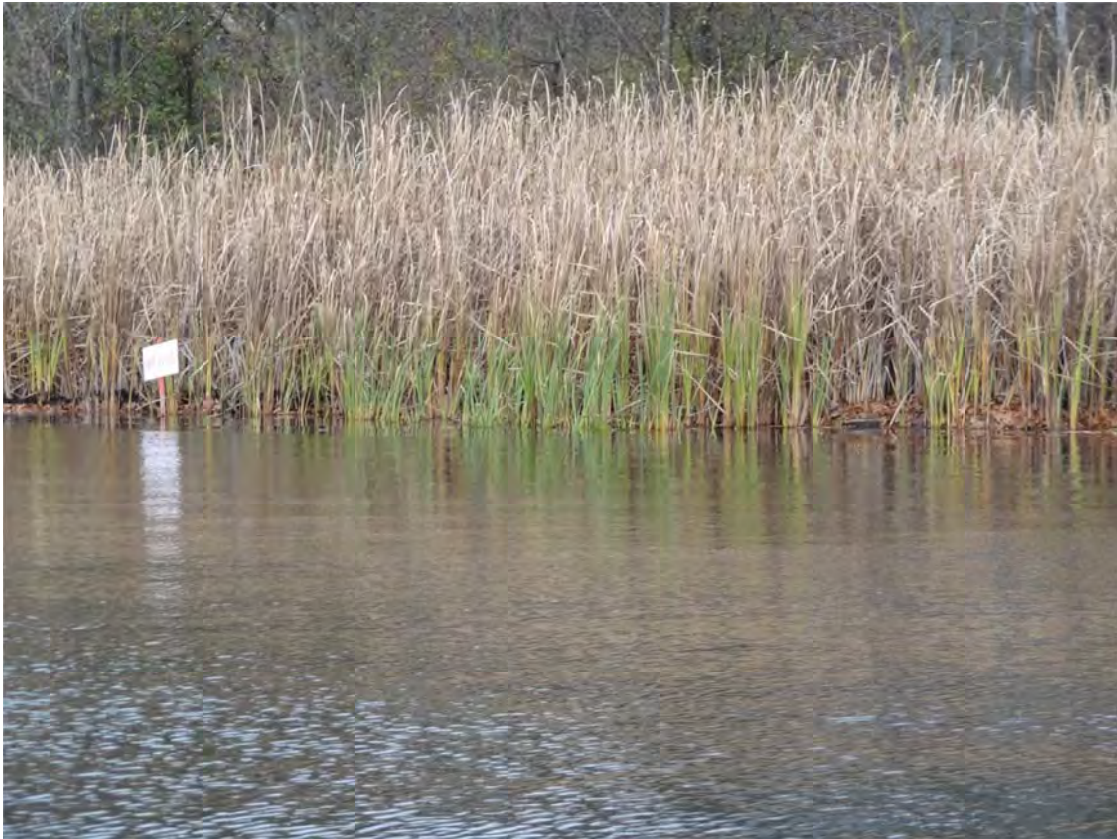
**13. North cove of Morrow Lake, no sheen observed.**

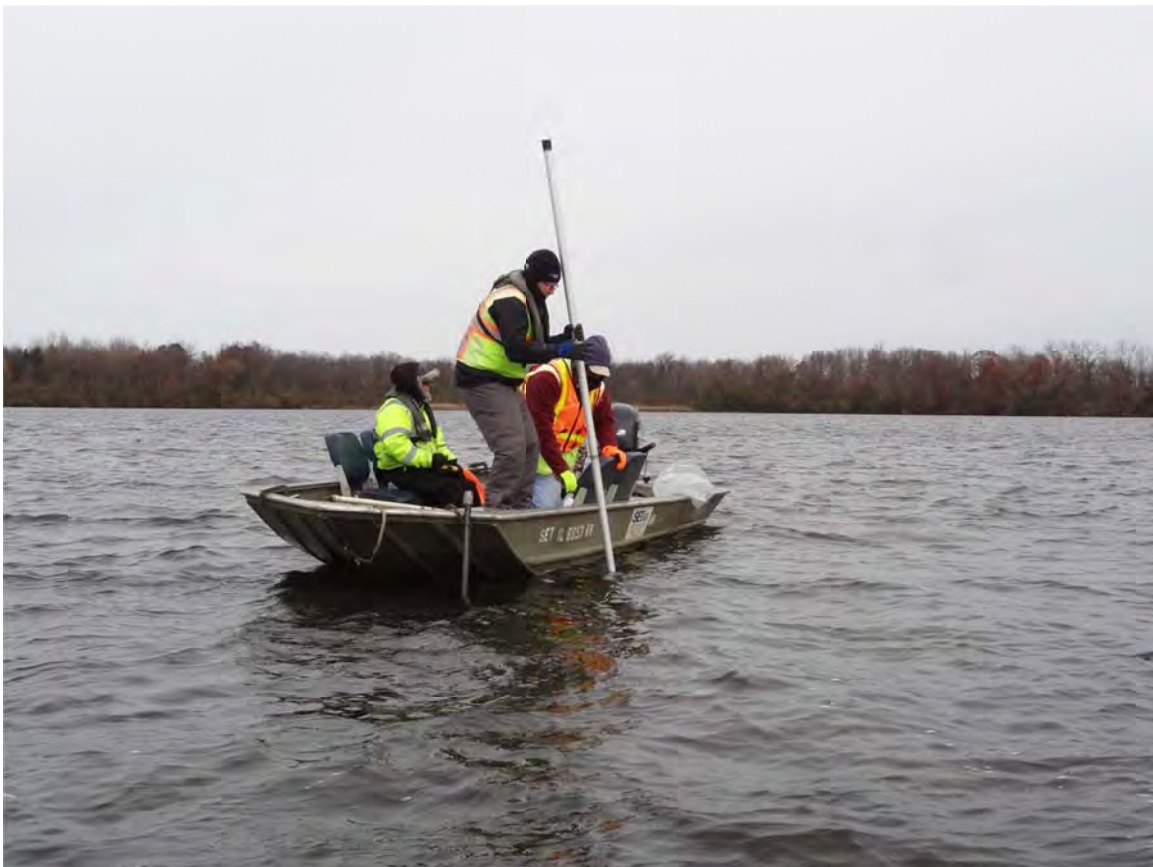
**14. Poling crew observed delineating points in Morrow Lake Fan.**

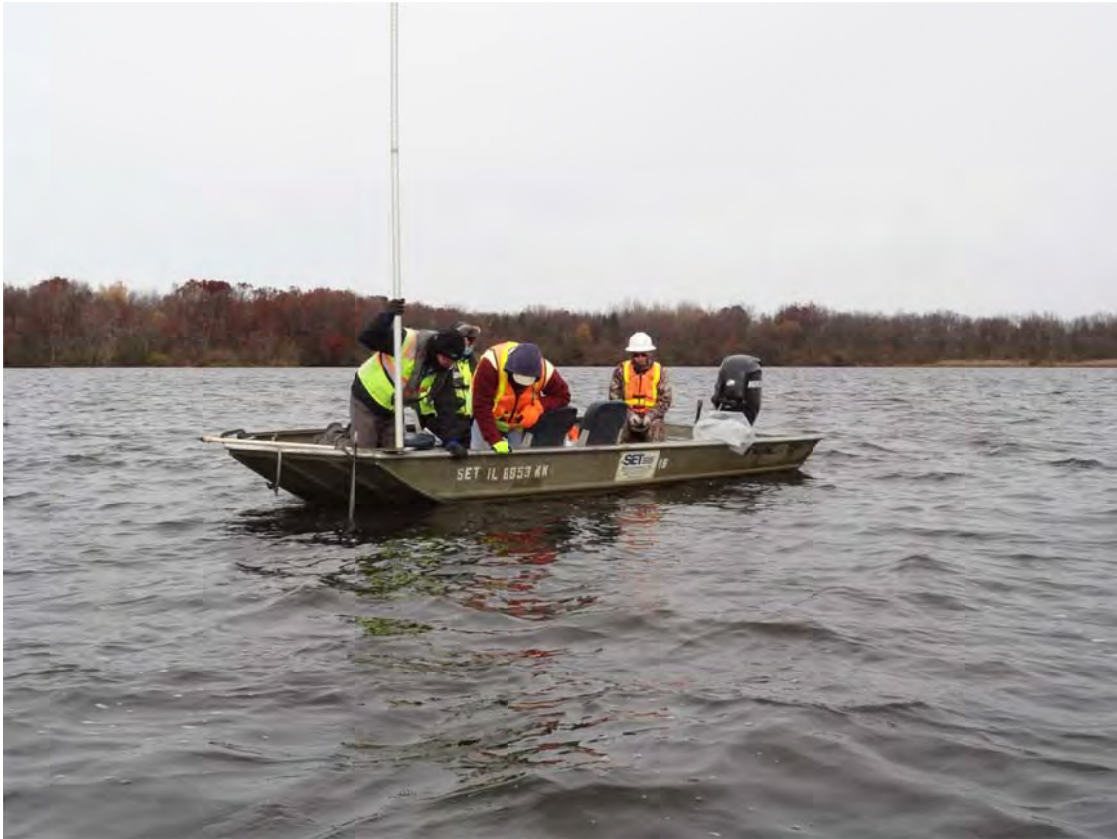
**15. Poling crew delineating points on Morrow Lake Fan.**

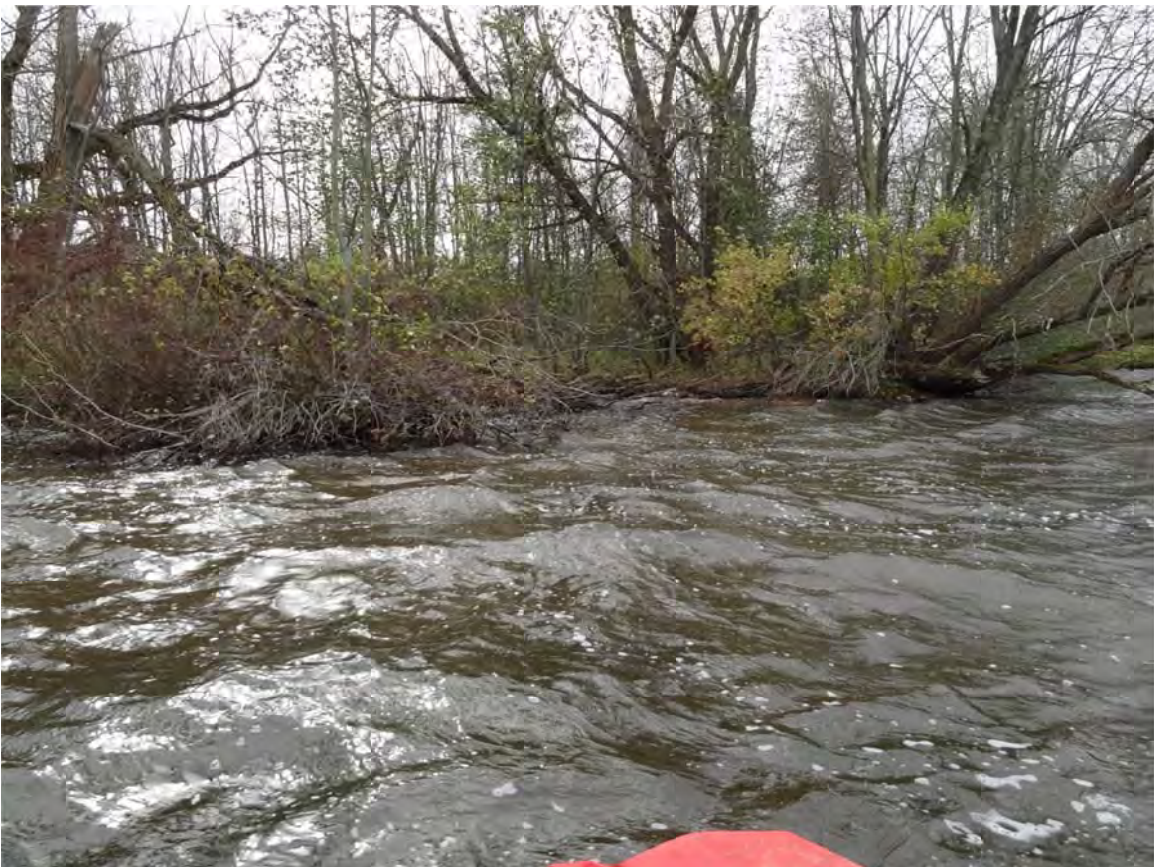
**16. South cove of Morrow Lake, no sheen observed on white caps in south cove.**
