Situation Photo Log

Wednesday, October 31, 2012

Kalamazoo River / Enbridge Spill

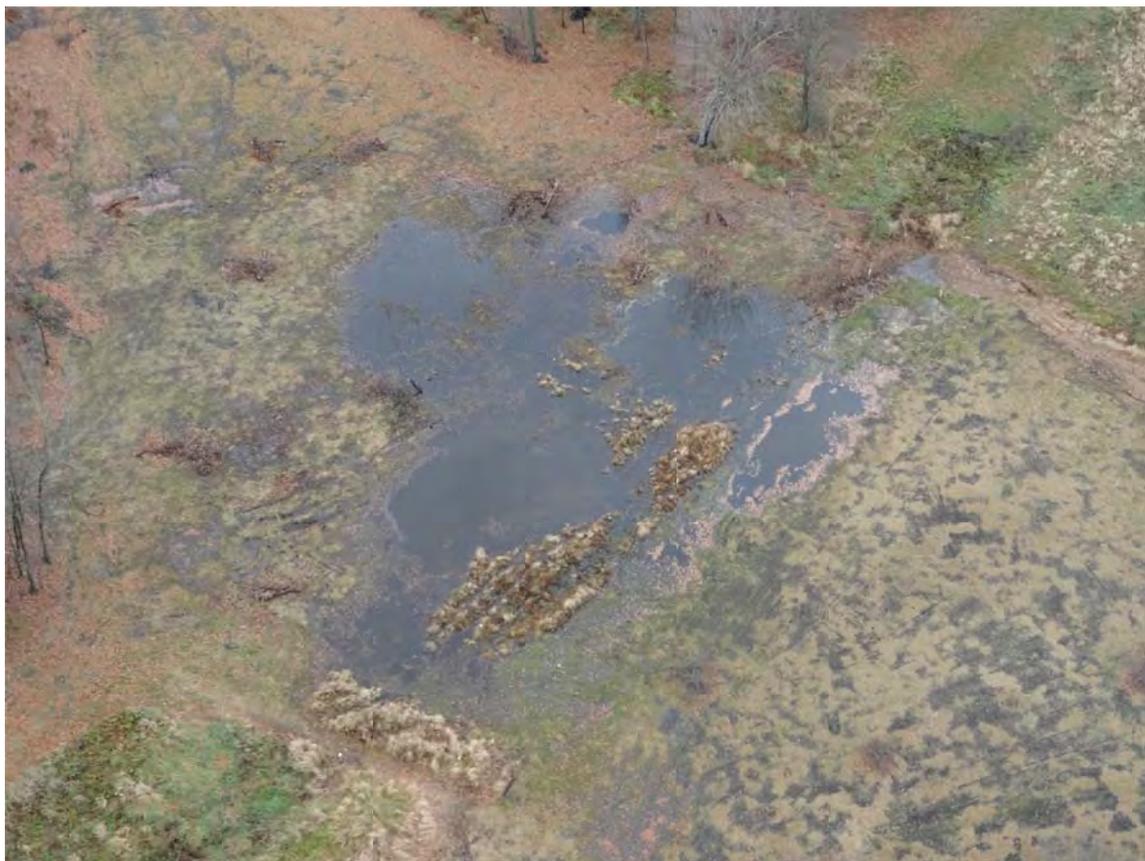
1. Source area, no sheen observed.

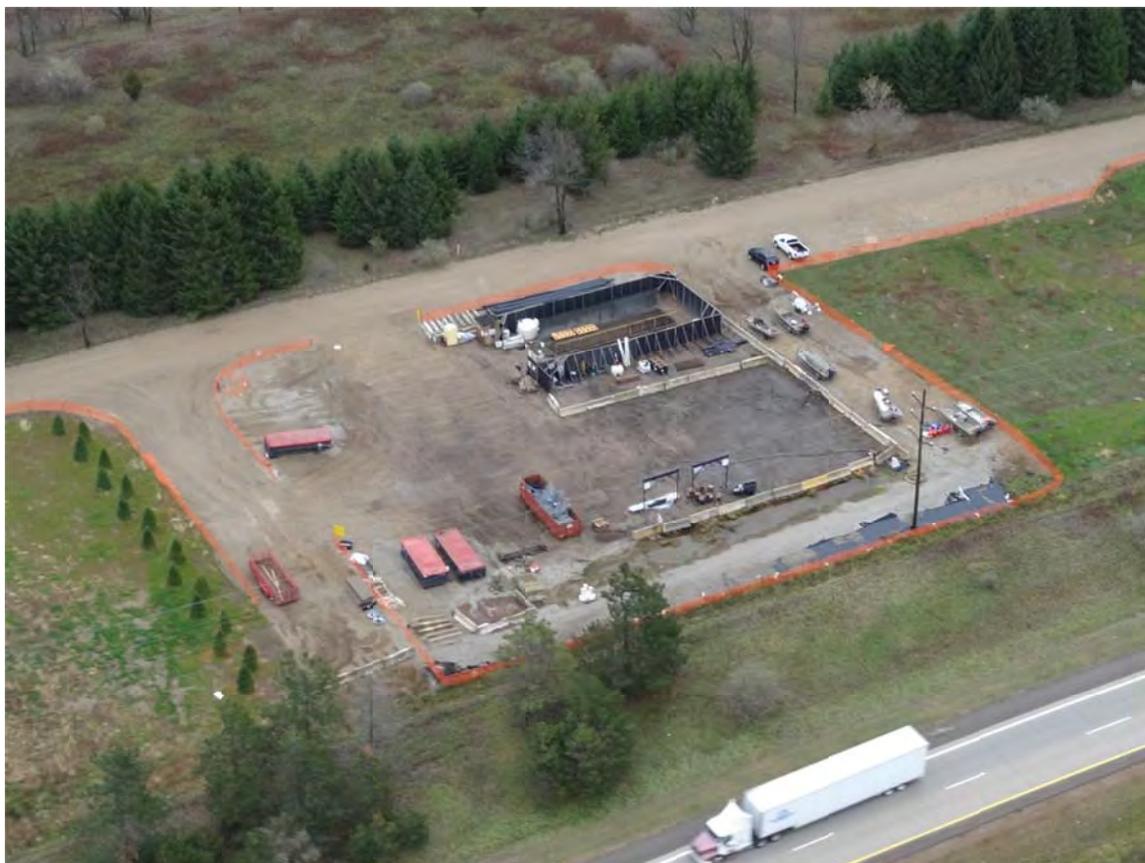
2. Frac-Tank City, no activity observed.

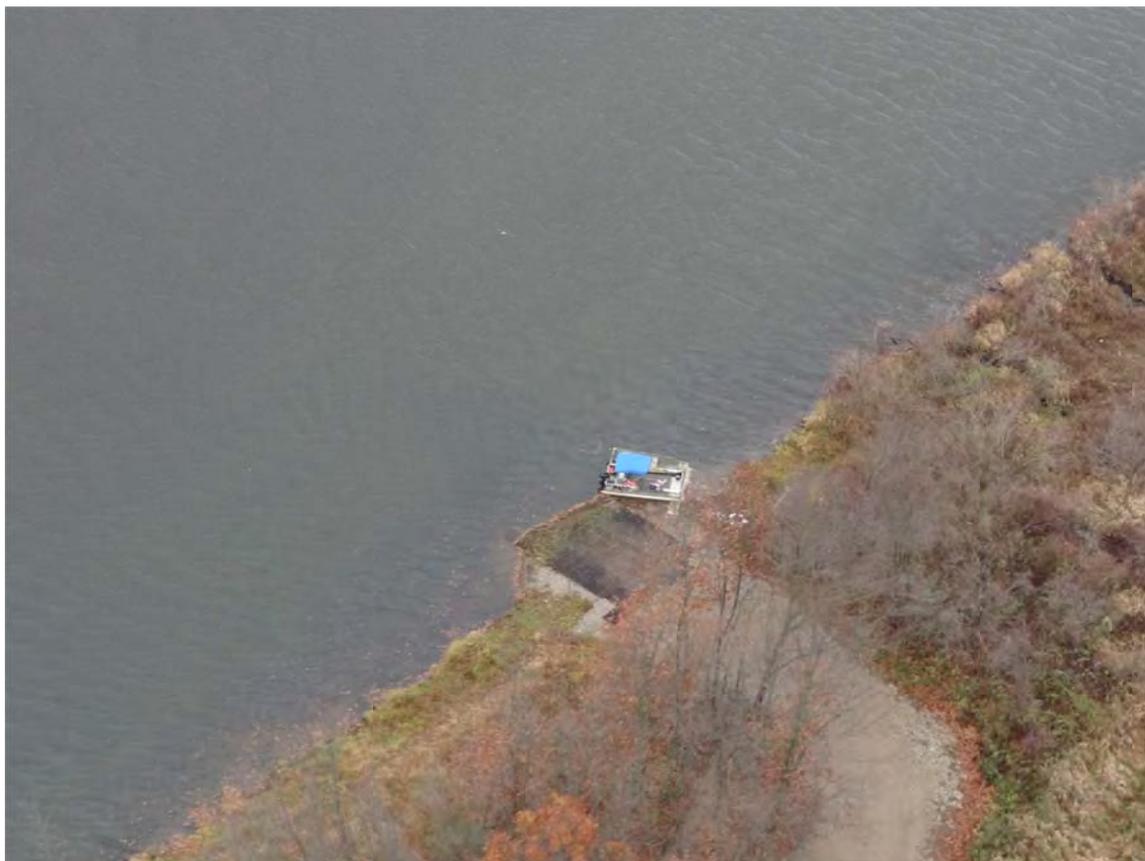
3. C0.4 boat launch, sweeper boat observed at boat launch.

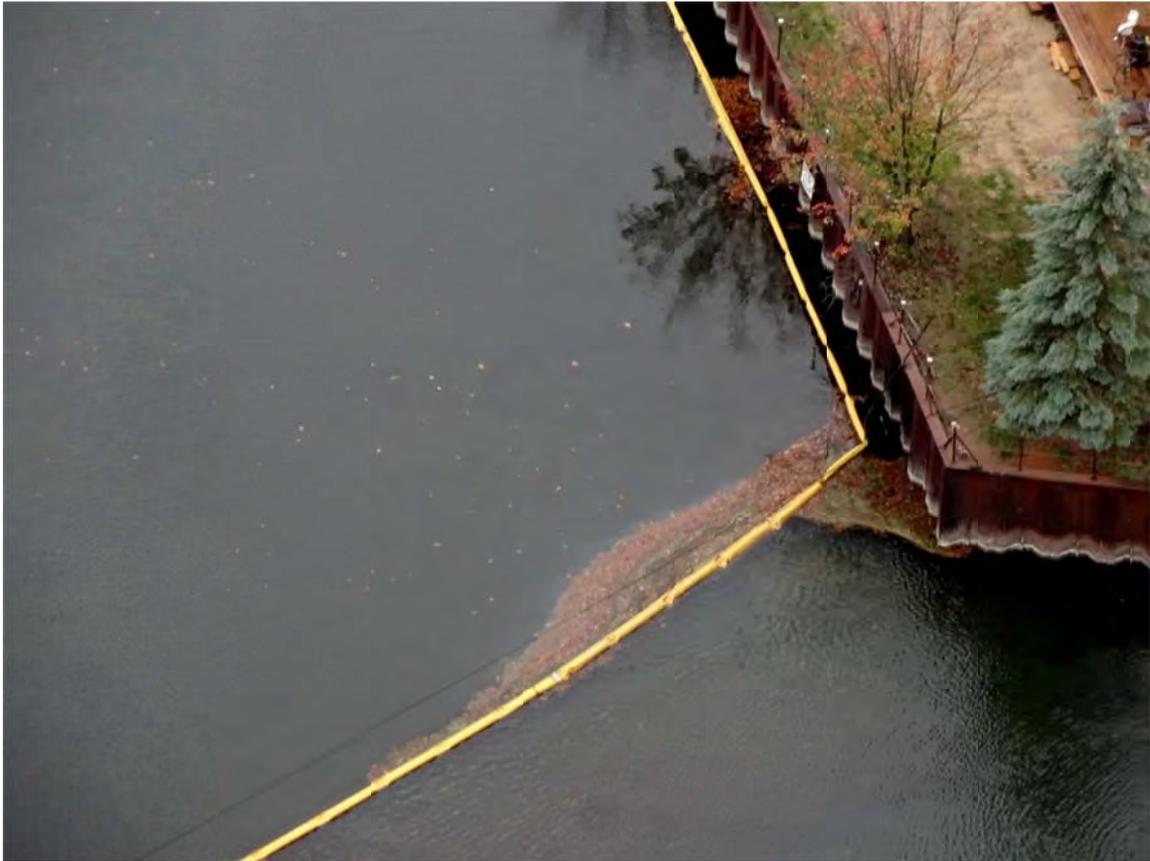
5. Debris and sheen observed at the Ceresco Dam control point.

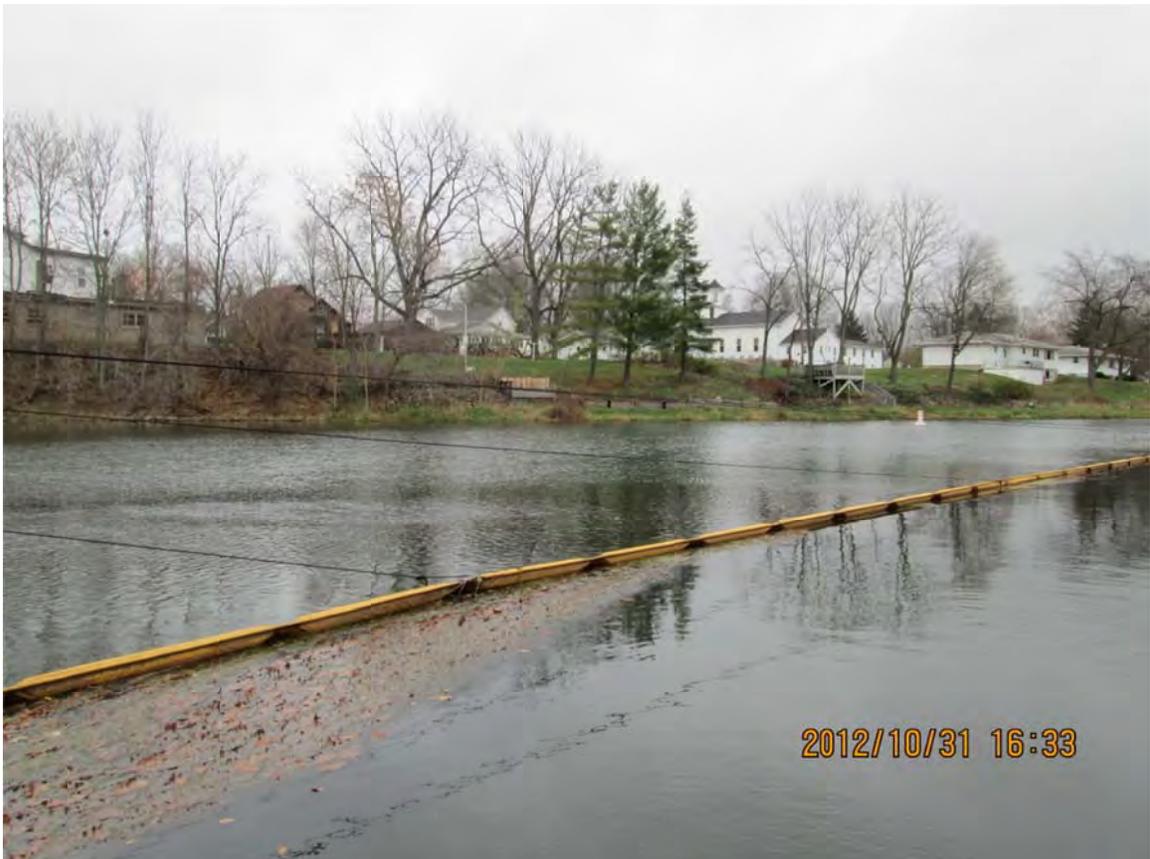
6. Debris and sheen observed at Ceresco Dam control point.

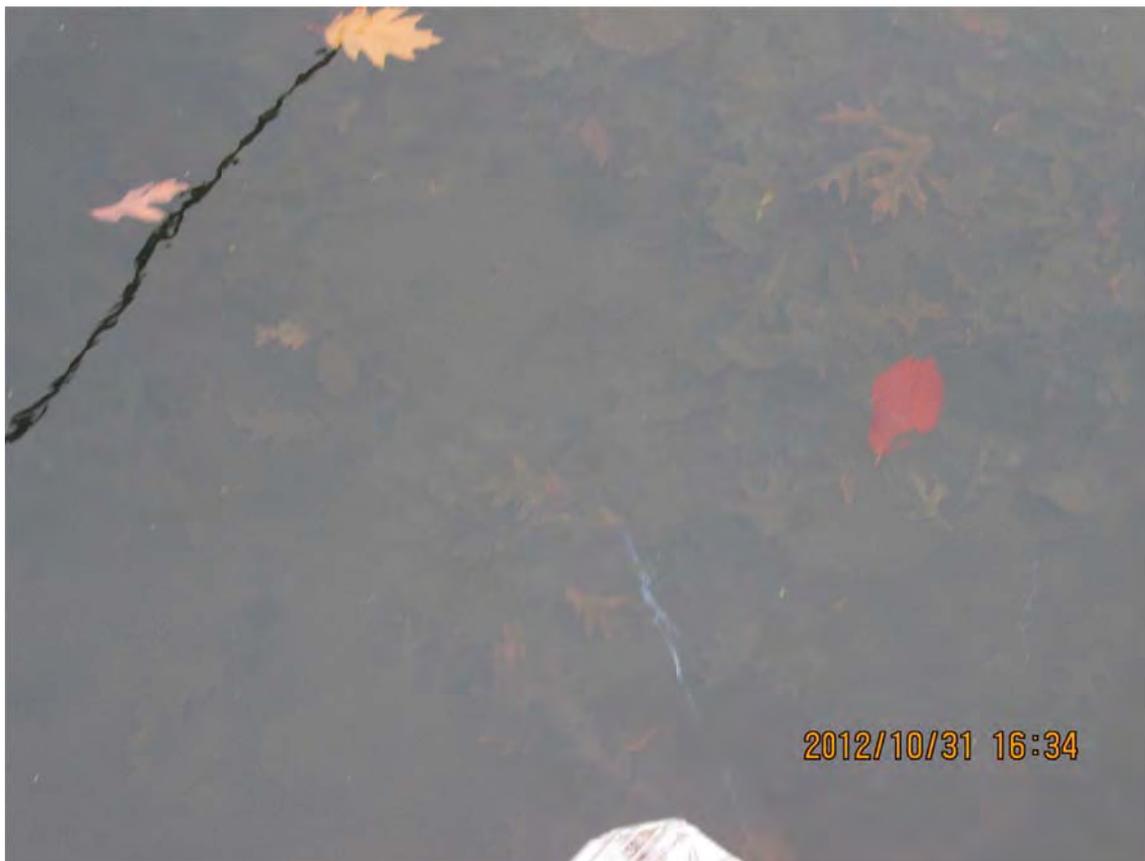
7. Sheen and tar globules observed at Ceresco Dam control point.

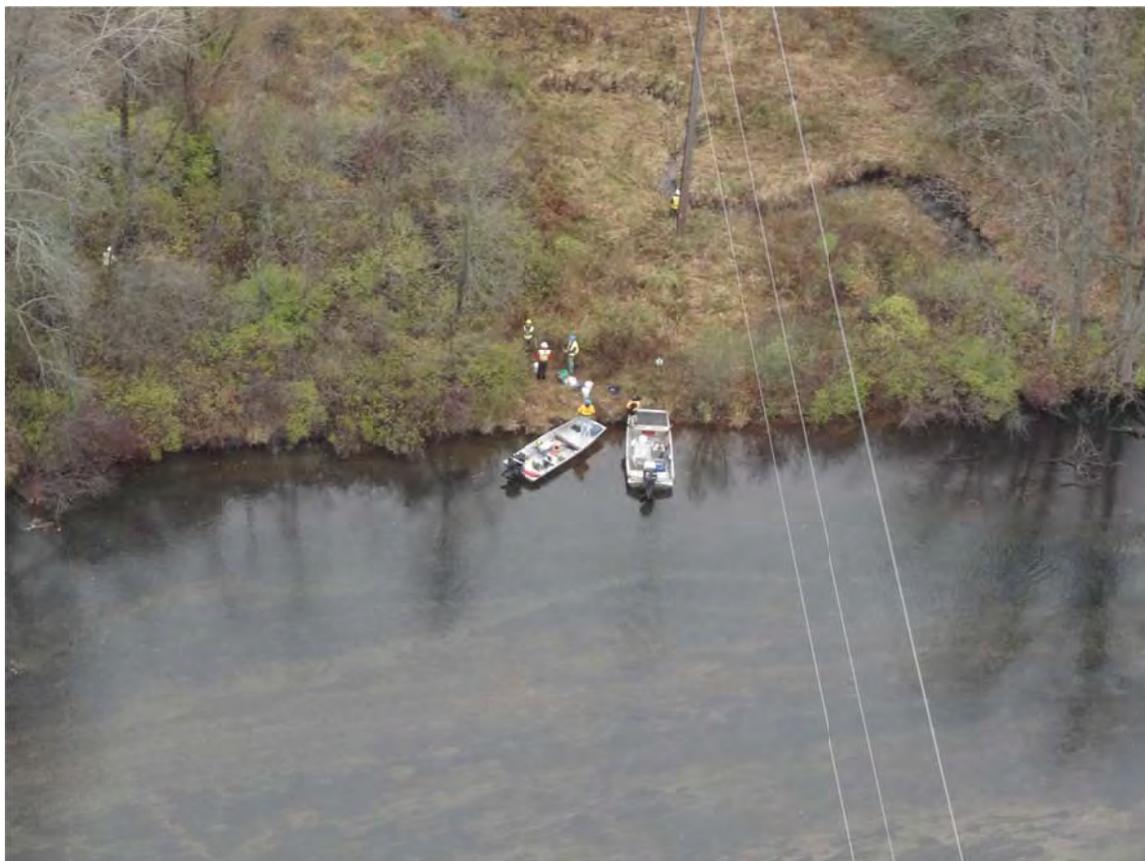
8. MP10.00 RDB, RI crew observed on northern bank of river.

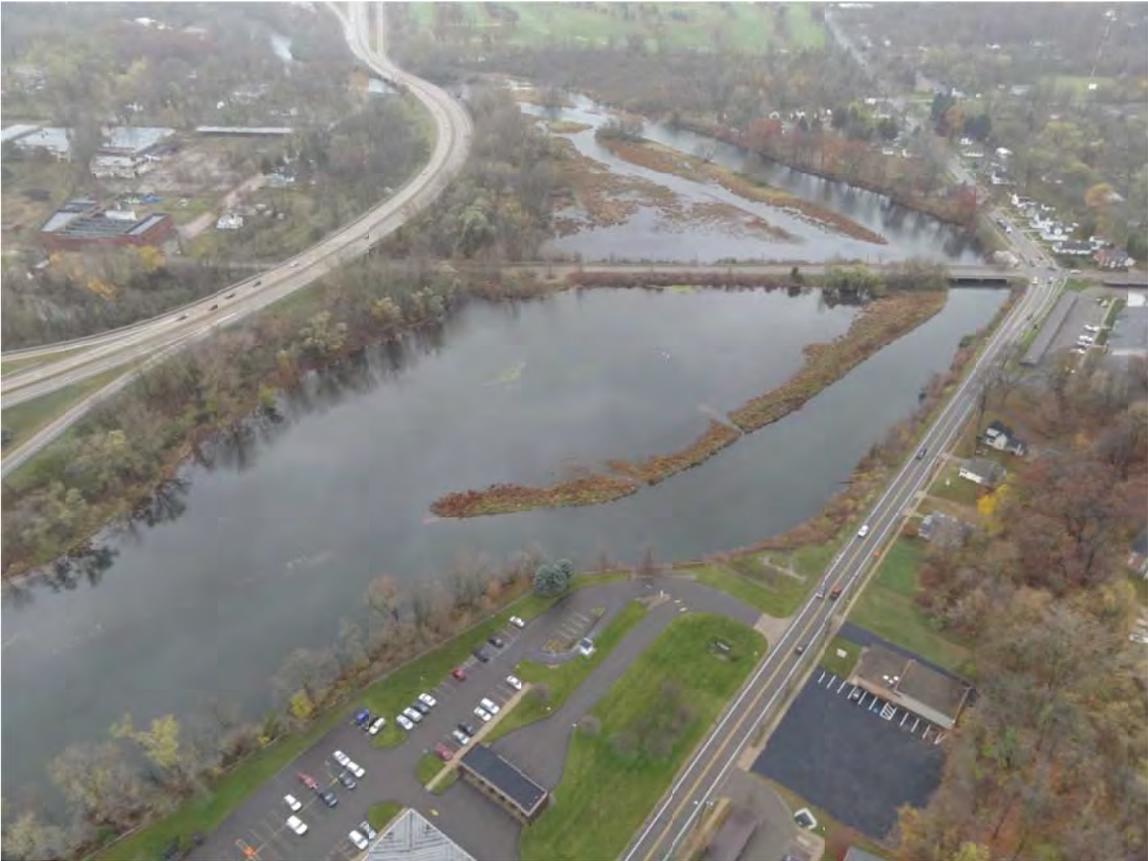
9. Overview of Mill Ponds, no sheen or activity observed.

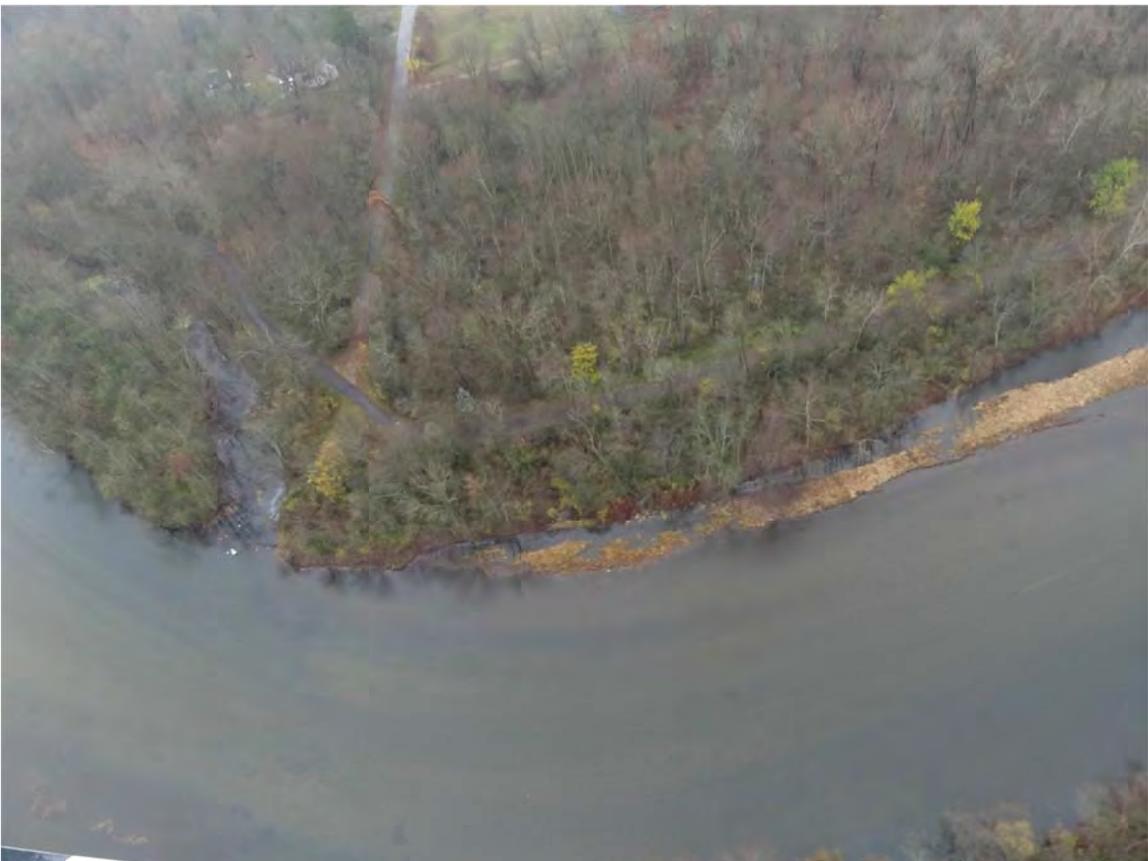
10. MP19.25 LDB sediment trap, sheen observed.

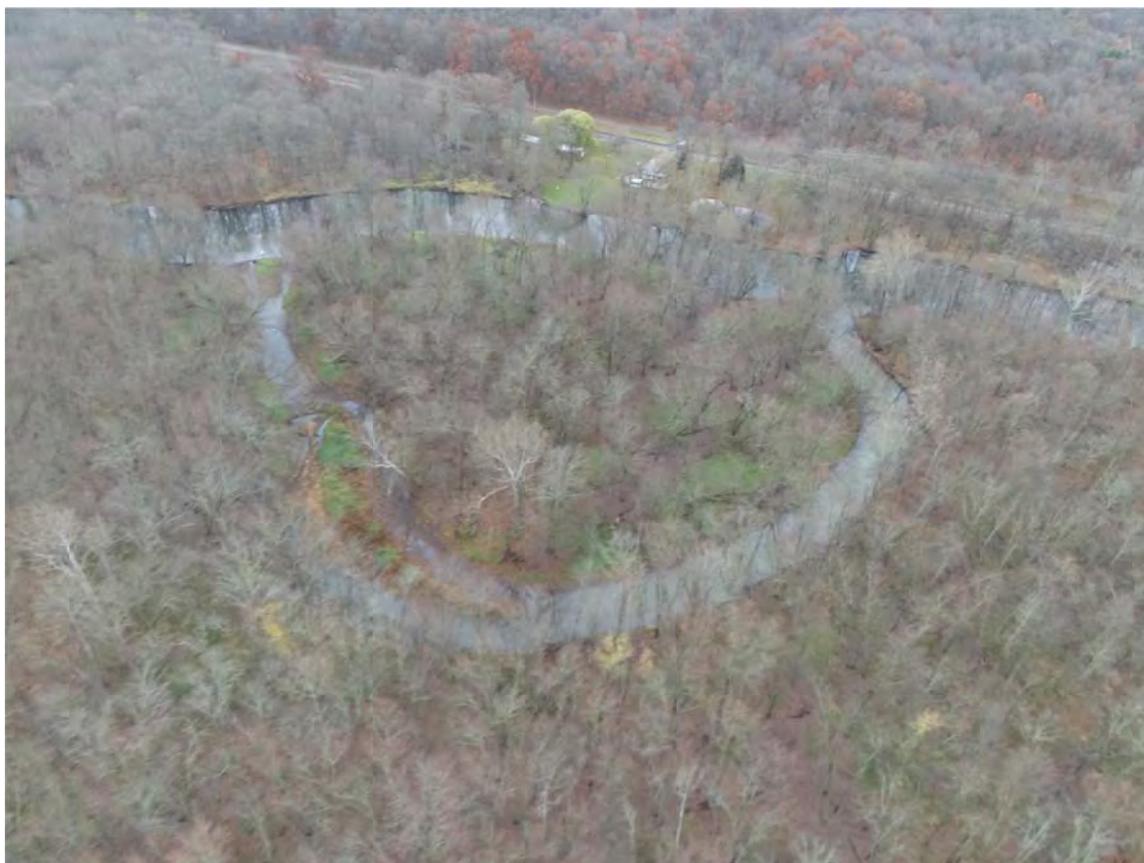
11. MP28.25 oxbow. Oxbow has filled in with water.

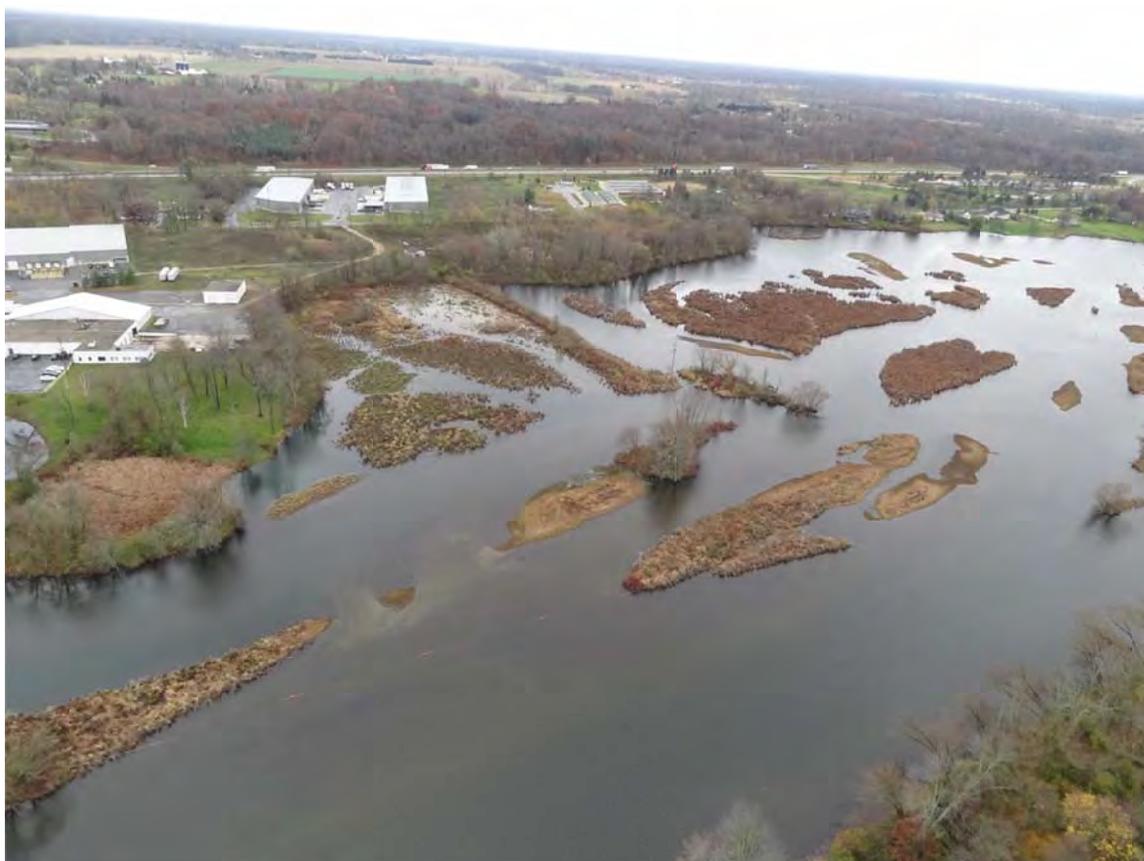
12. Morrow Lake Delta, no sheen observed.

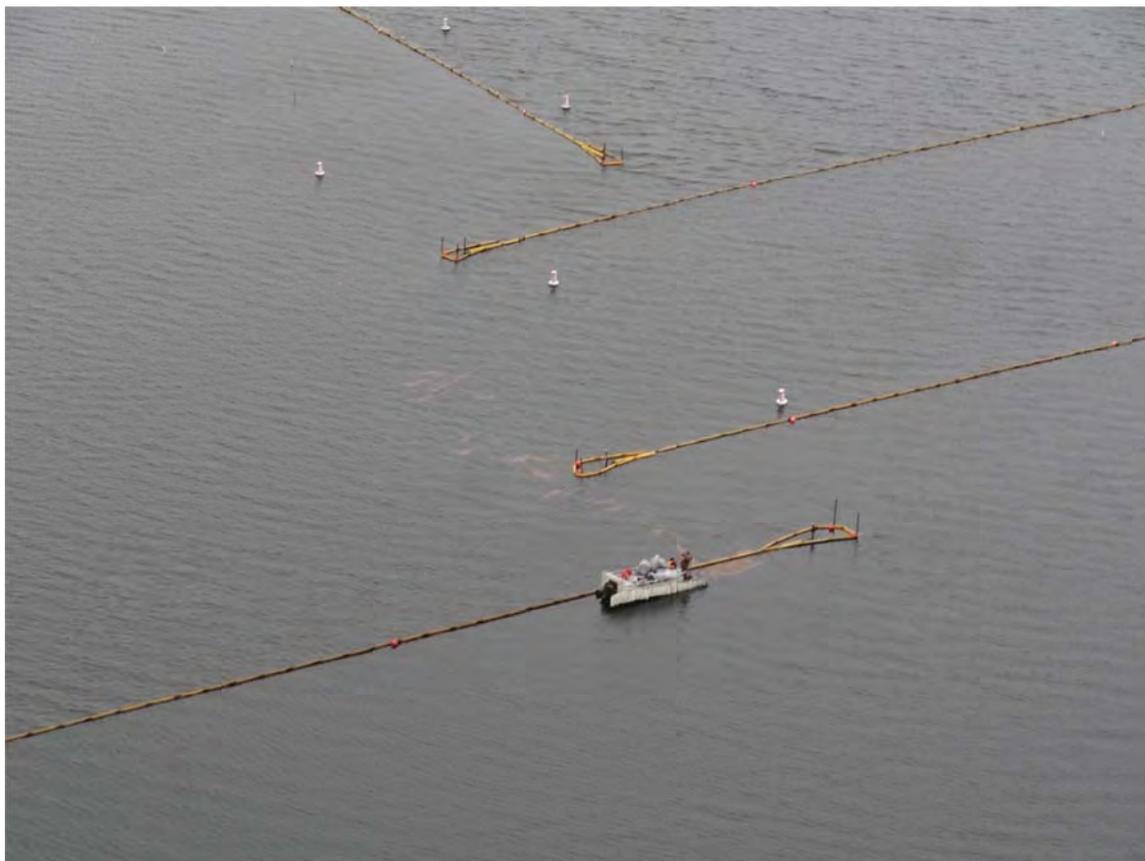
13. E4.0 containment system, observed crew removing debris from containment boom.

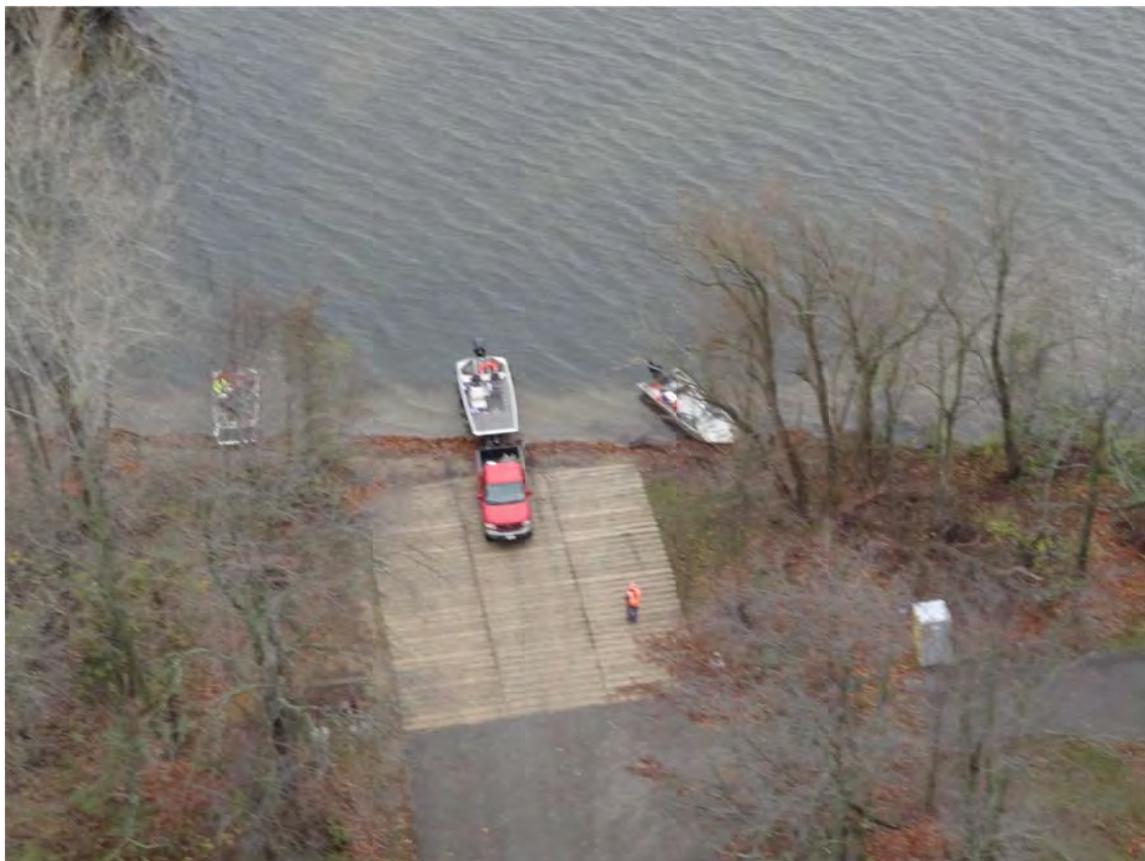
14. E4.0 boat launch, crew observed launching boats for Morrow Lake monitoring crews.

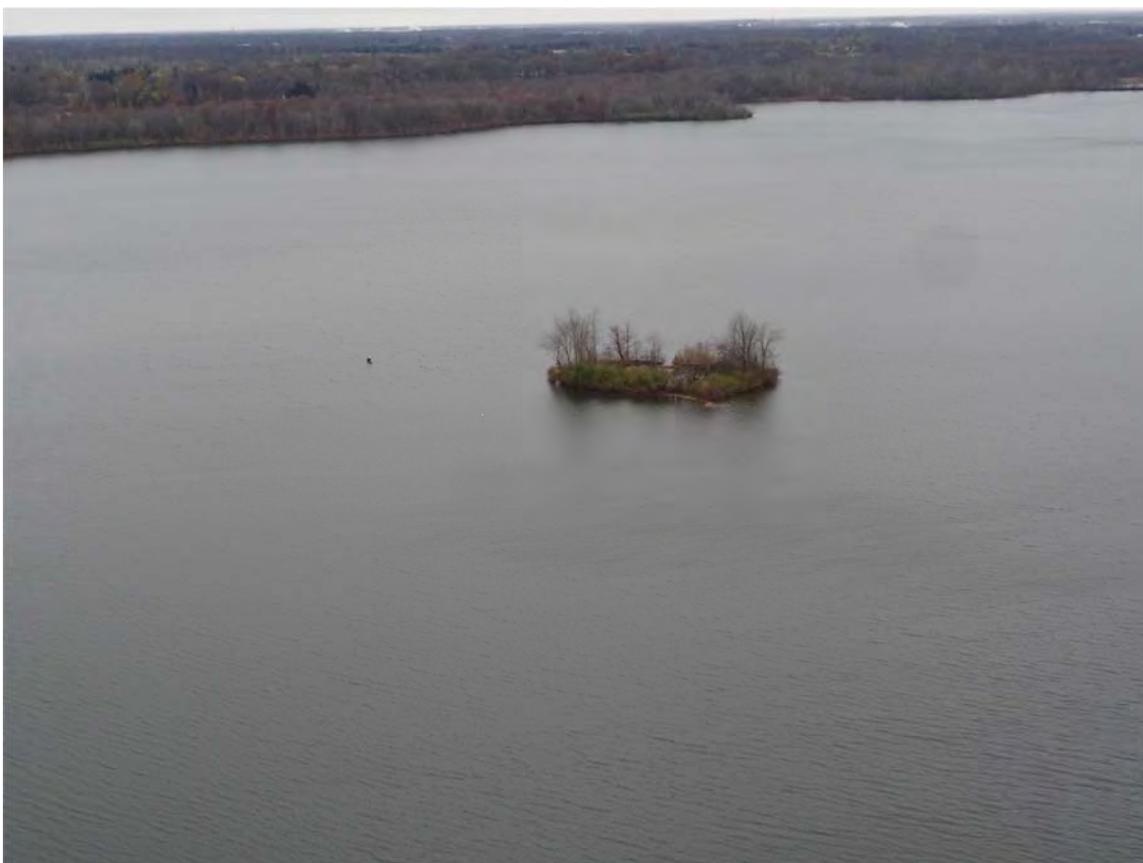
15. Hunters observed south of Rowe Island.
