# Situation Photo Log

Saturday, November 3, 2012

Kalamazoo River / Enbridge Spill

Prepared by:  
Larry Rader  
START-USEPA  
Situation Unit

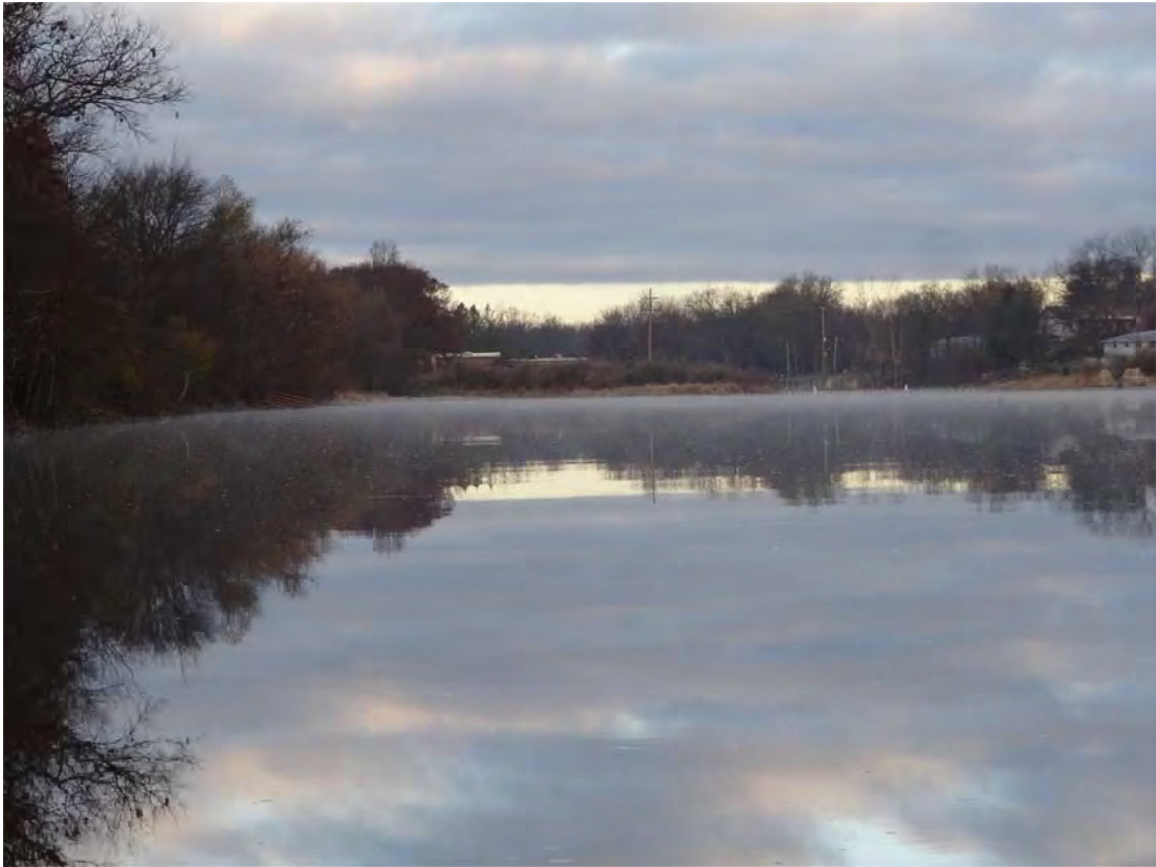
1. MP 5.5 LDB, a few sheen ribbons observed.

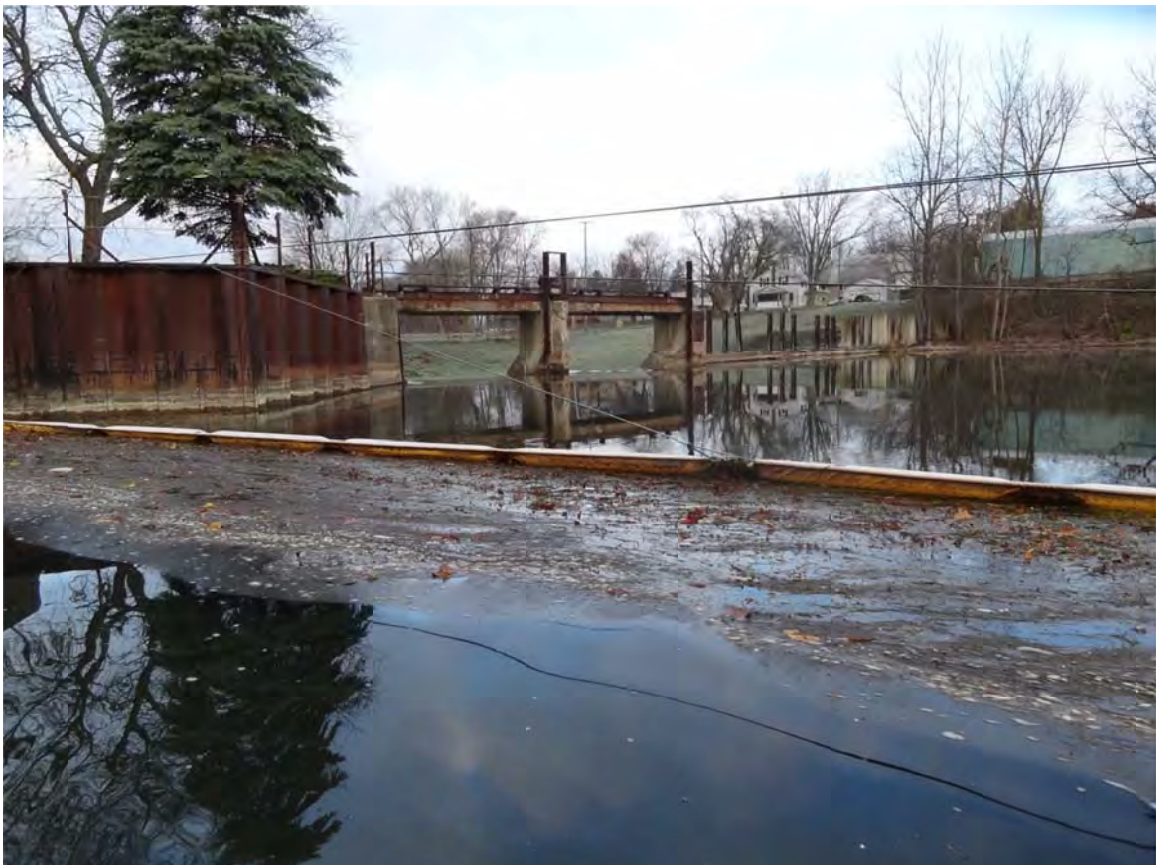
2. Ceresco Dam control point, sheen and debris observed.

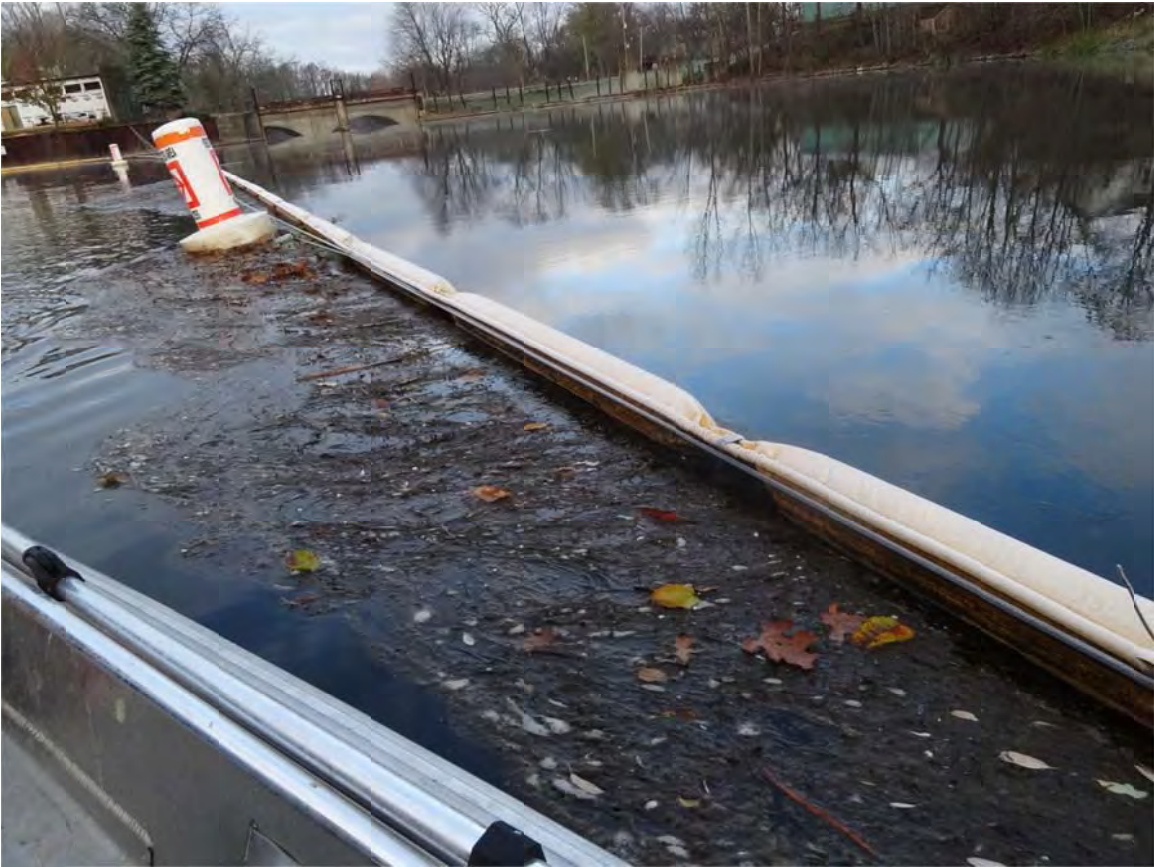
3. Debris along Ceresco Dam control point.

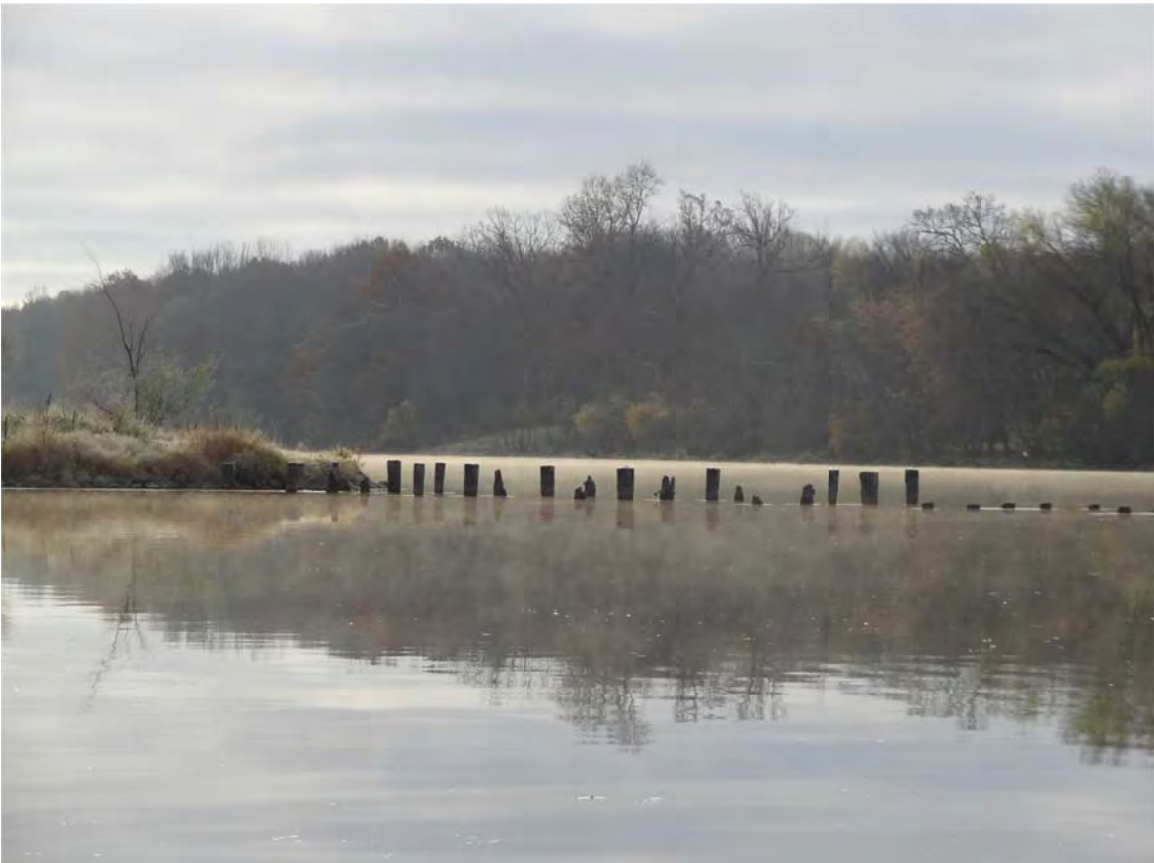
4. View from trestle at MP 5.75, no sheen observed.

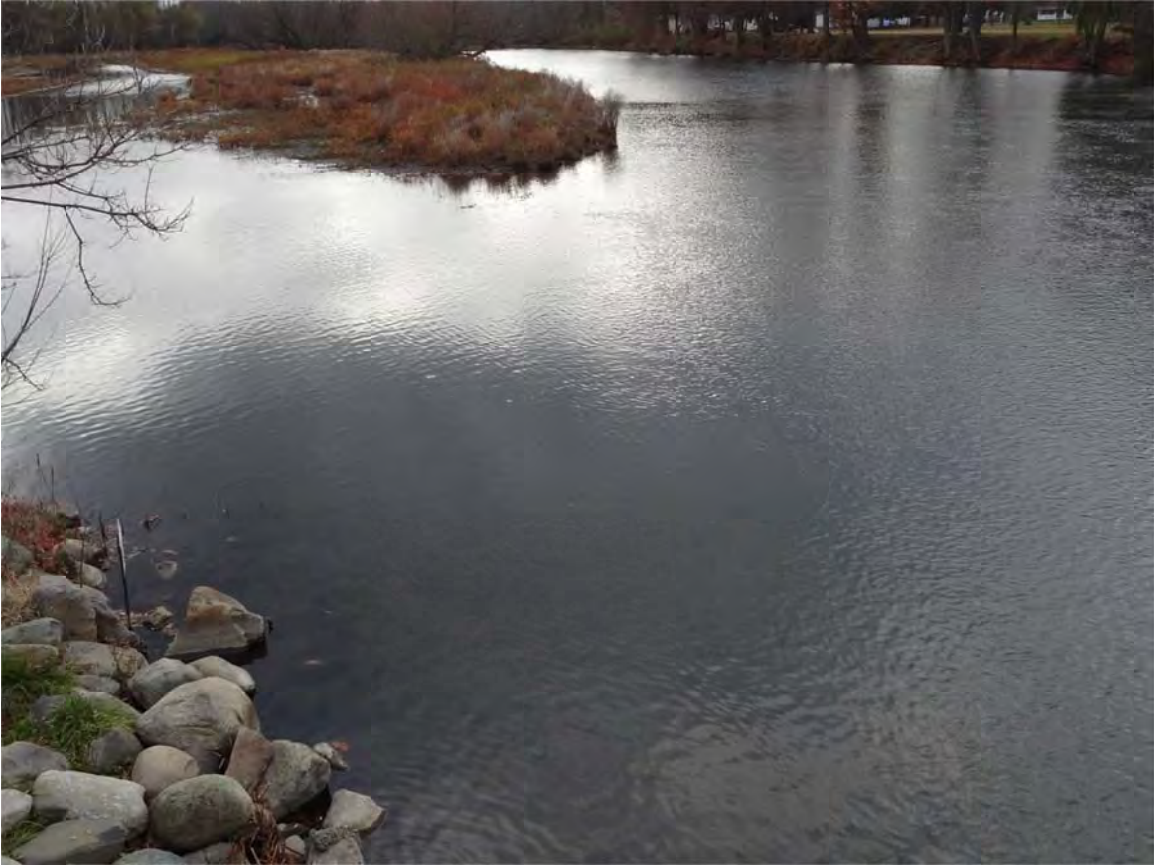
5. MP 15.0 South Mill Pond looking south, sheen observed, but not in sufficient quantity to warrant a sheen response.

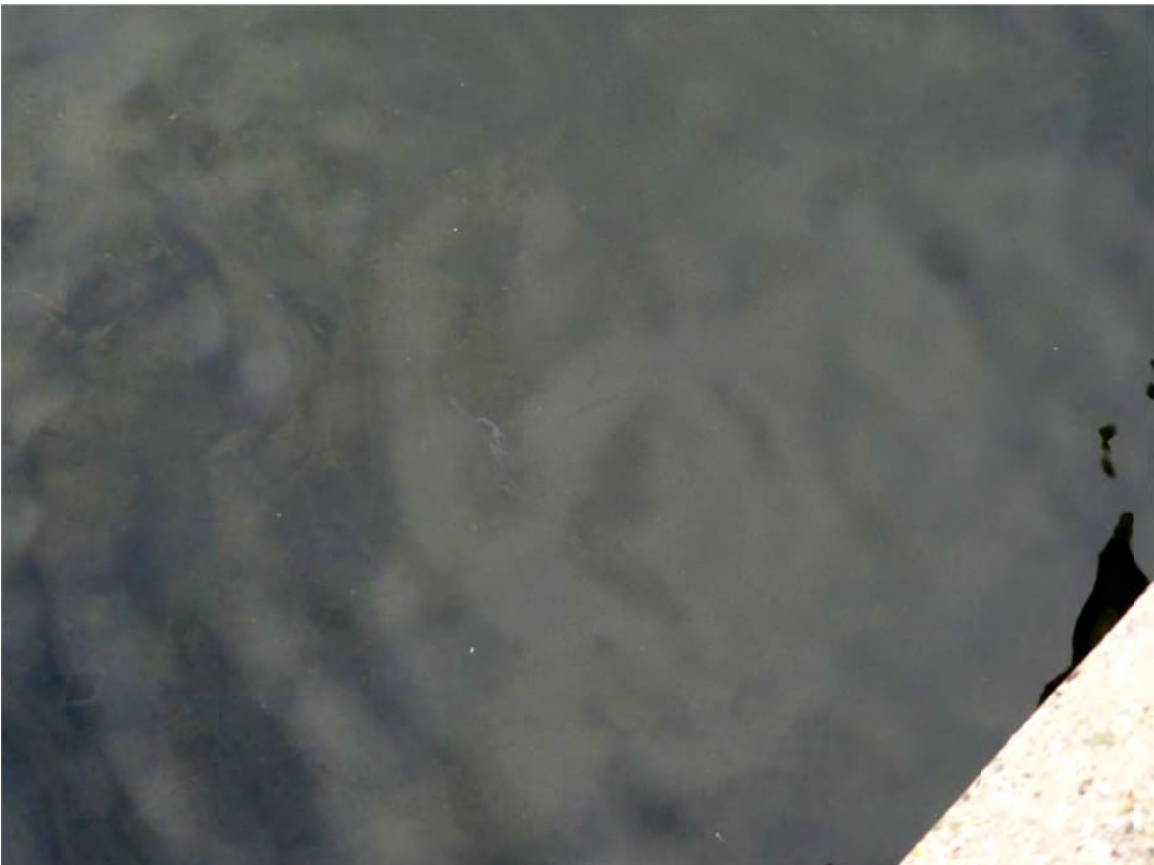
6. Sheen observed at MP 15.0 South Mill Pond, sheen quantity did not warrant a sheen response.

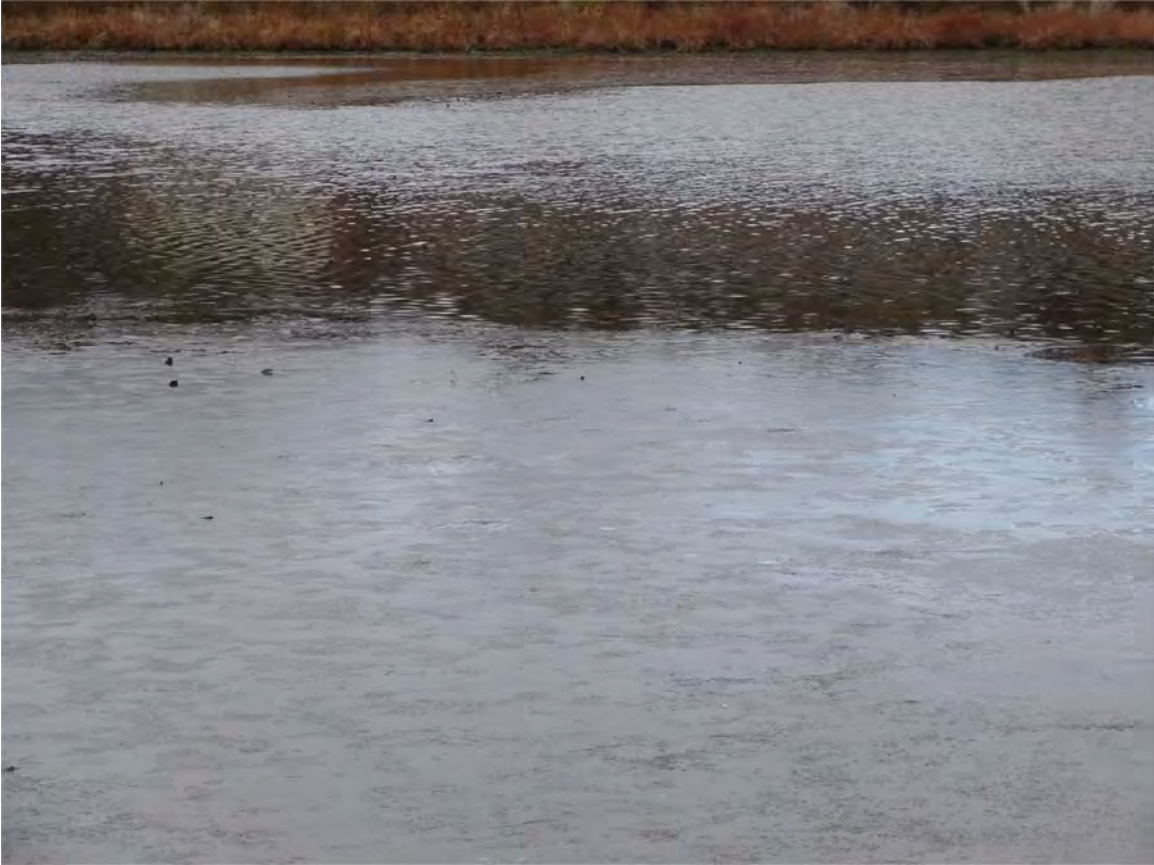
**7. Ice observed forming in east end of North Mill Pond.**

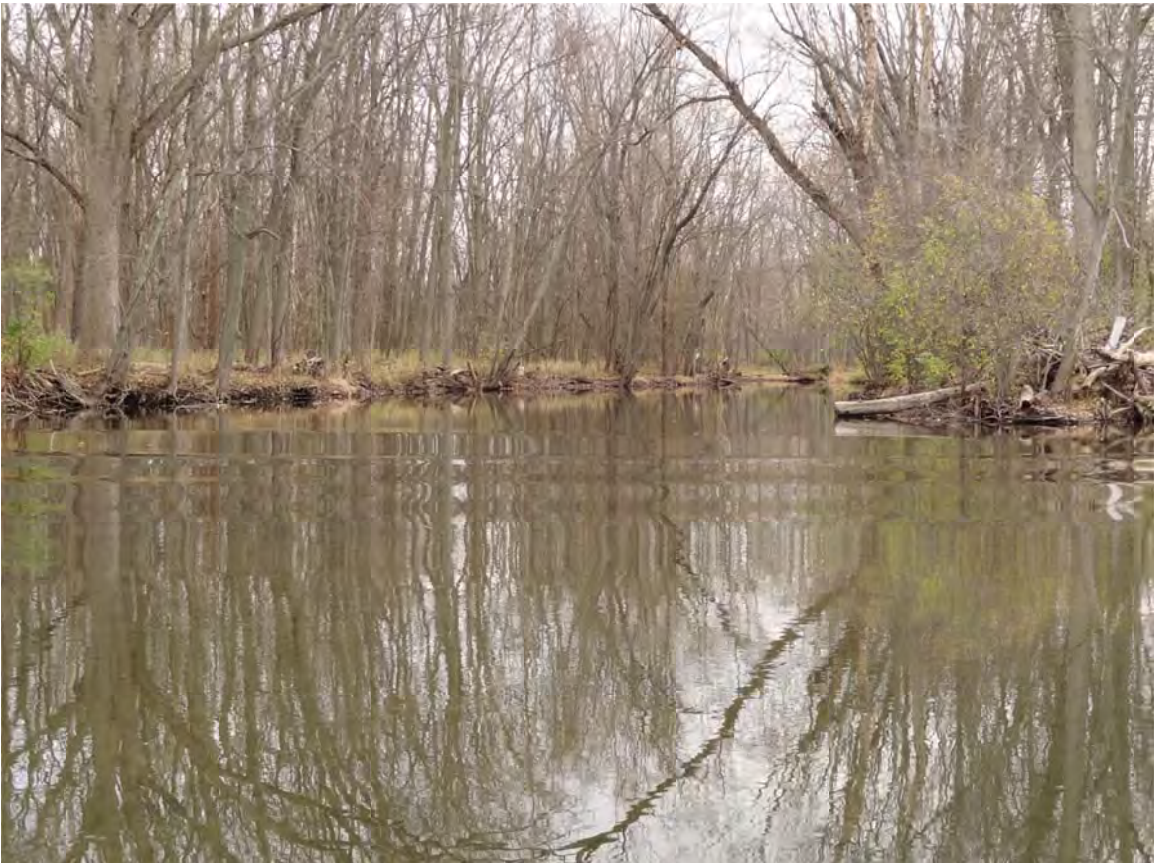
**8. MP 36.1 former sediment trap location. Sediment trap structure and associated buoys have been removed.**

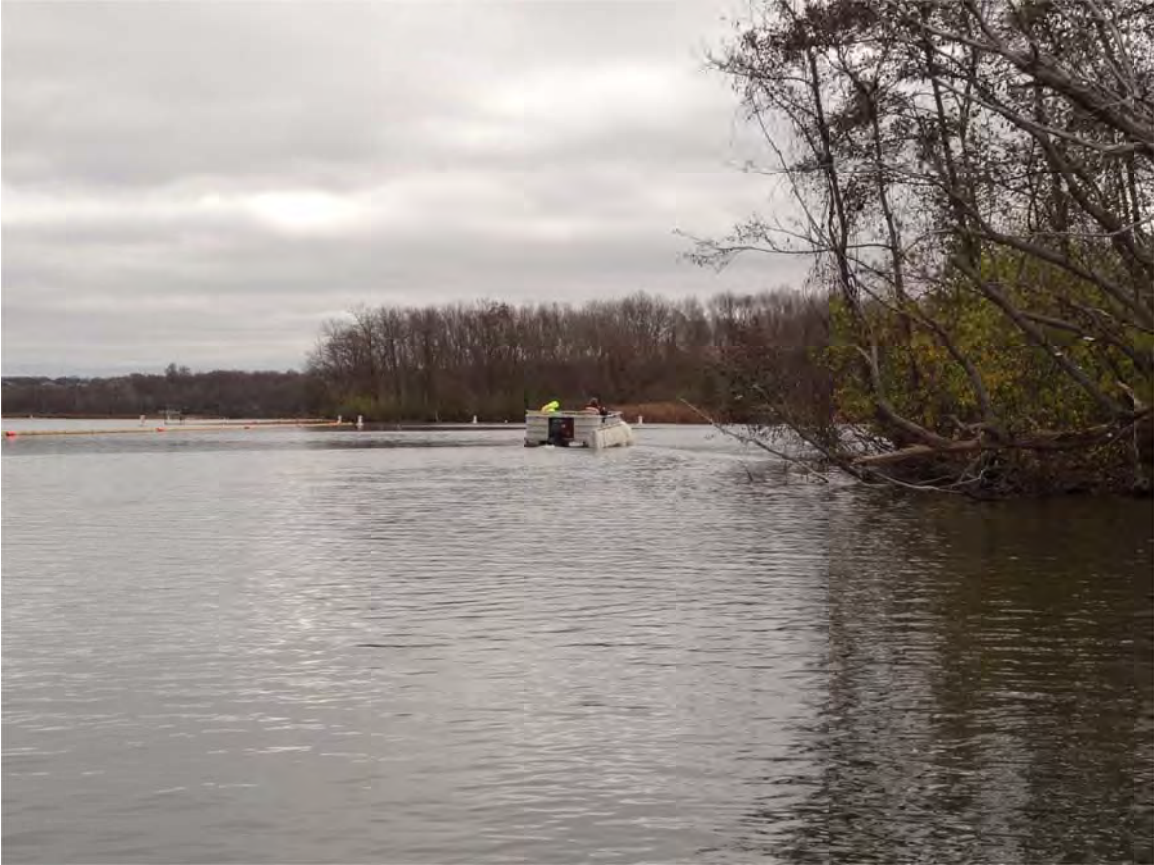
9. E4.0 boat launch, sheen sweep boat observed mobilizing into Morrow Lake Delta.

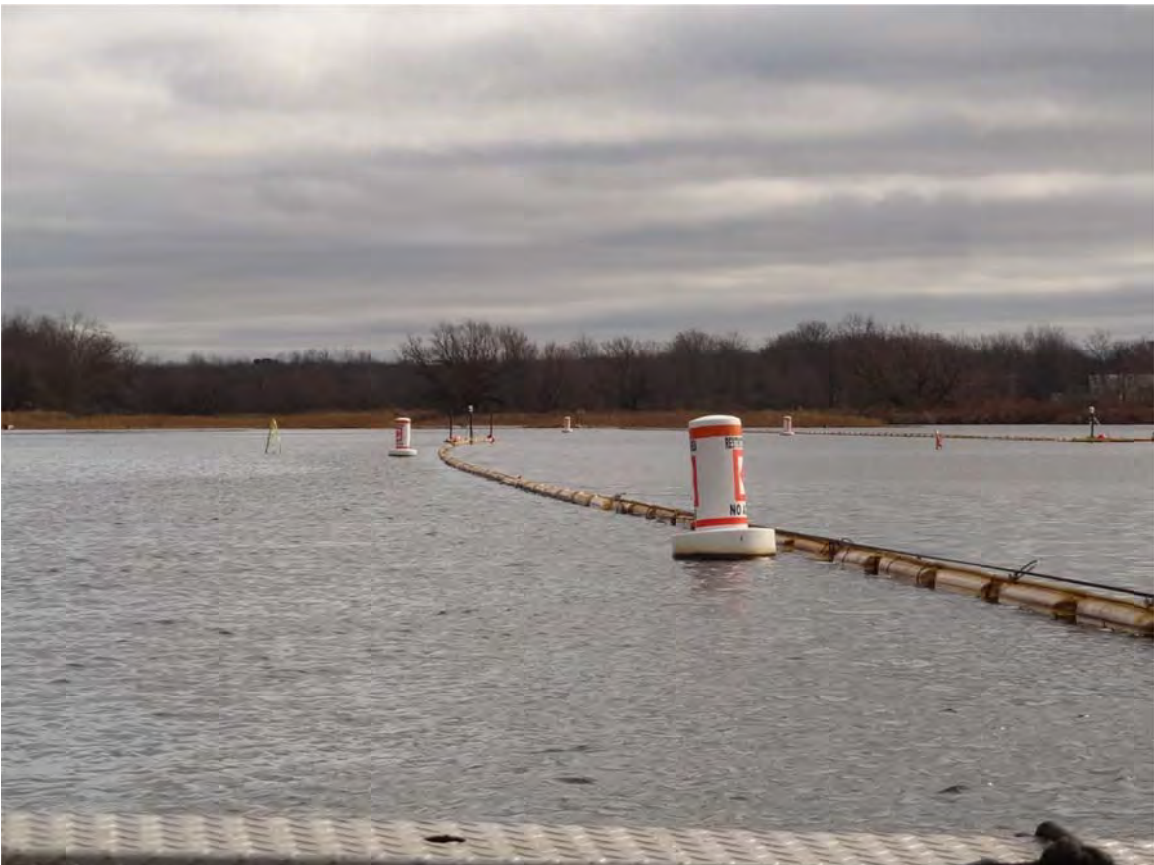
10. Containment boom configuration C, no sheen observed in choppy water.

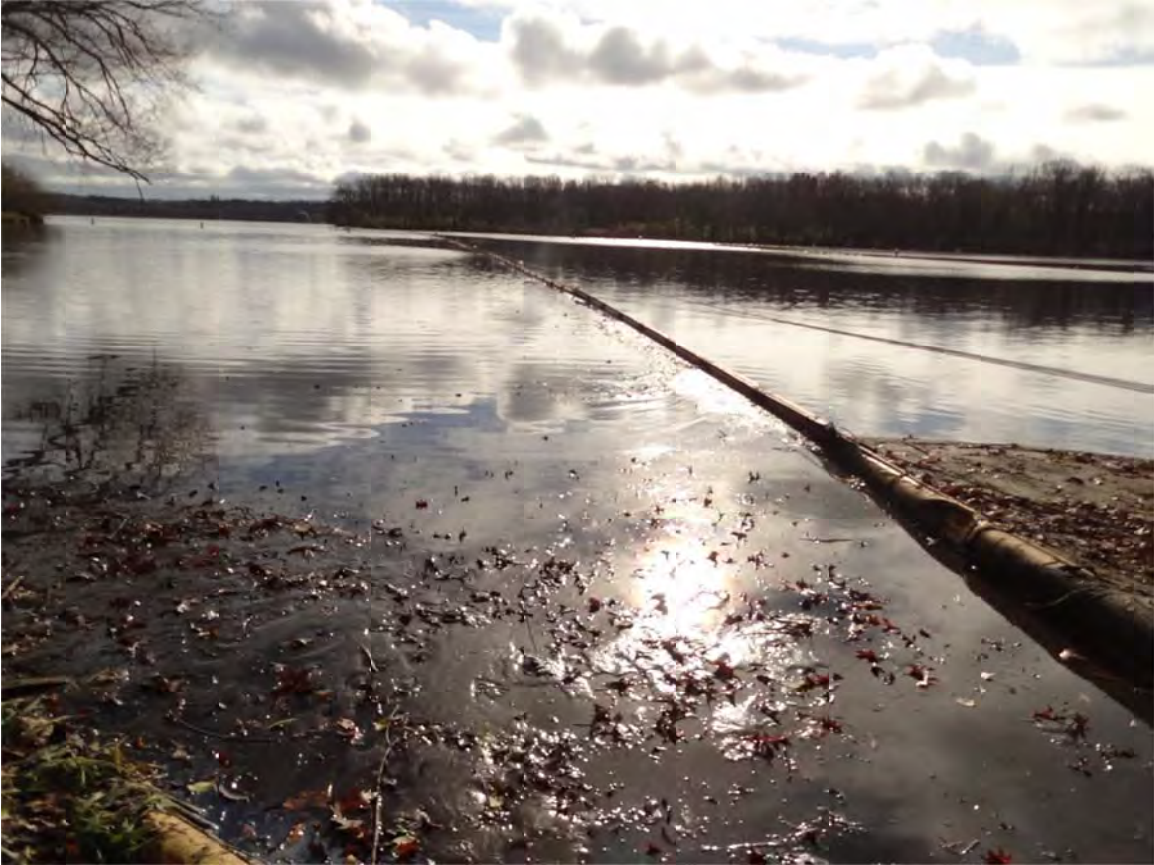
11. E4.0 control point, no sheen observed.

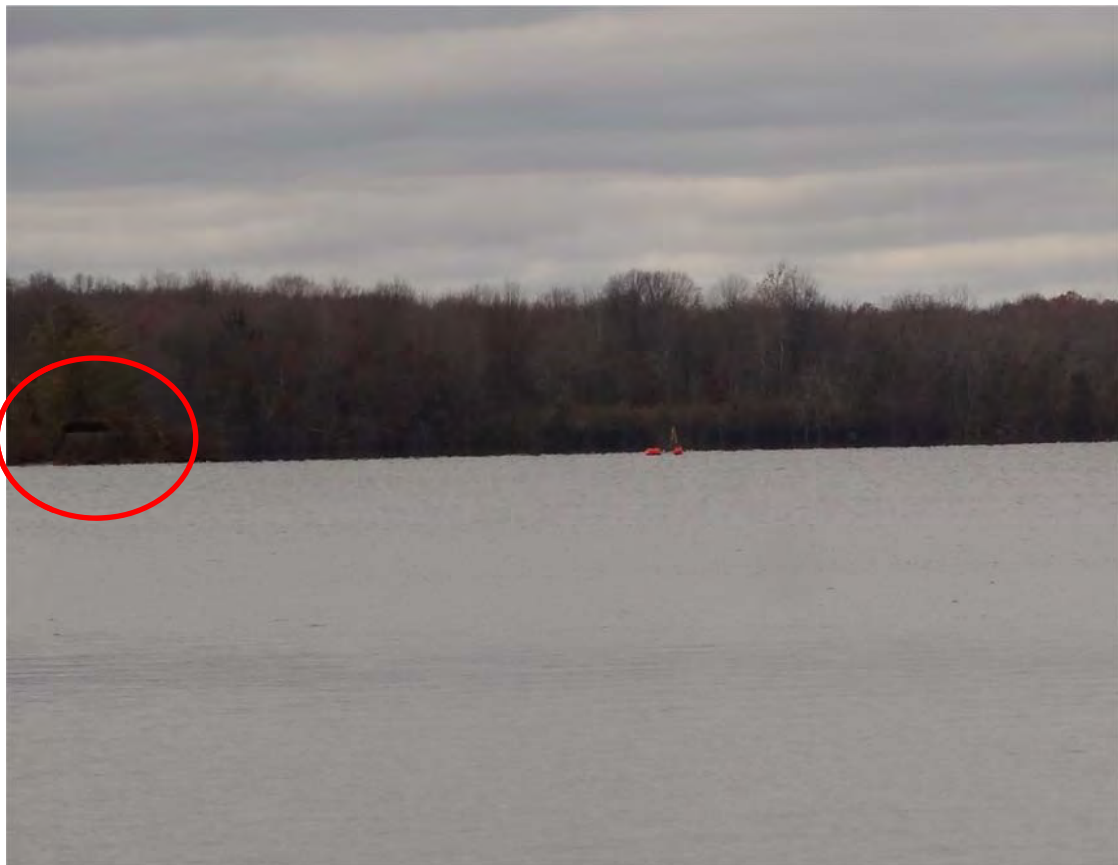
12. Hunters observed on Morrow Lake in North Cove, South Cove, and on two islands.
