Situation Photo Log

Tuesday, November 6, 2012

Kalamazoo River / Enbridge Spill

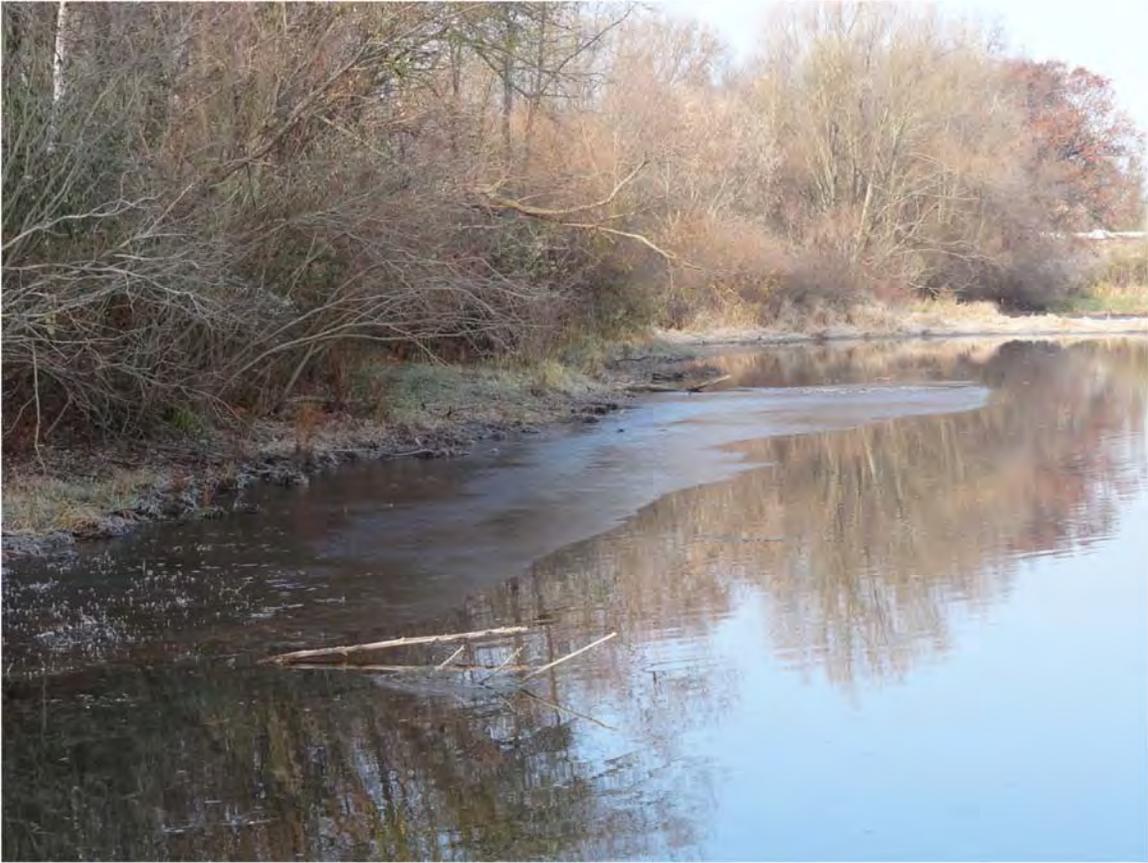
1. MP5.5 LDB observed bank ice forming.

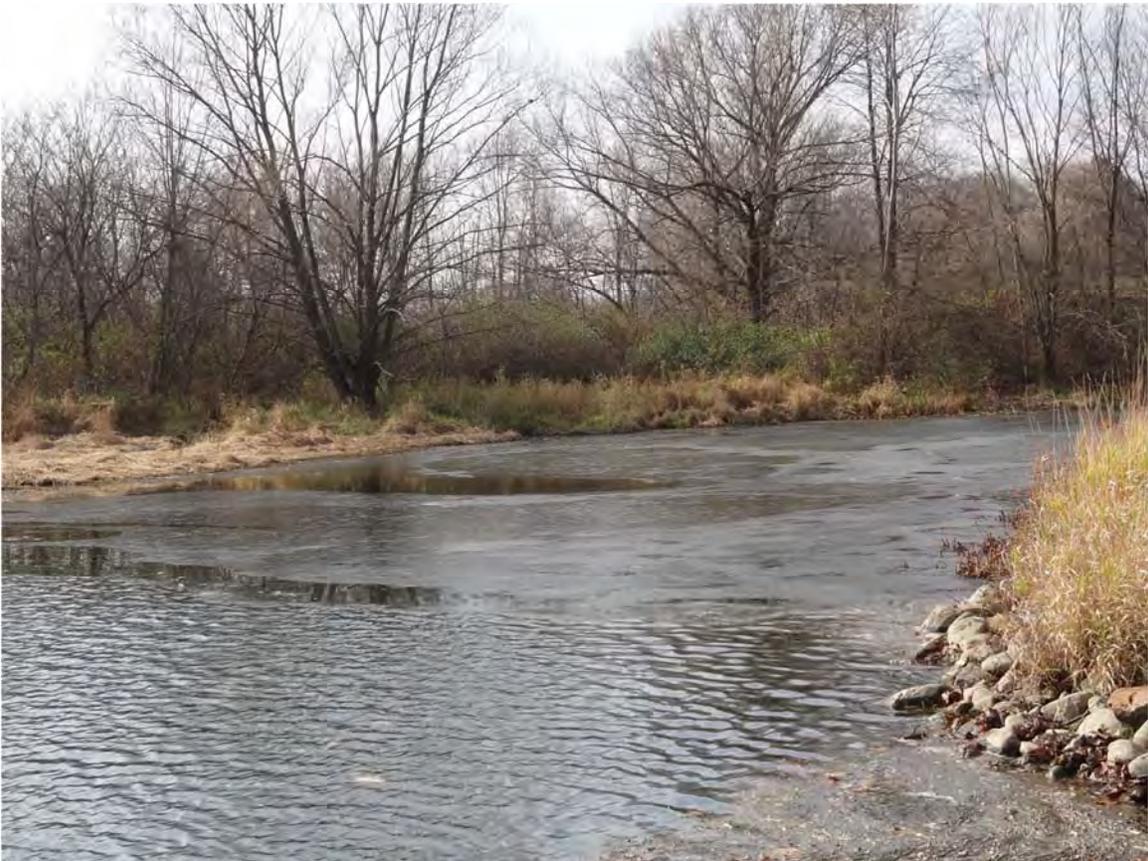
2. MP5.63 LDB observed sheet ice forming.

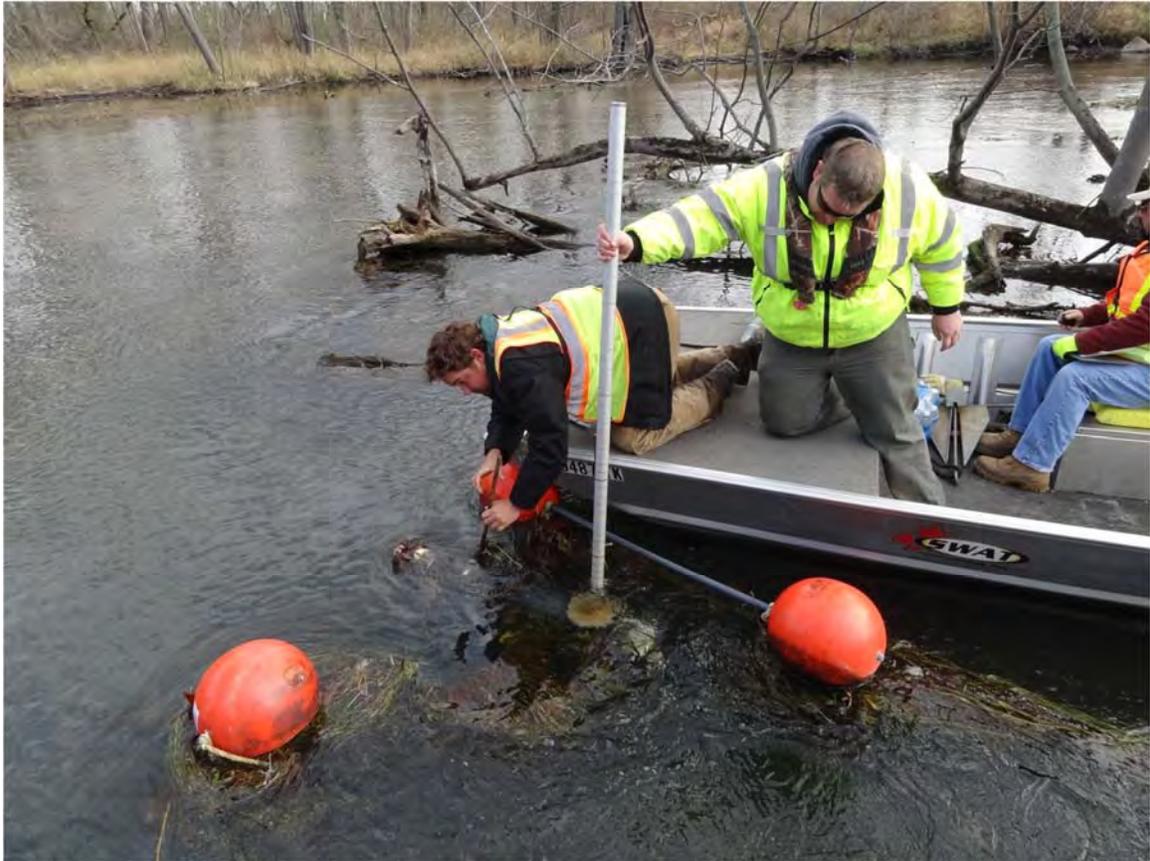
3. Up river of the confluence observed a crew removing the Walling Tube Sampling Devices.

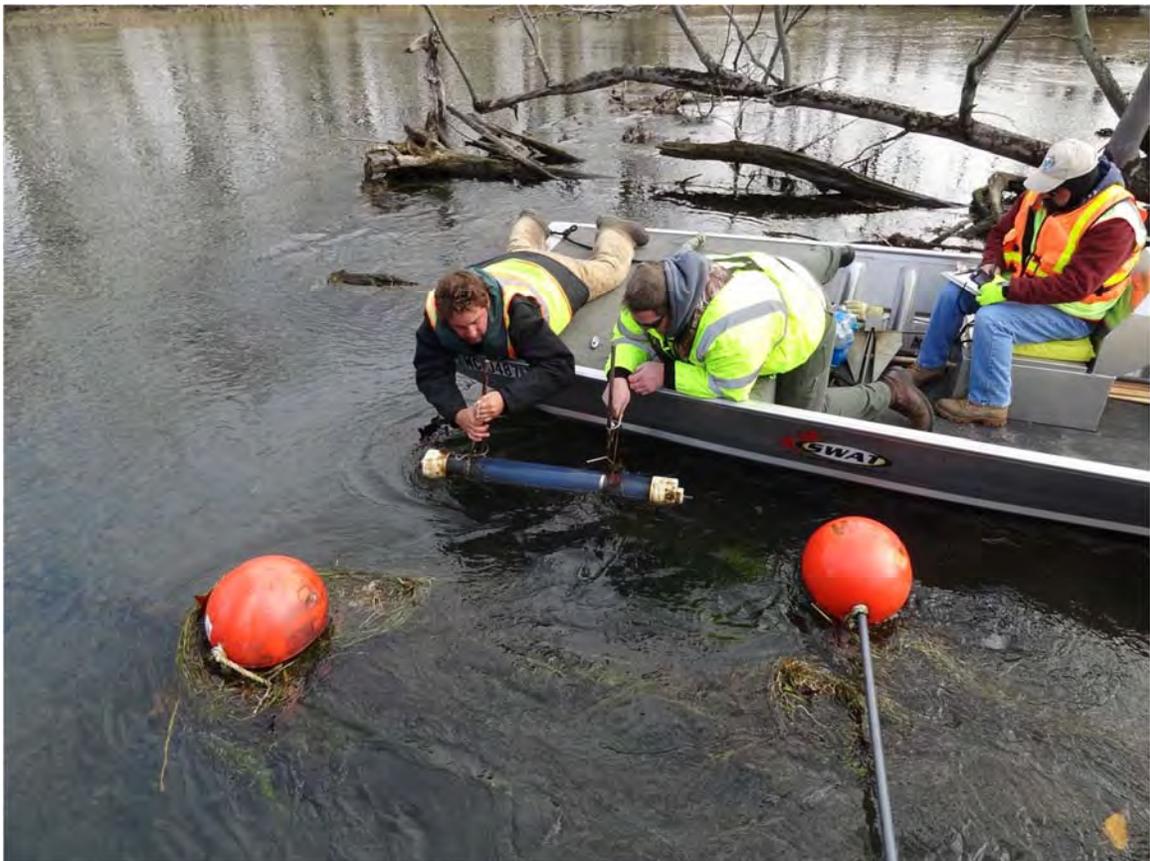
4. Up river of the confluence observed a crew removing the Walling Tube Sampling Devices.

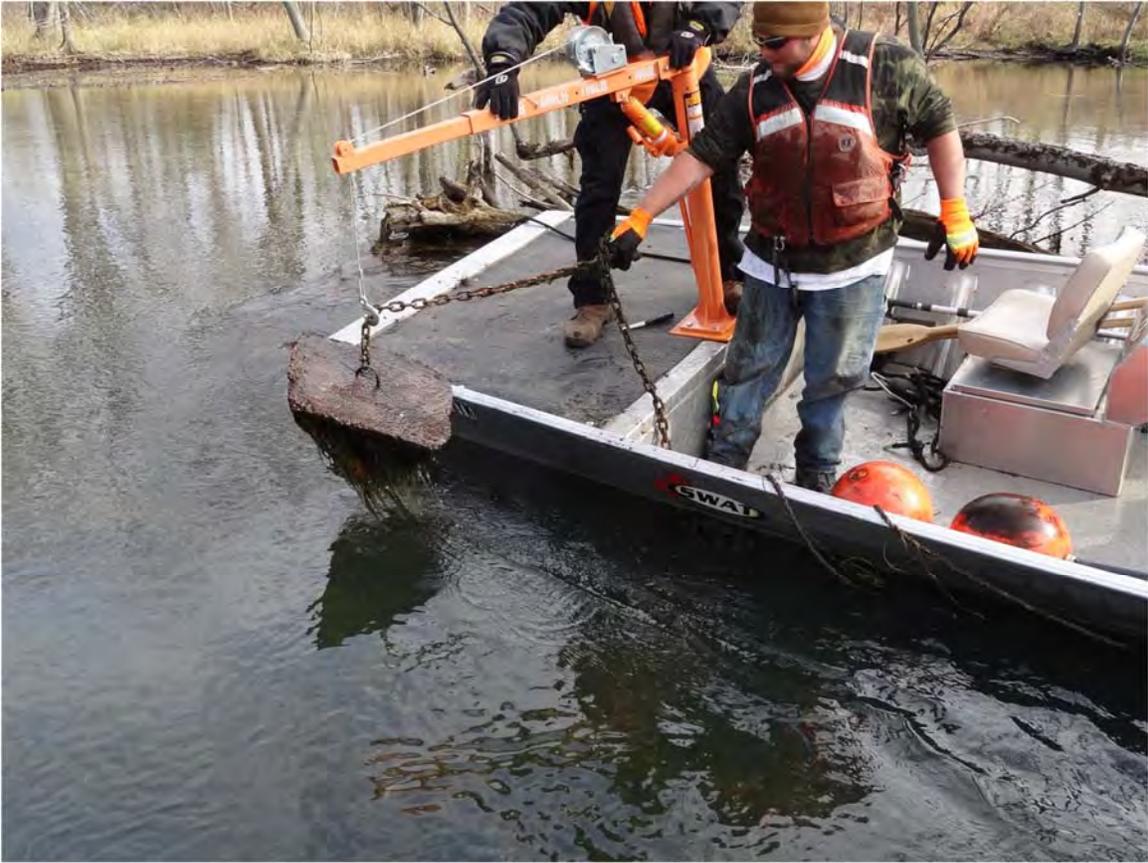
5. Up river of the confluence observed a crew removing a Walling Tube anchor.

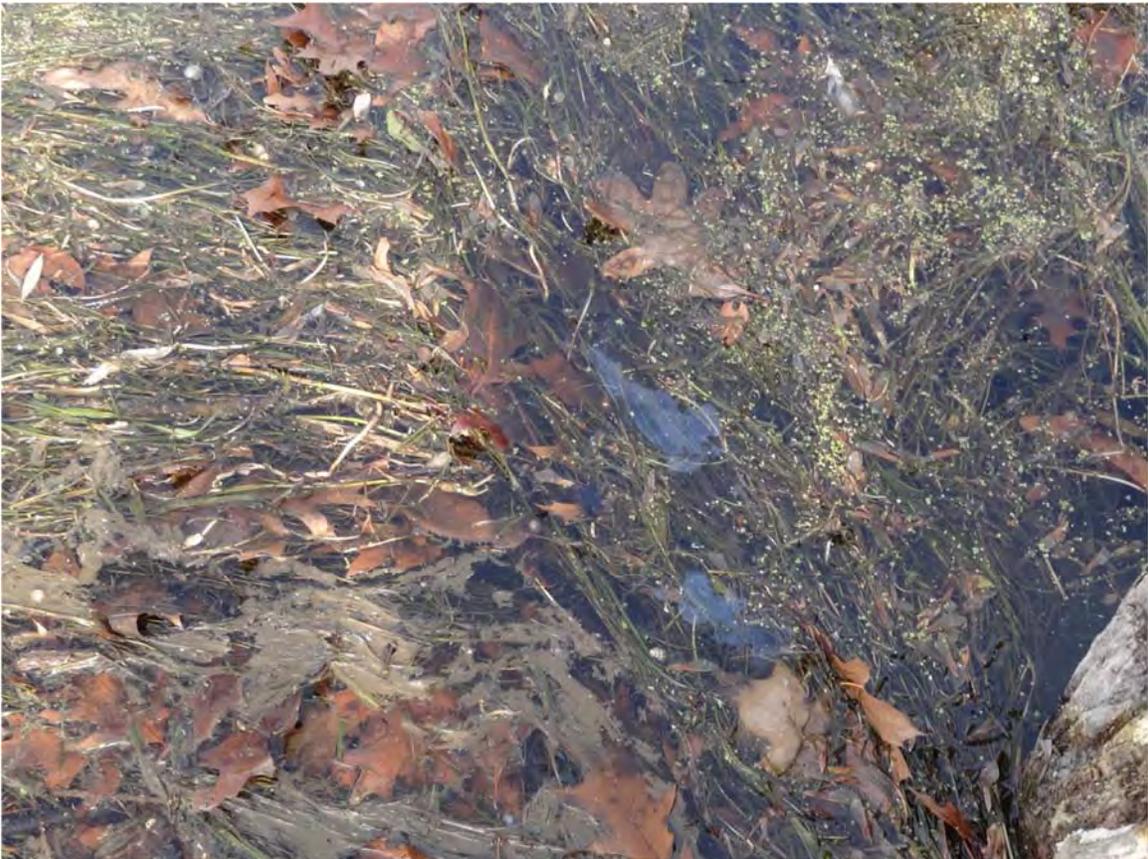
6. MP5.63 Railroad Trestles observed sheen collecting in the debris.

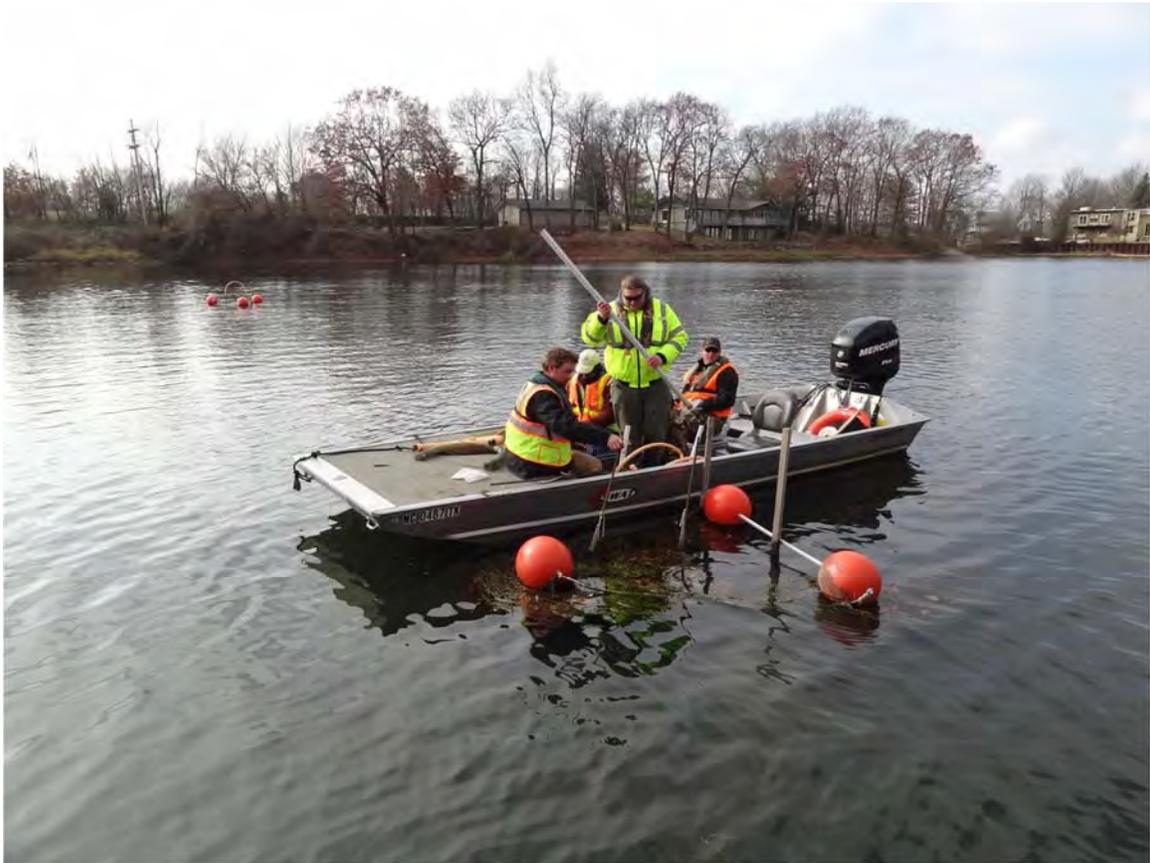
7. Ceresco Dam observed a crew removing Walling Tube Sampling Devices.

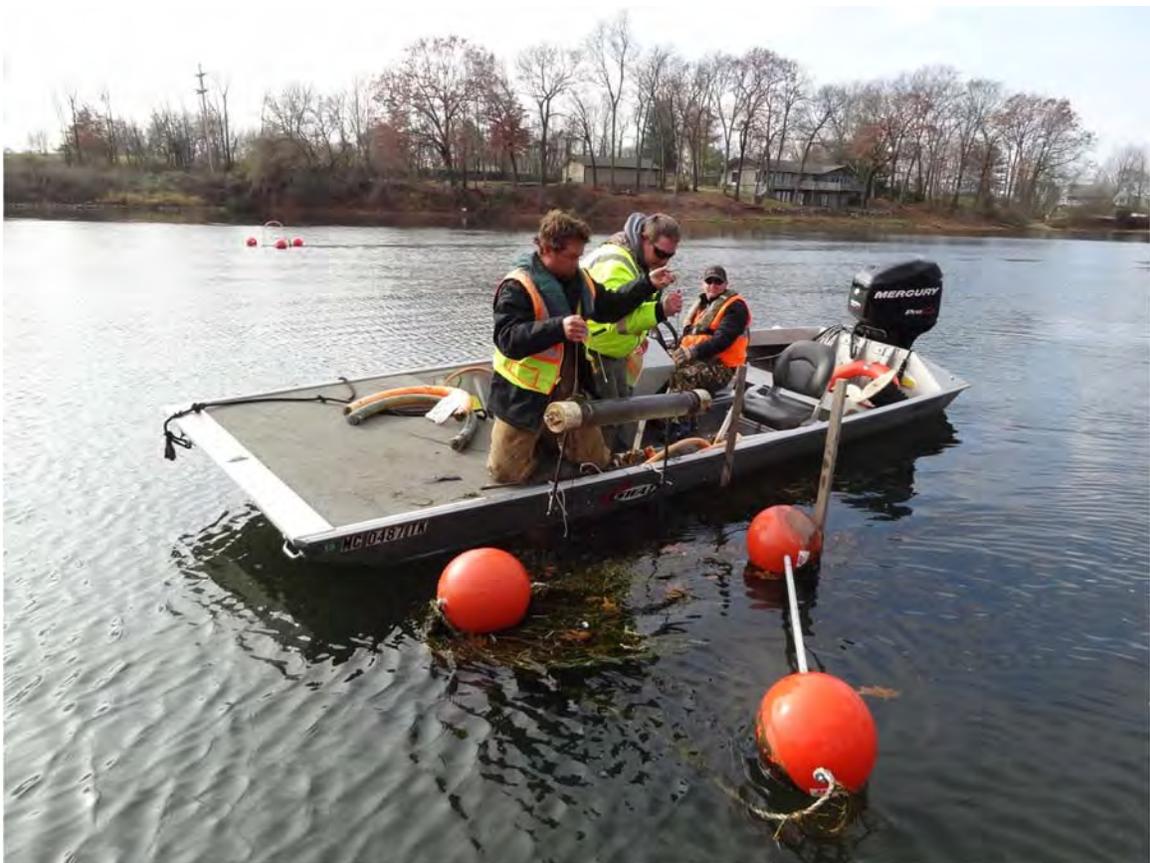
8. Ceresco Dam observed a crew removing Walling Tube Sampling Devices.

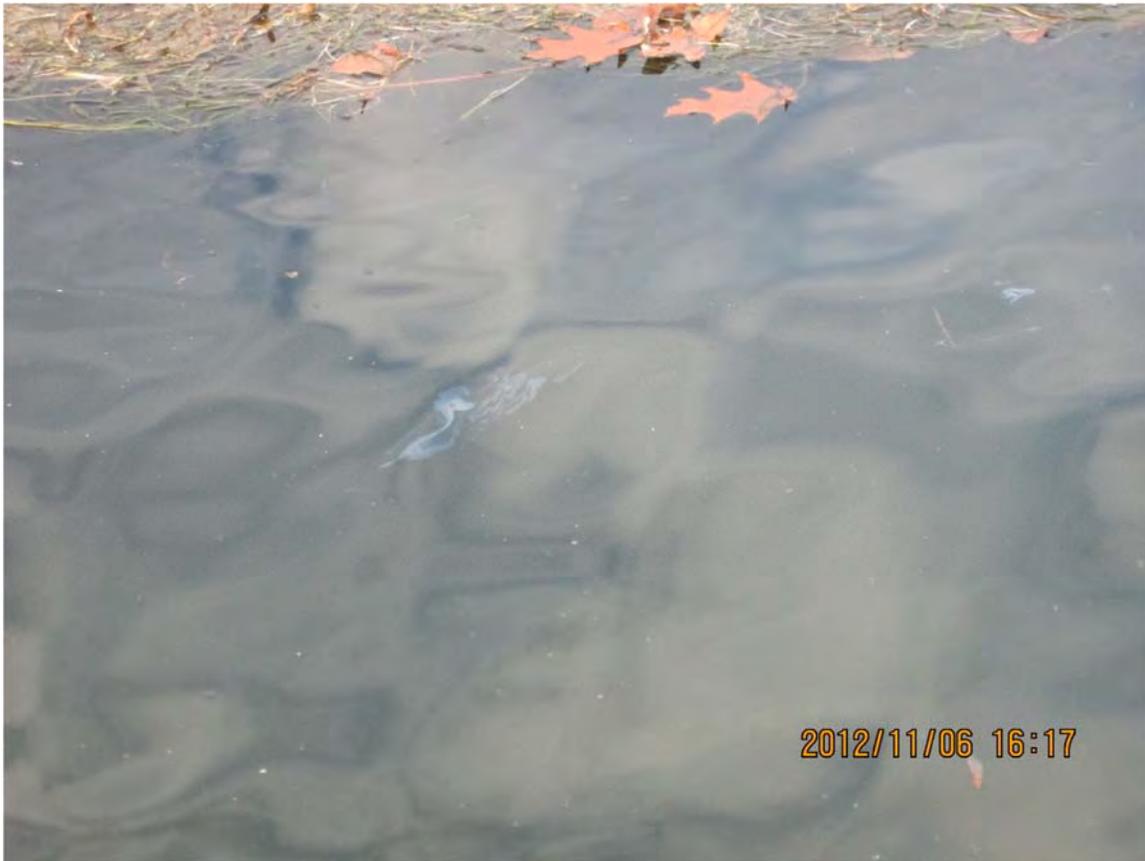
9. Ceresco Dam observed sheen collecting along the control point boom.

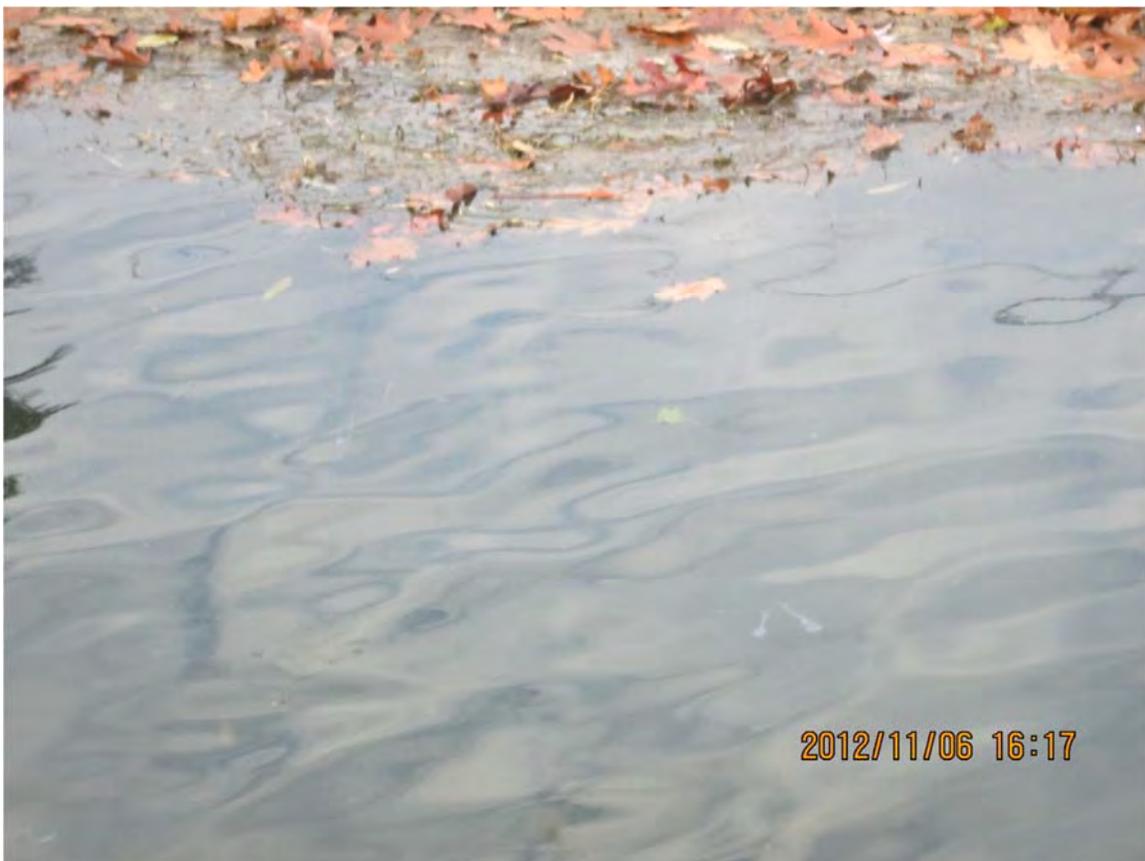
10. Ceresco Dam observed sheen collecting along the control point boom.

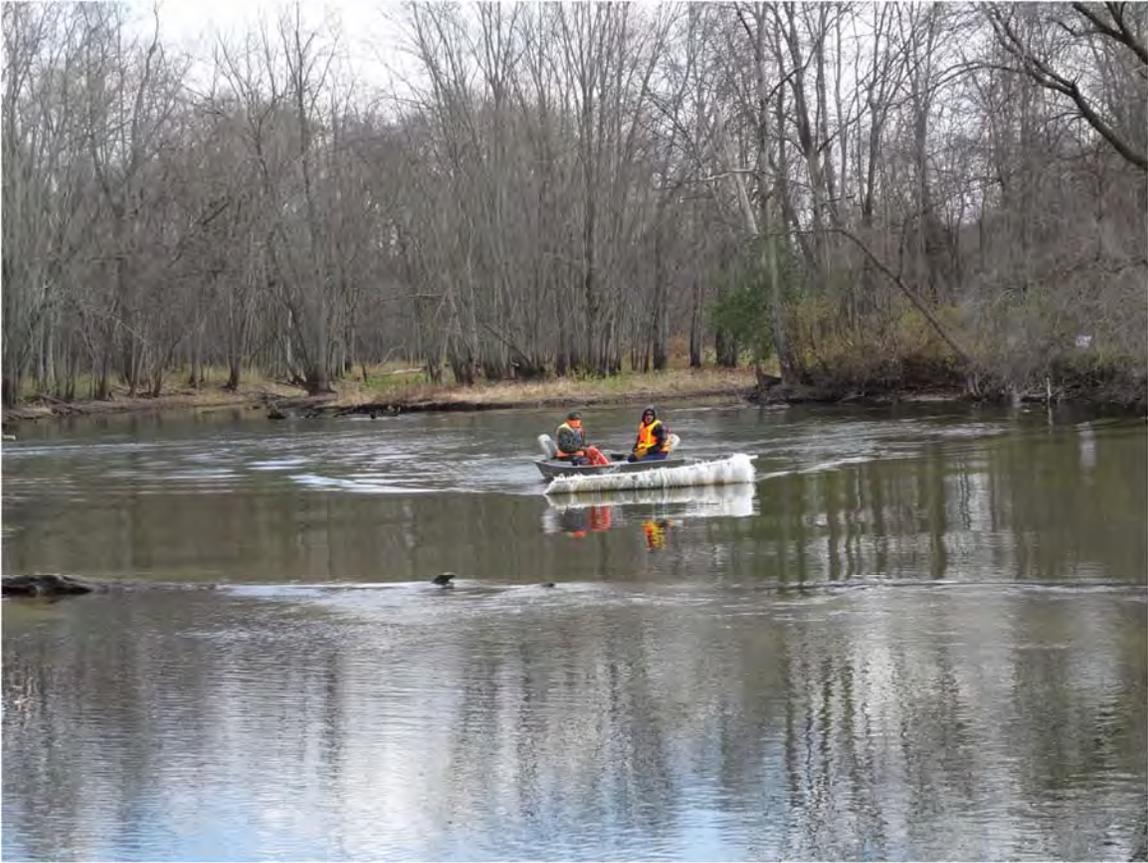
11. MP26.25 observed a sheen sweep boat operating in the area between MP21.5 – MP30.8.

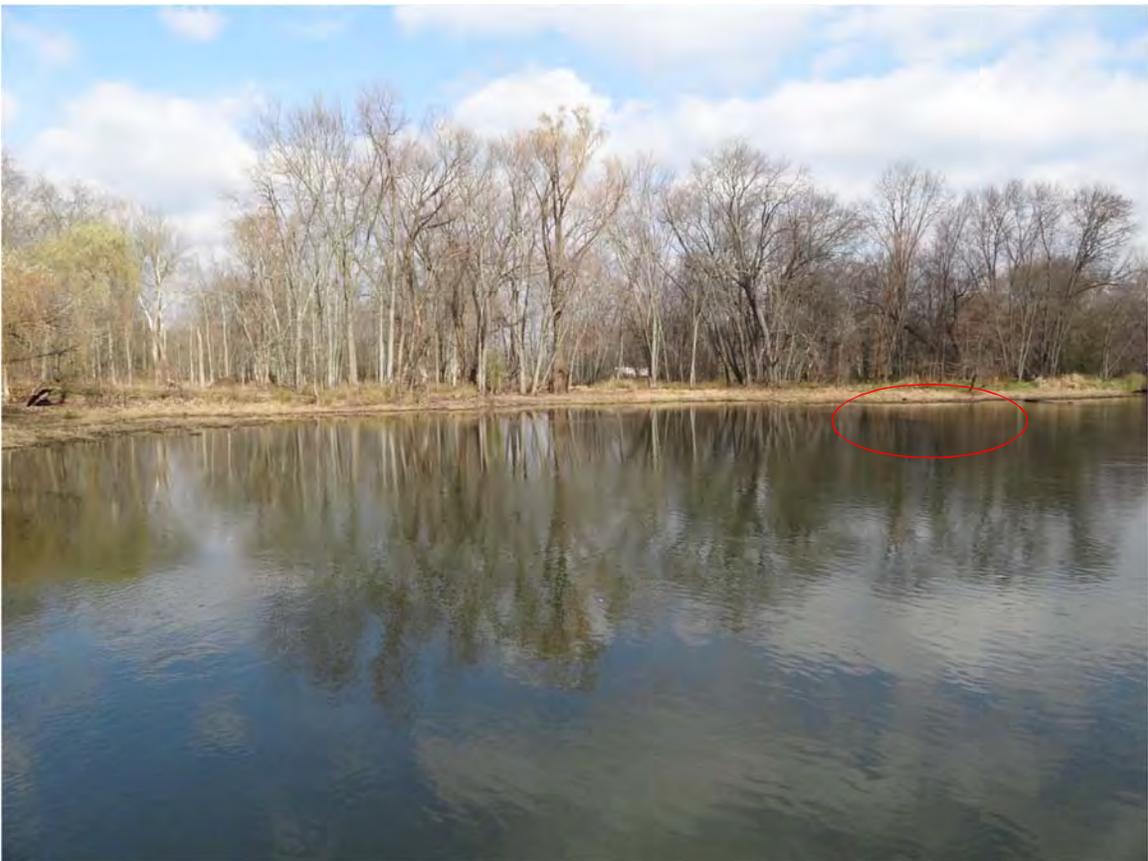
12. MP26.25 RDB area where sheen was observed.

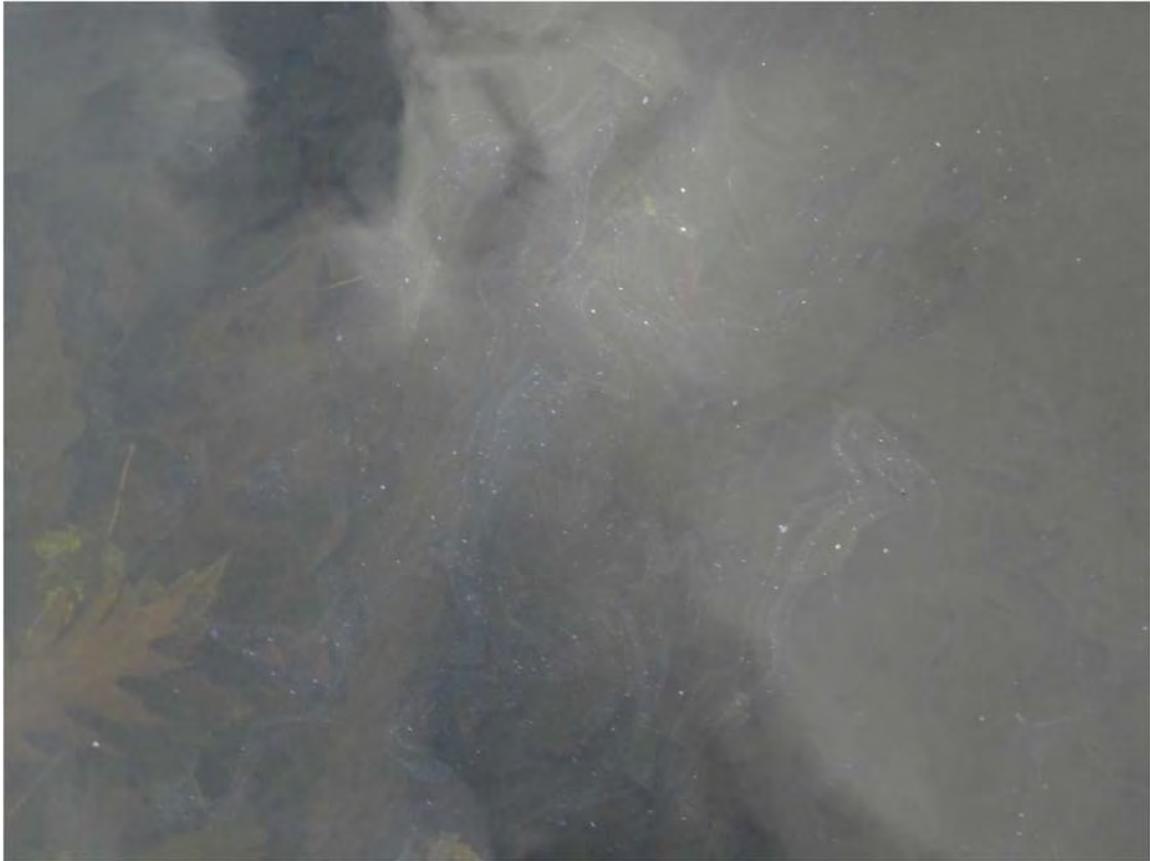
13. MP26.25 Spontaneous sheen observed. Quantity of sheen would not warrant a sweep boat.

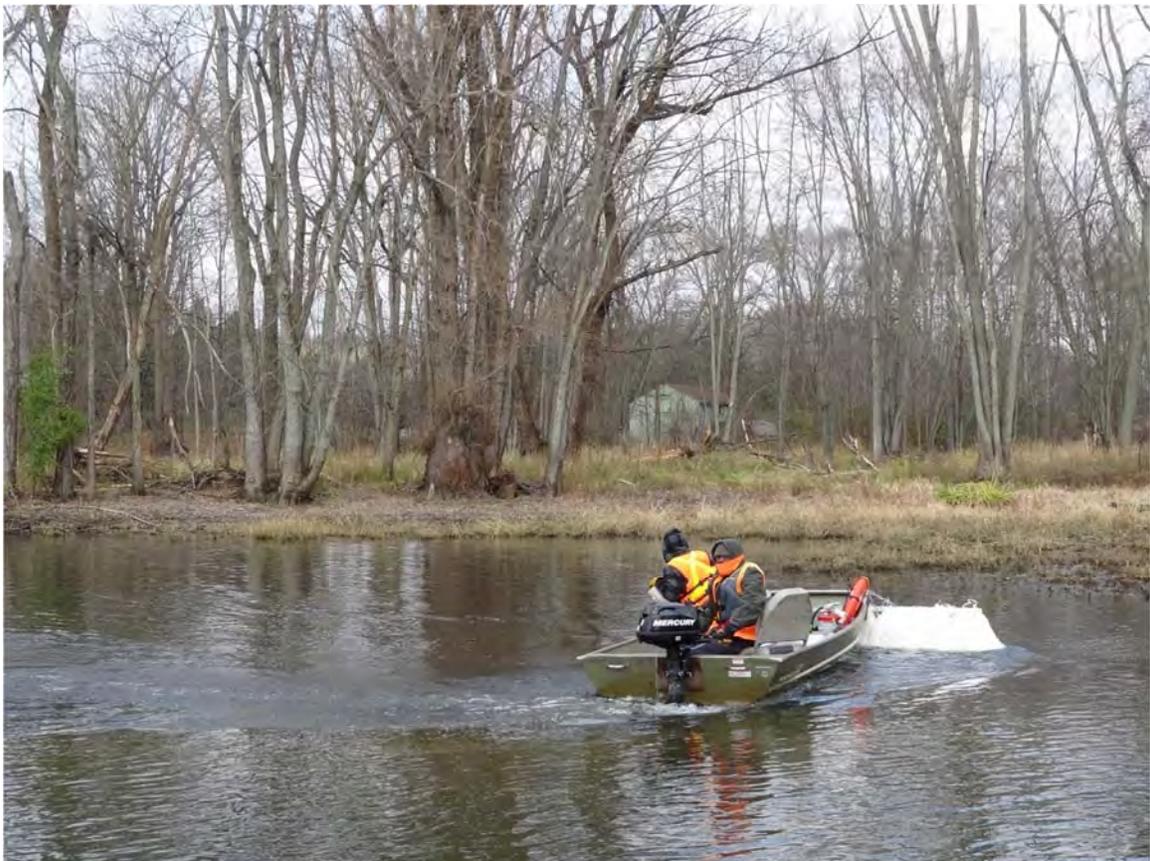
14. MP26.25 RDB observed the sheen sweep boat responding to the sheen observed.

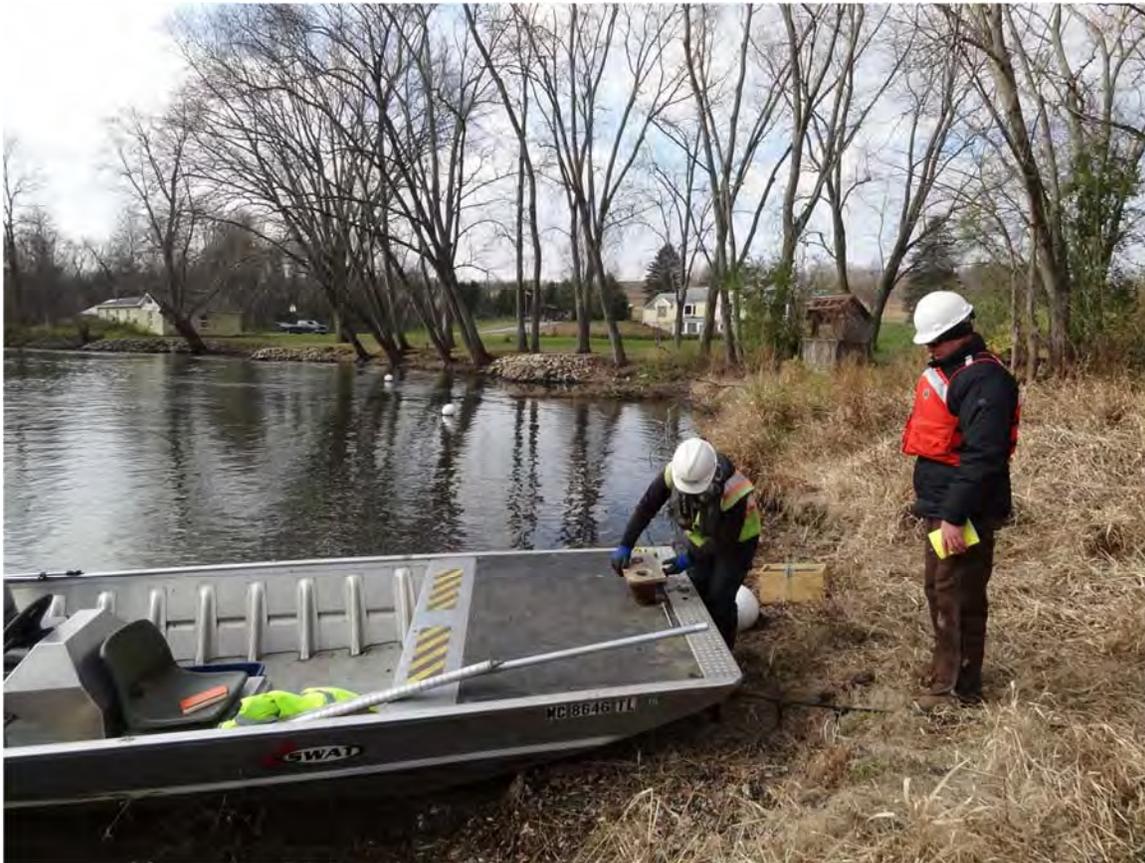
15. MP26.0 Observed a crew sampling CSD.

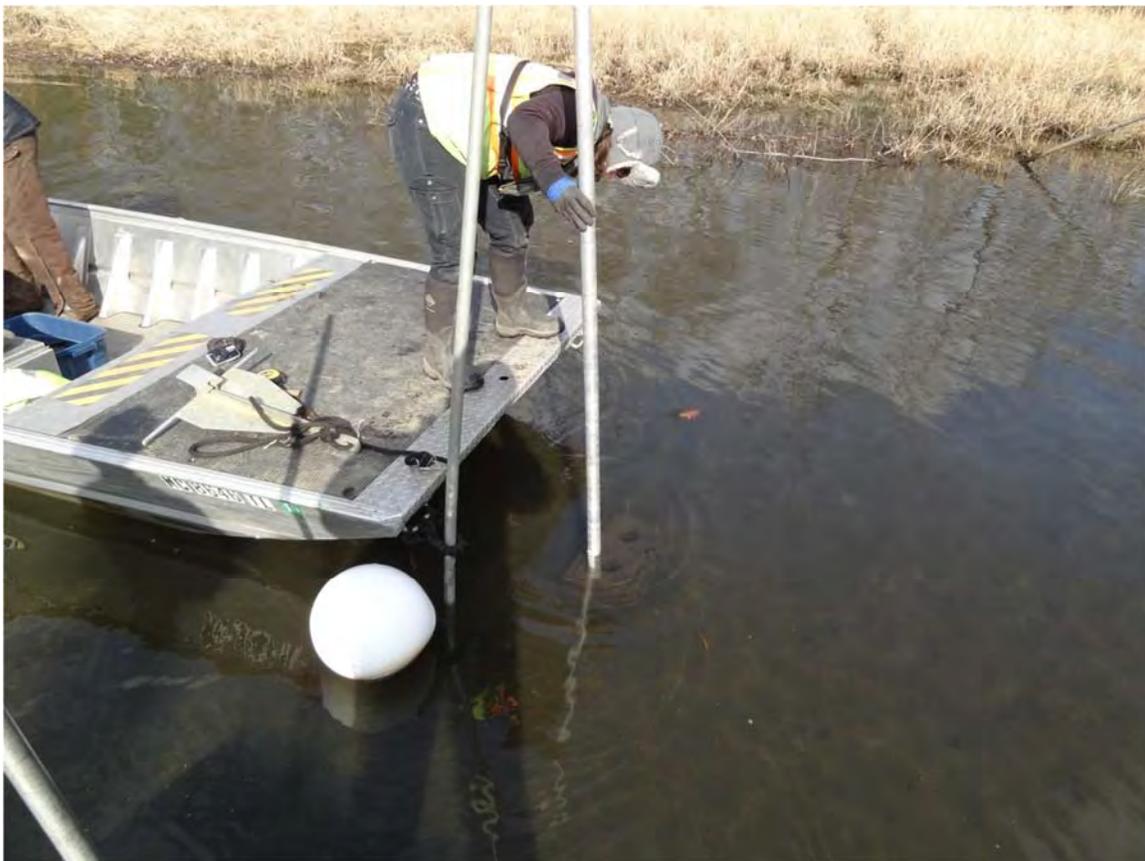
16. MP26.0 Observed a crew sampling CSD.

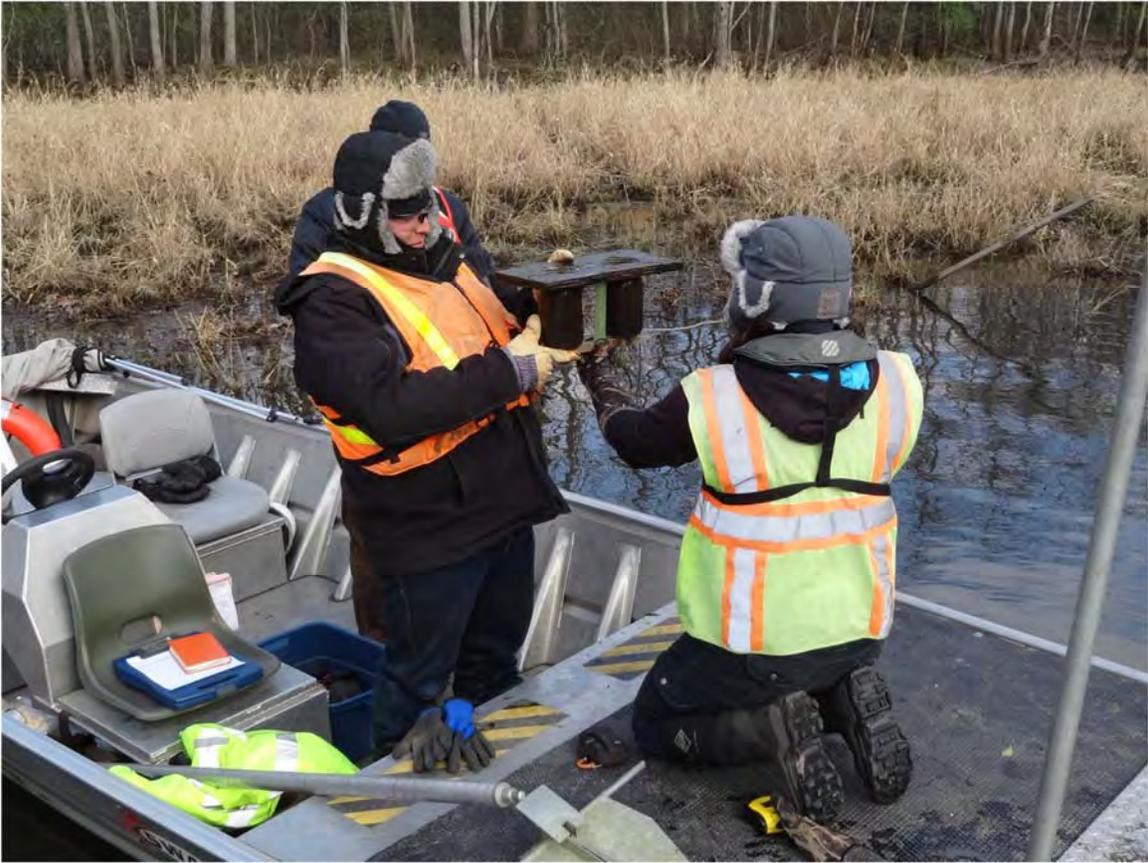
17. MP26.0 Observed a crew sampling CSD.

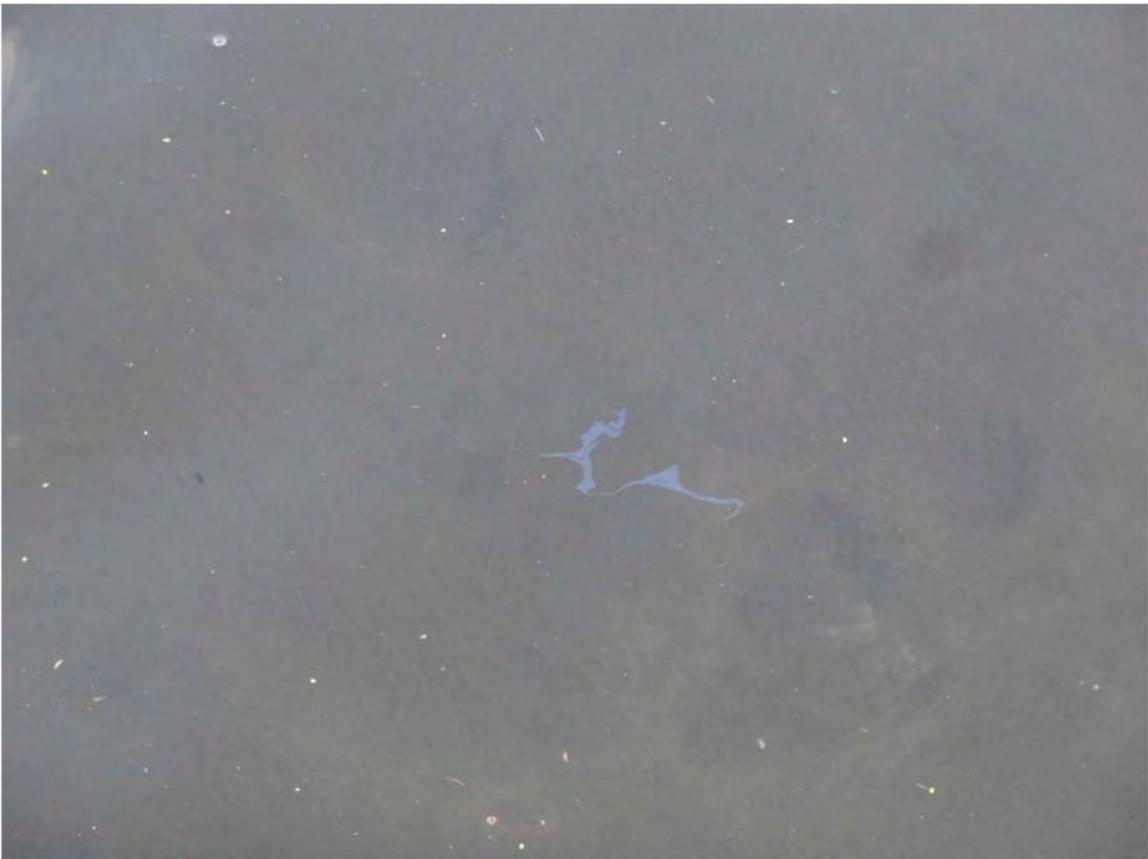
18. MP26.0 Observed sheen around the area where the crew was sampling the CSD.

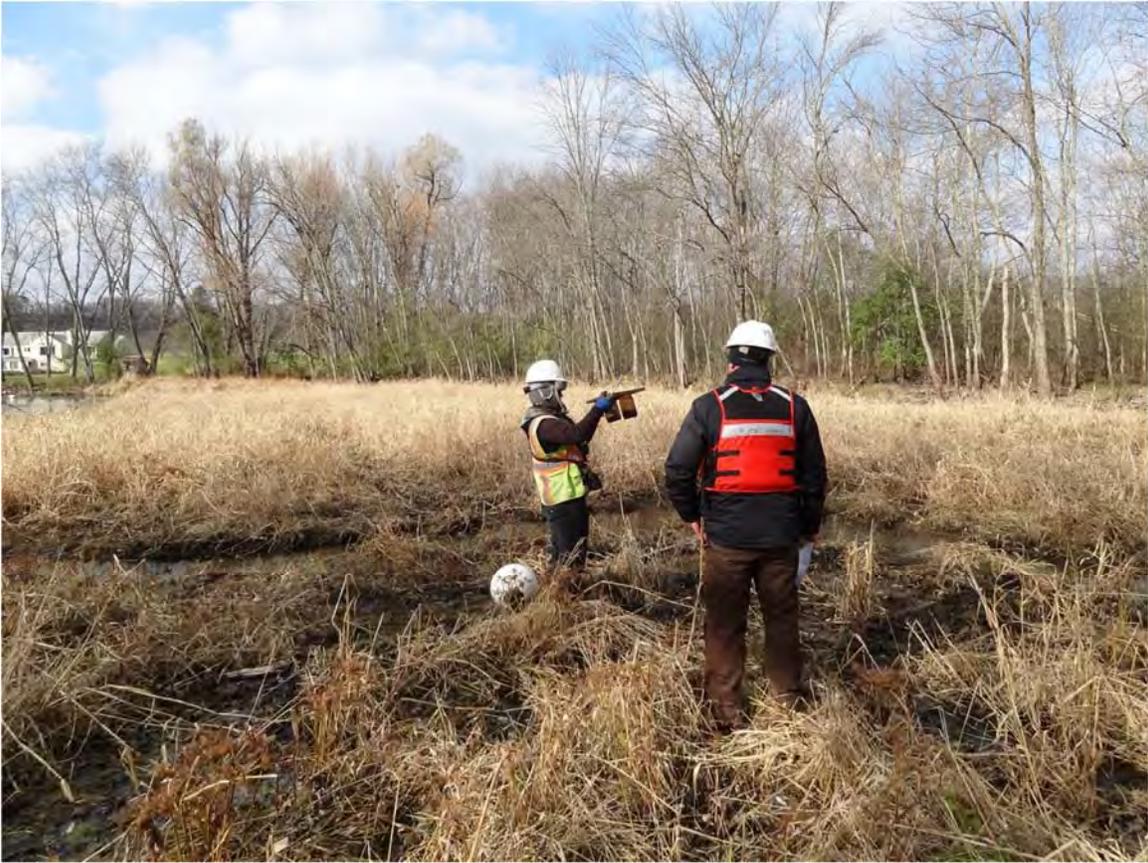
19. MP26.0 Observed a crew sampling CSD.

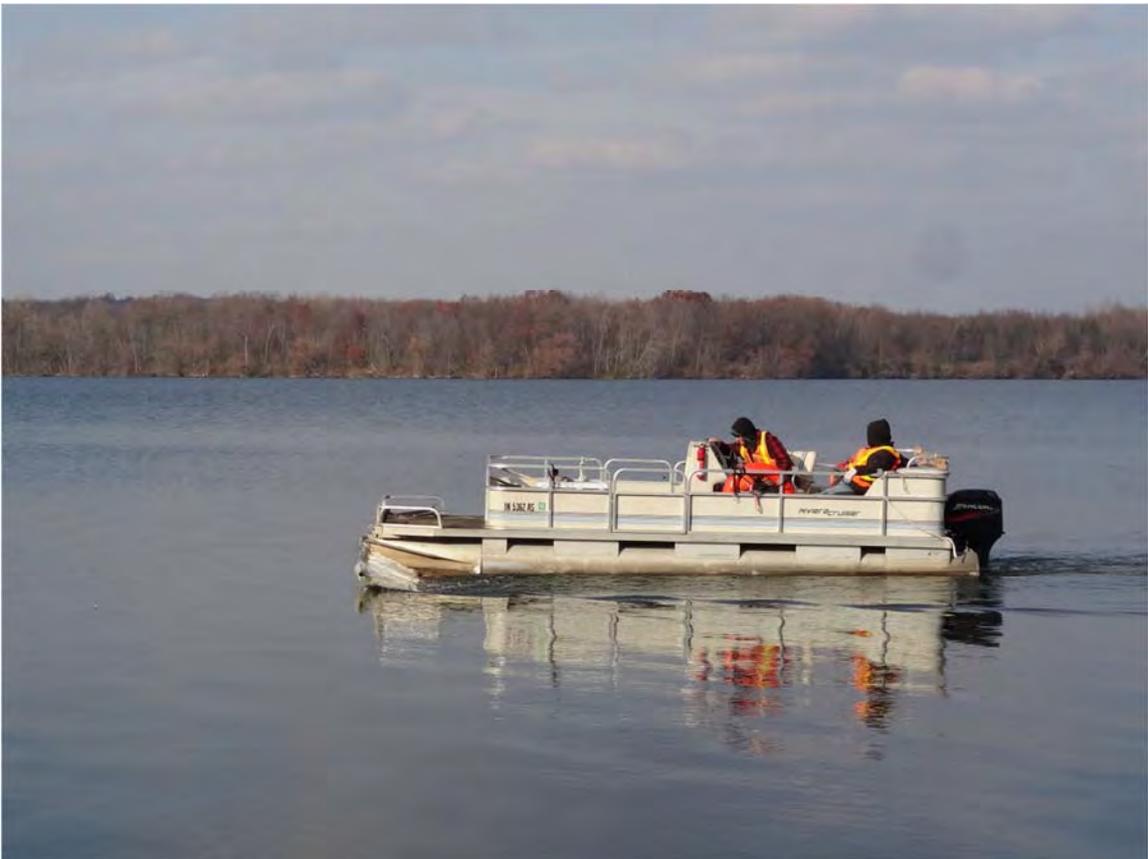
20. Morrow Lake observed a sweep boat operating in the south cove.

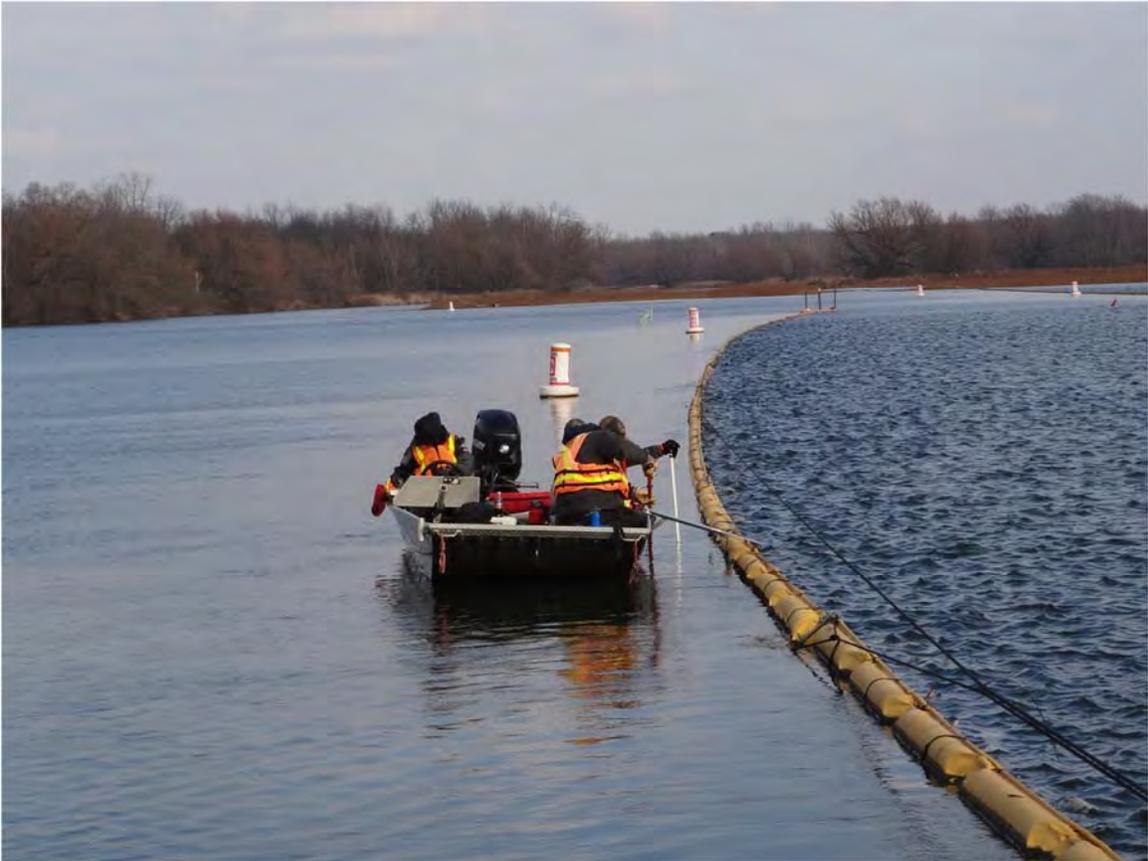
21. Morrow Lake Delta Gate C observed a crew performing curtain inspections.

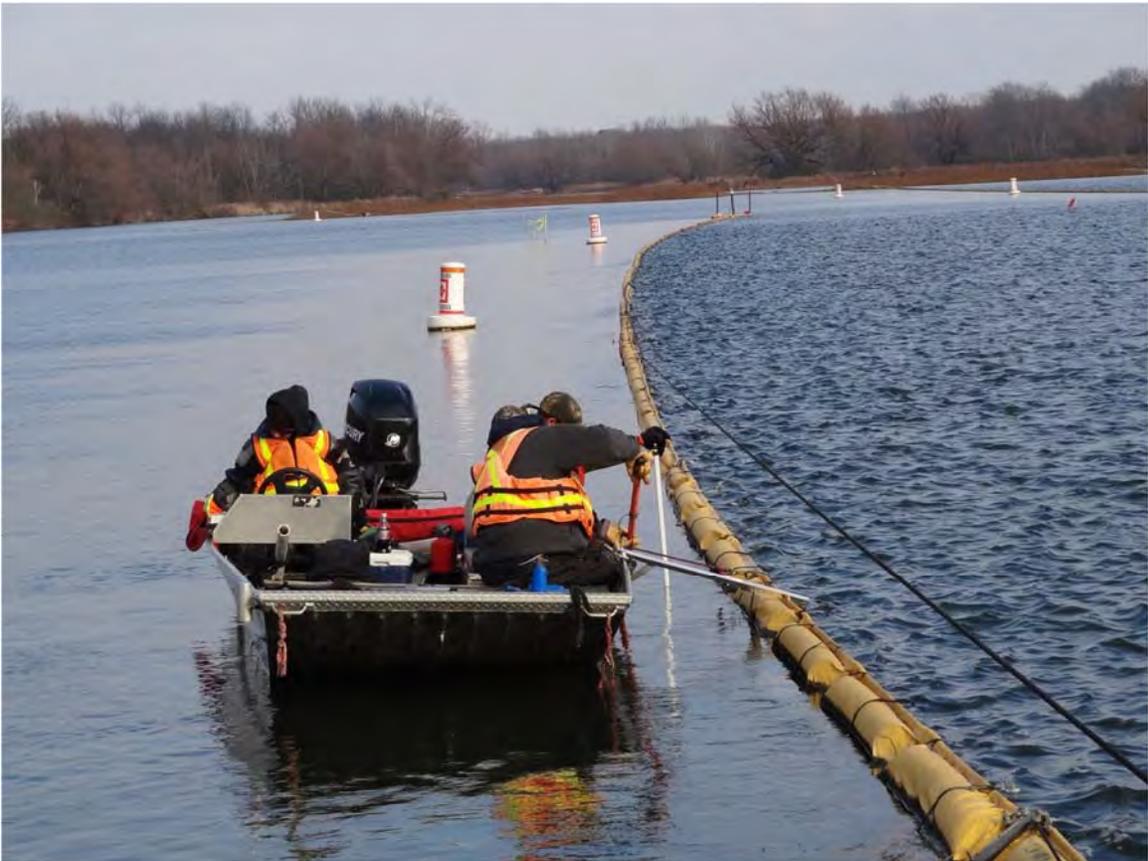
22. Morrow Lake Delta Gate C observed a crew performing curtain inspections.
