# Situation Photo Log

Wednesday, November 7, 2012

Kalamazoo River / Enbridge Spill

Prepared by:  
Matthew Haak  
START-USEPA  
Situation Unit

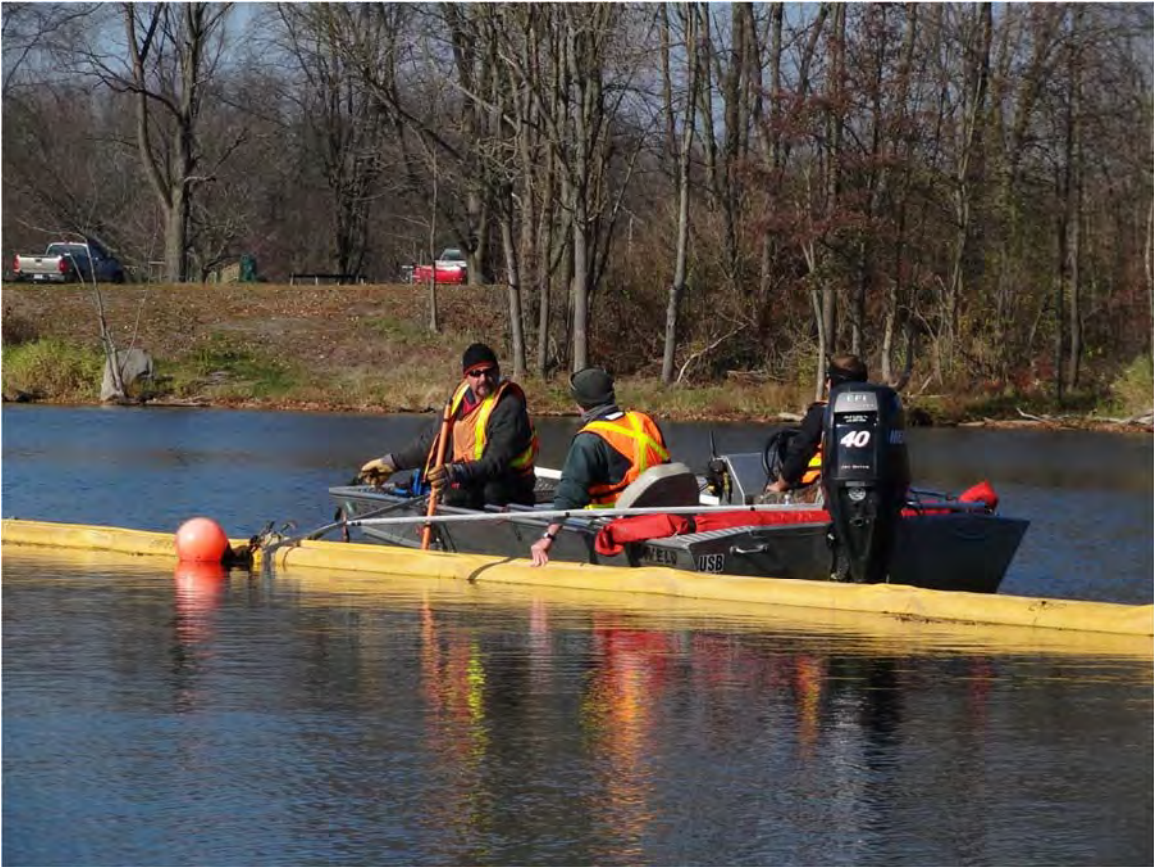
1. Morrow Lake Delta Gate E observed a crew inspecting the curtain.

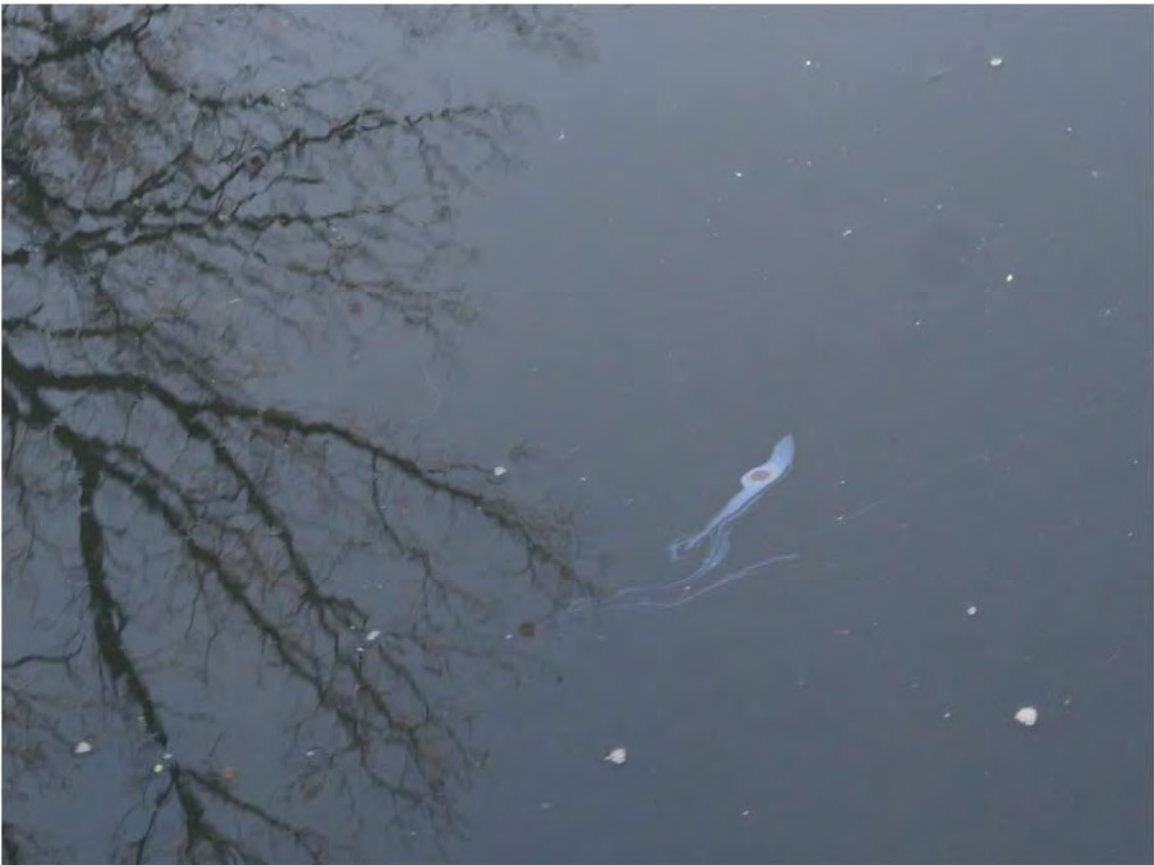
2. MP5.35 LDB sheen and tar globs observed.

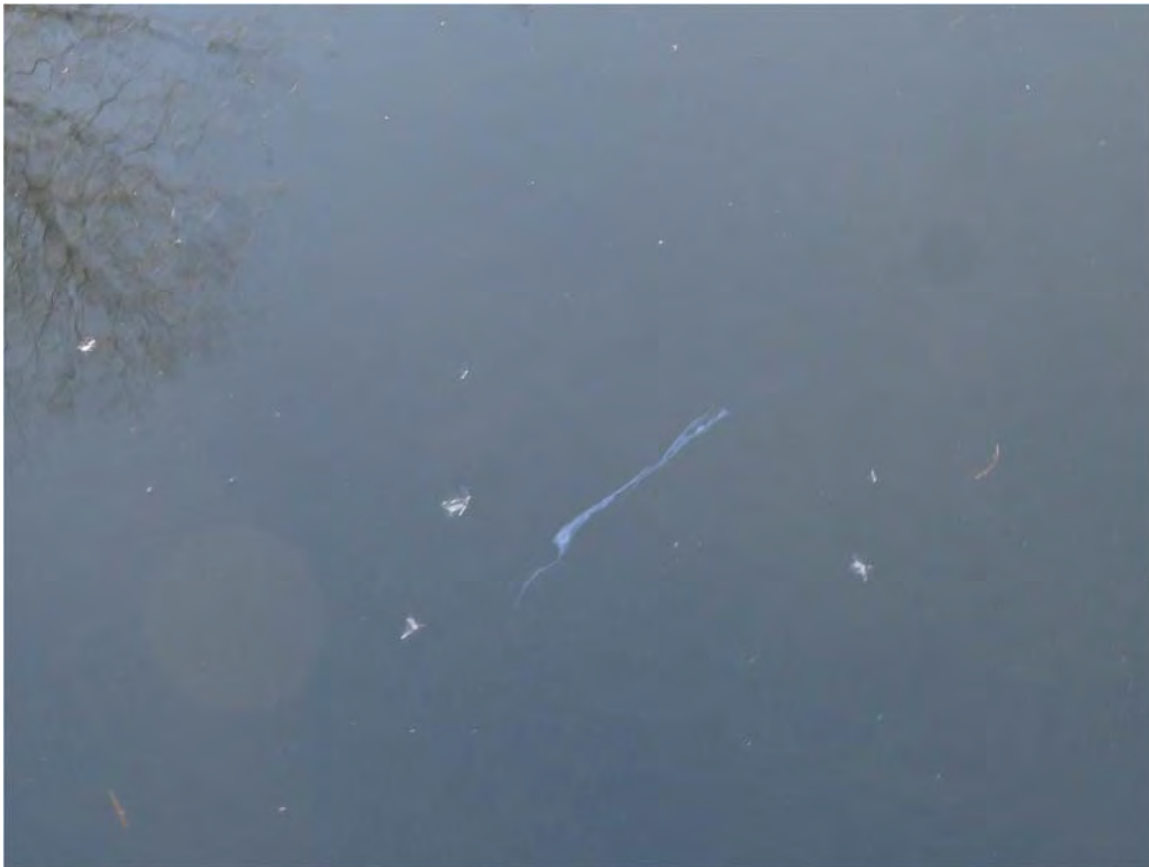
3. MP5.45 LDB sheen and tar globs observed.

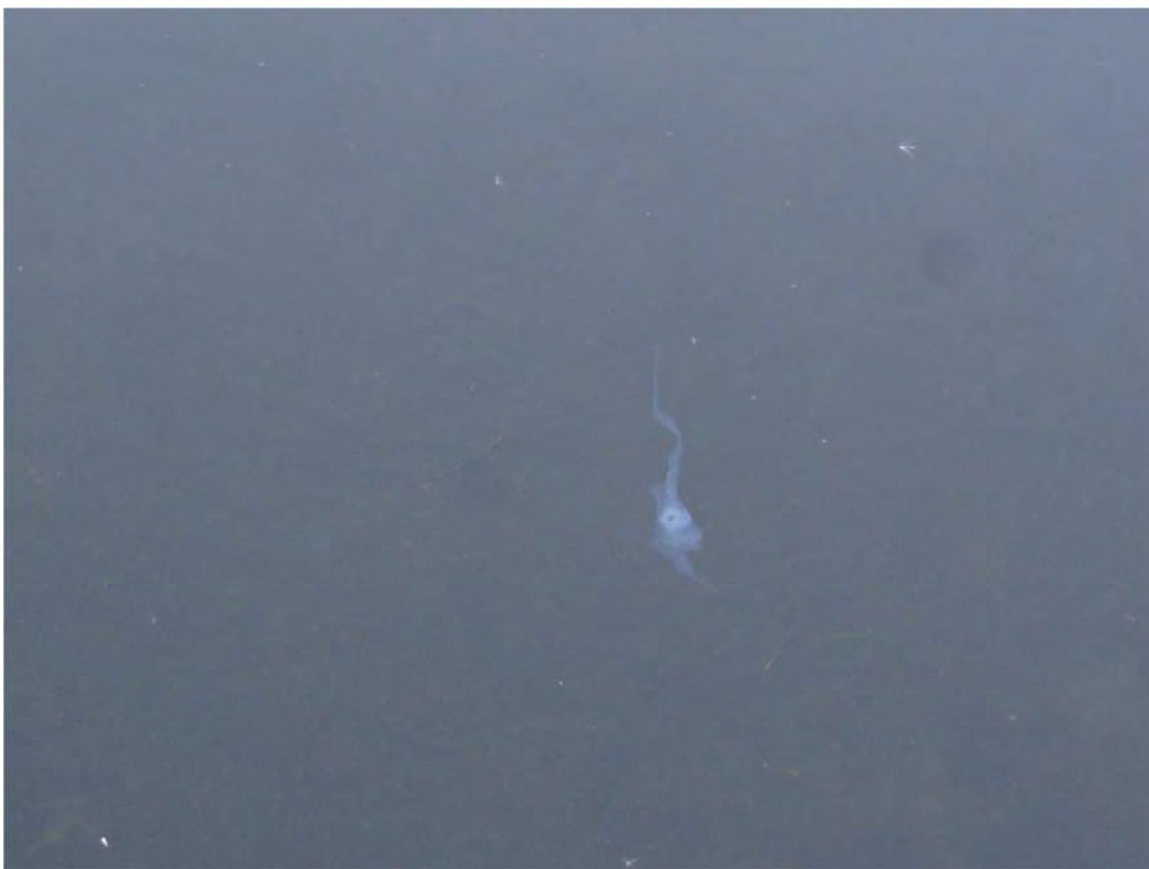
4. MP5.45 LDB sheen and tar globs observed.

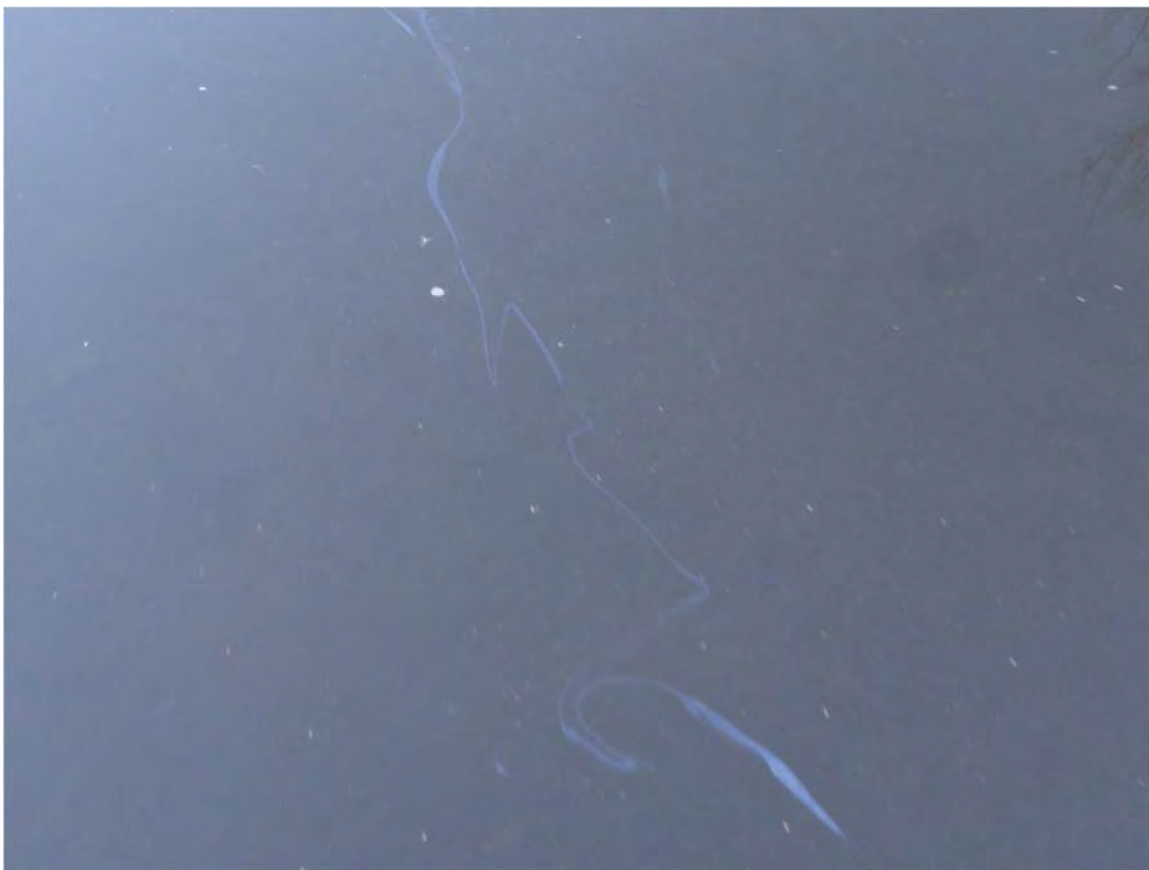
5. MP5.55 LDB sheen and tar globs observed.

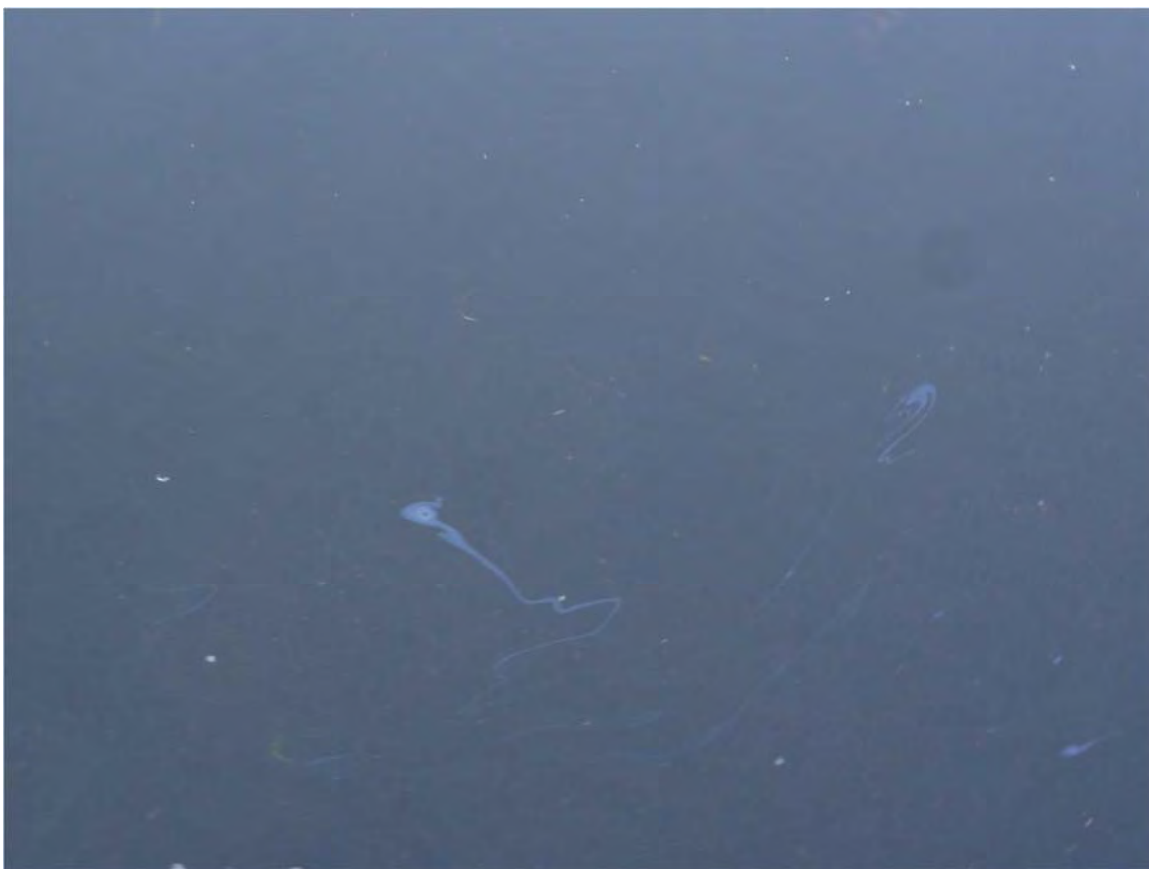
6. MP5.55 LDB sheen and tar globs observed.

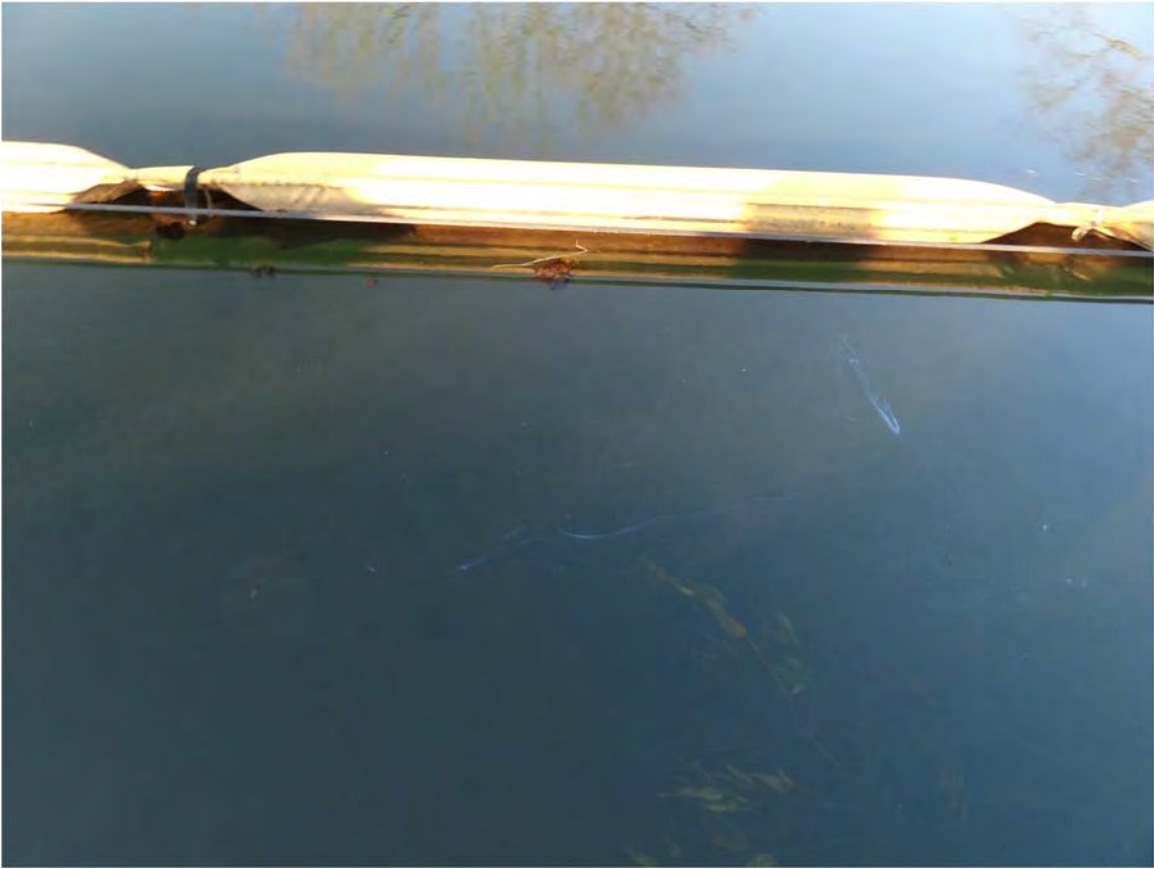
7. Ceresco Dam observed sheen collecting along the control point boom.

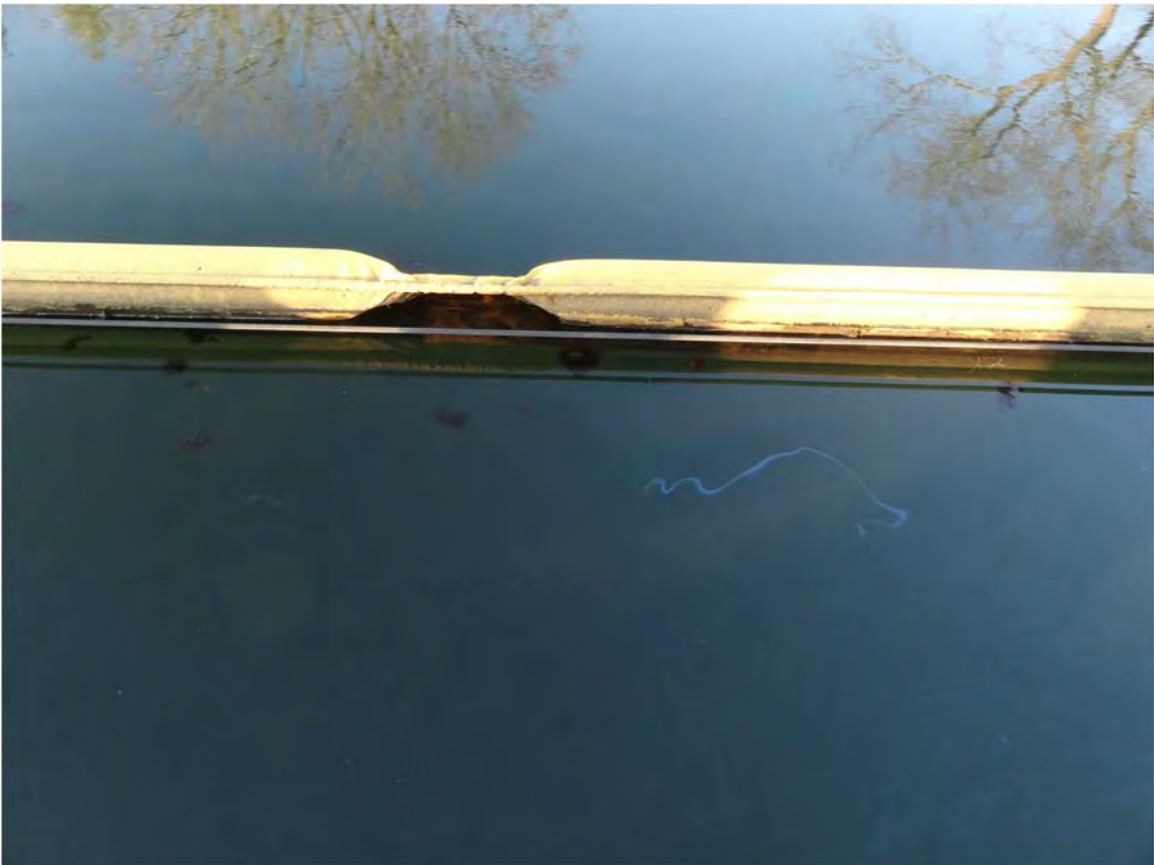
8. Ceresco Dam observed sheen collecting along the control point boom.

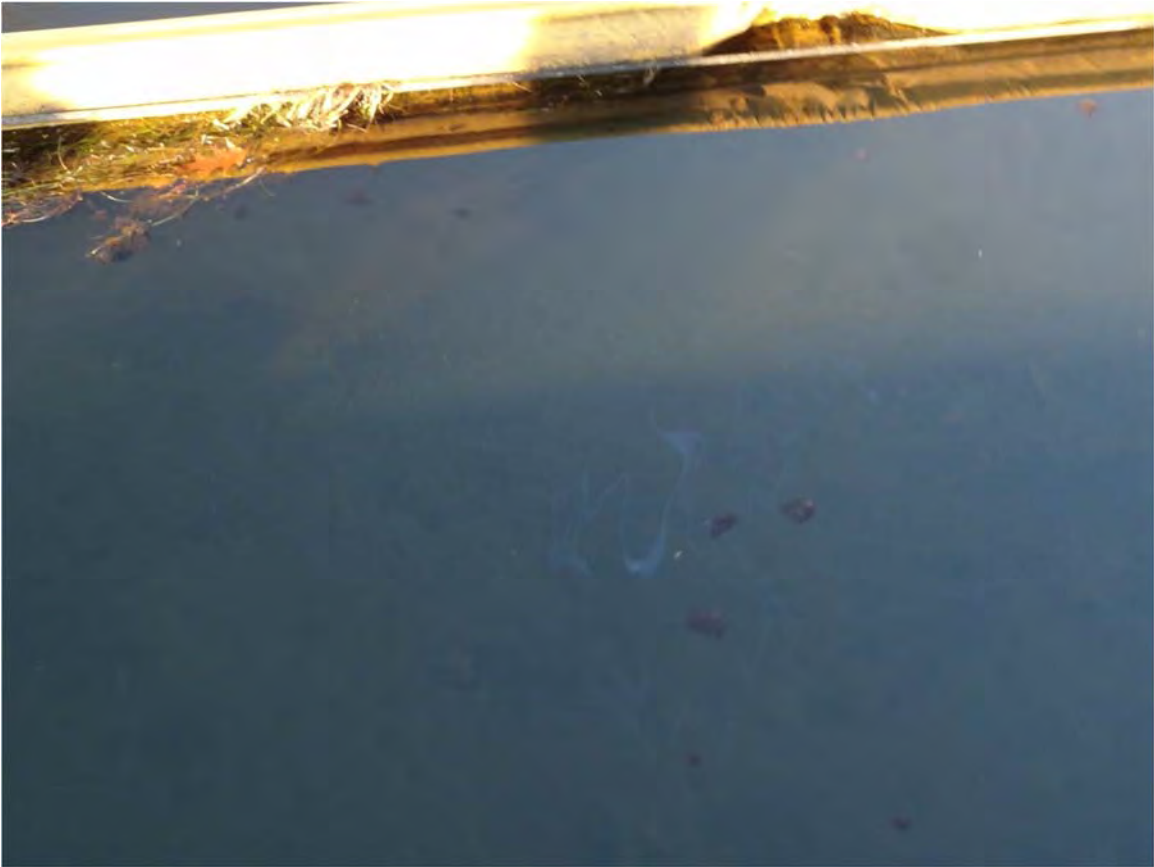
9. Ceresco Dam observed sheen collecting along the control point boom.

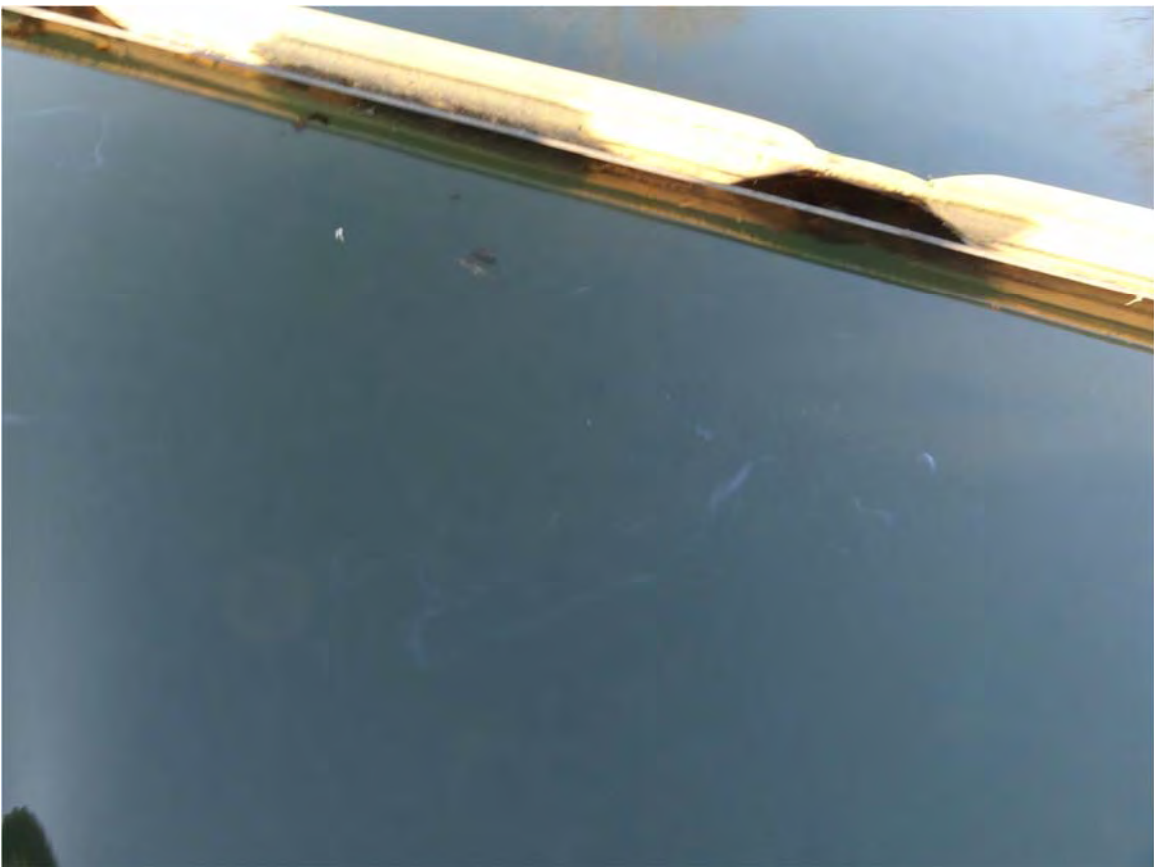
10. Ceresco Dam observed sheen collecting along the control point boom.
