Situation Photo Log

Saturday, November 10, 2012

Kalamazoo River / Enbridge Spill

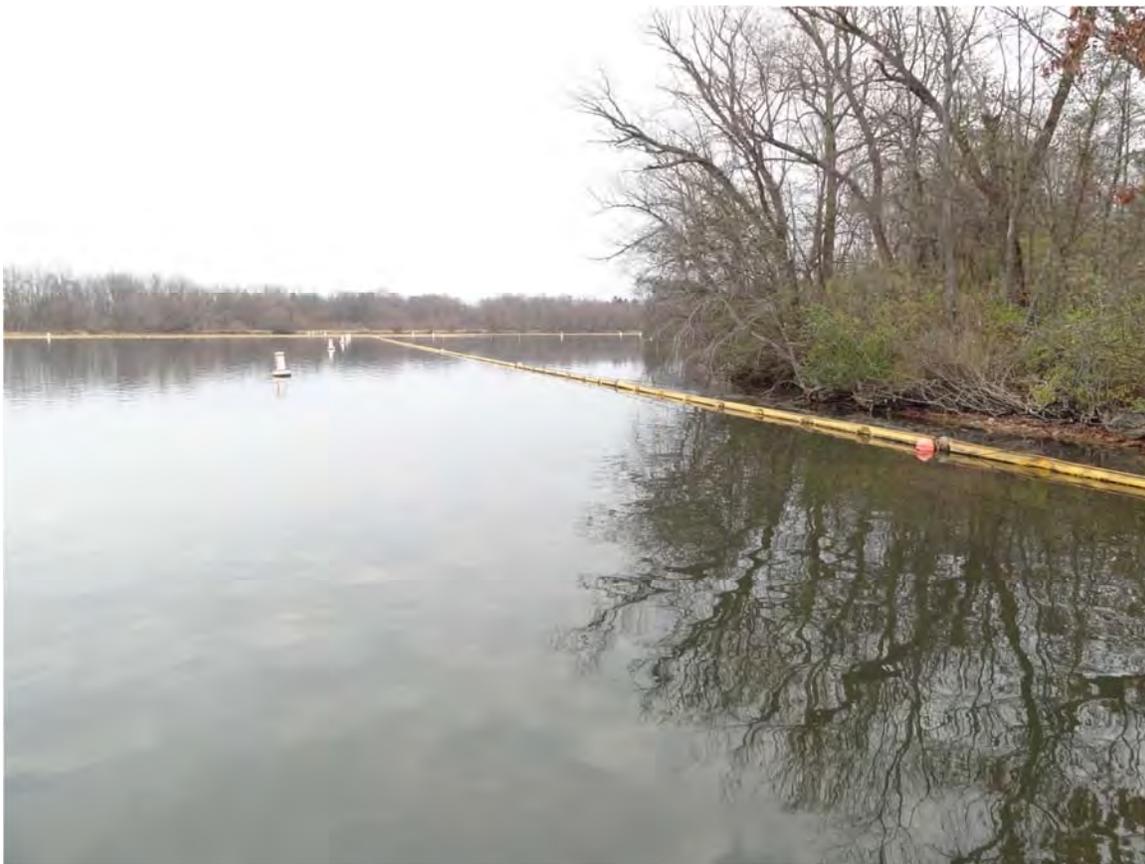
1. Morrow Lake Delta Gate F observed tar globs and sheen collecting along the boom.

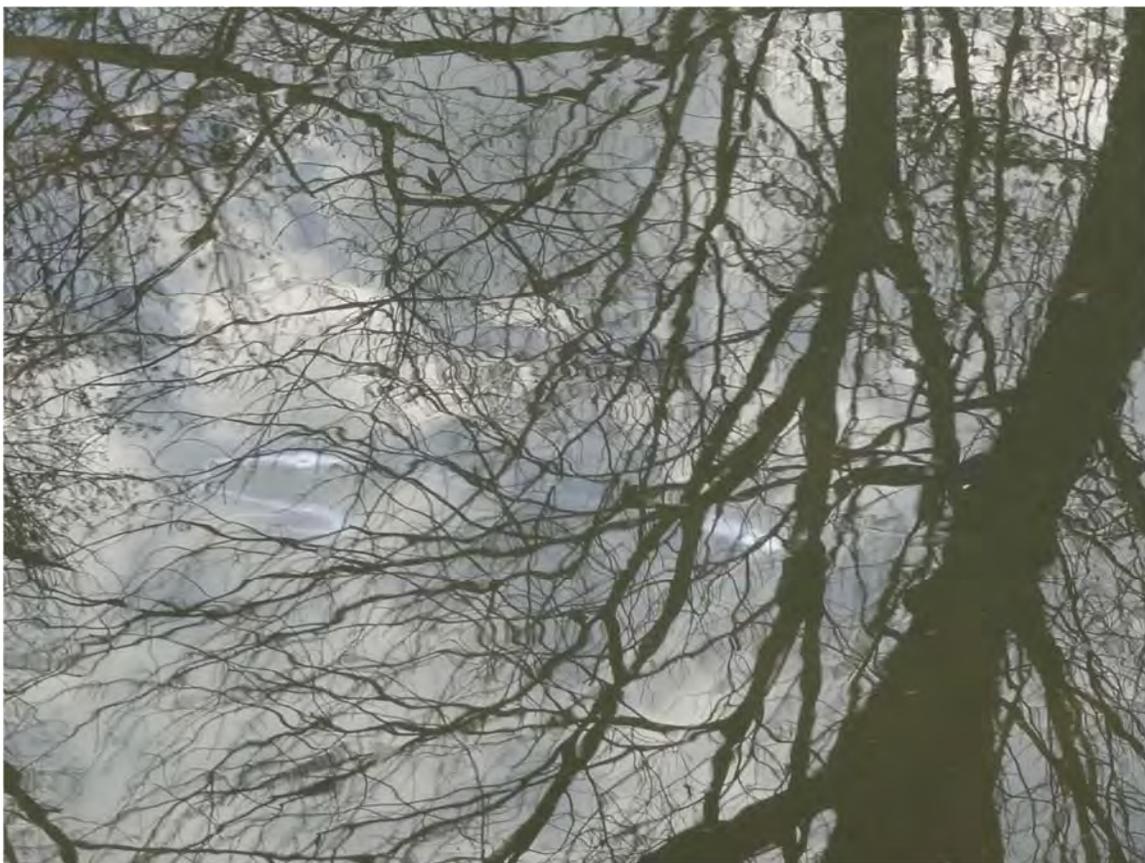
2. Morrow Lake Delta Gate F observed tar globs and sheen collecting along the boom.

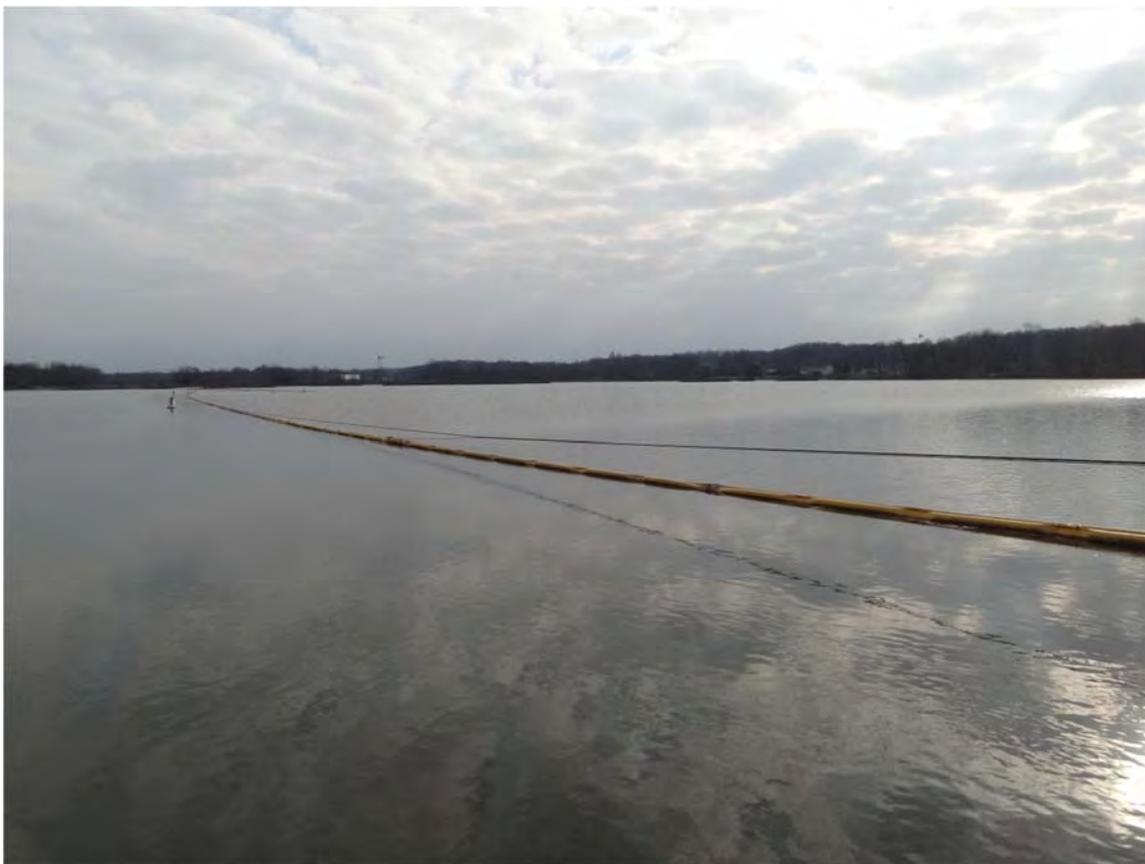
3. Morrow Lake Delta Gate C observed tar globs and sheen collecting along the boom.

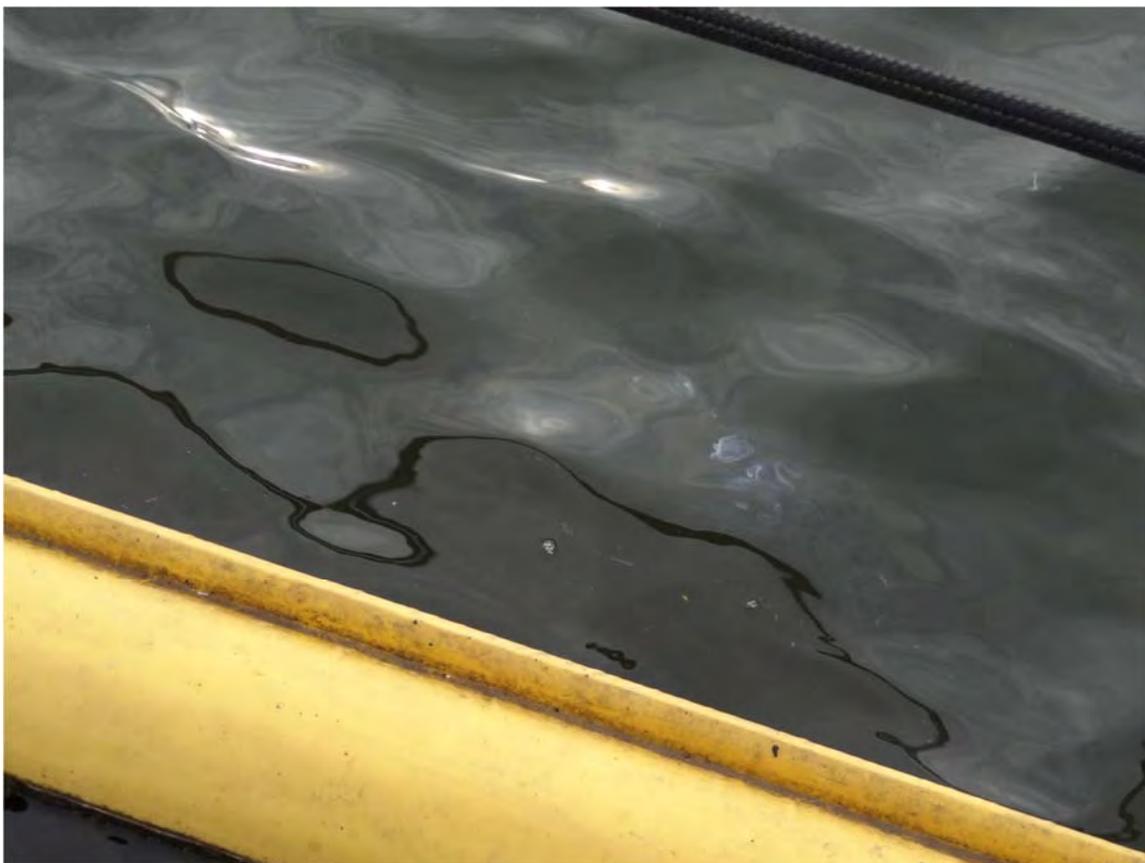
4. Morrow Lake Delta Gate C observed tar globs and sheen collecting along the boom.

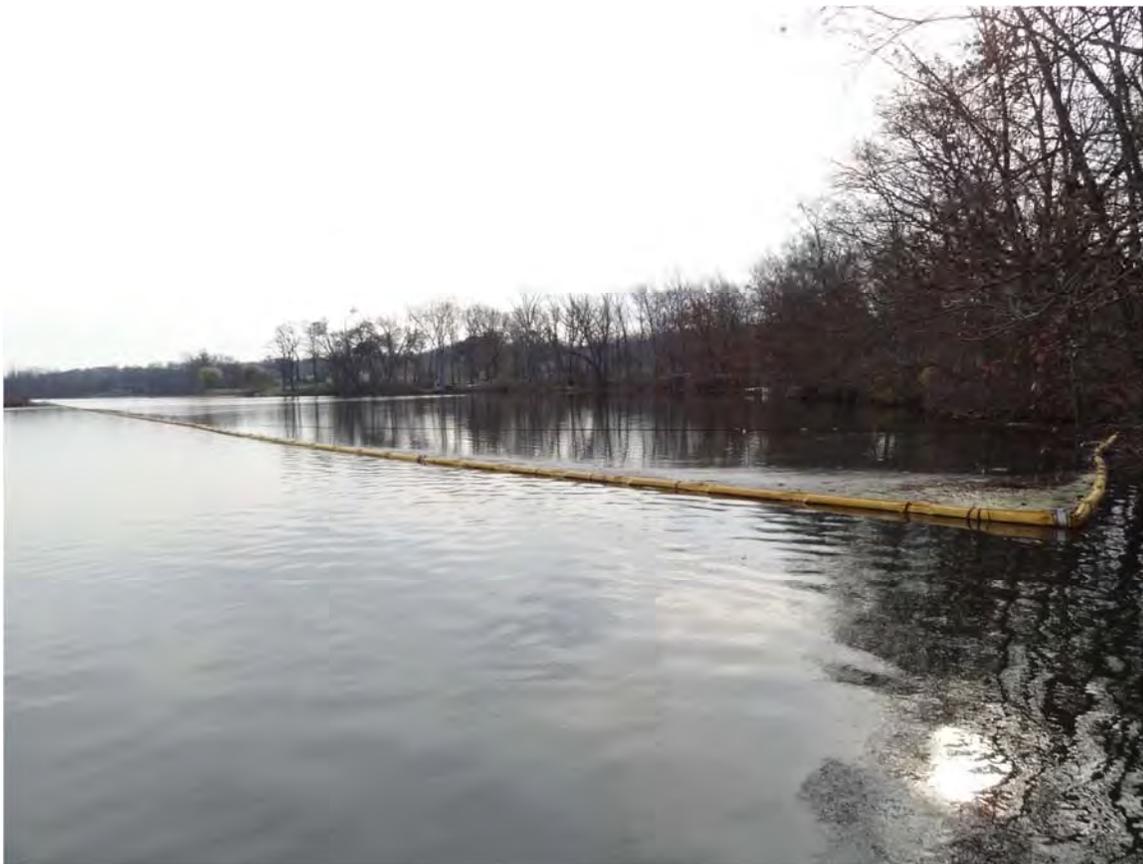
5. Morrow Lake Delta Gate B observed tar globs and sheen collecting along the boom.

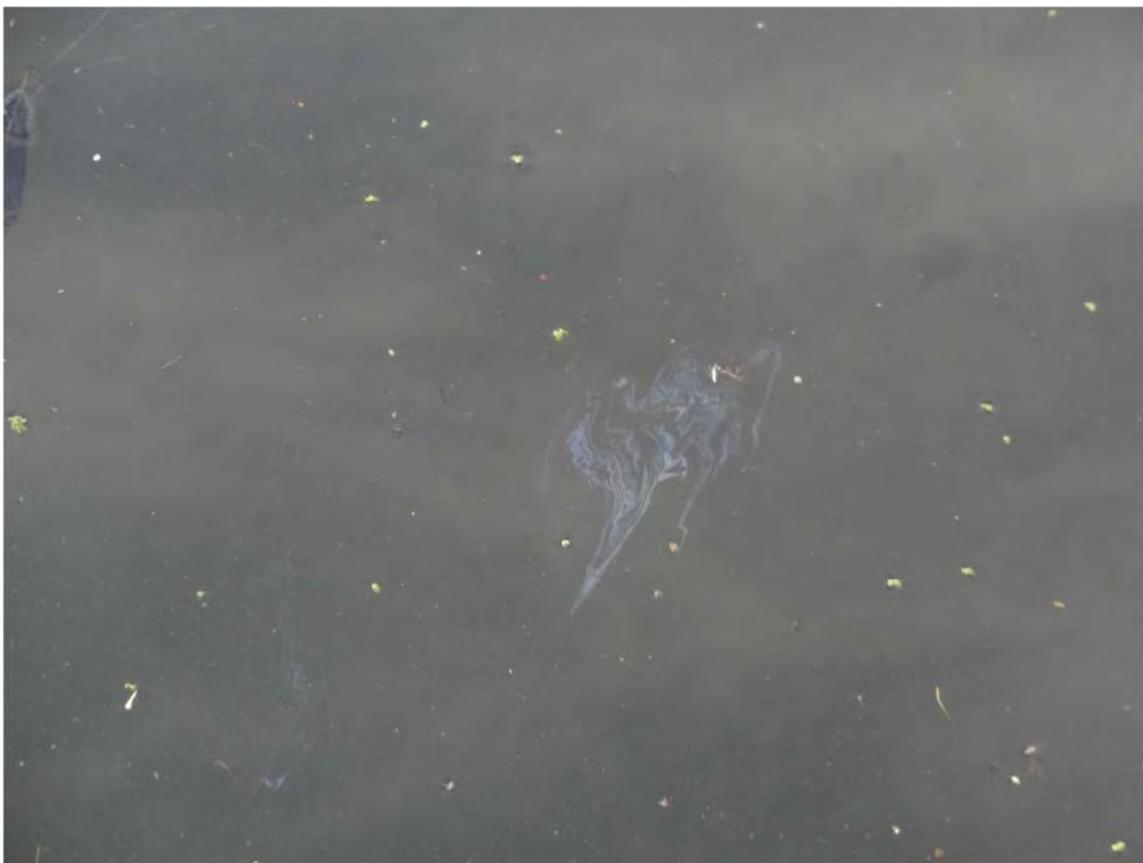
6. Morrow Lake Delta Gate B observed tar globs and sheen collecting along the boom.

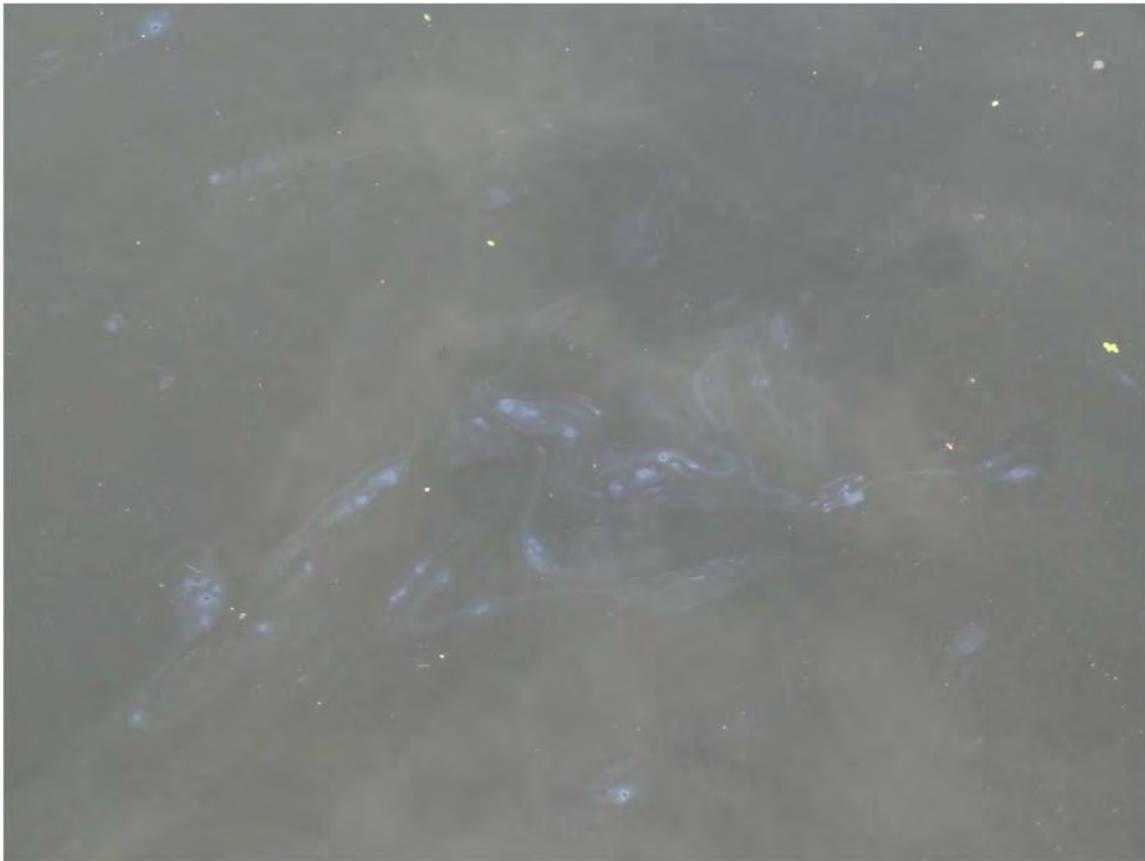
7. Morrow Lake Delta Gate B observed tar globs and sheen collecting along the boom.

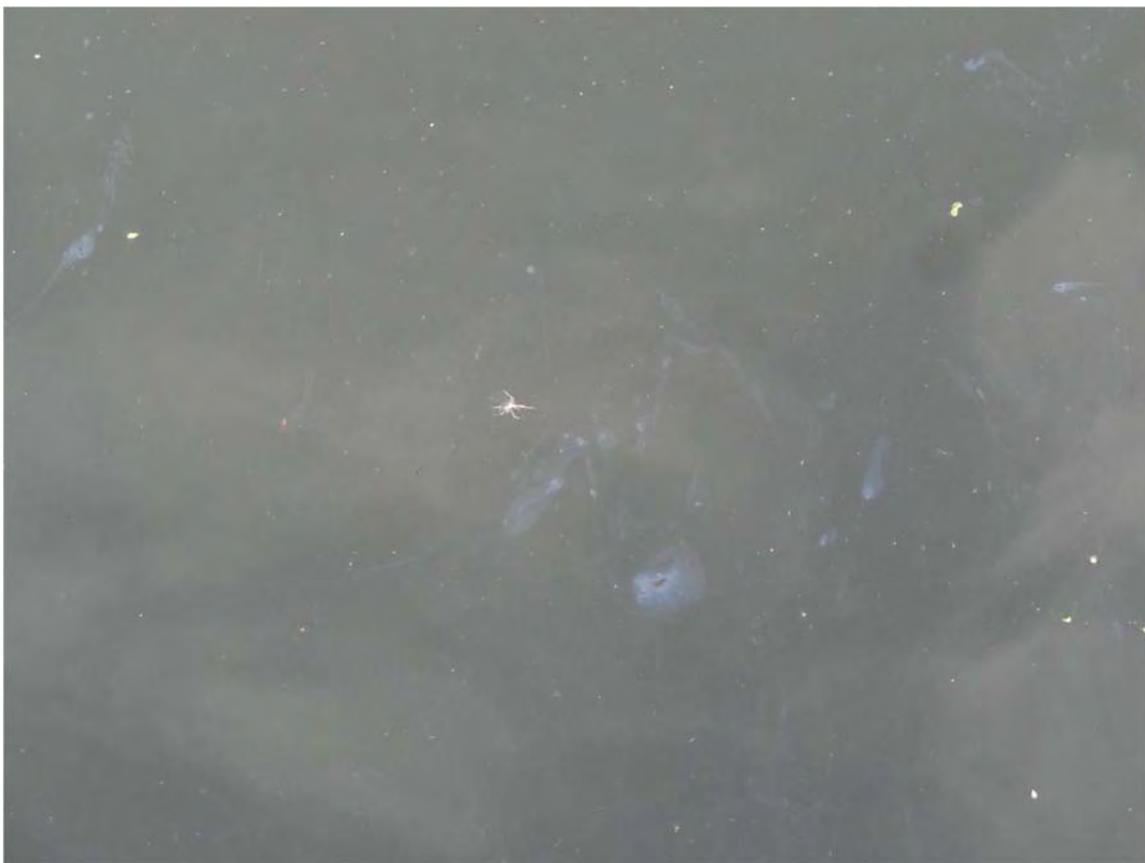
8. Morrow Lake Delta Gate B observed tar globs and sheen collecting along the boom.

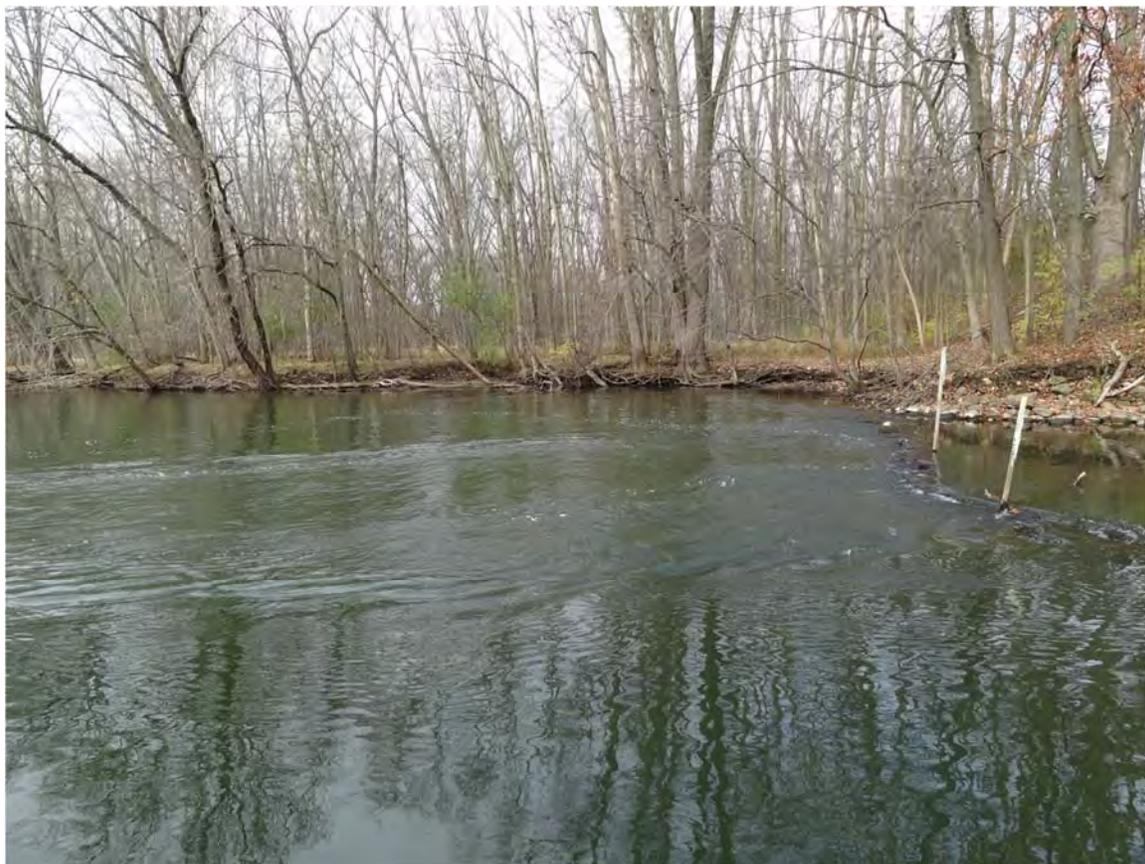
11. MP23.10 RDB area where sheen and tar globs were observed.

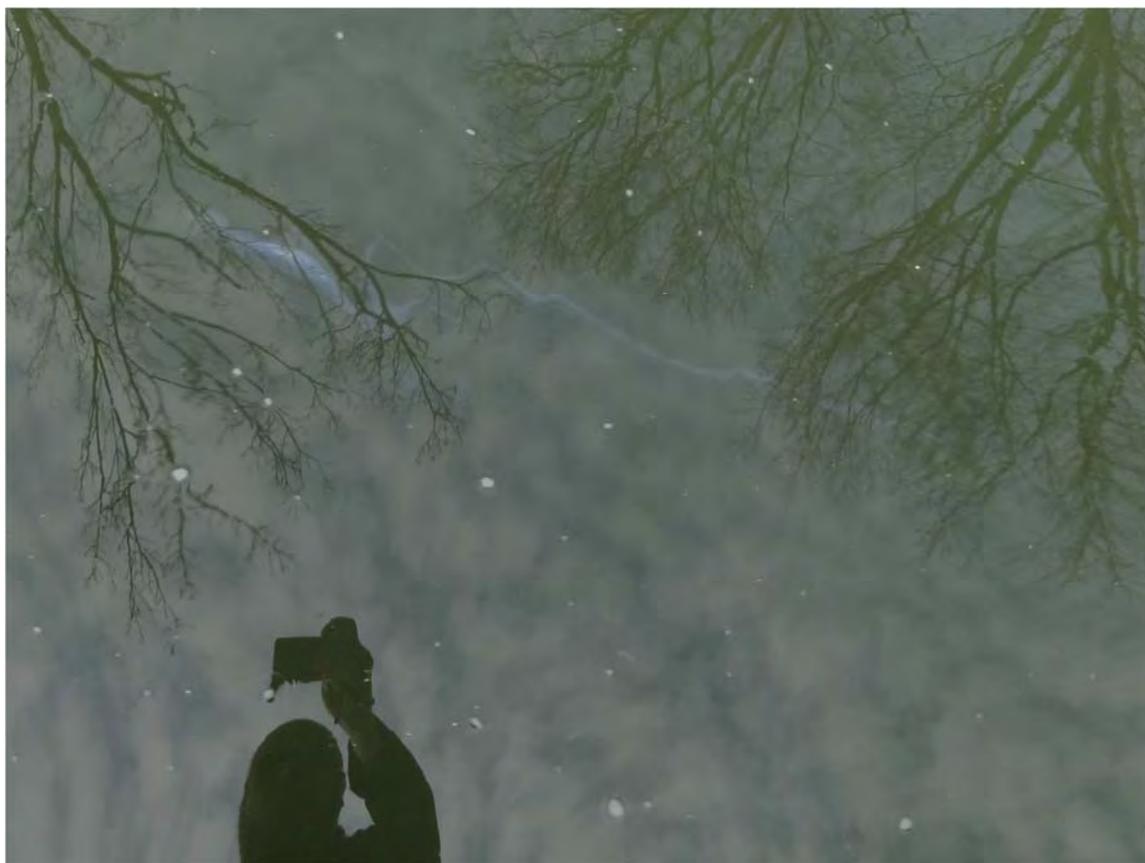
12. MP23.10 RDB sheen and tar globs observed.

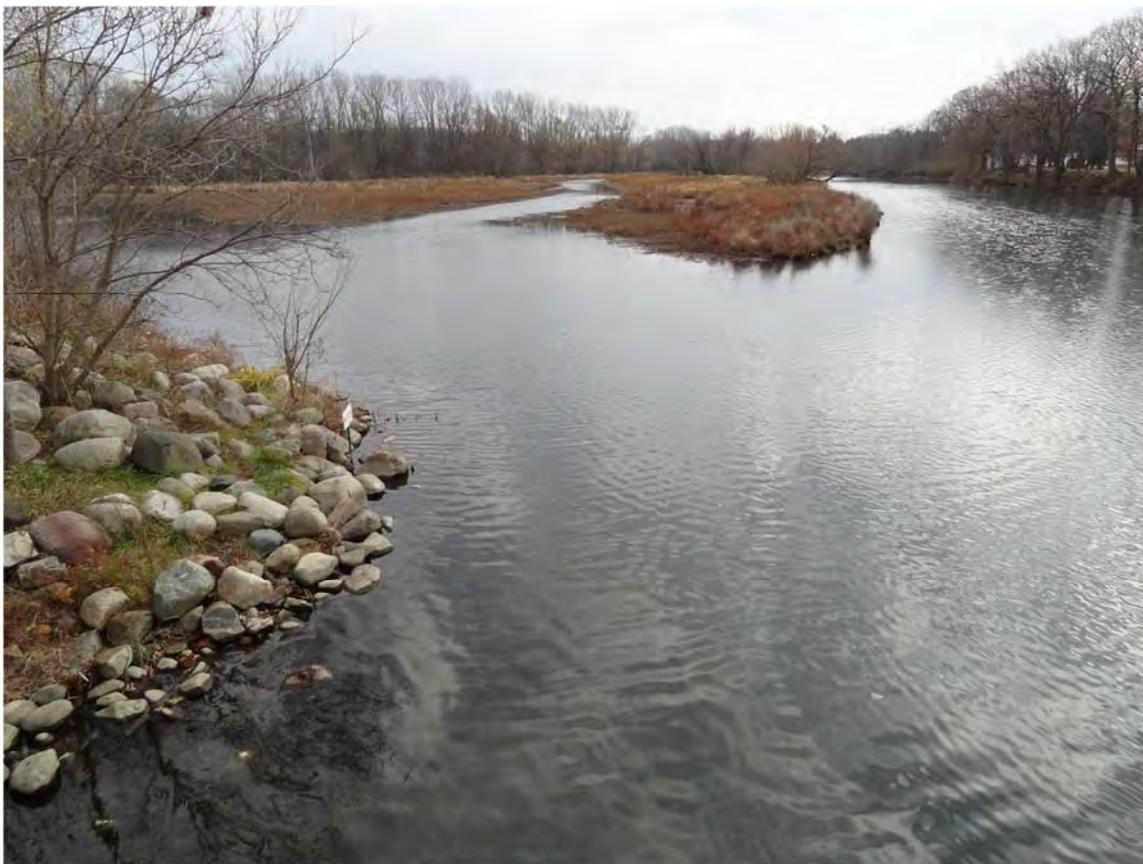
13. Observed sheen and tar globs flowing out of the South Mill Pond.

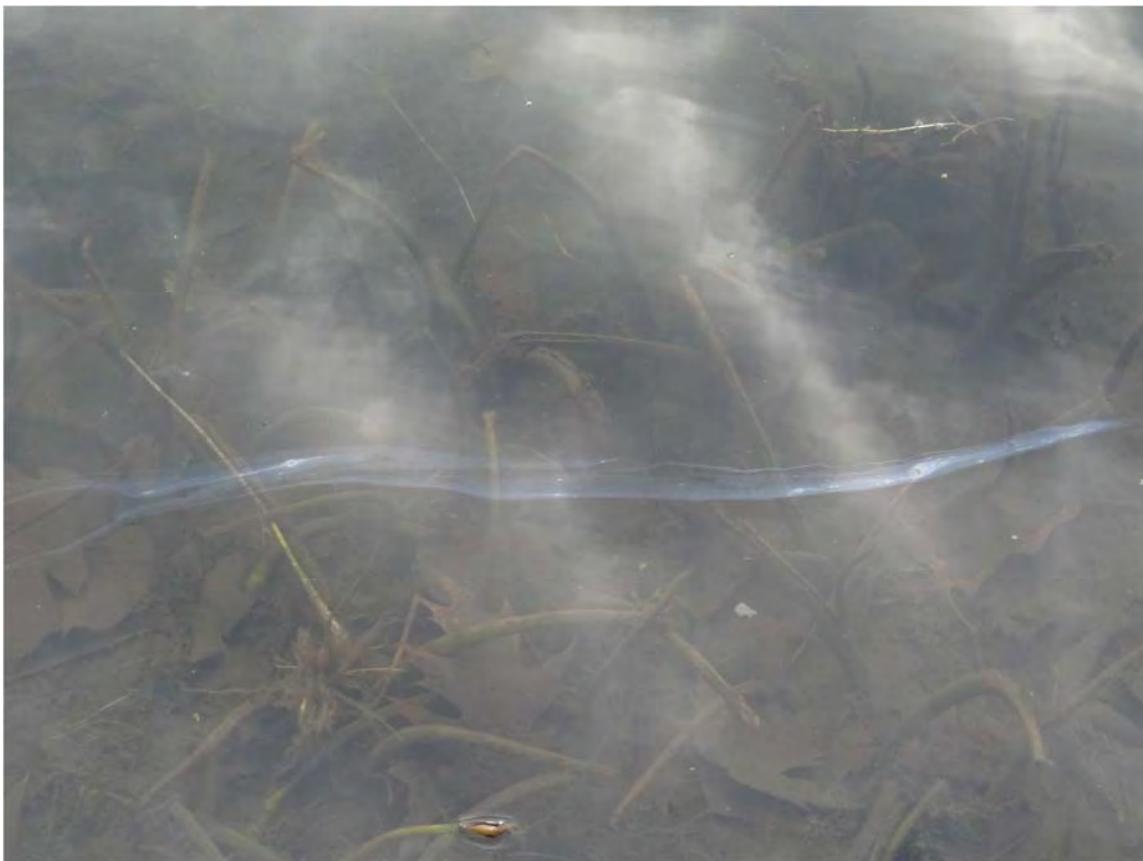
14. Observed sheen and tar globs flowing out of the South Mill Pond.

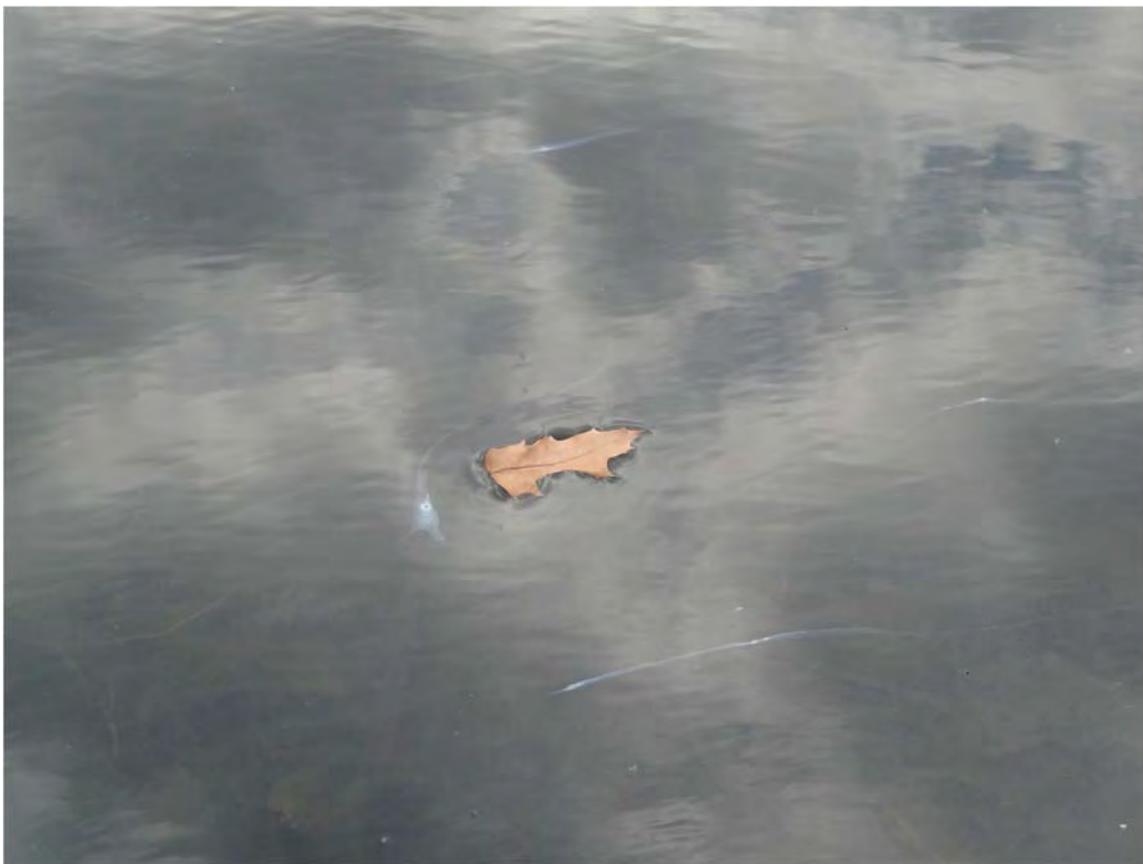
15. Observed sheen and tar globs flowing out of the South Mill Pond.

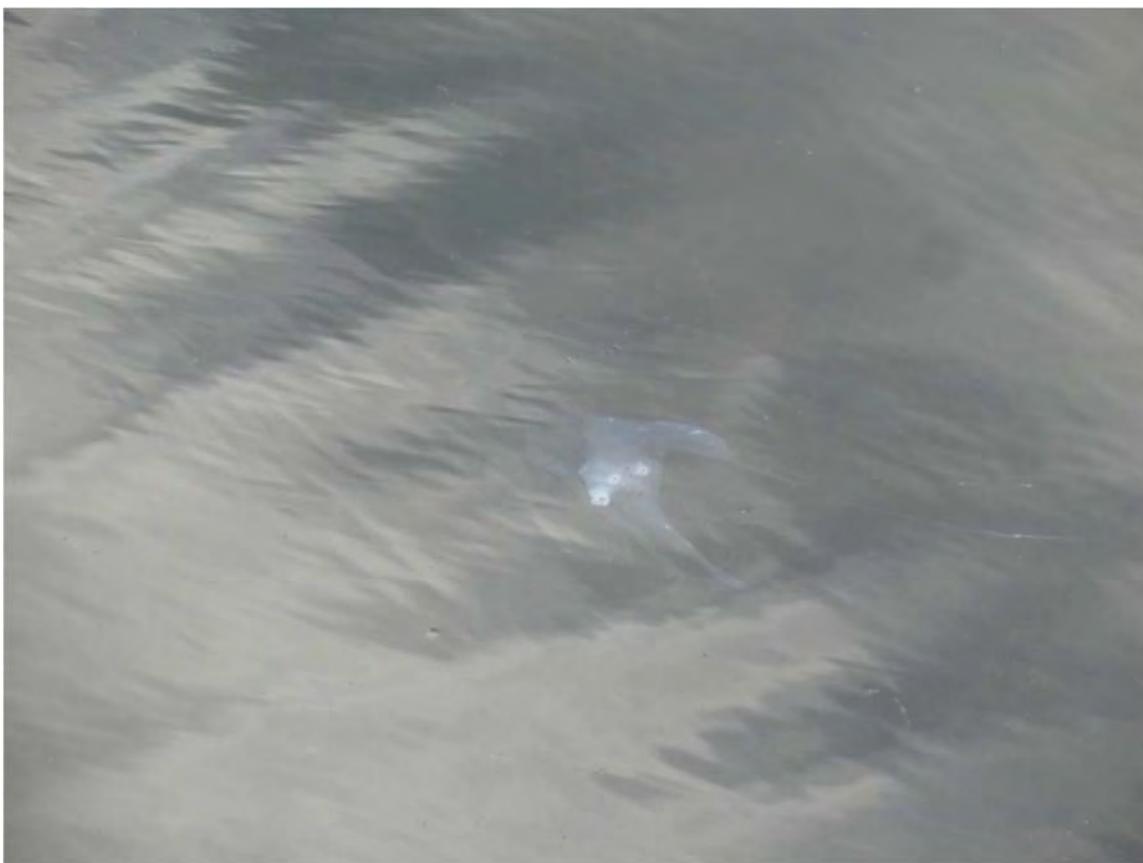
16. Observed sheen and tar globs flowing out of the South Mill Pond.

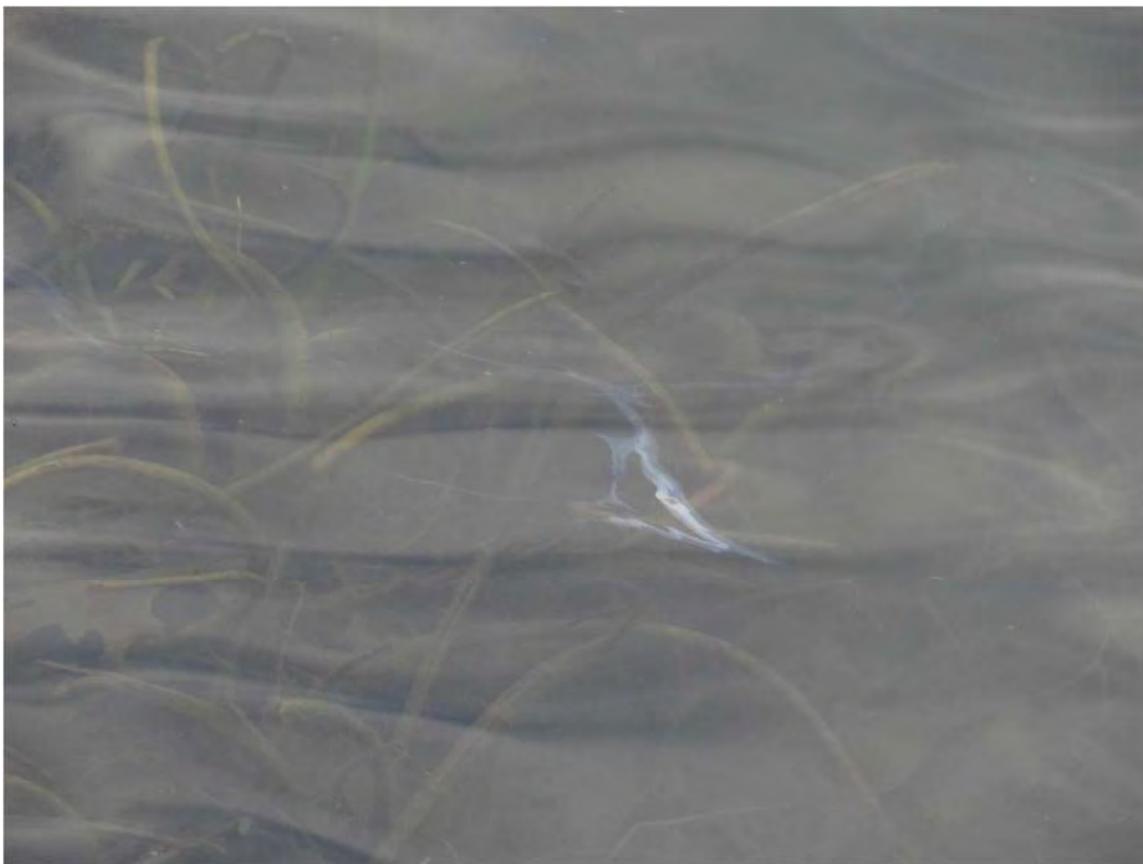
17. Observed sheen and tar globs flowing out of the South Mill Pond.

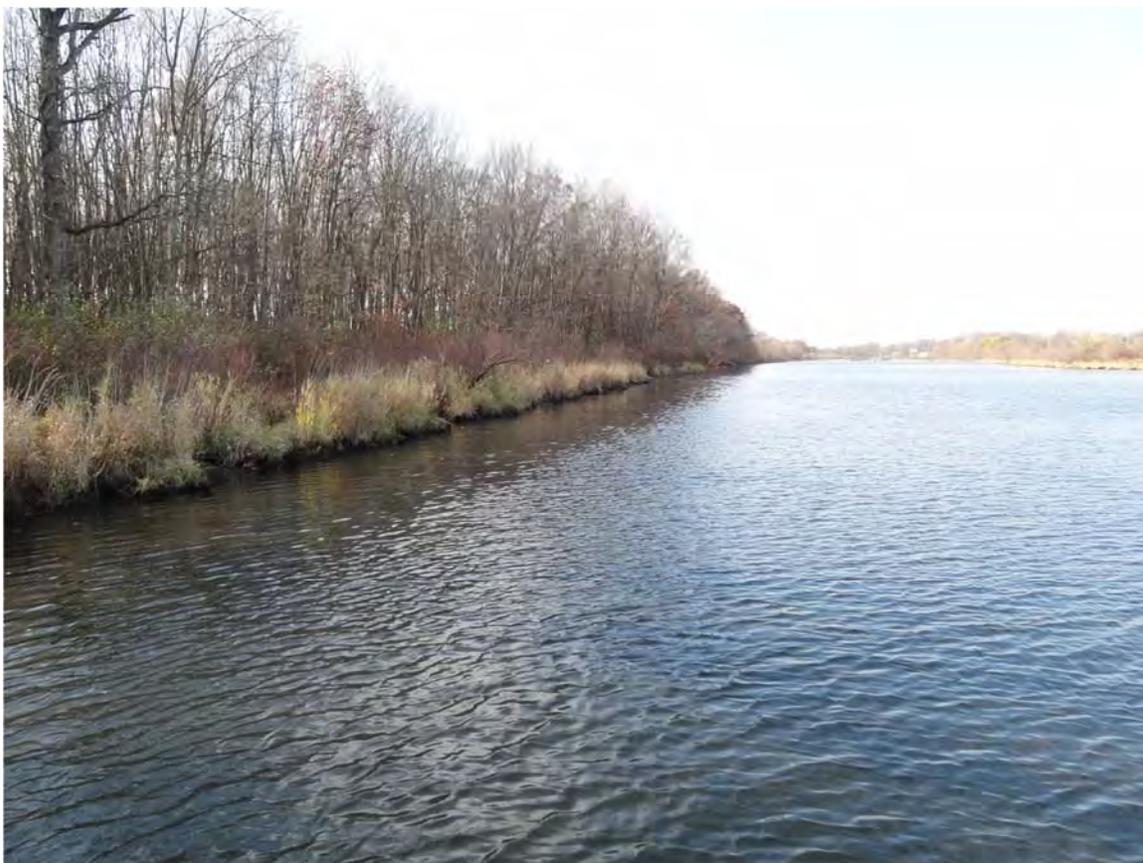
18. MP5.10 – MP5.35 area where large area sheen and tar globs were observed.

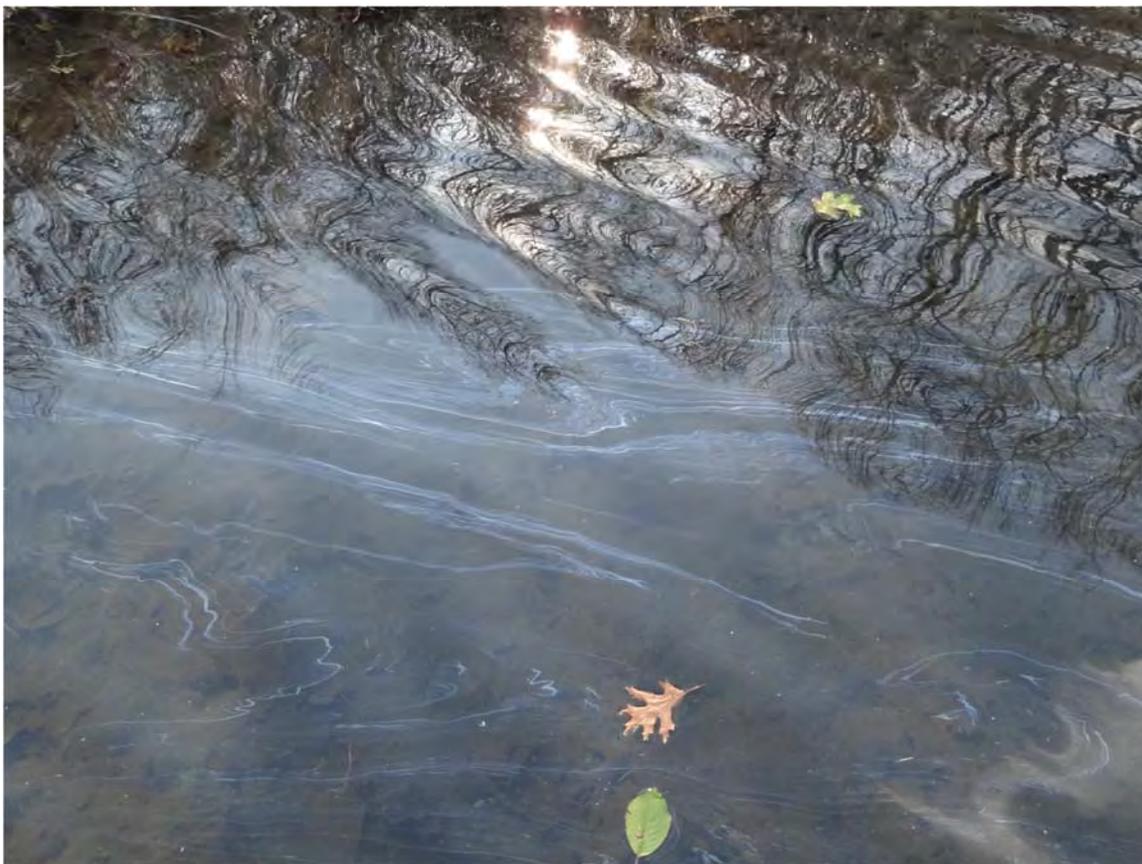
19. MP5.10 – MP5.35 large area sheen and tar globs observed.

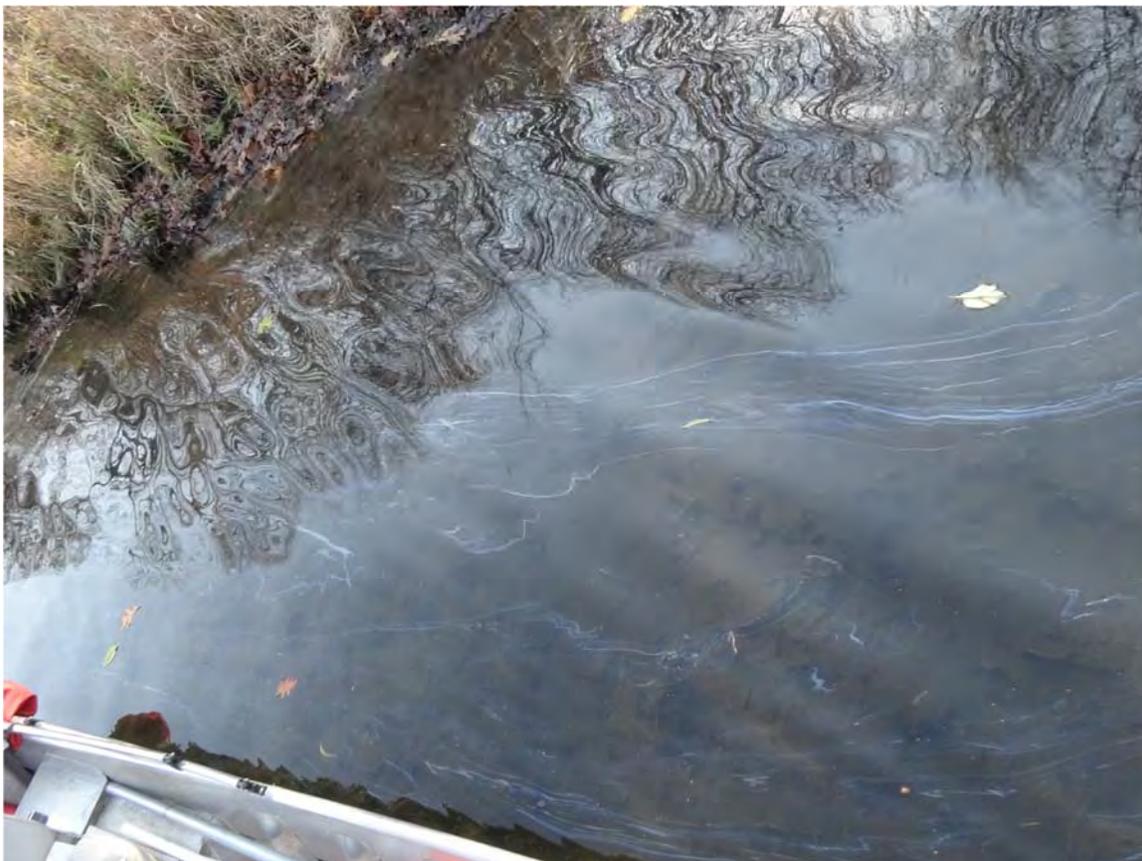
20. MP5.10 – MP5.35 large area sheen and tar globs observed.

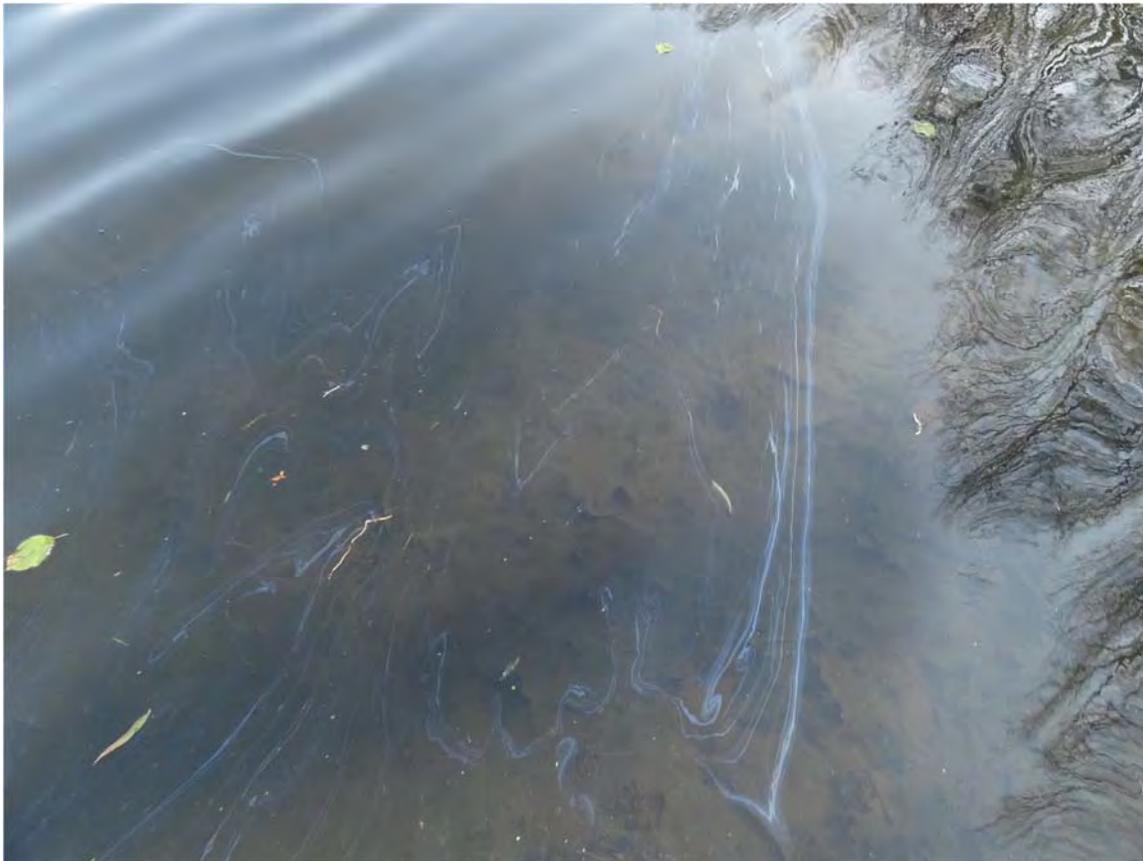
21. MP5.10 – MP5.35 large area sheen and tar globs observed.

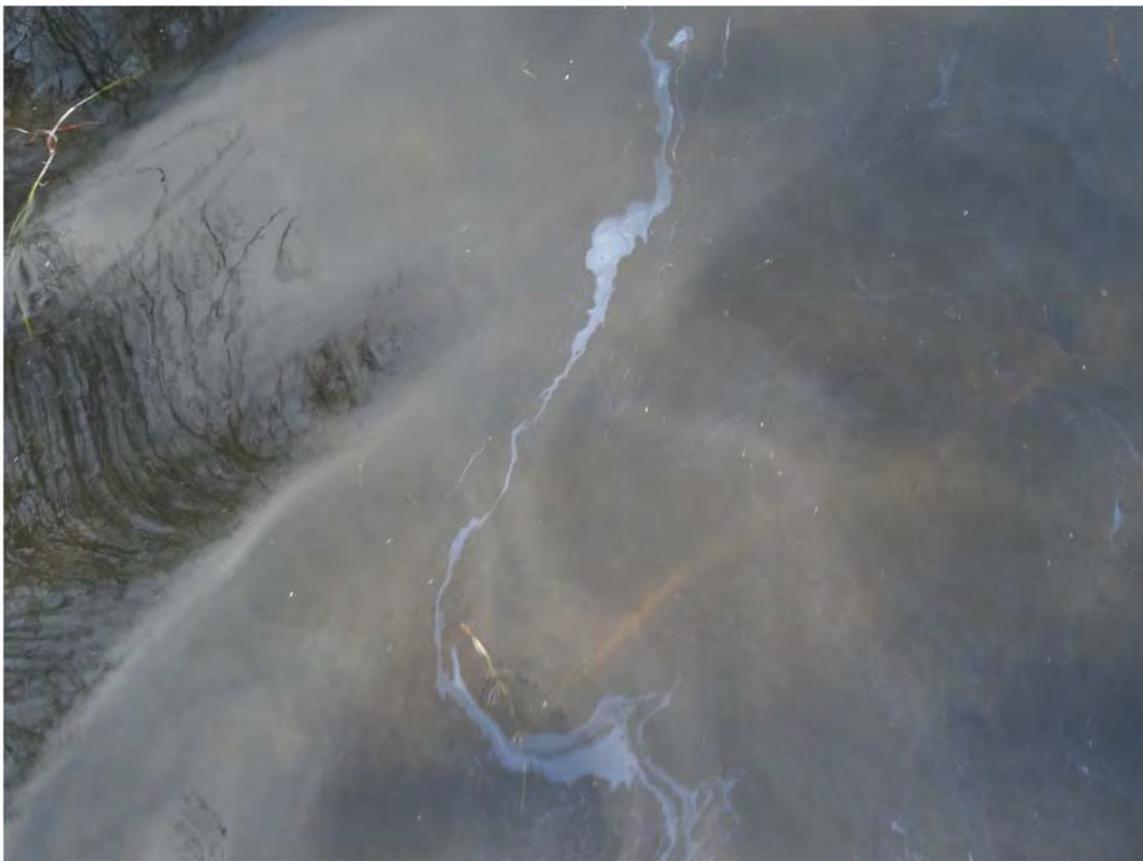
22. MP5.10 – MP5.35 large area sheen and tar globs observed.

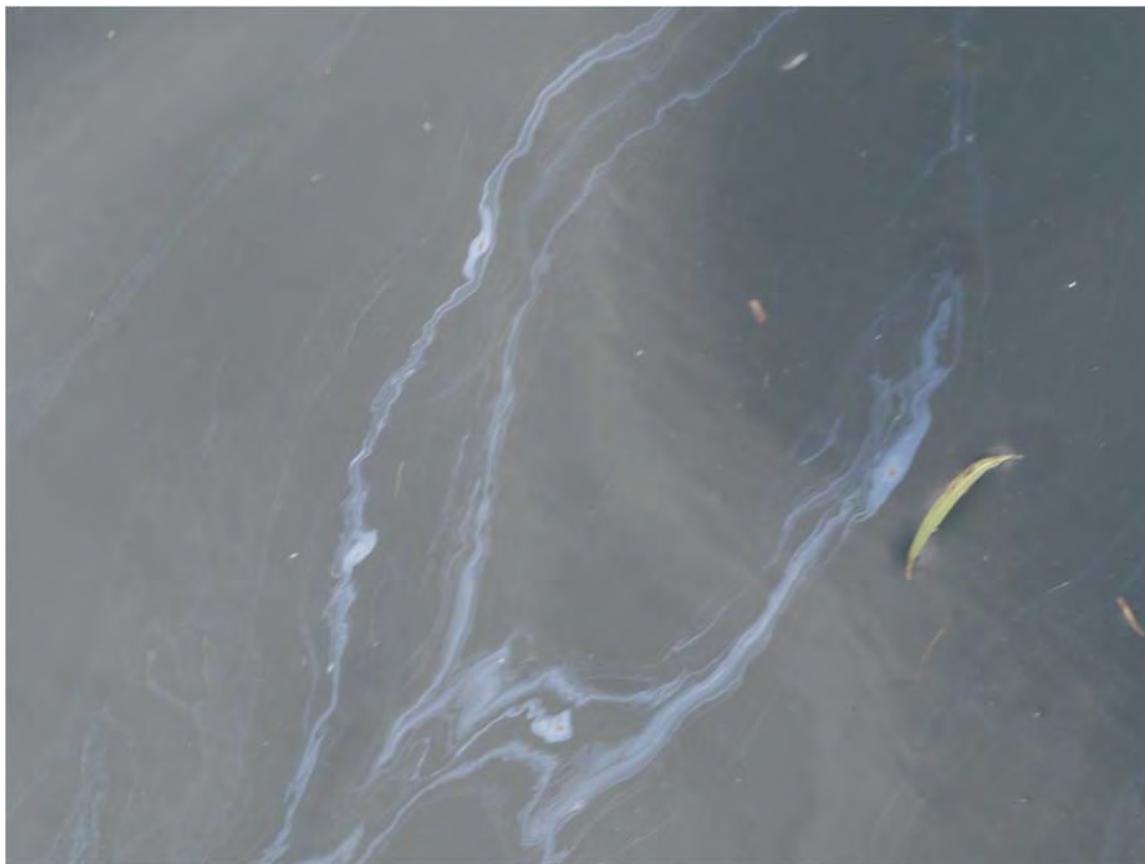
23. MP5.10 – MP5.35 large area sheen and tar globs observed.

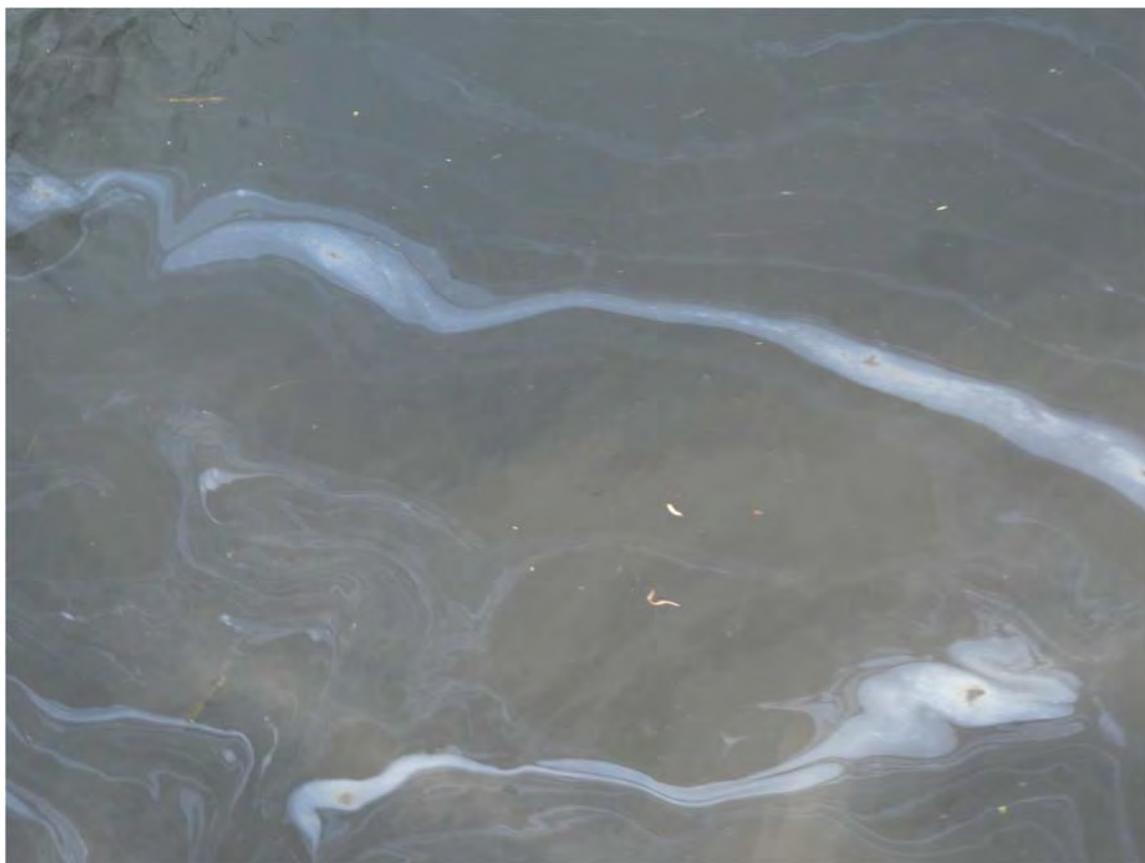
24. MP5.10 – MP5.35 large area sheen and tar globs observed.

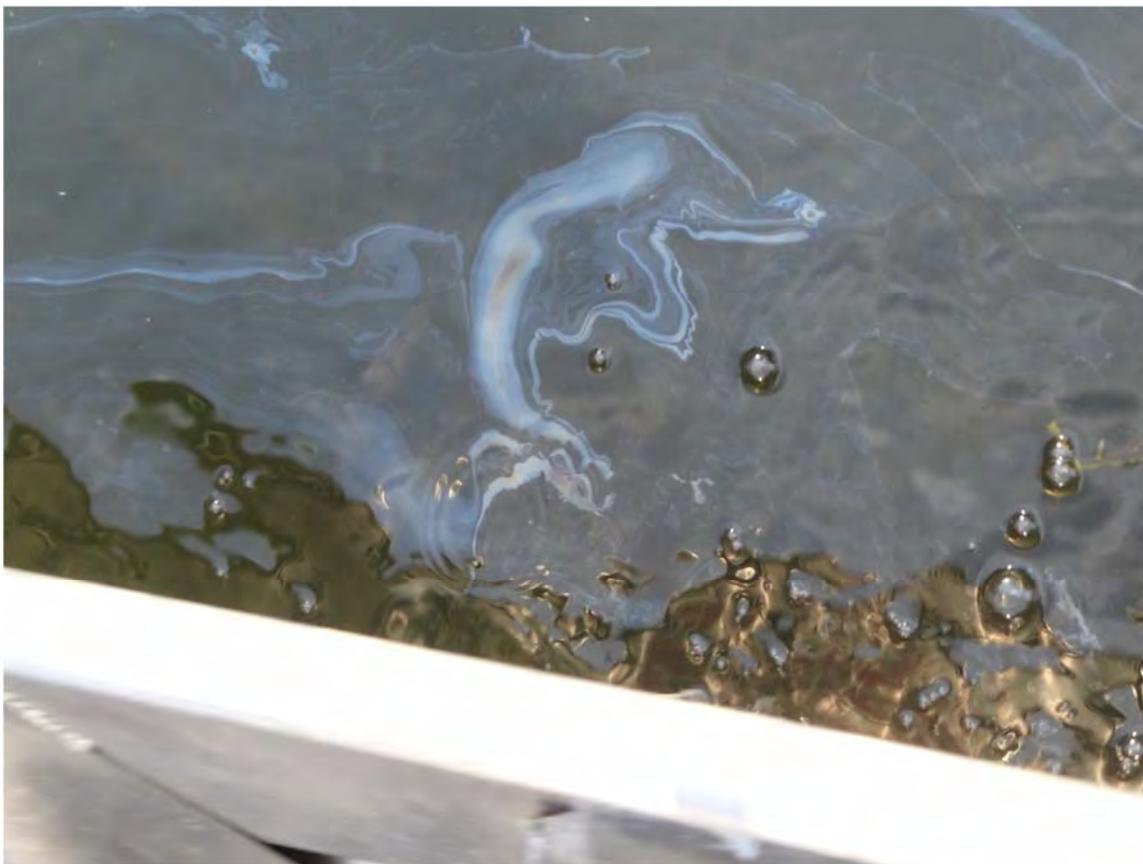
25. MP5.10 – MP5.35 large area sheen and tar globs observed.
