Situation Photo Log

Saturday, November 10, 2012

Kalamazoo River / Enbridge Spill

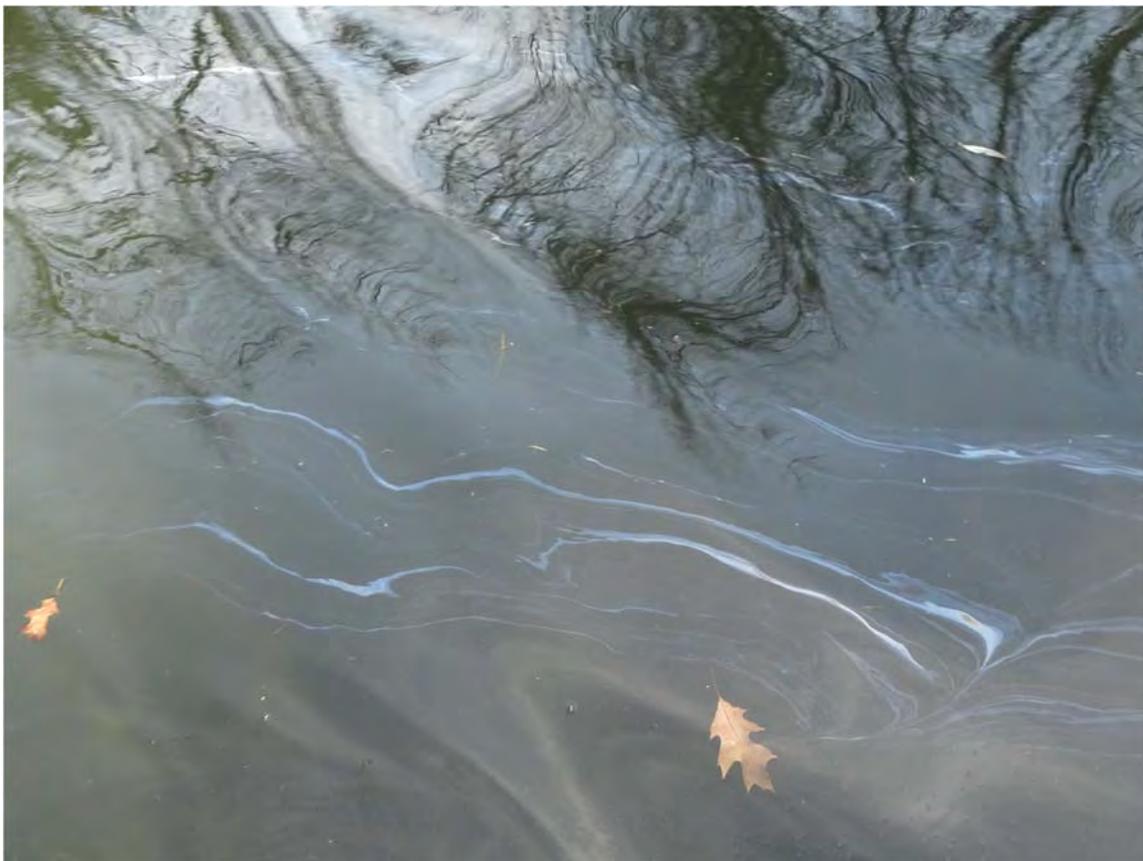
26. MP5.10 – MP5.35 large area sheen and tar globs observed.

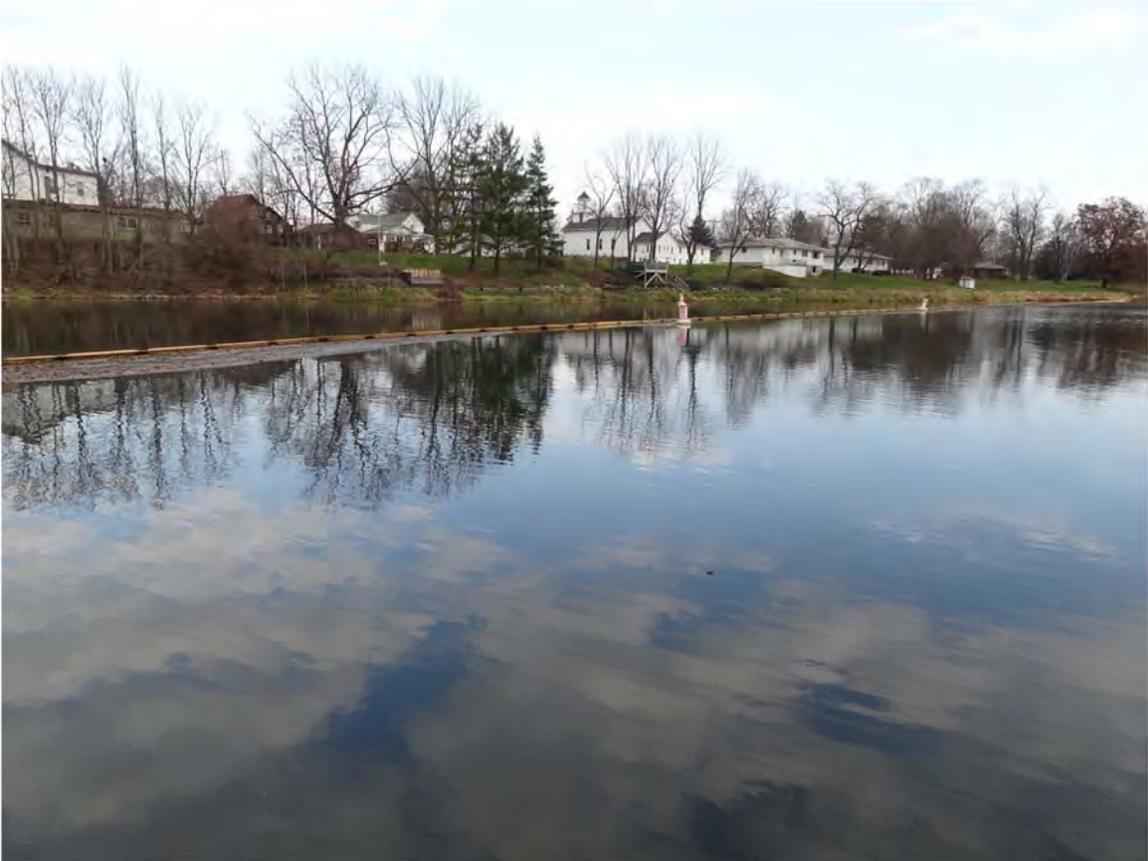
27. Ceresco Dam Control Point Boom observed sheen and tar globs accumulating along the boom.

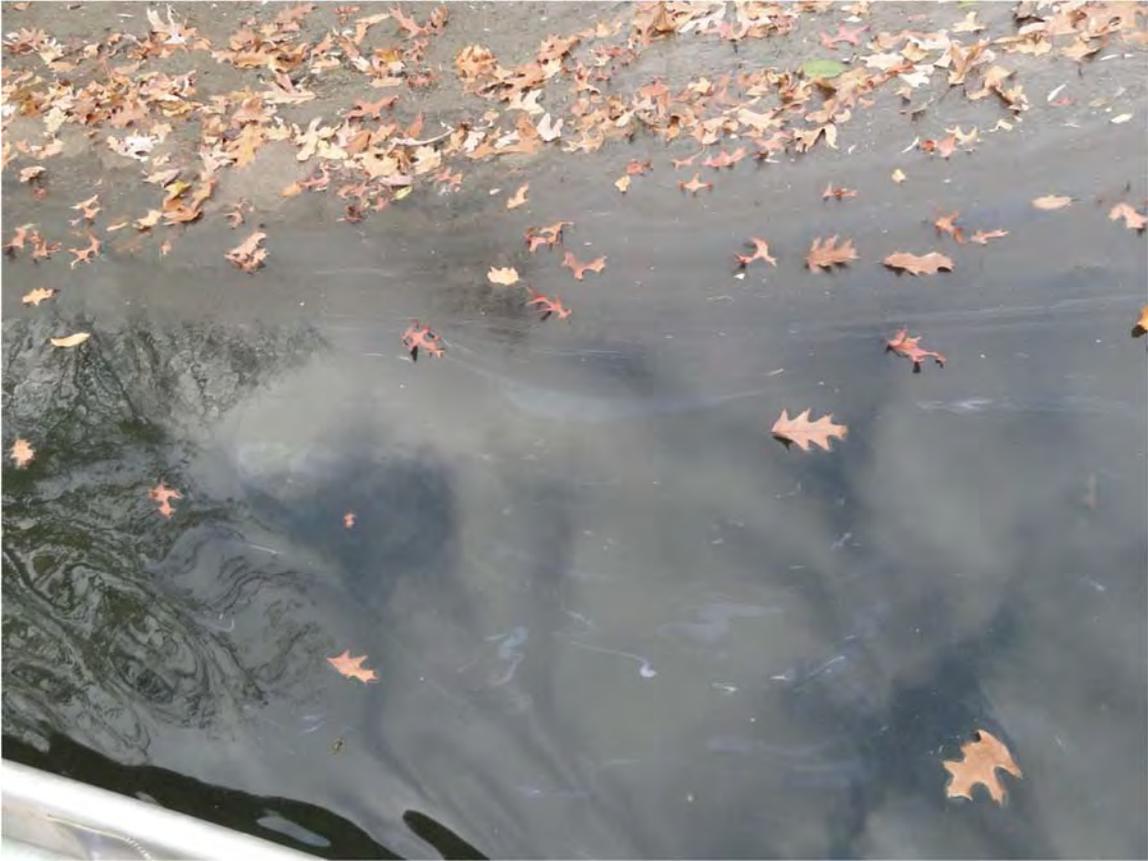
28. Ceresco Dam Control Point Boom observed sheen and tar globs accumulating along the boom.

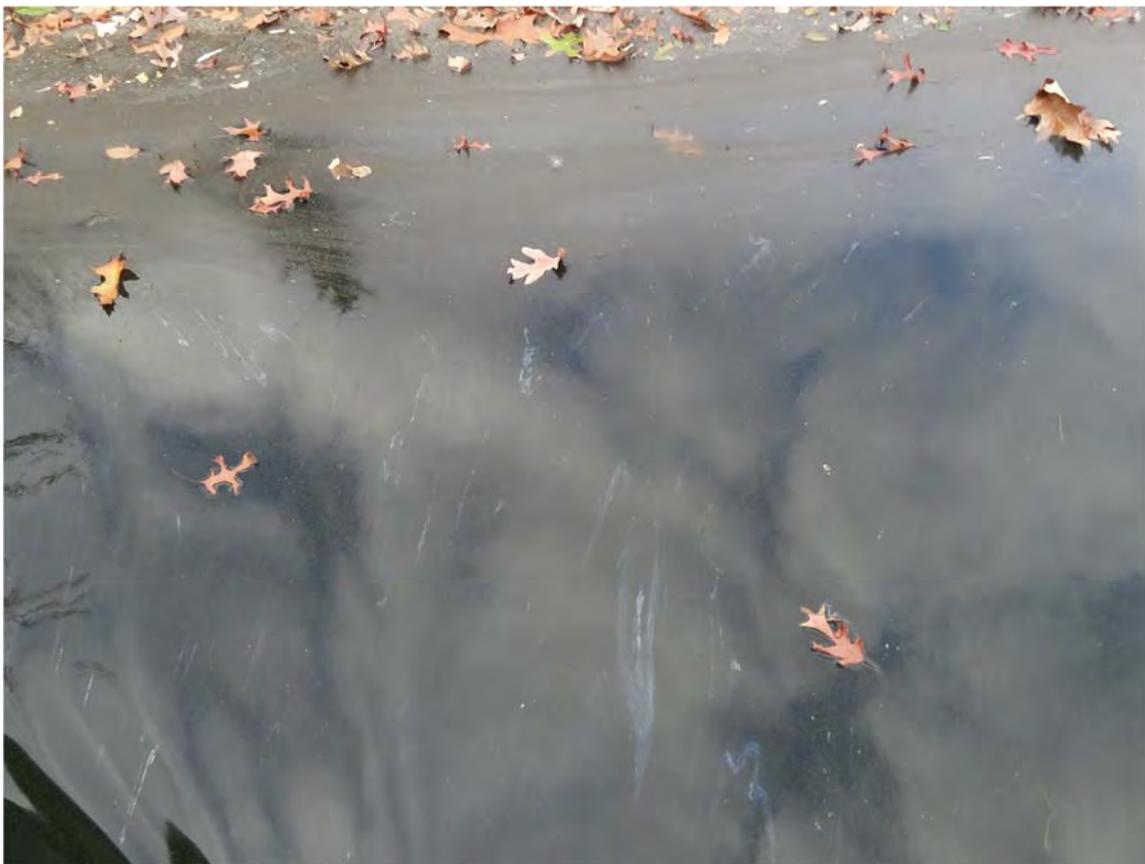
29. Ceresco Dam Control Point Boom observed sheen and tar globs accumulating along the boom.

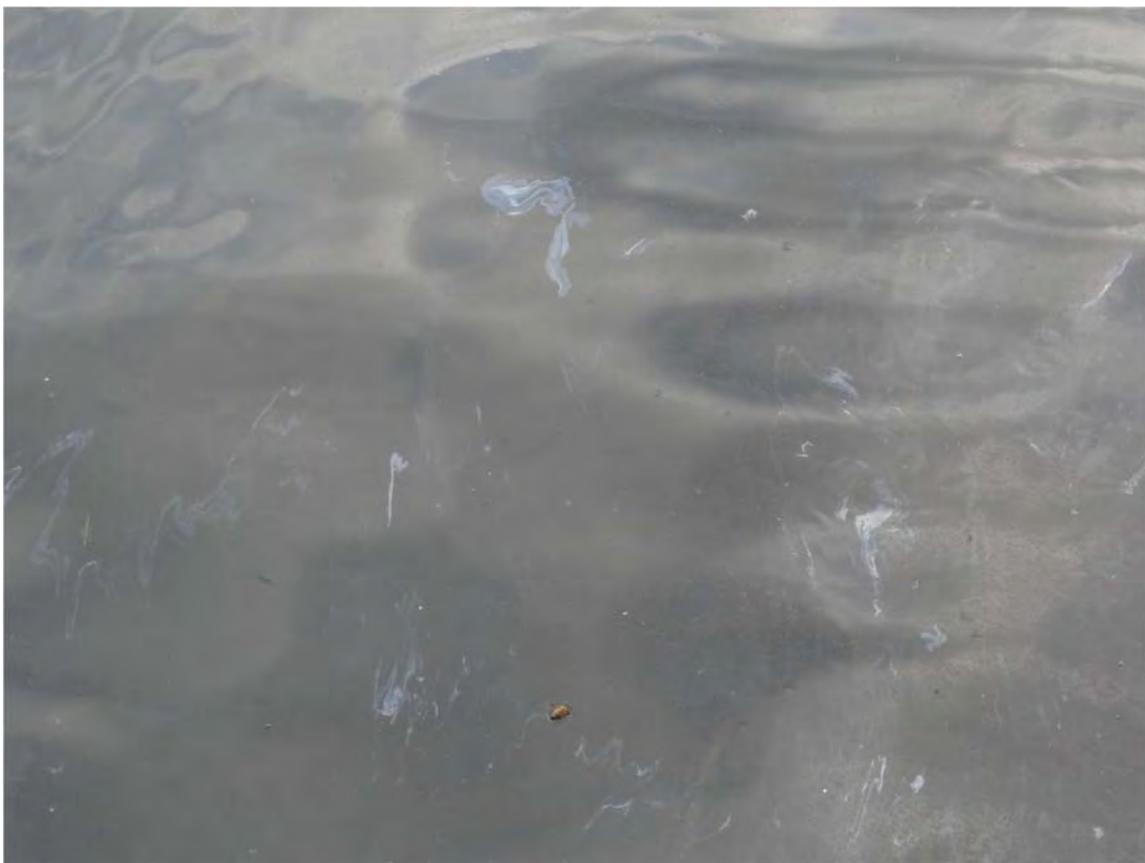
30. Ceresco Dam Control Point Boom observed sheen and tar globs accumulating along the boom.

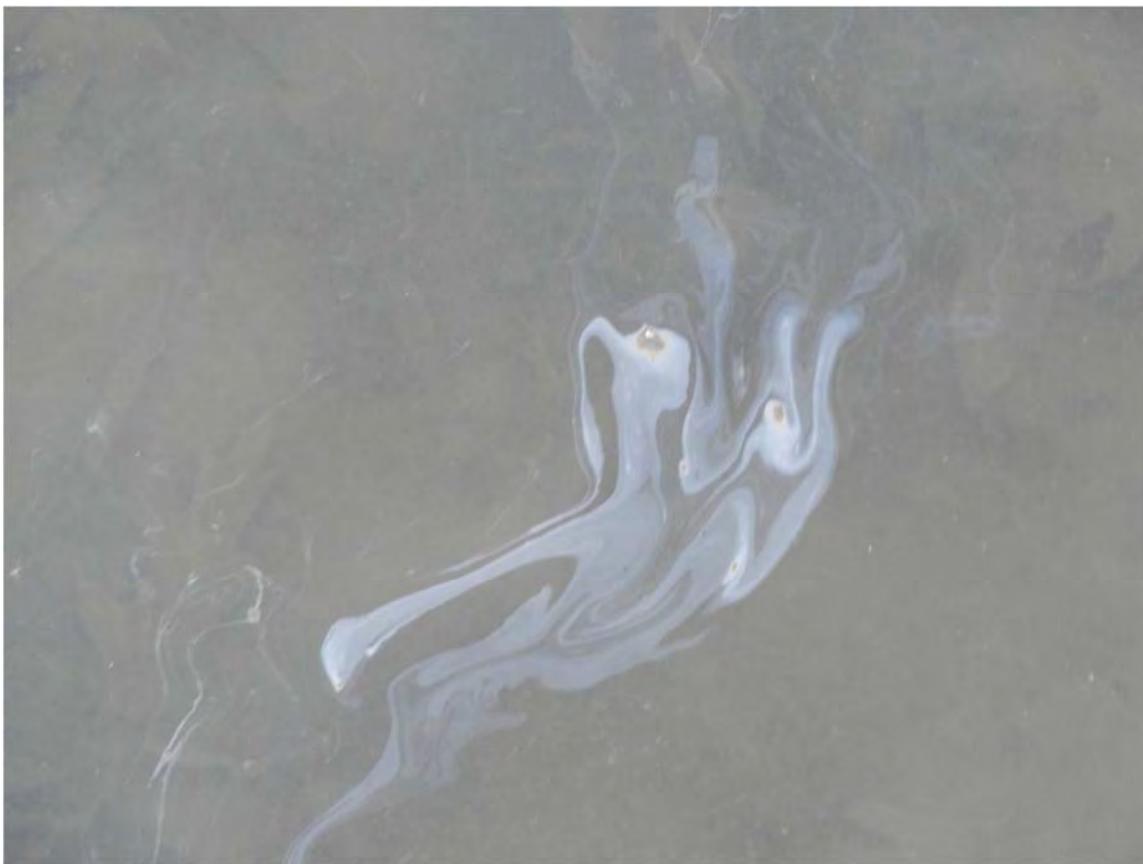
31. Ceresco Dam Control Point Boom observed sheen and tar globs accumulating along the boom.

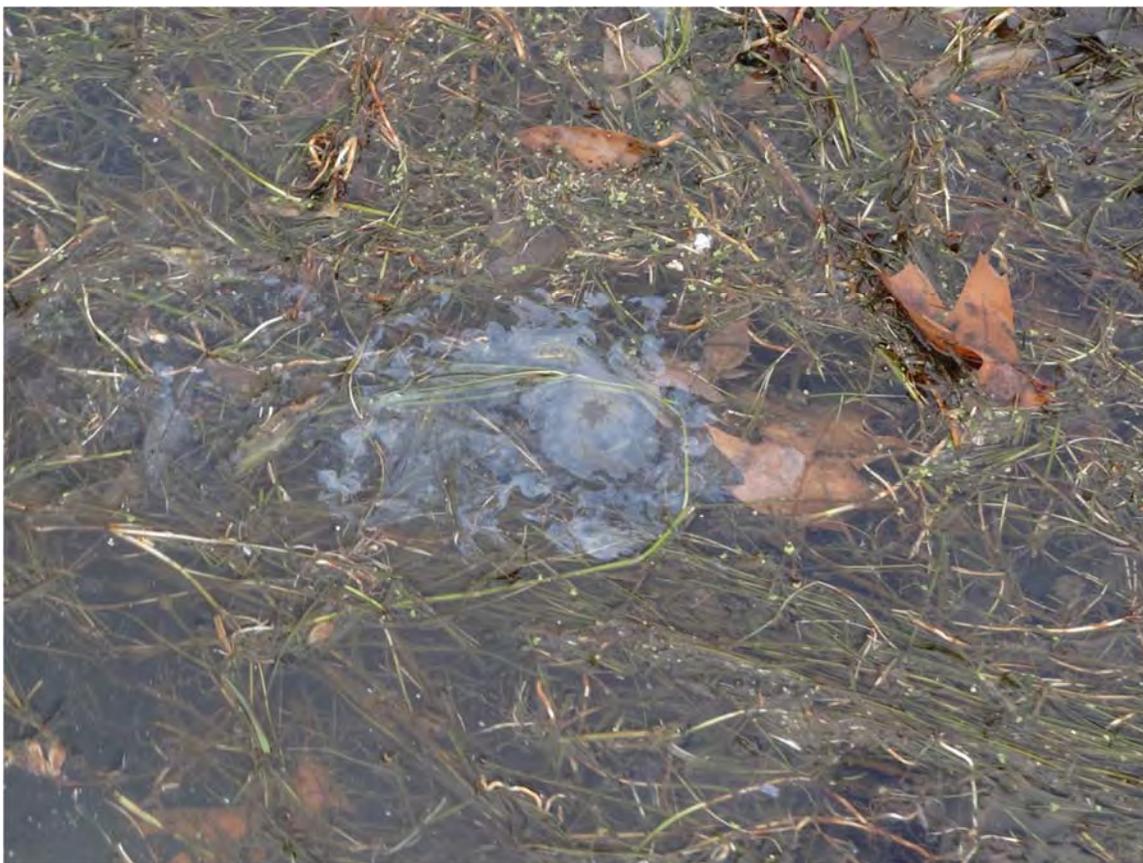
32. Ceresco Dam Control Point Boom observed sheen and tar globs accumulating within the debris along the boom.

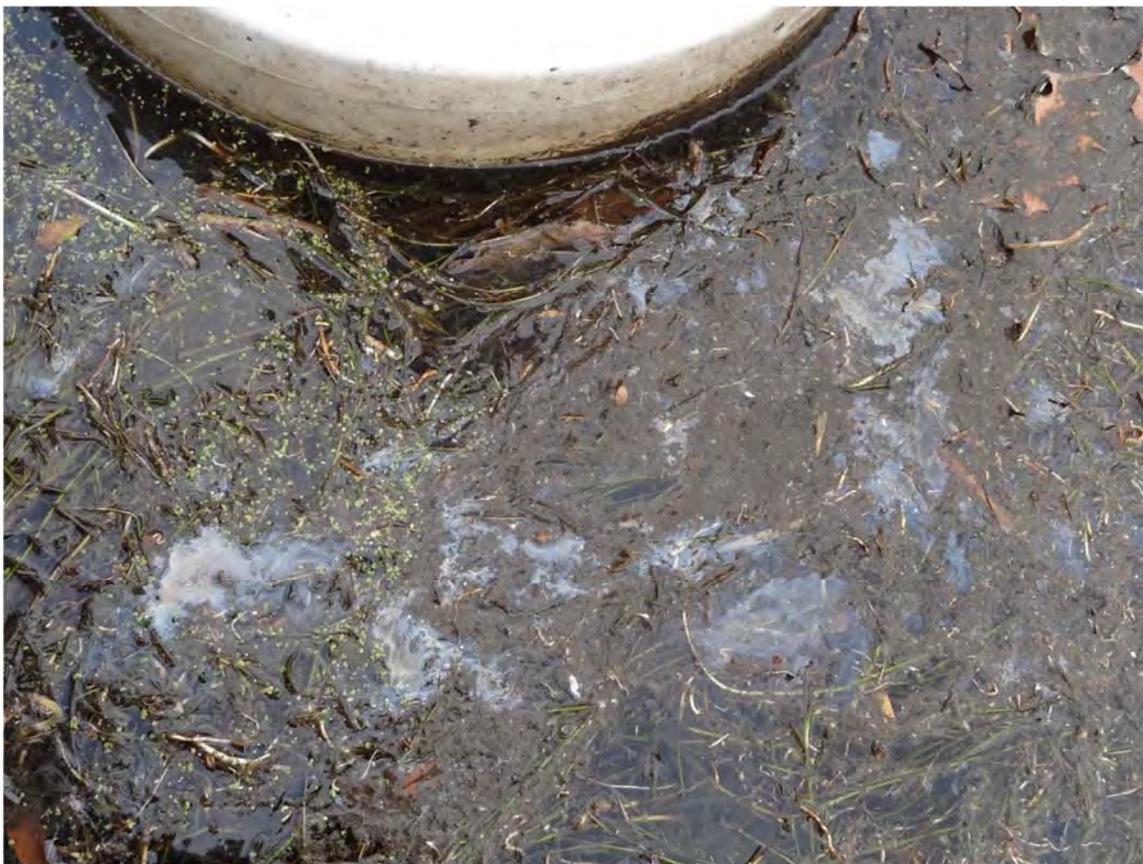
33. Ceresco Dam Control Point Boom observed sheen and tar globs accumulating within the debris along the boom.

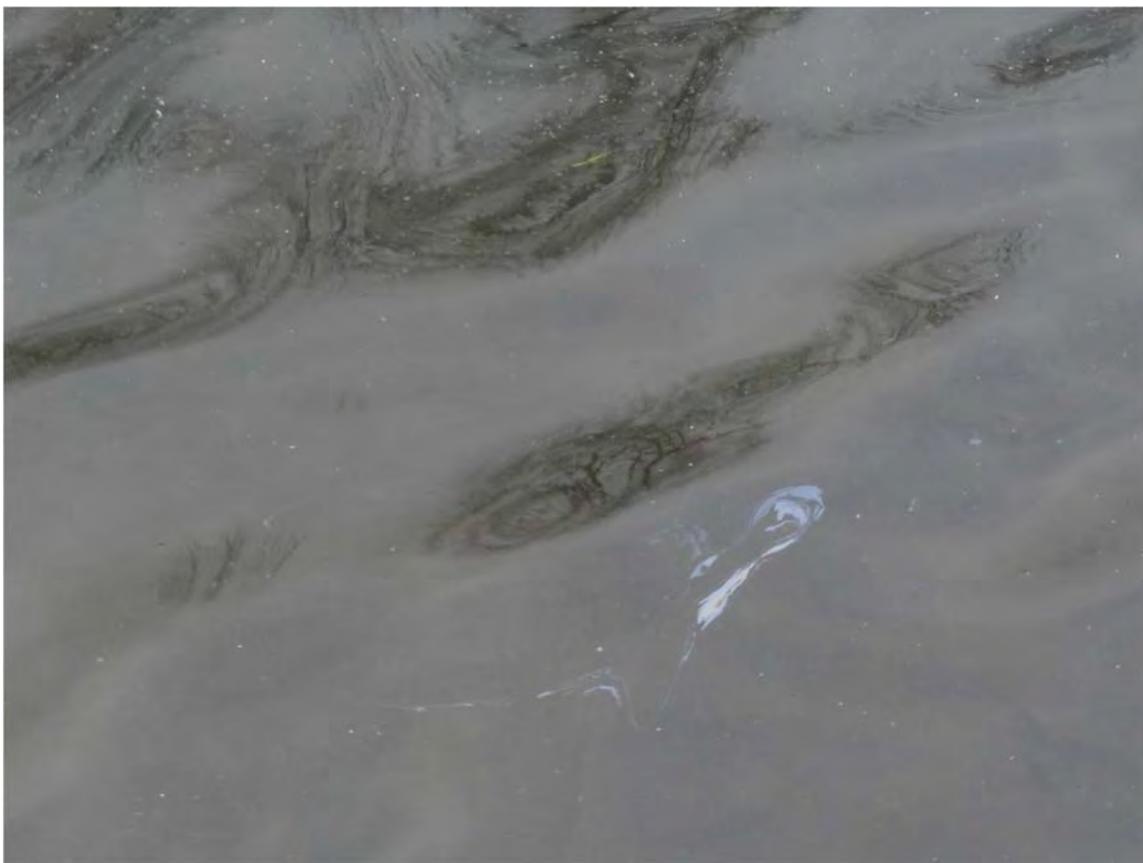
34. Ceresco Dam Control Point Boom observed sheen and tar globs accumulating along the upper end of the boom.

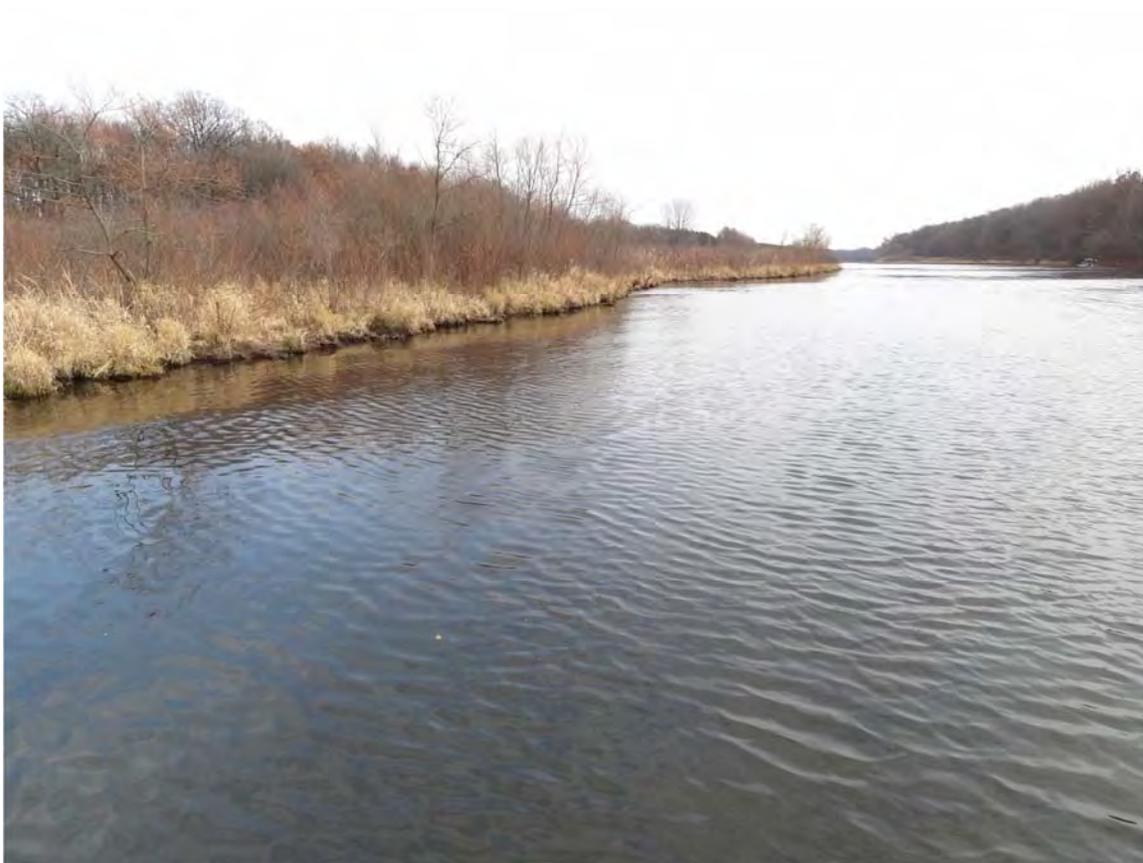
36. MP5.25 RDB area where sheen and tar globs were observed.

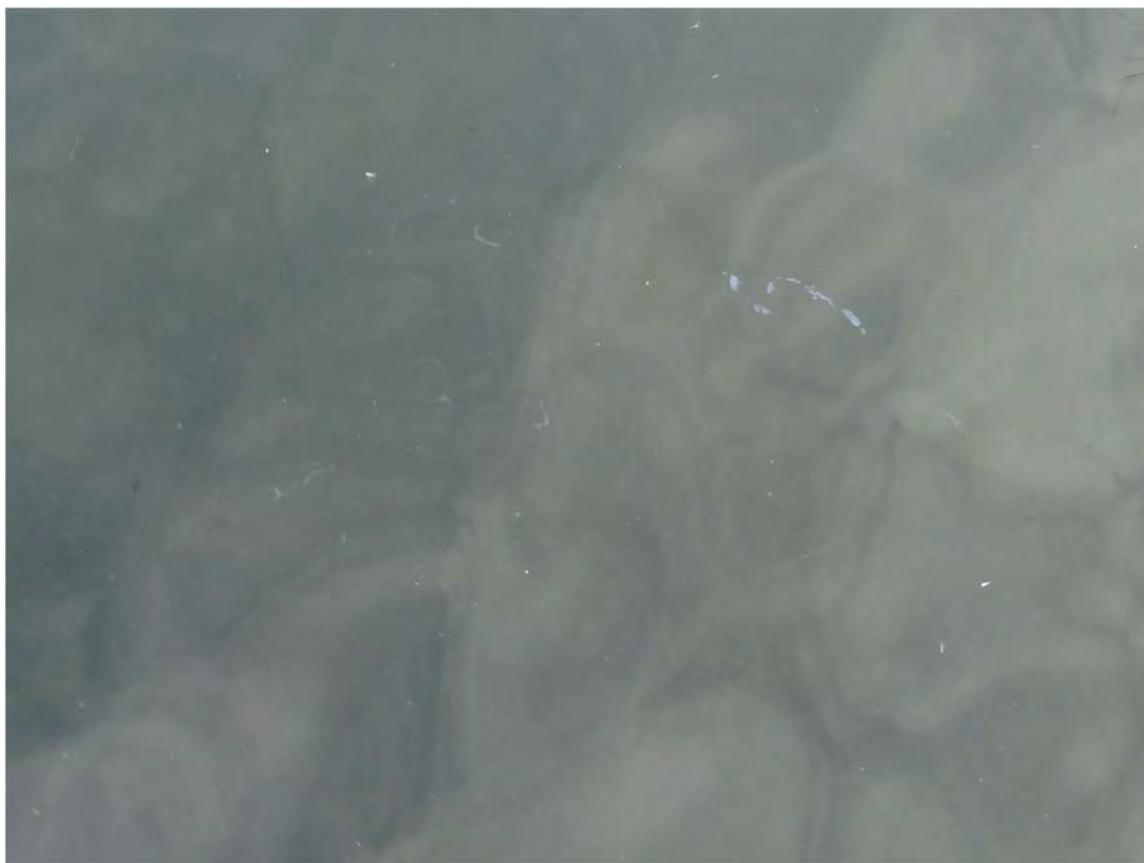
38. MP5.25 RDB area where sheen and tar globs observed.

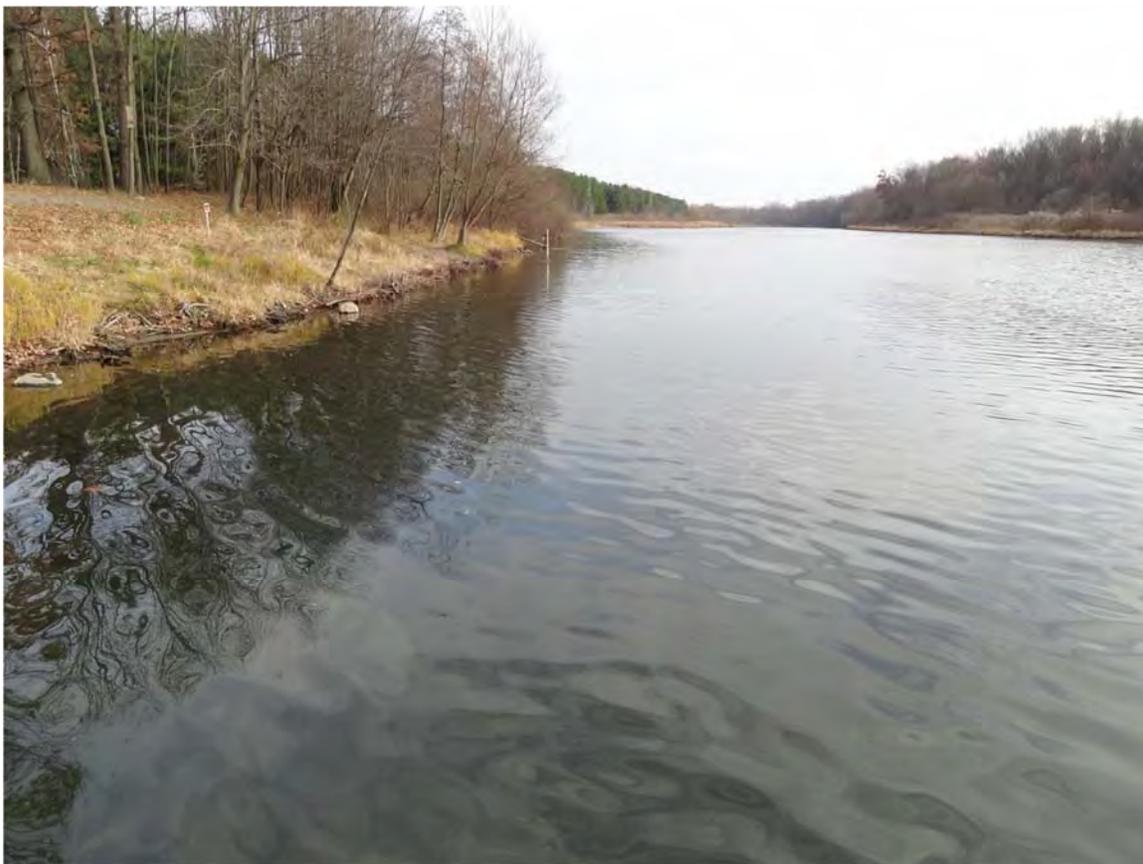
39. MP5.15 RDB area where sheen and tar globs were observed.

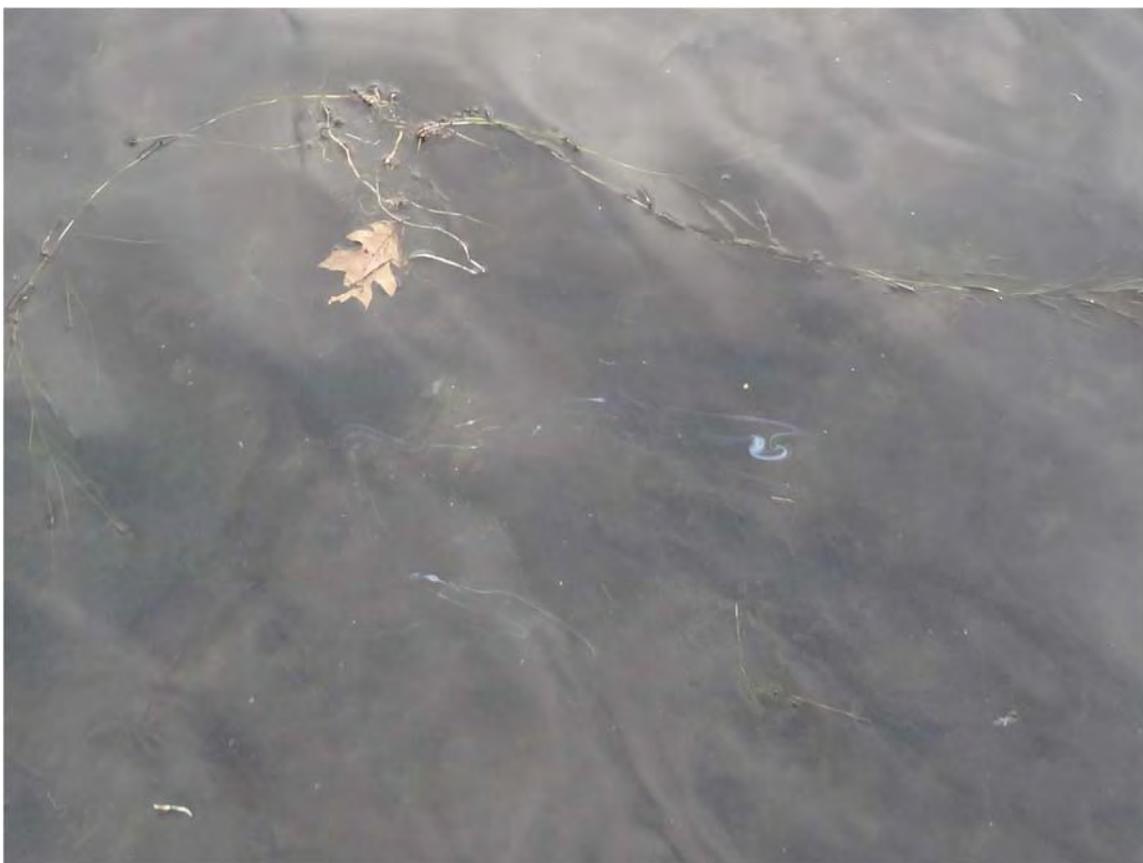
40. MP5.15 RDB sheen and tar globs observed.

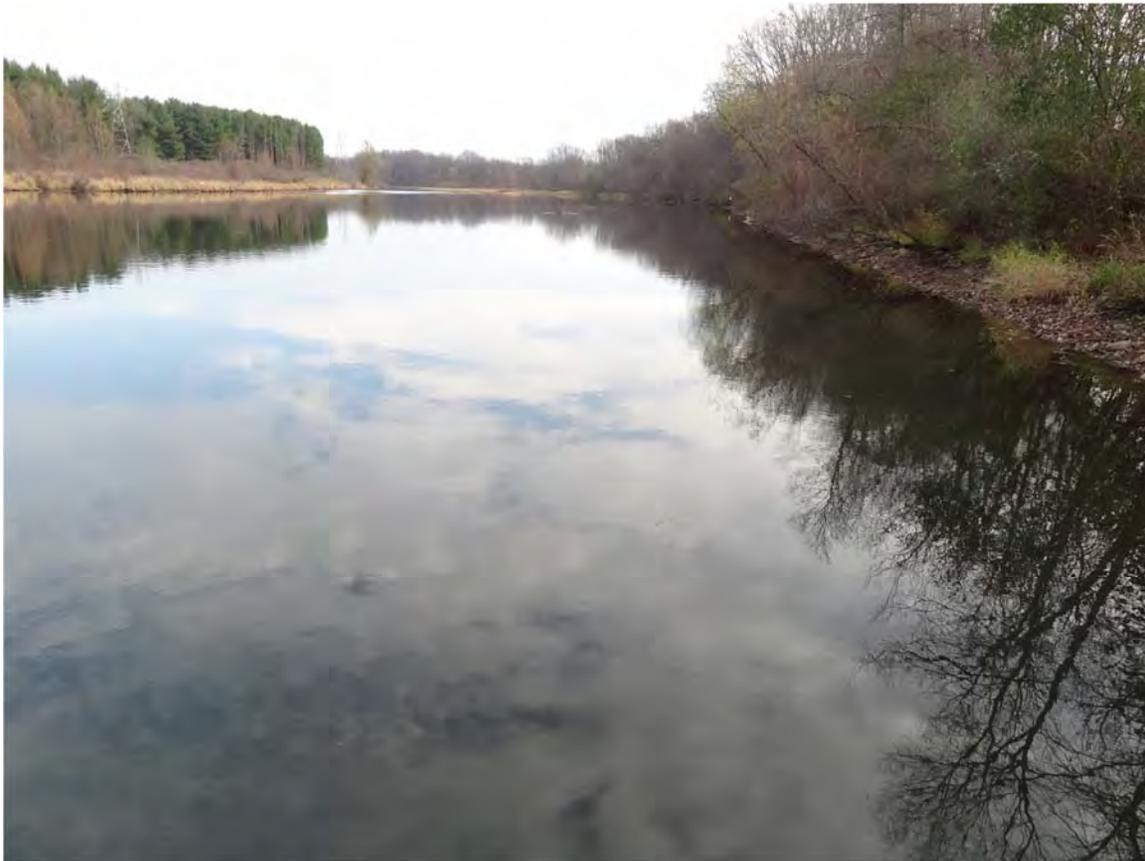
41. MP4.75 LDB area where sheen was observed.

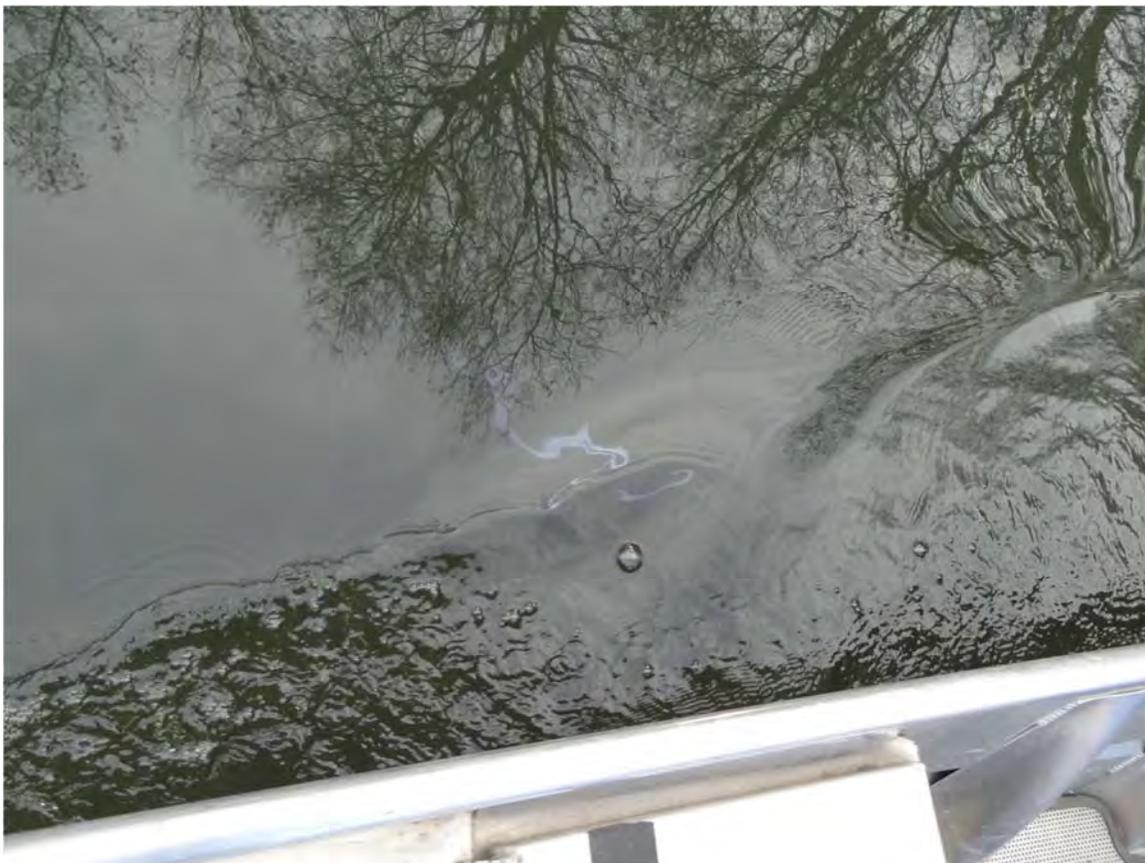
42. MP4.75 LDB sheen observed.

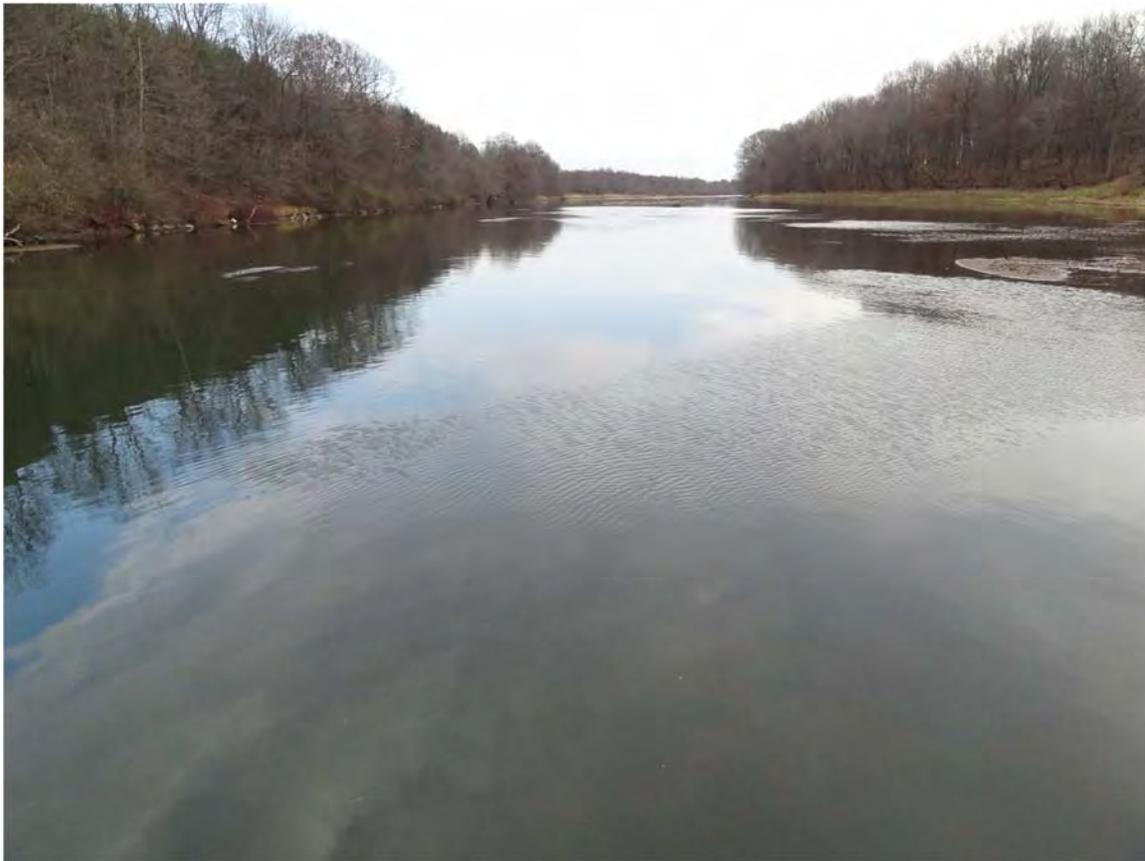
43. MP4.5 LDB area where sheen and tar globs were observed.

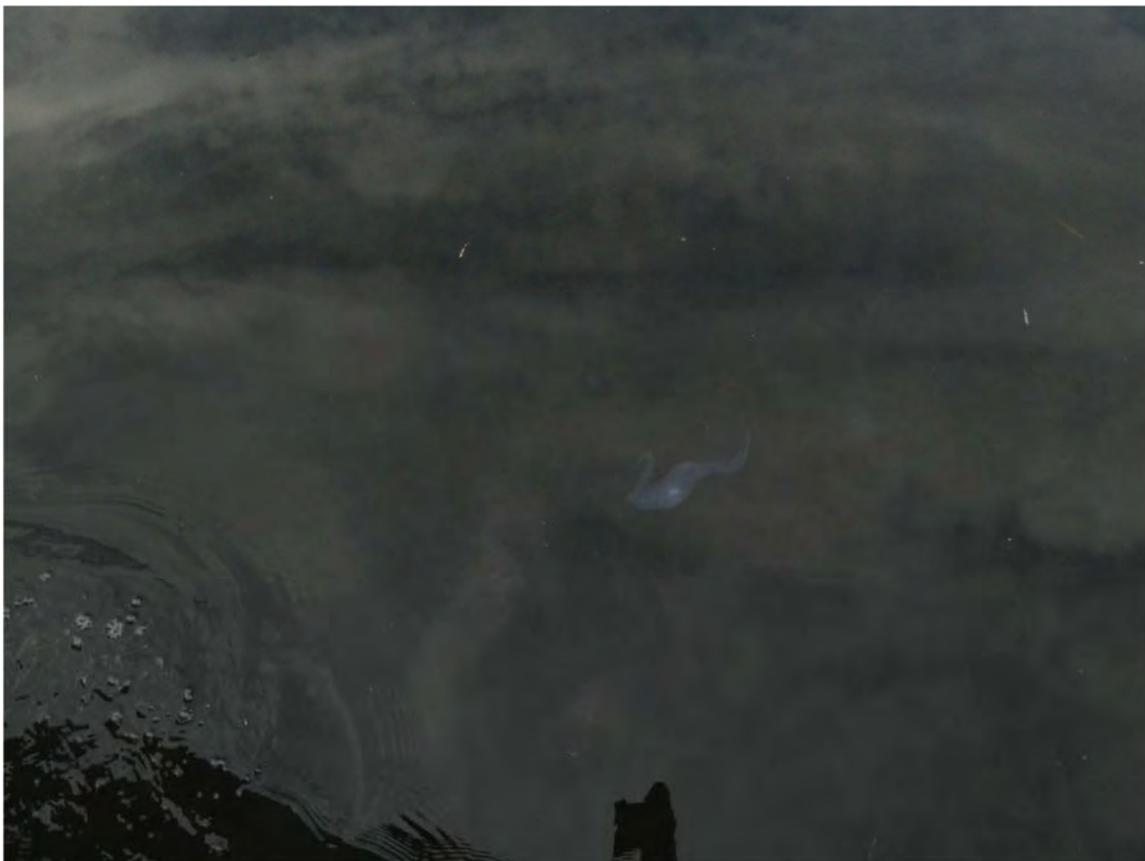
44. MP4.5 LDB sheen and tar globs observed.

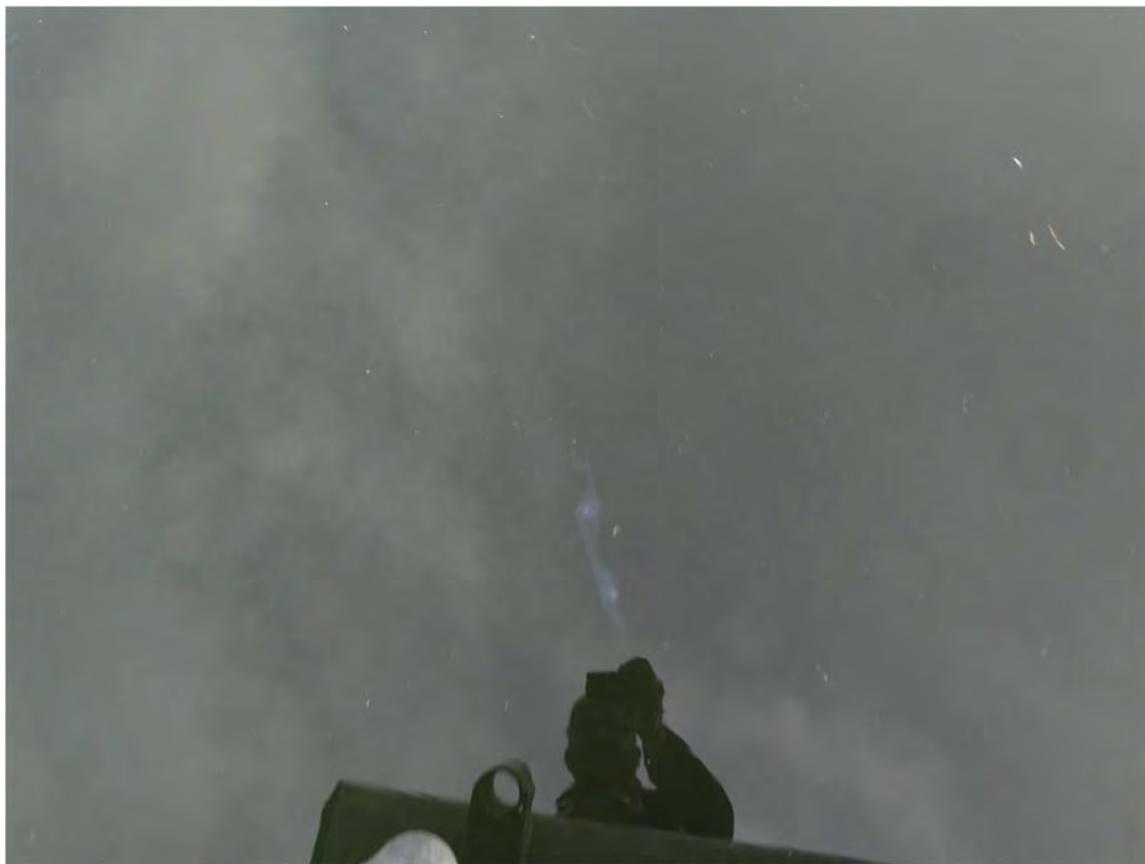
45. MP4.5 LDB sheen and tar globs observed.

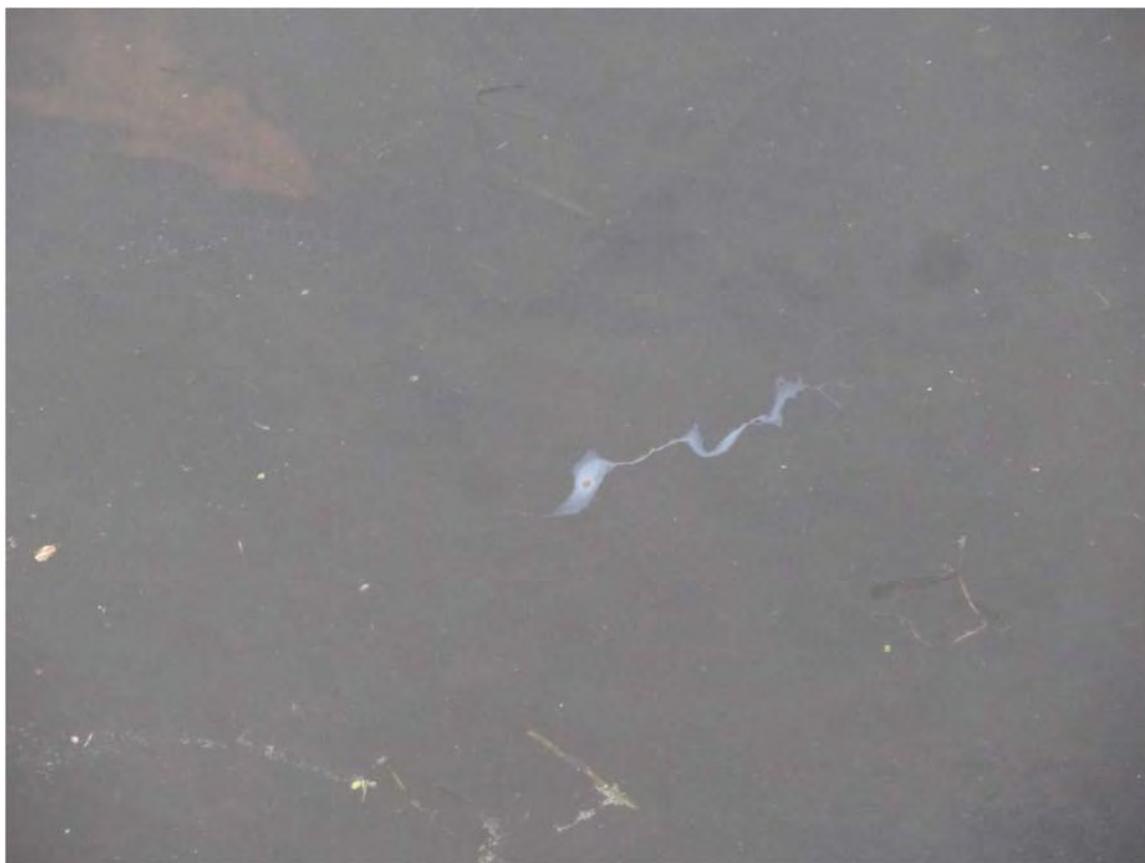
46. Observed sheen and tar globs floating past the C0.4 water level gauge.
