Situation Photo Log

Monday, November 12, 2012

Kalamazoo River / Enbridge Spill

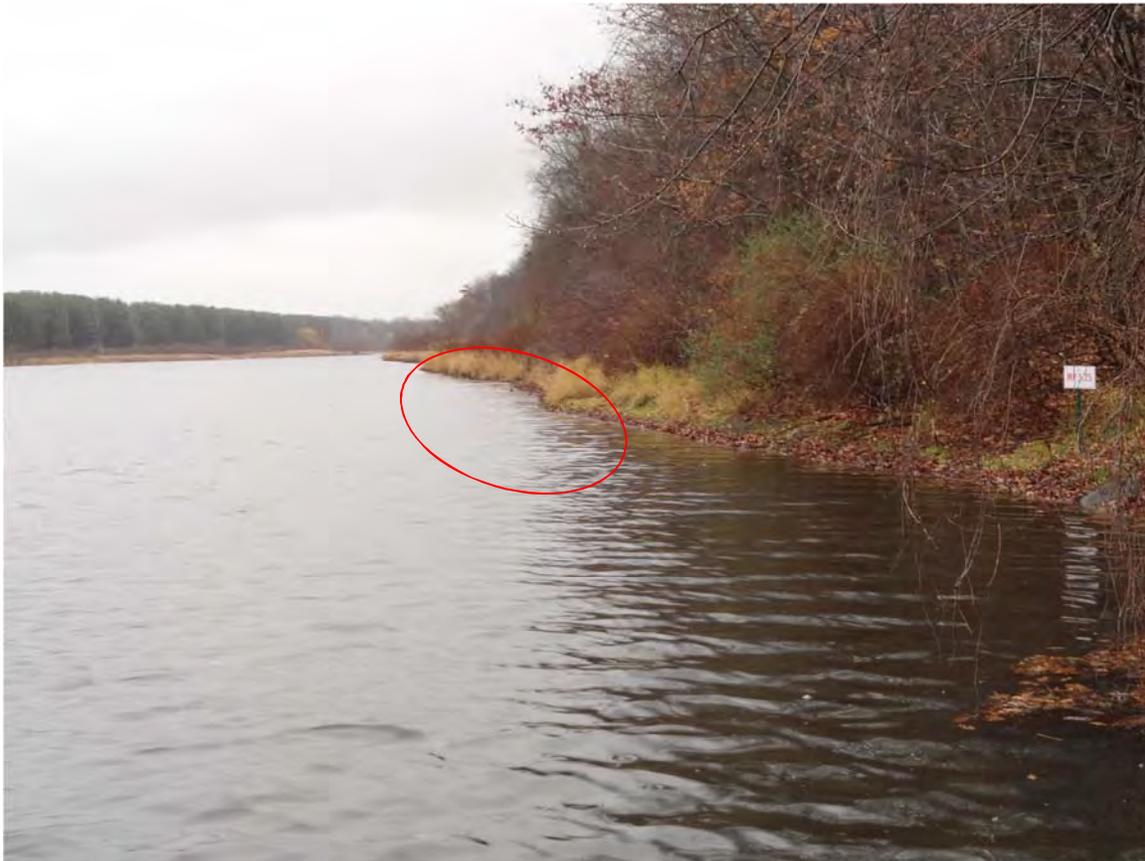
1. MP5.20 LDB Area where sheen and tar globs were observed.

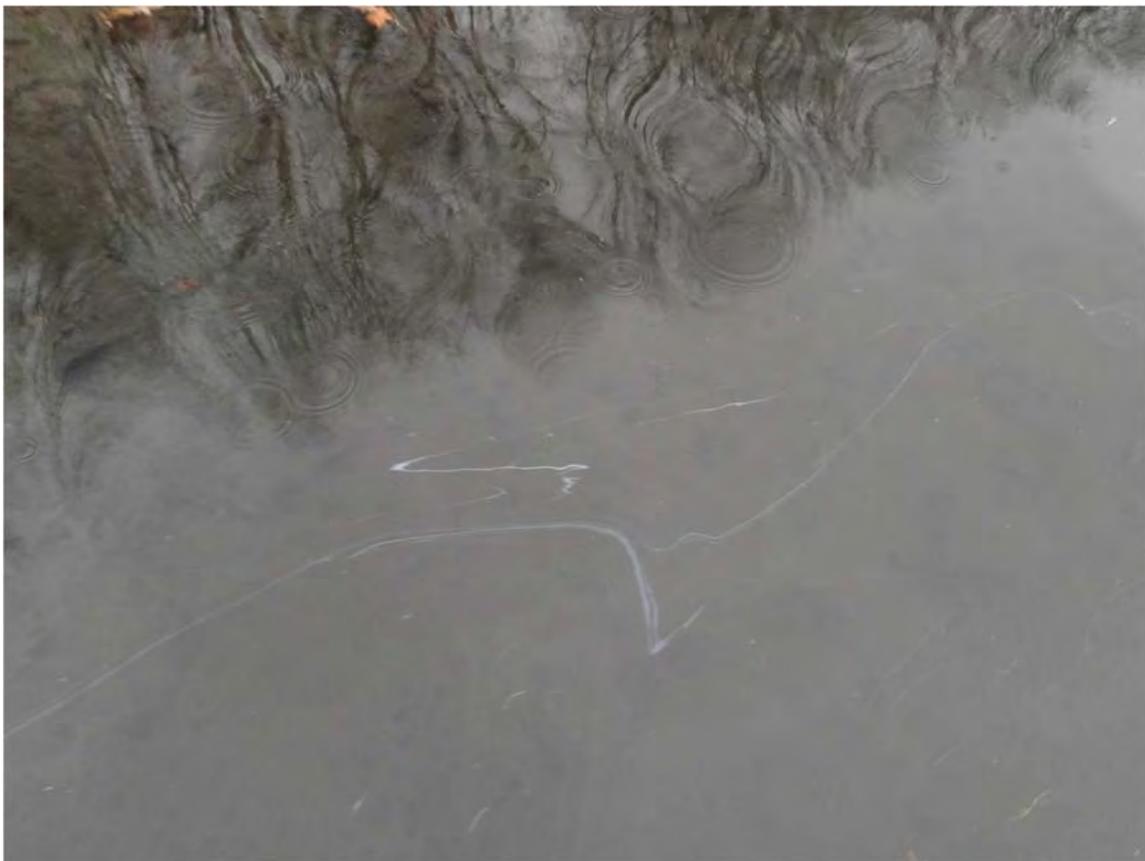
2. MP5.20 LDB spontaneous sheen and tar globs observed.

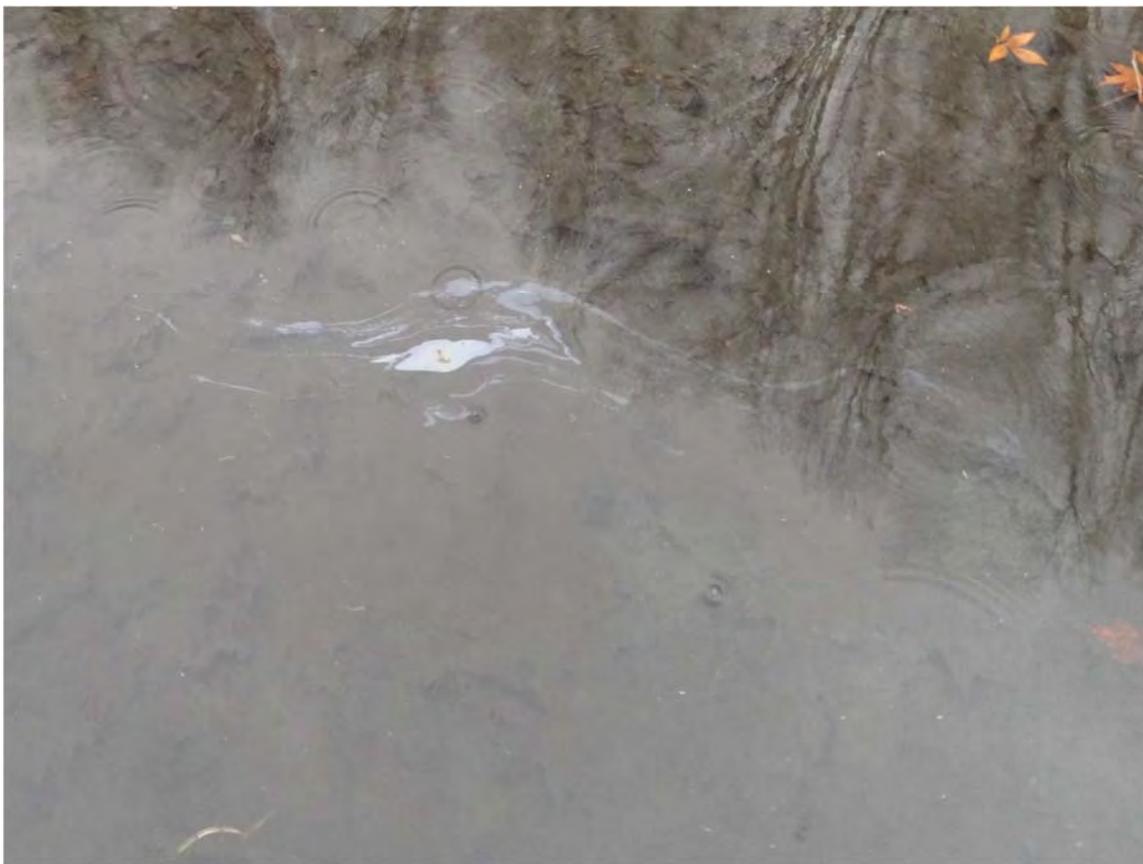
3. MP5.20 LDB spontaneous sheen and tar globs observed.

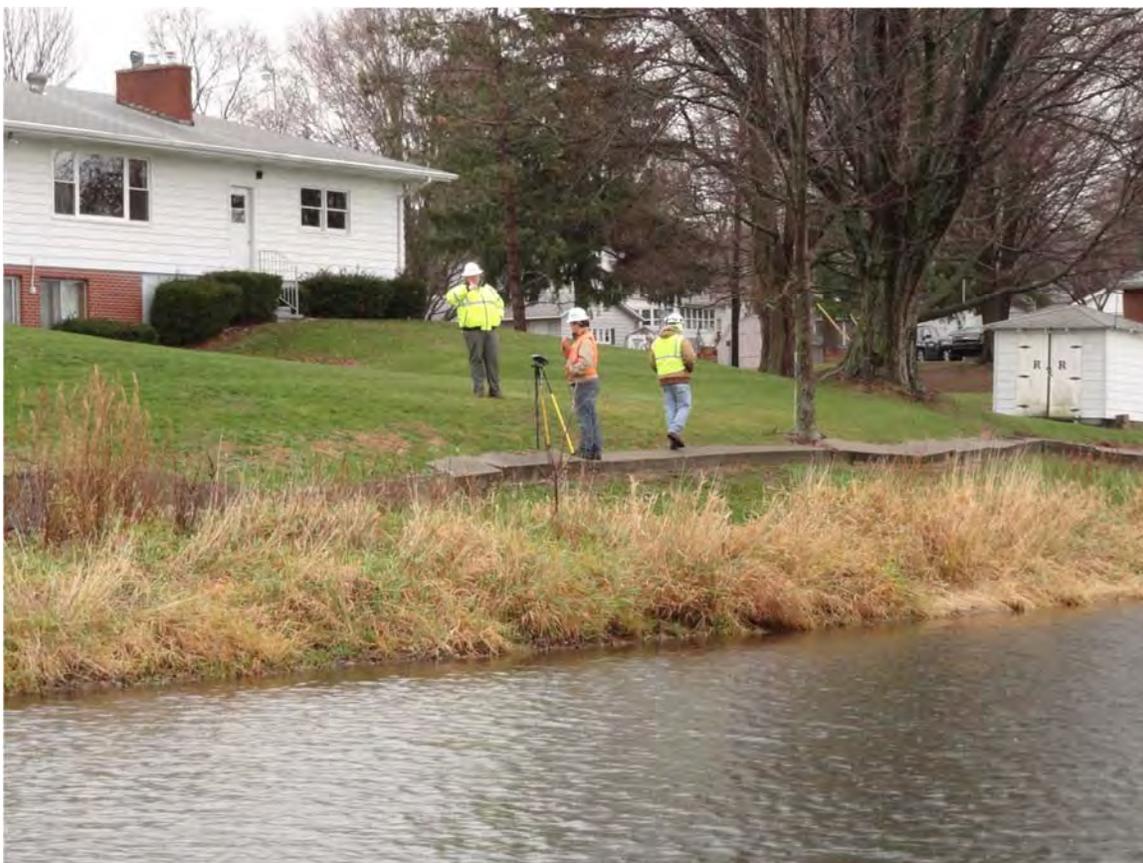
4. Ceresco Dam observed a crew surveying an anchor point for the bathymetry survey.

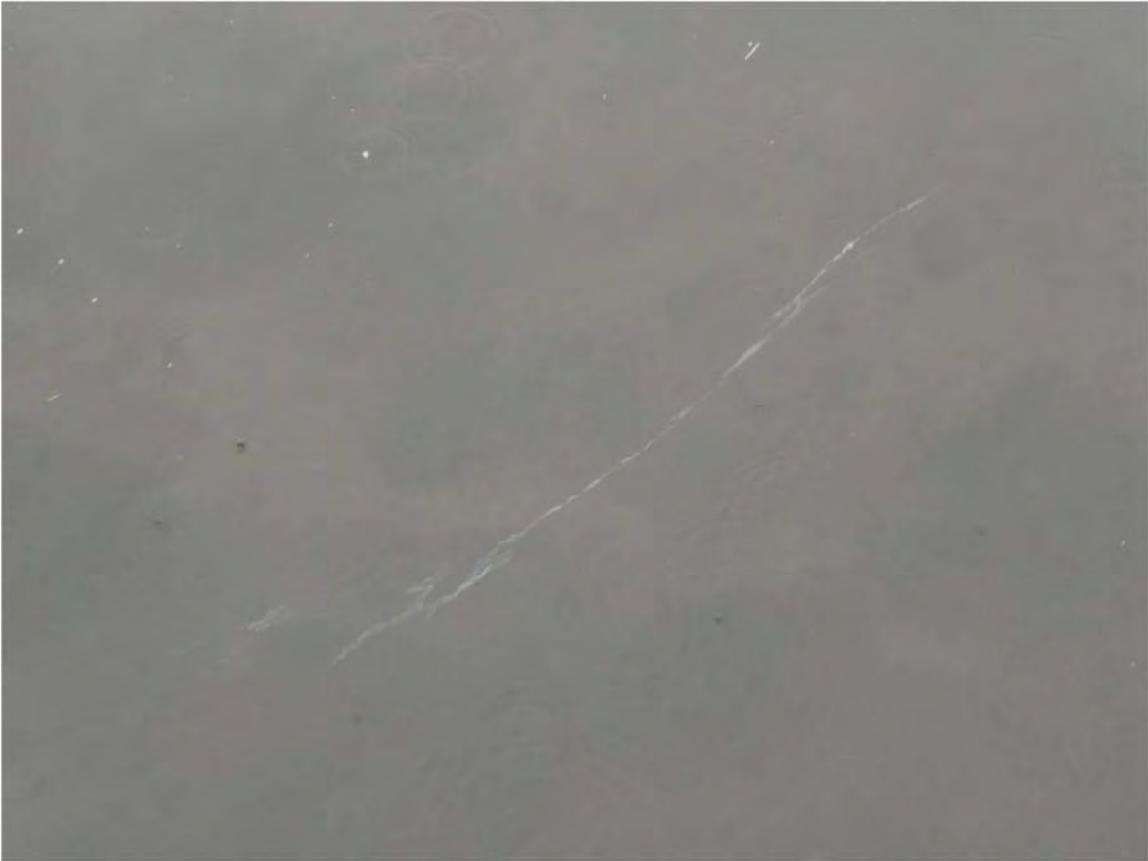
5. MP5.5 Center channel observed sheen and tar globs.

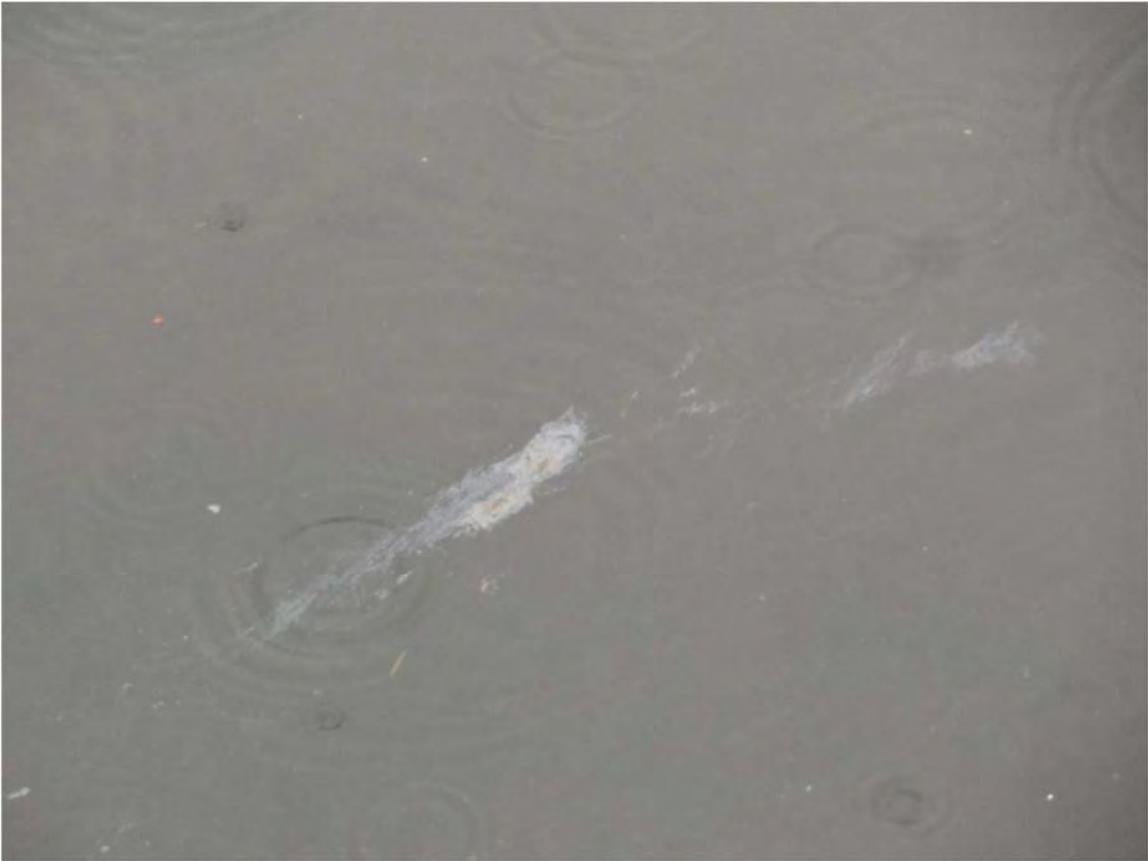
6. MP5.5 Center channel observed sheen and tar globs.

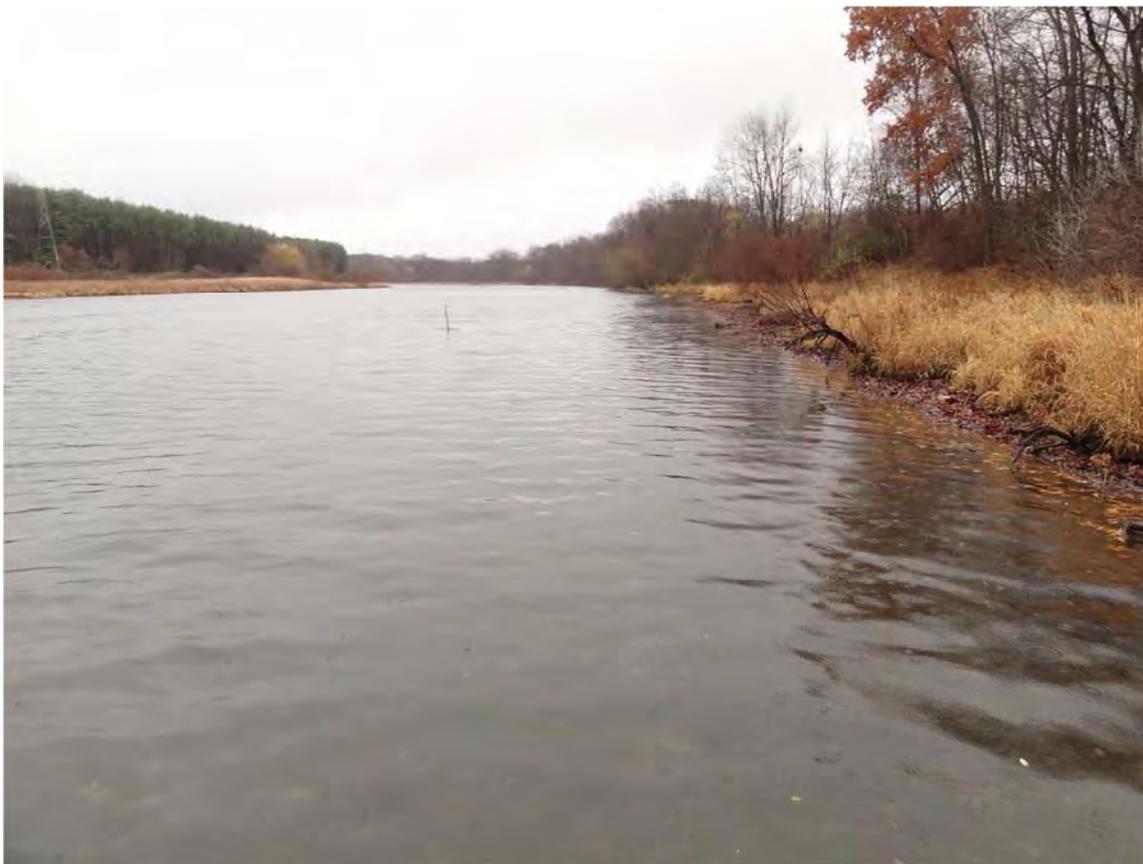
7. MP4.75 LDB area where sheen and tar globs were observed.

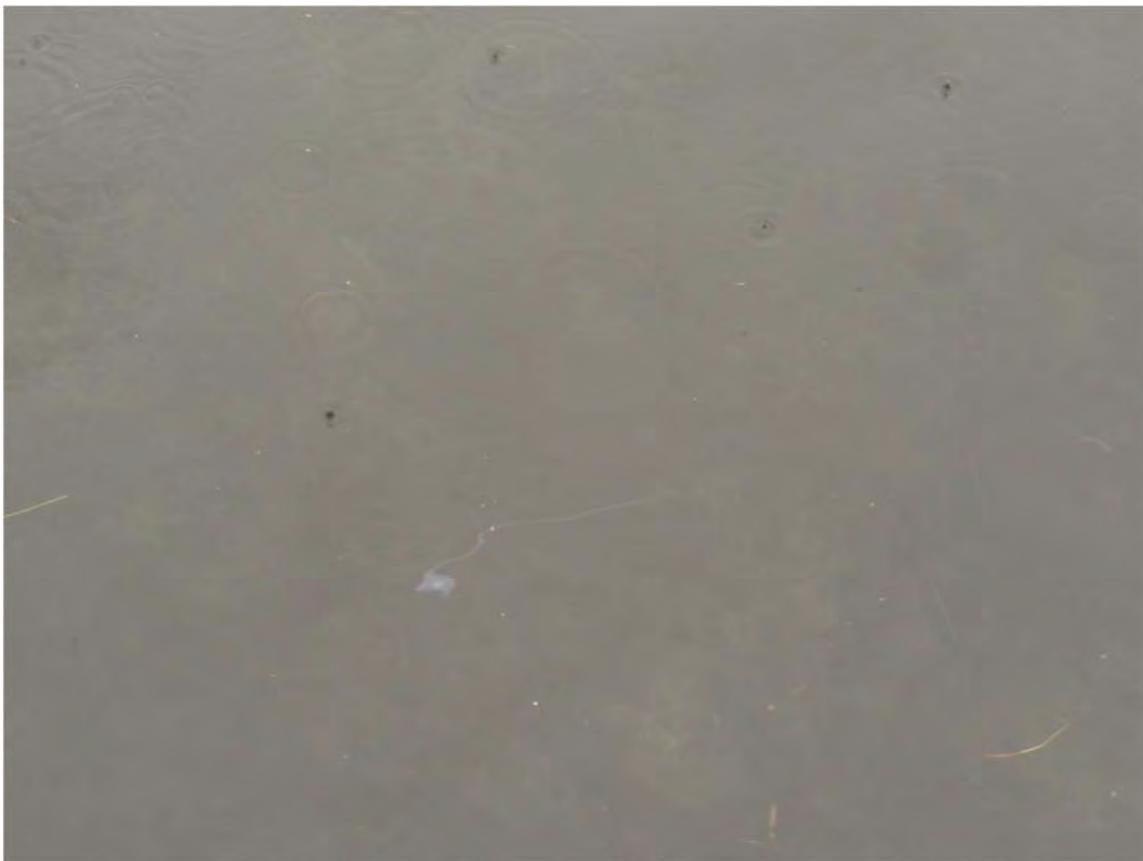
8. MP4.75 LDB sheen and tar globs observed.

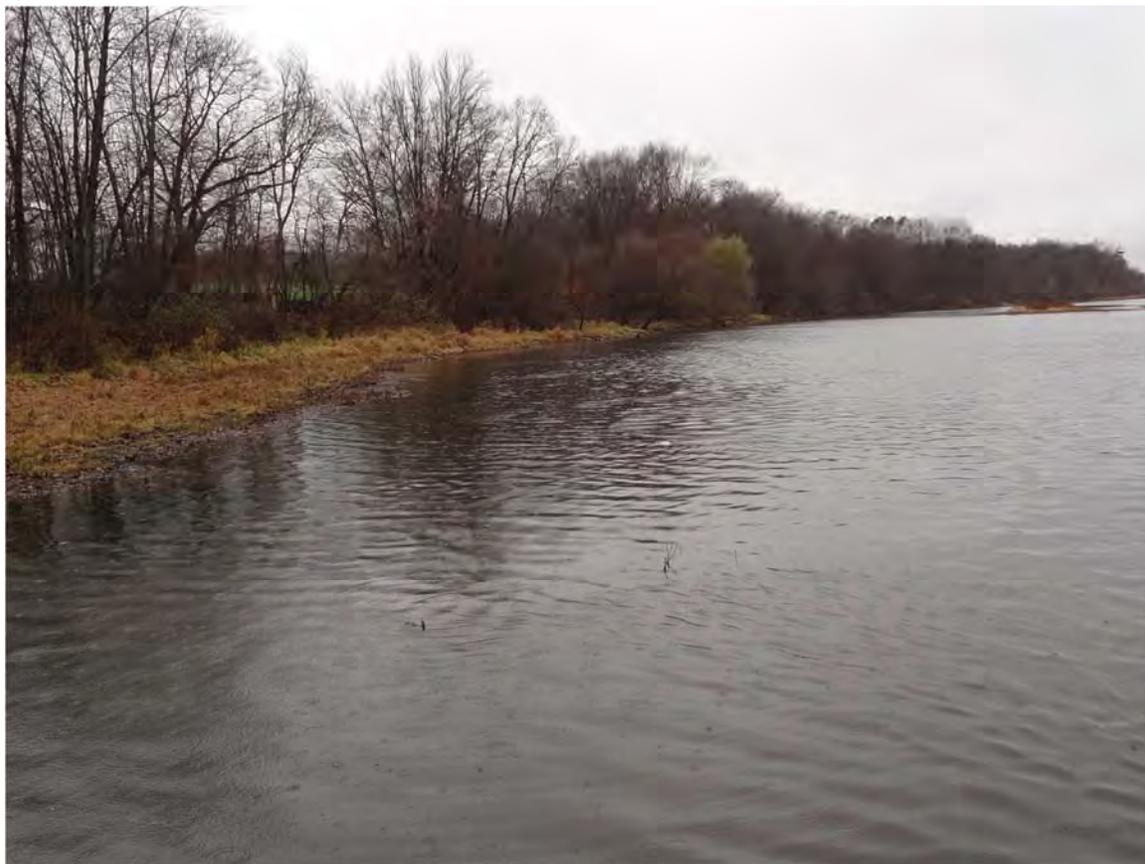
9. MP4.5 LDB Area where sheen and tar globs observed from boat agitation.

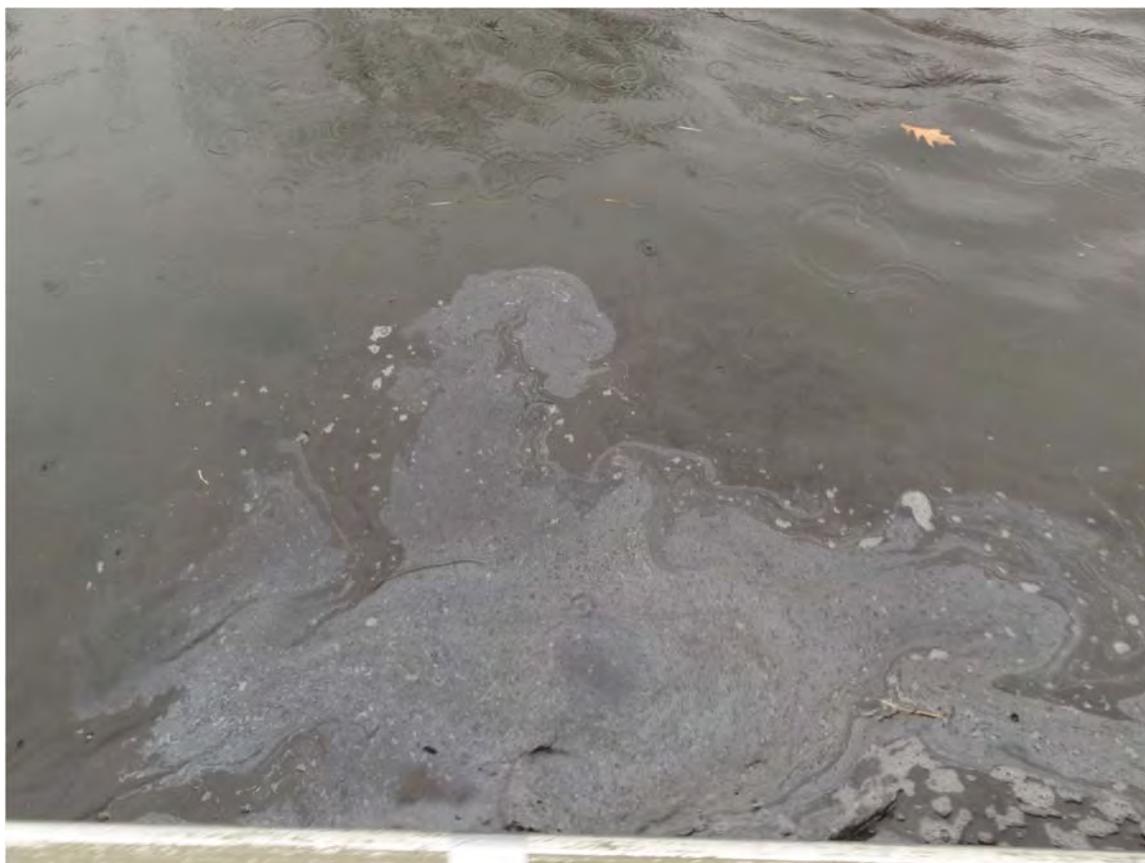
10. MP4.5 LDB sheen and tar globs observed from boat agitation.

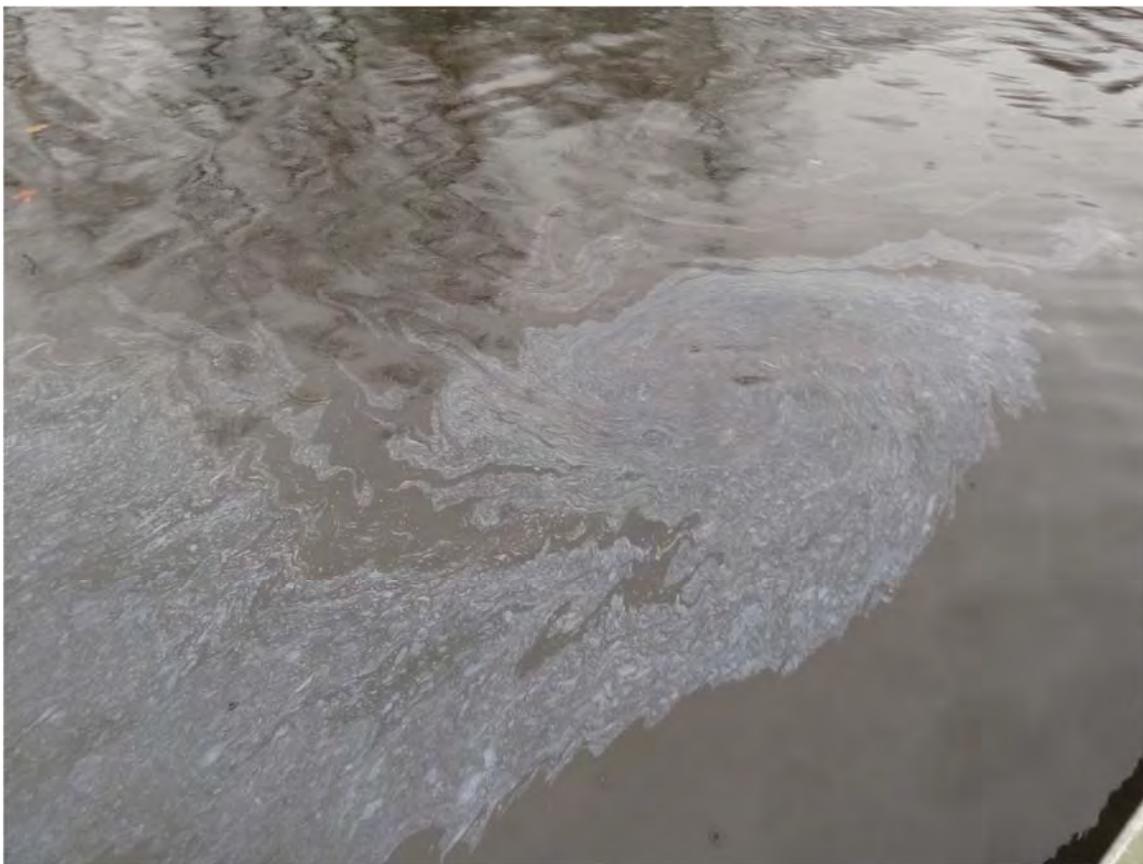
11. MP4.5 LDB sheen and tar globs observed from boat agitation.

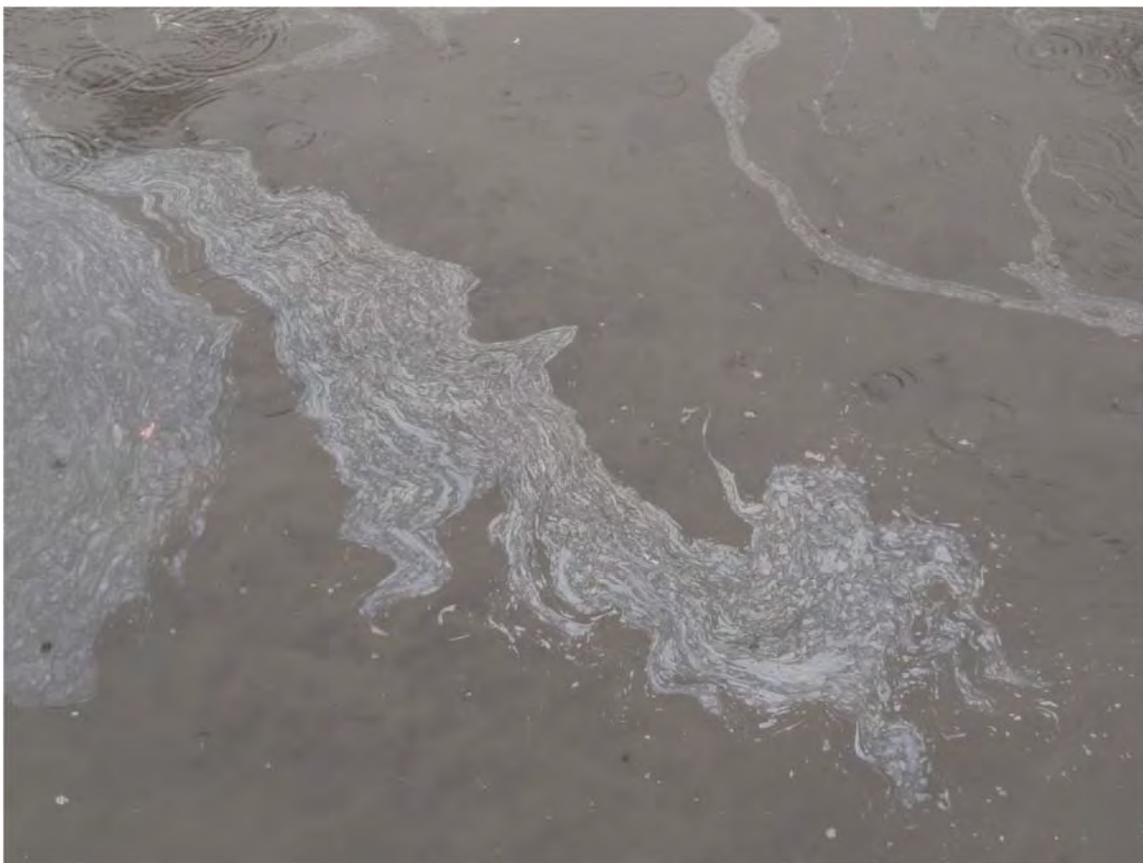
12. MP4.5 LDB sheen and tar globs observed from boat agitation.

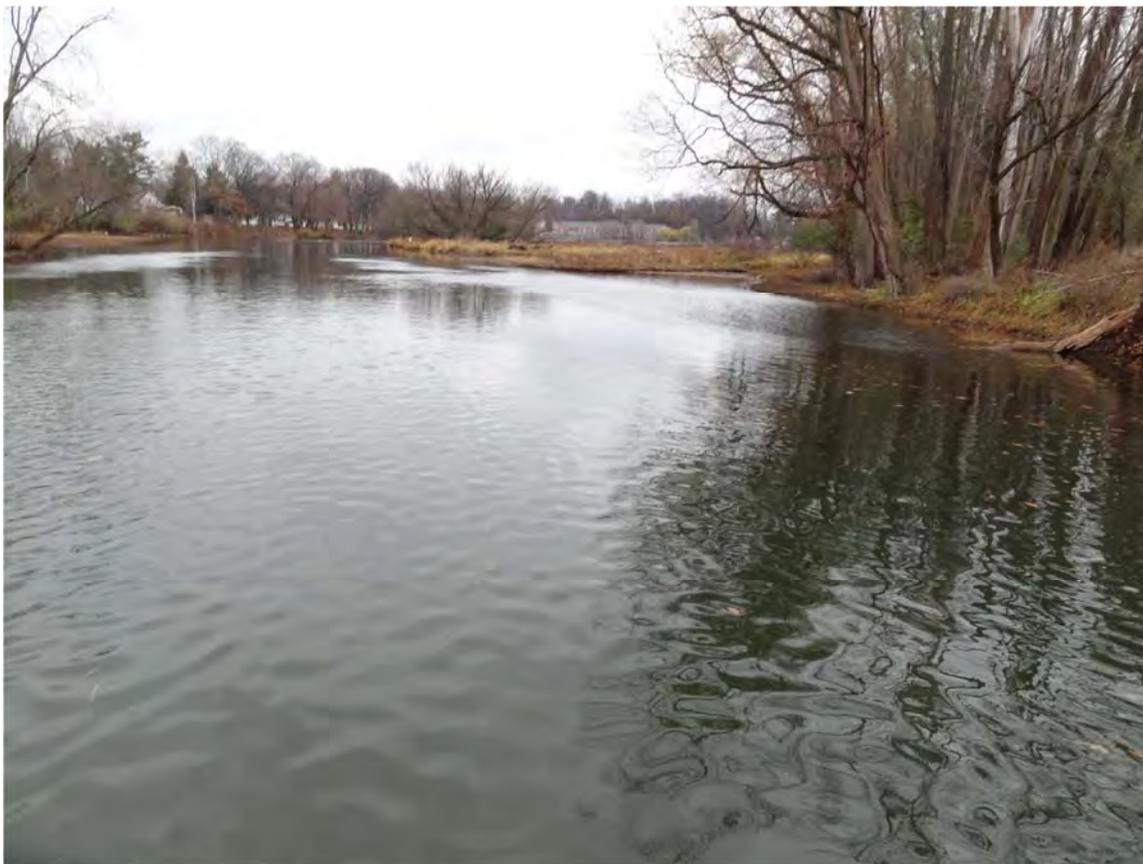
13. MP15.0 area where sheen and tar globs were observed in the river channel.

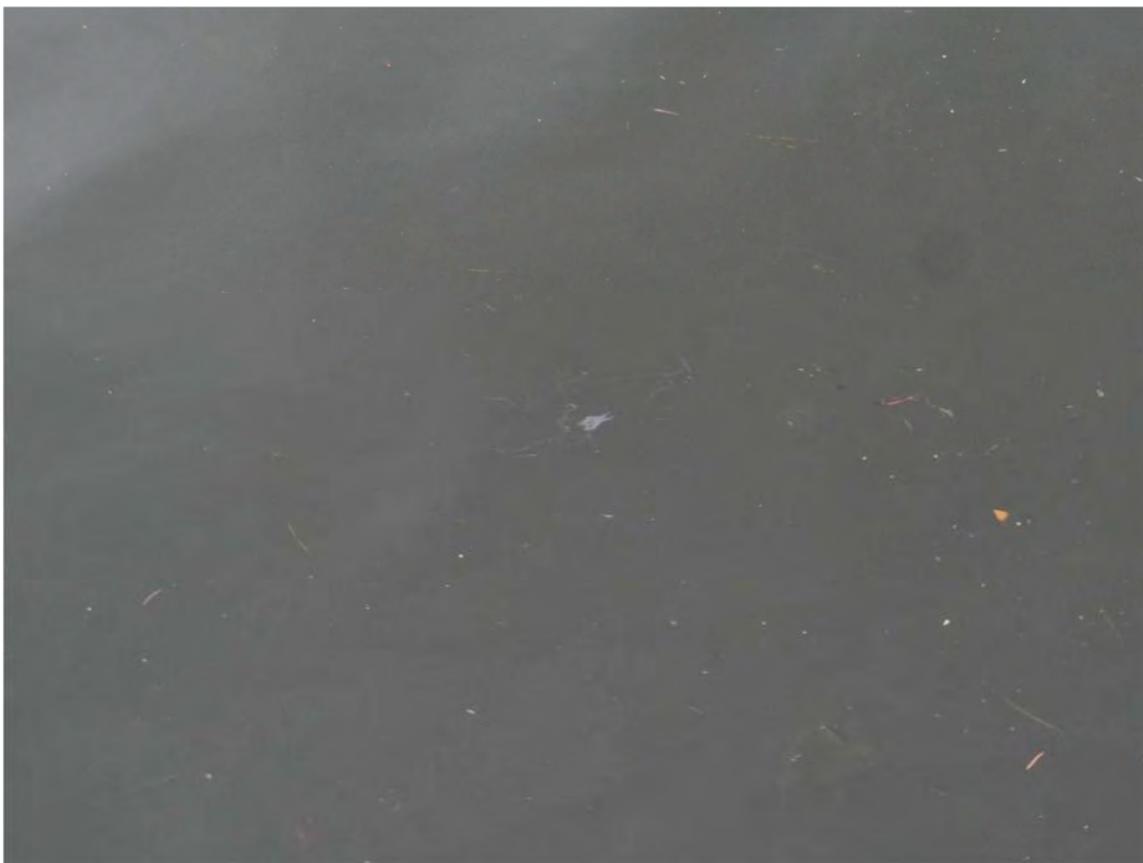
14. MP15.0 sheen and tar globs observed in the river channel.

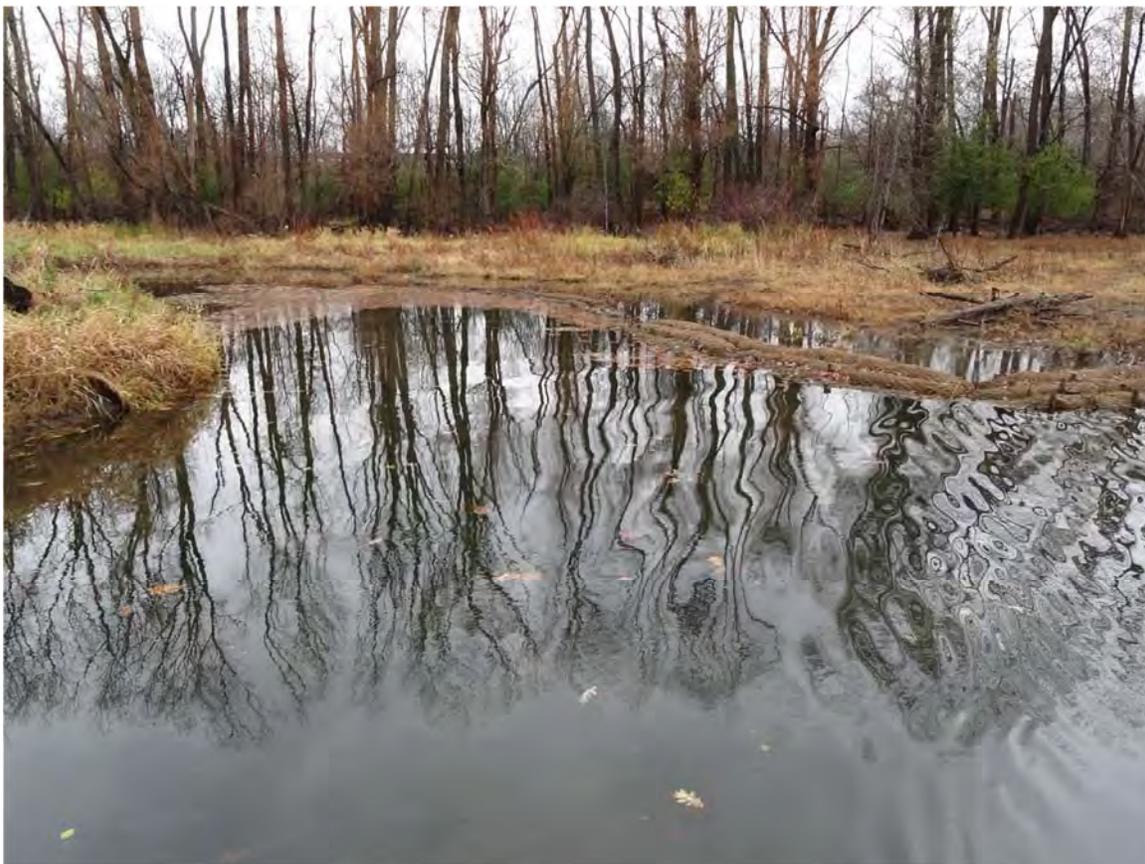
15. MP15.0 RDB South Mill Pond area where sheen and tar globs were observed.

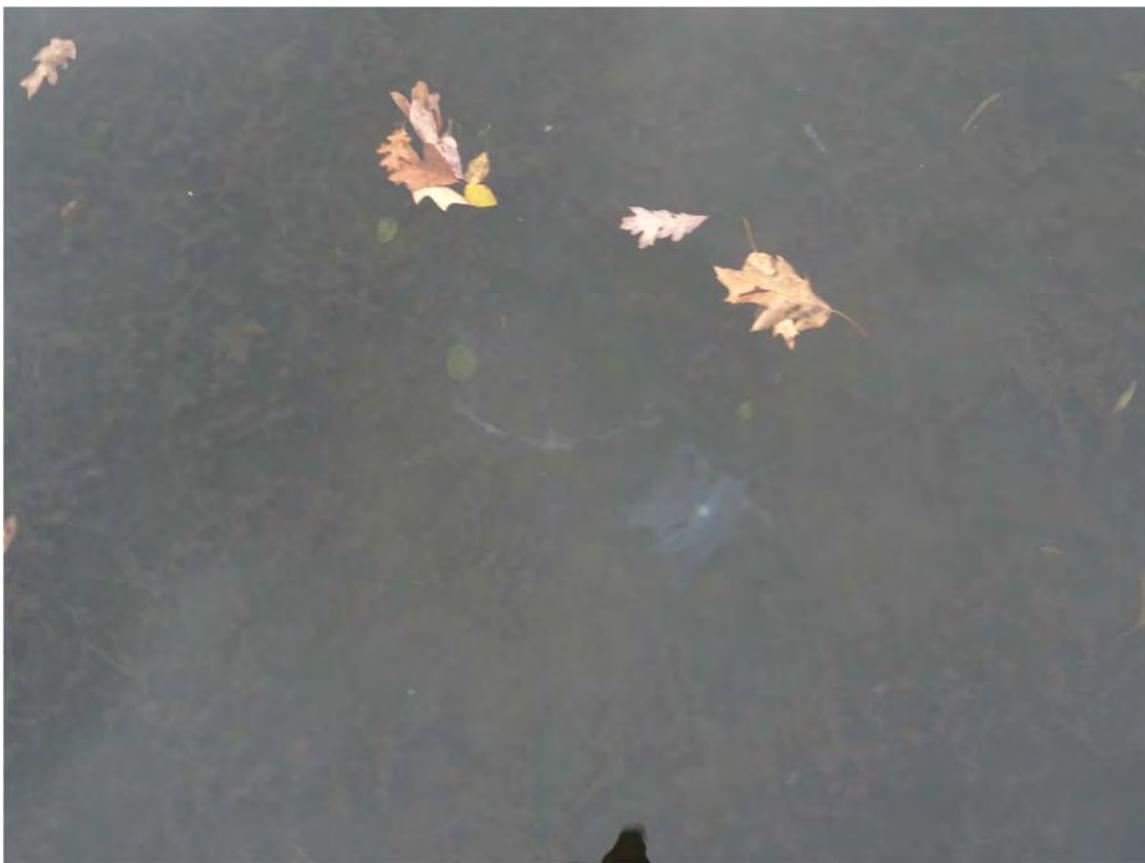
16. MP15.0 RDB South Mill Pond sheen and tar globs observed.

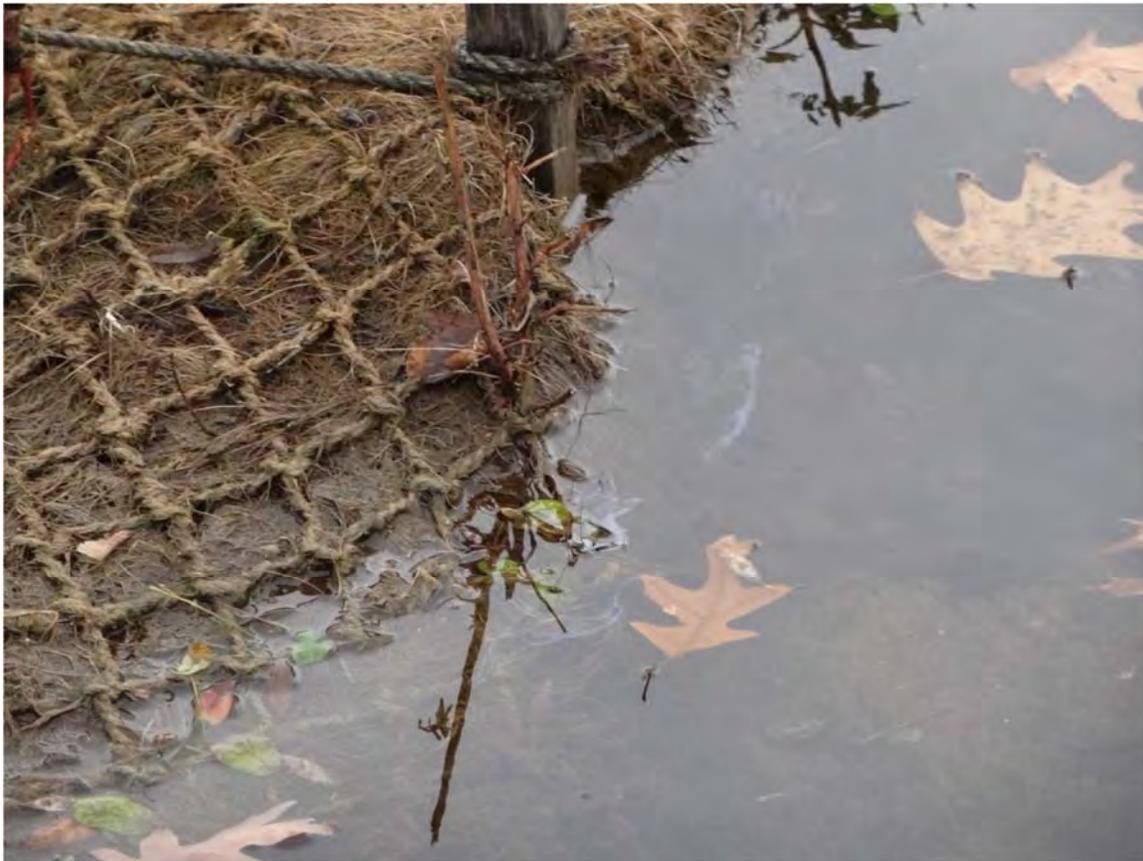
17. MP15.0 RDB South Mill Pond sheen and tar globs observed.

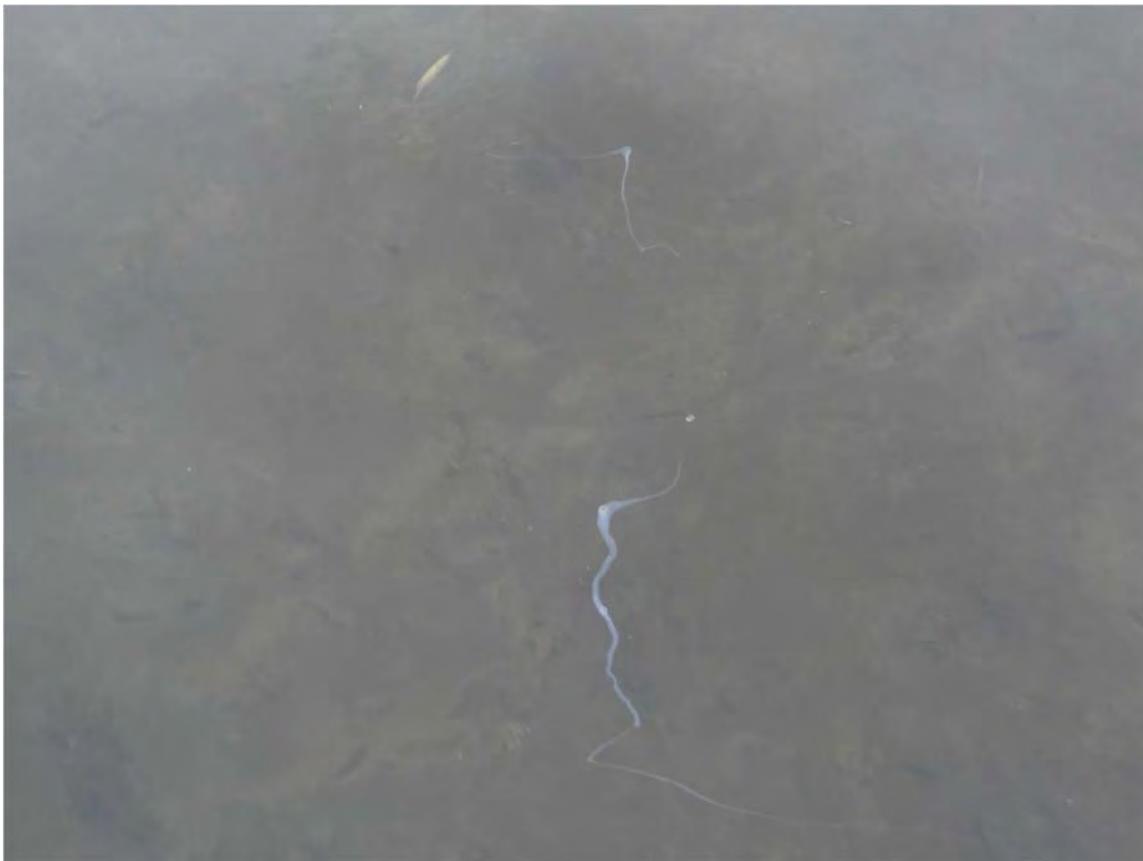
18. MP15.25 RDB South Mill Pond sheen and tar globs observed.

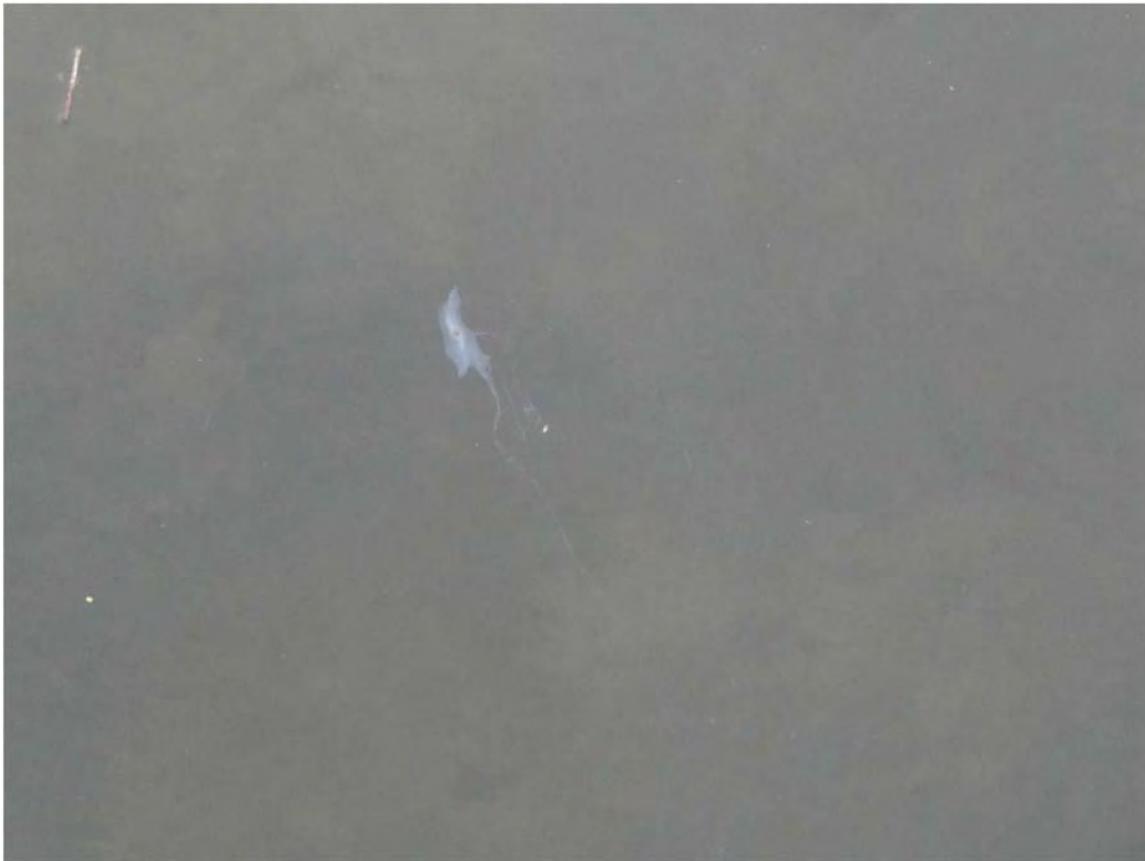
19. MP15.25 RDB South Mill Pond sheen and tar globs observed.

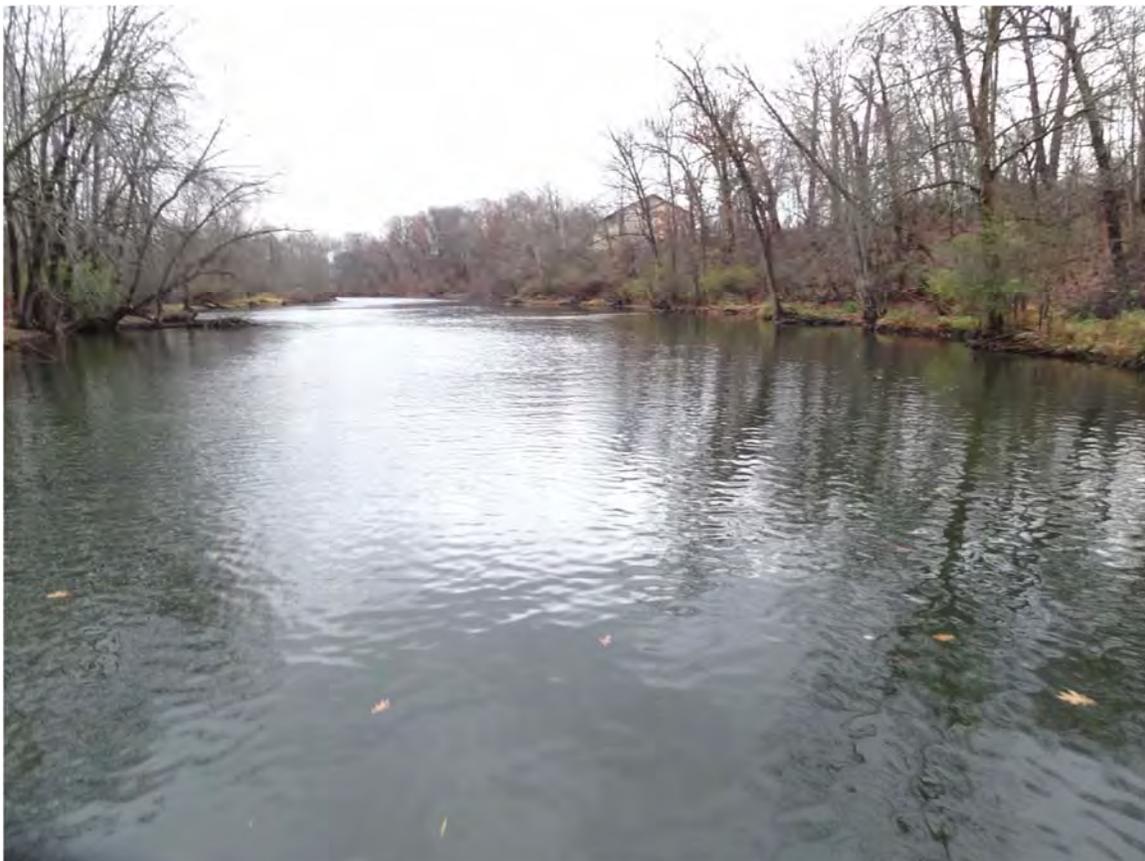
20. MP14.75 LDB area where sheen and tar globs were observed.

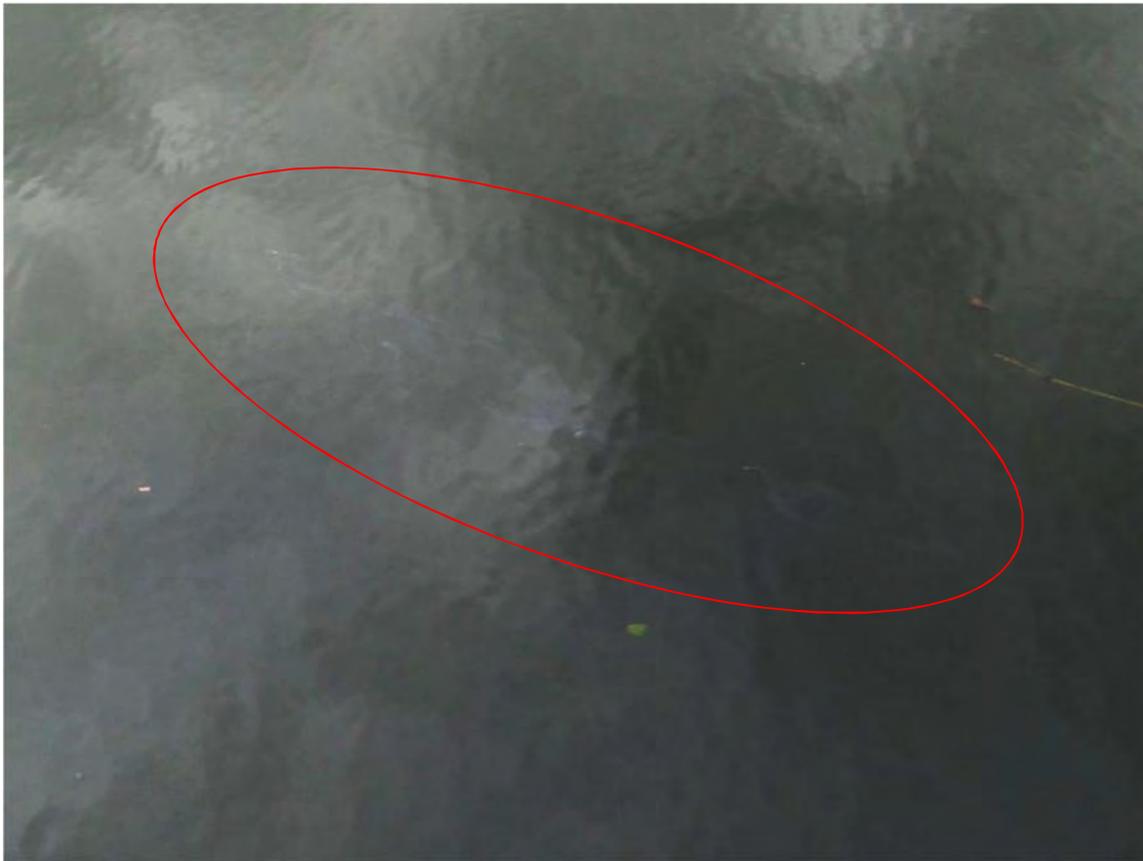
21. MP14.75 LDB sheen and tar globs observed.

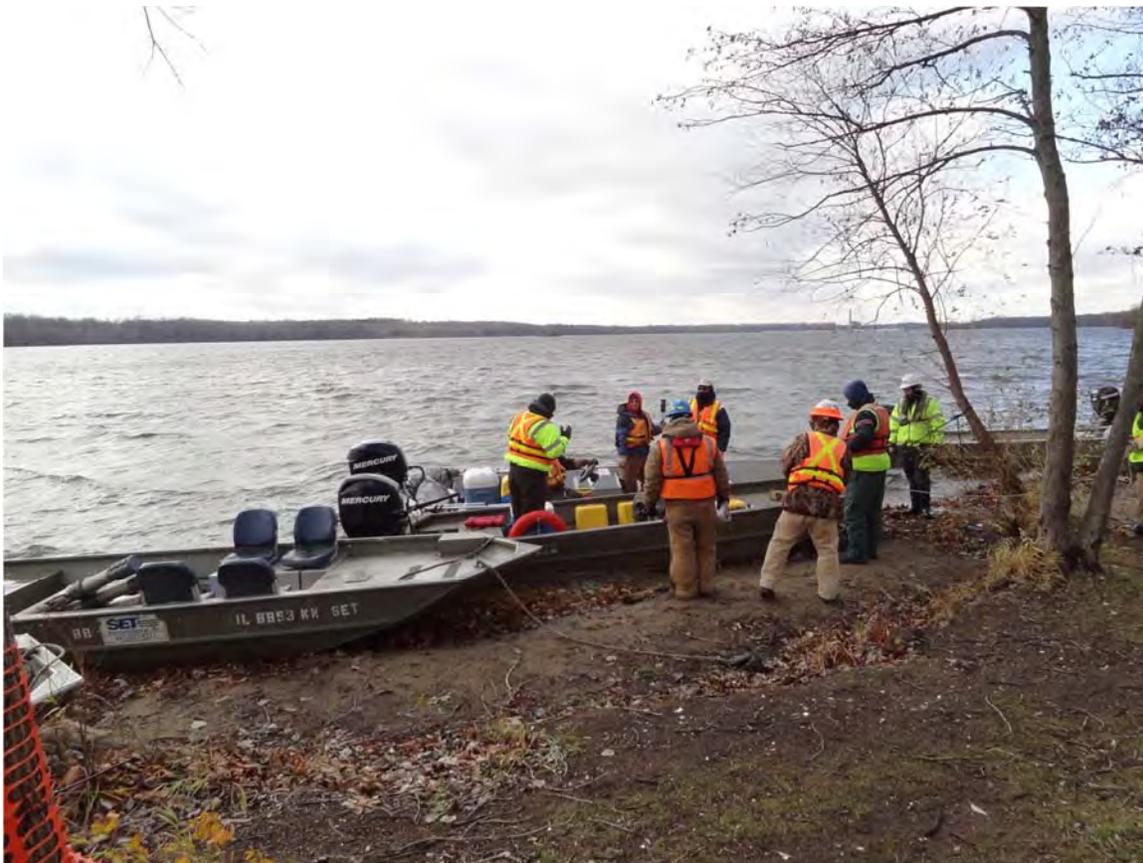
22. E4 Boat Launch Bathymetry team departing.

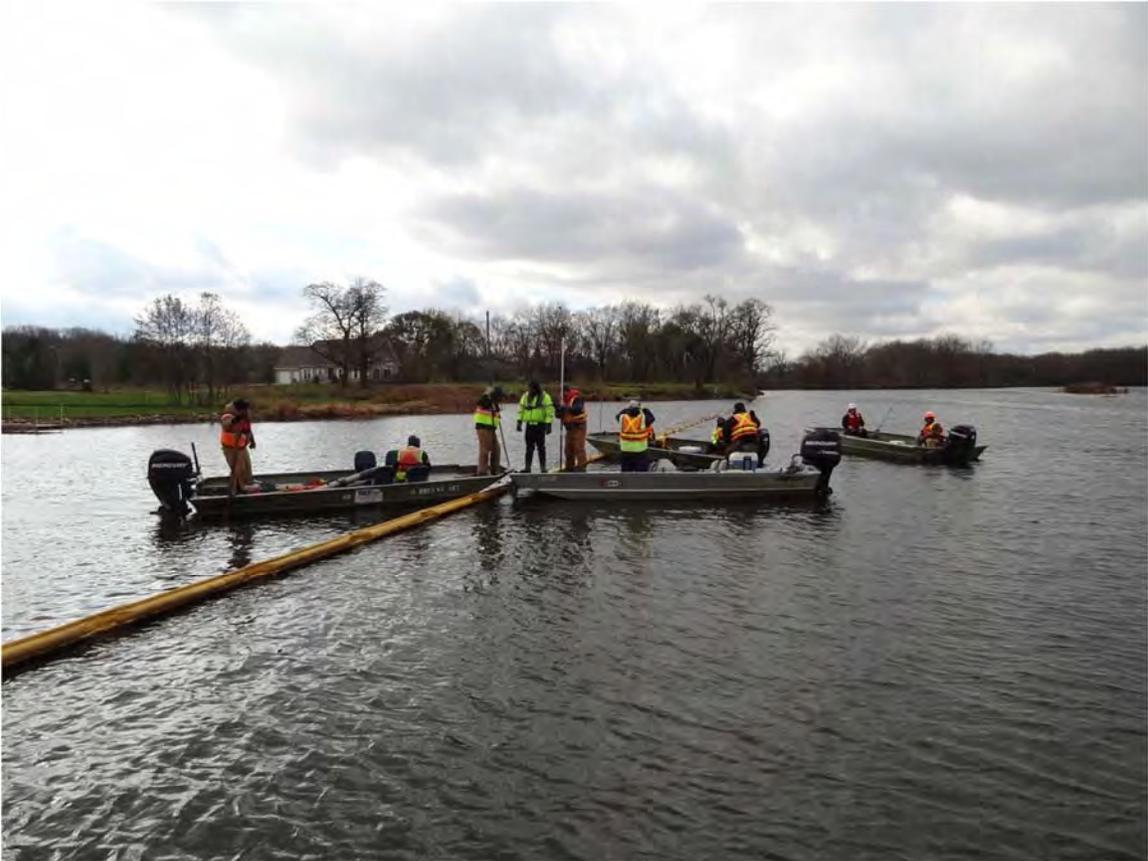
23. Morrow Lake Delta Gate A observed the Bathymetry team.
