Situation Photo Log

Monday, November 12, 2012

Kalamazoo River / Enbridge Spill

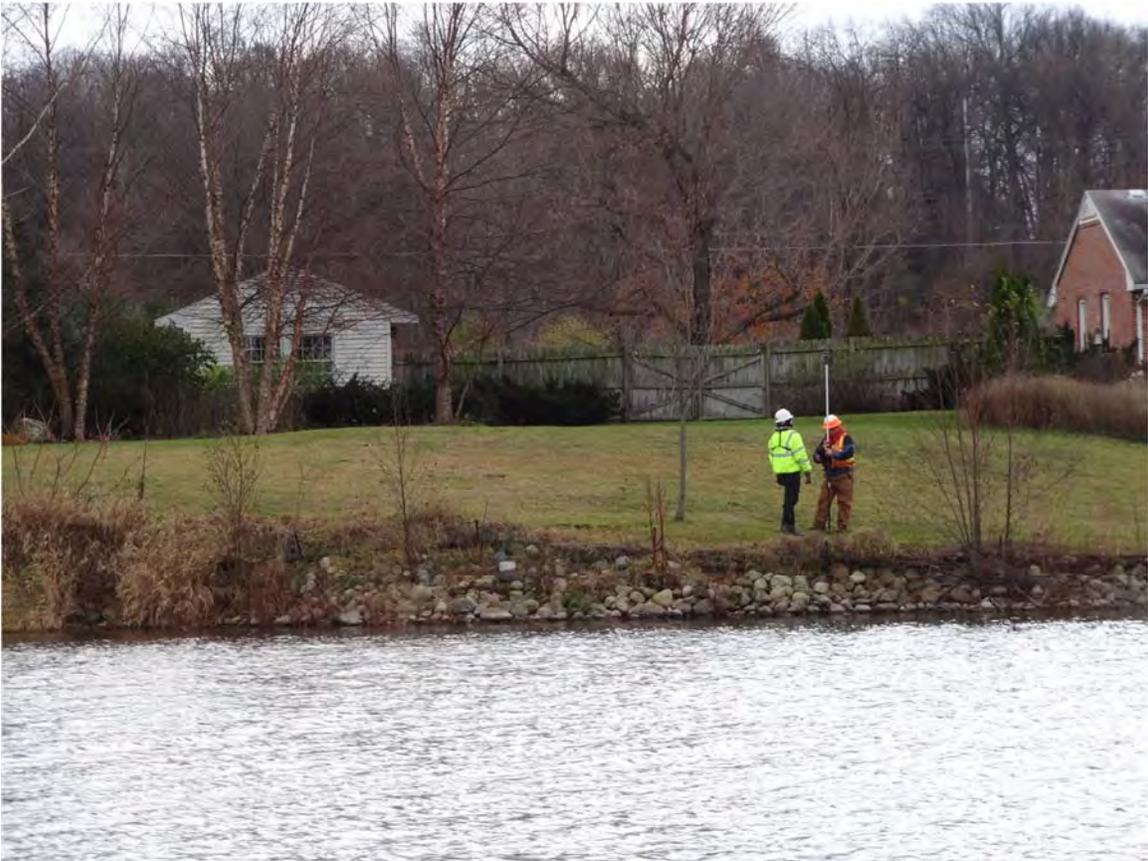
24. Morrow Lake Delta Gate A observed the Bathymetry team.

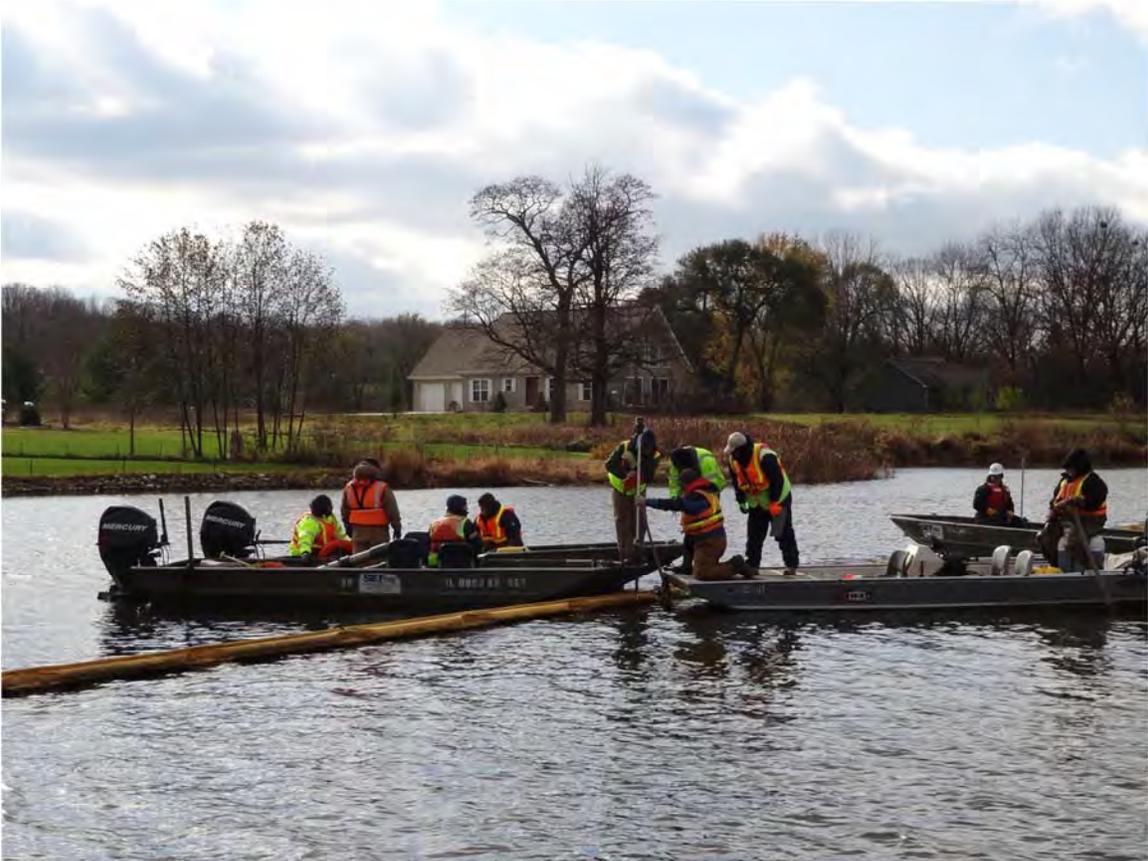
25. Morrow Lake Delta Gate A observed the Bathymetry team.

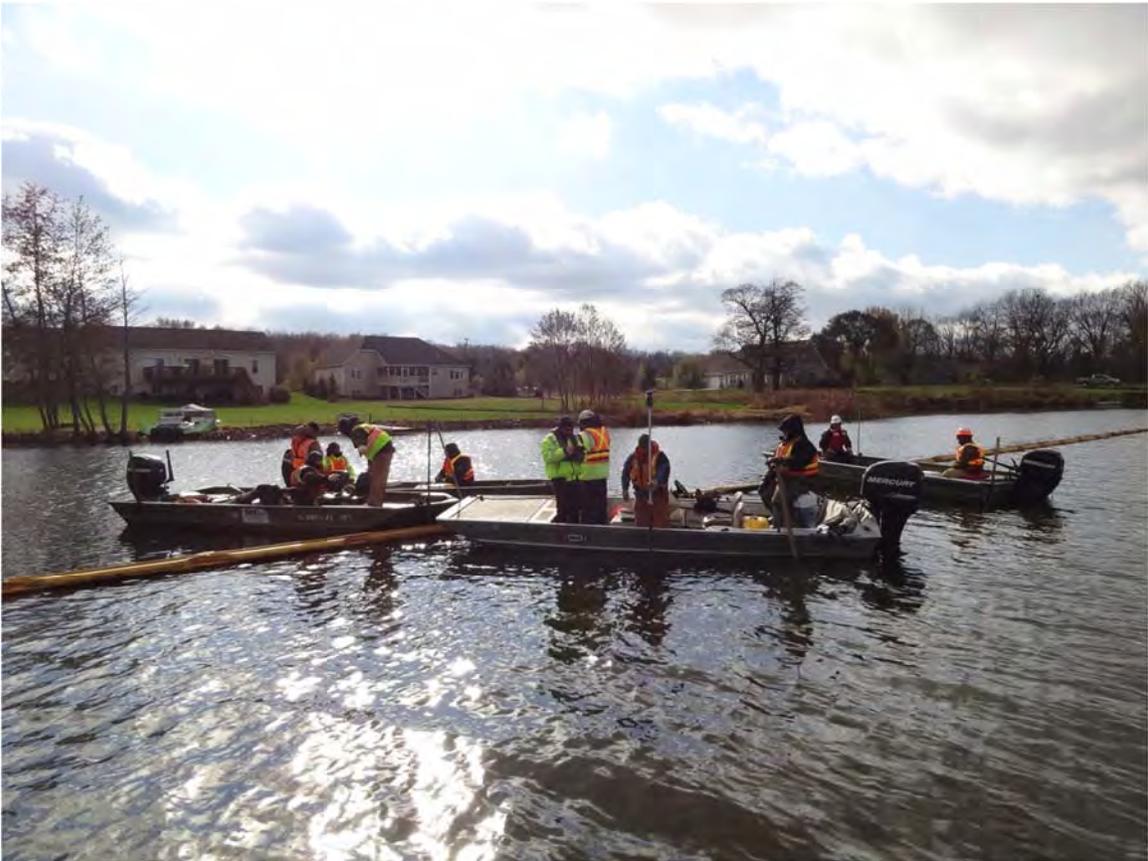
26. Morrow Lake Delta Gate A observed the Bathymetry team.
