Situation Photo Log

Wednesday, November 14, 2012

Kalamazoo River / Enbridge Spill

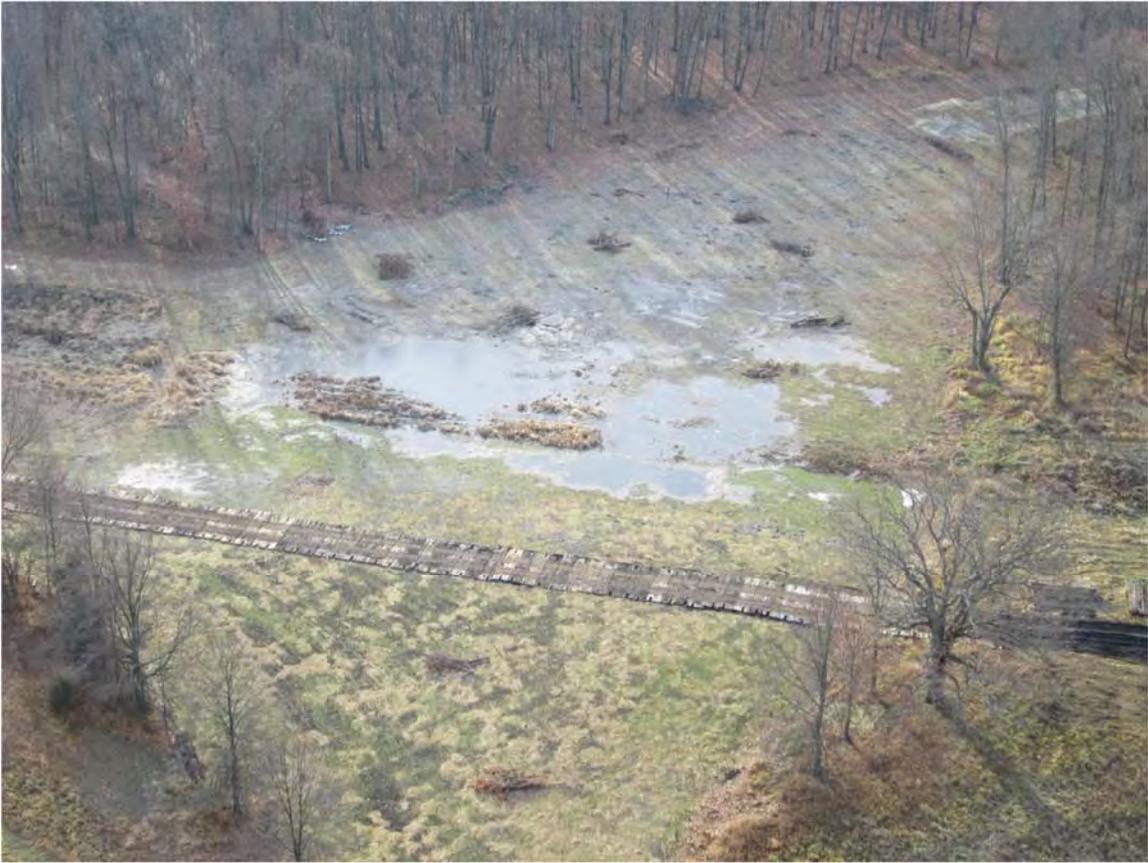
1. Source area, observed the new line 6B work.

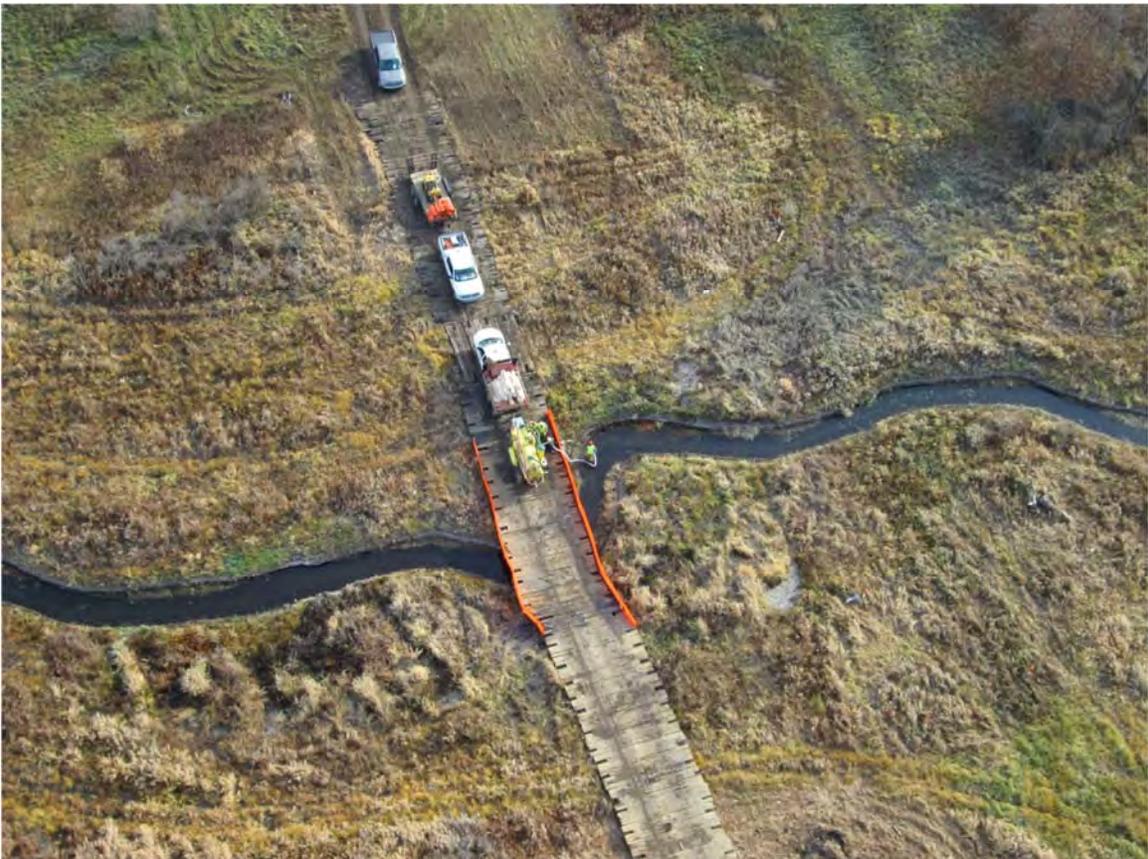
2. Talmadge Creek, observed the new line 6B work.

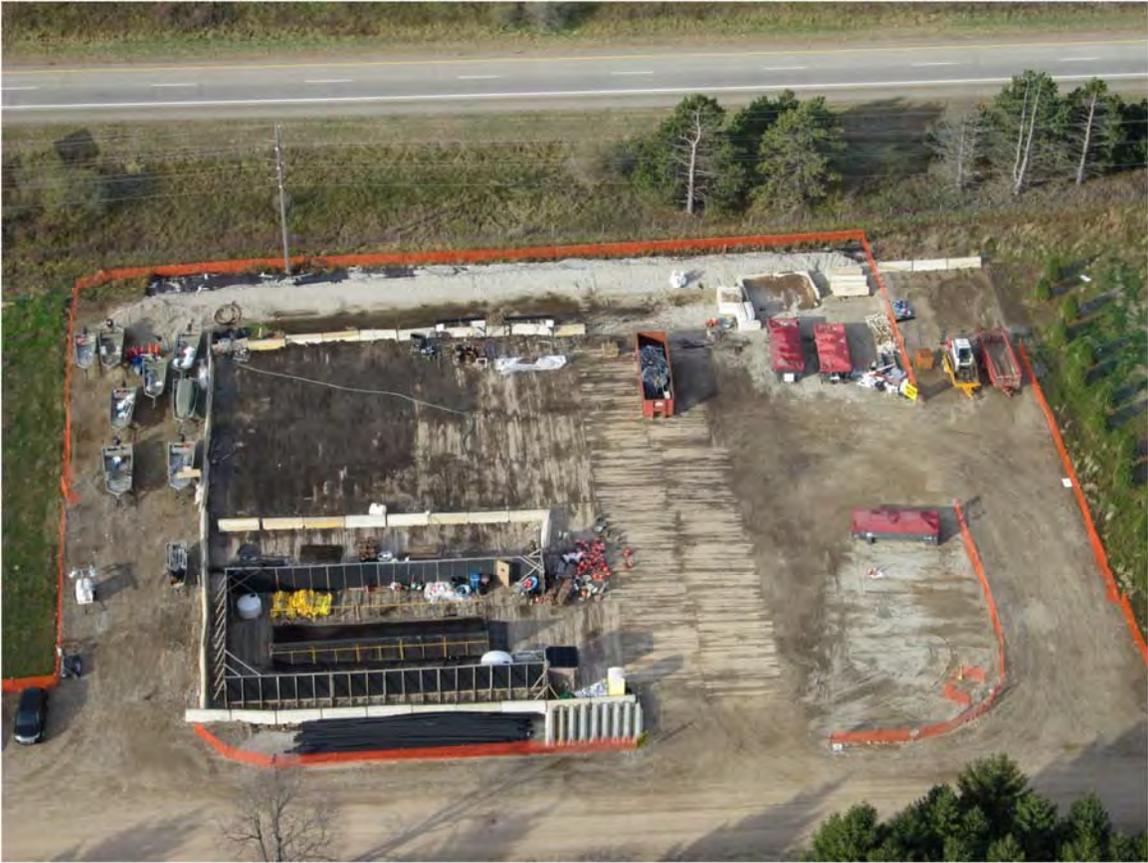
3. Frac-Tank decontamination pad no activity observed.

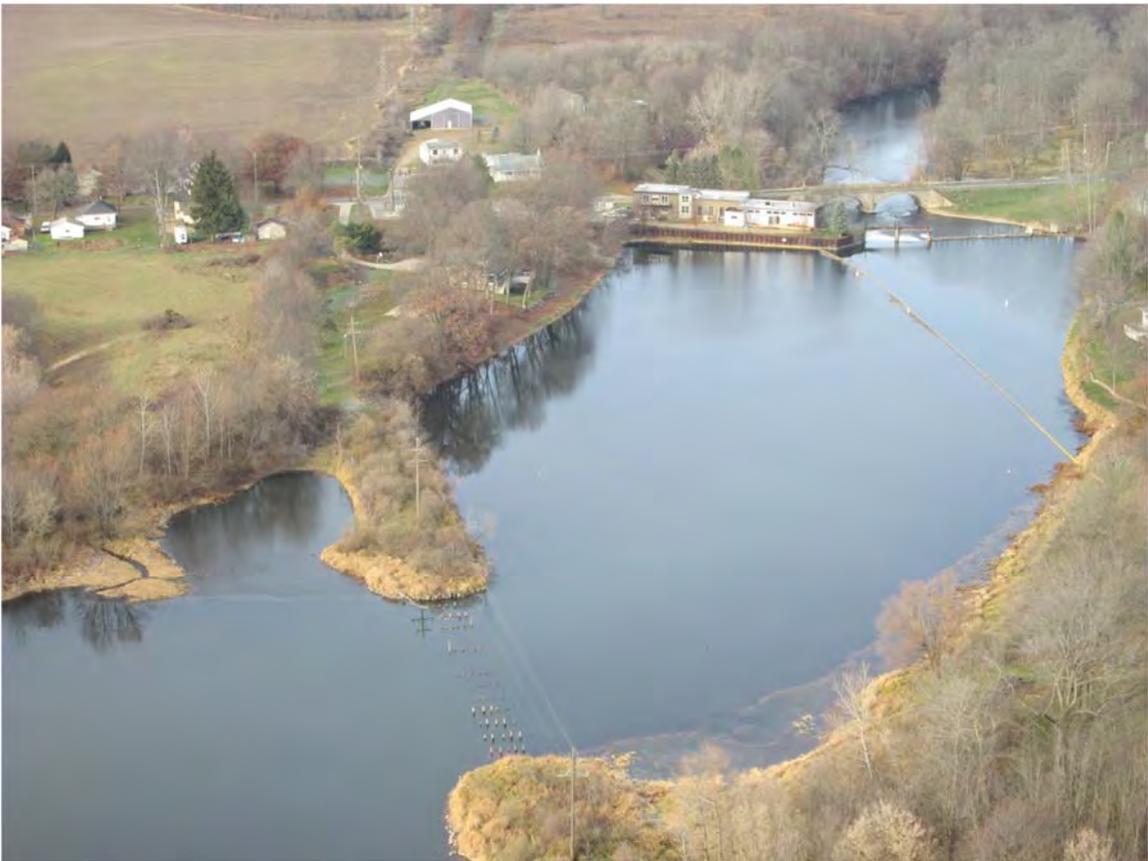
4. Ceresco Dam overview.

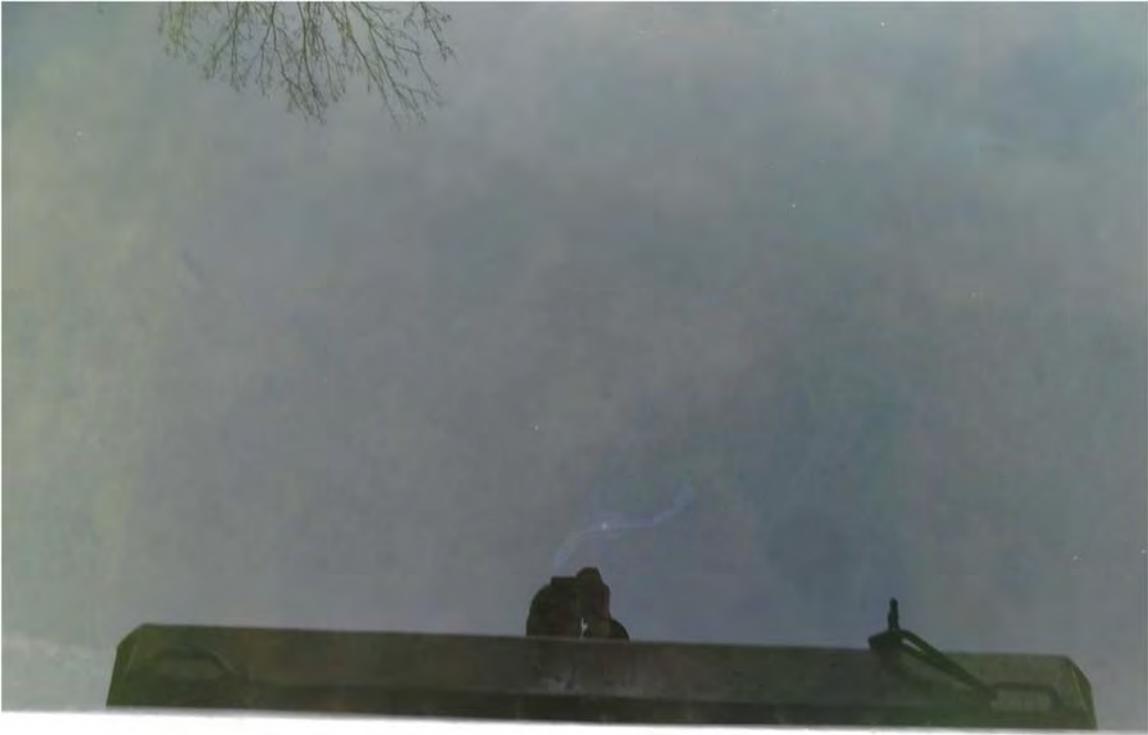
5. Ceresco Dam control point boom observed sheen and tar globs collecting along the boom.

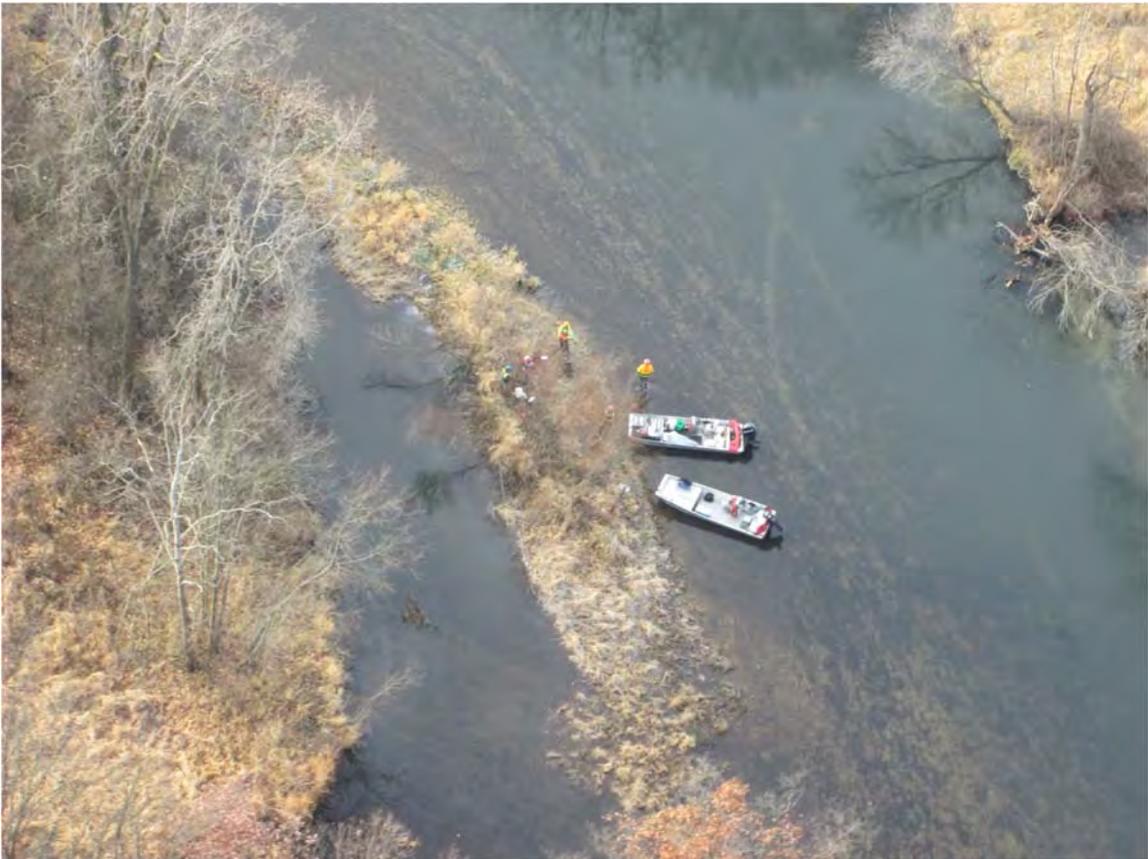
6. MP10.5 RDB observed an RI crew.

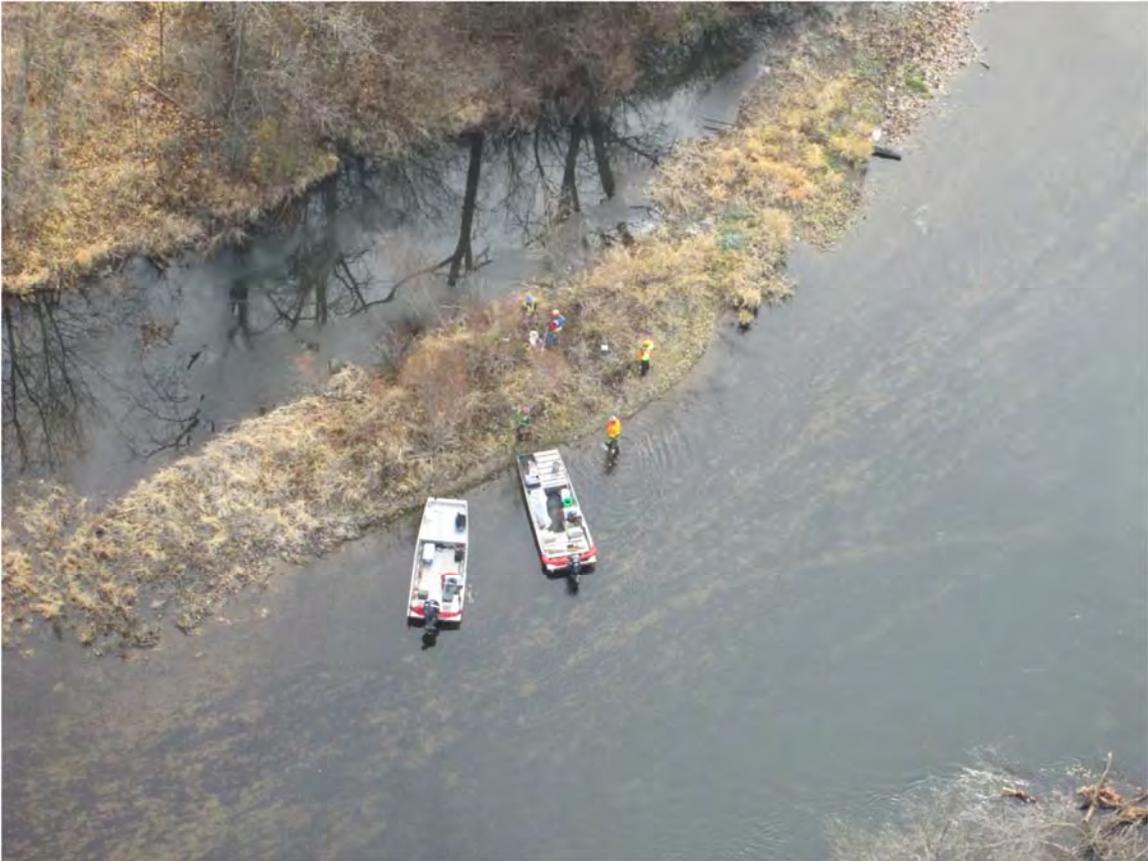
7. MP10.5 RDB observed an RI crew.

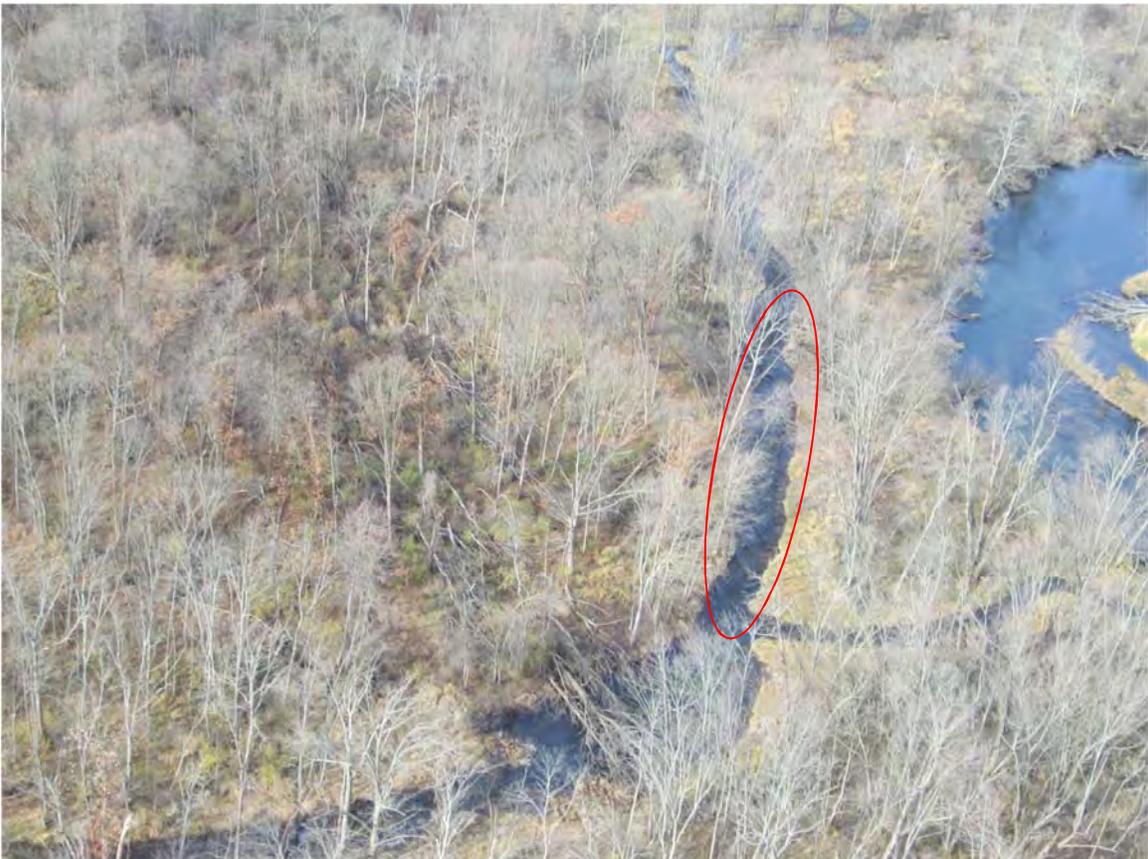
8. MP11.75 back water channel observed sheen.

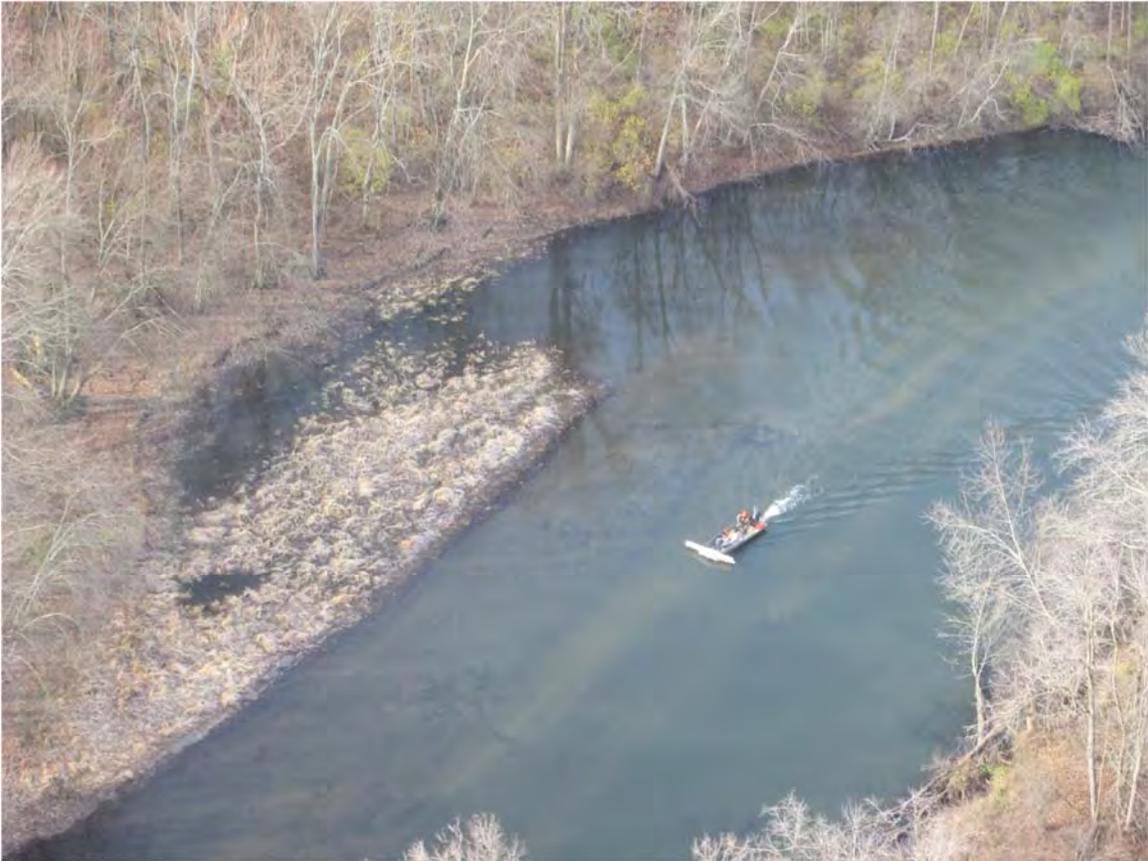
9. MP23.5 observed a sweep boat operating.

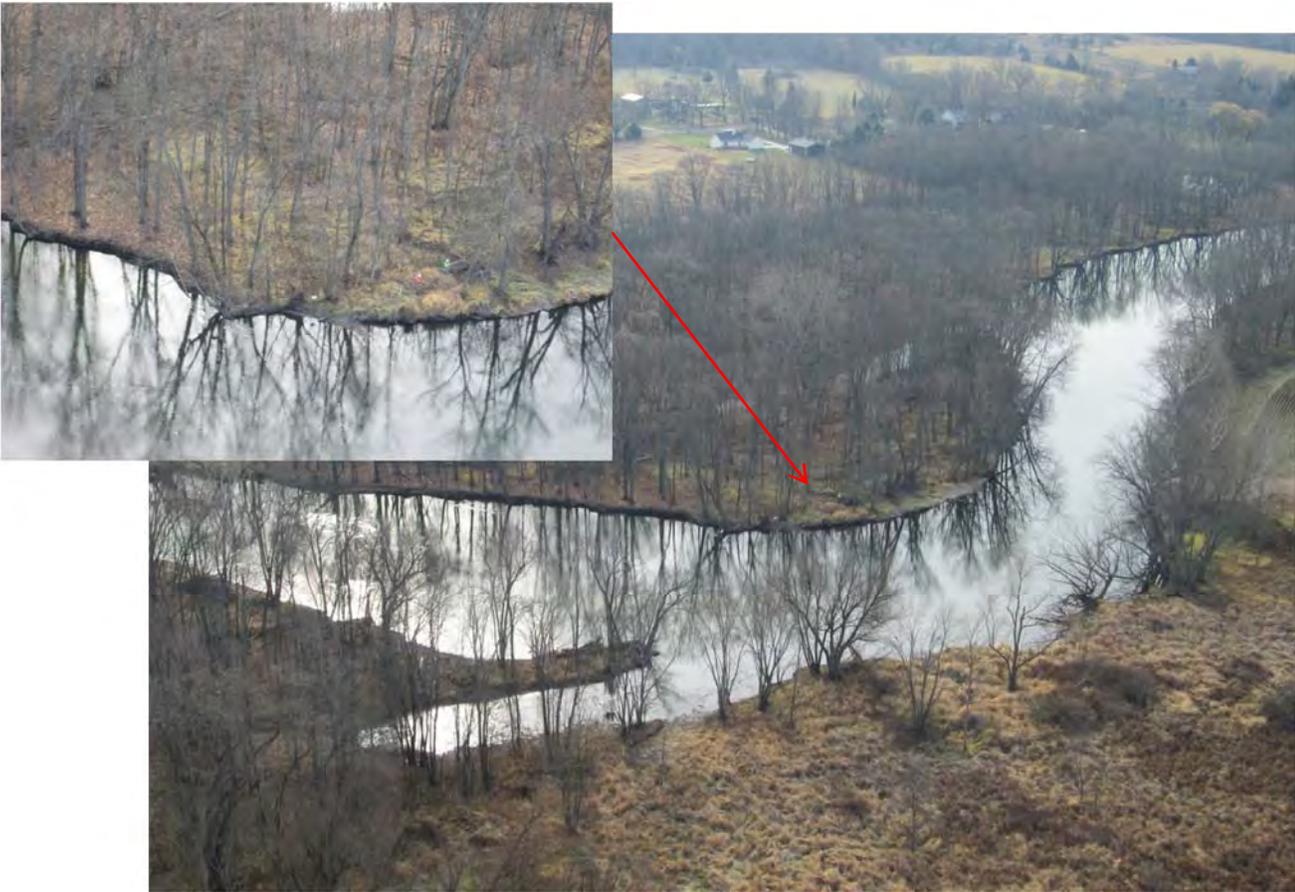
10. MP33.0 A&B sediment traps observed a crew setting a monument.

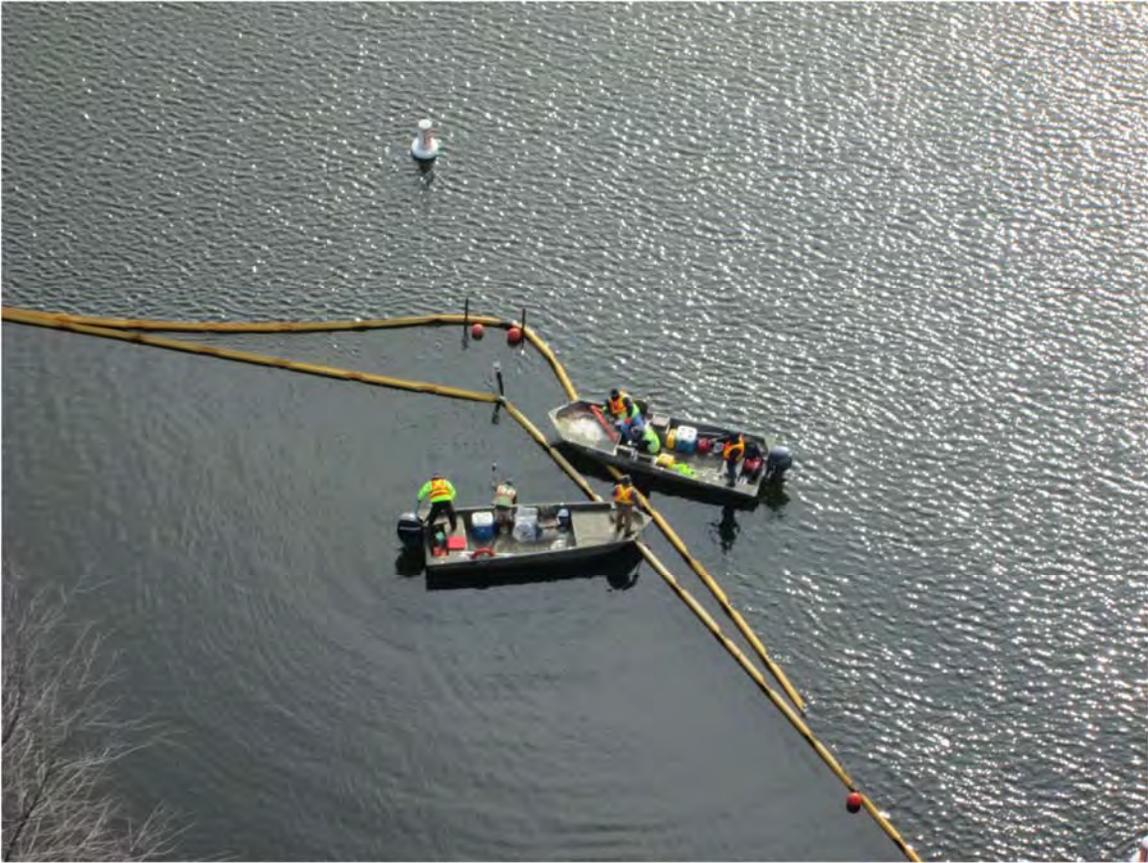
11. Morrow Lake Delta observed the Bathymetry team at Gate D.

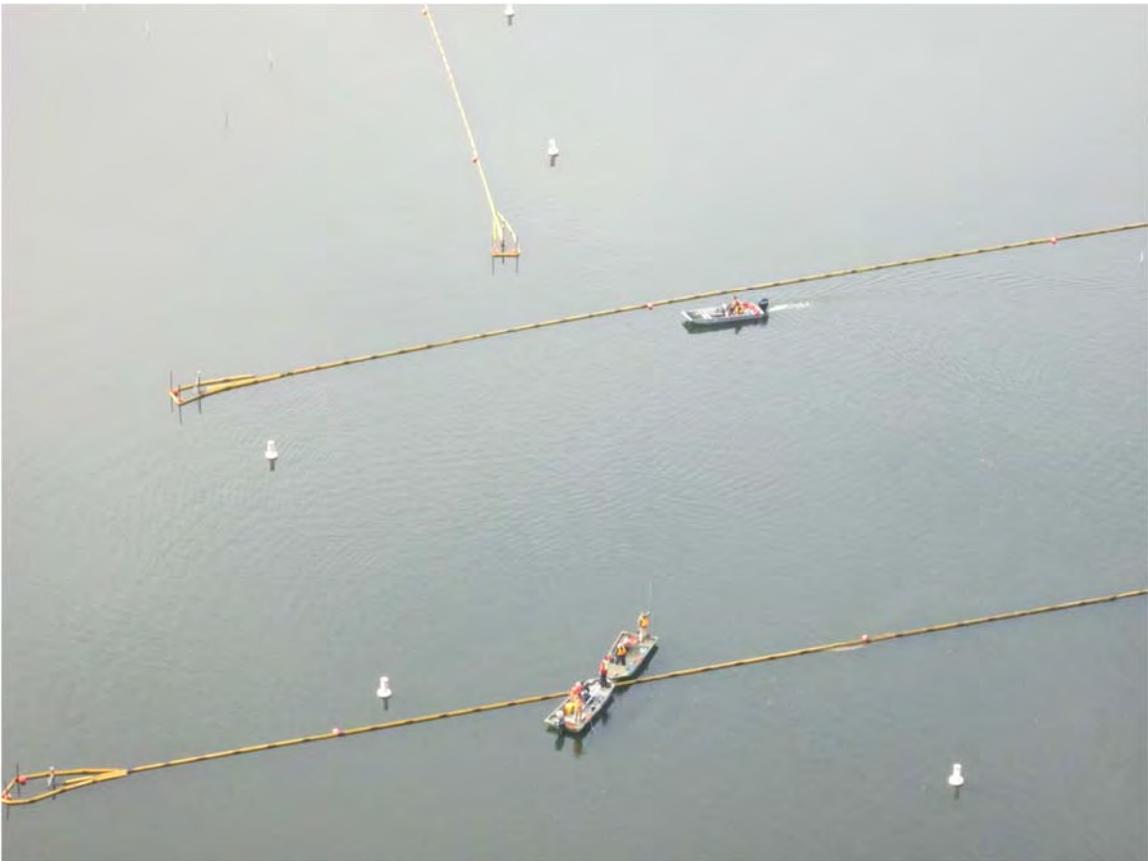
12. Morrow Lake Delta observed the Bathymetry team at Gate E.

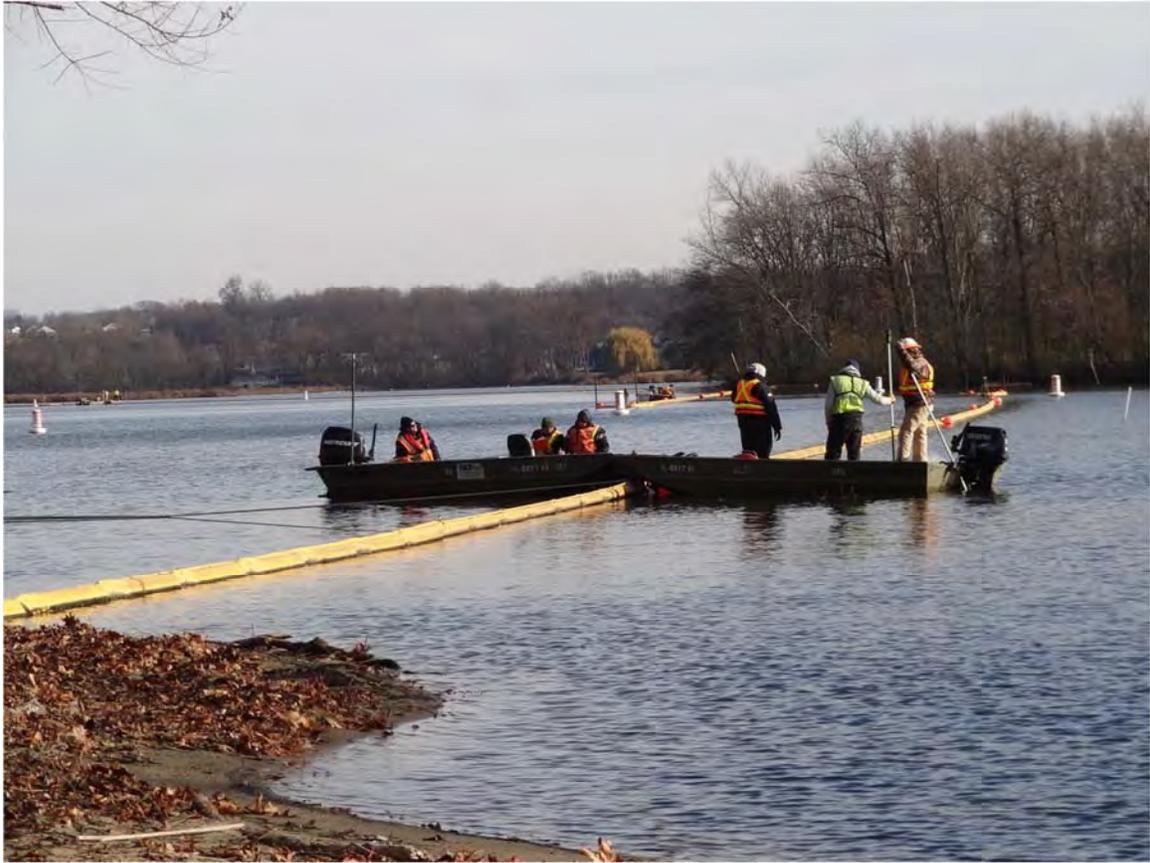
13. Morrow Lake Delta observed the Bathymetry team at Gate E.

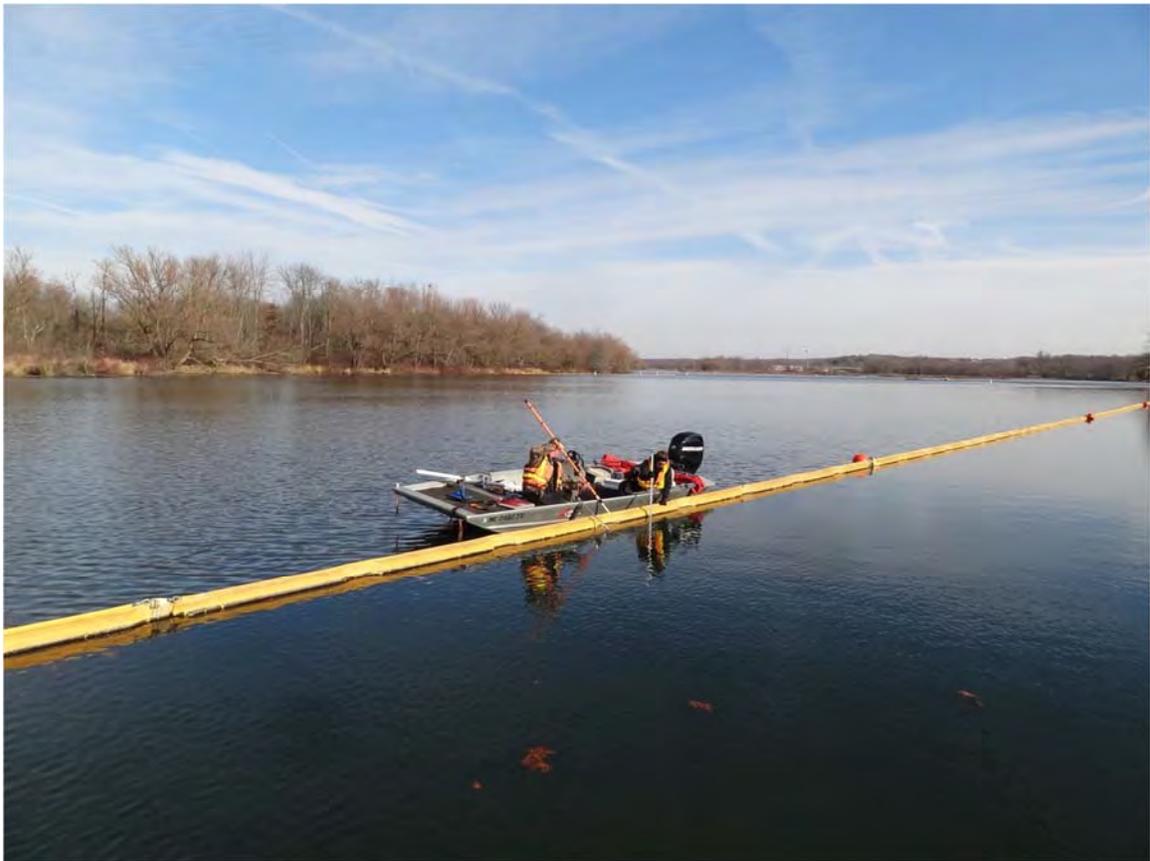
14. Morrow Lake Delta Gate E observed a crew inspecting the curtain.

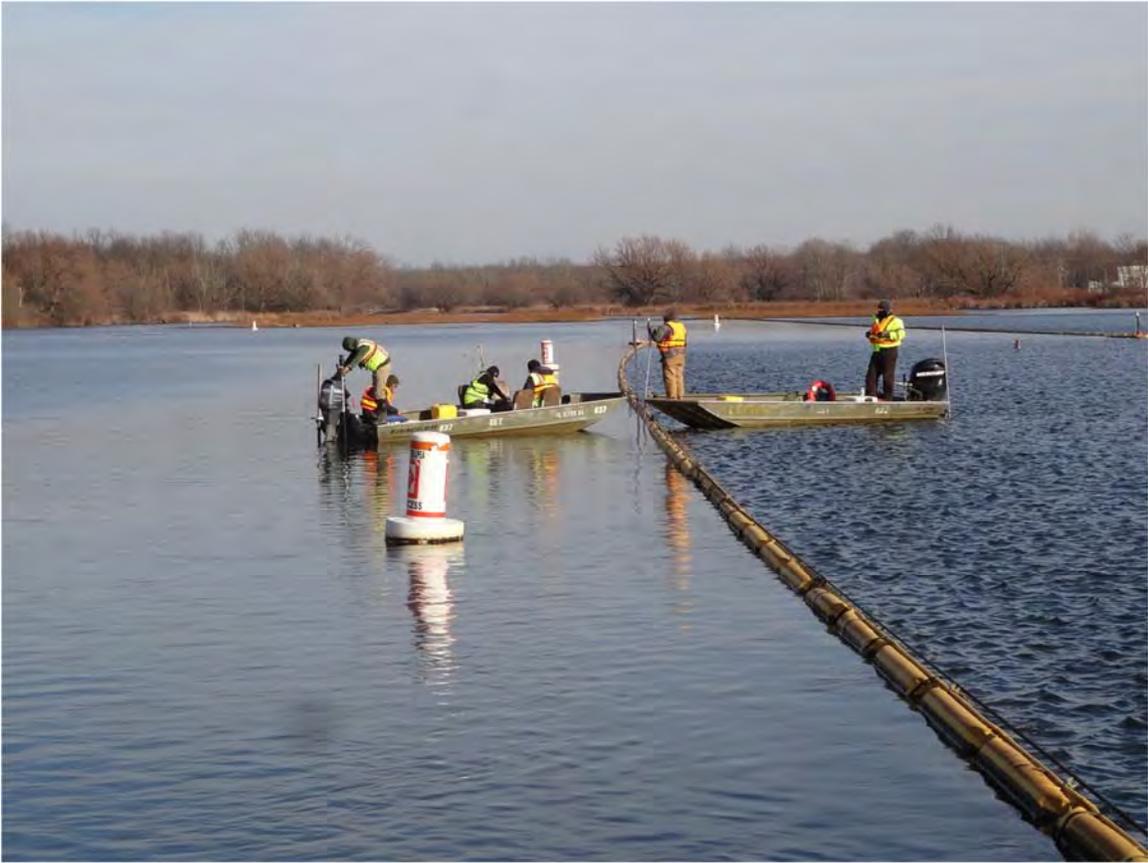
15. Morrow Lake Delta observed the Bathymetry team at Gate C.

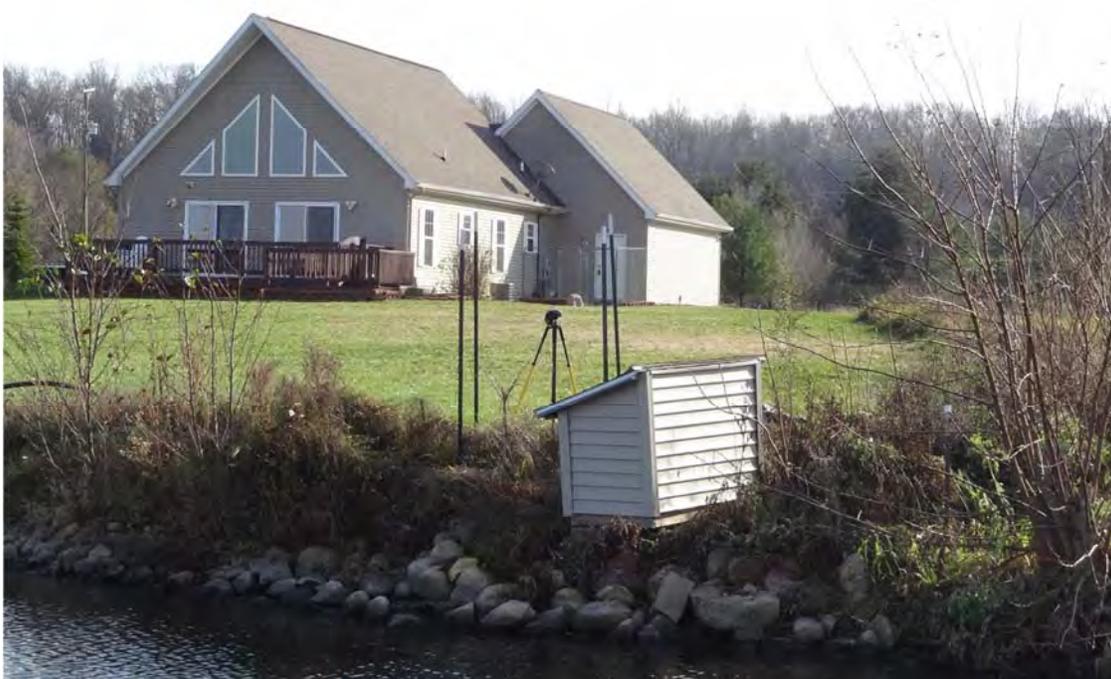
16. Morrow Lake Delta observed a crew surveying the monument along the south shoreline.
