Situation Photo Log

Friday, November 16, 2012

Kalamazoo River / Enbridge Spill

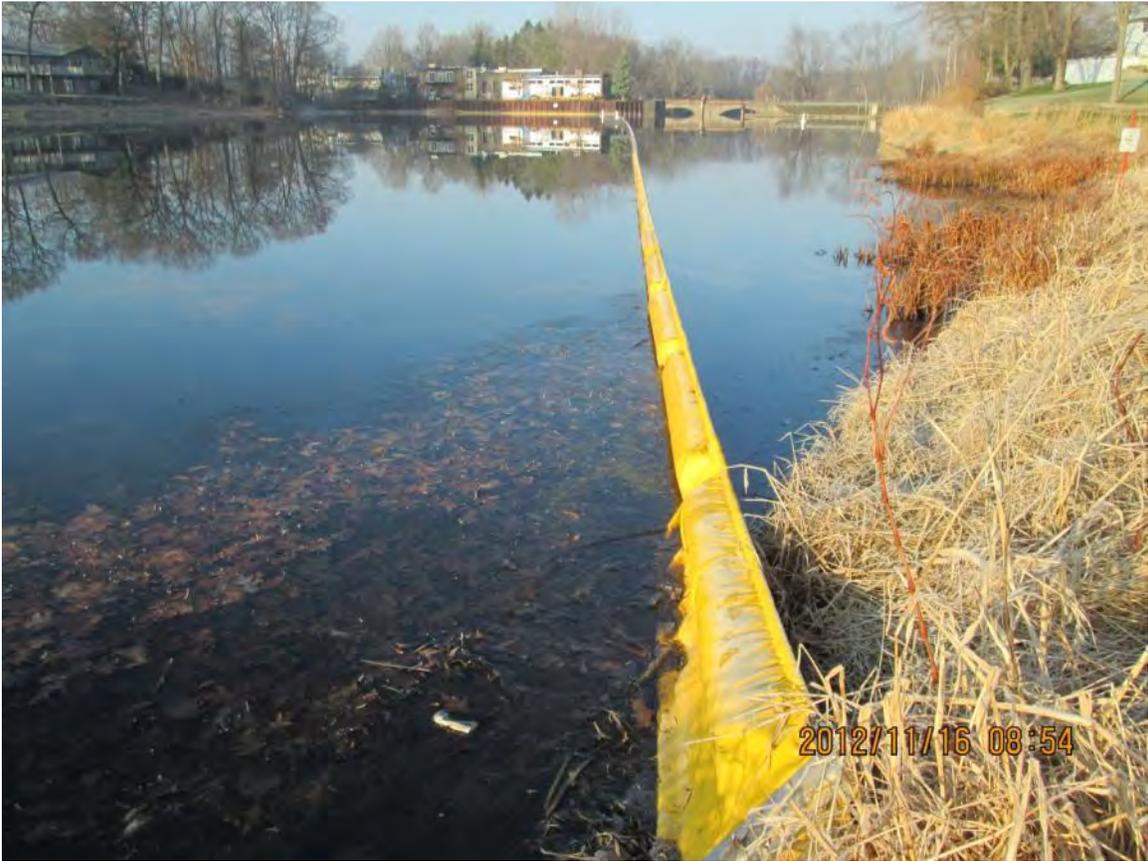
1. Ceresco Dam Control Point Boom.

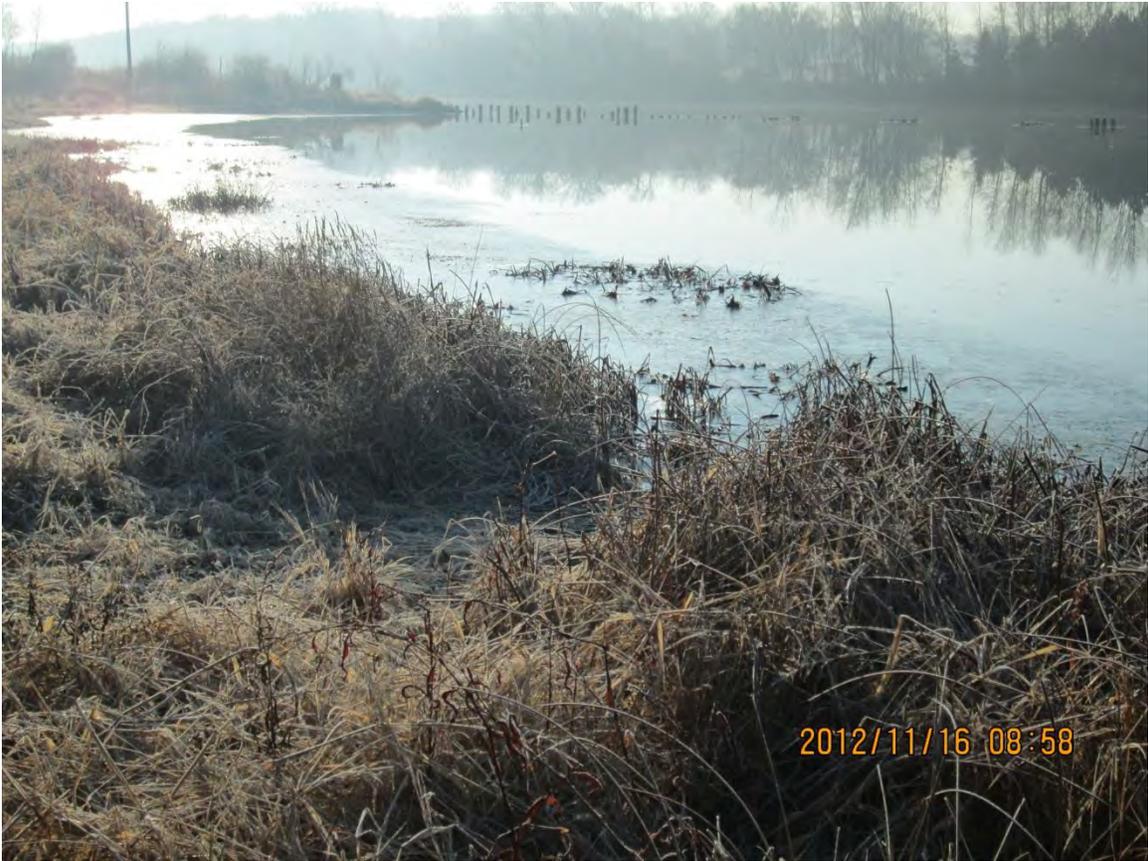
2. MP5.63 RDB. Thin layer of ice observed along shoreline during morning inspection.

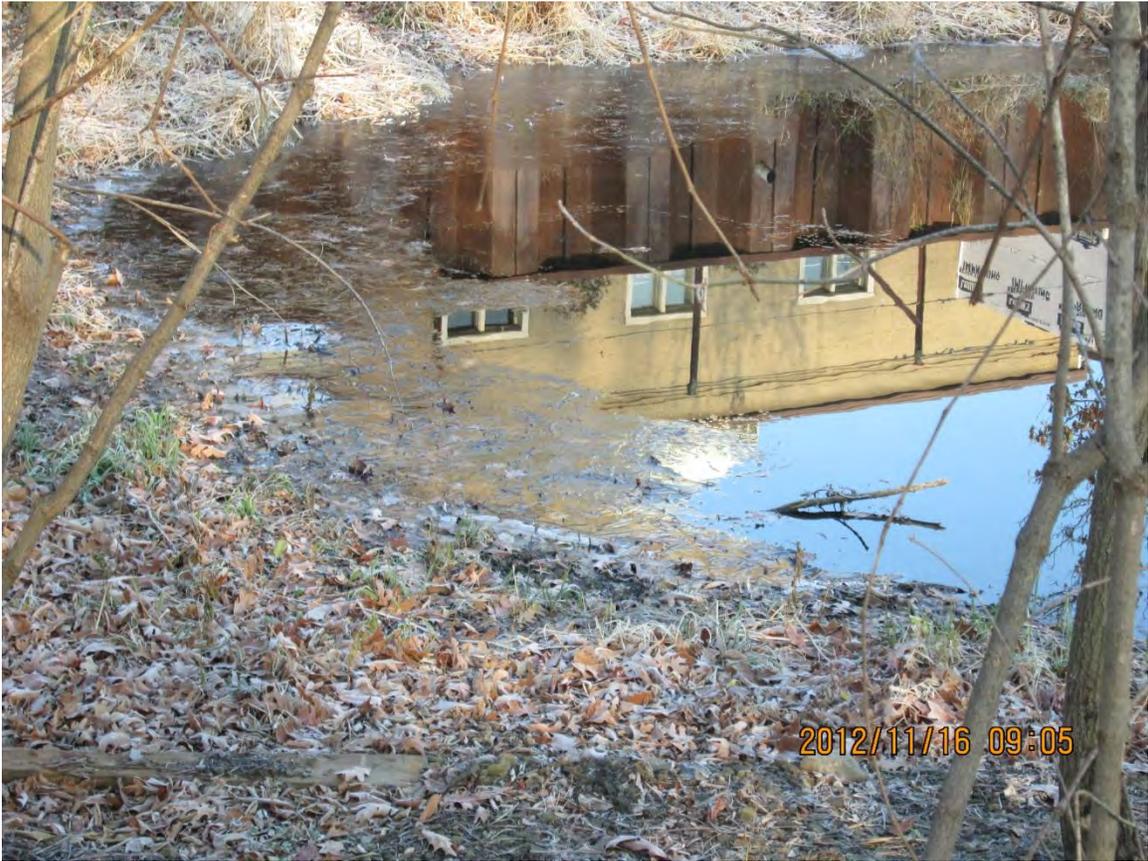
3. MP5.80 LDB observed very thin shoreline ice along southwest corner at Ceresco Dam.

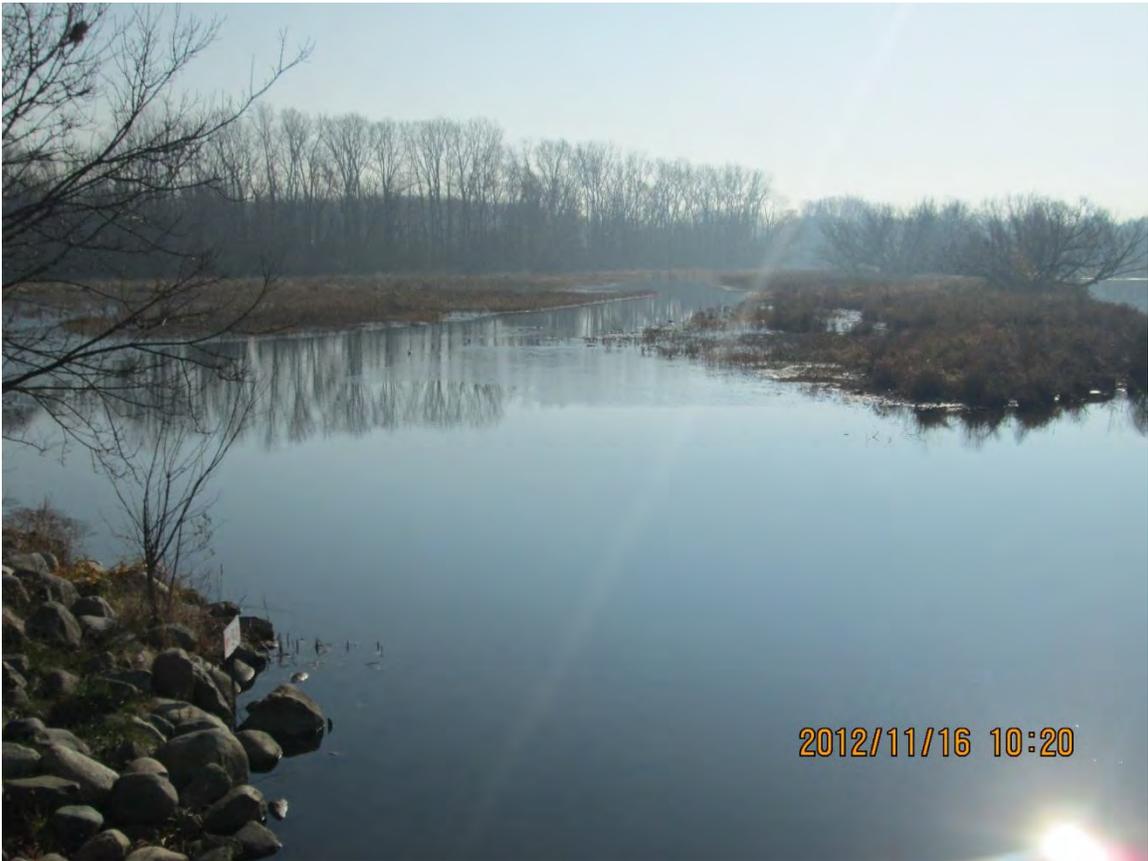
4. MP15.25 South Mill Pond as observed from Burnham Street Bridge.

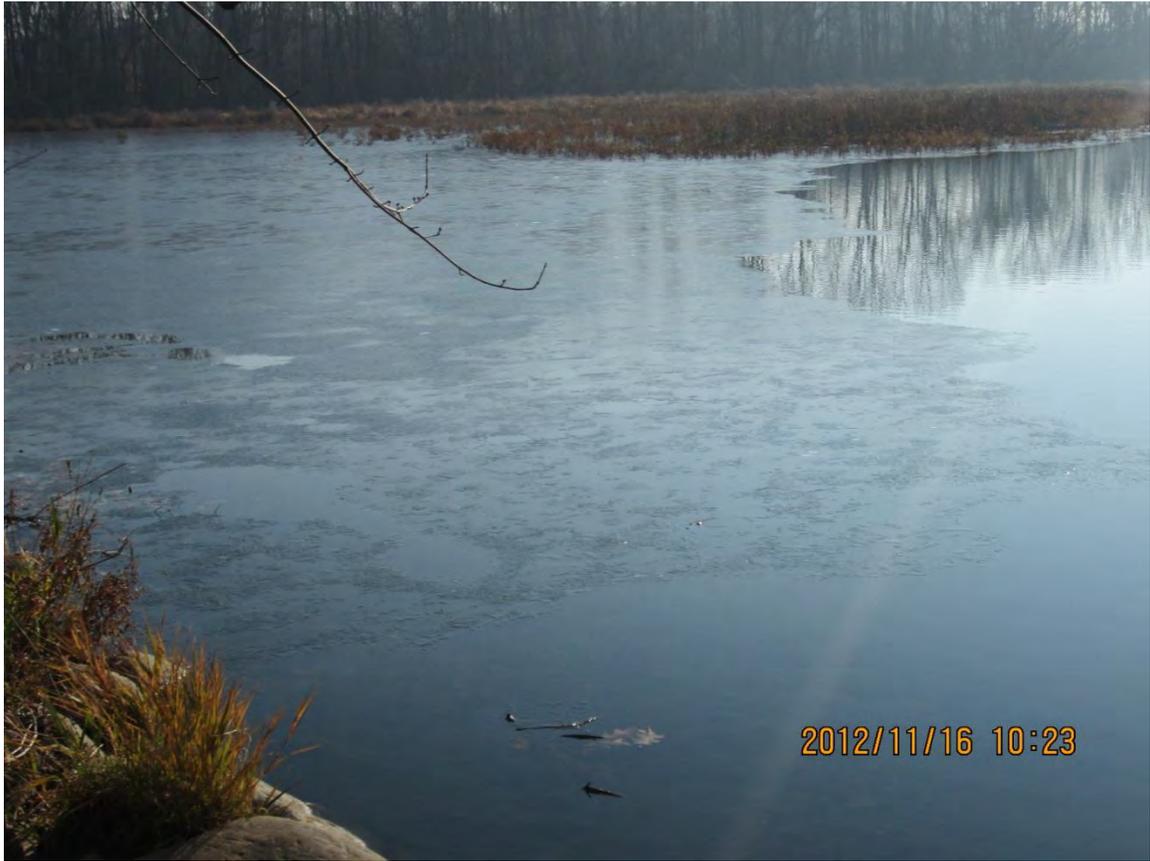
5. MP15.25 South Mill Pond ice observed melting.

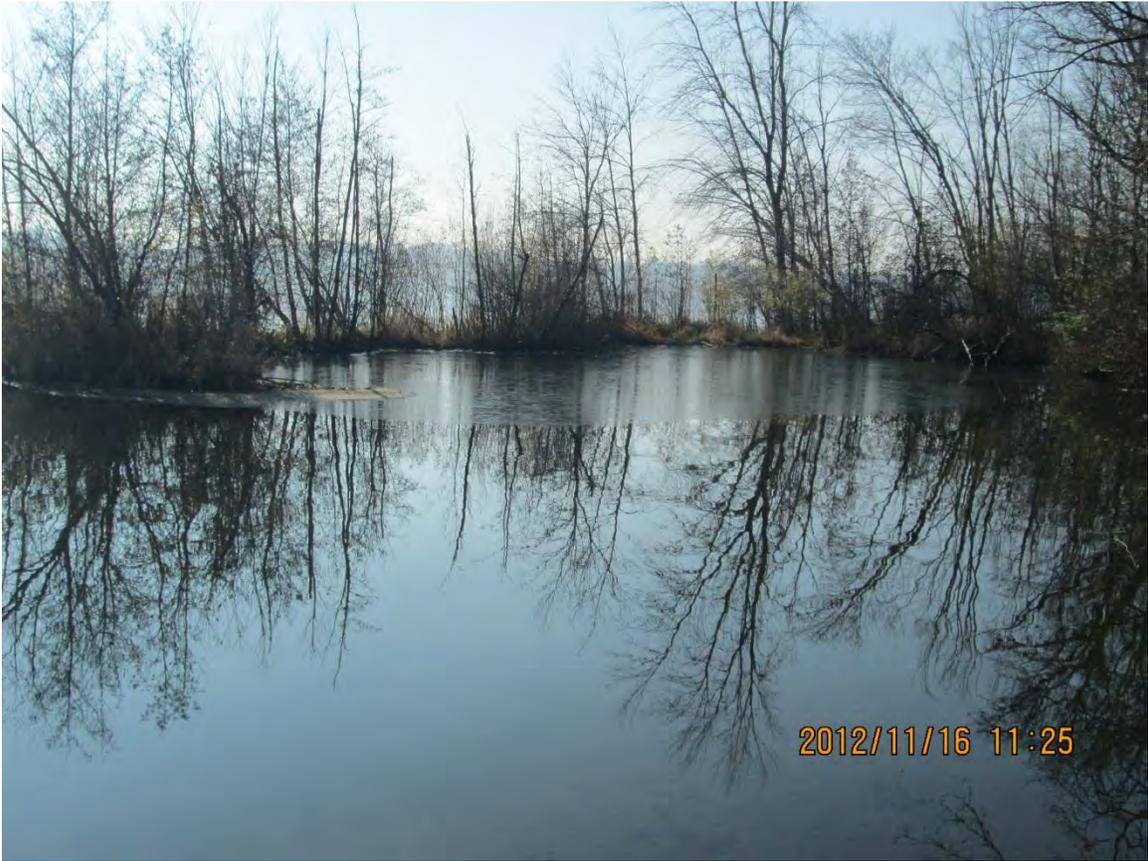
7. Morrow Lake North Cove ice observed in southwest nook in cove.

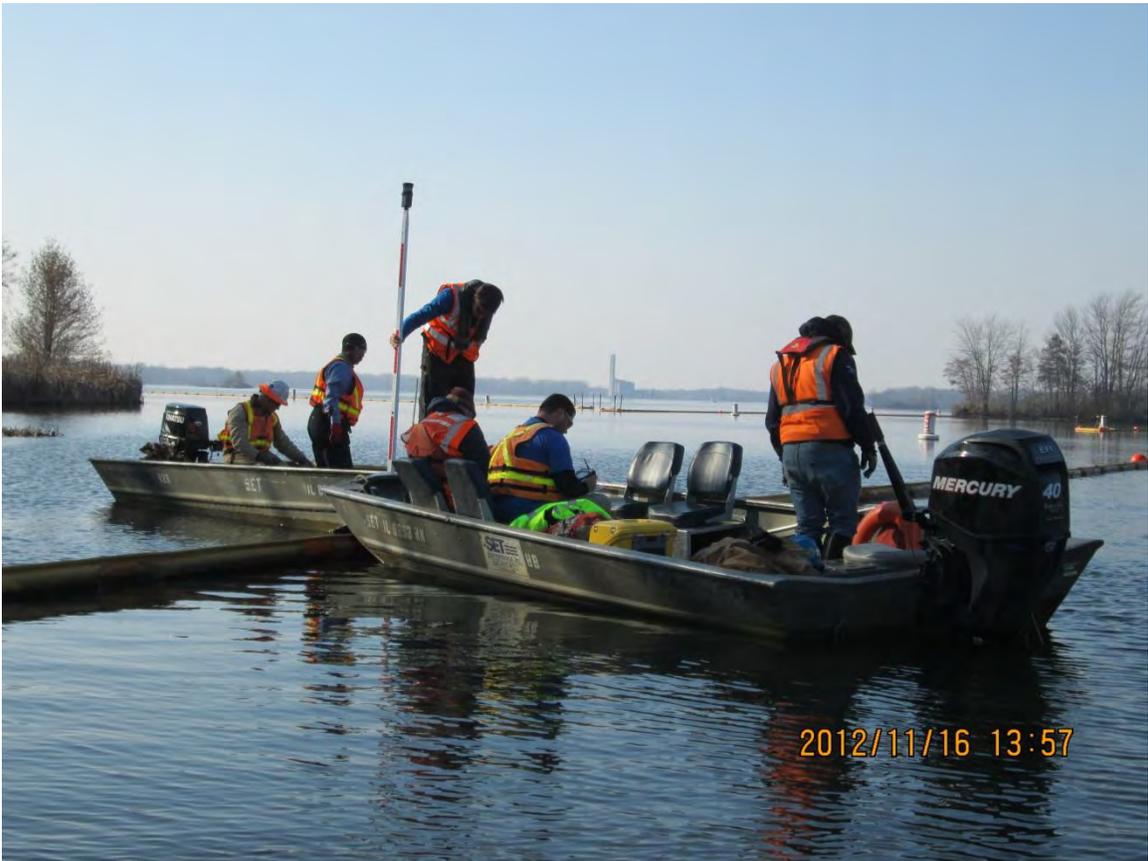
8. Morrow Lake Delta Gate E South observed a Bathymetry team.

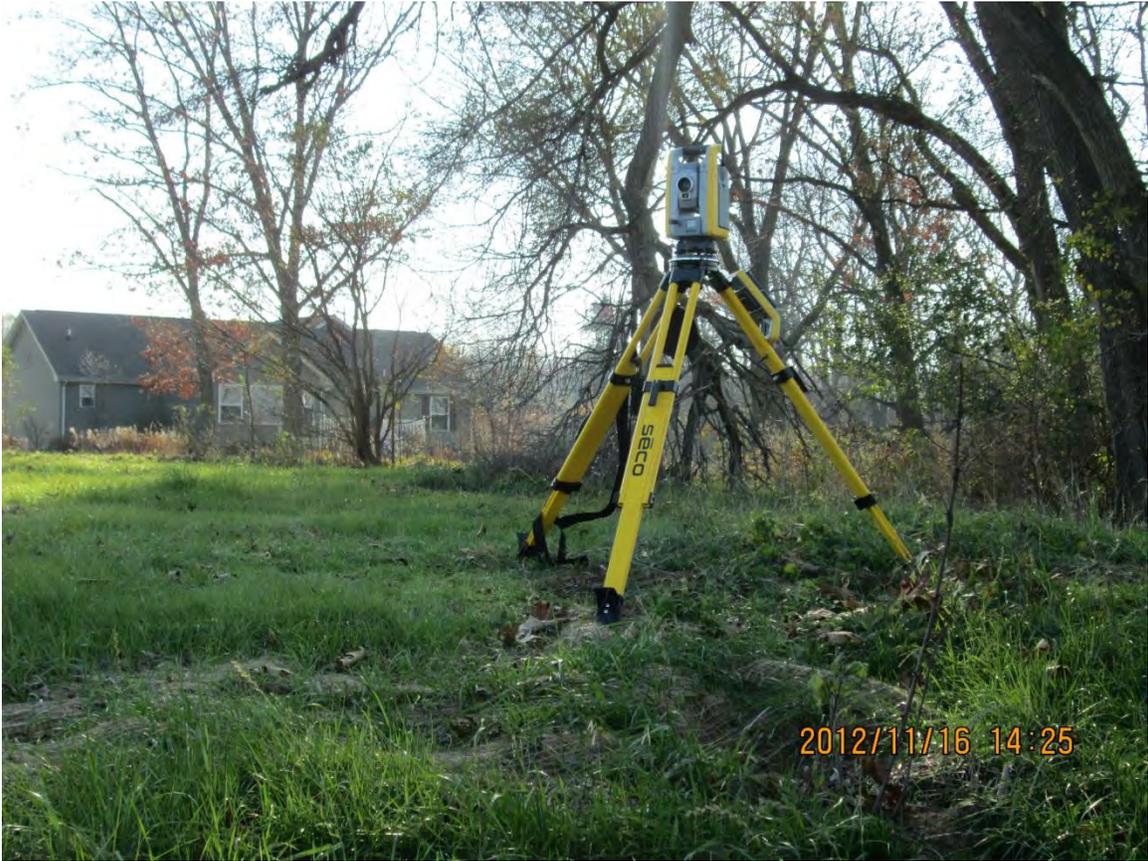
9. Morrow Lake Delta observed Bathymetry survey transit.

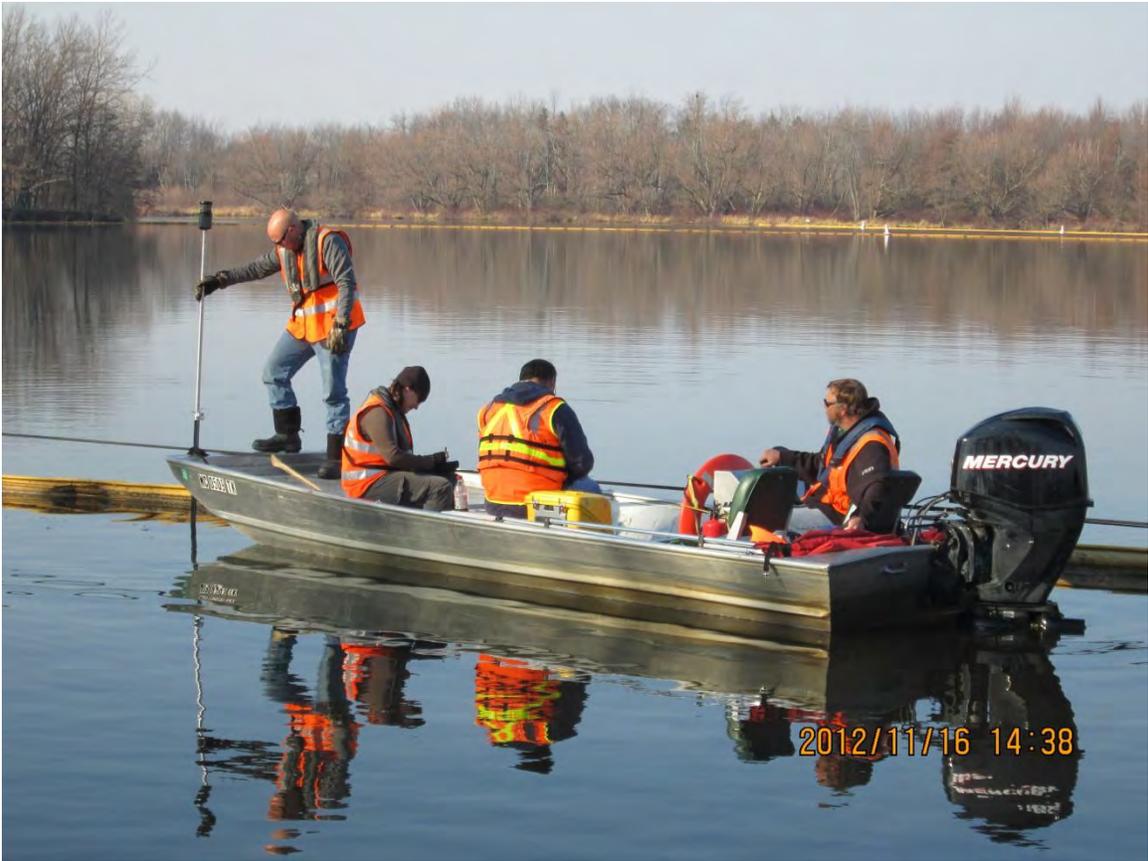
10. Morrow Lake Delta Gate B observed Bathymetry team.

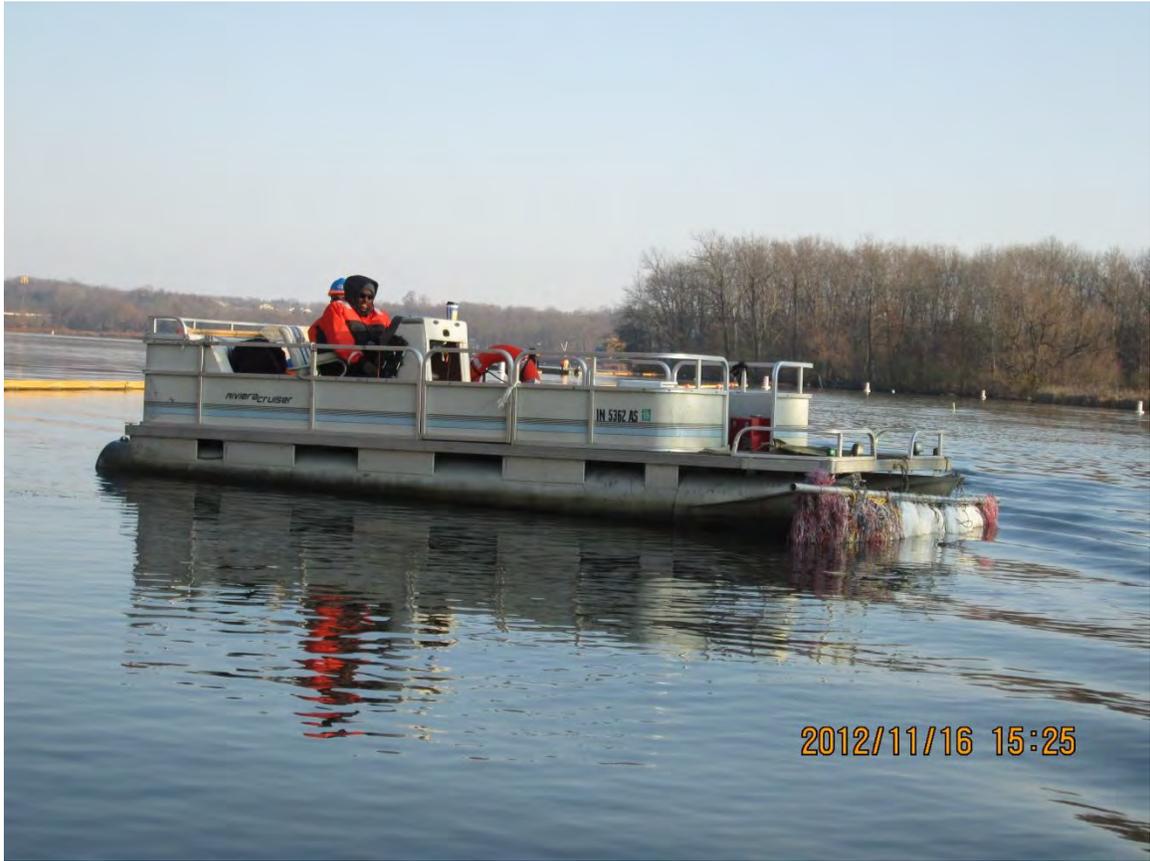
11. Morrow Lake Delta observed sweep boat crew.
