Situation Photo Log

Saturday, November 17, 2012

Kalamazoo River / Enbridge Spill

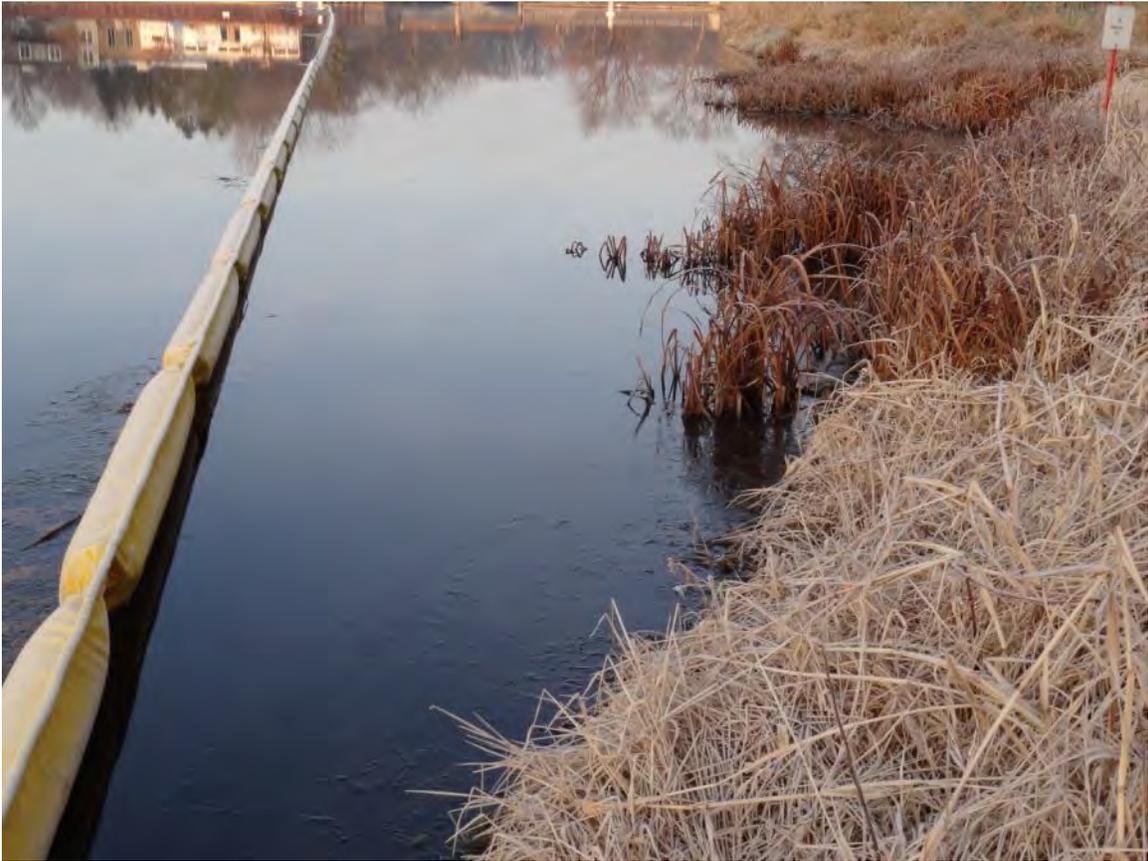
1. Ceresco Dam Control Point Boom.

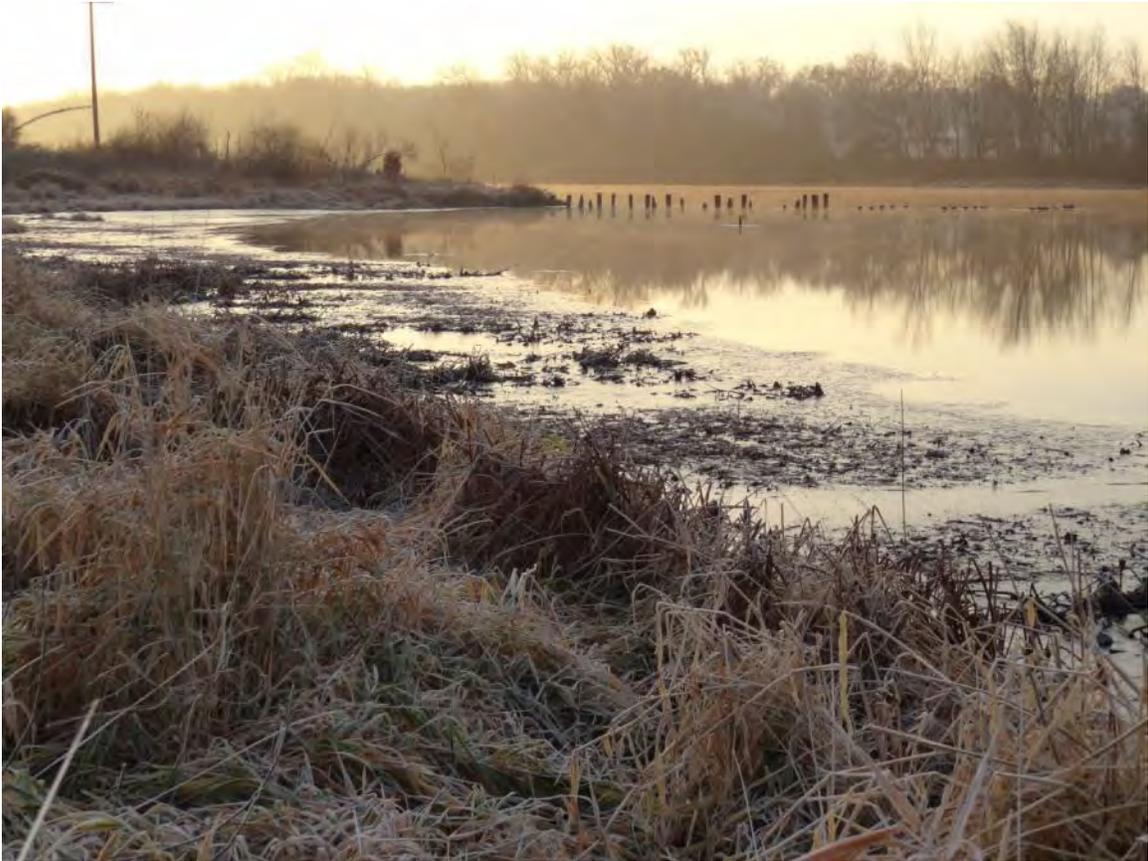
2. MP5.63 RDB observed very thin layer of shoreline ice

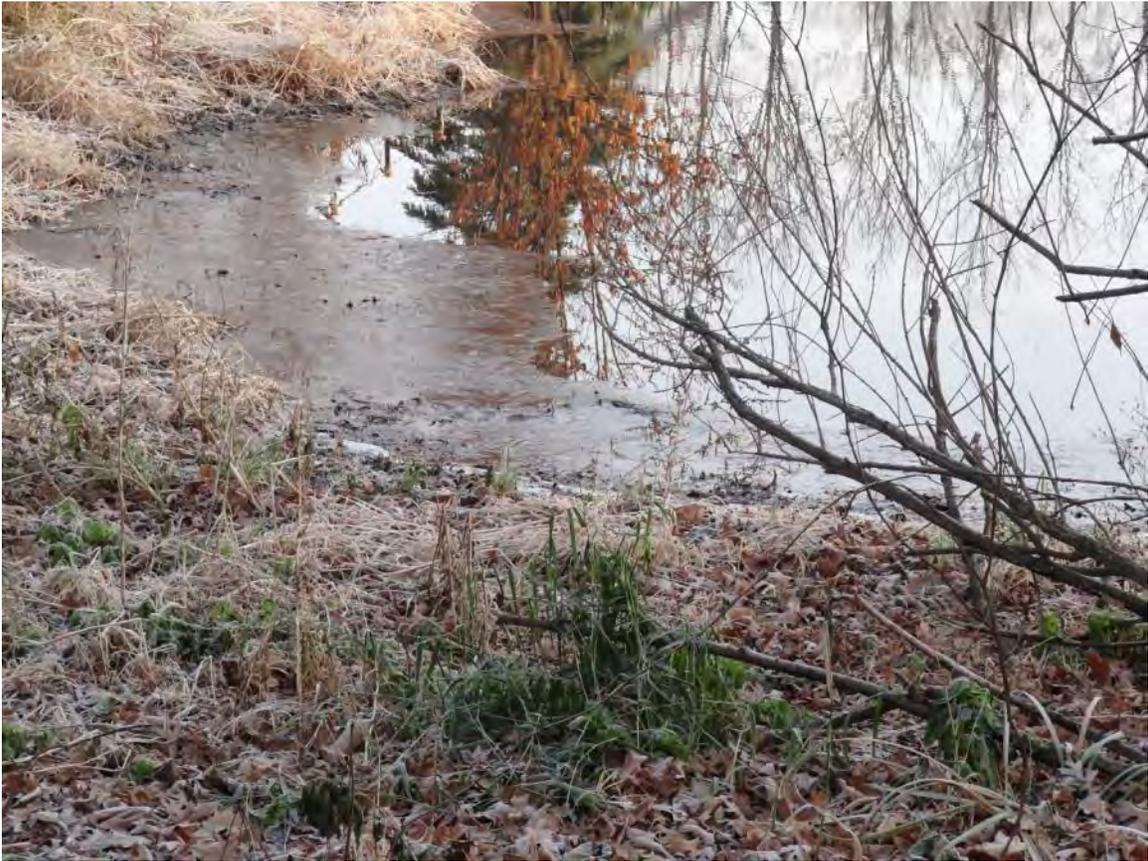
3. MP5.80 LDB observed very thin shoreline ice along southwest corner at Ceresco Dam.

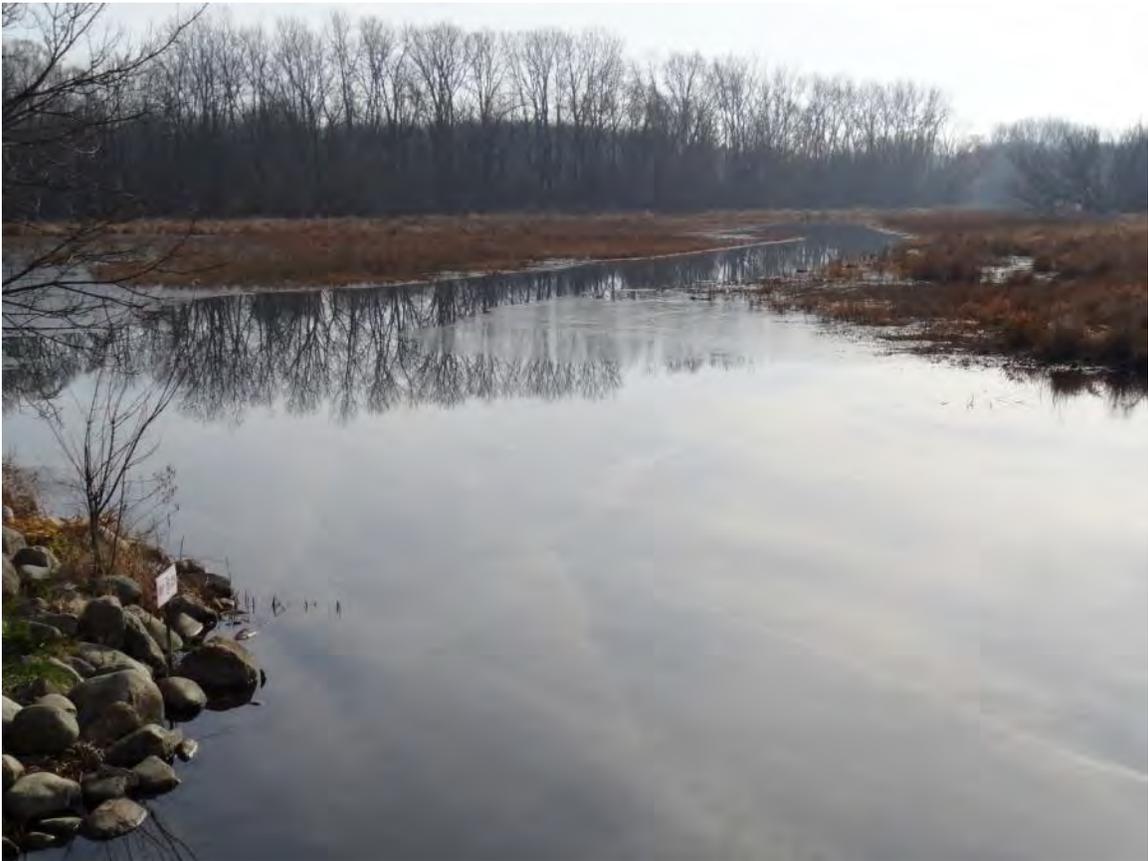
4. MP15.25 South Mill Pond observed from Burnham Street Bridge.

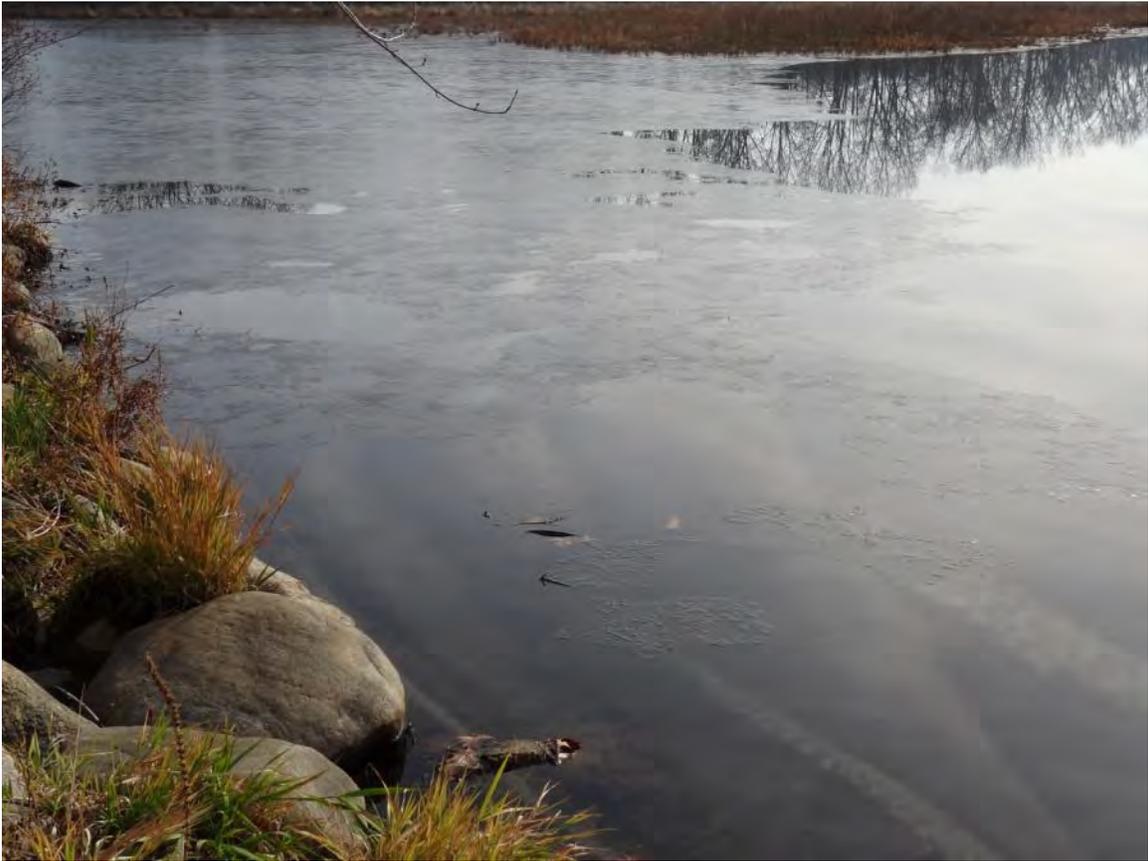
5. MP15.25 South Mill Pond observed very thin patches of ice.

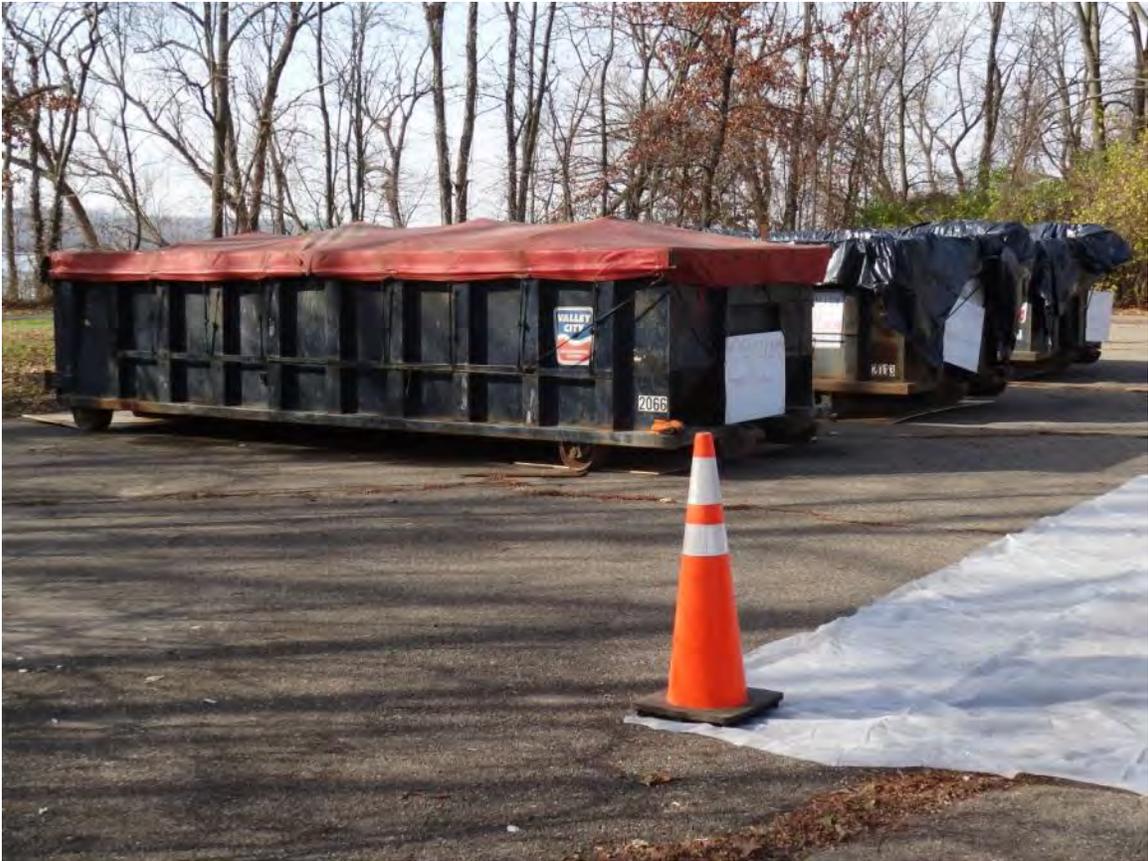
6. E4 Boat Launch. Observed roll-offs staged for disposal of oily debris, boom and curtain.

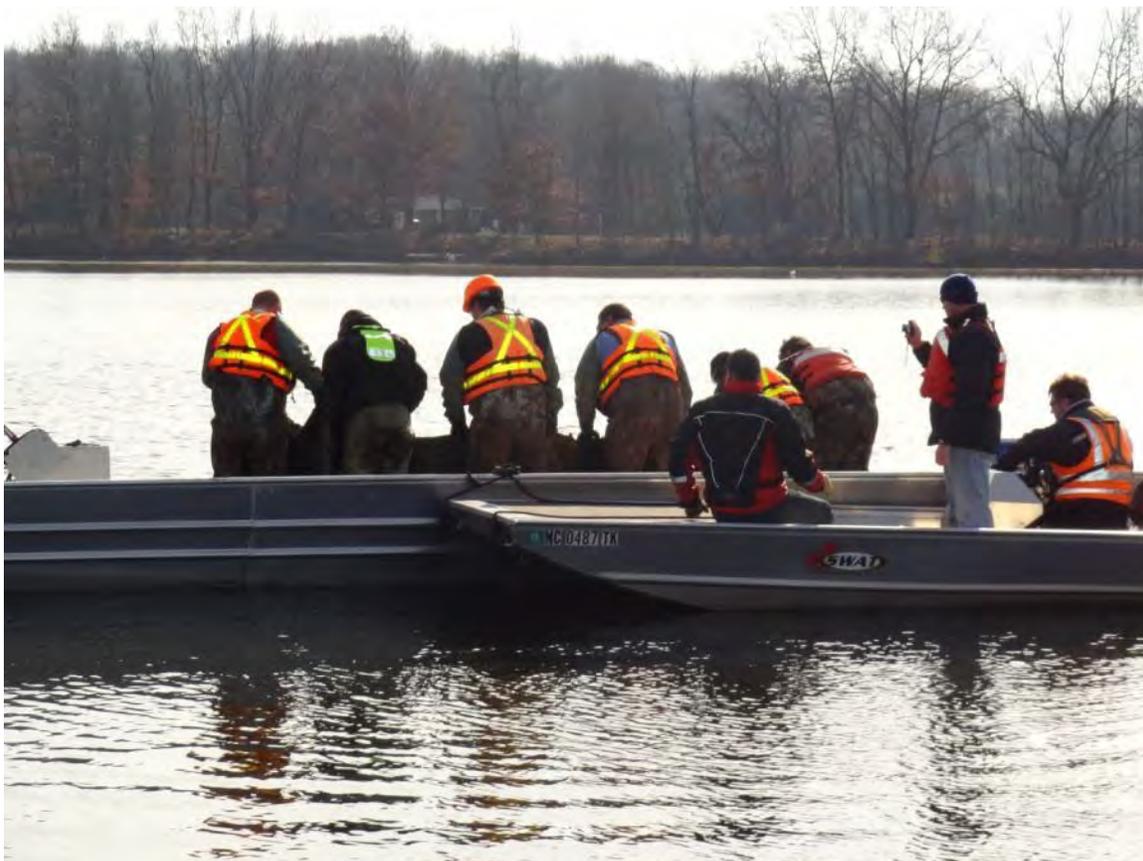
7. Morrow Lake Delta Gate C East observed crew removing curtain from hard boom.

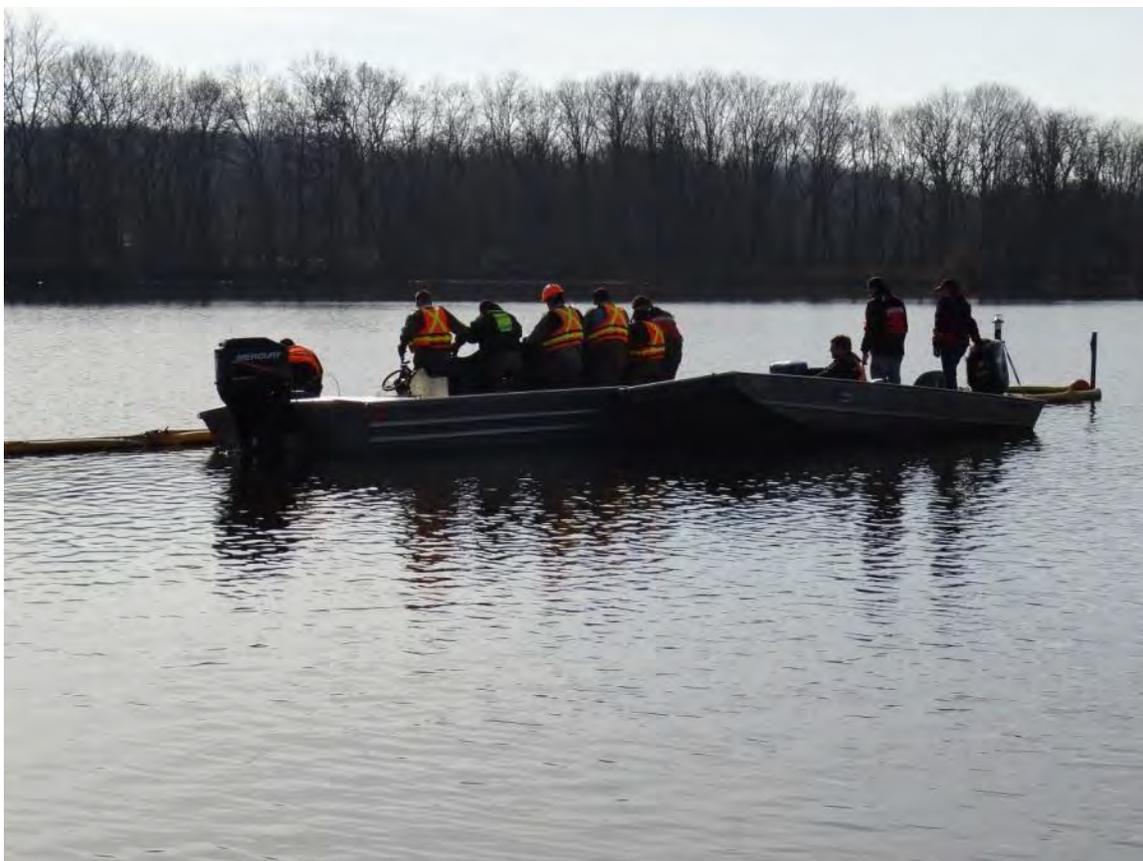
8. Morrow Lake Delta Gate C East observed crew placing removed curtain into boat.

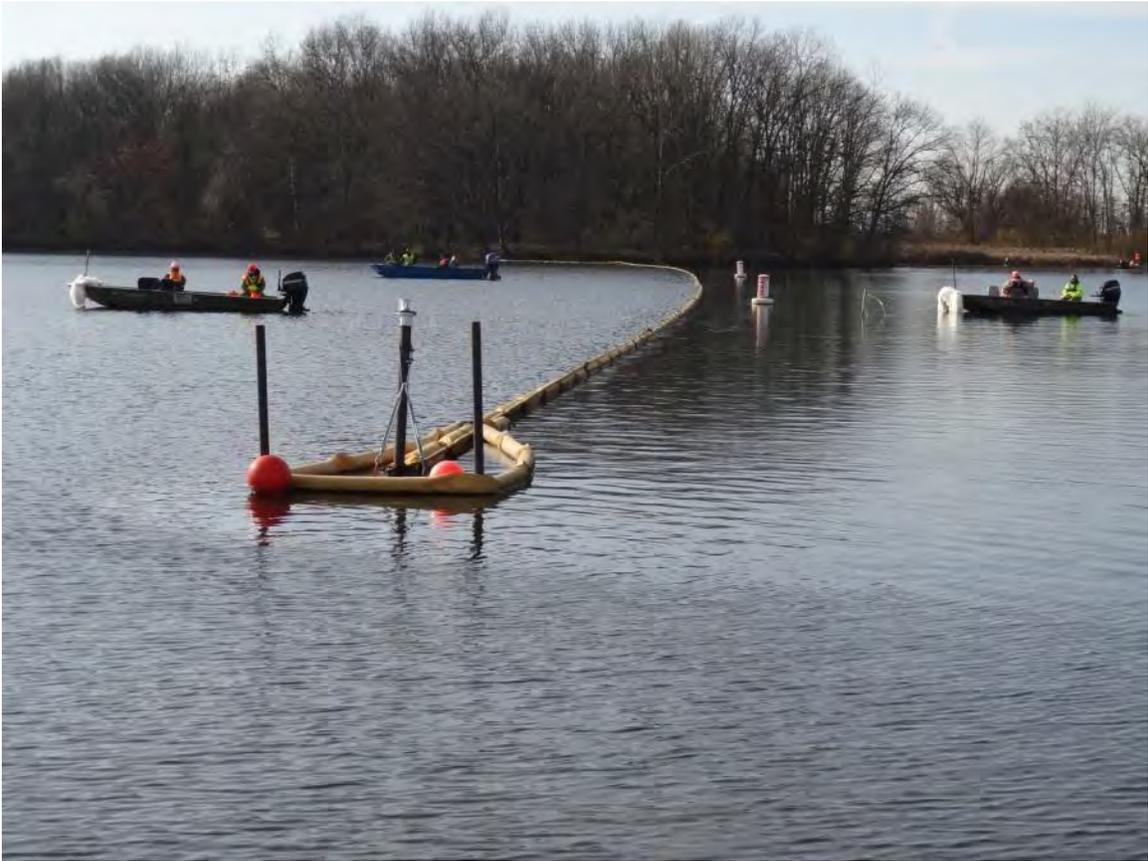
9. Morrow Lake Delta Gate C observed sweep boats and turbidity monitoring crew downstream from curtain removal activities.

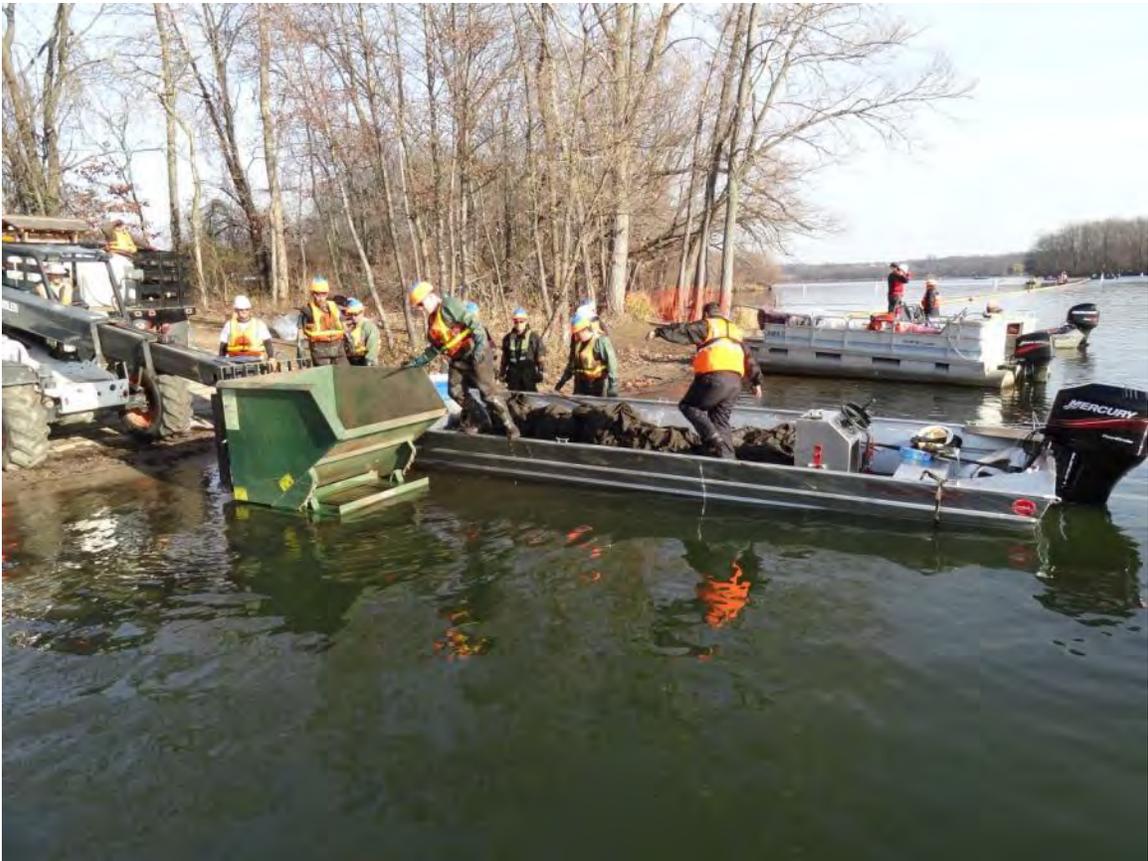
10. E4 Boat Launch observed crew preparing to offload curtain removed from Morrow Lake Delta Gate C.

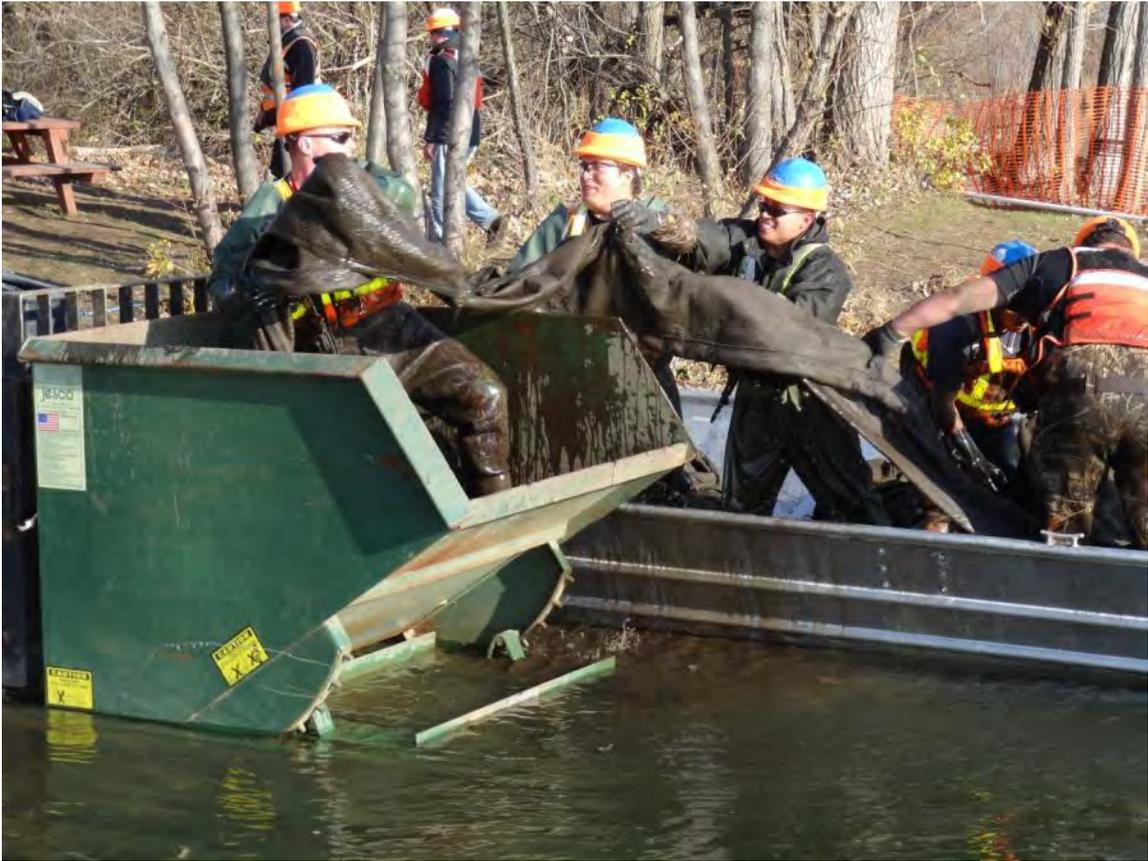
11. E4 Boat Launch observed crew offloading curtain removed from Morrow Lake Delta Gate C.

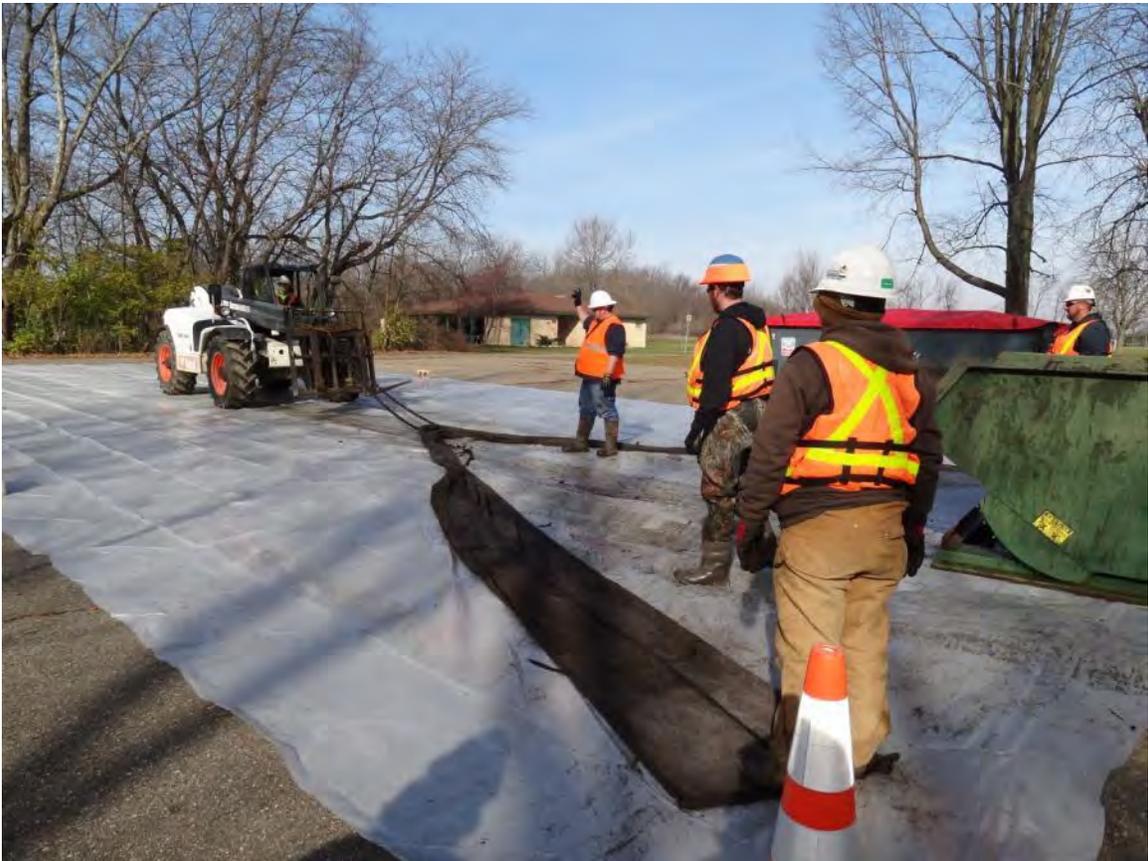
12. E4 Boat Launch Staging Area observed chain being removed from curtain with Lull.

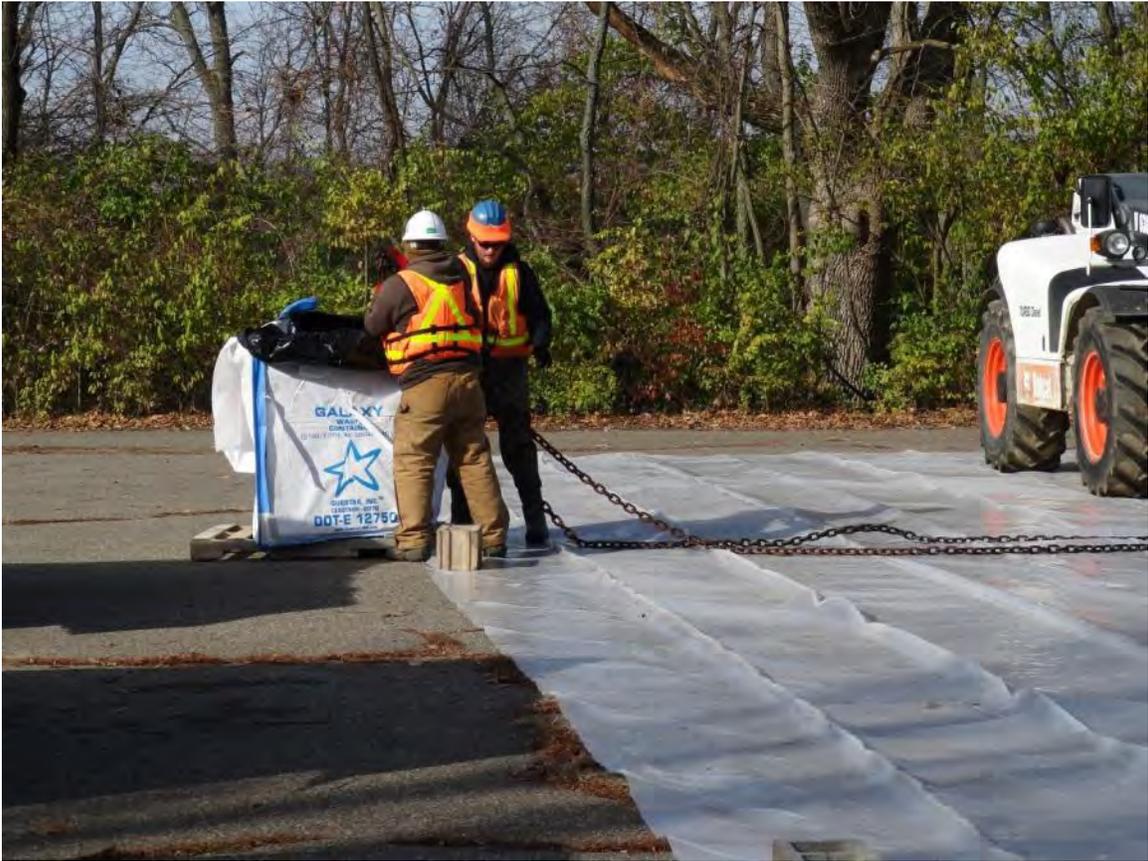
13. E4 Boat Launch Staging Area observed crew placing chain removed from curtain into cubic yard sacks.

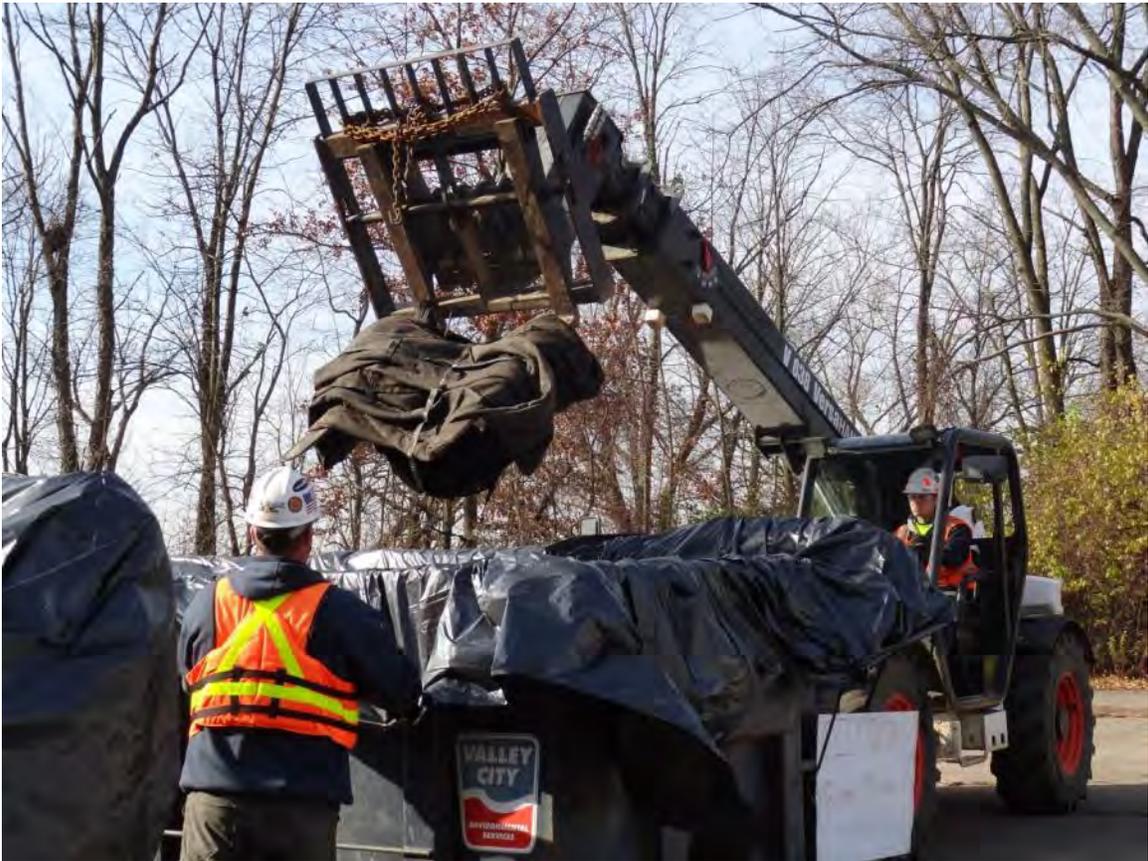
14. E4 Boat Launch Staging Area observed curtain disposed of in roll-offs.

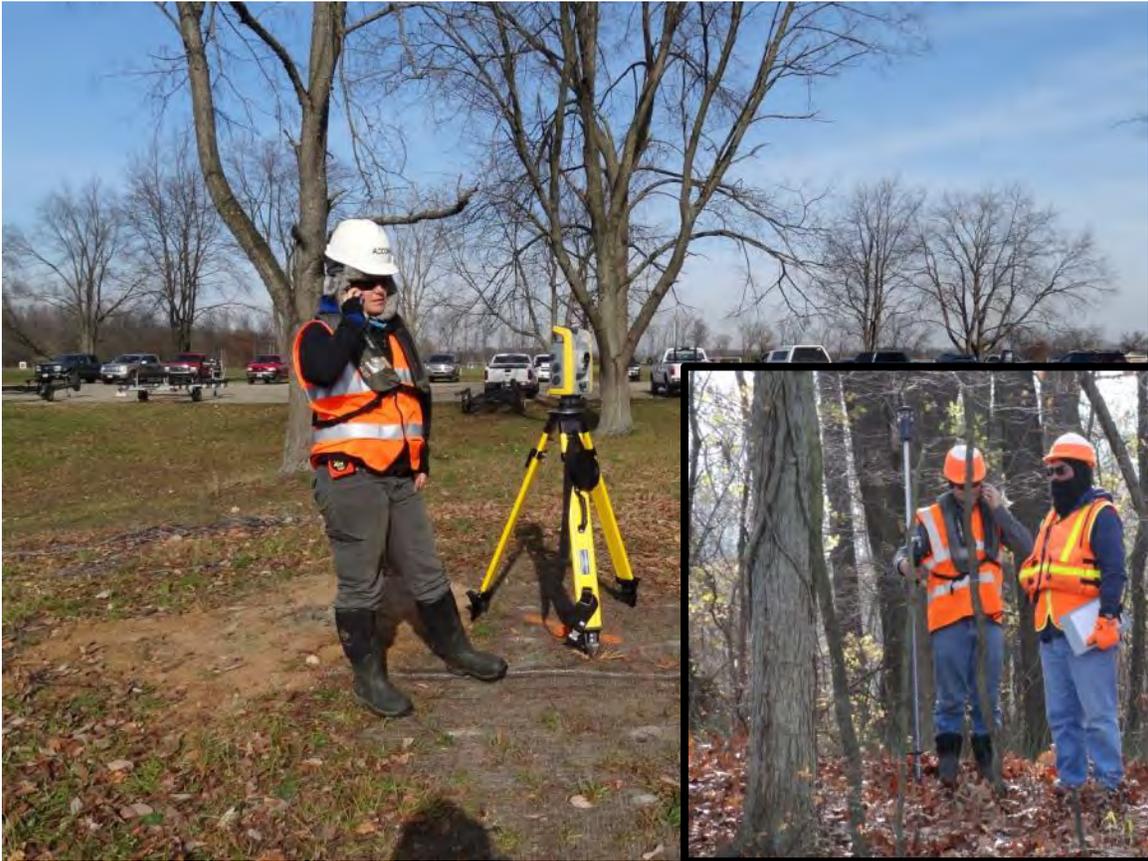
15. Morrow Lake Delta observed Bathymetry Crew making adjustments to survey transit.

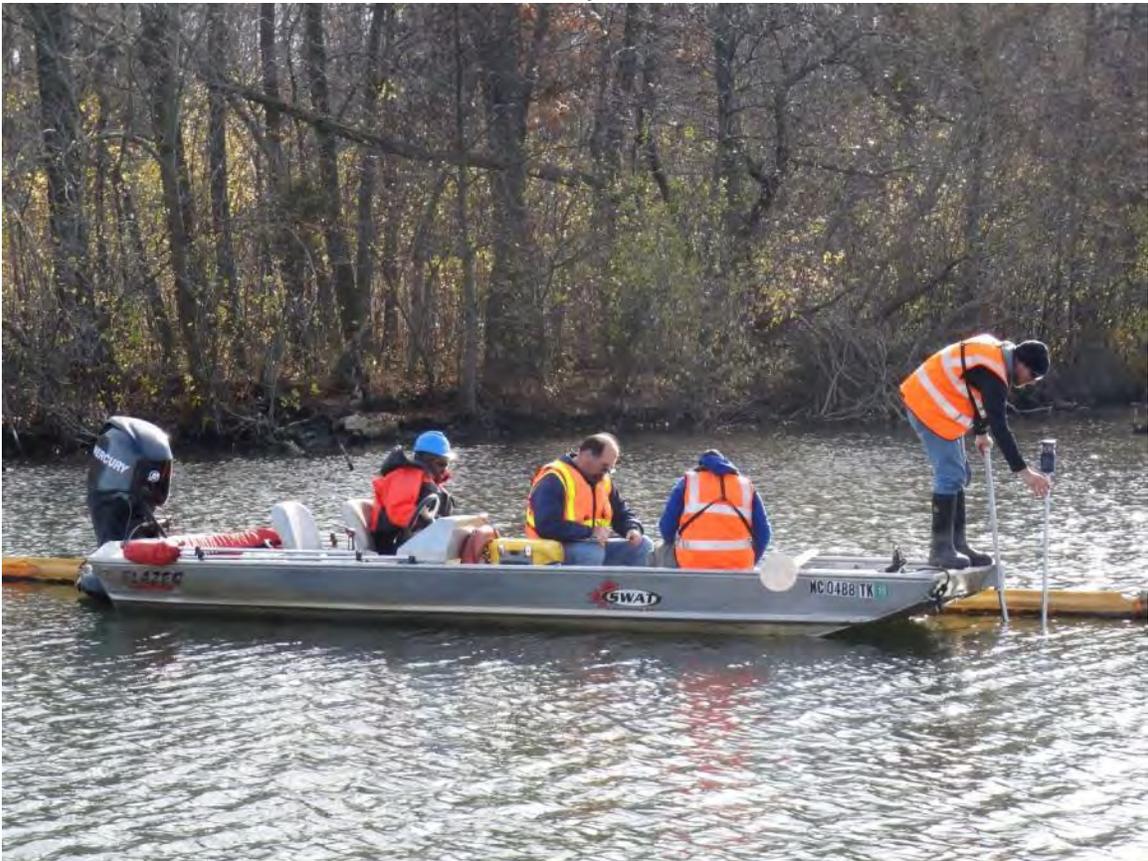
16. Morrow Lake Delta Gate E South Bathymetry Crew collecting measurements after adjusting survey transit.

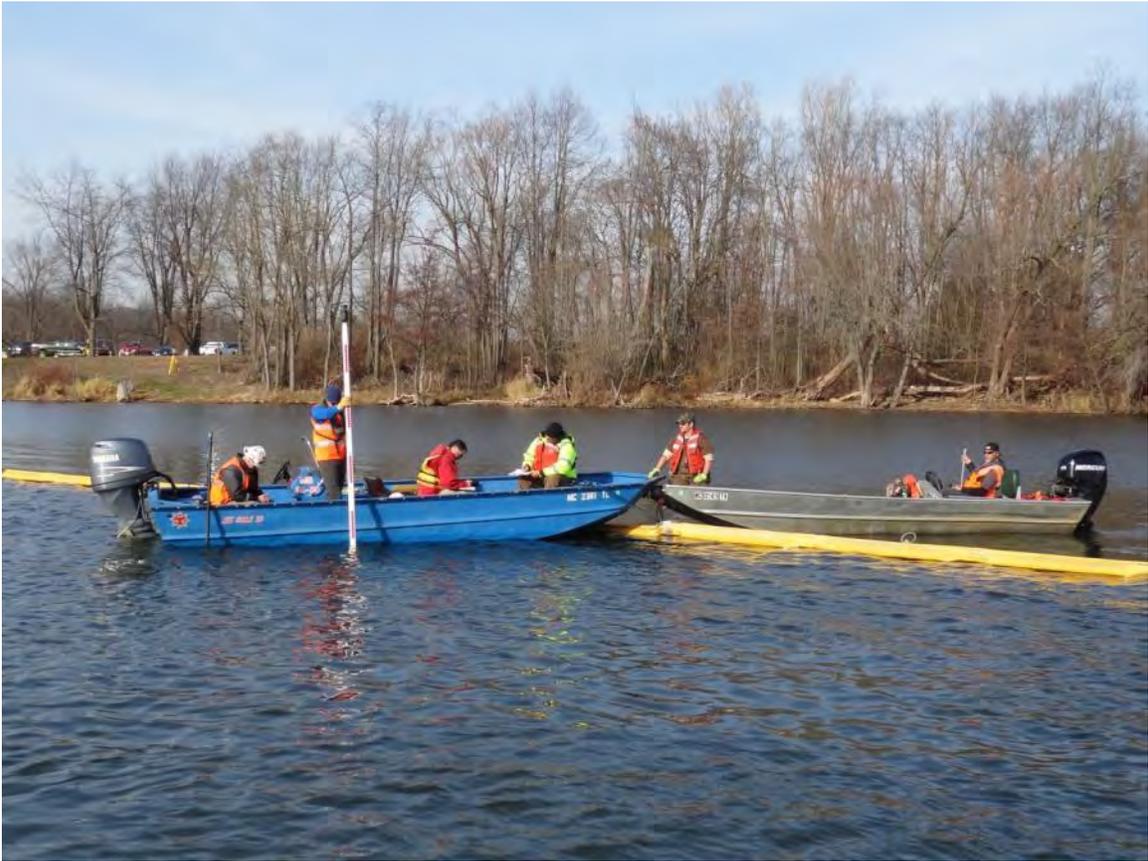
17. Morrow Lake Delta Gate E North observed Bathymetry crew collecting measurements.
