Situation Photo Log

Sunday, November 18, 2012

Kalamazoo River / Enbridge Spill

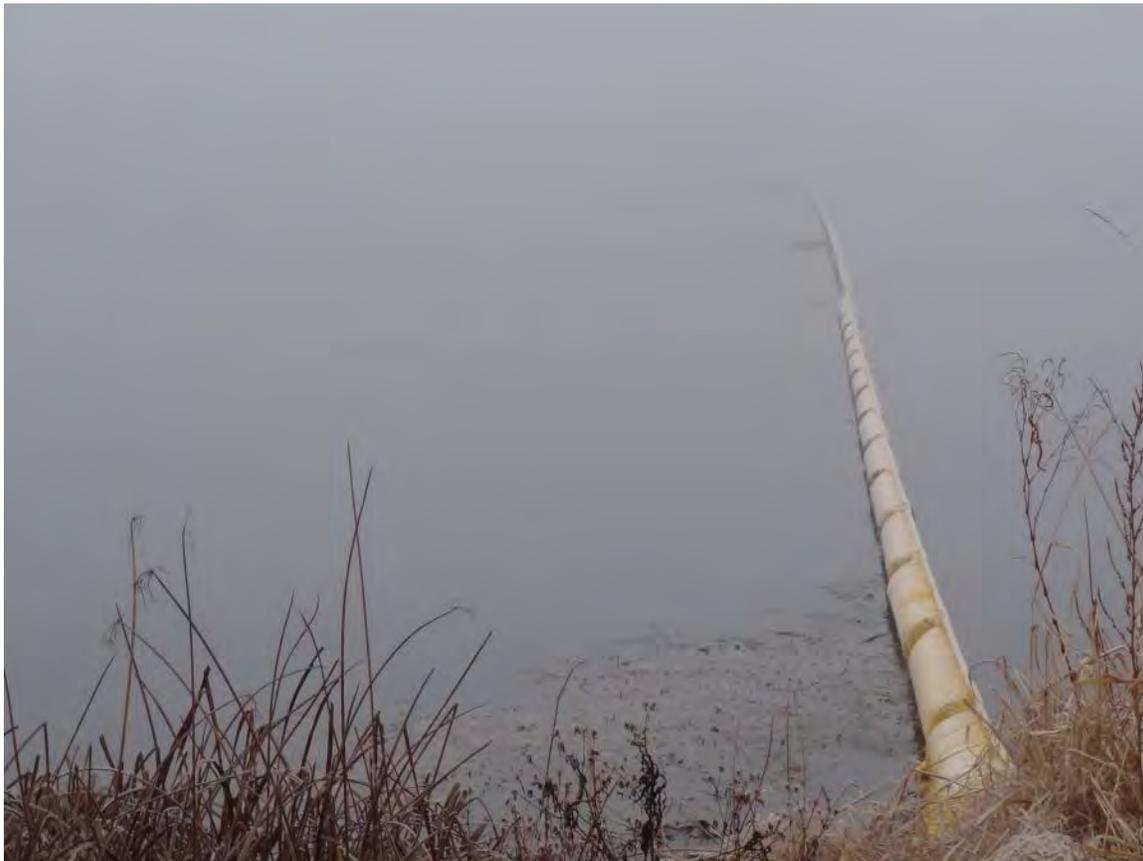
1. MP5.75 RDB Ceresco Dam Control Point Boom.

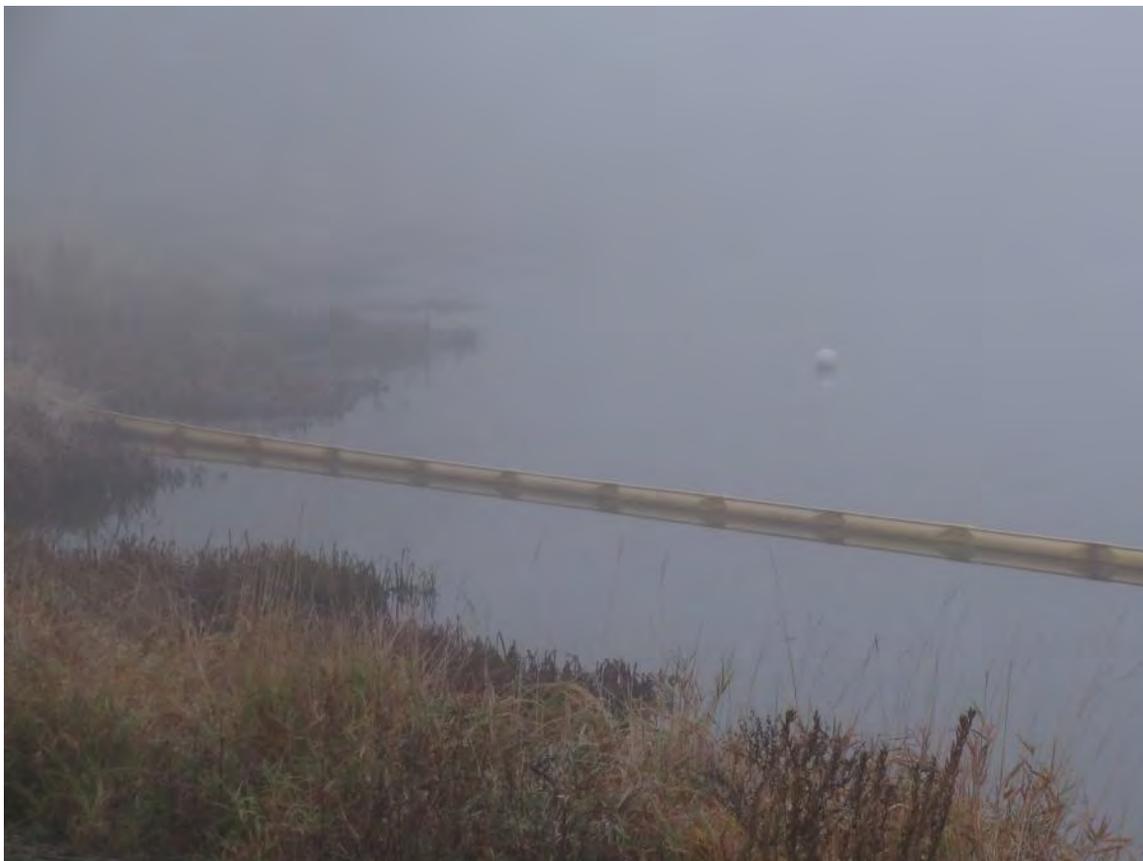
2. MP5.75RDB observed no ice forming along shoreline.

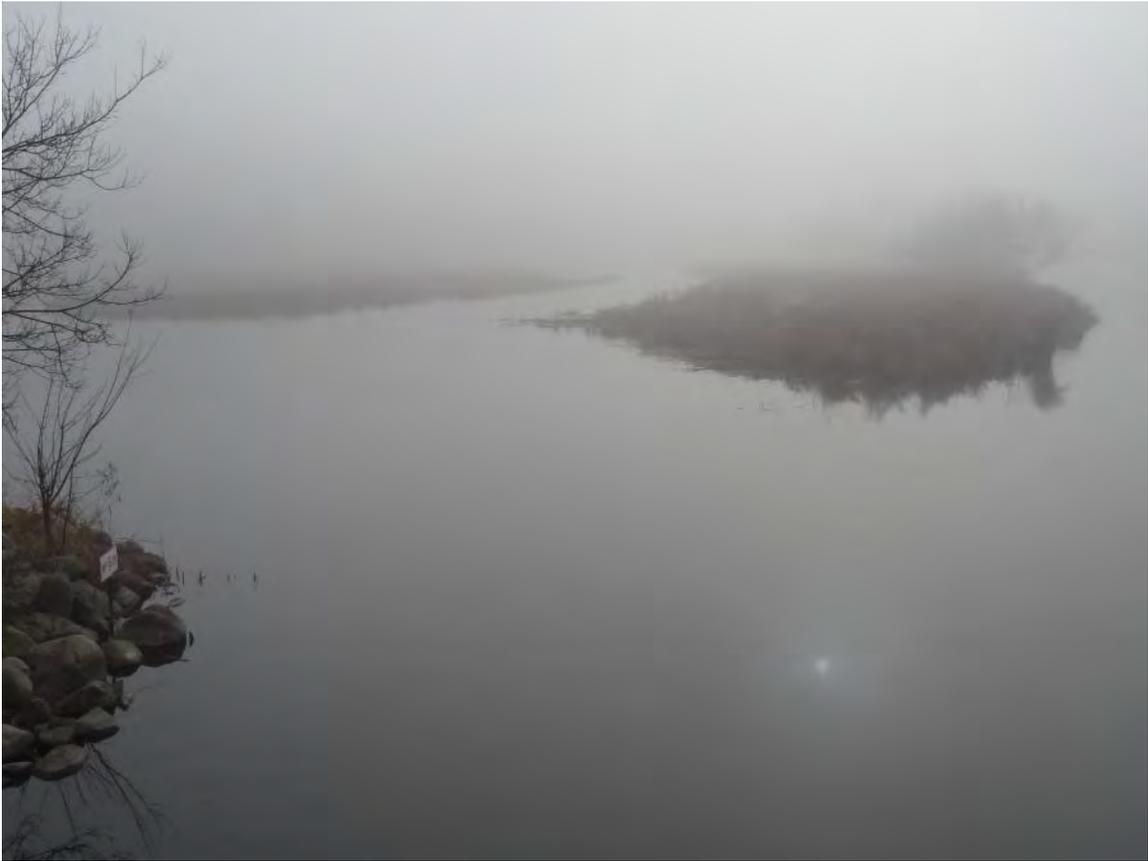
3. MP15.25 no ice observed in South Mill Pond.

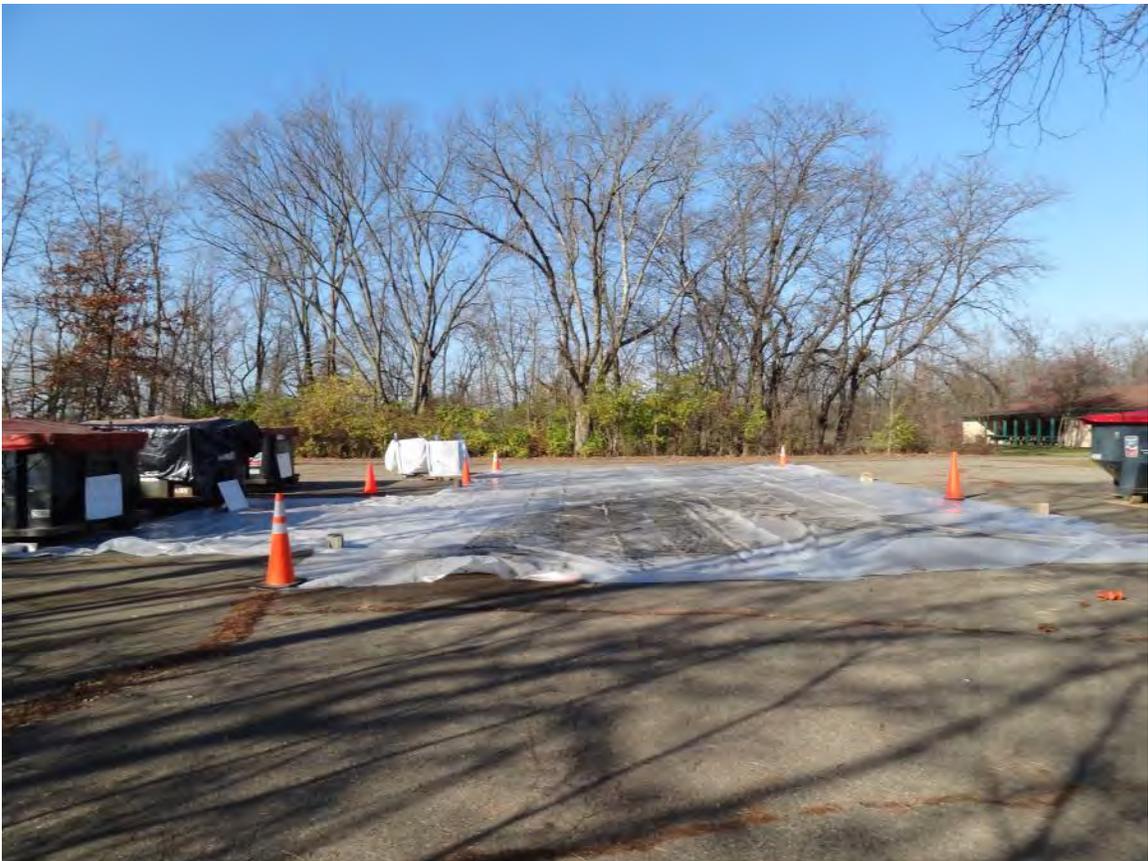
4. E4 Boat Launch. Staging area for curtain disposal.

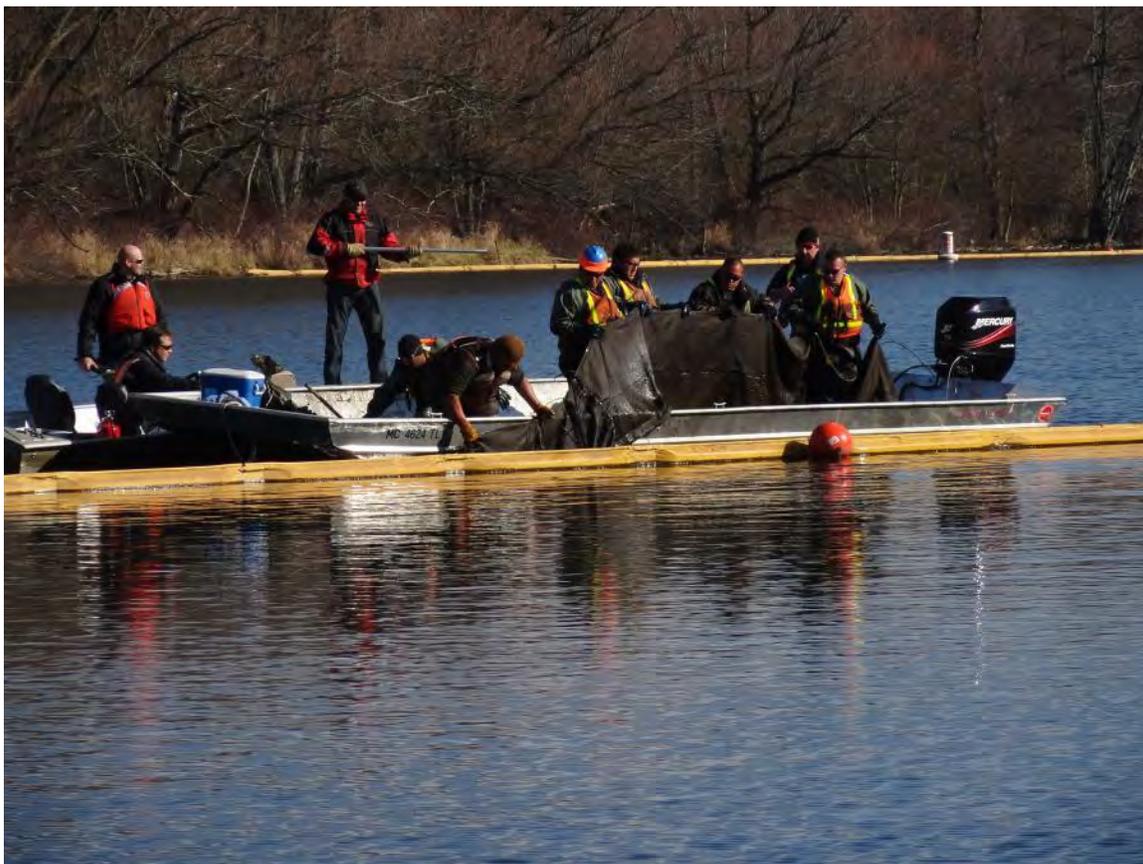
5. Morrow Lake Delta Gate E South observed crew removing curtain from boom.

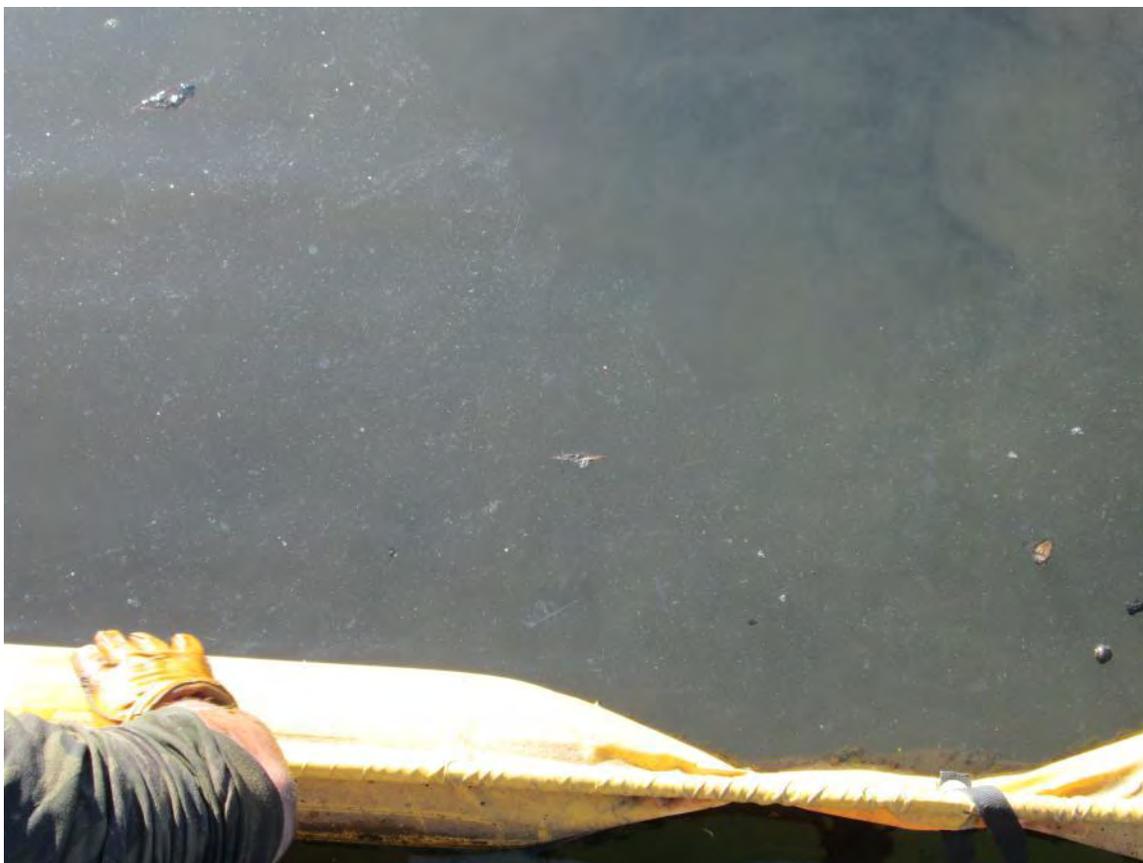
6. Morrow Lake Delta Gate E South sheen observed during curtain removal.

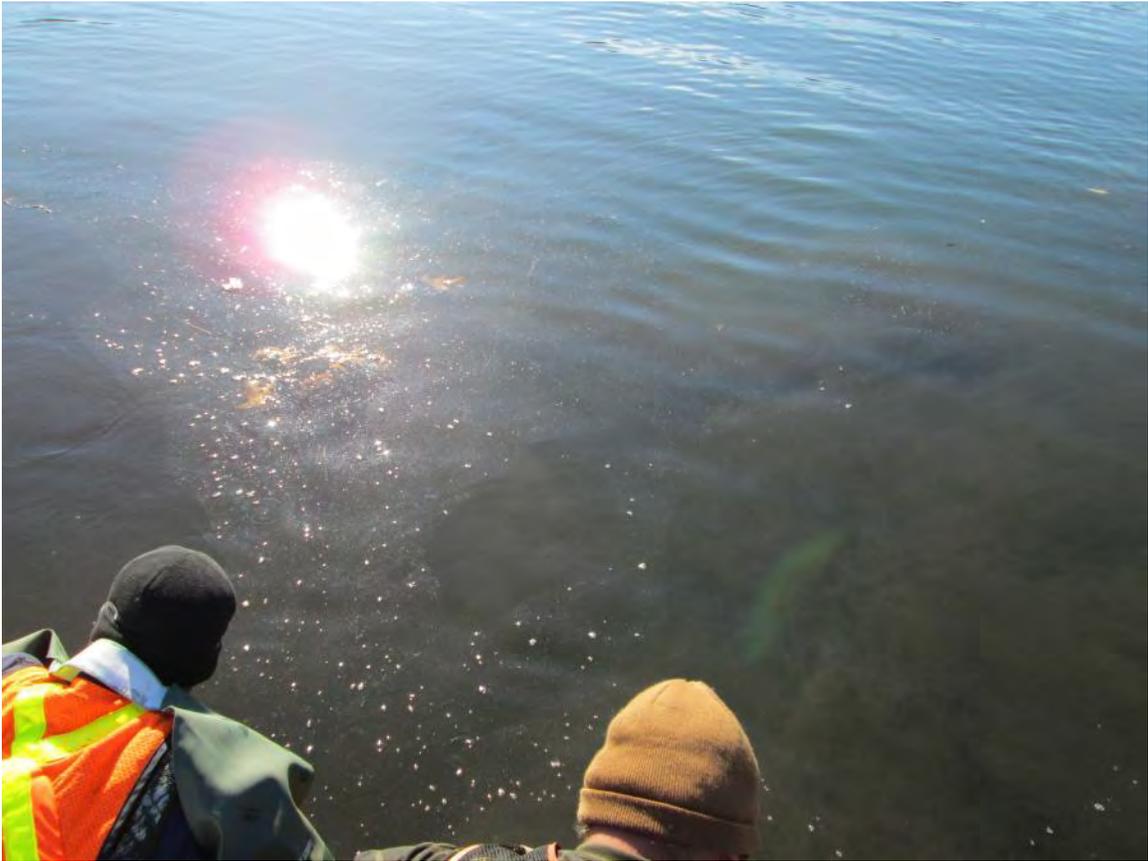
7. Morrow Lake Delta Gate E South sheen observed during curtain removal.

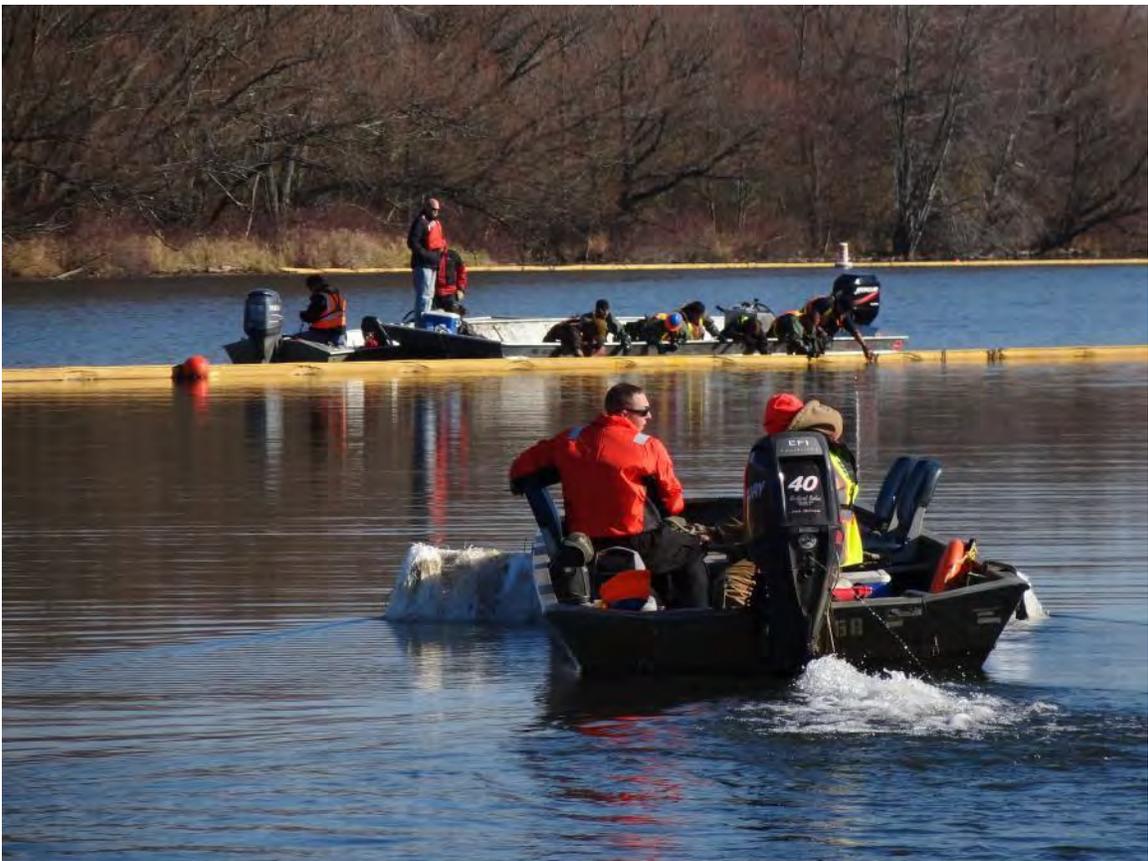
8. Morrow Lake Delta Gate E South observed sweep boat responding to sheen observed during curtain removal.

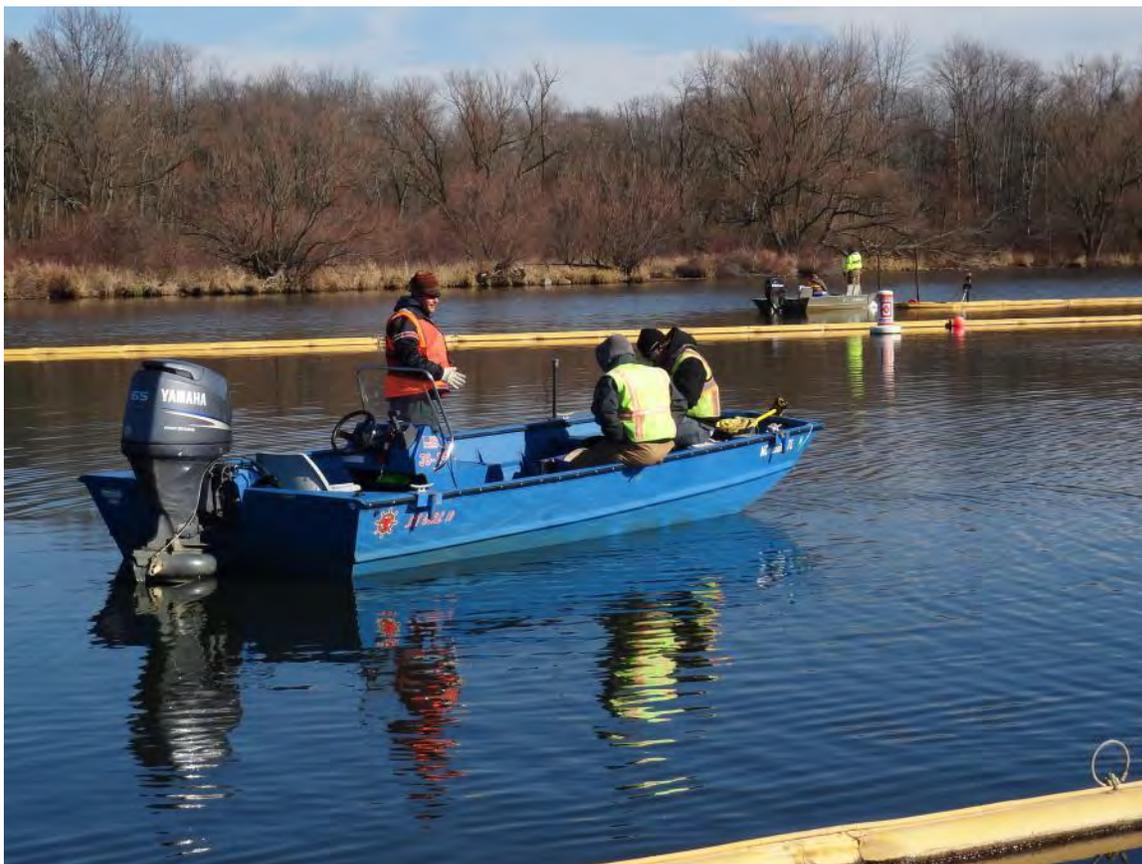
9. Morrow Lake Delta observed turbidity monitoring crew downstream from curtain removal at Gate E South.

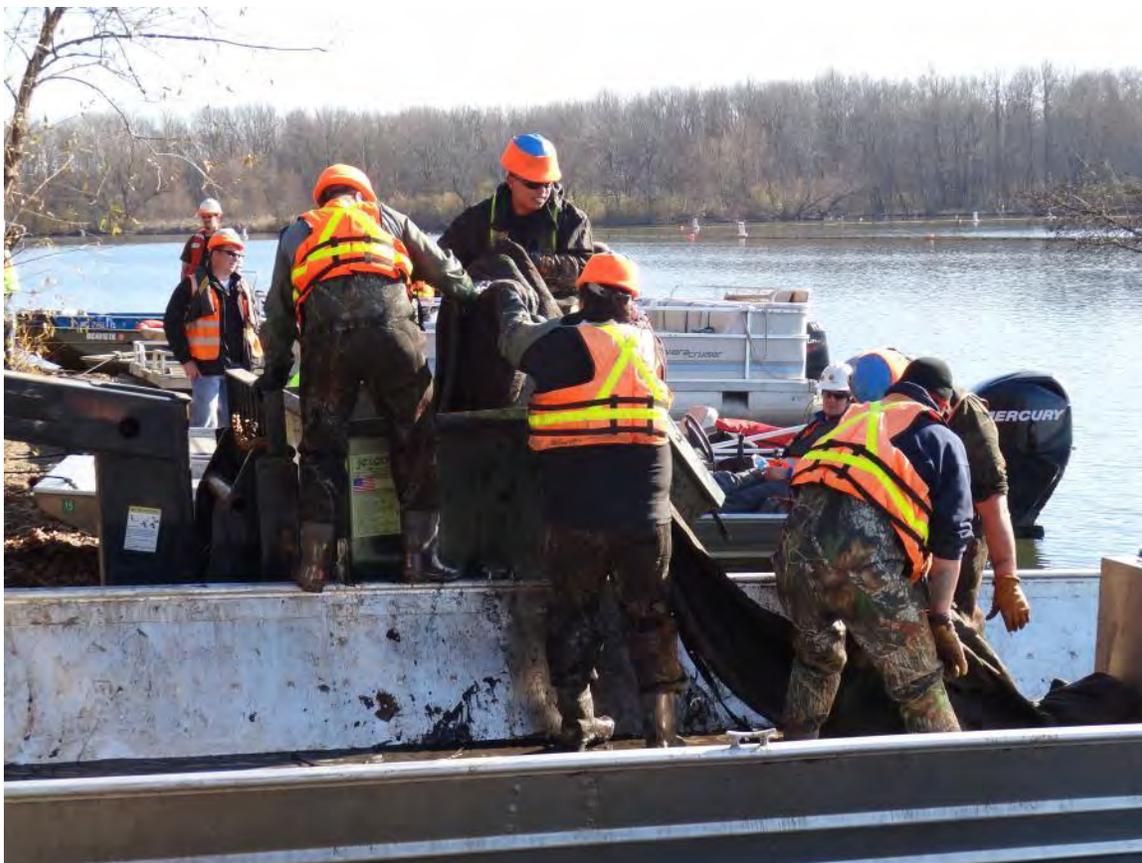
10. E4 Boat Launch observe crew unloading curtain removed from Morrow Lake Delta Gate E South.

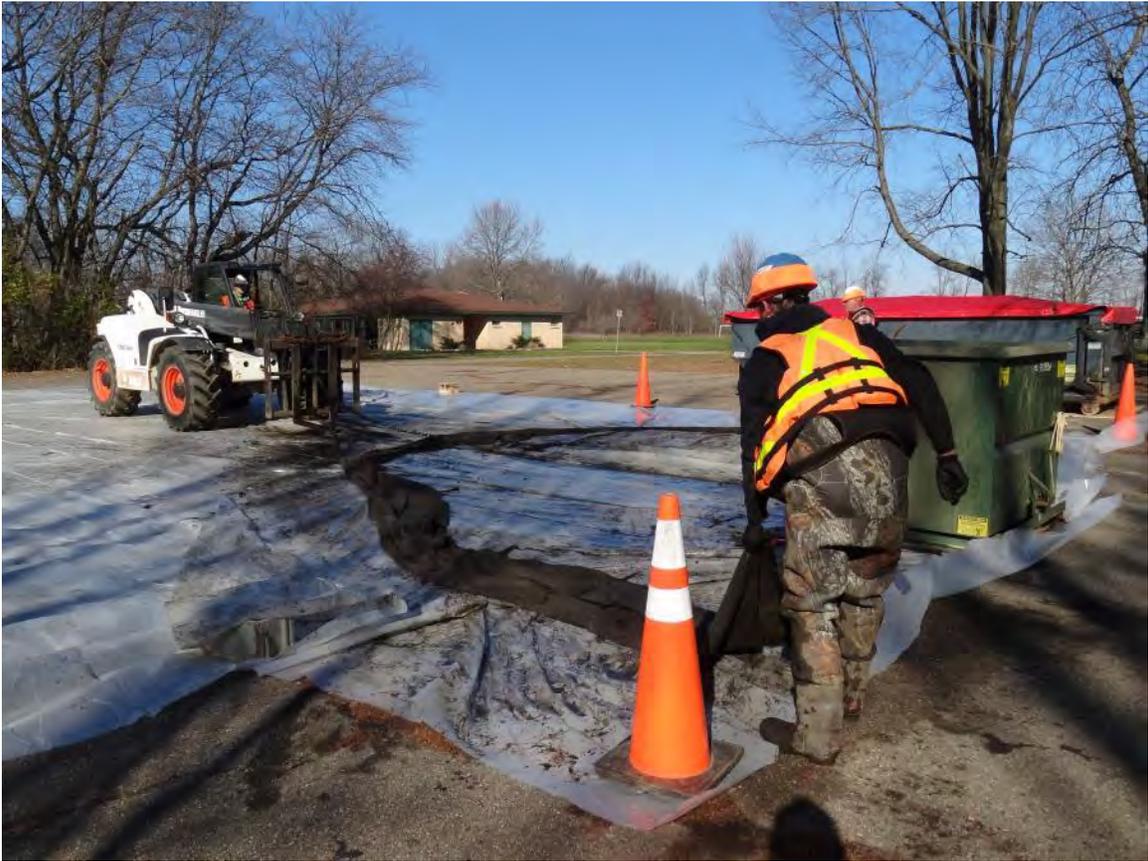
11. E4 Staging Area observed crew removing chain from curtain.

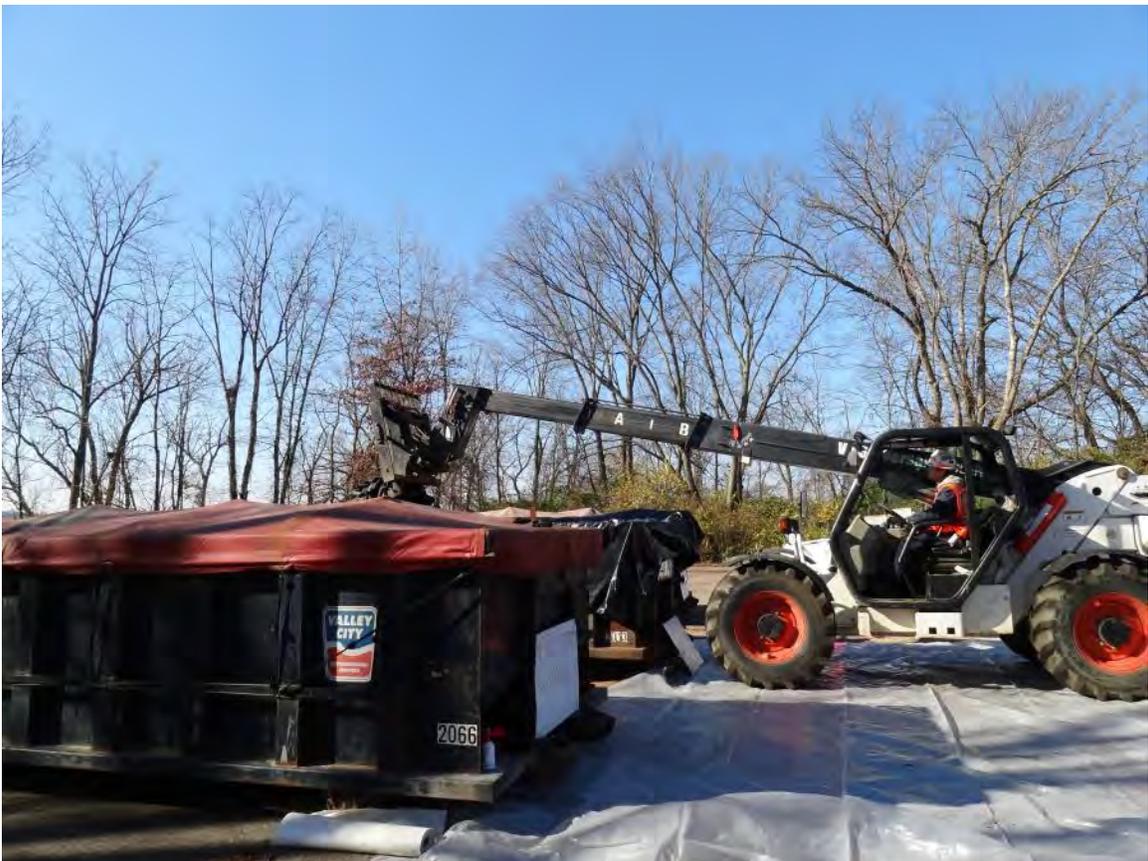
12. E4 Staging Area observed curtain being placed in roll-off by Lull.

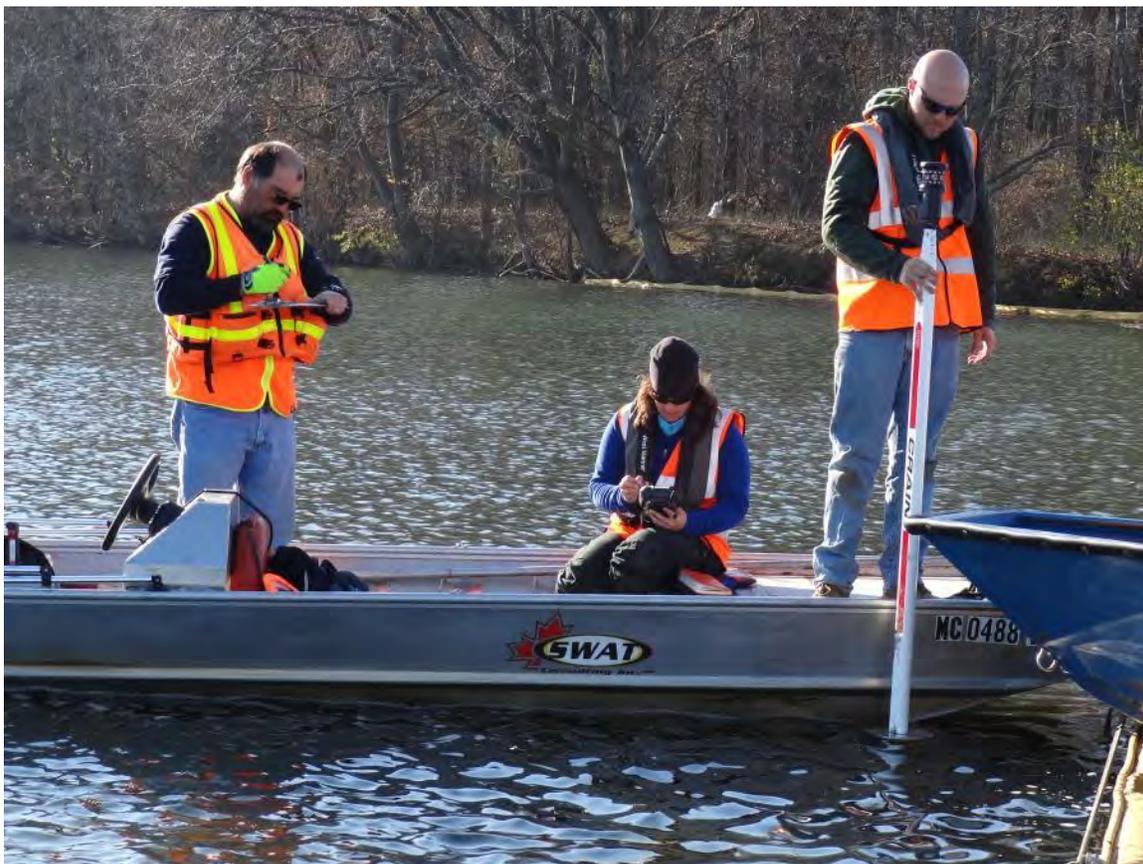
13. Morrow Lake Delta Gate C West observed a Bathymetry Crew collecting measurements along boom post curtain removal.

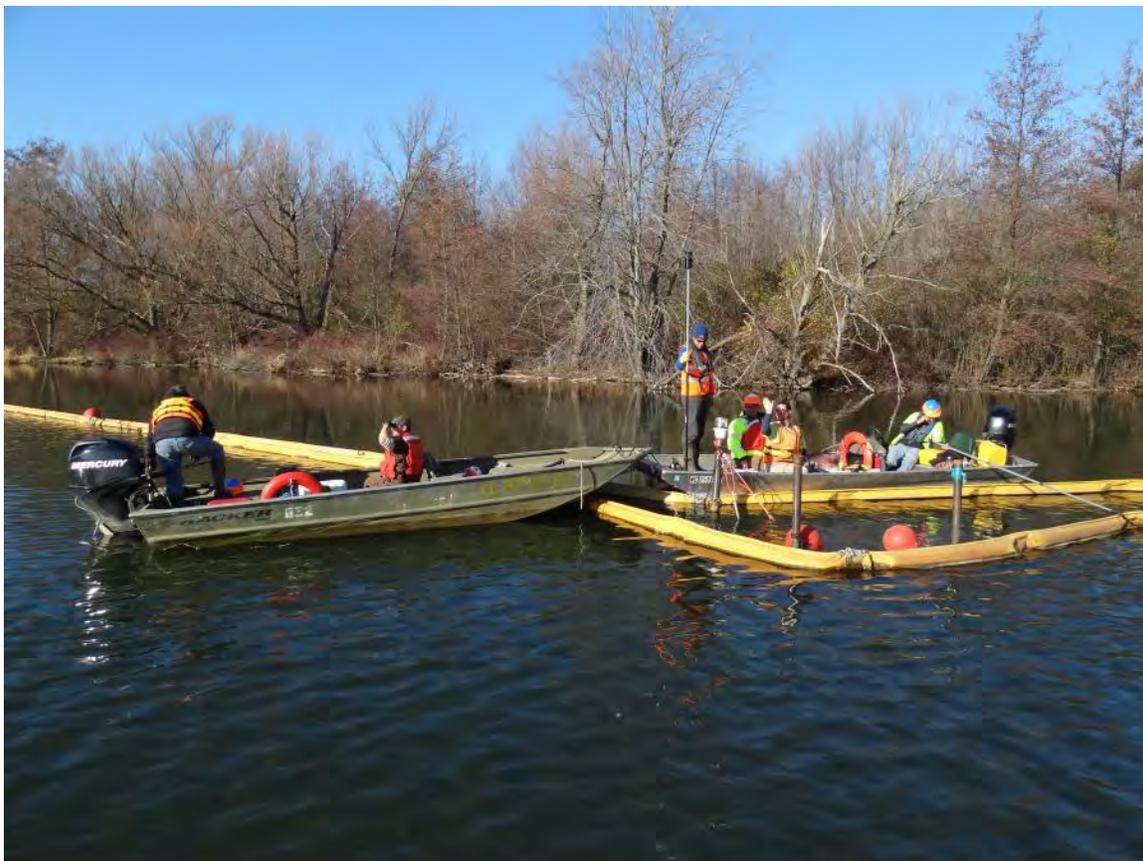
14. Morrow Lake Delta Gate D observed a Bathymetry Crew collecting measurements post curtain removal.
