# Situation Photo Log

Monday, November 19, 2012

Kalamazoo River / Enbridge Spill

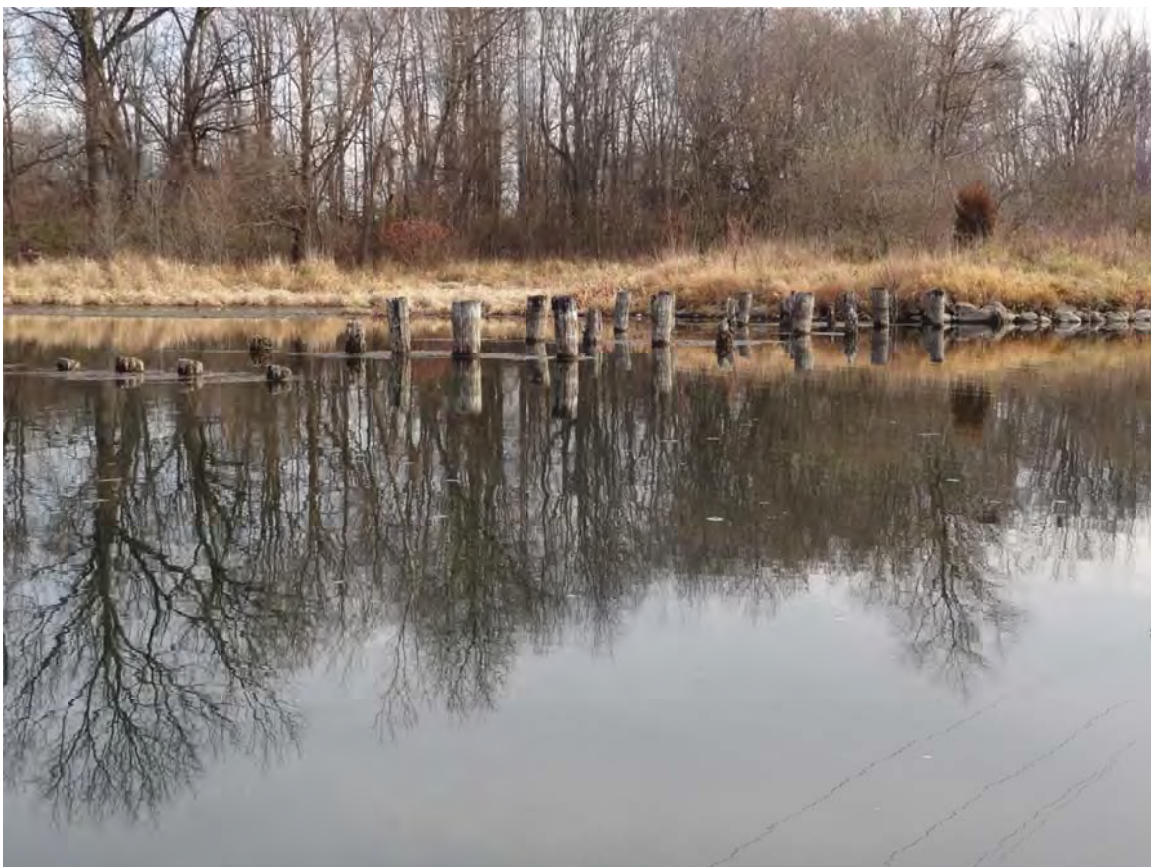
1. MP5.63 RDB, Ceresco Dam trestle, no sheen observed.

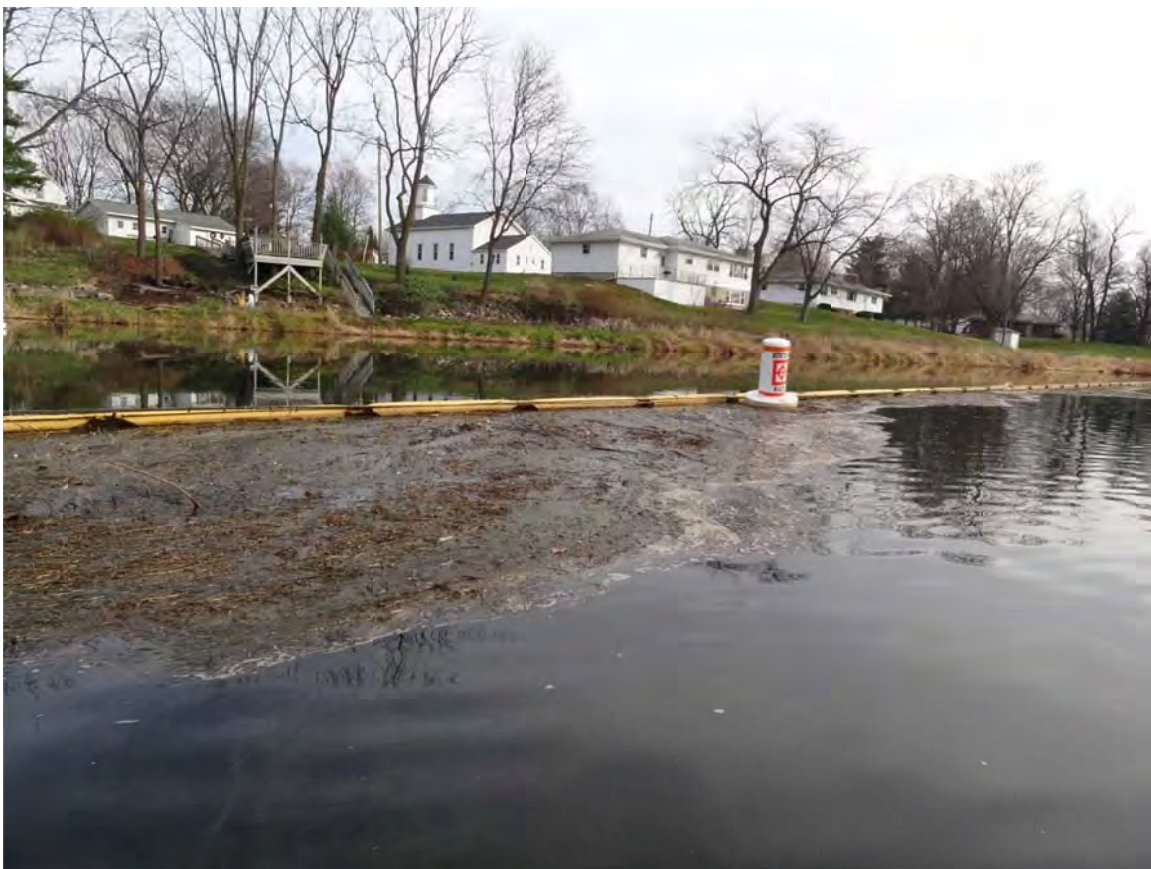
2. MP5.75 Ceresco Dam control point, debris observed along containment boom.

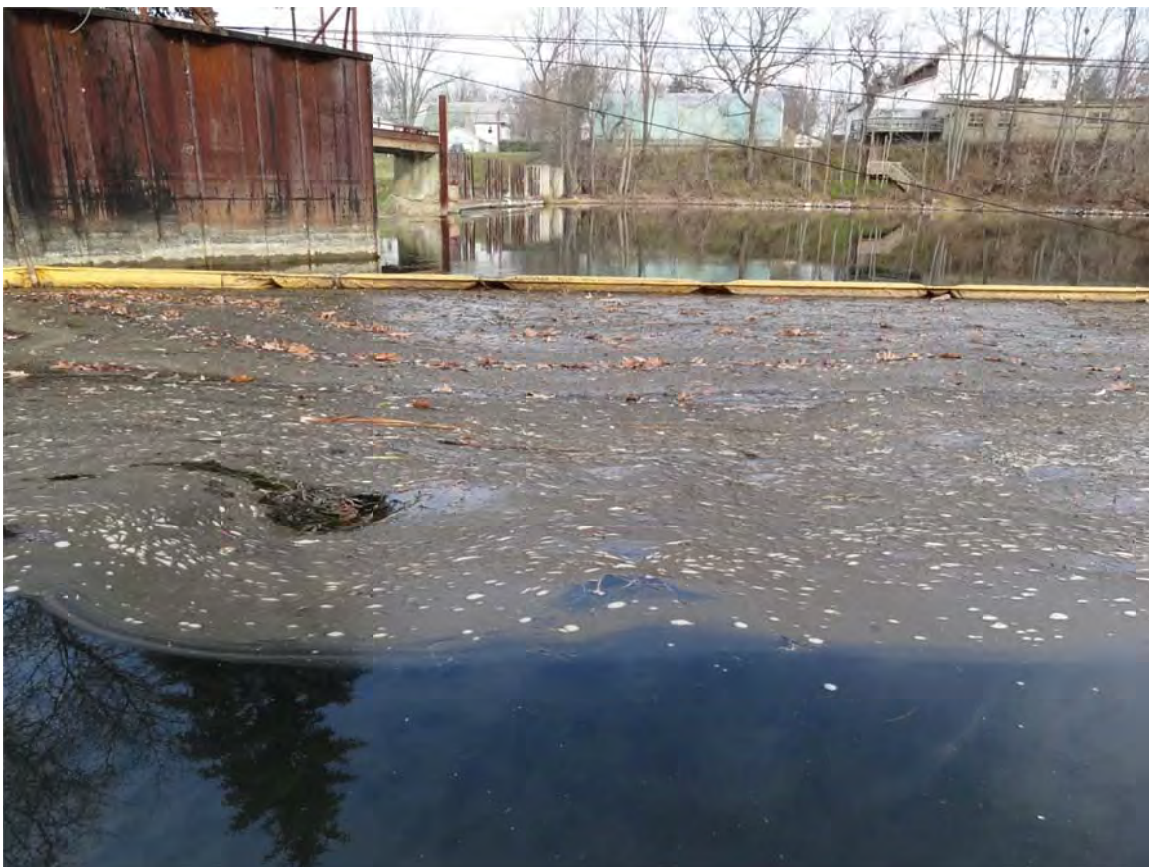
3. Debris observed along Ceresco Dam control point.

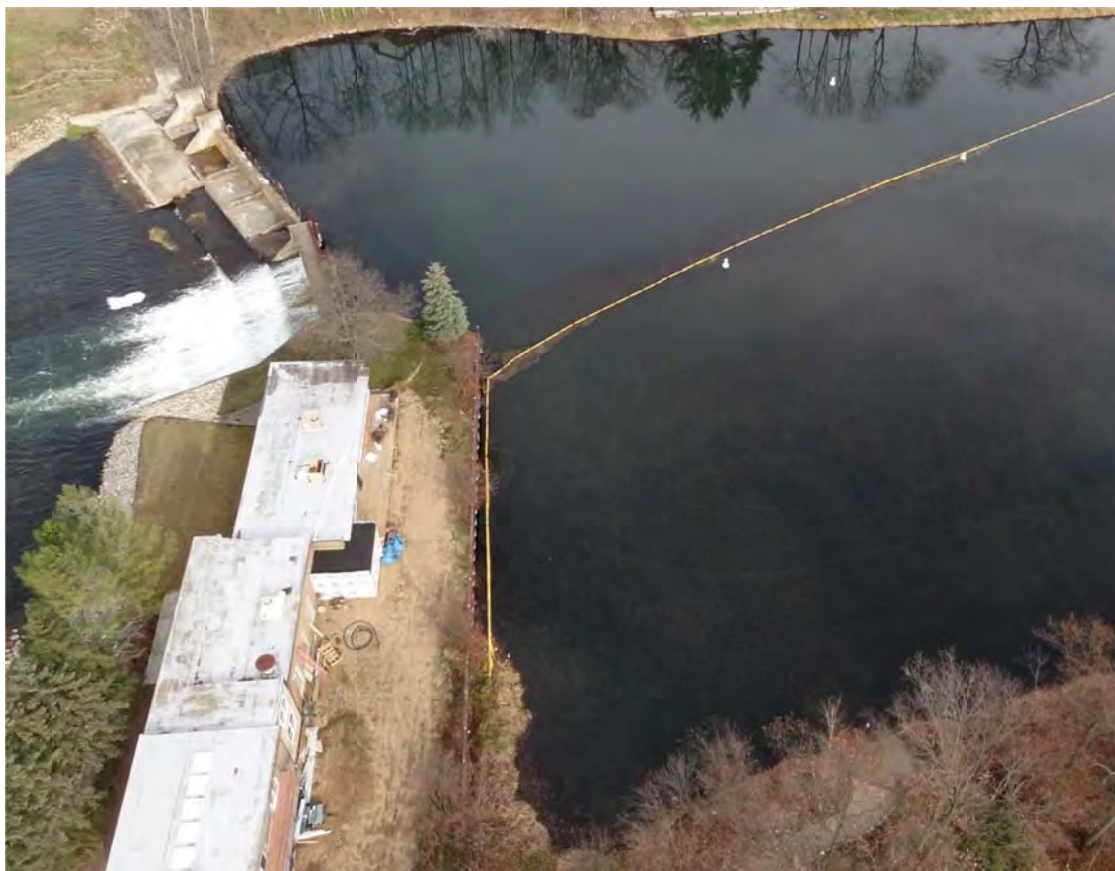
4. Ceresco Dam during afternoon overflight, debris had been removed from containment boom.

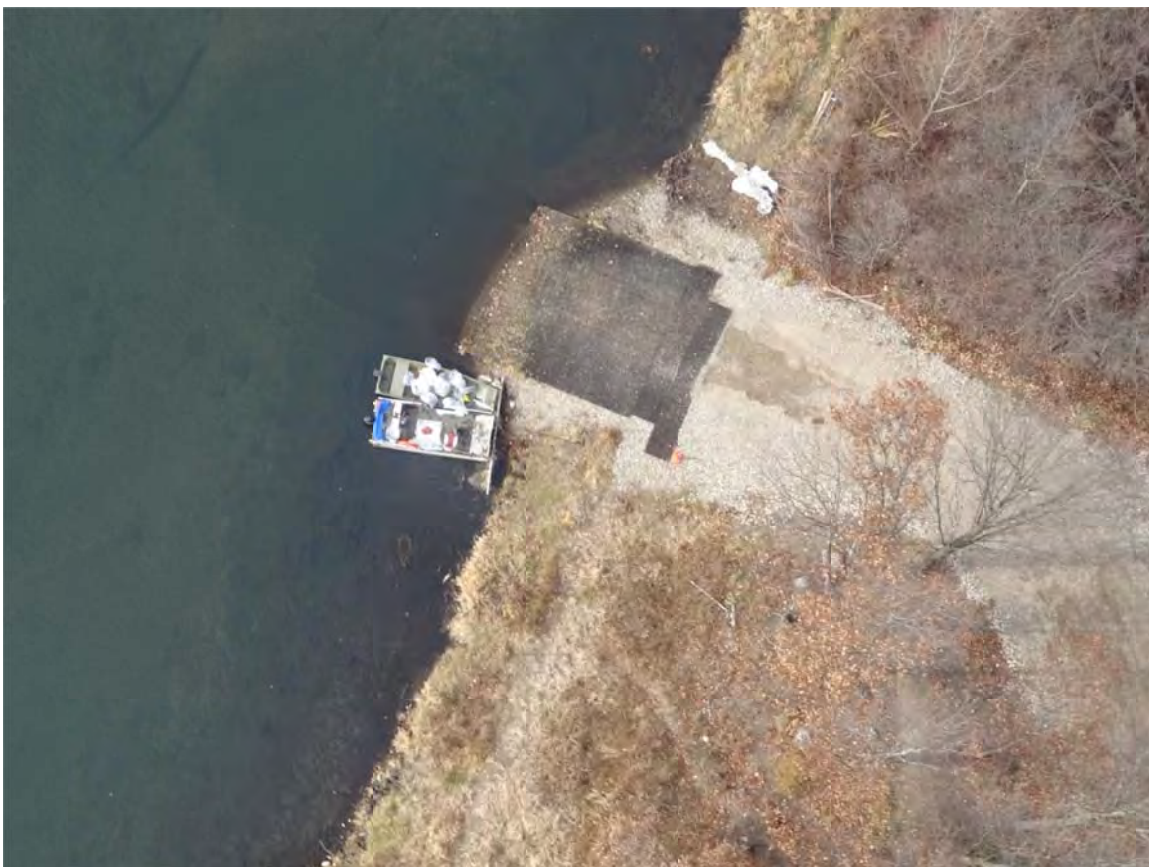
5. Debris bags observed in boats parked at C0.4 boat launch.

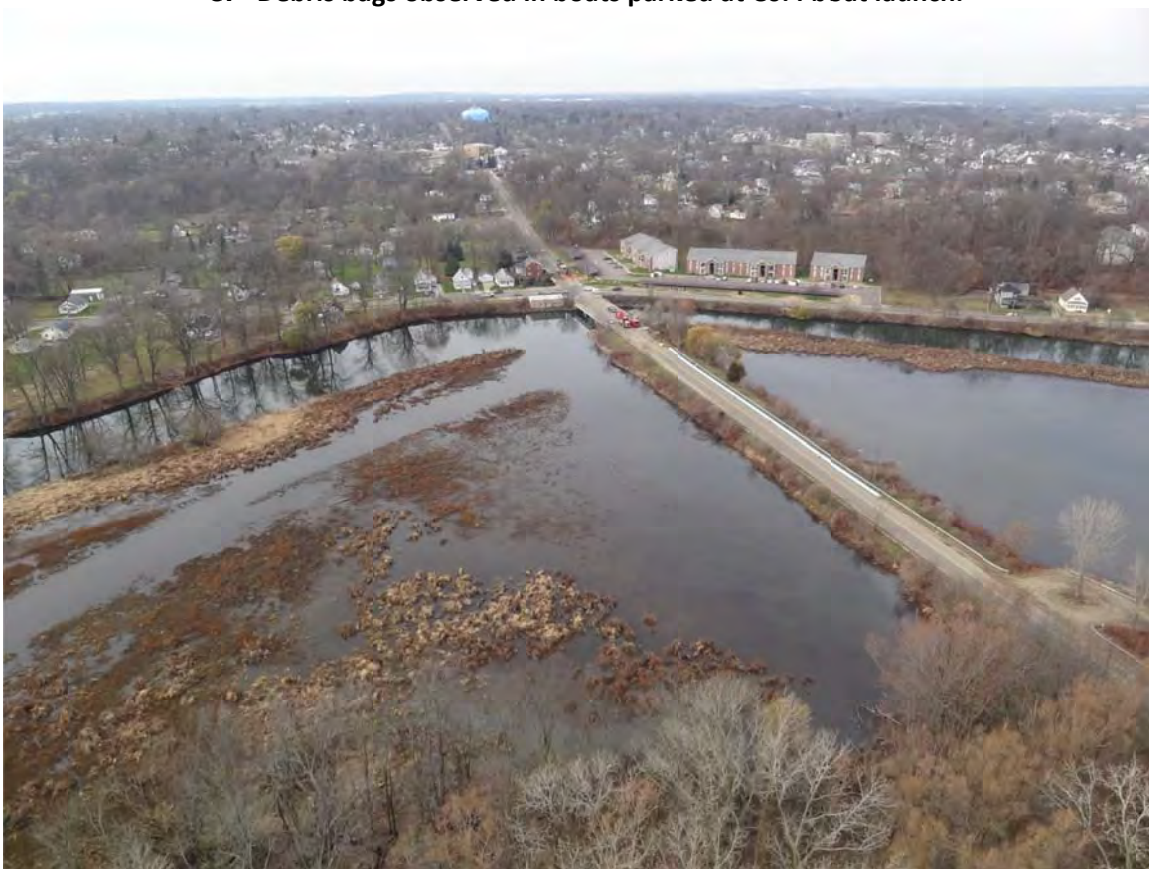
6. Mill Ponds, no sheen observed.

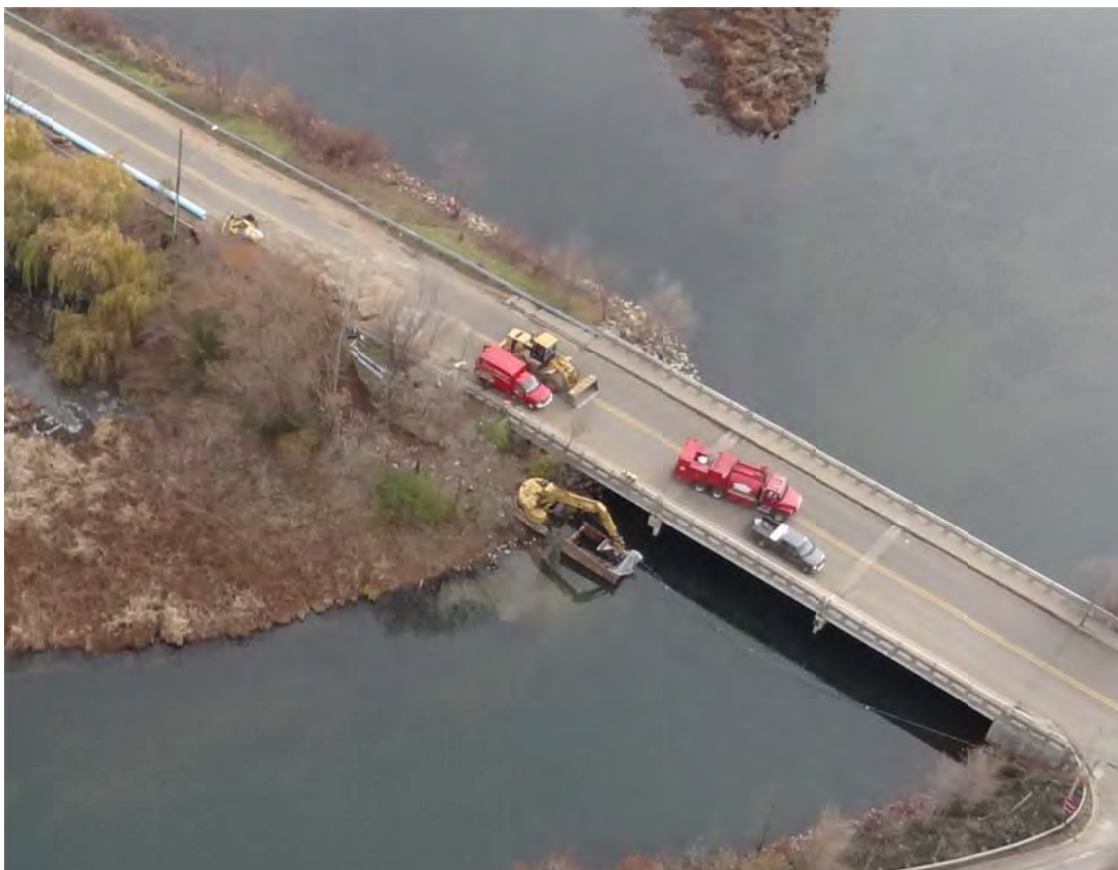
7. Observed crews installing utility piping in river at Burnham Street Bridge (Mill Ponds).

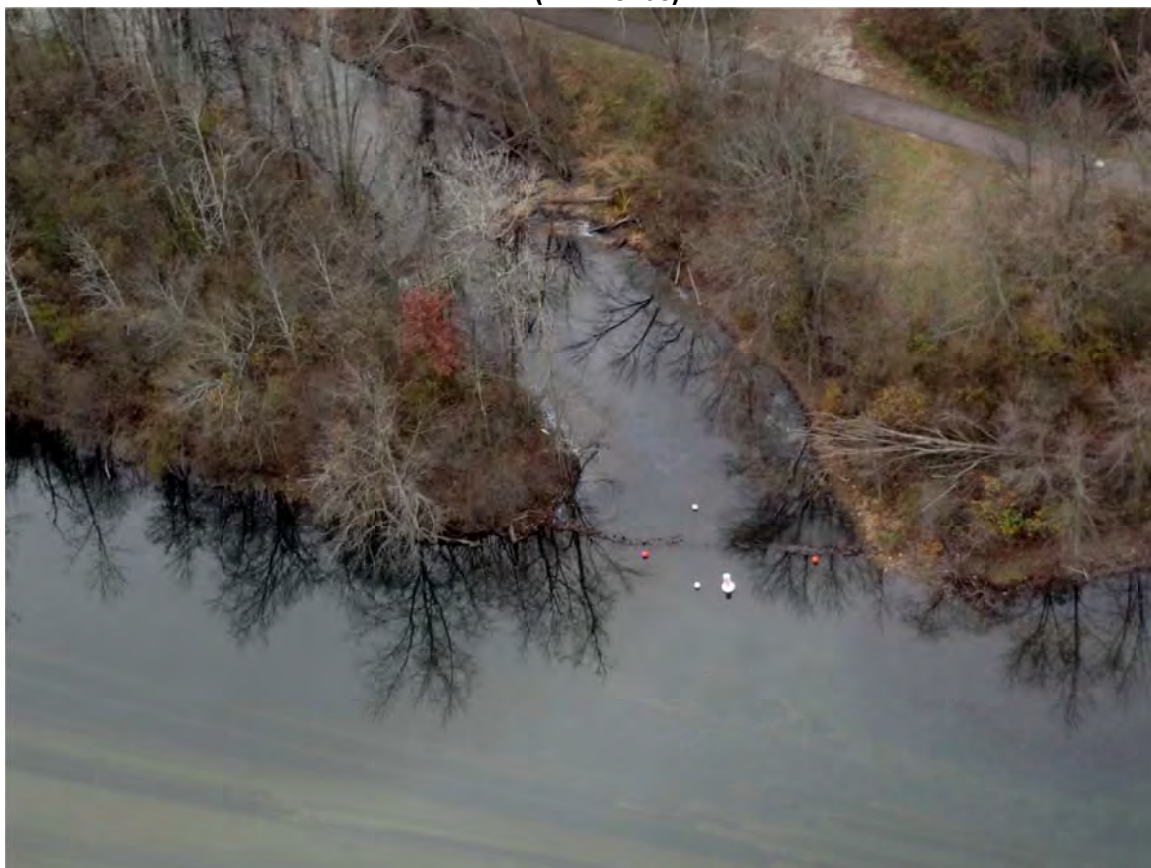
8. MP 19.25 sediment trap, sheen observed within containment. Sheen test conducted by inspection crew was conclusive for biogenic sheen.

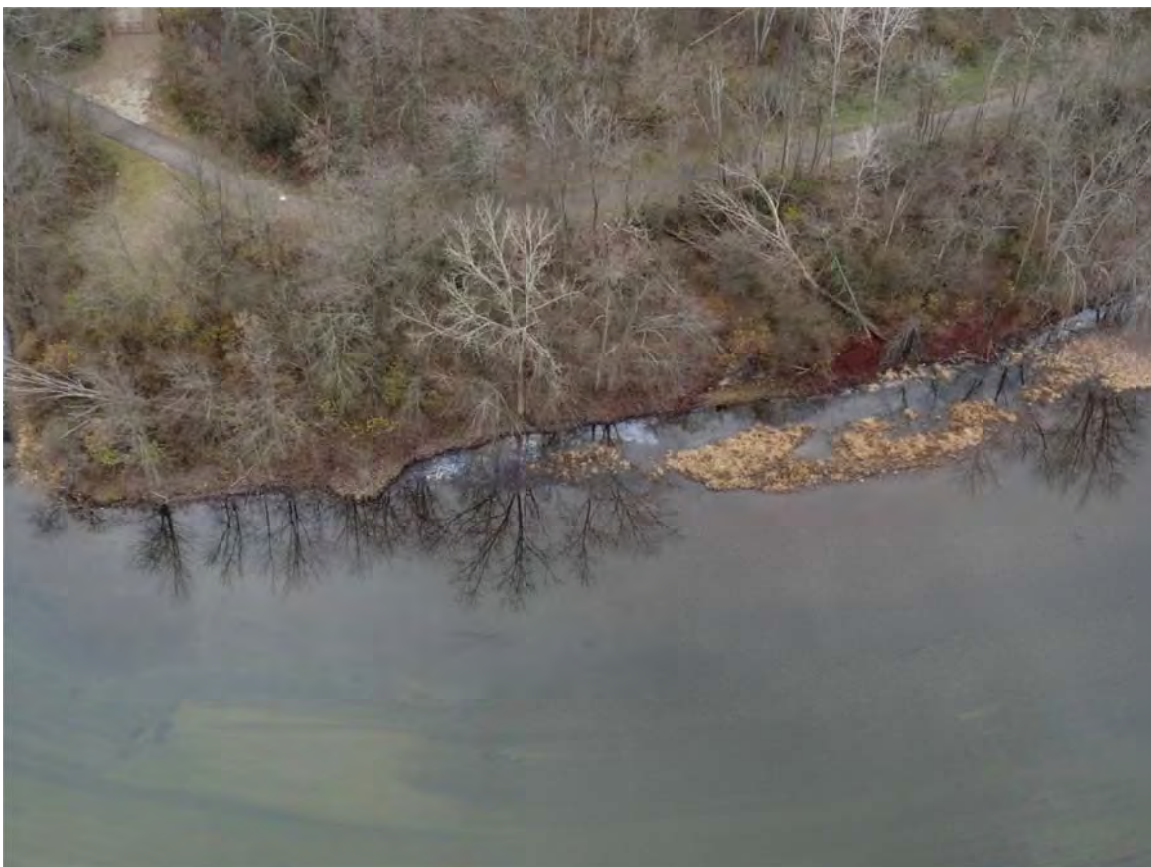
9. MP 19.25 LDB, sheen observed along shoreline just downstream from sediment trap. Sheen test conducted by inspection crew was conclusive for biogenic sheen.

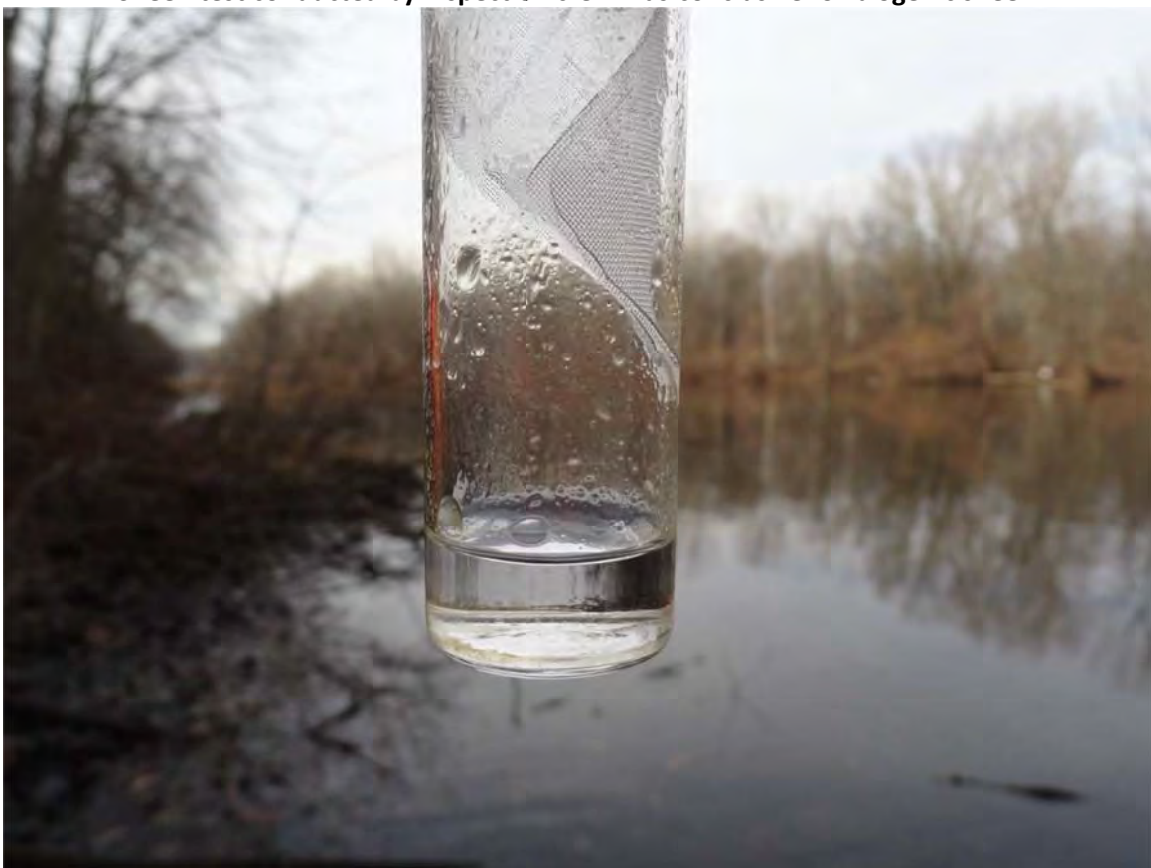
10. Sheen test results from MP19.25, sheen was conclusive for biogenic sheen.

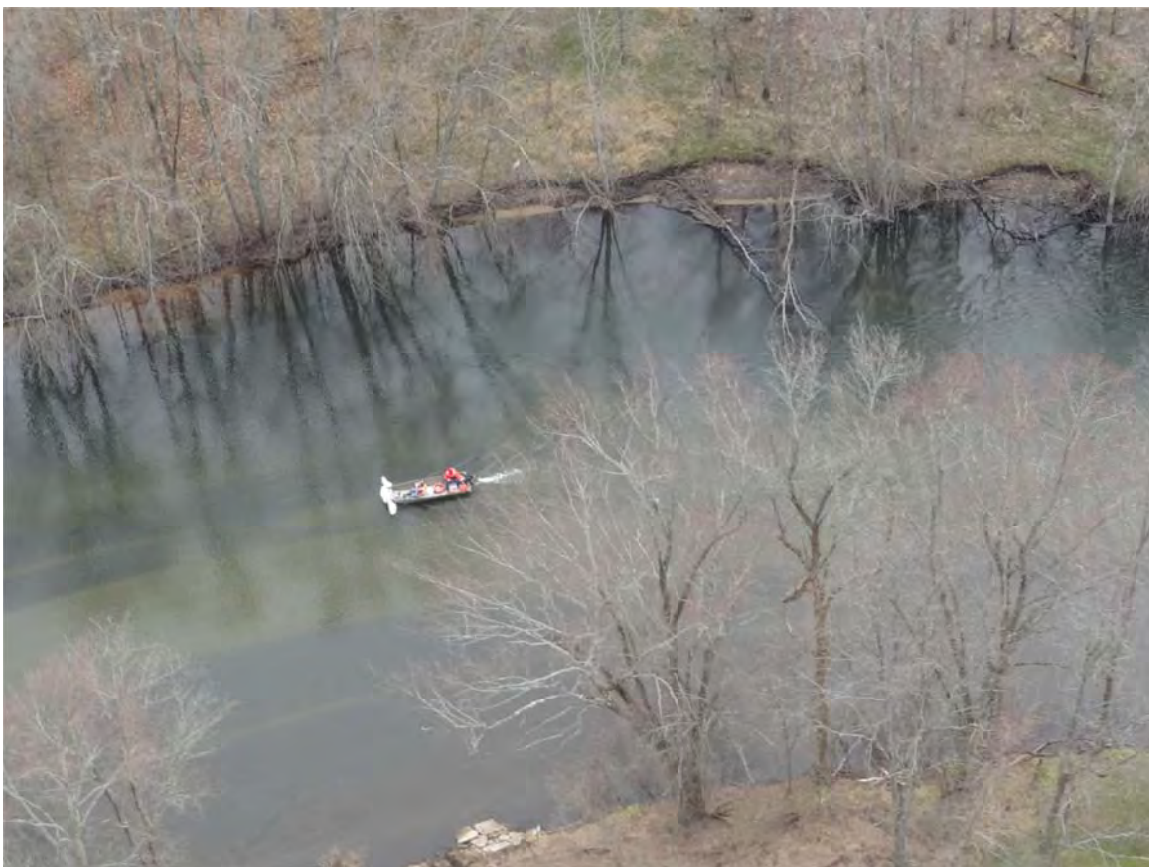
**11. Sheen sweepers boat observed heading upstream near MP 27.0.**

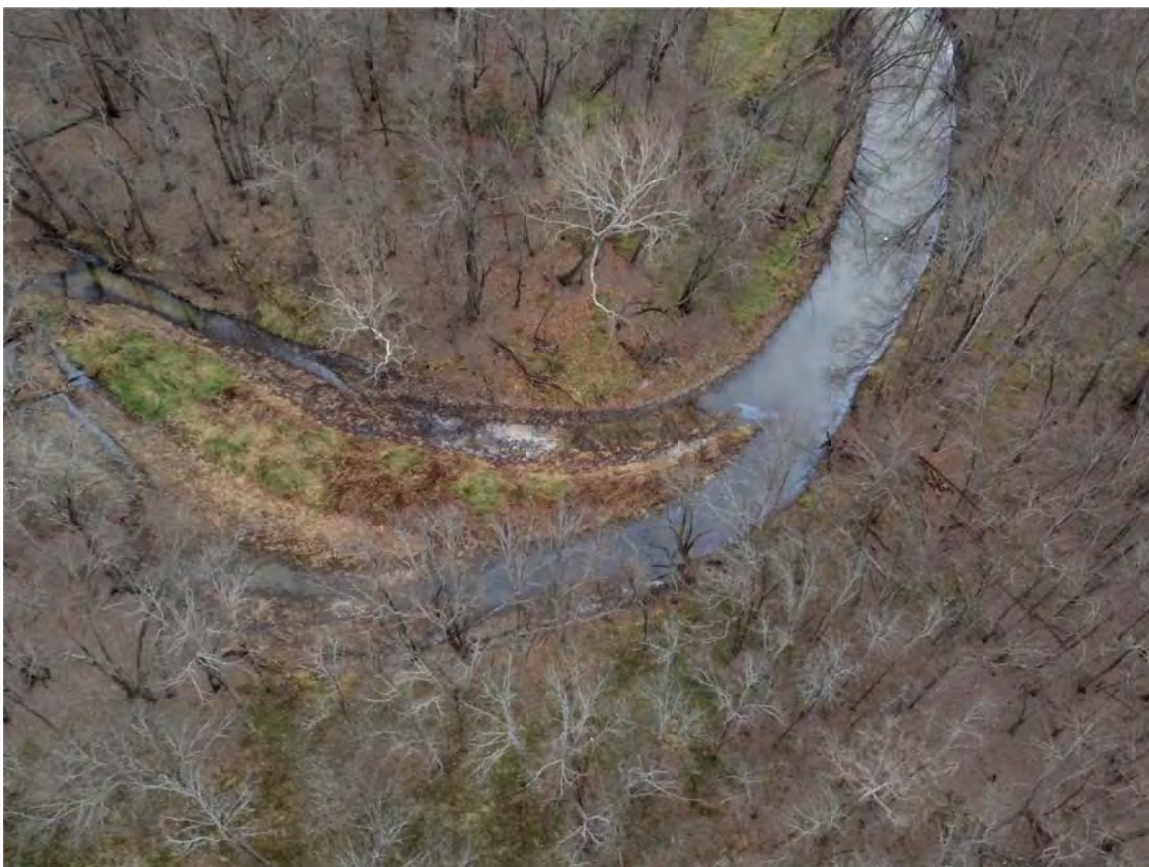
**12. MP 28.25 oxbow, sheen observed in back channel of oxbow.**

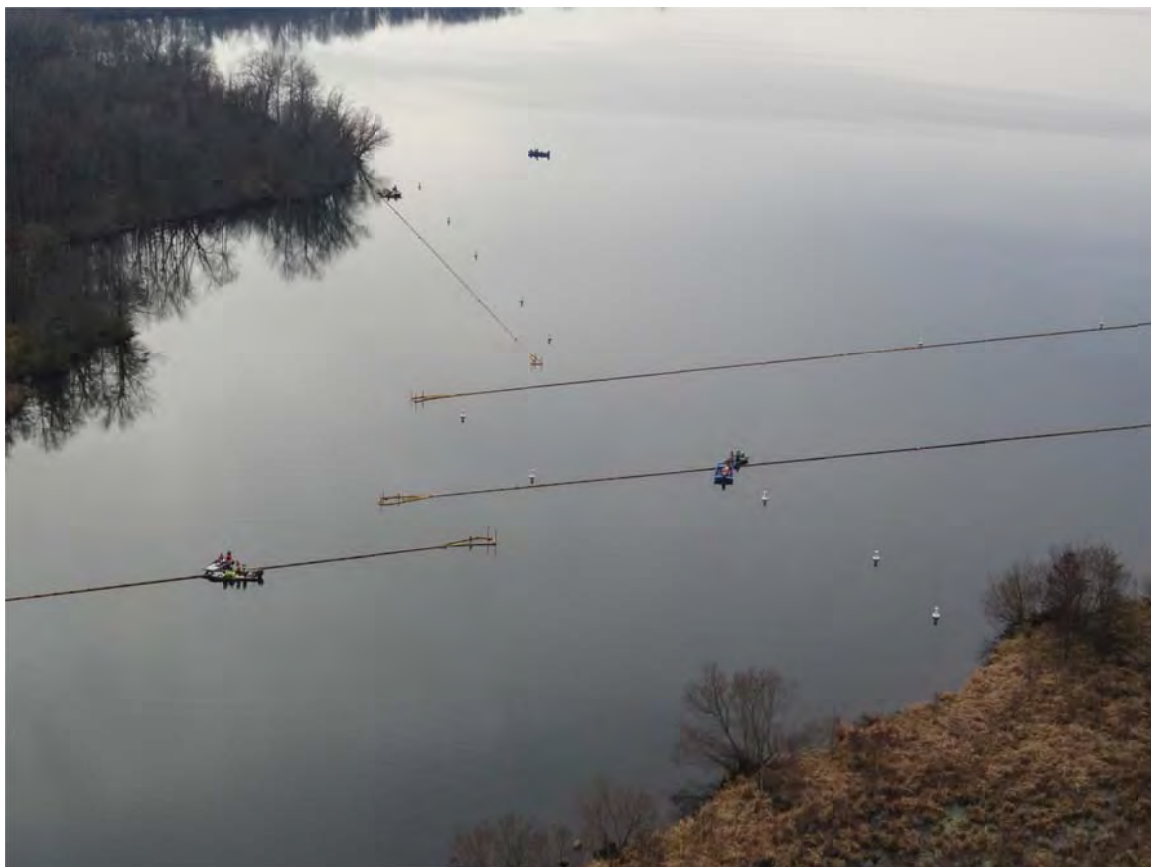
**13. E4 containment system, observed post-curtain removal bathymetry survey crews along Boom E in western end of delta.**

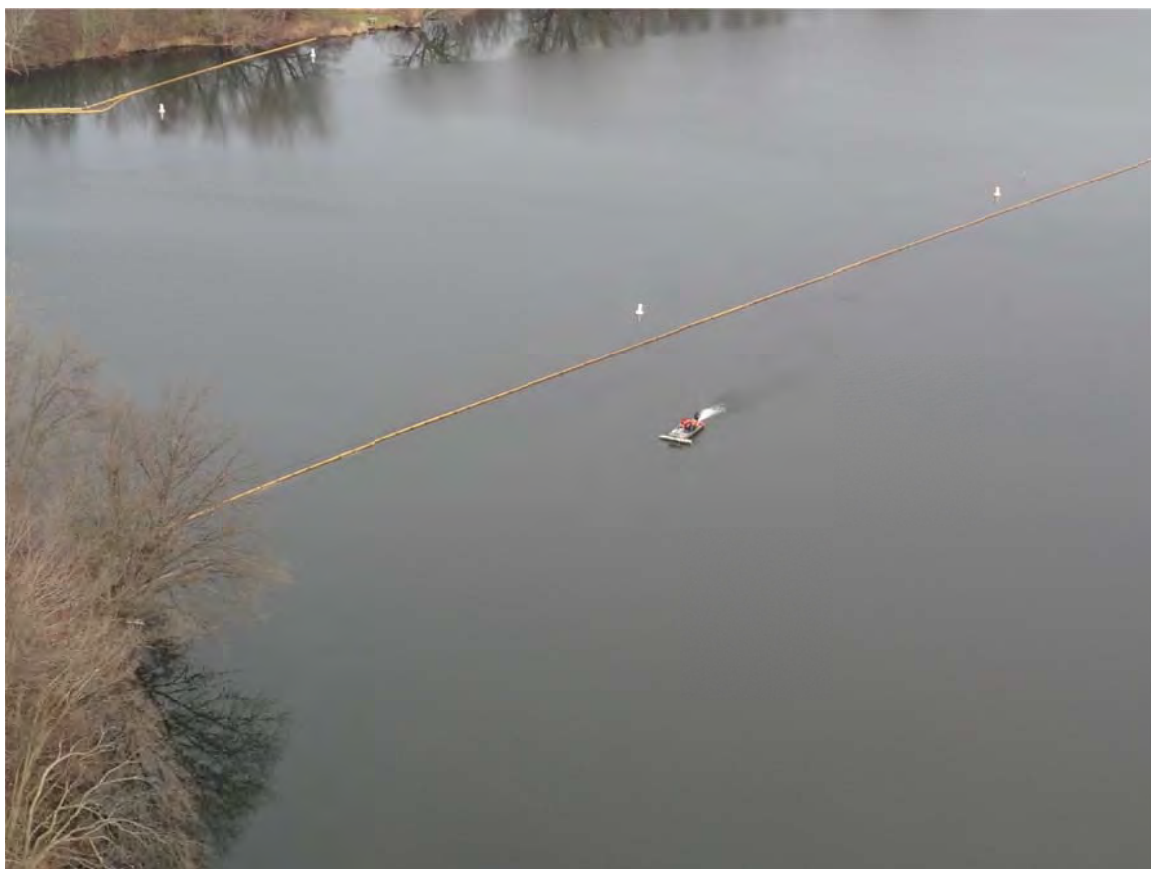
**14. Observed sheen sweeper boat operating in southwest corner of Morrow Lake Delta.**

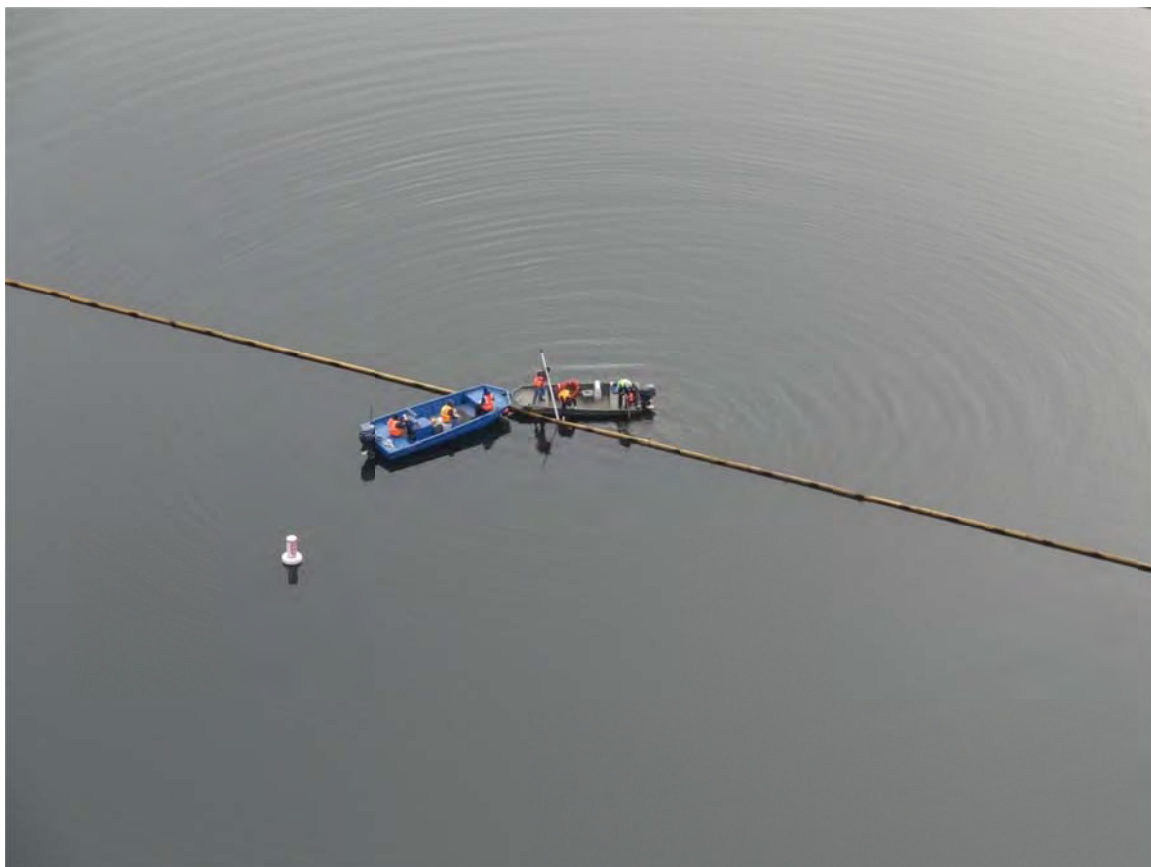
**15. Observed post-curtain removal bathymetry crew working along boom E in west end of Morrow Lake Delta.**

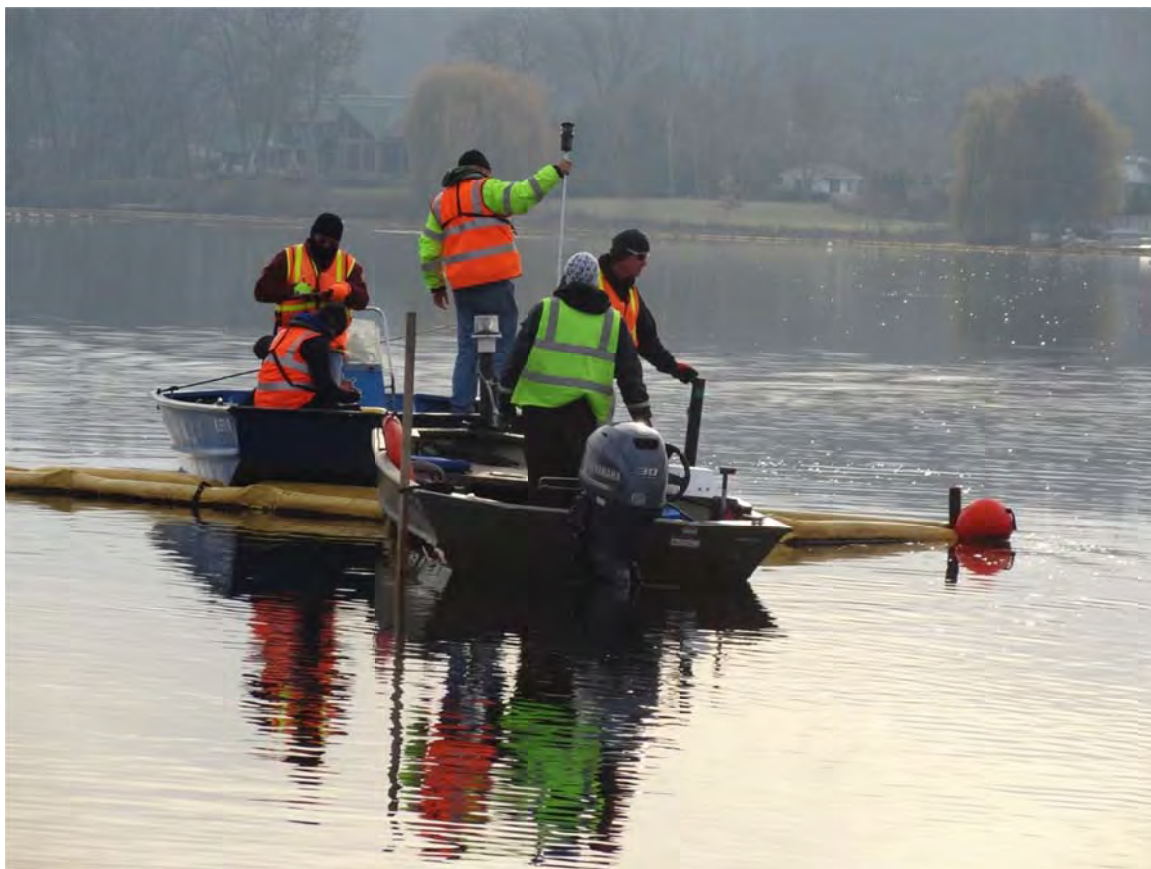
**16. Post-curtain removal bathymetry crew working along boom E in west end of Morrow Lake Delta.**

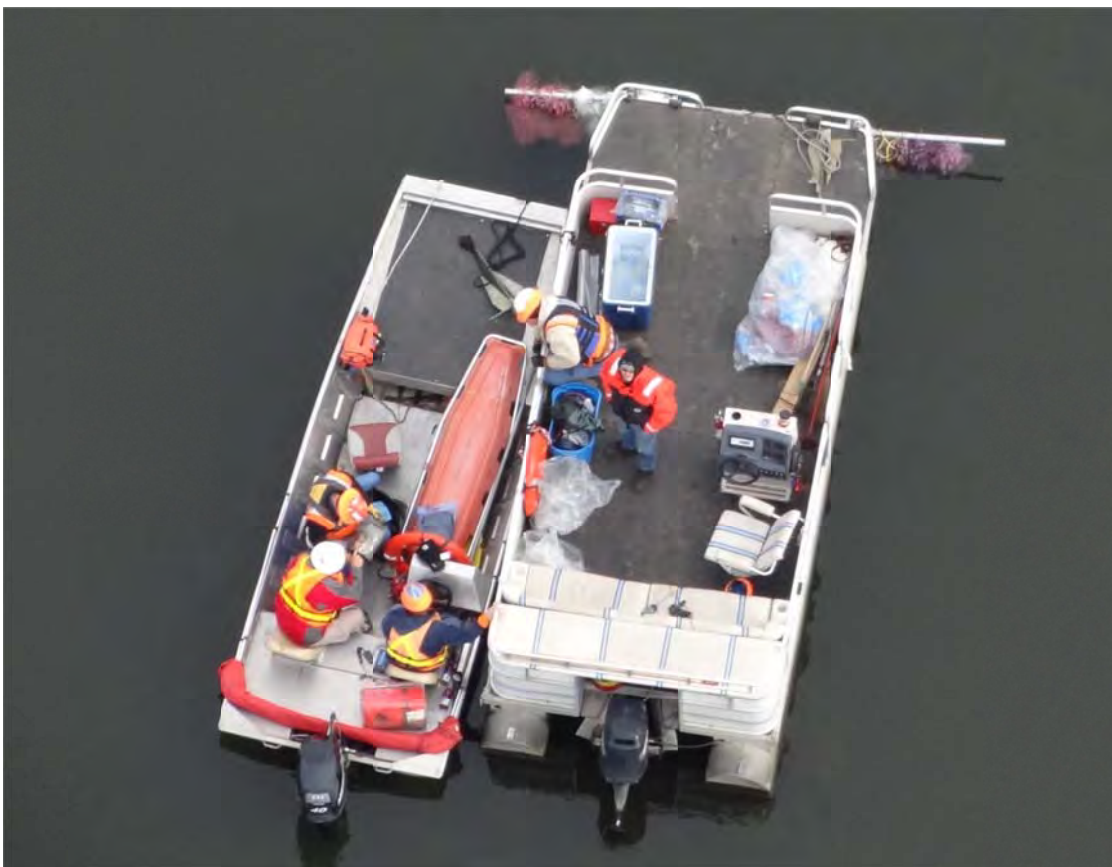
17. Sheen sweeper boat and Health & Safety boat on Morrow Lake.

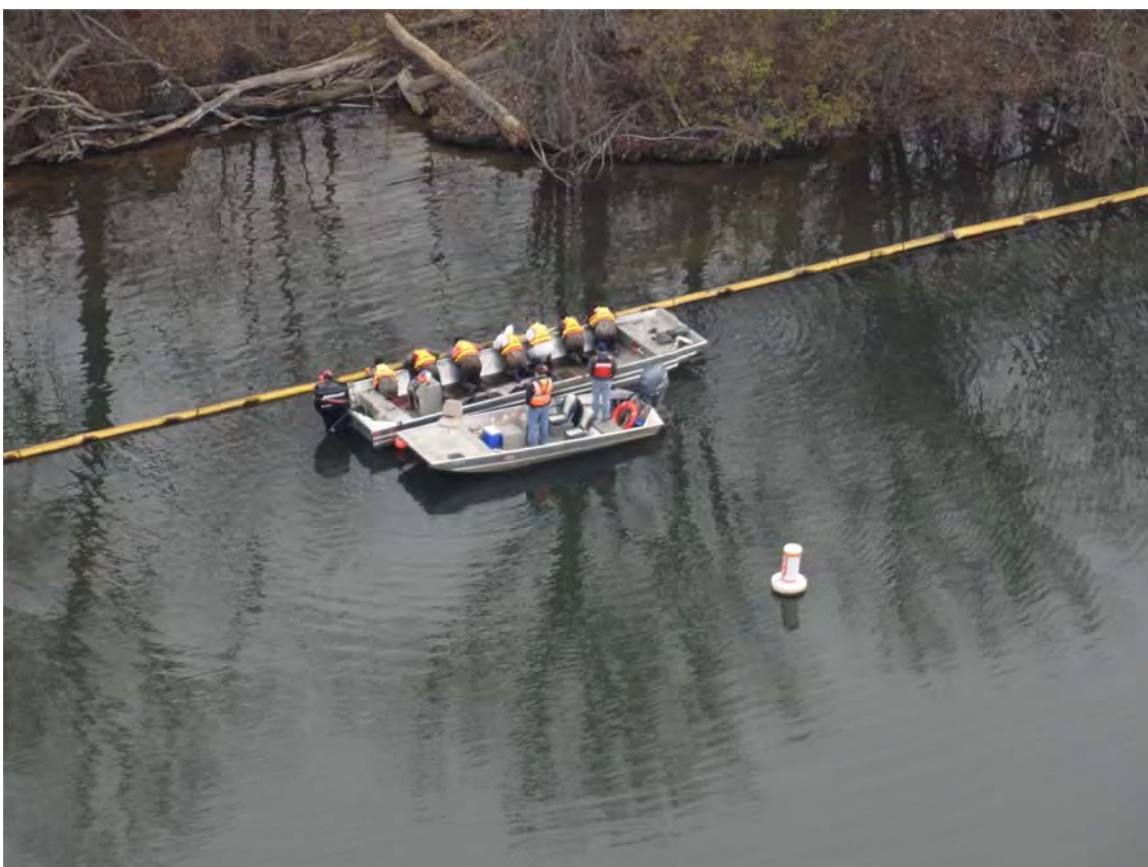
18. Observed crews removing sediment curtain from Boom F in neck of Morrow Lake.

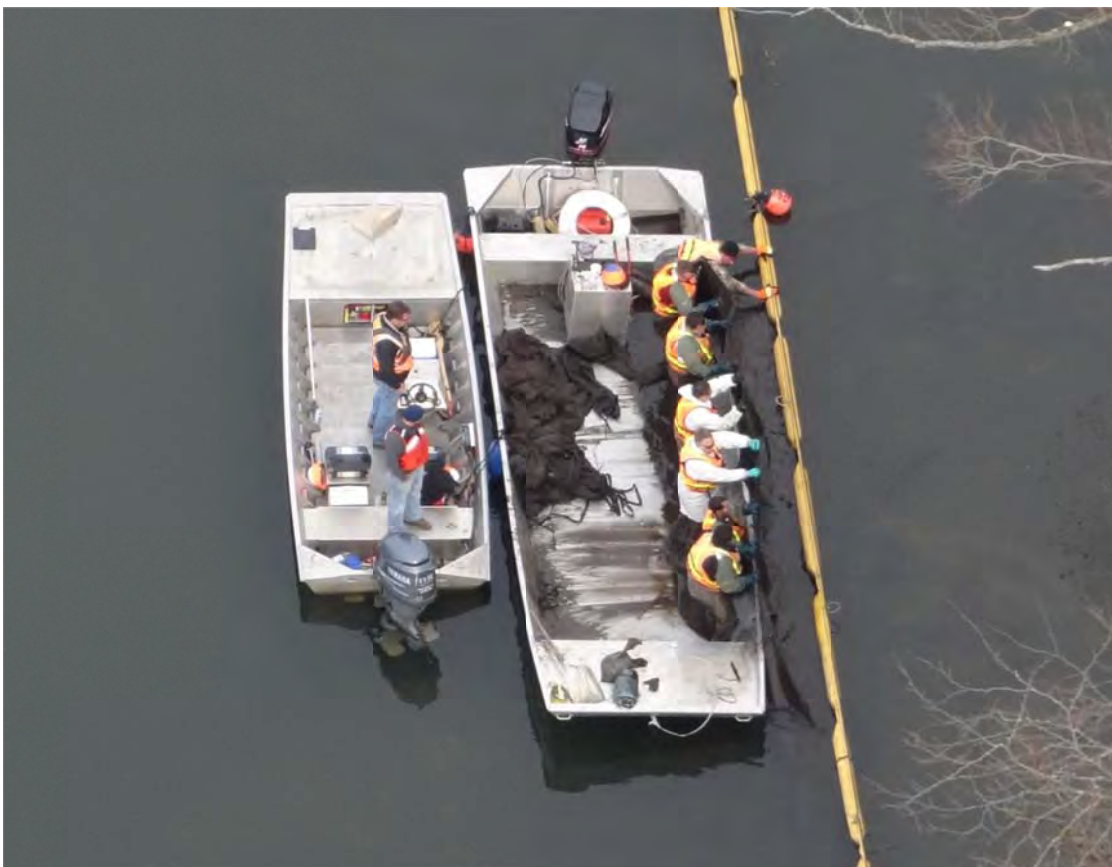
19. Observed crews removing sediment curtain from Boom F in neck of Morrow Lake.

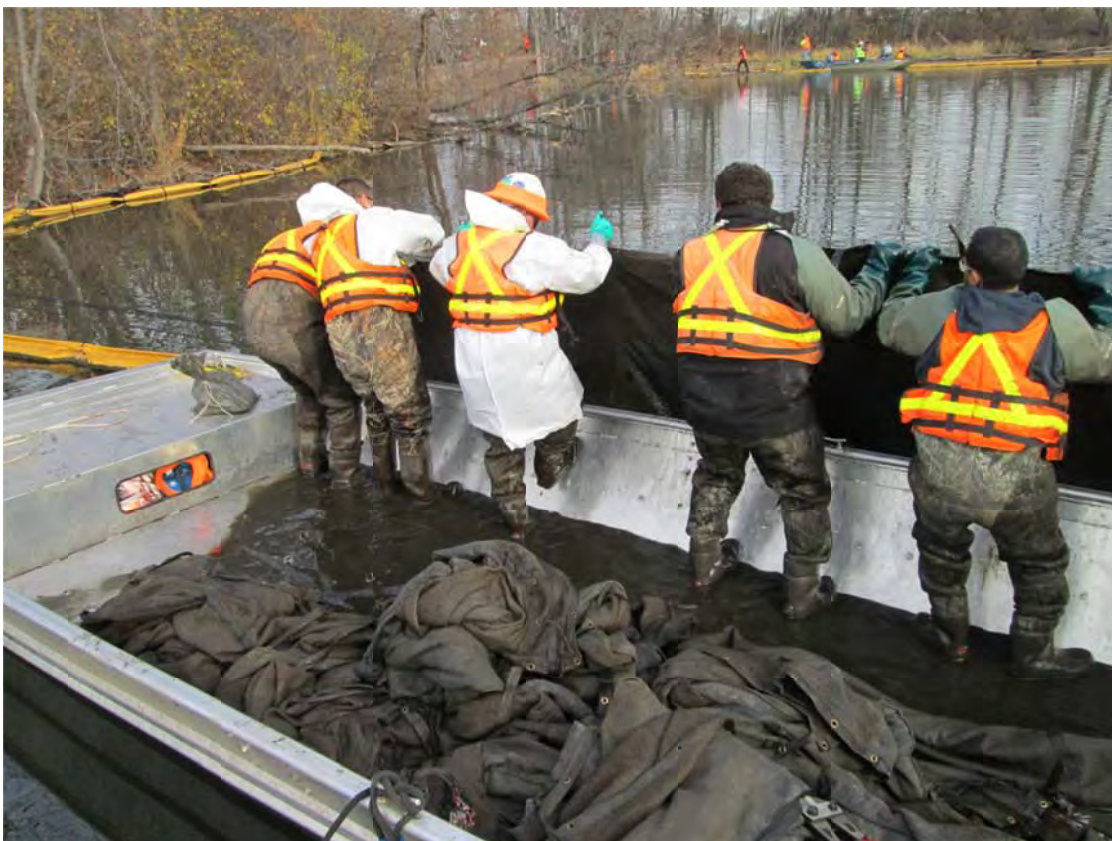
20. Observed crews removing sediment curtain from boom in Morrow Lake.

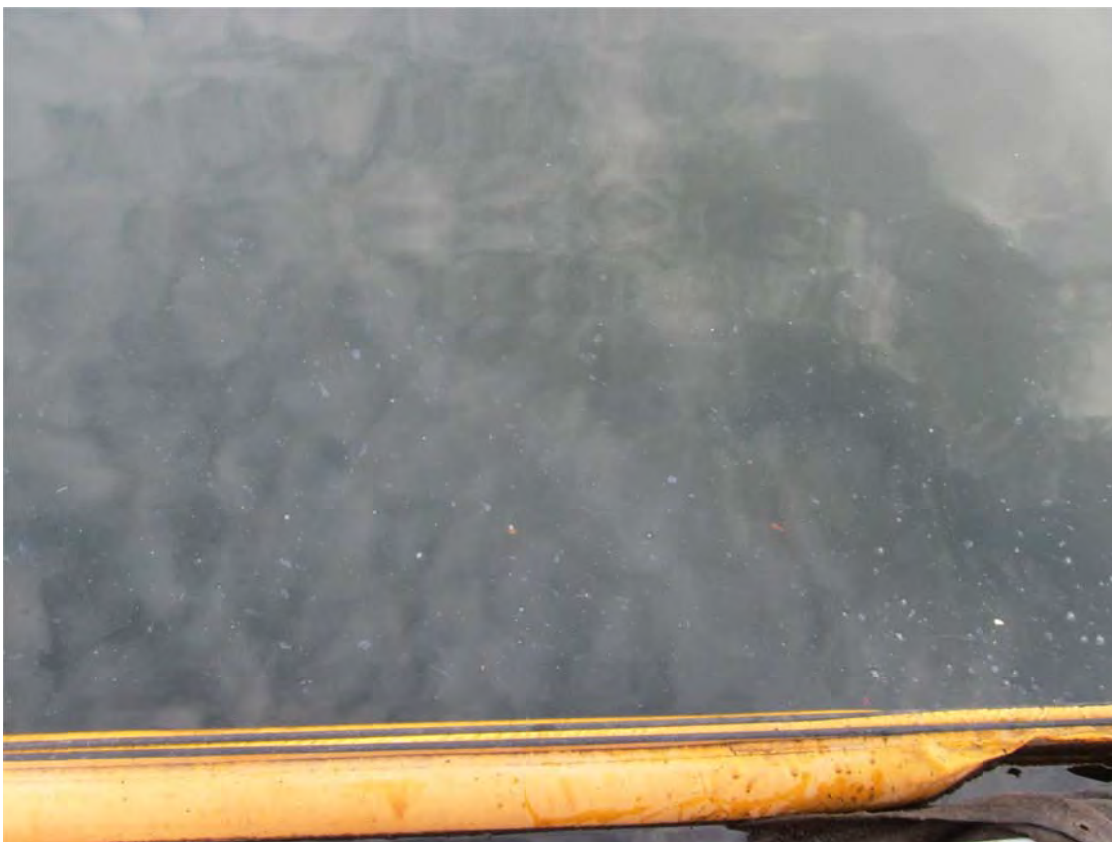
21. Sheen and tar globules generated during sediment curtain removal activities.

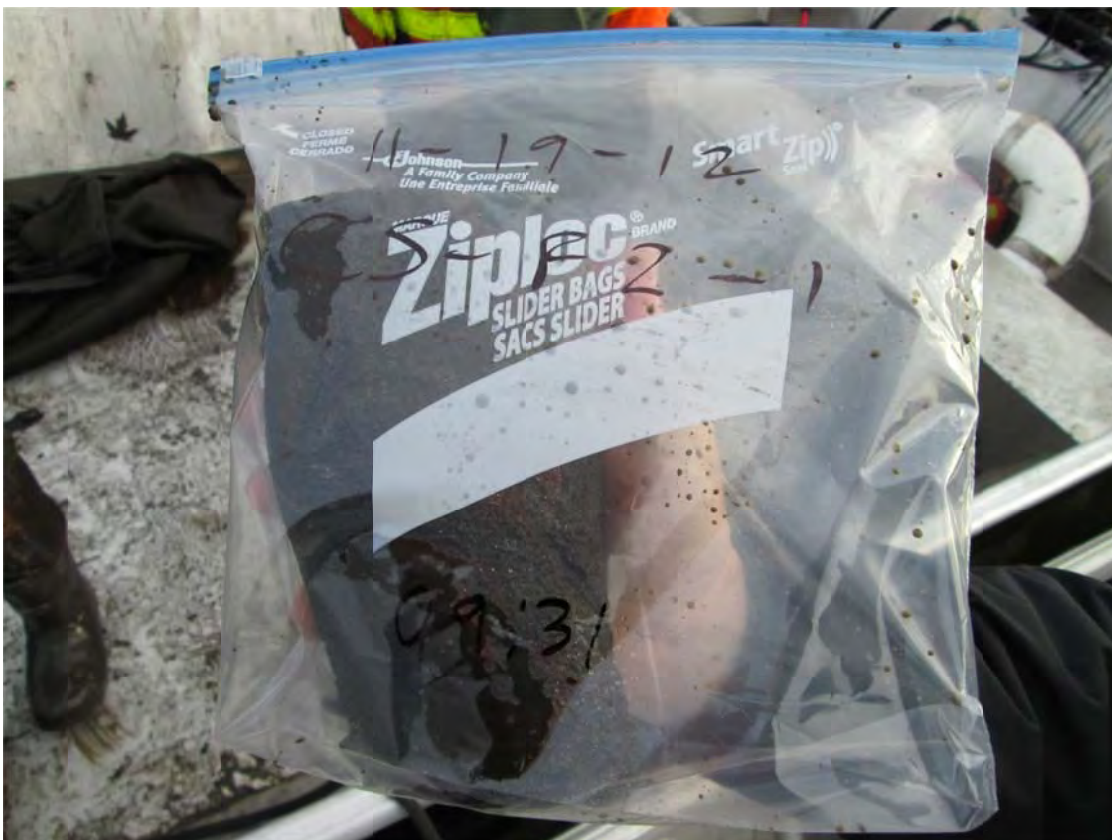
22. Photo of sediment curtain sample collected for analyses during removal activities.

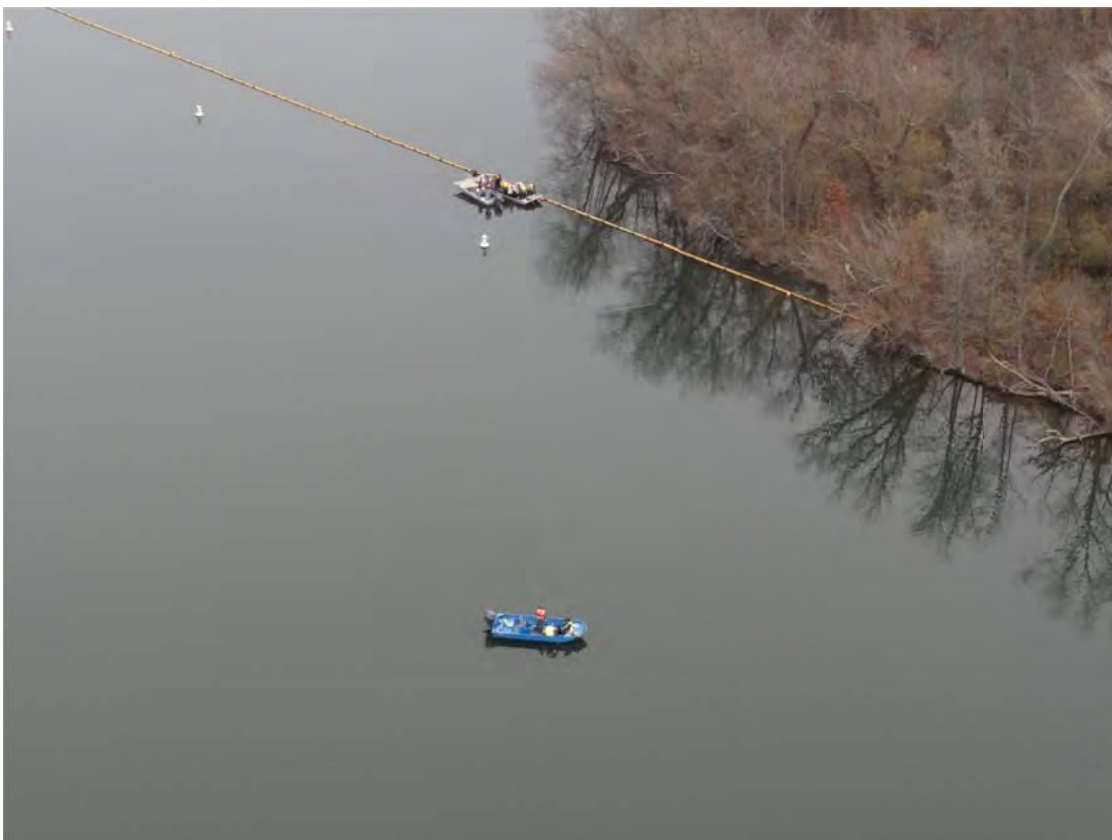
**23. Aerial shot of curtain removal crew and downstream turbidity monitoring crew. No turbidity issues observed during overflight.**
