# Situation Photo Log

Tuesday, November 20, 2012

Kalamazoo River / Enbridge Spill

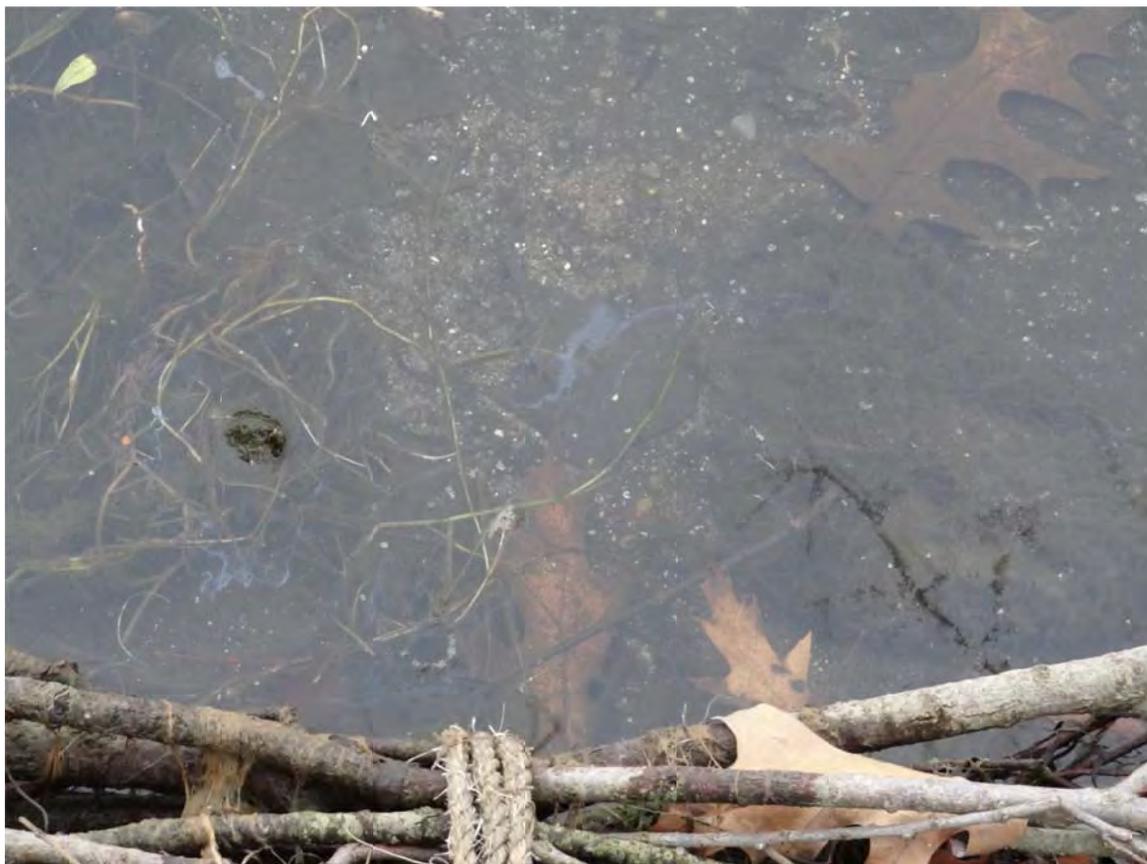
1. Spontaneous sheen observed along the RDB at the C0.4 boat launch water level gauge.

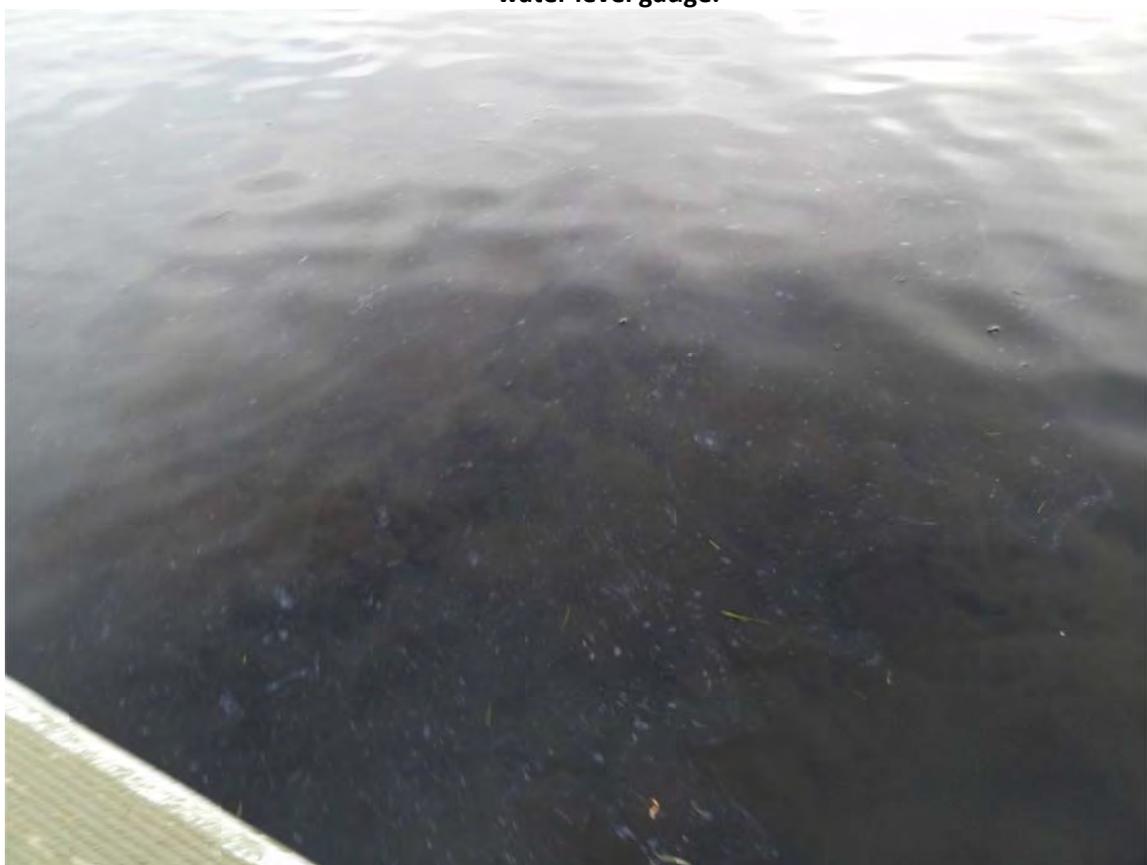
2. MP5.5, boat agitated sheen observed in the river channel just upstream from the Cereco Dam trestle.

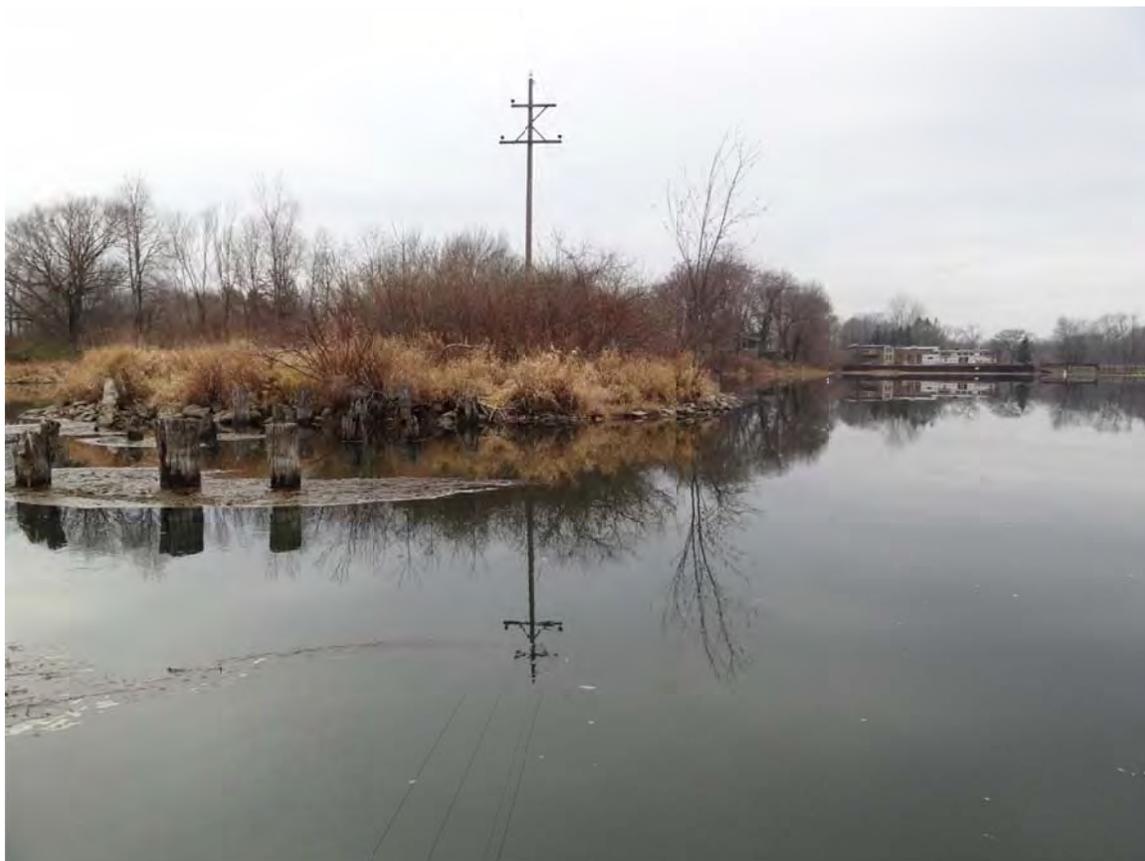
3. Ceresco Dam trestle, no sheen or ice observed.

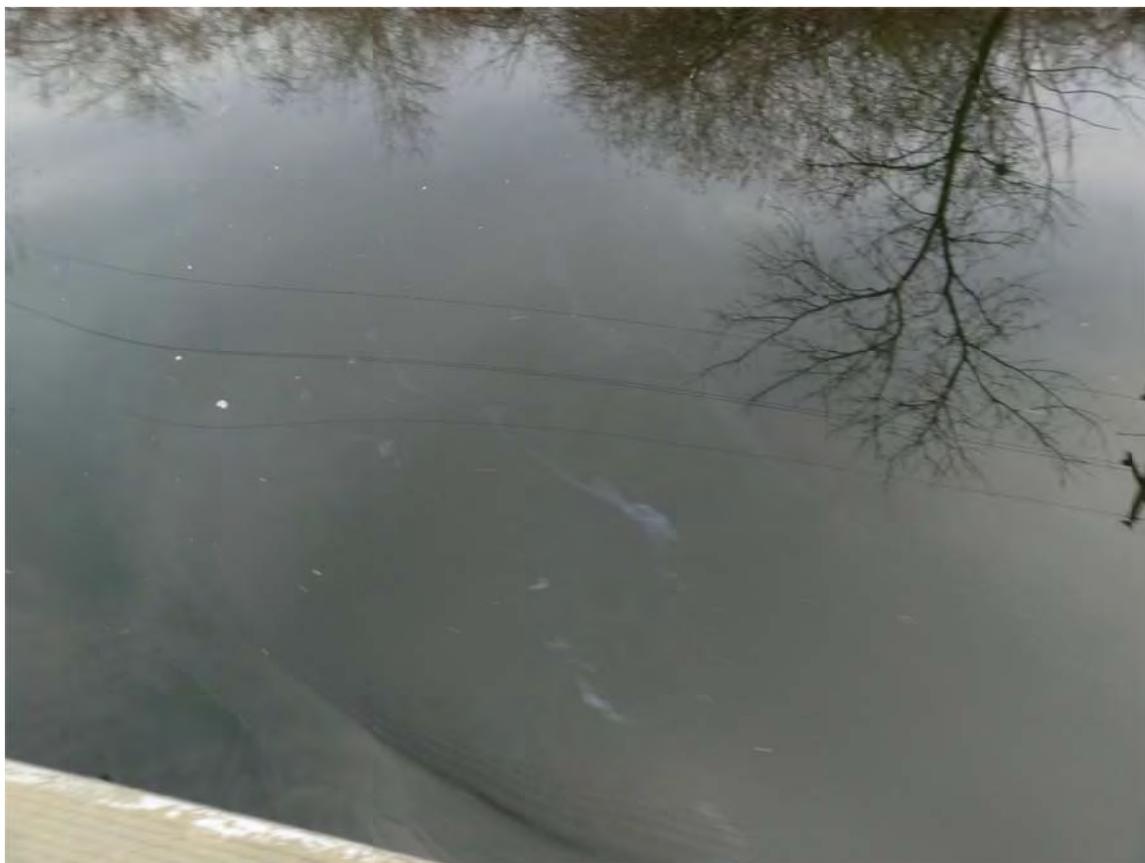
4. MP 5.75 LDB, spontaneous sheen observed just downstream from trestle.

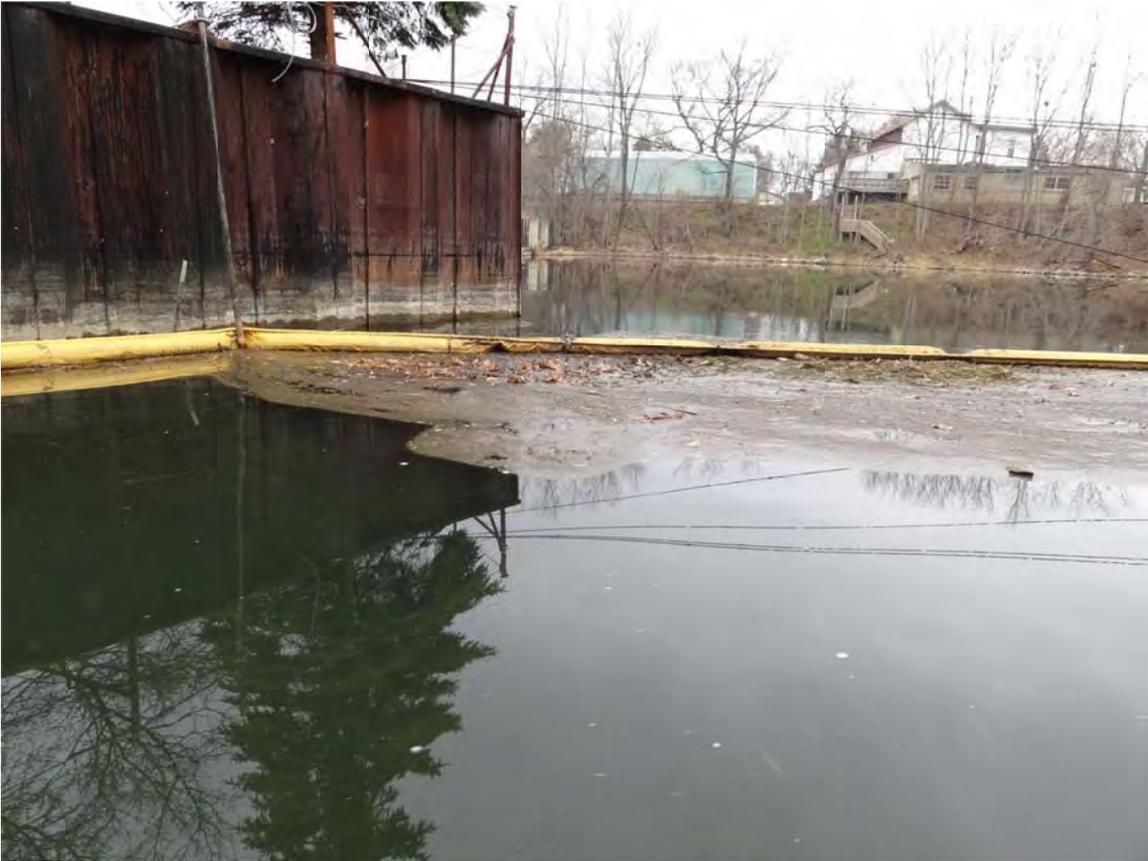
5. Ceresco Dam control point, debris observed within containment.

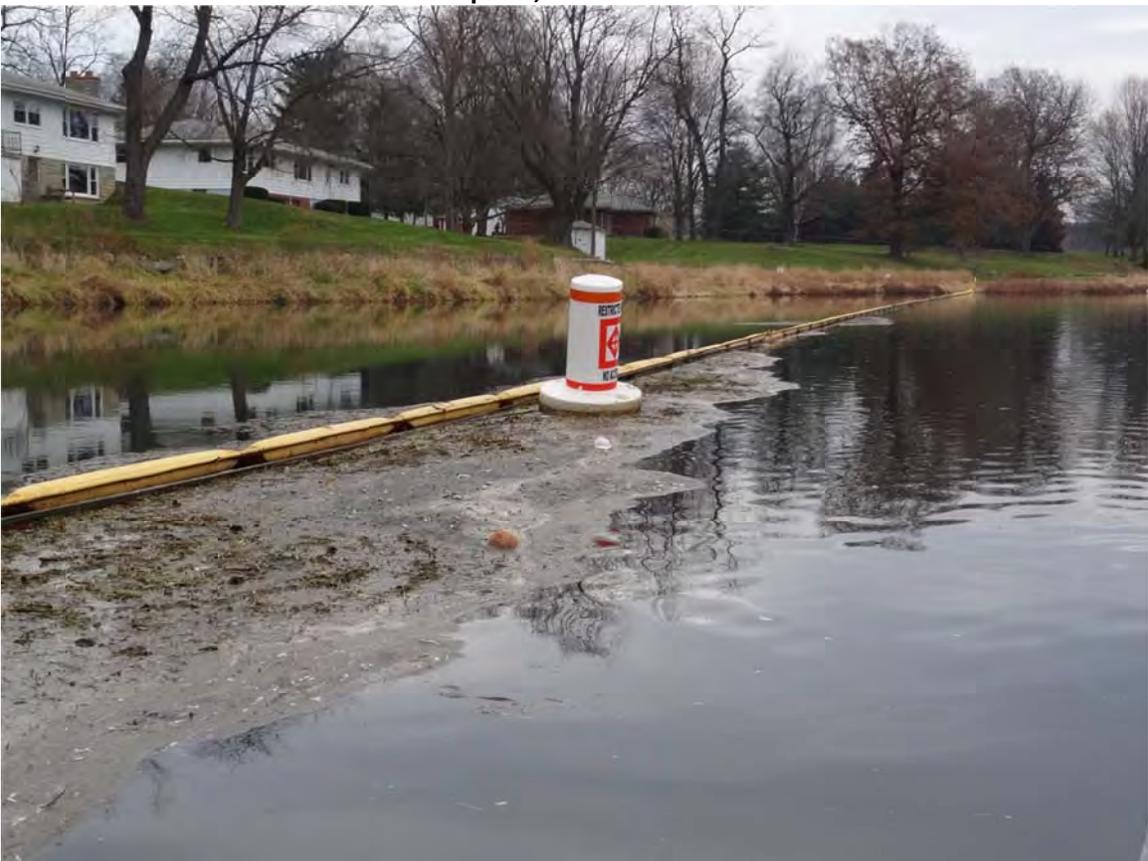
6. Debris observed along Ceresco Dam control point.

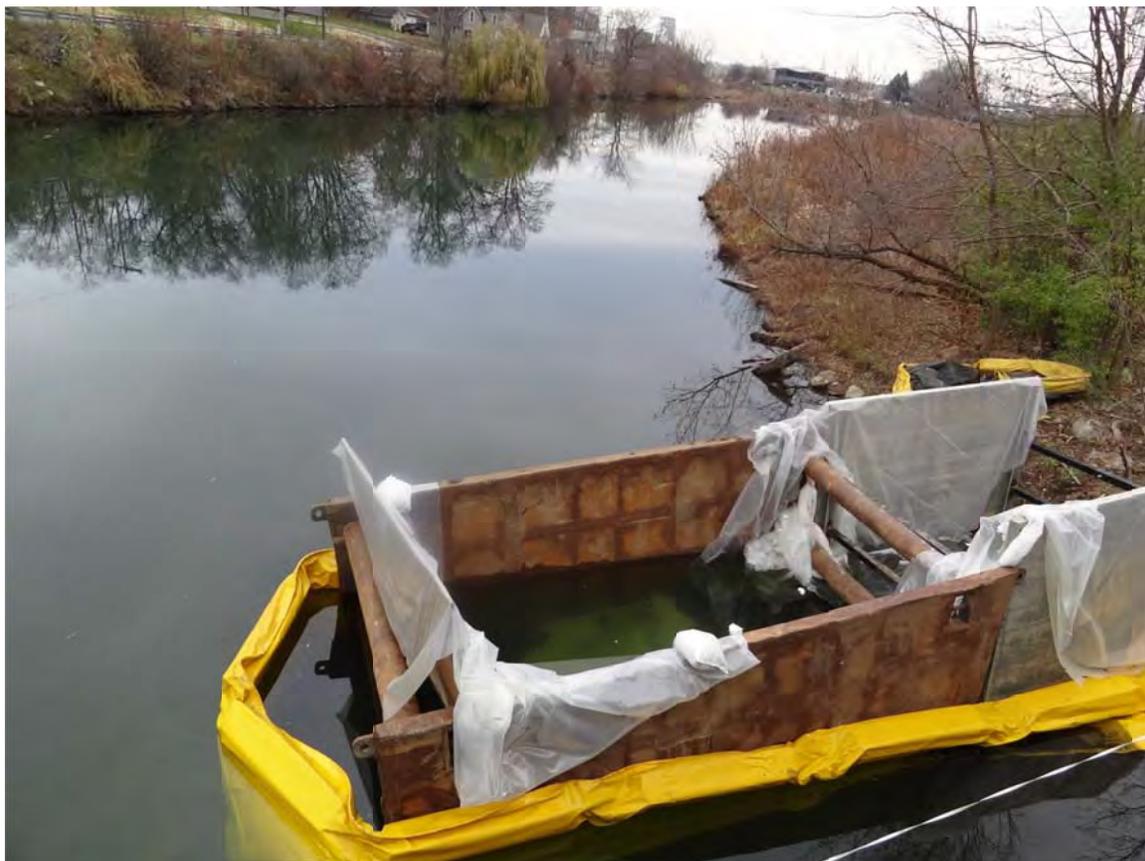
7. MP 15.5 Burnham Street bridge. Excavation trench box used for utility installation still in place on north side of bridge.

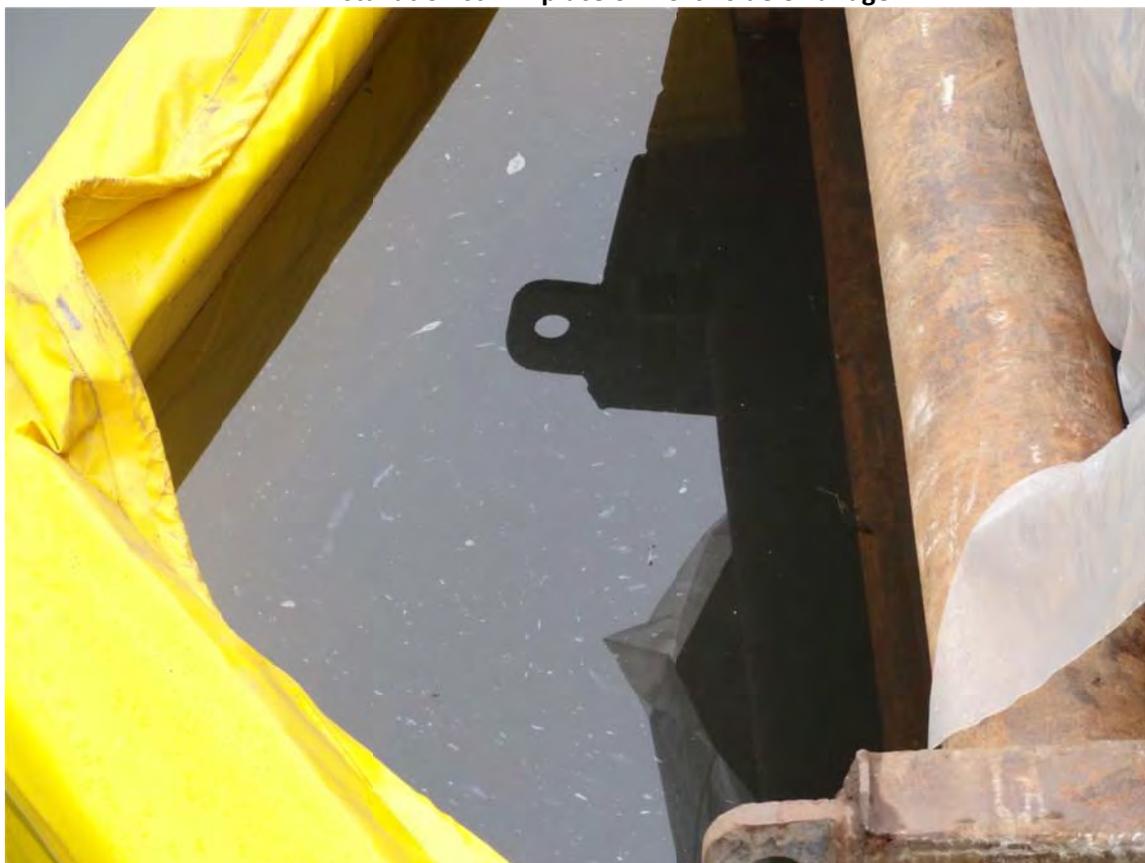
8. MP15.5, sheen observed within containment boom around excavation trench box.

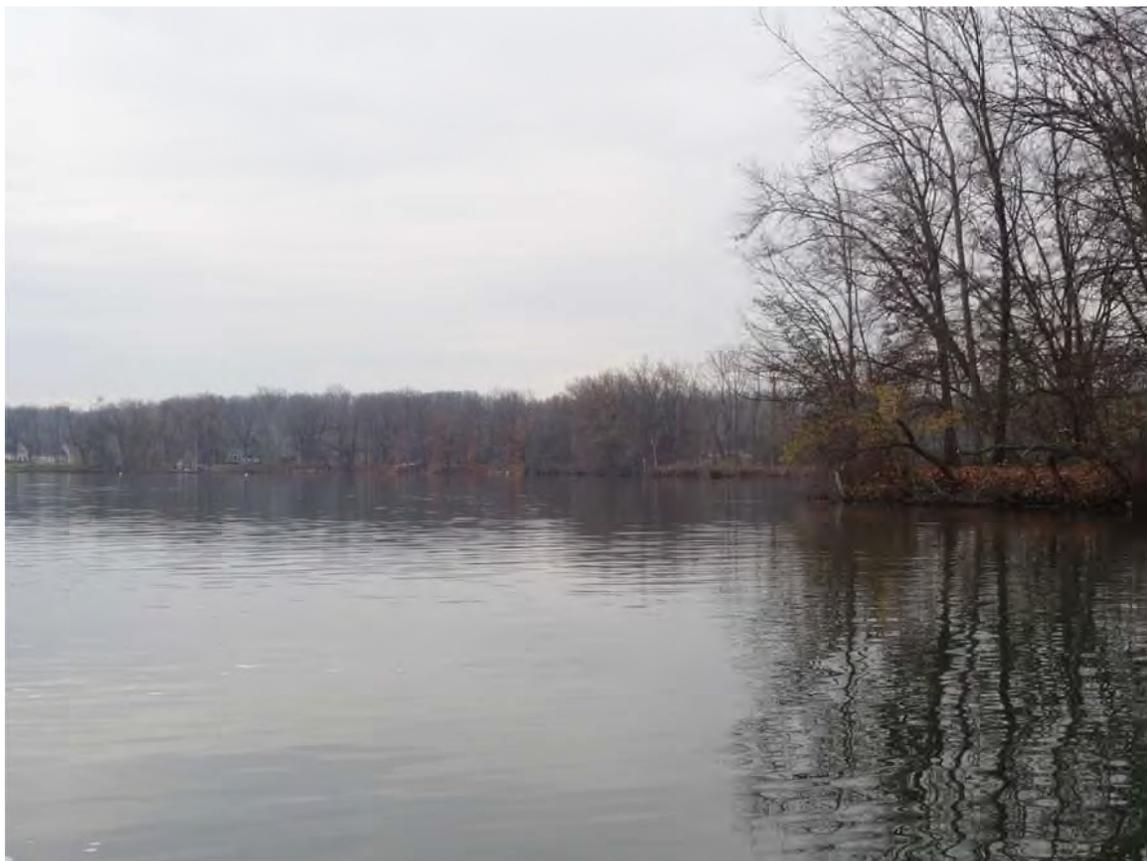
9. Southwest corner of Morrow Lake Delta, booms A, B, C1 and C2 have been removed.

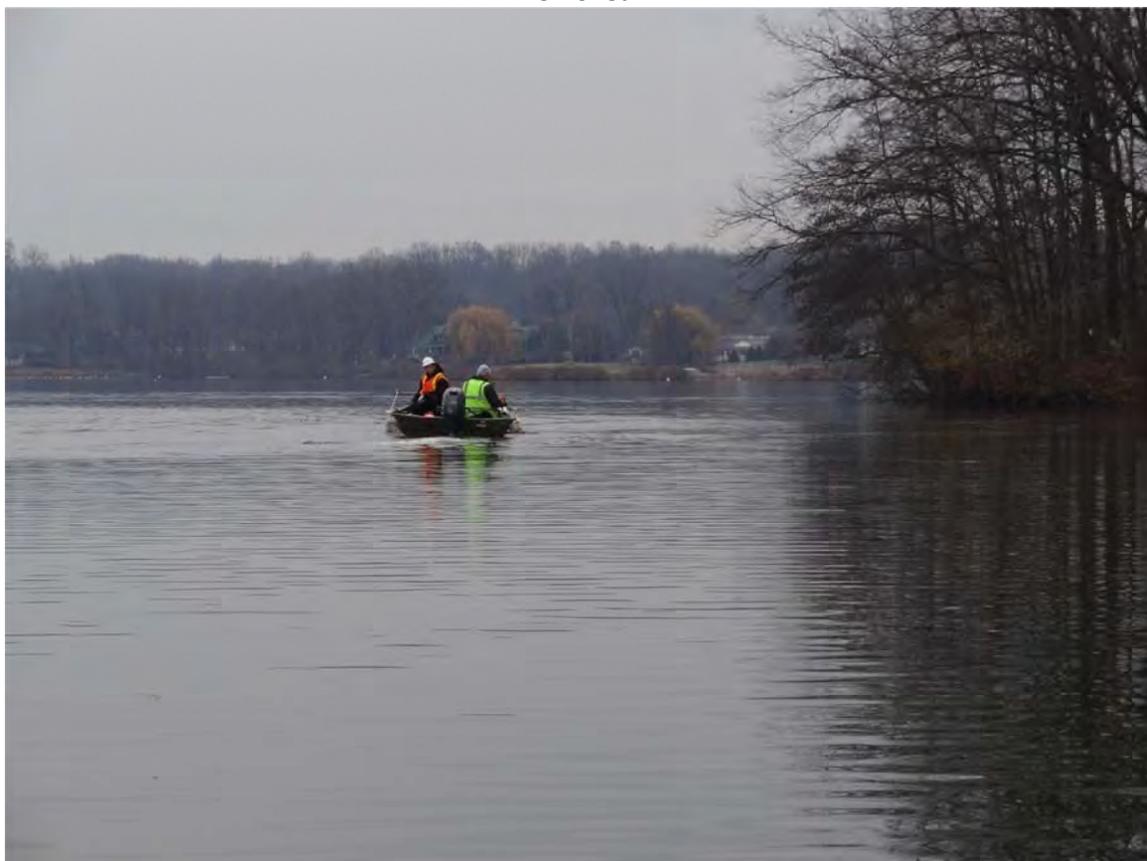
10. Sheen sweeper boat observed in the western end of Morrow Lake Delta.

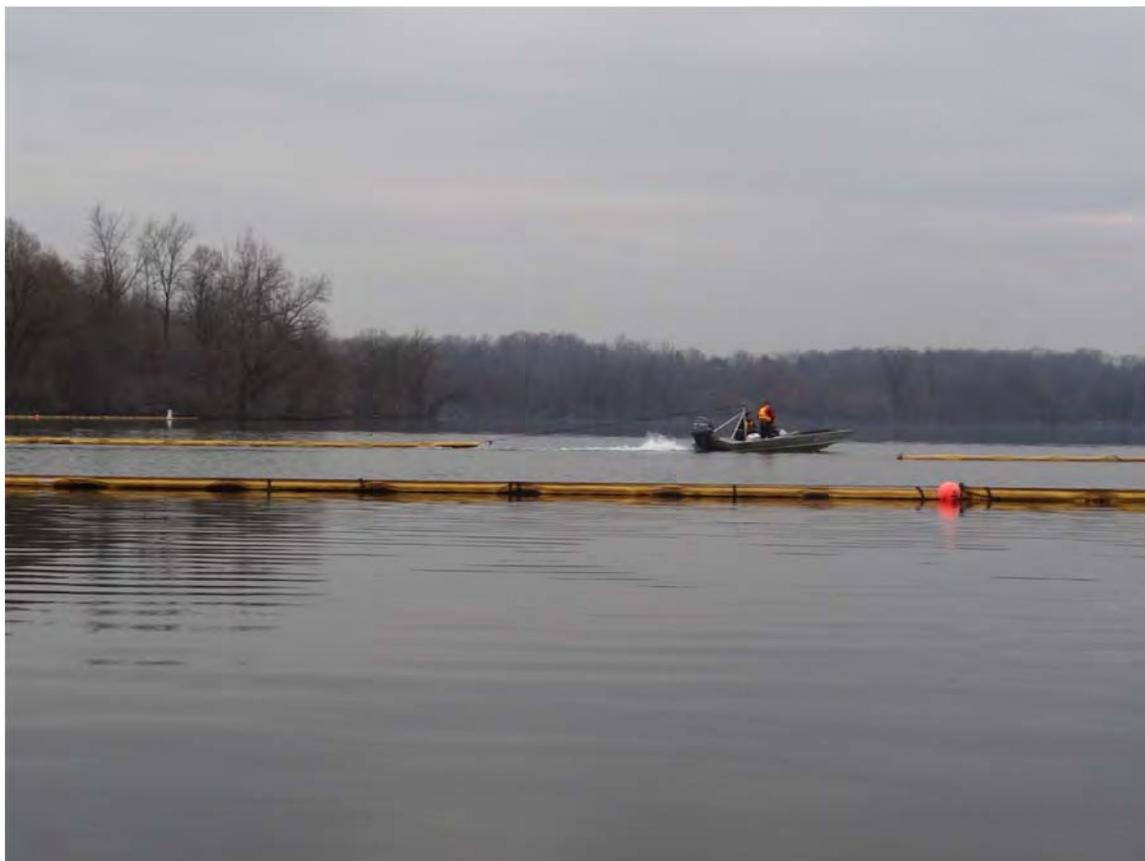
11. Crews towing boom into E4 boat launch for removal.

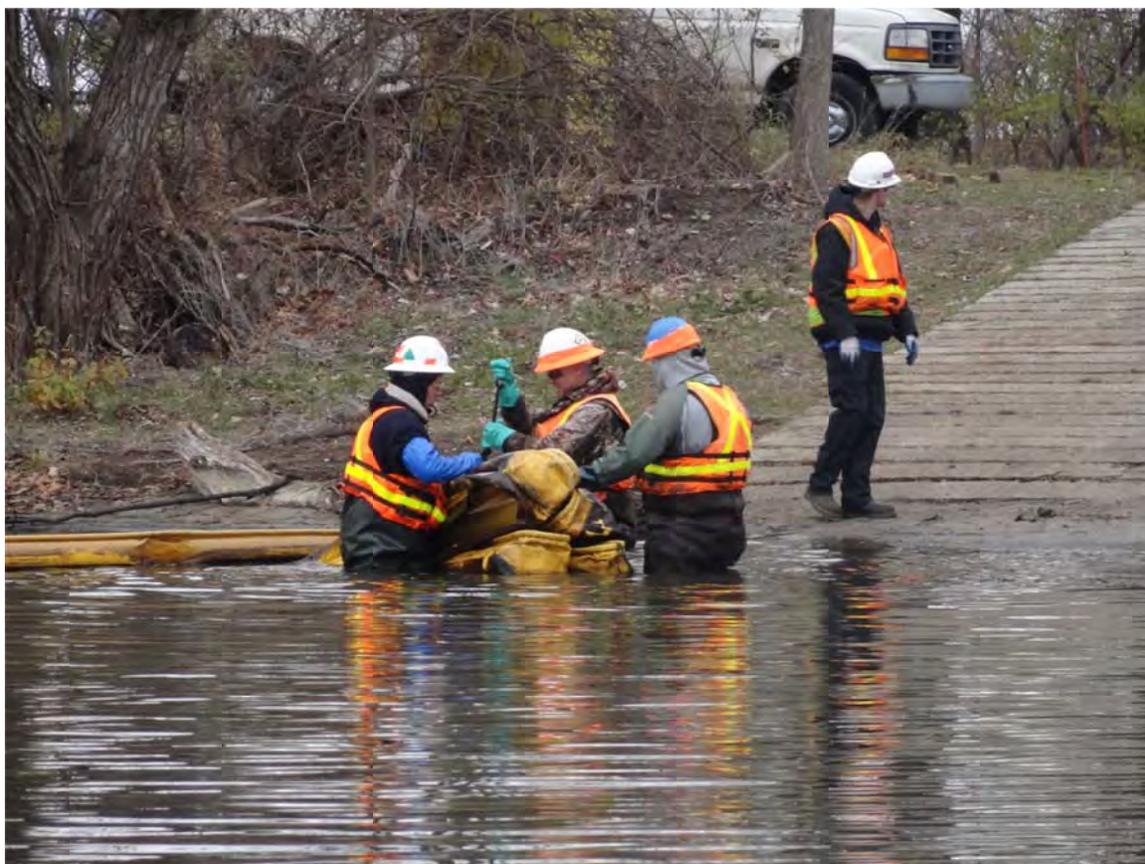
12. Crews dismantling containment boom and tying it up for disposal.

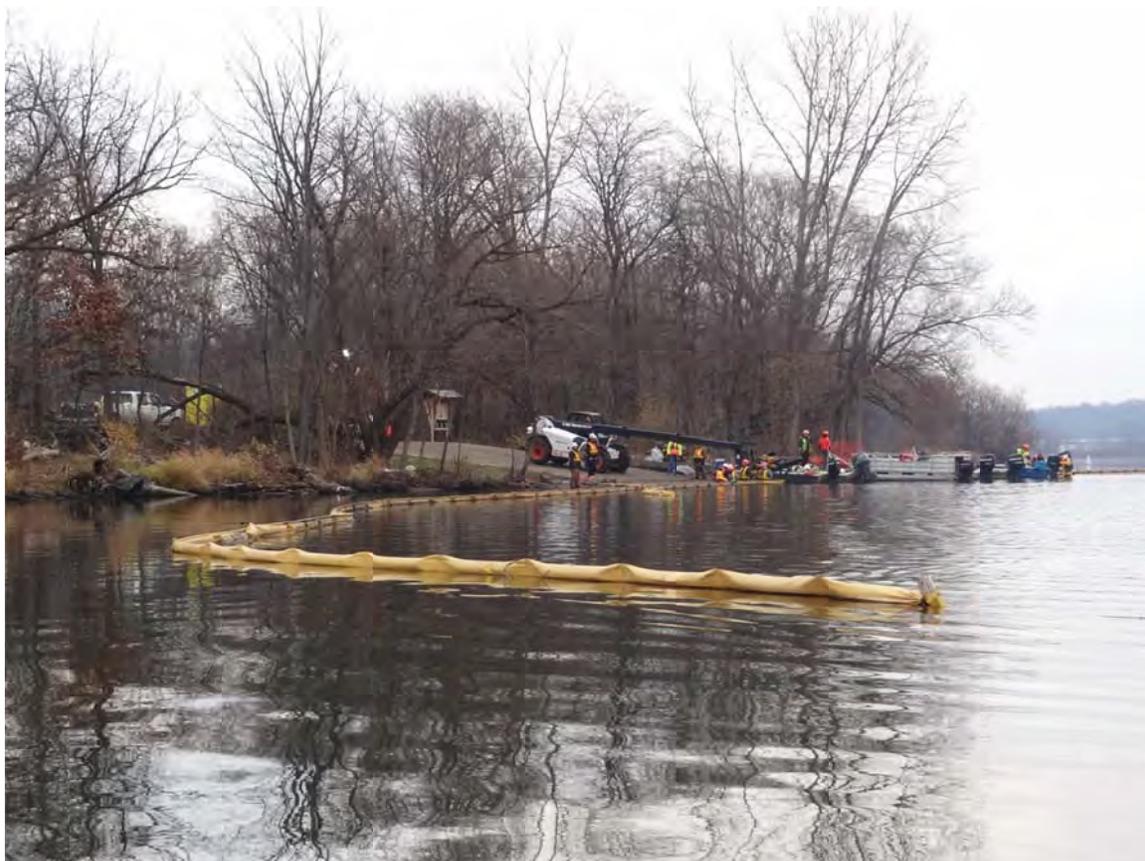
13. View of containment boom staged at boat launch for removal.

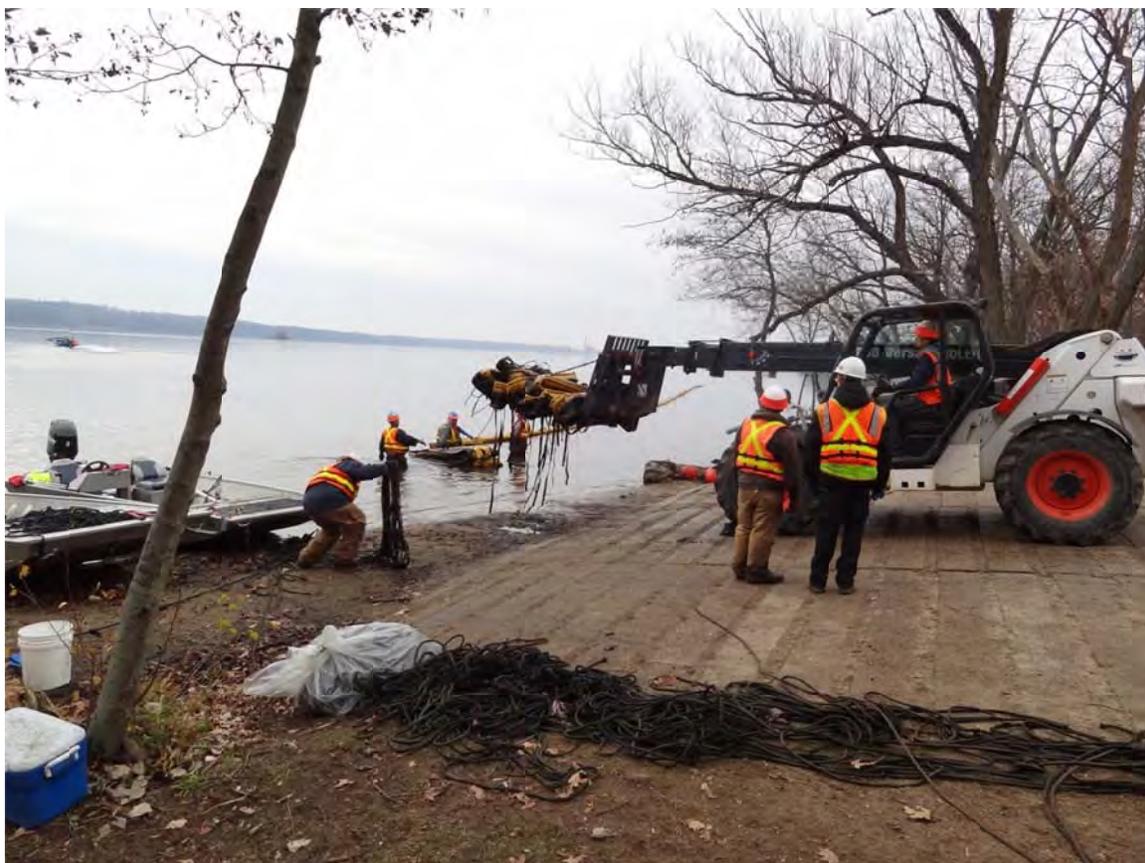
14. Crews loading up containment boom bundles for placement in roll-off box.

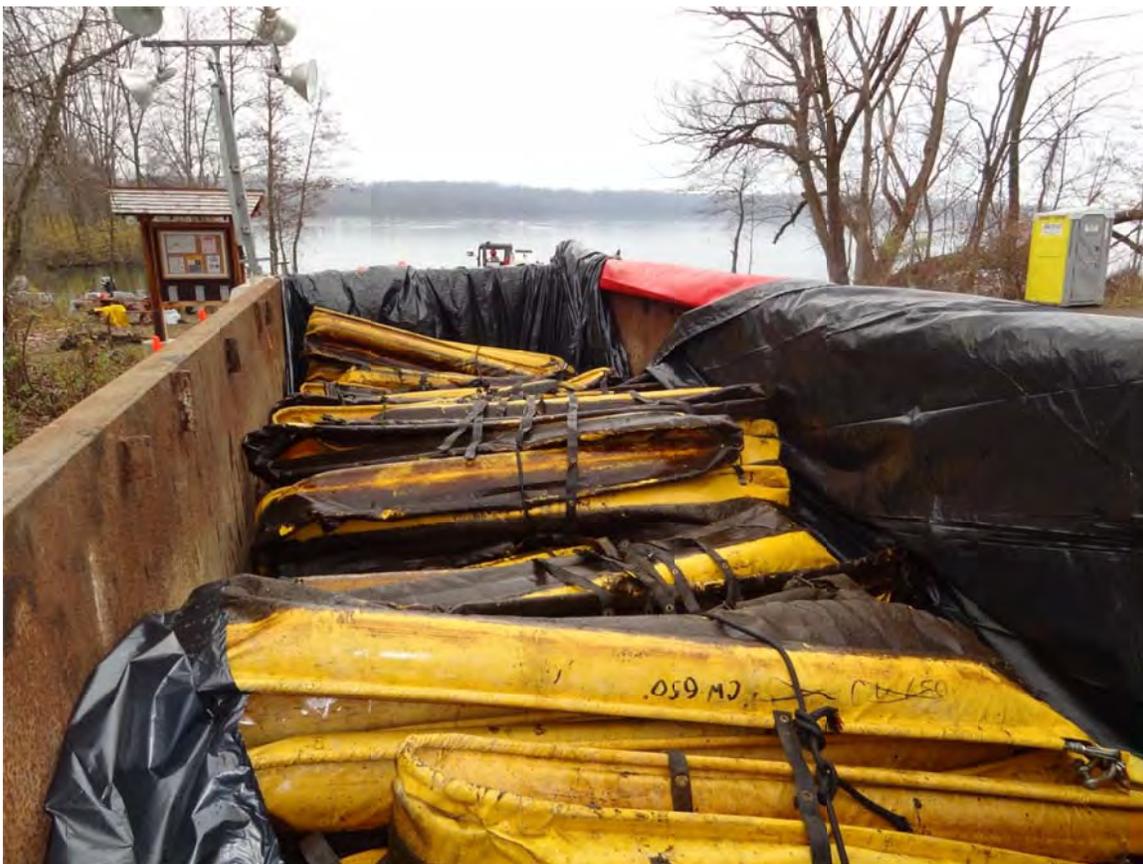
15. Containment boom placed in roll-off box for transport & disposal.

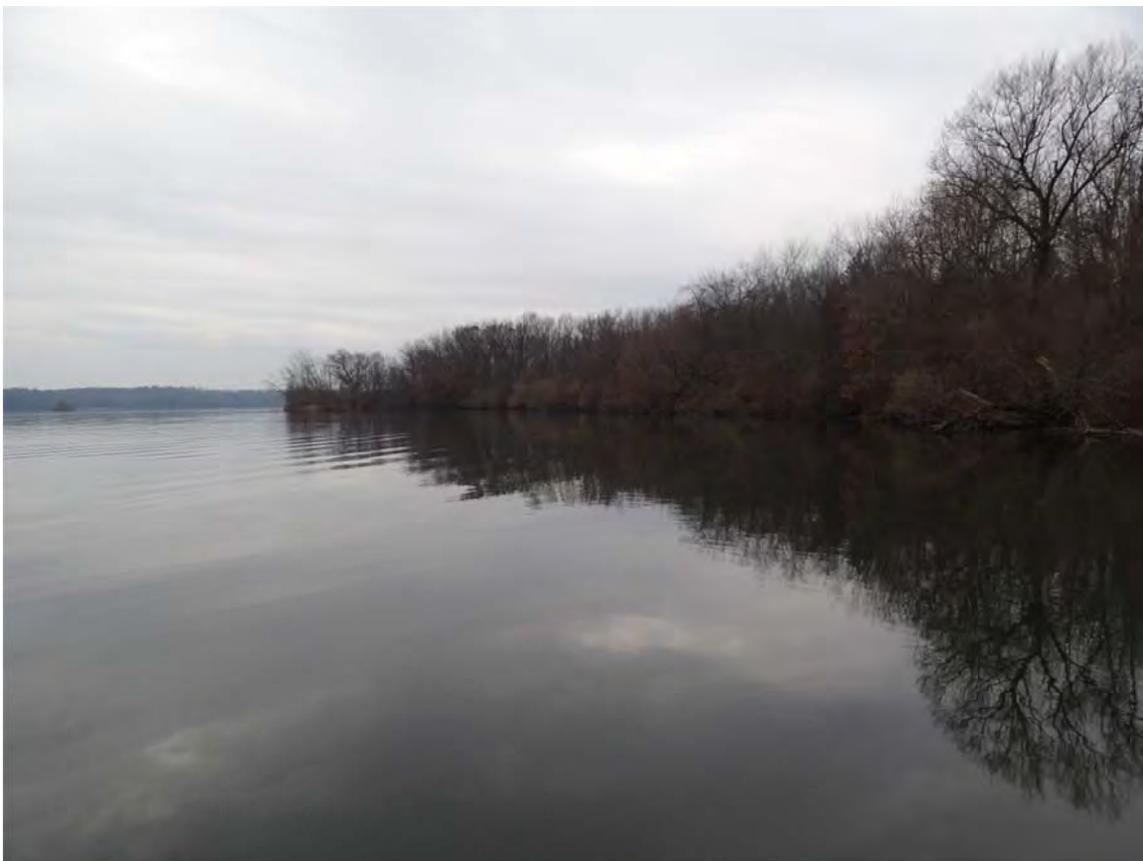
16. North cove of Morrow Lake, no sheen or ice observed.
