Situation Photo Log

Wednesday, November 21, 2012

Kalamazoo River / Enbridge Spill

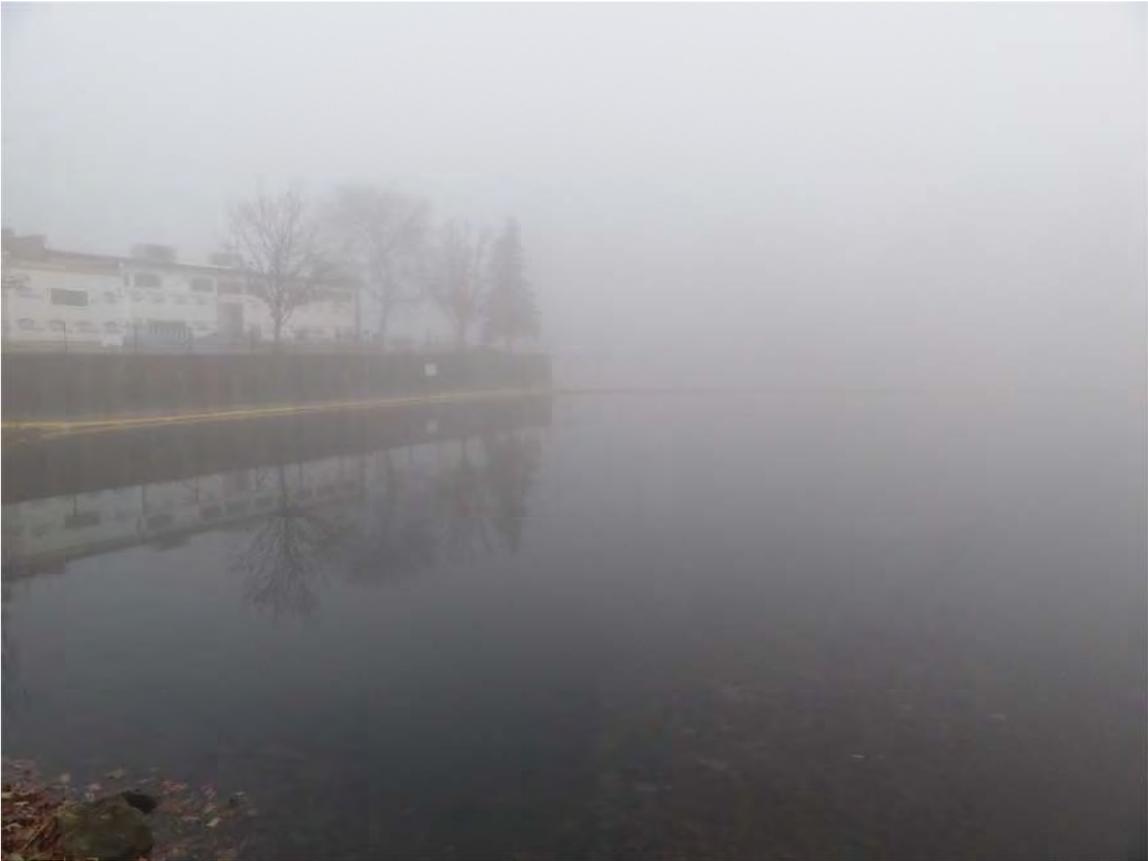
1. Morning fog at Ceresco Dam. Water operations were postponed in the morning until approximately 09:30 am due to low visibility.

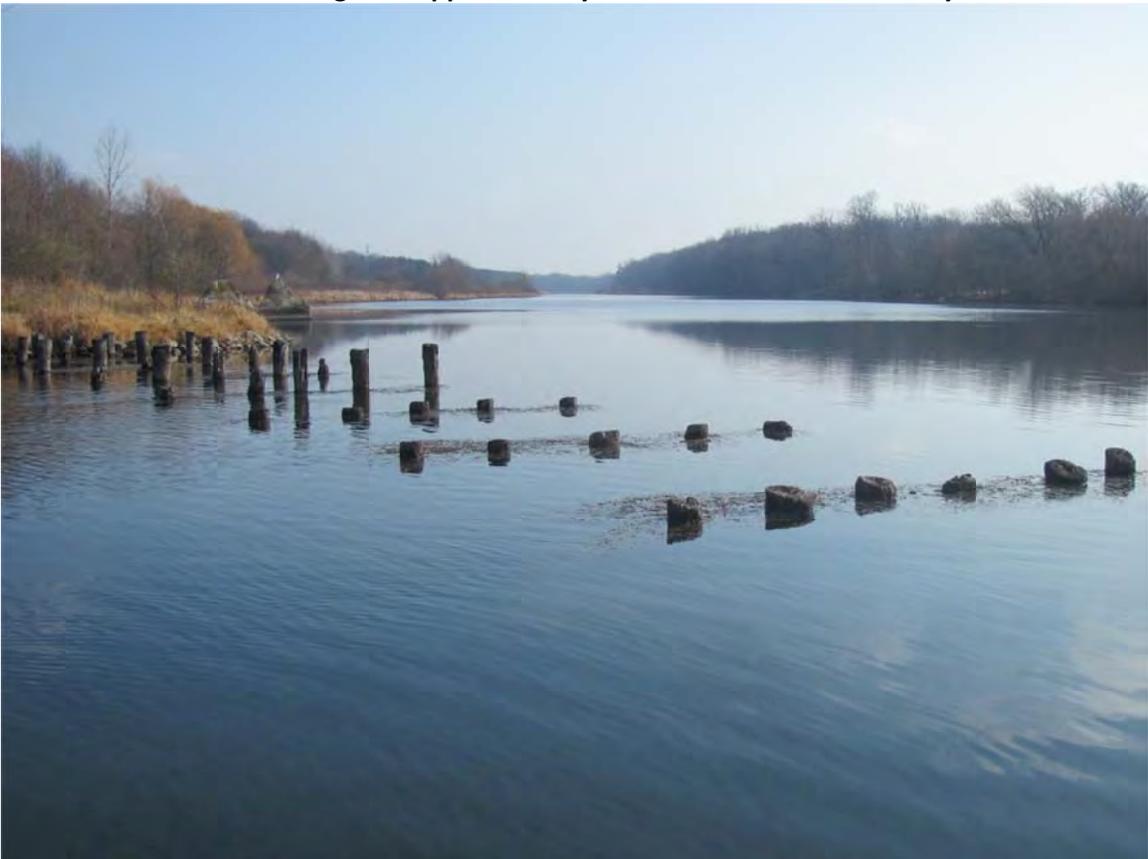
2. MP5.75 trestle following resumption of activities, no sheen or ice observed here.

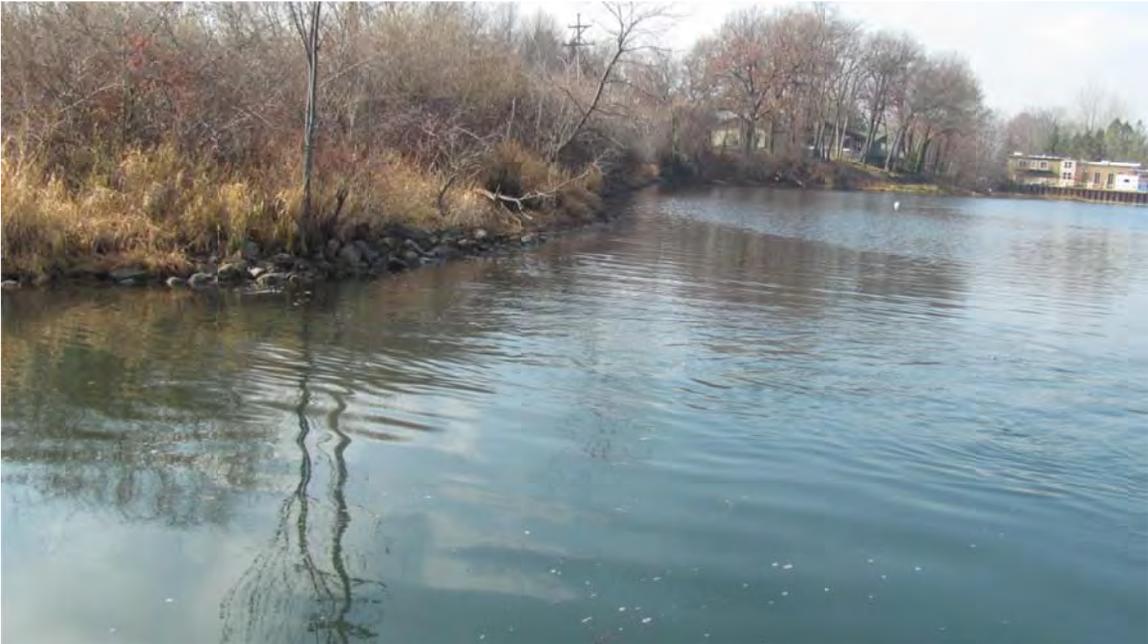
3. LDB below Ceresco Dam trestle, no sheen or ice observed.

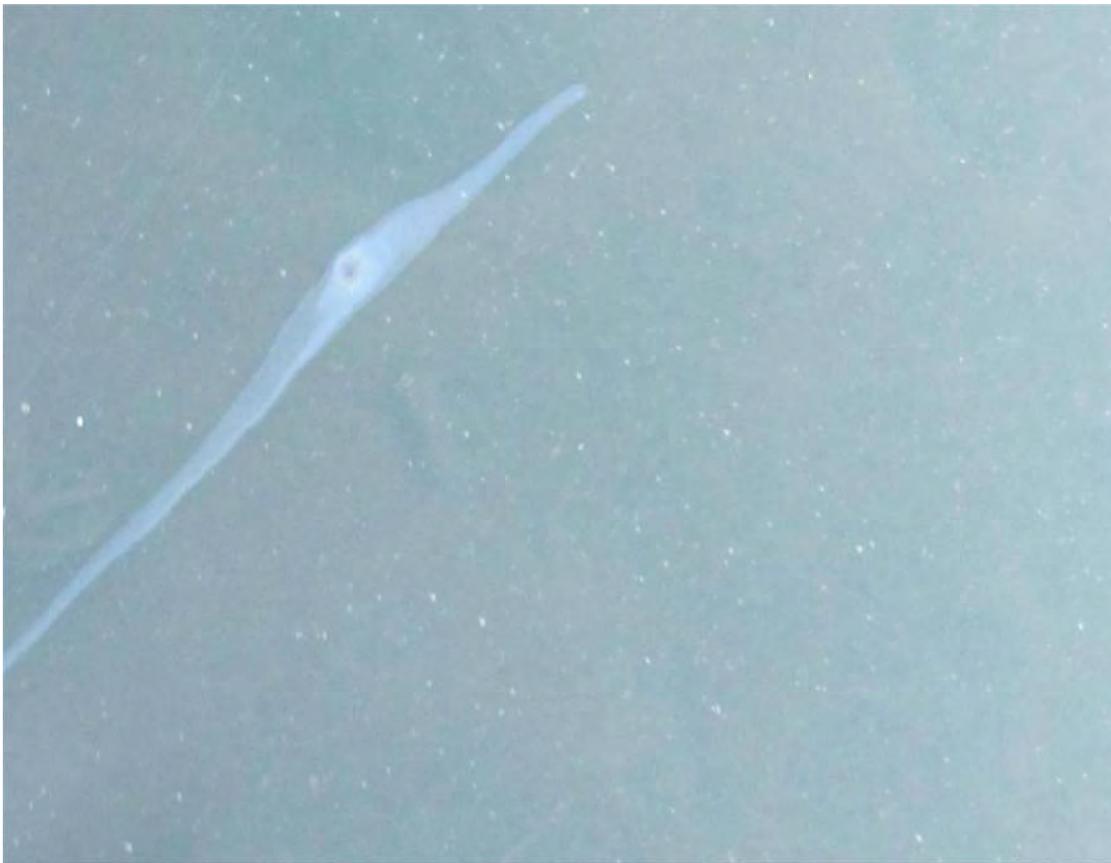
4. Ceresco Dam containment boom, tar globule and sheen observed.
Quantity did not warrant a sheen response.

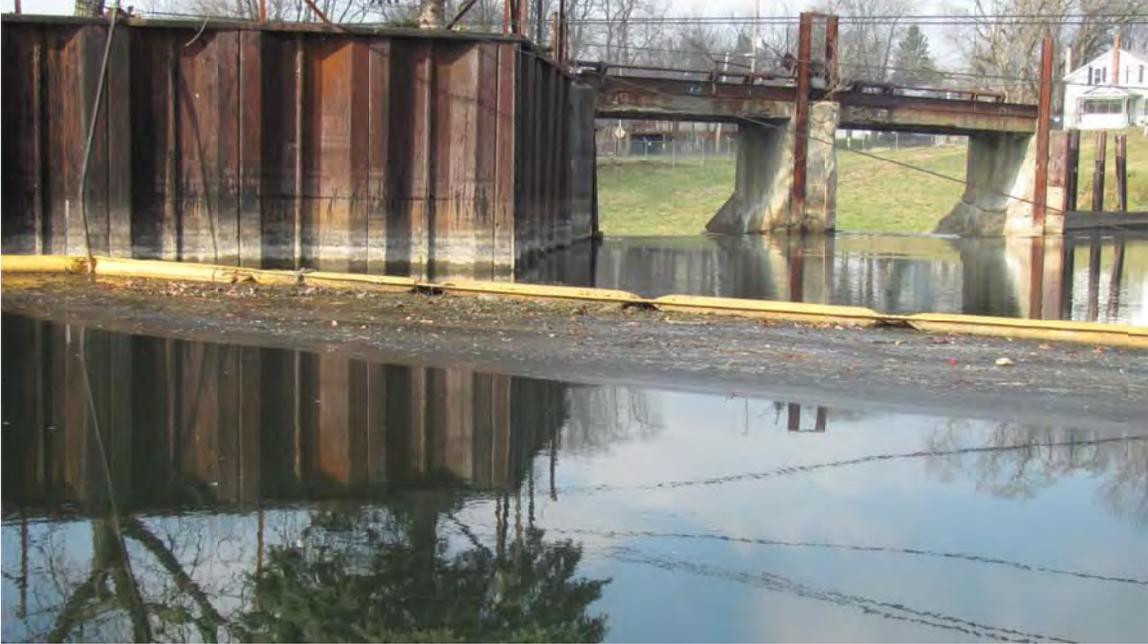
5. Ceresco Dam control point, debris observed within containment.

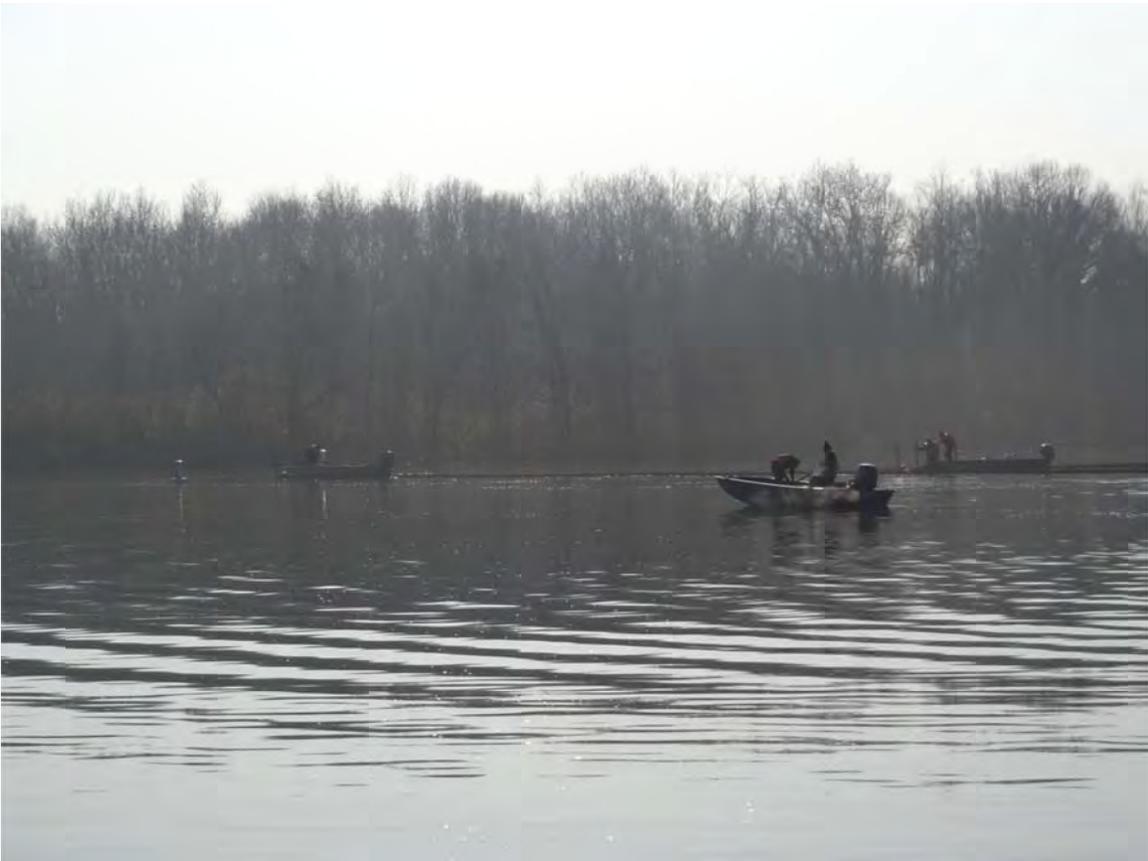
6. Morrow Lake neck, crews observed disconnecting boom from configuration F.

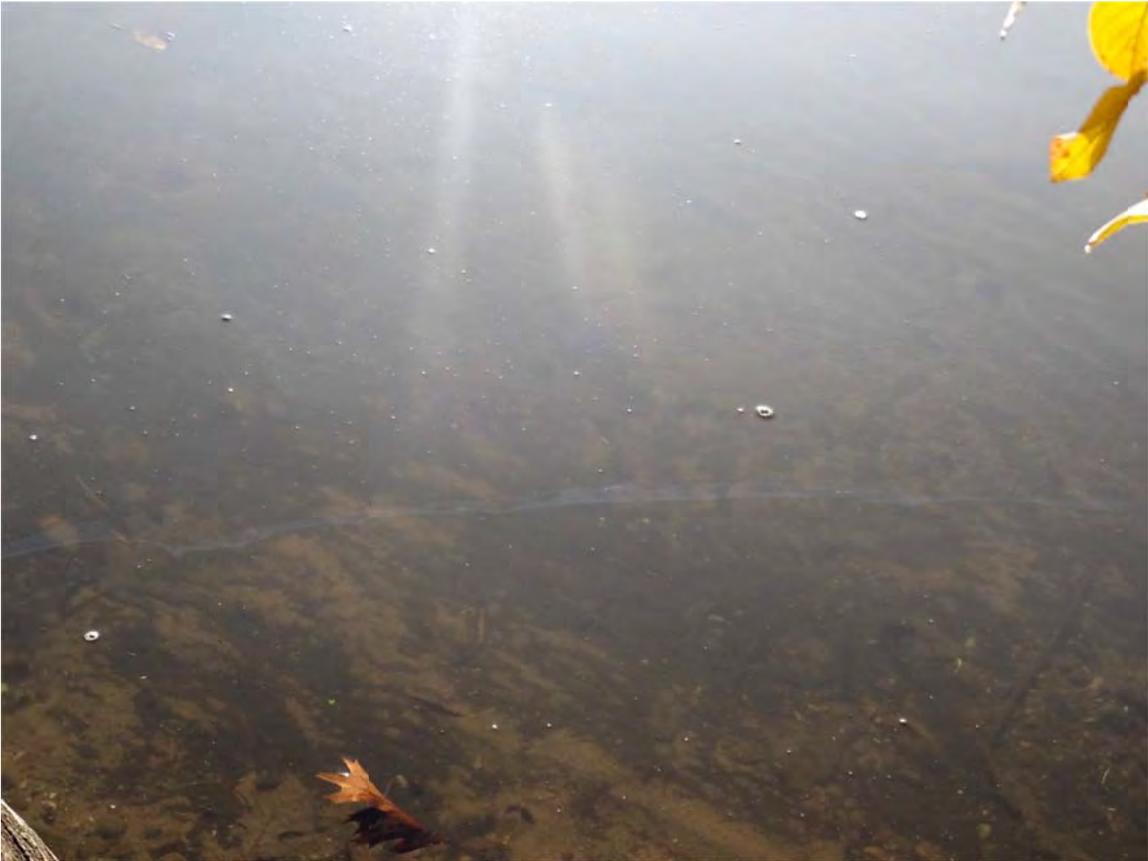
7. Former E4.0 control point location, sheen ribbon observed along RDB.

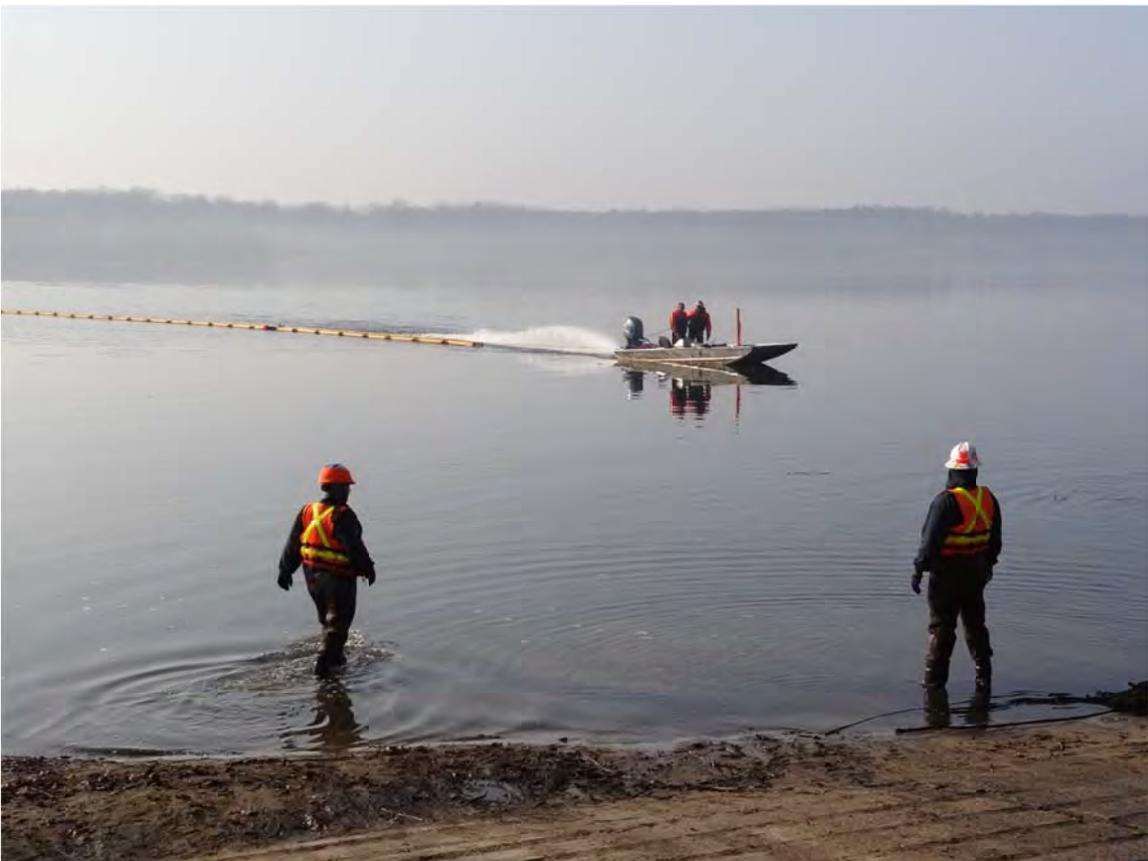
8. E4.0 boat launch, crews towing boom from configuration F in to boat launch for removal from lake.

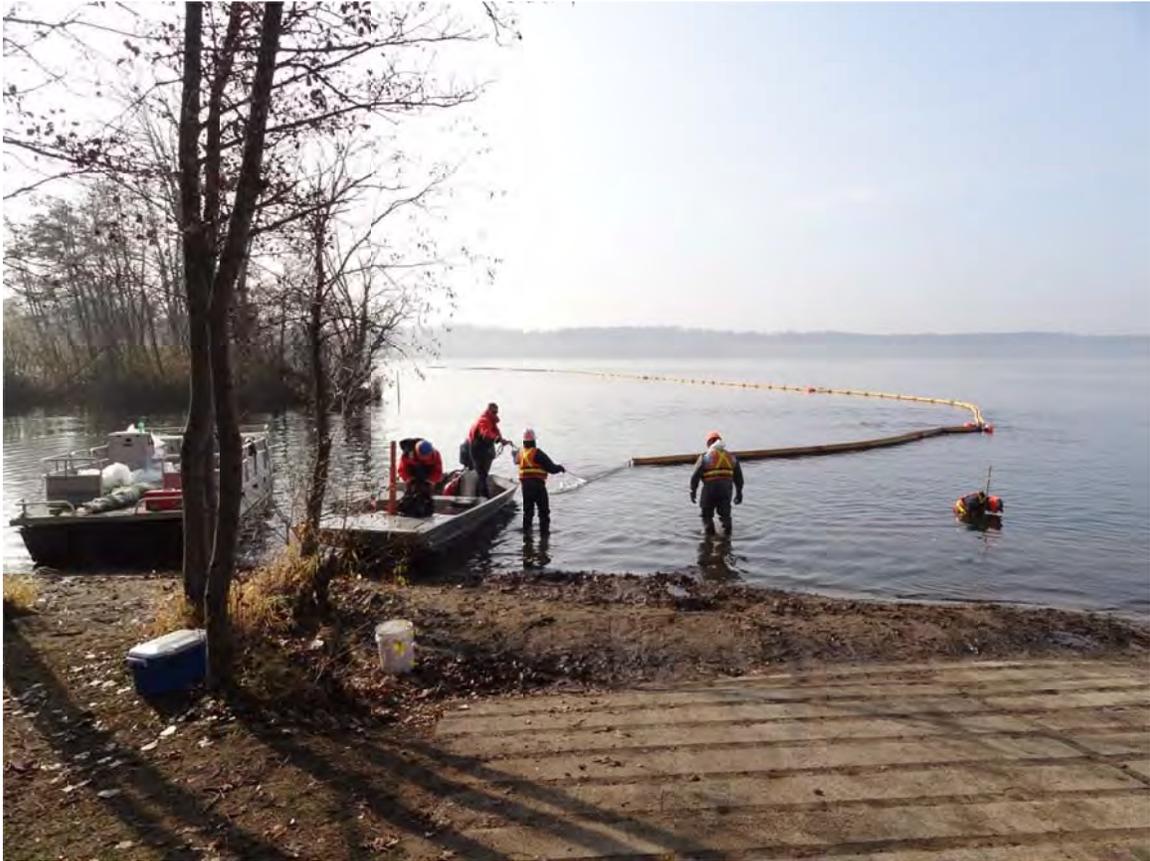
9. E4.0 boat launch, crews towing boom from configuration F in to boat launch for removal from lake.

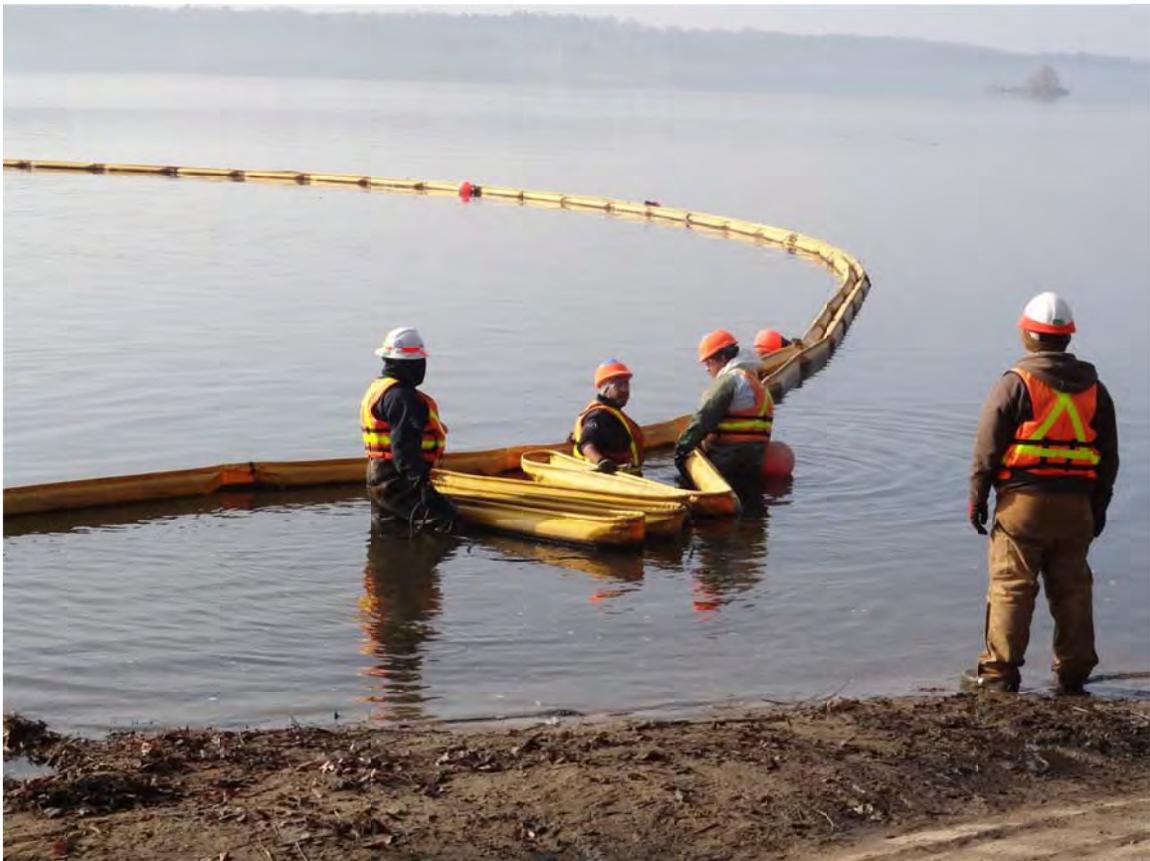
10. Crews disconnecting and folding up boom for removal.

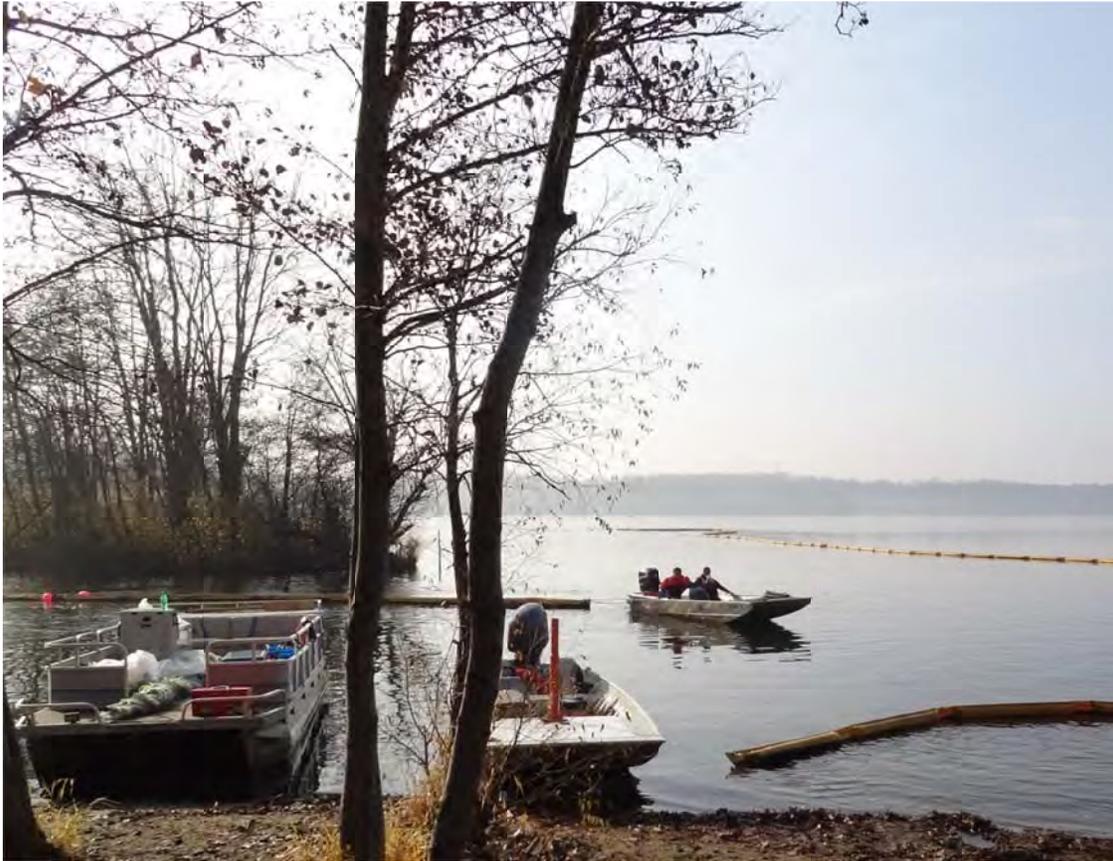
11. Crews towing in second section of boom from configuration F.

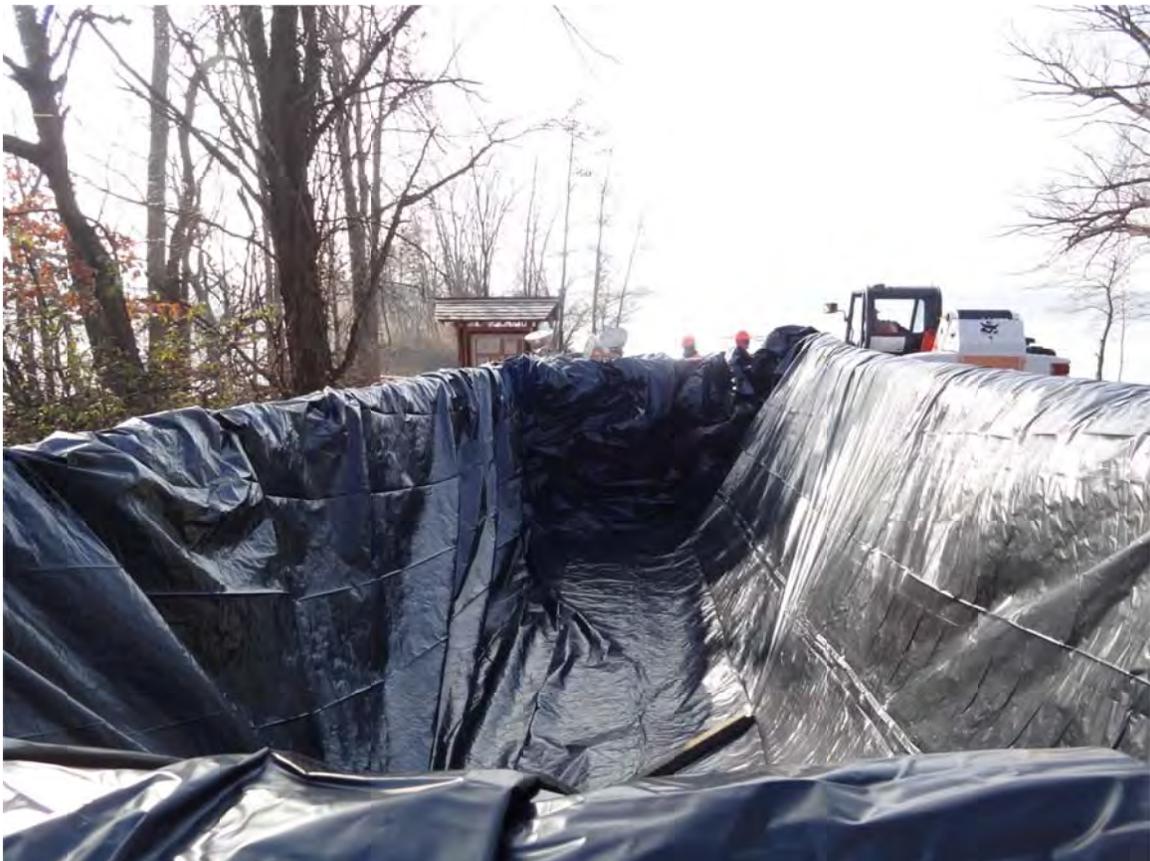
12. Empty roll-off box staged for containment boom removed from lake.
