# Situation Photo Log

Friday, November 23, 2012

Kalamazoo River / Enbridge Spill

Prepared by:  
Matthew Haak  
START-USEPA  
Situation Unit Leader

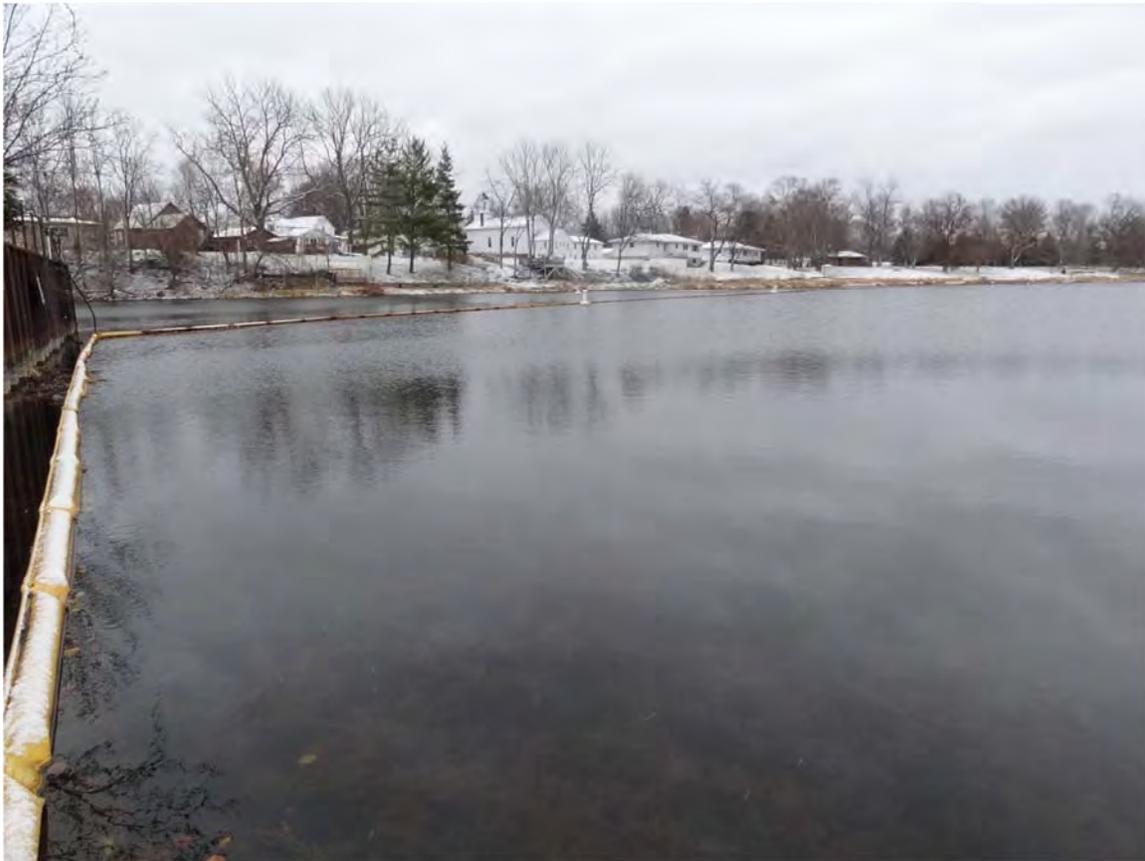
1. Ceresco Dam control point boom, no sheen or ice observed.

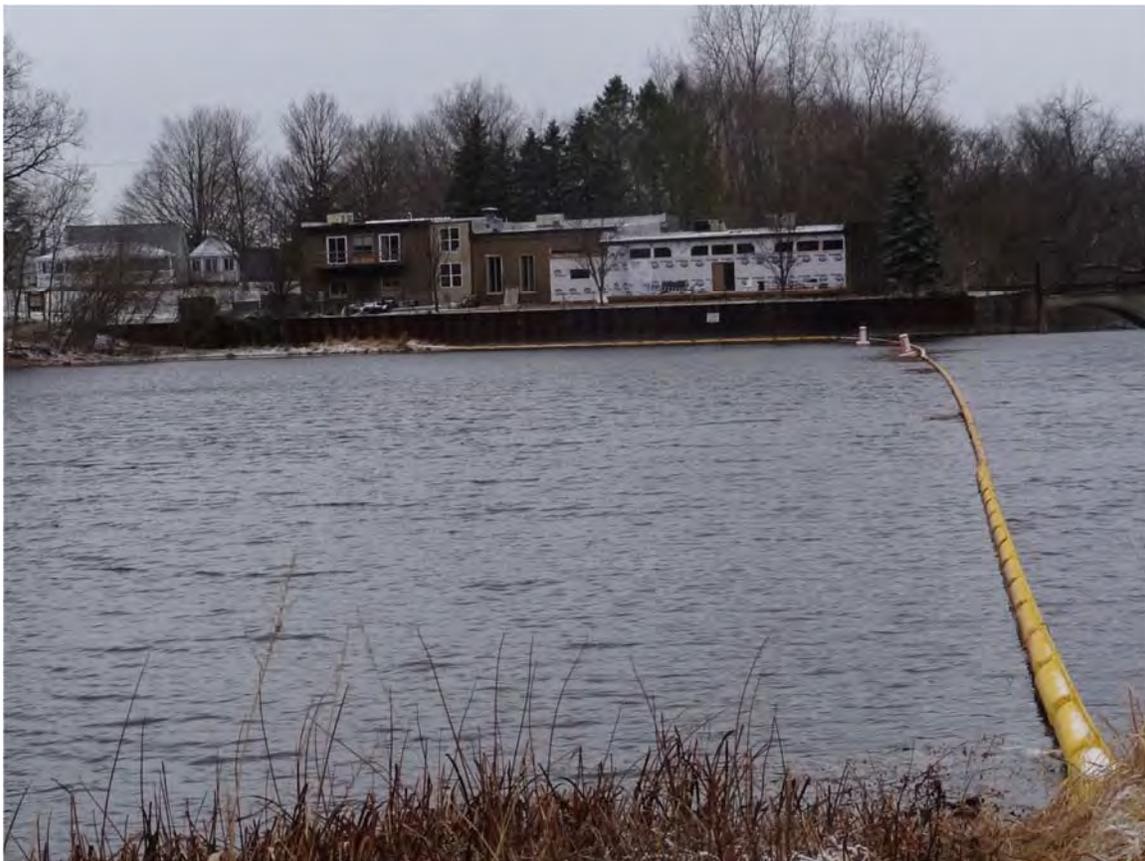
2. Ceresco Dam control point boom, no sheen or ice observed.

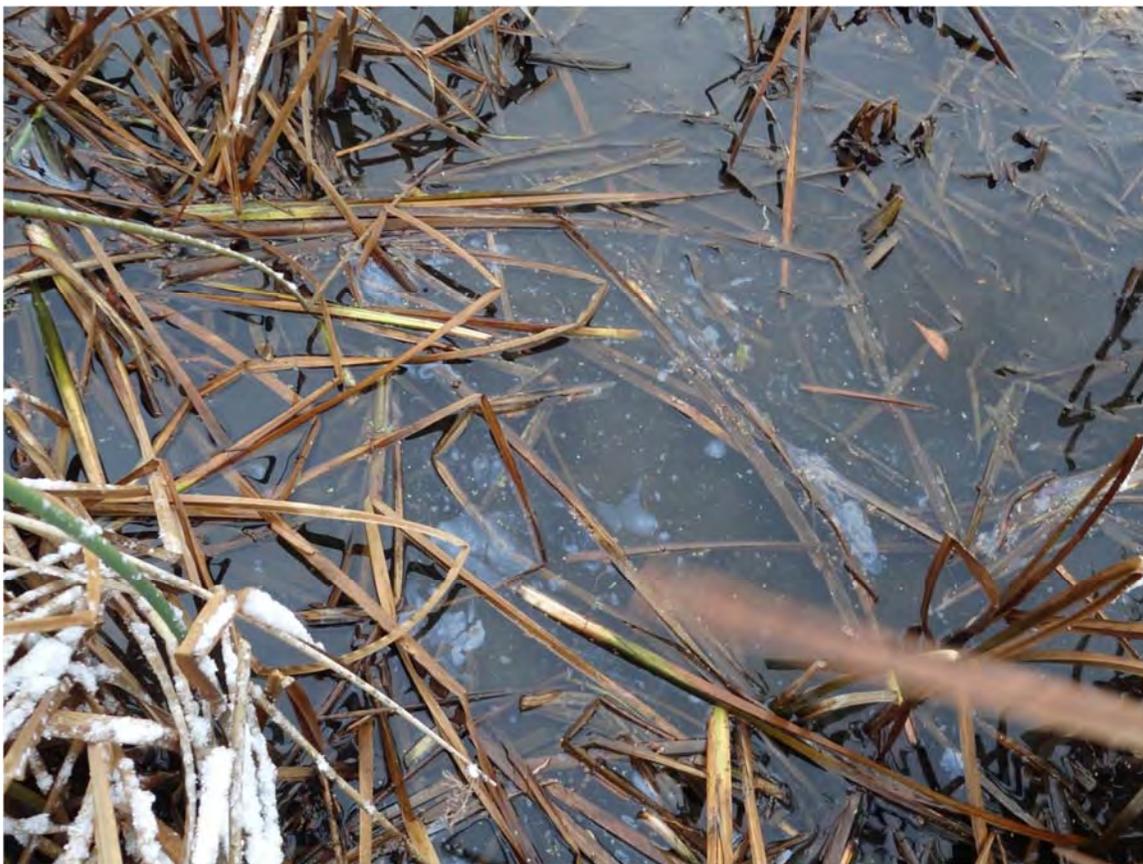
3. Ceresco Dam MP5.75 RDB sheen observed within the vegetation.

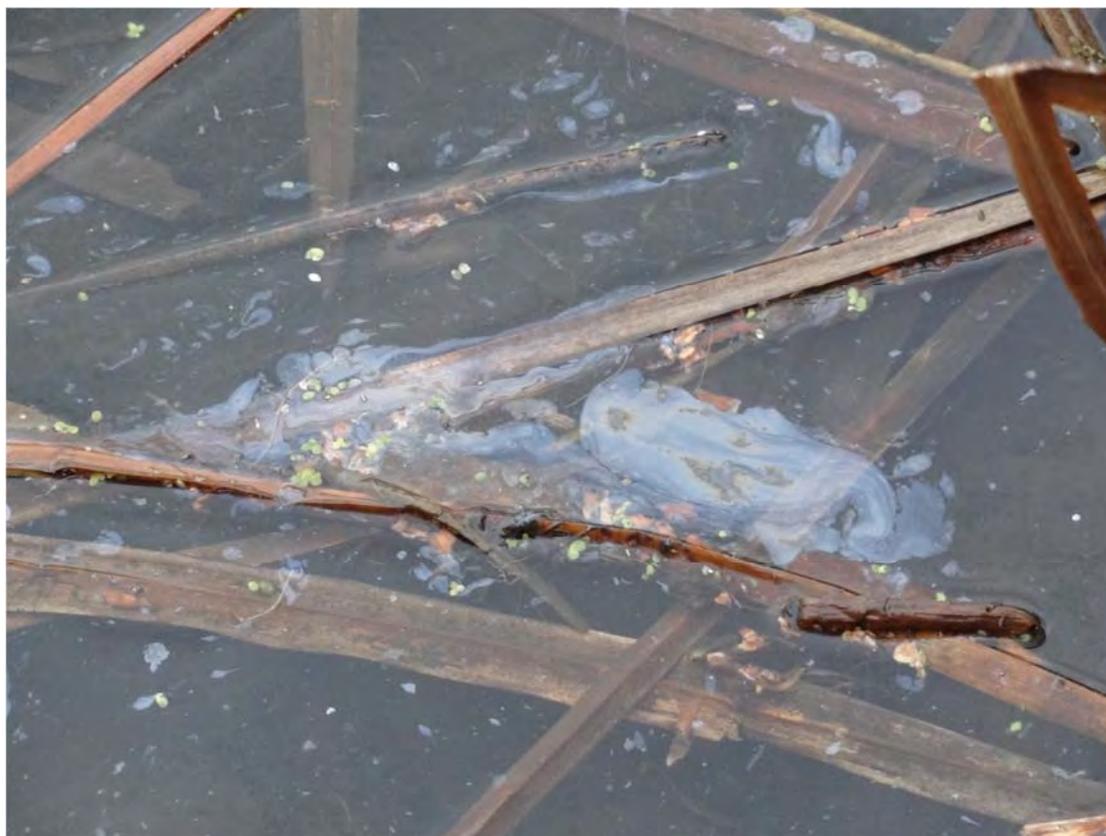
4. Ceresco Dam MP5.75 RDB sheen observed within the vegetation.

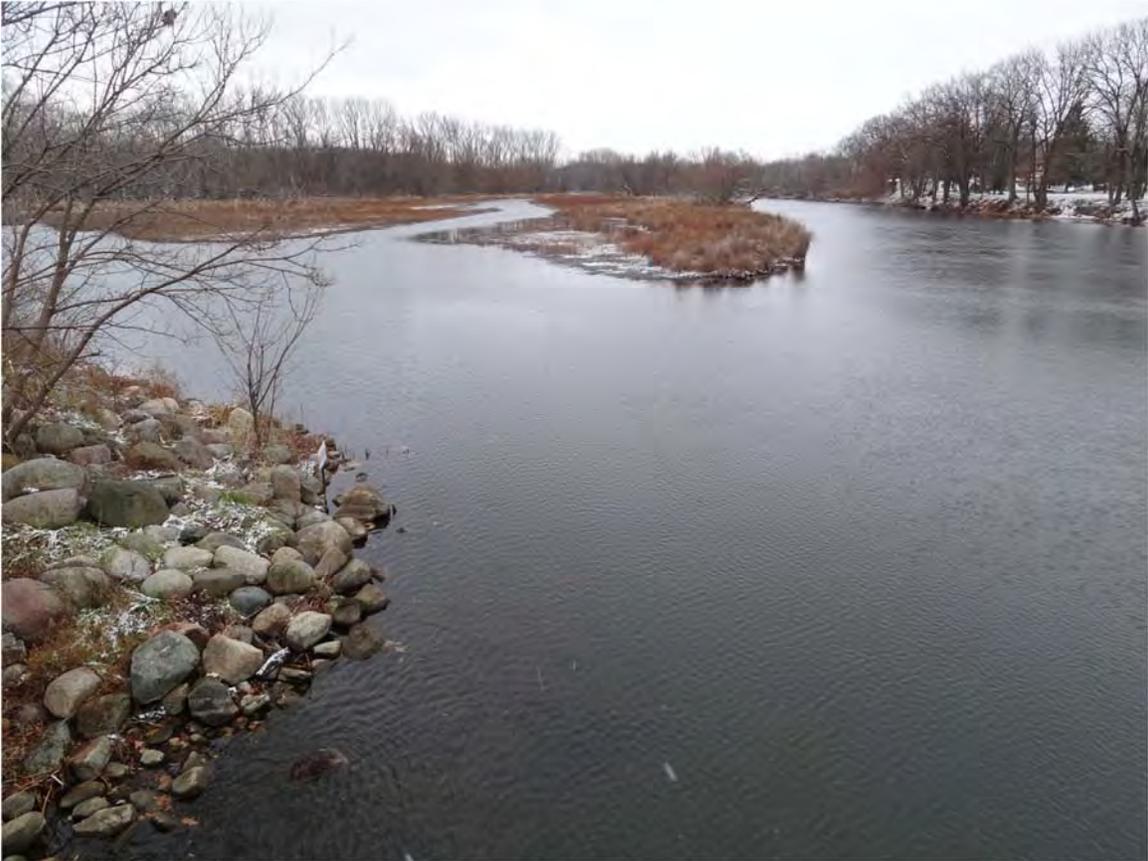
5. MP15.5 South Mill Pond no ice or sheen observed.
