# Situation Photo Log

Sunday, November 25, 2012

Kalamazoo River / Enbridge Spill

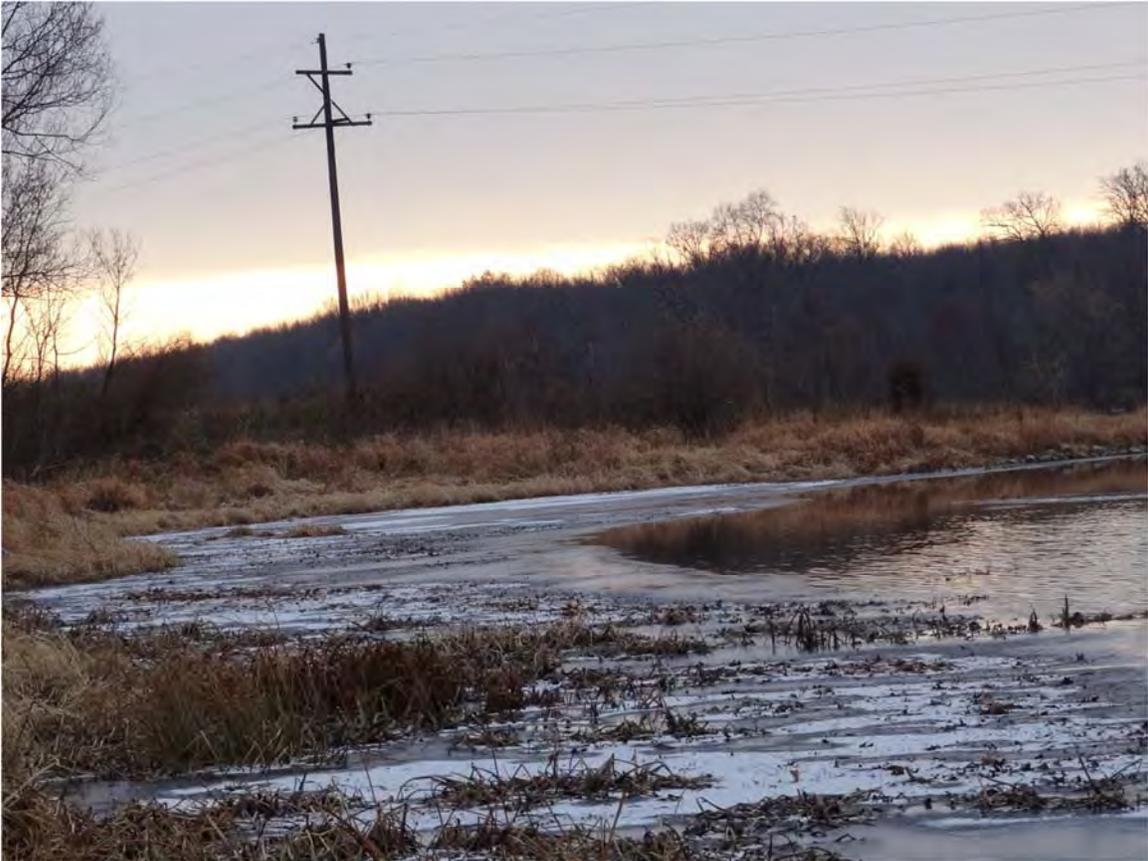
1. MP5.63 RDB observed a very thin layer of ice forming.

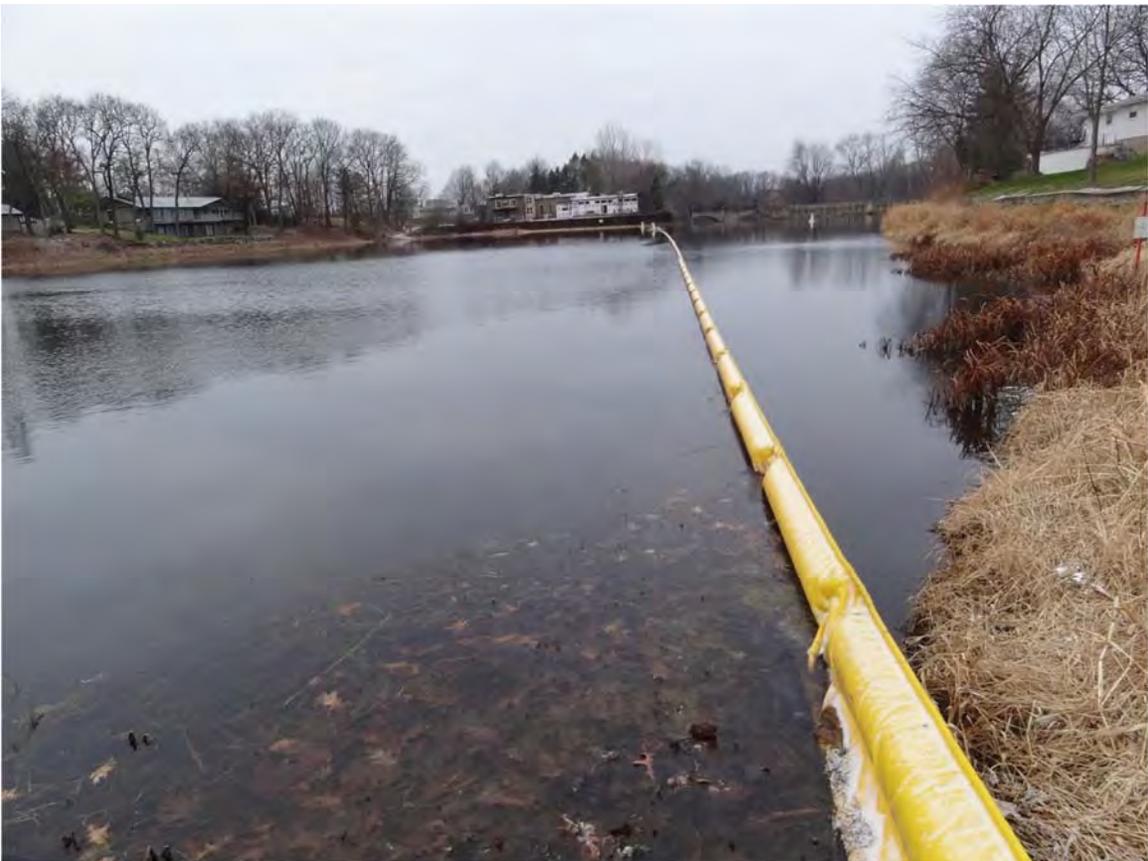
2. Ceresco Dam control point boom no sheen or ice observed.

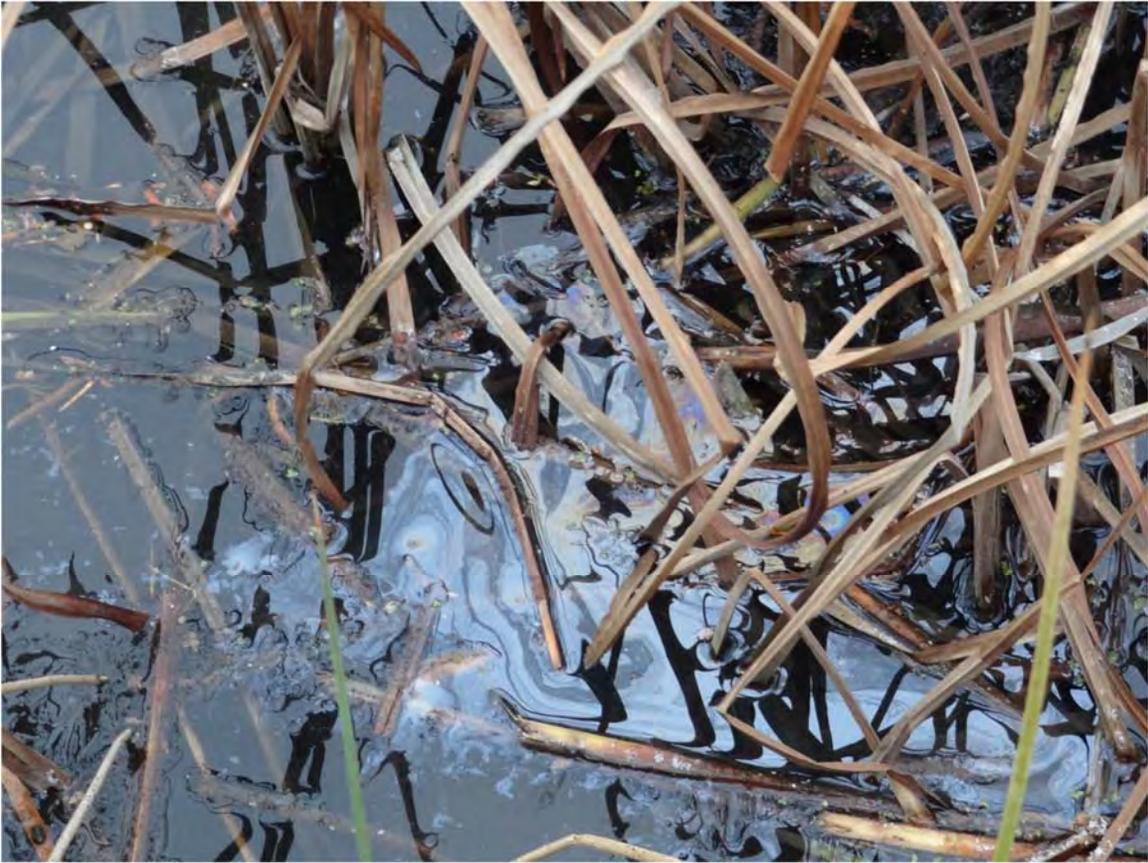
3. MP5.70 RDB observed sheen and tar globs within the vegetation.

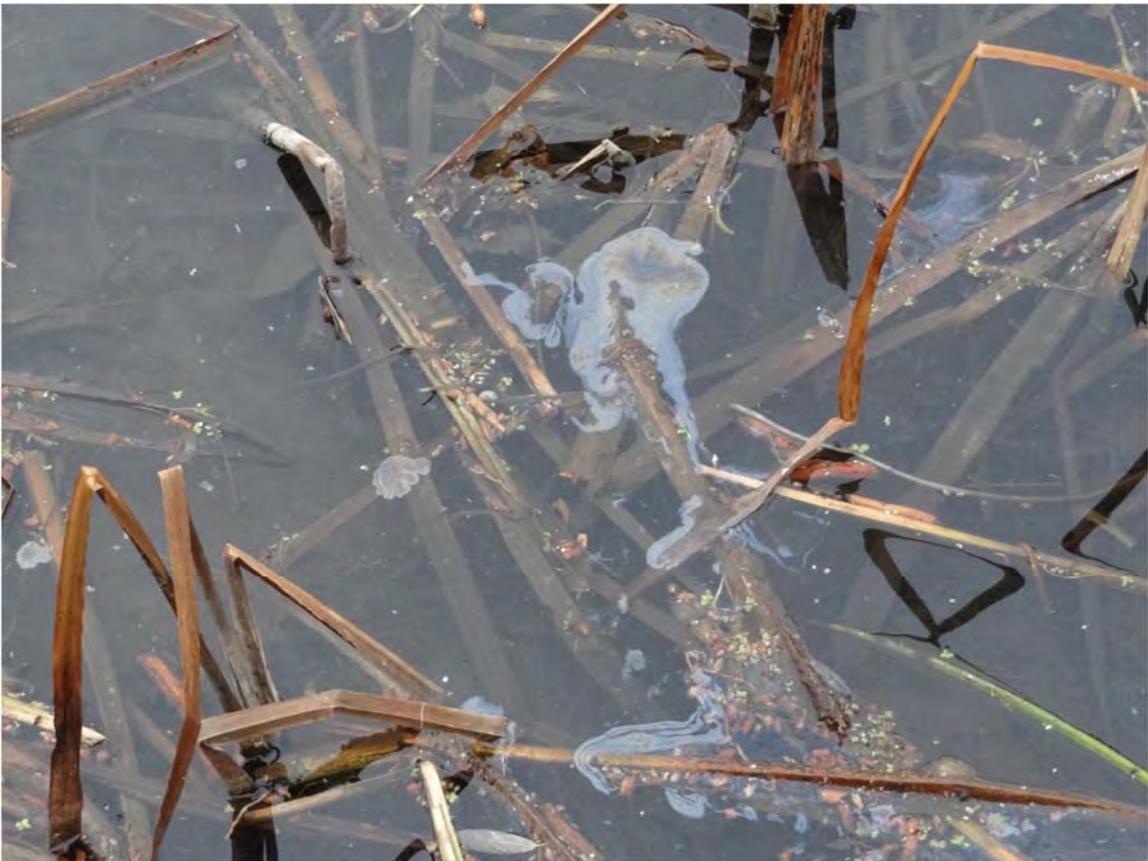
4. MP5.70 RDB observed sheen and tar globs within the vegetation.

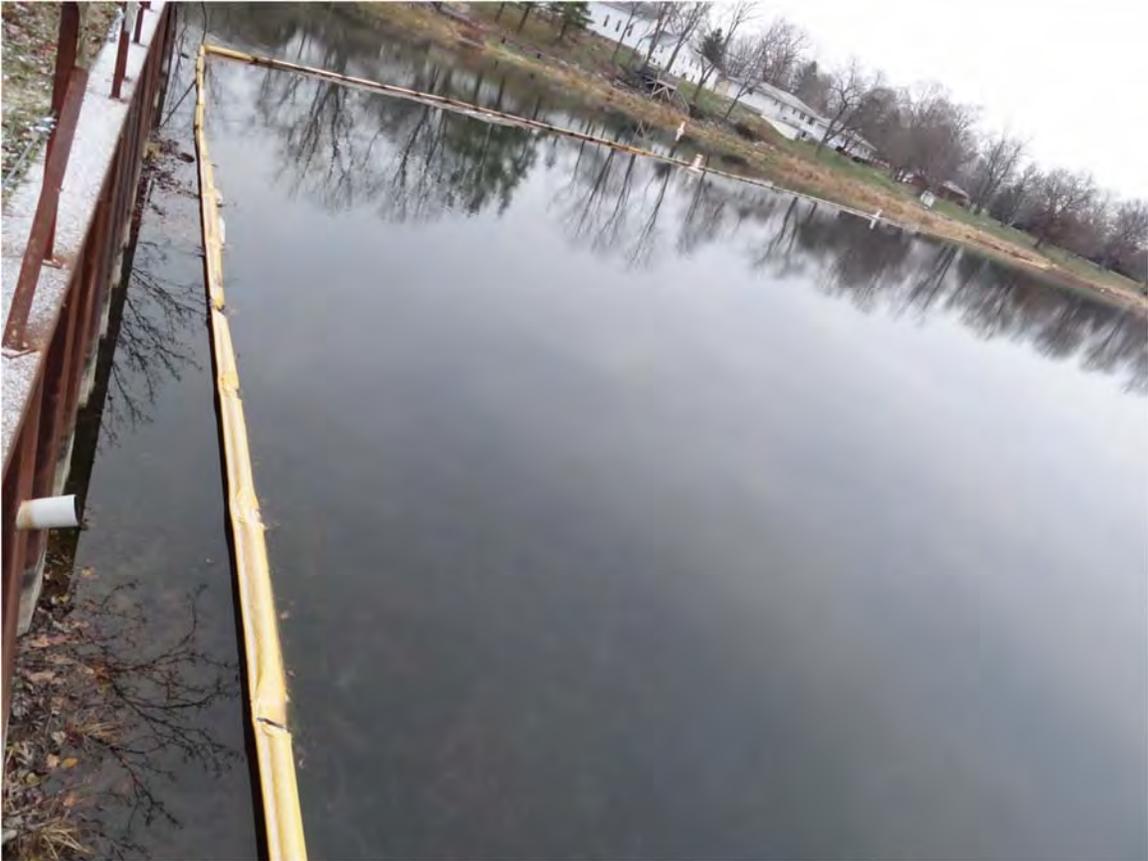
5. Ceresco Dam control point, no ice observed forming along the boom.

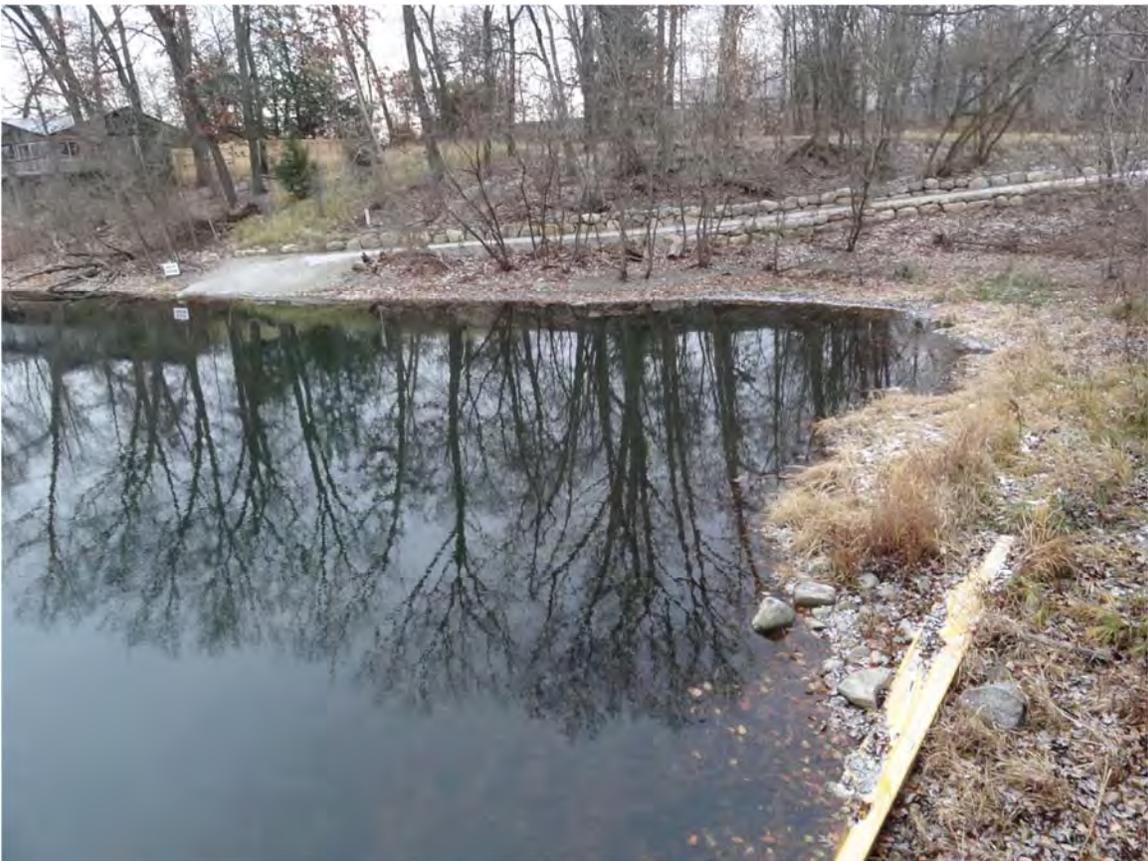
6. Ceresco Dam impoundment no ice observed forming along the LDB.

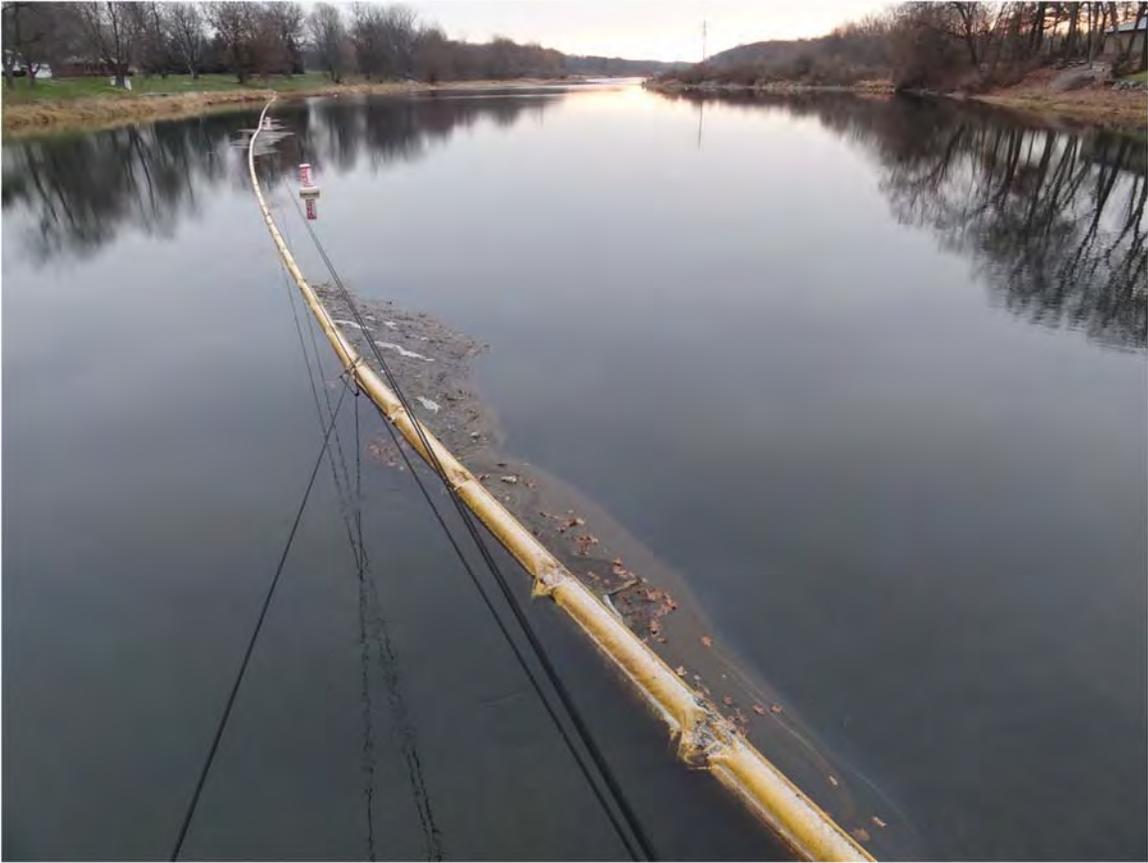
7. Ceresco Dam control point, no ice observed forming along the boom.

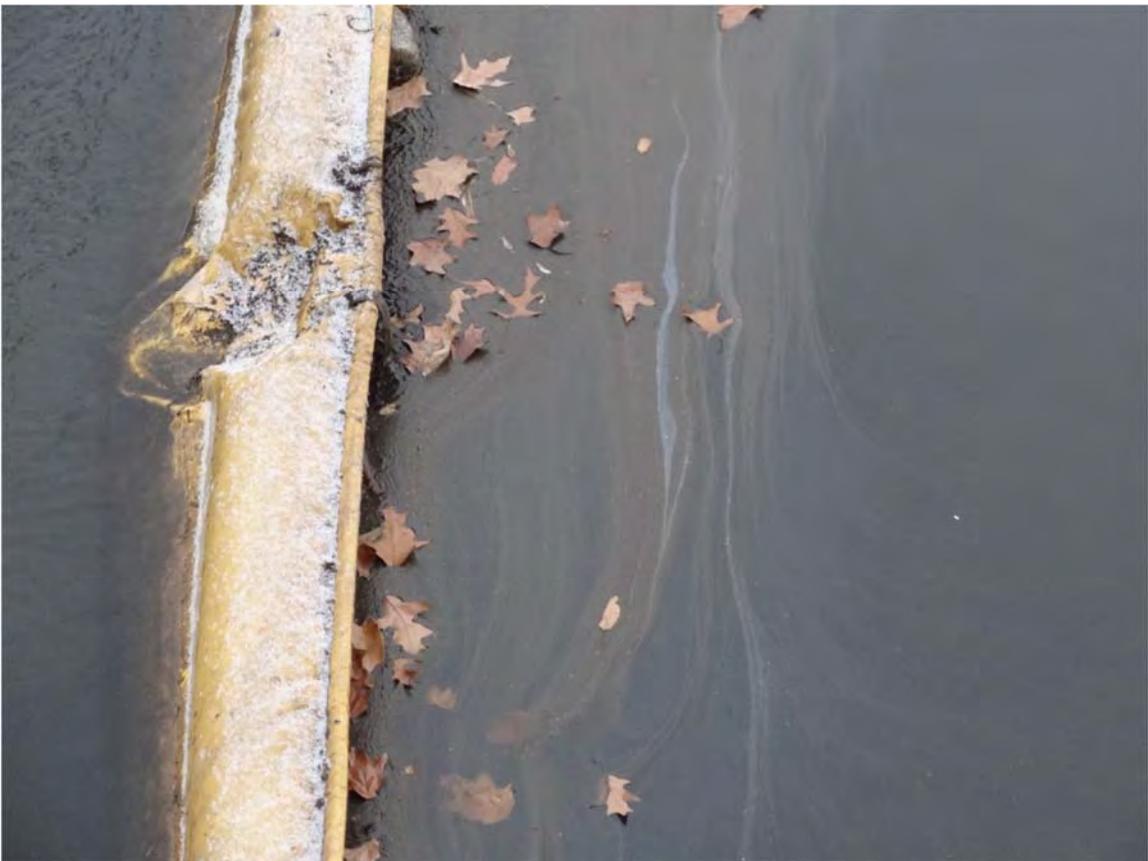
8. Ceresco Dam control point boom observed sheen collecting along the boom.

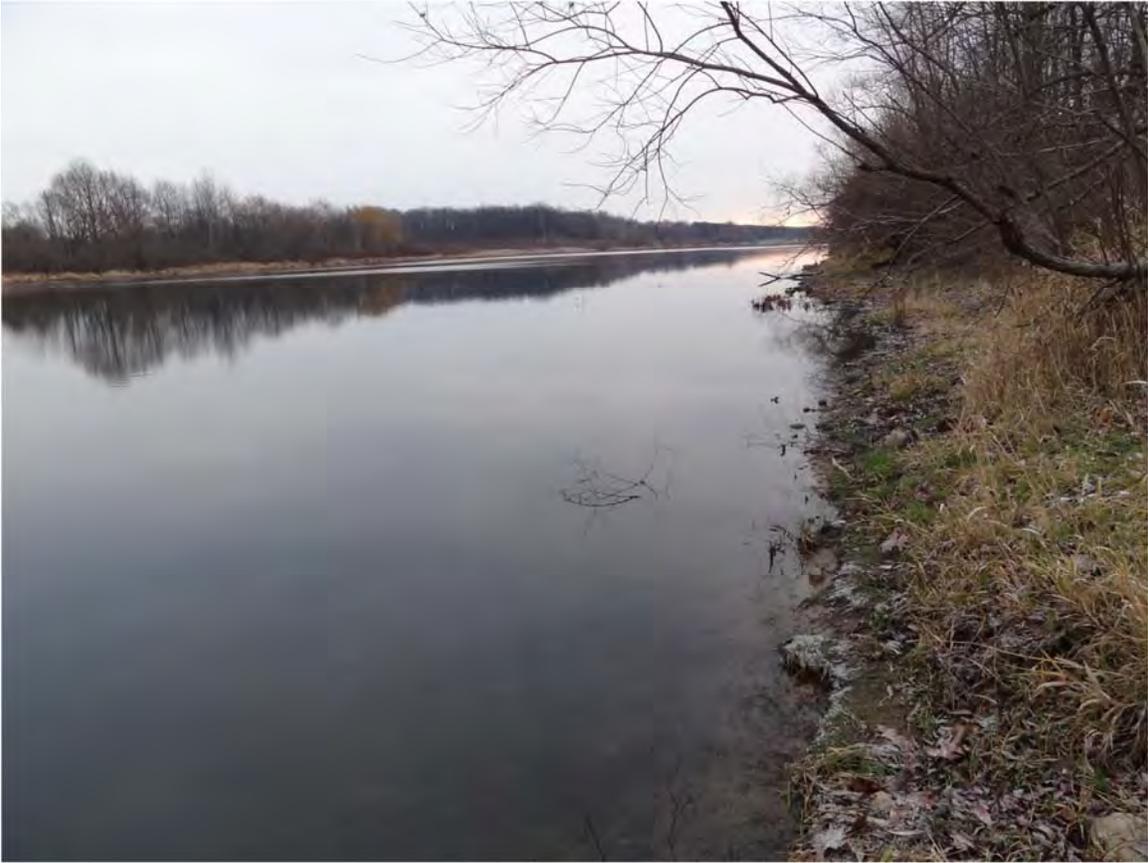
9. MP5.5 LDB observed no ice forming along the river bank.

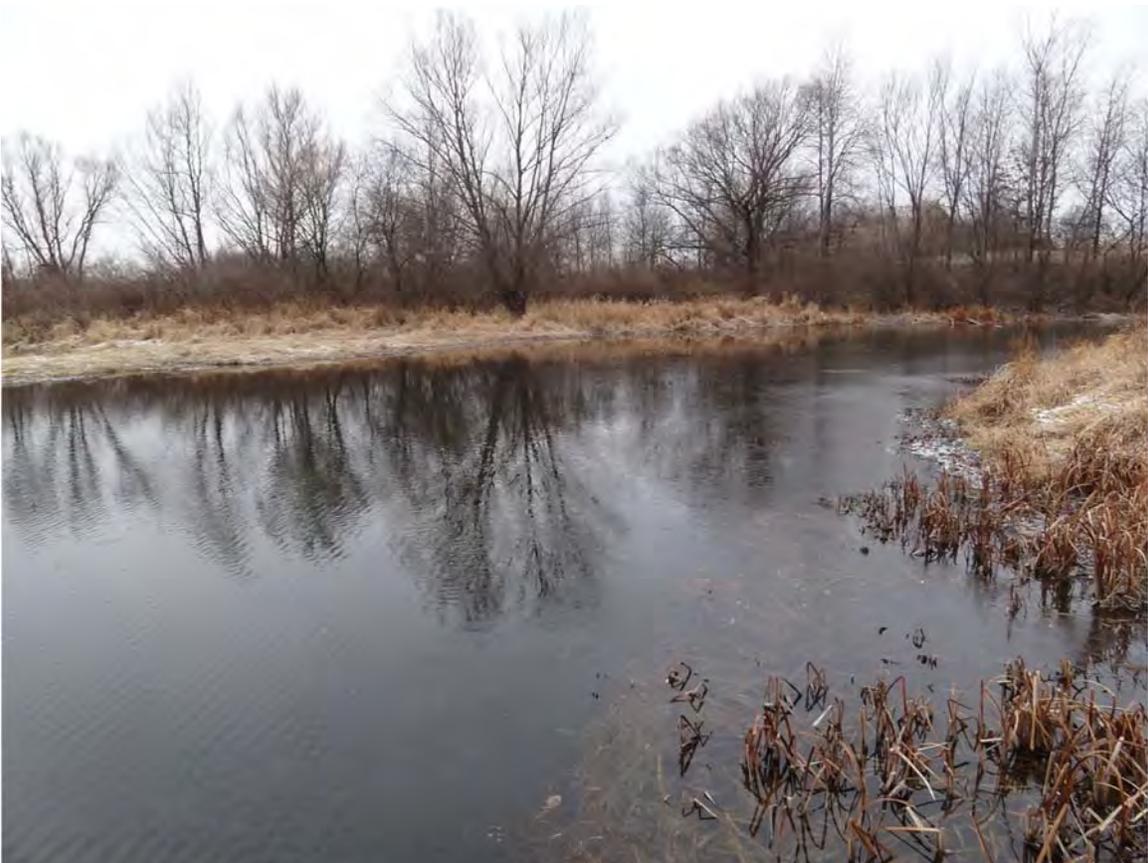
10. MP5.63 LDB above the railroad trestles observed a very thin layer of ice forming.

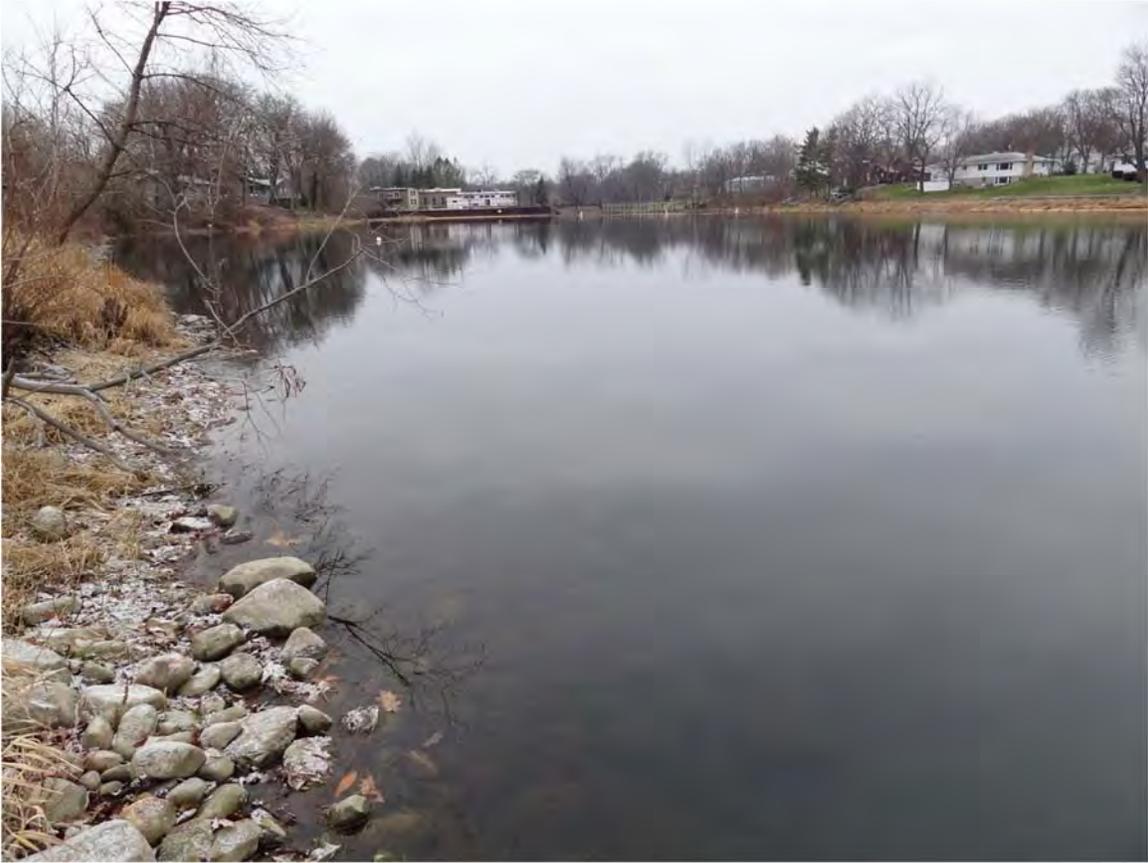
11. MP5.63 LDB no ice observed, sheen was observed.

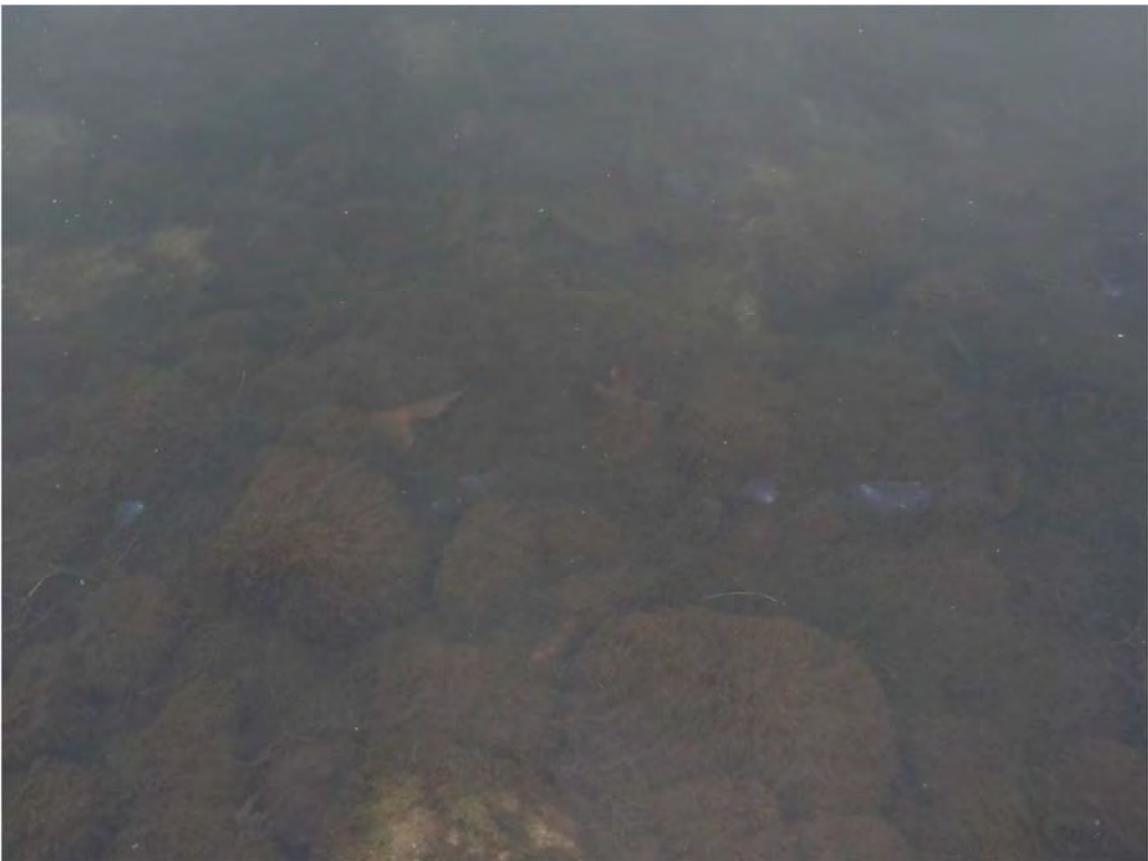
12. MP5.63 LDB no ice observed, sheen was observed.

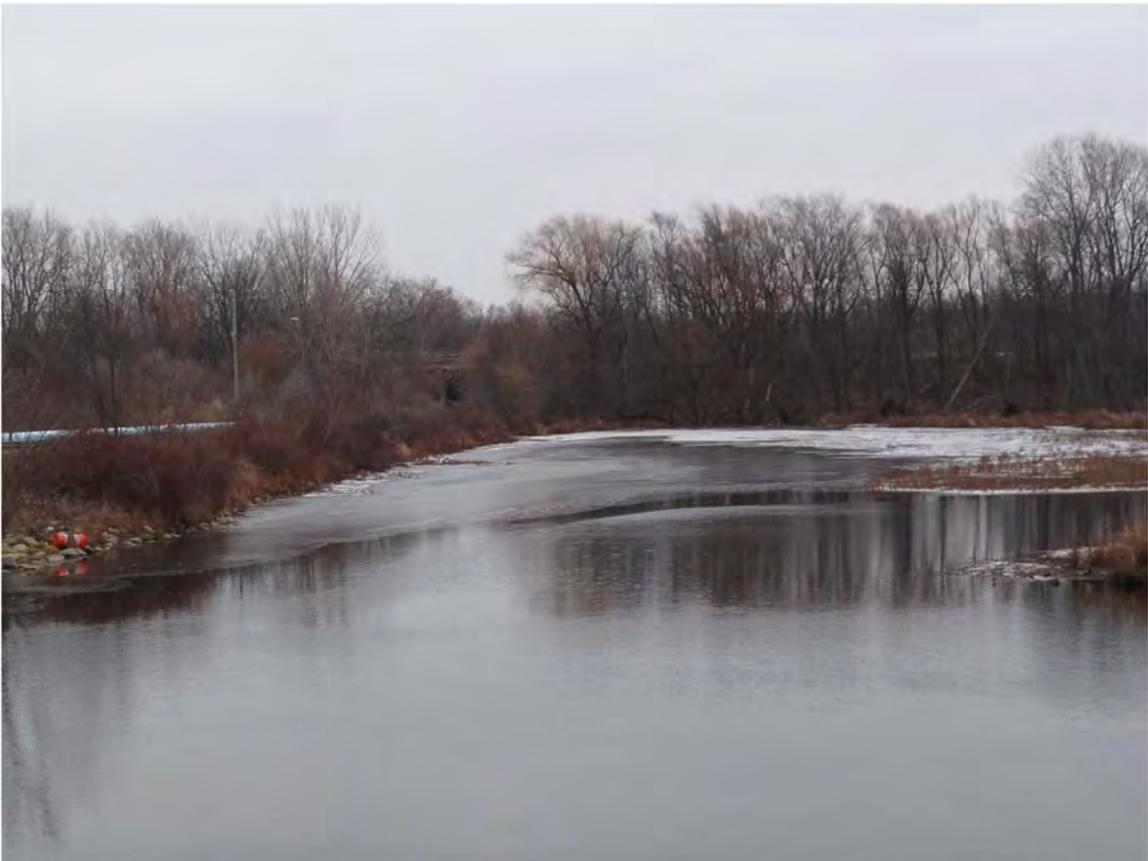
14. MP15.5 South Mill Pond observed ice forming.

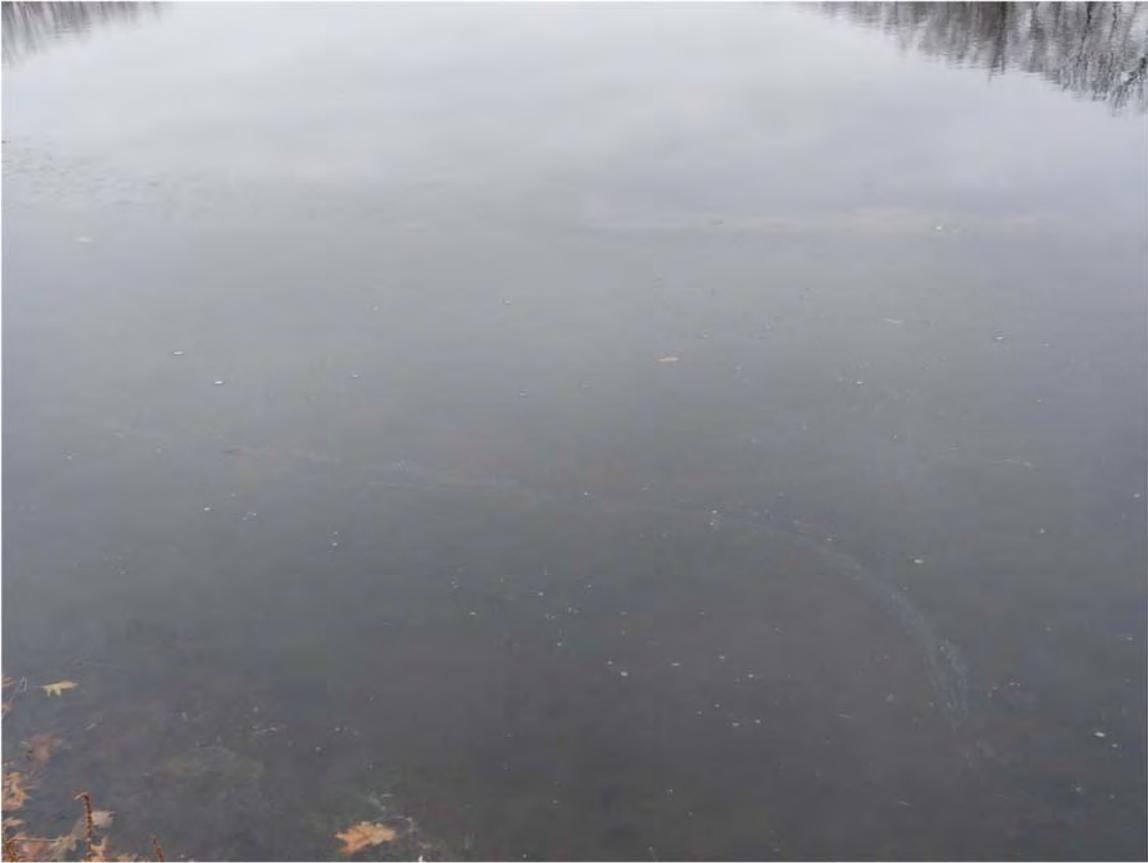
15. MP15.5 South Mill Pond observed sheen and tar globs within the ice.

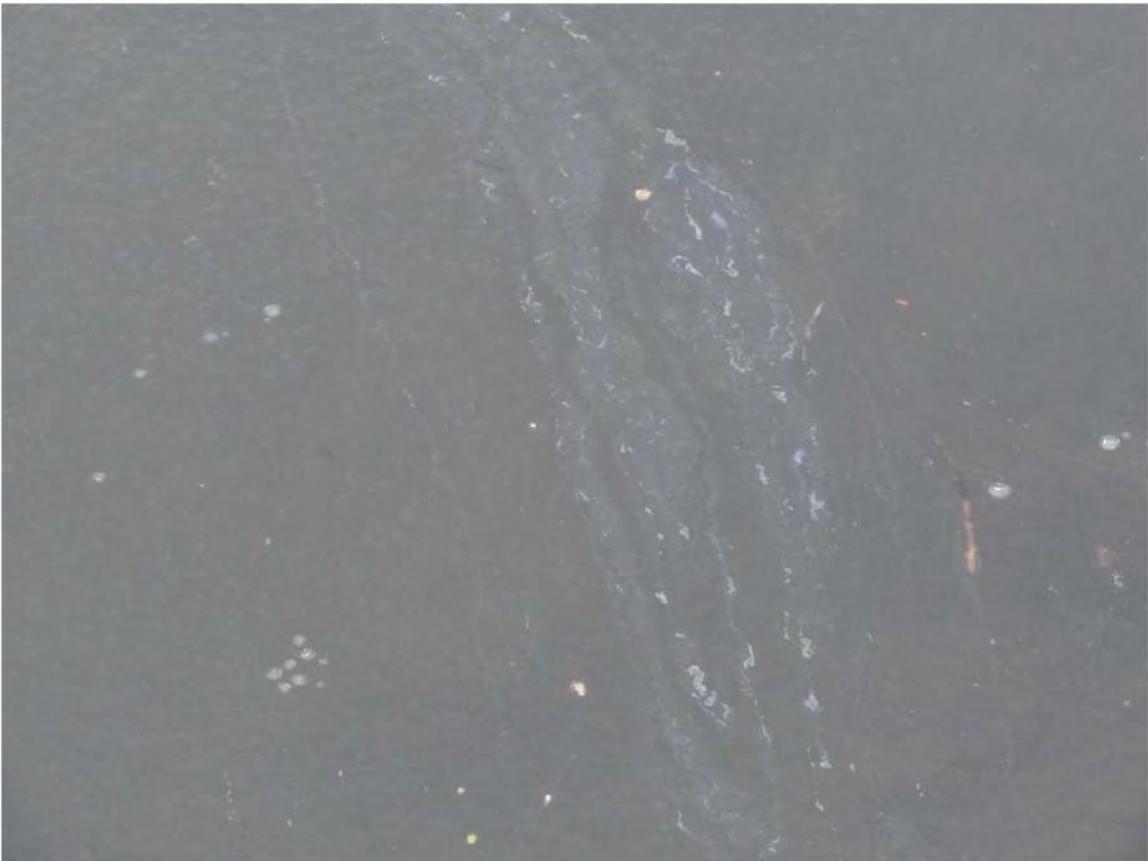
16. MP15.5 South Mill Pond observed sheen and tar globs within the ice.

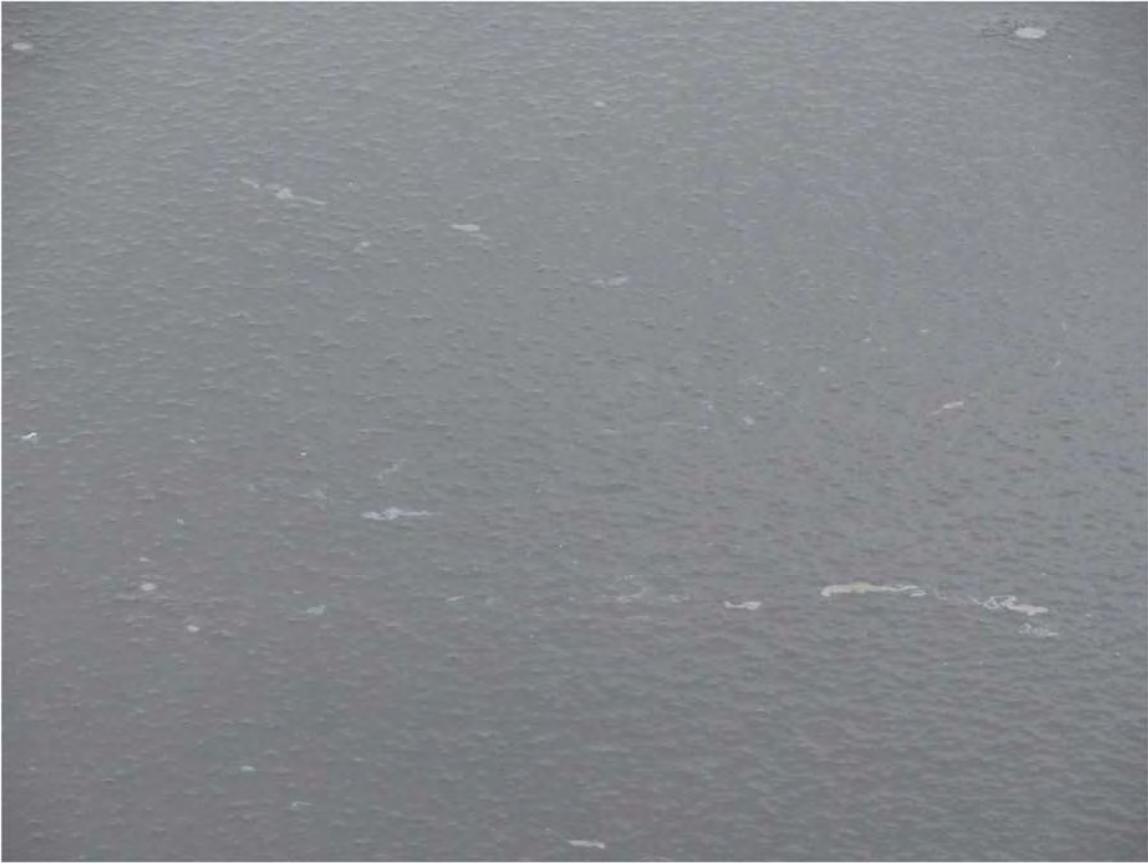
17. MP15.5 South Mill Pond observed sheen and tar globs within the ice.

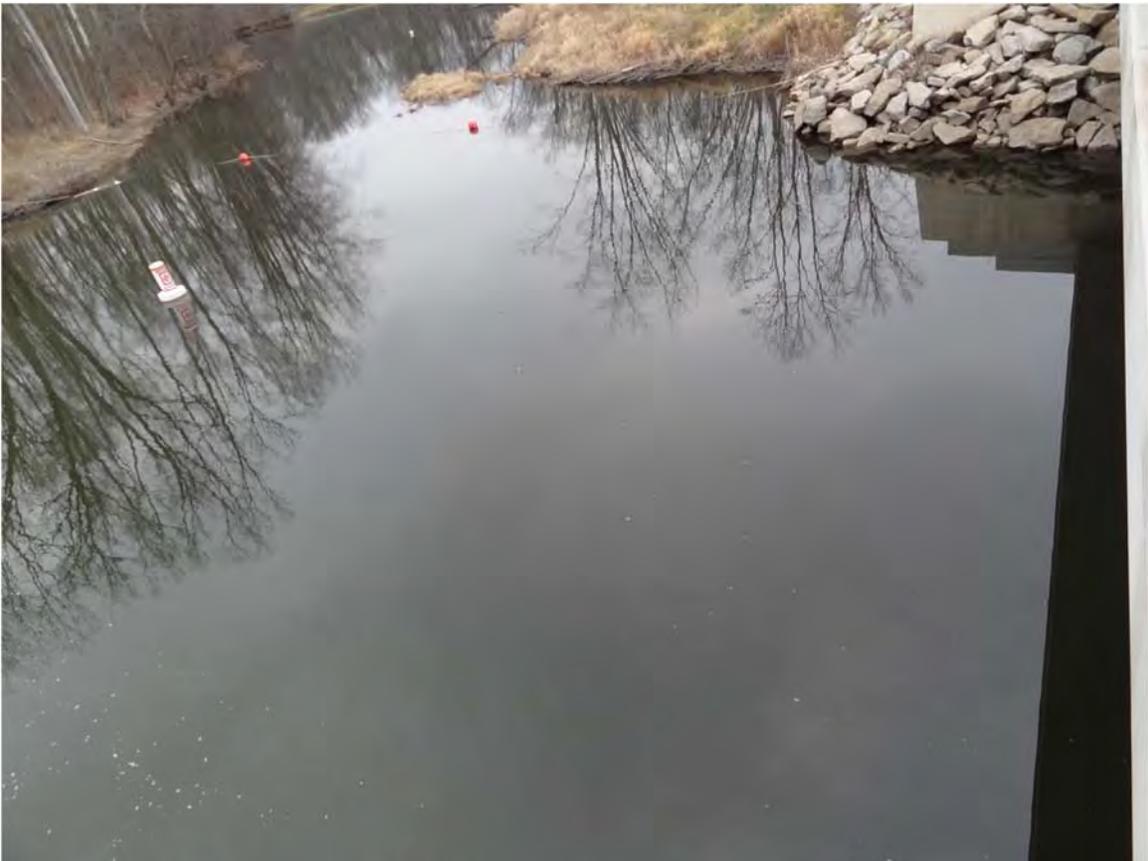
18. MP21.5 Custer Bridge no ice or sheen observed.

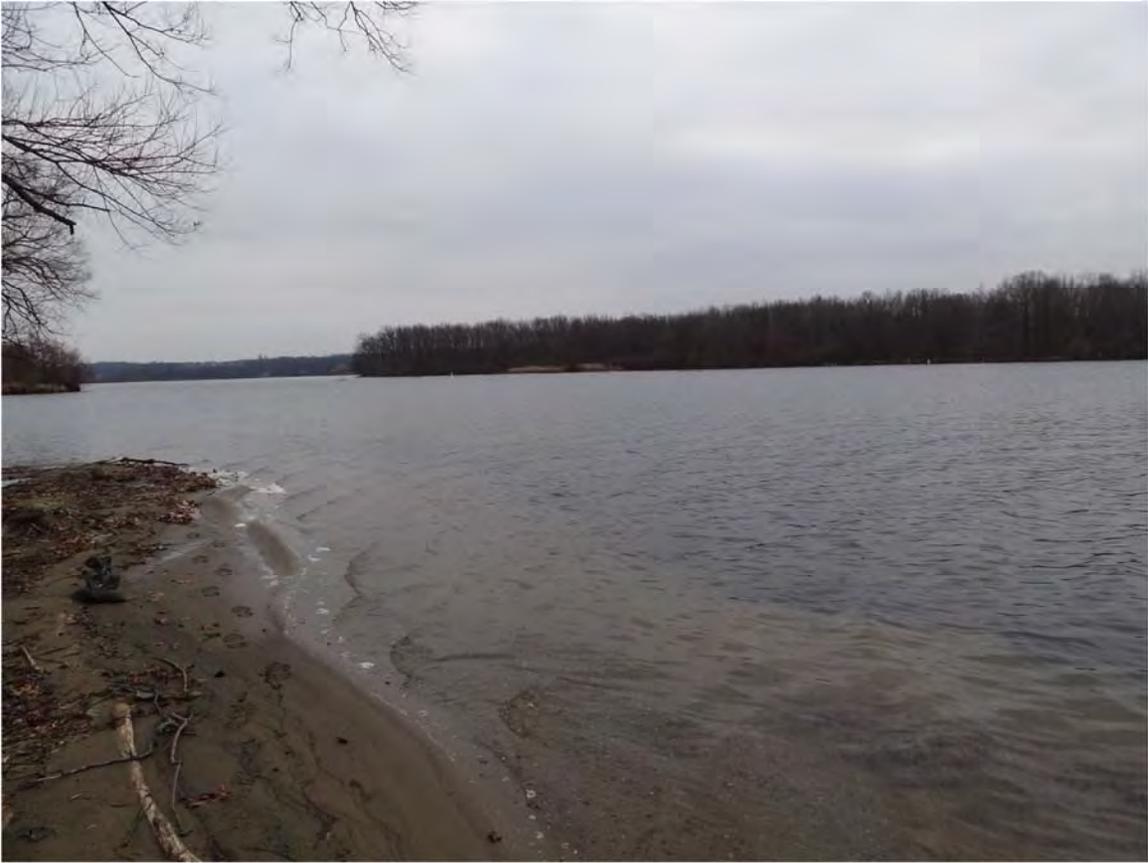
**19. Morrow Lake Delta no ice observed forming within the neck of the delta.**

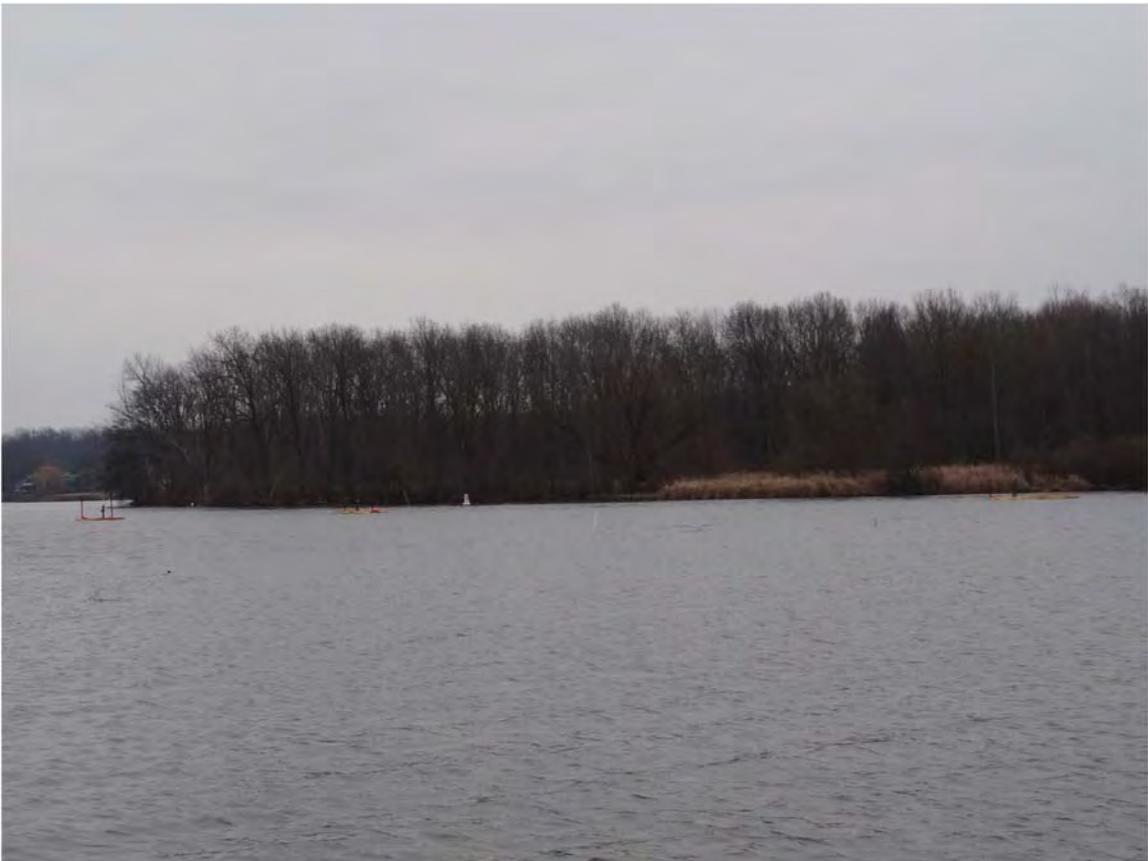
**20. Morrow Lake Delta observed the anchor poles and boom in place.**
