# Situation Photo Log

Monday, November 26, 2012

Kalamazoo River / Enbridge Spill

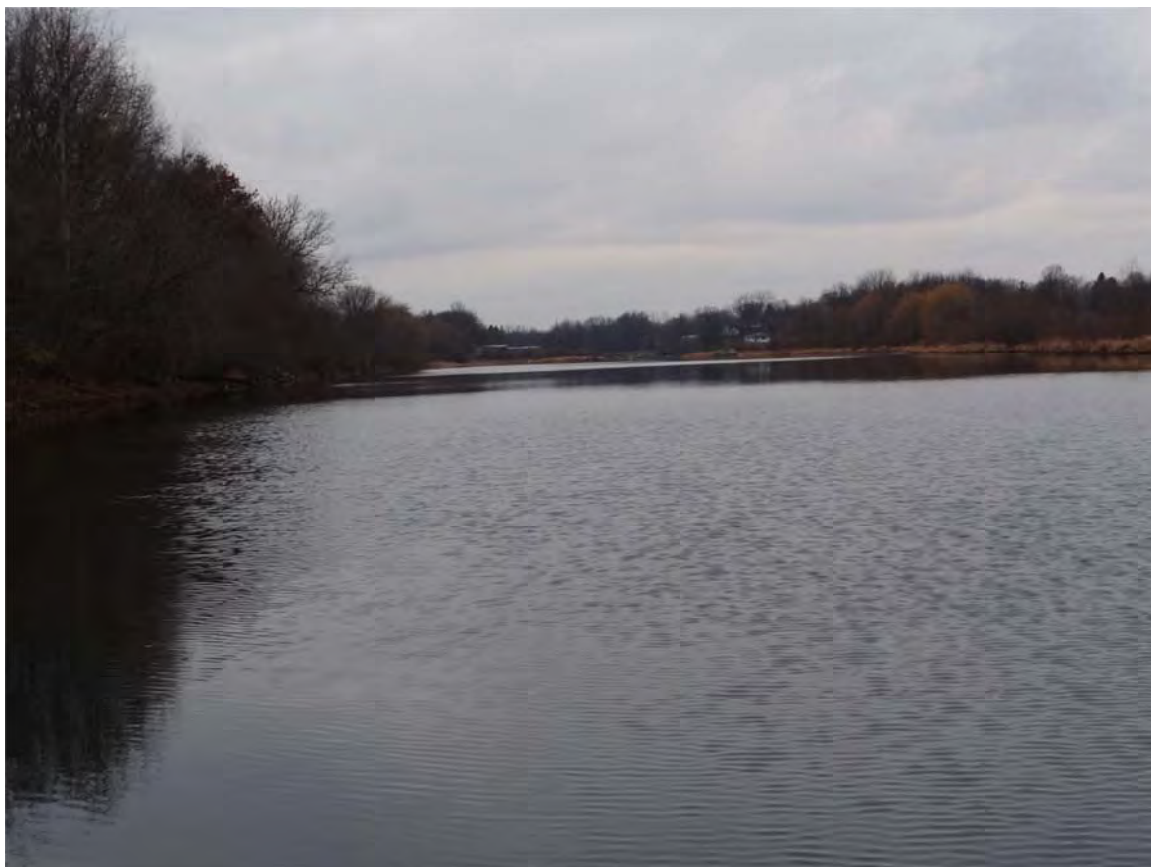
1. MP5.5 LDB, no ice or sheen observed along river shoreline in this area.

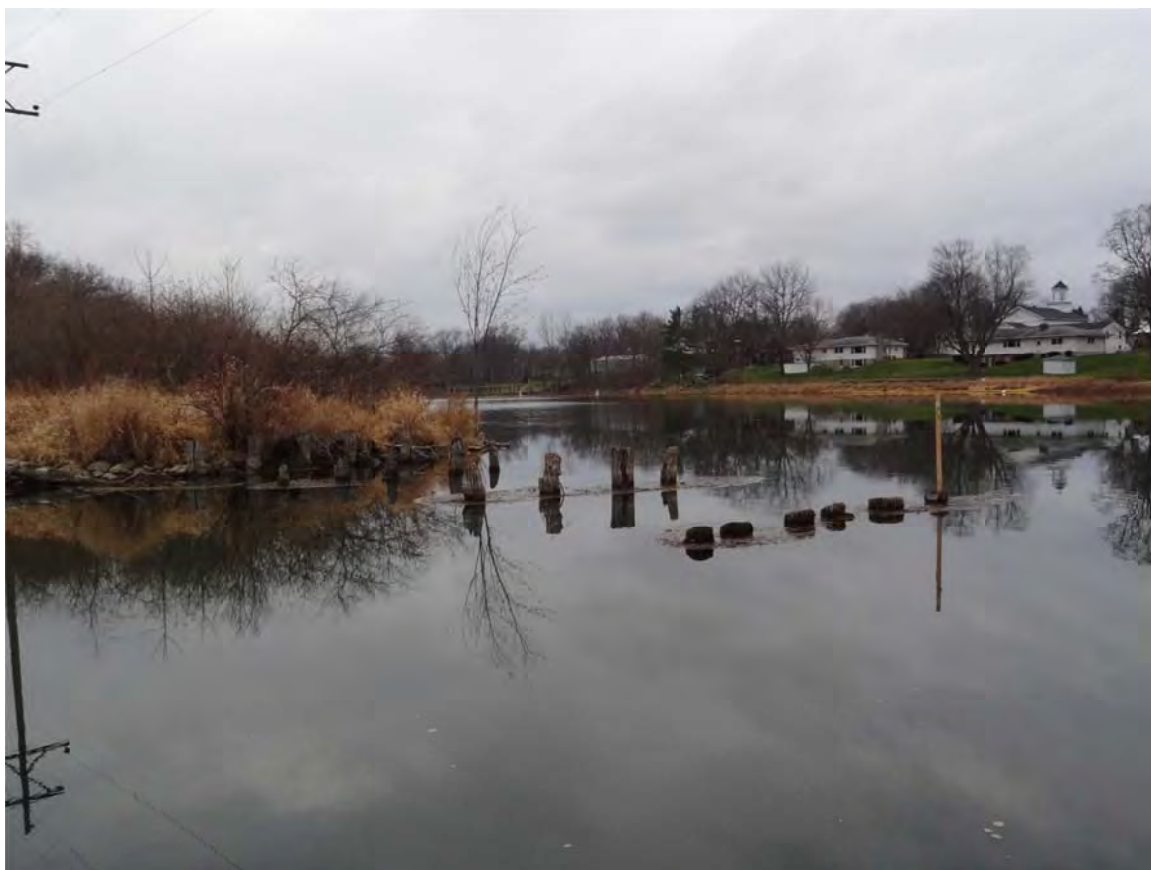
2. Ceresco Dam trestle, no sheen observed.

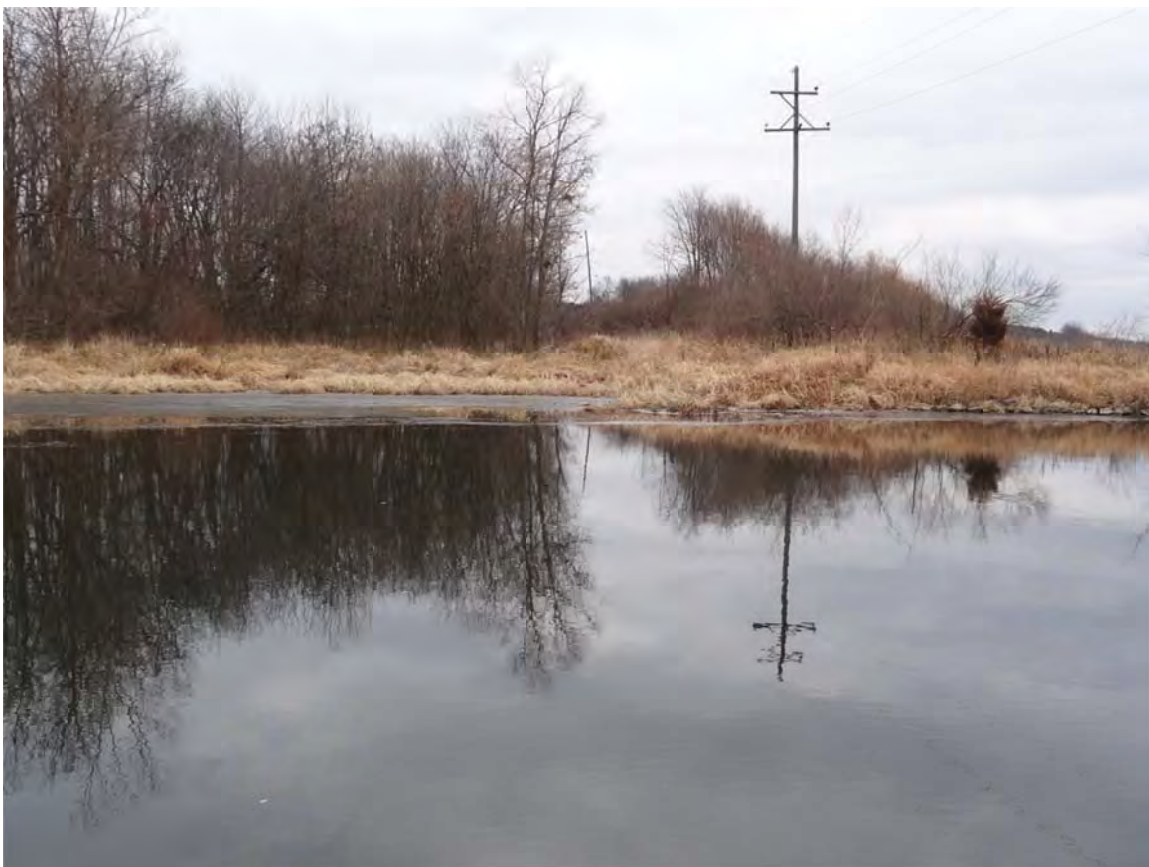
3. MP5.63 RDB, observed thin layer of ice on downstream side of trestle.

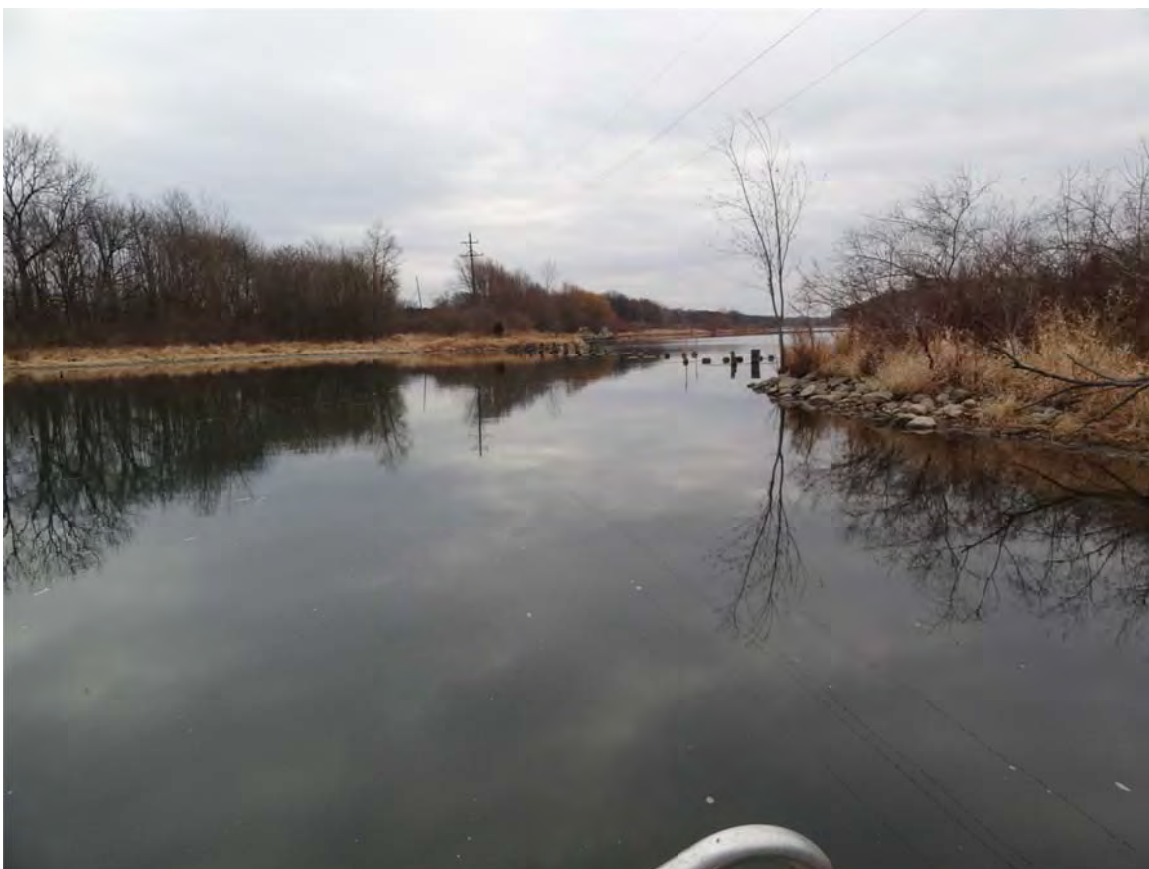
4. MP5.63 LDB, no sheen or ice observed in this area.

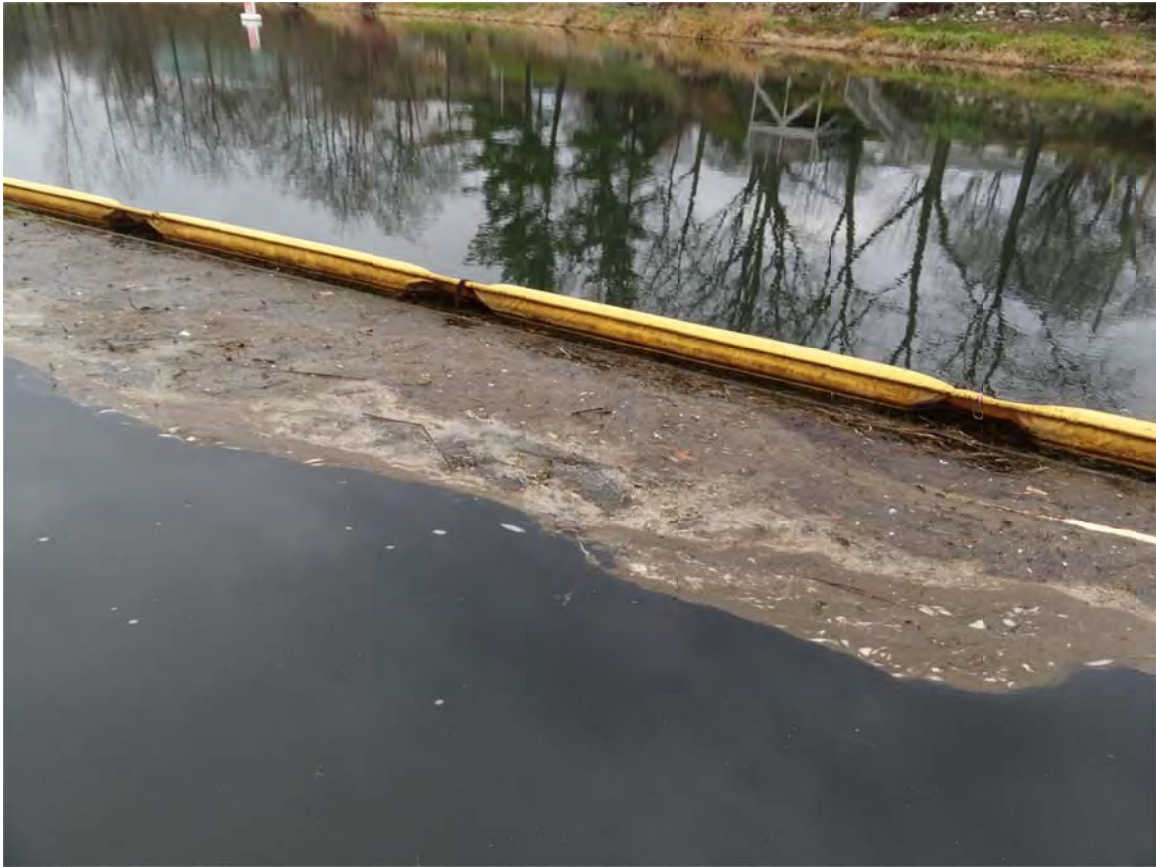
5. Ceresco Dam control point boom, some debris and sheen observed.

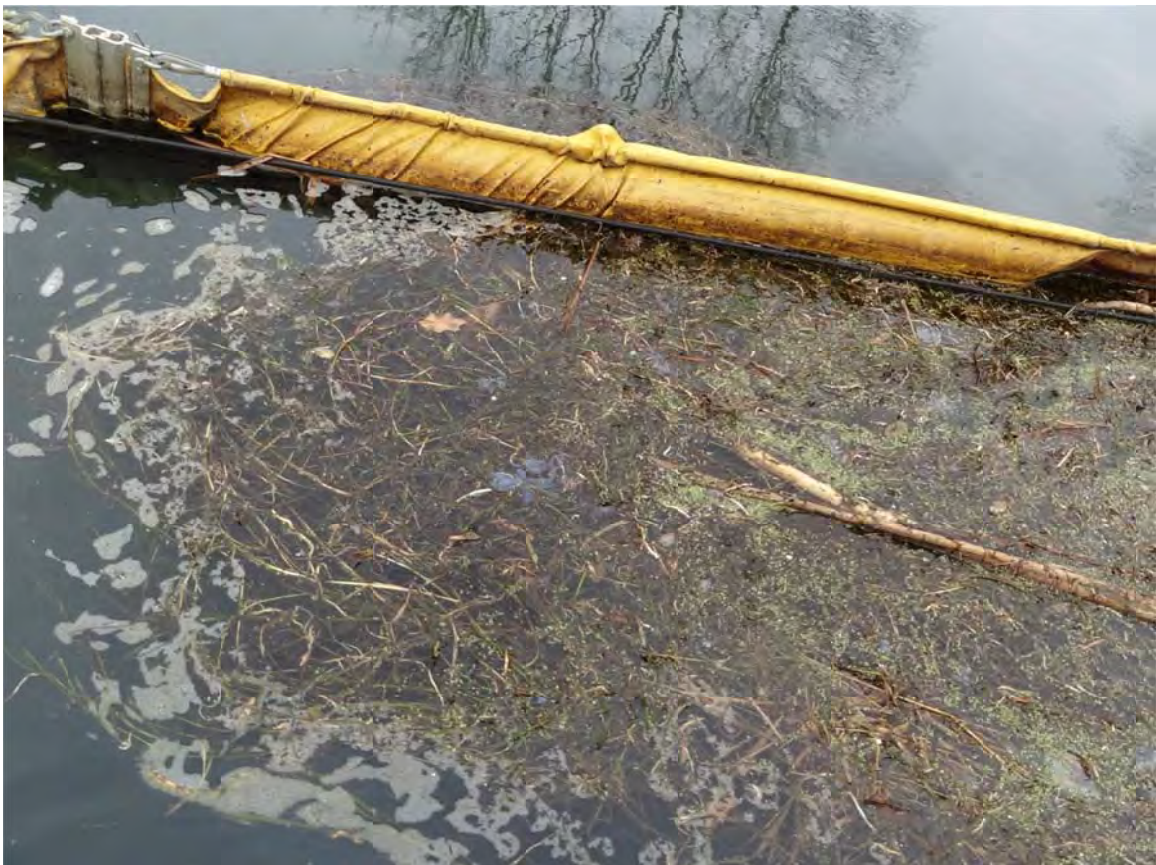
6. Ceresco Dam control point, sheen observed mingled with debris in containment.

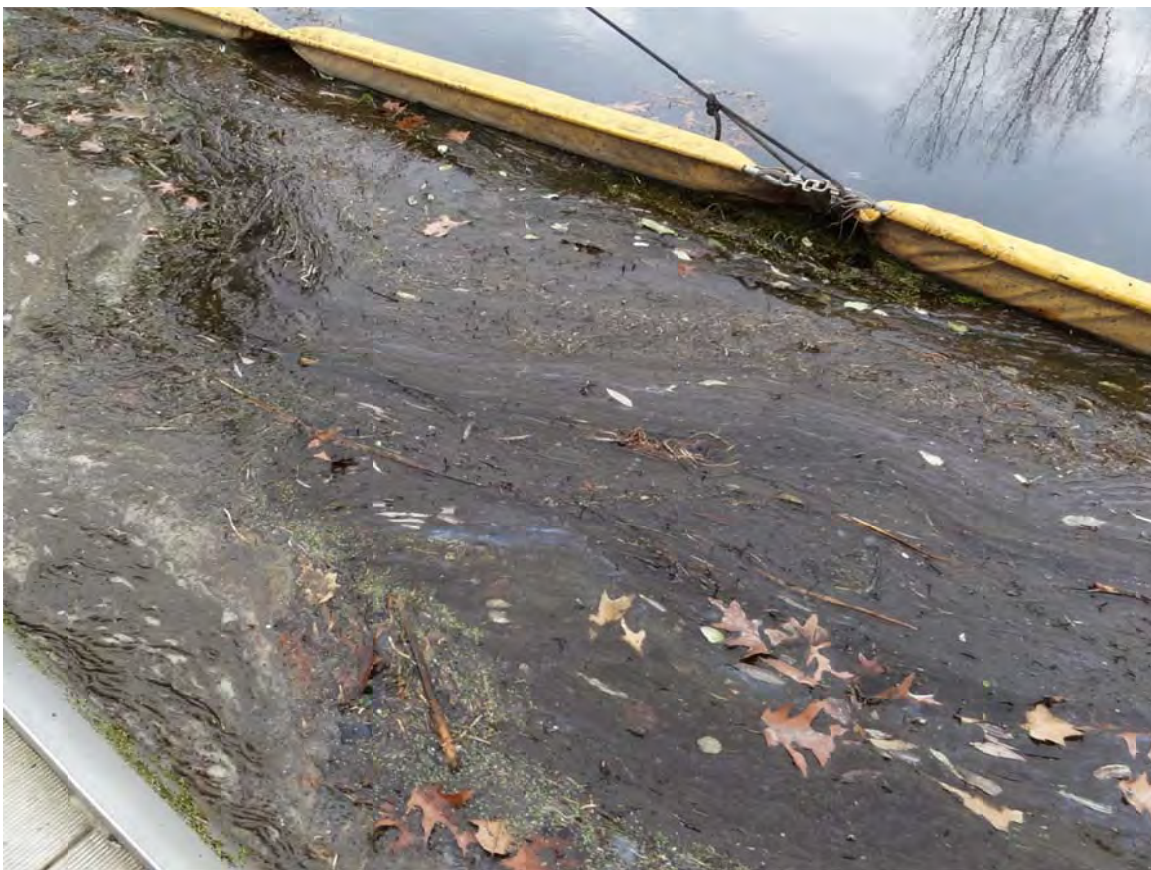
7. Ceresco Dam control point, sheen observed within containment.

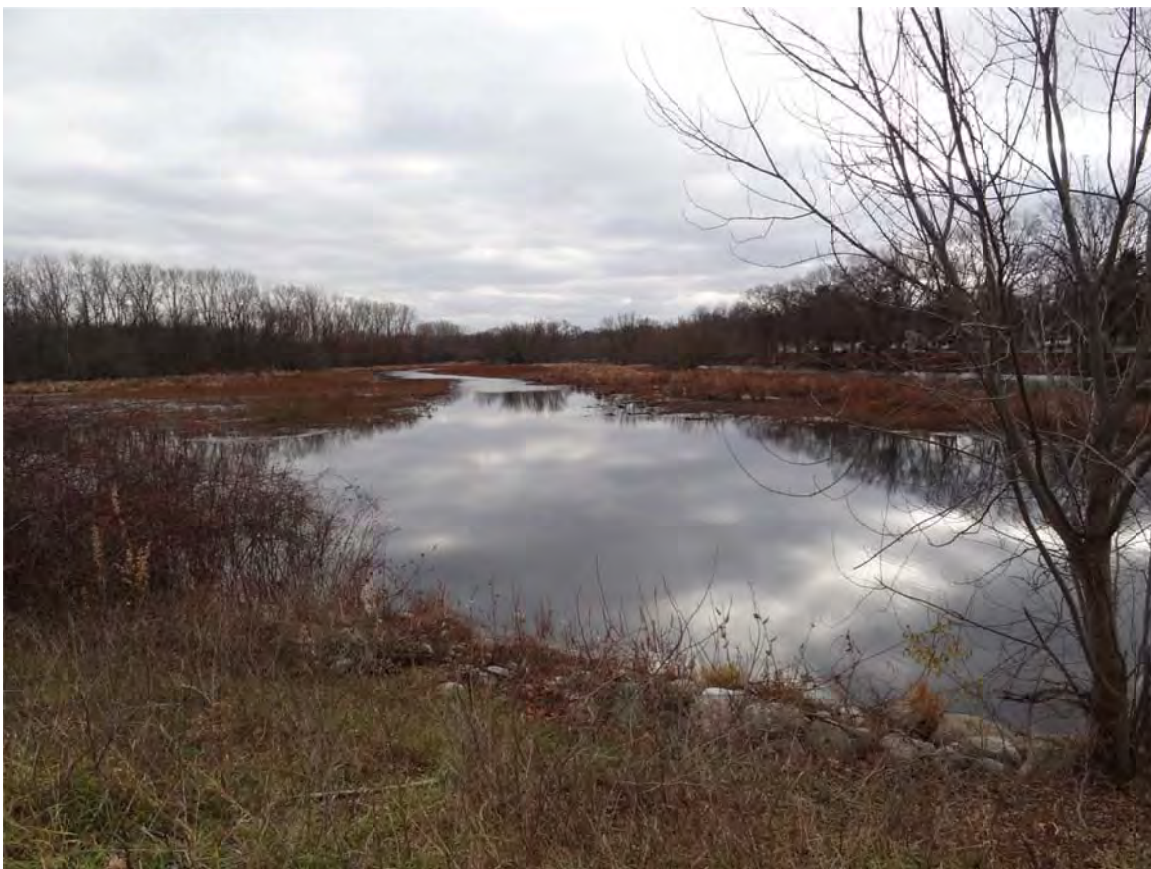
8. MP 15.5, south side of Mill Pond. No sheen observed, some ice observed in stagnant water in eastern side of Mill Ponds.

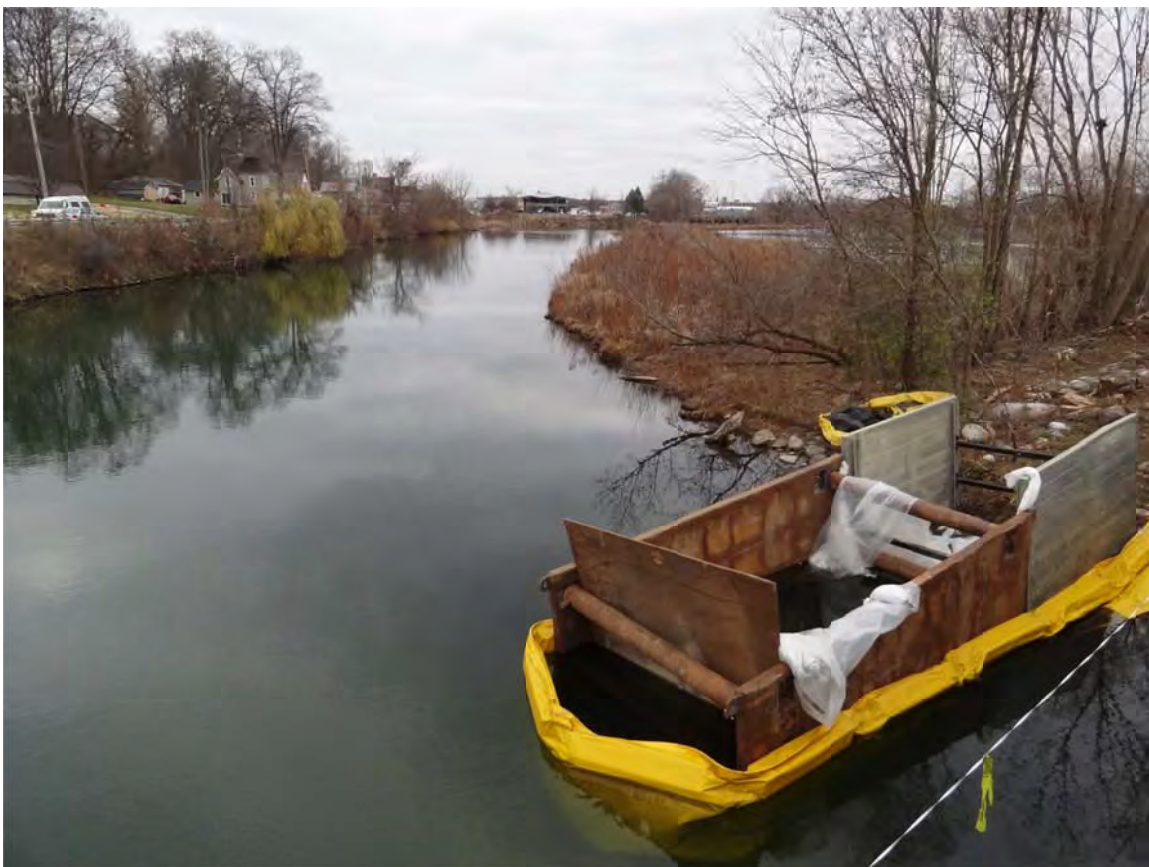
**9. MP 15.5 north Mill Pond. Utility excavation work continues on northern side of Burnham Street Bridge. No sheen observed.**

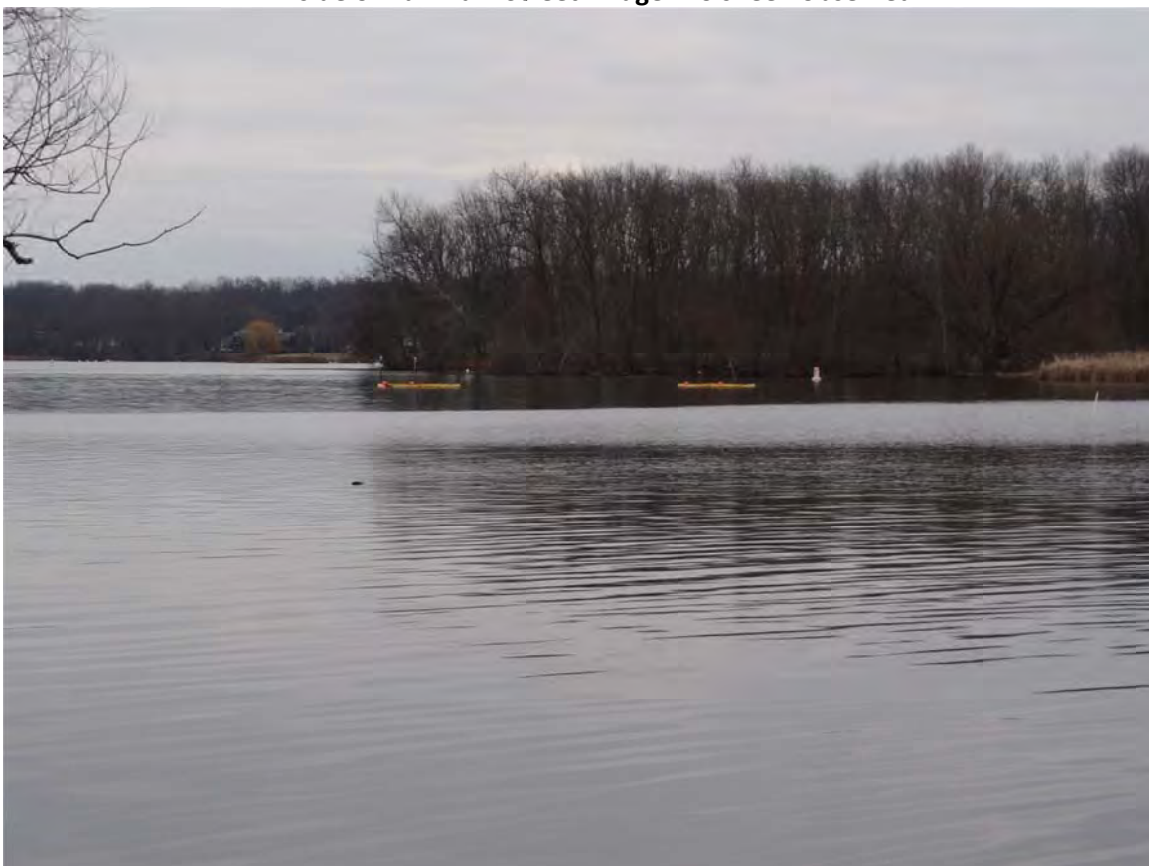
**10. Morrow Lake Delta, no ice observed forming within the neck of the delta.**

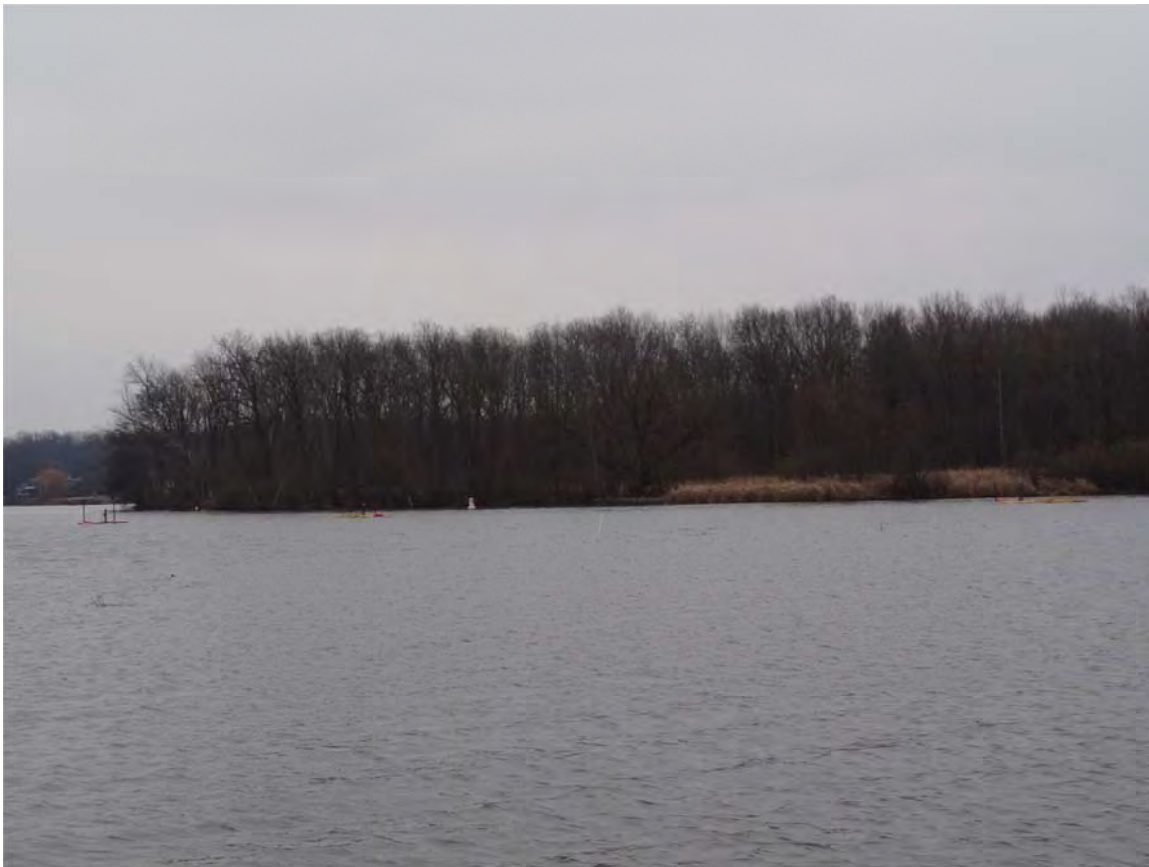
**11. Morrow Lake Delta observed the anchor poles and boom in place.**

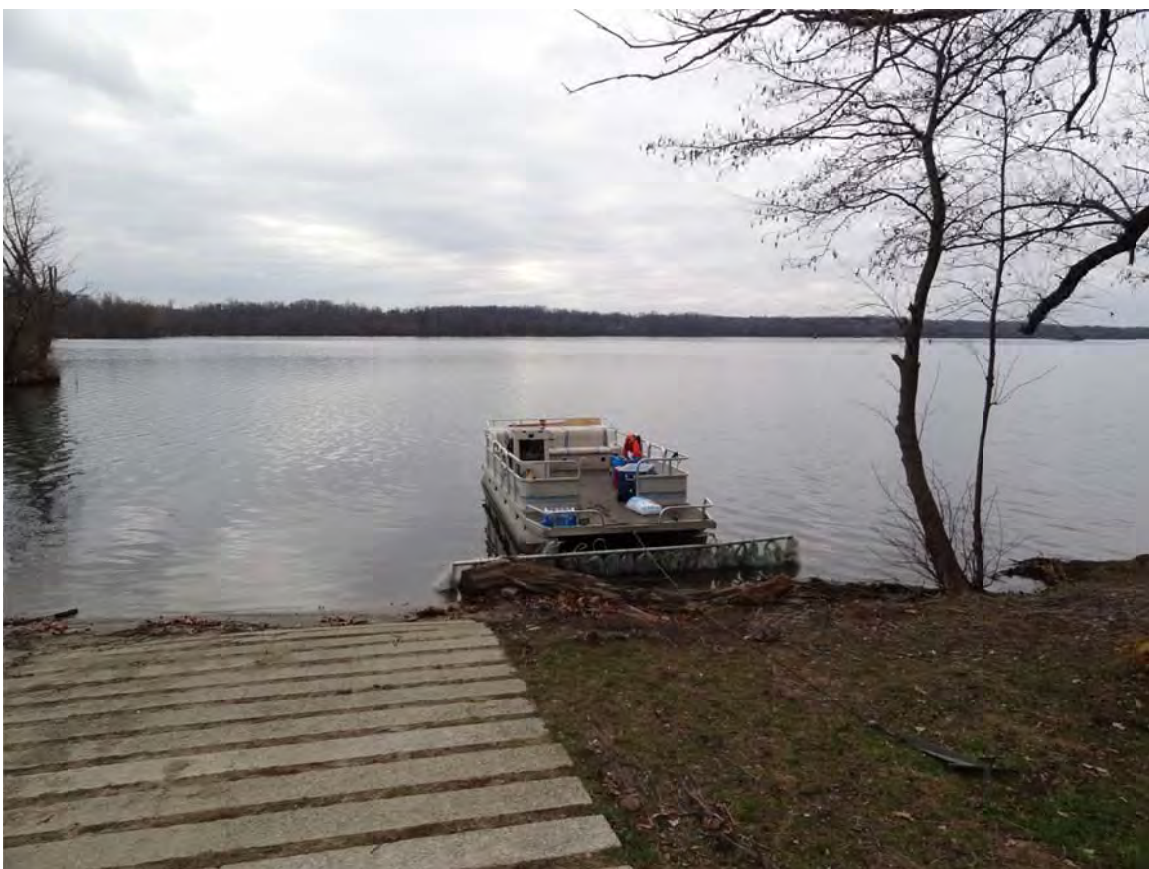
**12. E4.0 boat launch. No sheen or ice observed.**
