# Situation Photo Log

Wednesday, November 28, 2012

Kalamazoo River / Enbridge Spill

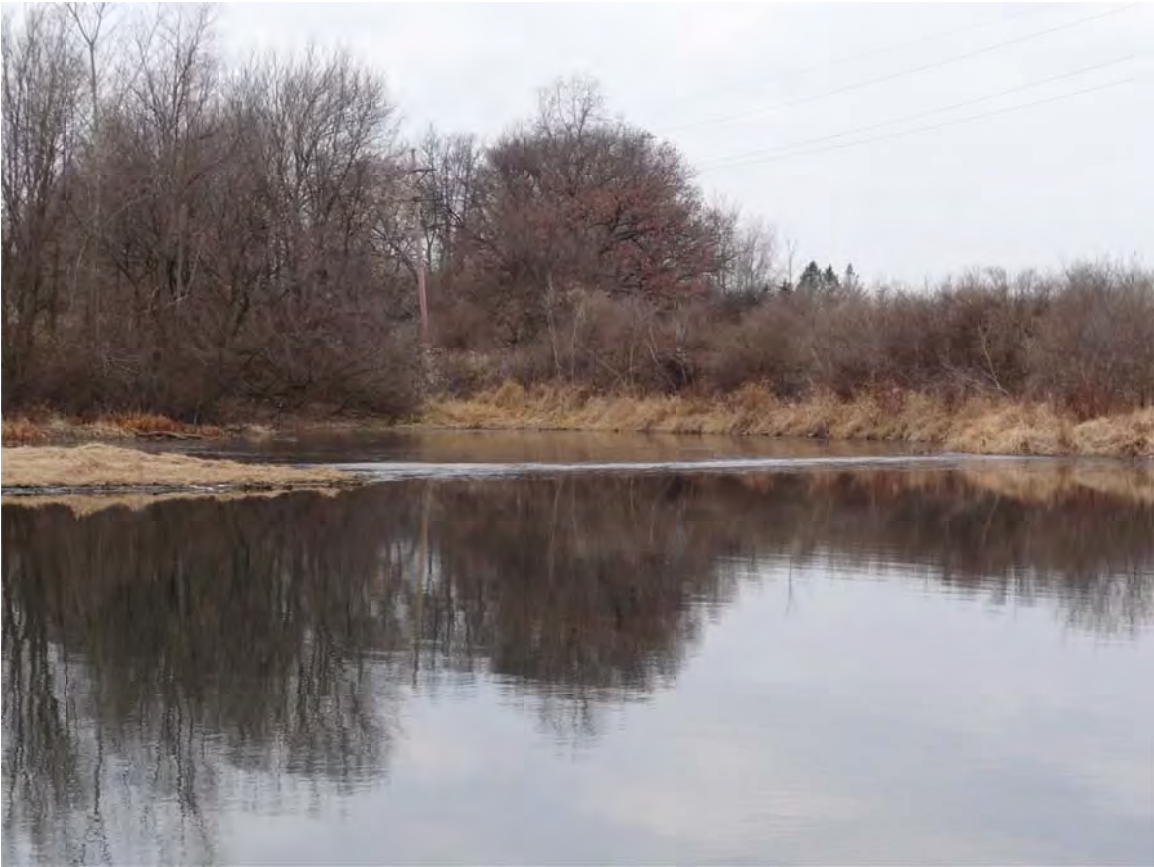
**1. MP5.63 LDB, bank ice observed along river shoreline on upstream side of trestle.**

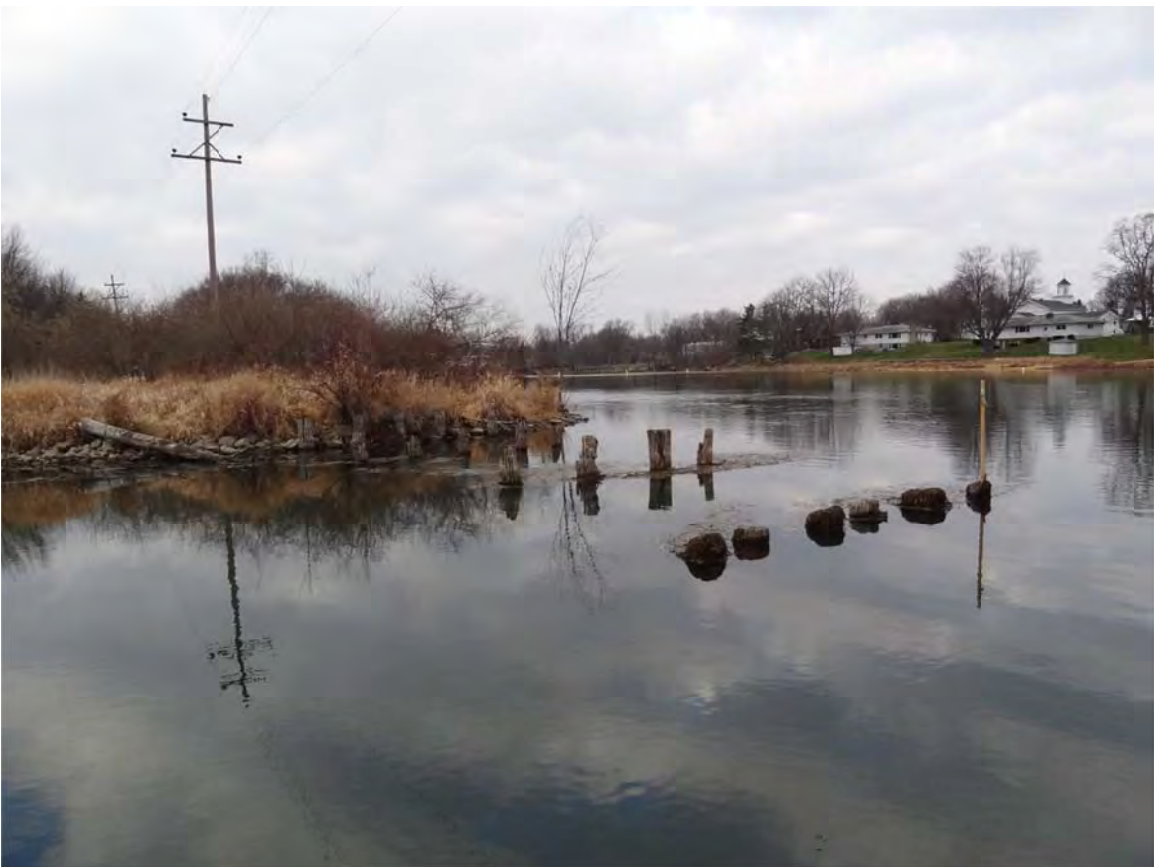
**2. Ceresco Dam trestle, no sheen observed.**

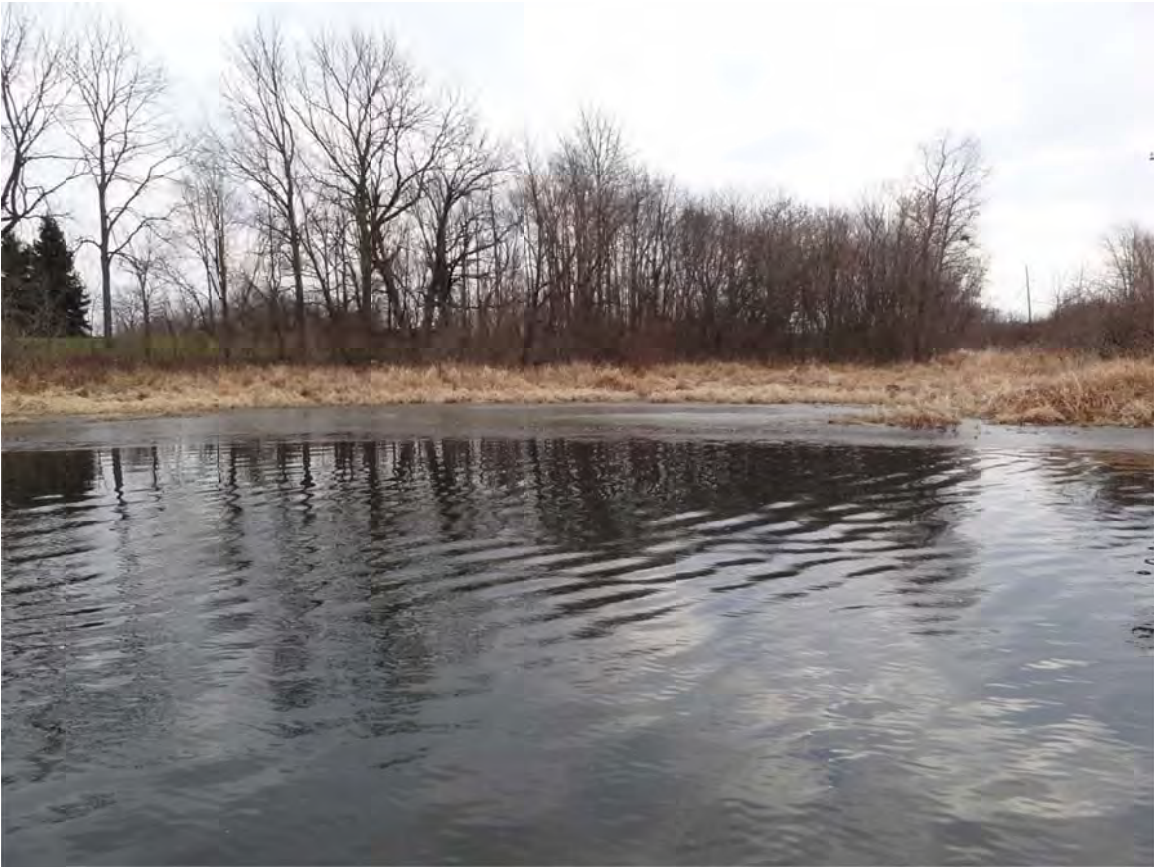
3. MP5.63 RDB, observed thin layer of ice on downstream side of trestle.

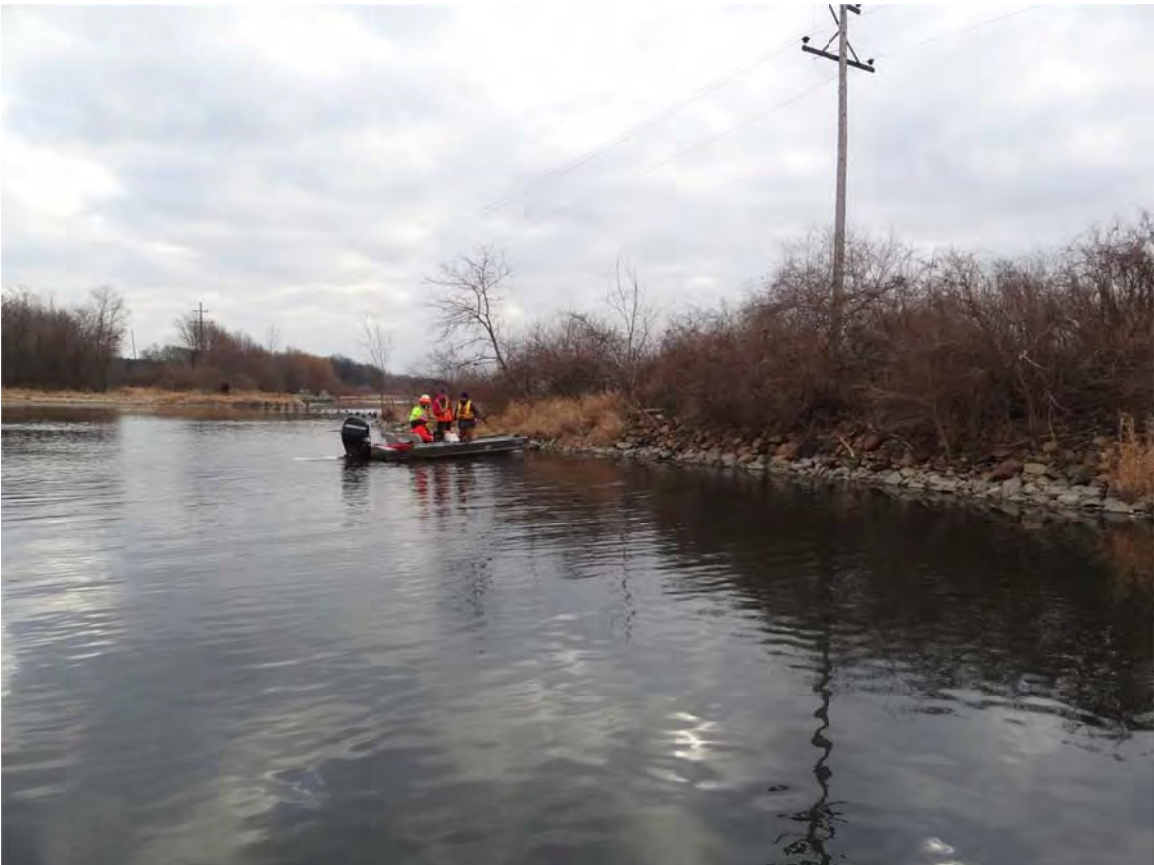
4. MP5.63 LDB, bathymetry survey crew observed on downstream side of trestle.

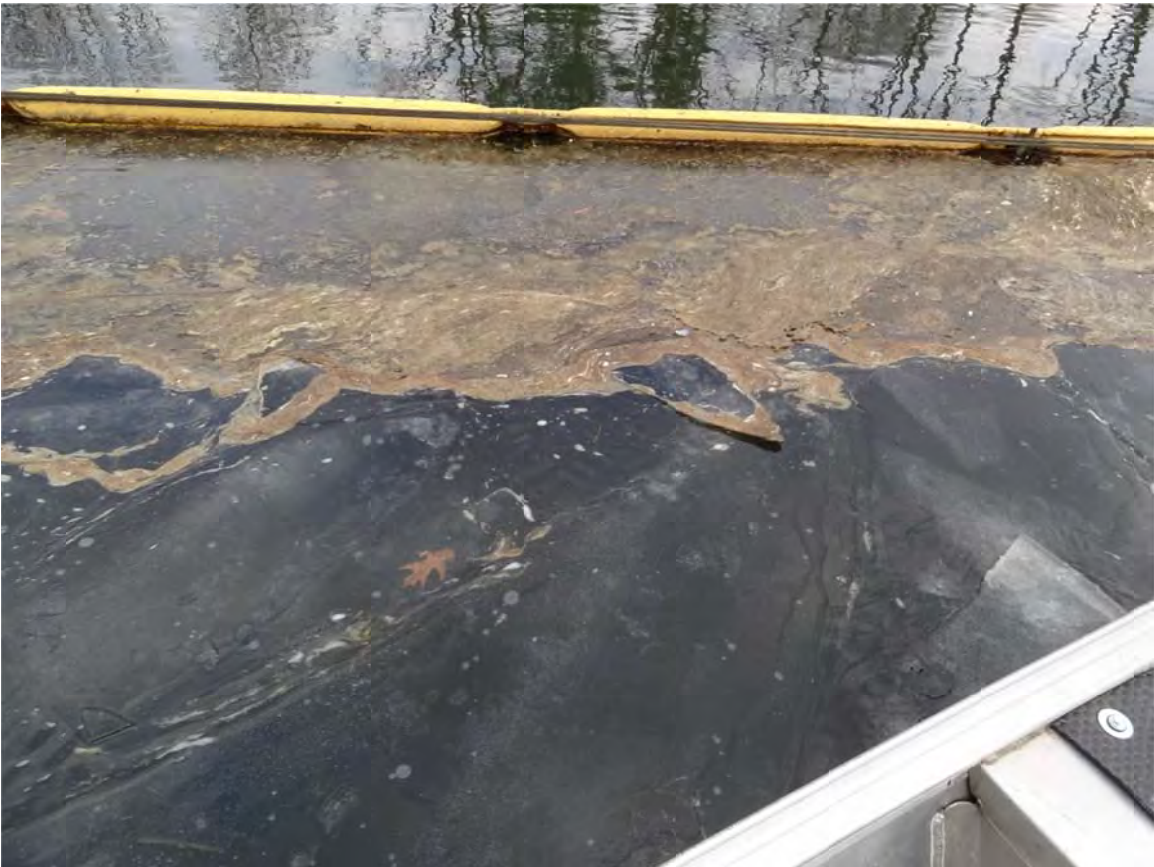
5. Ceresco Dam control point boom, some debris and ice observed.

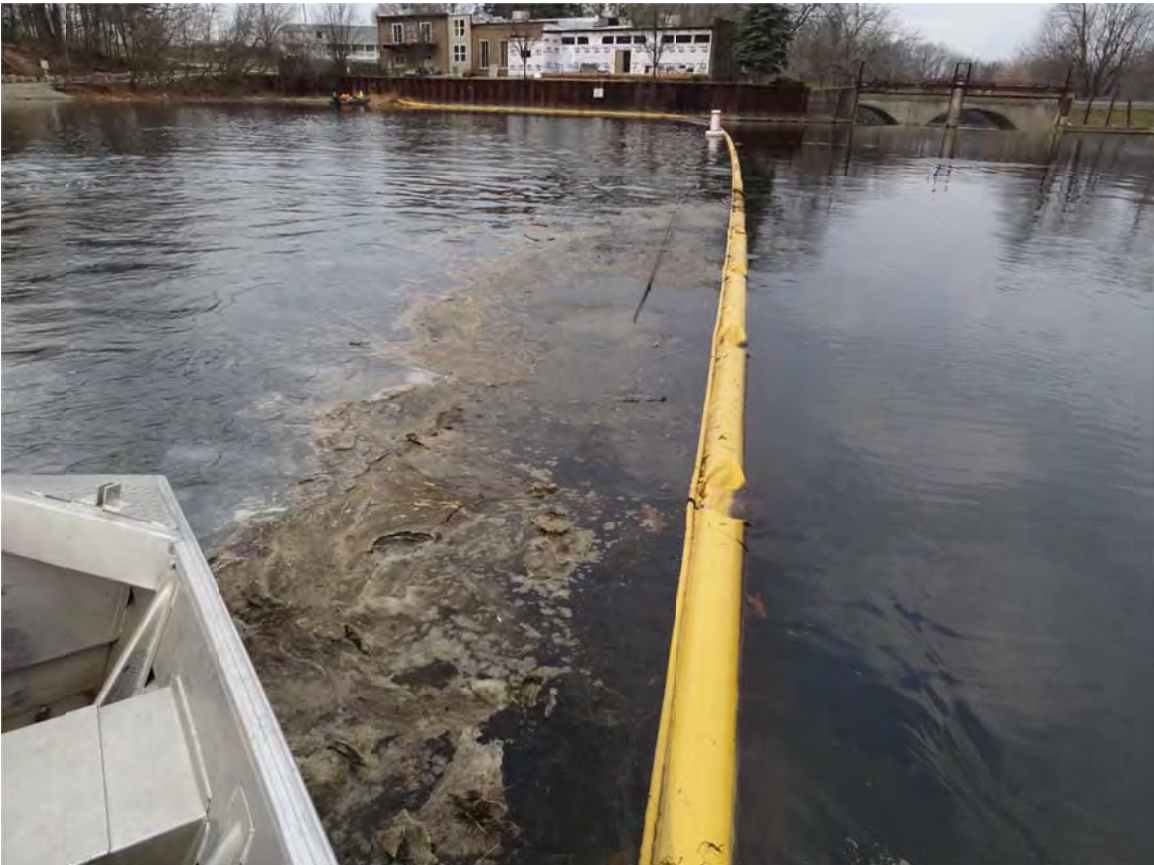
6. Ceresco Dam control point, frozen debris and ice fragments observed along containment boom.

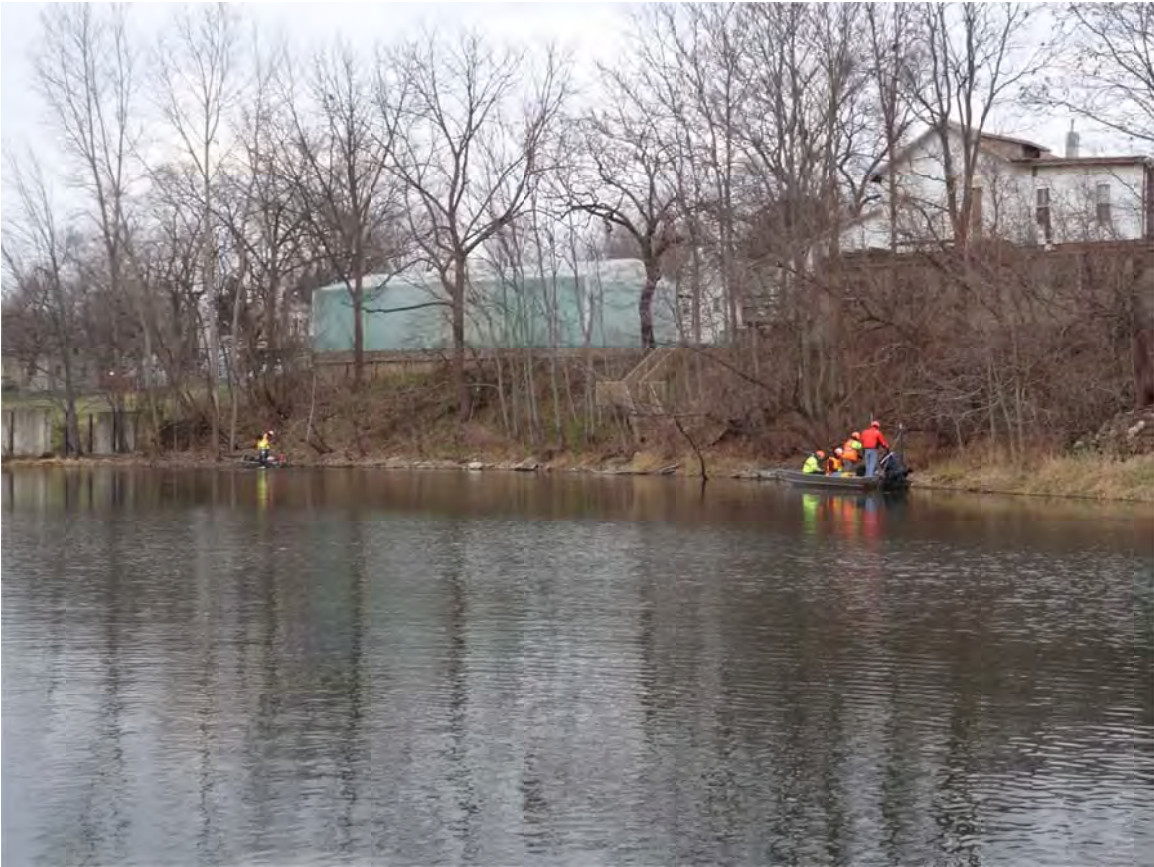
7. MP 5.7 RDB, bathymetry crews observed along north shore of river above Ceresco Dam.

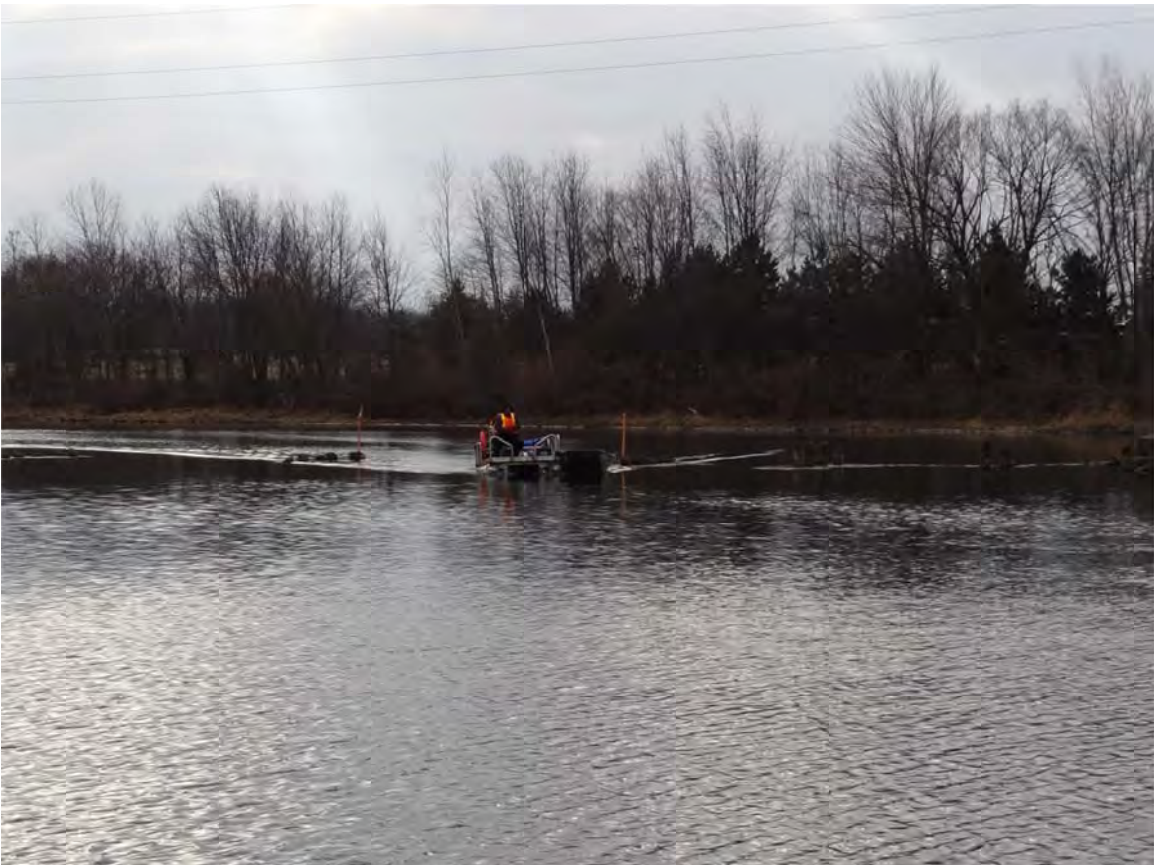
8. Debris collection crew observed mobilizing to Ceresco Dam control point.

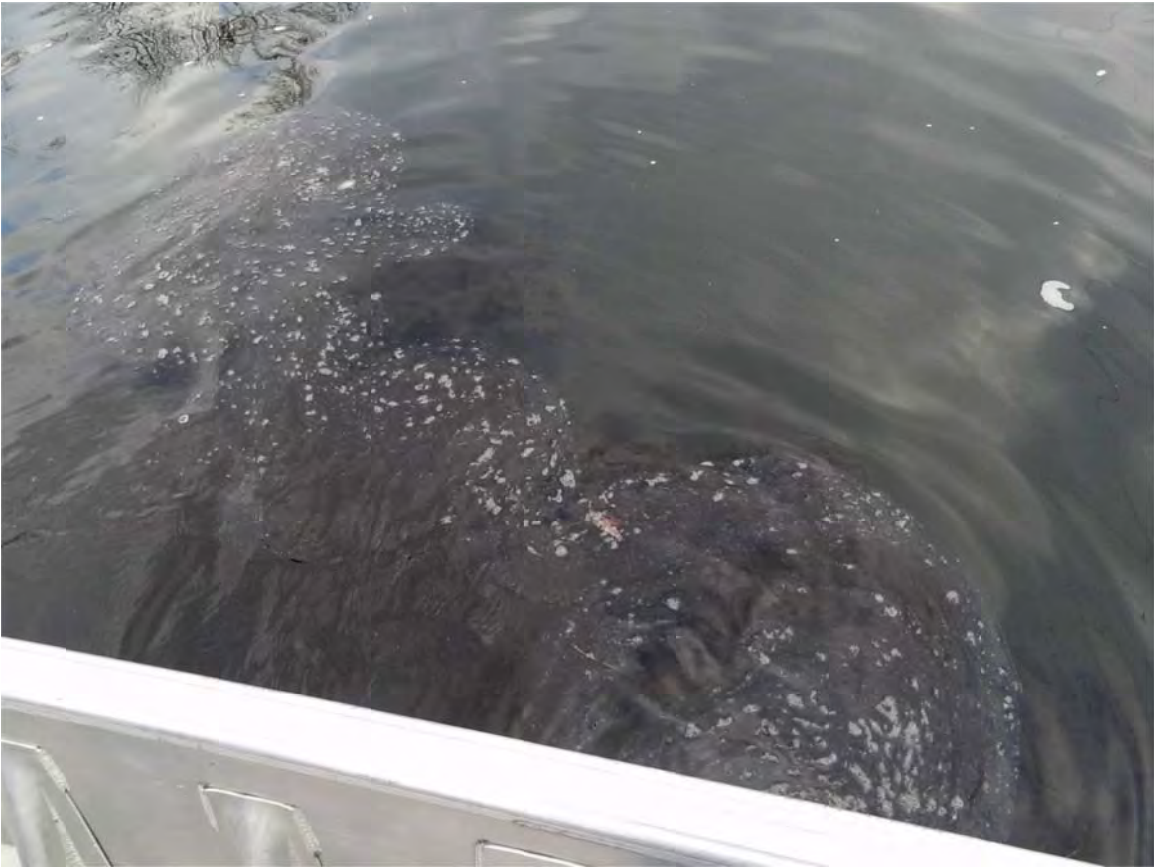
9. Boat-agitated sheen observed at Ceresco Dam trestle.

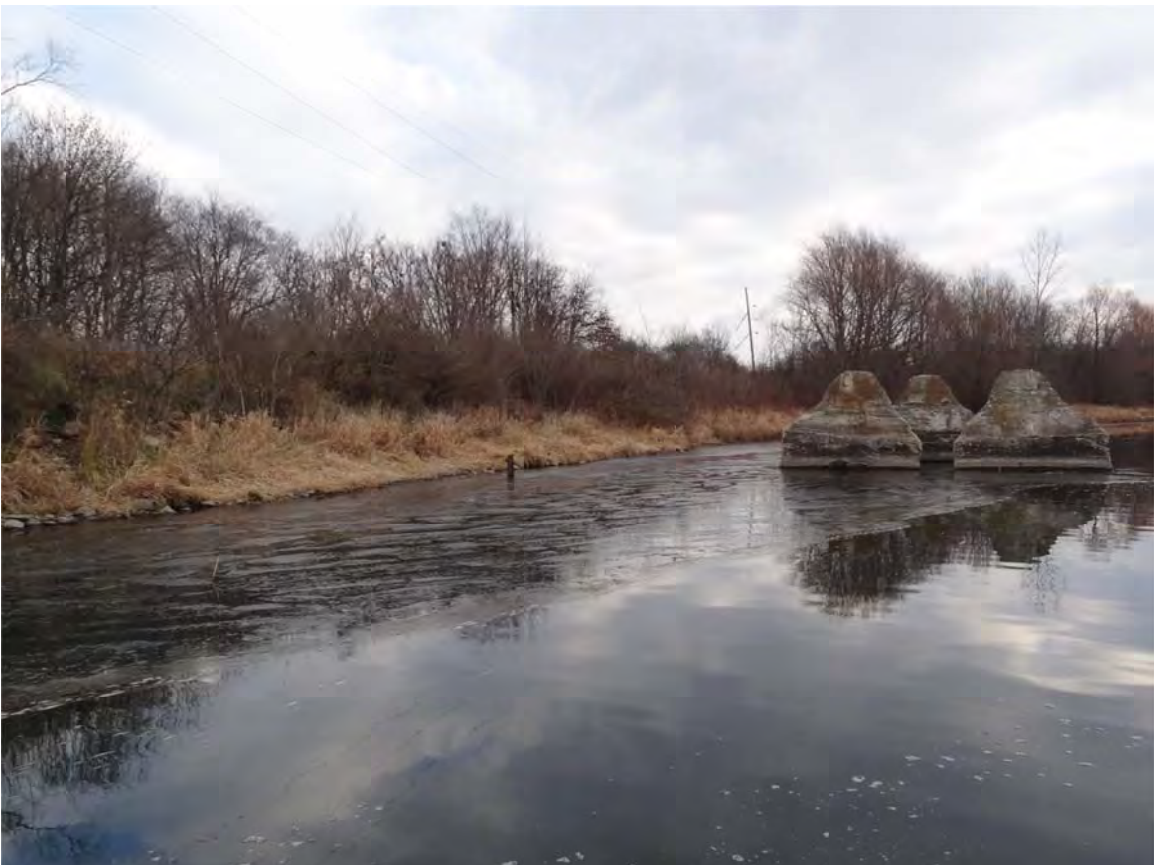
10. MP 5.63 RDB, ice observed along shoreline on upstream side of trestle.

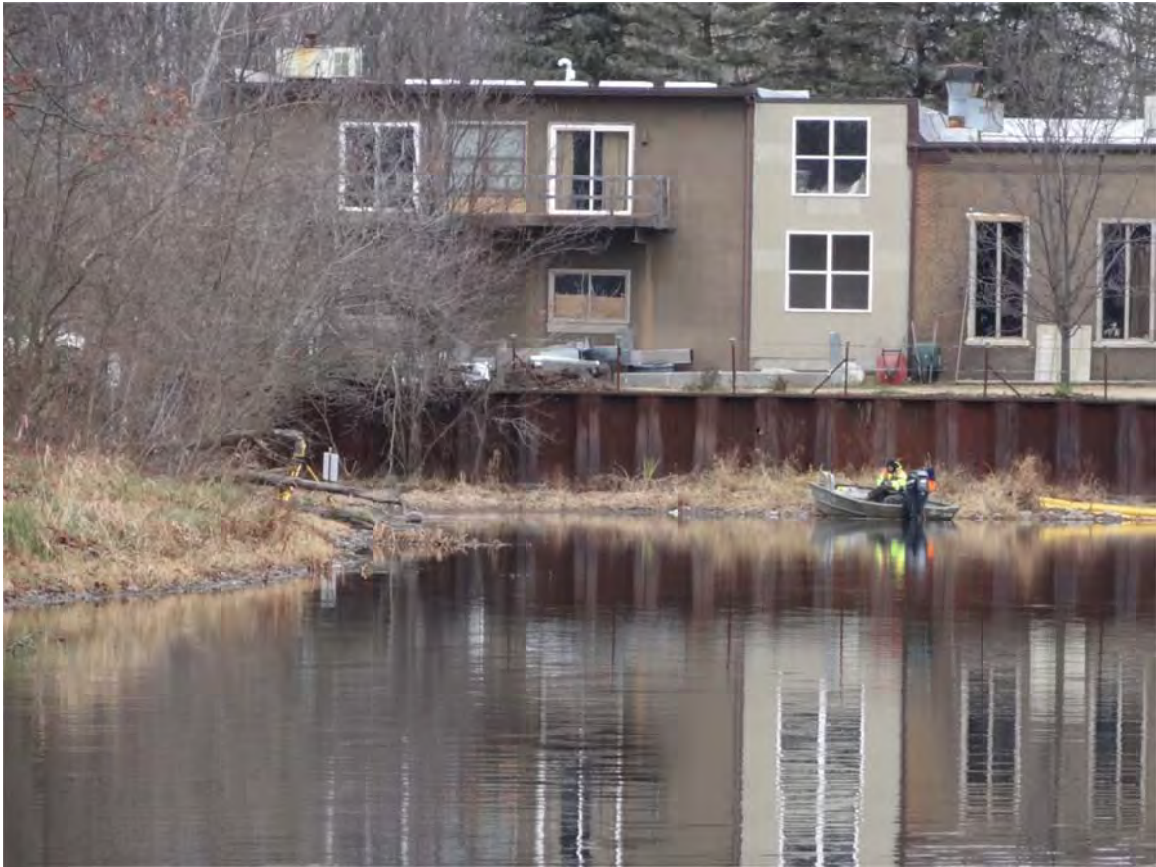
11. MP 5.7 LDB, bathymetry crew observed in southwest corner of river above Ceresco Dam. Some ice observed along shore at this location.

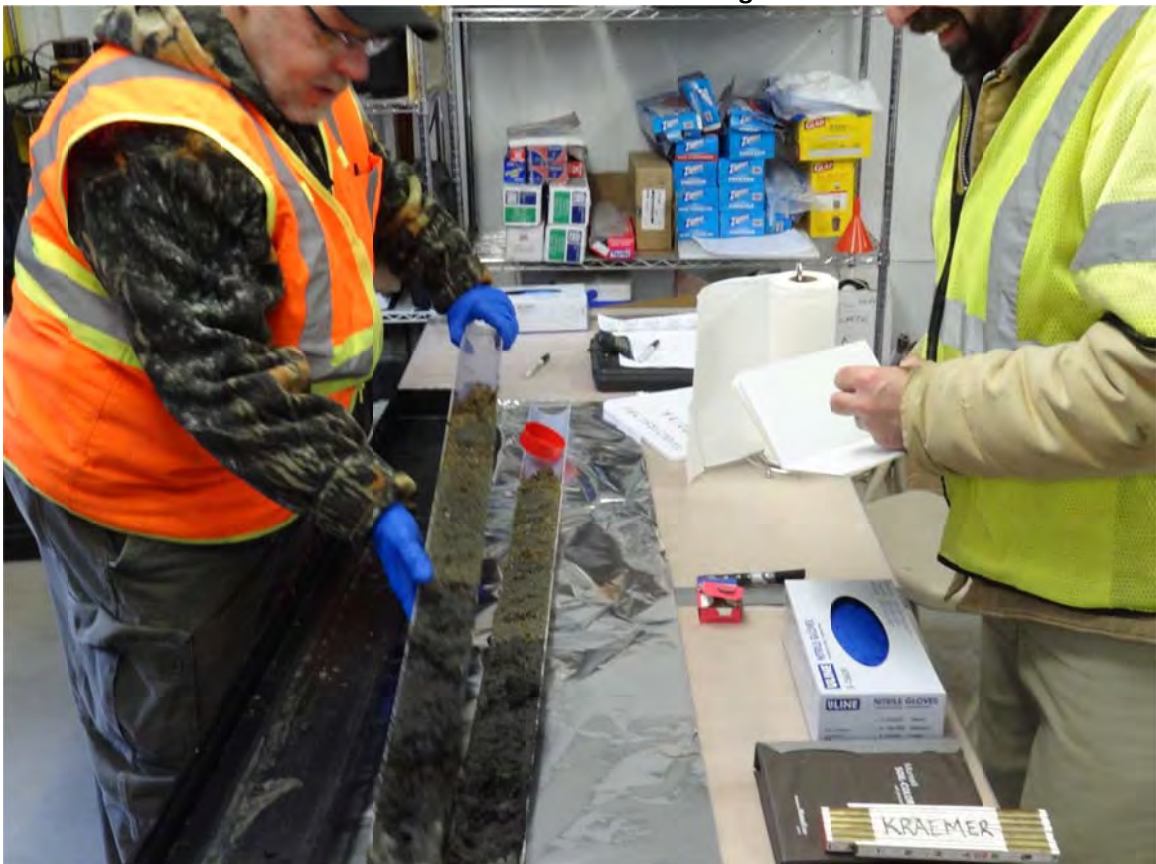
12. C3.2 field office, crews observed logging soil samples for oil quantification.

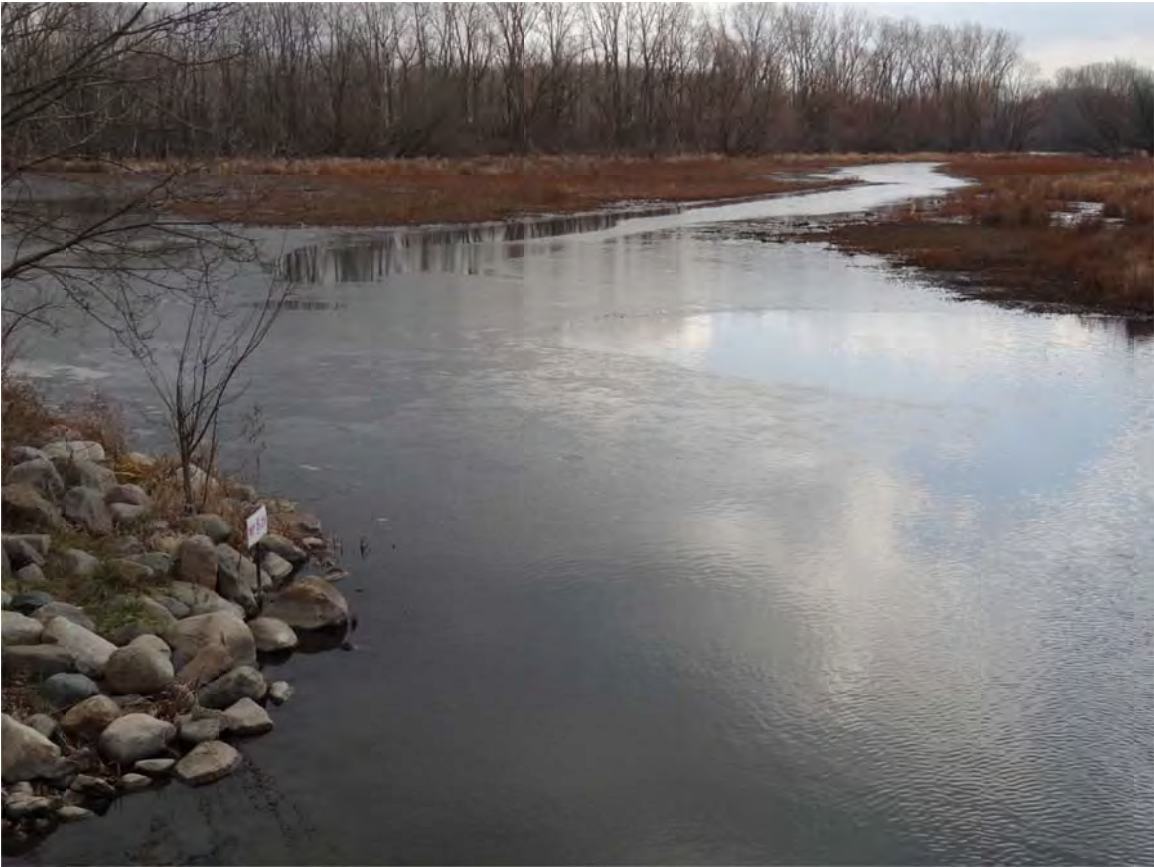
**13. MP 15.5 South Mill Pond, ice observed in backchannel areas east of river channel.**

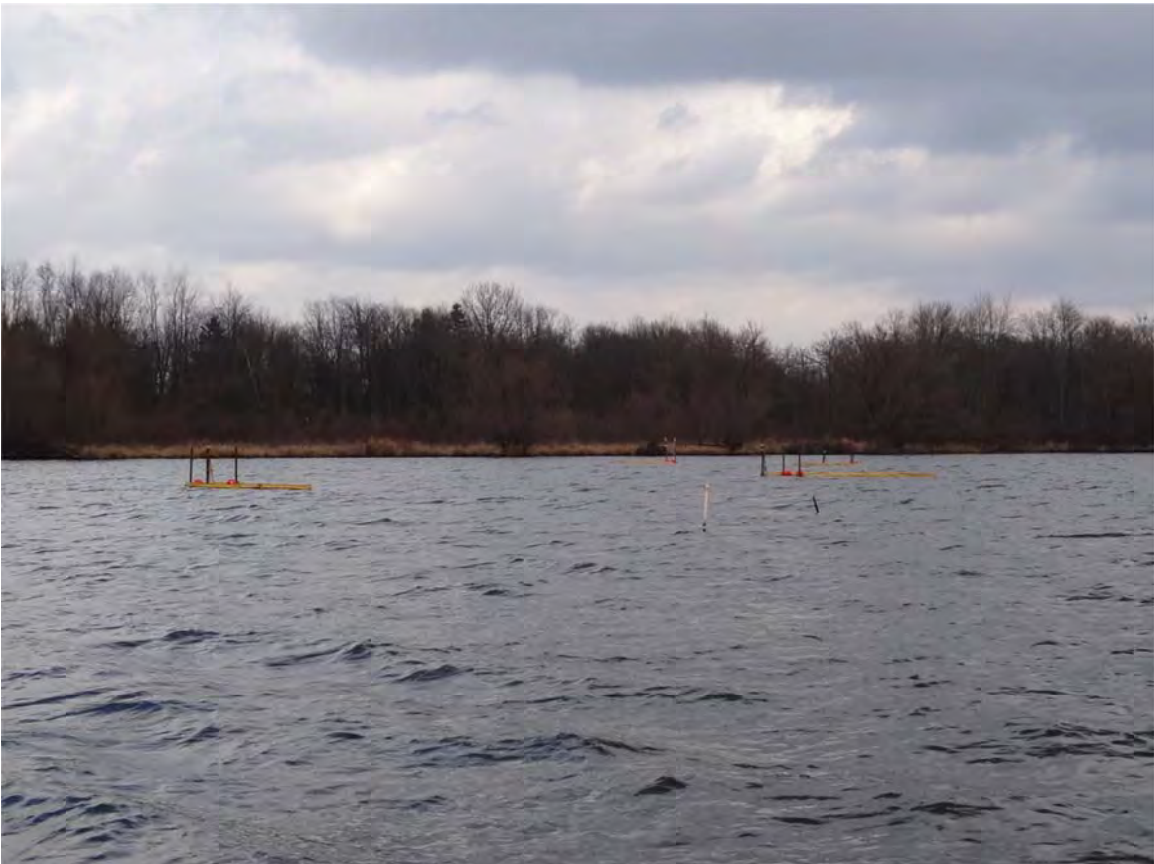
**14. Morrow Lake Delta, boom anchors remain in place.**

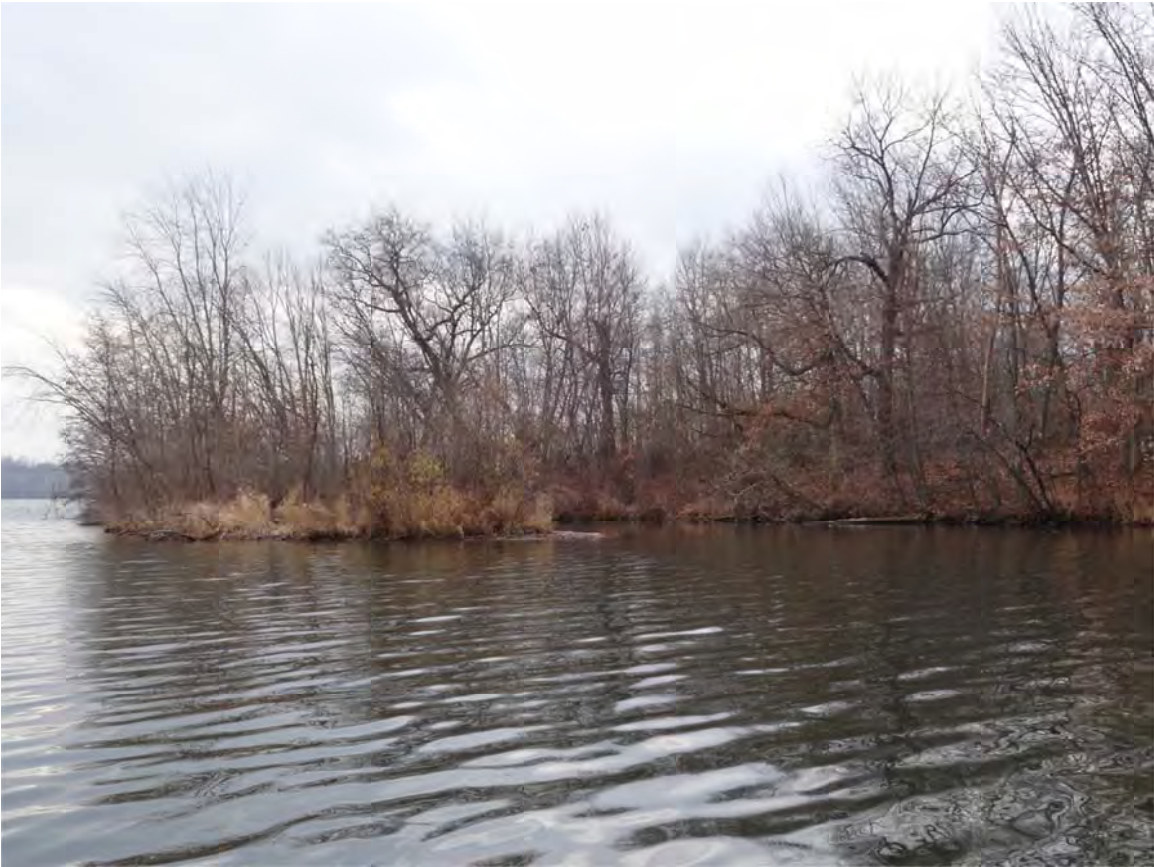
**15. Morrow Lake North Cove, no sheen or ice observed.**

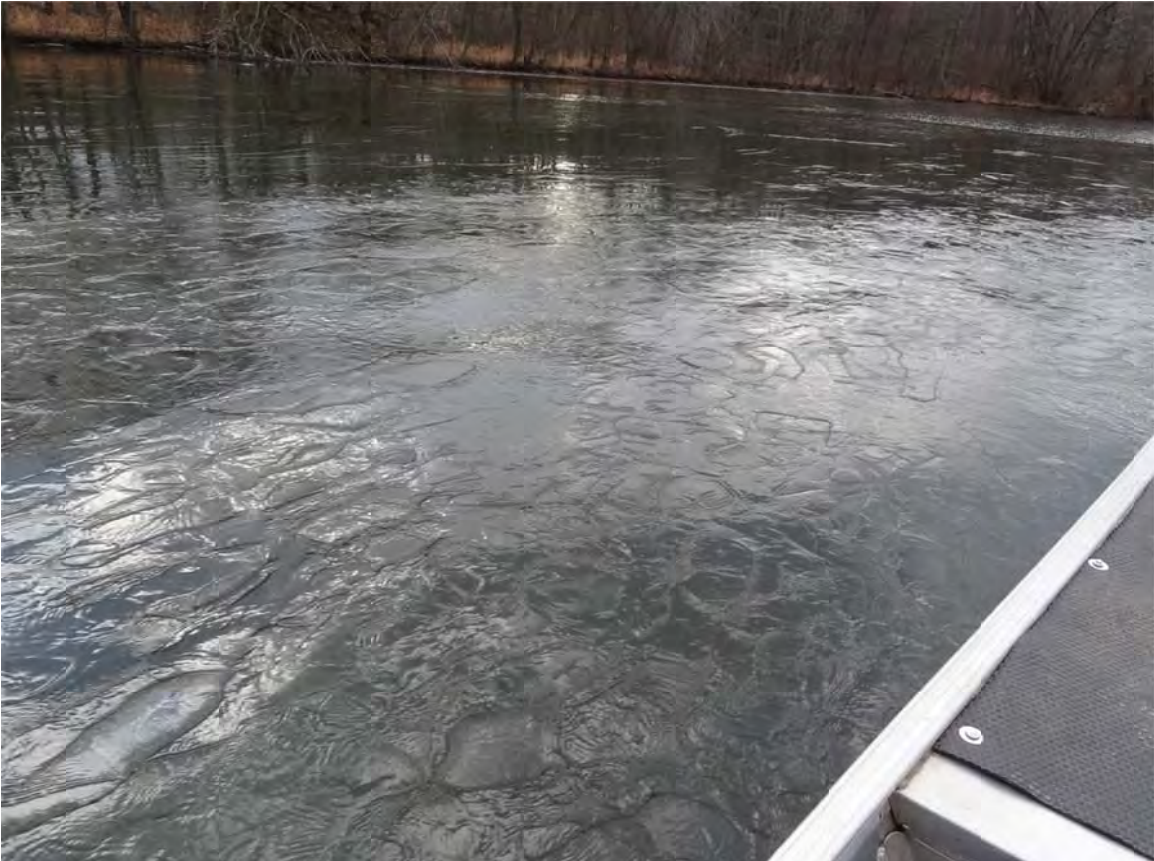
**16. Morrow Lake South Cove, broken surface ice observed throughout cove.**

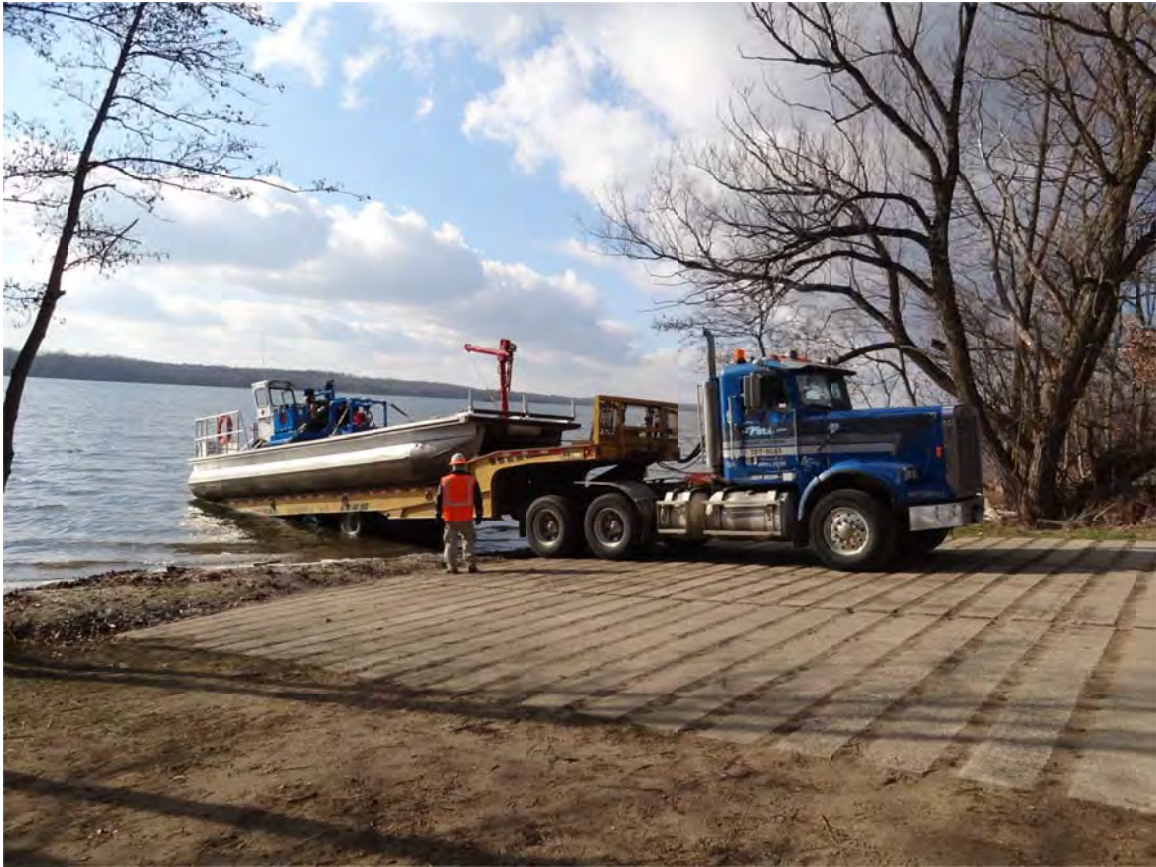
**17. E4.0 boat launch, crews observed unloading pontoon boat to be used for boom anchor removal.**

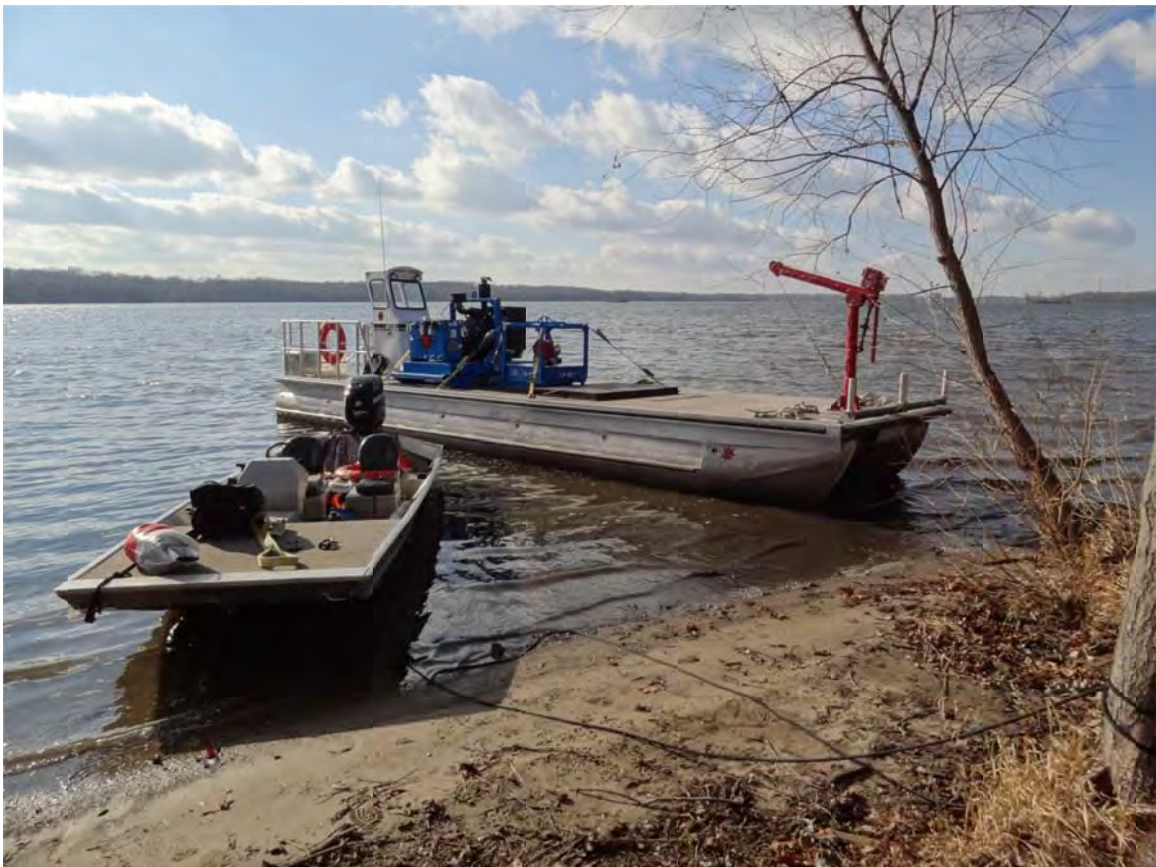
**18. Pontoon boat for boom anchor removal unloaded and staged at E4.0 boat launch.**
