Situation Photo Log

Thursday, November 29, 2012

Kalamazoo River / Enbridge Spill

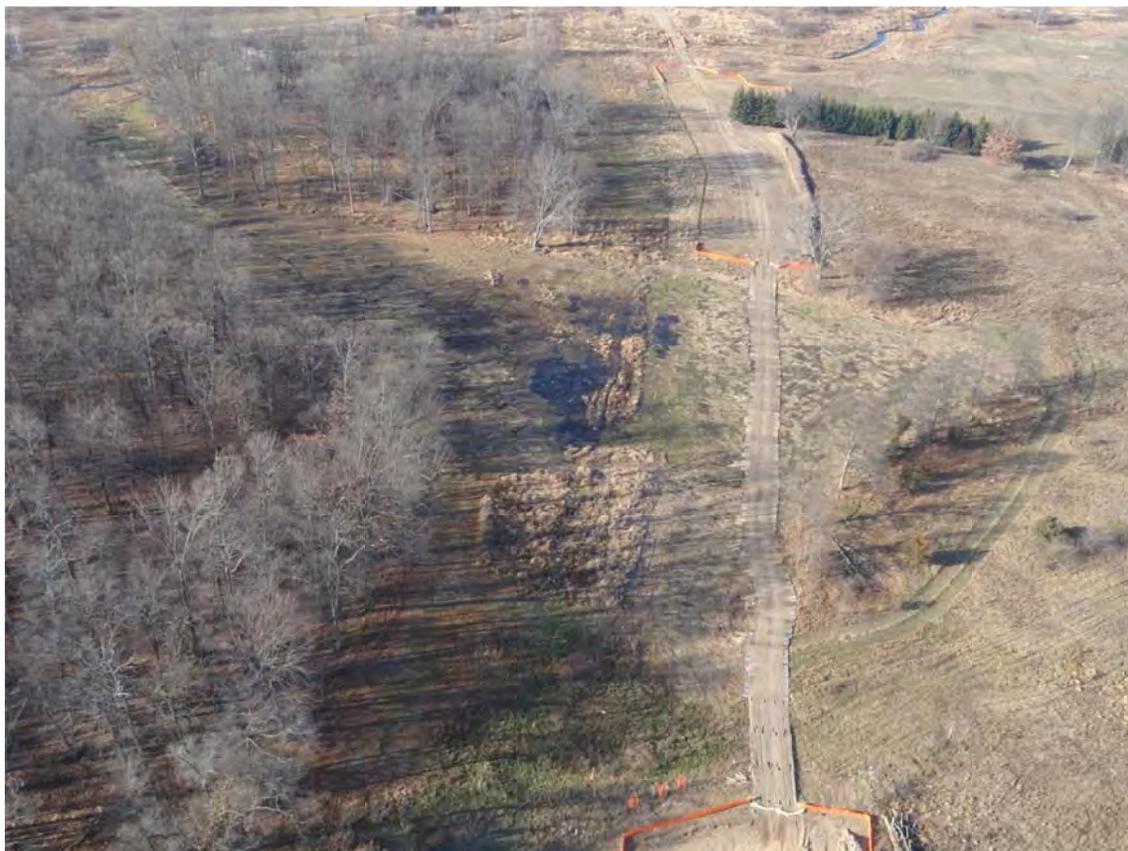
1. Source Area, ice observed on standing water in source area.

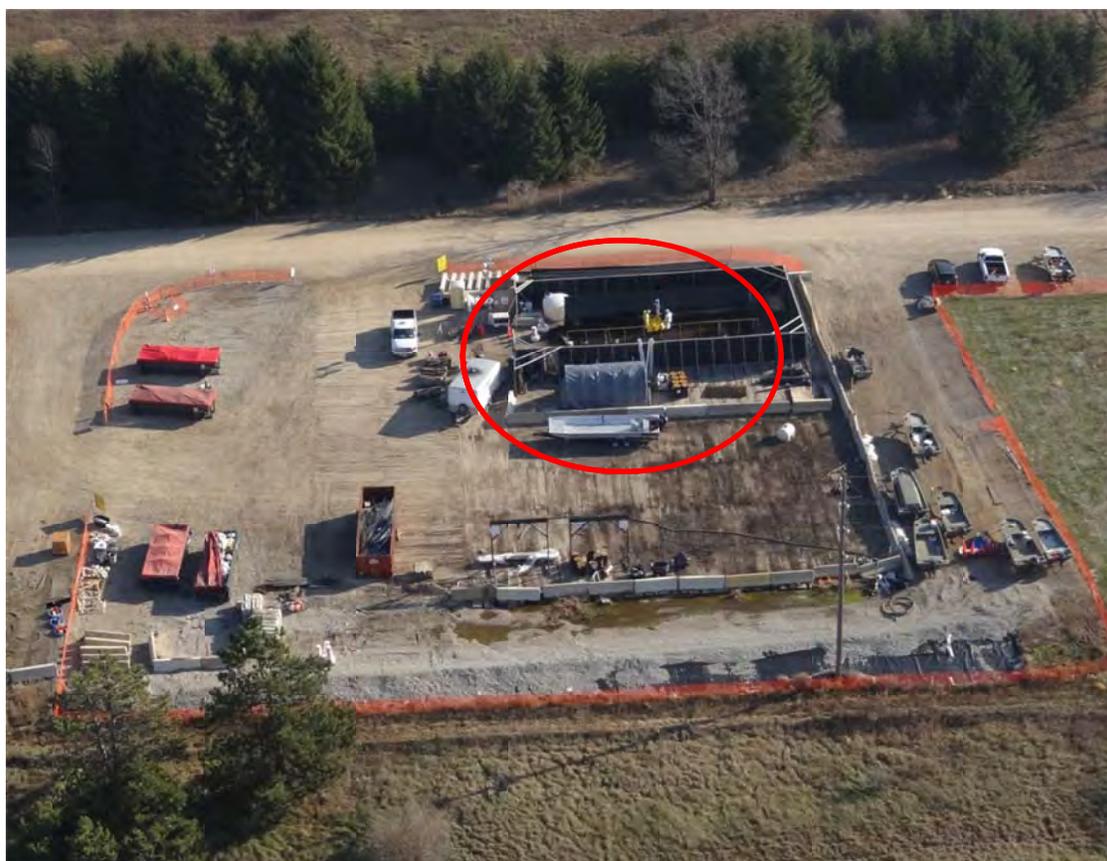
2. Frac Tank City, crews observed cleaning boom in the decon pad. Construction on the shelter adjacent to decon area appears to be complete.

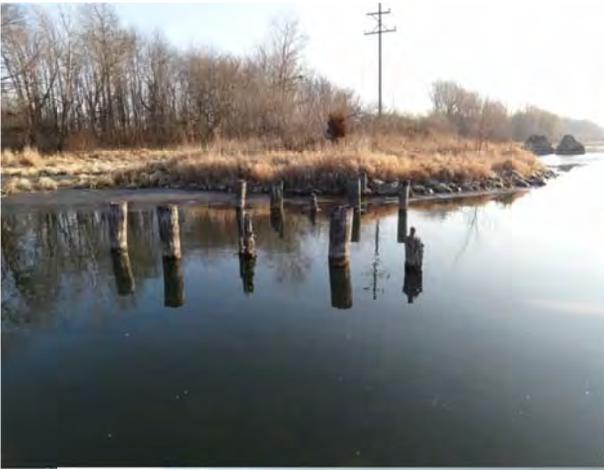
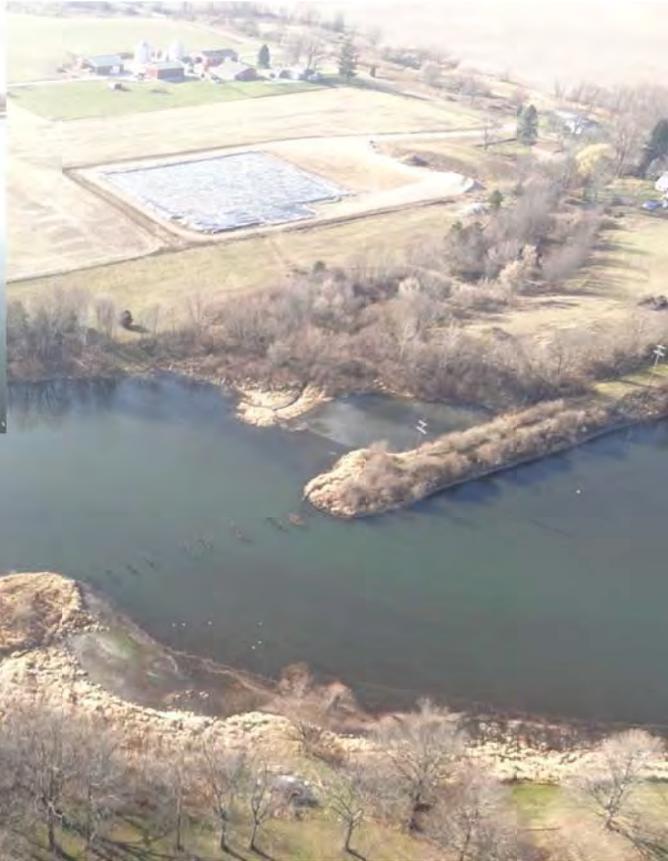
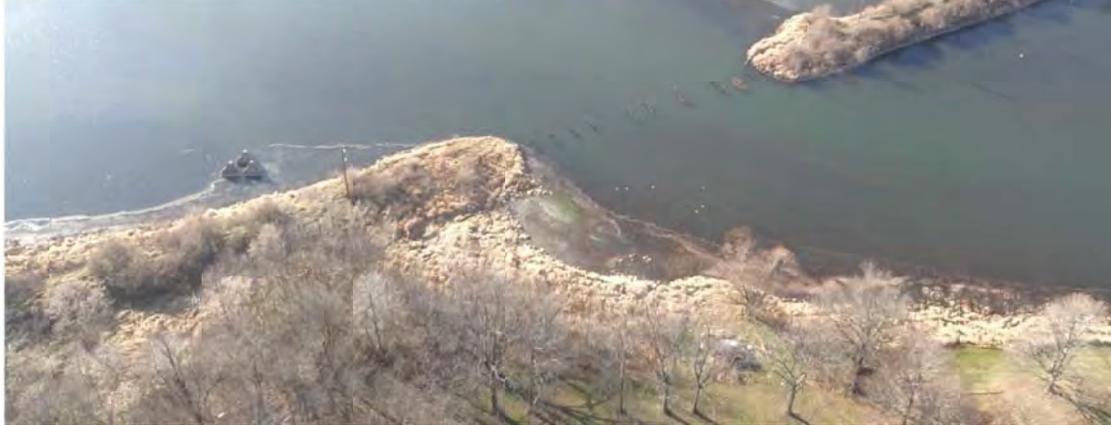
3. MP5.63, Ceresco Dam trestle, no sheen observed. Ice observed on both upstream and downstream sides of trestle on LDB and RDB.

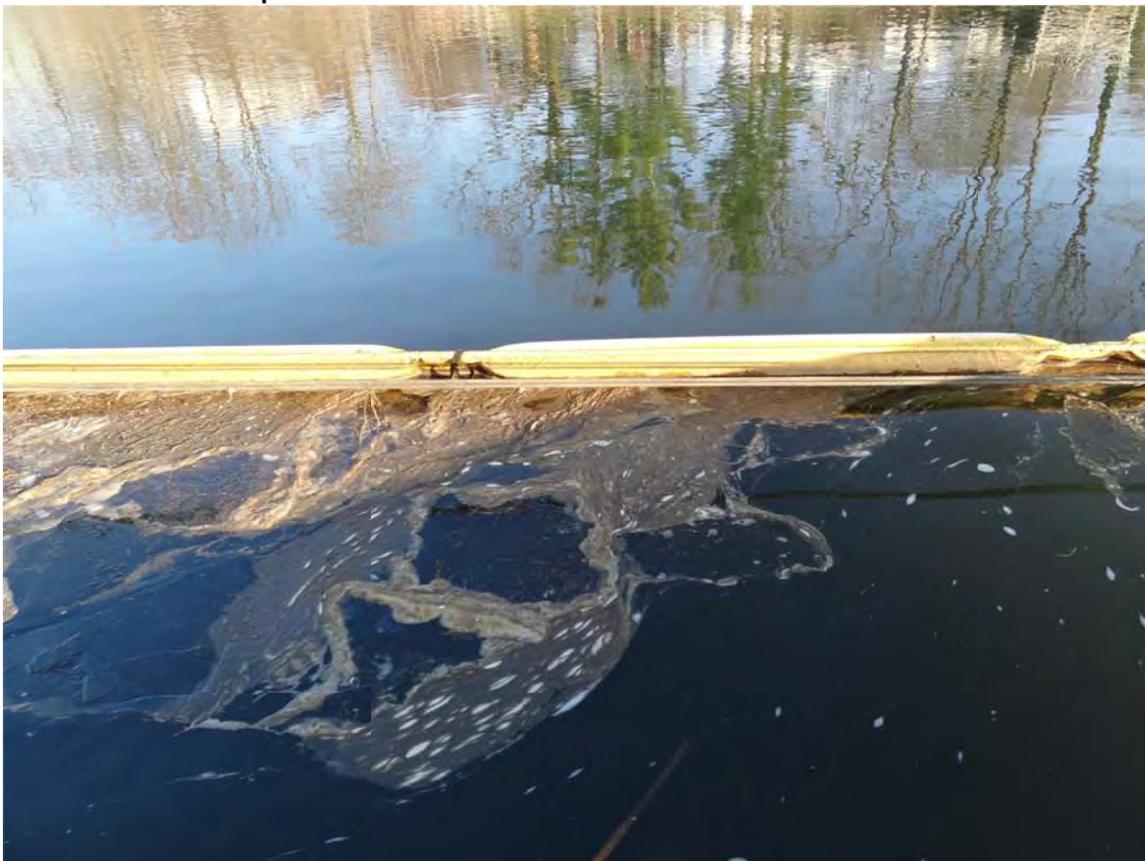
4. MP5.75 Ceresco Dam control point, debris and some ice fragments observed along containment boom.

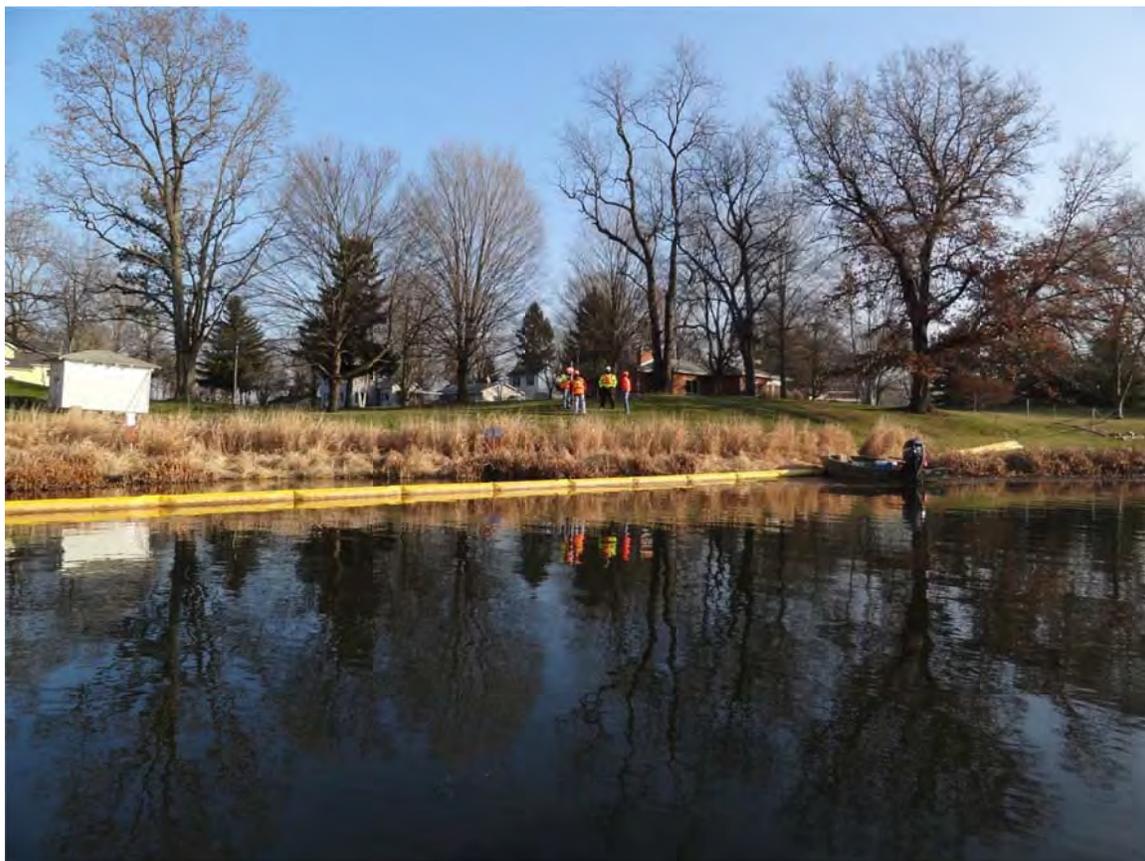
5. Bathymetry survey crews observed setting up near Ceresco Dam control point on RDB during morning ground survey.

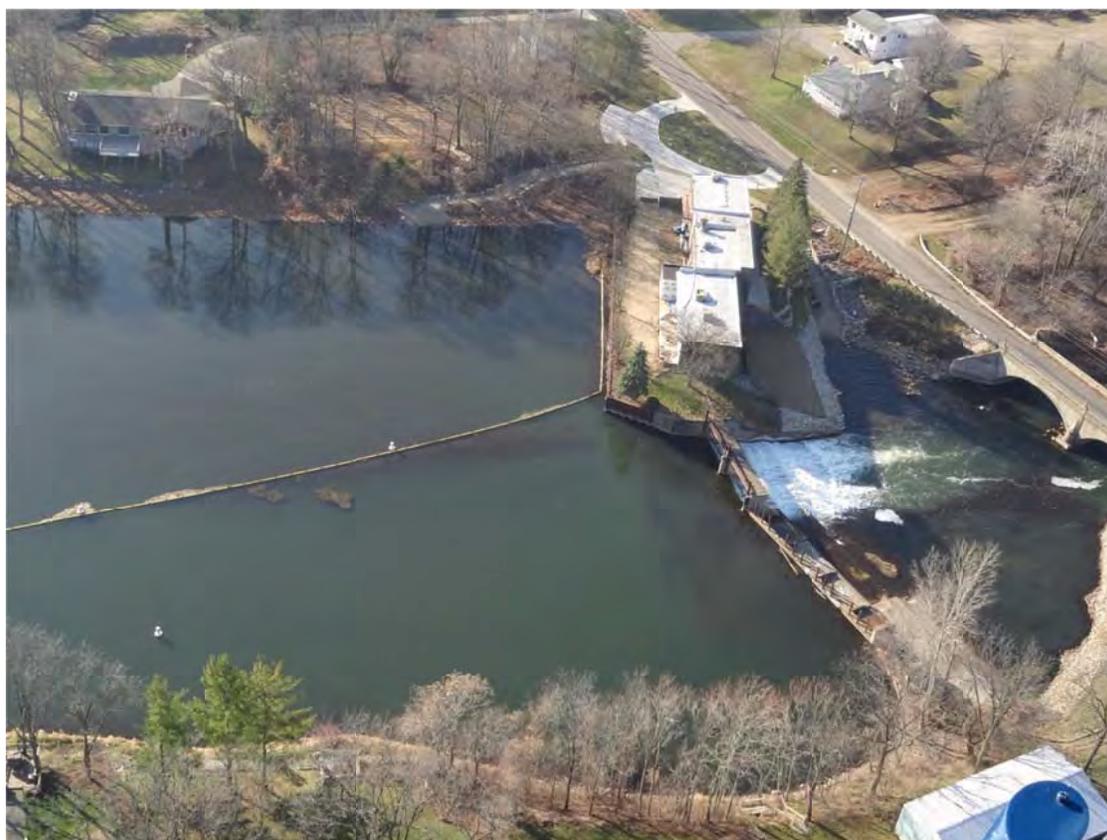
6. Ceresco Dam control point, some debris and ice fragments observed along boom.

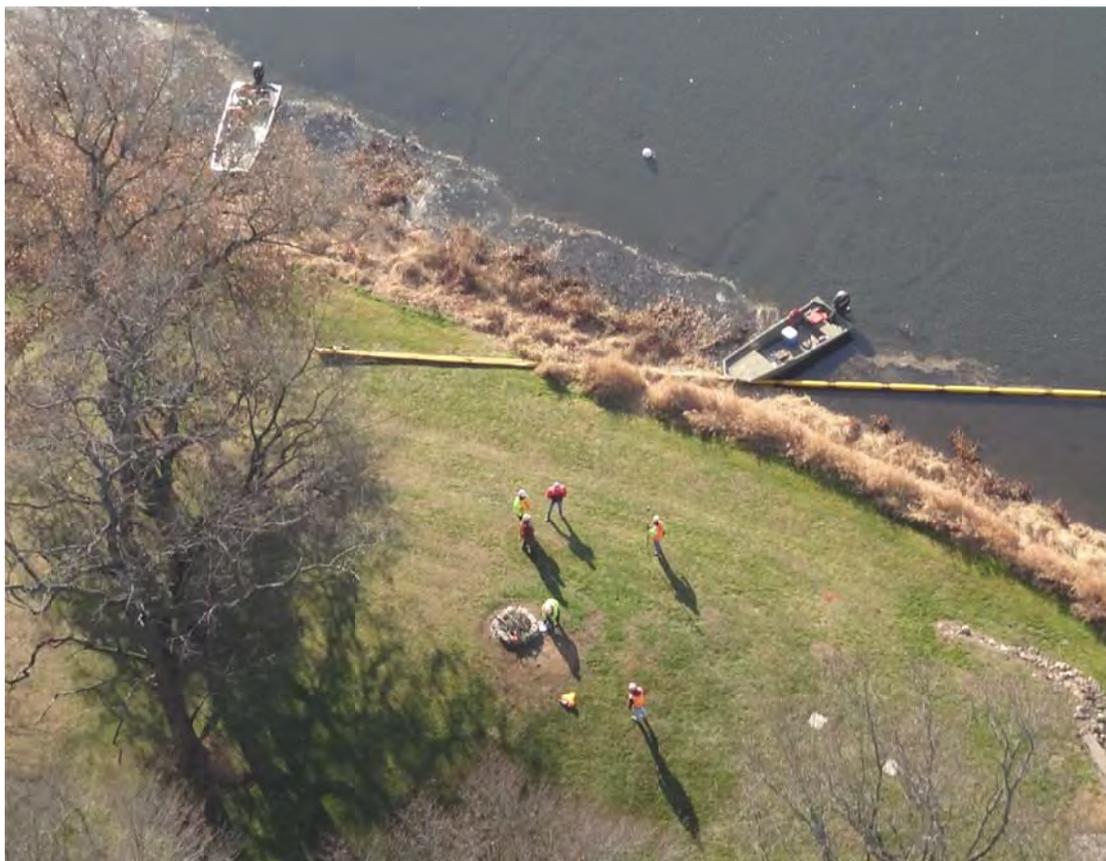
7. Bathymetry crew observed along LDB at Ceresco Dam impoundment.

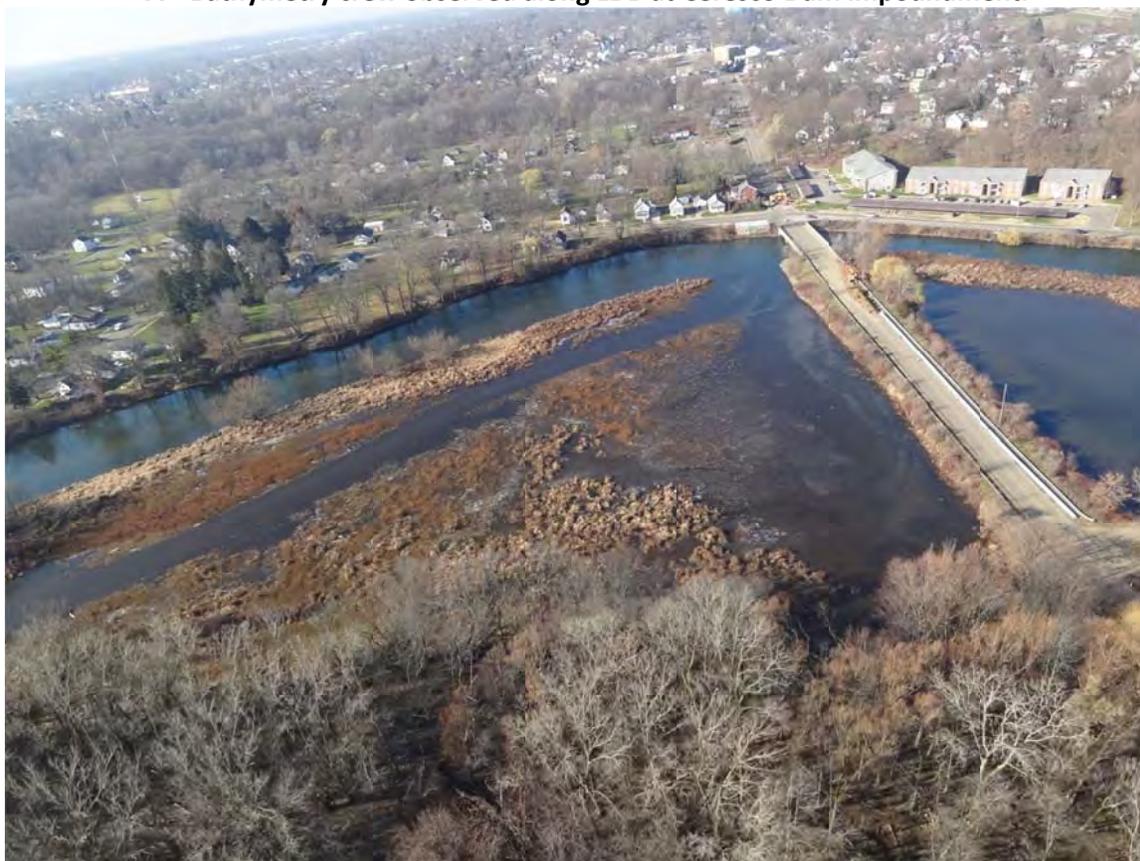
8. South Mill Pond, no sheen observed, ice observed in back channel areas.

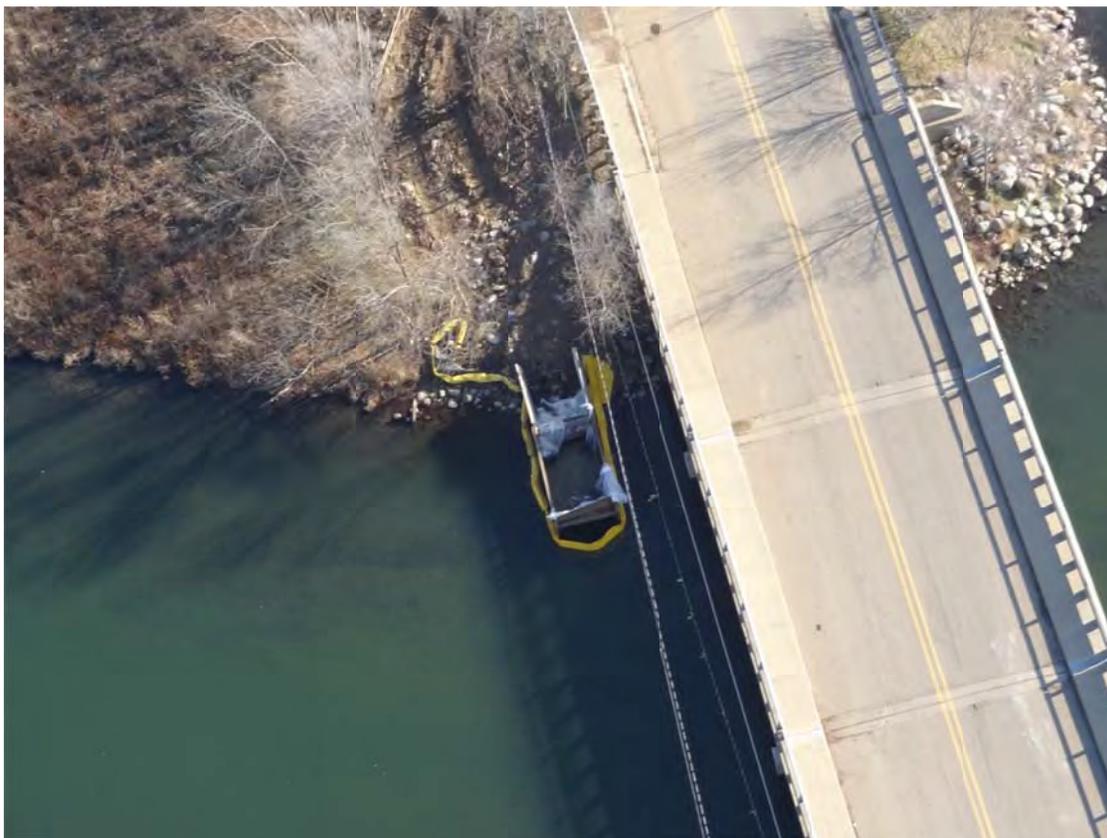
9. Observed trench box still in river on north side of Burnham Street Bridge.

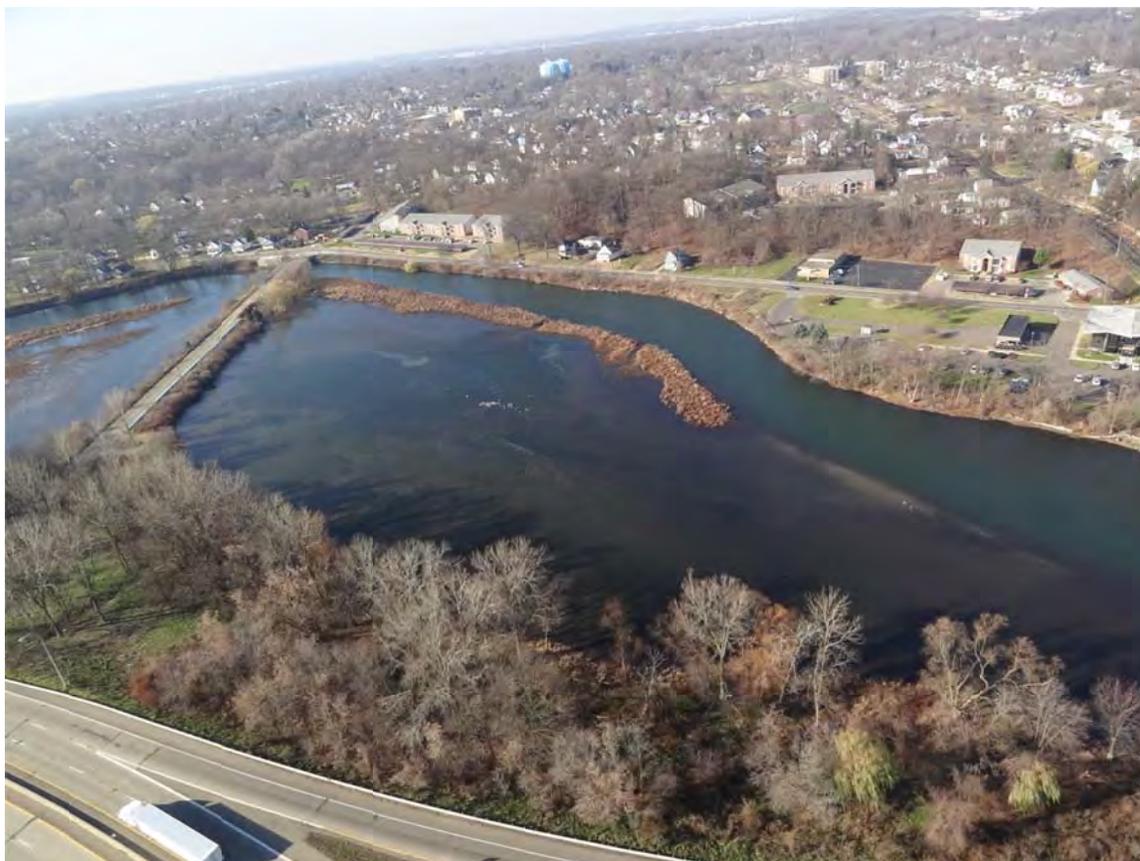
10. North Mill Pond, no sheen observed. Ice observed across most of backchannel area in eastern portion of Mill Pond.

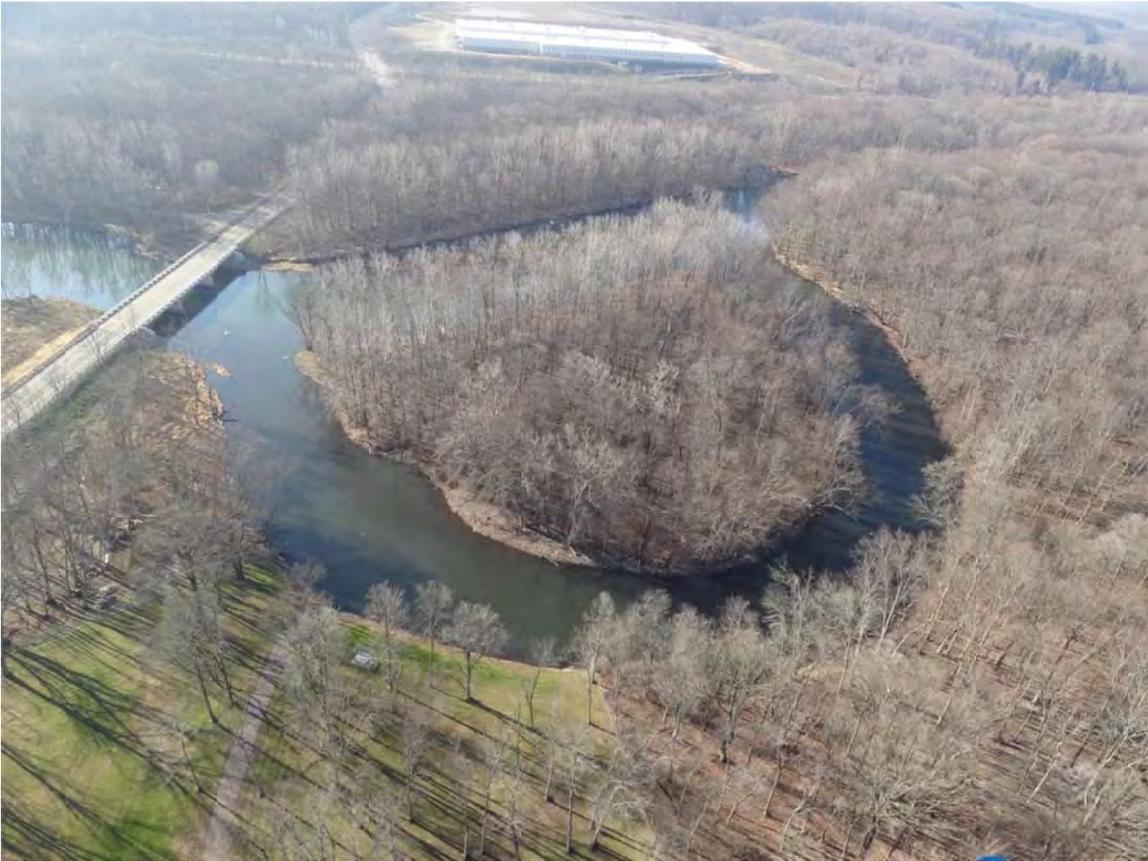
11. MP 21.25 oxbow, no sheen or ice observed.

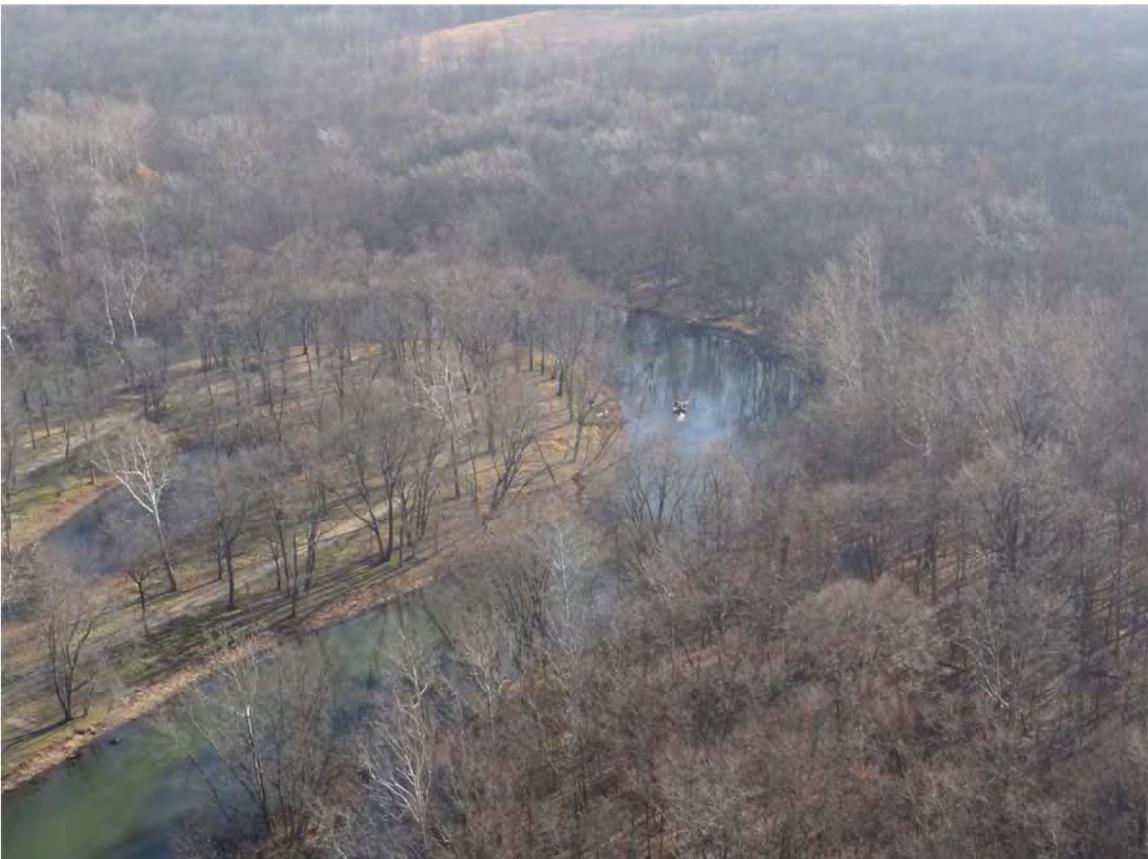
12. MP 27, sheen sweeper boat observed on river at Shady Bend Campground.

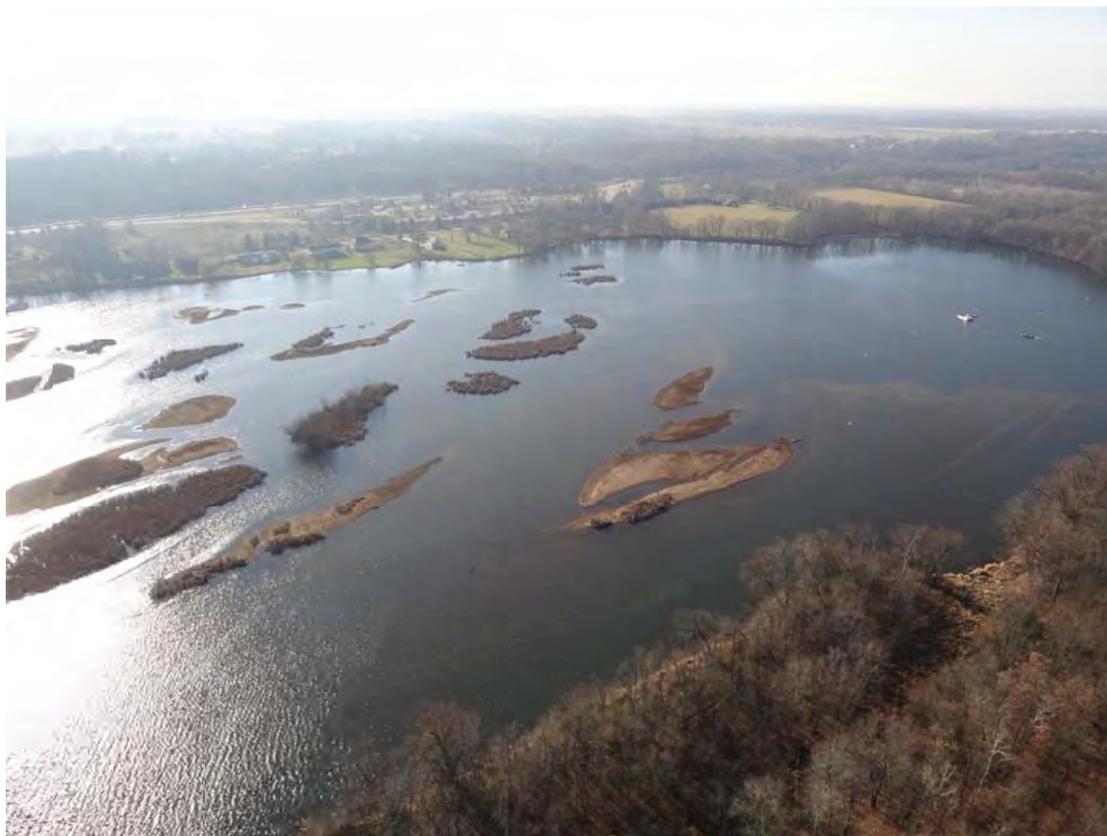
13. Morrow Lake Delta, crews observed pulling containment boom anchors in western end of delta.

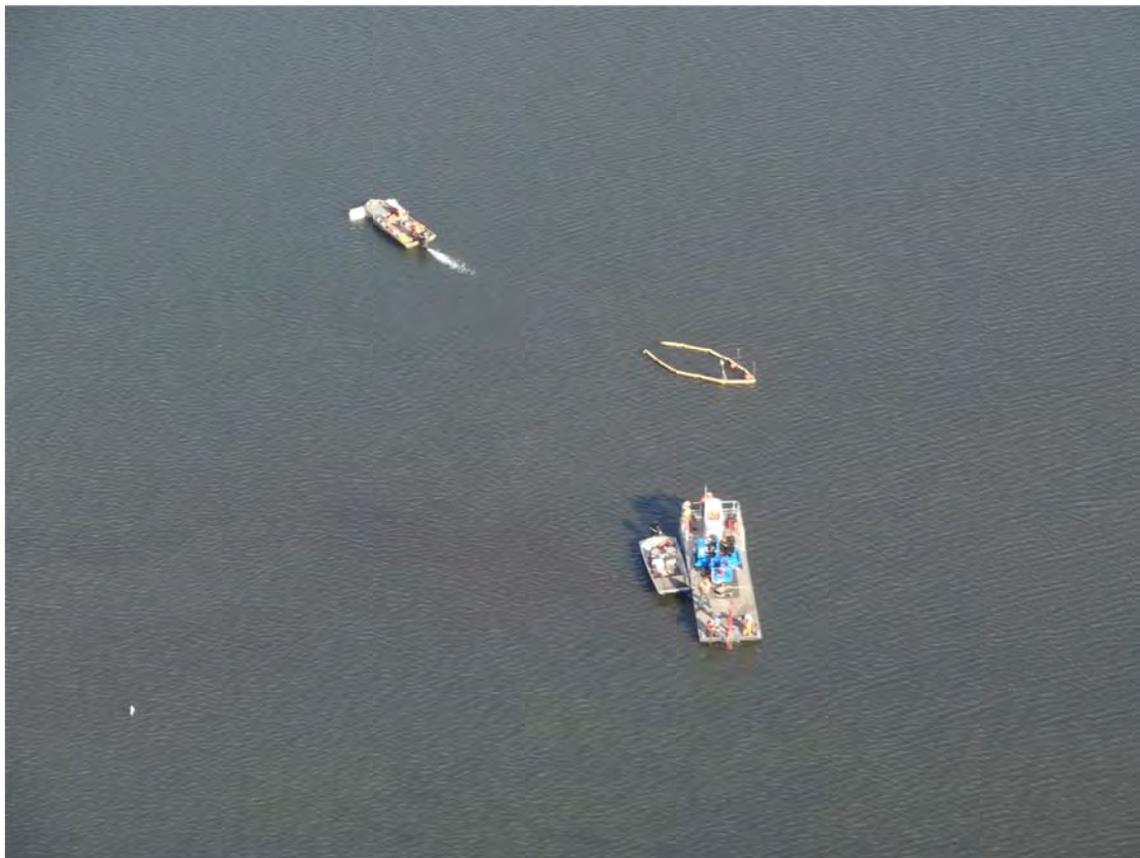
14. Western end of Morrow Lake Delta. Crews pulling containment boom anchors with pontoon boat.

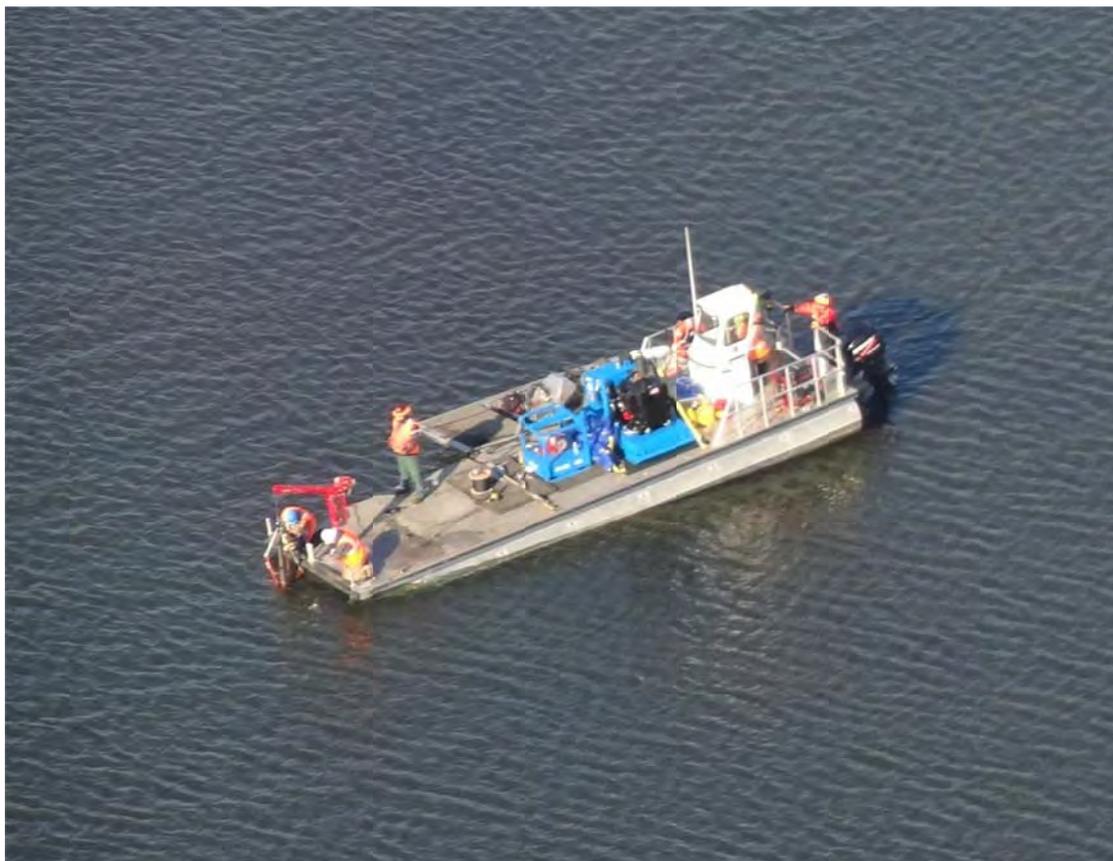
15. Close up of containment boom anchor removal in western end of Morrow Lake Delta.

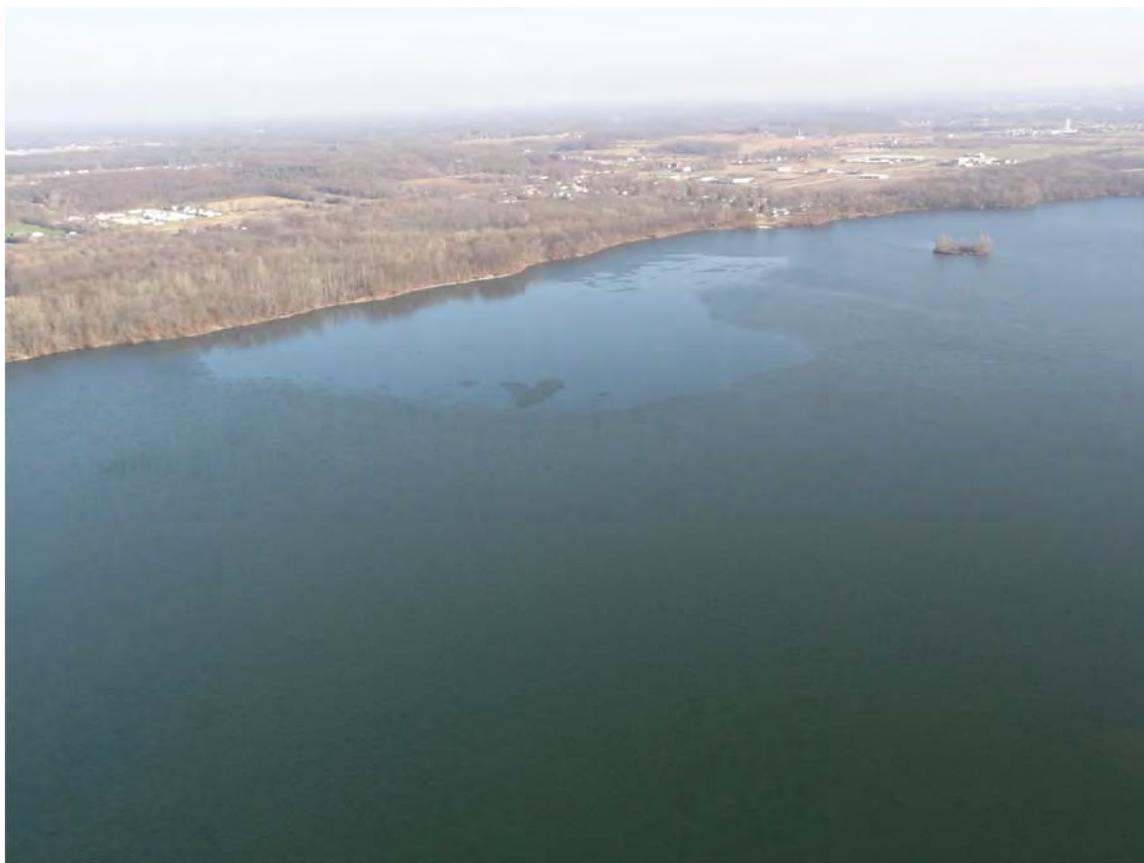
16. Surface ice observed in Morrow Lake west of Rowe Island.

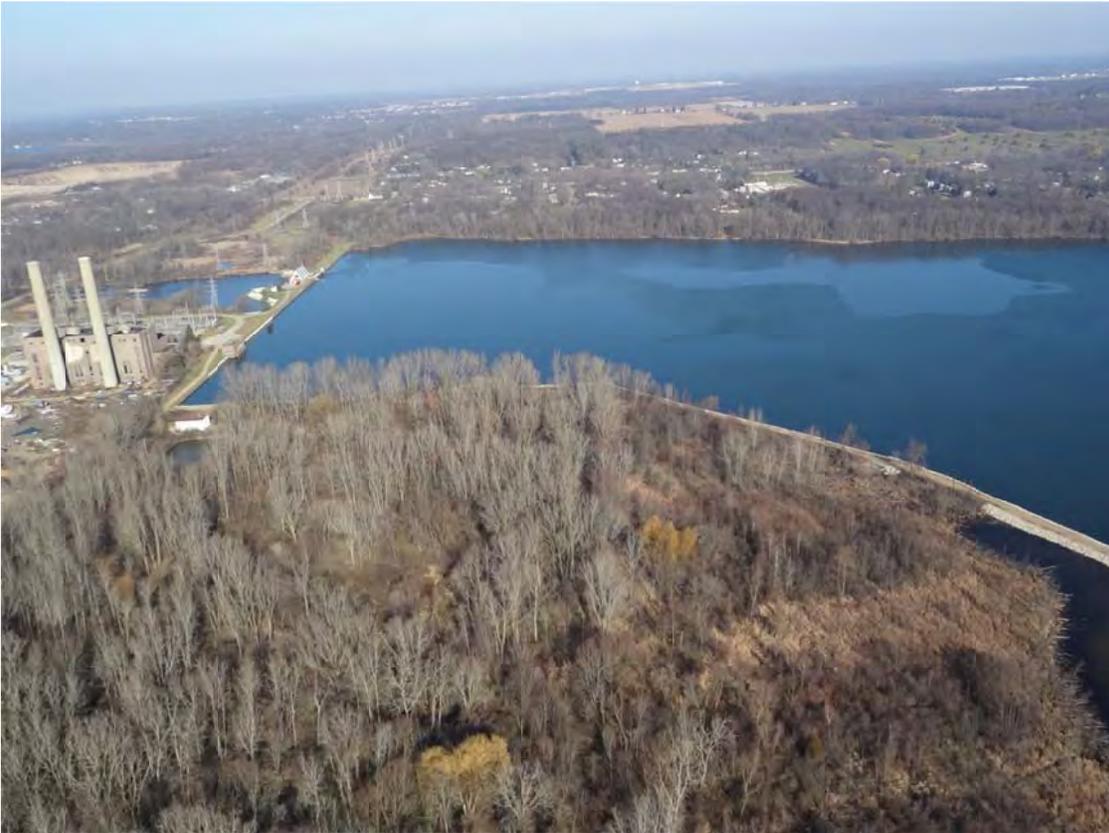
17. Surface ice observed in western end of Morrow Lake.

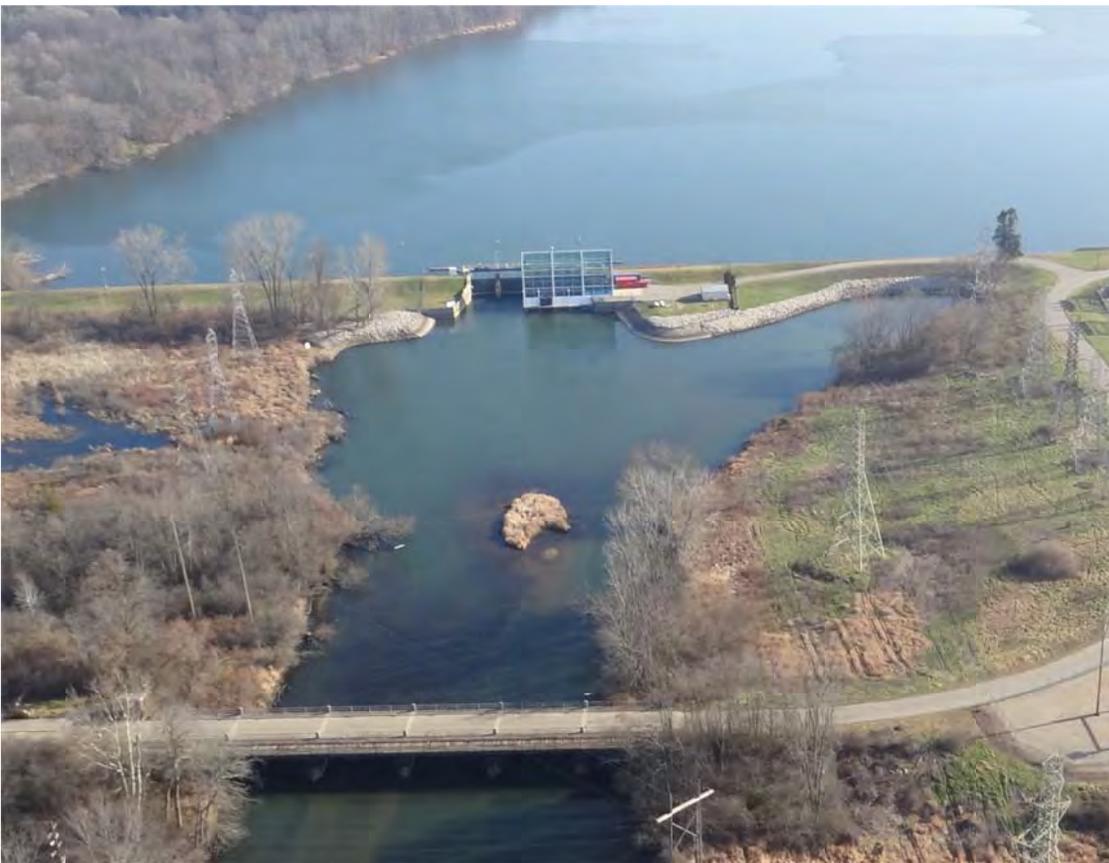
18. Morrow Lake Dam. No ice observed at dam.
