Situation Photo Log

Friday, November 30, 2012

Kalamazoo River / Enbridge Spill

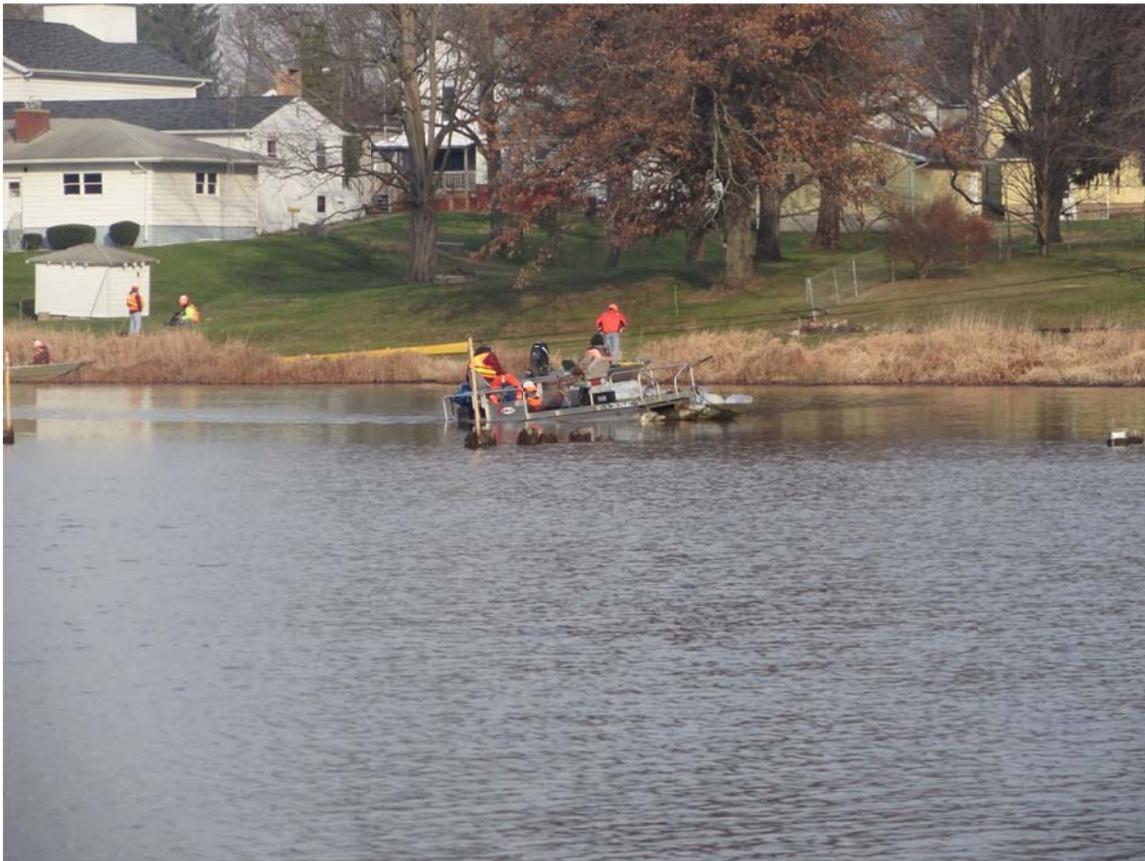
1. MP5.63 LDB, debris collection boat heading back to C0.4 boat launch.

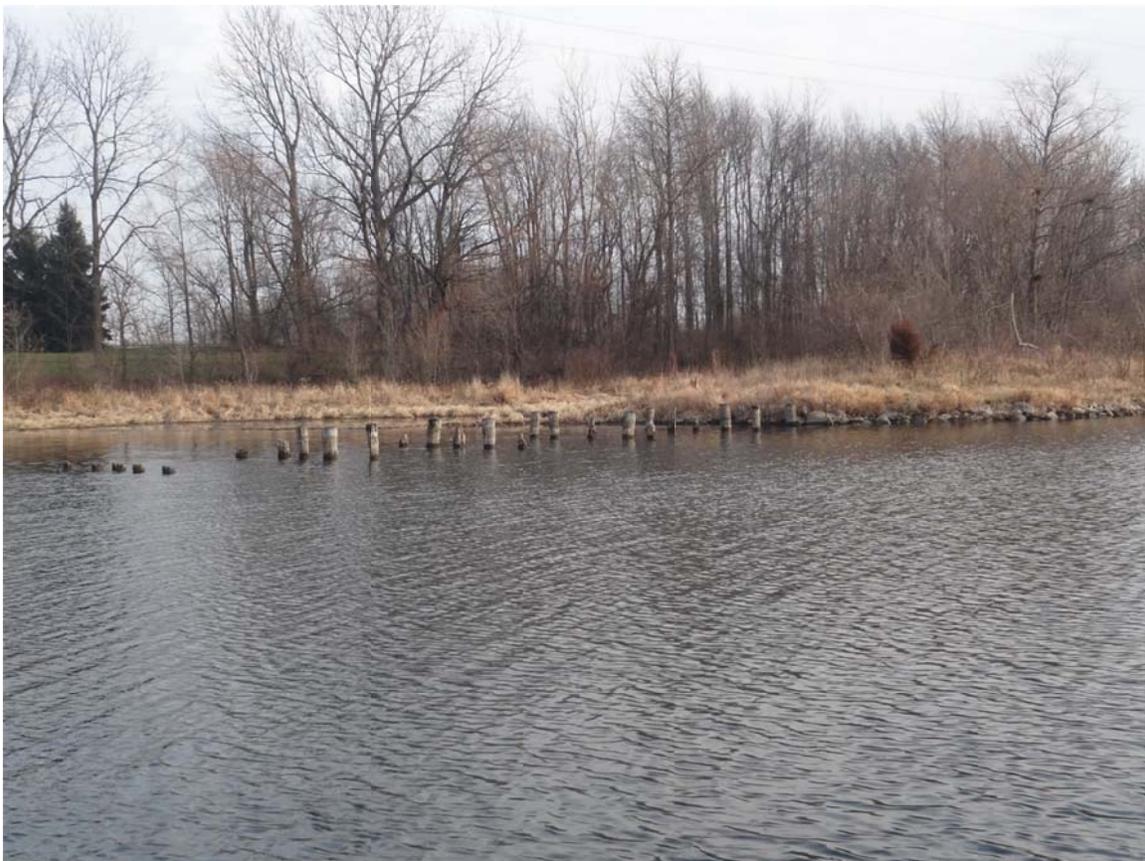
2. Ceresco Dam trestle, no sheen observed.

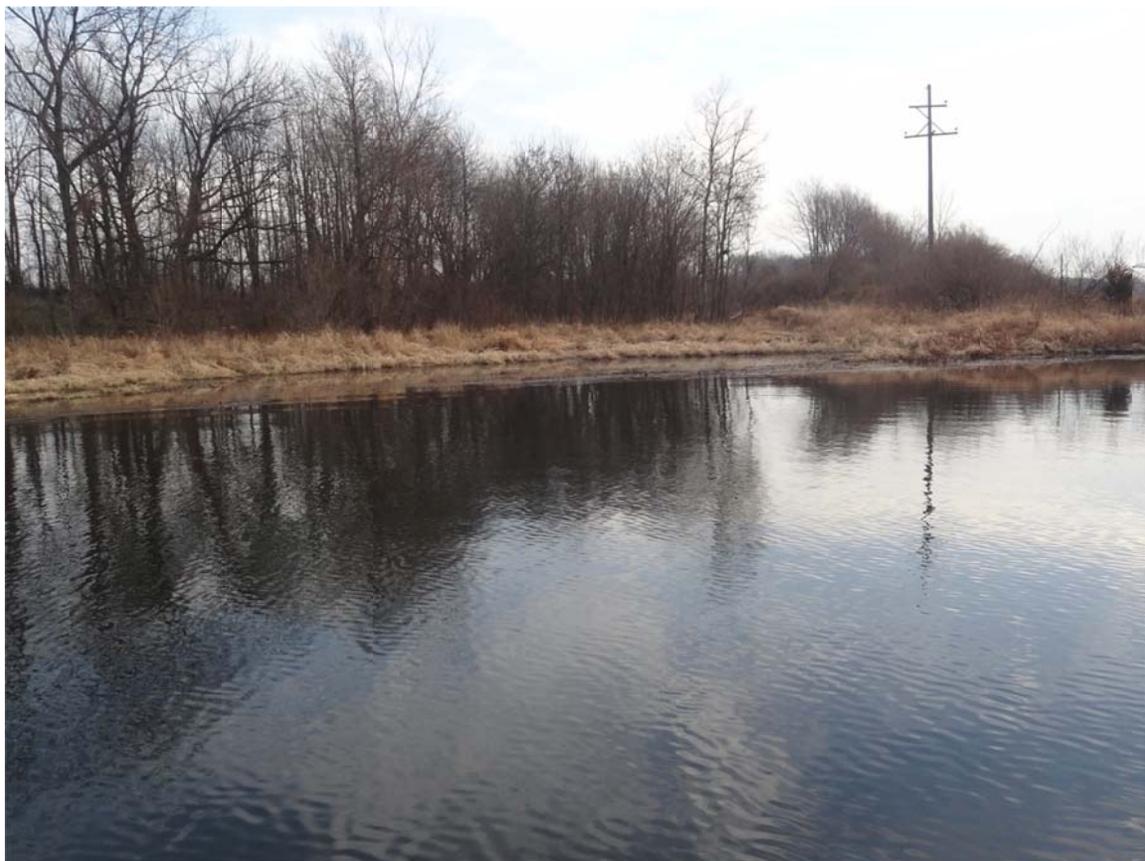
3. MP5.63 RDB, observed thin layer of ice on downstream side of trestle.

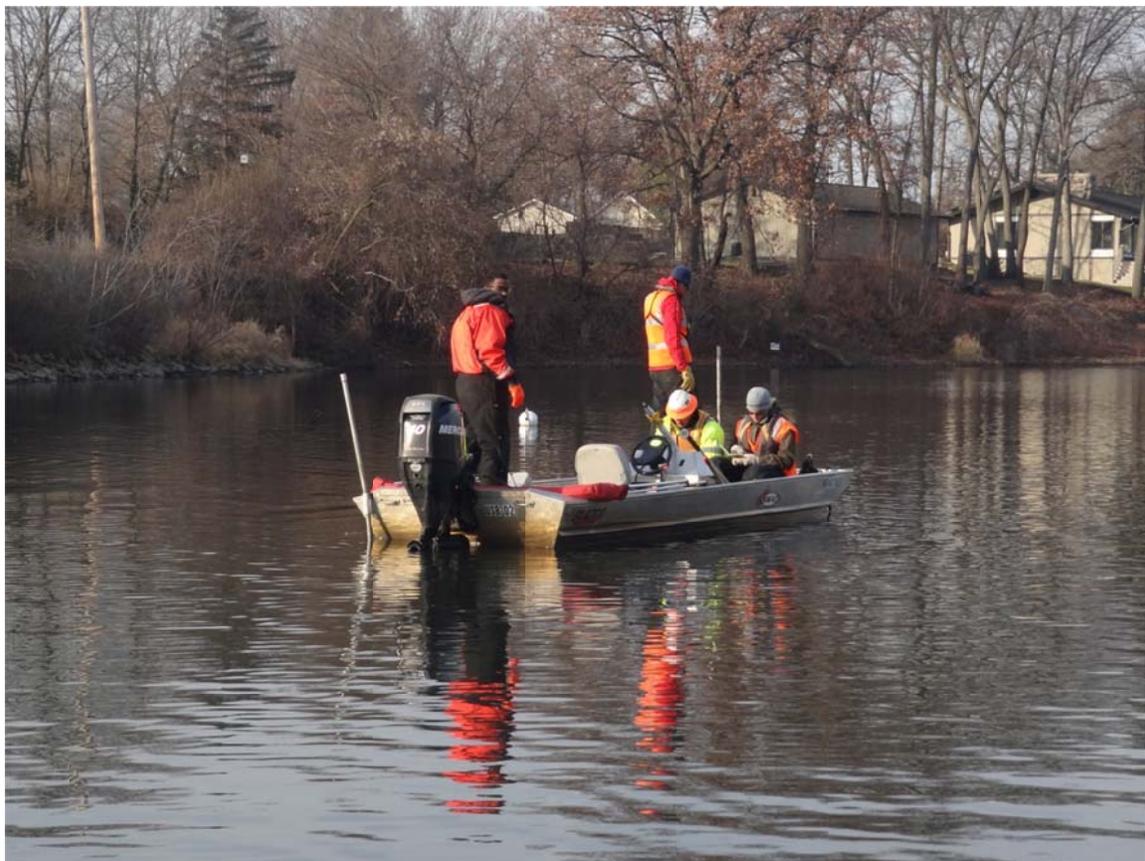
4. MP5.63 LDB, bathymetry survey crew observed on downstream side of trestle.

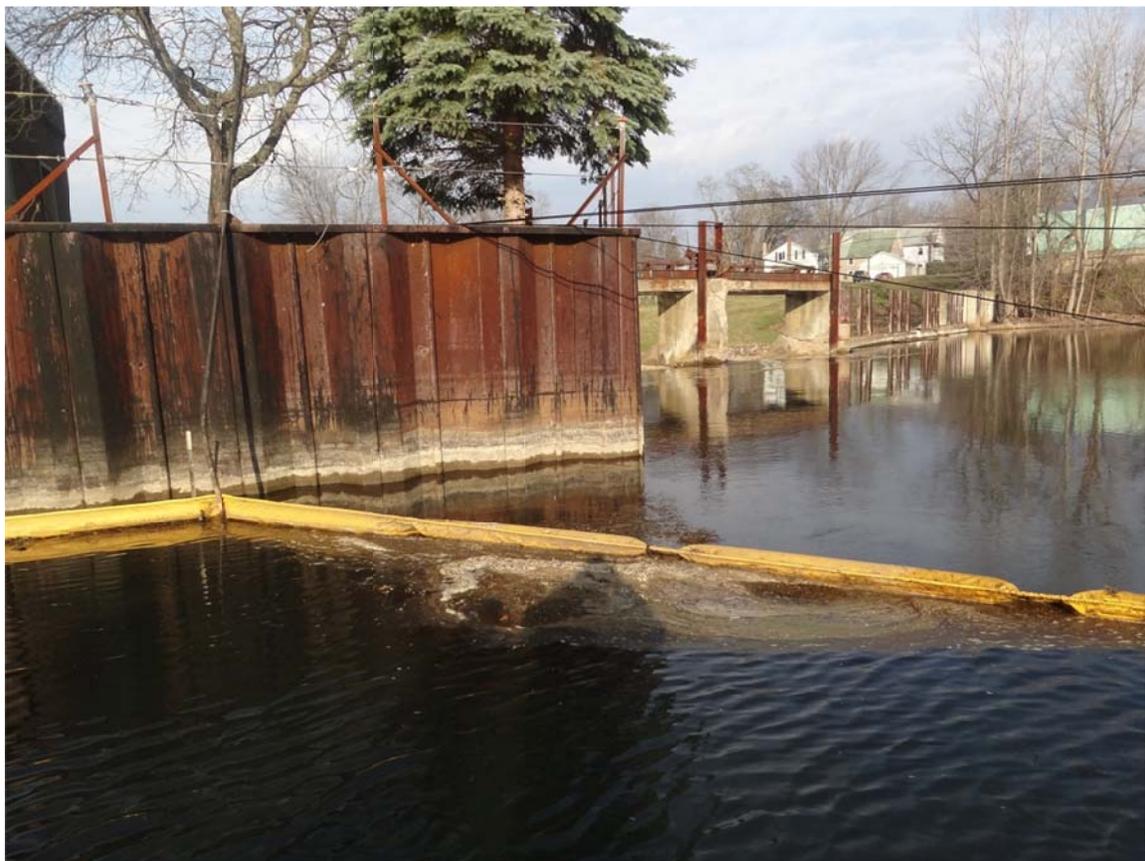
5. Ceresco Dam control point boom, crews were in process of removing debris at time of inspection.

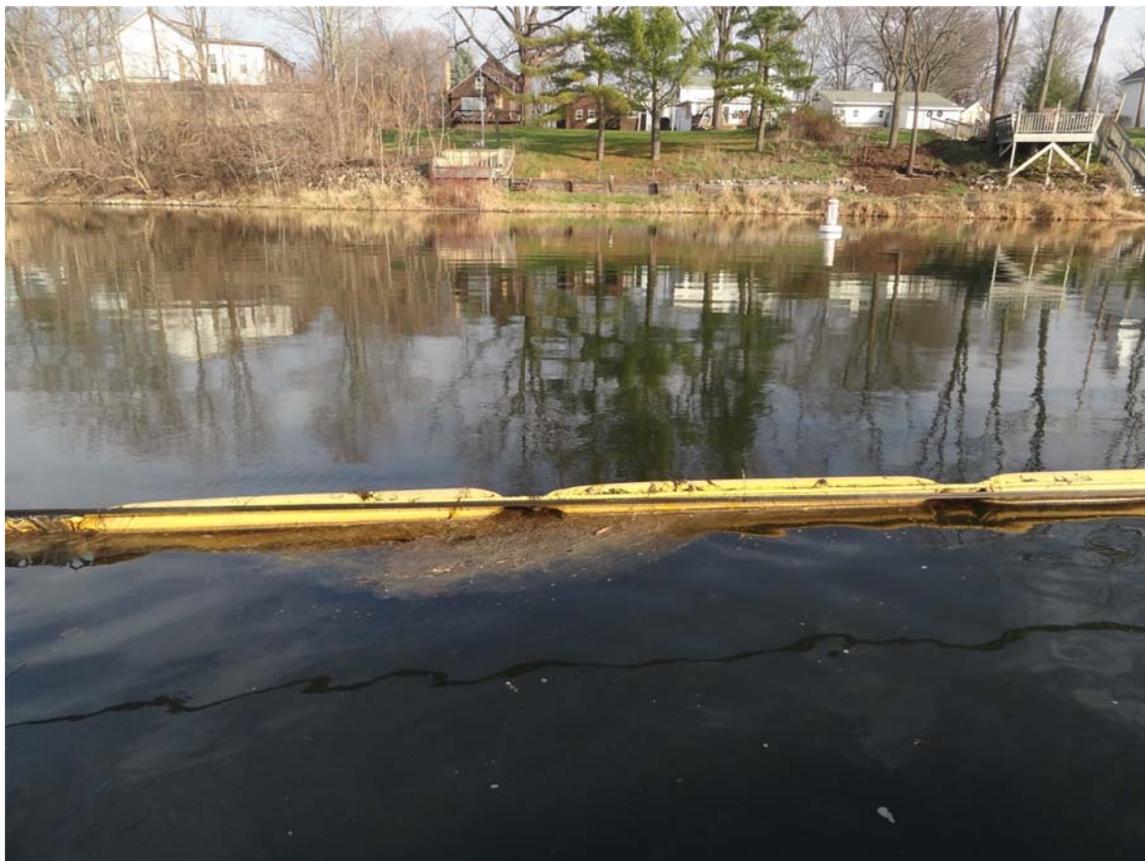
6. Ceresco Dam control point, minor debris observed along containment boom.

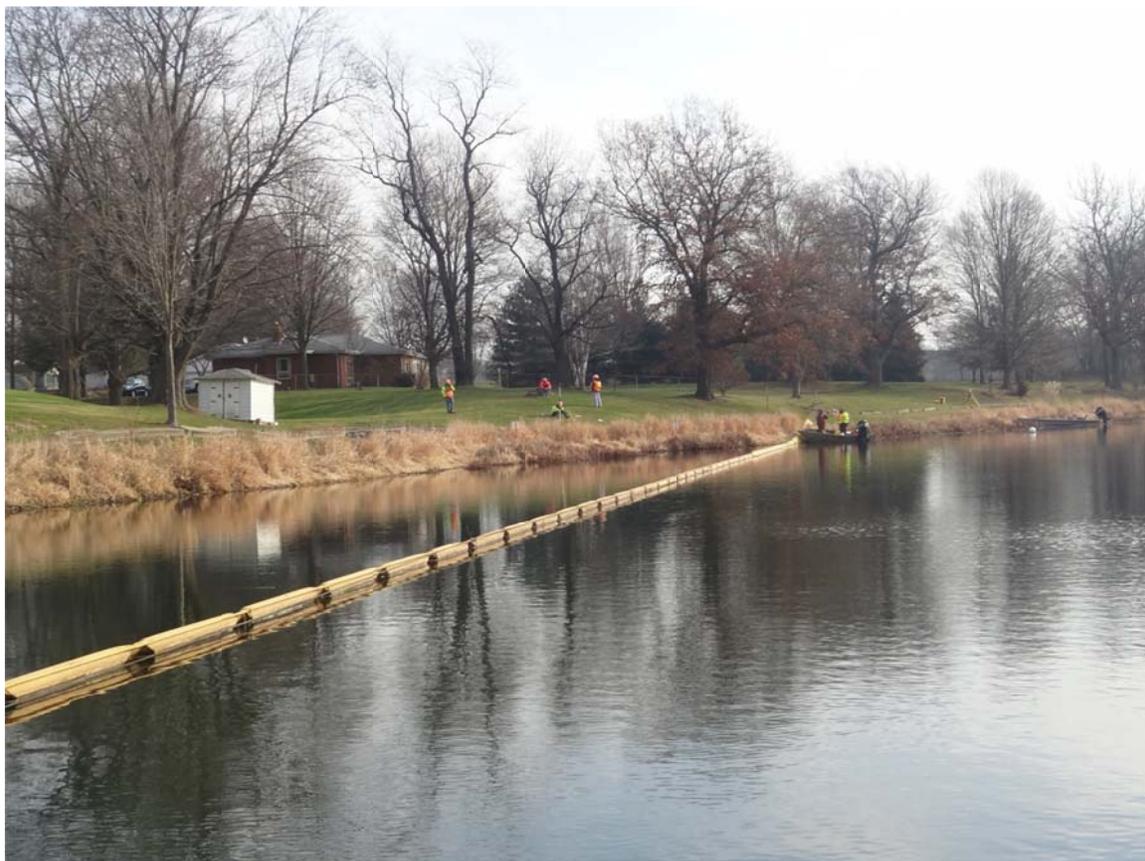
7. MP 5.7 RDB, bathymetry crews observed along north shore of river above Ceresco Dam.

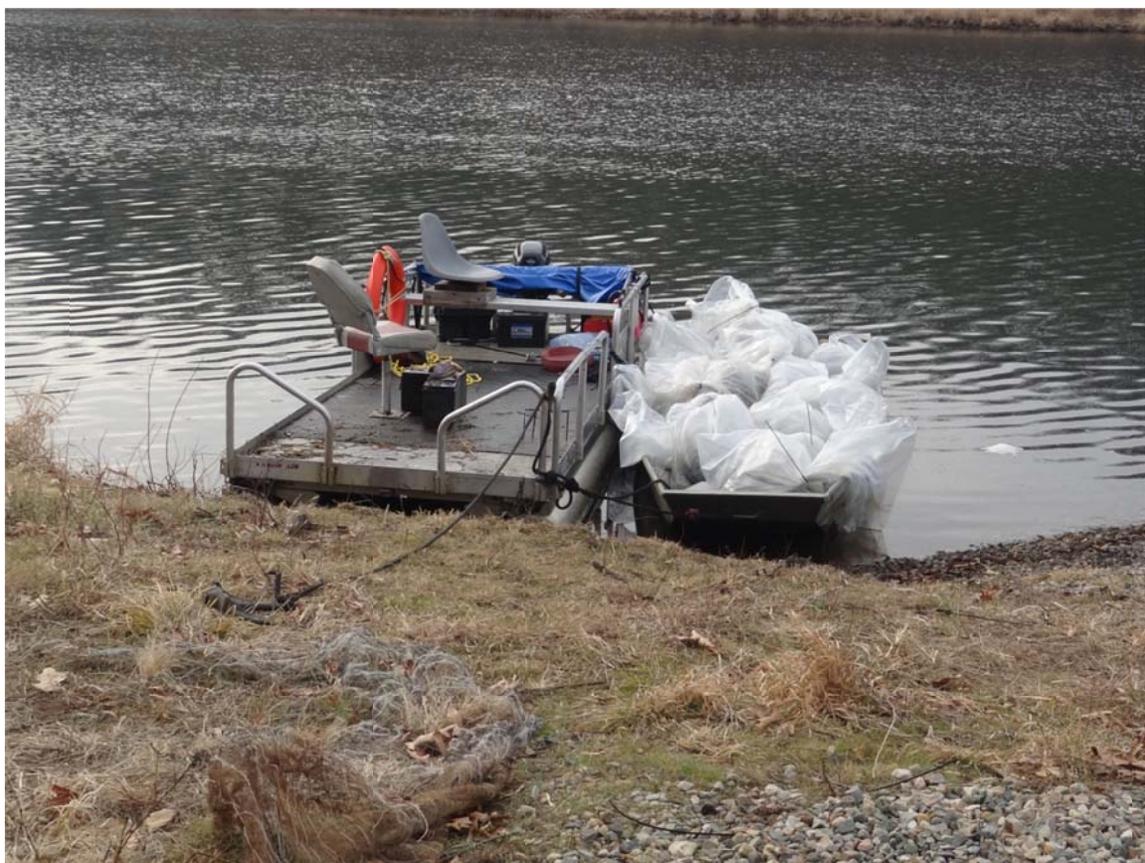
8. C0.4 boat launch, debris collection boat with debris ready to be off-loaded to roll-off box.

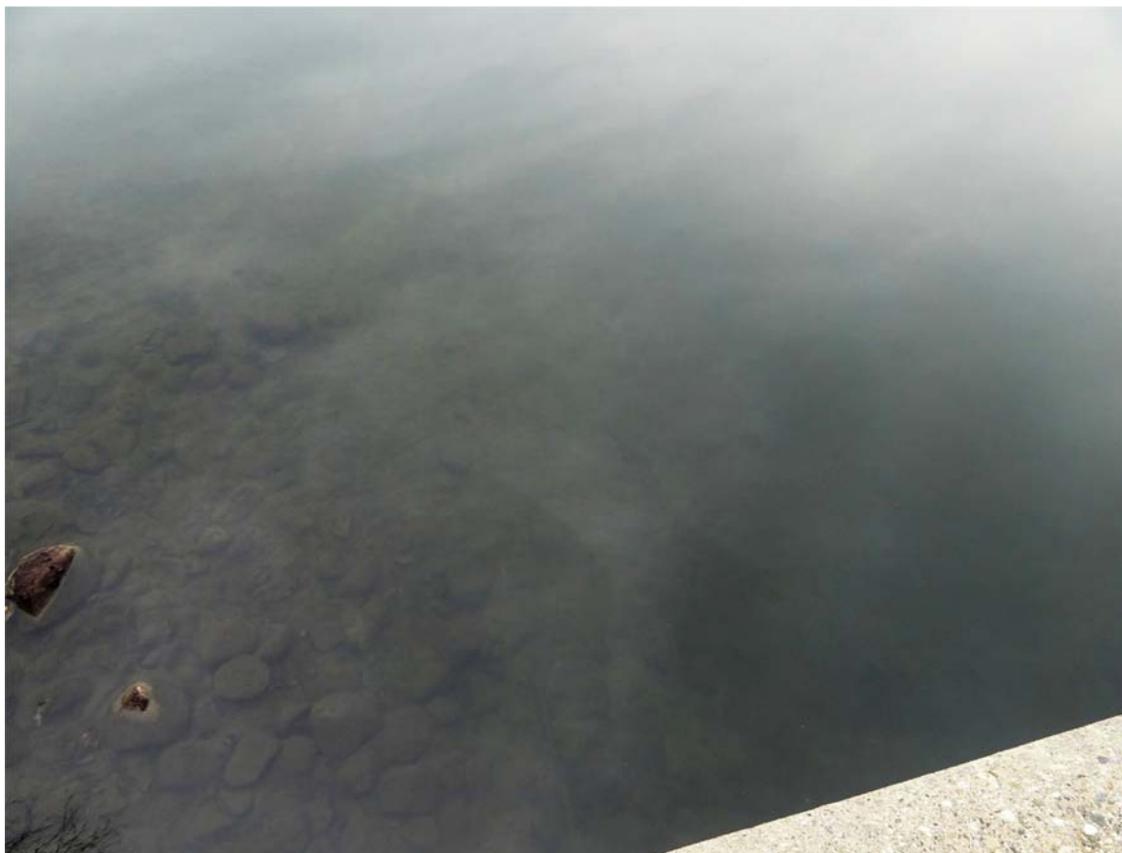
9. MP 15.5 RDB, steady spontaneous sheen observed coming from South Mill Pond back channel into main river channel and going under Burnham Street Bridge.

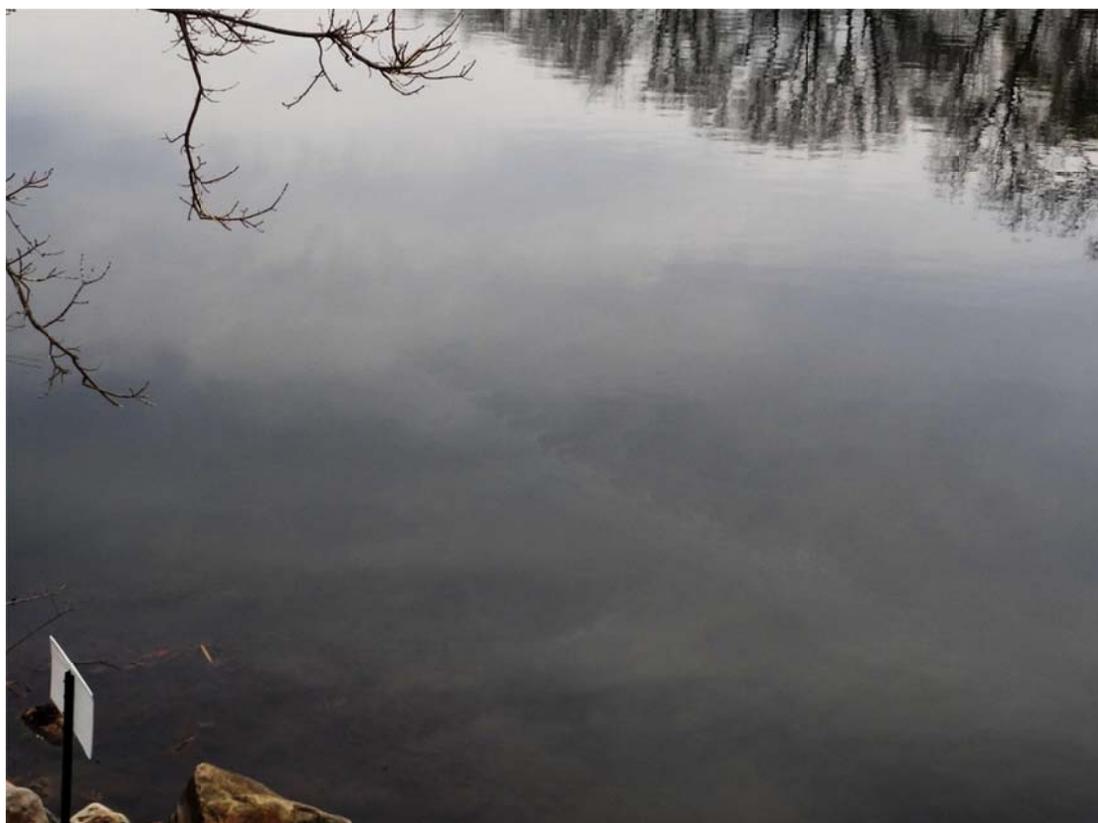
10. MP 15.5, spontaneous sheen trail coming from South Mill Pond. Recovery operations including sheen sweeping and boom deployment were initiated by Operations.

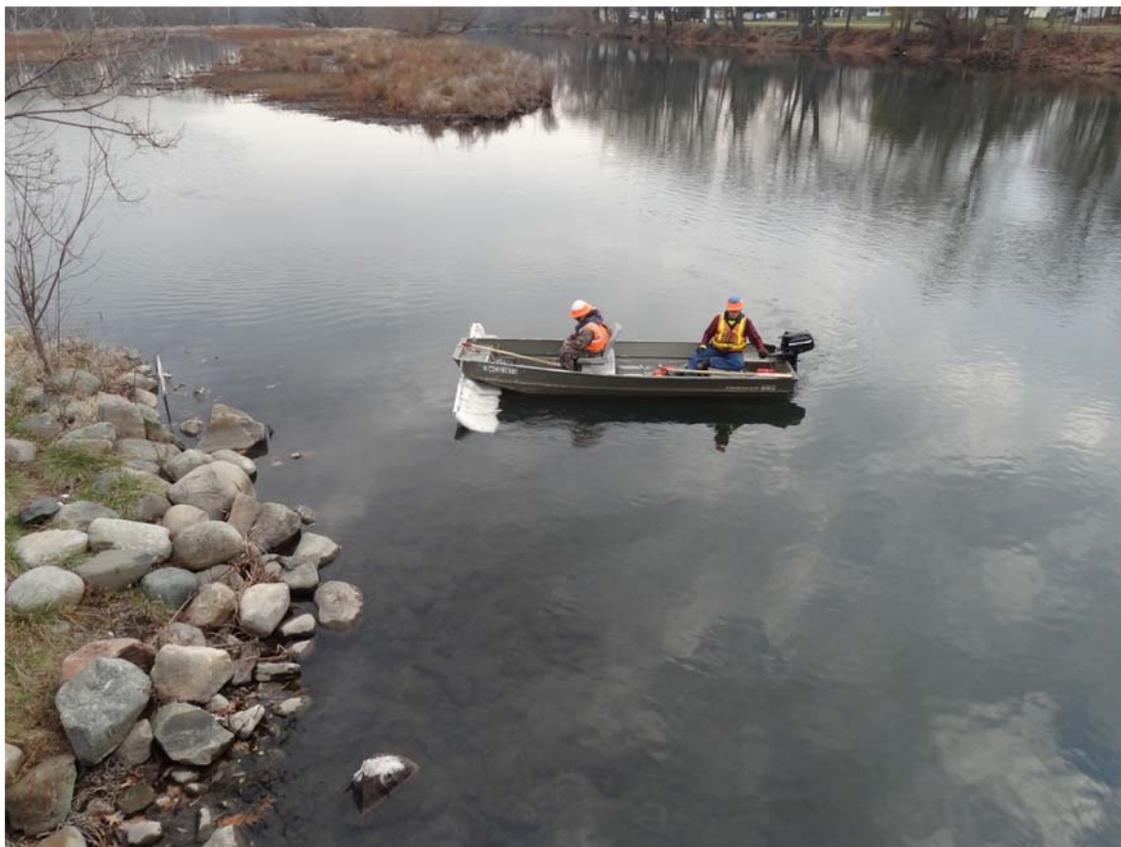
11. MP 15.5 RDB, sheen sweeper boat deployed to South Mill Pond.

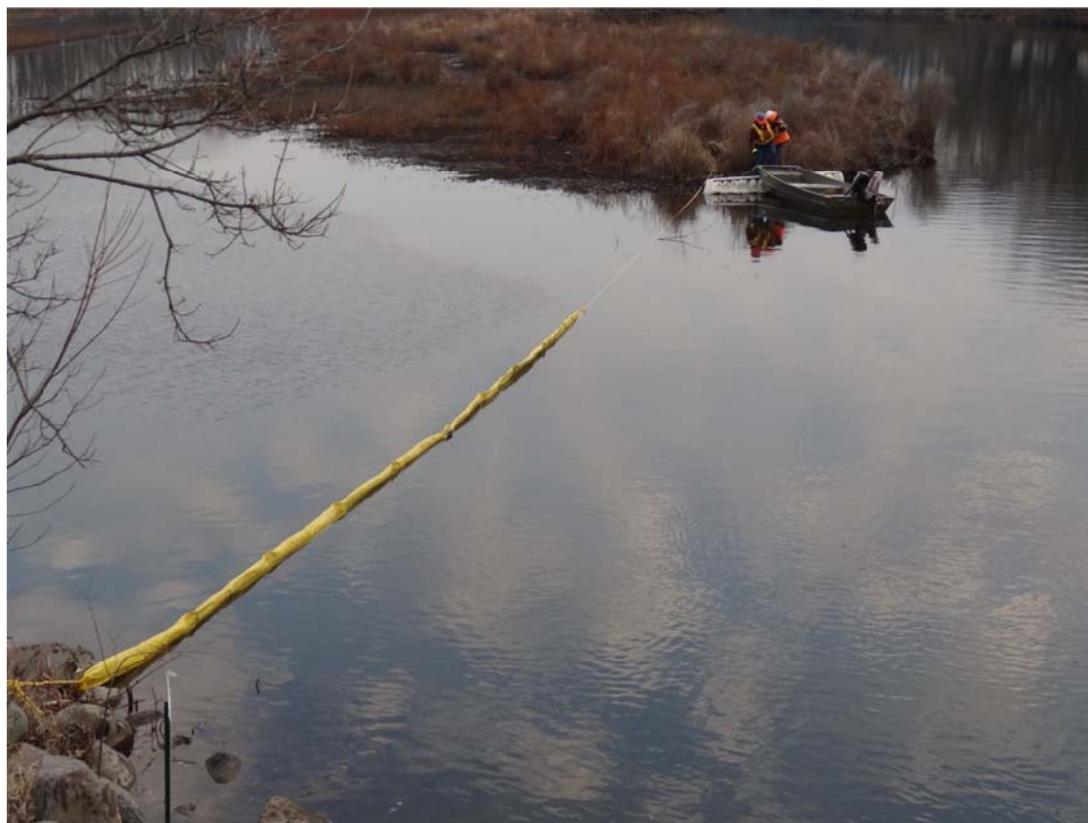
12. MP 15.5, crews deploying containment boom on backchannel at South Mill Pond.

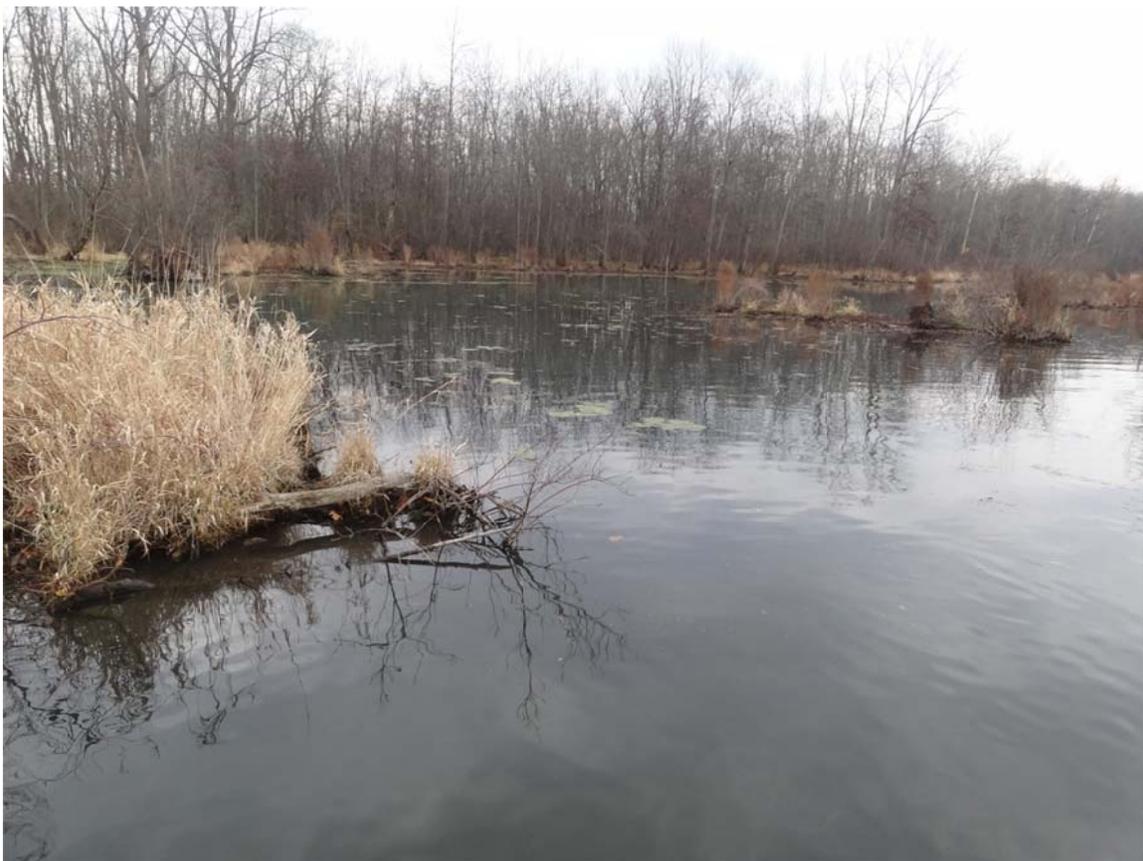
13. MP 36.5 RDB, sheen observed in river channel originating from wetland area along RDB.

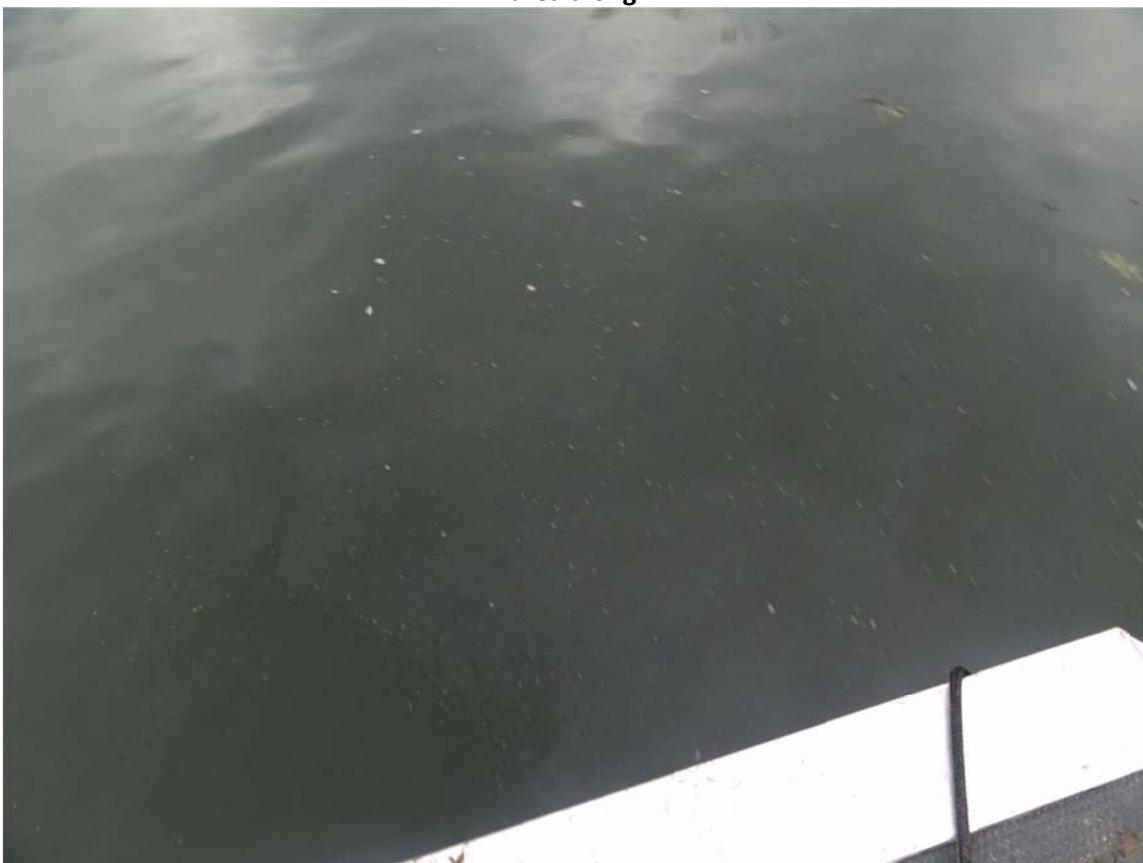
14. MP 36.5 RDB, spontaneous sheen trail and tar globules observed coming from back channel area along RDB.

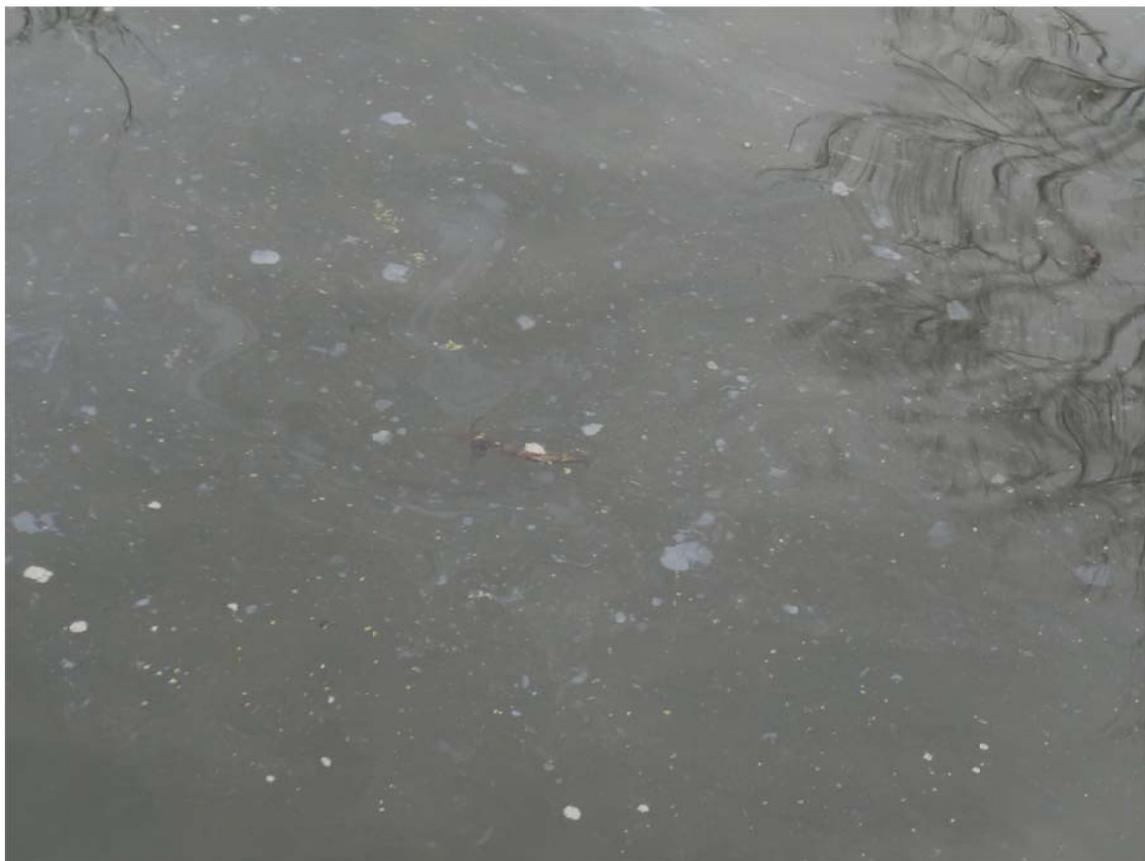
15. MP 36.5 RDB, sheen and tar globules observed. Operations notified and sweeper boat sent to recover oil.

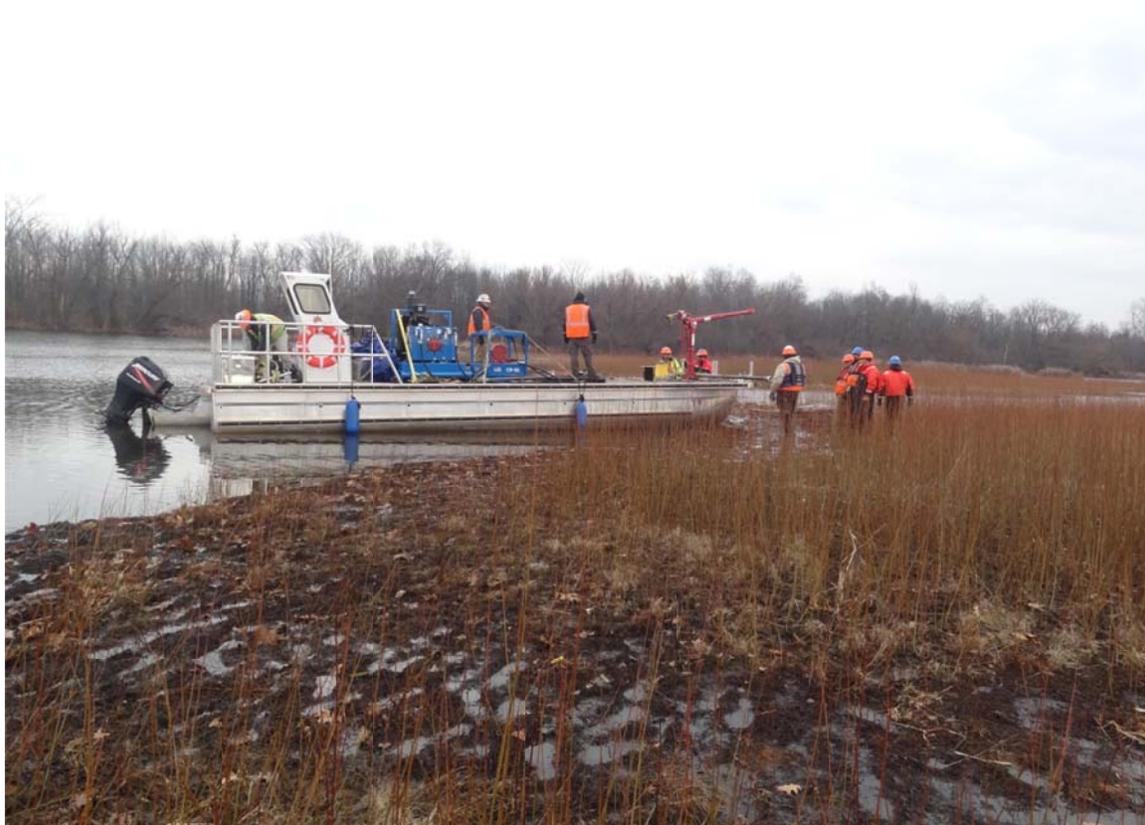
16. Morrow Lake Delta, boom anchor removal crew working to get pontoon boat off of island after pulling boom anchor post at this location.

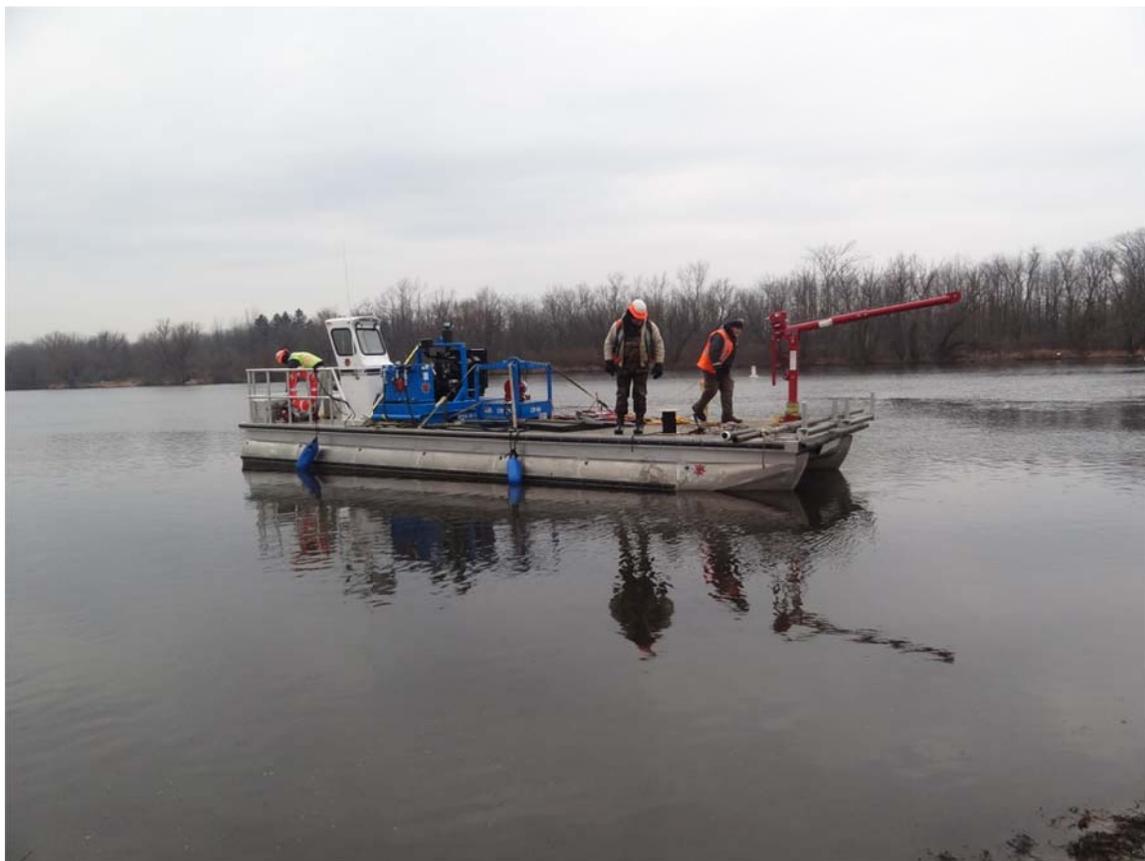
17. Morrow Lake Delta, crews moving pontoon boat to next anchor post removal location.

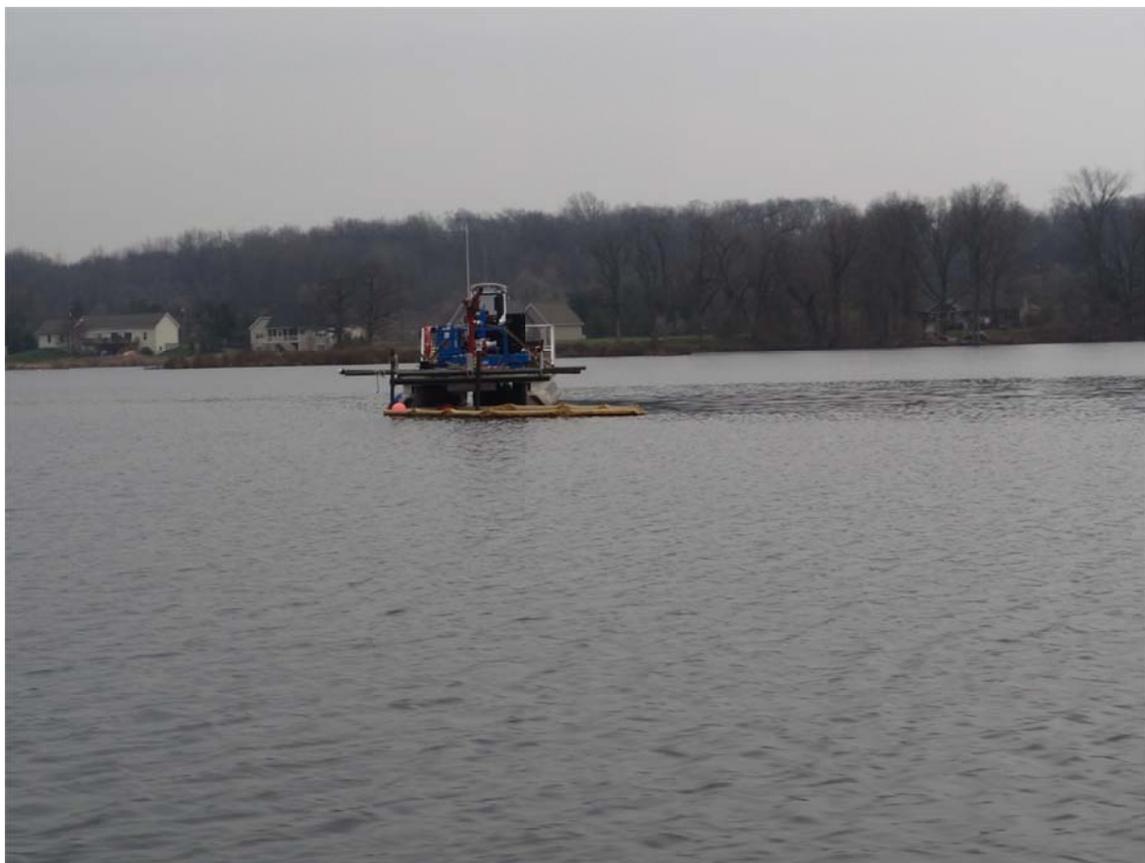
18. Morrow Lake Delta, pontoon boat staged at next anchor post removal point.
