Situation Photo Log

Saturday, December 1, 2012

Kalamazoo River / Enbridge Spill

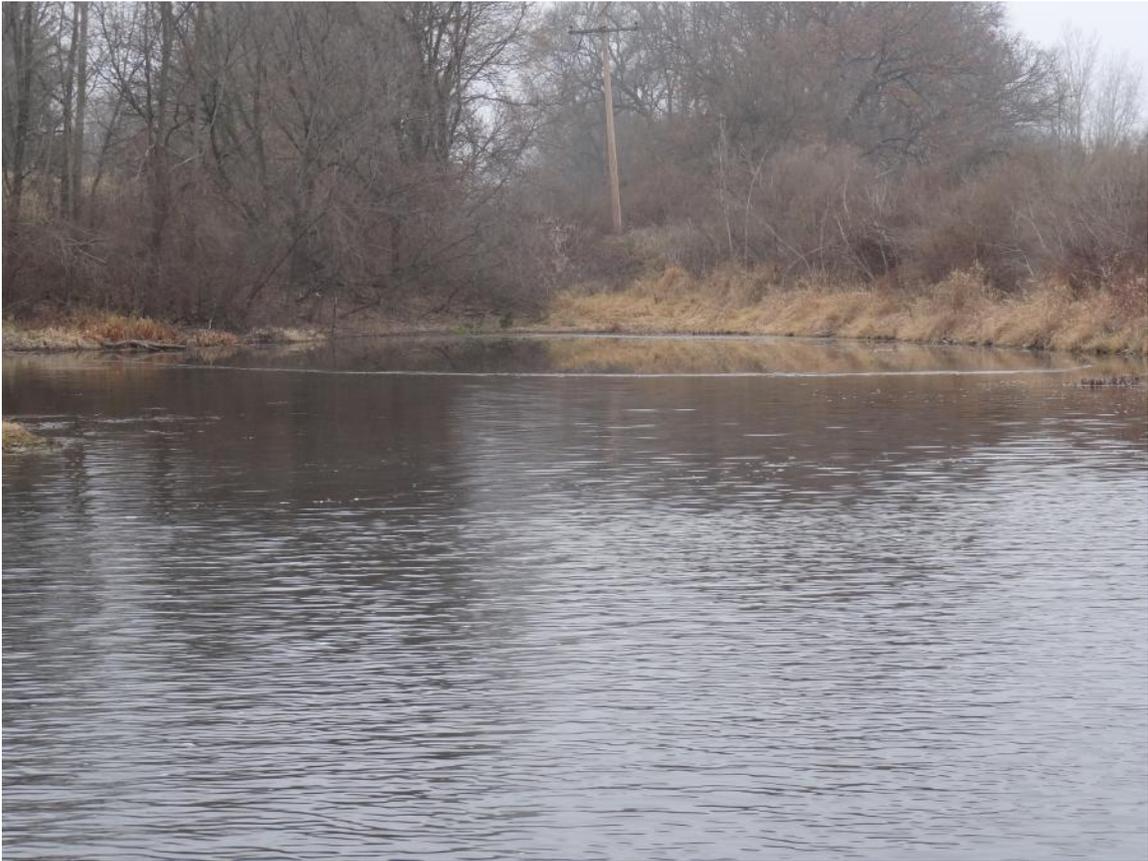
1. MP5.60 LDB, observed thin layer of ice on upstream side of trestle.

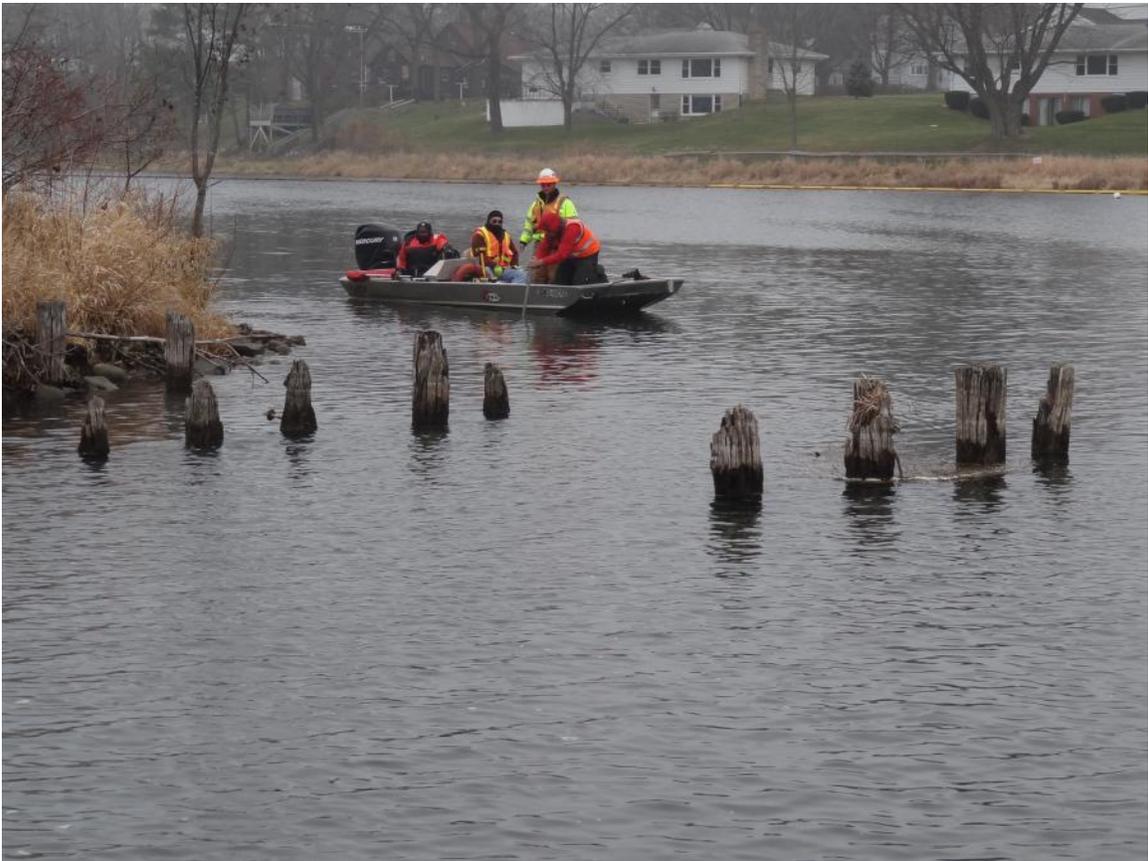
2. MP5.63 LDB, bathymetry survey crew observed on downstream side of trestle.

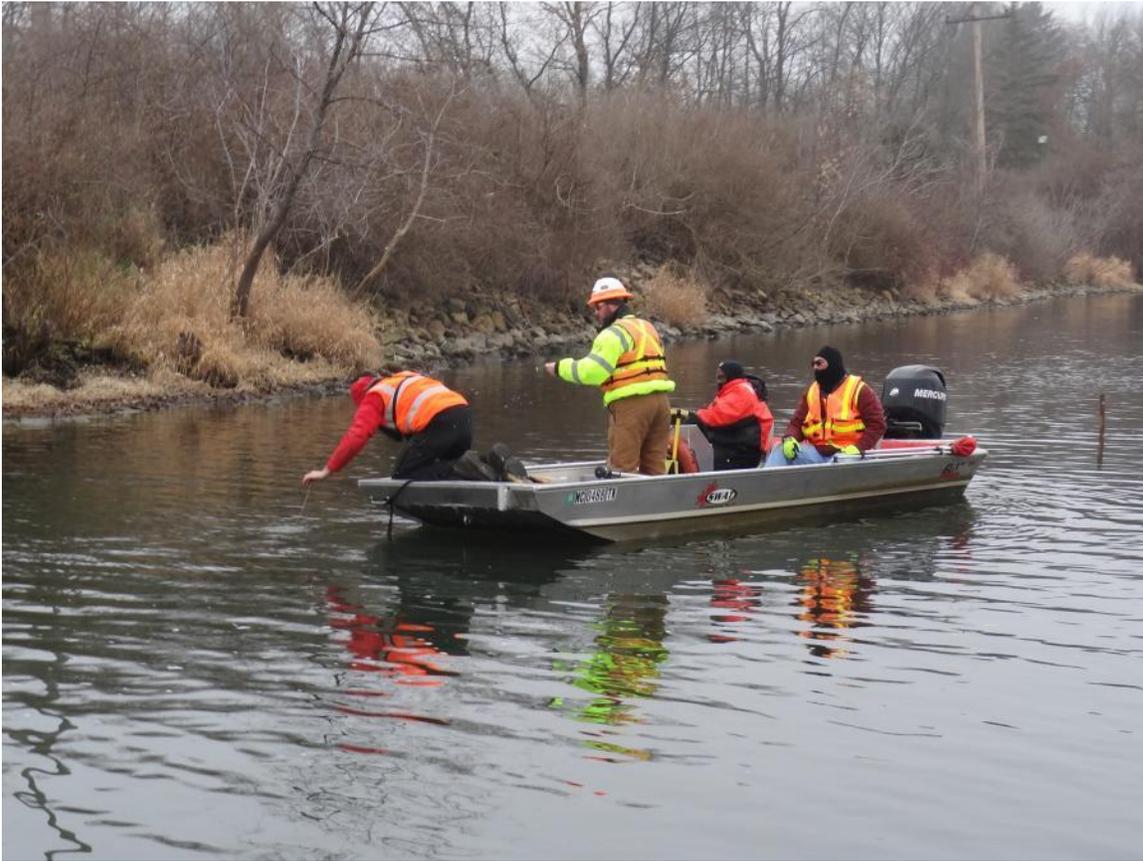
3. MP5.63 LDB, bathymetry survey crew observed positioning rope line for transect.

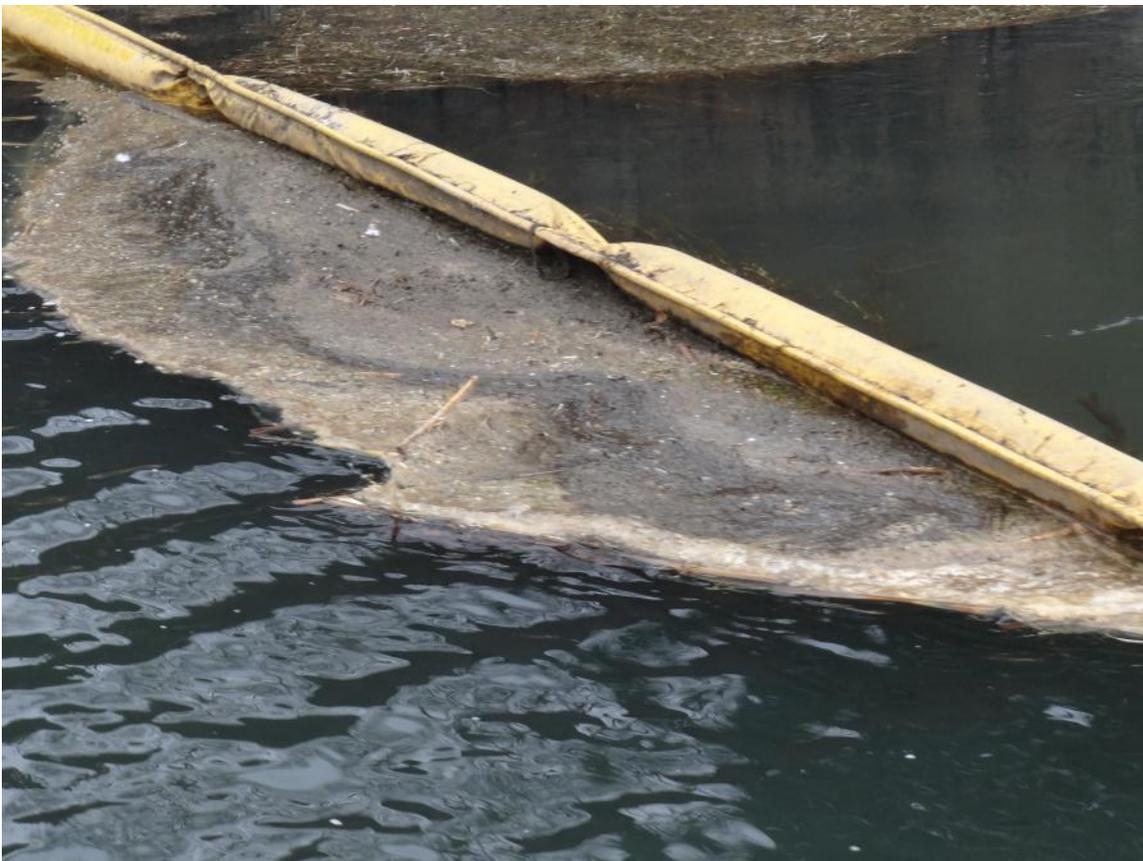
4. Ceresco Dam Control Point, minor debris along containment boom.

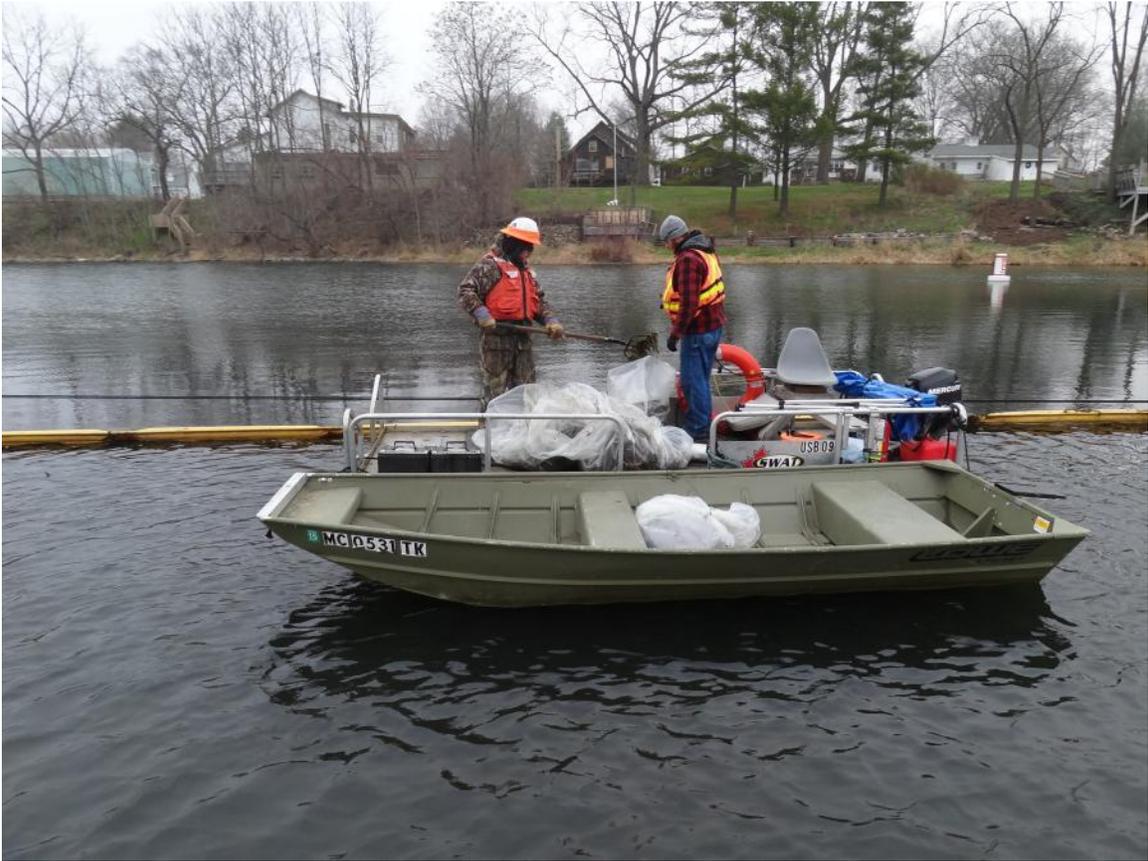
5. Ceresco Dam control point boom, crews removing debris along containment boom.

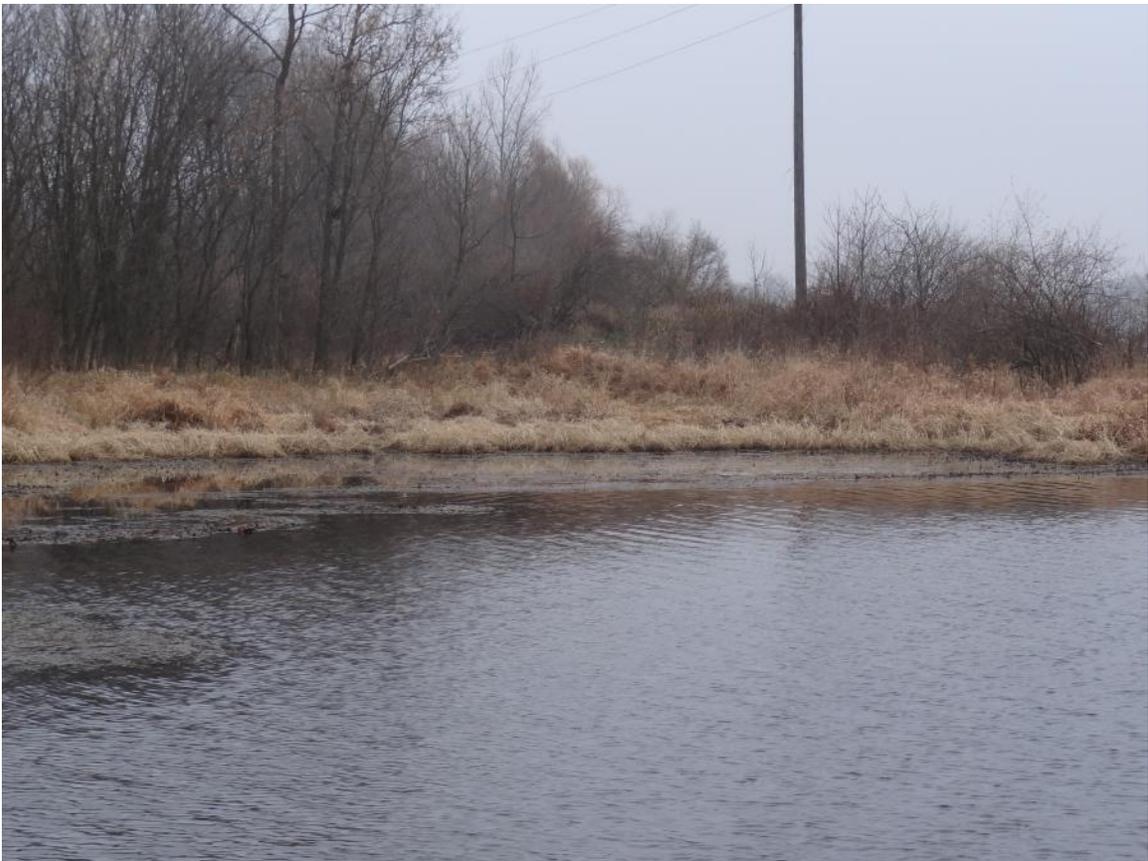
6. MP5.63 RDB, no ice observed on downstream side of trestle.

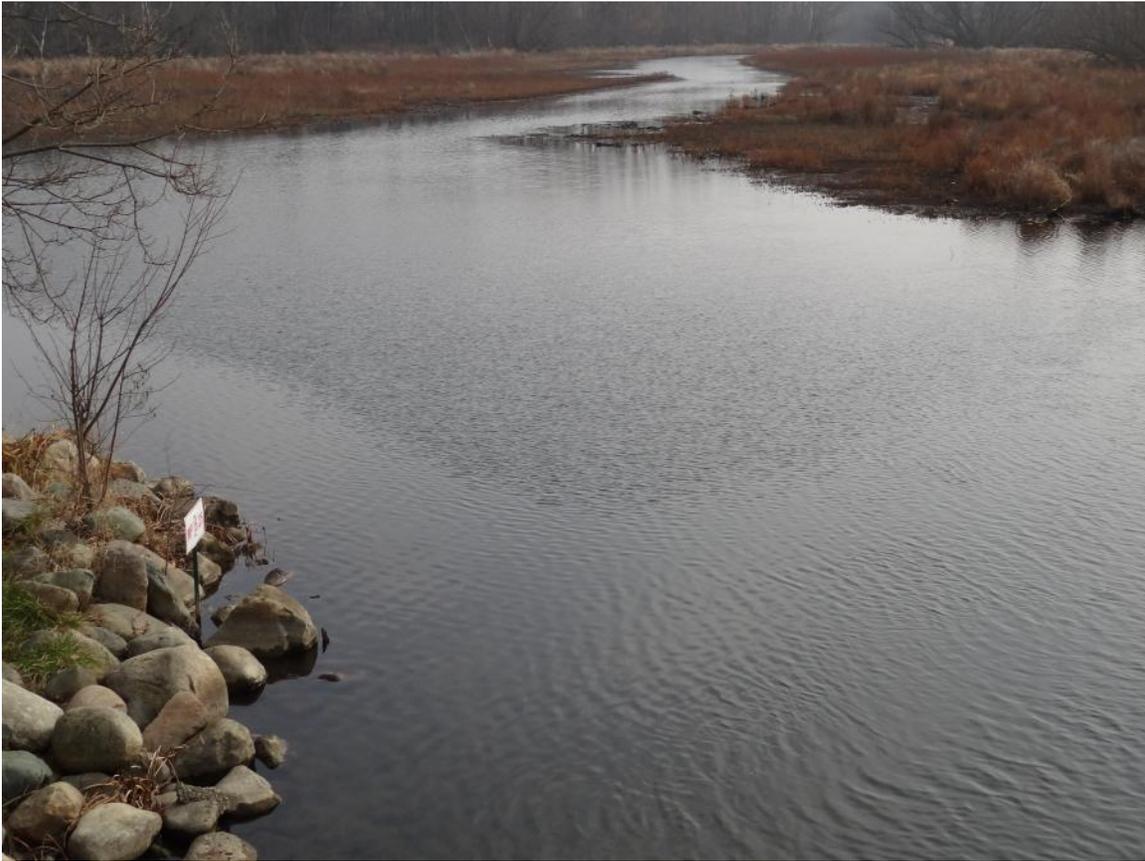
7. MP 15.25 RDB, containment boom across backchannel has been removed.

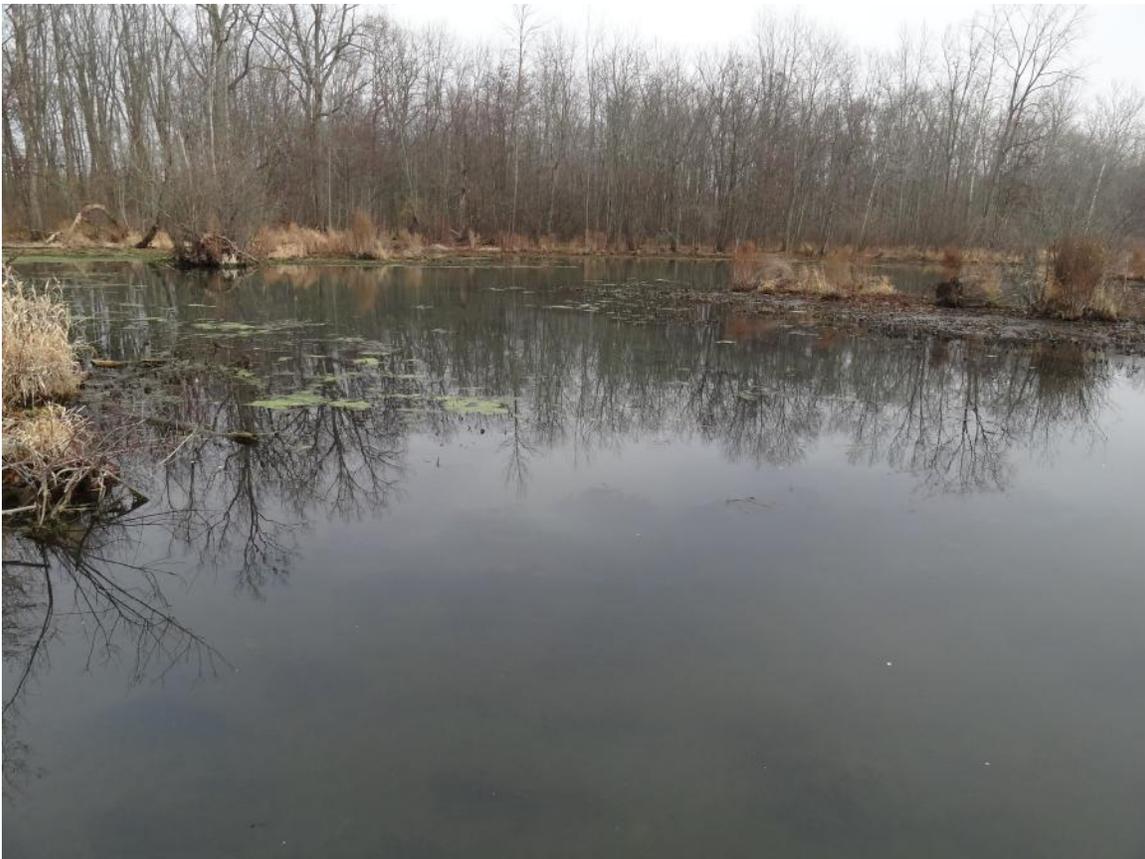
8. MP36.50 RDB, area where sheen was observed on river channel originating from wetland.

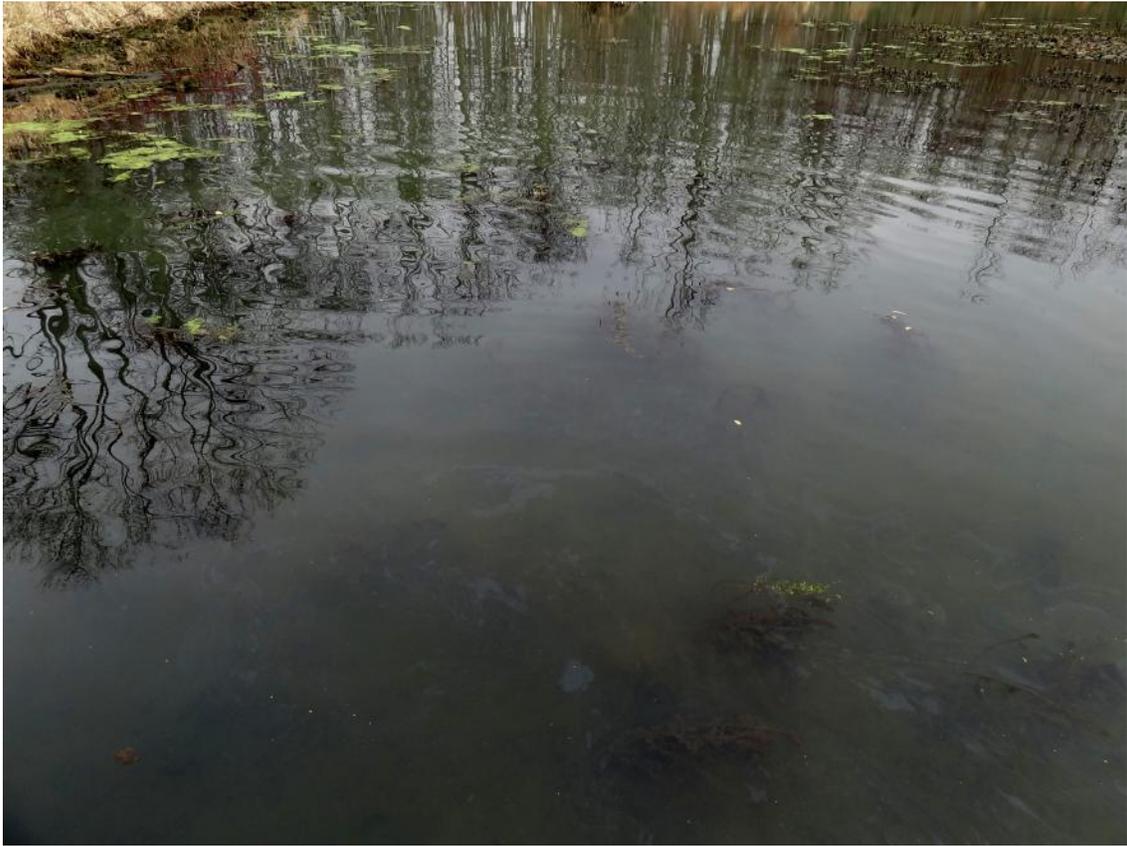
9. MP 36.50 RDB, sheen observed on river channel adjacent to wetland. Operations notified and sheen sweep performed.

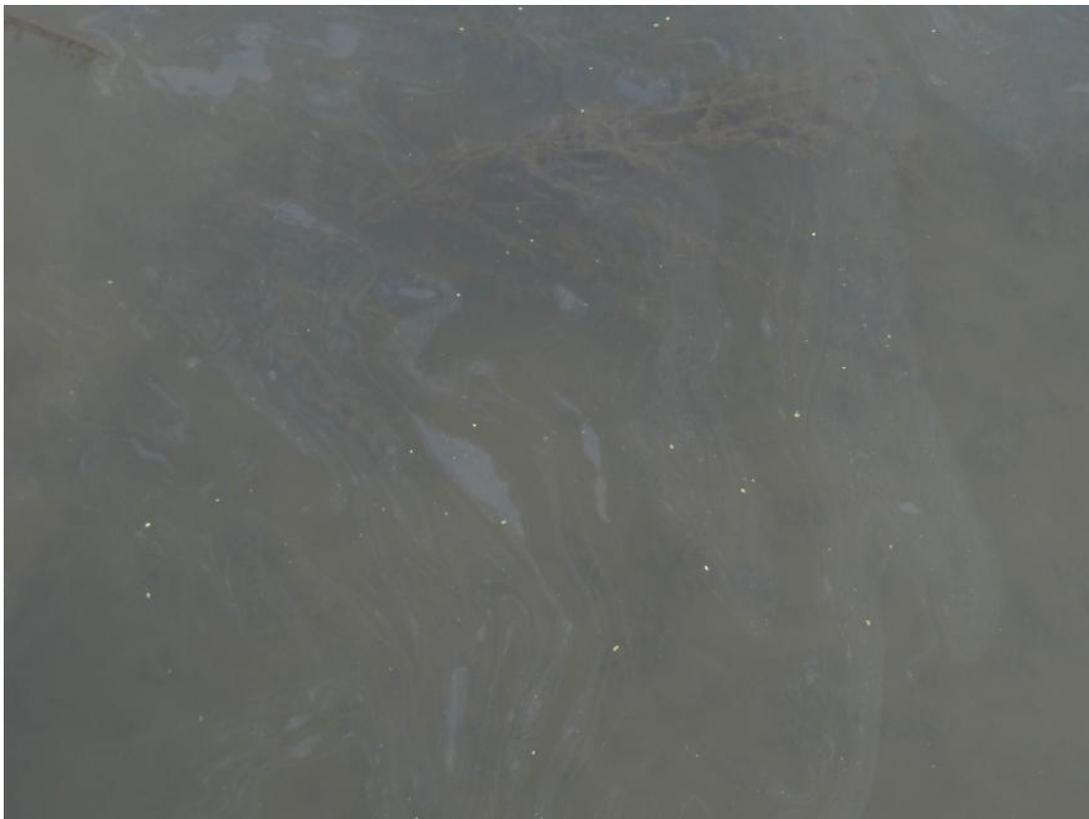
10. MP 36.50 RDB, sheen observed on RDB of river channel.

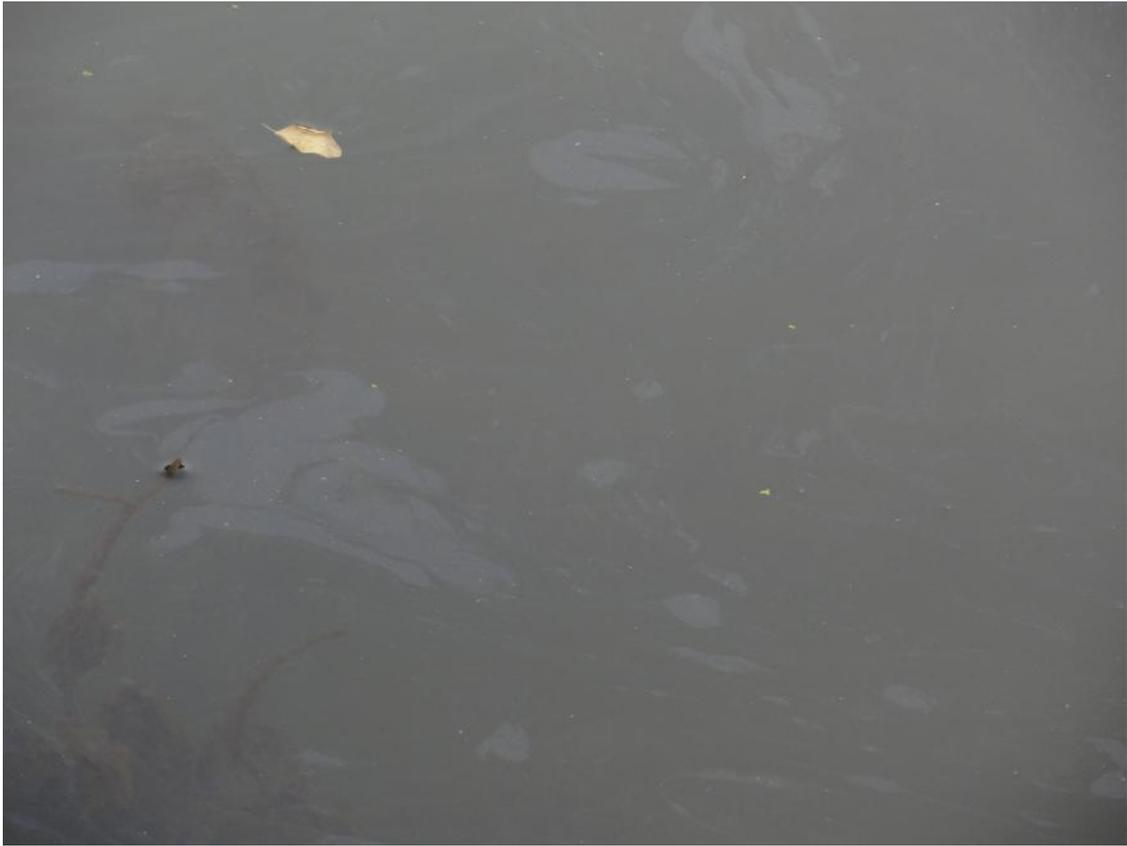
11. MP 36.50 RDB, sheen observed on river channel adjacent to wetland on RDB.

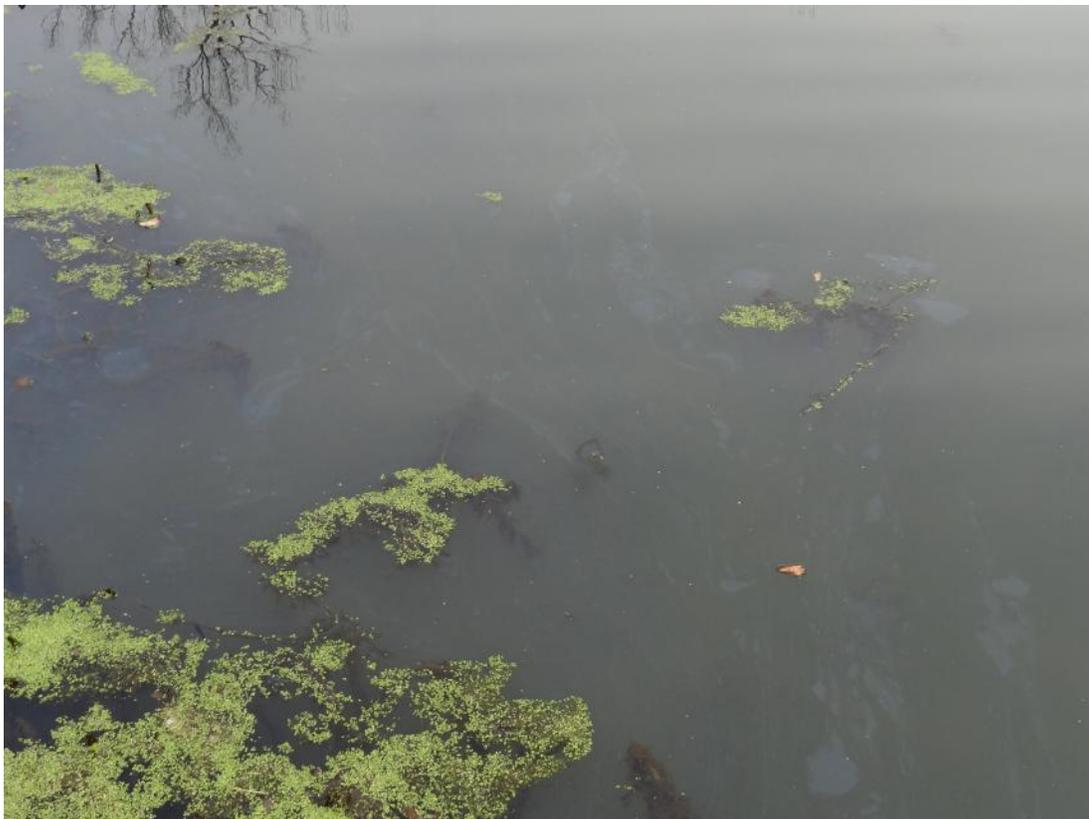
12. MP36.50 RDB, sheen observed along wetland adjacent to river channel.

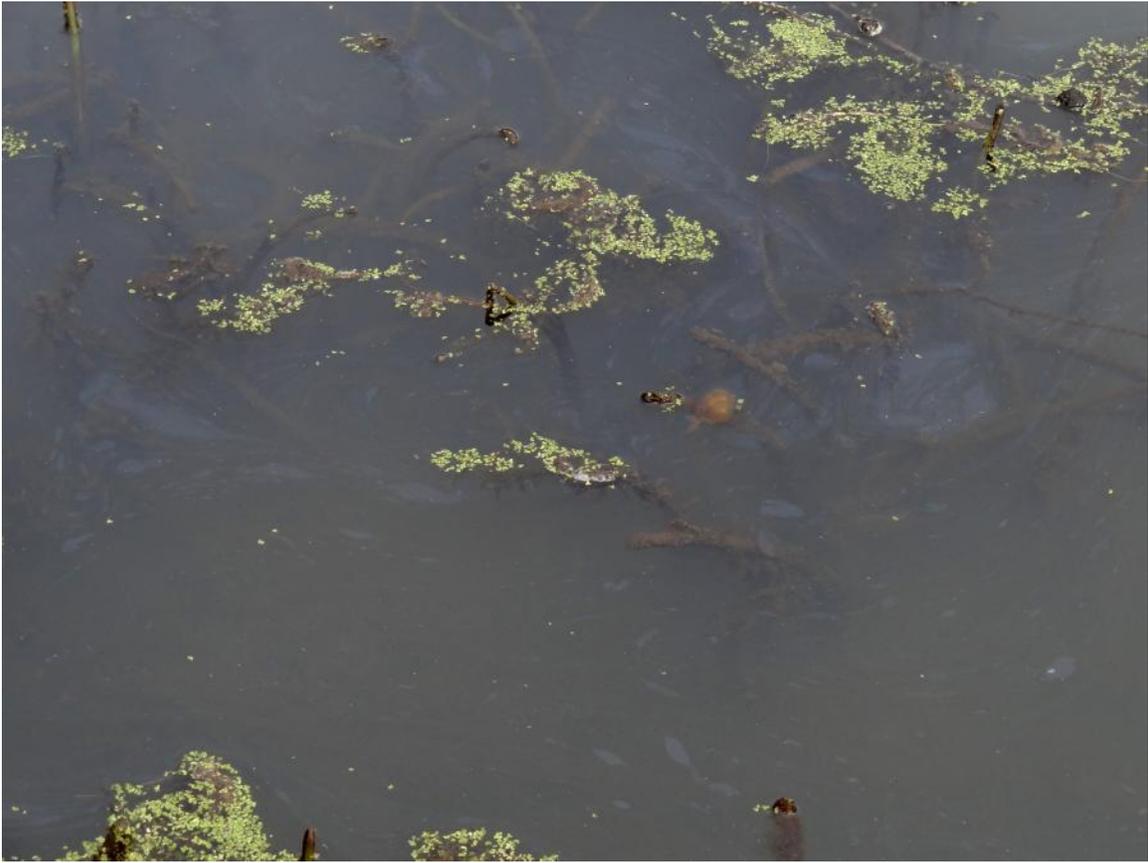
13. MP 36.5 RDB, sheen observed originating from wetland area along RDB

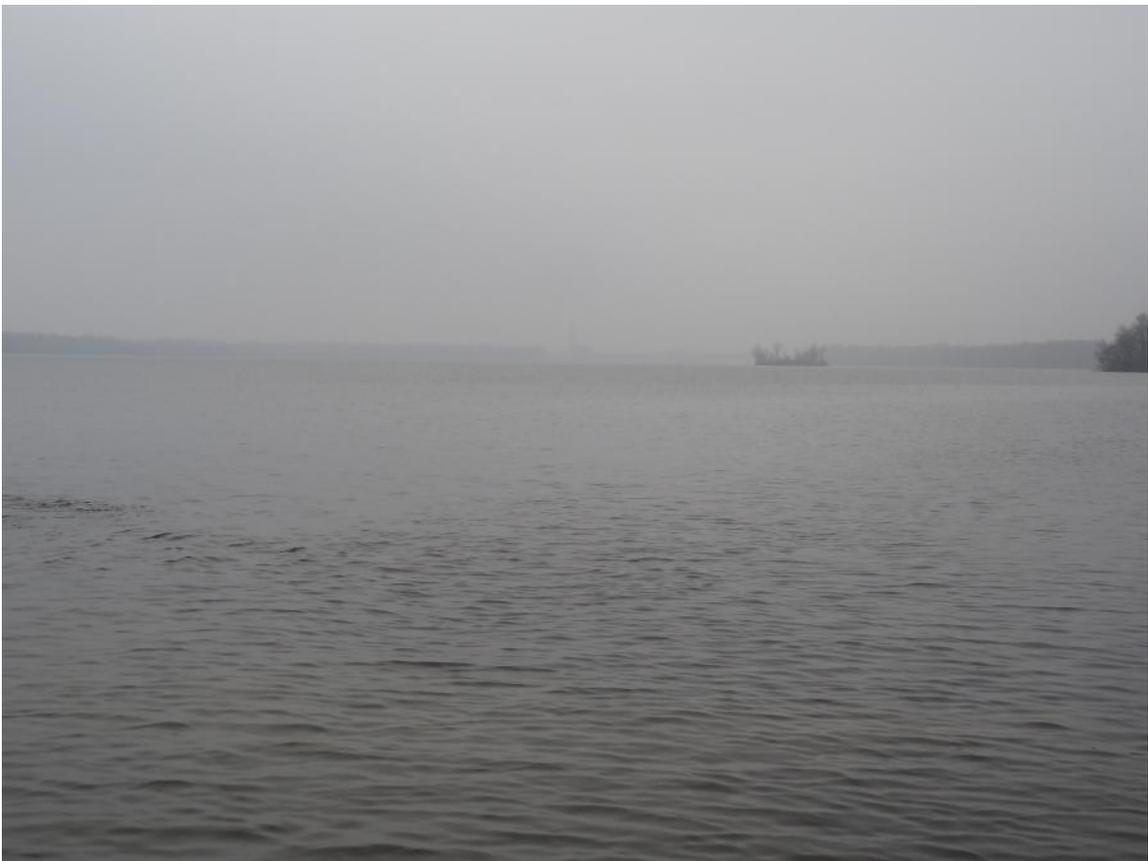
14. Morrow Lake, no sheen observed.
