# Situation Photo Log

Saturday, December 8, 2012

Kalamazoo River / Enbridge Spill

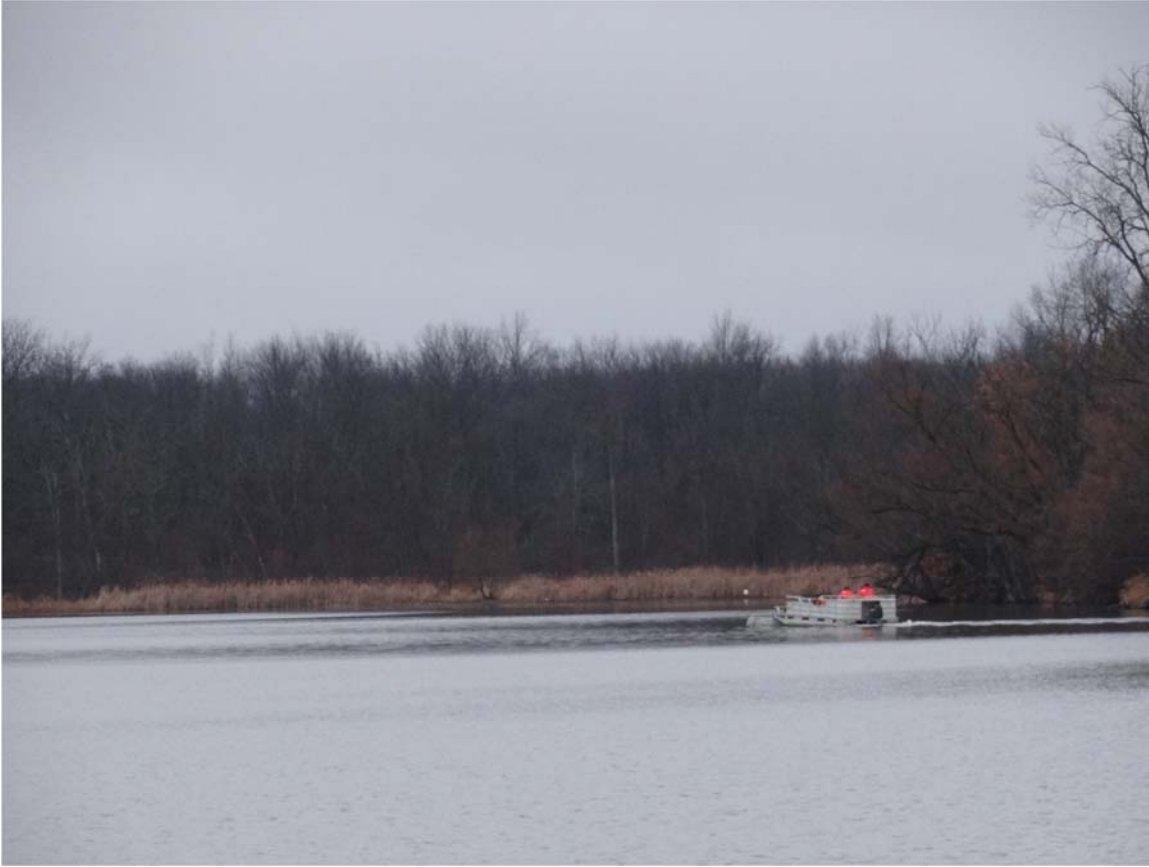
1. Morrow Lake observed a sweep boat in the north cove.

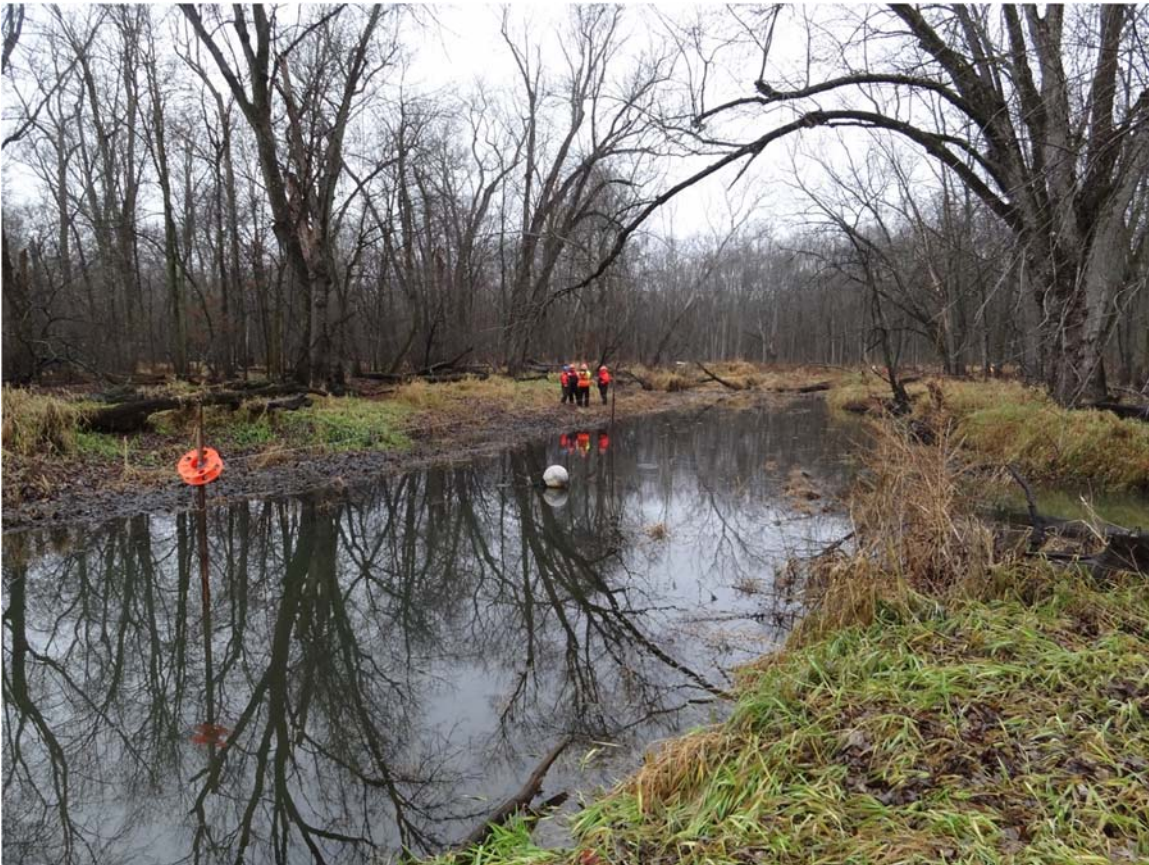
2. MP28.25 Sediment trap observed bathymetry teams.

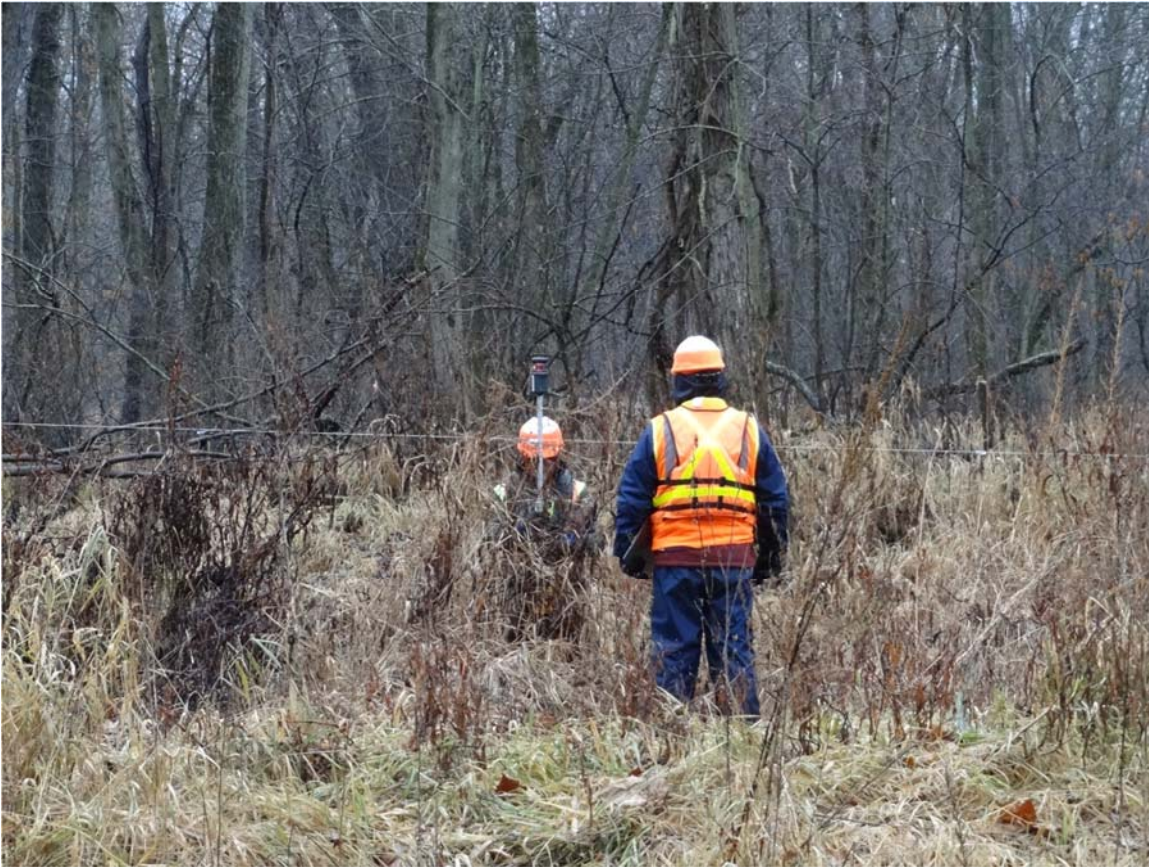
3. MP28.25 Sediment trap observed bathymetry teams.

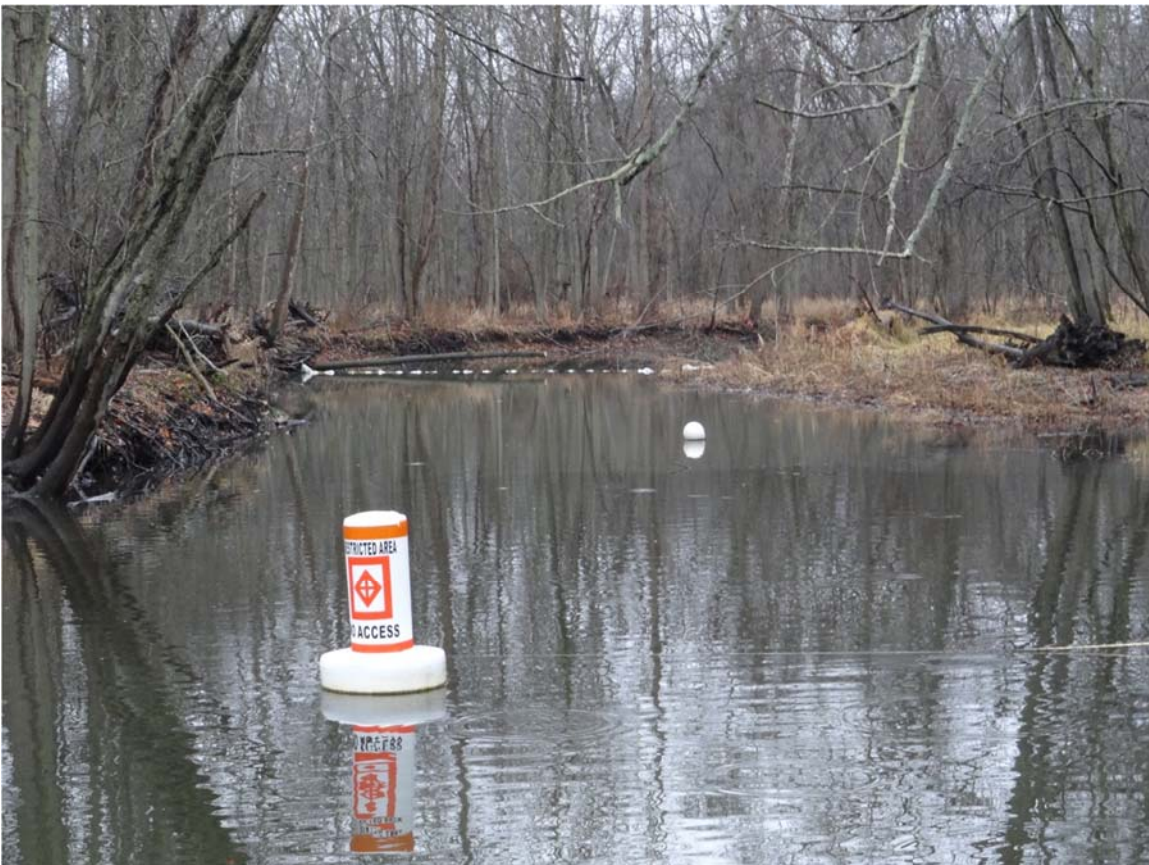
4. MP28.25 Sediment trap observed deployed snare boom to collect sheen and tar globs generated by the bathymetry teams.

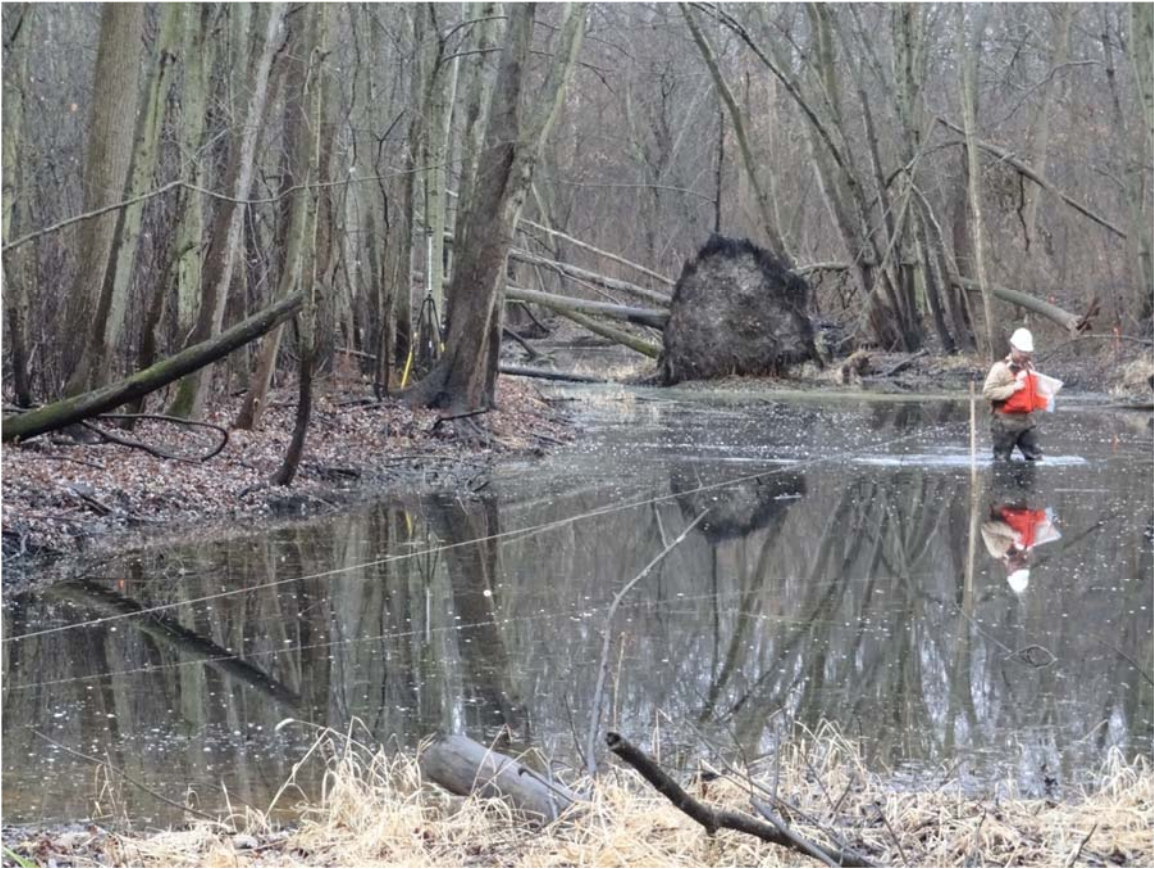
5. MP19.25 Sediment trap observed a bathymetry team.

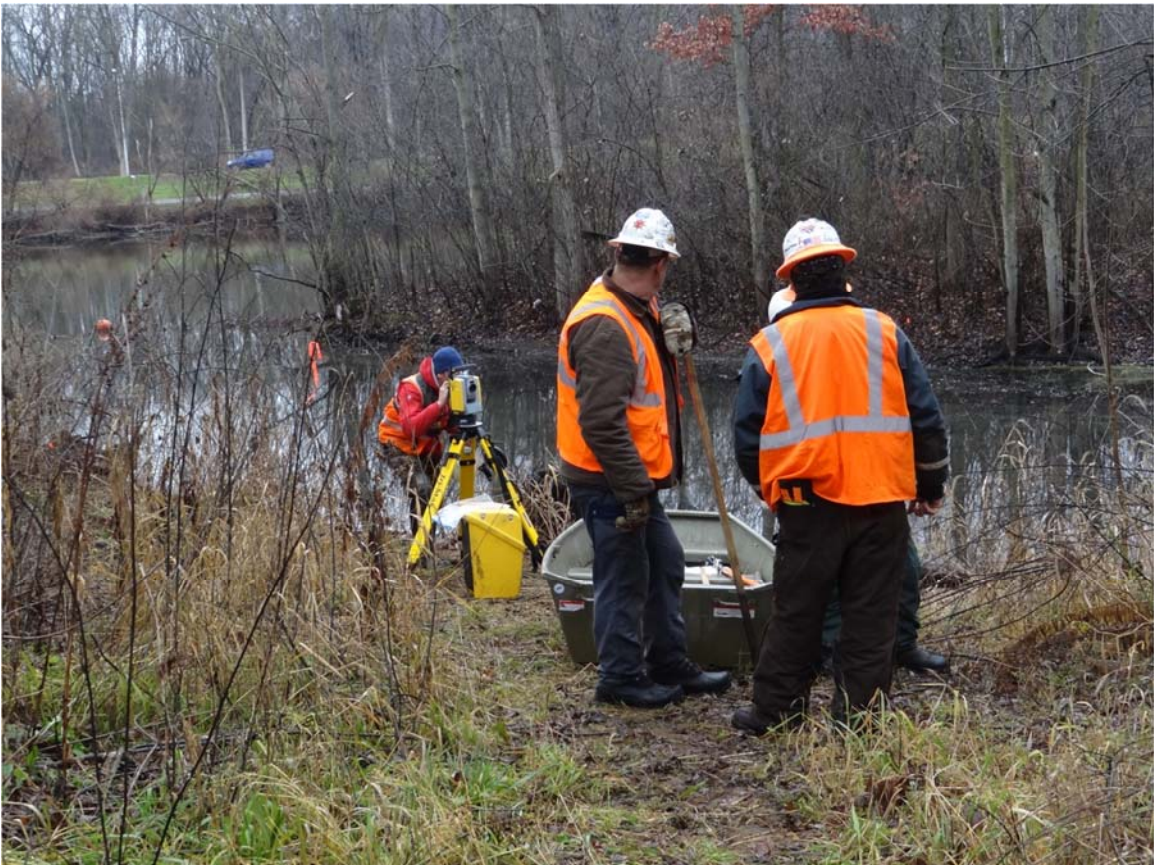
6. MP19.25 Sediment trap observed a bathymetry team.

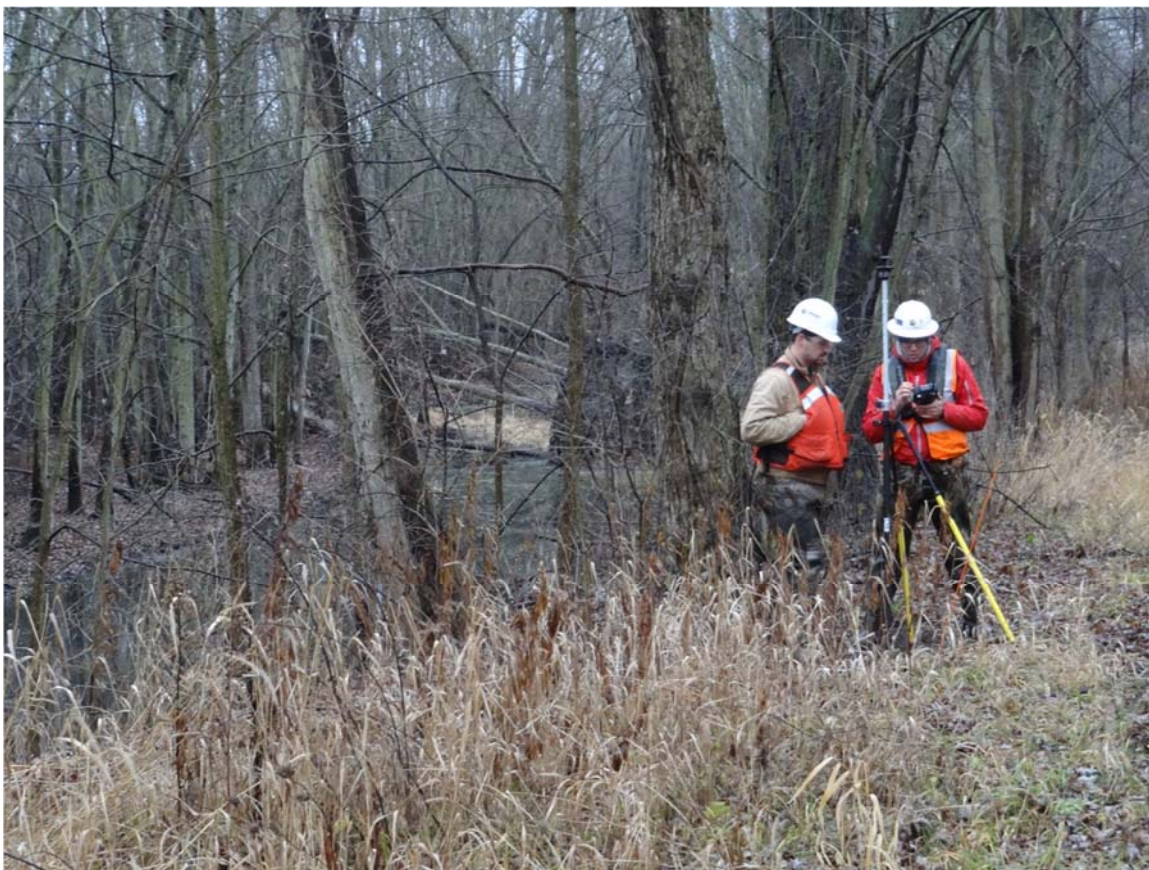
7. MP19.25 Sediment trap observed a bathymetry team.

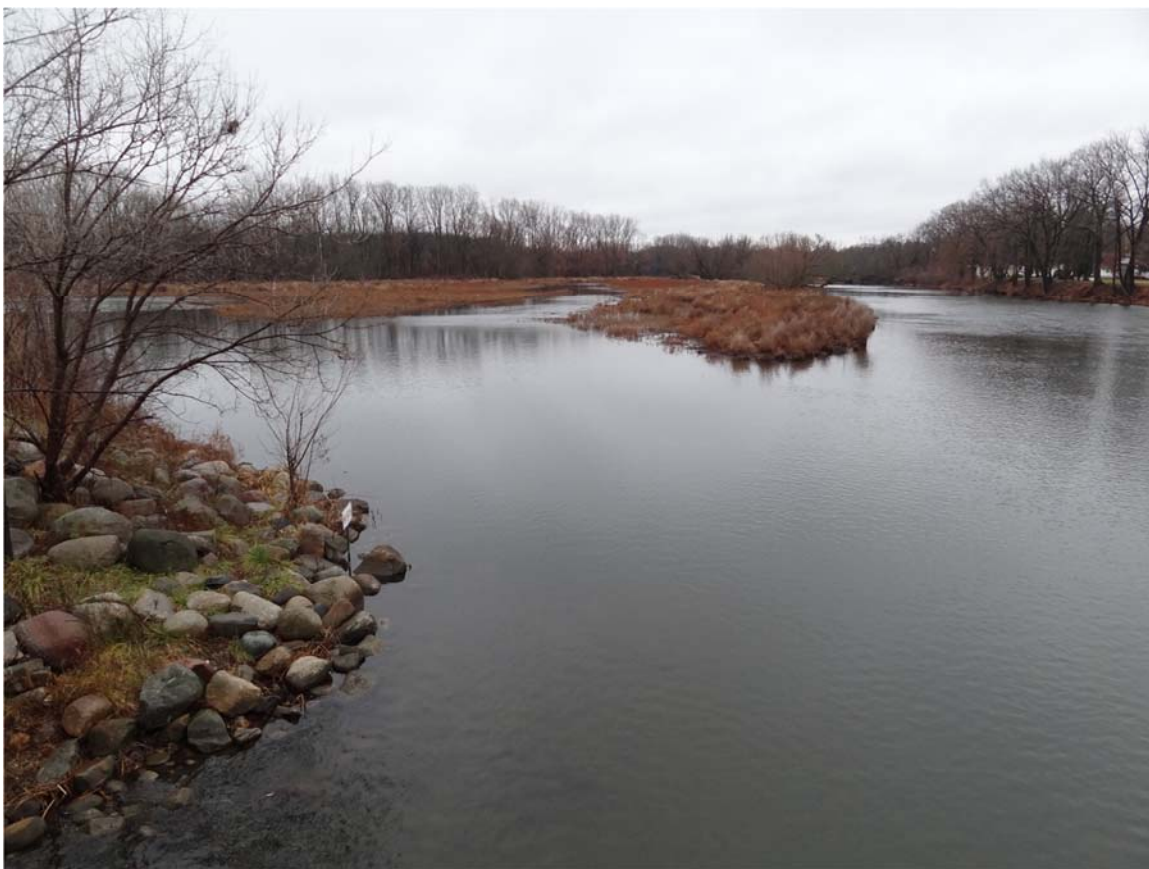
8. MP15.25 South Mill Pond no sheen observed.

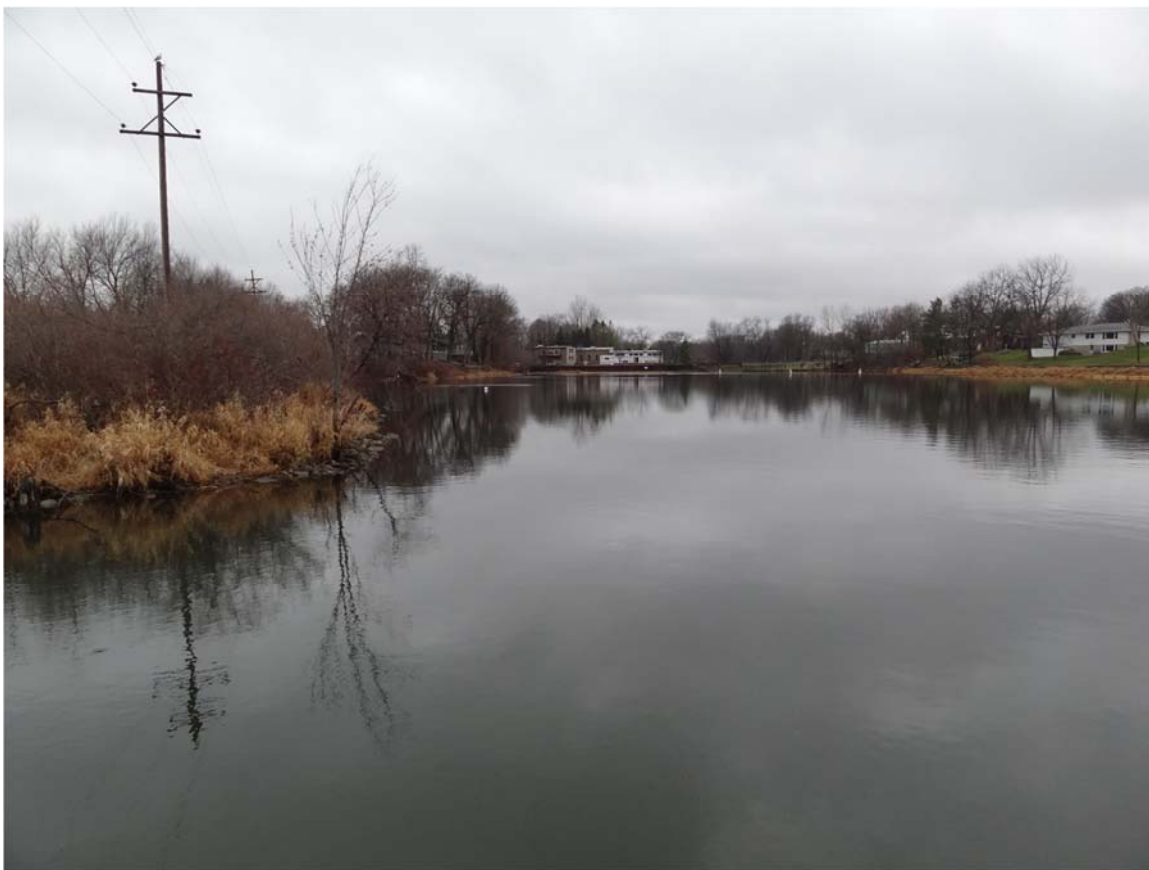
9. MP5.63 LDB area where sheen and tar globs were observed.

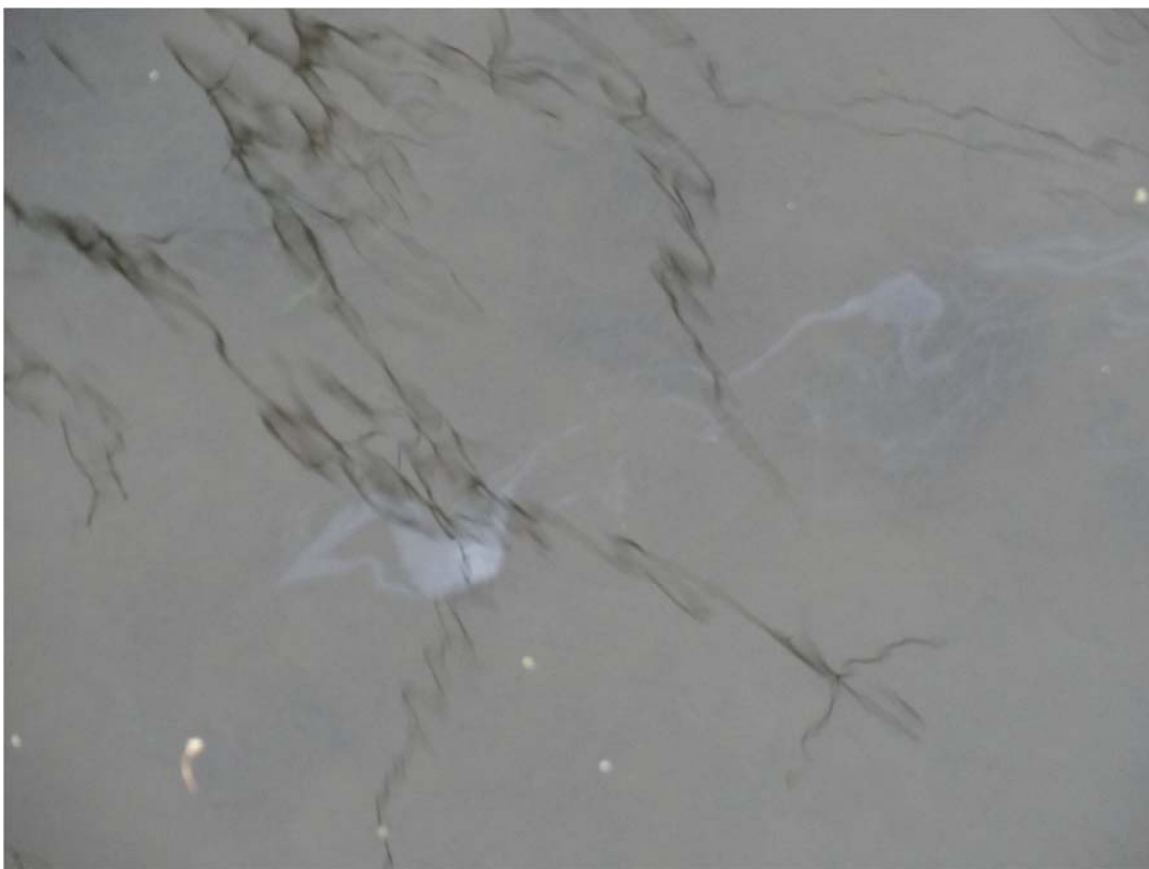
10. MP5.63 LDB sheen and tar globs observed.

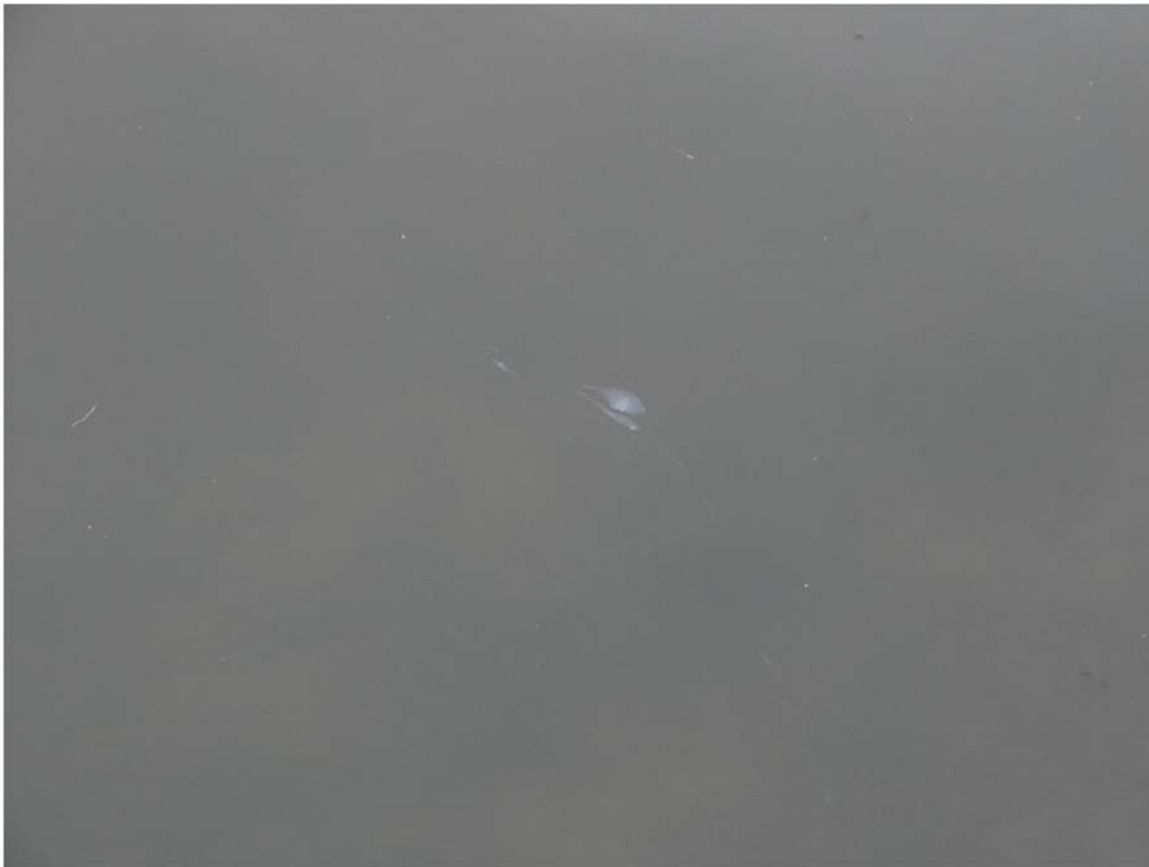
11. MP5.63 LDB sheen and tar globs observed.

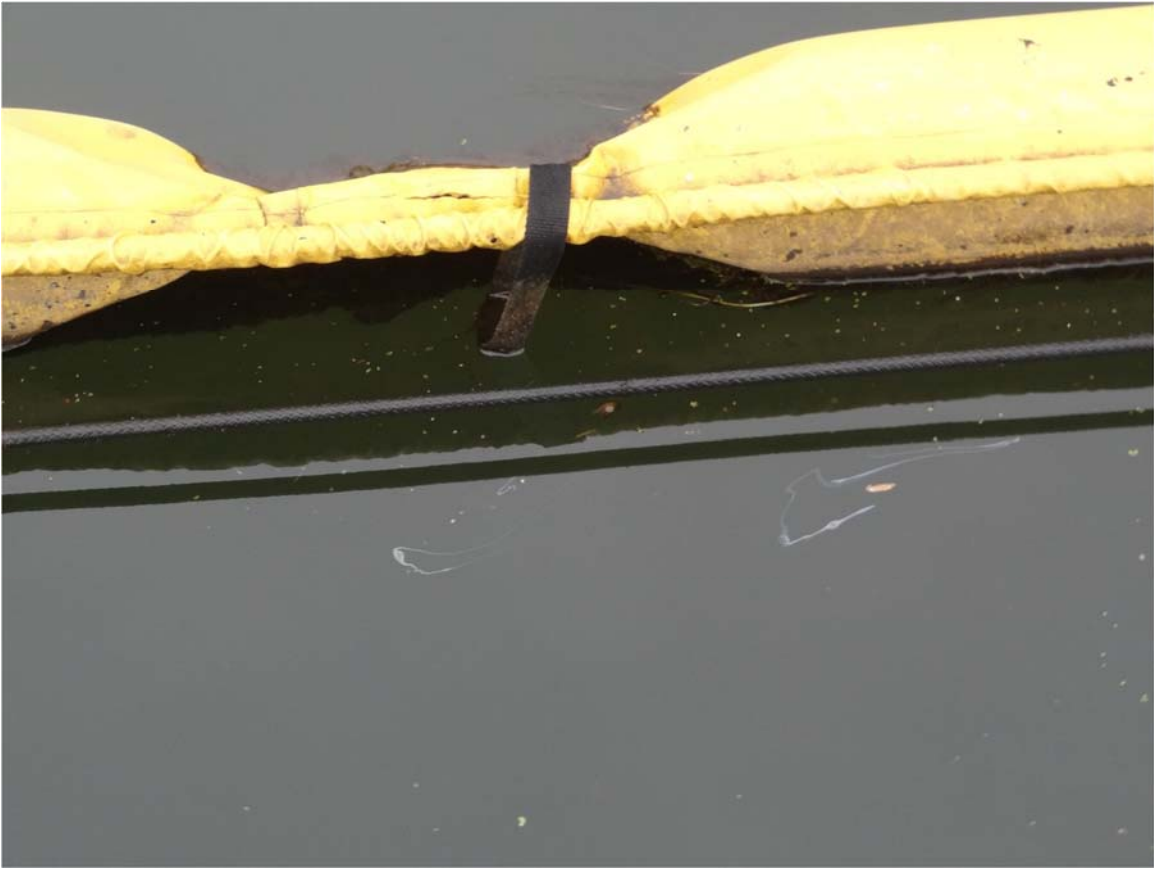
**13. Ceresco Dam control point boom observed sheen and tar globs collecting along the boom.**

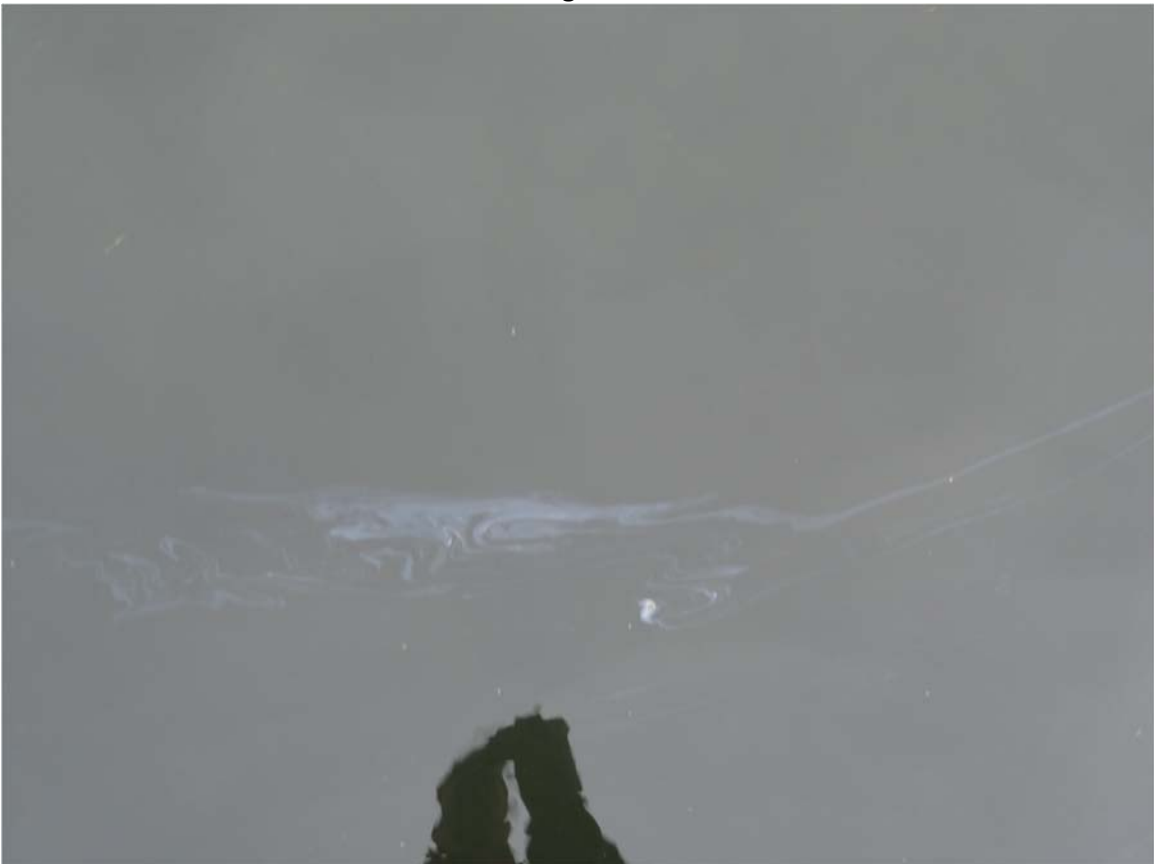
**14. Ceresco Dam control point boom observed sheen and tar globs collecting along the boom**
