# Situation Photo Log

Monday, December 10, 2012

Kalamazoo River / Enbridge Spill

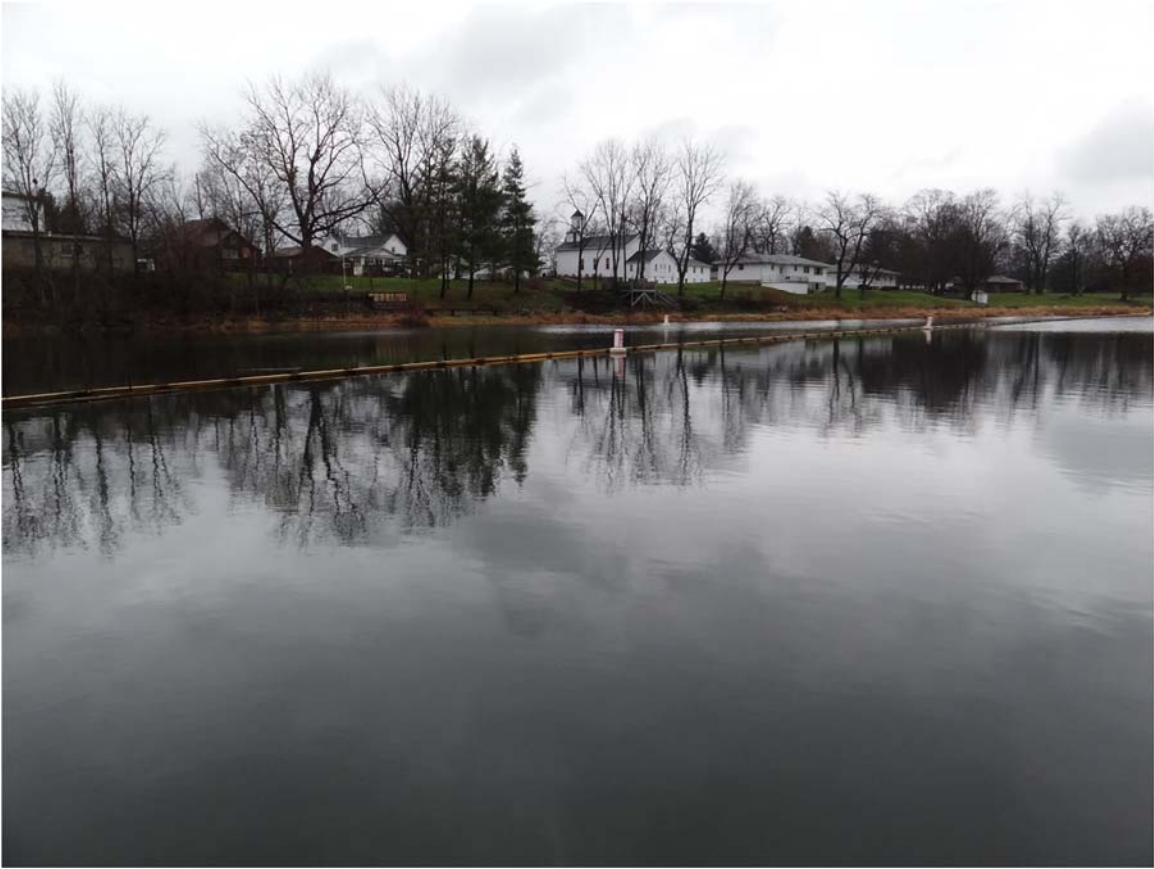
1. Ceresco Dam control point boom.

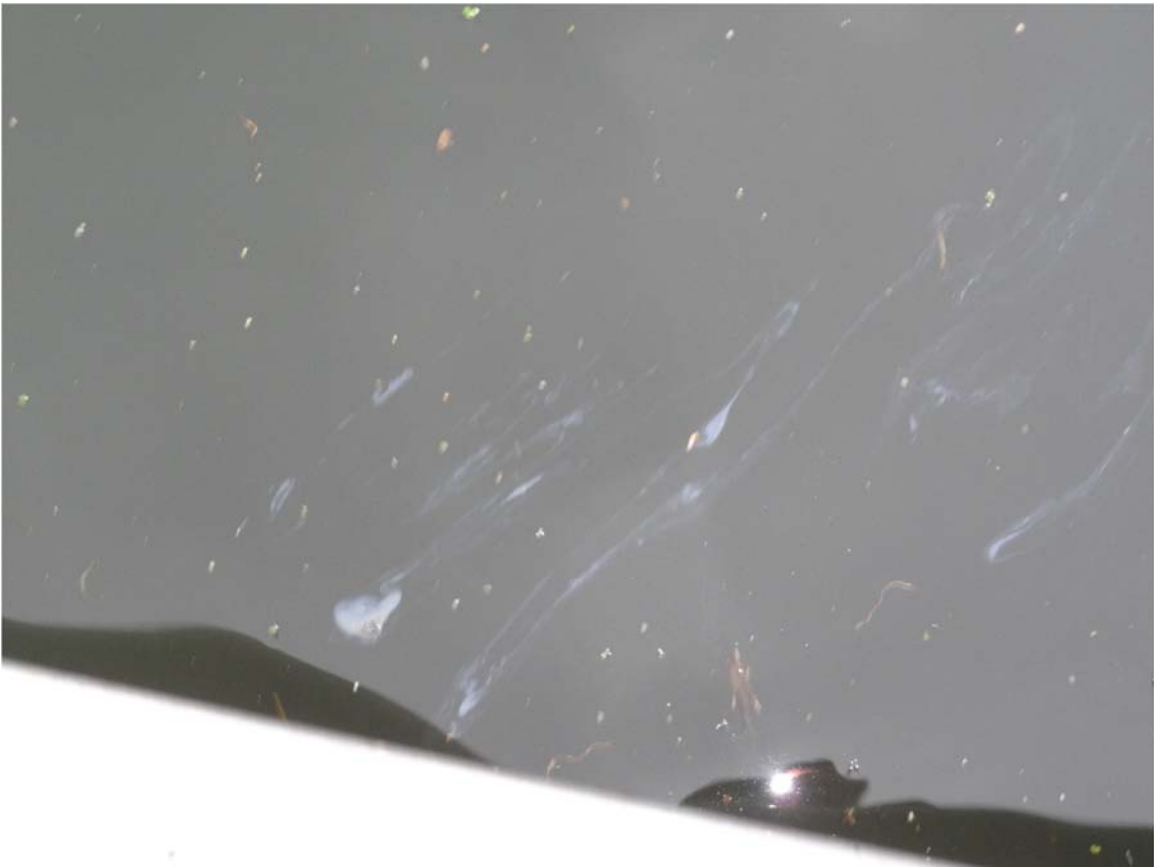
2. Ceresco Dam control point boom observed sheen and tar globs collecting along the boom.

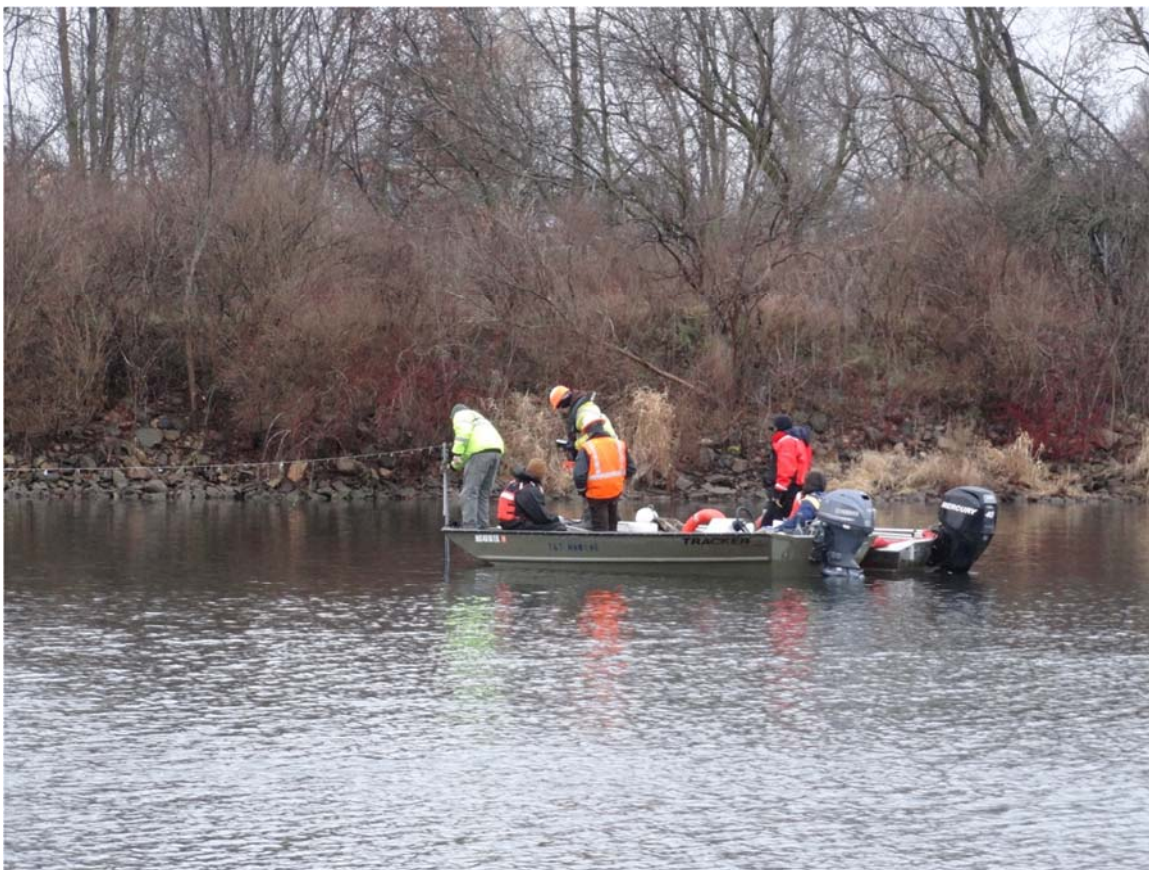
3. Ceresco Dam impoundment observed a bathymetry team.

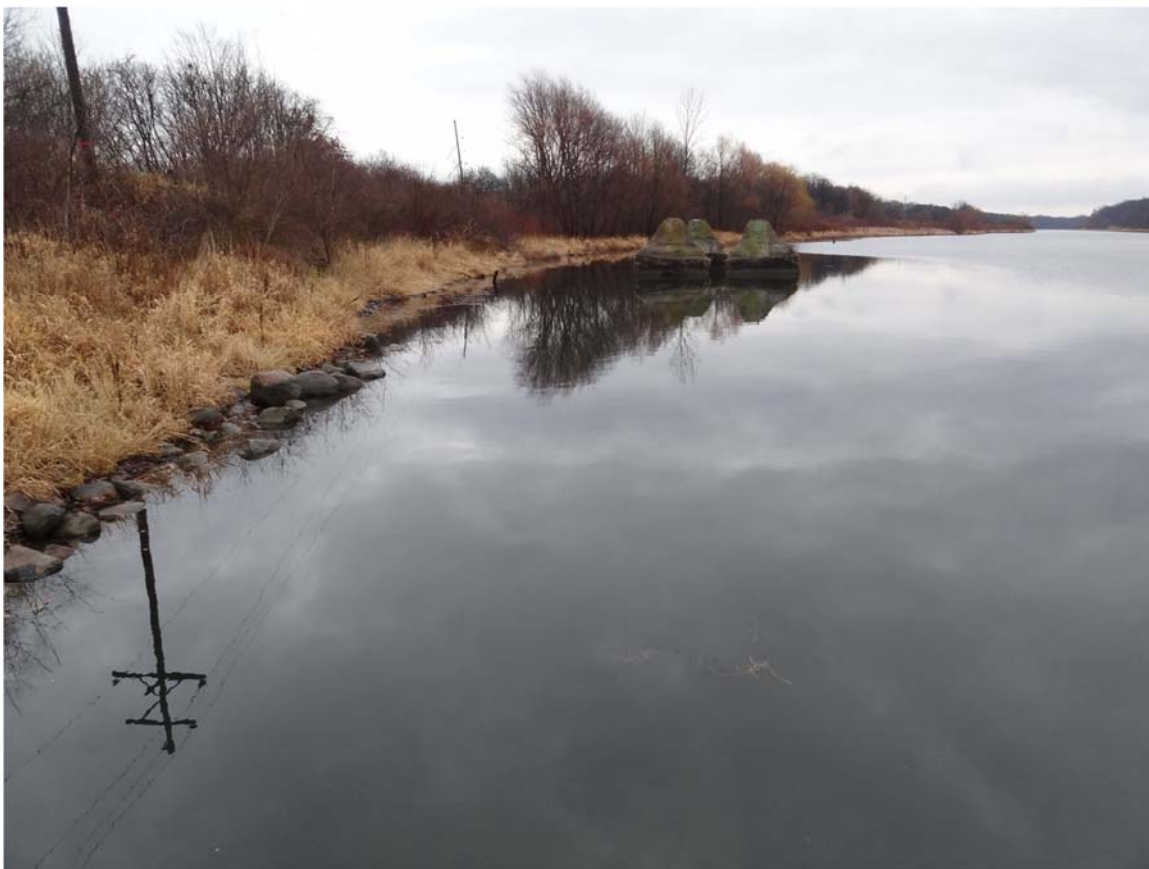
4. MP5.55 RDB area where sheen and tar globs were observed.

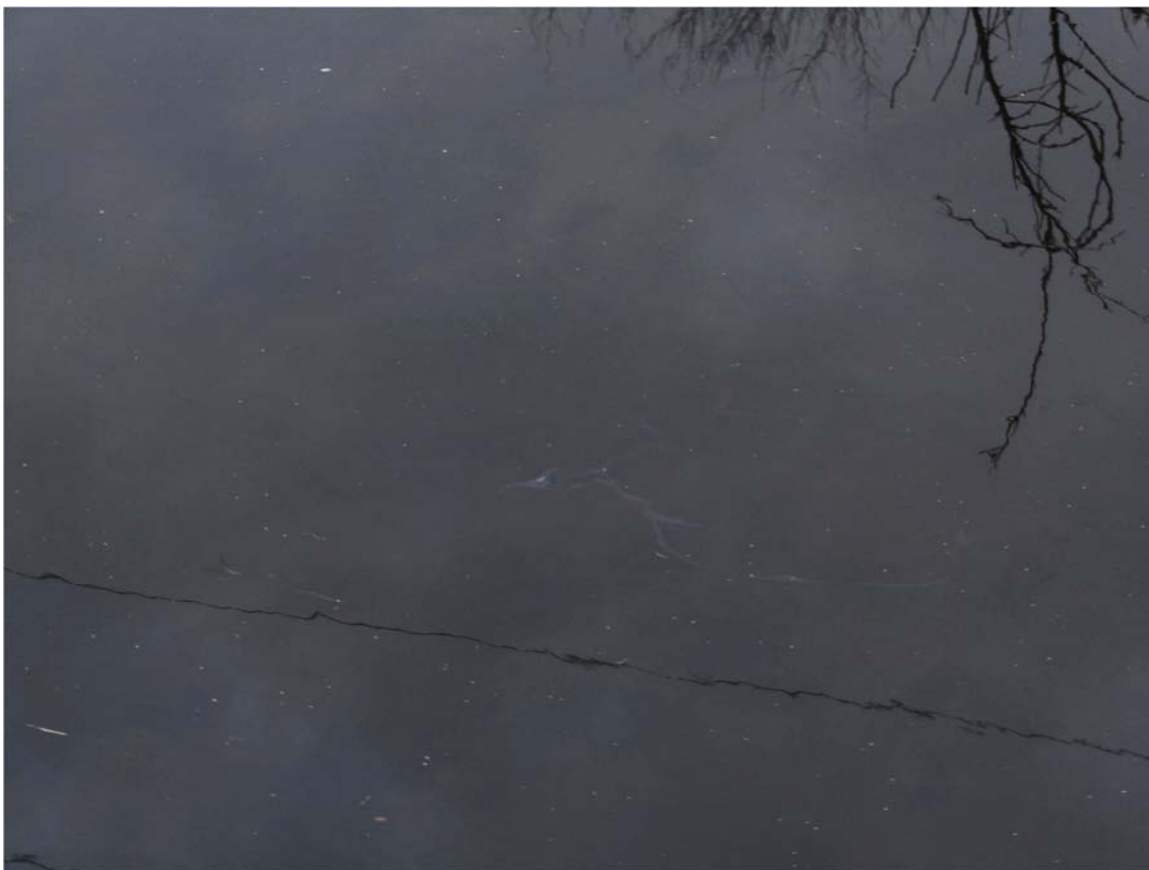
5. MP5.55 RDB sheen and tar globs observed.

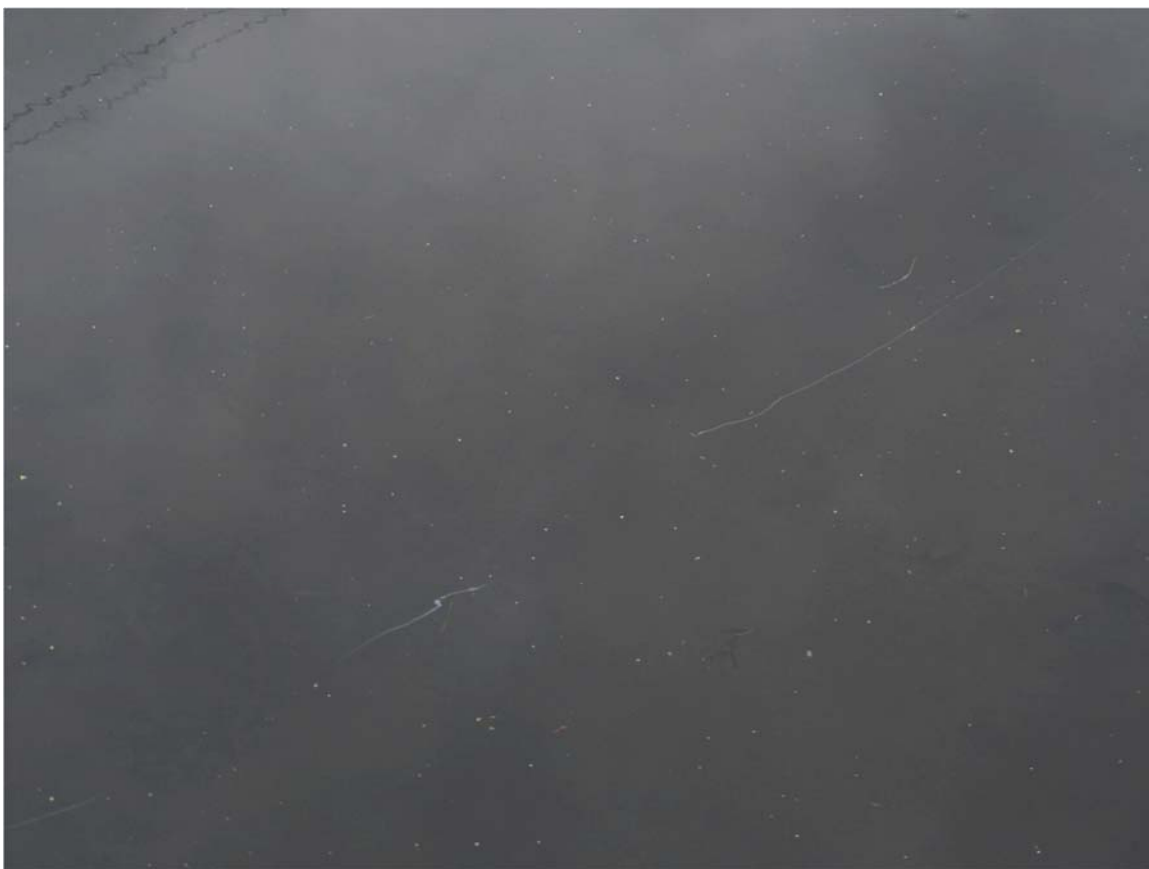
6. MP5.55 RDB sheen and tar globs observed.

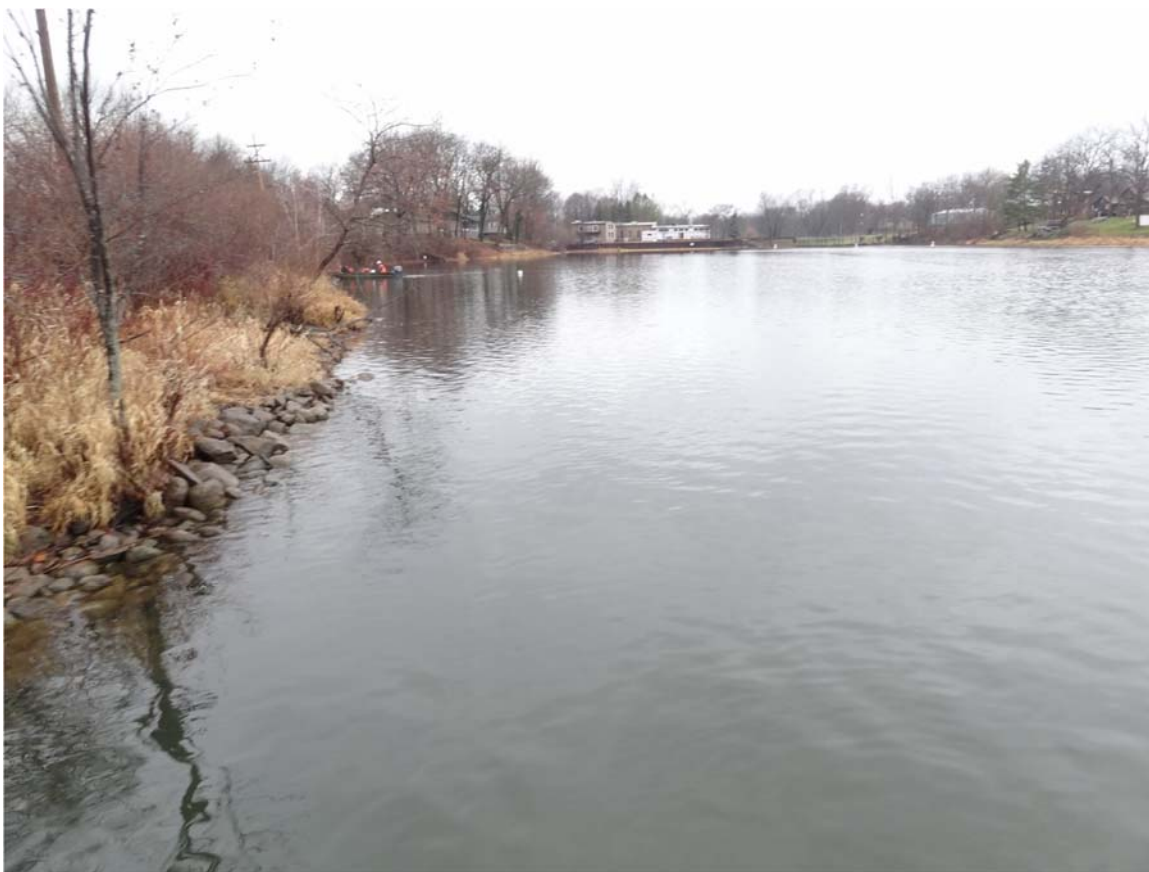
7. MP5.63 RDB area where sheen and tar globs were observed.

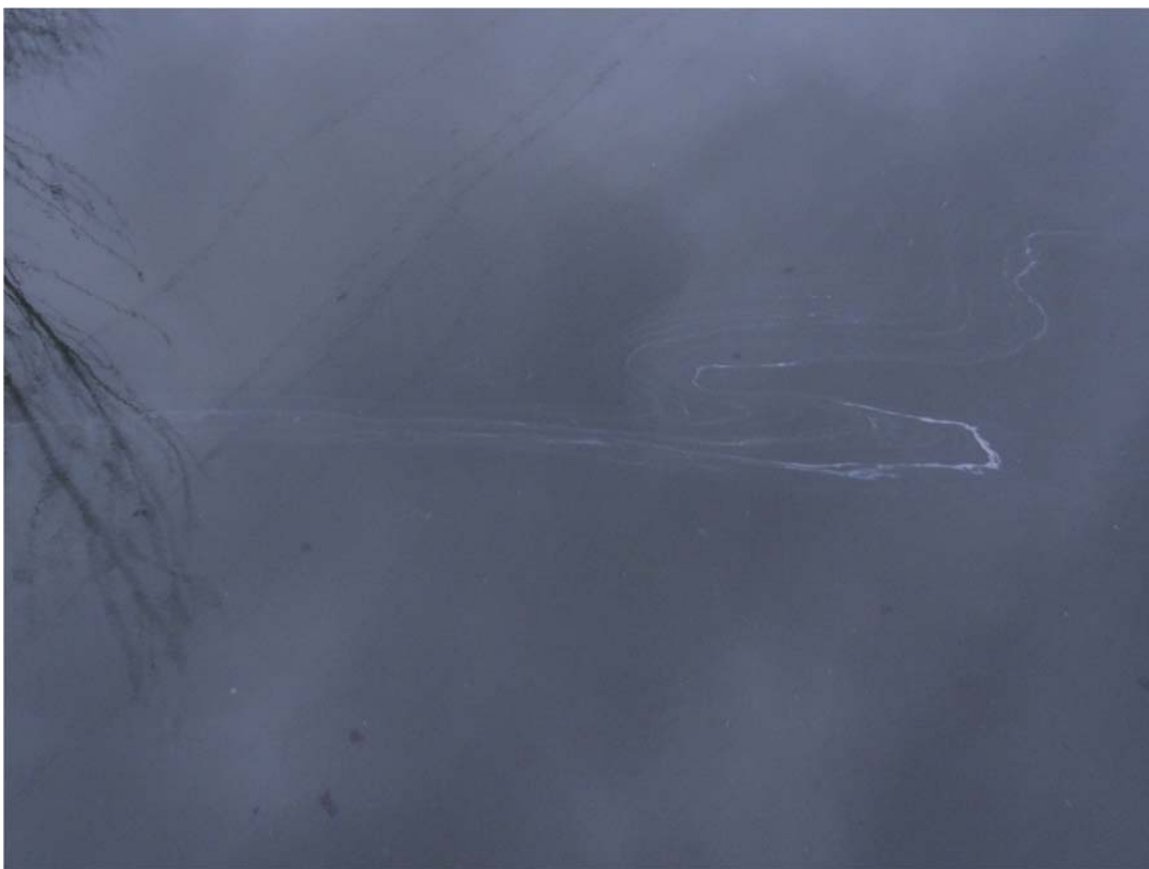
8. MP5.63 sheen and tar globs observed, sweep boat requested.

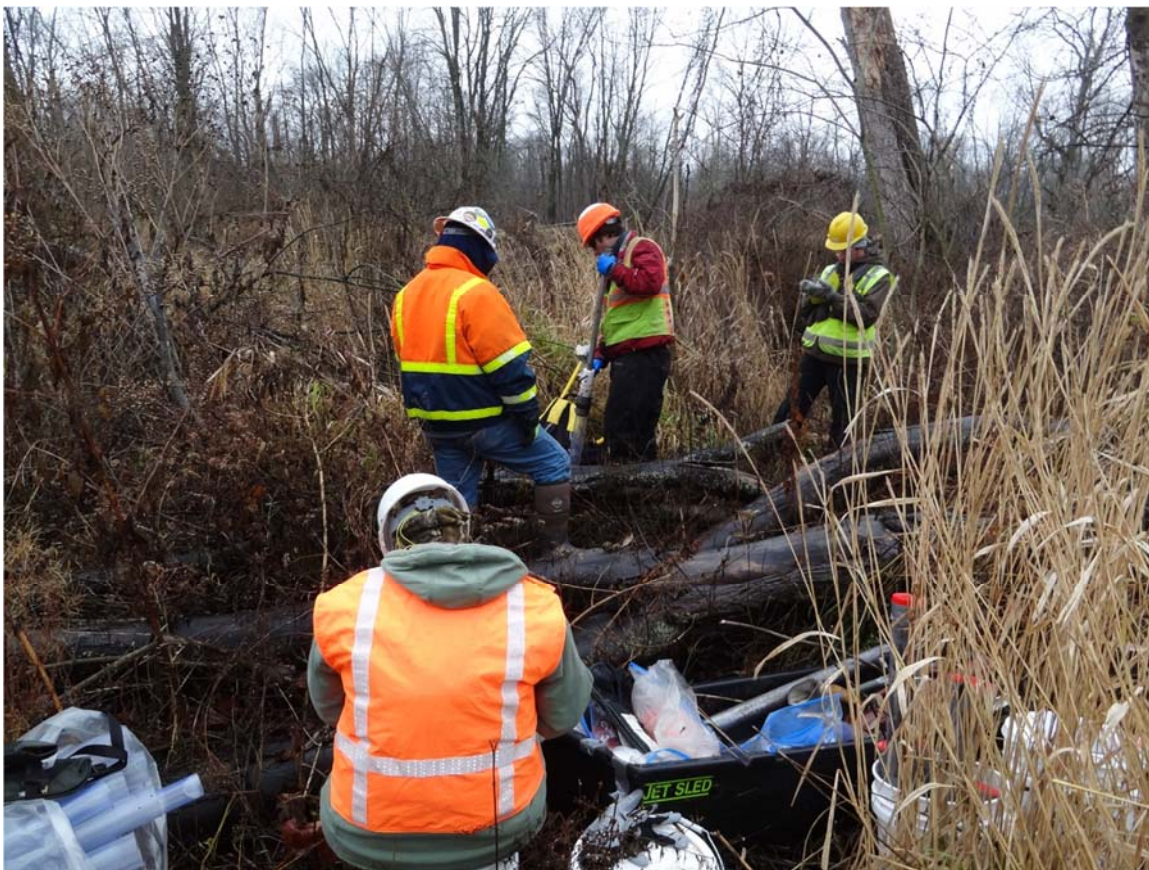
9. MP11.75 RDB observed an RI crew.

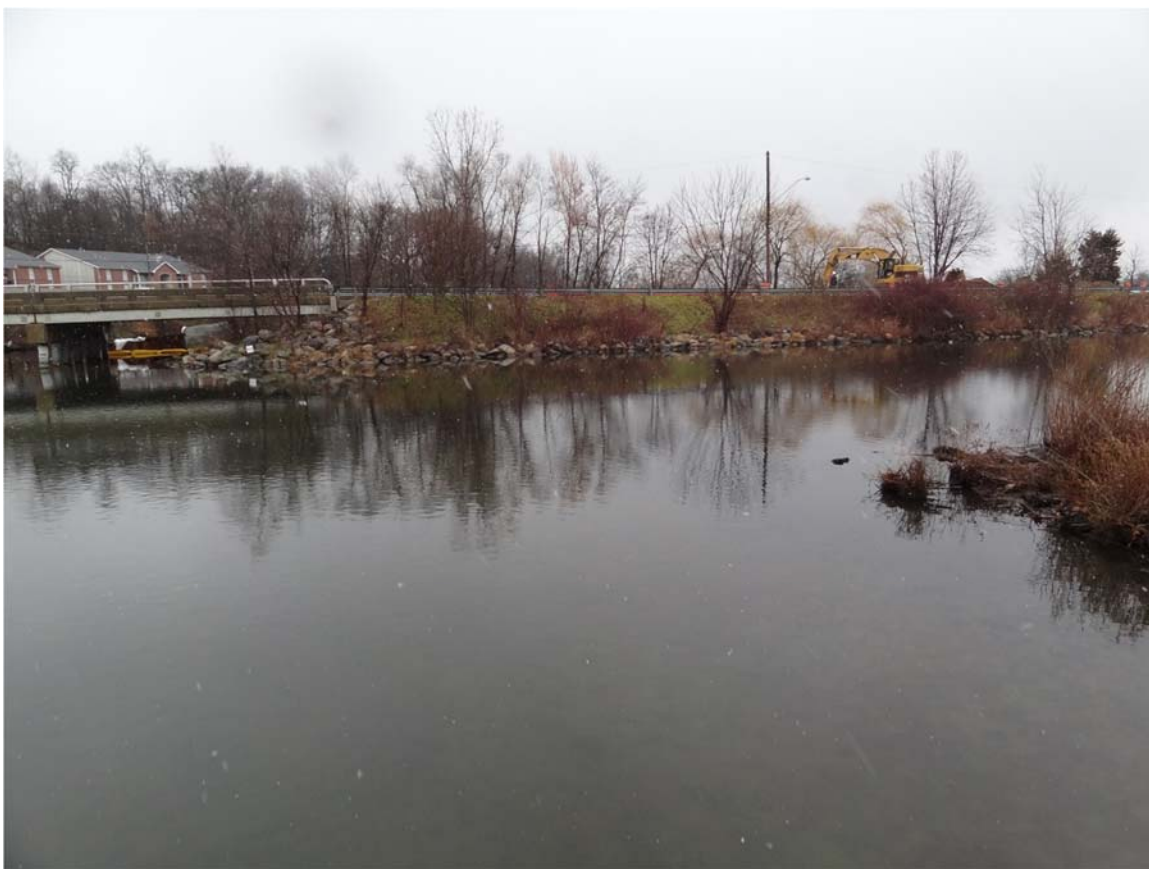
10. MP15.25 South Mill Pond no sheen observed.

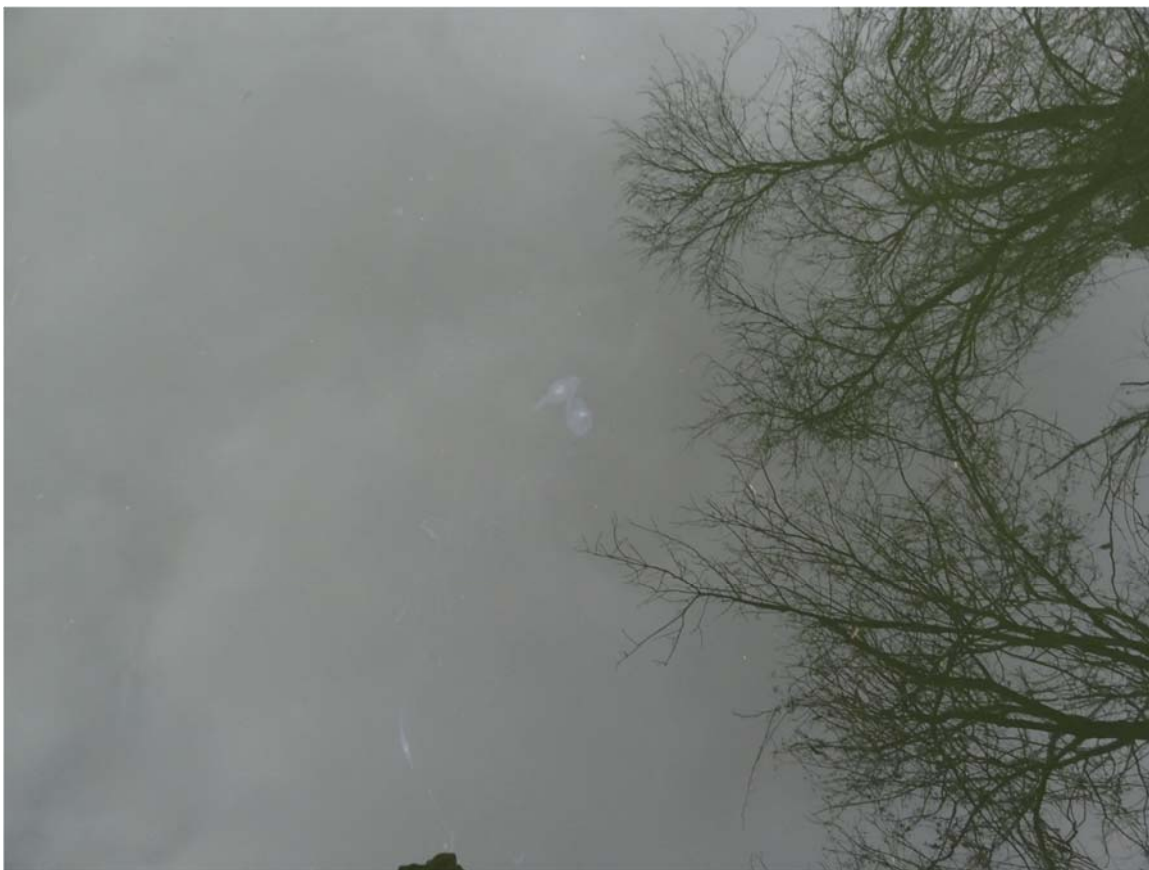
11. MP15.65 LDB sheen and tar globs observed.

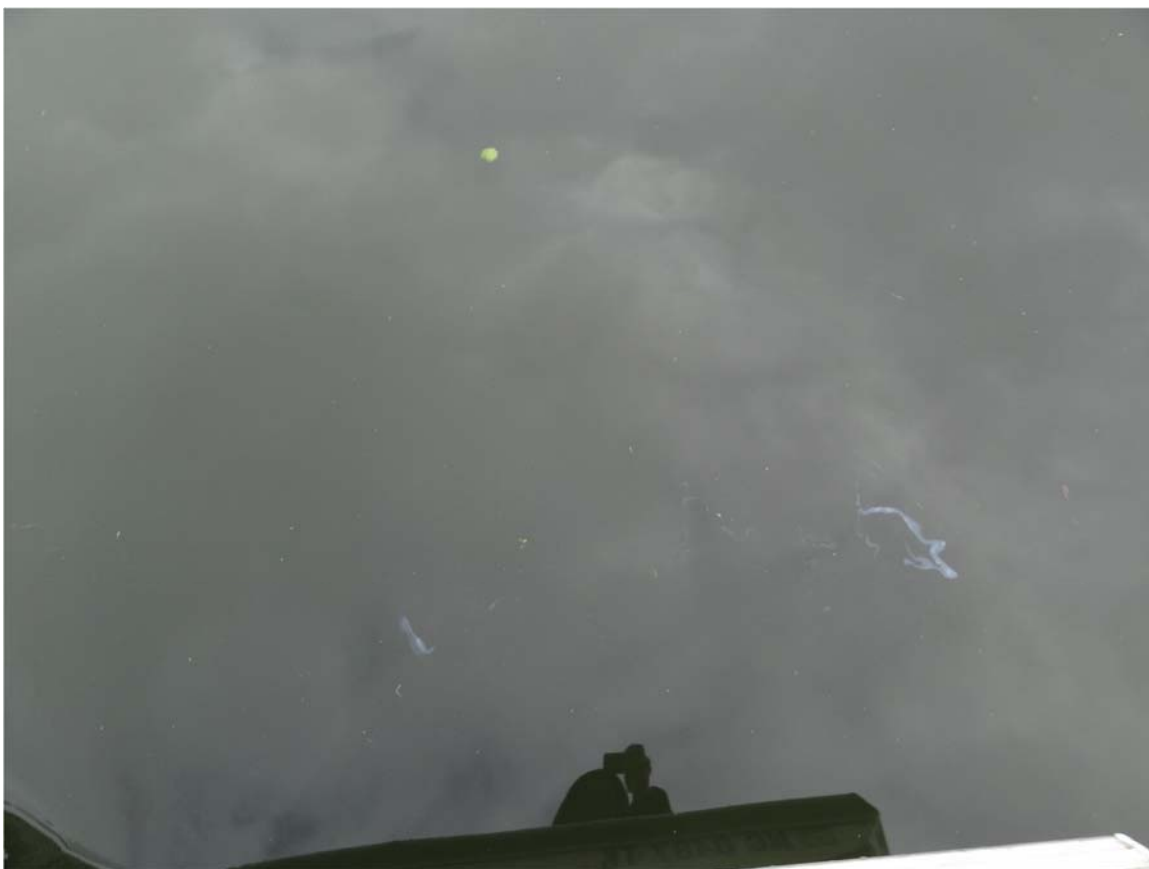
12. MP15.65 LDB sheen and tar globs observed.

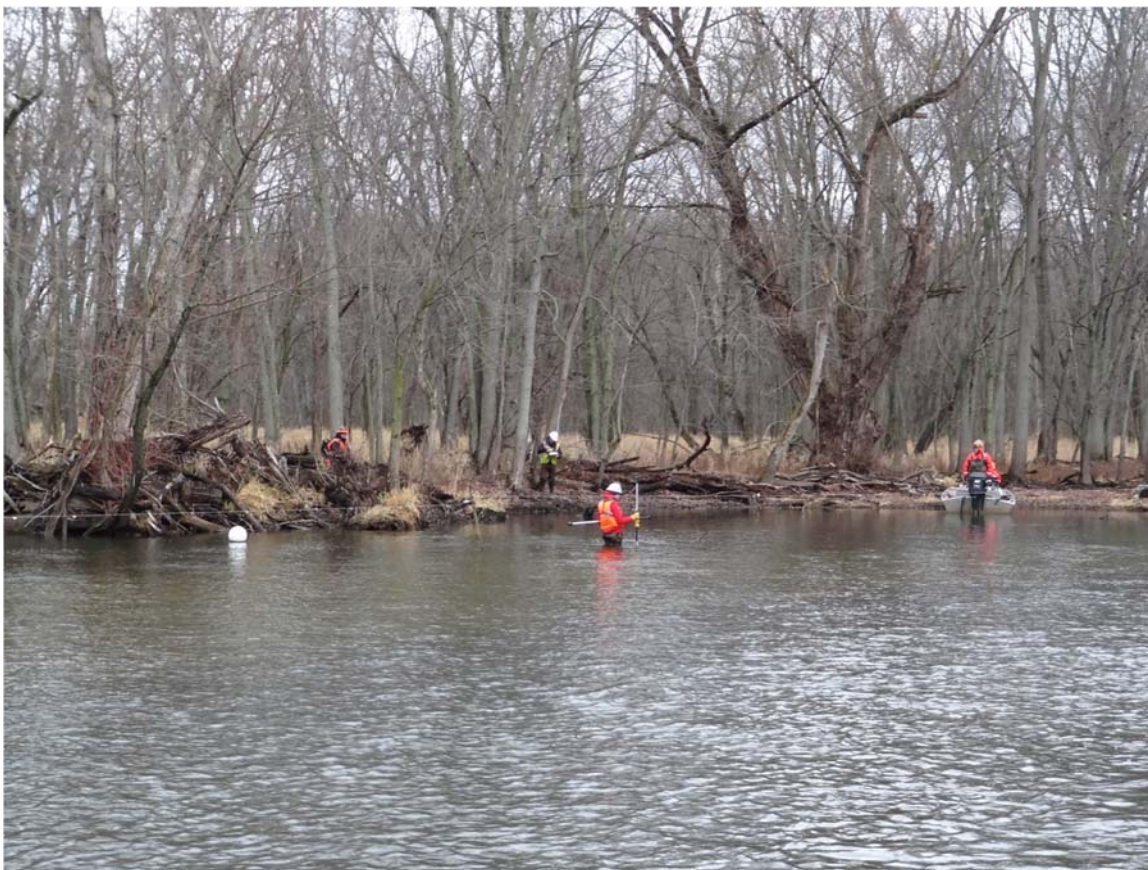
13. MP33.0 A Sediment trap observed a bathymetry team.

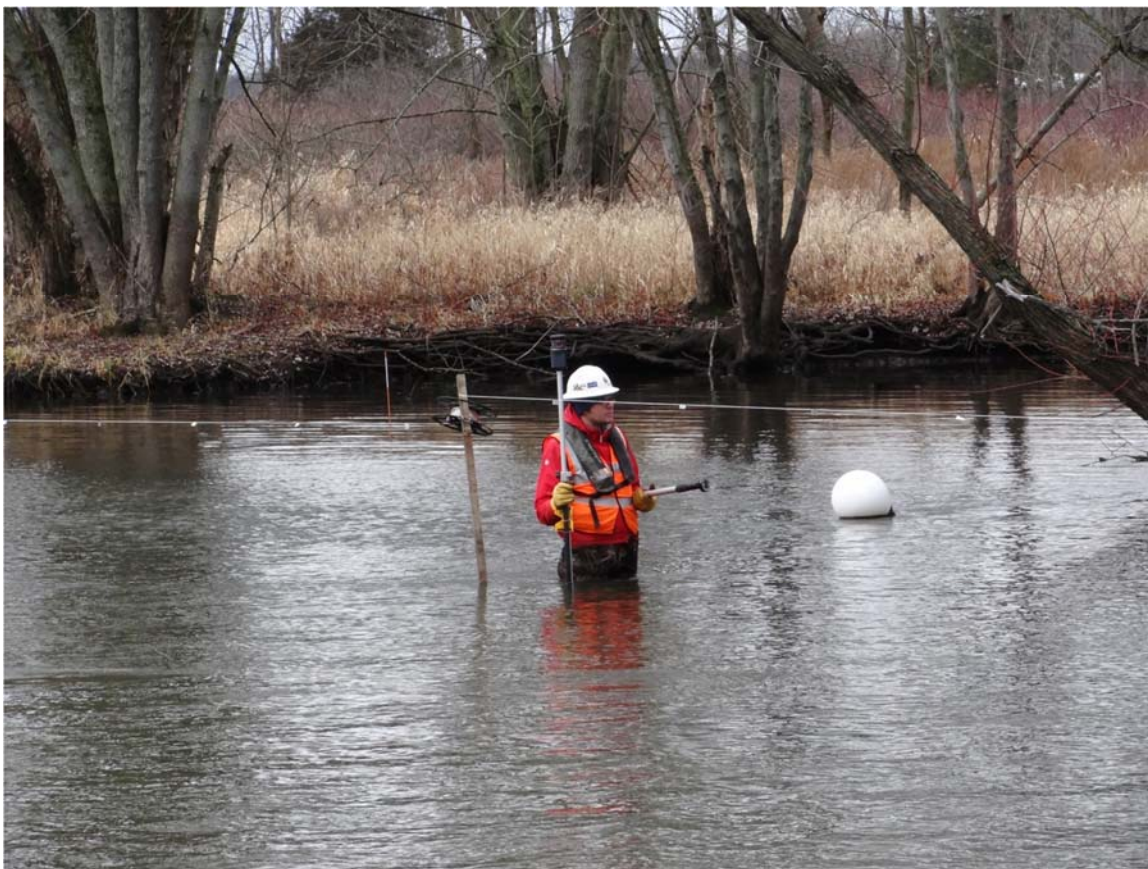
14. MP33.0 A Sediment trap observed a bathymetry team.

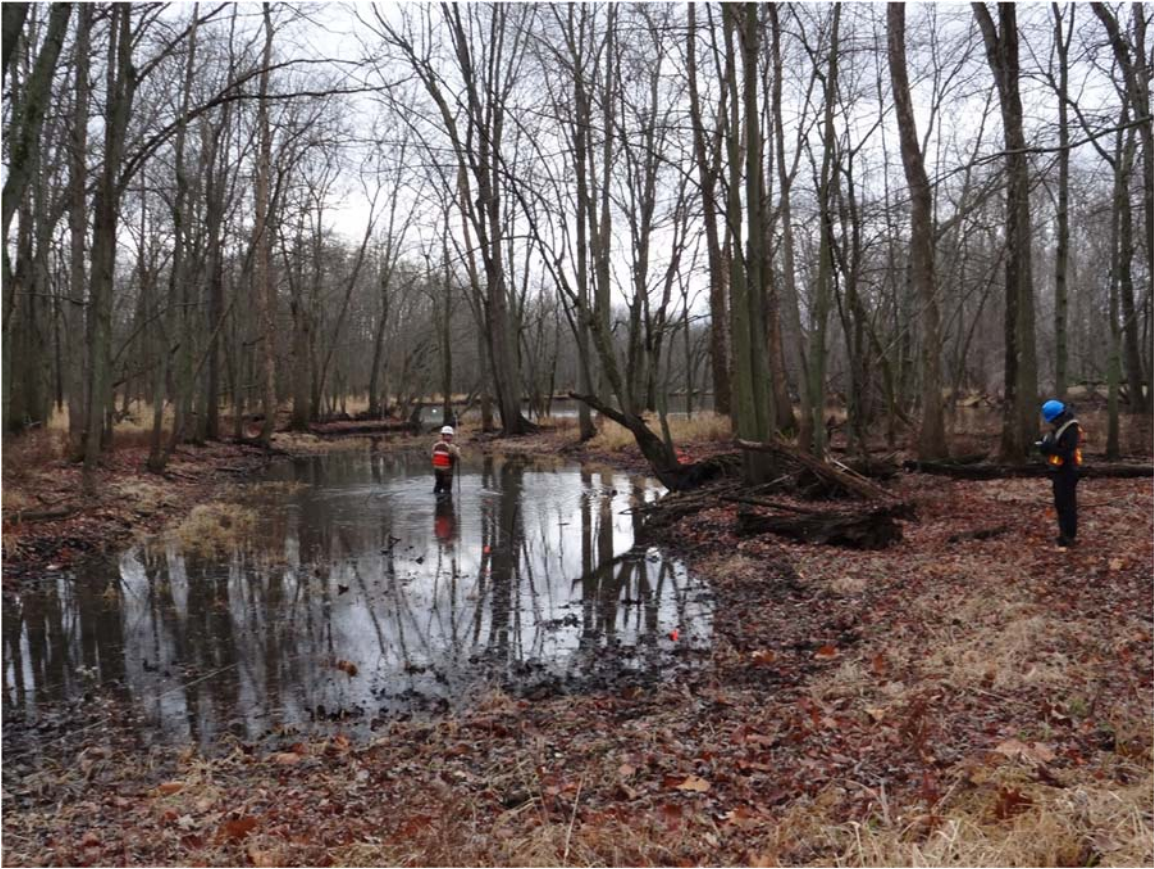
15. MP33.0 B Sediment trap observed a bathymetry team.

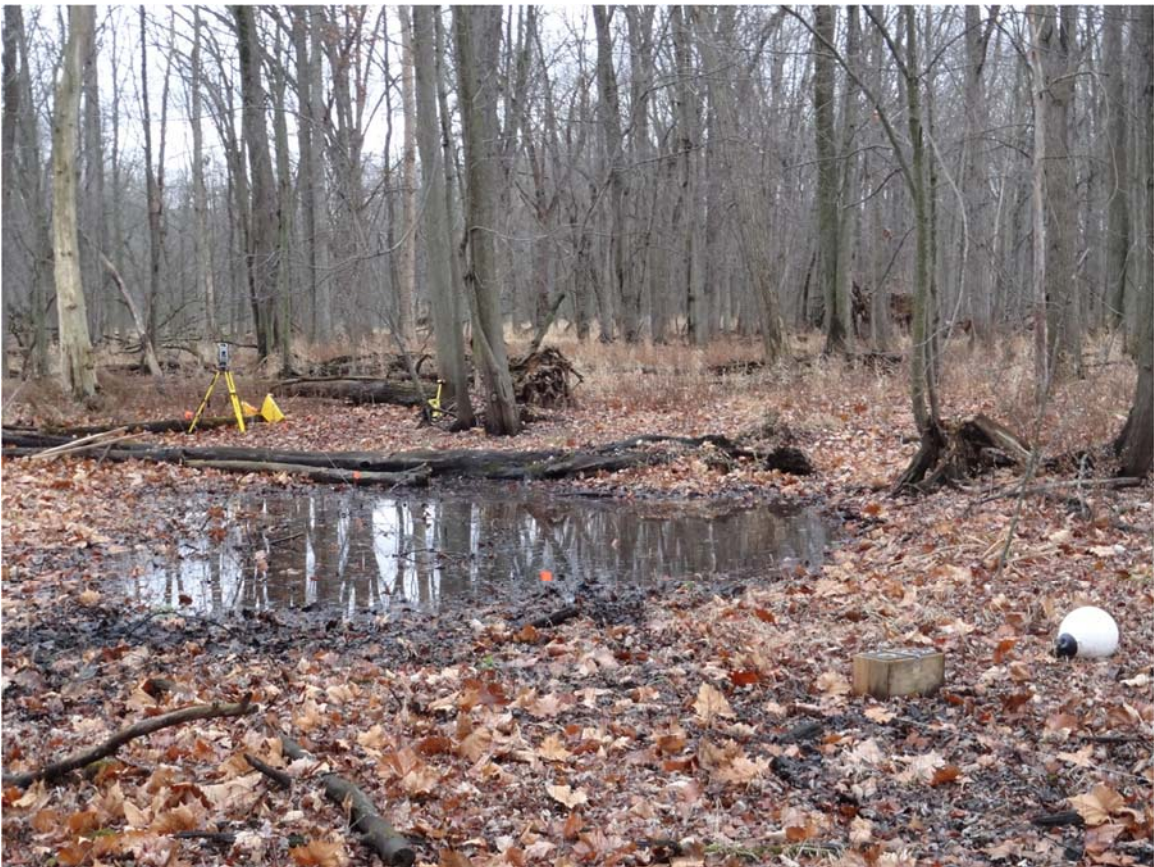
16. MP33.0 B Sediment trap observed a bathymetry team.

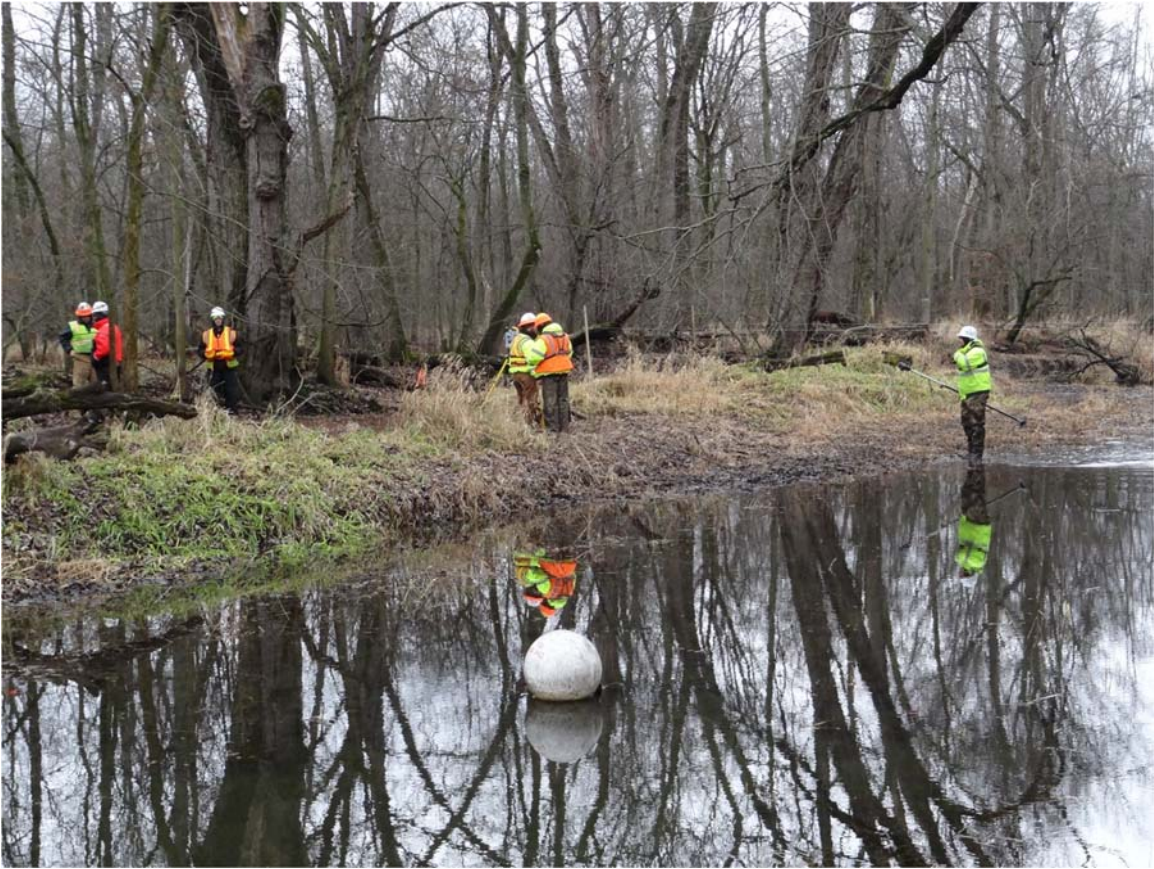
17. MP28.25 Sediment trap observed a bathymetry team.

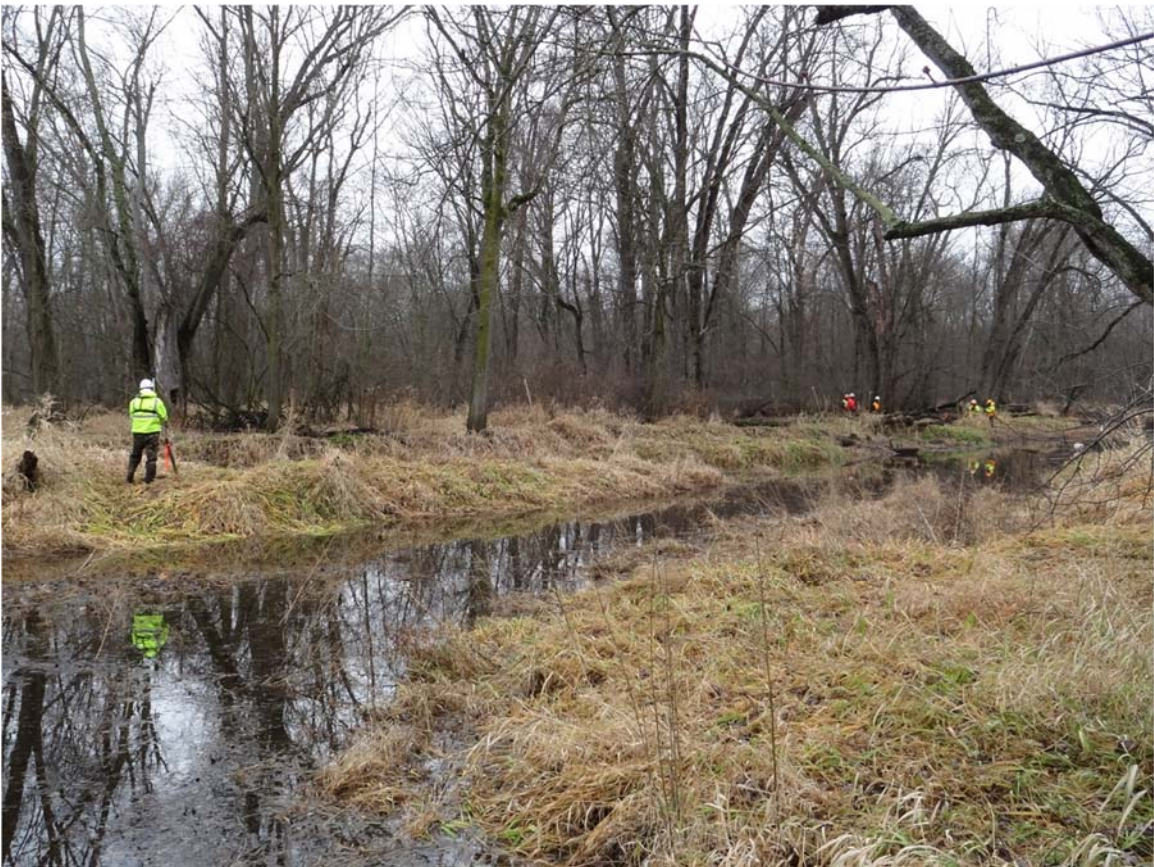
18. MP28.25 Sediment trap observed a bathymetry team.

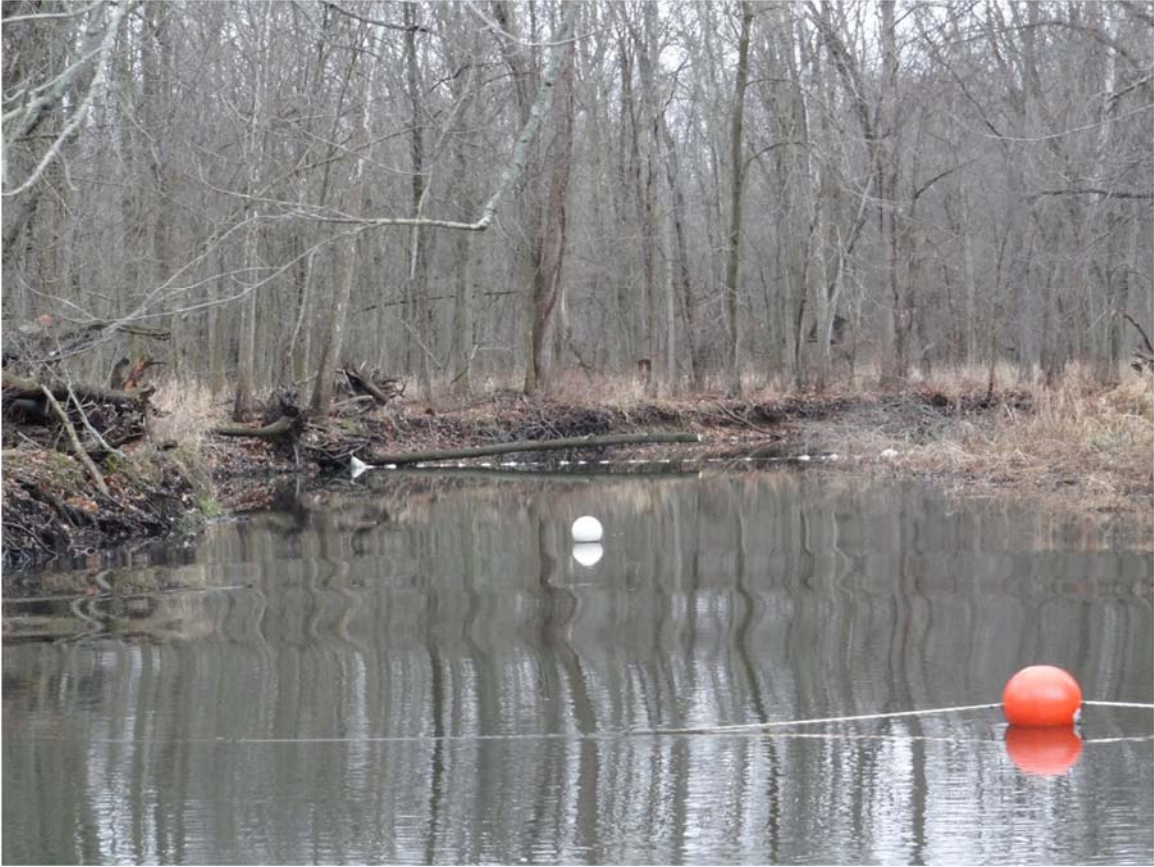
**19. MP28.25 Snare boom remains across the channel to collect sheen and tar globs generated by the bathymetry team.**

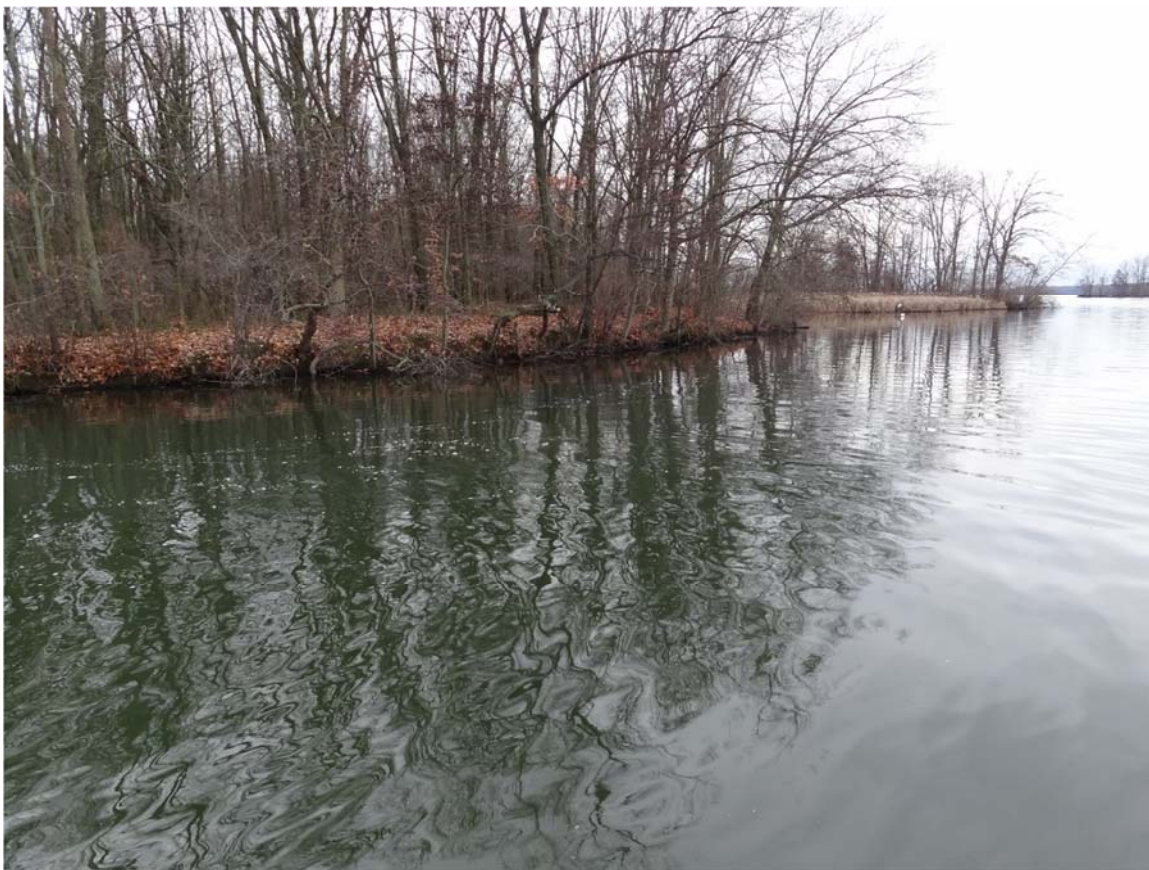
21. MP37.5 LDB Morrow Lake Delta area where sheen was observed.

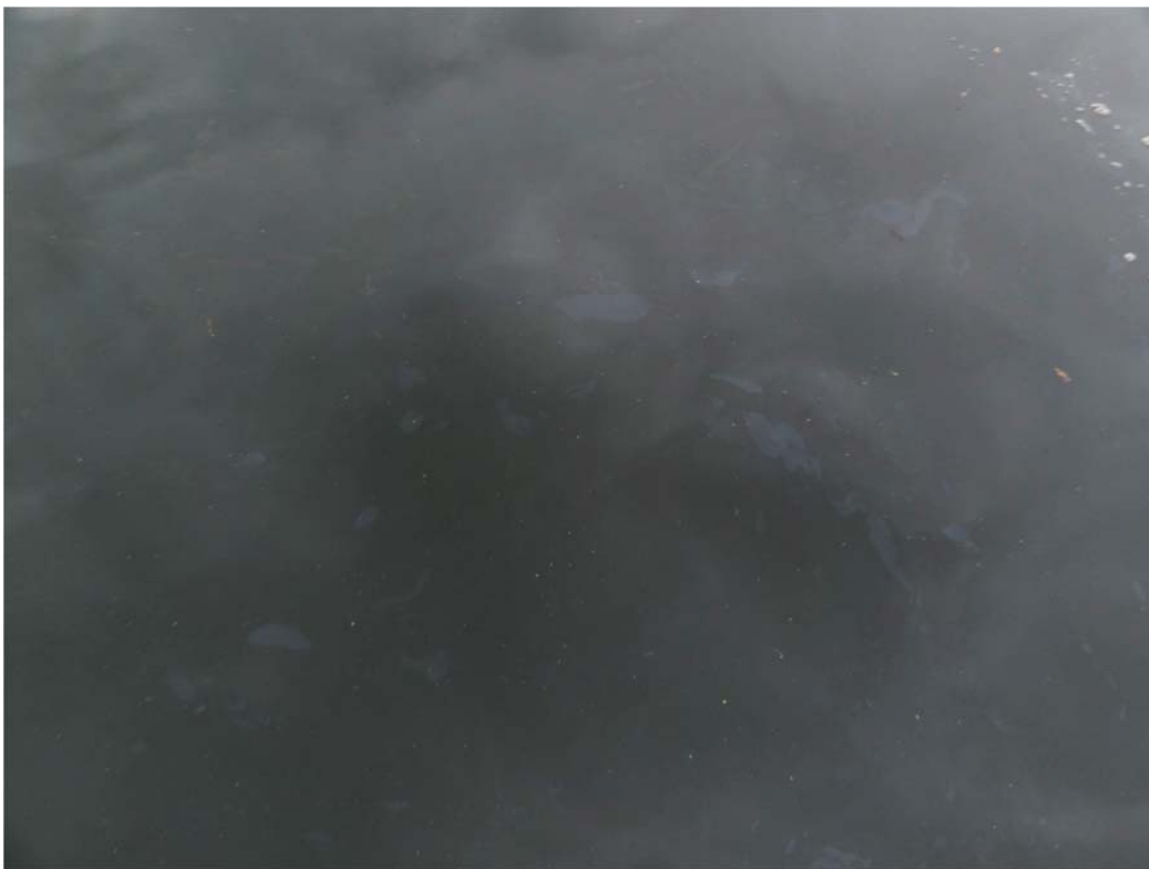
22. MP37.5 LDB Morrow Lake Delta sheen was observed.

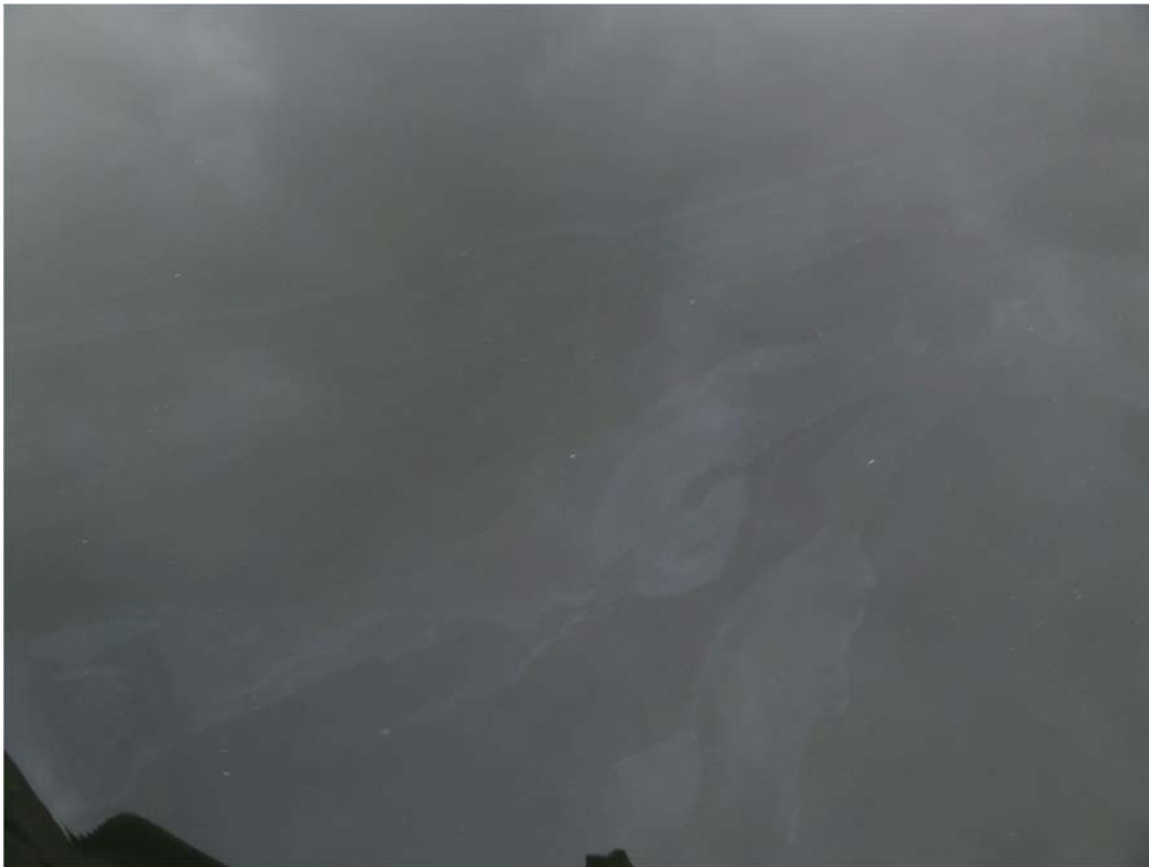
23. MP37.5 LDB Morrow Lake Delta sheen was observed.
