# Situation Photo Log

Tuesday, December 11, 2012

Kalamazoo River / Enbridge Spill

Prepared by:  
Matthew Haak  
START-USEPA  
Situation Unit Leader

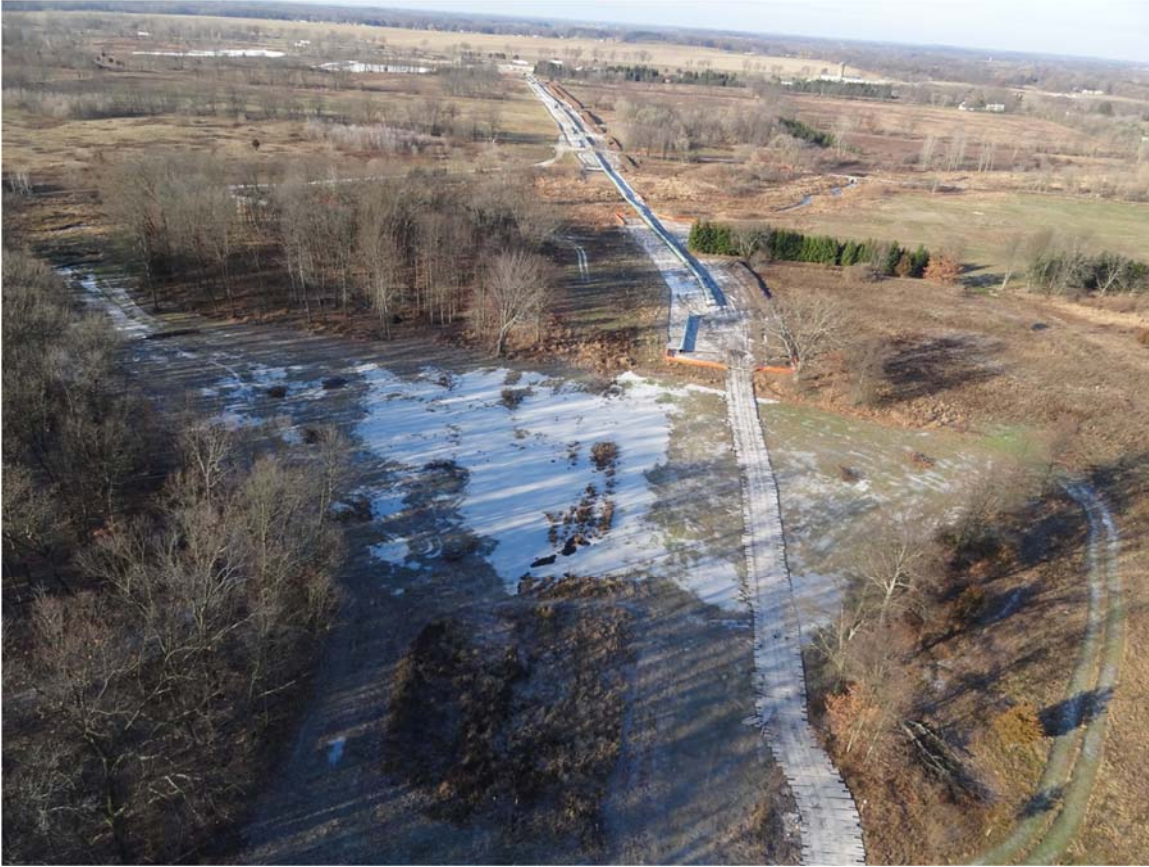
1. Source Area observed the pipeline installation preparation work continuing at the source area and across Talmadge Creek.

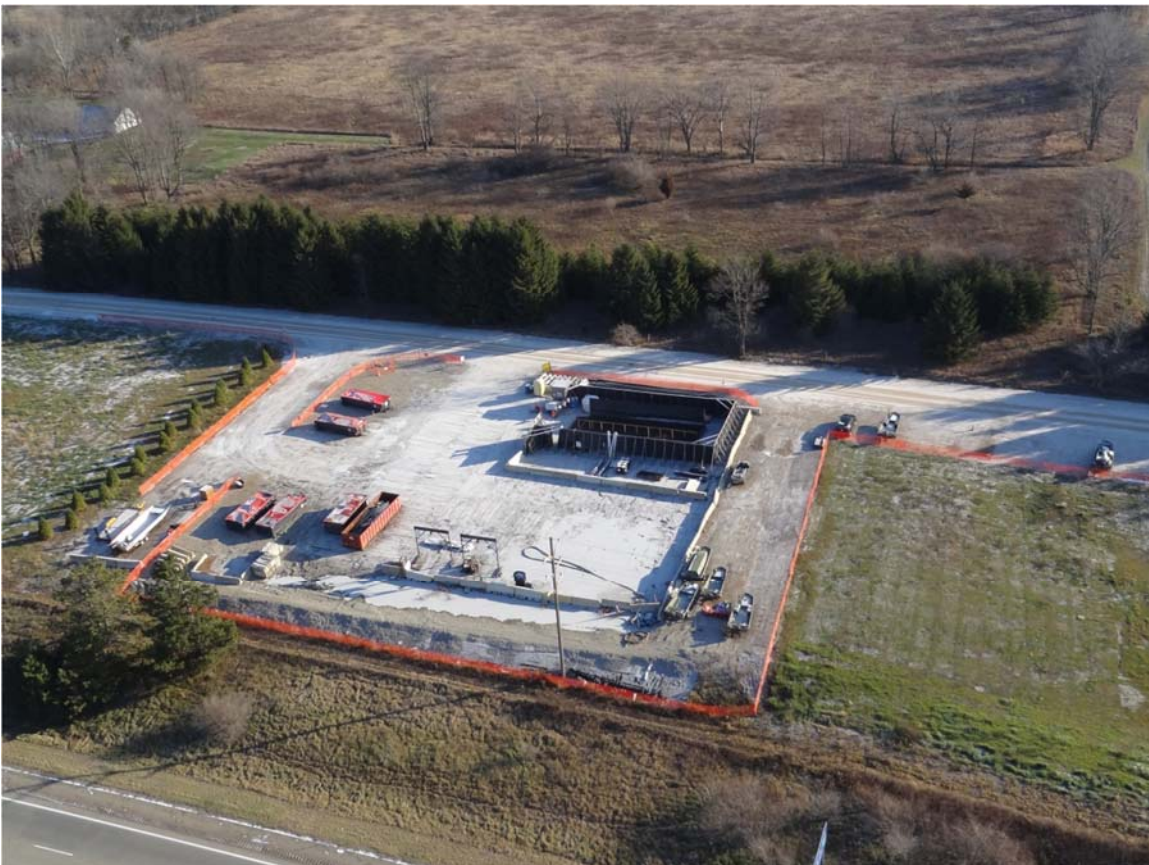
2. Frac Tank City, no decon operations observed.

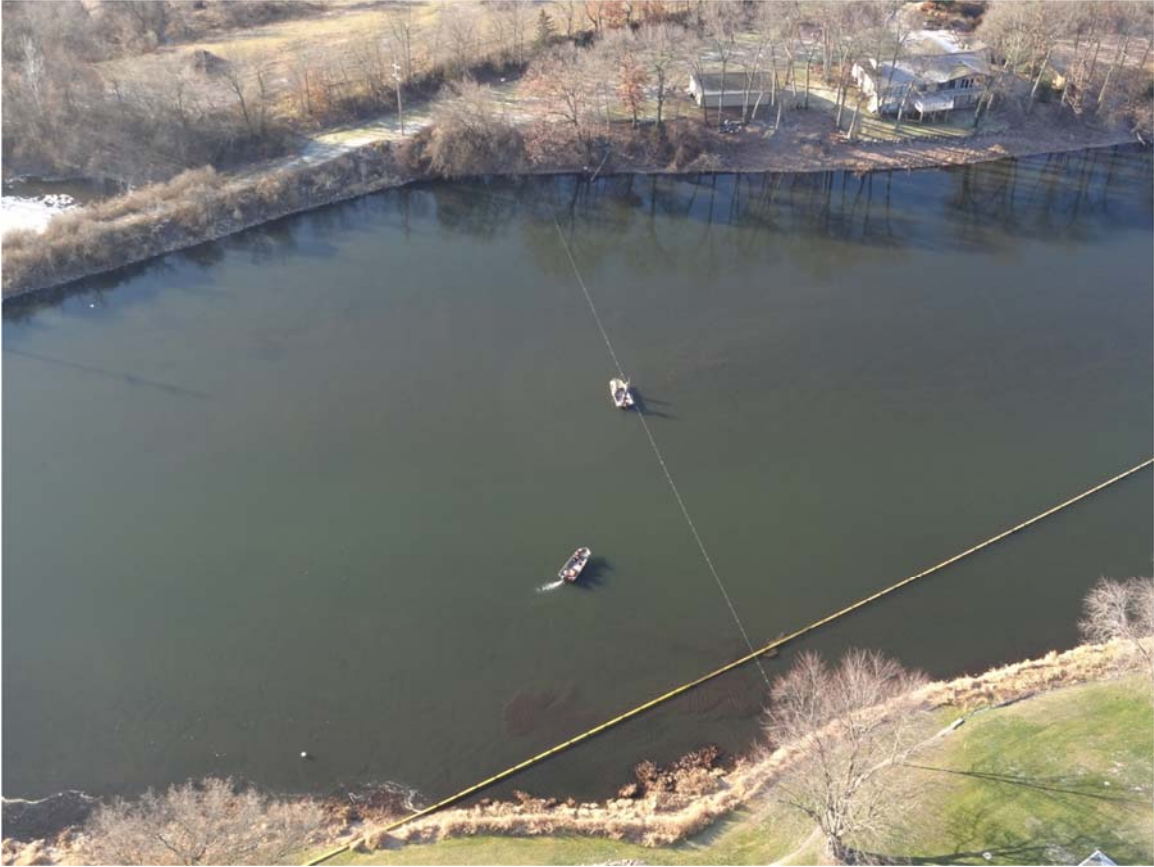
3. Ceresco Dam impoundment observed a bathymetry crew.

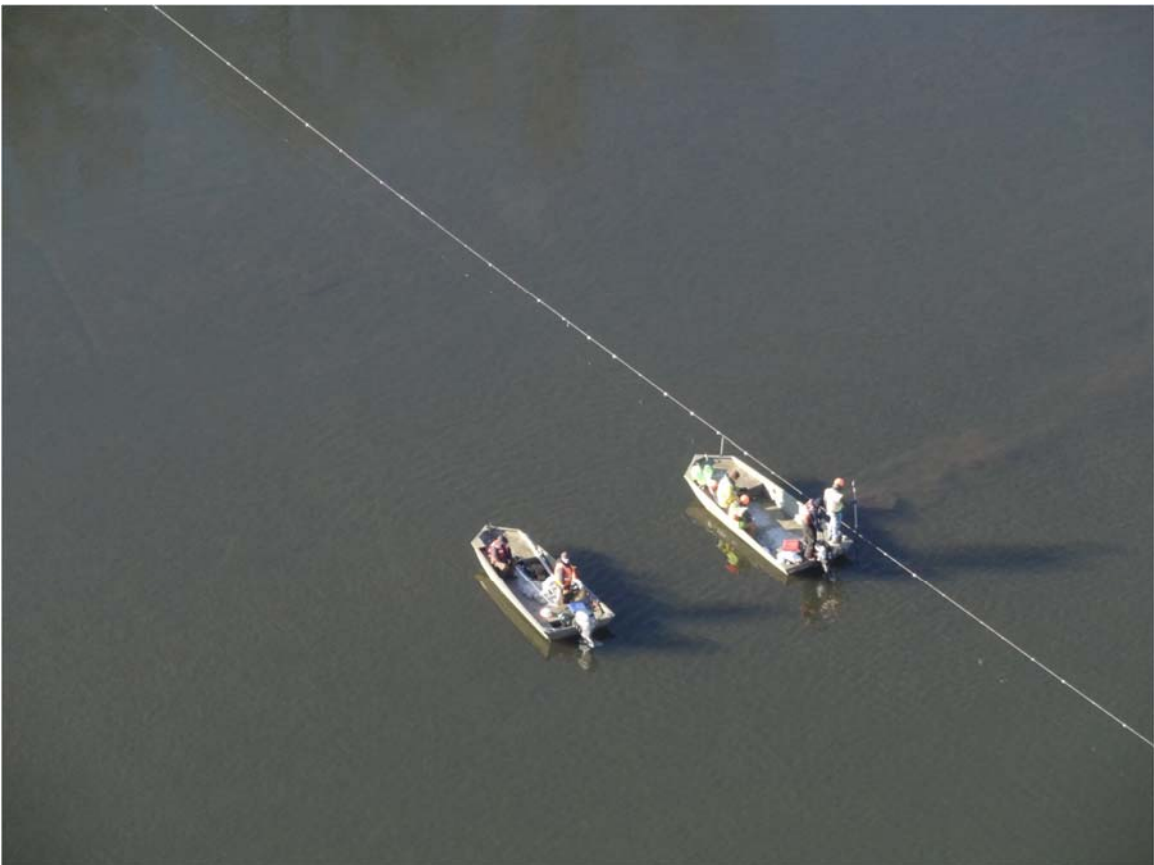
4. Ceresco Dam impoundment observed a bathymetry crew.

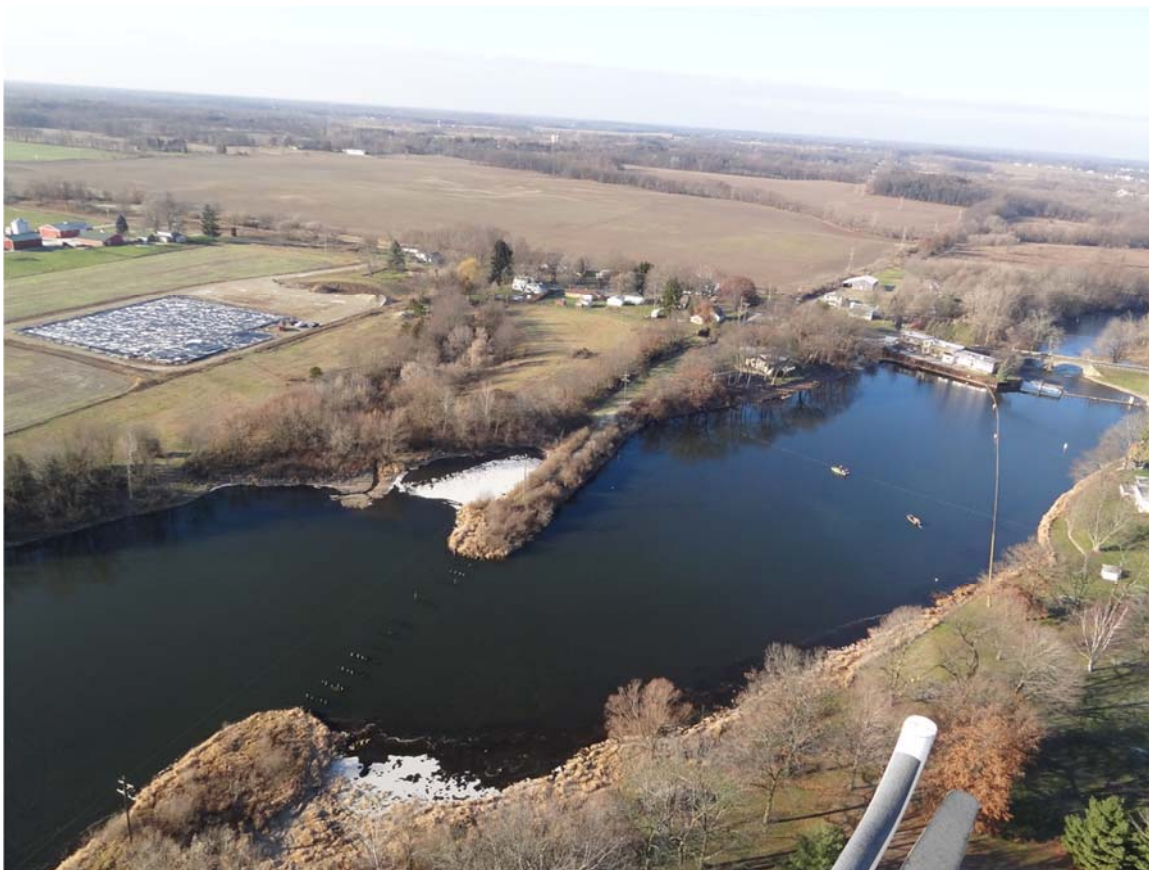
5. MP5.63 LDB & RDB observed ice forming.

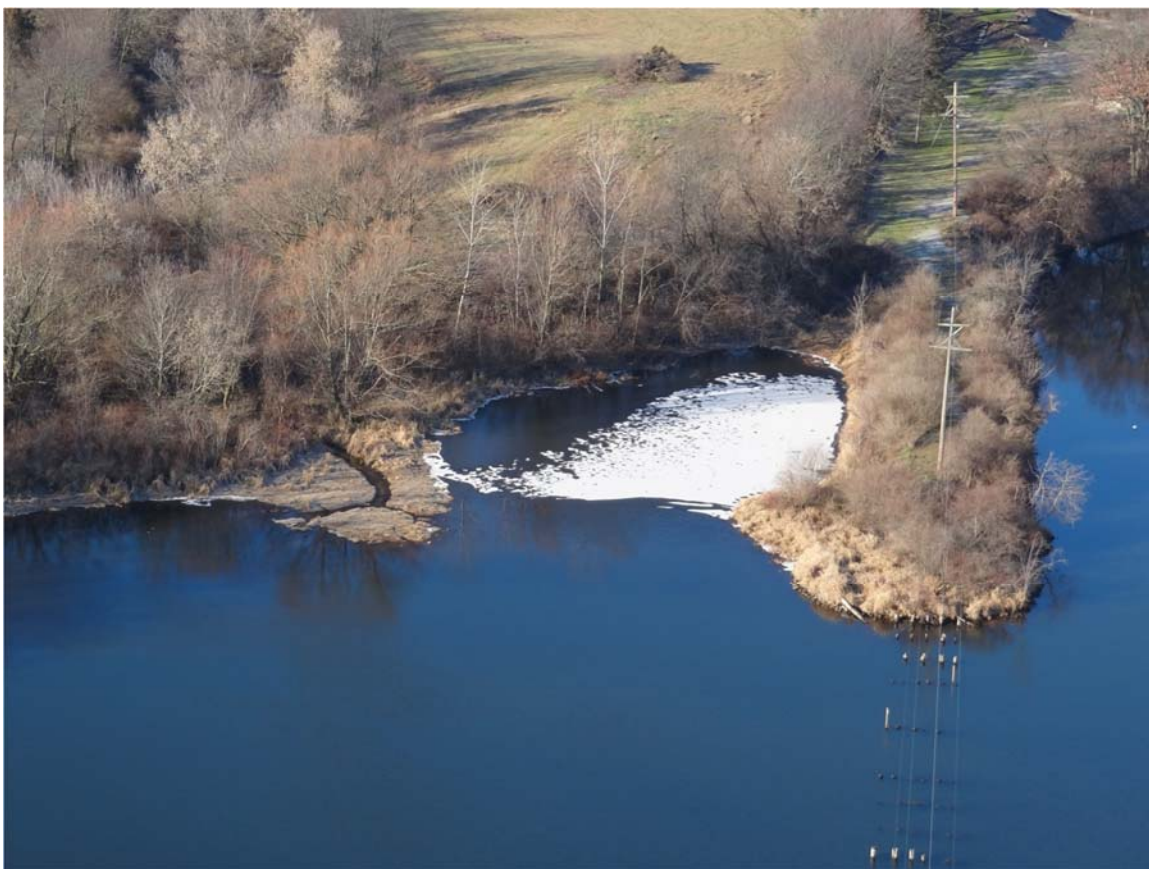
6. MP5.63 LDB observed ice forming.

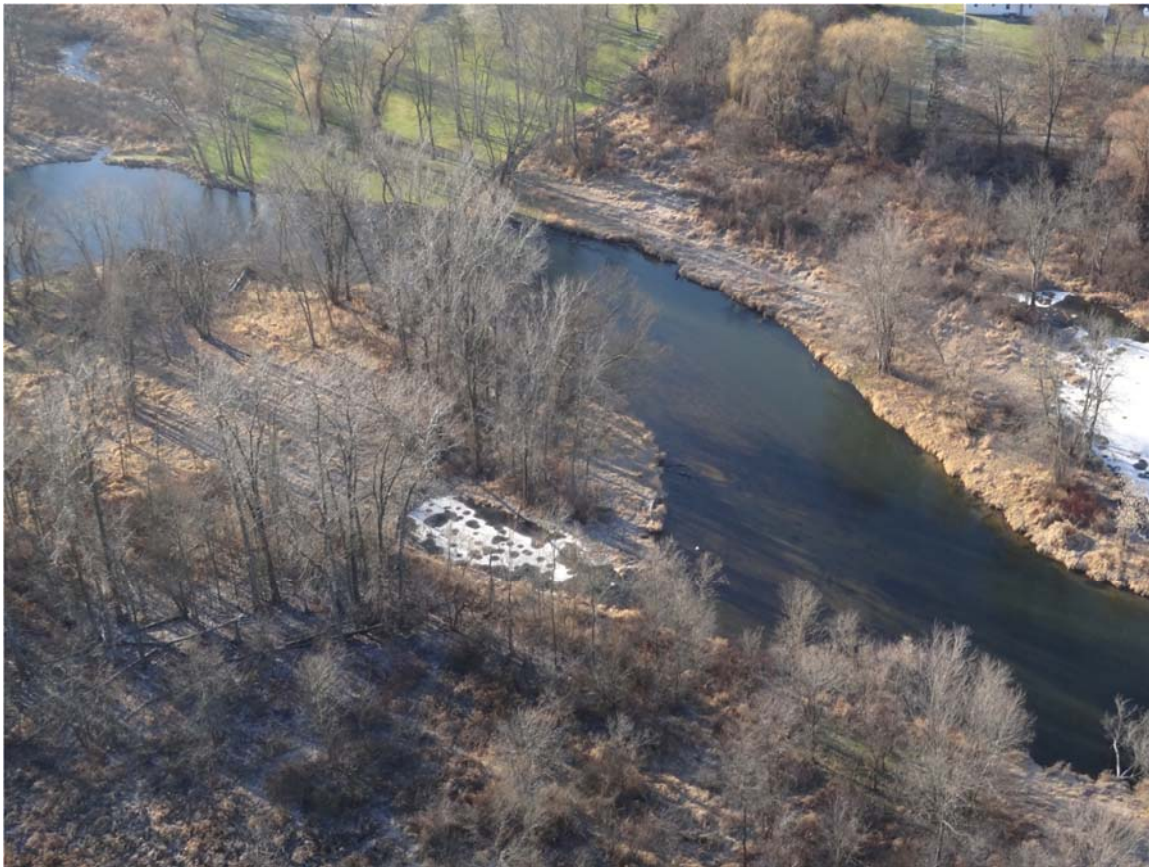
7. MP10.4 RDB Sediment Trap observed ice beginning to form.

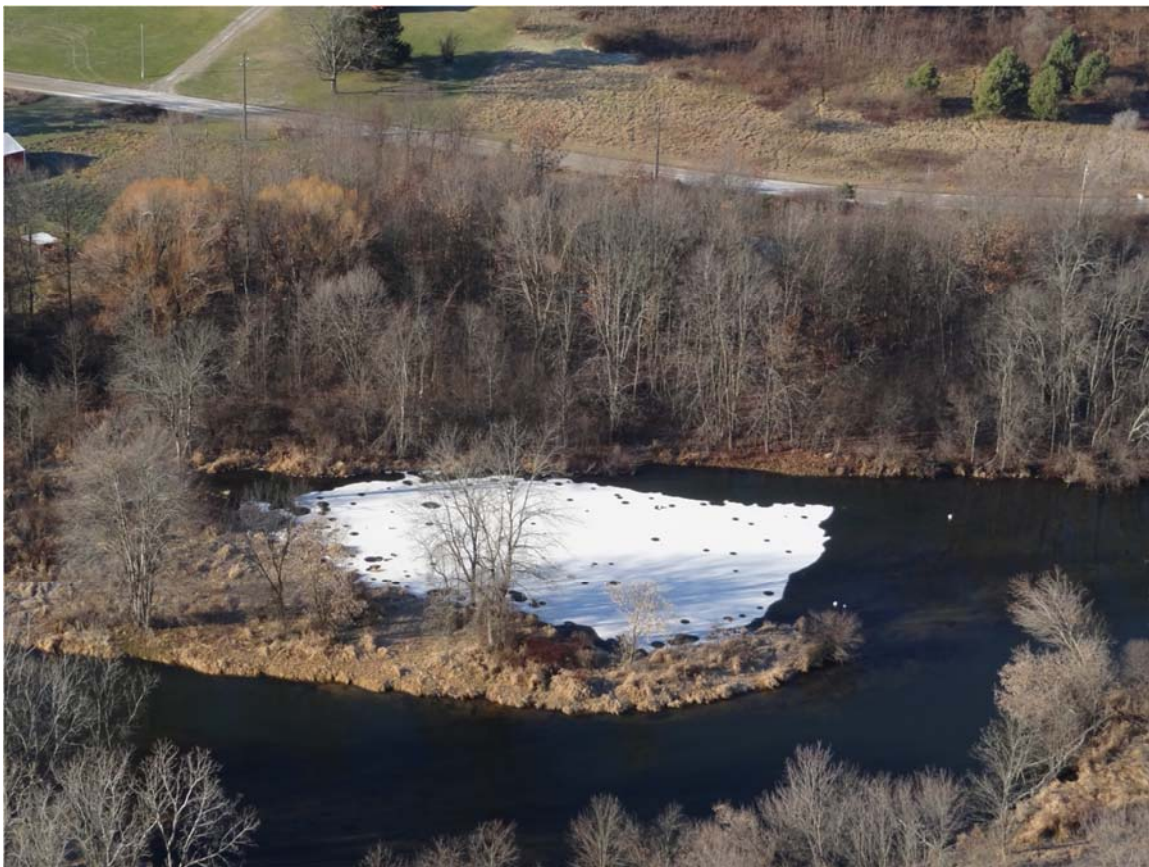
8. MP10.5 LDB Sediment Trap observed ice beginning to form.

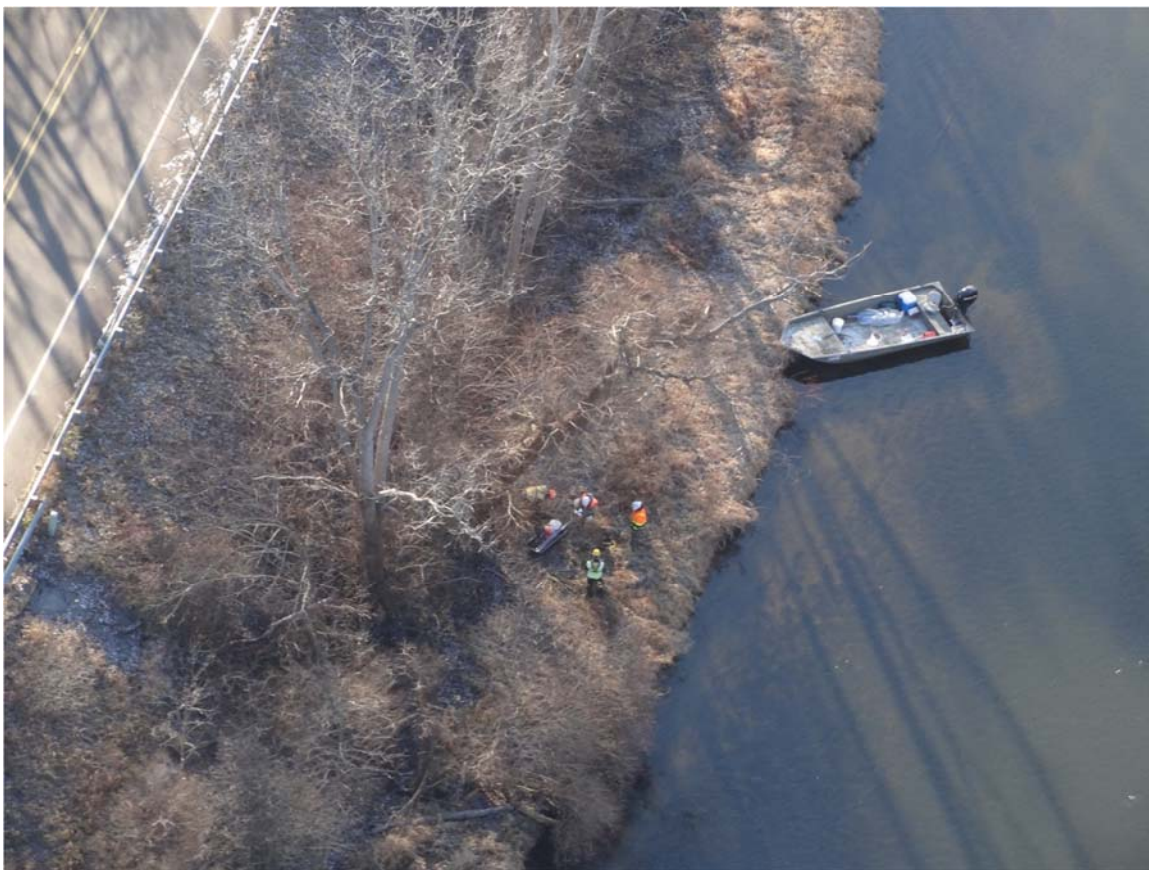
9. MP12.25 LDB observed an RI crew.

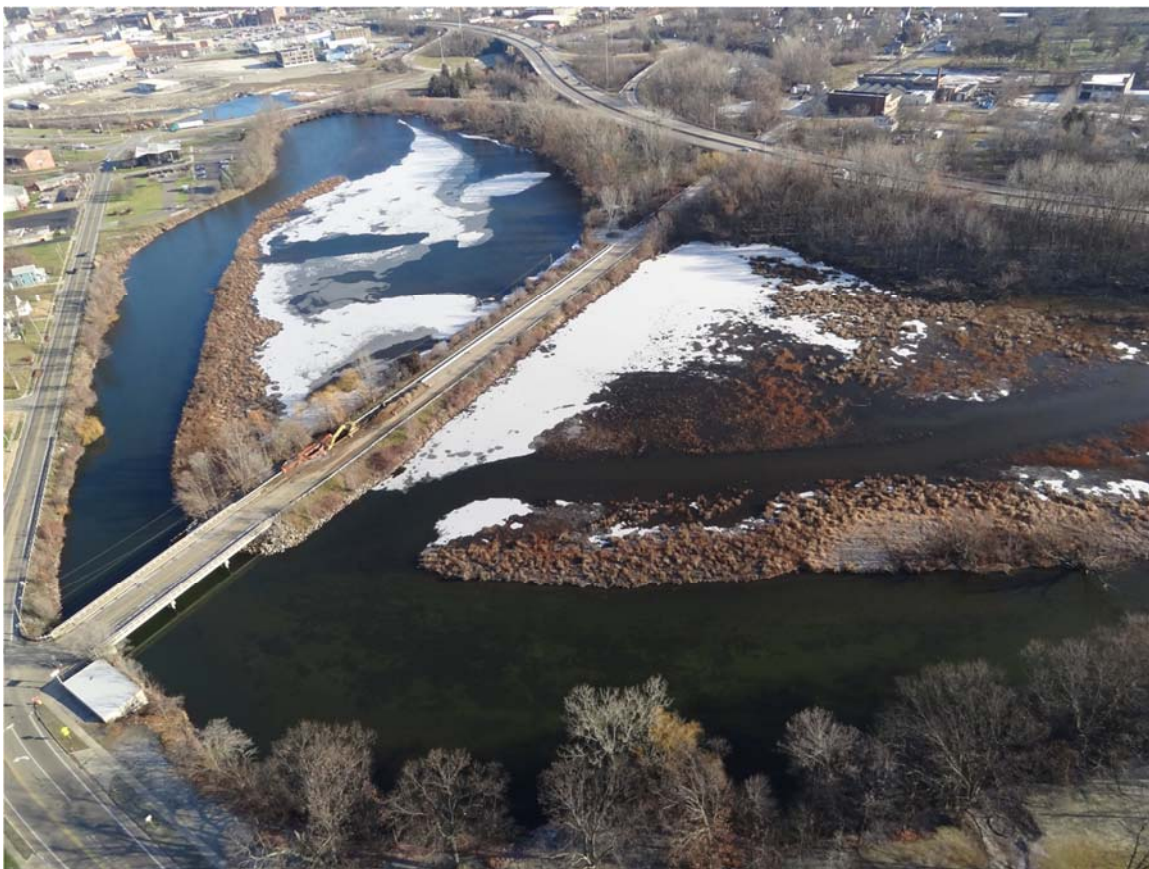
10. North and South Mill Ponds observed ice forming.

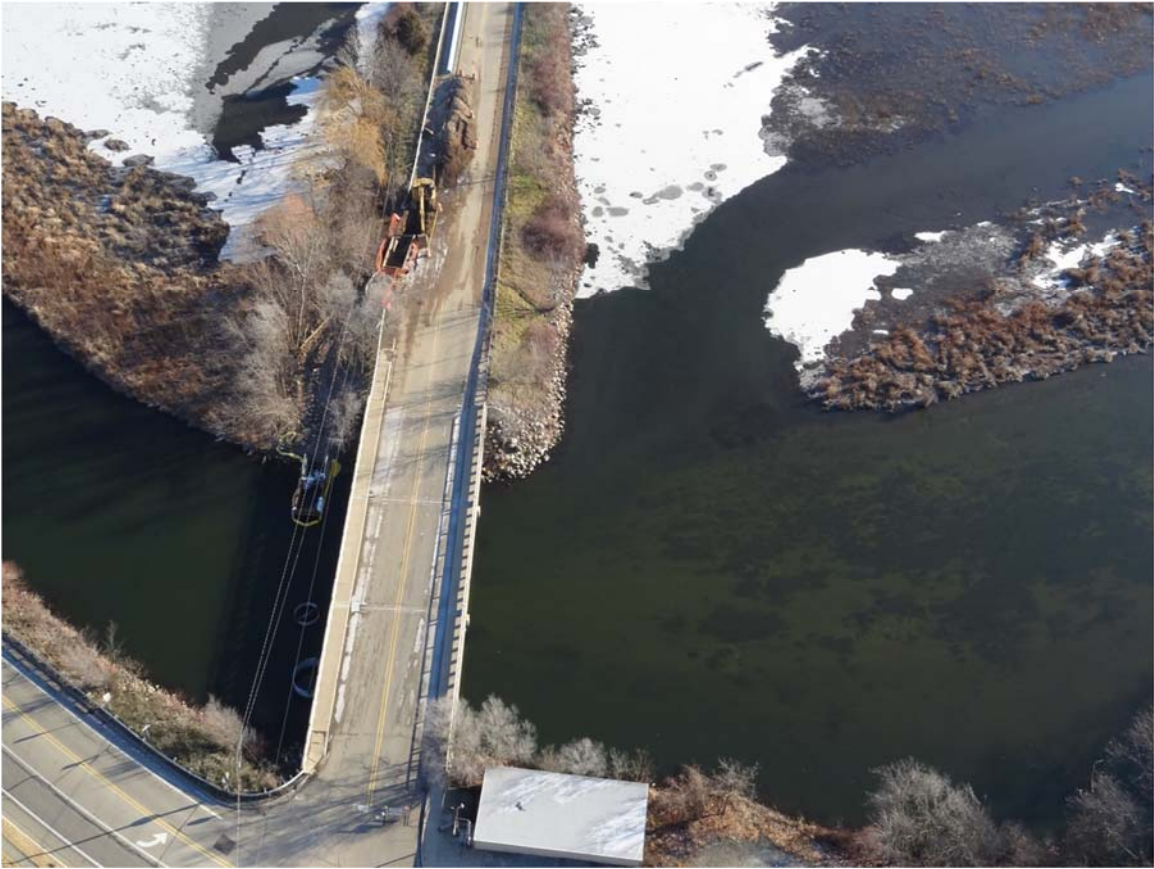
11. MP15.25 South Mill Pond no sheen observed.

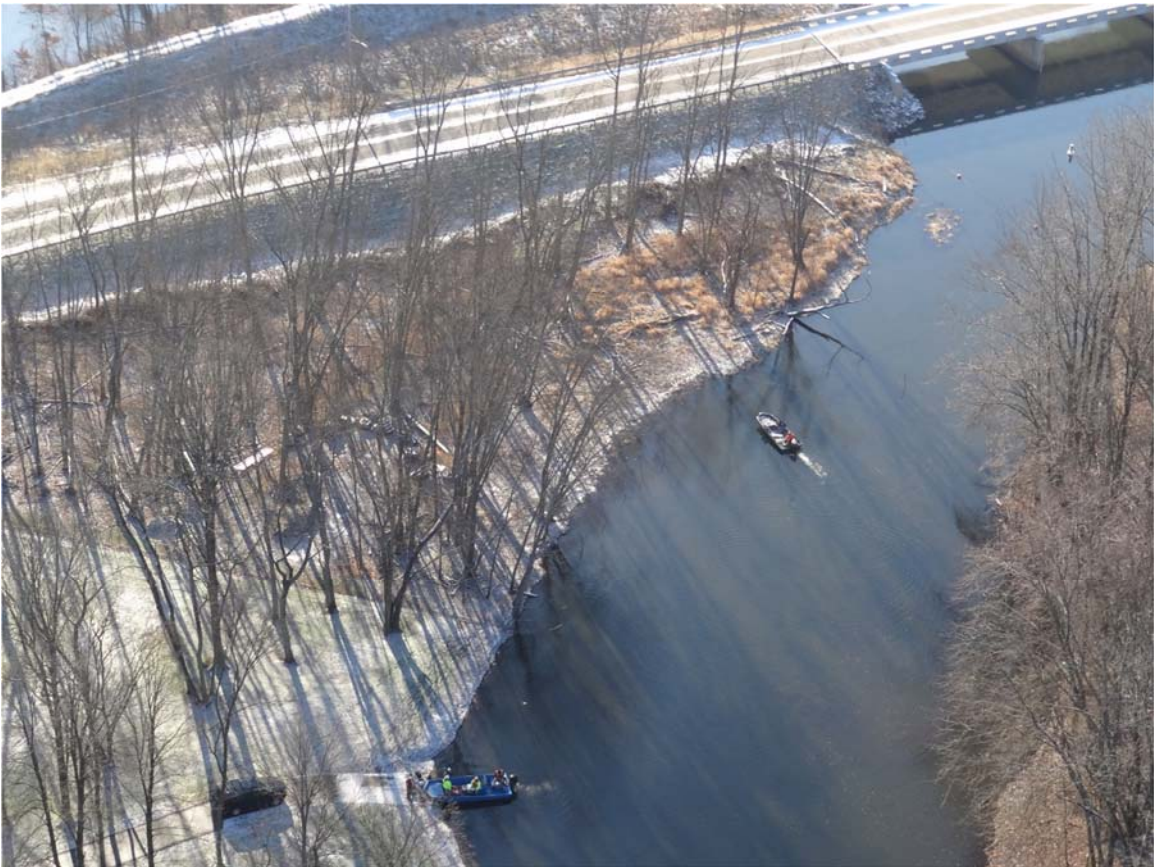
12. MP21.5 Sediment Trap observed a bathymetry crew.

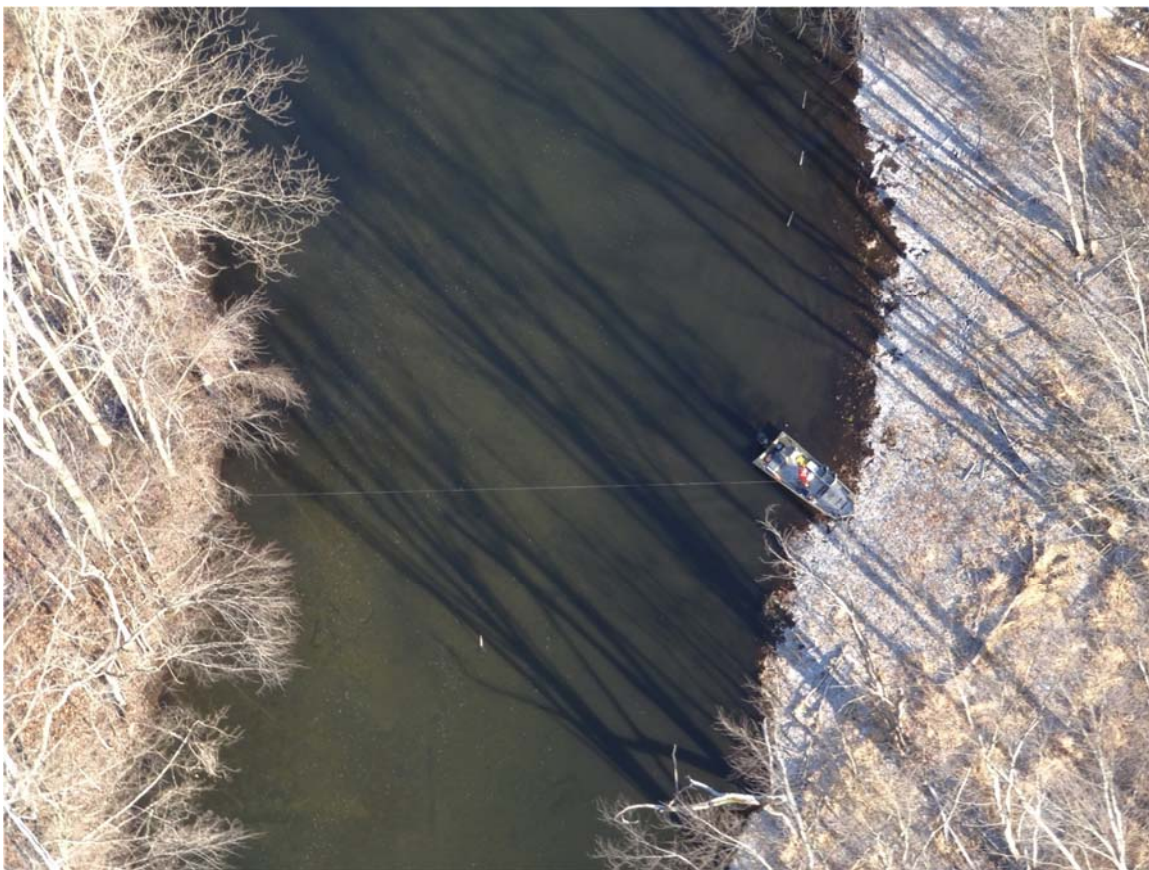
**13. MP21.5 Sediment Trap observed a bathymetry crew.**

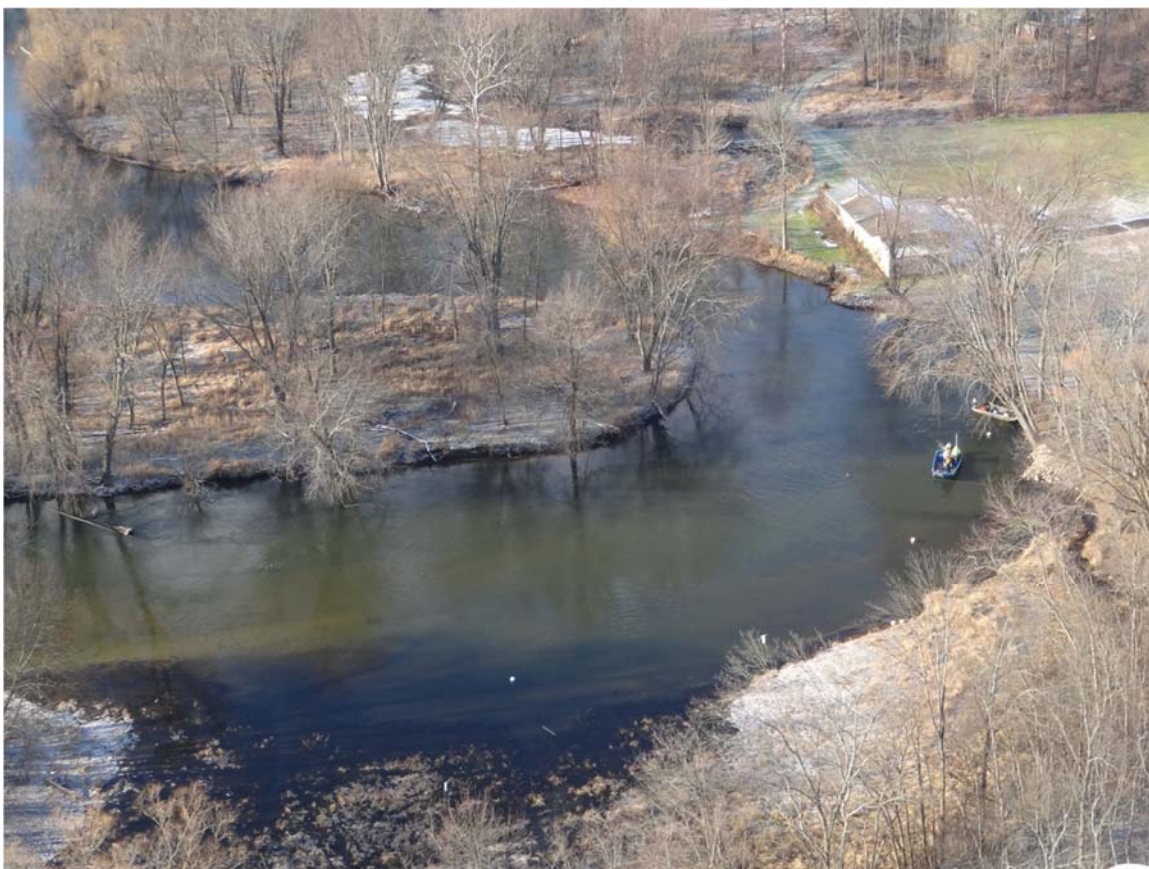
**14. MP26.25 Sediment Trap observed a bathymetry crew.**

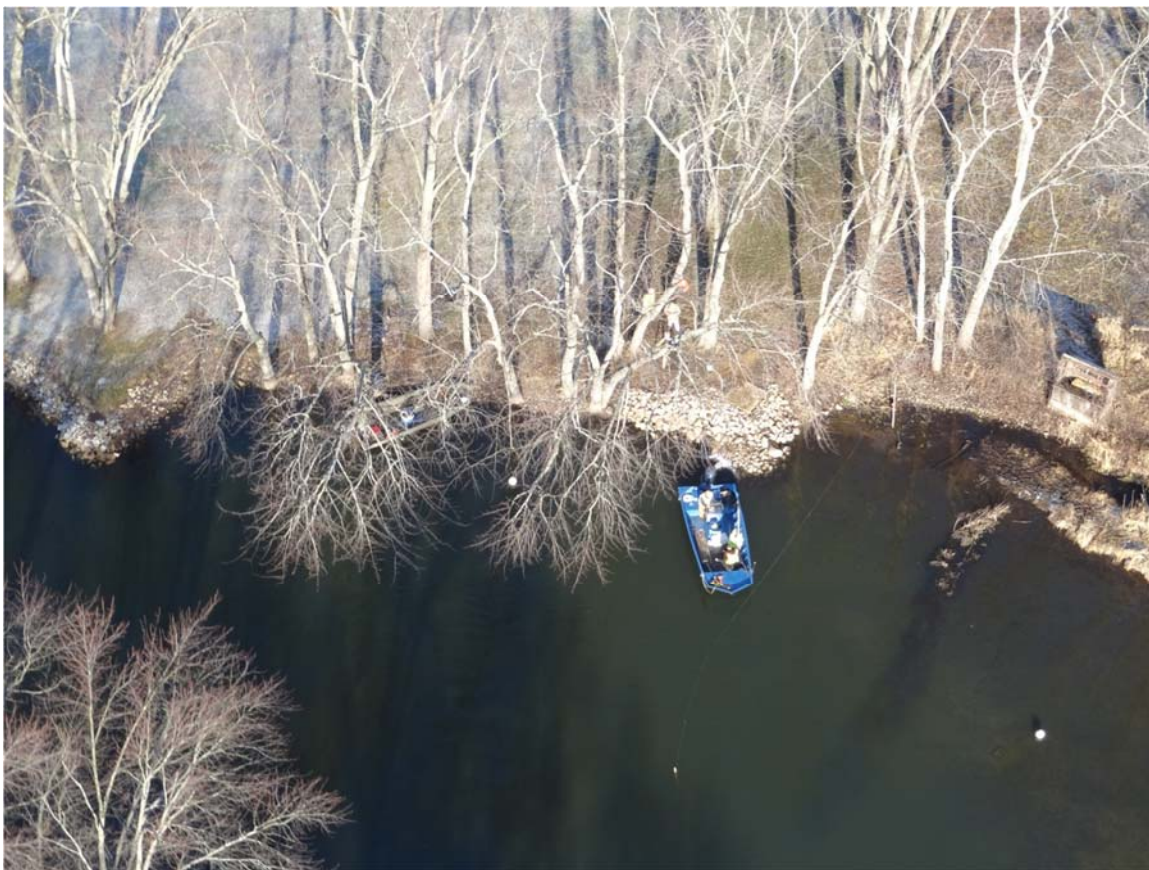
15. MP26.25 Sediment Trap observed a bathymetry crew.

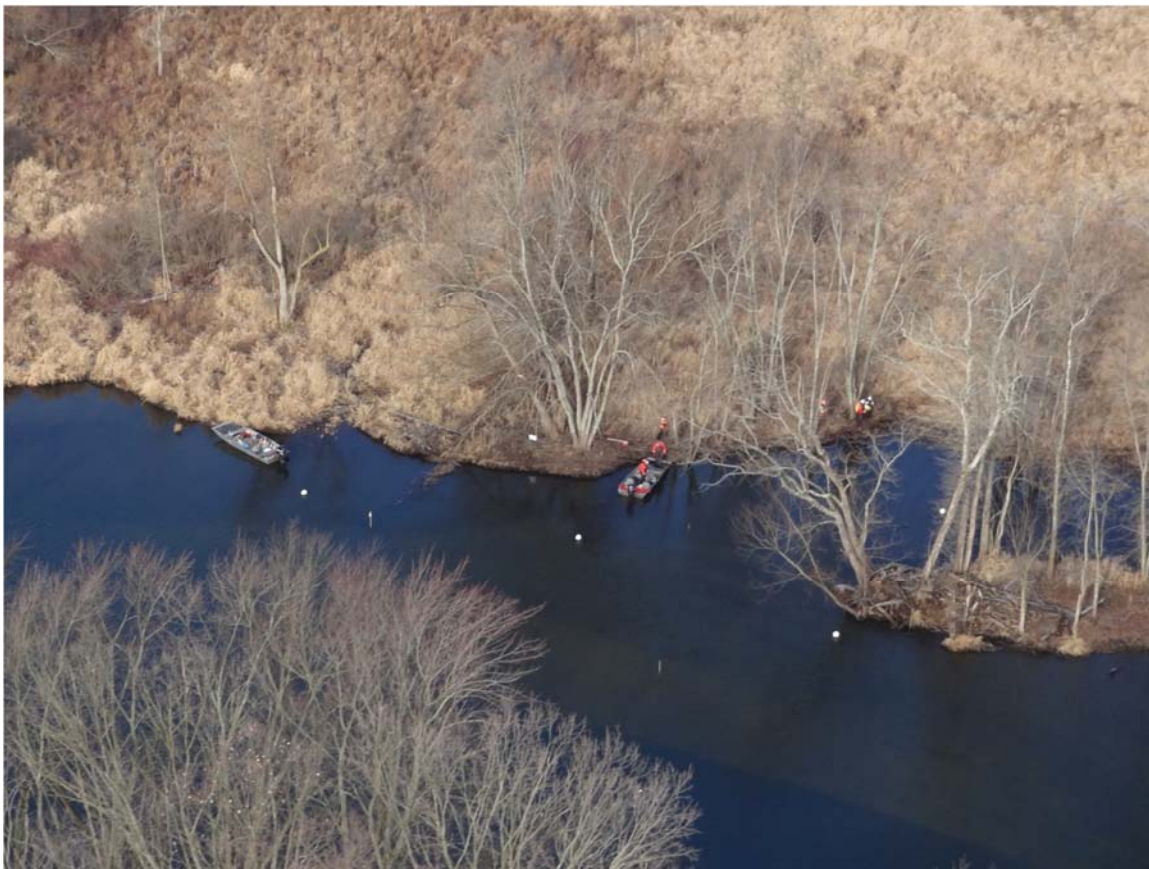
16. MP33.0A Sediment Trap observed a bathymetry crew.

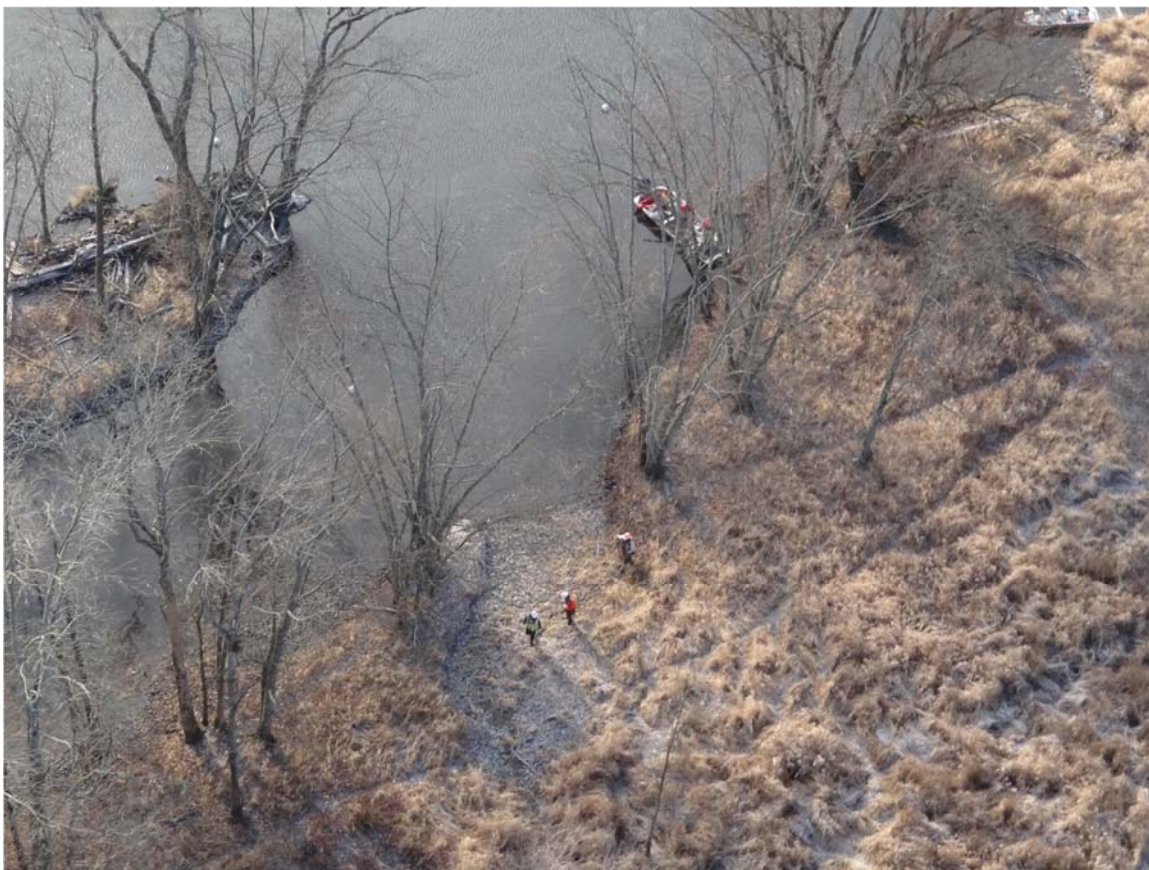
17. MP33.0A Sediment Trap observed a bathymetry crew.

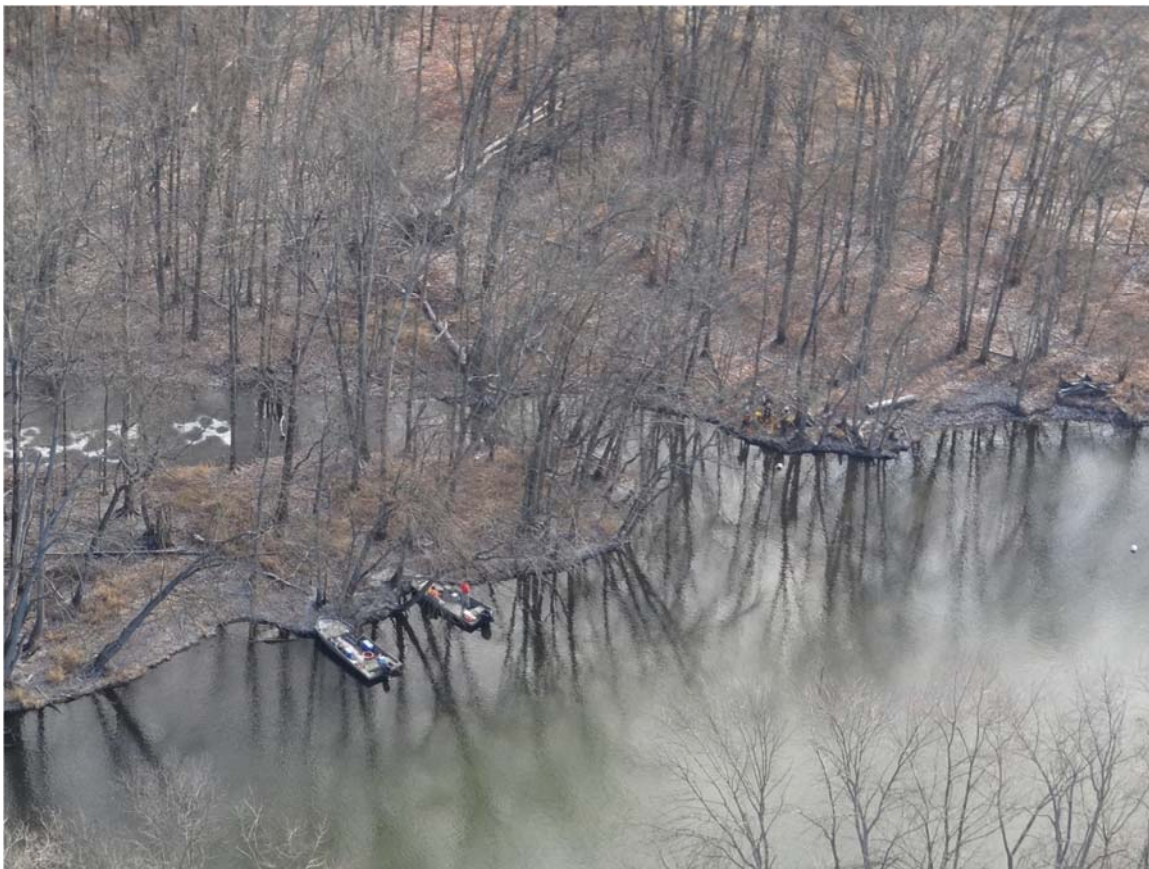
18. MP33.0B Sediment Trap observed a bathymetry crew.

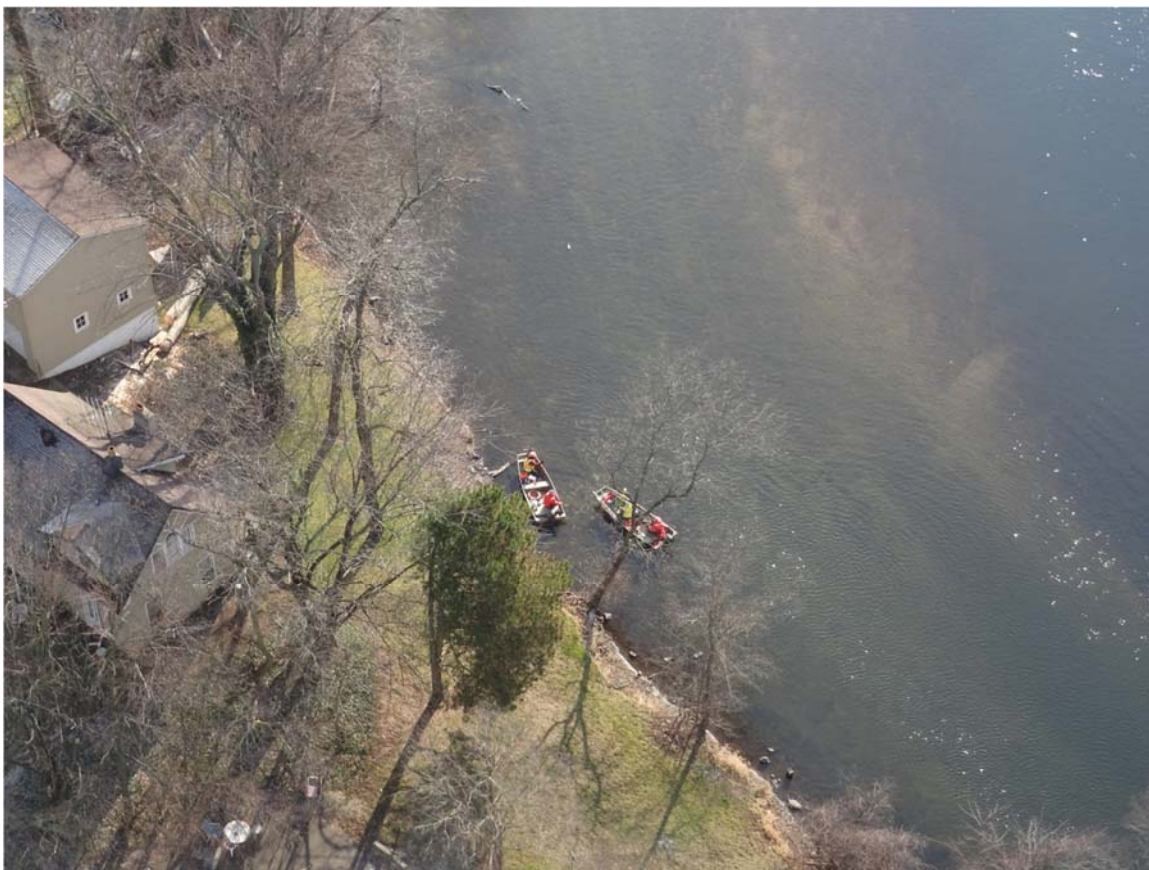
**19. Poling crew observed below Morrow Lake Dam.**

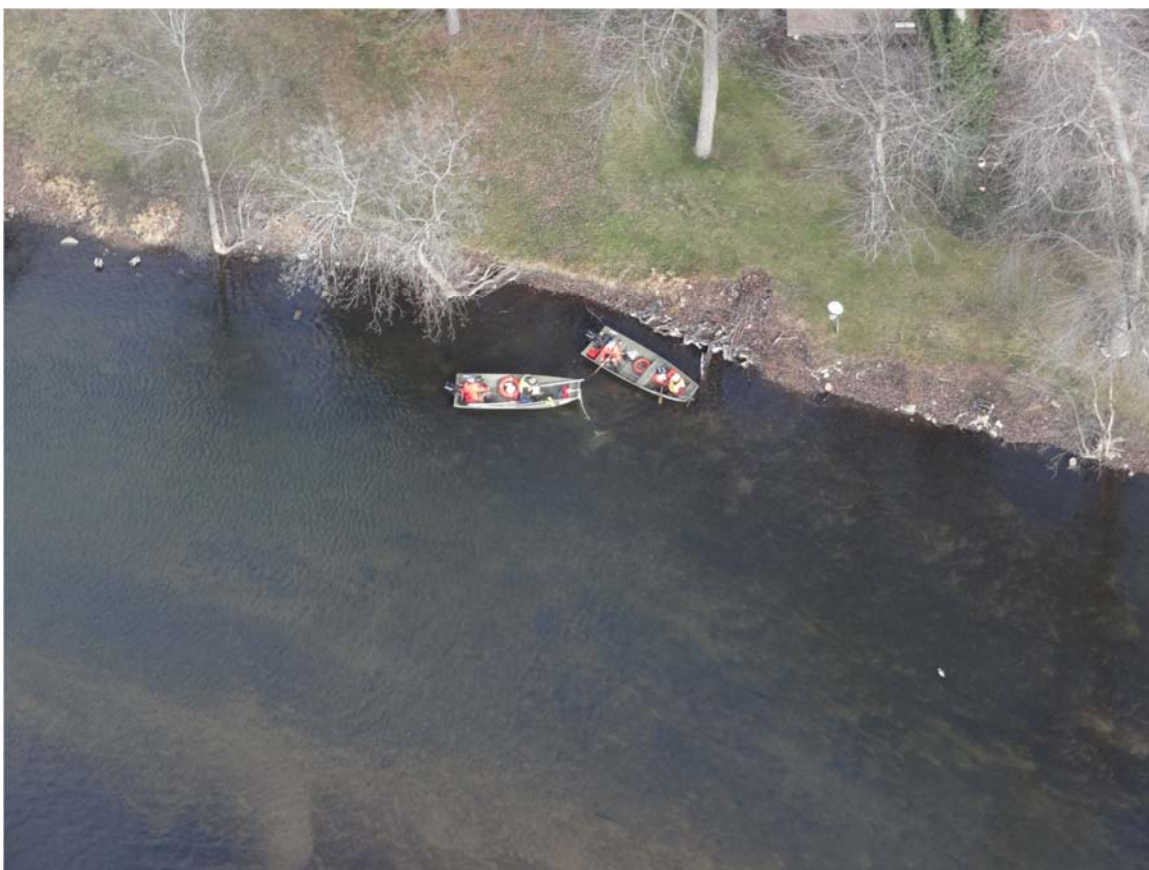
**20. Poling crew observed below Morrow Lake Dam.**
