# Situation Photo Log

Wednesday, December 12, 2012

Kalamazoo River / Enbridge Spill

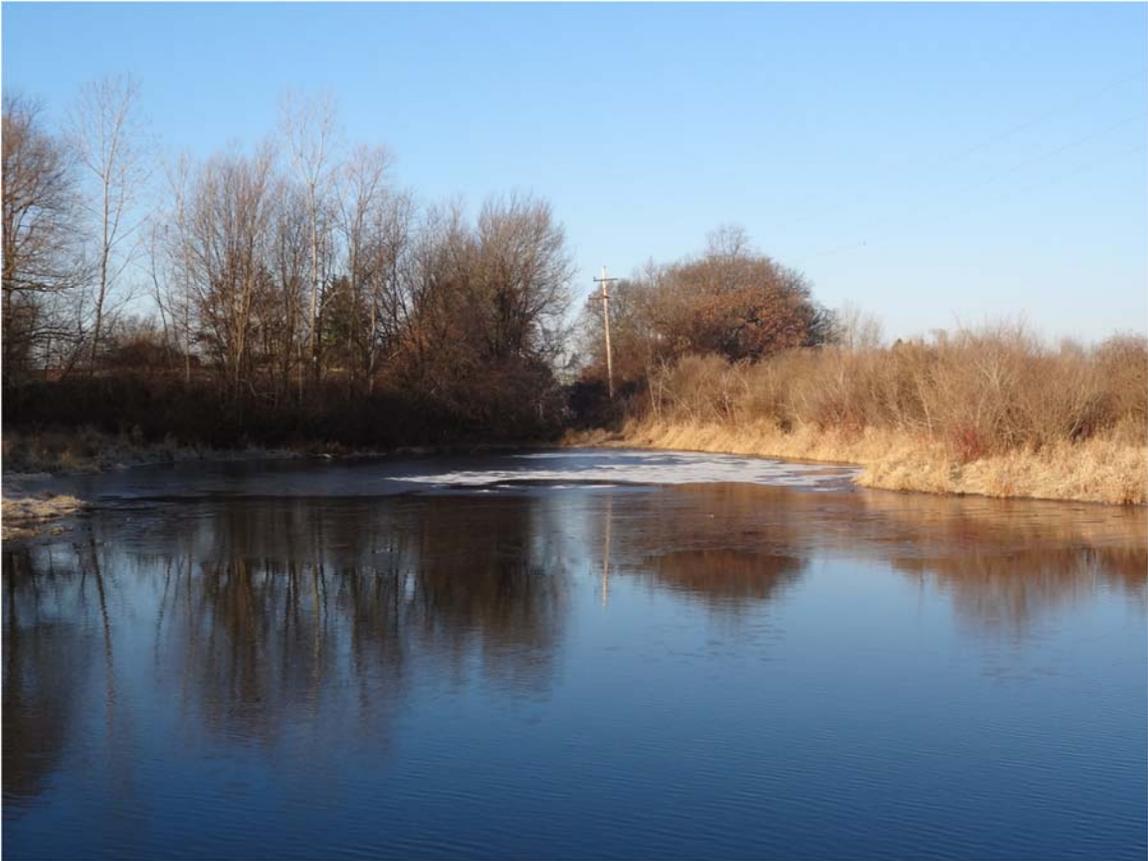
1. MP5.63 LDB ice observed forming above the railroad trestles.

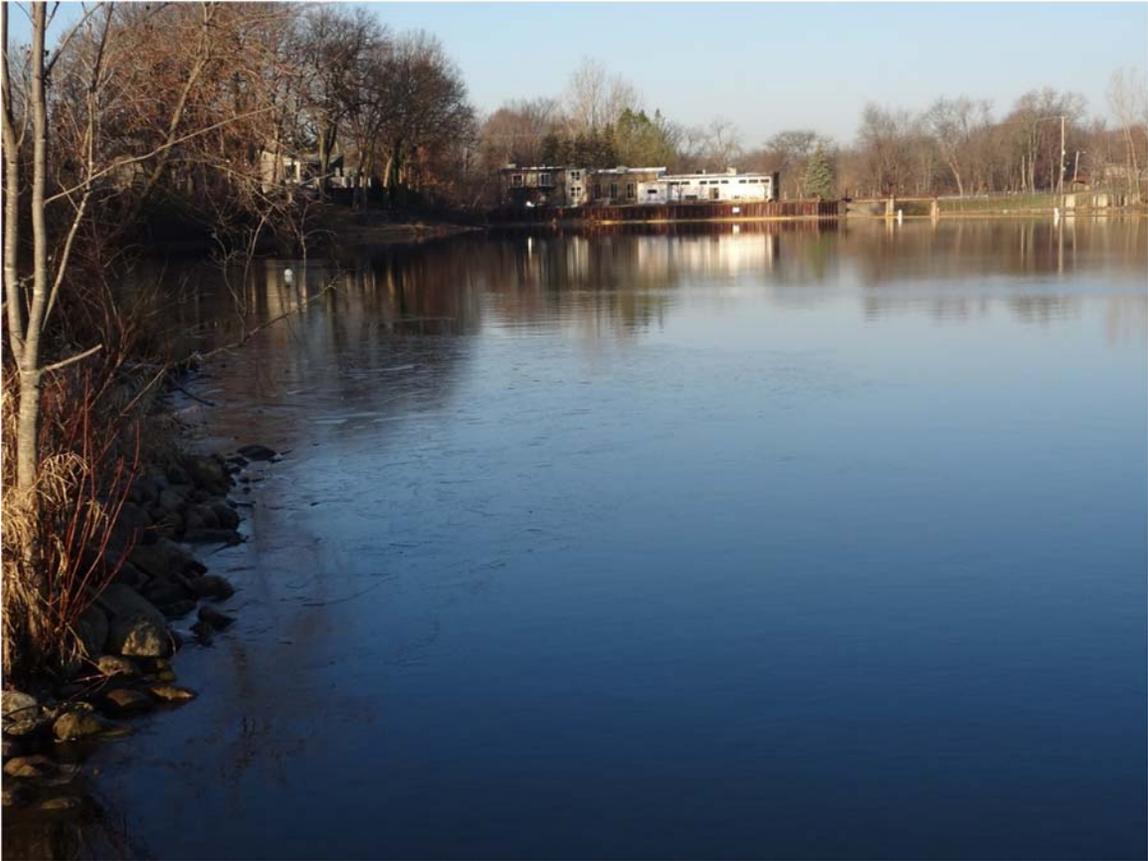
2. MP5.63 LDB ice observed forming below the railroad trestles.

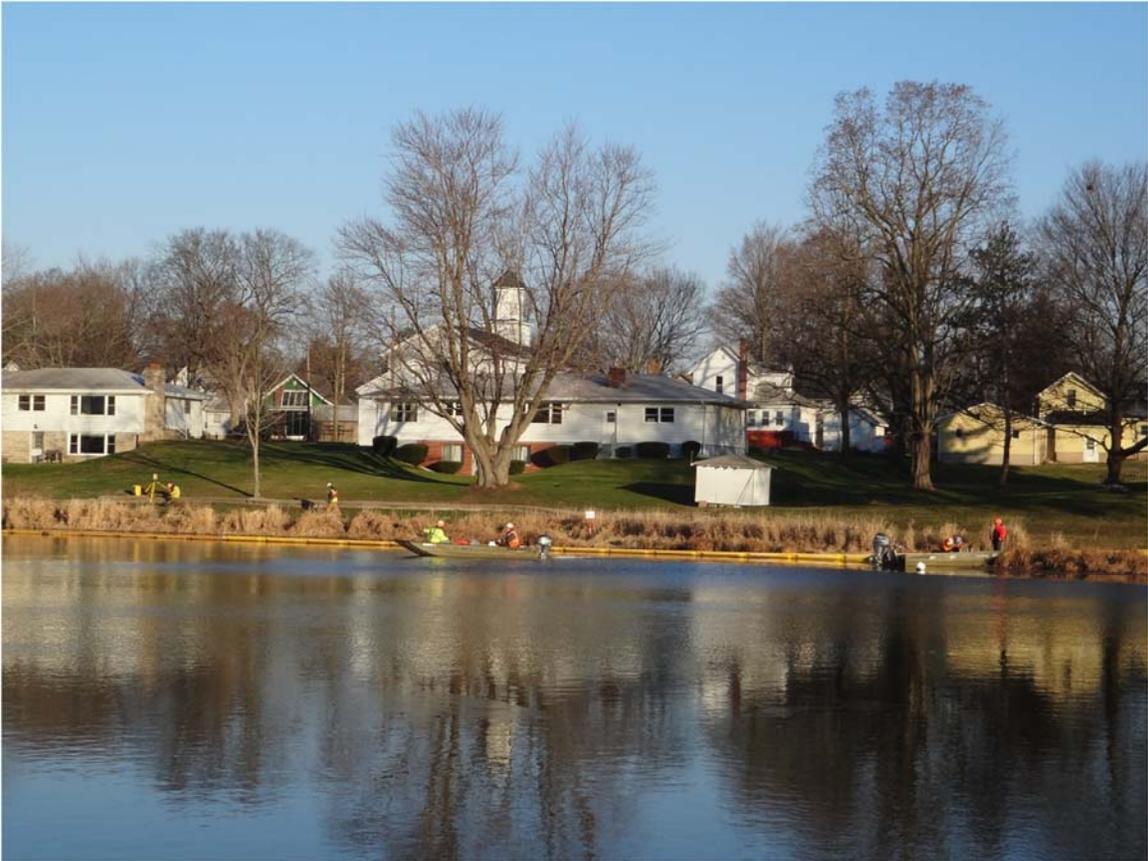
3. Ceresco Dam impoundment observed a bathymetry team.

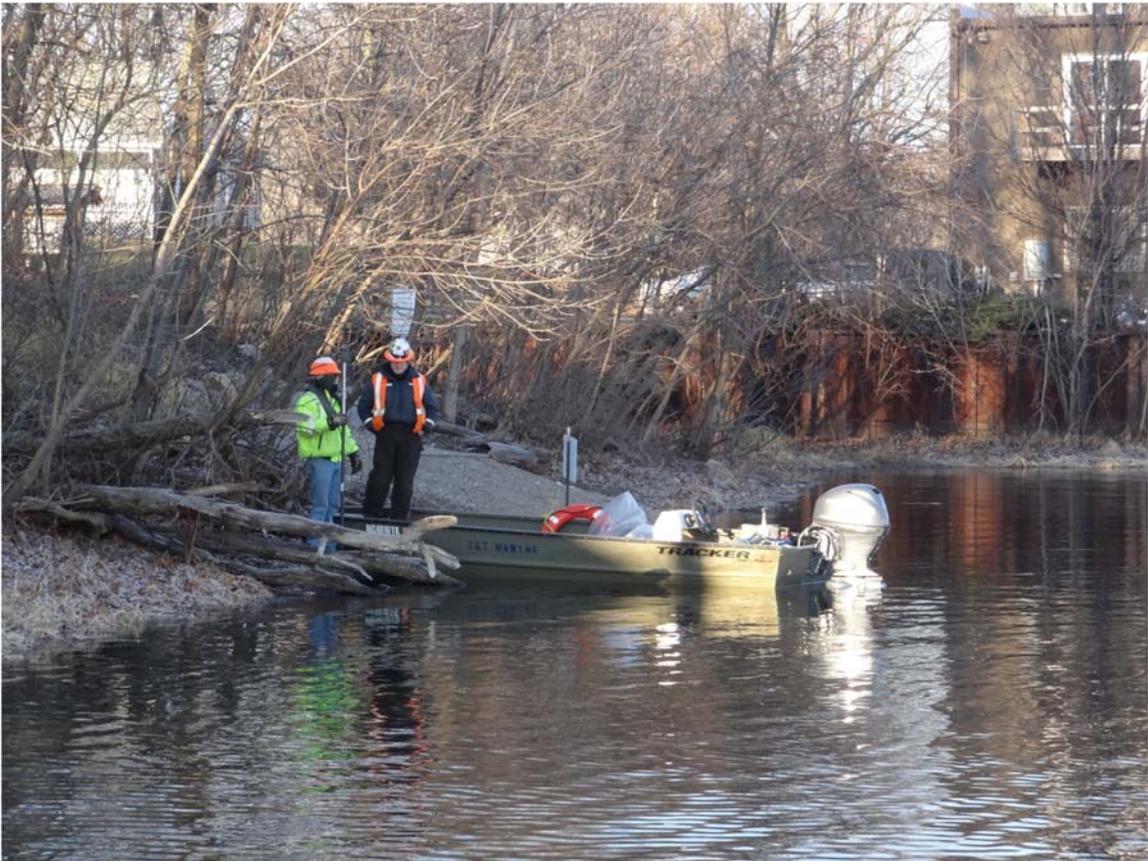
4. Ceresco Dam impoundment observed a bathymetry team.

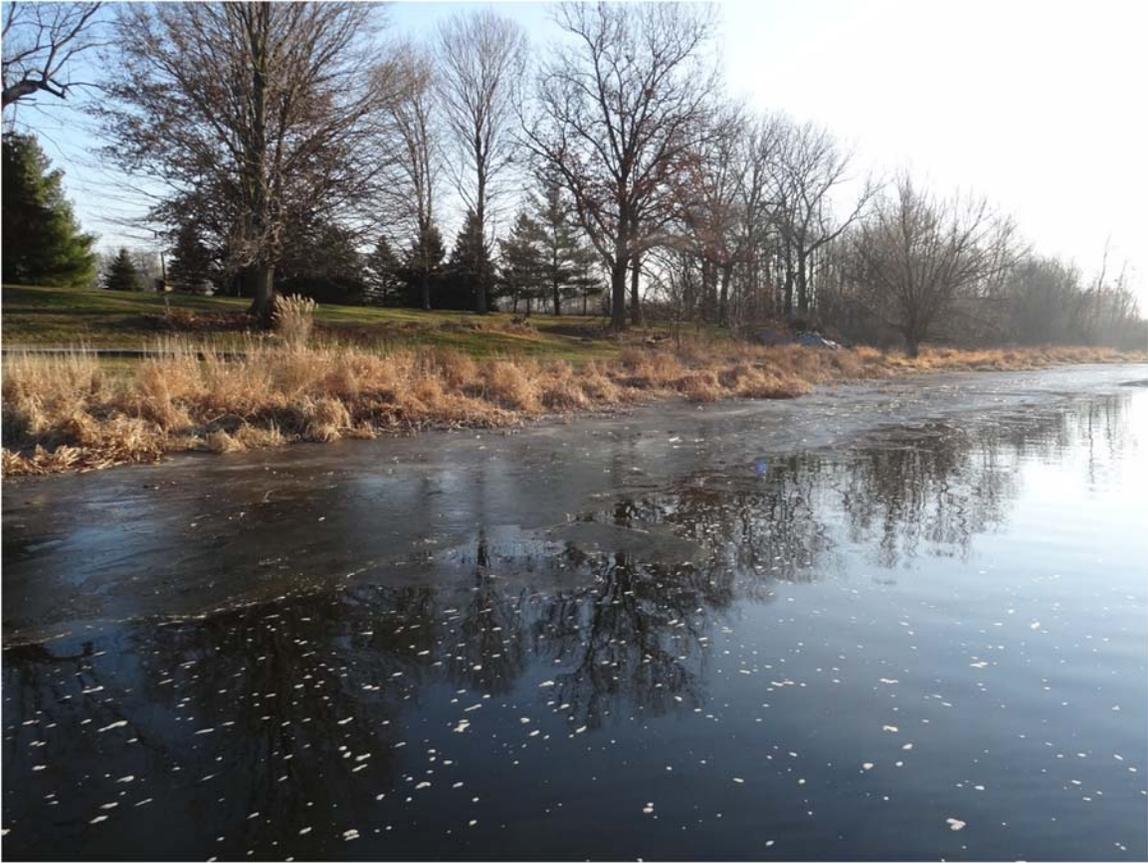
5. MP5.63 – MP5.70 RDB observed ice forming.

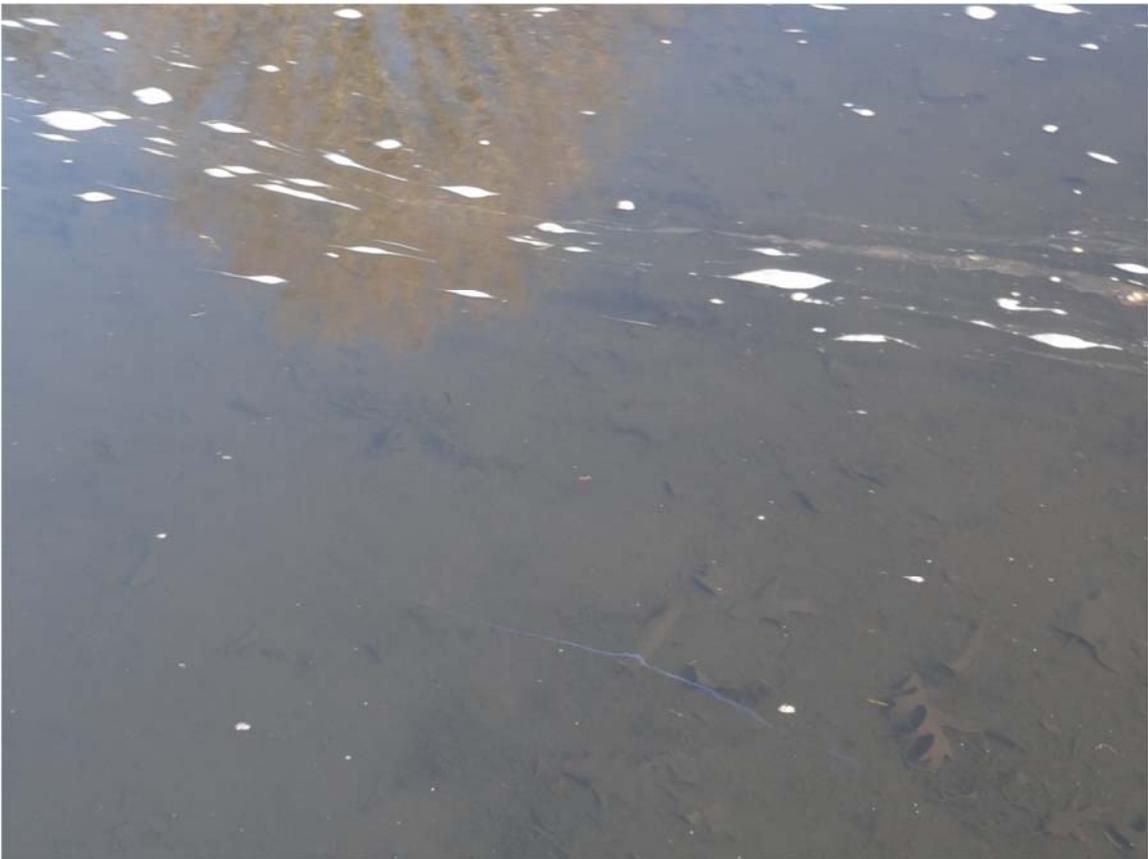
6. MP5.63 RDB sheen observed.

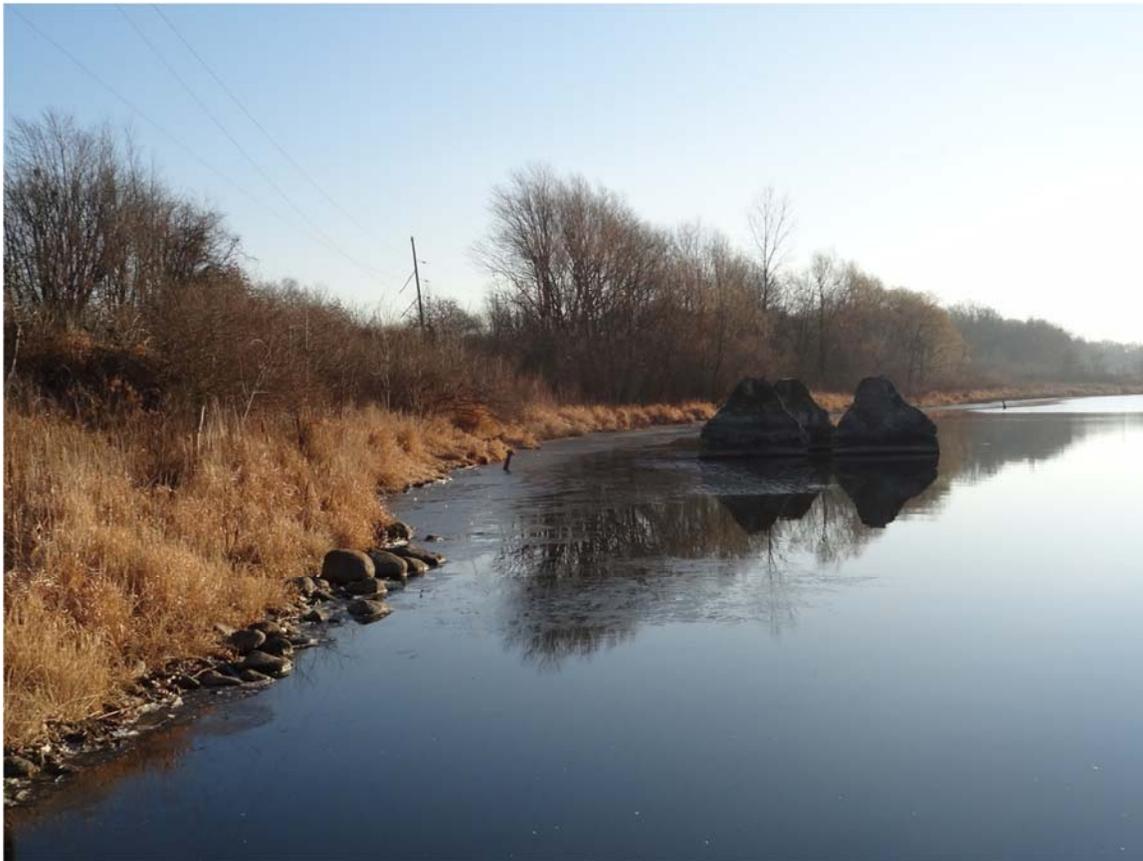
7. MP5.55 RDB observed ice forming above the railroad trestles.

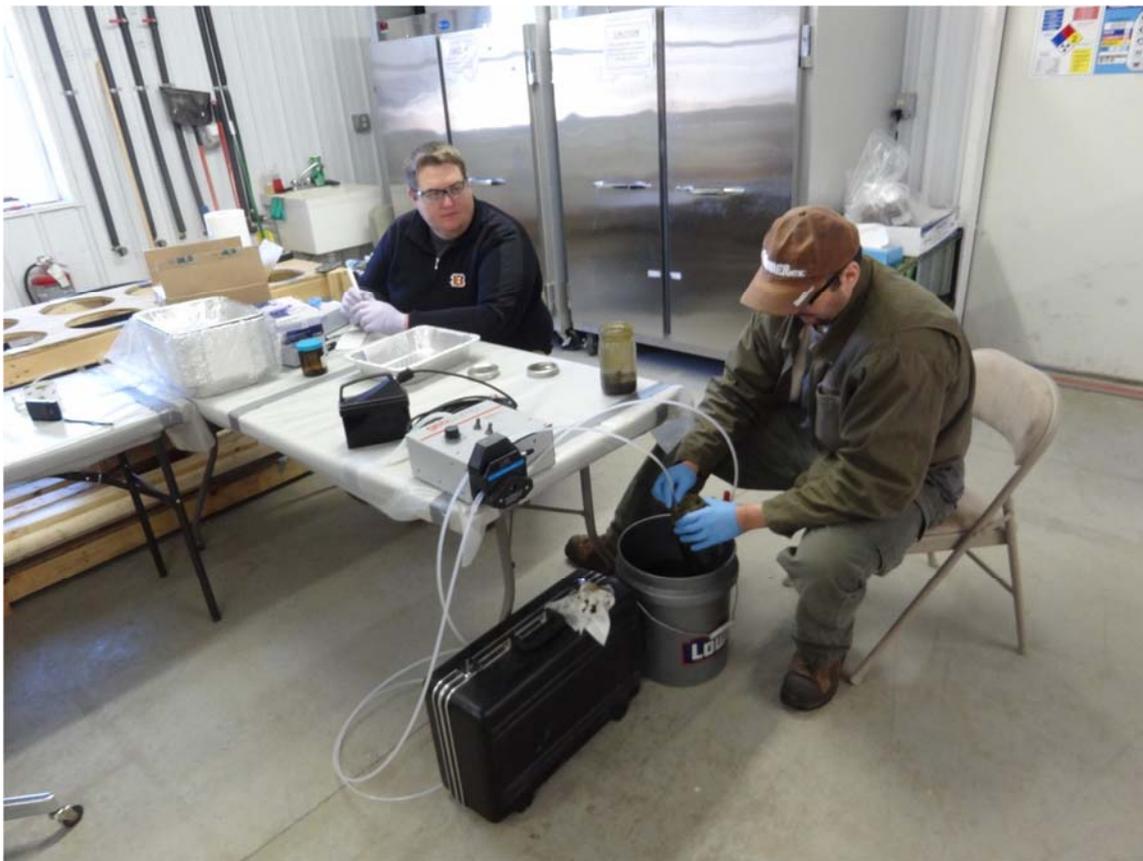
8. Observed a crew decanting and sampling the CSDs.

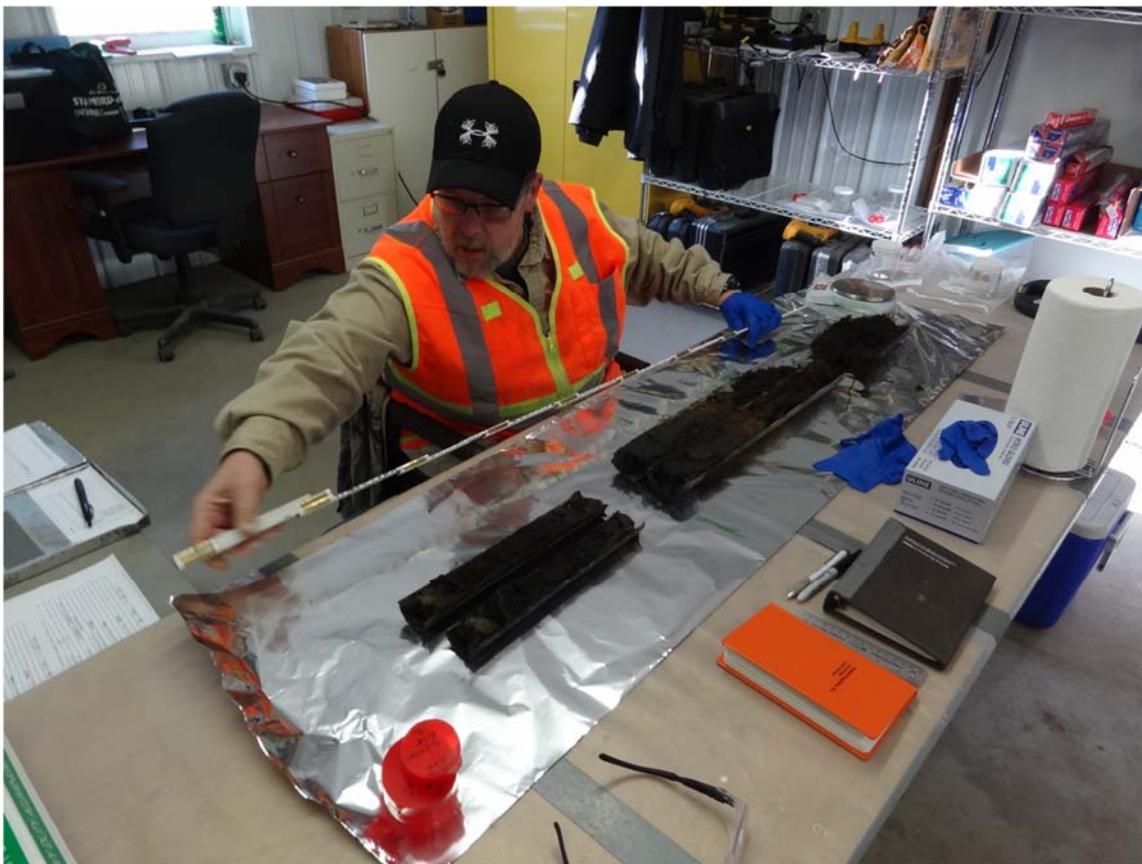
9. Observed core logging.

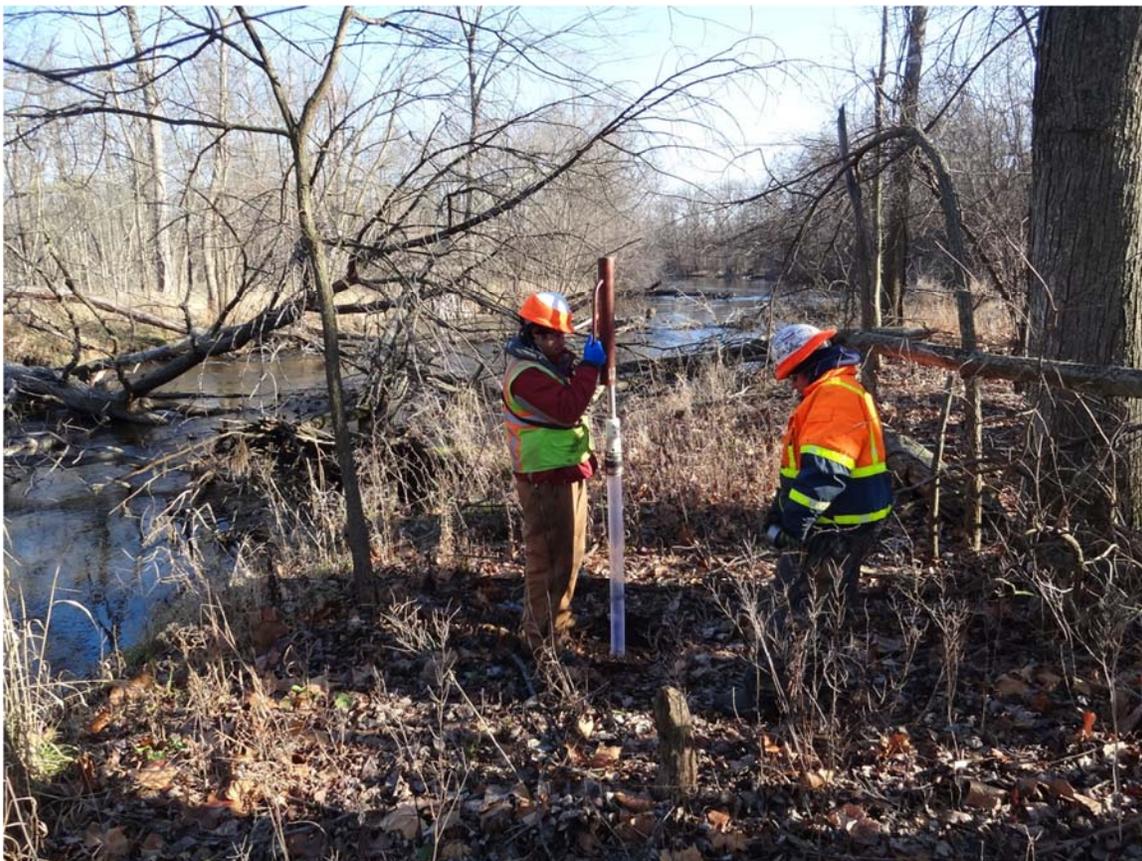
10. MP12.5 LDB observed an RI crew.

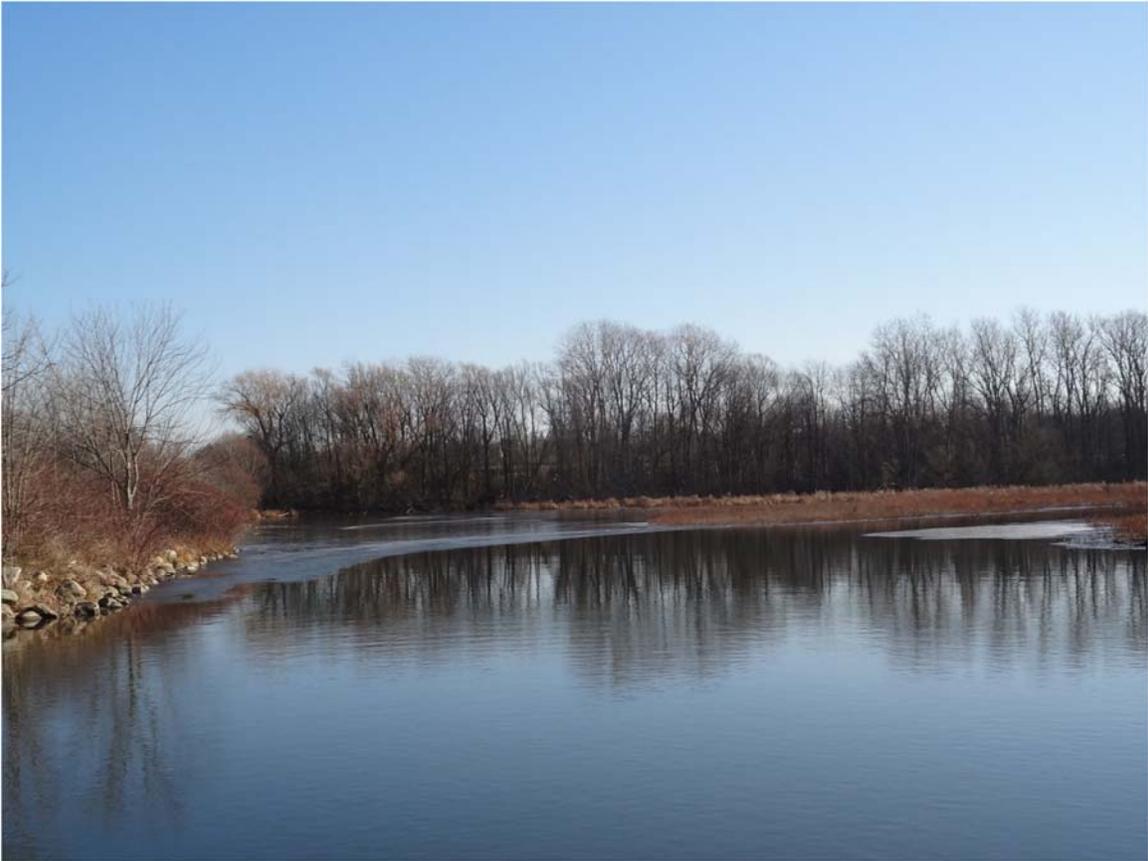
11. MP15.25 South Mill Pond observed ice forming.

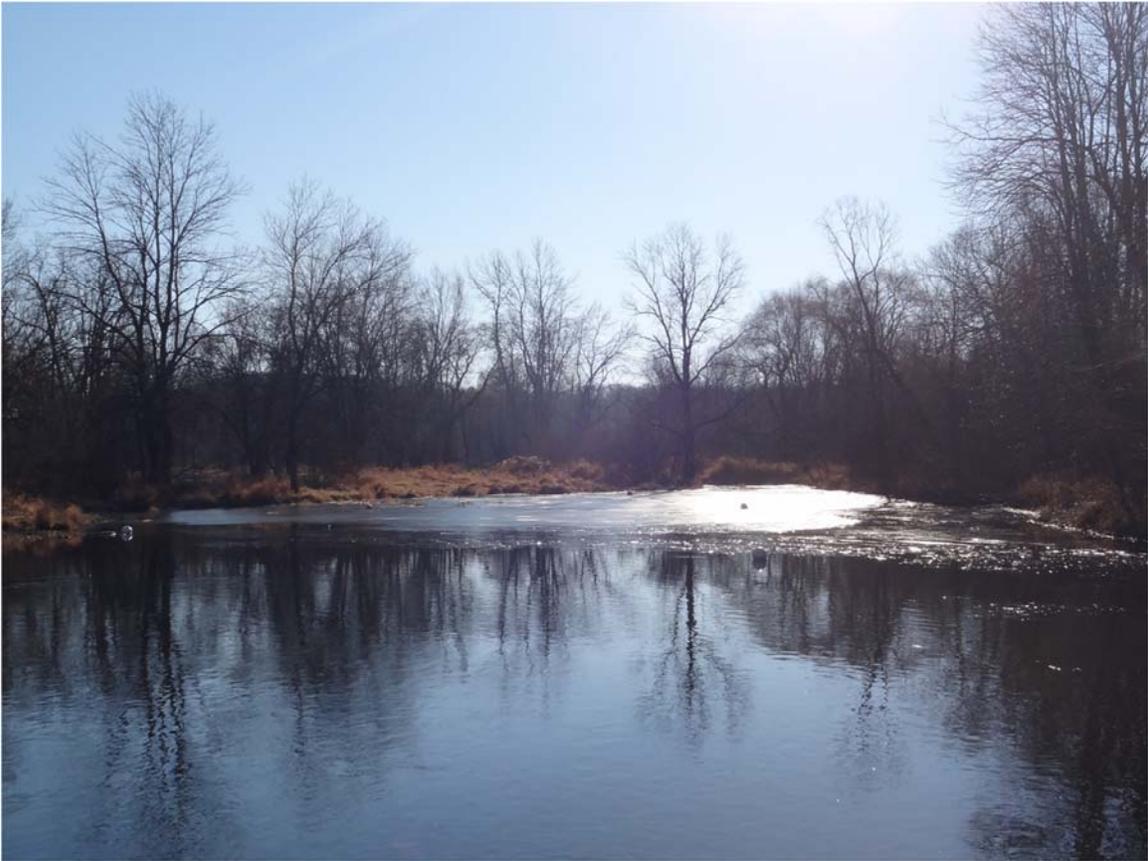
12. MP10.5 LDB Sediment Trap observed ice forming.

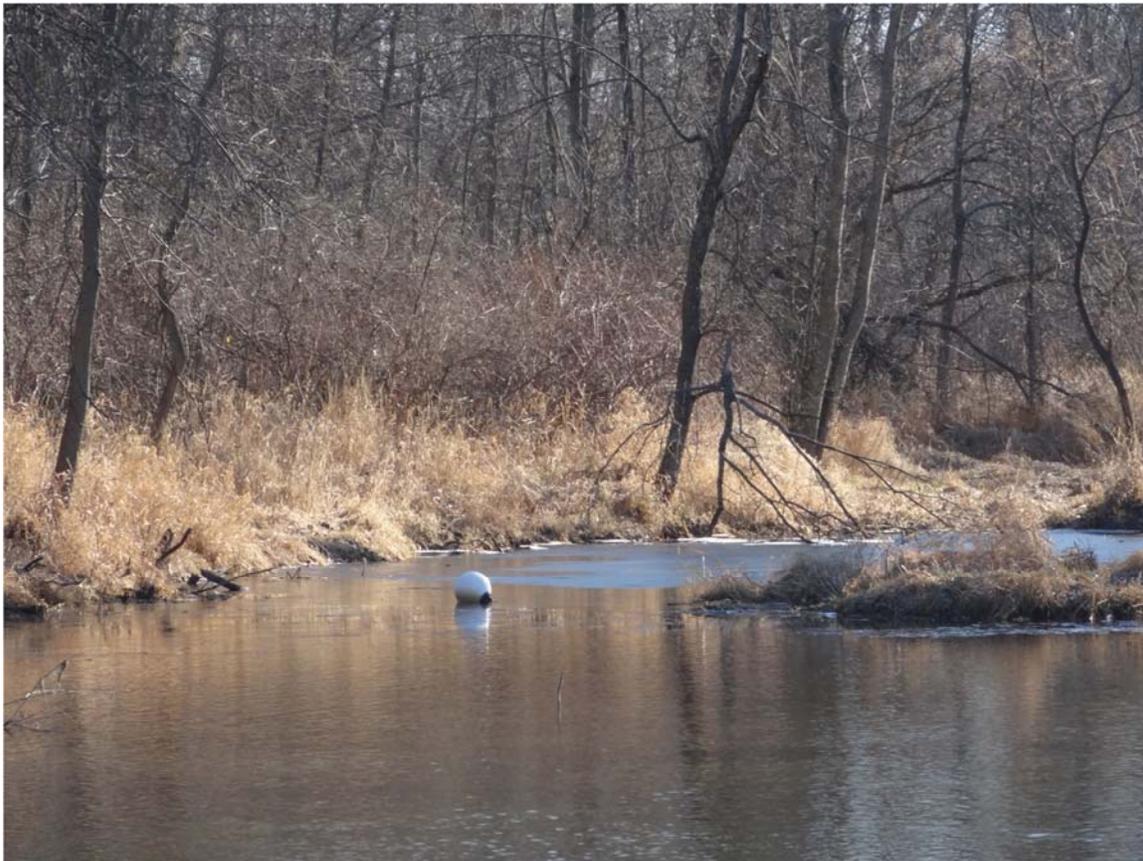
13. MP10.4 RDB Sediment Trap observed ice forming.

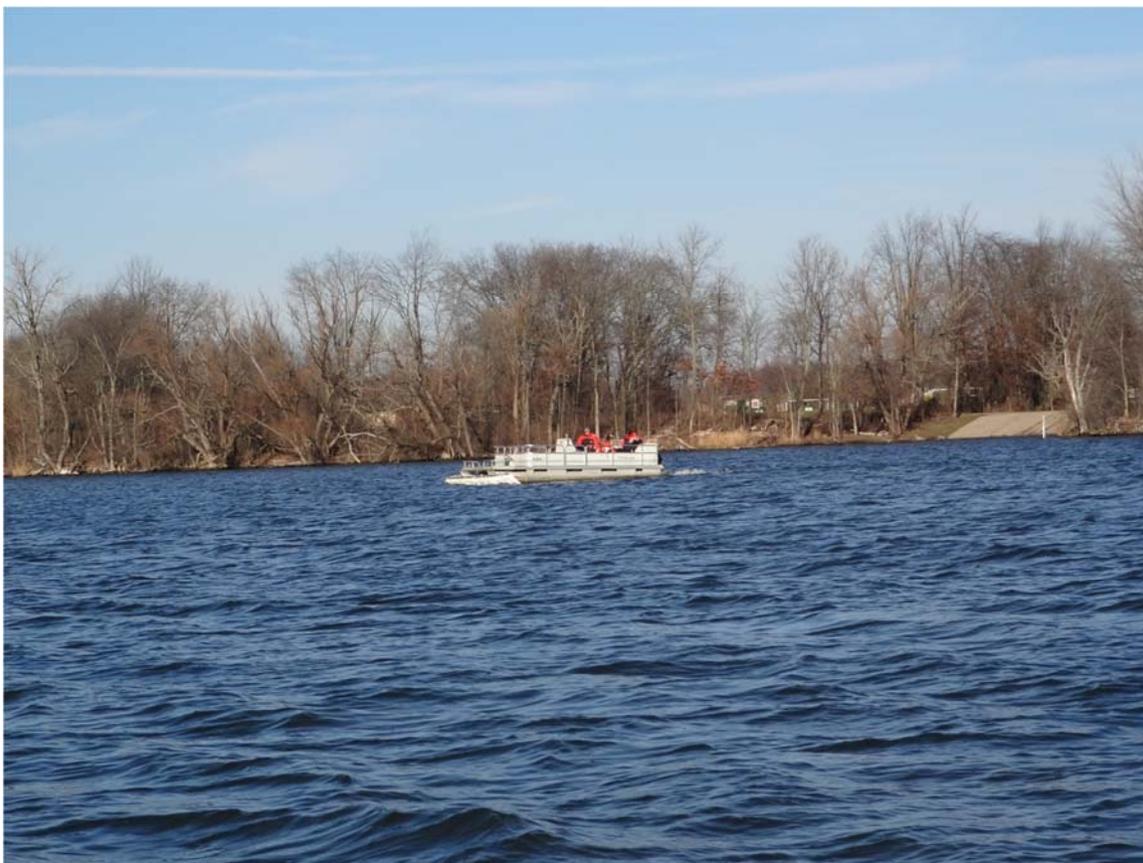
14. Morrow Lake observed a sweep boat operating.

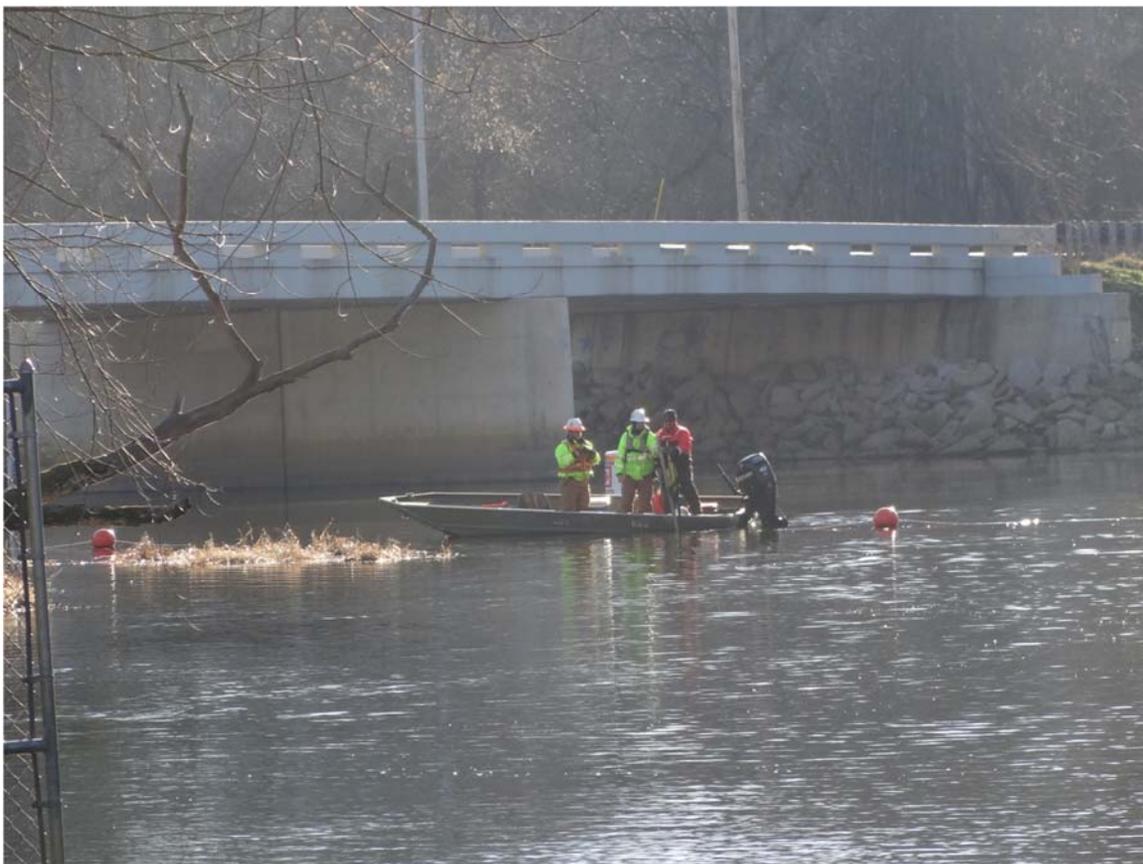
15. MP21.5 Sediment trap observed a bathymetry team.

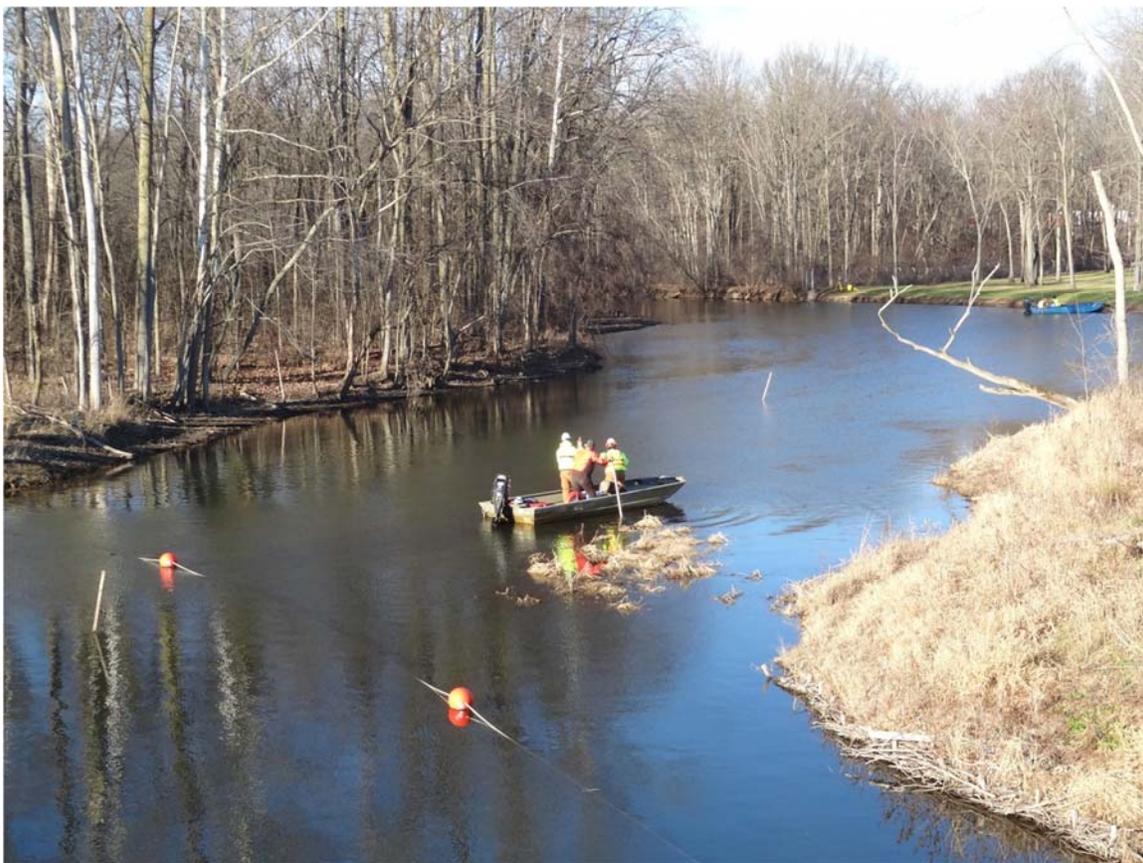
16. MP21.5 Sediment trap observed a bathymetry team.

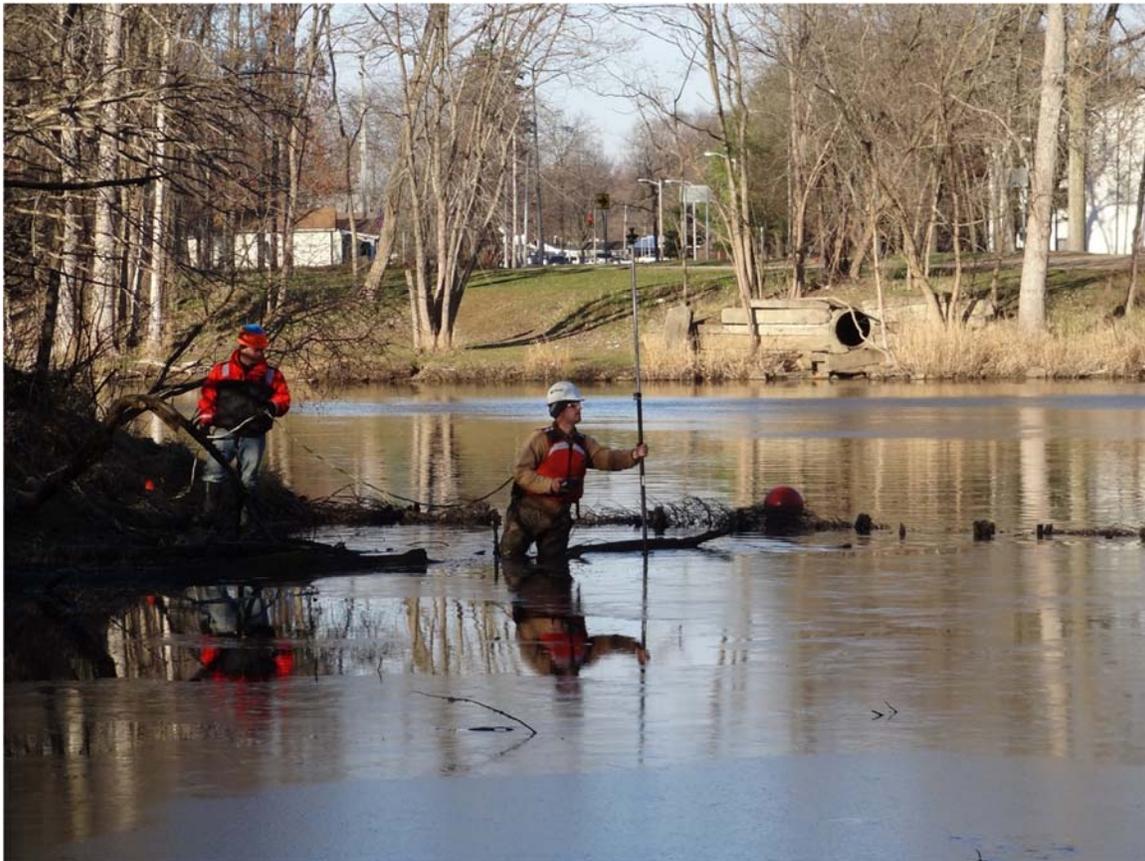
17. MP19.25 Sediment trap observed a bathymetry team.

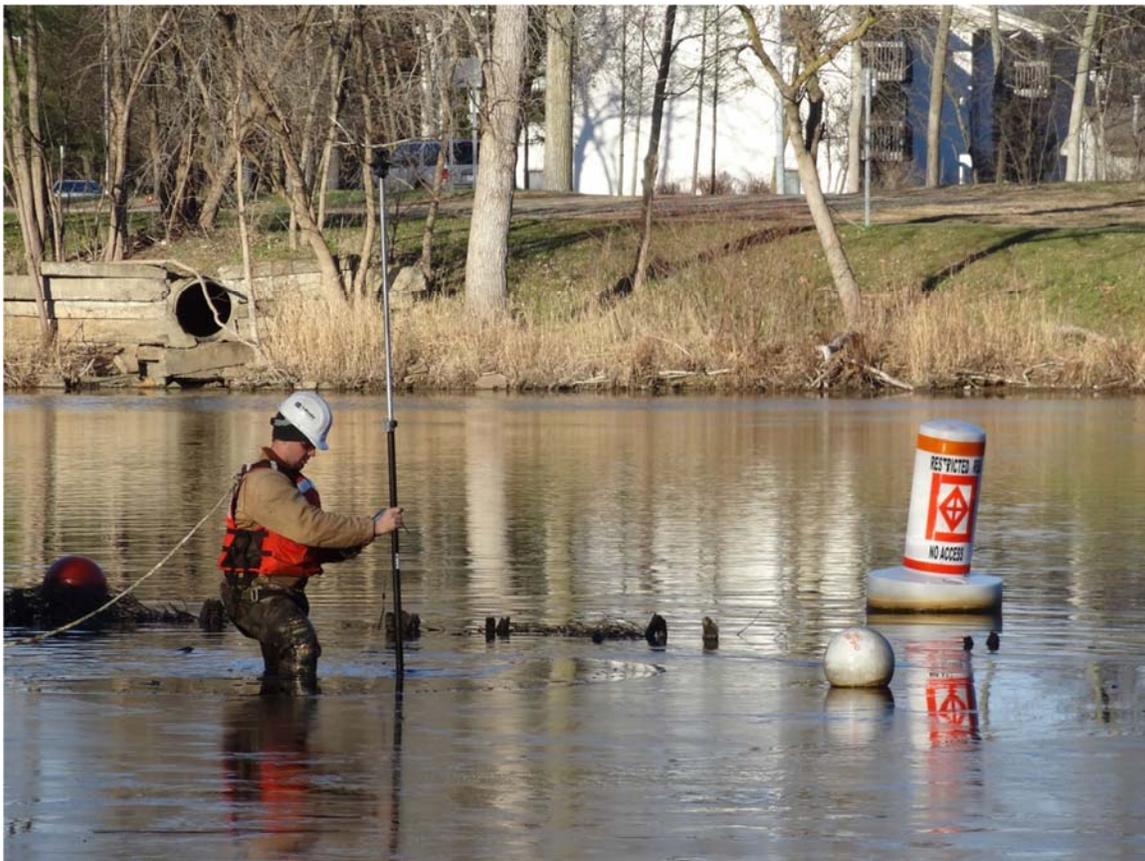
18. MP19.25 Sediment trap observed a bathymetry team.
