Situation Photo Log

Saturday, December 15, 2012

Kalamazoo River / Enbridge Spill

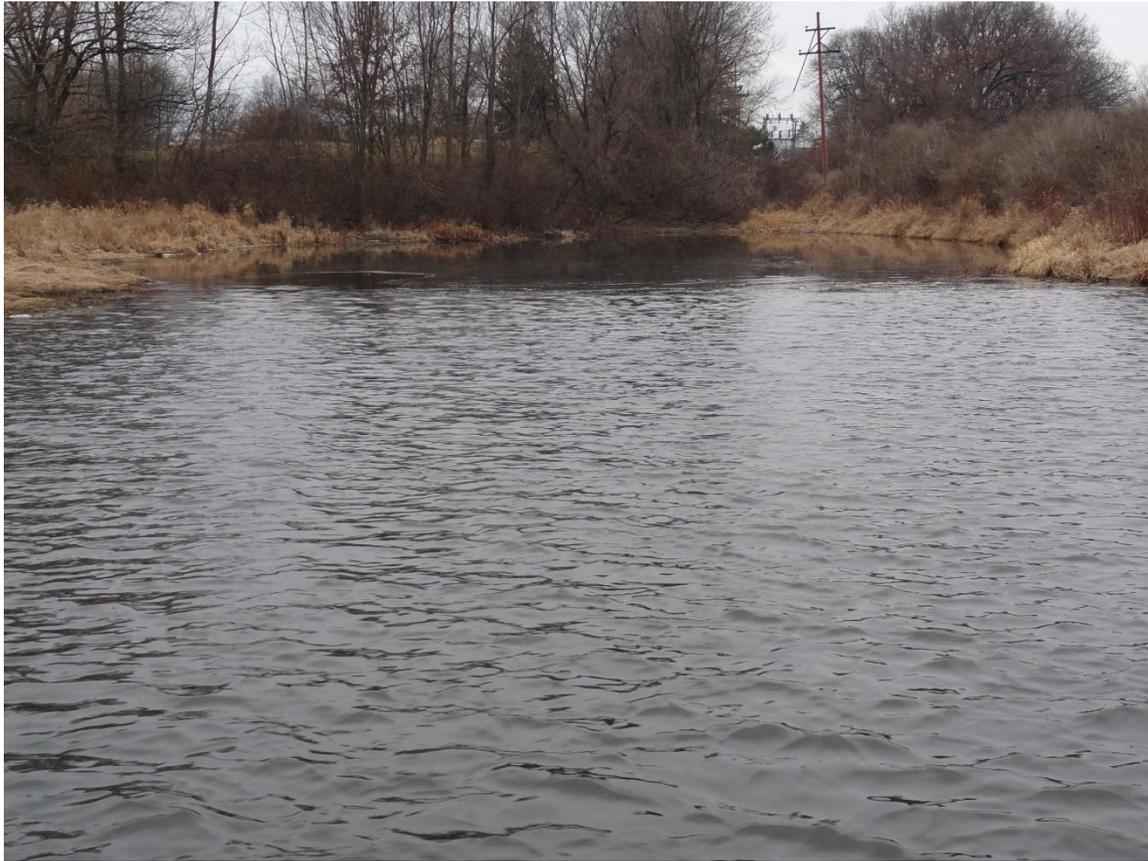
1. MP5.60 LDB ice observed.

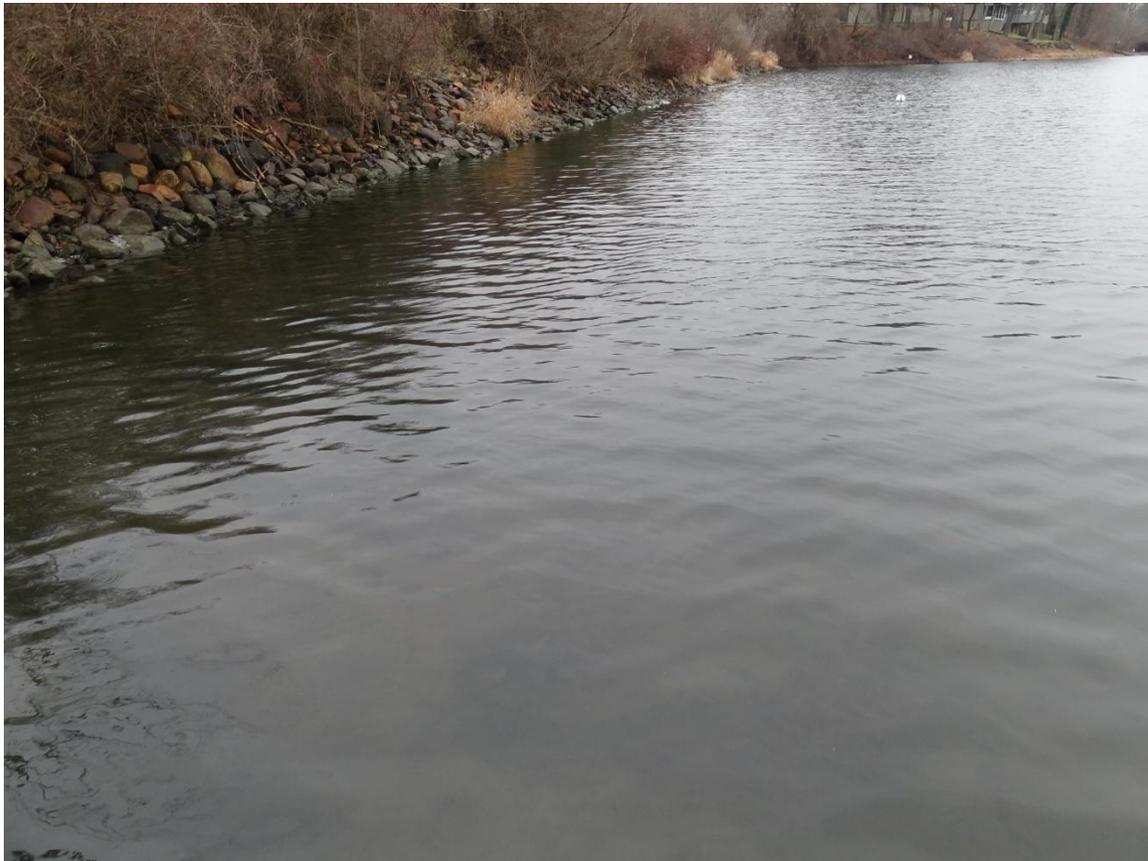
2. MP5.63 – MP5.75 LDB no ice observed.

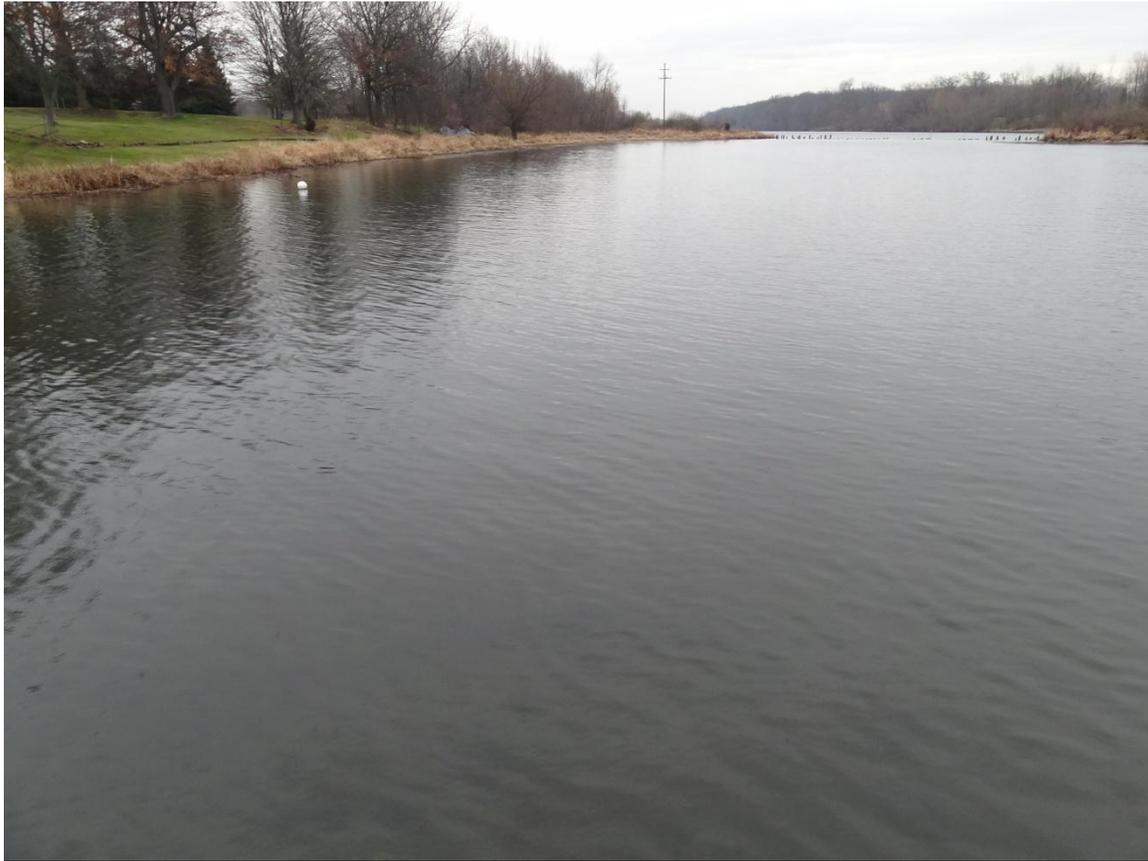
3. MP5.63 – MP5.75 RDB no ice observed.

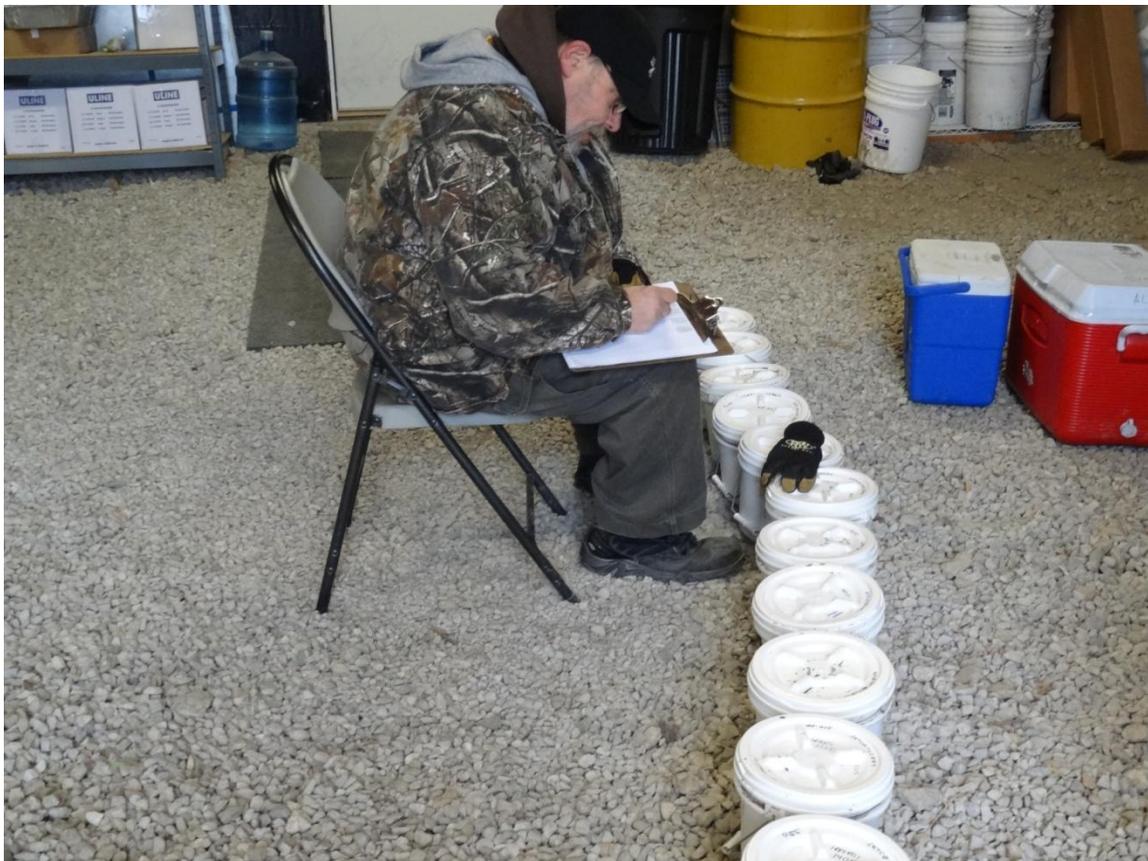
4. Observed sample logging at the C3.2 Pole Barn.

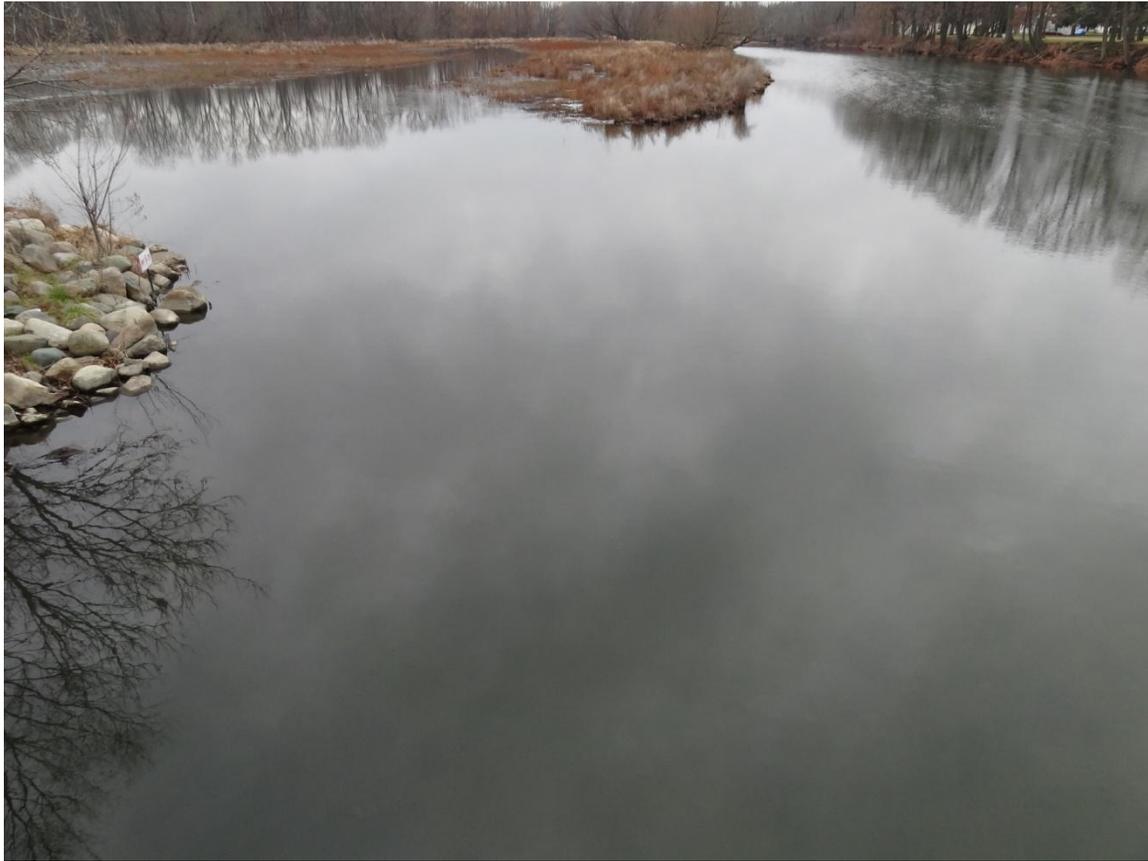
5. MP15.25 South Mill Pond area where sheen and tar globs were observed.

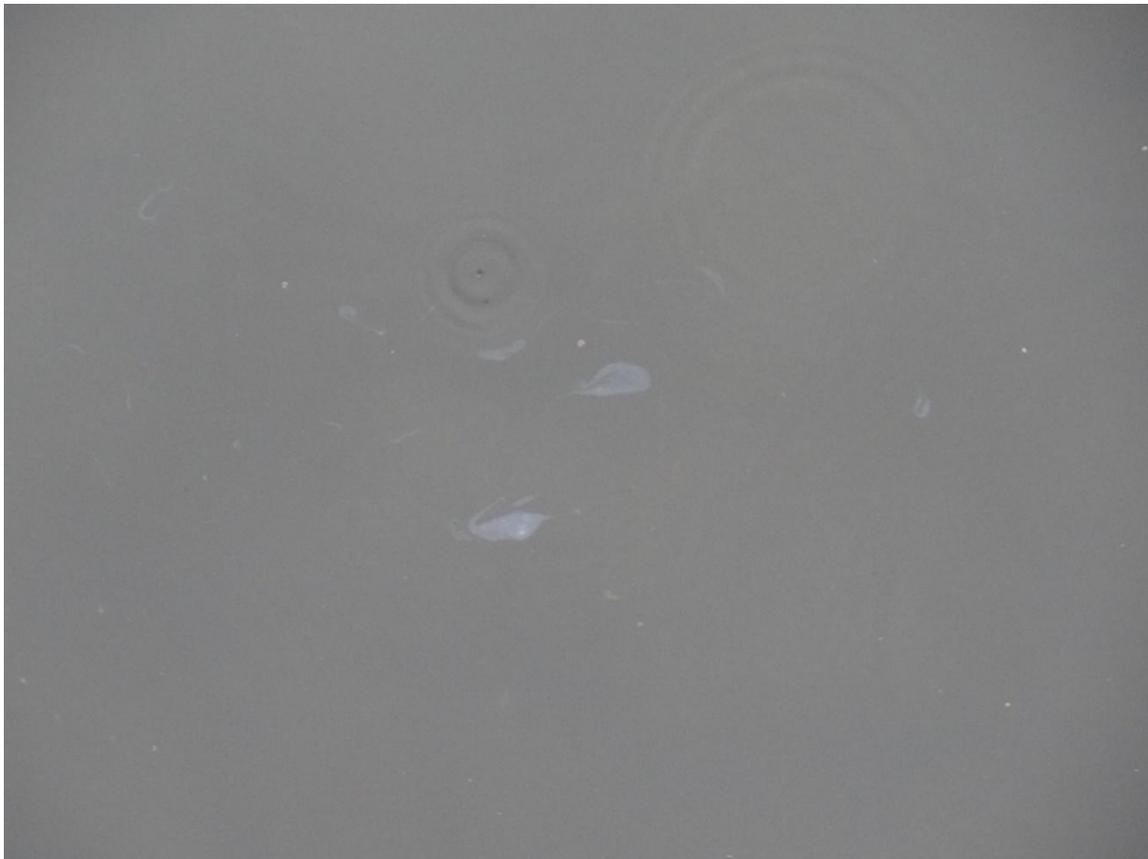
6. MP15.25 RDB sheen and tar globs observed

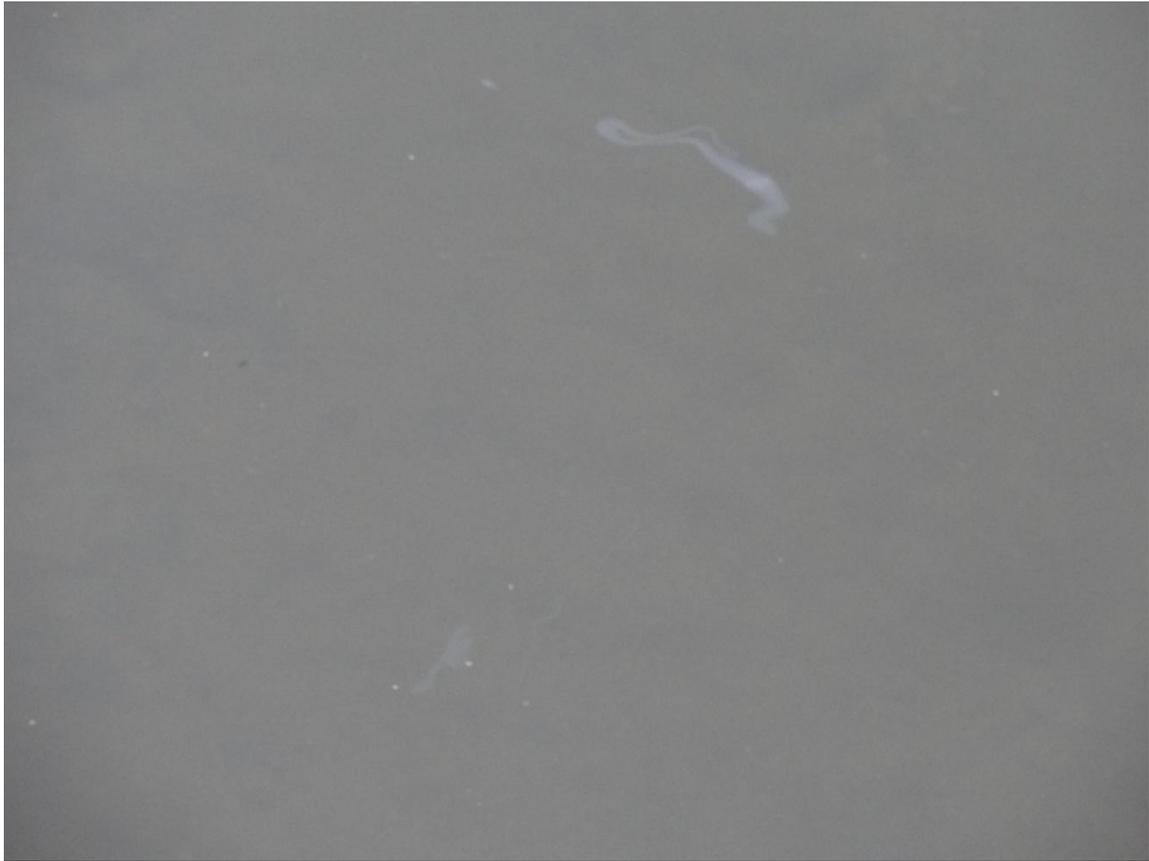
7. MP15.25 RDB sheen and tar globs observed.

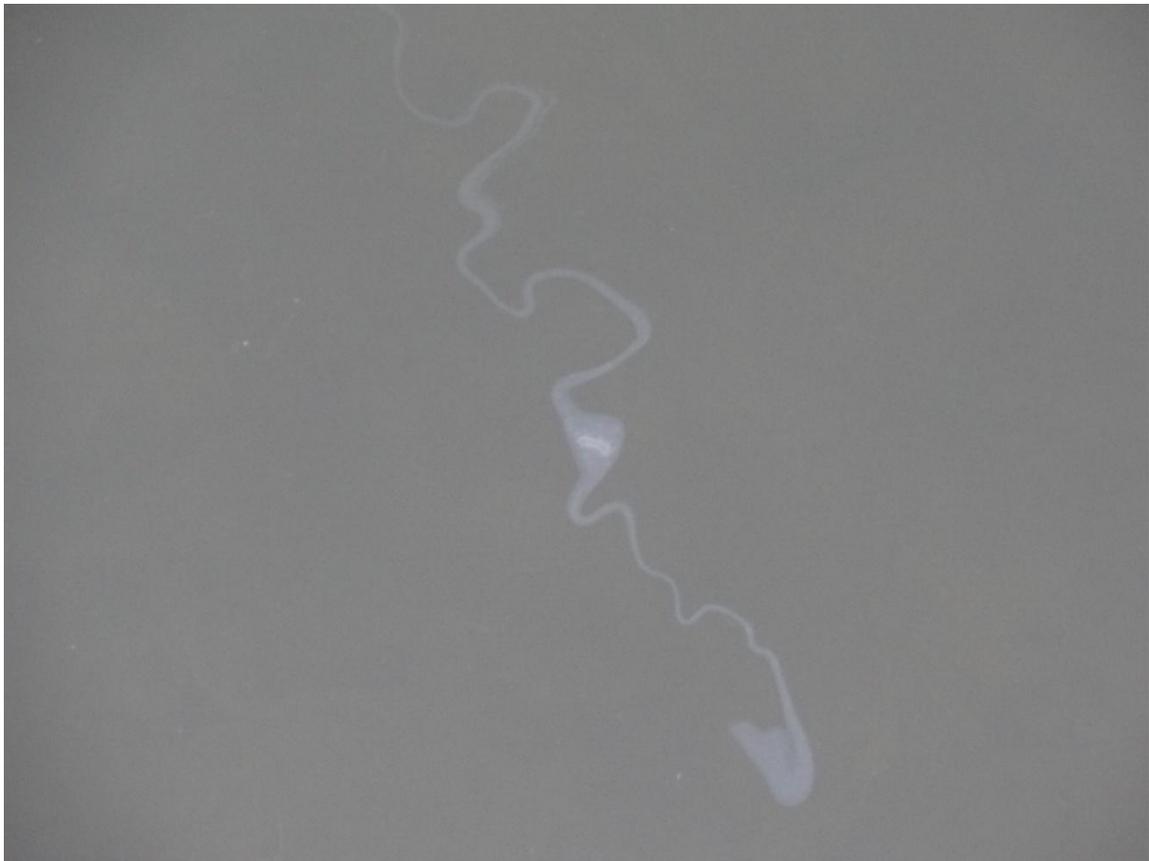
8. MP15.25 RDB sheen and tar globs observed.

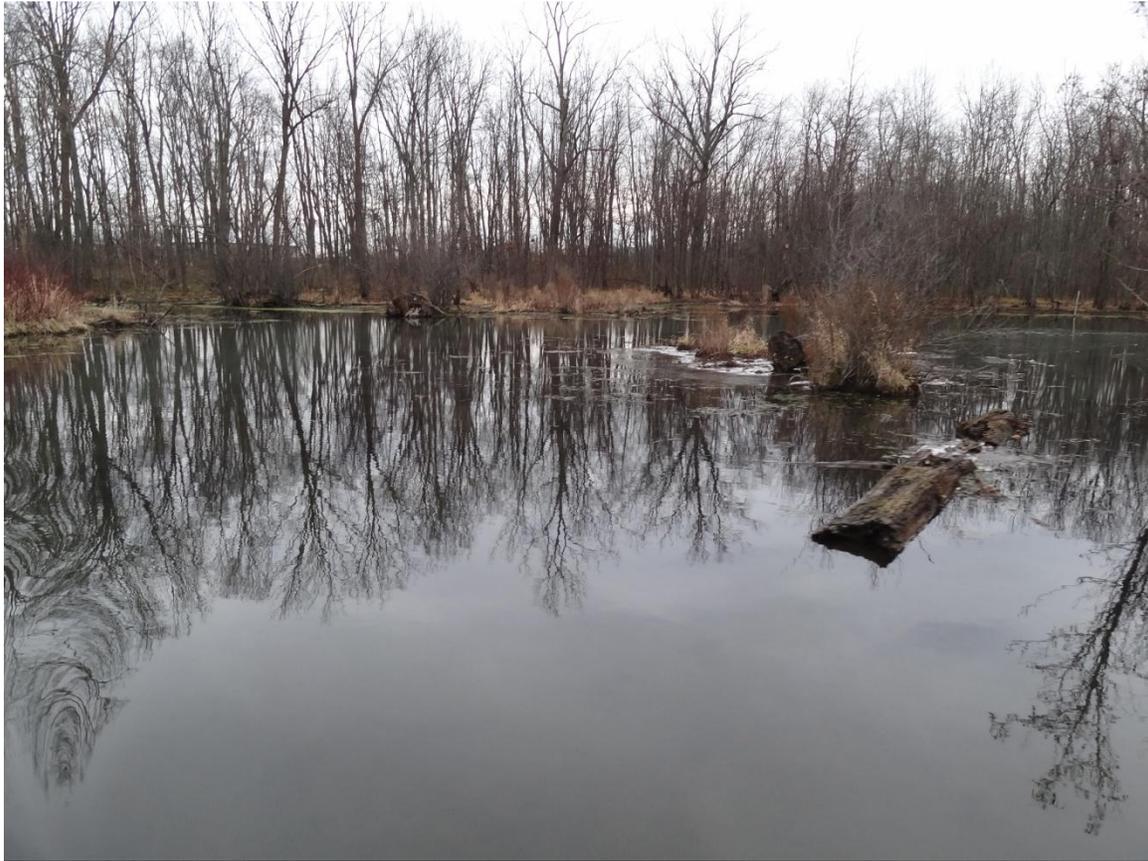
9. MP36.50 RDB no sheen observed.

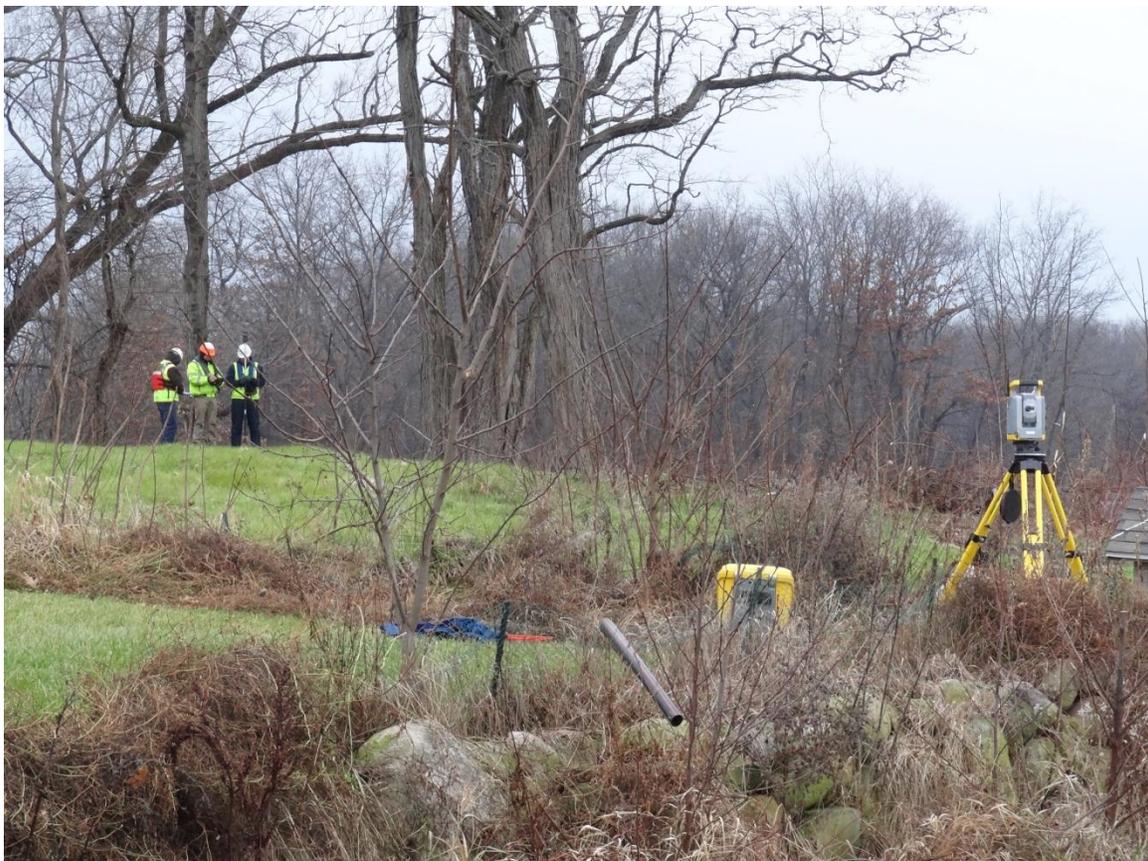
10. Morrow Lake Delta observed a bathymetry team at former E4 Boom A location.

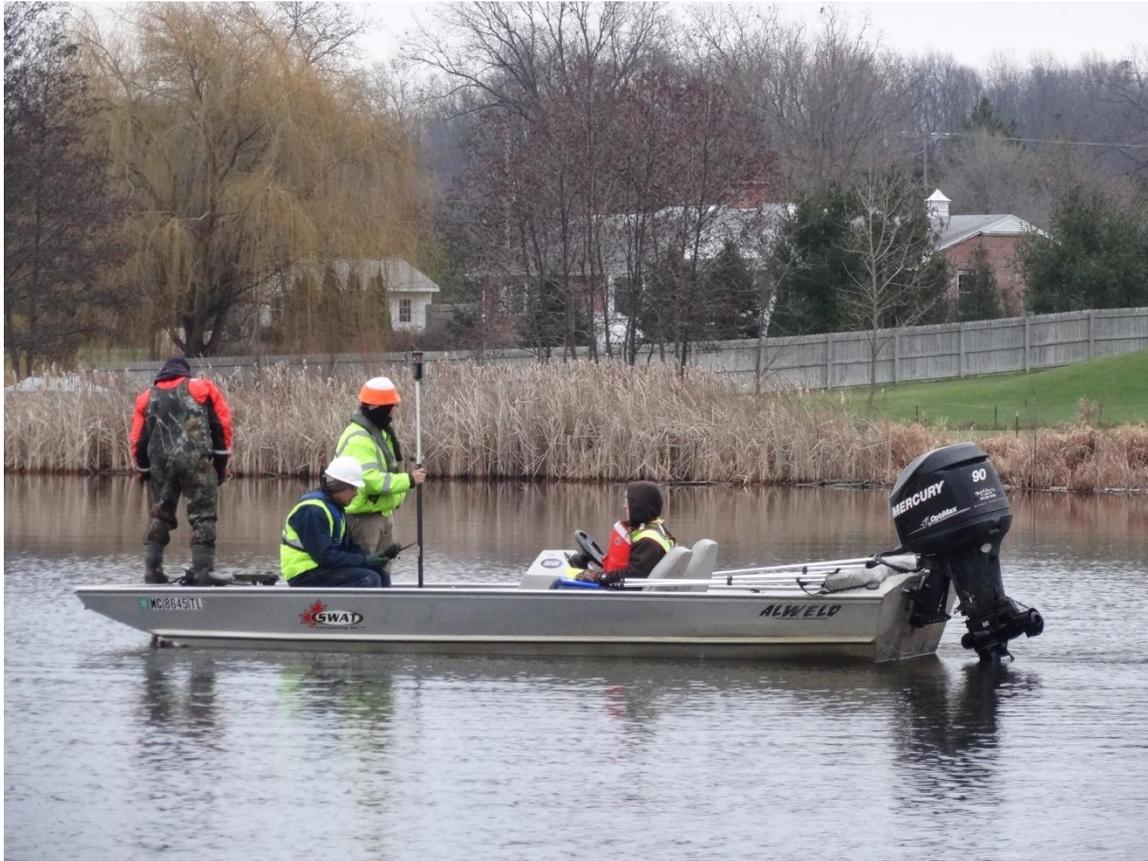
11. Morrow Lake Delta observed a bathymetry team at former E4 Boom A location.

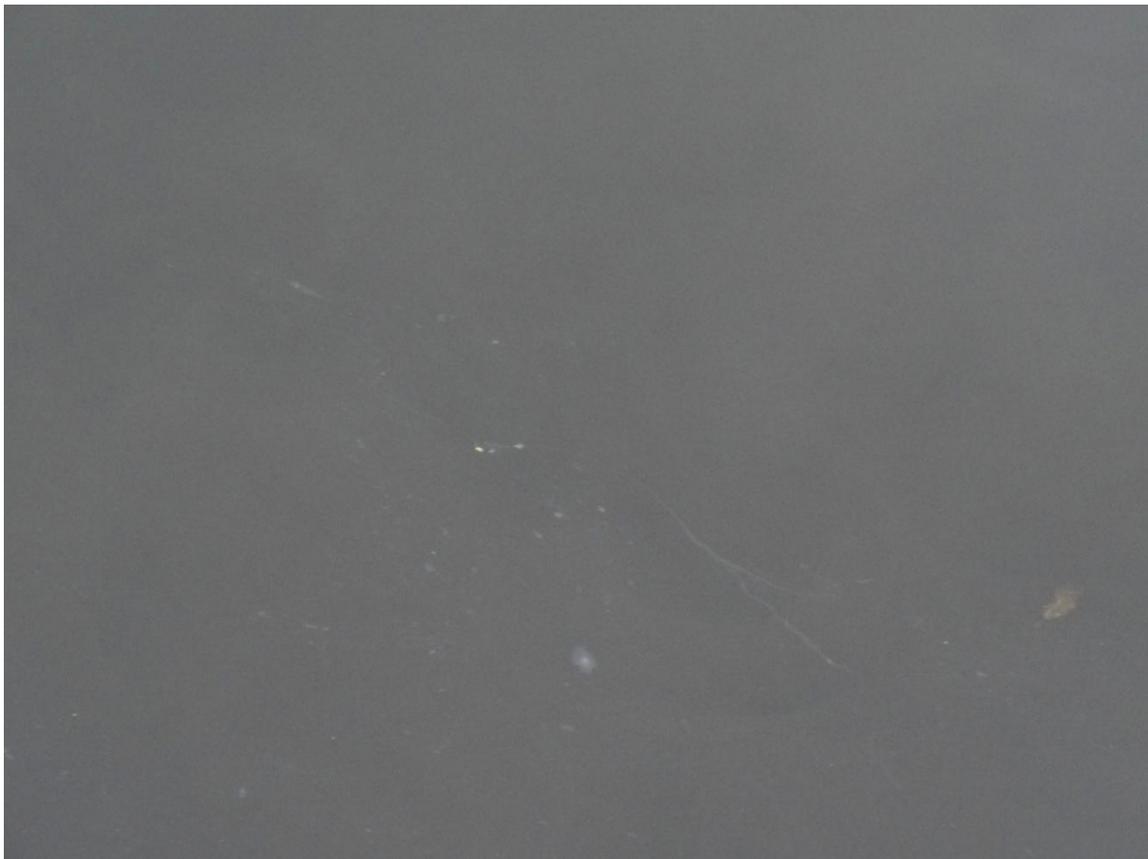
12. Morrow Lake Delta observed sheen generated by bathymetry crew boat.

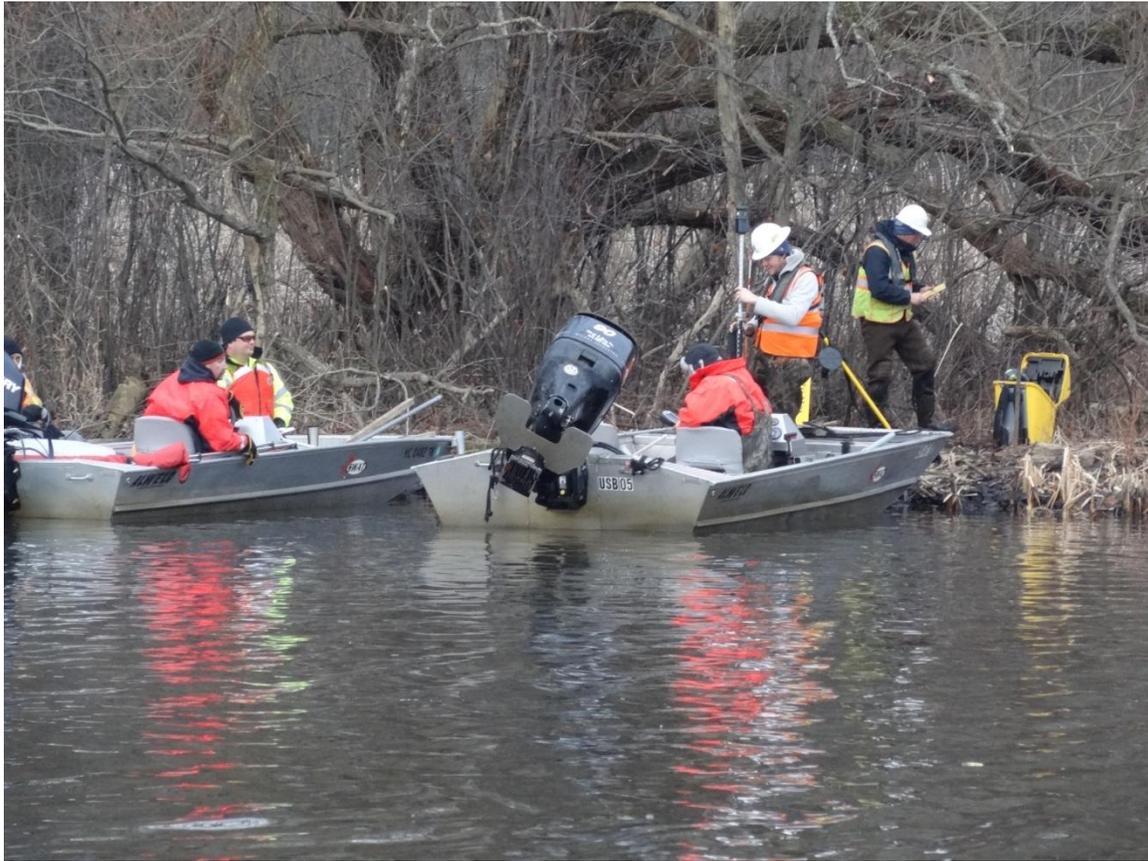
13. Morrow Lake Delta observed a bathymetry team at MP37.75 Island sediment trap.

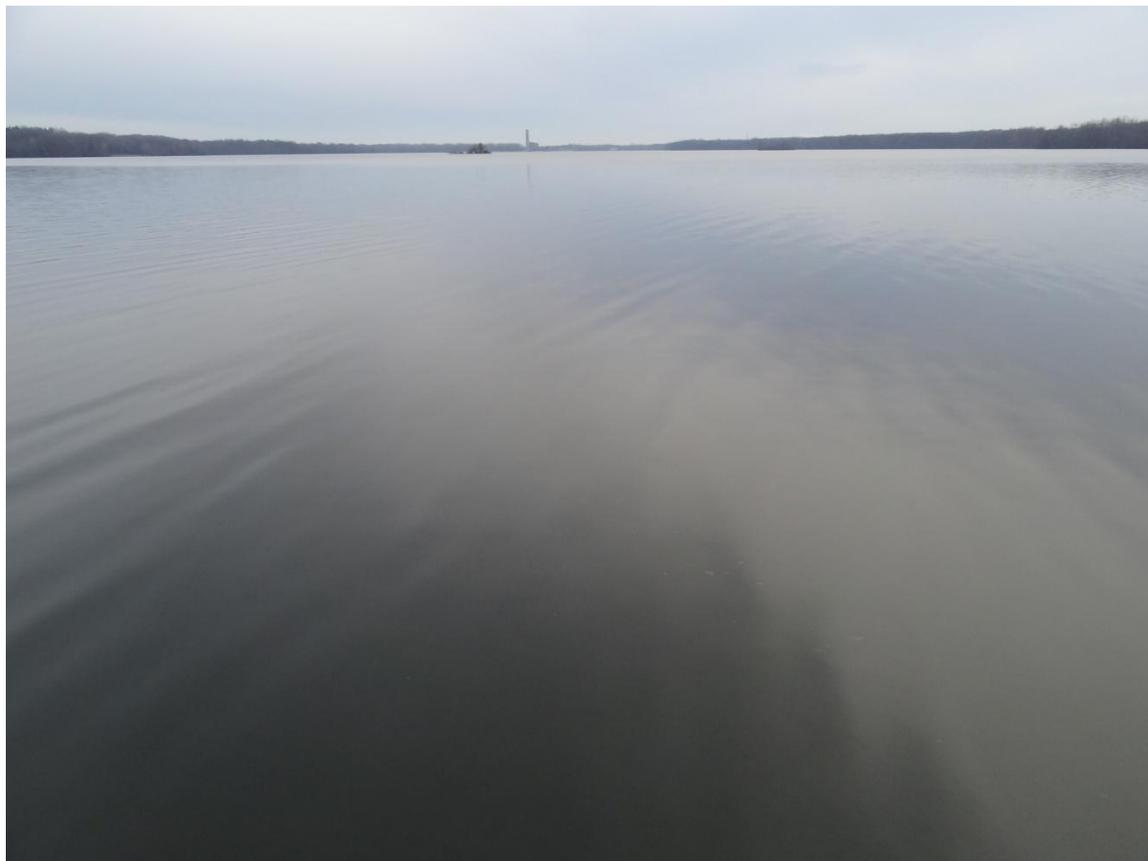
14. Morrow Lake no ice observed.
