Situation Photo Log

Monday, December 17, 2012

Kalamazoo River / Enbridge Spill

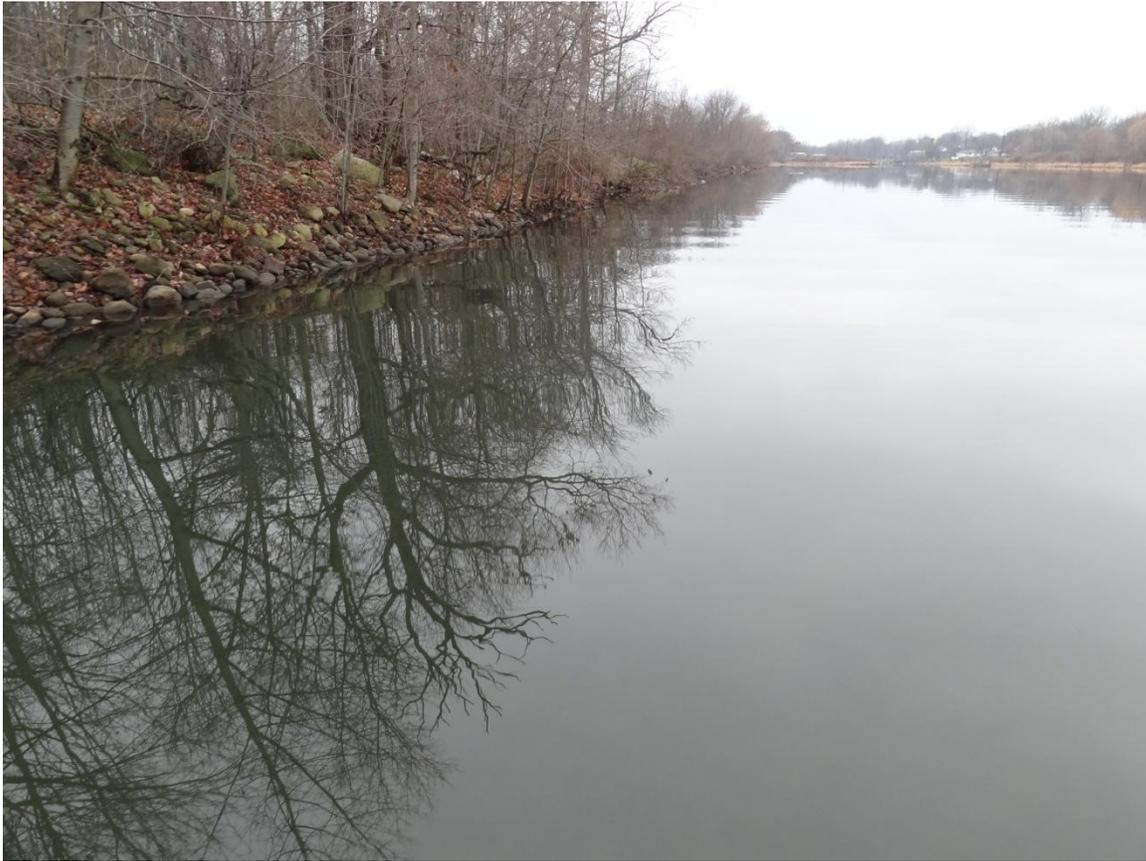
1. MP5.15 – MP5.60 LDB area where sheen and tar globs were observed.
Sweep boat requested.

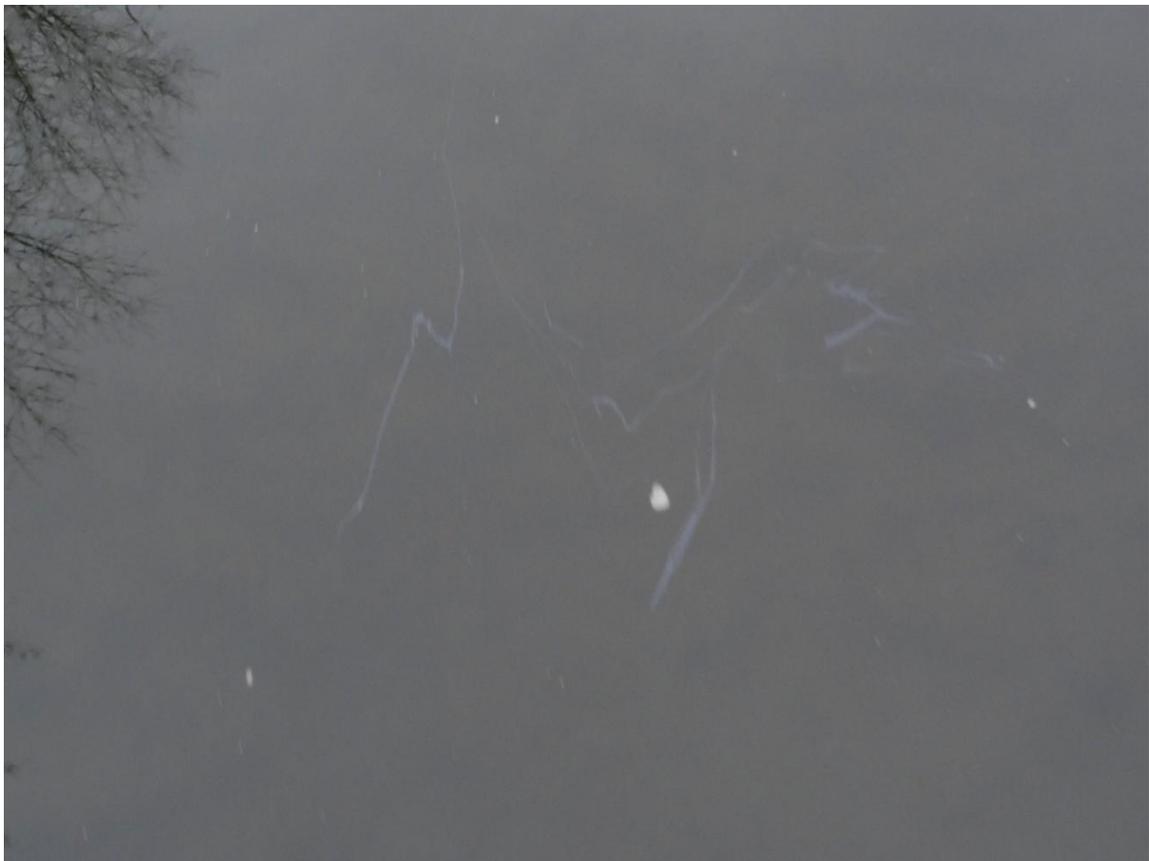
2. MP5.15 – MP5.60 LDB sheen and tar globs observed.

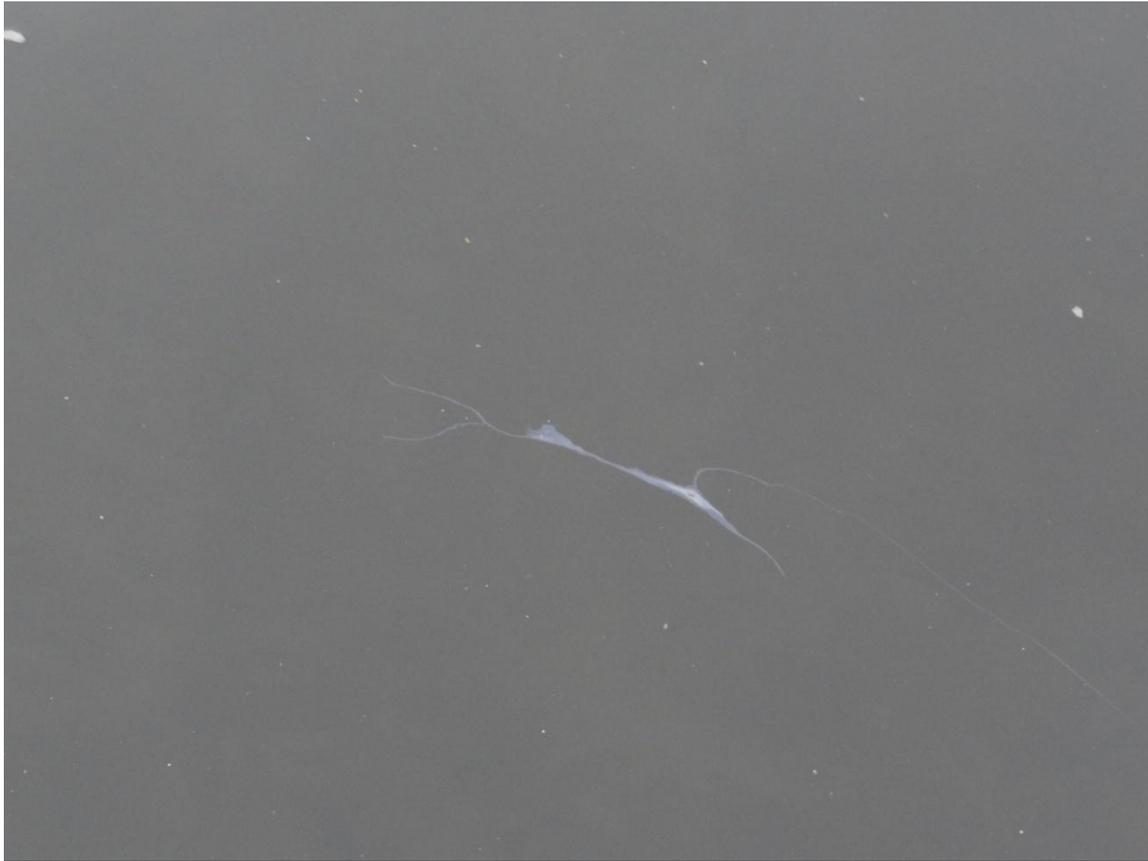
3. MP5.15 – MP5.60 LDB sheen and tar globs observed.

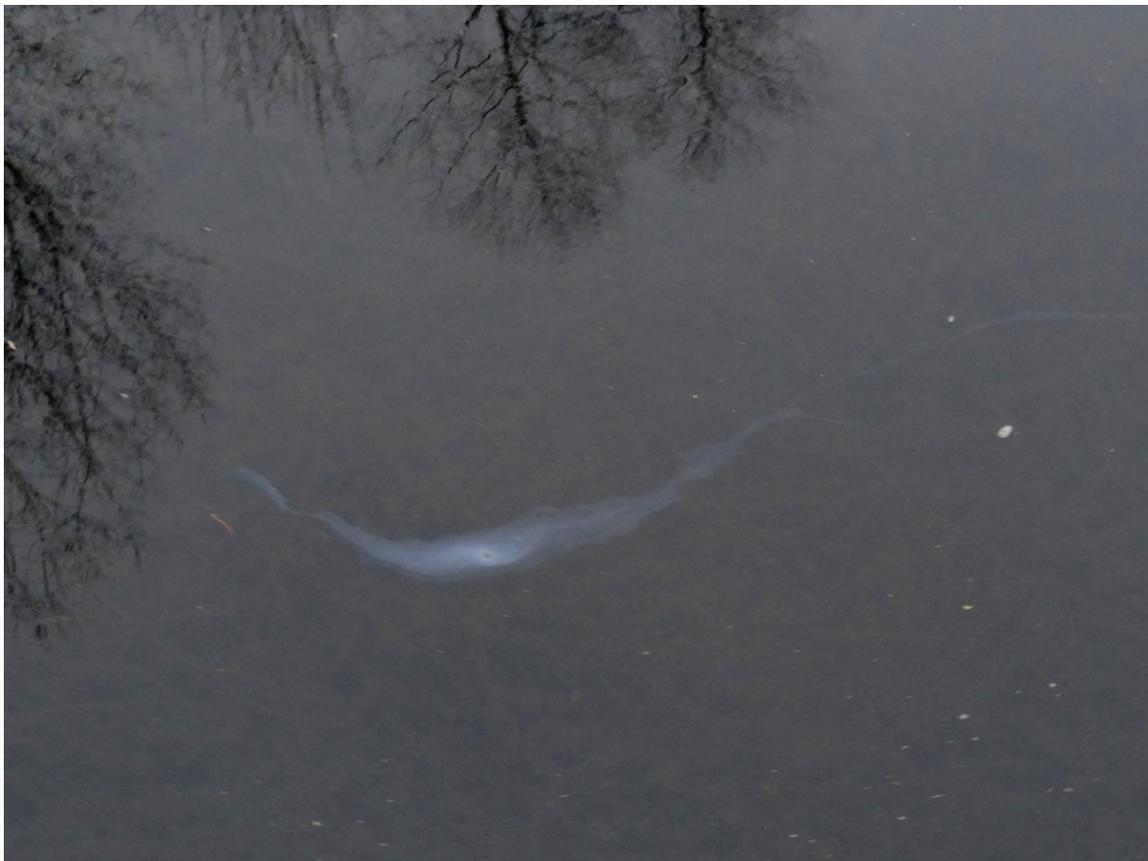
4. MP5.15 – MP5.60 LDB sheen and tar globs observed.

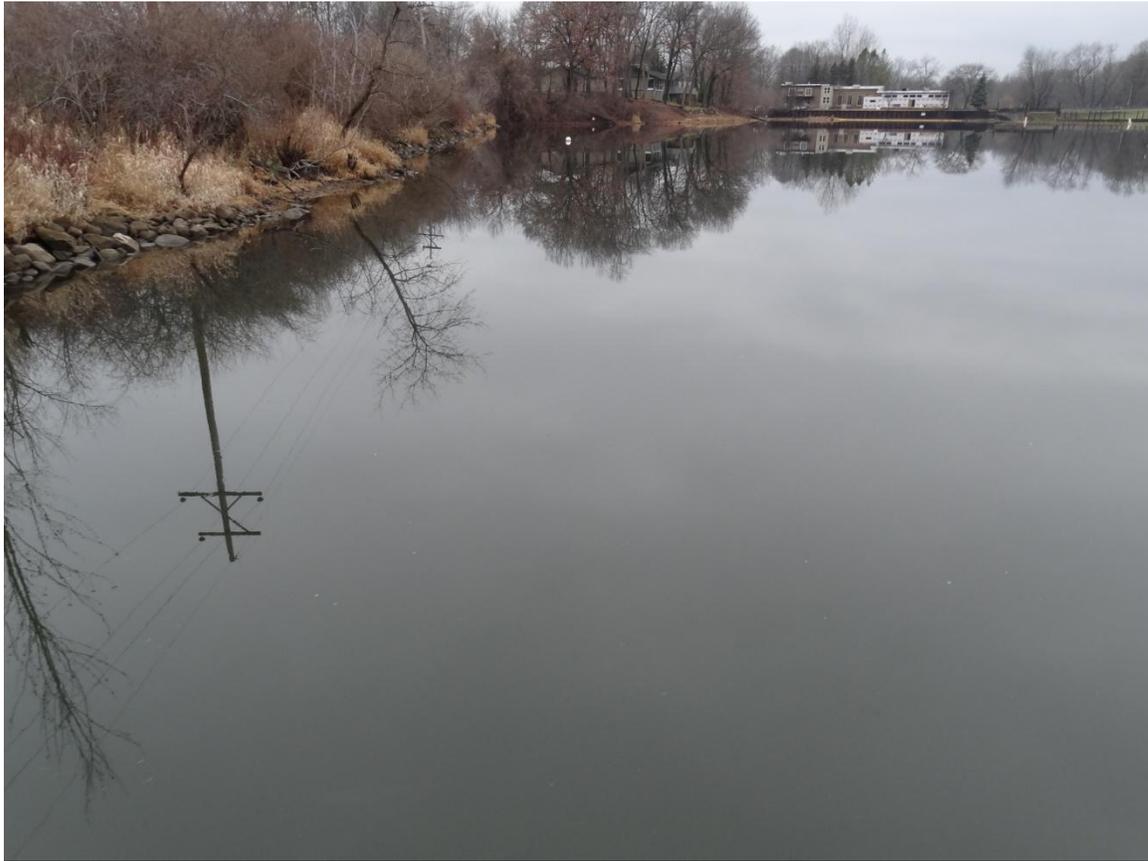
5. MP5.63 – MP5.80 LDB area where sheen and tar globs were observed.
Sweep boat requested.

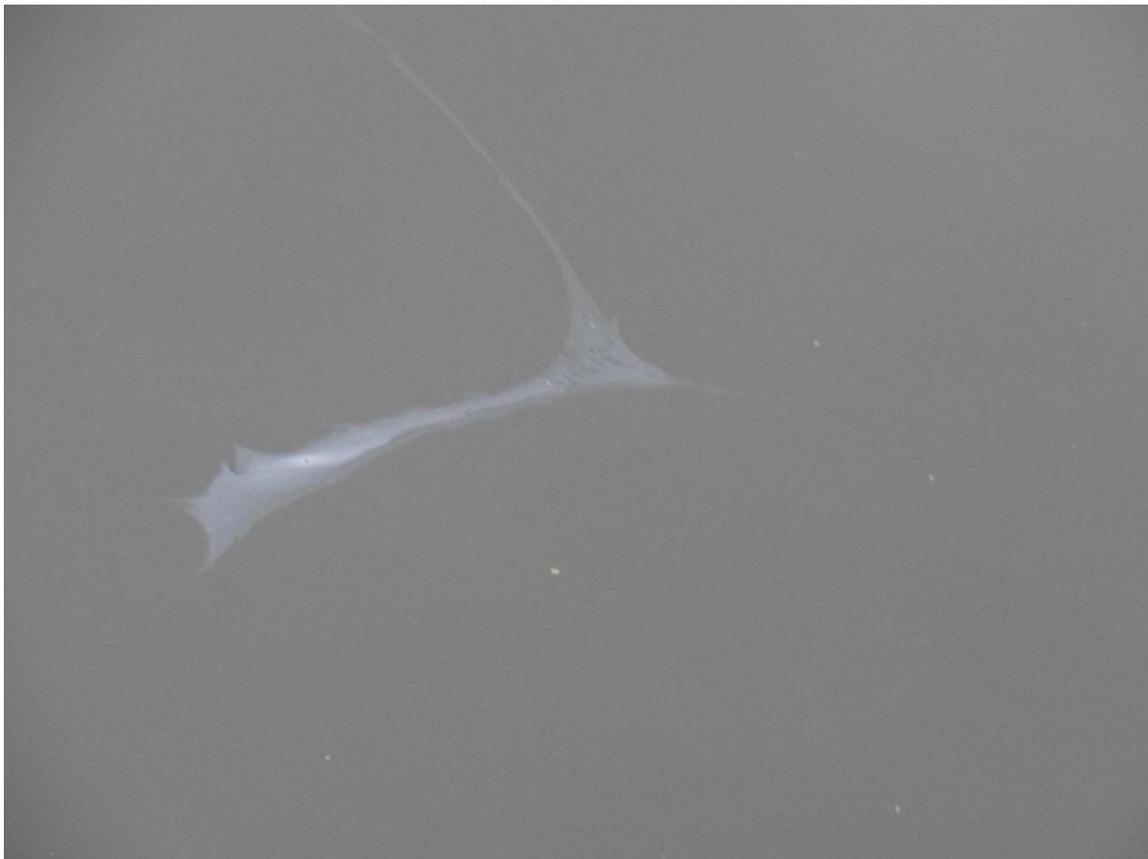
6. MP5.63 – MP5.80 LDB sheen and tar globs observed.

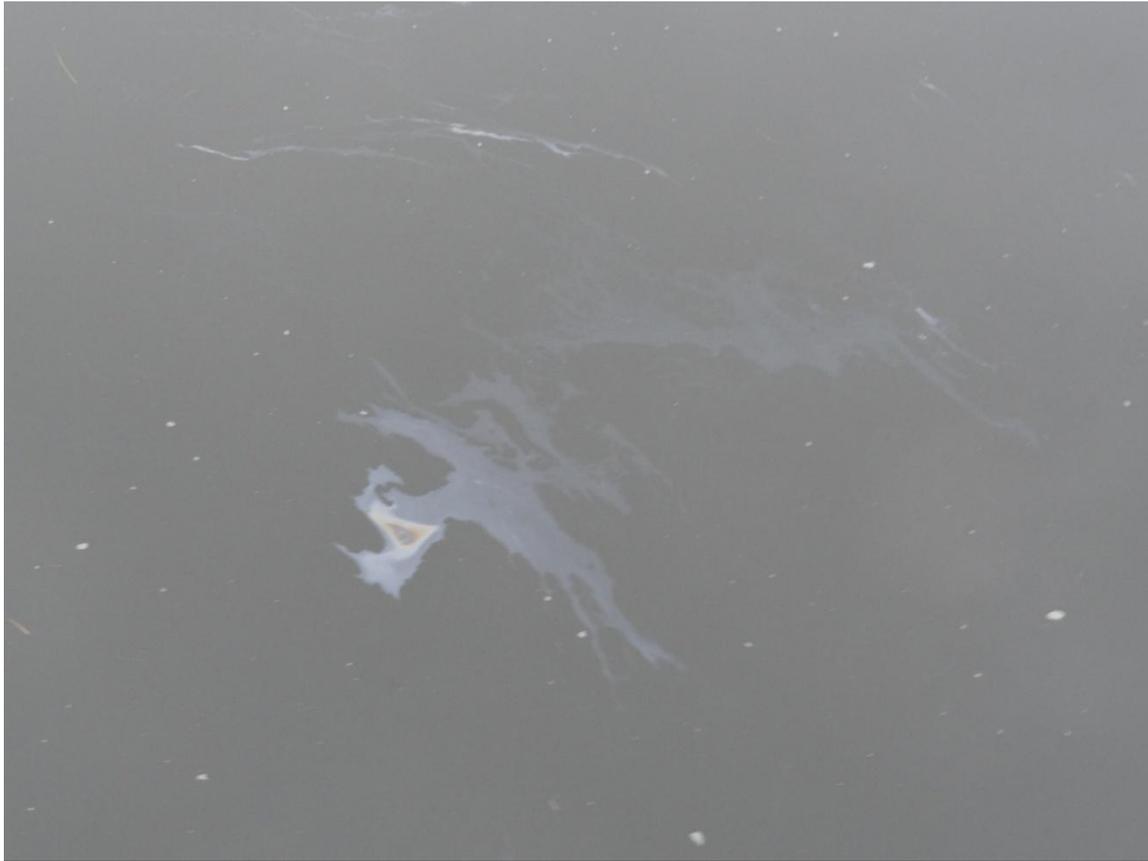
7. MP5.63 – MP5.80 LDB sheen and tar globs observed.

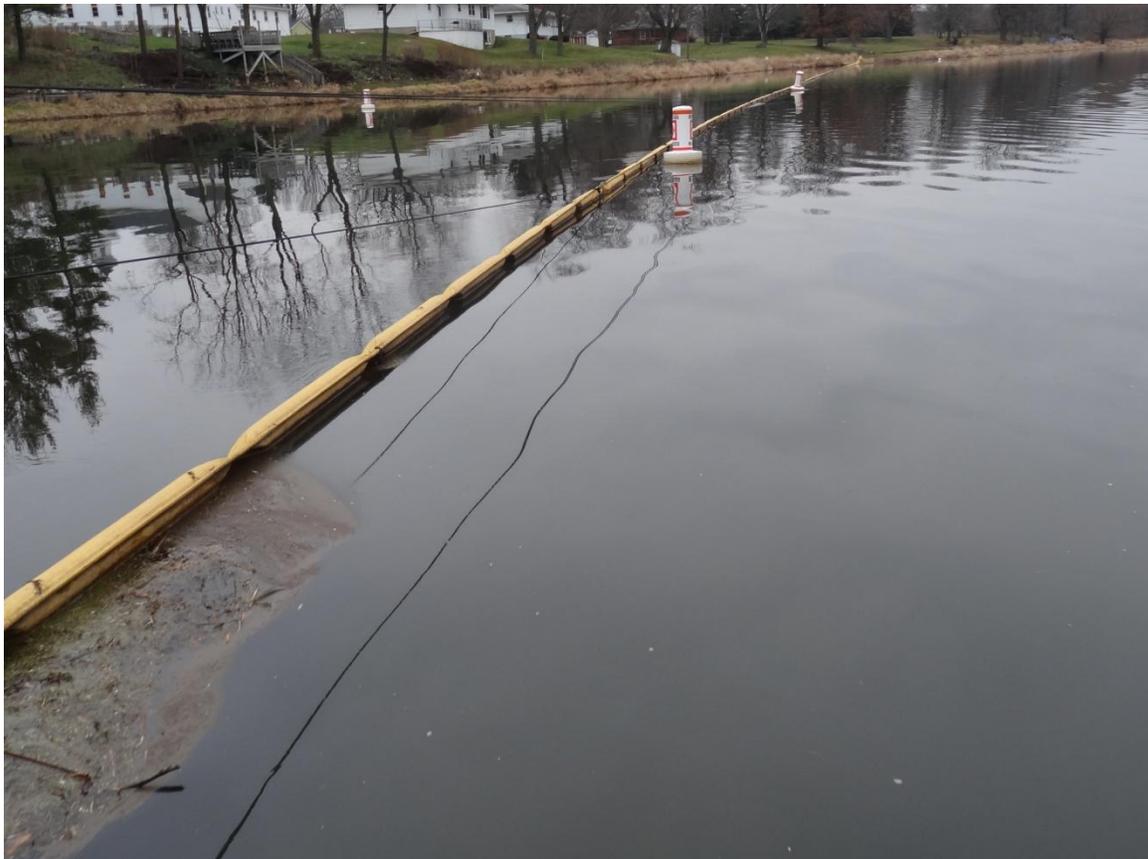
8. Ceresco Dam control point boom observed sheen and tar globs collecting along boom. Sweep boat requested.

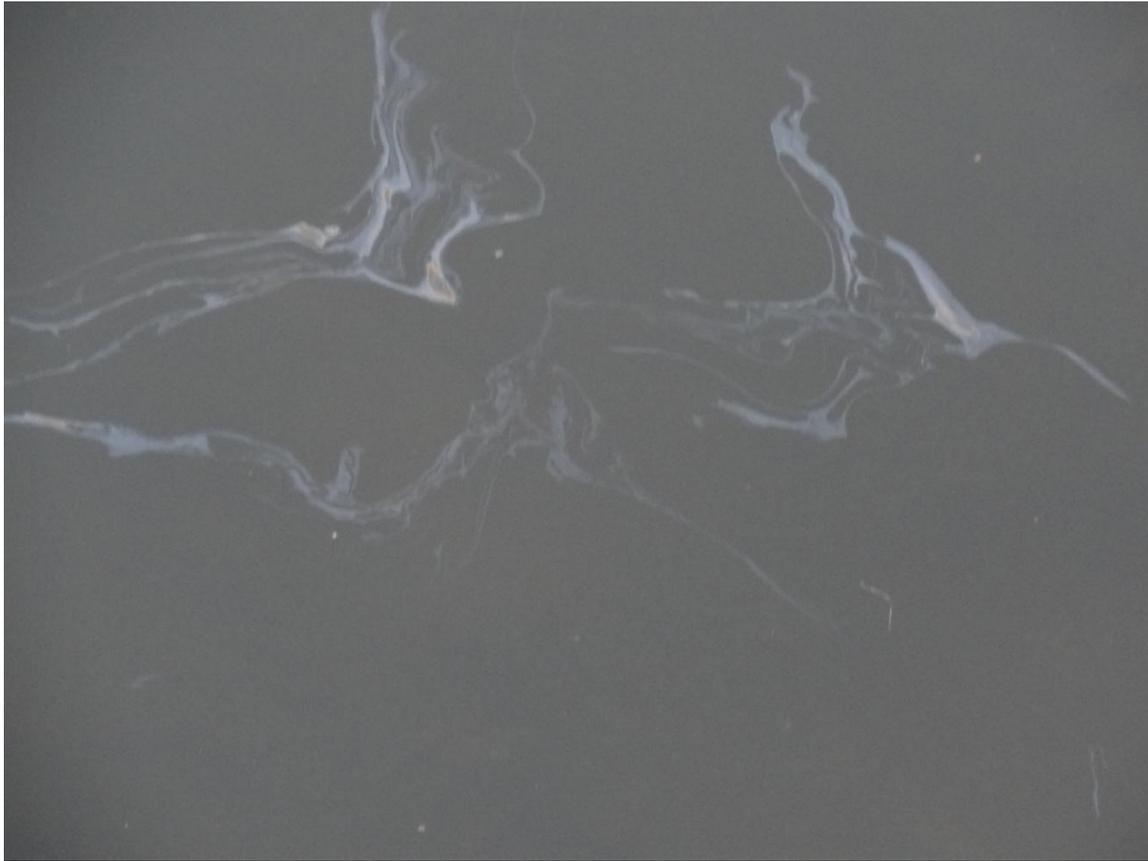
9. Ceresco Dam control point boom sheen and tar globs observed.

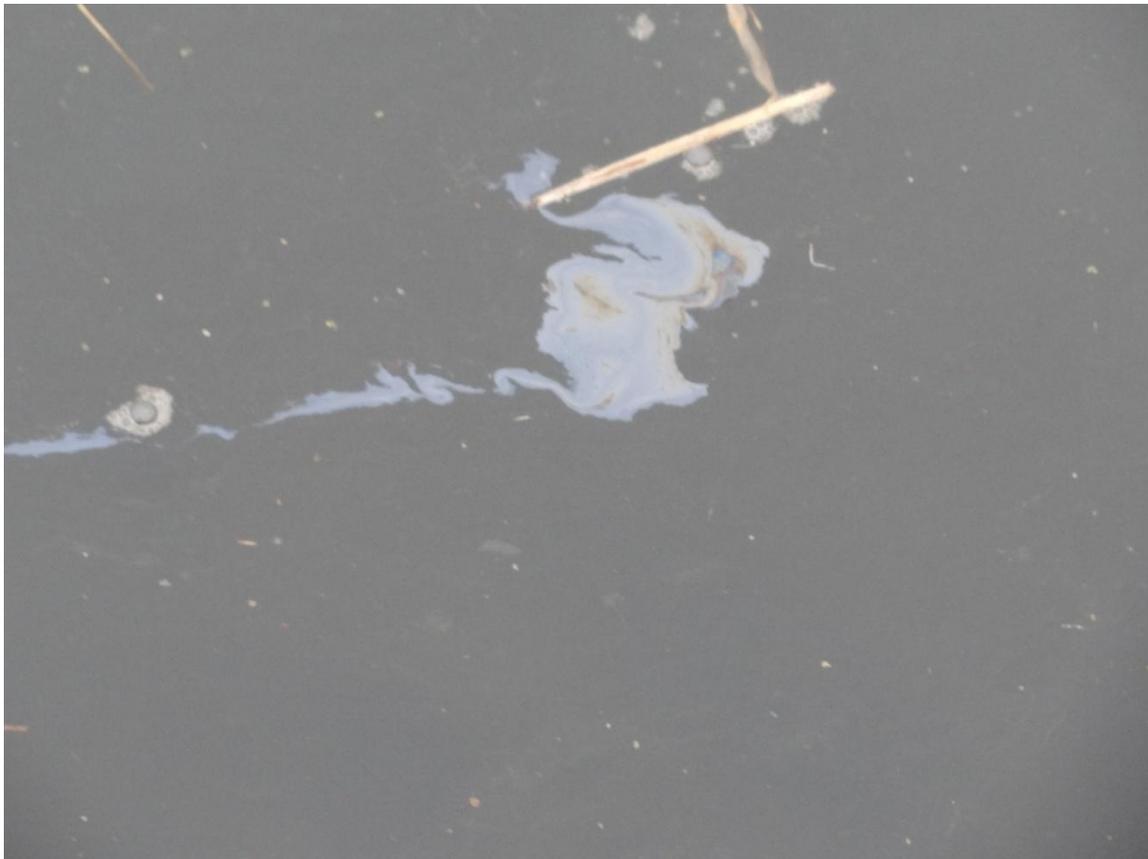
10. Ceresco Dam control point boom sheen and tar globs observed.

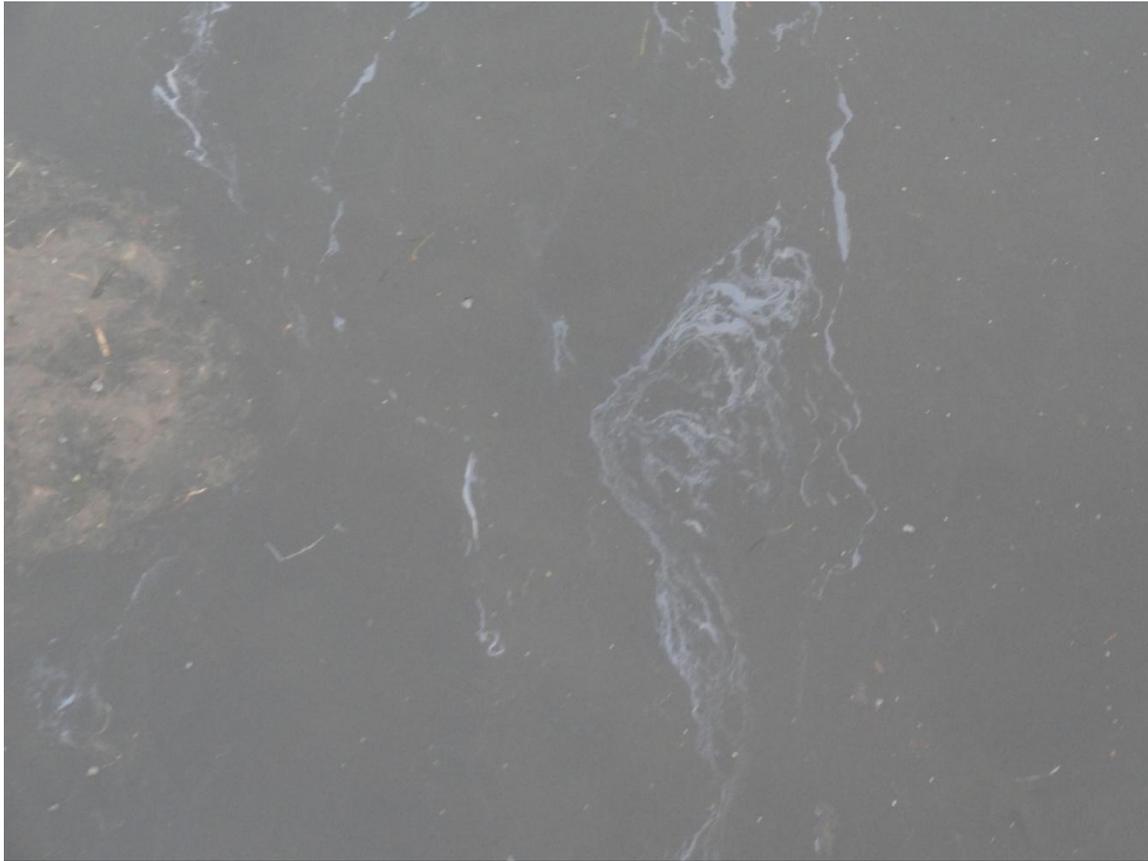
11. Ceresco Dam control point boom sheen and tar globs observed.

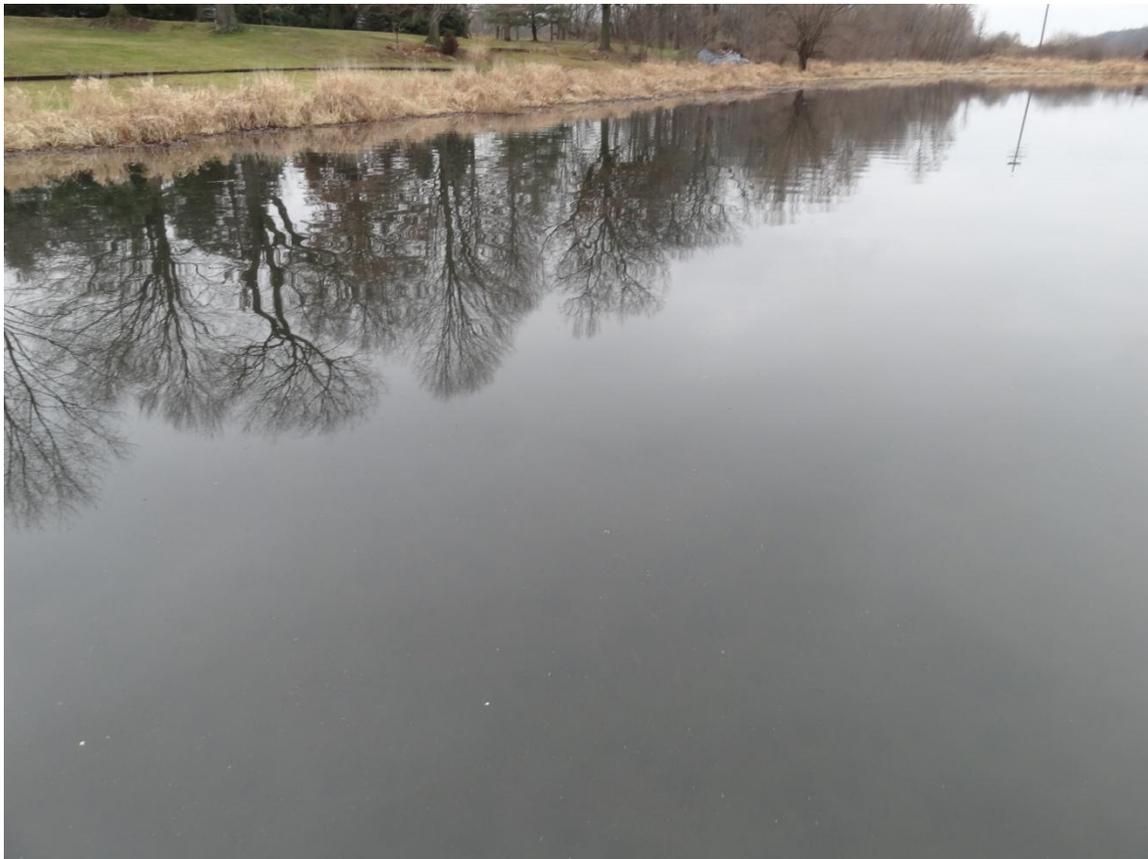
12. MP5.63 – MP5.65 RDB sheen and tar globs observed. Sweep boat requested.

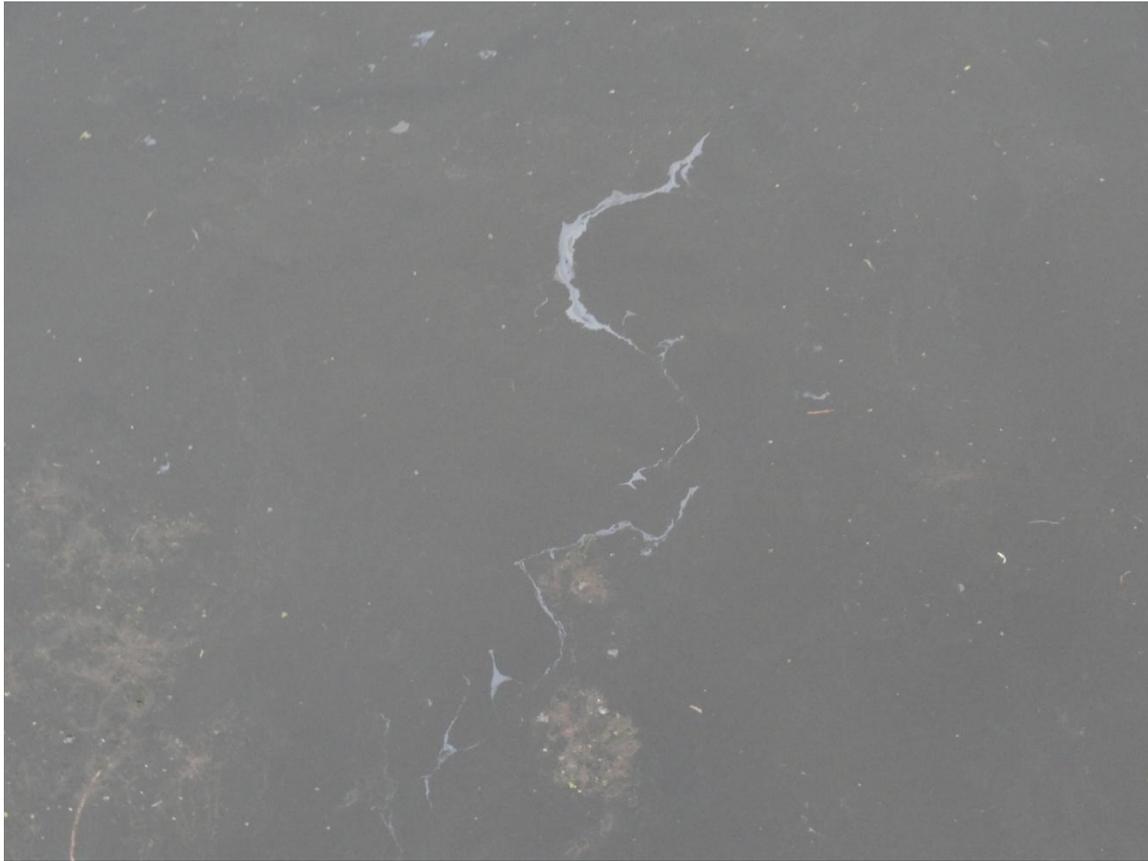
13. MP5.63 – MP5.65 RDB sheen and tar globs observed.

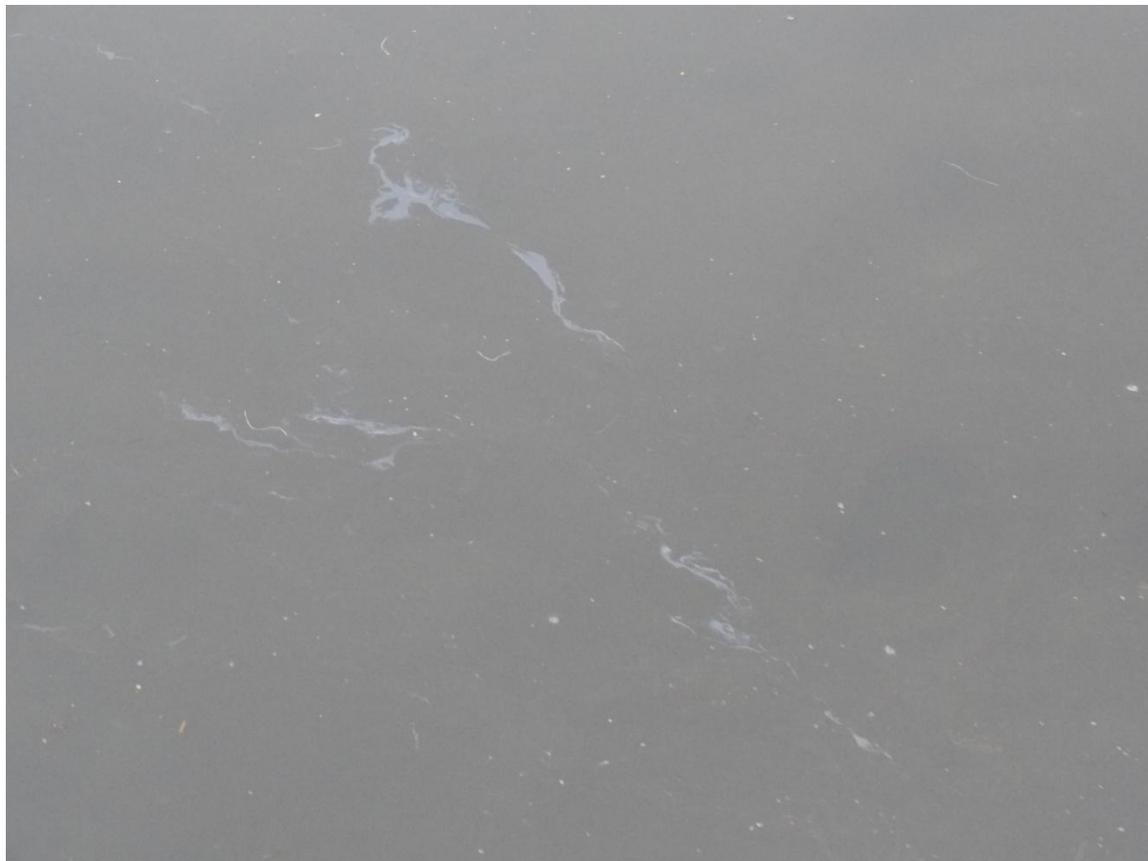
14. MP5.63 – MP5.65 RDB sheen and tar globs observed.

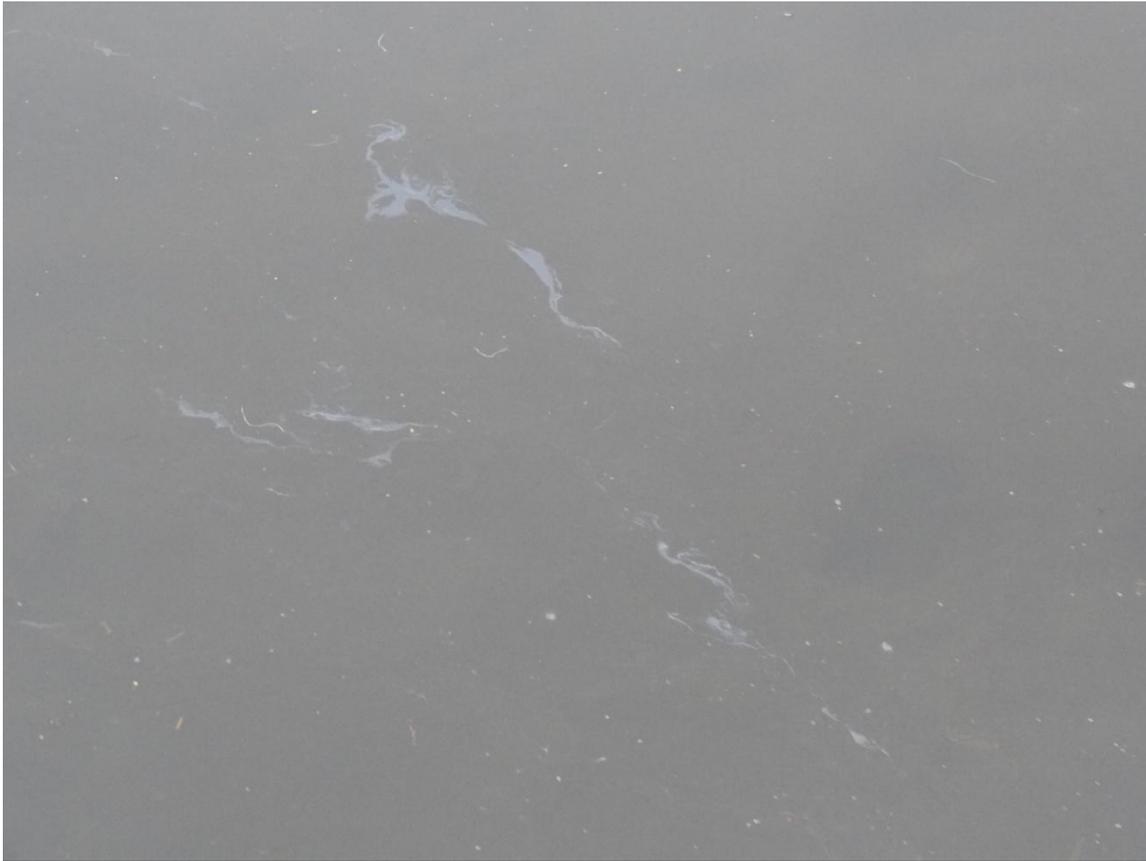
15. MP5.63 – MP5.65 RDB sheen and tar globs observed.

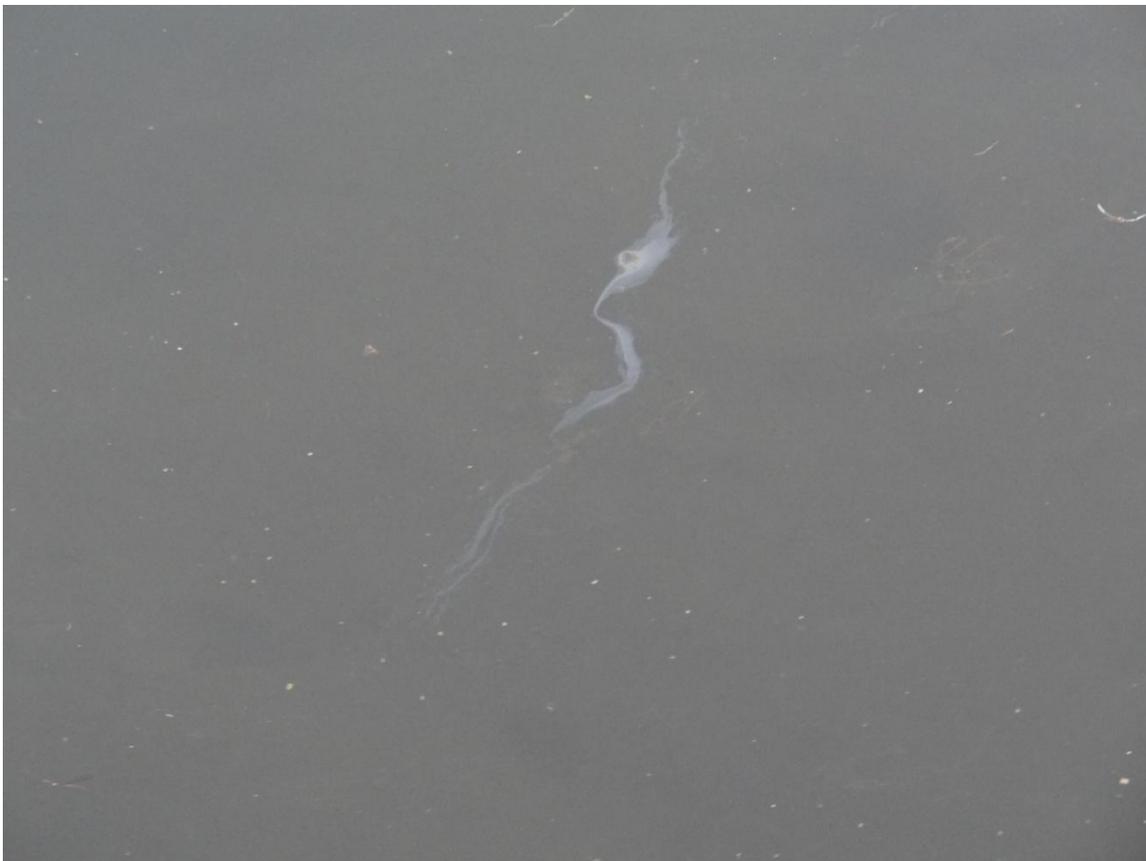
16. MP5.63 – MP5.65 sheen and tar globs observed.

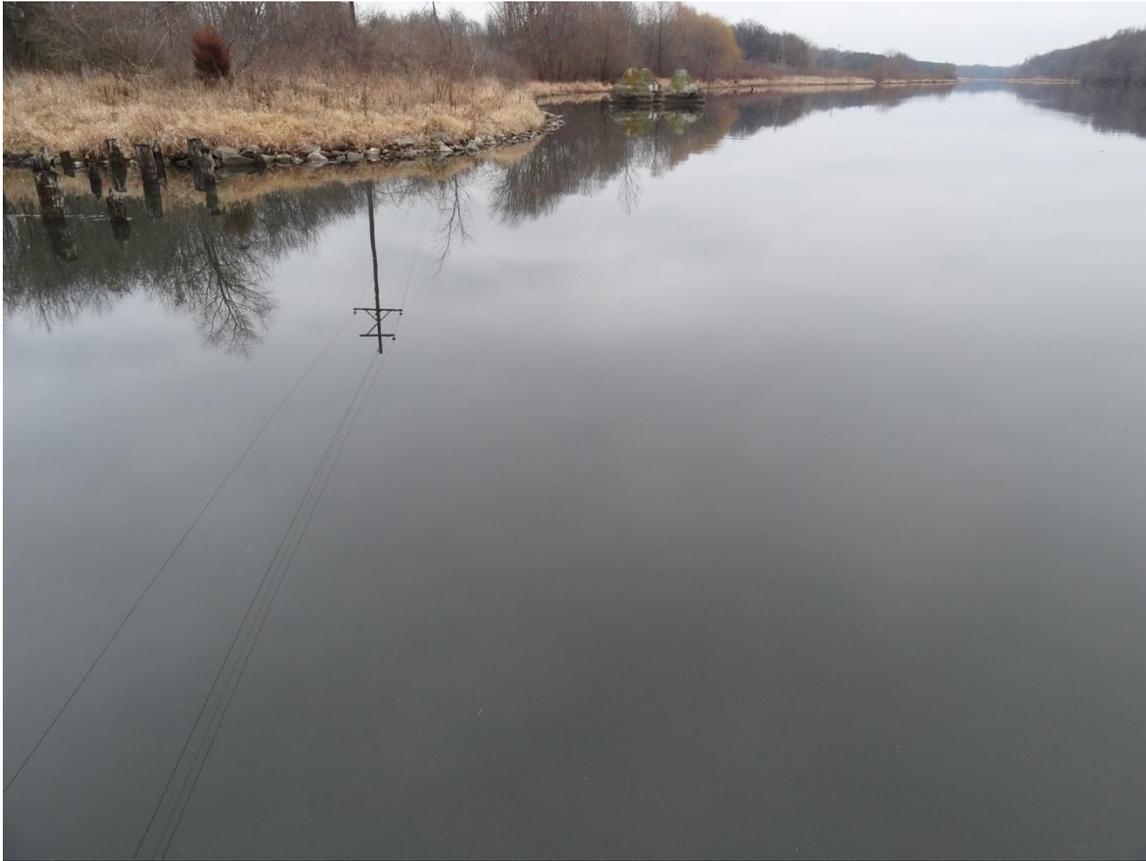
17. MP5.50 – MP5.60 RDB area where sheen and tar globs observed. Sweep boat requested.

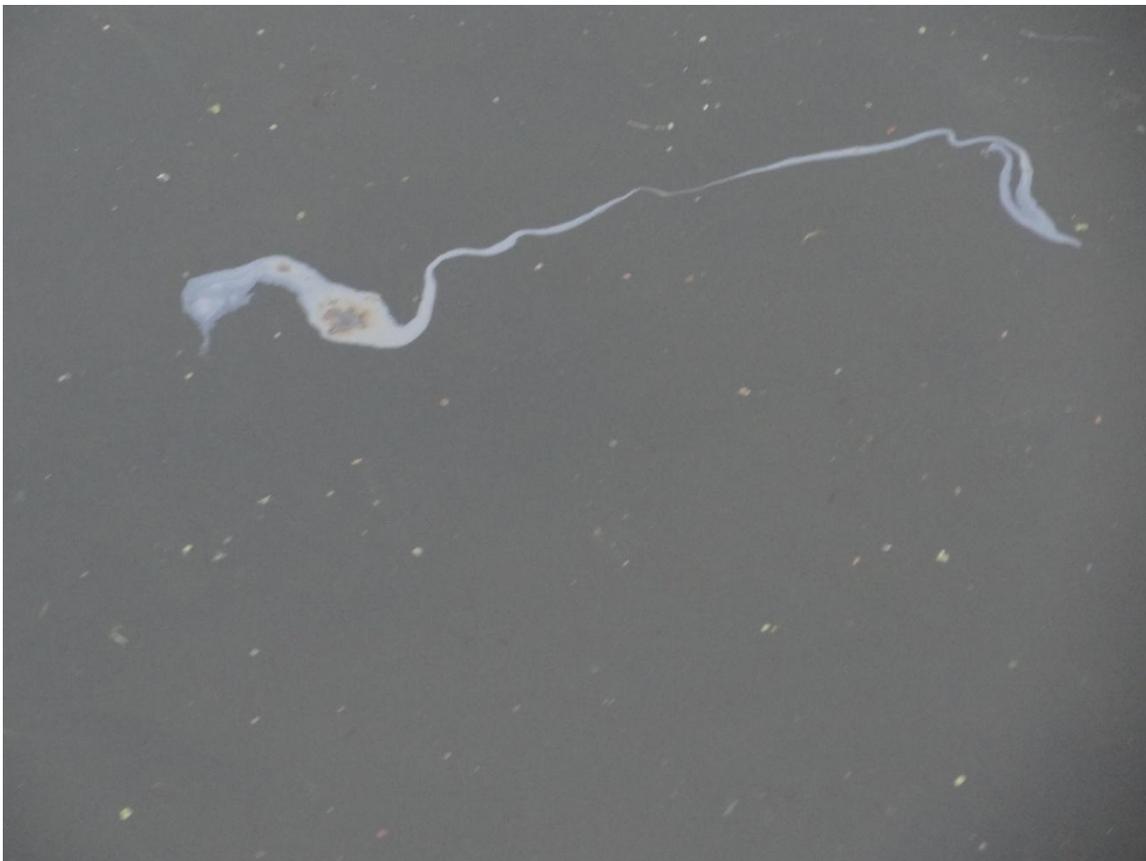
18. MP5.50 – MP5.60 RDB sheen and tar globs observed.

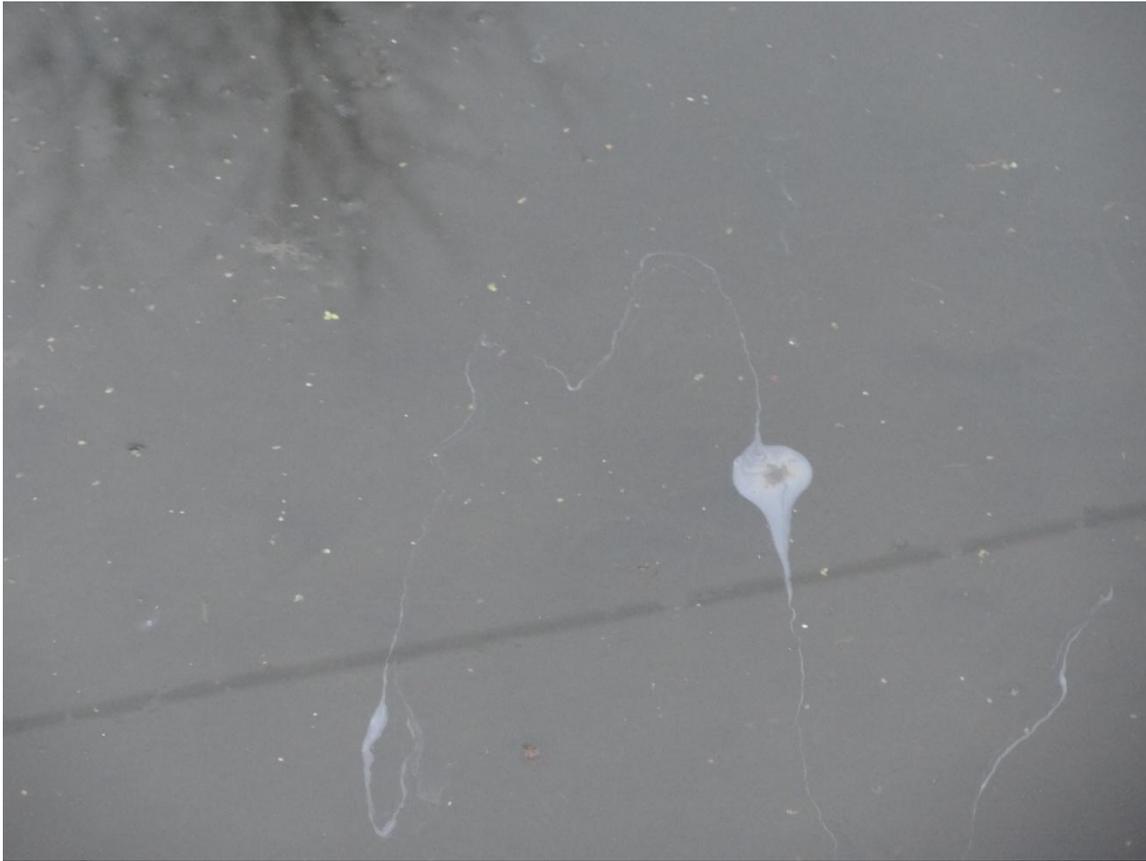
19. MP 5.50 – MP5.60 RDB sheen and tar globs observed.

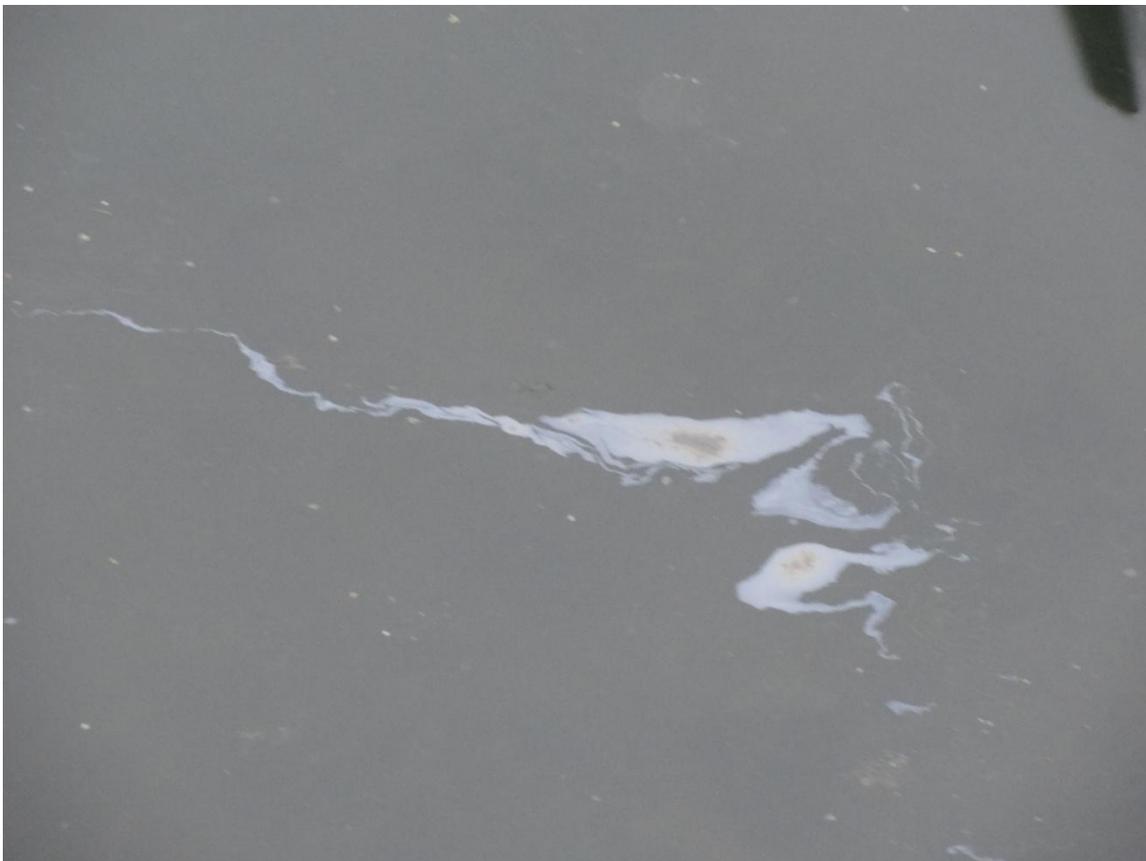
20. MP5.50 – MP5.60 RDB sheen and tar globs observed.

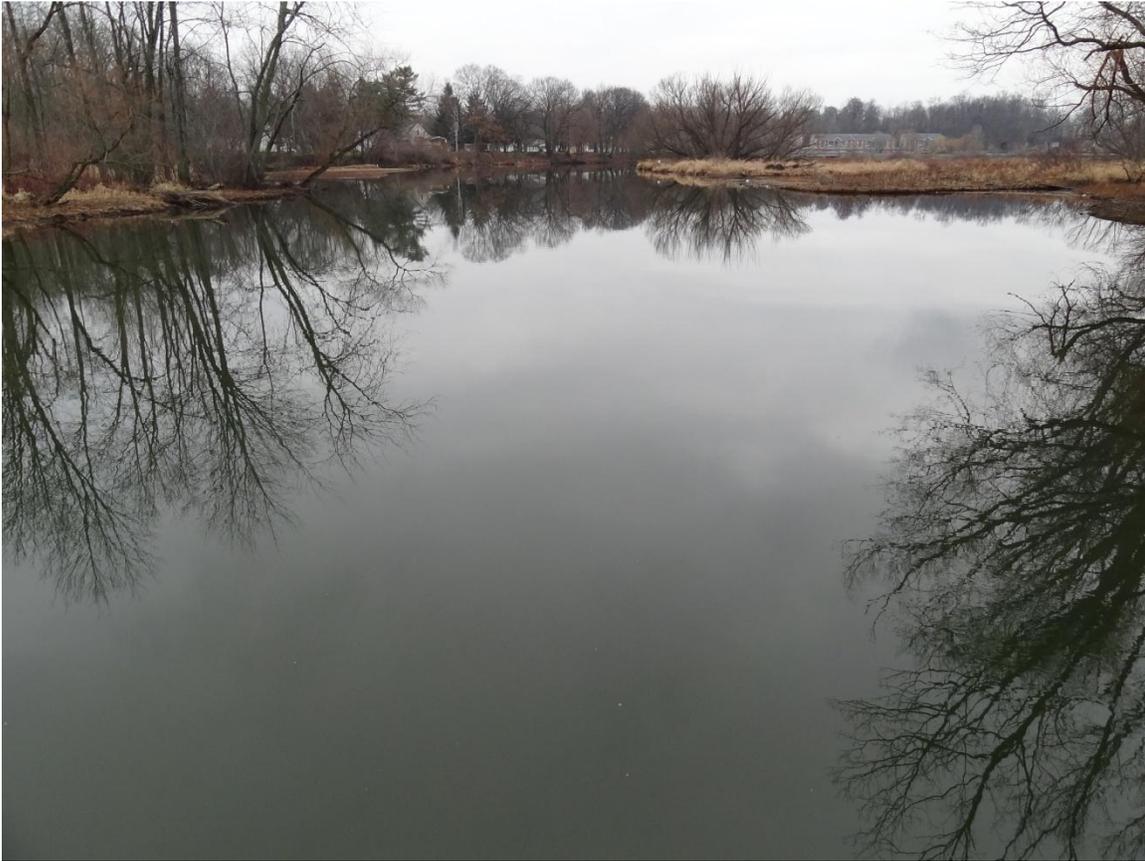
23. MP14.75 – MP15.00 RDB sheen and tar globs observed.

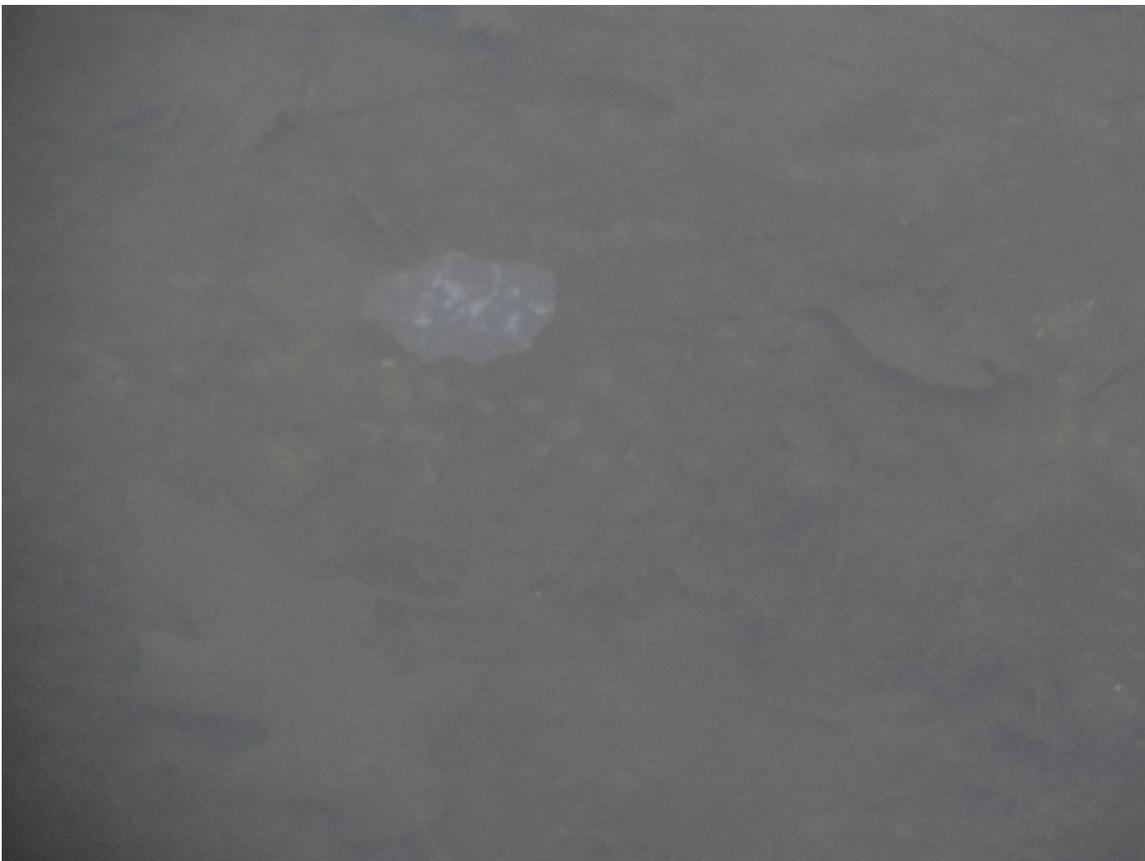
24. MP14.75 – MP15.00 RDB sheen and tar globs observed.

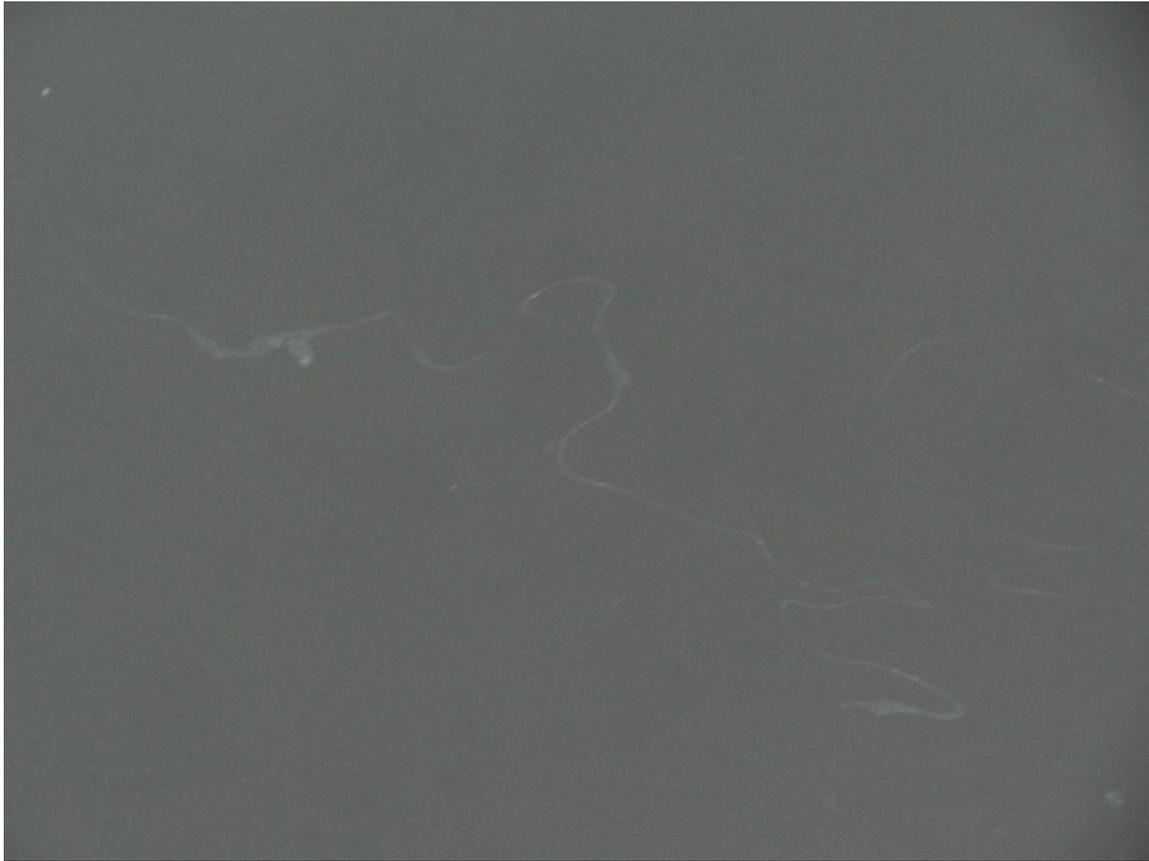
25. MP14.75 – MP15.00 RDB sheen and tar globs observed.
